A total of 202 features were recorded, mapped, and photographed for the U12n Tunnel complex. The project area encompassed 600.8 acres (243.1 hectares) at the portal and mesa areas. At the U12n portal area are ten sub-areas containing features related to the construction, testing, and general everyday activities within the tunnel. These include concrete foundations for buildings, communications equipment, mining equipment, rail lines, retention ponds, storage containers, and access control facilities. Only a telephone trailer remains on the telephone pad as all of the other buildings have been removed from the portal area. The microwave tower, portions of the rail lines, the muck car dump, rotary dump, and wash rack are still in place. Also, the traffic control point and powder magazines along N Tunnel Road are intact. At the mesa area are four sub-areas containing features generally related to pre- and post-shot drilling, recording facilities, and ventilation equipment. These include concrete foundations, instrument cable holes, and drill holes. The concrete foundations were for buildings and small equipment. Concrete pads and various equipment remain at the cable hole locations bu

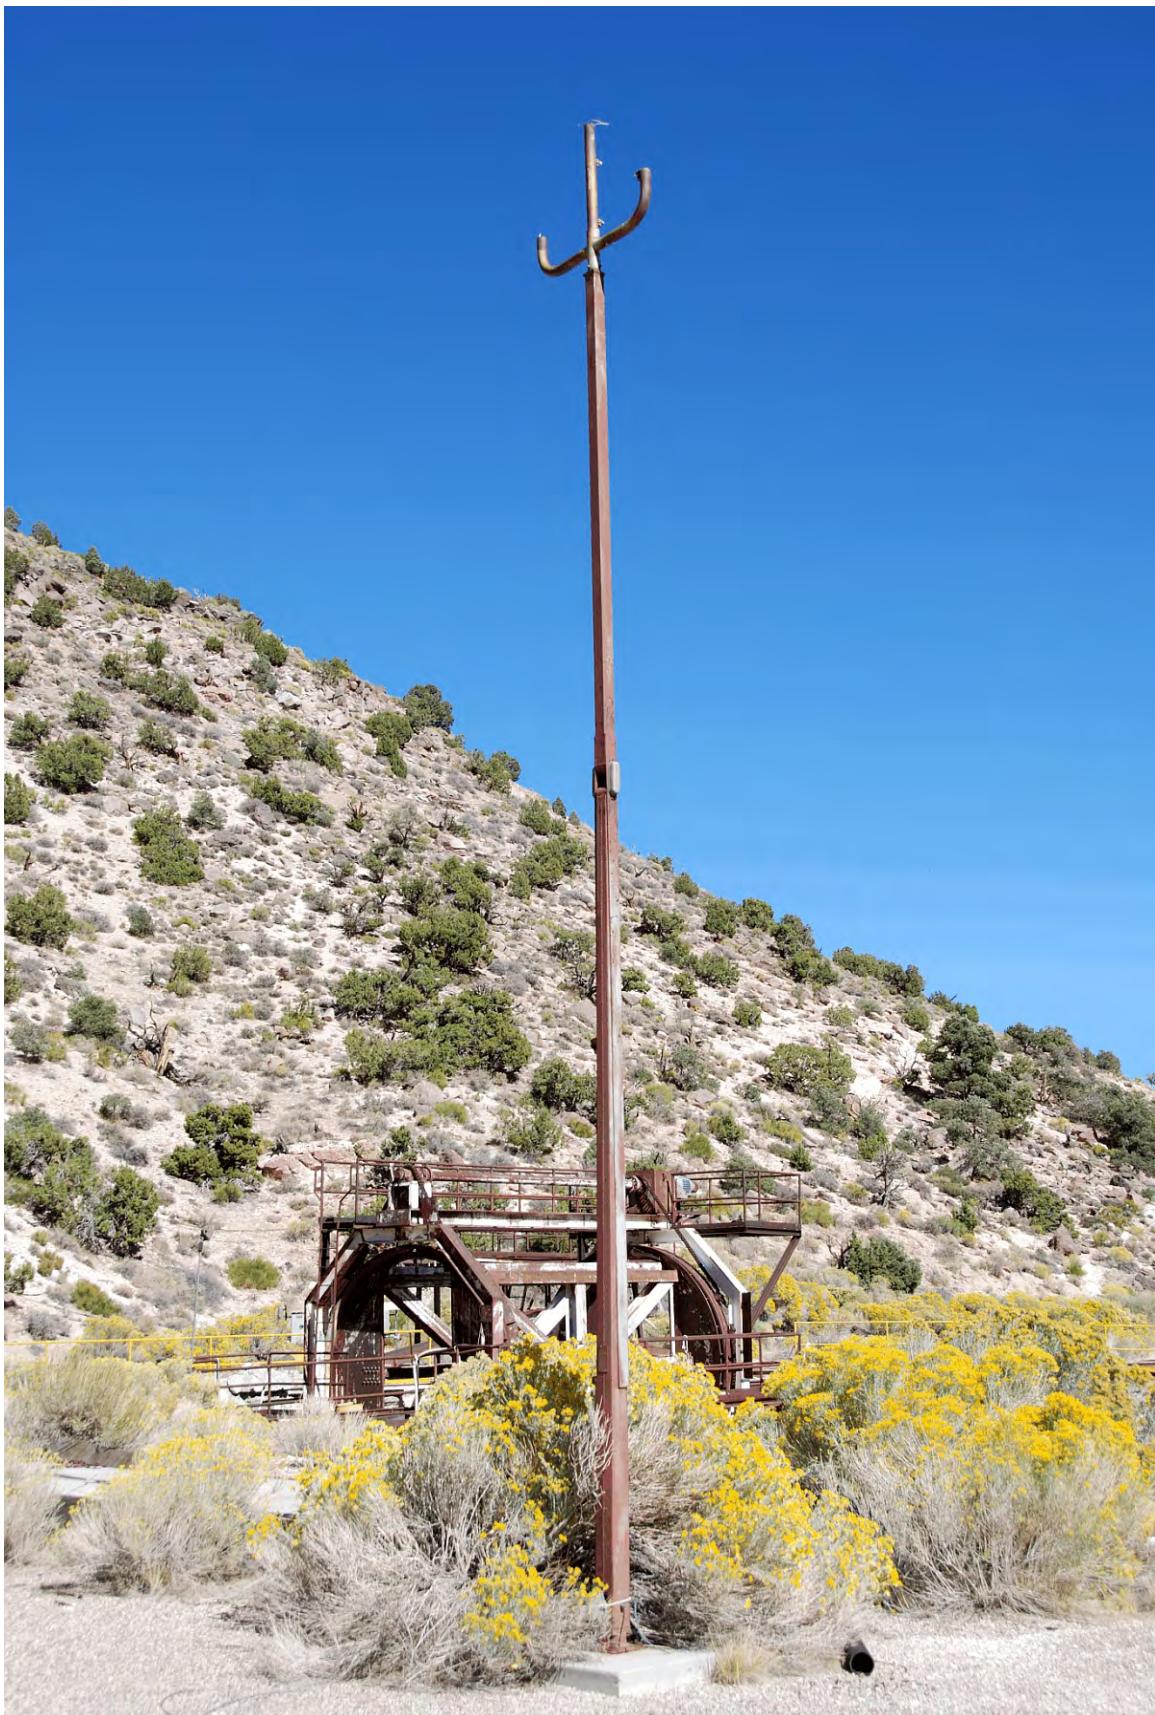
Figure 160. Feature 26, metal light pole, U12n Tunnel, view northeast (2008).

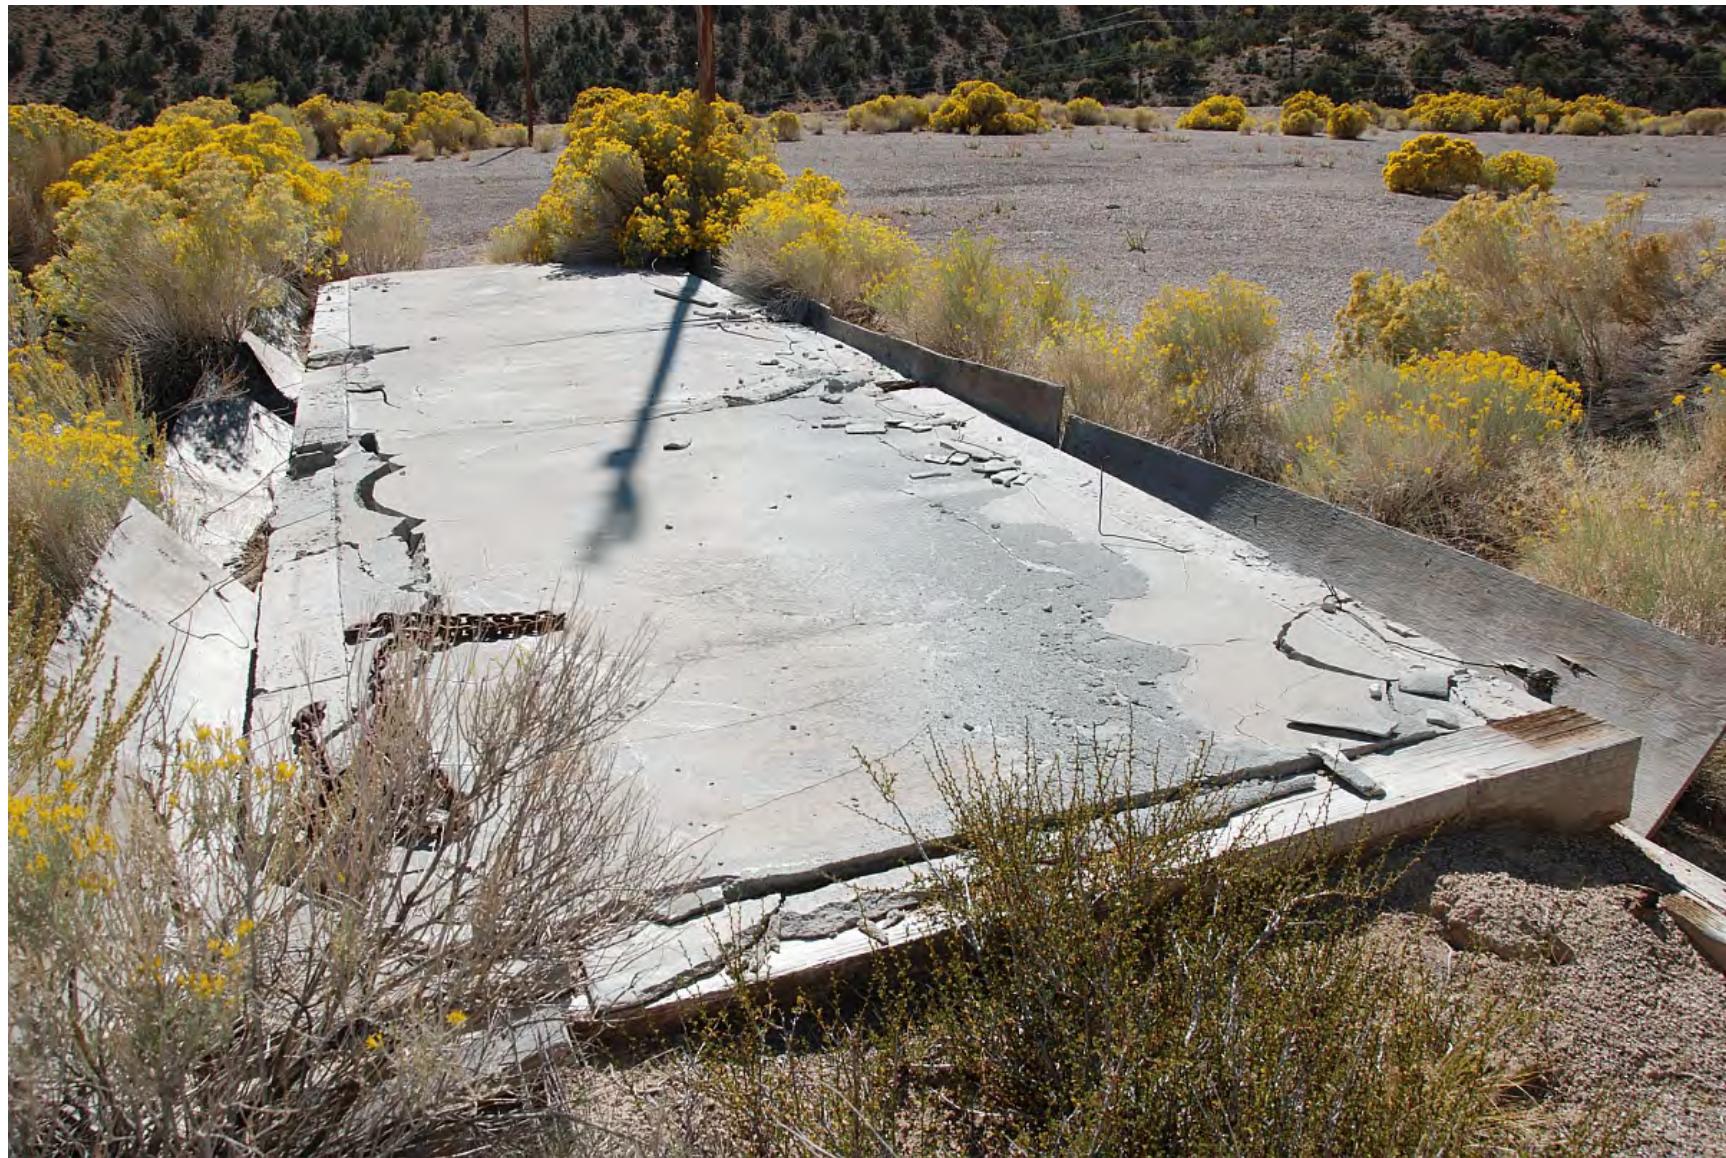
Feature 27 (Figure 161) is a concrete pad for lubrication and oil dispensing drums and spill containment racks (on engineering drawing JS-012-U12n.24-C3) at UTM coordinates 571857 E, 4117203 N. It is 26 ft 8 inches (8.2 m) north-south by 8 ft east-west and 1 ft thick. The pad was formed in three sections that are separated by 8 x 8 inch milled lumber beams and the outside formed with 1/2-inch plywood (still present). The north section is 10 ft (3 m) north-south, the middle section is 5 ft 8 inches north-south, and the south section is 12 ft (3.4 m) north-south. Concrete was poured over the top of the beams providing a continuous surface. The concrete is now highly deteriorated and broken, and the beams are visible. Associated artifacts are chain, metal pipe, milled lumber fragments, and insulated wire.

Figure 161. Feature 27, concrete pad, U12n Tunnel, view south (2008).

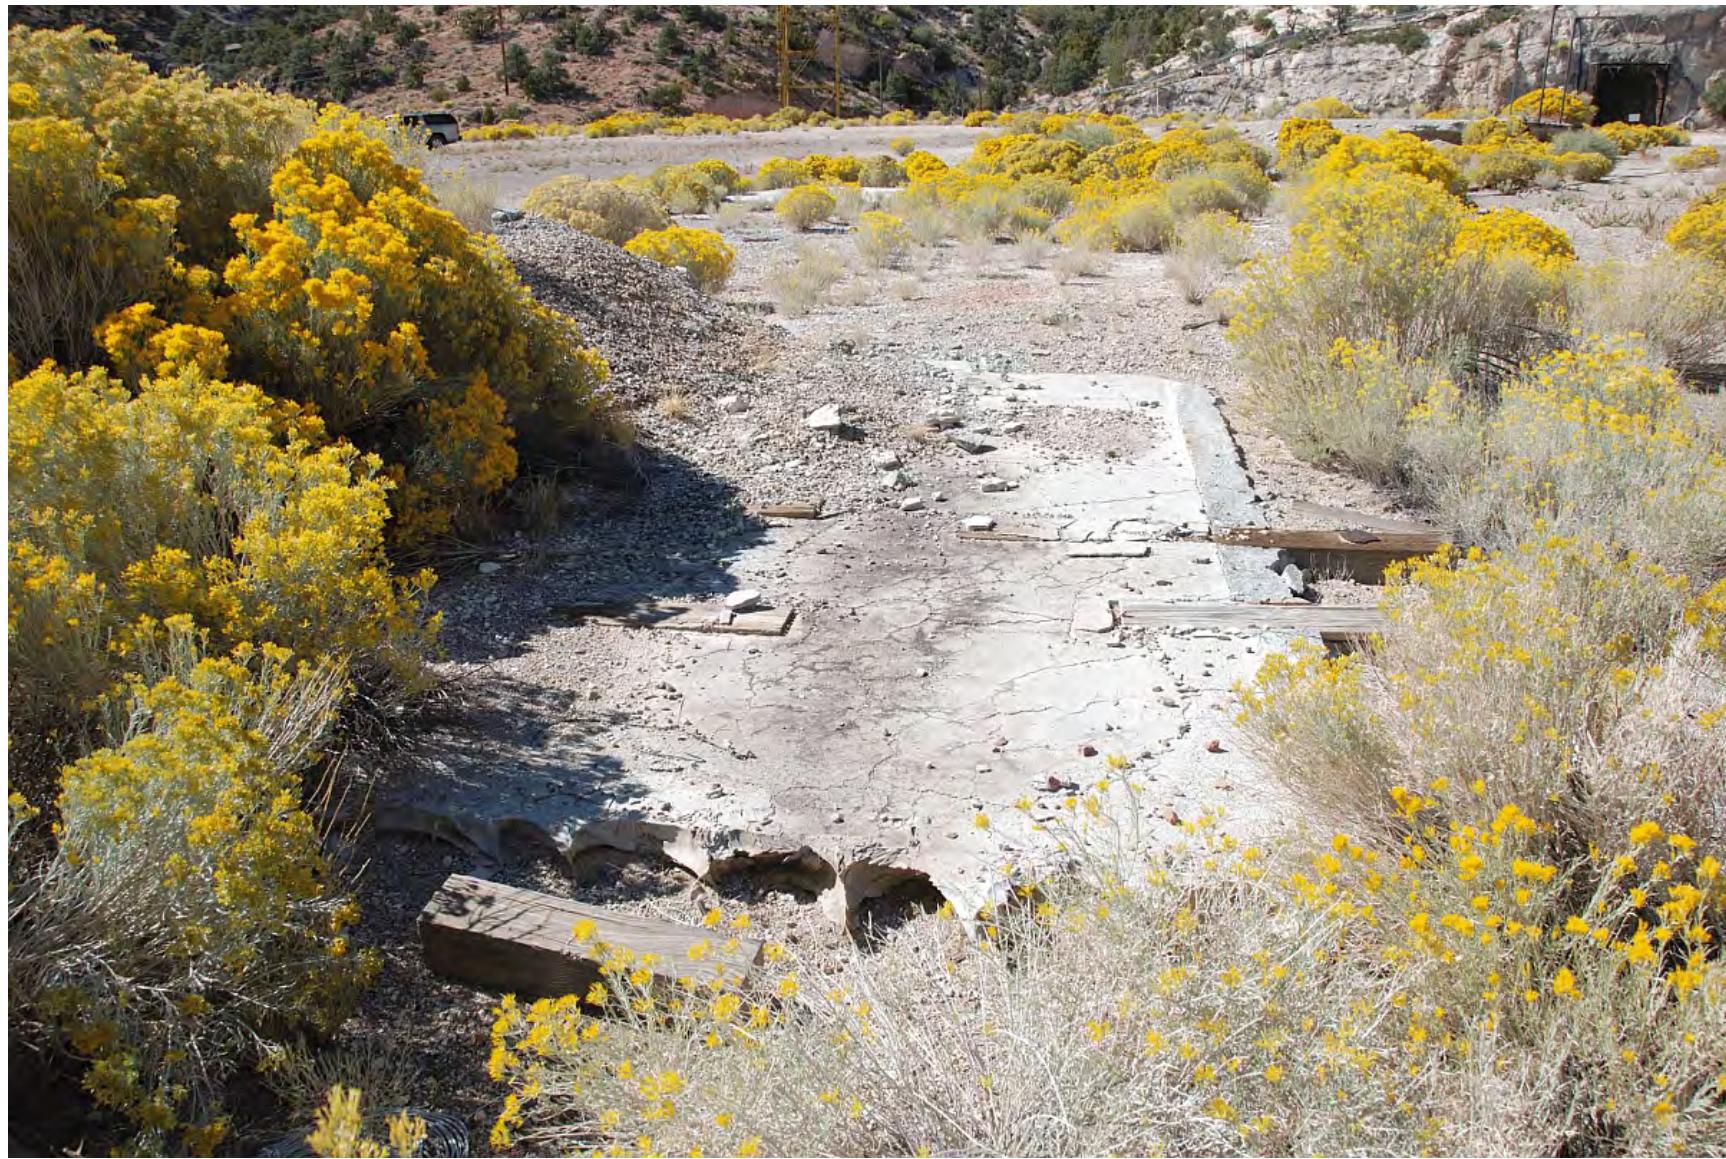
Feature 28 (Figure 162) is a concrete pad used for a skid mounted tank (on engineering drawing JS-012-U12n.24-C3) and a lube and oil at UTM coordinates 571852 E, 4117210 N. The feature appears similar to Feature 26, however much of the concrete is broken and covered with soil. The pad is 18 ft east-west by 8 ft north-south. It was formed in three sections that are separated by 8 x 8 inch milled lumber beams. The east section is 5 ft east-west, the middle section is 3 ft east-west, and the west section is 10 ft east-west. The concrete is now highly deteriorated and broken and the south side is covered with a mound of soil and gravel. Semicircular cavities along the edges is from sandbags used in forming the pad. Associated artifacts are milled lumber fragments.

Figure 162. Feature 28, concrete pad, U12n Tunnel, view northwest (2008).

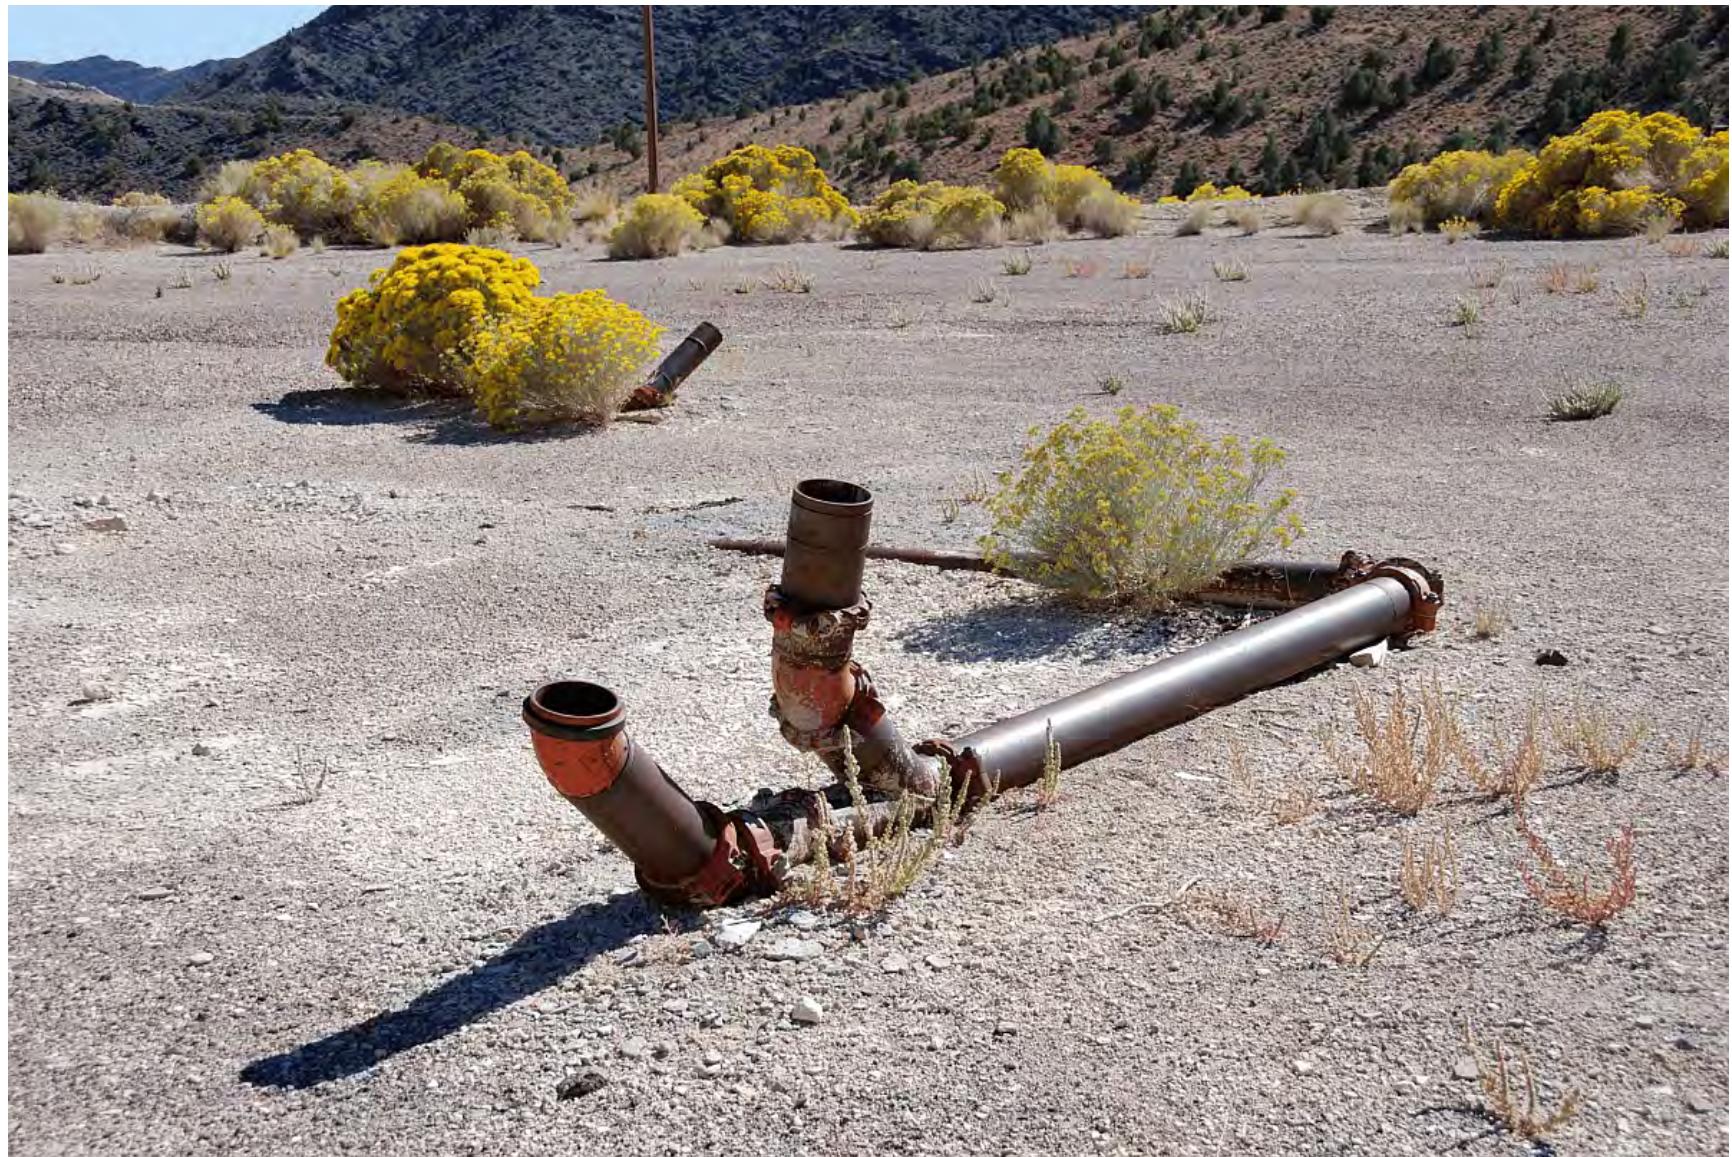
Figure 163. Feature 29, pipeline, U12n Tunnel, view southeast (2008).

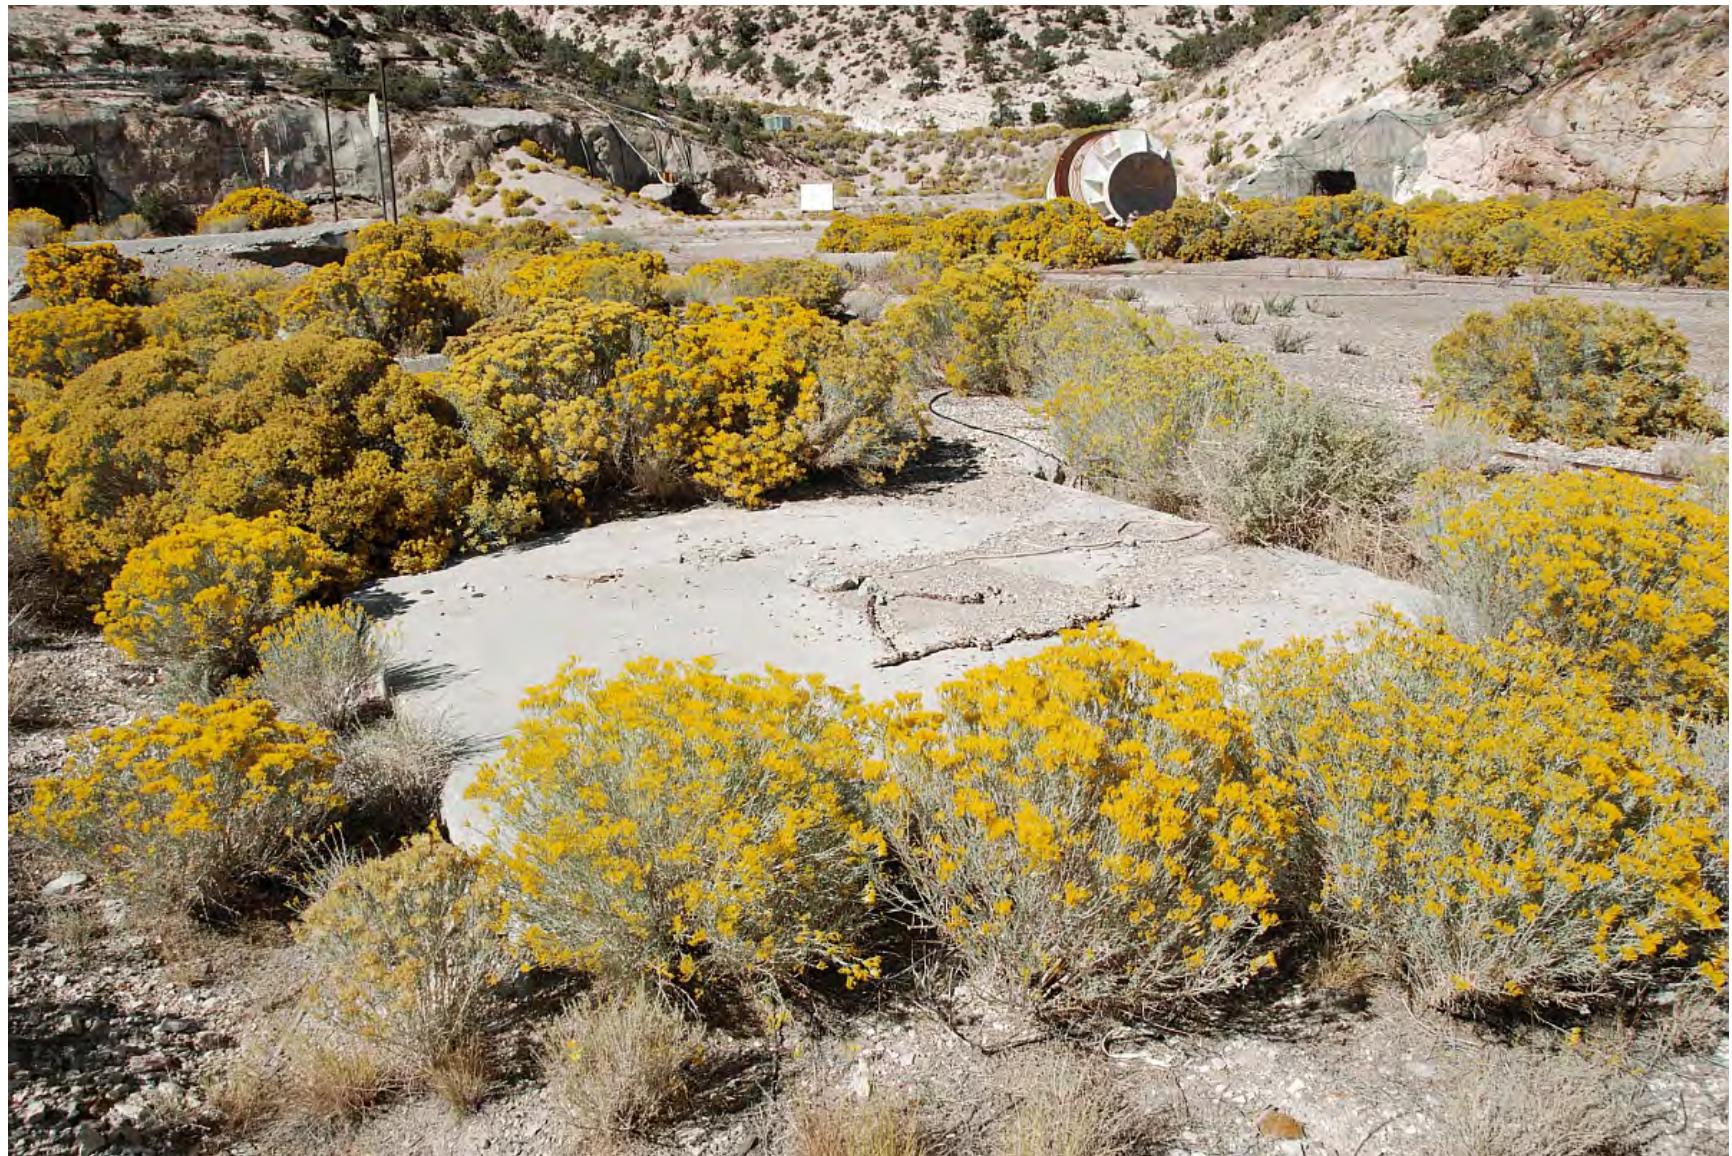
Feature 30 (Figure 164) is a concrete foundation at UTM coordinates 571835 E, 4117218 N. The surface of the 12 x 12 ft foundation is highly deteriorated and the west edge is covered with soil and gravel. Associated artifacts are a chain, washers, welding rods, and pipe fittings.

Figure 164. Feature 30, concrete foundation, U12n Tunnel, view northwest (2008).

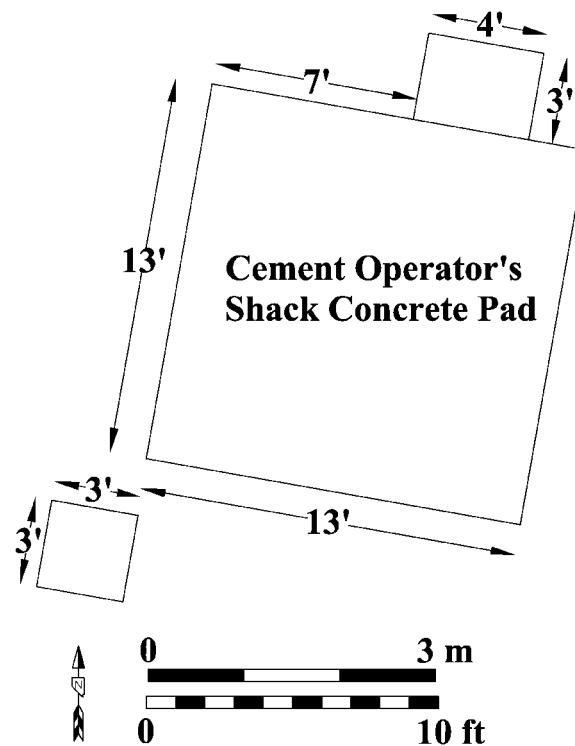
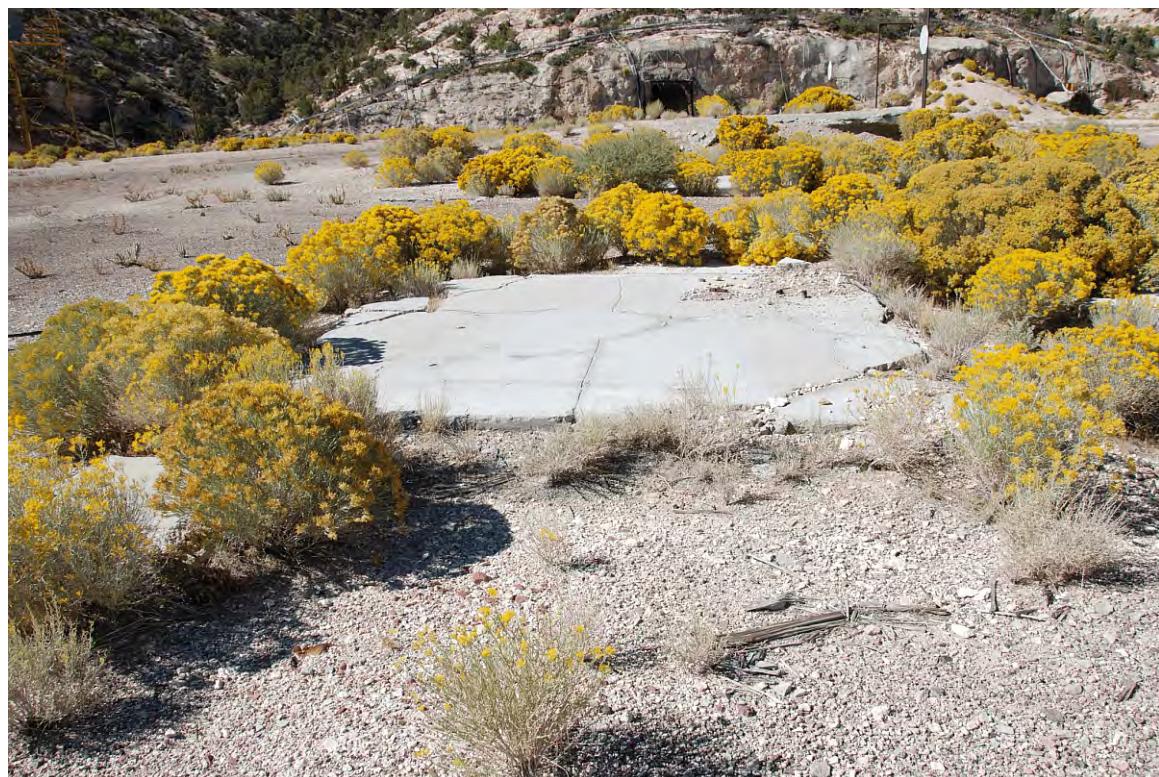
Feature 31 (Figure 165) is the cement operators shack concrete foundation at UTM coordinates 571834 E, 4117213 N. The surface of the 13 x 13 ft concrete foundation was smoothed but is now deteriorating with large cracks and pieces broken from the edges. Centered on the north side is a 4 ft east-west by 3 ft north-south concrete pad. A 3 x 3 ft concrete pad, is 2 ft from the southwest corner. This pad is similar to the one supporting the light pole at Feature 26. Associated artifacts are pipe fittings, broken glass, metal fragments, and bolts.

Figure 165. Plan map and photograph of Feature 31, cement operator's shack concrete foundation, U12n Tunnel, view northwest (2008).

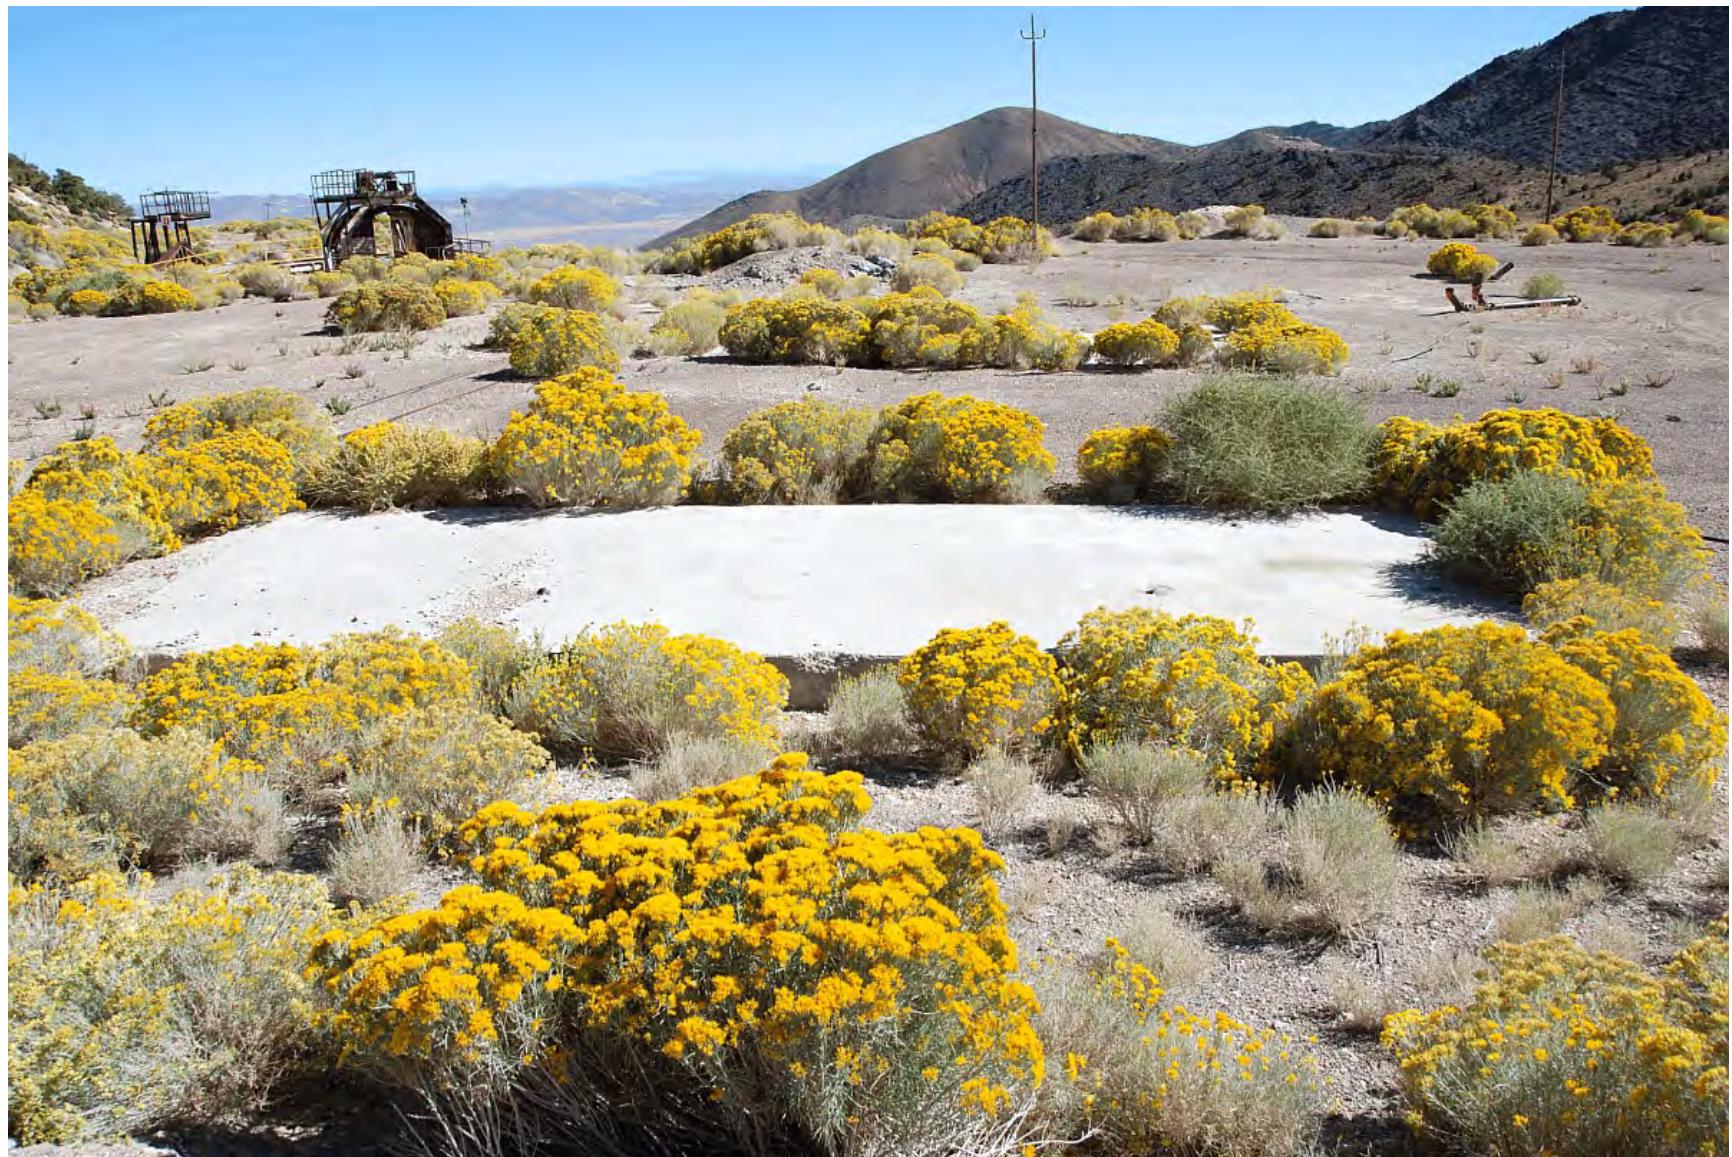
Feature 32 (Figure 166) is the liquid nitrogen plant concrete foundation at UTM coordinates 571830 E, 4117221 N. The foundation is 34 ft (10.4 m) north-south, 12 ft east-west, 6 inches thick, and has a smoothed surface. Rebar, 6-inch I-beam, and 1 1/4-inch (3.18 cm) bolts have been cut flush with the surface. The north edge of the foundation slopes to the surface and is 4 ft south of the rail lines.

Figure 166. Feature 32, liquid nitrogen plant concrete foundation, U12n Tunnel, view southeast (2008).

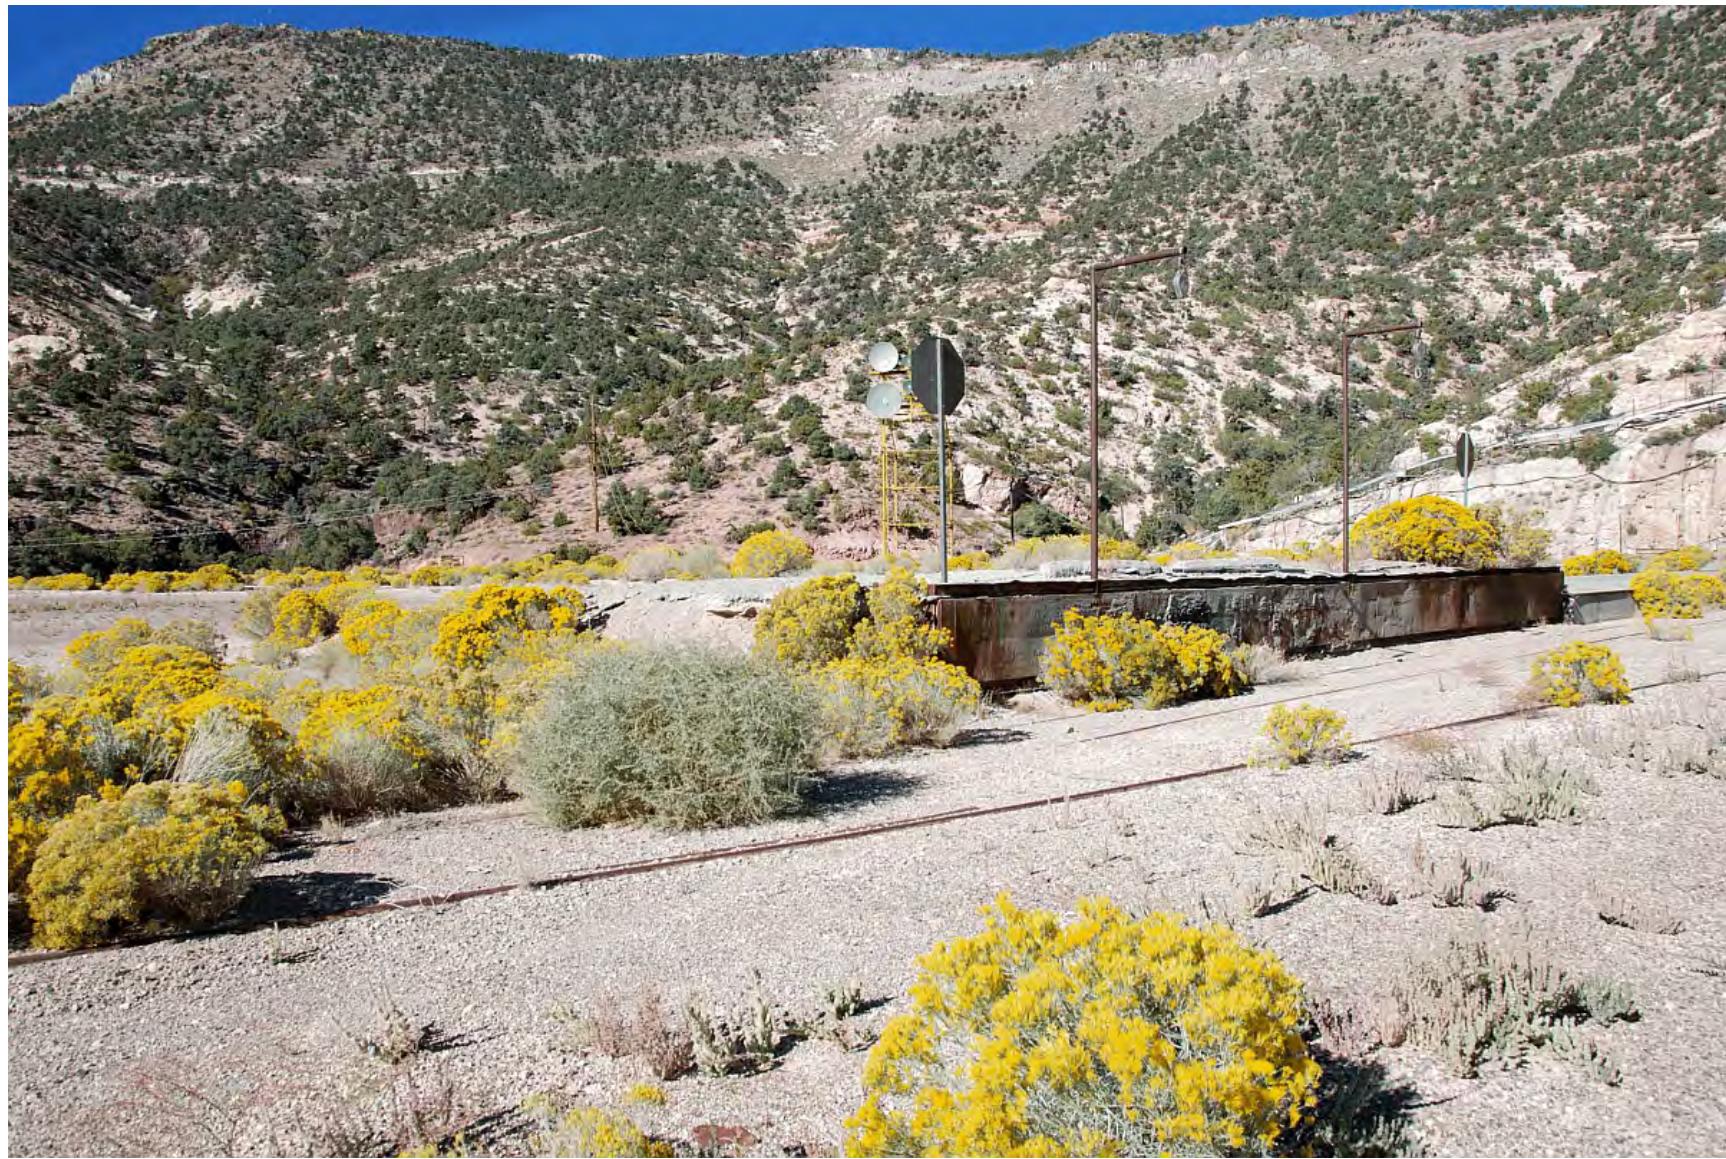
Figure 167. Feature 33, loading dock, U12n Tunnel, view west (2008).

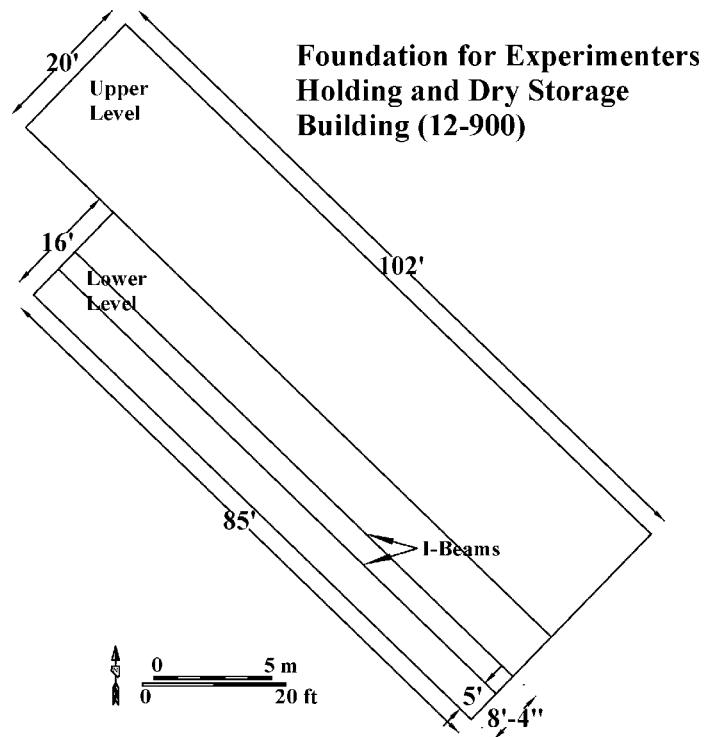
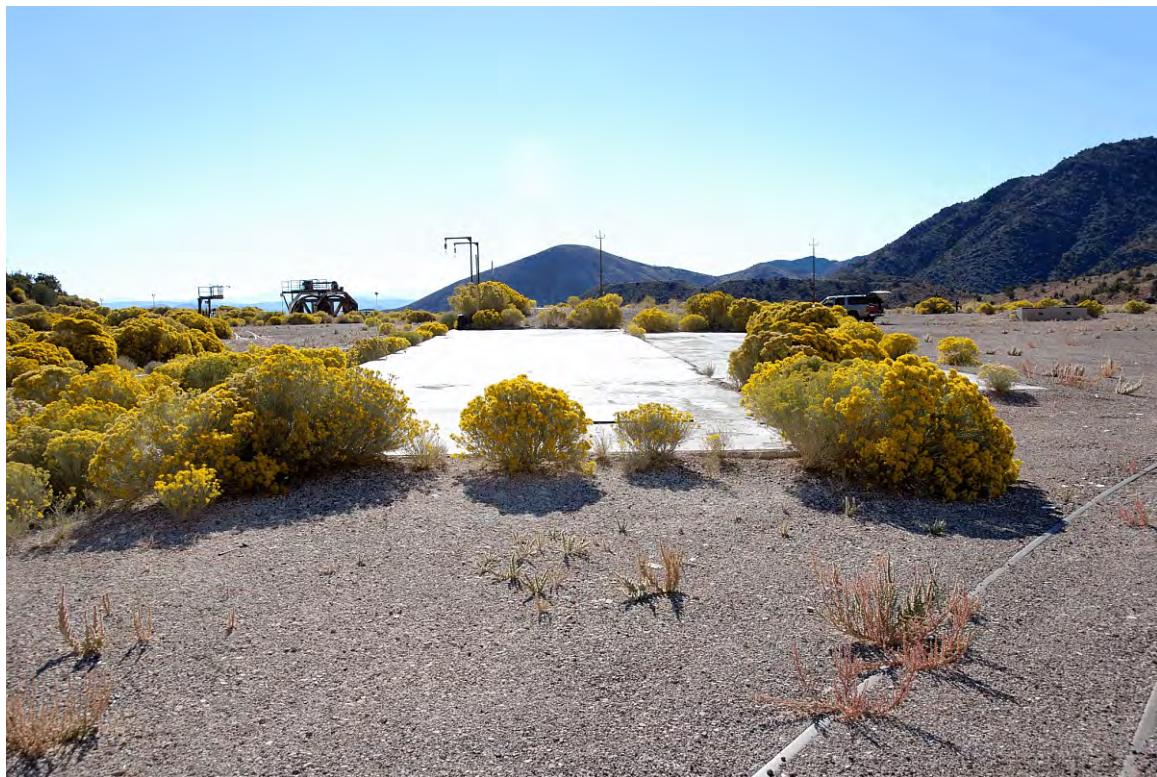
Feature 34 (Figure 168) is the concrete foundation for the experimenters holding and dry storage building (12-900) at UTM coordinates 571806 E, 4117256 N. It is constructed in two levels. The upper north level is 104 ft (31.7 m) east-west by 20 ft north-south, abuts the west end of Feature 32, and is 3 ft south of the rail lines that exit the U12n Extension Portal. The lower south level is 85 ft (25.9 m) east-west by 16 ft north-south. It is 4 inches below the upper level along the north side and abuts the west end of Feature 32. Two 6-inch I-beams are imbedded flush with the surface of the concrete and extend east-west the length of the lower level. The south I-beam is 5 ft (1.5 m) and the north I-beam is 8 ft 4 inches (2.54 m) from the south edge of the foundation. The surface of both levels have a smooth finish and metal conduit, pipe, and bolts have been cut flush with the concrete surface. Associated artifacts are metal fragments, washers, and bolts.

Figure 168. Plan map and photograph of Feature 34, concrete foundation (experimenters holding and dry storage), U12n Tunnel, view southeast (2008).

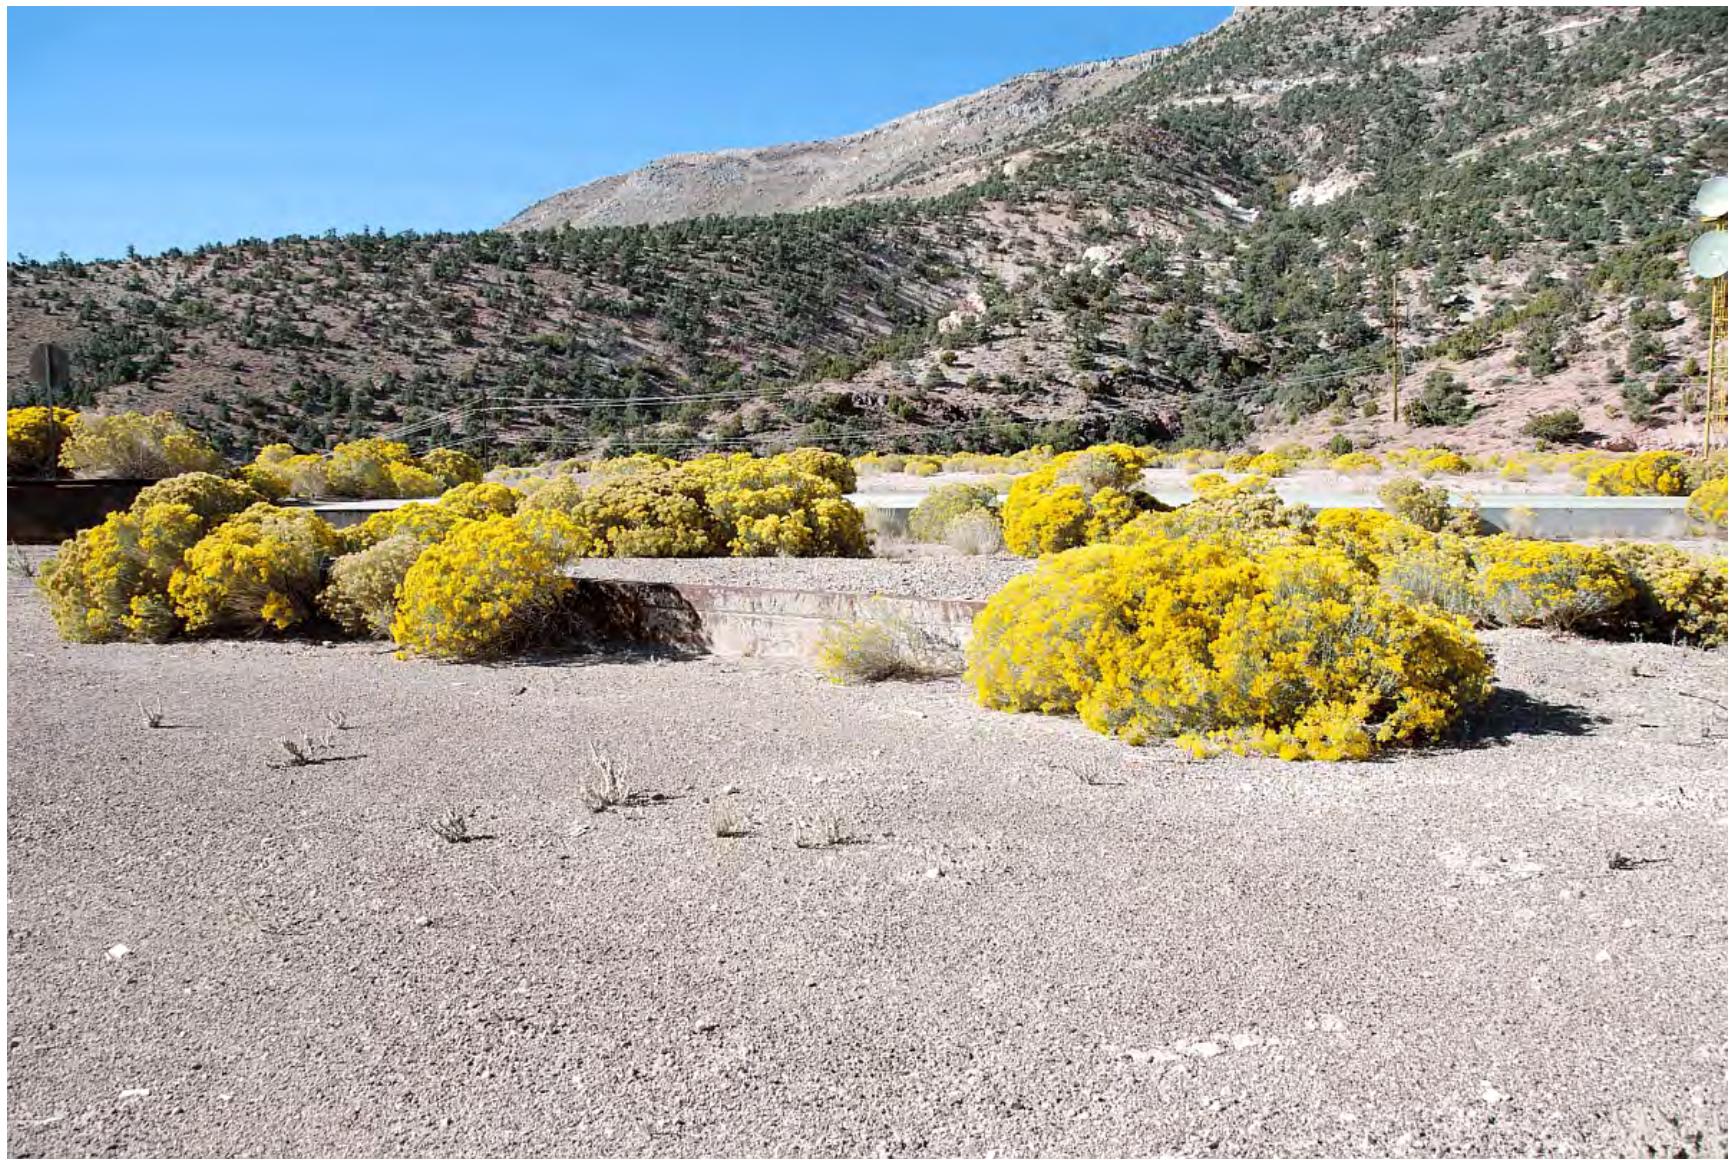
Figure 169. Feature 35, loading ramp, U12n Tunnel, view southwest (2008).

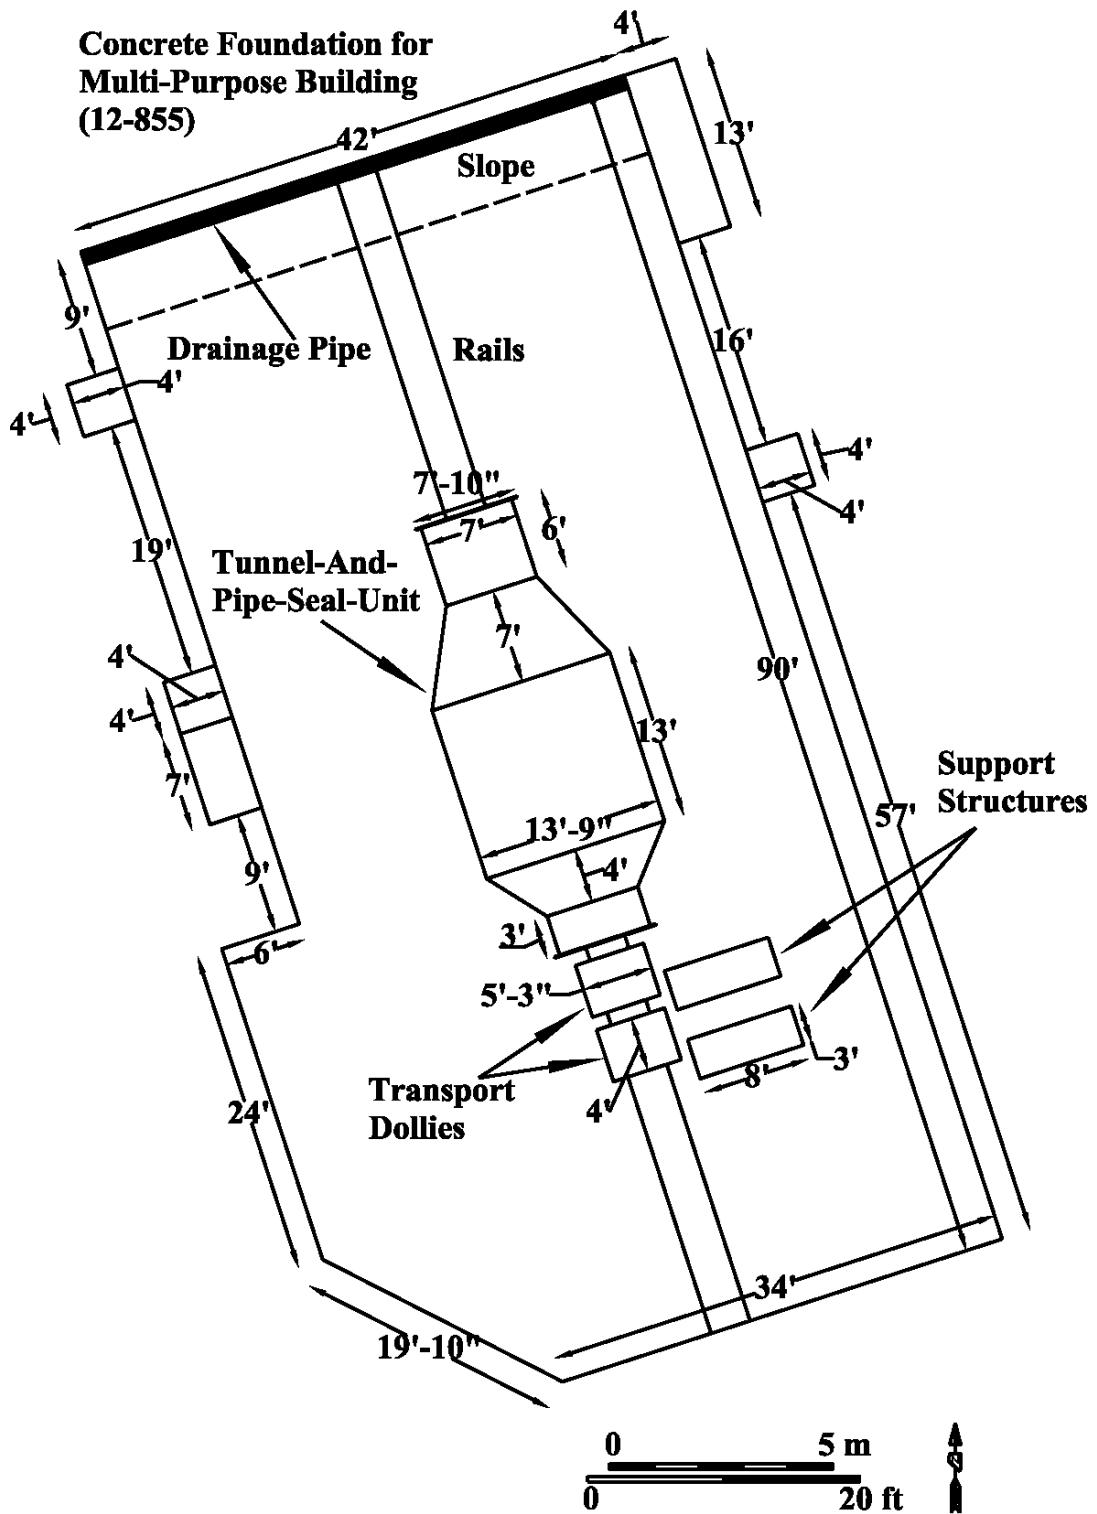
Feature 36 (Figures 170-172) is the concrete foundation for the multi-purpose building (12-855) at UTM coordinates 571837 E, 4117272 N. On top of the foundation is a tunnel-and-pipe-seal unit, two transport dollies, and two support structures for rail transport of the tunnel-and-pipe-seal underground. The foundation is generally rectangular in shape and 90 ft (27.4 m) north-south by 42 ft (12.8 m) east-west at the south end. It is 48 ft (14.6 m) east-west at 24 ft from the south end which is 34 ft (10.4 m) east-west. The north 6 ft of the foundation slopes from a 4 inch elevation to the ground surface and ends with a 1 ft wide metal drainage pipe buried in the surface. The west 60 ft

Figure 170. Plan map of Feature 36, concrete foundation for multi-purpose building and tunnel-and-pipe-seal unit, U12n Tunnel.

of the foundation was constructed with an outer 6 inch wide curbing that provided the form for the foundation. This was probably the first section constructed with the slope and south section built later. The remaining 24 ft of the foundation was not formed with a curbing and the surface has deteriorated with only small areas remaining with a smoothed surface. There are five concrete pads adjacent to the foundation, two on the east side and three on the west side. On the north side near the northeast corner is a 13 ft north-south by 4 ft east-west pad. Sixteen feet east of this pad is a 4 x 4 concrete pad, possibly for a pedestrian entrance into the building. Nine feet from the northwest corner is a 4 x 4 ft concrete pad possibly for a pedestrian entrance. Nineteen feet south of this pad is a similar 4 x 4 ft concrete pad that is adjacent to a 7 ft north-south by 4 ft east-west concrete pad. Two metal rail lines 3 ft apart have been cut off at the north and south edges of the foundation.
