A total of 202 features were recorded, mapped, and photographed for the U12n Tunnel complex. The project area encompassed 600.8 acres (243.1 hectares) at the portal and mesa areas. At the U12n portal area are ten sub-areas containing features related to the construction, testing, and general everyday activities within the tunnel. These include concrete foundations for buildings, communications equipment, mining equipment, rail lines, retention ponds, storage containers, and access control facilities. Only a telephone trailer remains on the telephone pad as all of the other buildings have been removed from the portal area. The microwave tower, portions of the rail lines, the muck car dump, rotary dump, and wash rack are still in place. Also, the traffic control point and powder magazines along N Tunnel Road are intact. At the mesa area are four sub-areas containing features generally related to pre- and post-shot drilling, recording facilities, and ventilation equipment. These include concrete foundations, instrument cable holes, and drill holes. The concrete foundations were for buildings and small equipment. Concrete pads and various equipment remain at the cable hole locations bu

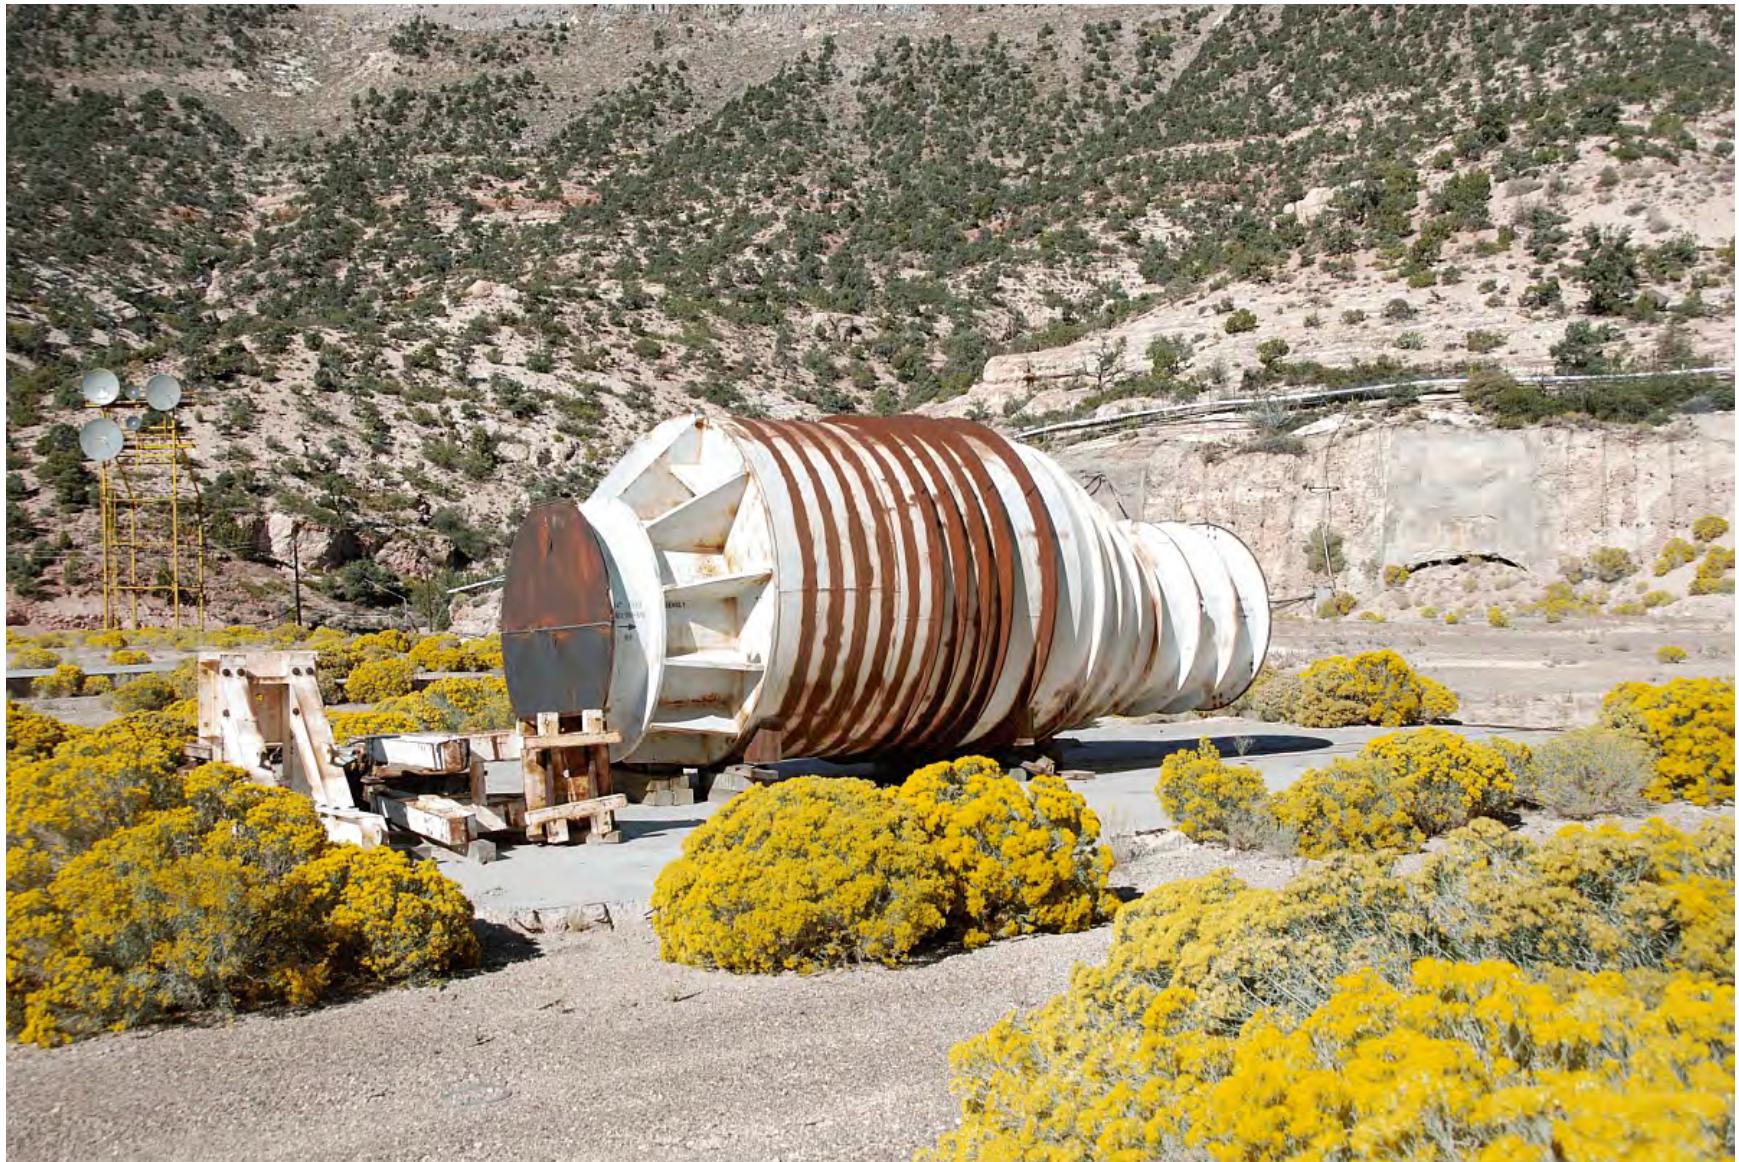
Figure 171. Feature 36, tunnel-and-pipe-seal unit, U12n Tunnel, view west (2008).

The tunnel-and-pipe-seal unit is 27 ft (8.2 m) from the north edge of the foundation and centered on the rail lines. The assembly is 33 ft 2 inches (10.1 m) in length, 13 ft 9 inches (4.2 m) in maximum diameter, and supported by 8 x 8 inch milled lumber cribbing. On the north end of the tunnel-and-pipe-seal unit is a 7 ft diameter flange welded to a 7 ft diameter tube that is 6 ft in length. The diameter flares over a 7 ft length to 13 ft 9 inches. The flare is not symmetrical but off-centered to the bottom of the assembly. The chamber is 13 ft in length then reduces back to a 7 ft diameter tube that extends 4 ft to the south. Attached to the south end of the tube is a 7 ft diameter flange. Two small access plates are on the south side of the unit. Extra support to the chamber is provided by 6 inch tall by 1 inch thick metal stiffener rings. Five rings are attached and five have not been attached.

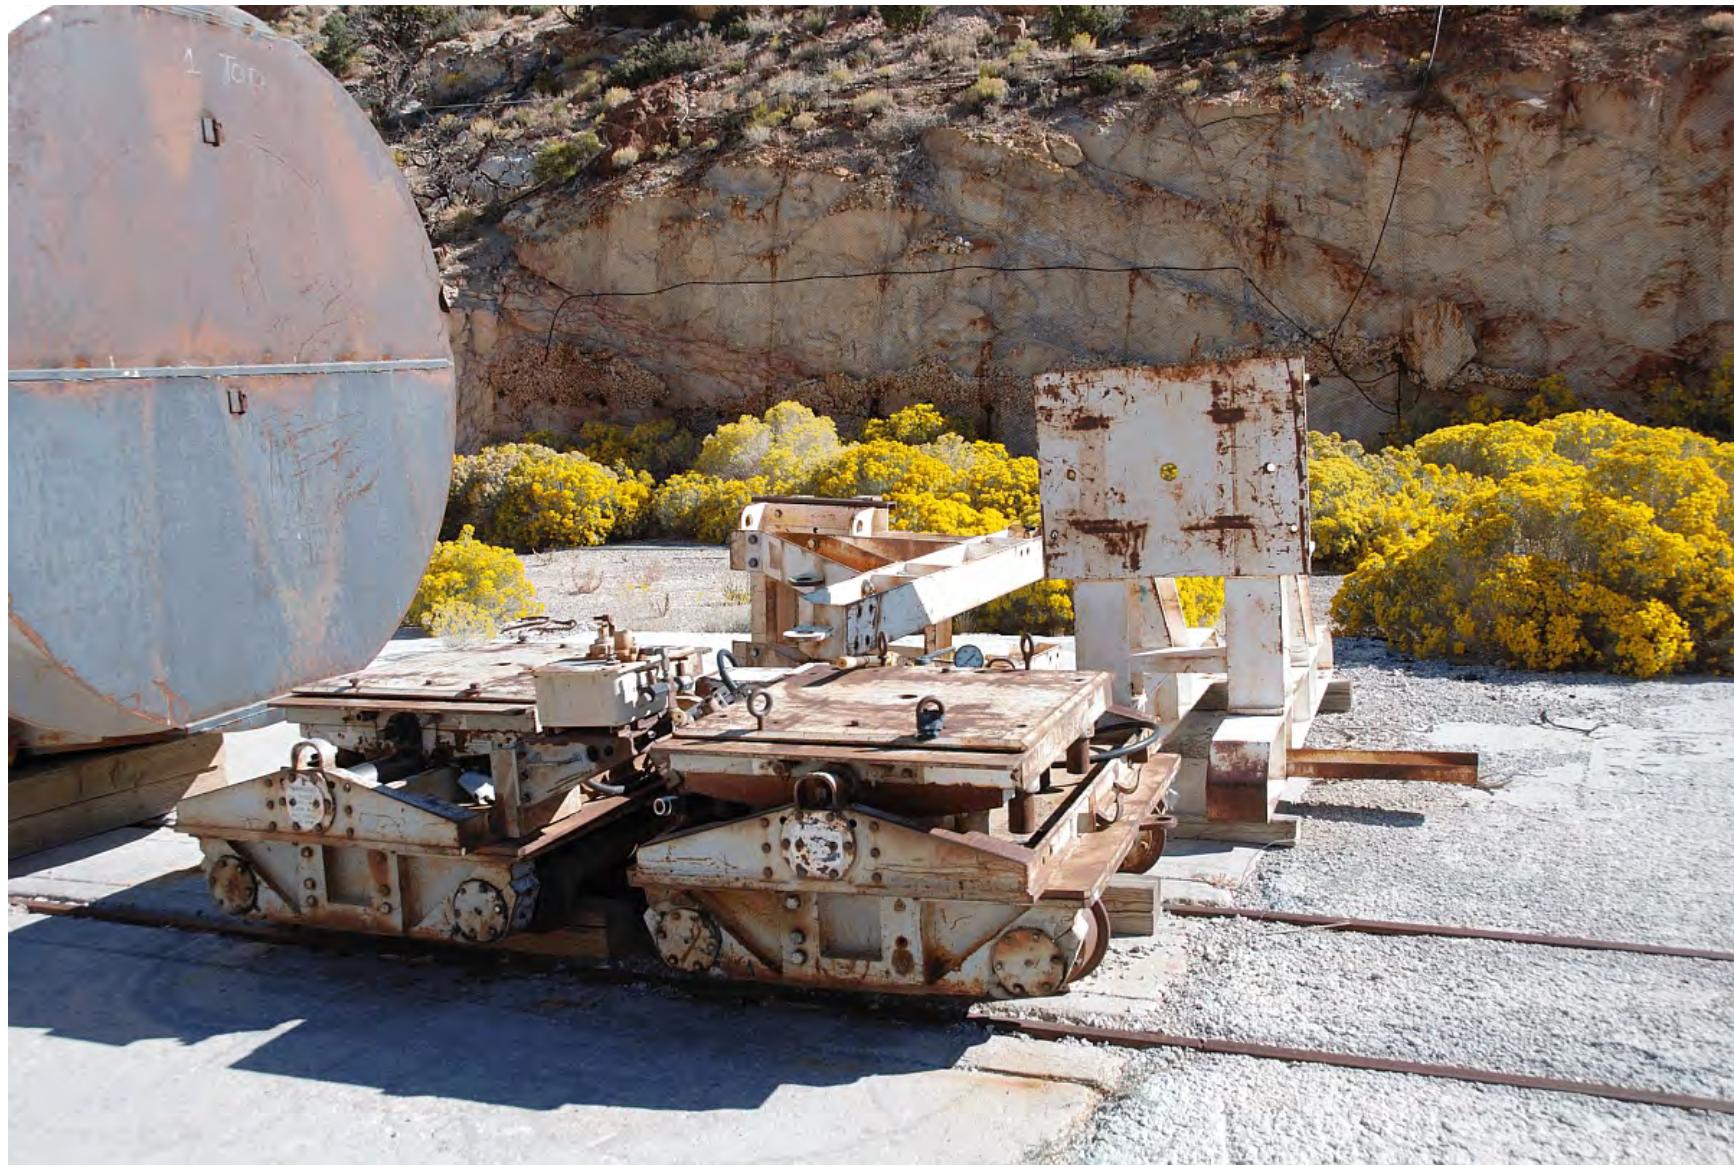
Feature 36 (Figures 170-172) is the concrete foundation for the multi-purpose building (12-855) at UTM coordinates 571837 E, 4117272 N. On top of the foundation is a tunnel-and-pipe-seal unit, two transport dollies, and two support structures for rail transport of the tunnel-and-pipe-seal underground. The foundation is generally rectangular in shape and 90 ft (27.4 m) north-south by 42 ft (12.8 m) east-west at the south end. It is 48 ft (14.6 m) east-west at 24 ft from the south end which is 34 ft (10.4 m) east-west. The north 6 ft of the foundation slopes from a 4 inch elevation to the ground surface and ends with a 1 ft wide metal drainage pipe buried in the surface. The west 60 ft

Figure 172. Feature 36, transport dollies and support structures, U12n Tunnel, view northeast (2008).

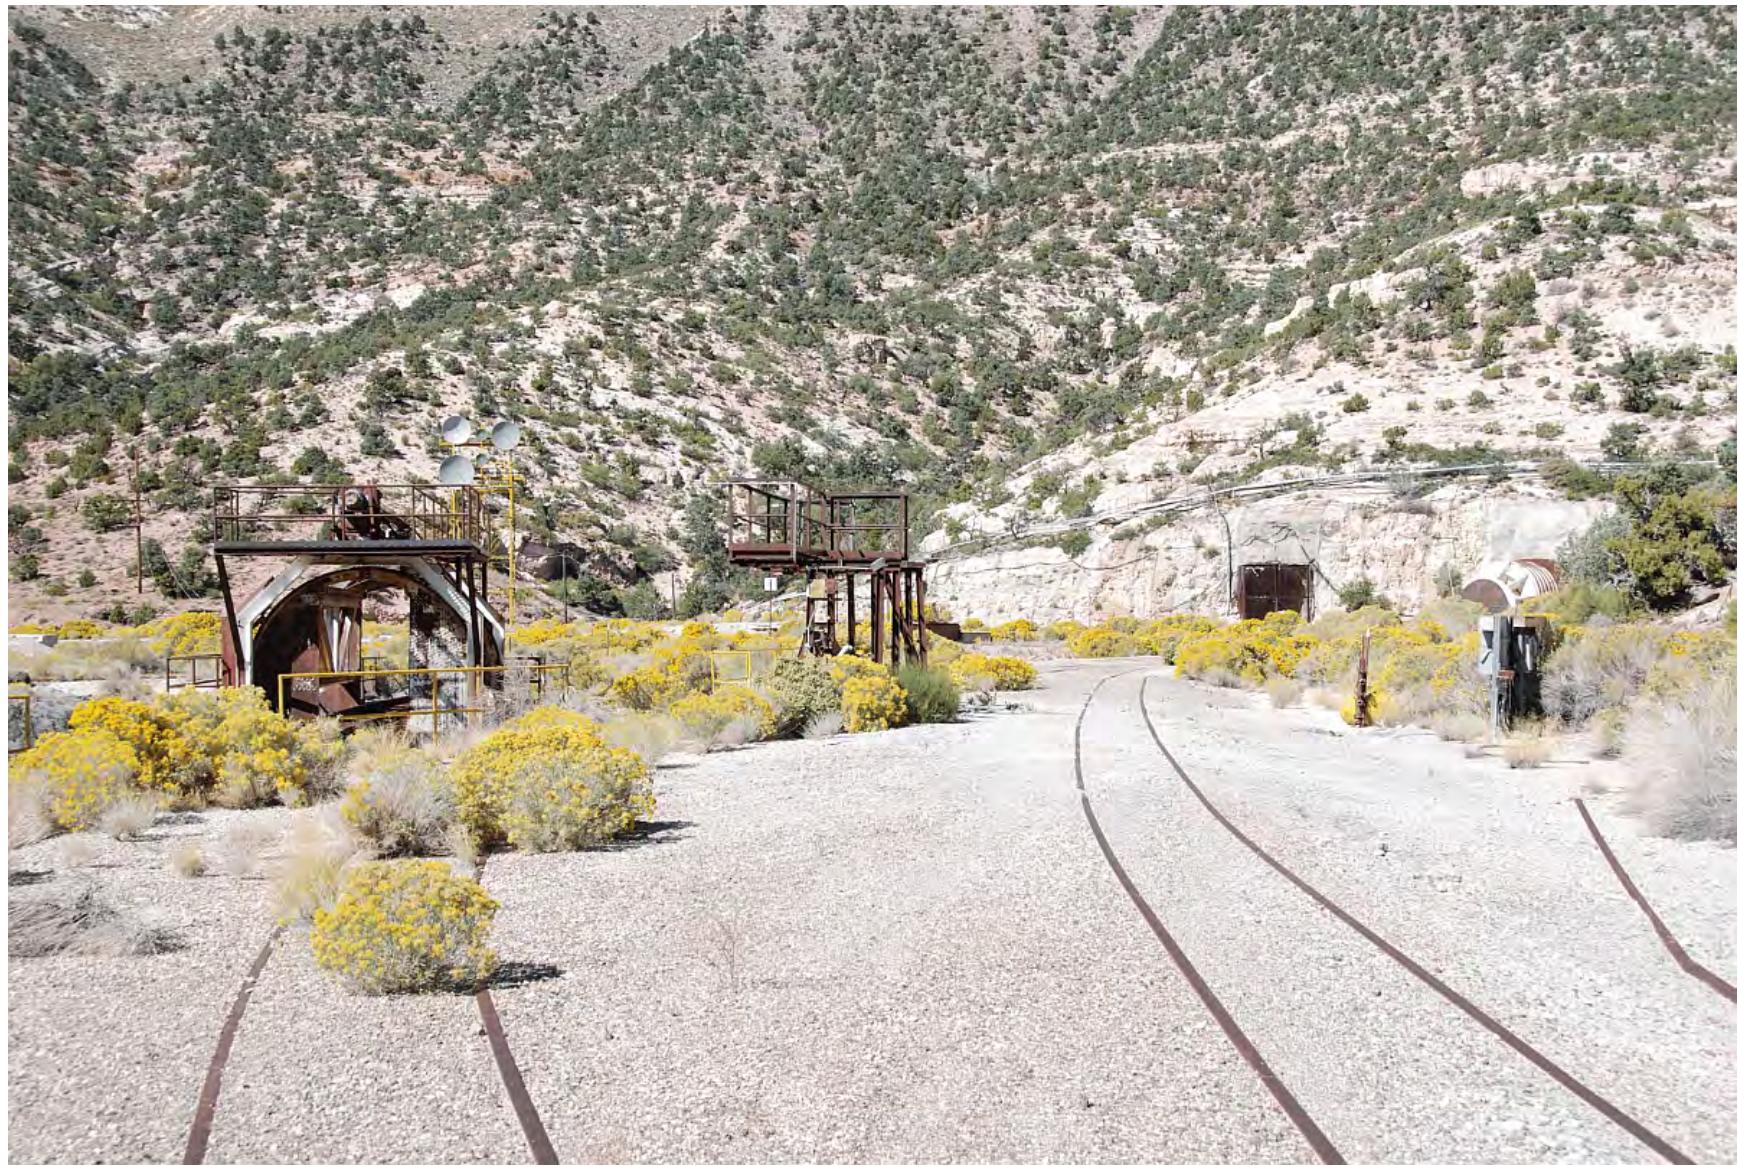
Figure 174. Feature 37, rail lines, U12n Tunnel, view northwest (2008).

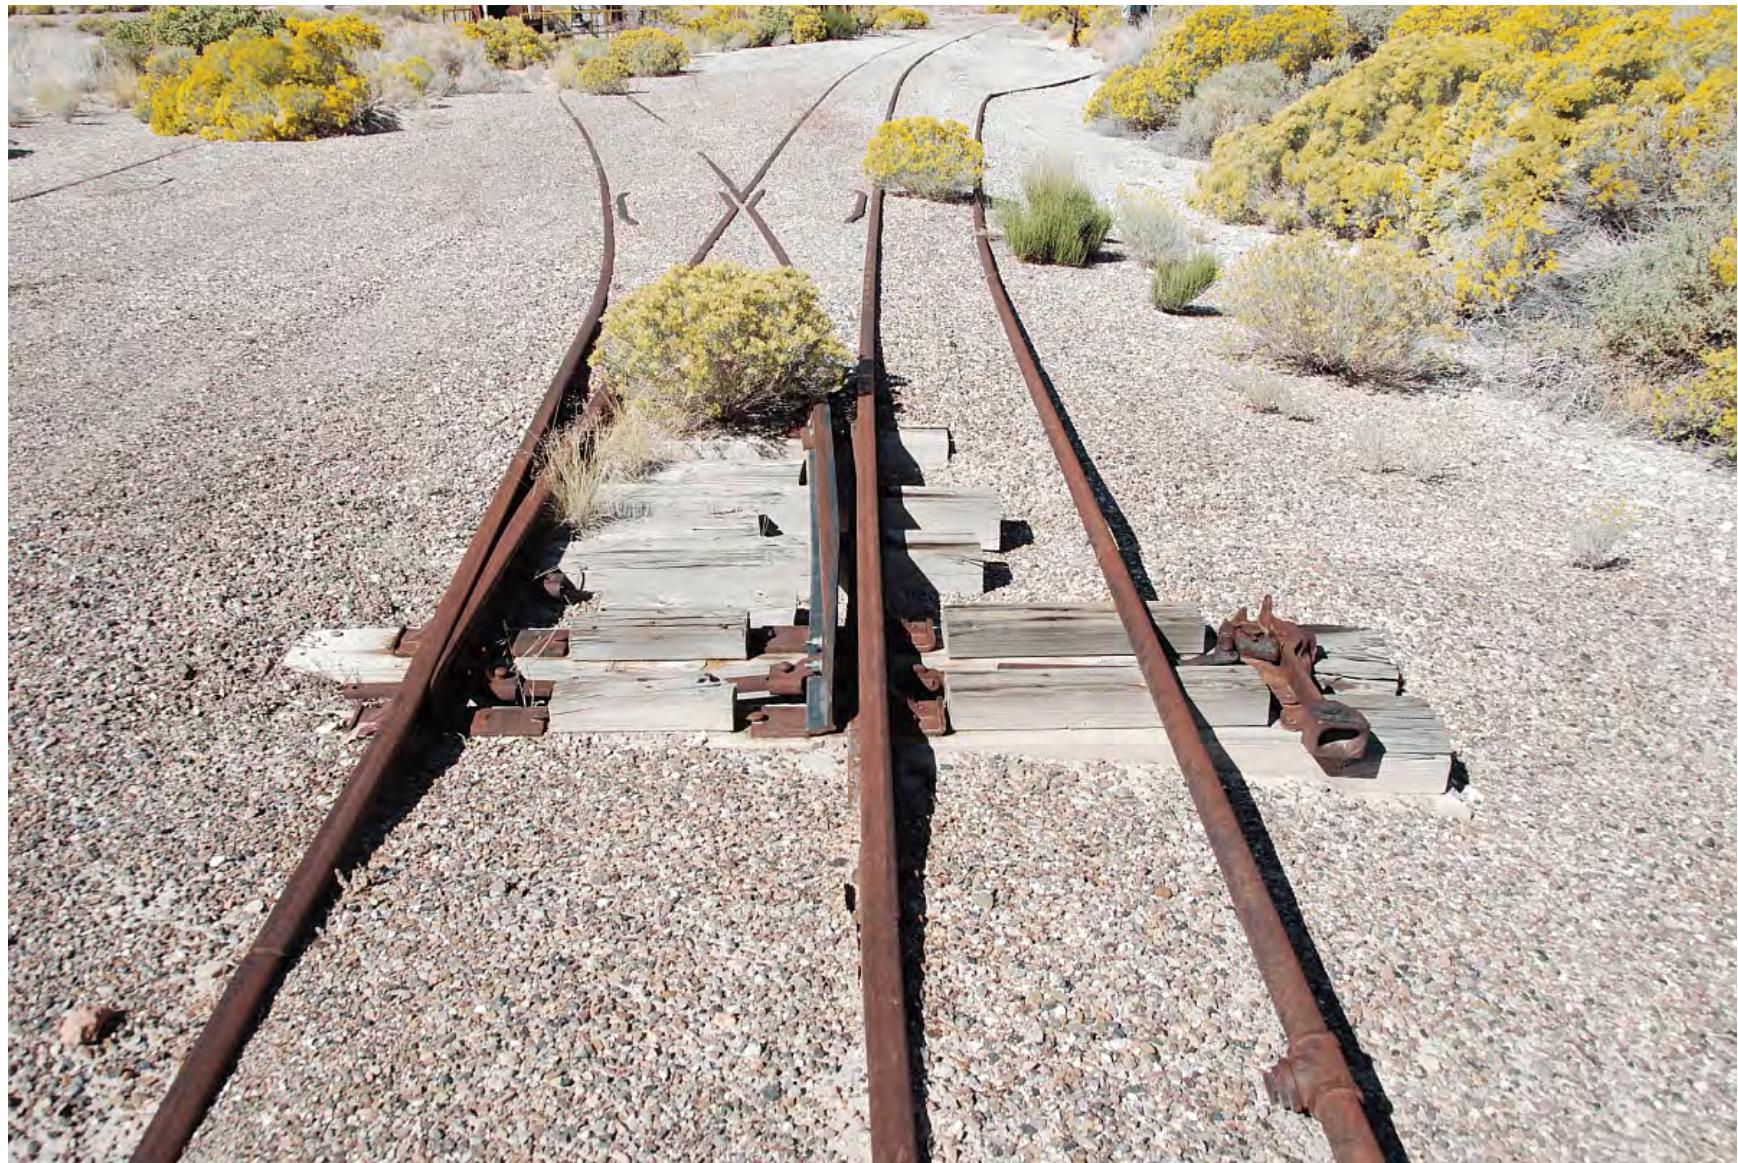
Figure 175. Feature 37, switch on rail lines, U12n Tunnel, view northwest (2008).

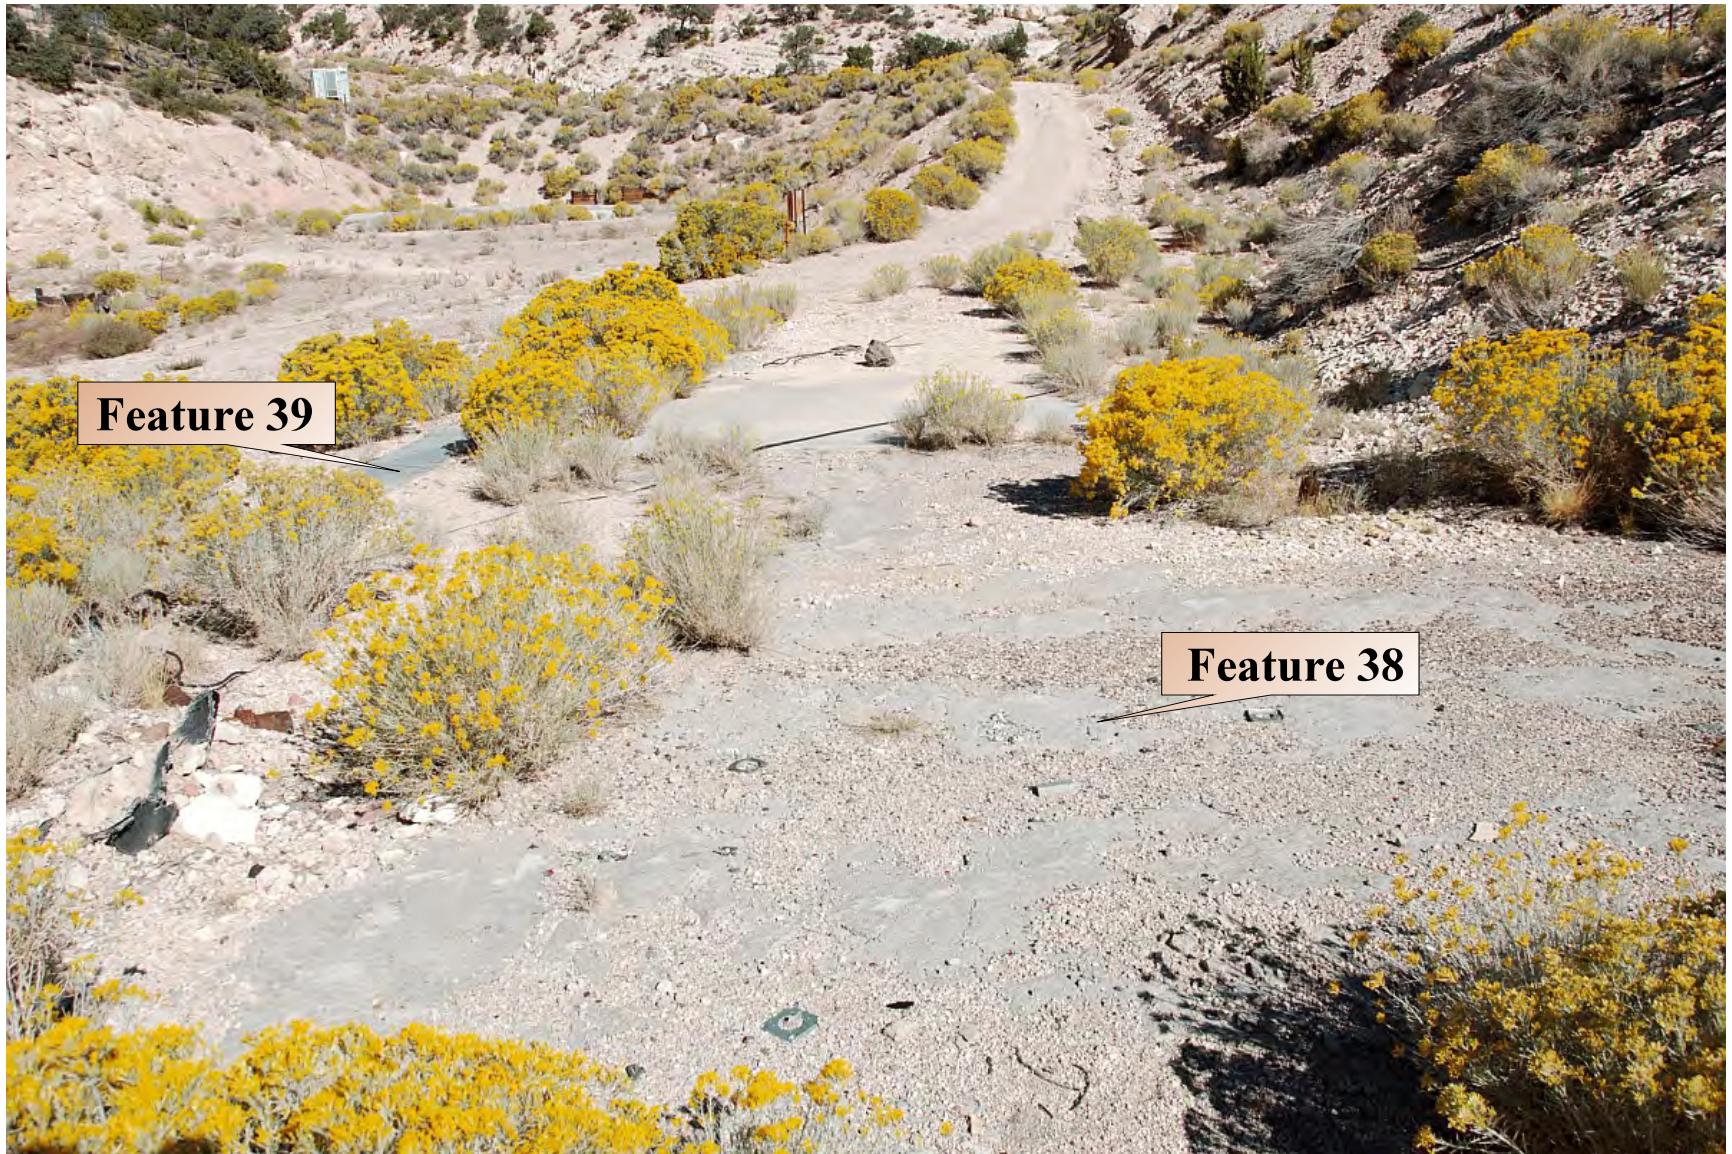
Feature 38 (Figure 176) is the concrete foundation for an electrical storage building at UTM coordinates 571838 E, 4117323 N. It is approximately 35 ft north-south by 13 ft east-west. Most of the foundation is covered with gravel and soil and the surface is highly deteriorated and broken. Associated artifacts are screws, insulated cable, insulated wire, wood fragments, and washers.

Figure 176. Feature 38, concrete foundation for electrical storage building and Feature 39, storm drainage channel, U12n Tunnel, view north (2008).

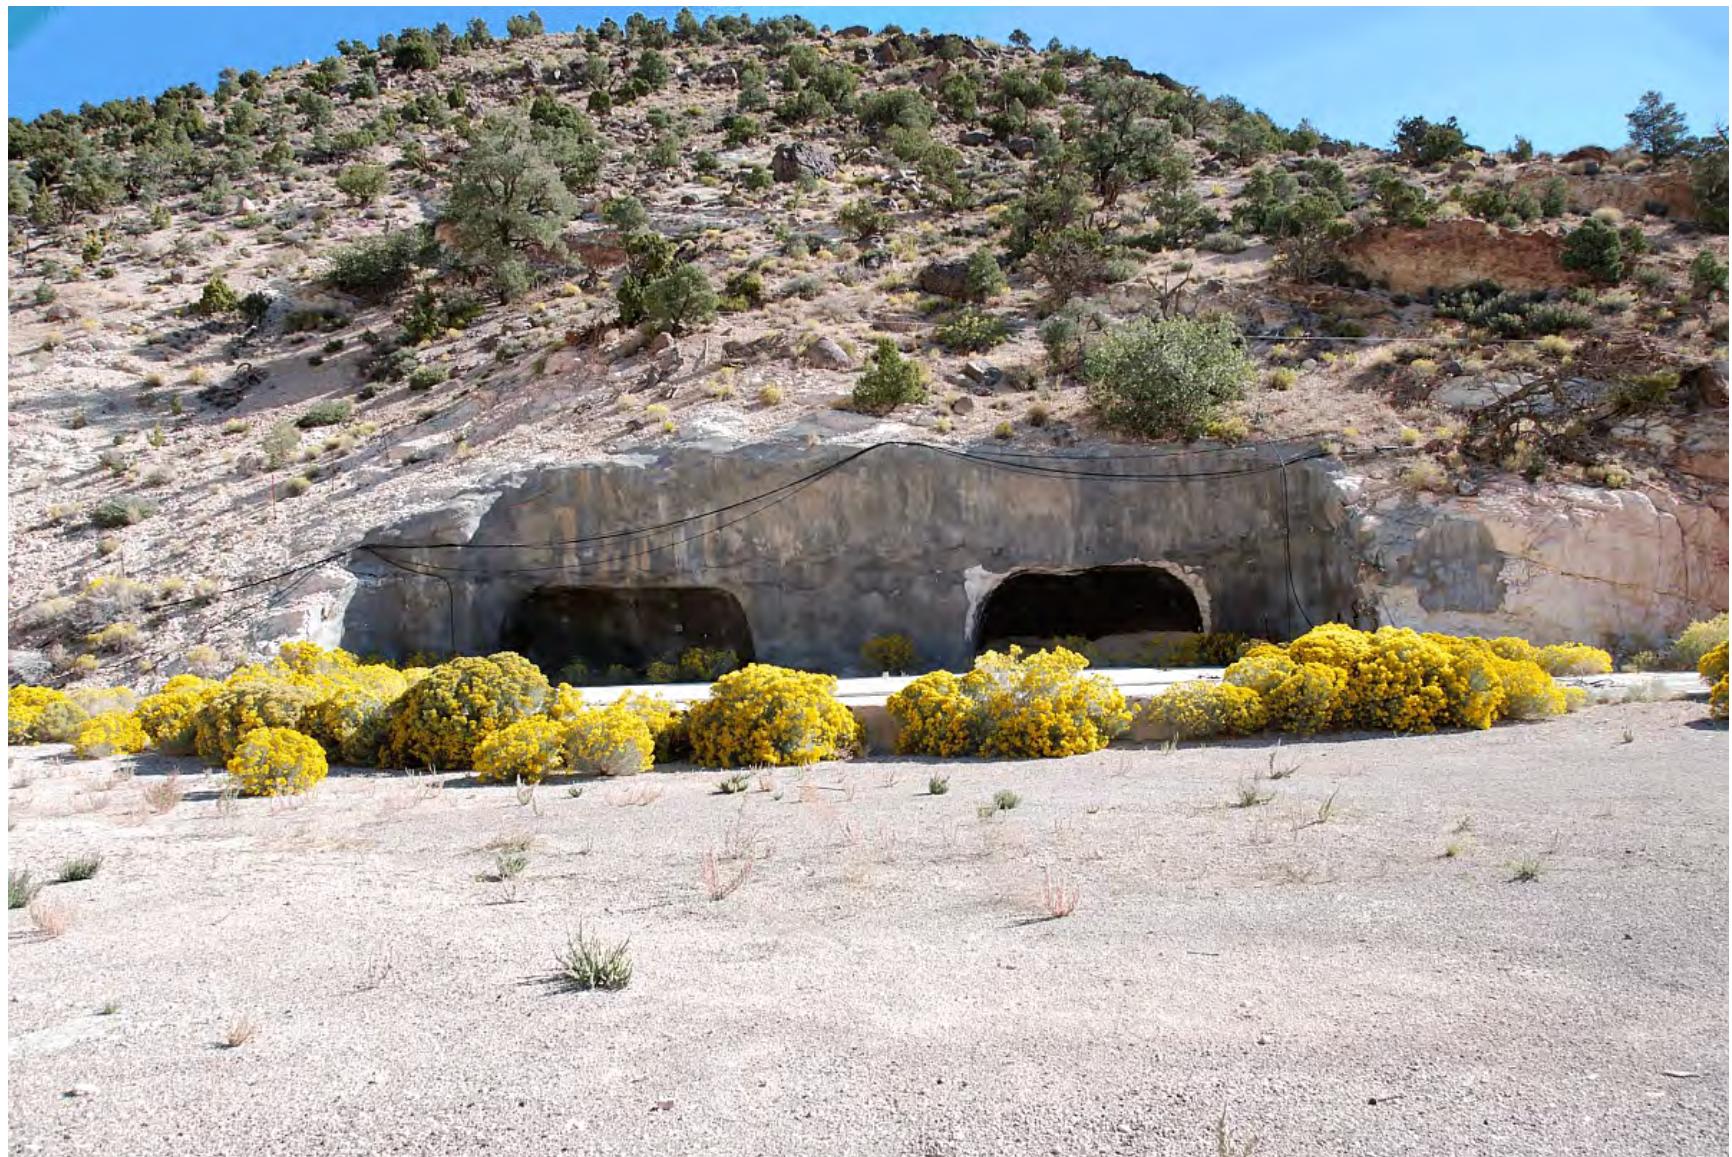
Figure 177. Feature 40, alcoves, U12n Tunnel, view northeast (2008).

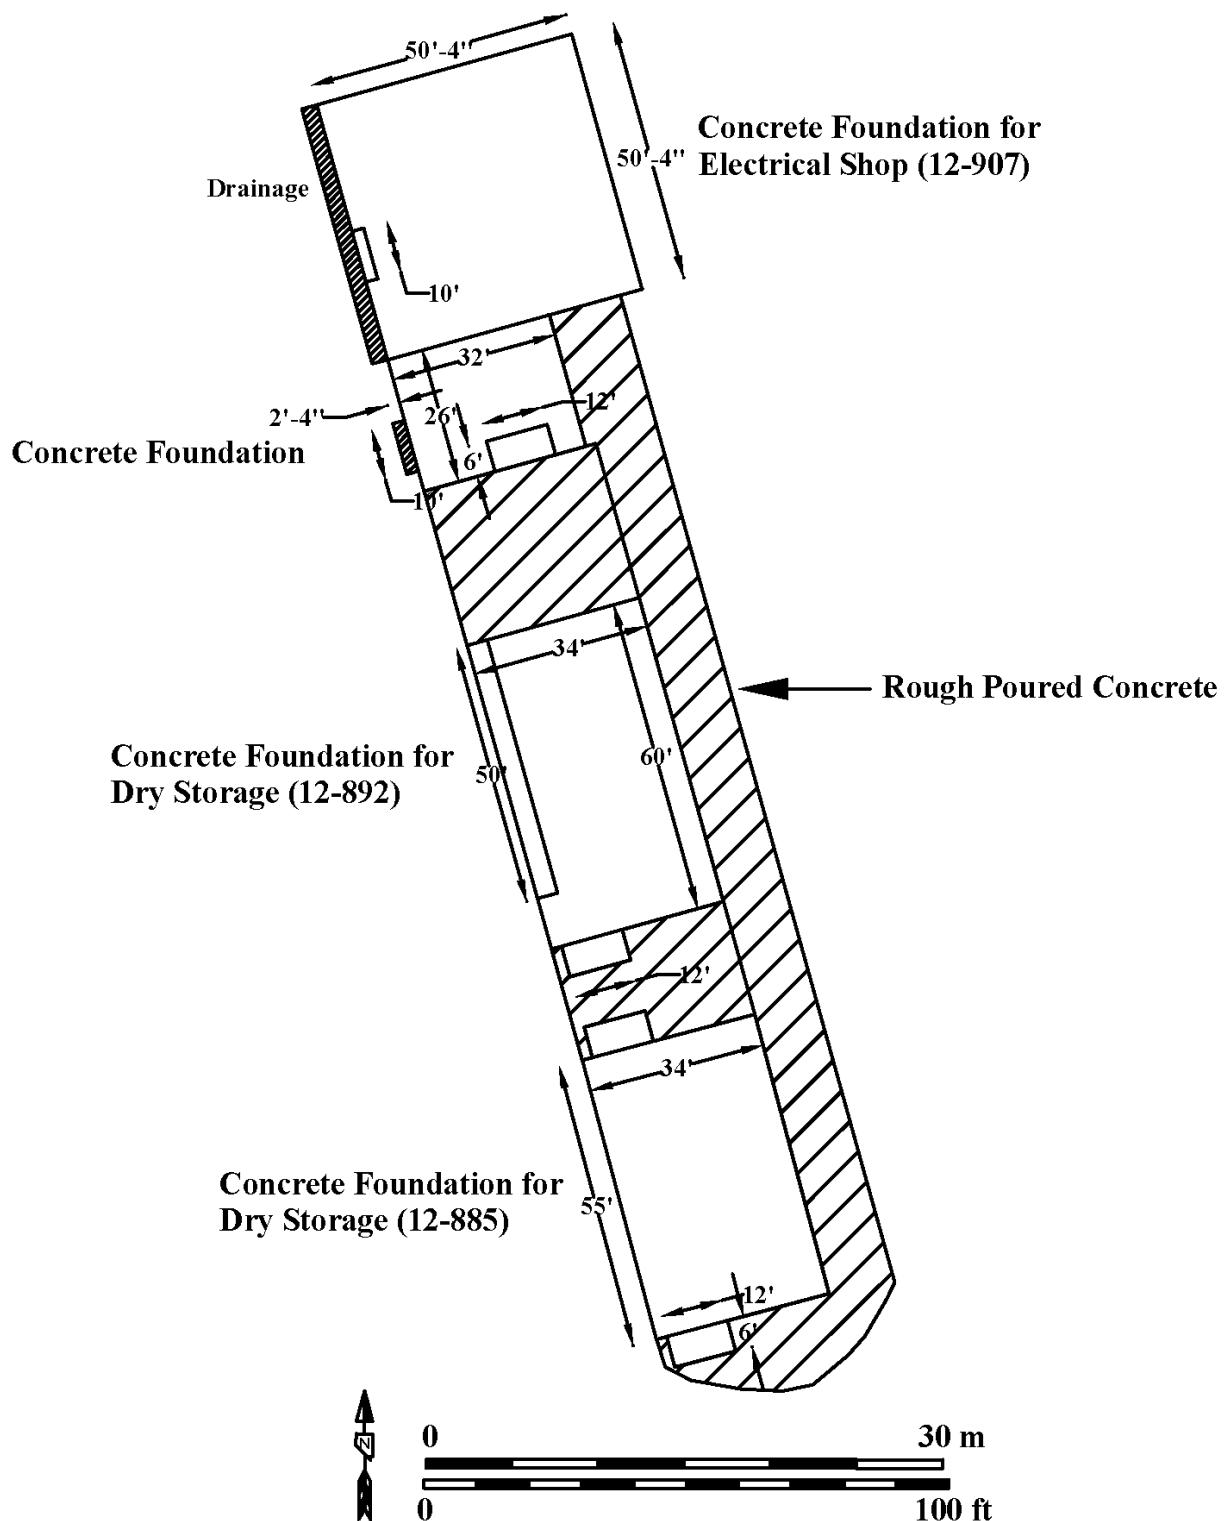
Feature 41 (Figures 178-180) consists of four joined concrete foundations along the northeast edge of the U12n Tunnel Portal pad. The four foundations were constructed separately but have been connected by concrete poured between and along the east sides providing one uninterrupted expanse of concrete. The overall dimensions of the feature are 262 ft (79.9 m) north-south by 50 ft 4 inches (15.3 m) east-west. The concrete foundations have a smooth finish while the joining concrete has a rough finish. Feature 39, the concrete drainage channel, extends north-south approximately 3 ft west, and is visible along the west side of the north two foundations. Each of the concrete foundations (north to south) will be described separately below.

The northern foundation is for the electrical shop (12-907) and is 50 ft 4 inches (15.3 x 15.3 m) square at UTM coordinates 571854 E, 4117312 N. The west 7 ft of the foundation slopes slightly

Figure 178. Plan map of Feature 41, concrete foundations (electrical shop and dry storage), U12n Tunnel.

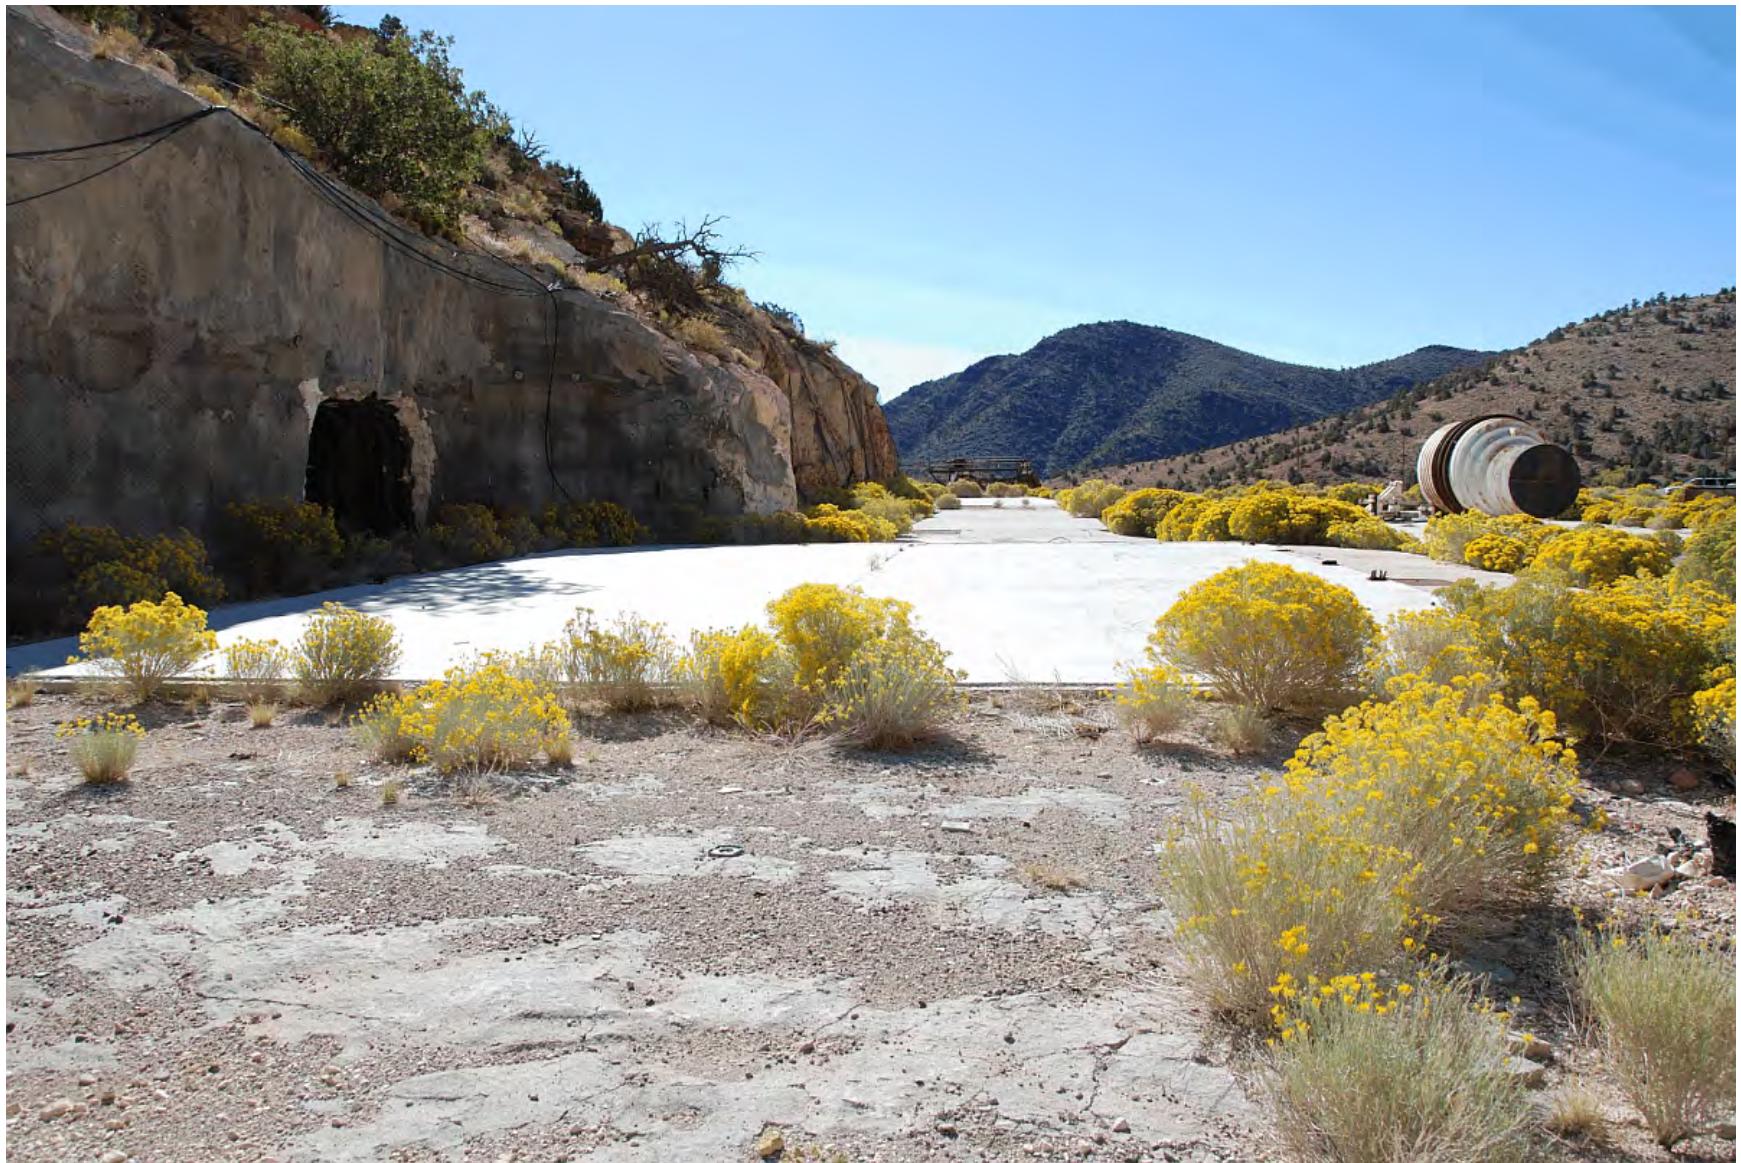
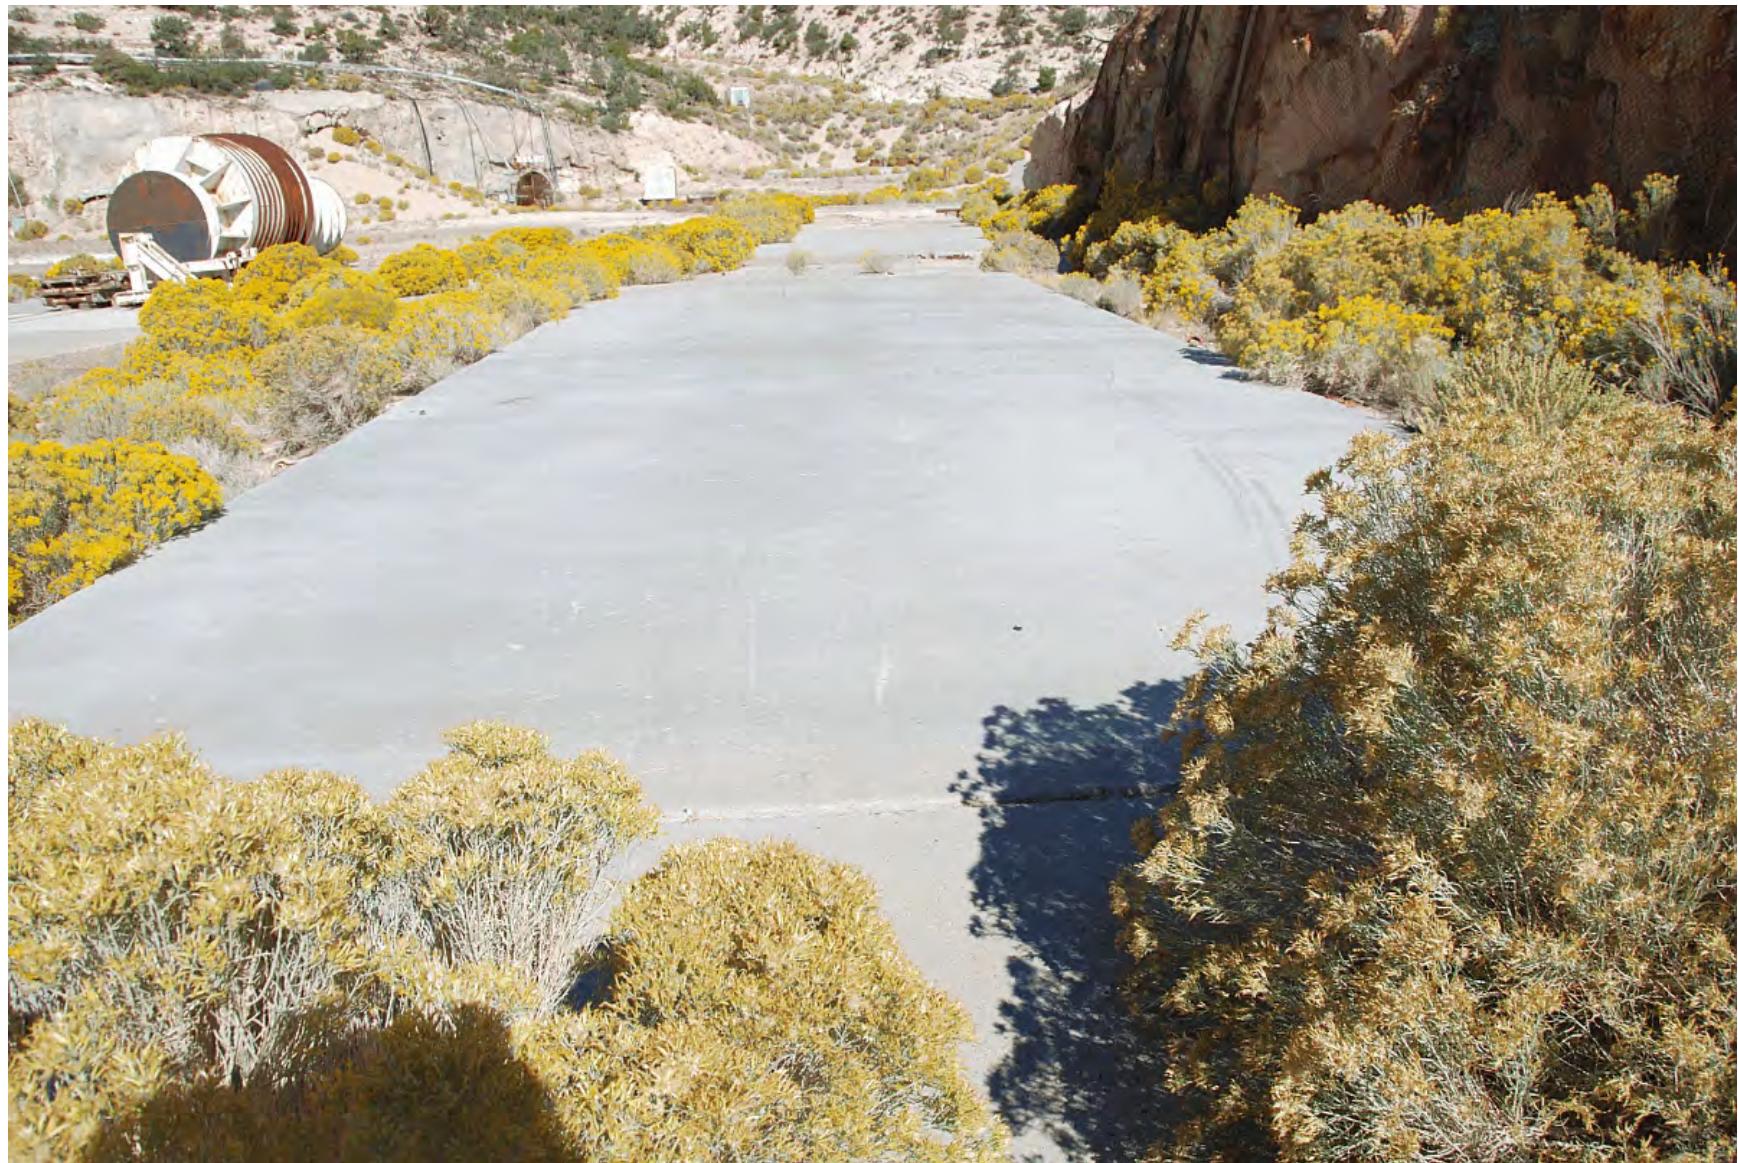
Figure 179. Feature 41, concrete foundations, U12n Tunnel, view southeast (2008).

to the west. A 3 ft wide metal plate covers an underground drainage along the west edge of the foundation. Three inch angle iron has been placed around the top north, east, and south surface edges but is not continuous as some pieces have been removed. Bolts that attached a structure to the concrete have been cut flush with the surface and 6 x 6 inch metal plates that supported I-beams are still attached at several locations.

The second foundation is 1 ft 4 inch (40.6 cm) lower than the electrical shop foundation and abuts it along the south edge. It was used to stage electrical equipment. The rectangular foundation is 32 ft (9.8 m) east-west by 26 ft (7.9 m) north-south and at UTM coordinates 571852 E, 4117296 N. A 6 ft north-south by 12 ft east-west ramp has been formed within the foundation along the southern edge. A 10 ft north-south by 2 ft 4 inch (71.1 m) metal covered underground drainage is along the west edge of the foundation. Associated artifacts are electrical cable, wire, conduit, bolts, nuts, and screws.

The third foundation is for dry storage (12-892) at UTM coordinates 571858 E, 4117280 N. It is rectangular, 34 ft east-west by 60 ft north-south. The west edge, 4 ft east-west by 50 ft north-south, is 4 inches below the remainder of the foundation and appears to have been used as a walk way. A 6 ft north-south by 12 ft east-west ramp is along the south side of the foundation, 2 ft from the southwest corner. Bolts that attached a structure to the concrete have been cut flush with the surface. Associated artifacts are electrical cable, pipe connections, flanges, conduit, electrical box parts, brass valves, PVC connections, plugs, and chain links.

The southern most foundation is for dry storage (12-885) at UTM coordinates 571864 E, 4117255 N. It is rectangular, 34 ft east-west by 55 ft (16.8 m) north-south. Along the north and south edges are 6 x 12 ft ramps 2 ft from the west edge. Associated artifacts are galvanized pipe, PVC pipe, unions, plugs, and collars.

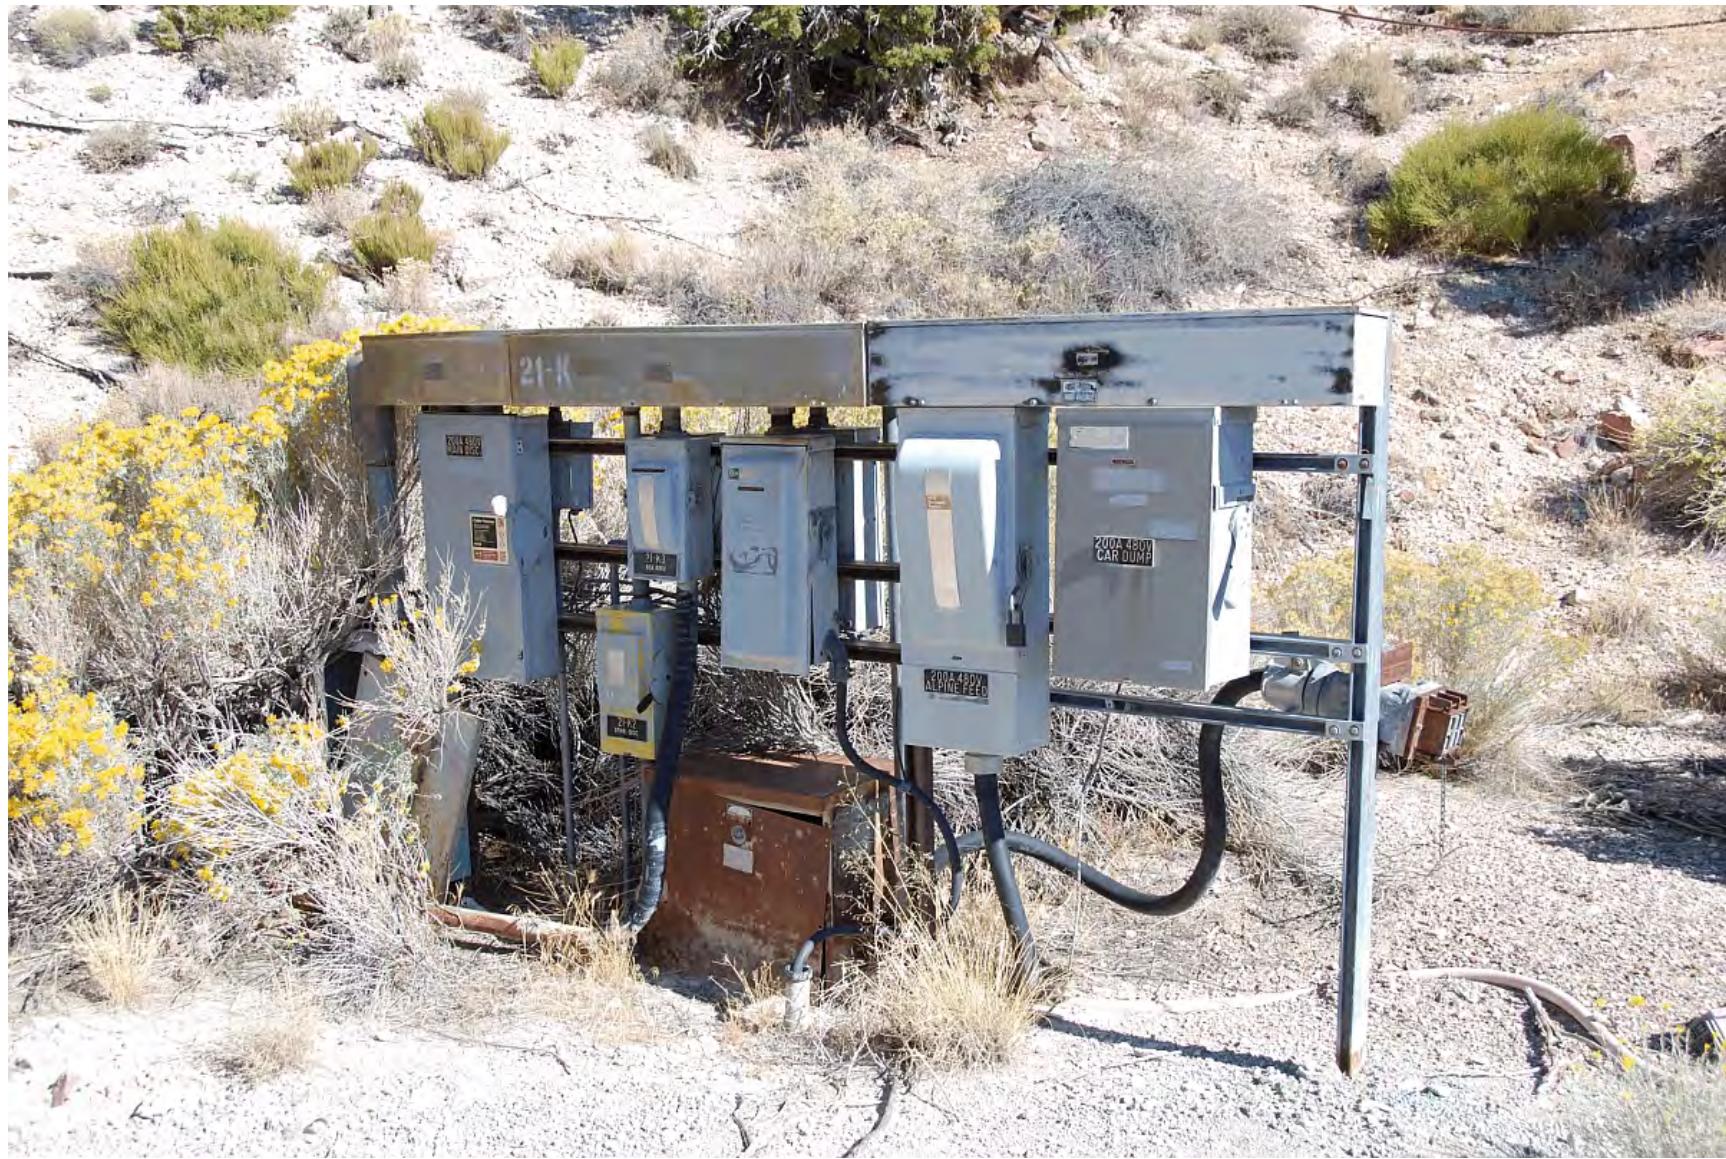
Figure 181. Feature 42, electrical panel backboard, U12n Tunnel, view north (2008).
