A total of 202 features were recorded, mapped, and photographed for the U12n Tunnel complex. The project area encompassed 600.8 acres (243.1 hectares) at the portal and mesa areas. At the U12n portal area are ten sub-areas containing features related to the construction, testing, and general everyday activities within the tunnel. These include concrete foundations for buildings, communications equipment, mining equipment, rail lines, retention ponds, storage containers, and access control facilities. Only a telephone trailer remains on the telephone pad as all of the other buildings have been removed from the portal area. The microwave tower, portions of the rail lines, the muck car dump, rotary dump, and wash rack are still in place. Also, the traffic control point and powder magazines along N Tunnel Road are intact. At the mesa area are four sub-areas containing features generally related to pre- and post-shot drilling, recording facilities, and ventilation equipment. These include concrete foundations, instrument cable holes, and drill holes. The concrete foundations were for buildings and small equipment. Concrete pads and various equipment remain at the cable hole locations bu

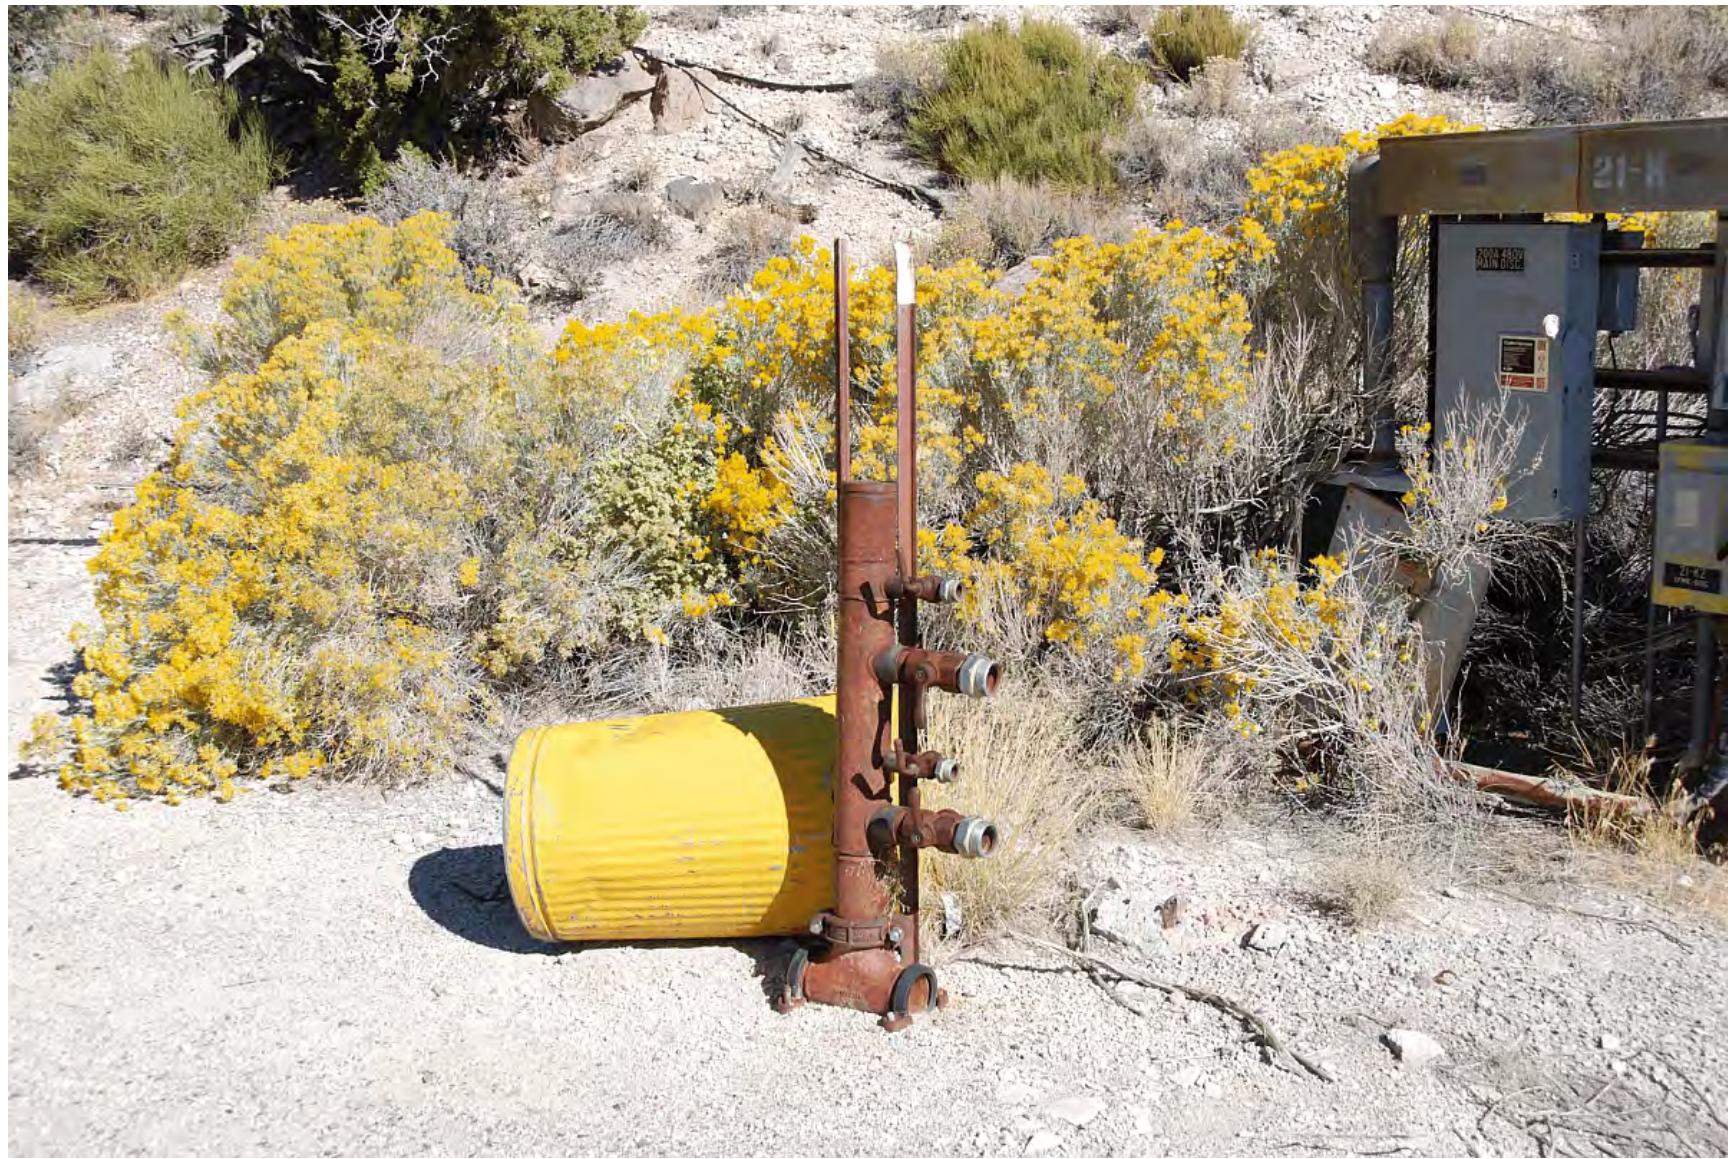
Feature 43 (Figure 182) is a pipe manifold at UTM coordinates 571888 E, 4117225 N. It probably was used for water and consists of a 4-inch Victaulic pipe riser that is 4 ft in height. The bottom of the riser is a Victaulic T that is not connected to other pipe and is supported by two metal T posts. Welded onto the south side of the riser are two 2-inch and two 1-inch ball valves. Near the riser is a 2 ft 10 inch tall by 1 ft 10 inch diameter yellow painted galvanized trash can with a locked top.

Figure 182. Feature 43, pipe manifold, U12n Tunnel, view north (2008).

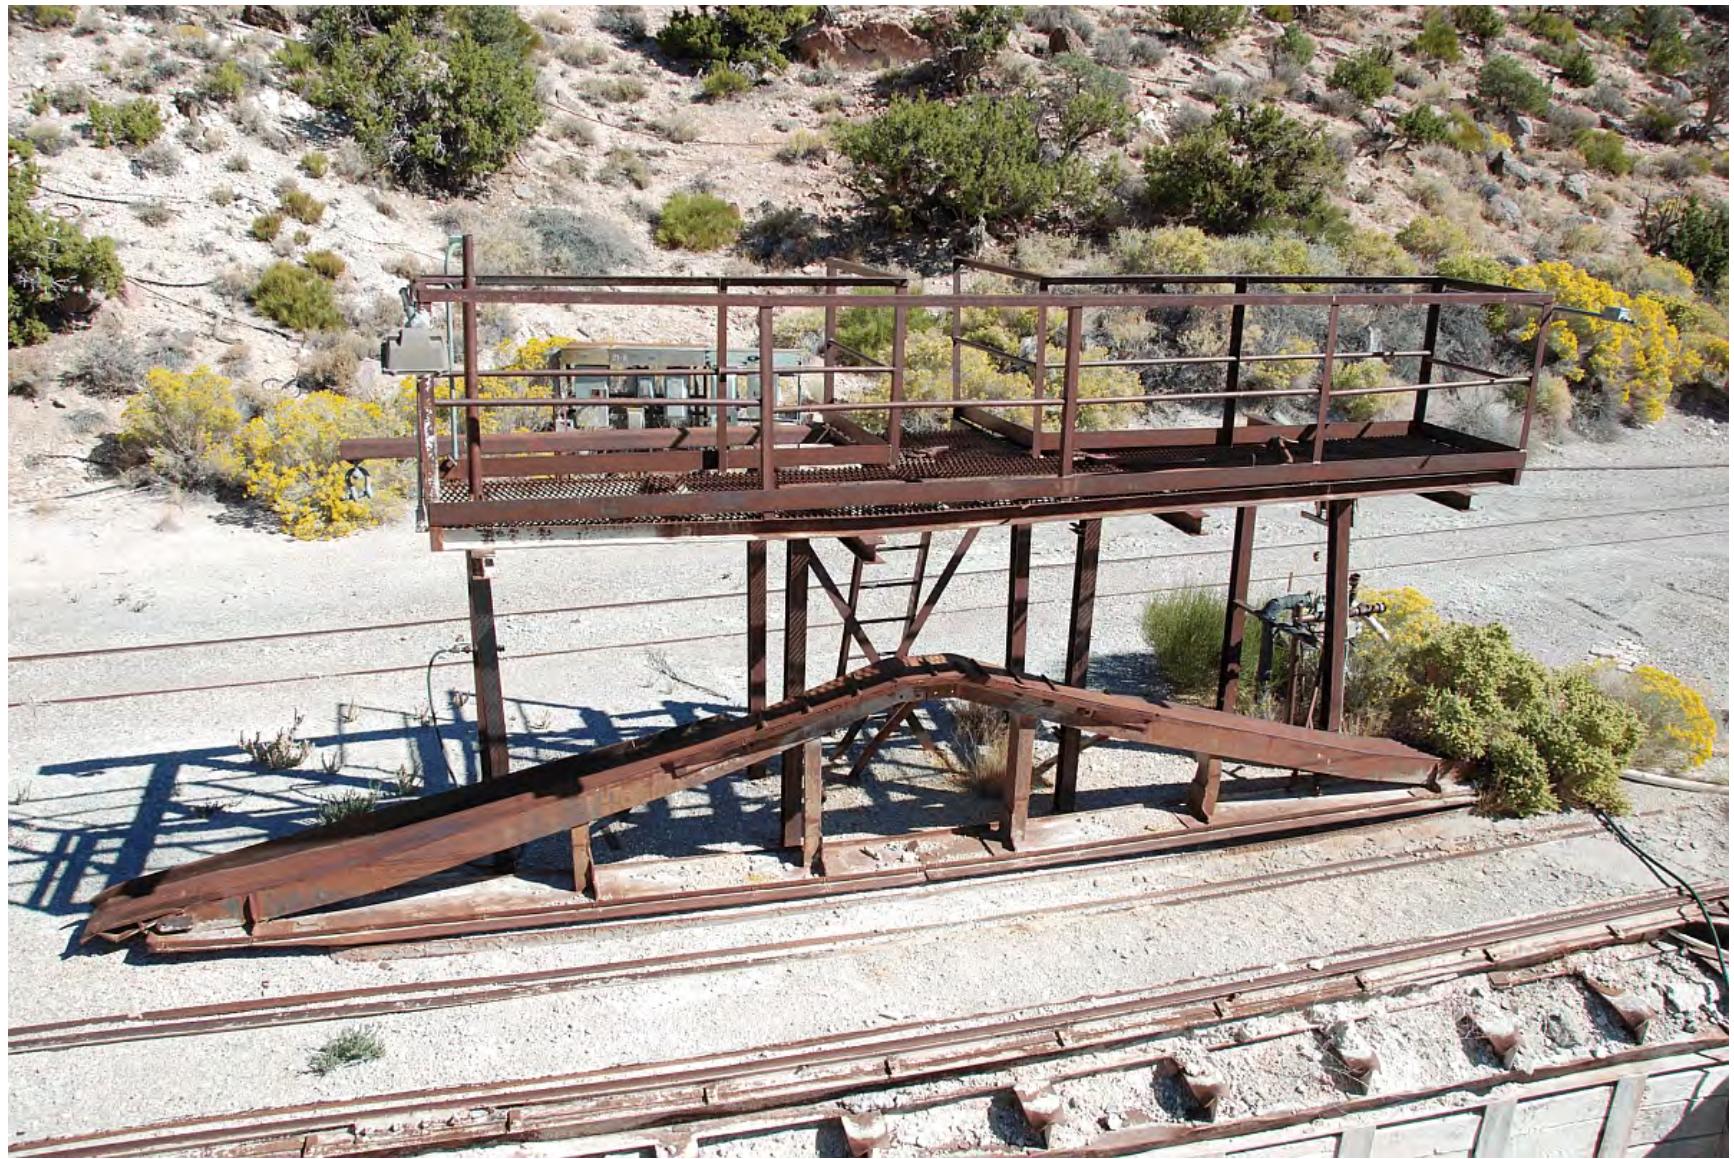
Figure 183. Feature 44, camel back dump, U12n Tunnel, view northwest (2008).

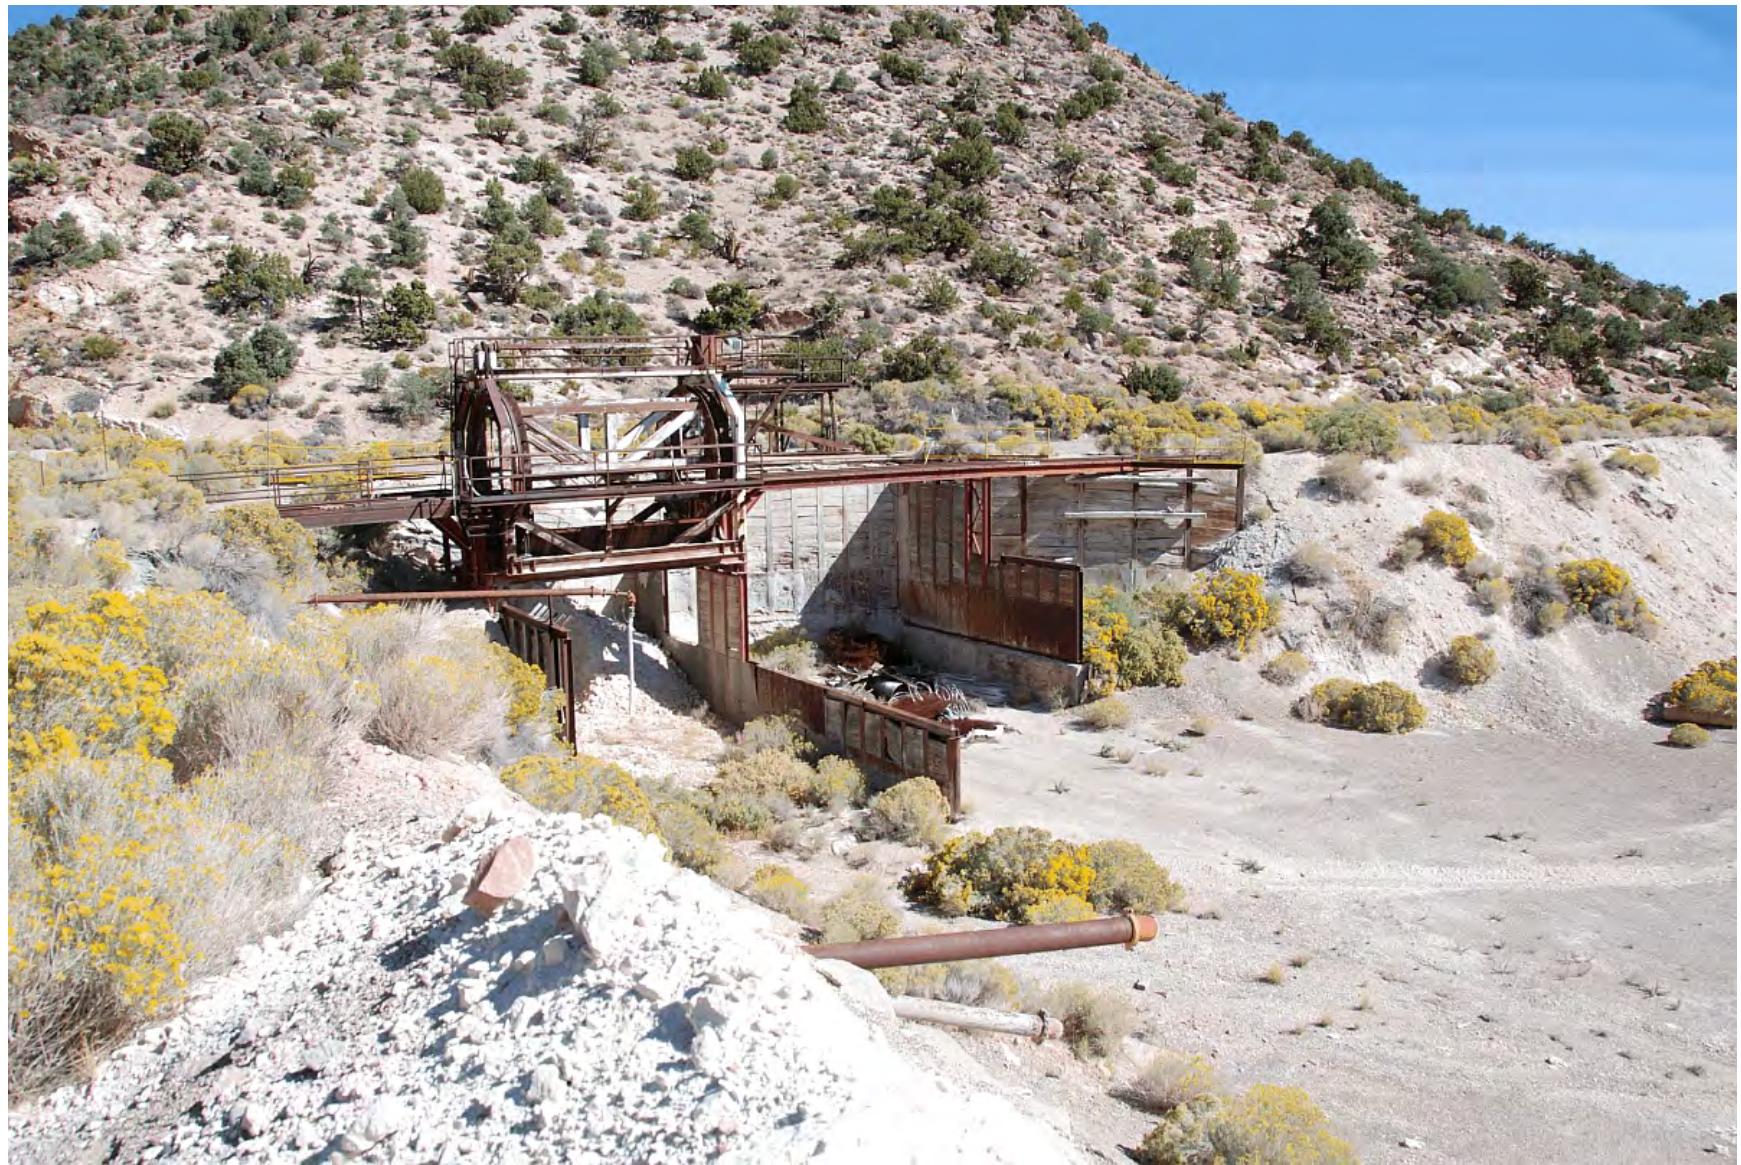
Feature 45 (Figures 184-188) is concrete walls along the north side of the tailings dump area, a metal walk, two concrete pads, and the rotary dump at UTM coordinates 571887 E, 4117204 N. The outer concrete walls support the side of the tailings dump area that is 22 ft (6.7 m) below the surrounding surface. The walls roughly form a U-shape and are 22 ft tall and constructed of 8-inch vertical I-beams spaced 3 ft apart and filled with 2 x 12 inch wood lagging. Because the 8-inch I-beam is wider than the 2 inch width of the lagging, wood blocks are wedged in the gaps. From the southeast corner, the wall extends 19 ft at 310 degrees. The wall then splits and continues south and west. The south wall is 30 ft in length at 190 degrees. The west wall turns to 310 degrees and extends 26 ft. At the end of the west wall, the wall splits again into two sections and extends south and southwest. The south section turns to 190 degrees and extends 62 ft (18.9 m). This section supports the east end of the rotary dump. The southwest section turns 260 degrees for 34 ft 4 inches (10.5 m). At the end of this section, the wall turns to 190 degrees and extends 50 ft. This section supports the west end of the rotary dump and much of it is covered with tailings.

Figure 185. Feature 45, dump area walls and rotary dump, view northeast (2008).

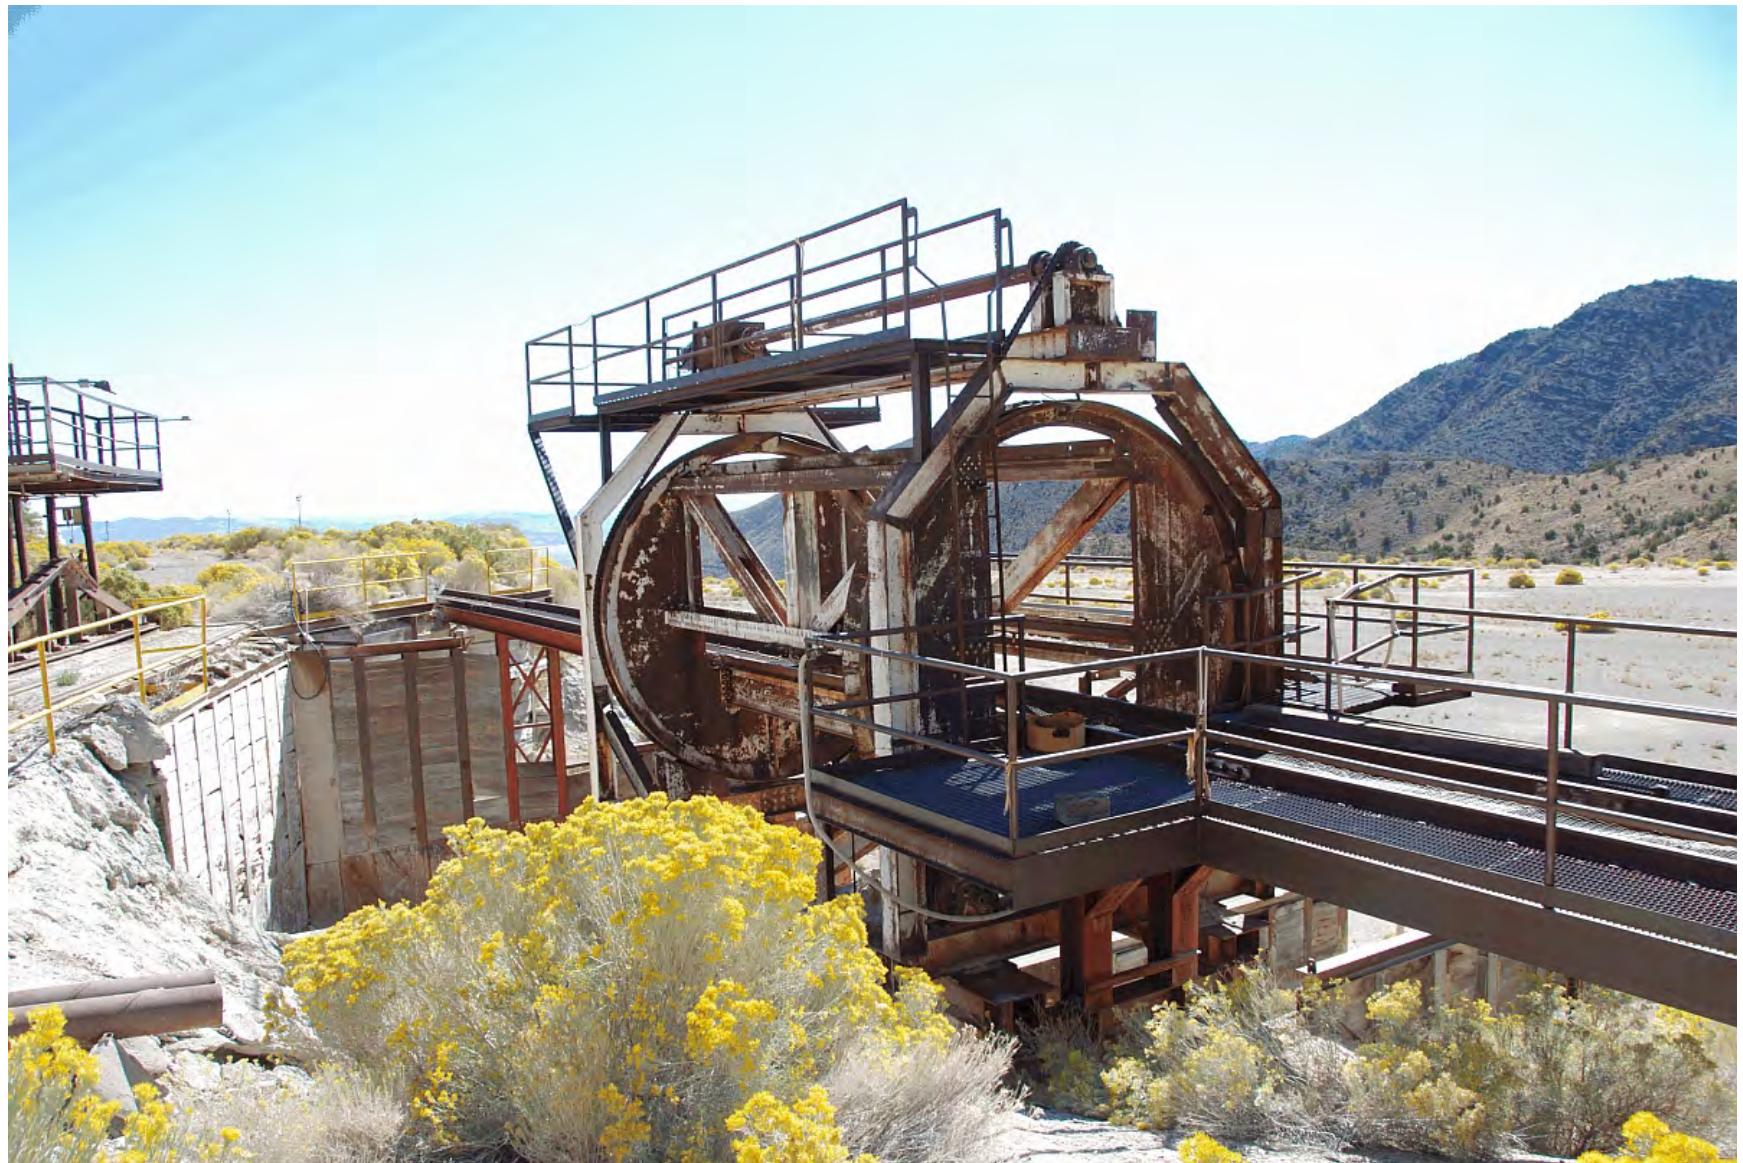
Figure 186. Feature 45, rotary dump, view southeast (2008).

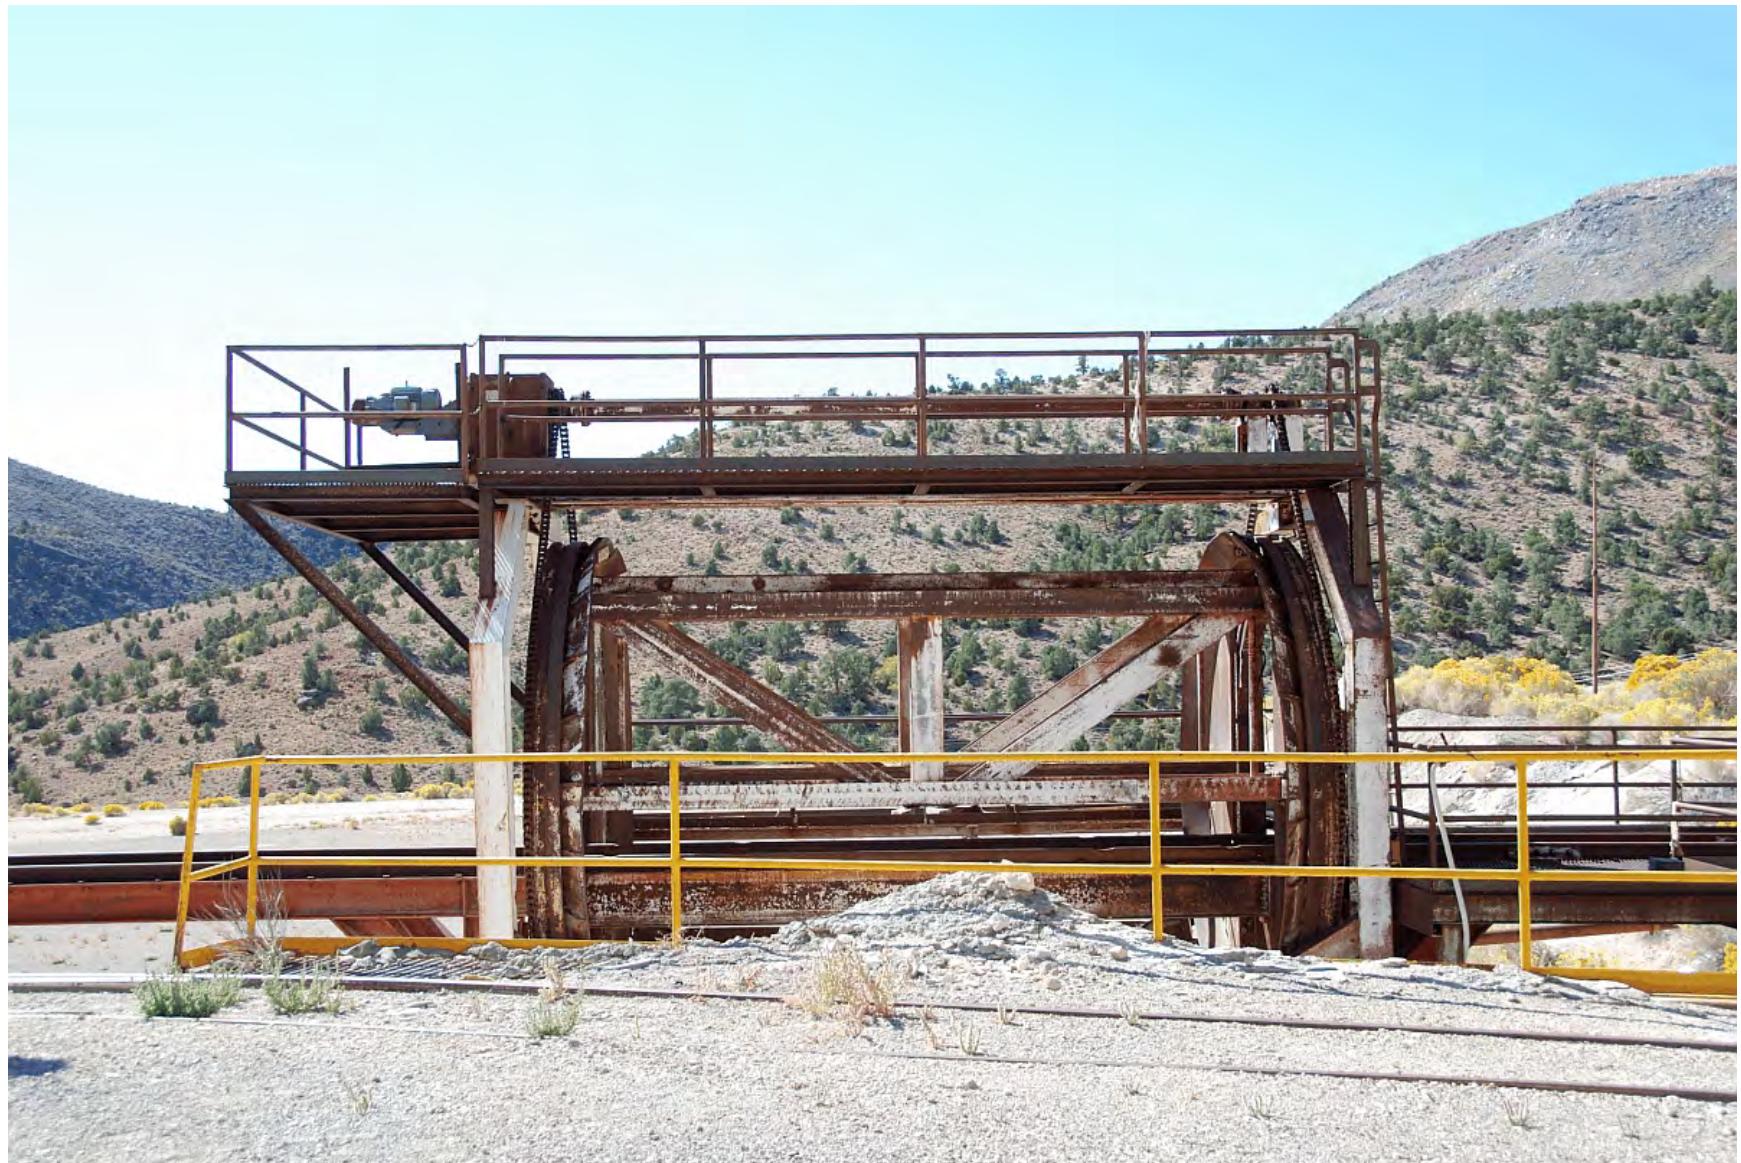
Figure 187. Feature 45, rotary dump, U12n Tunnel, view south (2008).

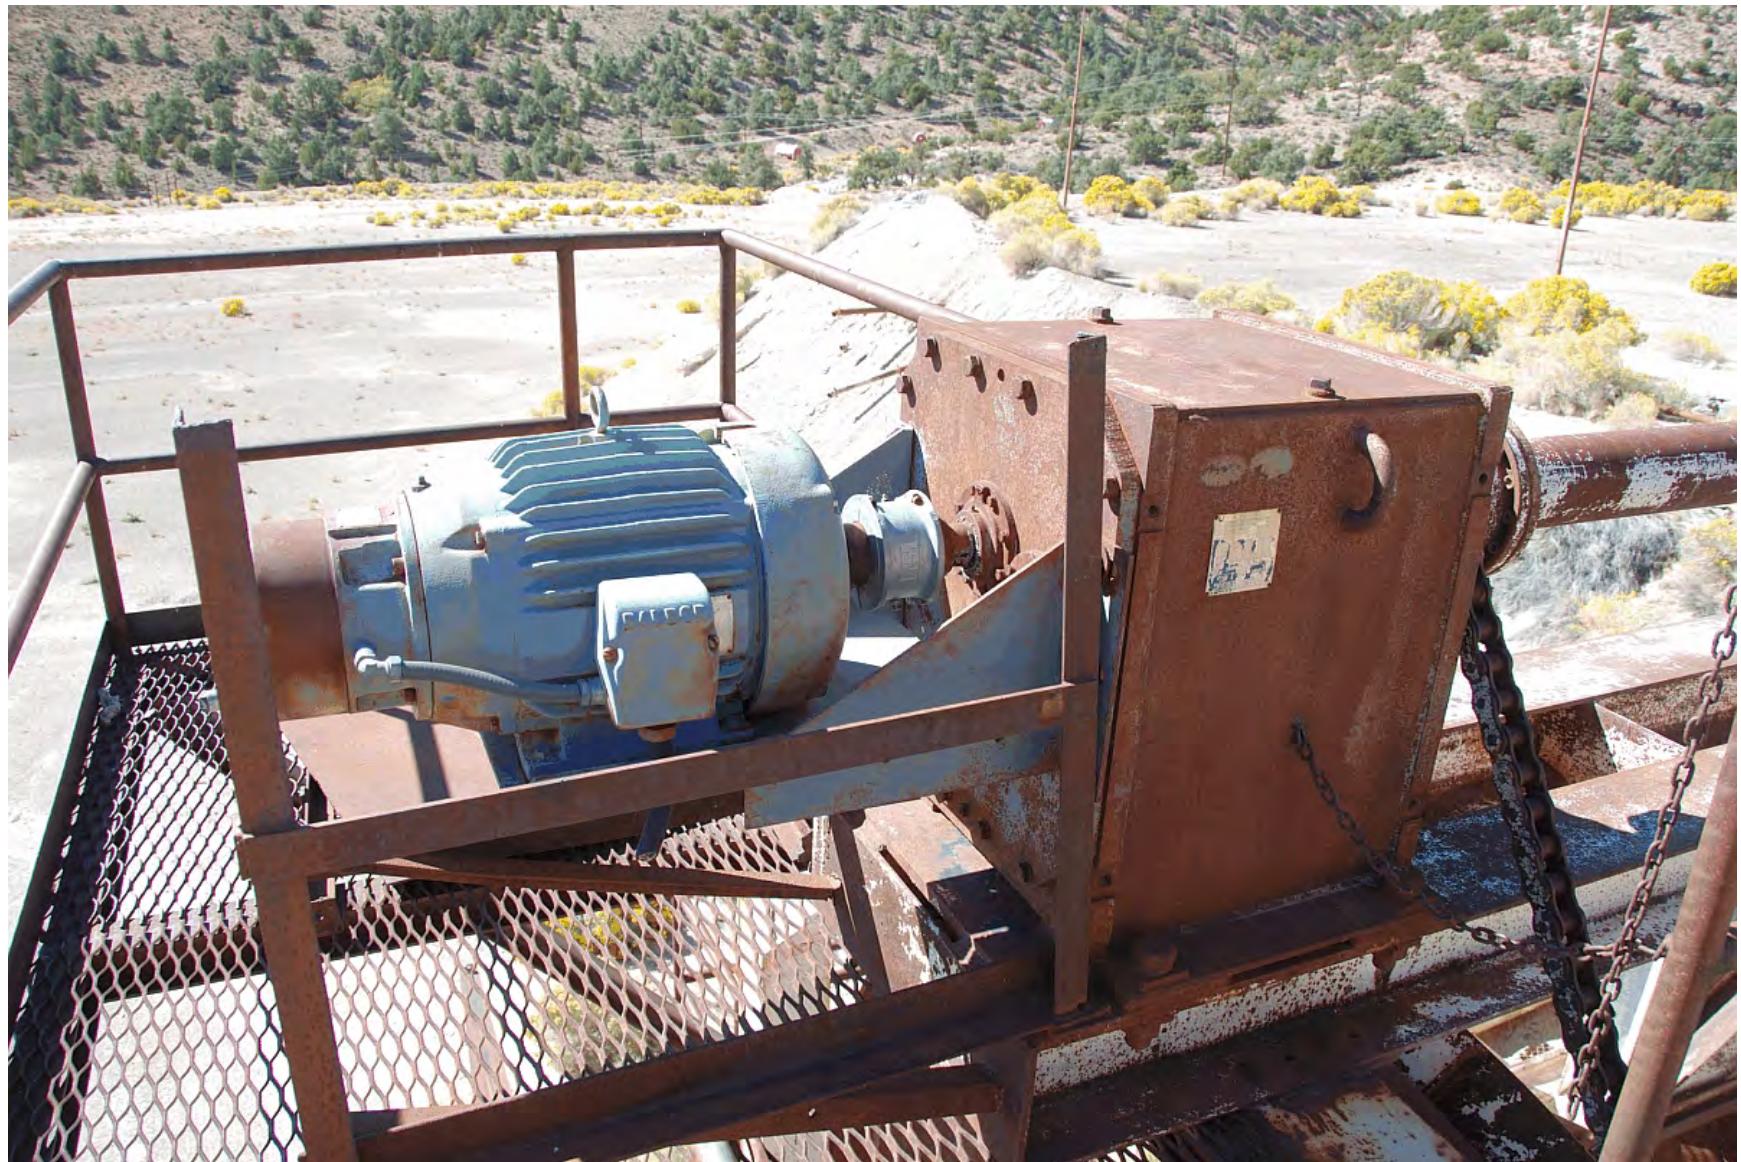
Figure 188. Feature 45, motor and gear reducer, U12n Tunnel, view south (2008).

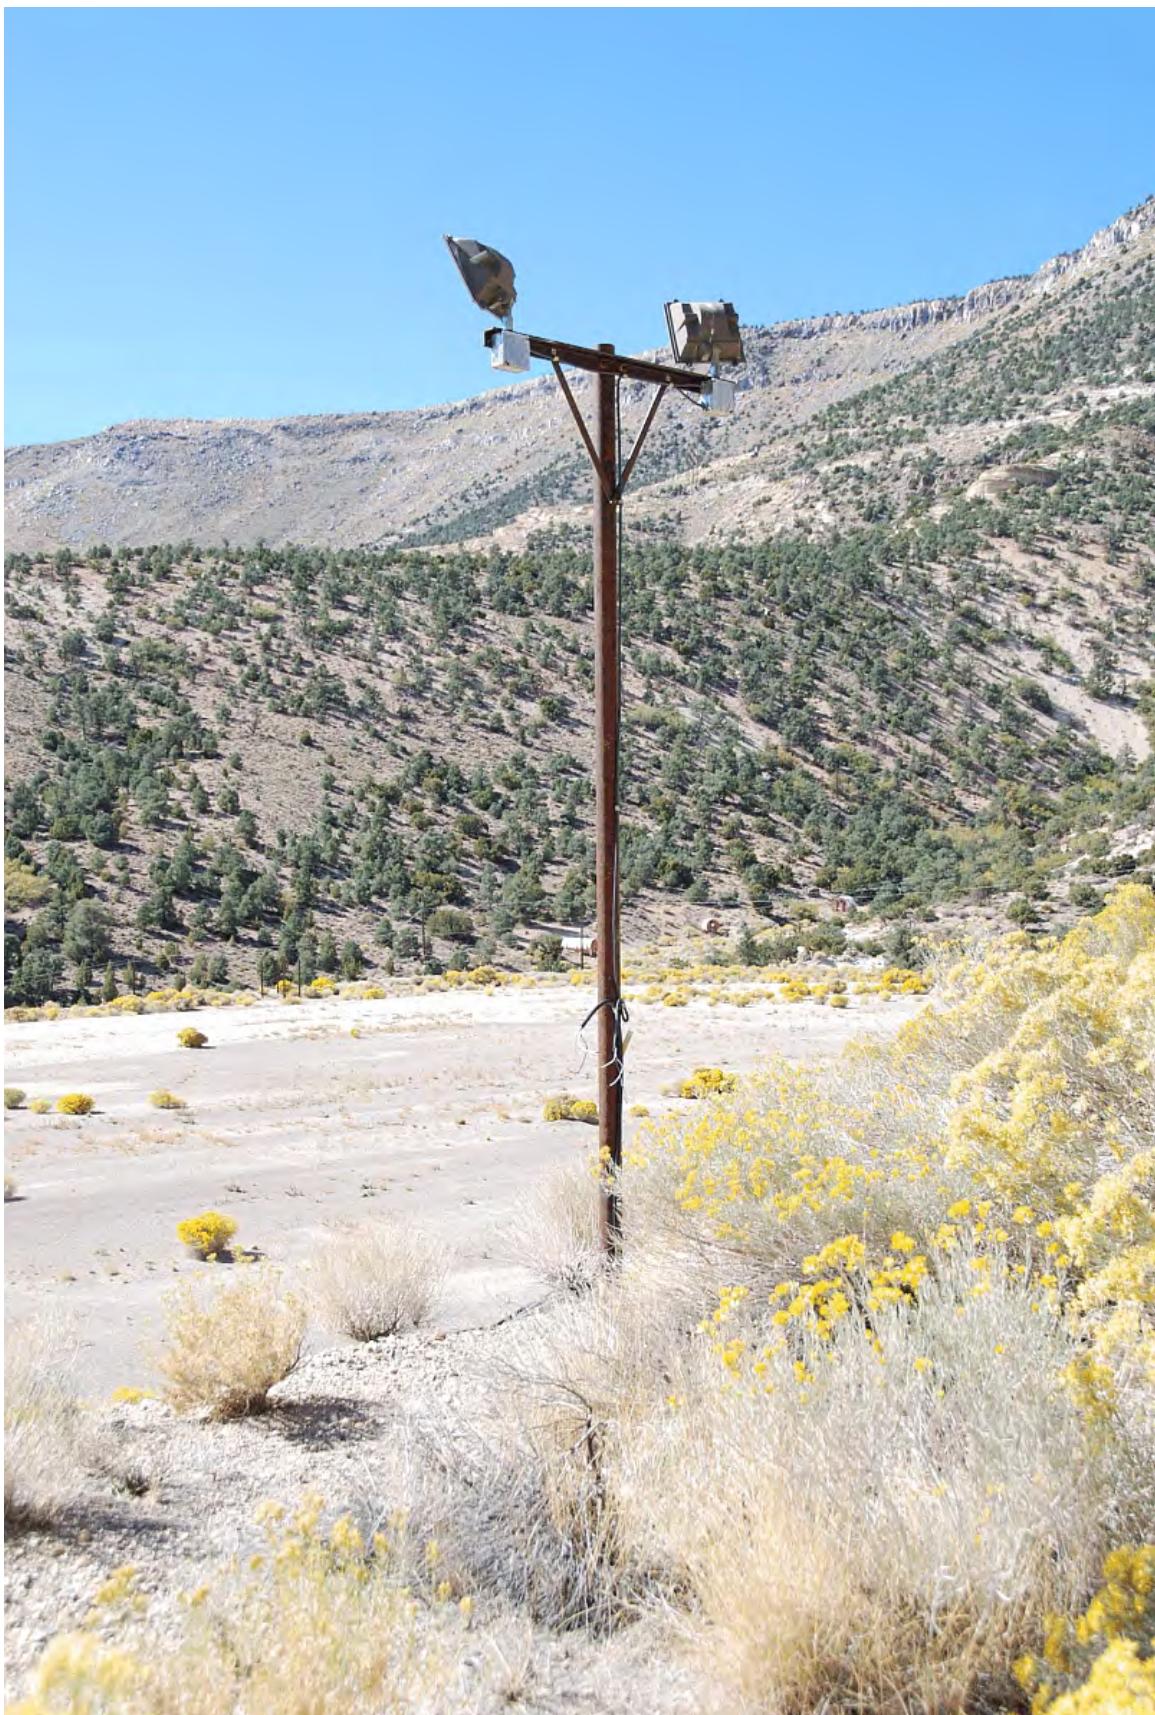
Figure 189. Feature 46, light pole, U12n Tunnel, view southwest (2008).

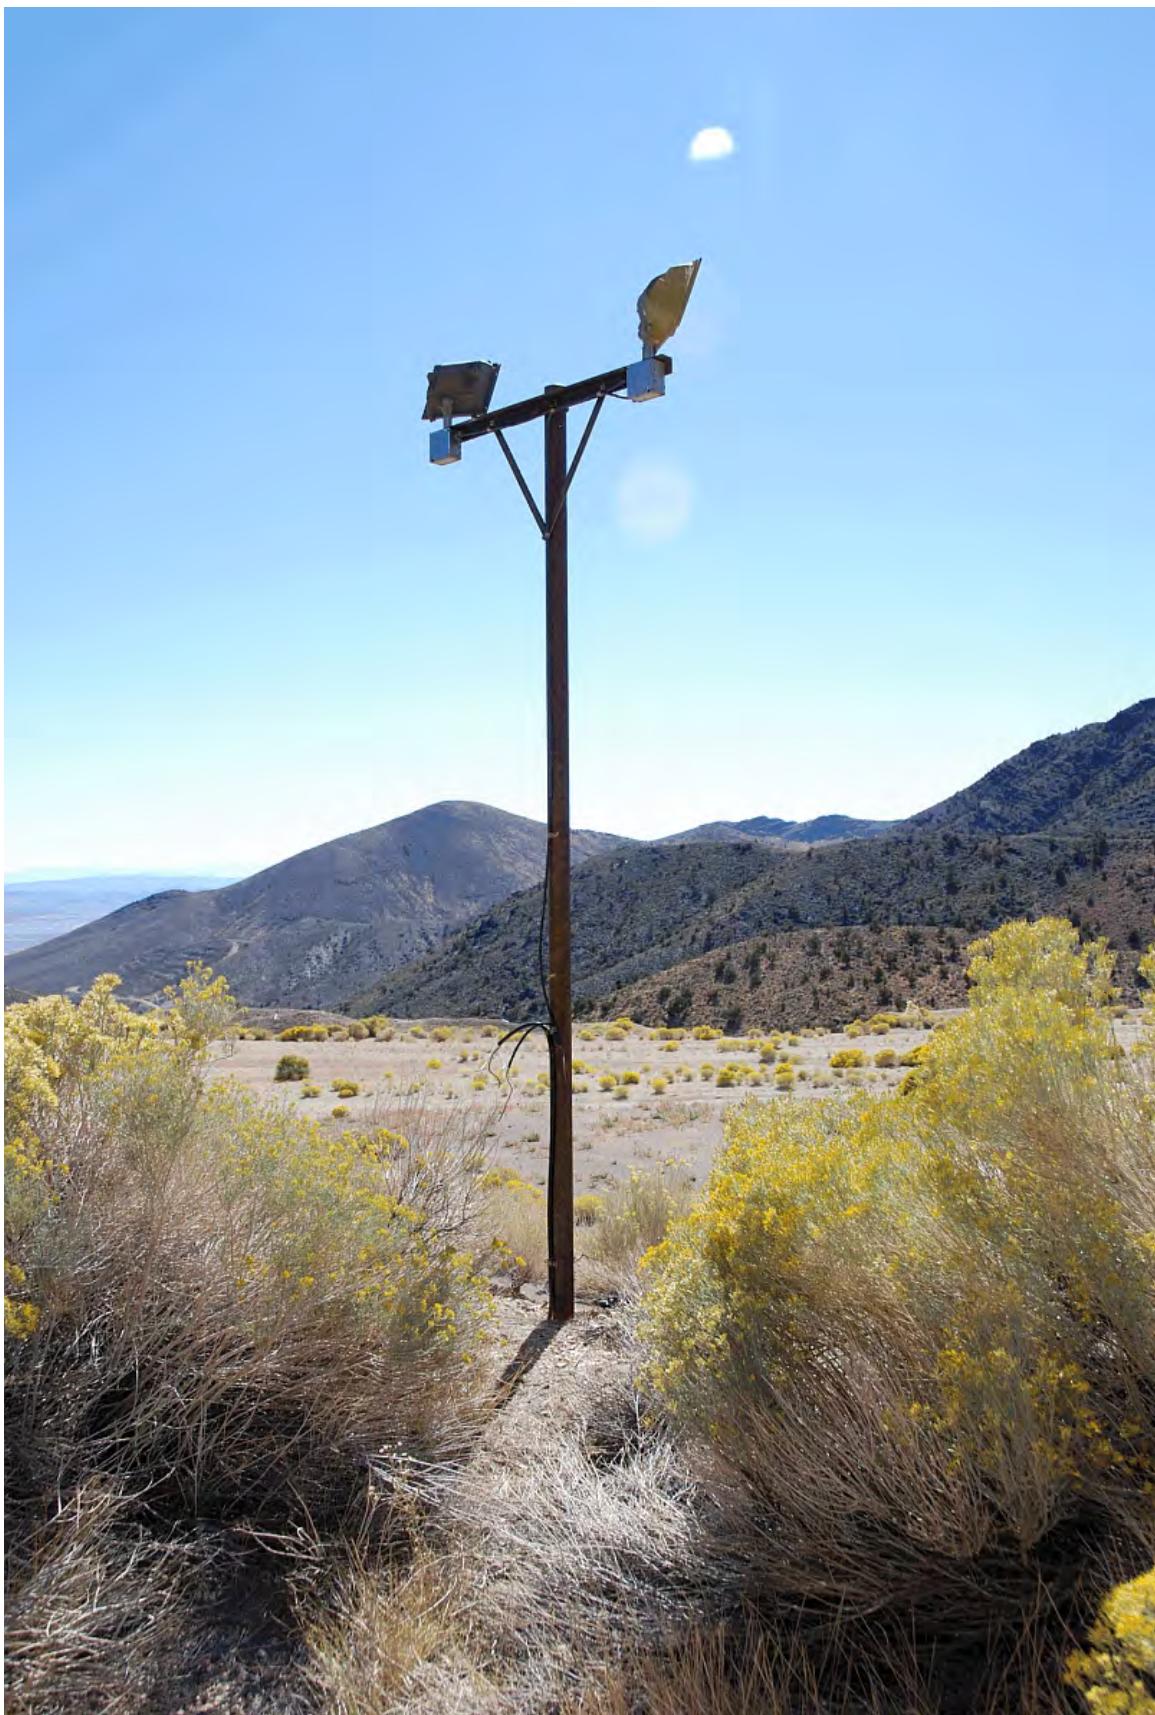
Figure 190. Feature 47, light pole, U12n Tunnel, view southwest (2008).

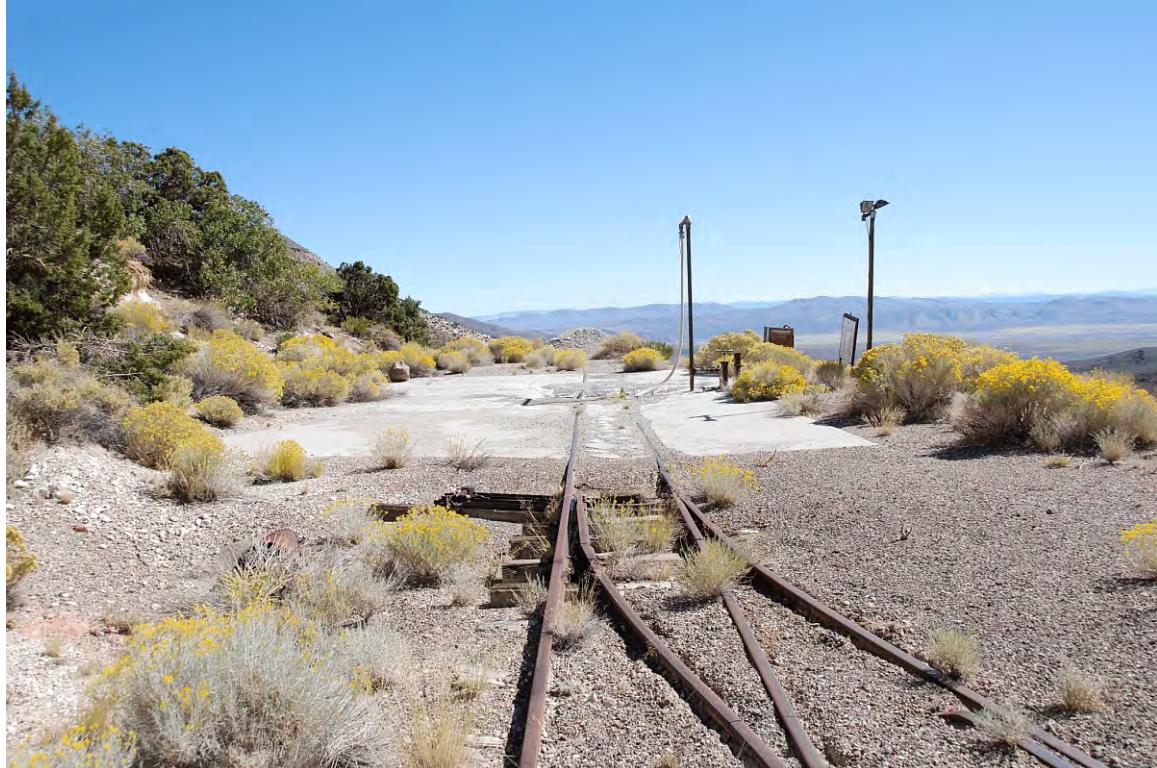
Figure 191. Plan map and photograph of Feature 48, wash area, U12n Tunnel, view east (2008).

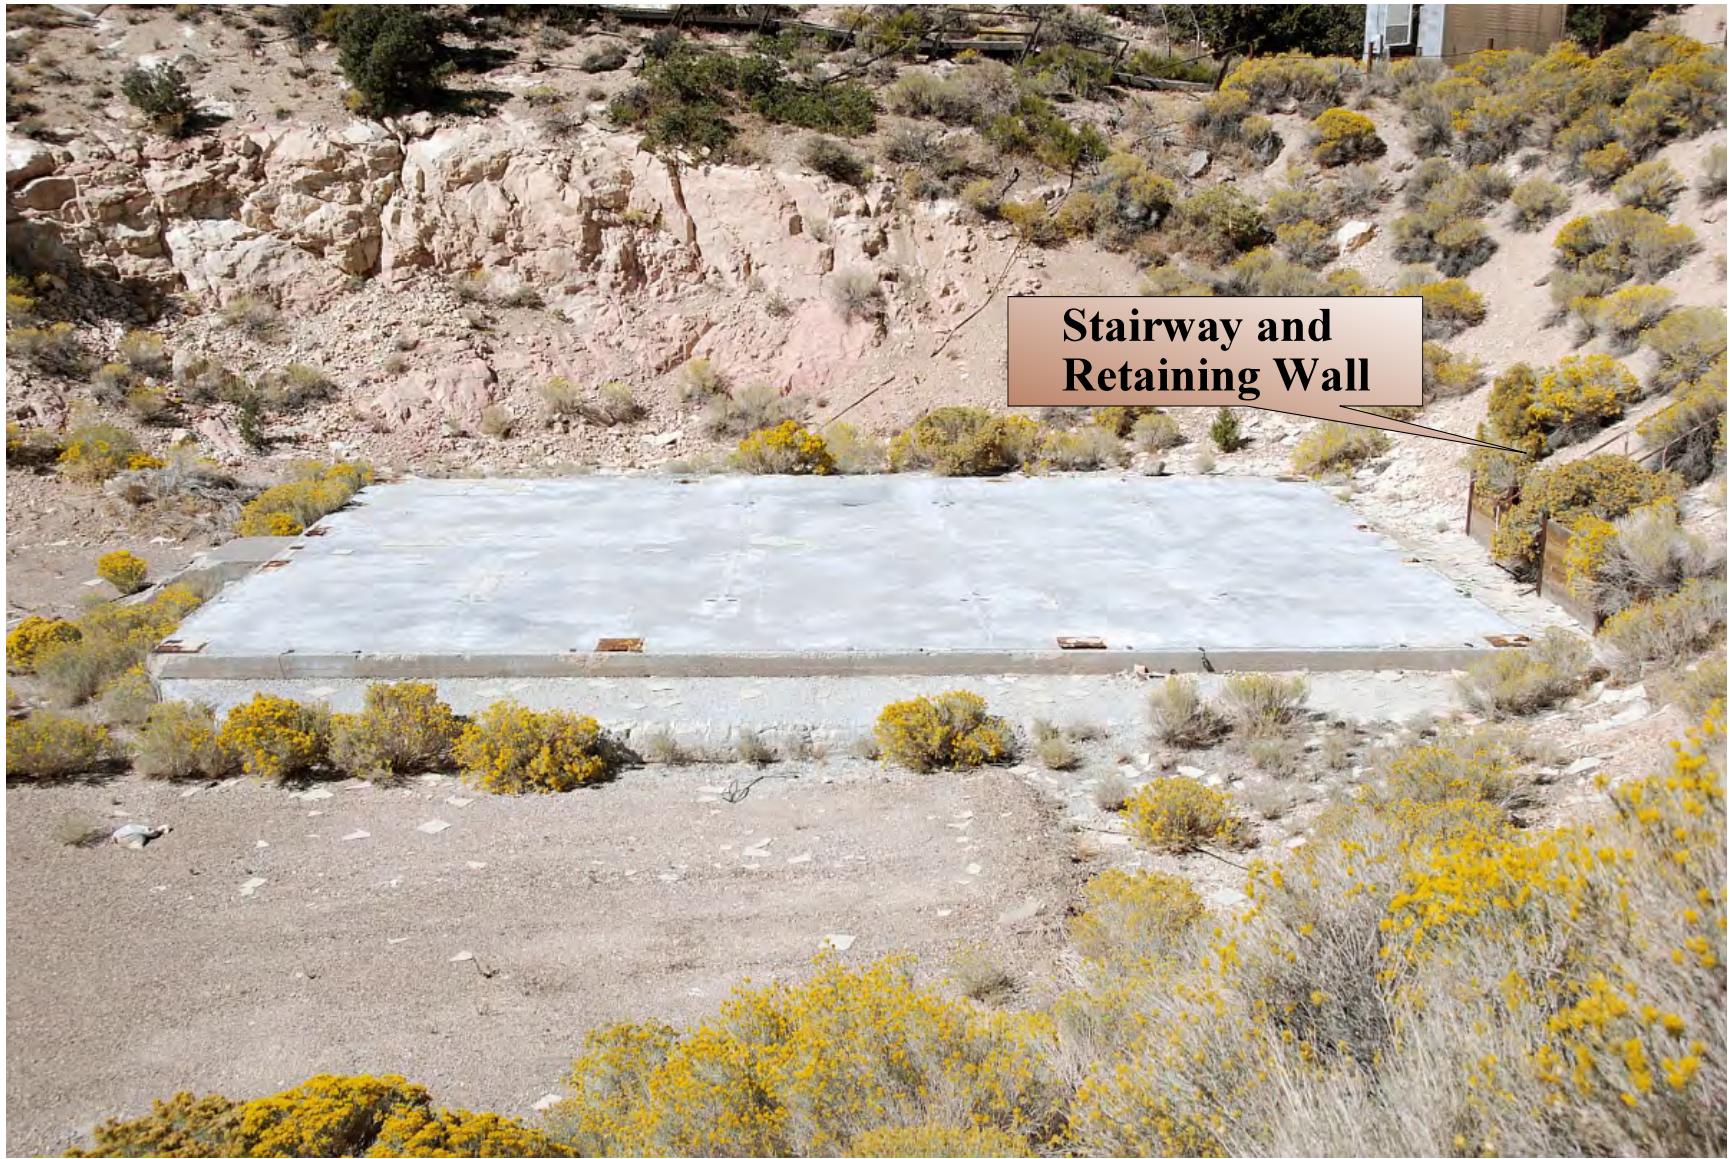
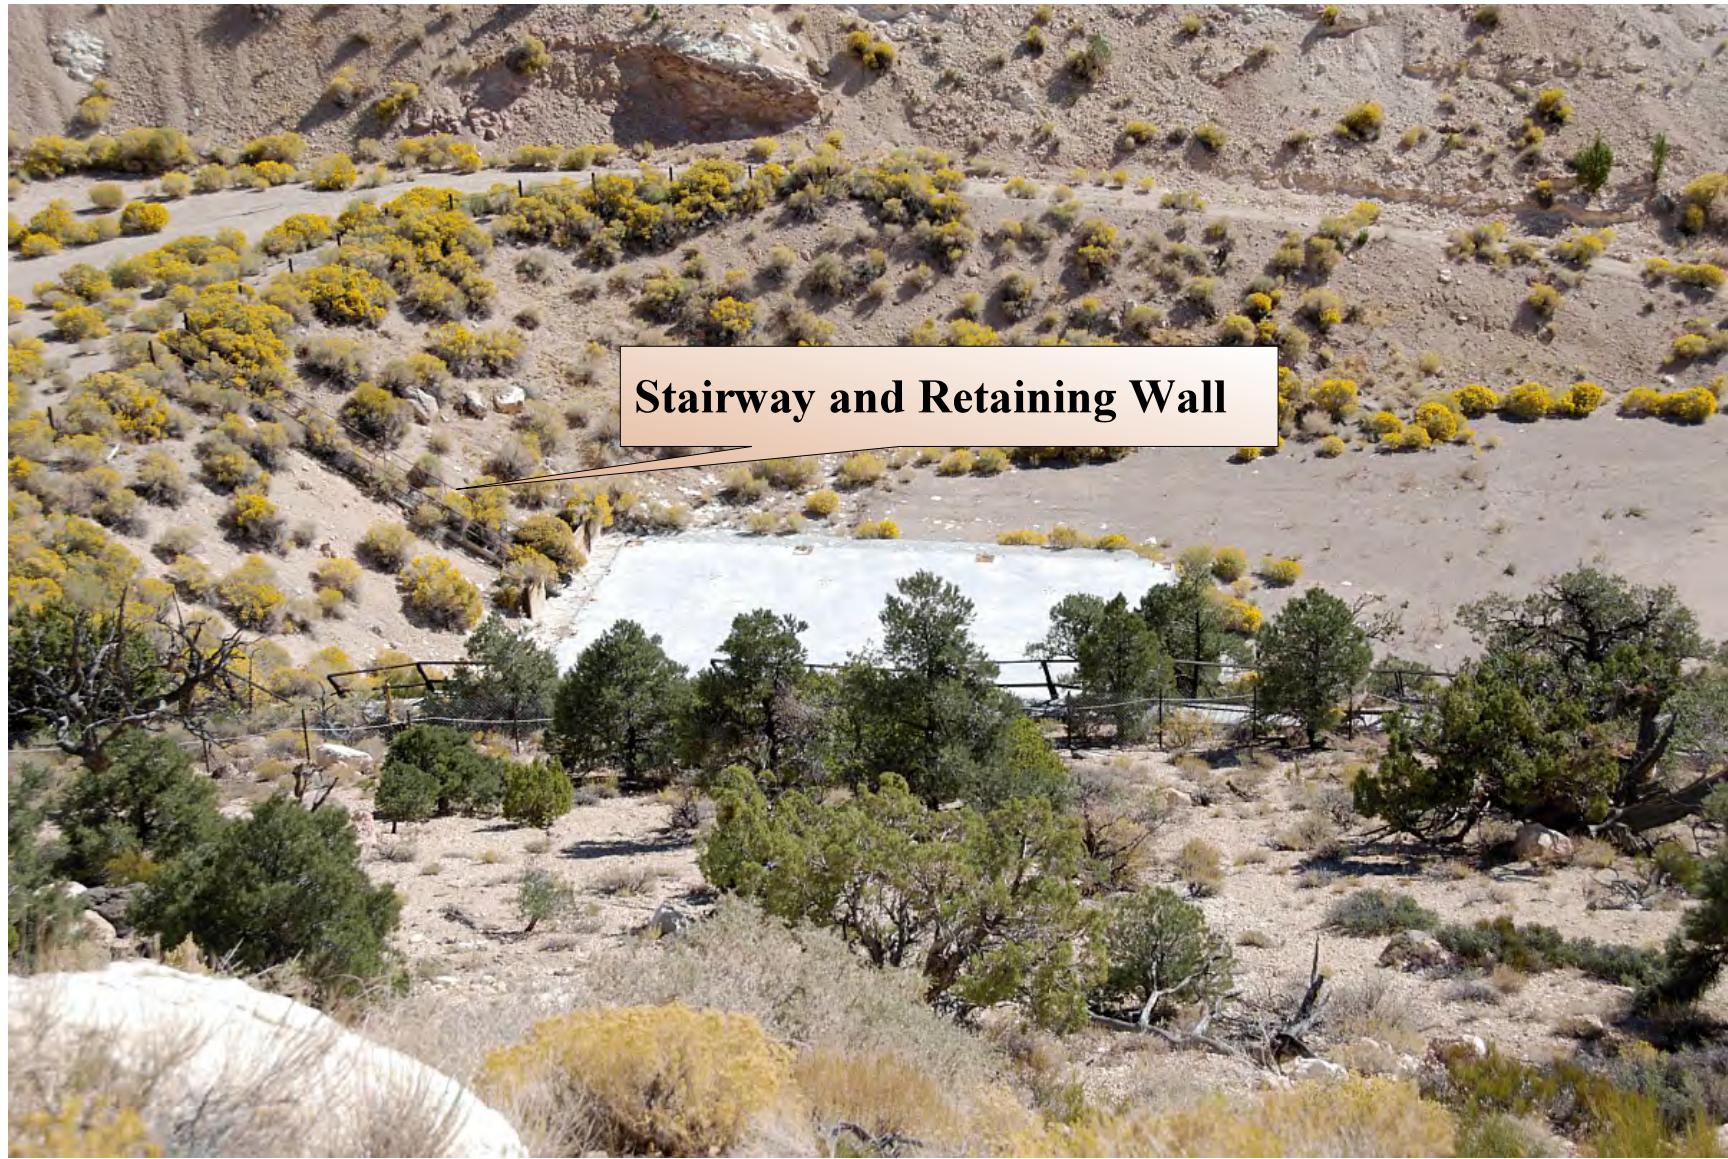
Feature 49 (Figures 192-194) is the concrete foundation for the Reynolds Electrical and Engineering Company (REECO) office building (12-891), retaining walls, and stairs at UTM coordinates 571808 E, 4117387 N at an elevation of 6,030 ft (1,837.9 m). The north and west sides of the foundation abut the steep east slope of Rainier Mesa. The foundation was constructed in two levels. The upper

Figure 193. Feature 49, concrete foundation for REECo office building, retaining wall and stairway on right, view west (2008).

level is 60 ft north-south by 41 ft east-west and is 1 ft above the lower level. Embedded in the concrete around the perimeter are 2 ft square metal plates for the attachment of I-beam posts to support the building structure (now missing). The surface was covered with 1 ft square asphalt tiles of which only a few remain in place. The lower level is 1 ft below the upper level and varies in length and width. On the east side, it extends 6 ft east-west and 60 ft north-south. On the south side, it extends 3 ft north-south and 47 ft east-west. The east and south sides join at a beveled corner. The lower west level extends 49 ft (14.9 m) north-south from the northwest corner and is 4 ft east-west but does not extend to the southwest corner of the upper level. The lower north level is 28 ft east-west and 4 ft north-south and mostly covered with soil from the slope. It does not extend to the east and west sides of the upper level but is 6 ft from the northeast corner and 7 ft from the northwest corner. Along the north edge of the foundation are two metal and wood retaining walls and metal stairs. The retaining walls are constructed of vertical 6-inch I-beam 4 ft in height. Between the I-beams is 2 x 12 inch milled lumber lagging. The east section of the wall is 15 ft east-west and the west section is 6 ft east-west and separated by 4 ft. In the gap between the retaining wall are 4 ft wide galvanized stairs. The treads are galvanized metal with 1 1/2-inch pipe hand rails and posts. The stairs extend from the portal level up-slope to the level with the telephone trailer and foundation for the RNS/DNA Office. Associated artifacts are asphalt tile fragments, electrical conduit, electrical wire, and metal fragments.
