A total of 202 features were recorded, mapped, and photographed for the U12n Tunnel complex. The project area encompassed 600.8 acres (243.1 hectares) at the portal and mesa areas. At the U12n portal area are ten sub-areas containing features related to the construction, testing, and general everyday activities within the tunnel. These include concrete foundations for buildings, communications equipment, mining equipment, rail lines, retention ponds, storage containers, and access control facilities. Only a telephone trailer remains on the telephone pad as all of the other buildings have been removed from the portal area. The microwave tower, portions of the rail lines, the muck car dump, rotary dump, and wash rack are still in place. Also, the traffic control point and powder magazines along N Tunnel Road are intact. At the mesa area are four sub-areas containing features generally related to pre- and post-shot drilling, recording facilities, and ventilation equipment. These include concrete foundations, instrument cable holes, and drill holes. The concrete foundations were for buildings and small equipment. Concrete pads and various equipment remain at the cable hole locations bu

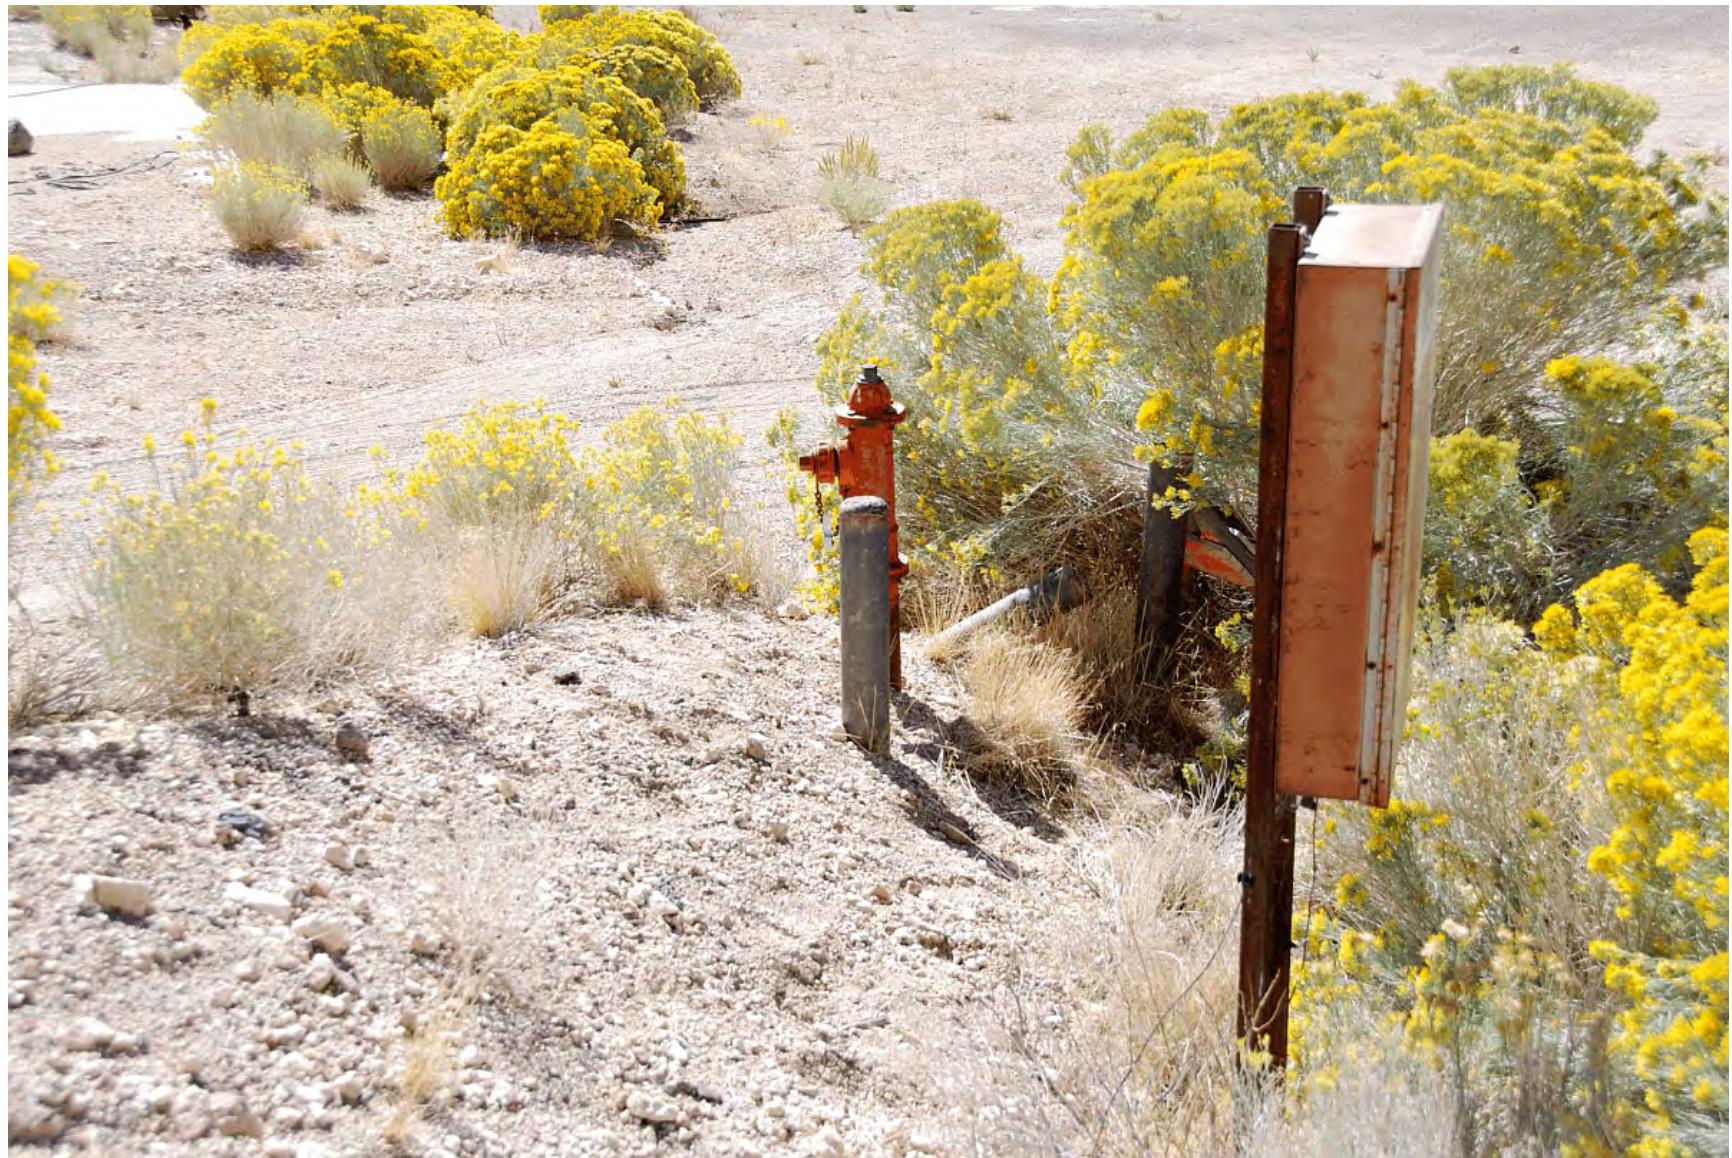
Figure 195. Feature 50, fire hydrant, electrical panel, and pipe, U12n Tunnel, view south (2008).

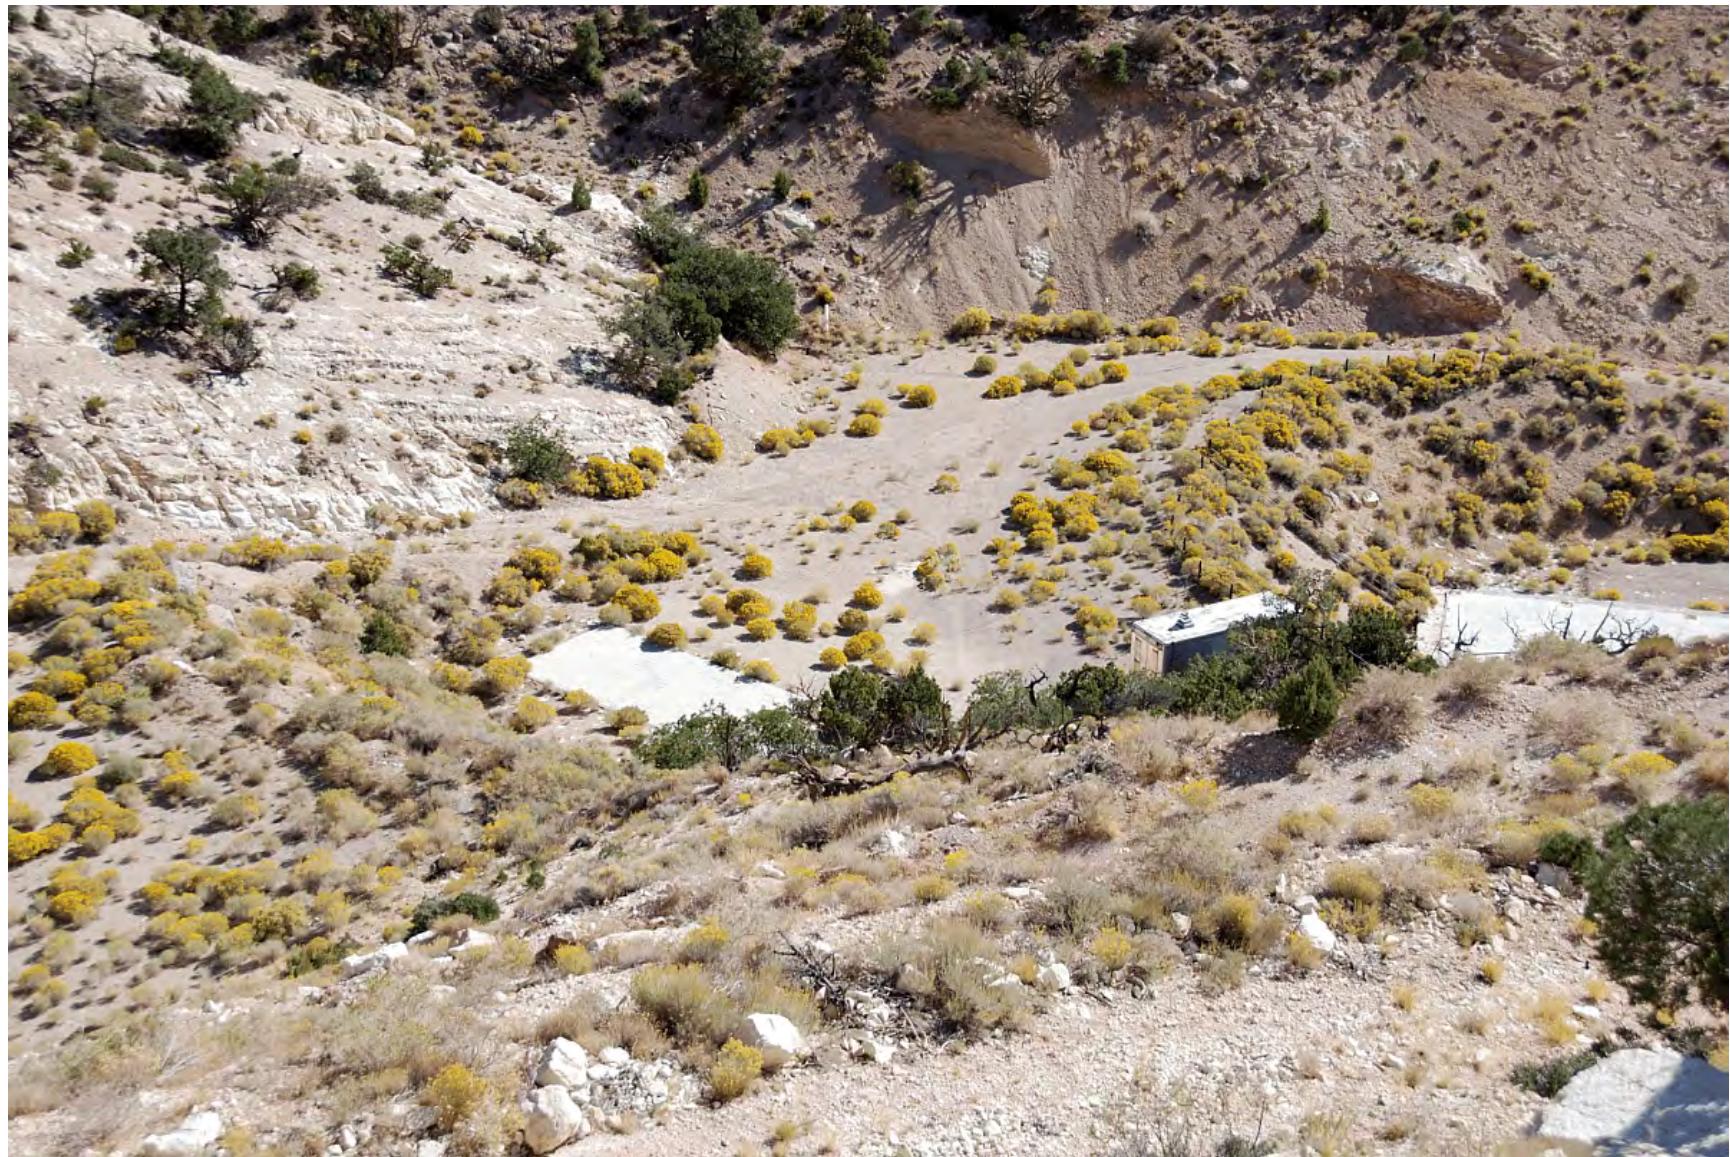
Adjacent to and north of the portal pad is a smaller irregular-shaped telephone pad (Figures 197-198). The pad is cut into the steep face of Rainier Mesa at an elevation 6,040 ft (1,841 m) and is 230 ft (70.1 m) east-west by 110 ft (33.5 m) north-south and encompasses 0.39 acres (0.16 hectares). The

Figure 198. Overview of the telephone pad, U12n Tunnel, view east (2008).

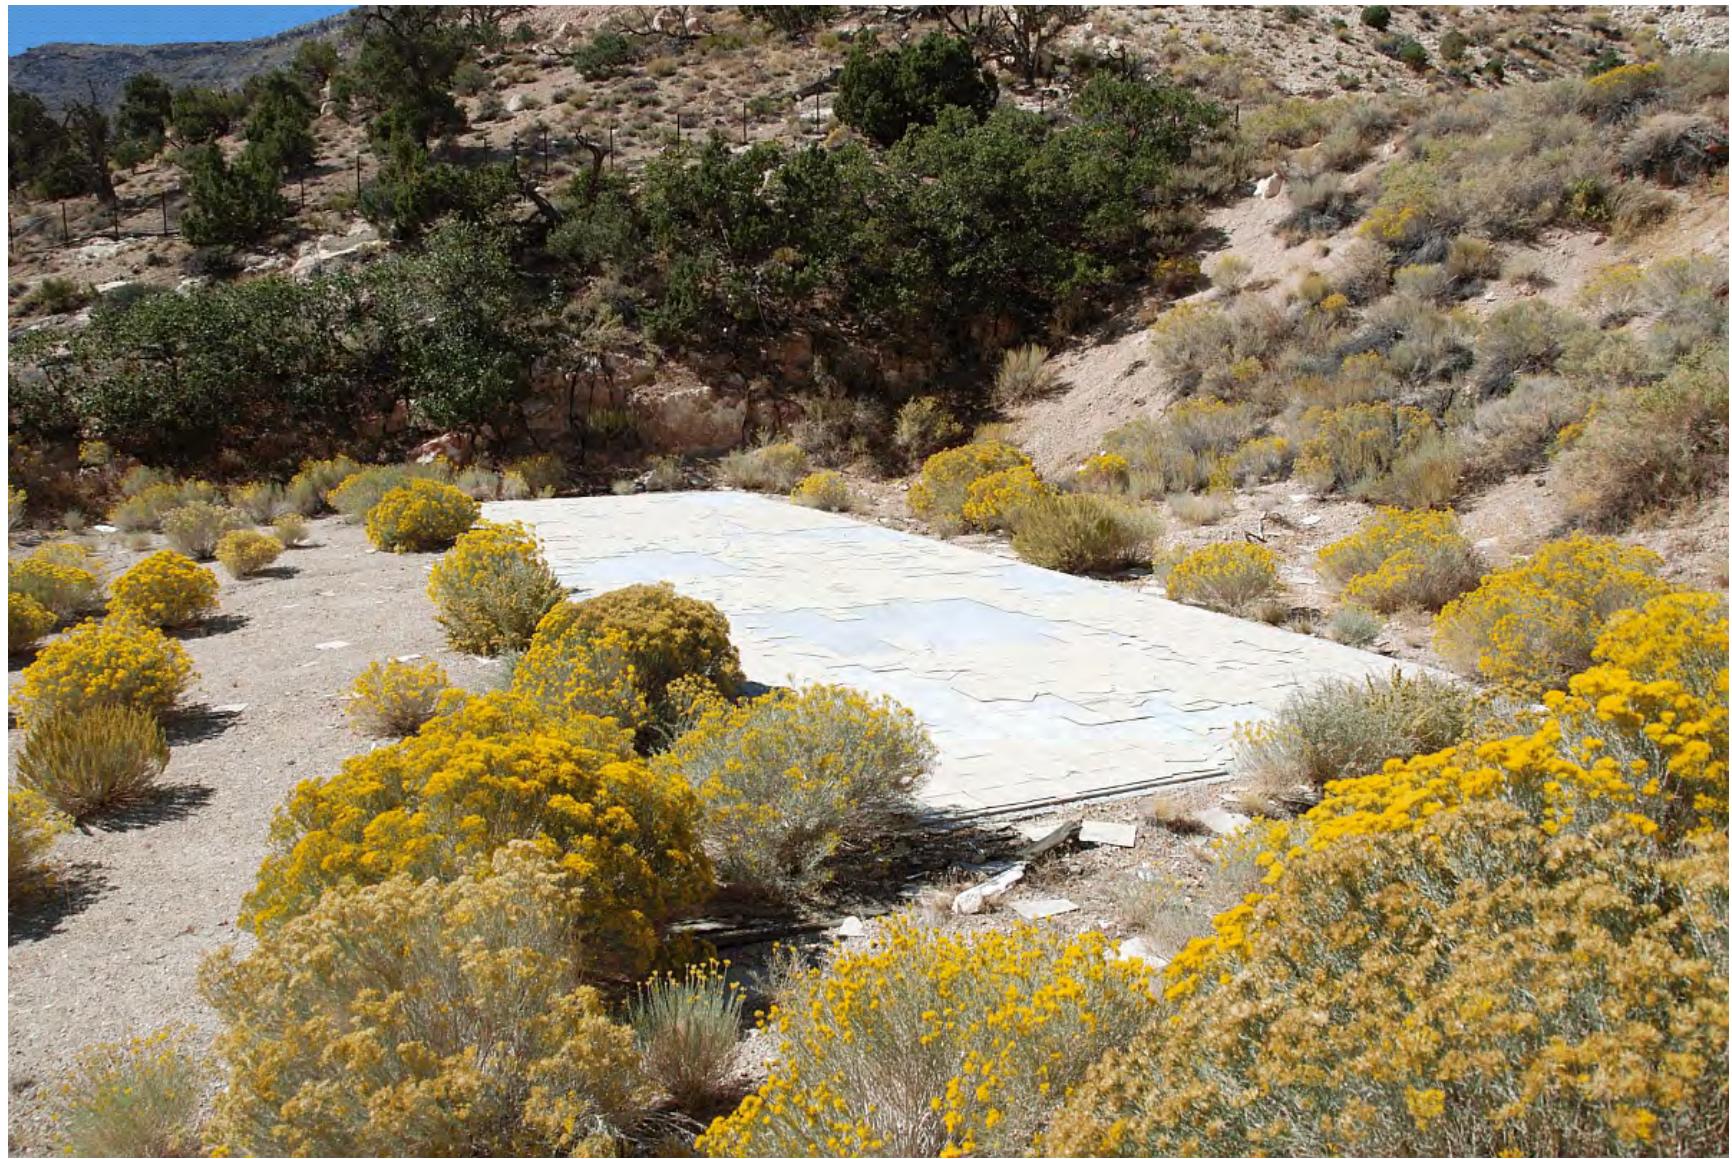
Feature 52 (Figure 199) is the concrete foundation for the RSN/DNA office building (12-921) on the telephone pad at UTM coordinates 571777 E, 4117429 N. The foundation is 61 ft 6 inches (18.7 m) north-south by 21 ft east-west. The surface was covered with 1 ft square asphalt floor tiles but they are deteriorating and some are missing. On the north edge at the west corner and the south edge at the west corner are 6 x 6 ft concrete pads used for personnel entrances. Associated artifacts are asphalt tiles, milled lumber fragments, metal fragments, and a galvanized trash can.

Figure 199. Feature 52, concrete foundation for the RSN/DNA office building, view southwest (2008).

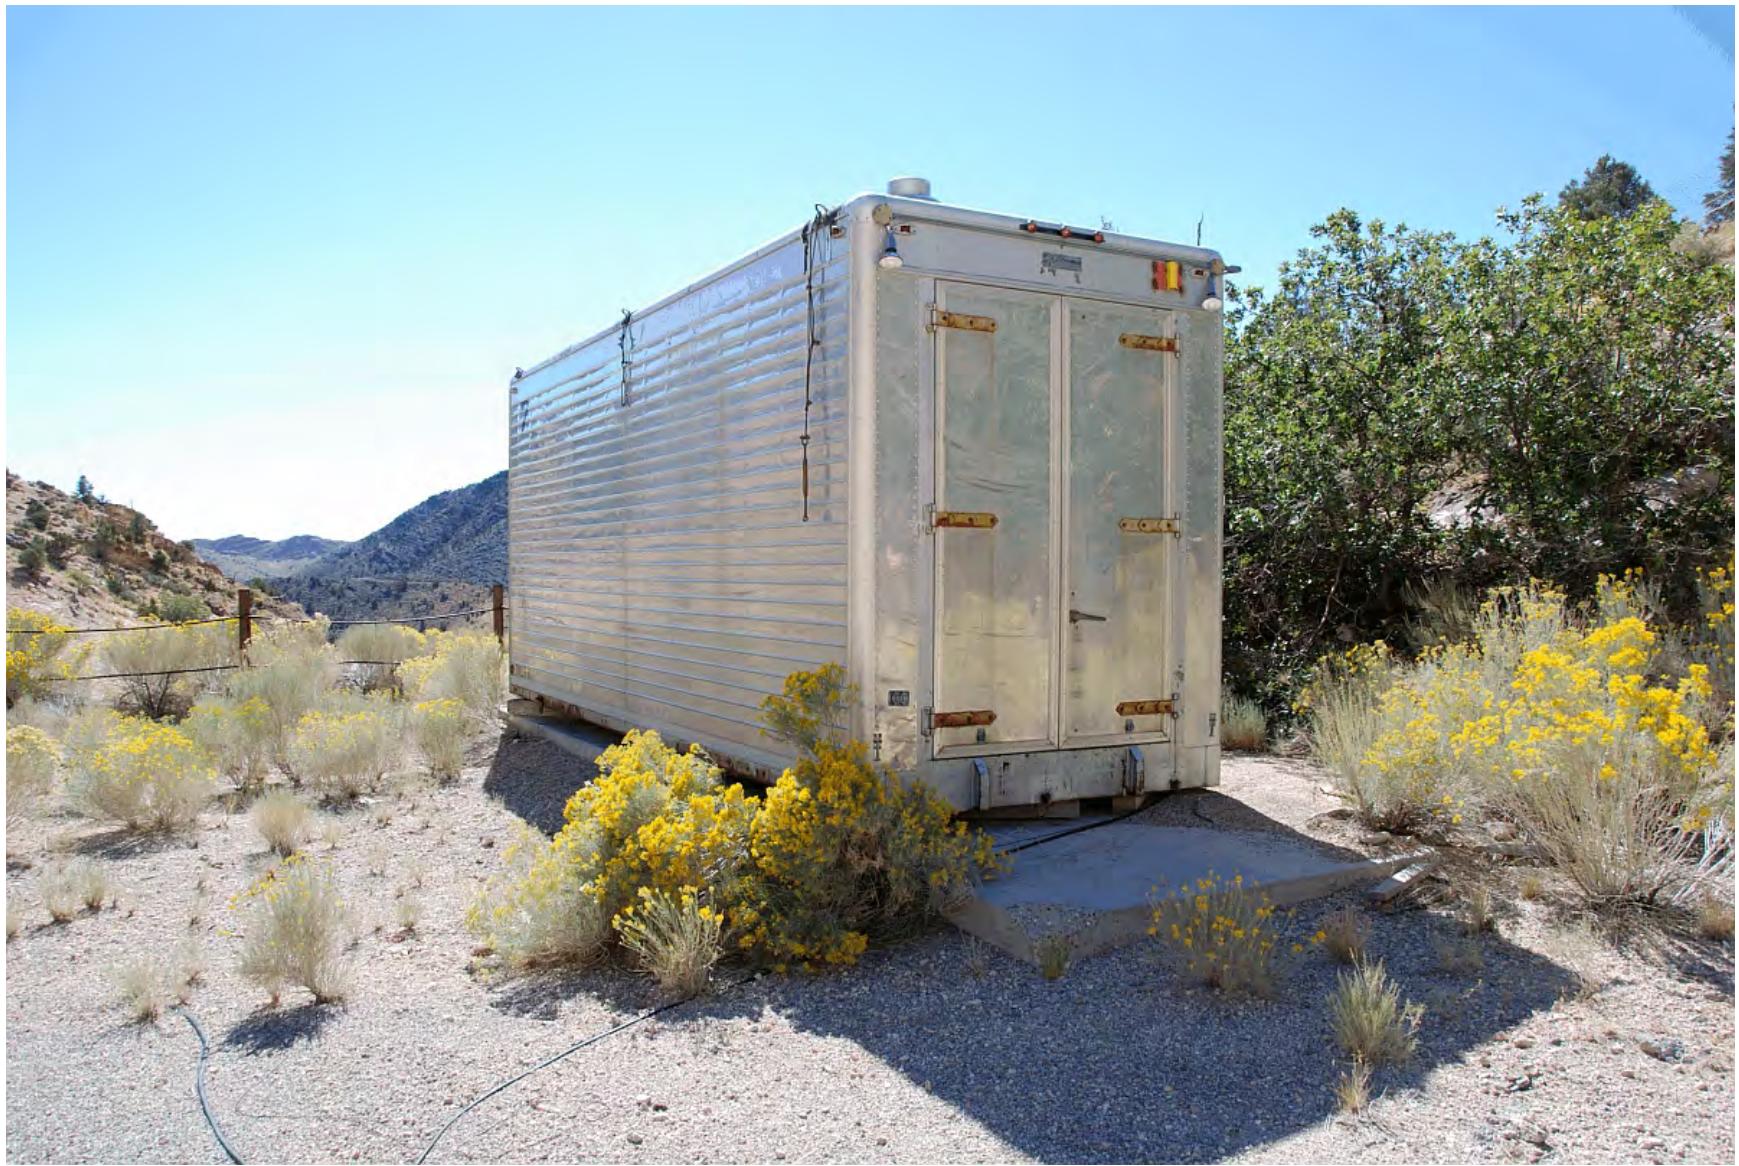
Feature 53 (Figures 200-201) is a concrete foundation and telephone trailer on the telephone pad at UTM coordinates 571777 E, 4117402 N. The concrete foundation is 30 ft north-south by 8 ft east-west. The foundation supports an aluminum sided trailer that is 23 ft 8 inch (7.2 m) north-south by 7 ft 8 inch (2.4 m) east-west. It is 10 ft in height and the north exterior side is labeled BELL TELEPHONE Co. OF NEVADA. Attached to the south exterior side is a 5 ft 10 inch (1.8 m) tall by 2 ft 7 inch (0.8 m) wide by 1 ft thick aluminum air conditioning system. Entrance into the trailer is through two 2 ft 6 inch wide by 7 ft 10 inch (2.4 m) tall doors in the west side of the trailer. The interior of the trailer is paneled with painted Masonite and contains fluorescent lighting fixtures that extend the length of the trailer and are mounted on the east and west walls. On the east wall at the north end is a 6 ft 8 inch tall by 11 ft long fuse panel. The fuse banks within the panel are labeled as to which building or equipment they are associated (BLD 921, BLD 891, etc.). A push button telephone is within the panel. North of the panel is a thermostat that controls the air conditioning system. The floor is Masonite panels. Electrical cables enter through the southeast corner at the floor level. Associated artifacts are a sawhorse, metal chair, electrical cables and wire, a metal trash can, and record books.

Figure 200. Feature 53, telephone trailer and concrete foundation, U12n Tunnel, view southeast (2008).

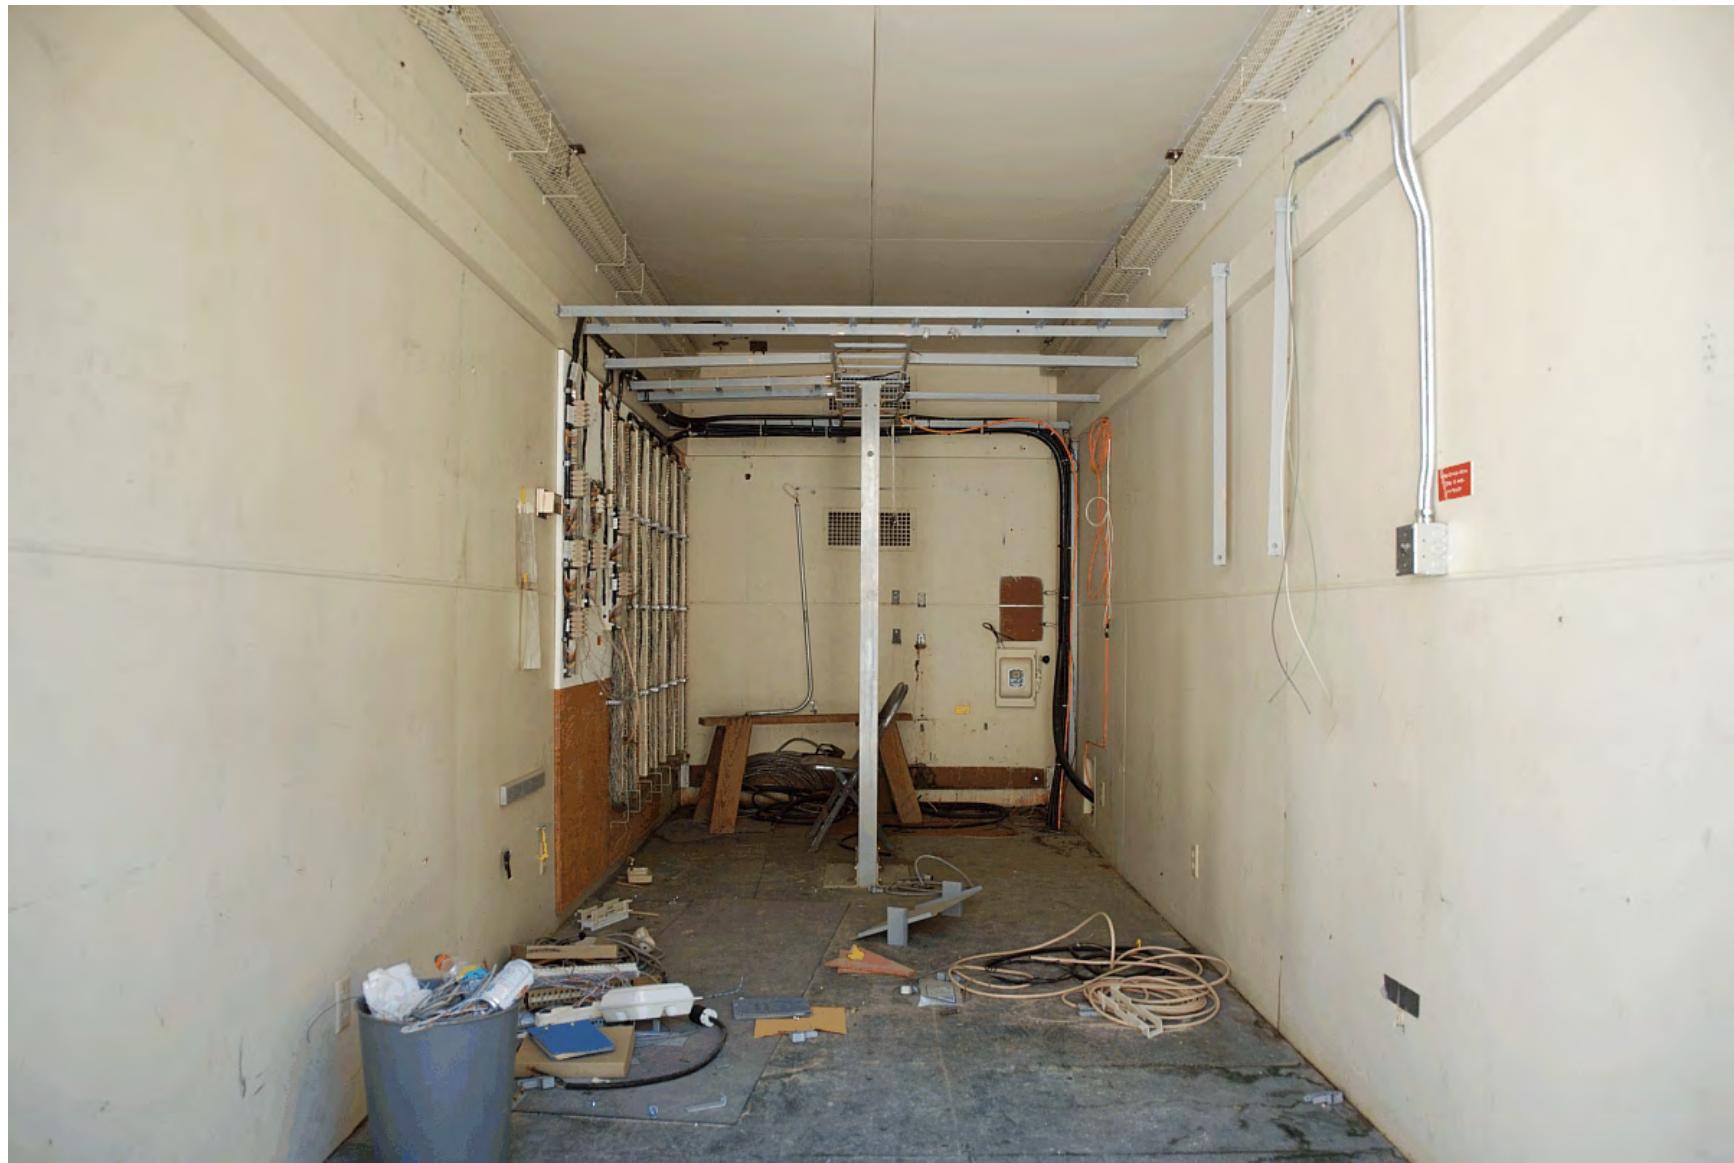
Figure 201. Feature 53, telephone trailer interior, view southeast (2008).

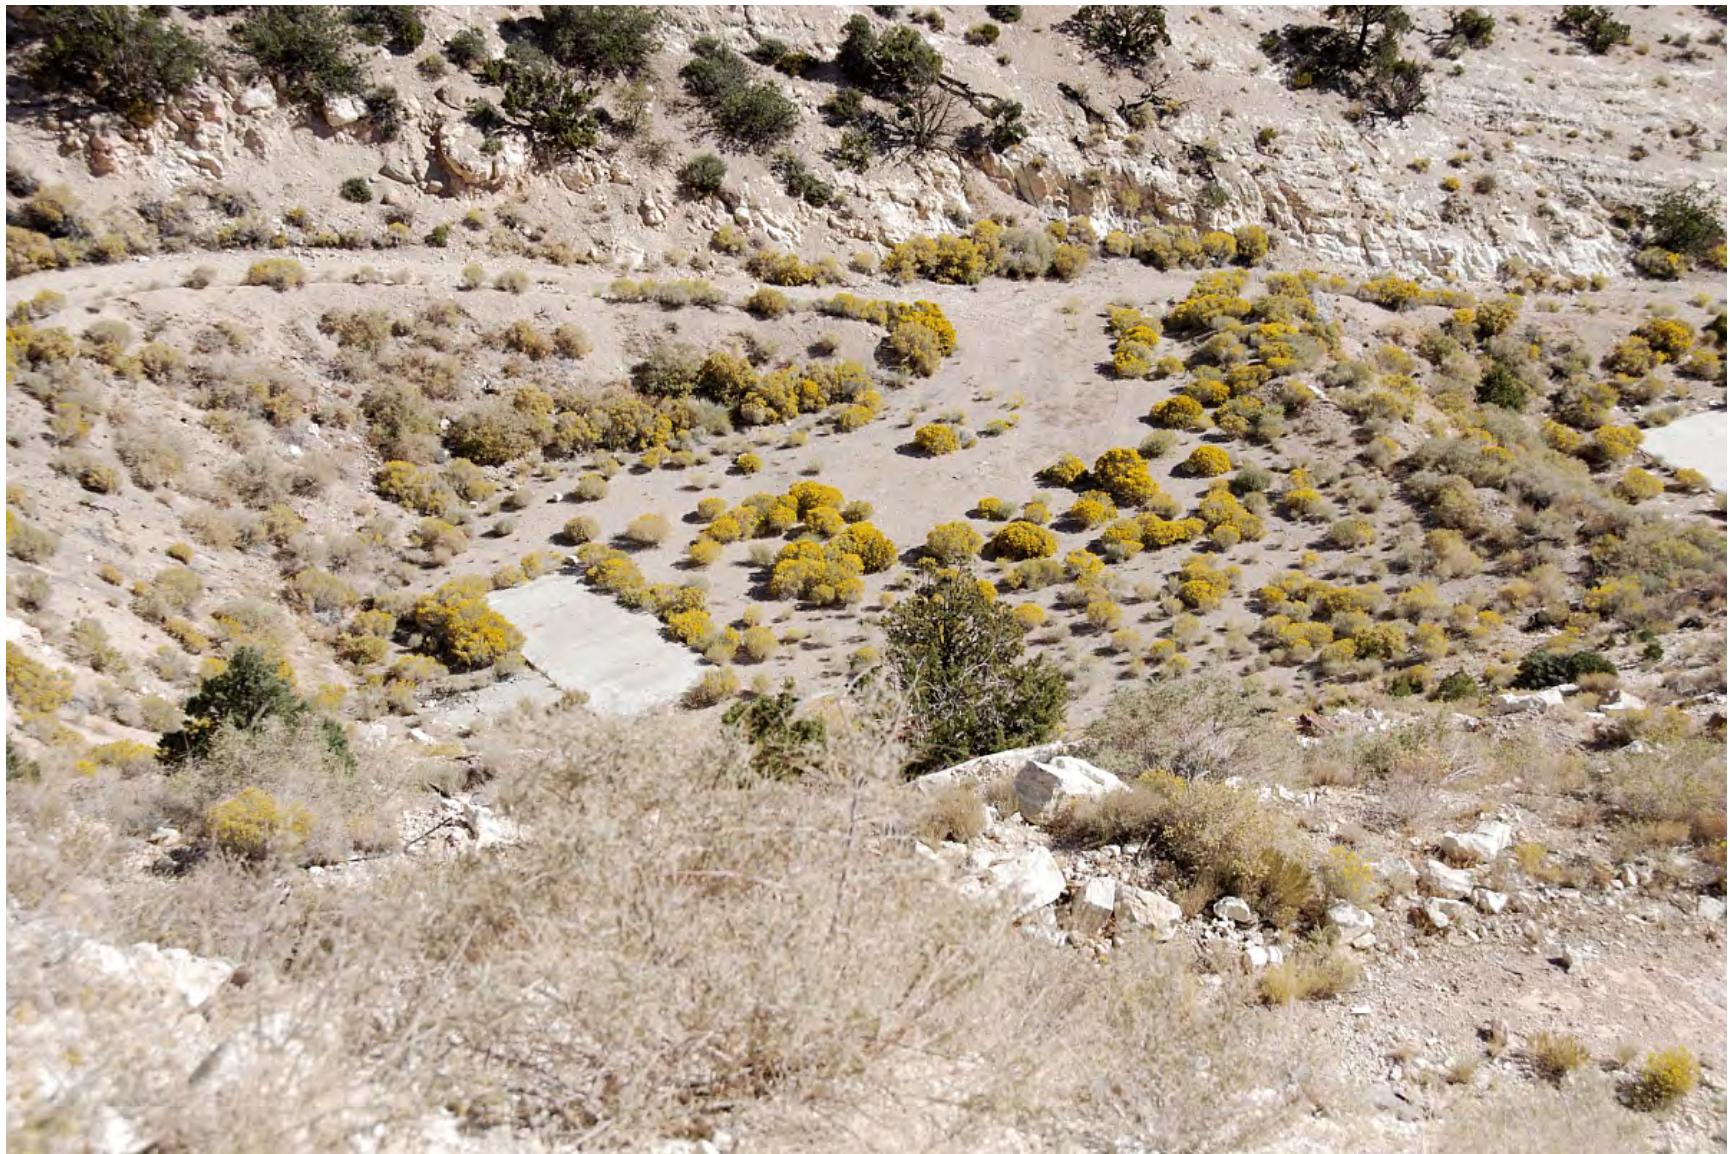
Figure 202. Overview of the cooling tower pad, U12n Tunnel, view east (2008).

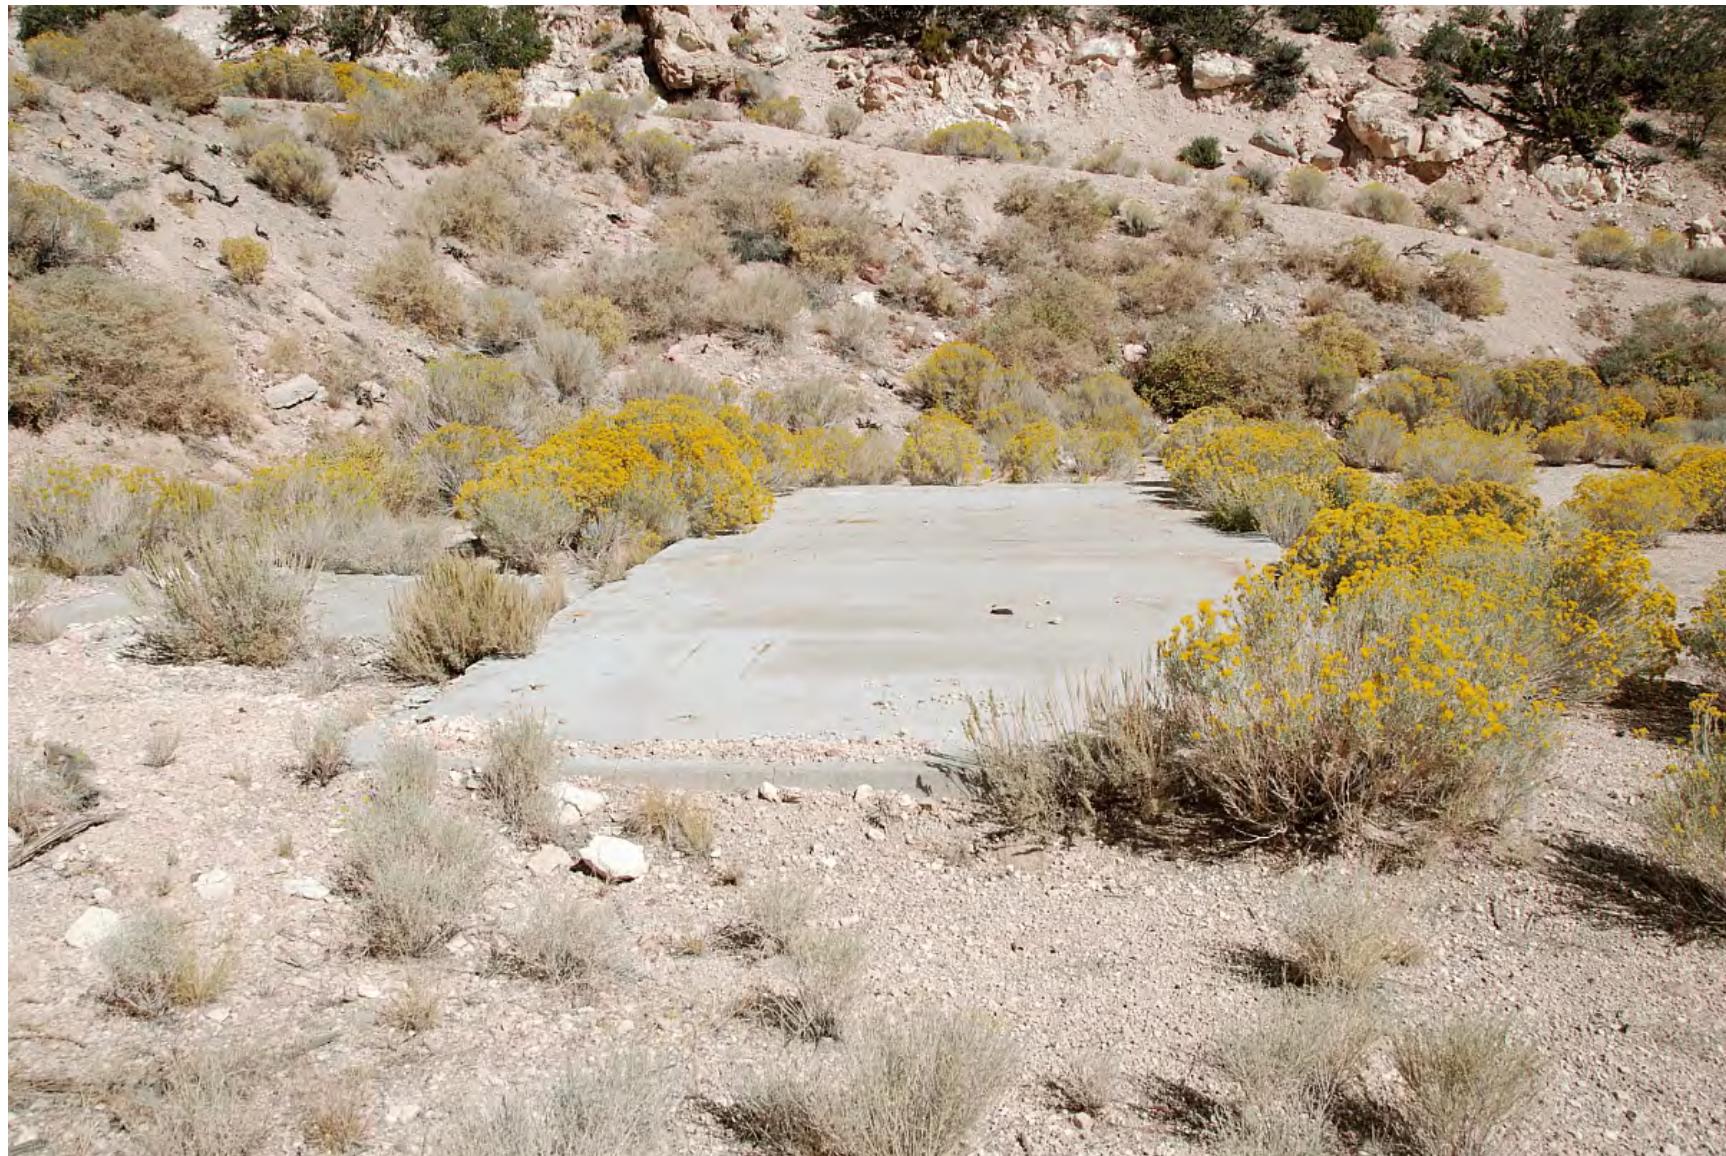
Feature 54 (Figure 203) is the concrete foundation on the cooling tower pad at UTM coordinates 571730 E, 4117467 N. The foundation is for the cooling tower (water) and is 32 ft north-south by

Figure 203. Feature 54, concrete foundation for the cooling tower, U12n Tunnel, view northeast (2008).

16 ft east-west. The surface of the concrete was brushed and there are impressions of metal plates in the foundation. Attached to the west edge and 3 ft from the northwest corner is a 3 x 3 ft concrete pad used to support pumping equipment. Along the west edge and 8 ft from the southwest corner is a 15 ft east-west by 8 ft north-south concrete pad. It is 3 inches west of the west edge and not attached to the foundation. Associated artifacts are rope, metal fragments, milled lumber fragments, and bolts.

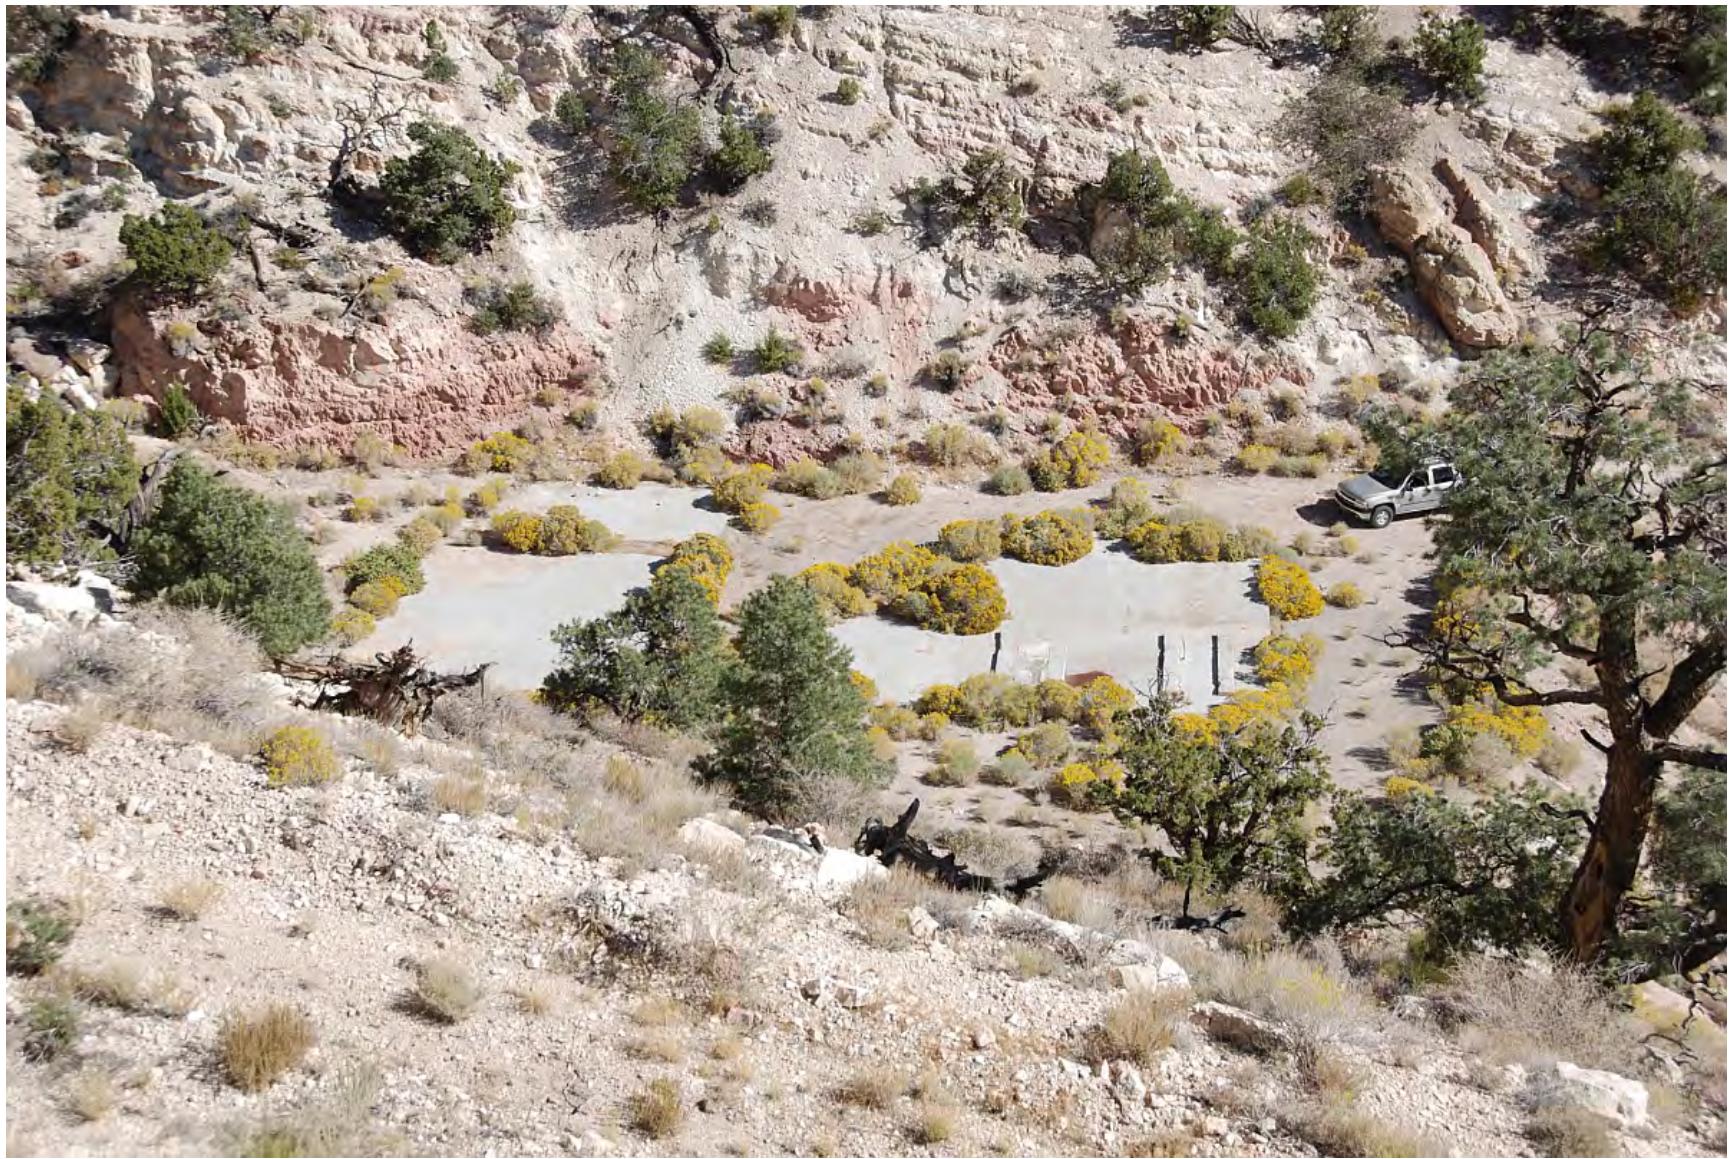
Above the water cooling tower pad is the rectangular ventilation pad (Figures 197 and 204). It is a dirt pad at an elevation of 6,120 ft (1,865m) and is 115 ft (35.1 m) northwest-southeast by 105 ft (32 m) northeast-southwest and encompasses 0.22 acres (.089 hectares). The north and west edges of the terrace are defined by the steep slope of Rainier Mesa and the south and east edges slopes sharply to the water cooling pad and eventually to the portal pad below. Three features (Features 55-57) recorded on the ventilation pad are concrete foundations for ventilation equipment, air compressors, and the operator's shack.

Figure 204. Overview of the ventilation pad, U12n Tunnel, view east (2008).

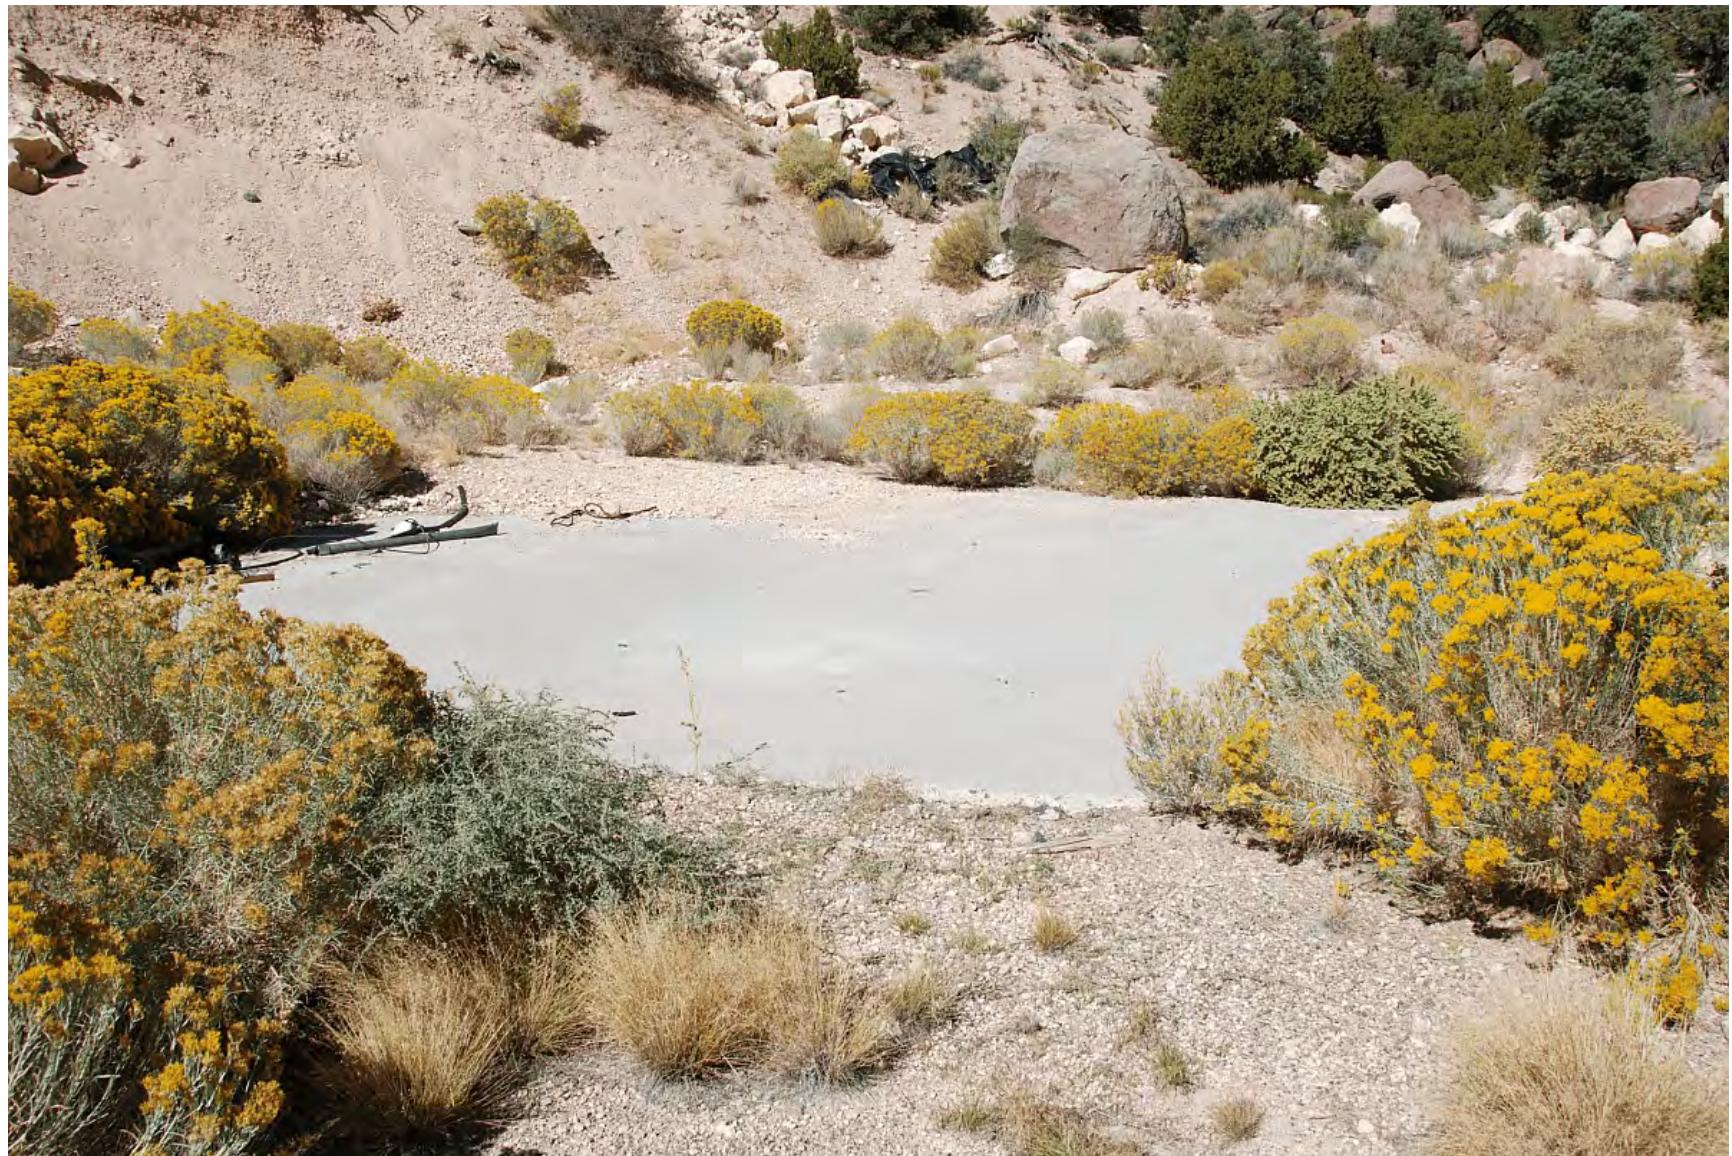
Feature 56 (Figure 206) is the concrete foundation for two air compressors at UTM coordinates 571699 E, 4117488 N. The foundation is on the ventilation fan pad and is 40 ft north-south by 30 ft east-west. Three inch conduit has been cut flush with the surface and the southwest corner of the pad is covered with rock and soil from the nearby slope. Associated artifacts are metal conduit, metal fragments, insulated cable, braided cable, and a wire rope sling.

Figure 206. Feature 56, concrete foundation for the two air compressors, U12n Tunnel, view west (2008).

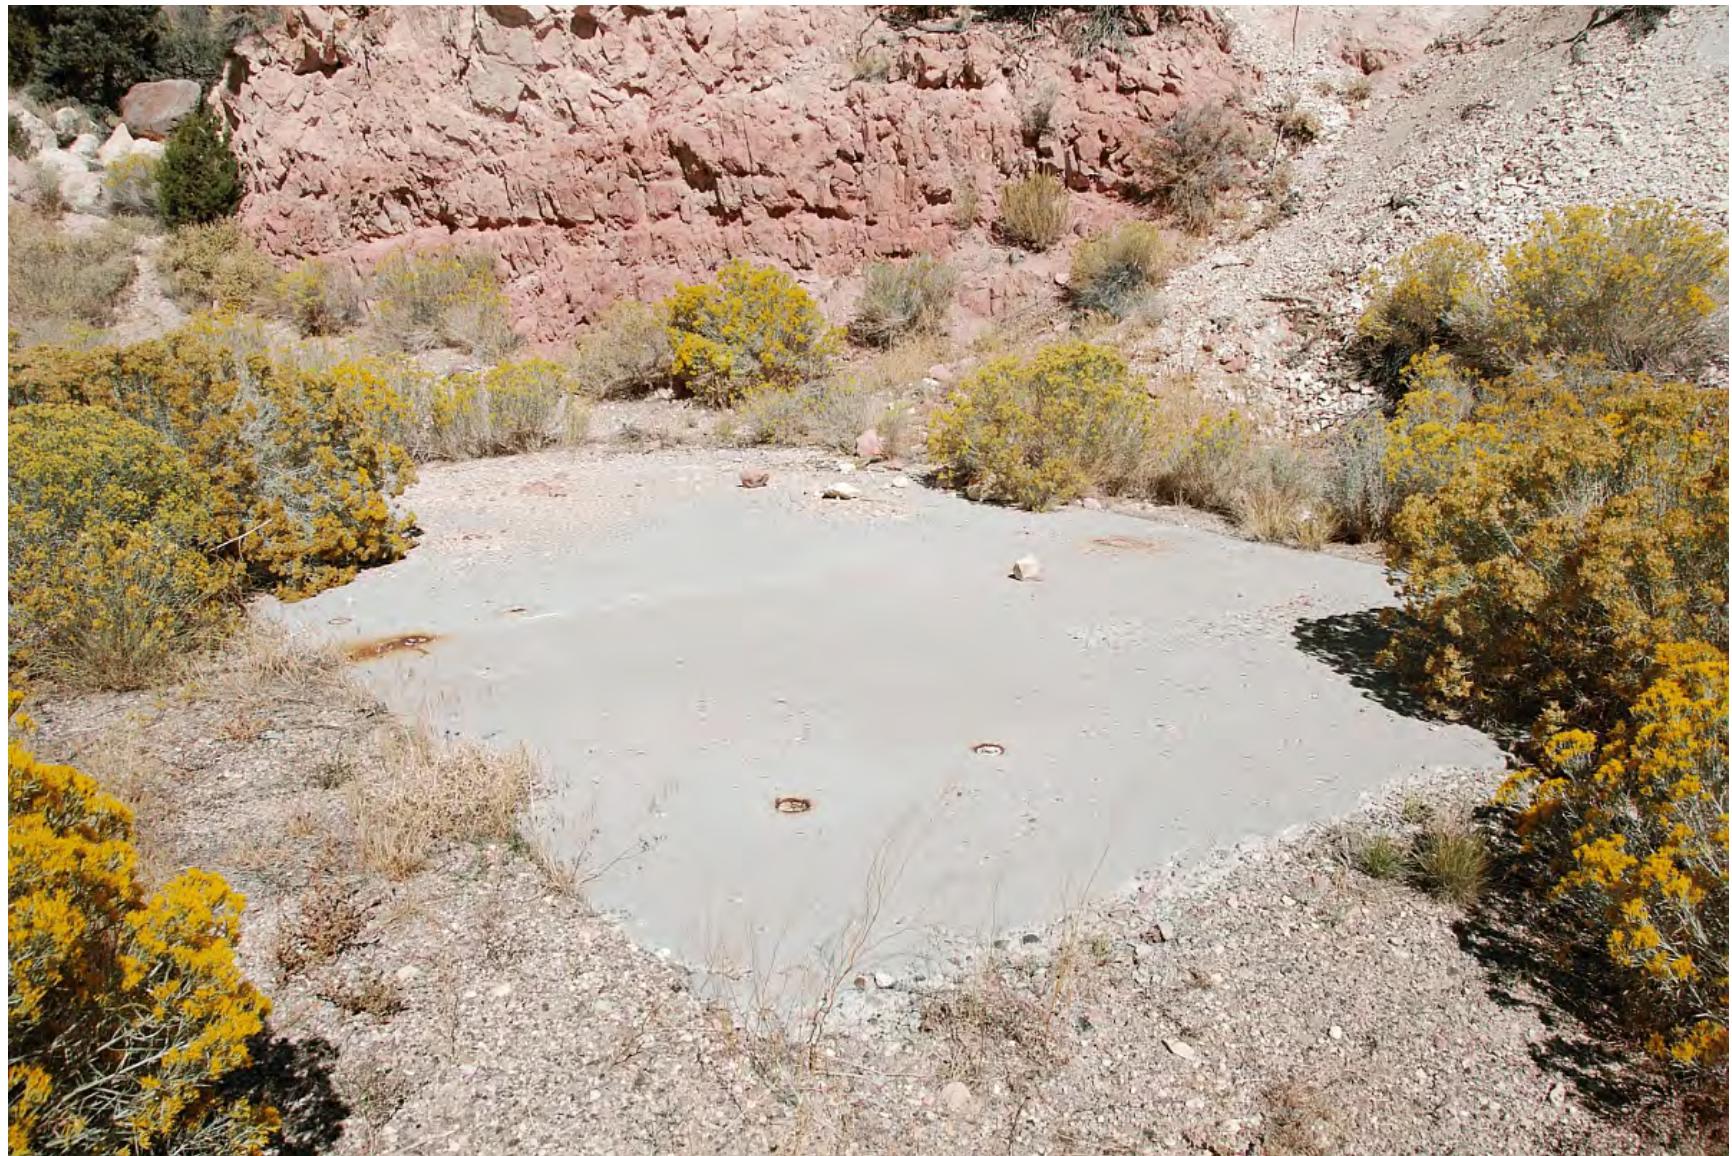
Feature 57 (Figure 207) is a concrete foundation for the compressor operator's shack at UTM coordinates 571705 E, 4117494 N. The foundation is on the ventilation pad and is 25 ft east-west by 15 ft north-south. The edges of the concrete are deteriorated and exposing gravel within the matrix. Various sized conduit has been cut flush with the surface. Associated artifacts are galvanized conduit and plexiglass.

Figure 207. Feature 57, concrete foundation for the compressor operator's shack, U12n Tunnel, view northwest (2008).
