A total of 202 features were recorded, mapped, and photographed for the U12n Tunnel complex. The project area encompassed 600.8 acres (243.1 hectares) at the portal and mesa areas. At the U12n portal area are ten sub-areas containing features related to the construction, testing, and general everyday activities within the tunnel. These include concrete foundations for buildings, communications equipment, mining equipment, rail lines, retention ponds, storage containers, and access control facilities. Only a telephone trailer remains on the telephone pad as all of the other buildings have been removed from the portal area. The microwave tower, portions of the rail lines, the muck car dump, rotary dump, and wash rack are still in place. Also, the traffic control point and powder magazines along N Tunnel Road are intact. At the mesa area are four sub-areas containing features generally related to pre- and post-shot drilling, recording facilities, and ventilation equipment. These include concrete foundations, instrument cable holes, and drill holes. The concrete foundations were for buildings and small equipment. Concrete pads and various equipment remain at the cable hole locations bu

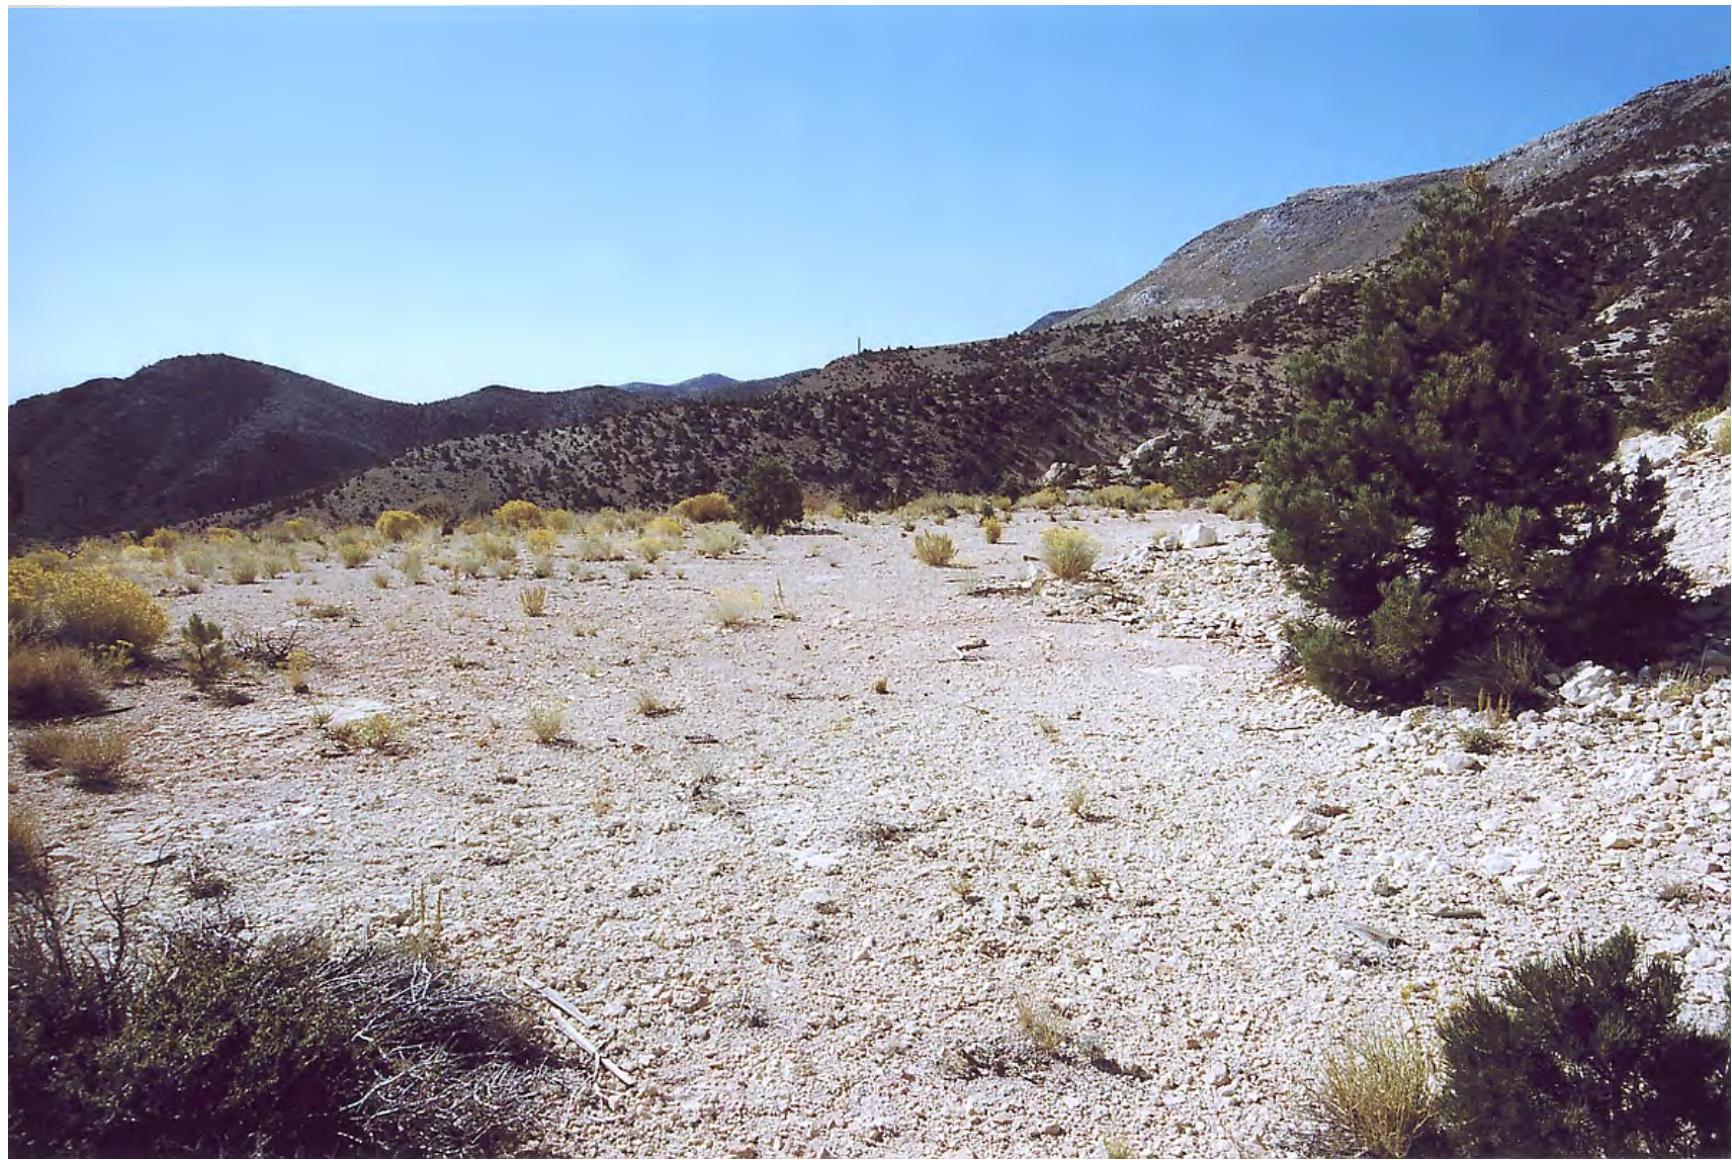
Figure 208. Overview of water tank pad, U12n Tunnel, view south (2008).

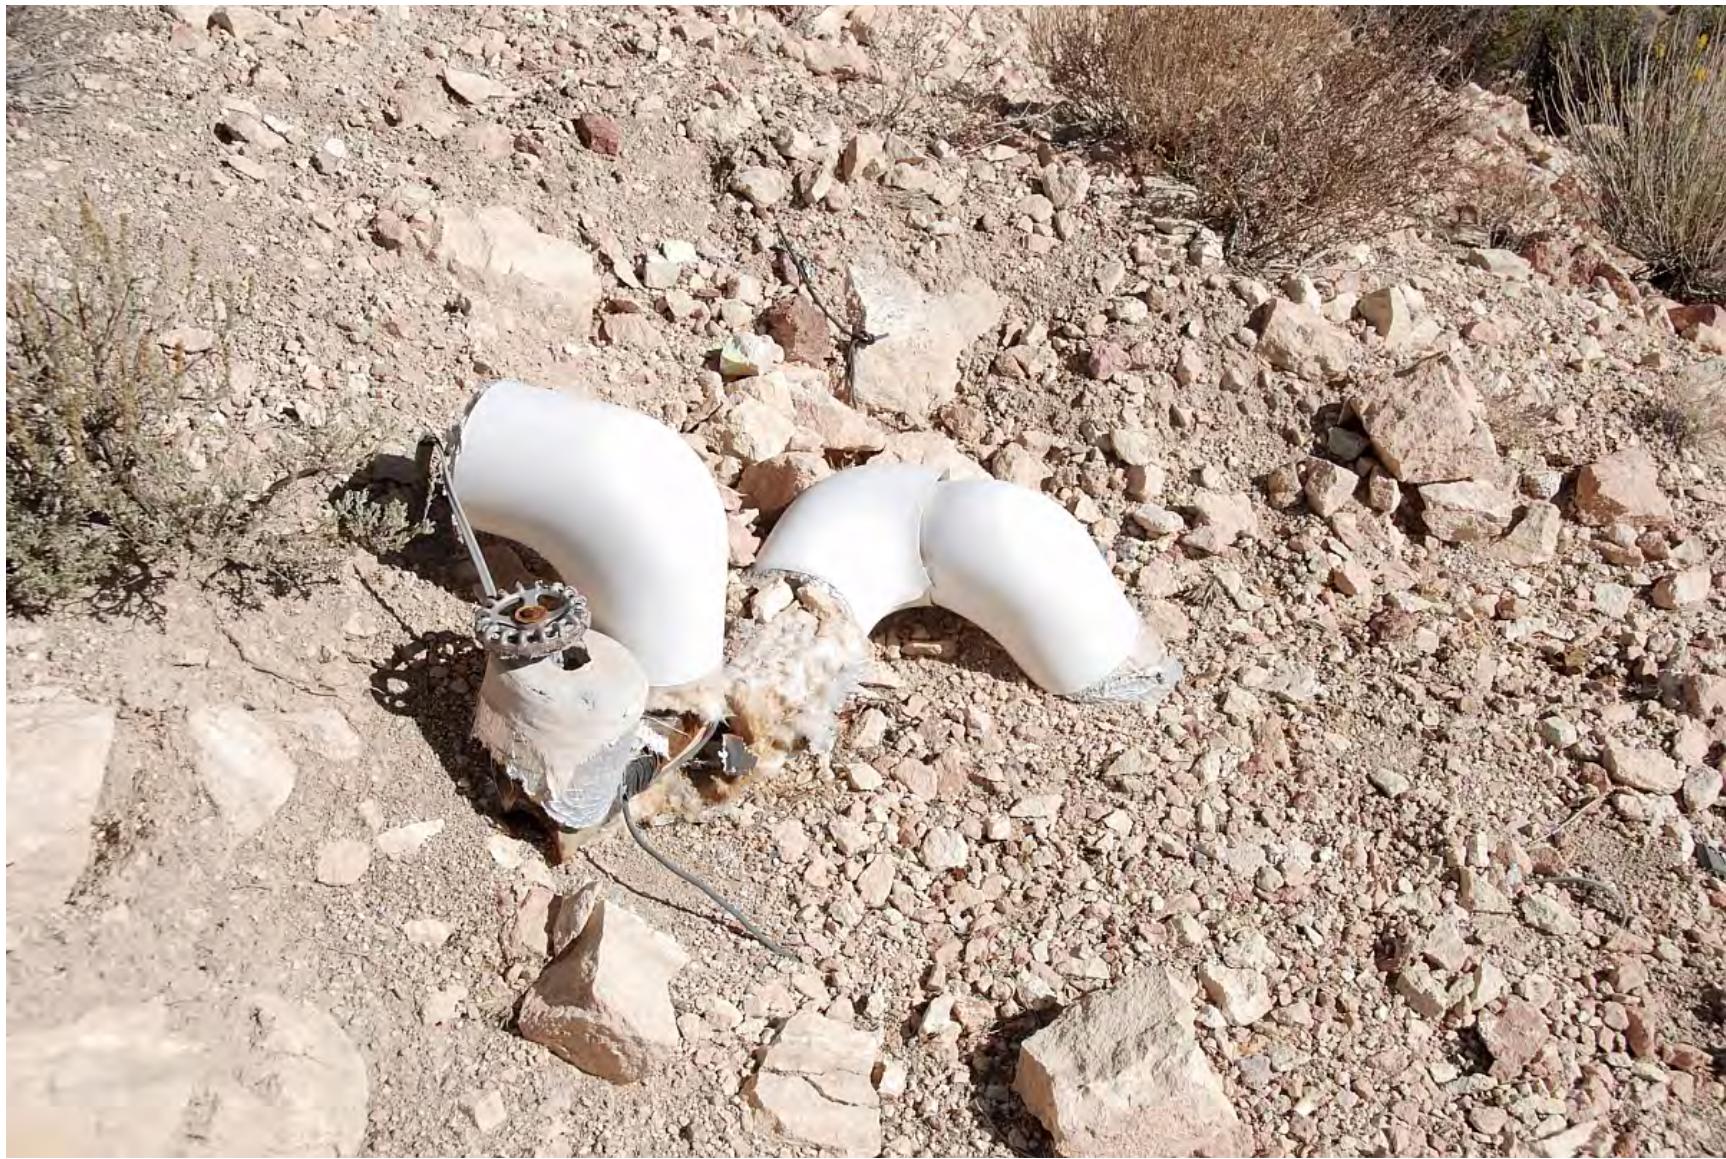
Feature 58 (Figure 209) is a metal gate valve, fiberglass insulated pipe connections, and electrical heat tape near the water tank pad at UTM coordinates 571678 E, 4117388 N. Visible above the surface is the handle for the gate valve and an insulated elbow (faces west) that is sealed with a flat steel plug. A second insulated elbow faces east and is connected to a third insulated elbow that extends below the surface. The connections are associated with a pipe line that carried water from the three tanks on the pad (20 ft to the west) down a drill hole approximately 180 ft deep to the U12n Tunnel main drift. Only milled lumber fragments remain on the pad.

Figure 209. Feature 58, metal gate valve and insulated elbows, U12n Tunnel, view northwest (2008).

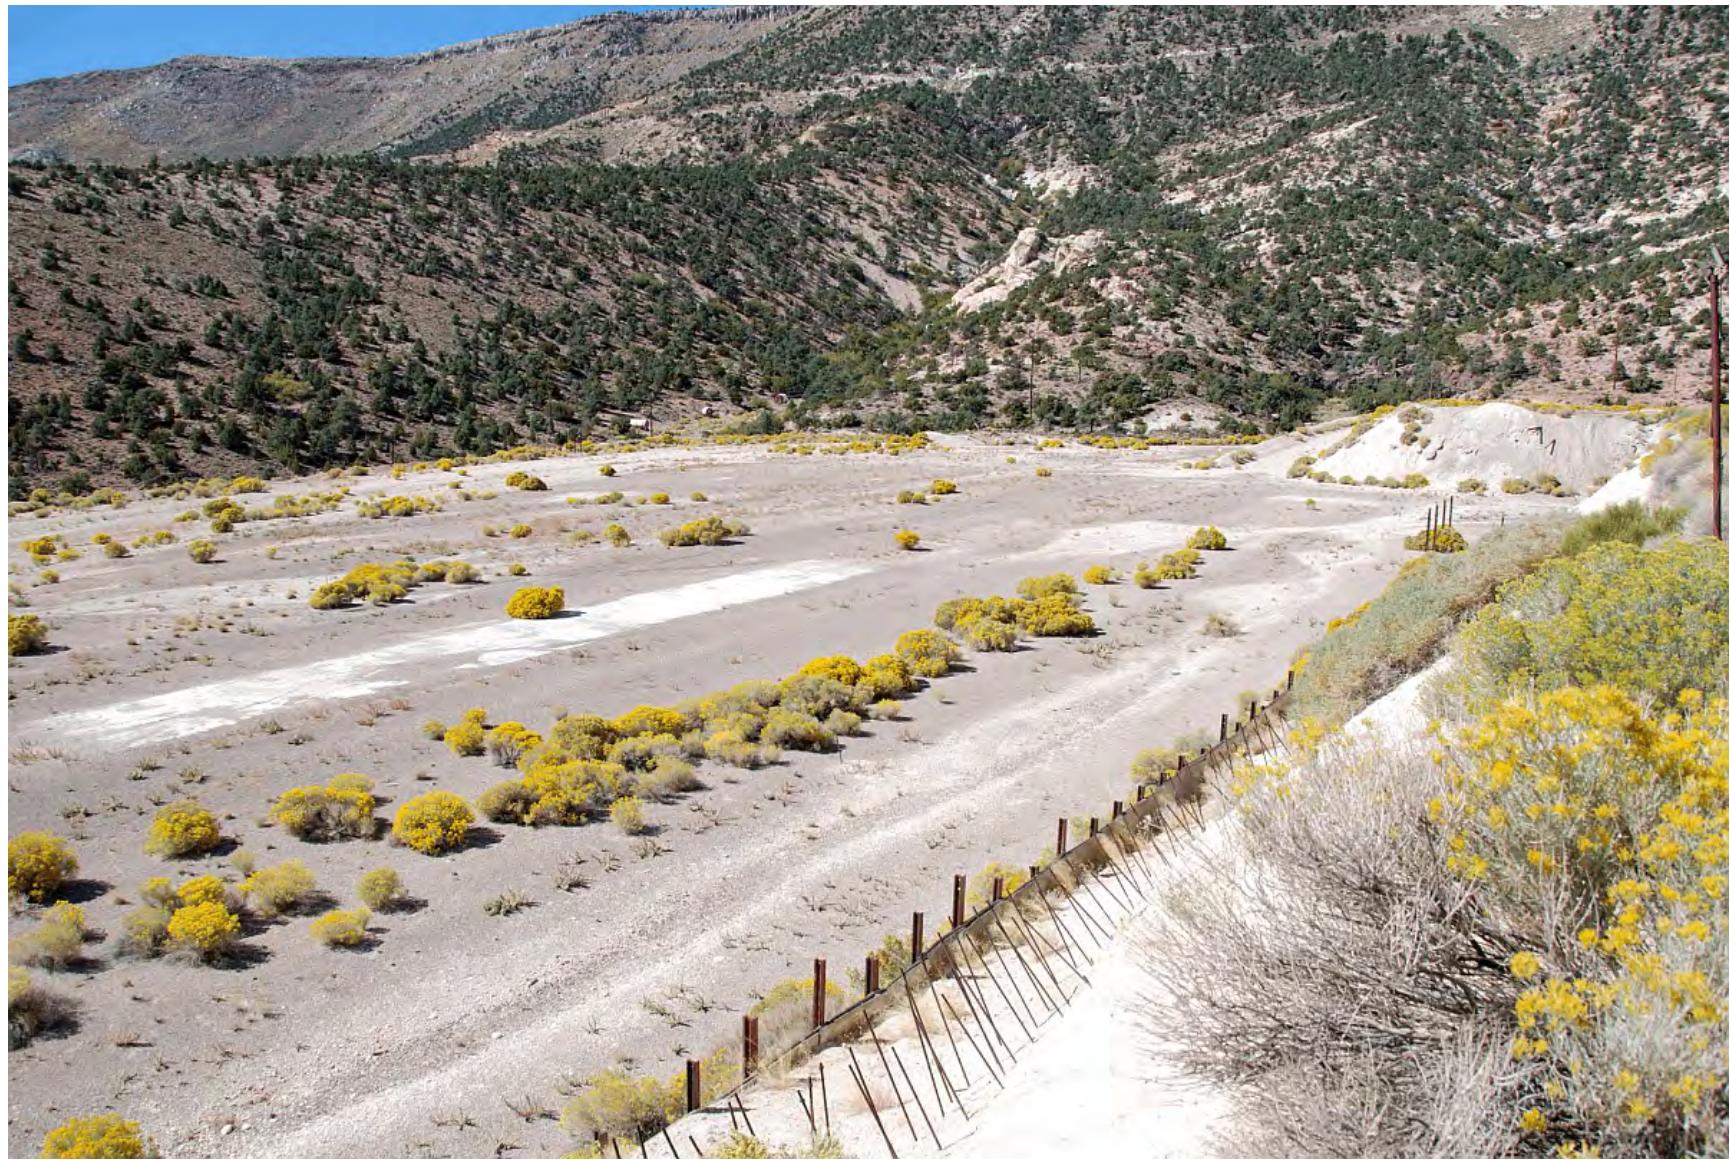
Figure 210. Overview of the muckpile (lower level), U12n Tunnel, view northwest (2008).

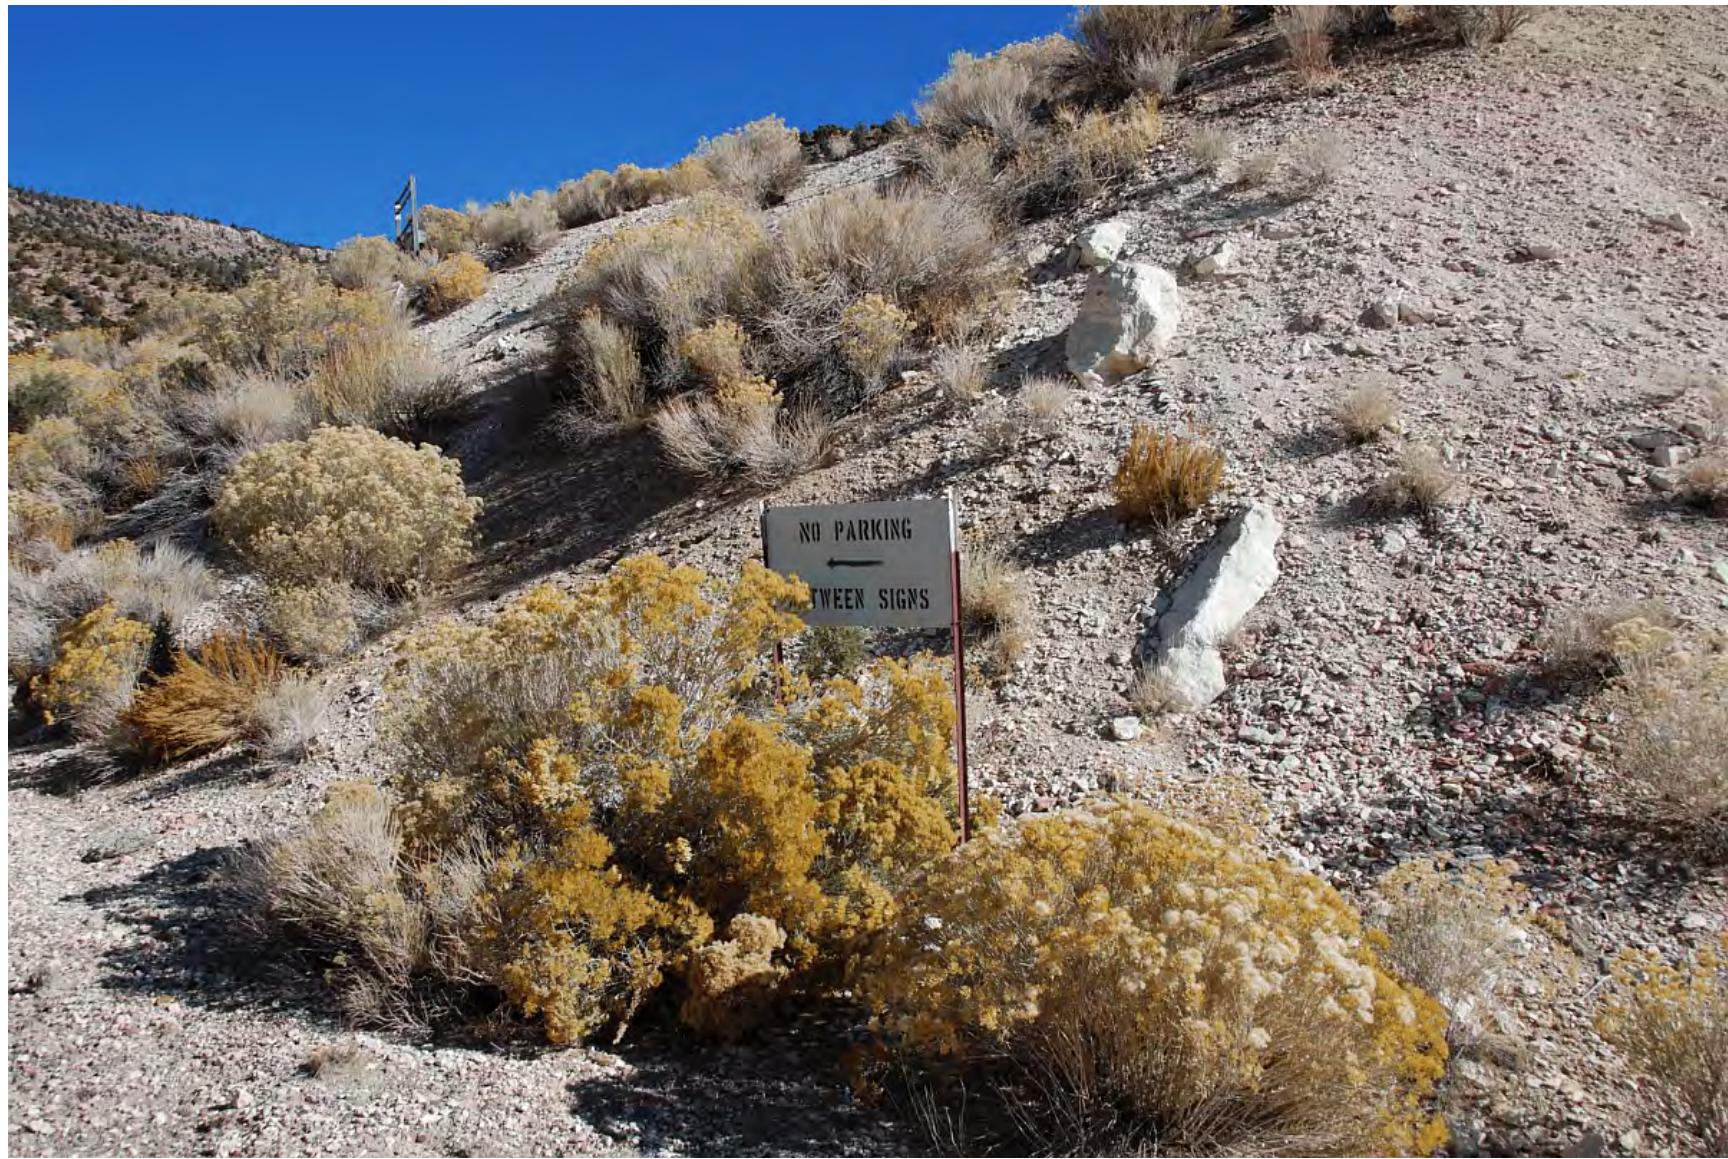
Feature 59 (Figure 211) is a metal sign along the N Tunnel Road at UTM coordinates 571741 E, 4117175 N, and near the entrance to the portal pad. It is 3 ft x 1 ft 6 inches, painted white with black

Figure 211. Feature 59, sign, U12n Tunnel, view northeast (2008).

lettering, and attached to two T posts that are 4 ft 6 inches (1.4 m) in height. The sign is labeled NO PARKING BETWEEN SIGNS. The second sign was not located.

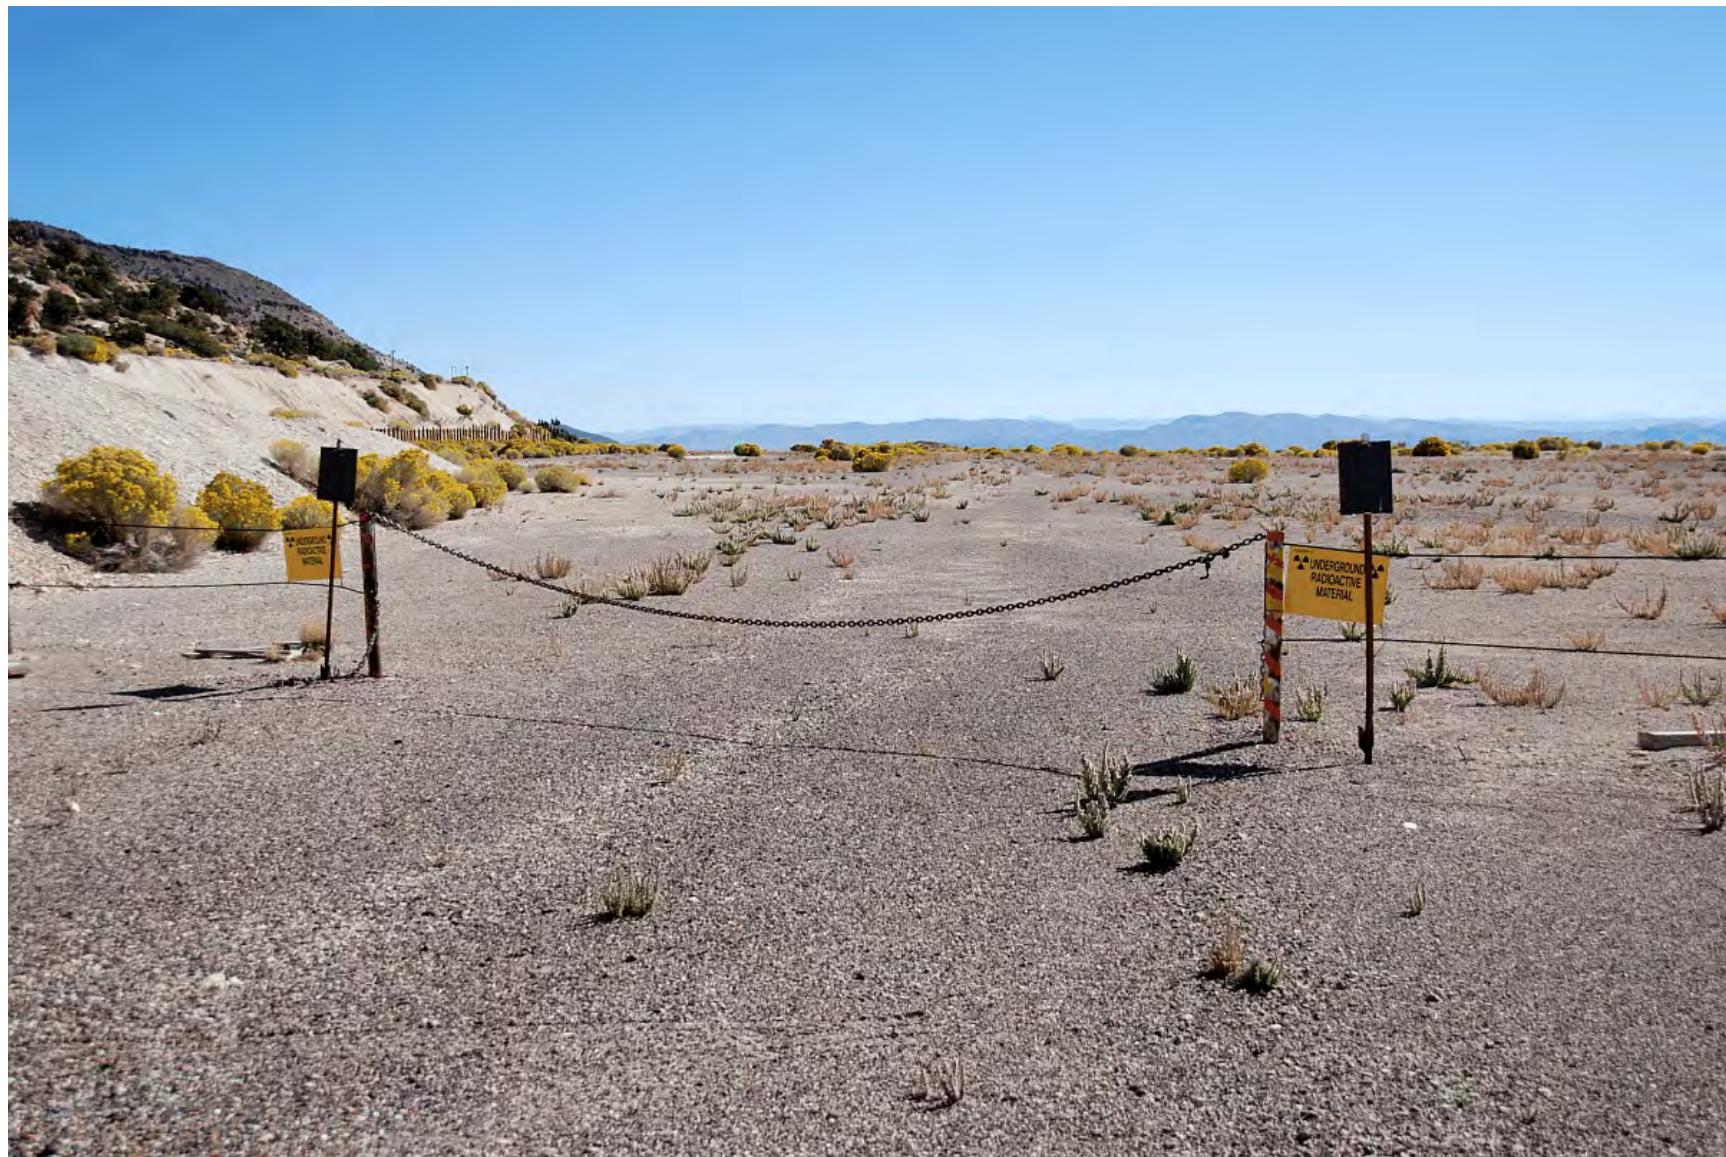
Feature 60 (Figure 212) is a cable fence and chain gate at UTM coordinates 571808 E, 4117142 N and at the west end of the muckpile. The fence posts are 3-inch pipe that are 3 ft 8 inches in height and have been secured to the surface with concrete. The fencing is two 3/8-inch (0.9 cm) cables that are inserted through holes in the post 1 ft 8 inches apart. Attached to the top cable are yellow signs with black lettering, UNDERGROUND RADIOACTIVE MATERIAL. No attempt was made to enter the muckpile because of this posting. The entrance to the muckpile on the lower level is secured by a chain welded to one post and locked to a second post. Metal T posts with plates, signs, are on each side of the gate but the lettering has faded.

Figure 212. Feature 60, fence and gate to the muckpile on lower level, U12n Tunnel, view east (2008).

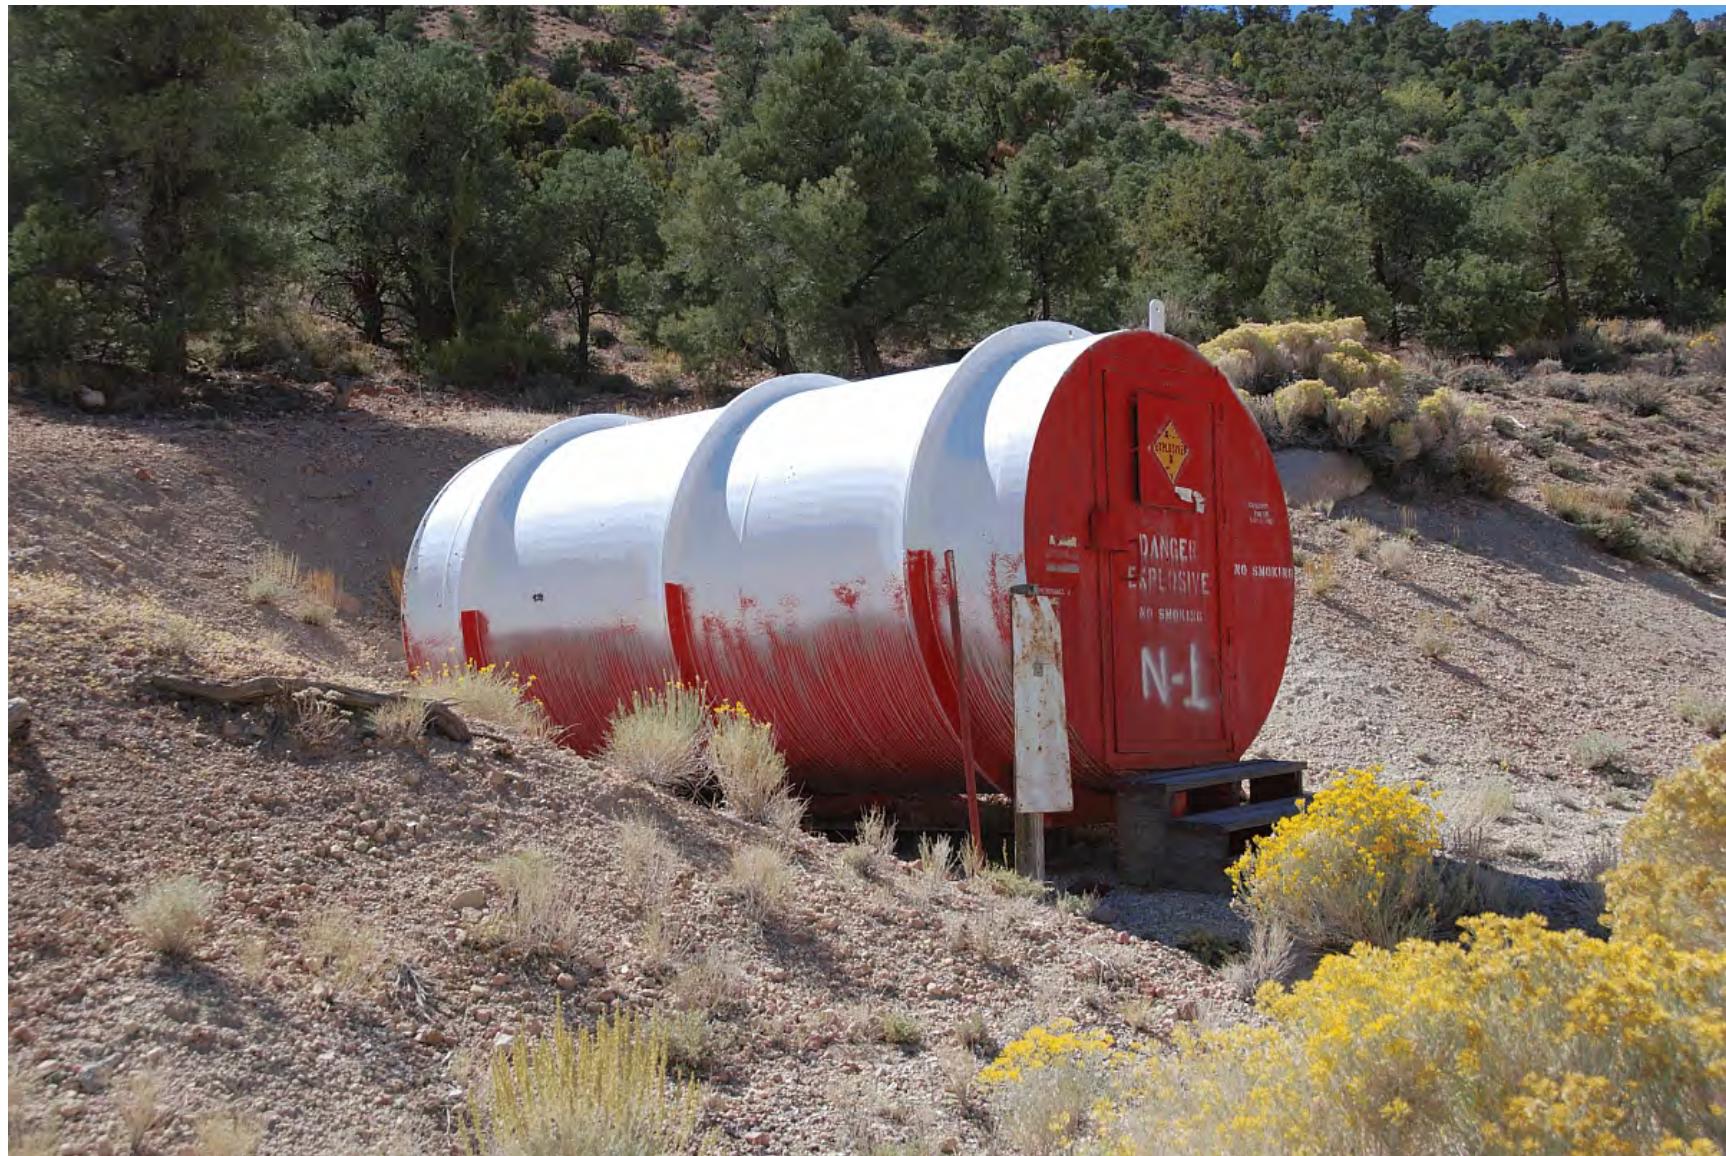
Feature 62 (Figure 215) is a powder magazine at UTM 571743 E, 4116999 N. It is a 7 ft diameter by 16 ft long cylindrical white metal magazine that appears to have been constructed from line-of-sight pipe. The ends of the pipe have been sealed with metal plates painted red. A 3 ft wide by 5 ft 9 inch tall door is in the north end provides access into the magazine. On the door are placards and stenciling for EXPLOSIVE A, NO SMOKING, and Capacity 500 lbs. Also, there is a paper tag with printed coordinates N 37.11905, W 116.11549. Spray painted on the door is N-1. The magazine is mounted on two 6-inch I-beam rails that extend the length of the pipe. Below the door are wood steps constructed of 3/4-inch plywood runners and 2 x 6 inch milled lumber steps. A 4 x 4 inch milled lumber post with a metal plate for mounting of a fire extinguisher is to the east of the door. Associated artifacts are a shovel and a metal plate.

Figure 215. Feature 62, powder magazine #1, U12n Tunnel, view southwest (2008).

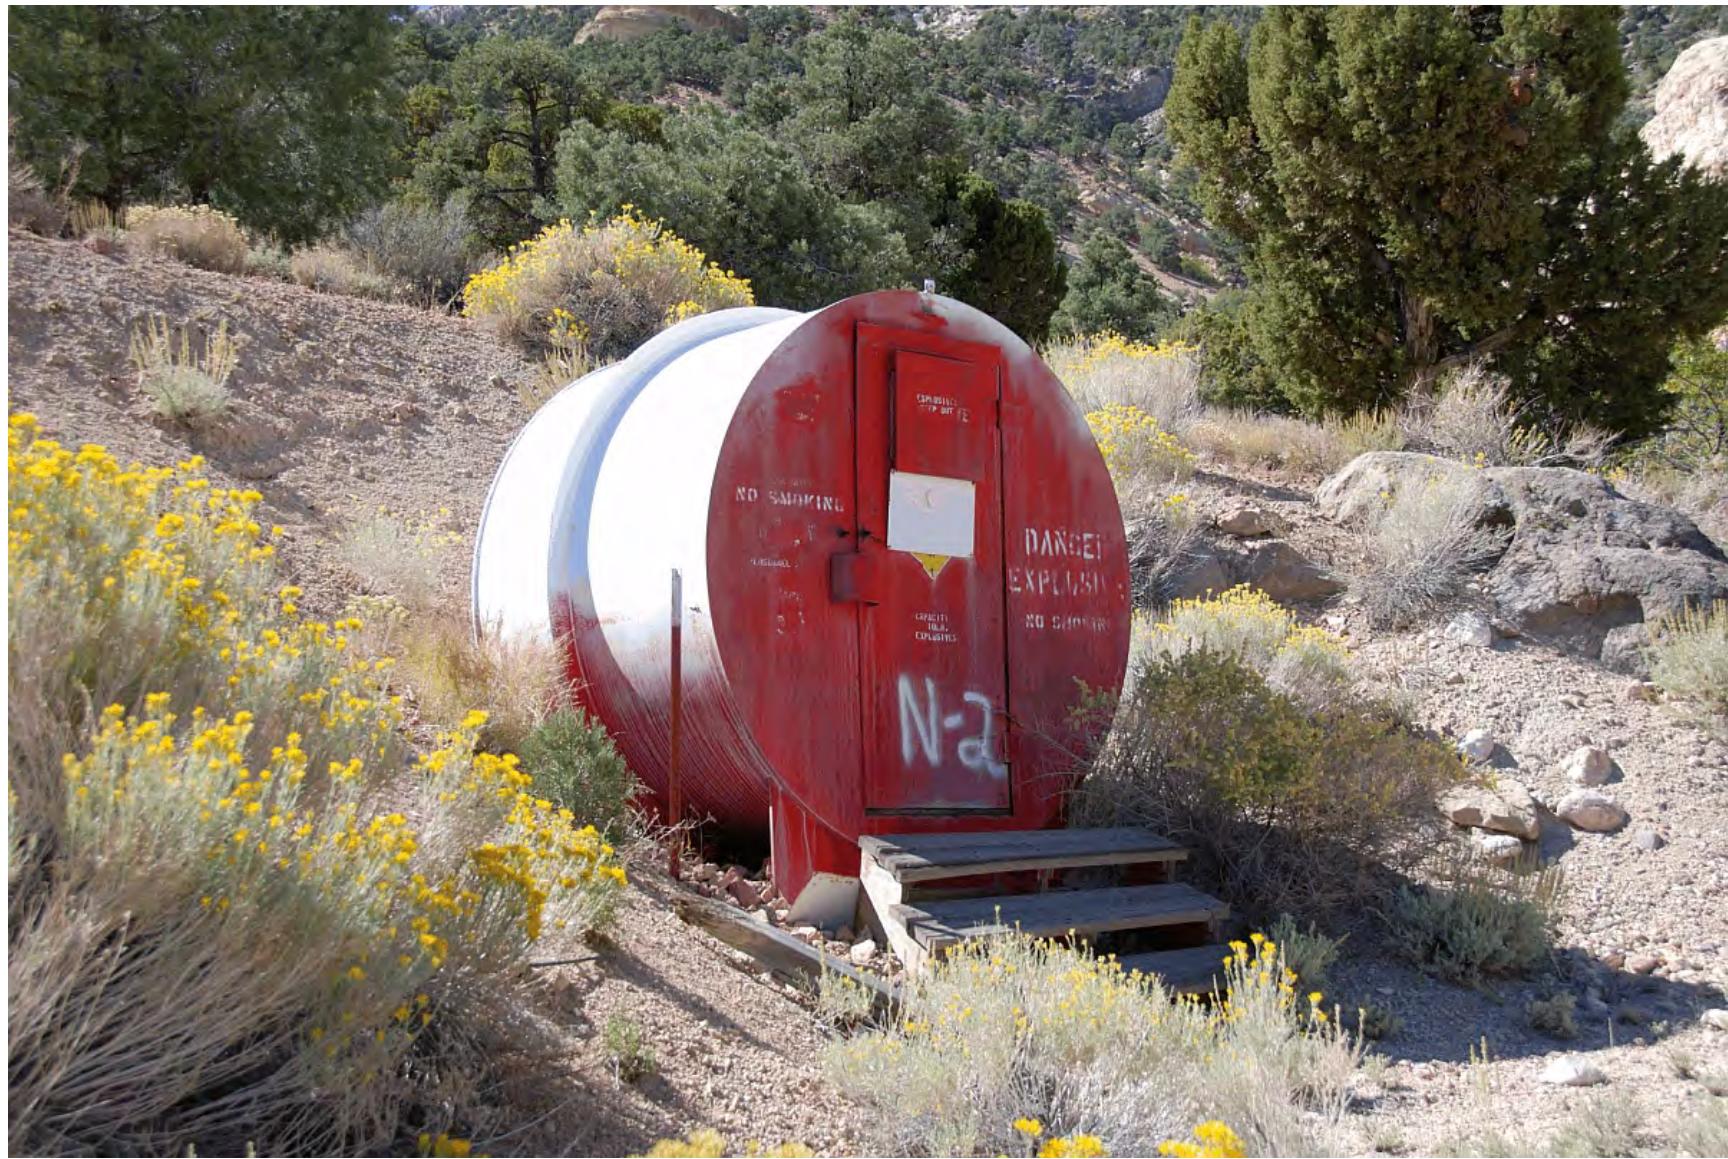
Feature 63 (Figure 216) is a powder magazine at UTM 571719 E, 4116997 N. It is a 7 ft diameter by 5 ft long cylindrical white metal magazine that appears to have been constructed from line-of-sight pipe. The ends of the pipe have been sealed with metal plates and painted red. A 3 ft wide by 5 ft 9 inch tall door is in the north end provides access into the magazine. On the door are placards and stenciling for EXPLOSIVE A, NO SMOKING, and Capacity 10 lbs. Also, there is a paper tag with printed coordinates N 37.11909, W 116.11565. Spray painted on the door is N-2. The magazine is mounted on two 6-inch I-beam rails that extend the length of the pipe. Below the door are wood steps constructed of 3/4-inch plywood runners and 2 x 6 inch milled lumber steps. A 4 x 4 inch milled lumber post with a metal plate for mounting of a fire extinguisher is on the surface east of the door.

Figure 216. Feature 63, powder magazine #2, U12n Tunnel, view southwest (2008).

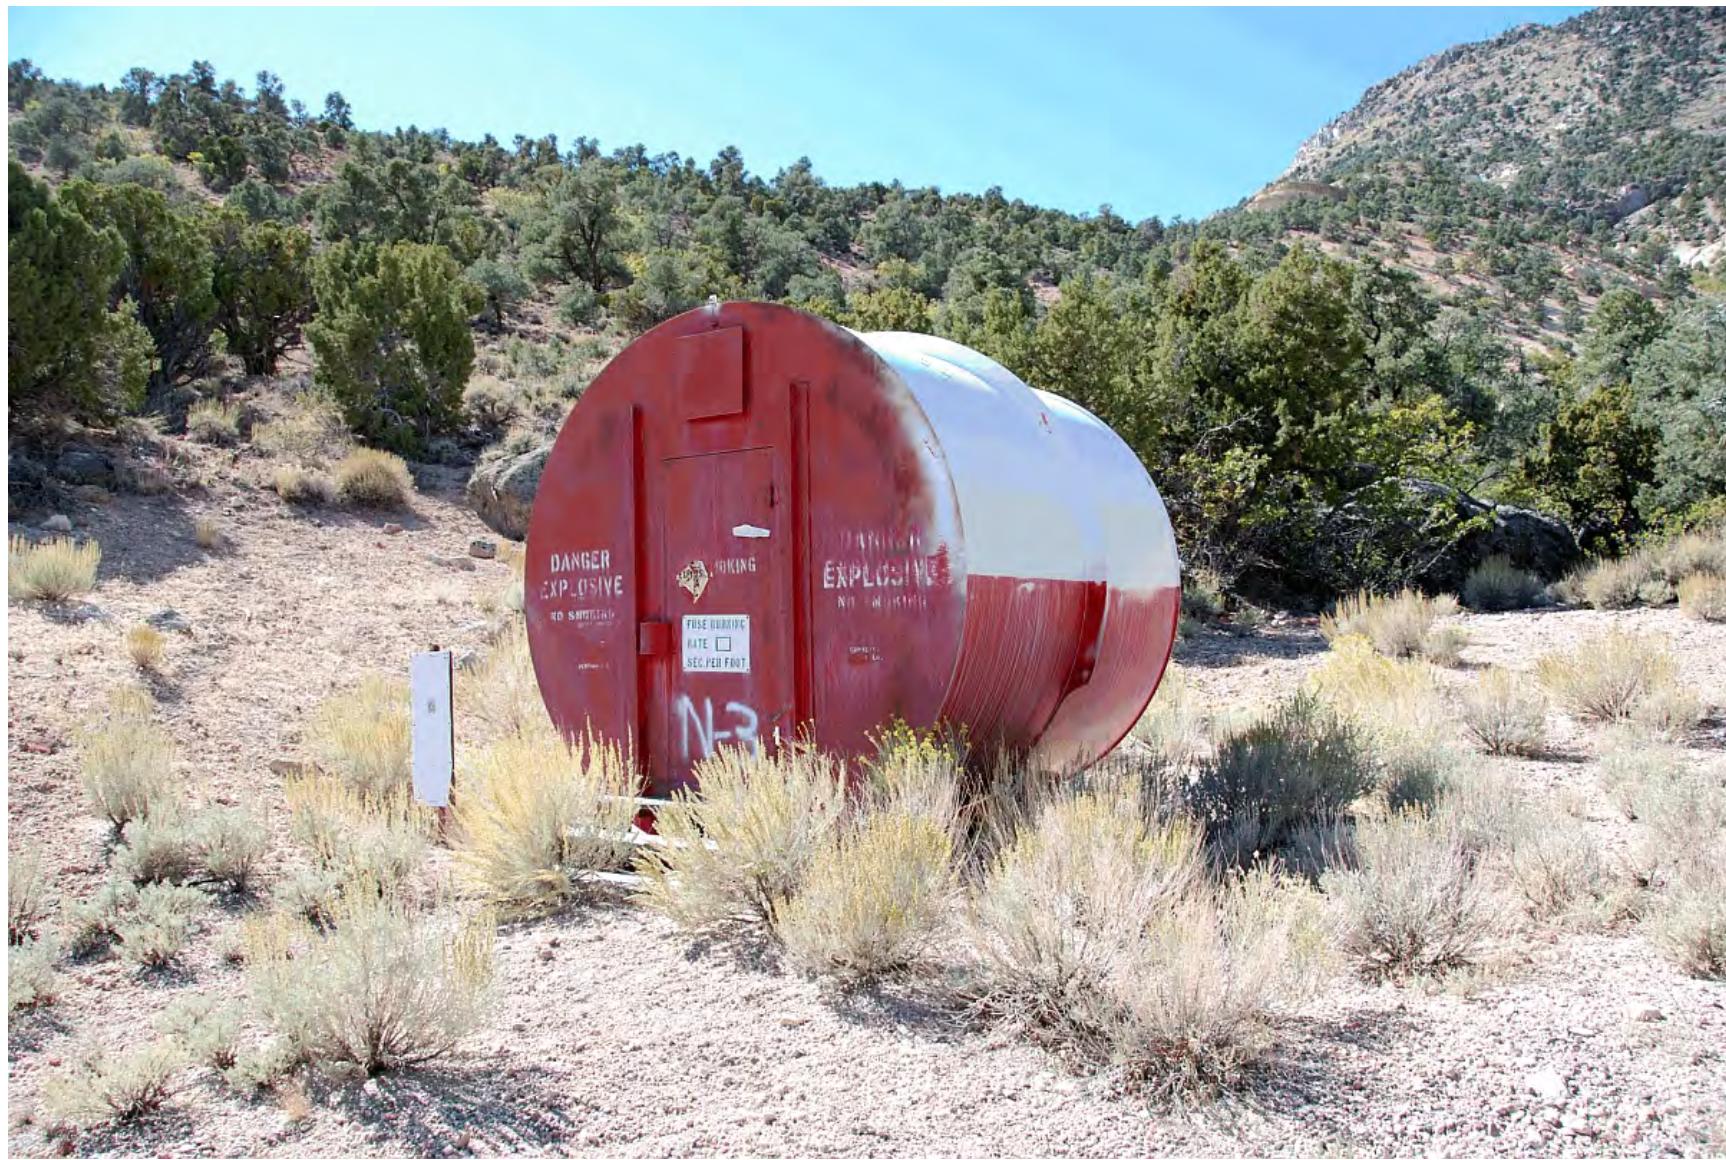
Feature 64 (Figure 217) is a powder magazine at UTM 571719 E, 4116997 N. It is a 10 ft diameter by 10 ft long cylindrical white metal magazine that appears to have been constructed from line-of-sight pipe. The ends of the pipe have been sealed with metal plates painted red. A 3 ft wide by 5 ft 9 inch tall door is in the north end provides access into the magazine. On the door are placards and stenciling for EXPLOSIVE A, NO SMOKING, Capacity 1500 lbs, and a metal plate labeled FUSE BURNING RATE SEC. PER FOOT. Spray painted on the door is N-3. The magazine is mounted on two 6-inch I-beam rails that extend the length of the pipe. Below the door are wood steps constructed of 3/4-inch plywood runners and 2 x 6 inch milled lumber steps. A metal T post and plate for mounting of a fire extinguisher is south of the door. Associated artifacts are a 10 ft long aluminum loading rack with 1 ft 8 inch wide rollers.

Figure 217. Feature 64, powder magazine #3, U12n Tunnel, view southwest (2008).

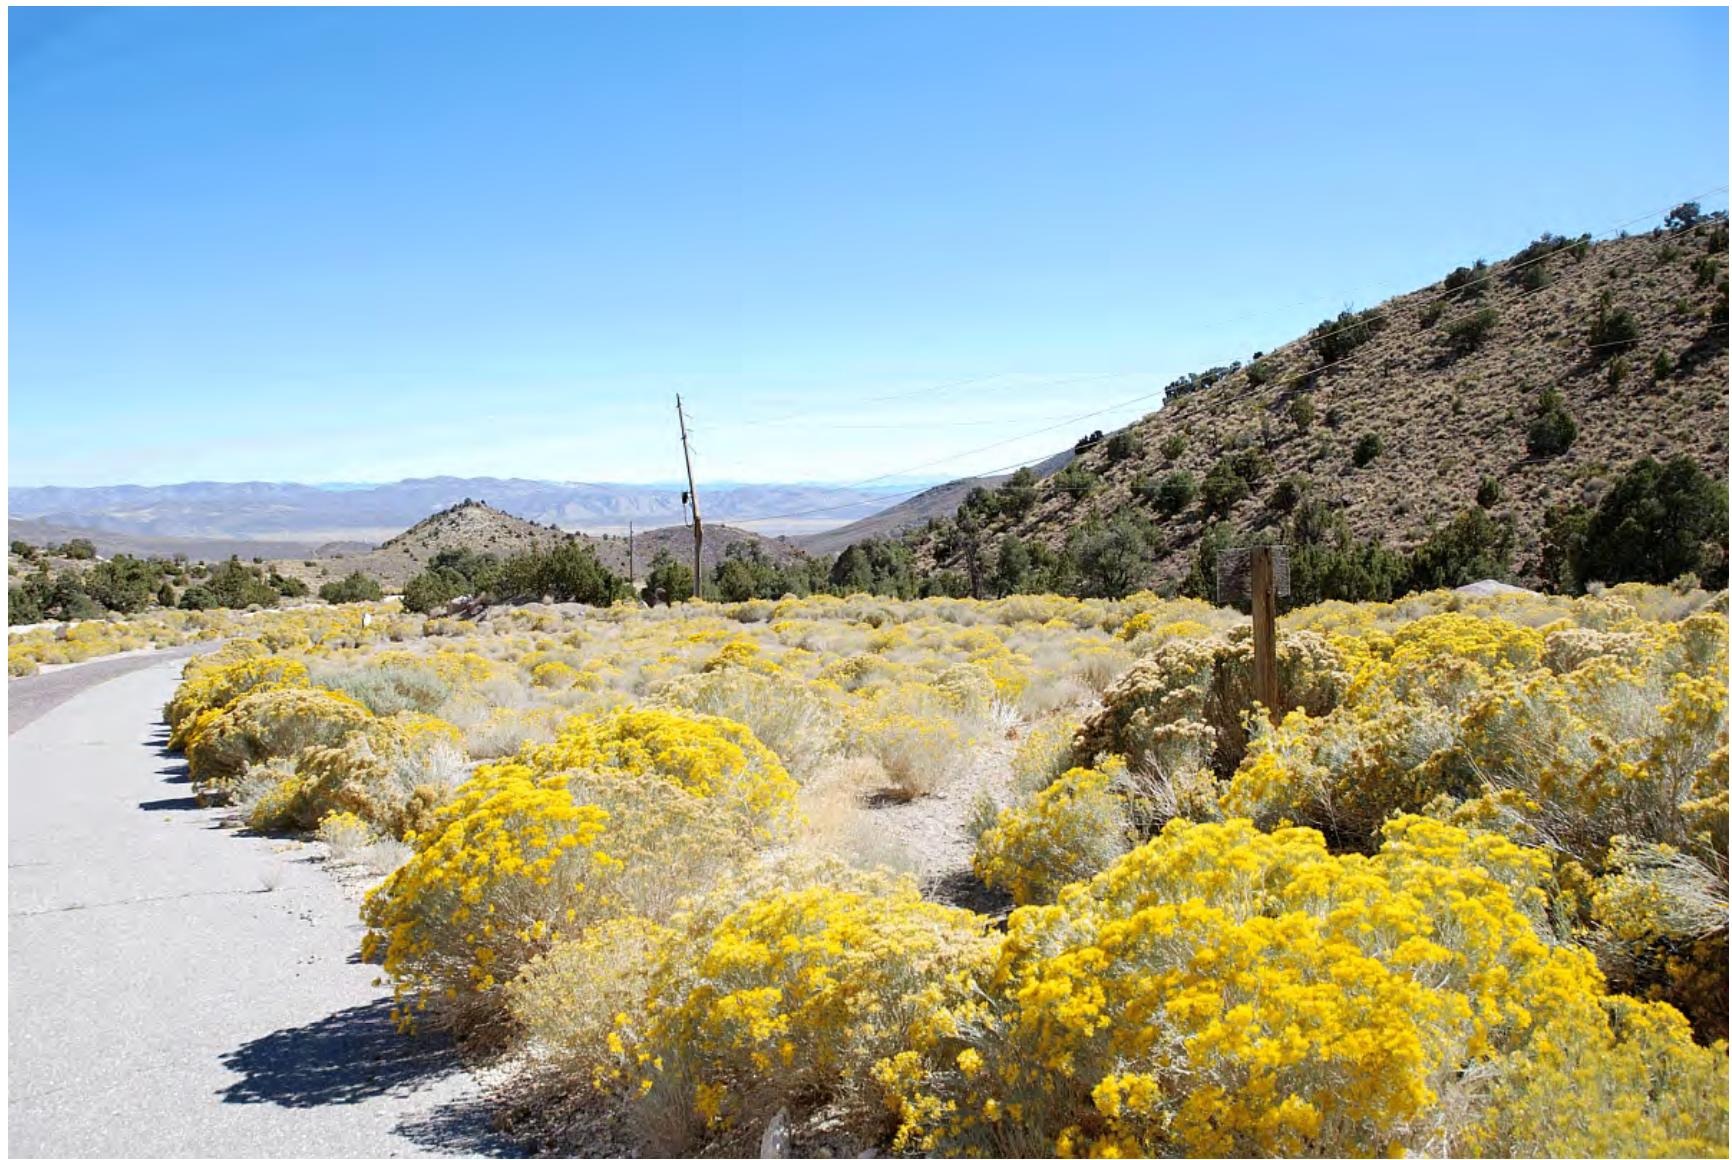
Figure 218. Overview of the parking area pad, U12n Tunnel, view southeast (2008).

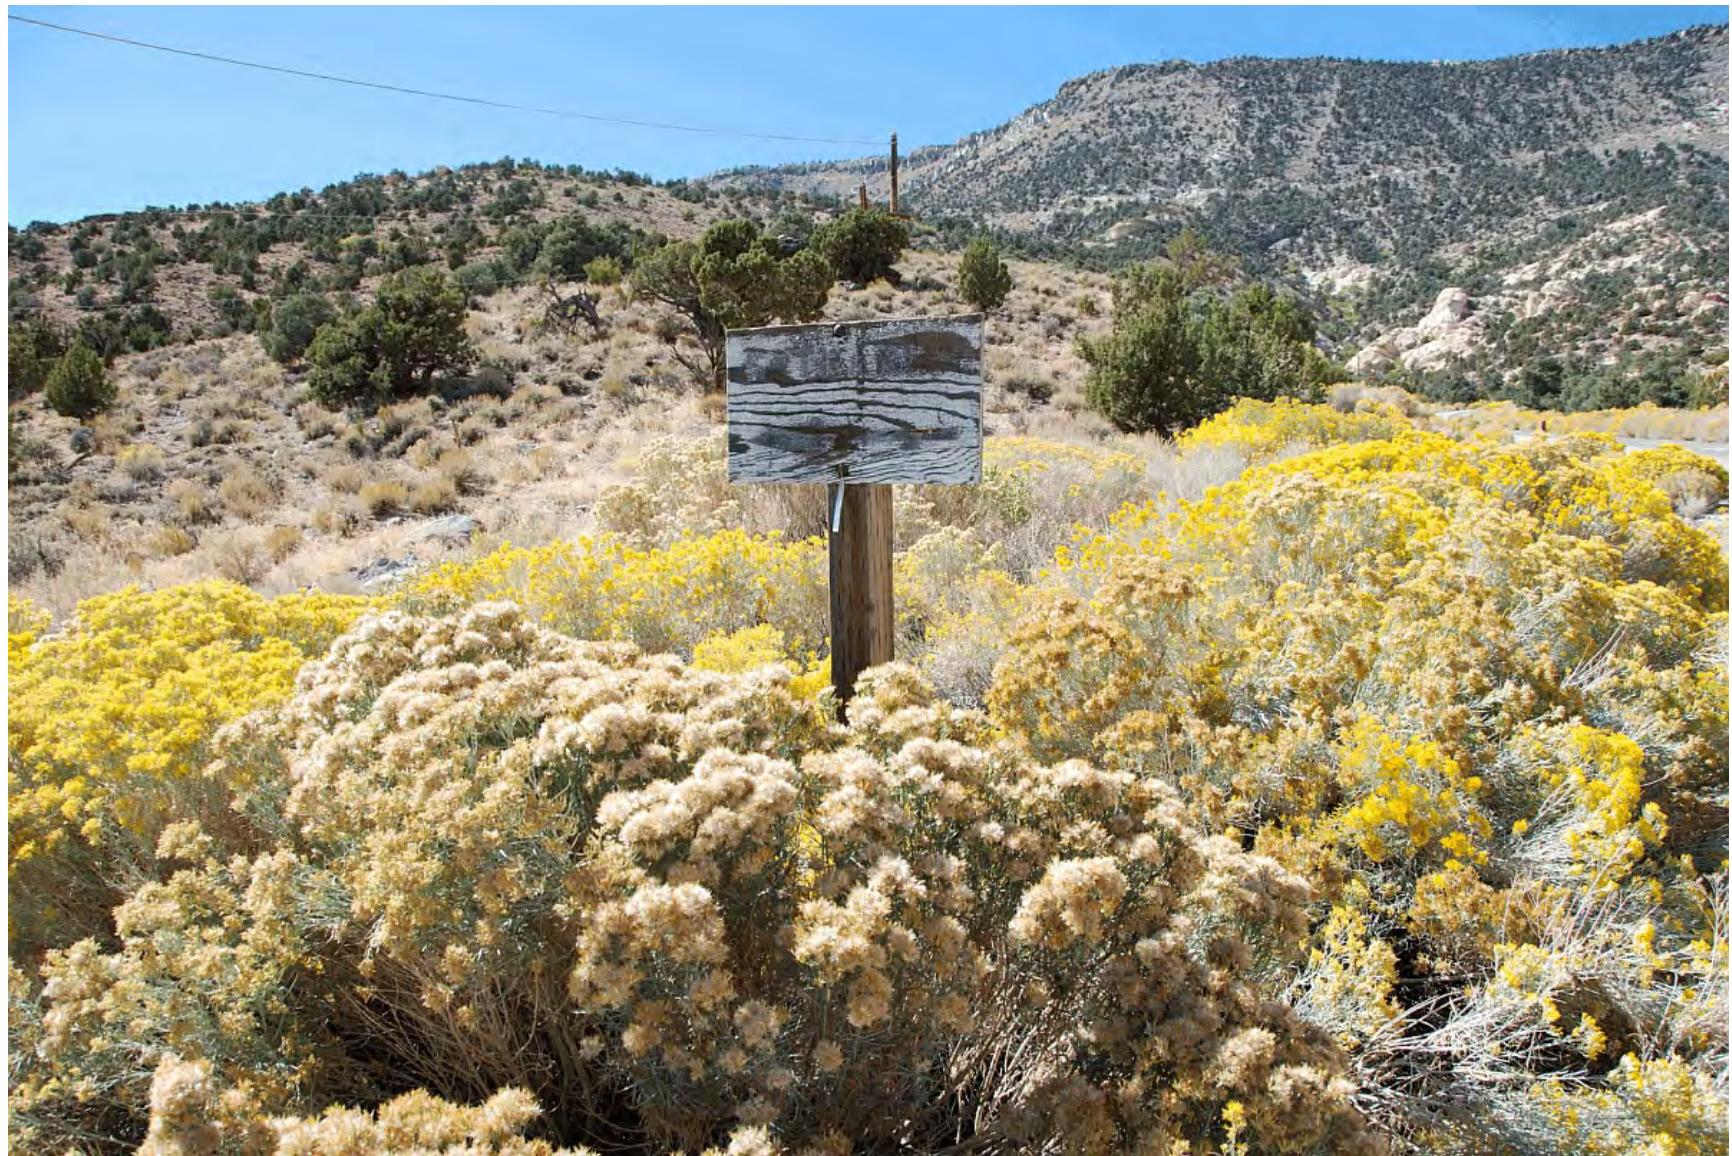
Feature 65 (Figure 219) is a wood sign and post at UTM coordinates 572056 E, 4117023 N at the parking area. The sign is 1 ft 6 inches x 1ft, made of 1/2-inch plywood, and has been painted white with black lettering that is not legible. The sign is attached with 3/8-inch carriage bolts to a 4 x 4 inch milled lumber post that is 5 ft 6 inches in height.

Figure 219. Feature 65, wood sign, U12n Tunnel, view west (2008).
