A total of 202 features were recorded, mapped, and photographed for the U12n Tunnel complex. The project area encompassed 600.8 acres (243.1 hectares) at the portal and mesa areas. At the U12n portal area are ten sub-areas containing features related to the construction, testing, and general everyday activities within the tunnel. These include concrete foundations for buildings, communications equipment, mining equipment, rail lines, retention ponds, storage containers, and access control facilities. Only a telephone trailer remains on the telephone pad as all of the other buildings have been removed from the portal area. The microwave tower, portions of the rail lines, the muck car dump, rotary dump, and wash rack are still in place. Also, the traffic control point and powder magazines along N Tunnel Road are intact. At the mesa area are four sub-areas containing features generally related to pre- and post-shot drilling, recording facilities, and ventilation equipment. These include concrete foundations, instrument cable holes, and drill holes. The concrete foundations were for buildings and small equipment. Concrete pads and various equipment remain at the cable hole locations bu

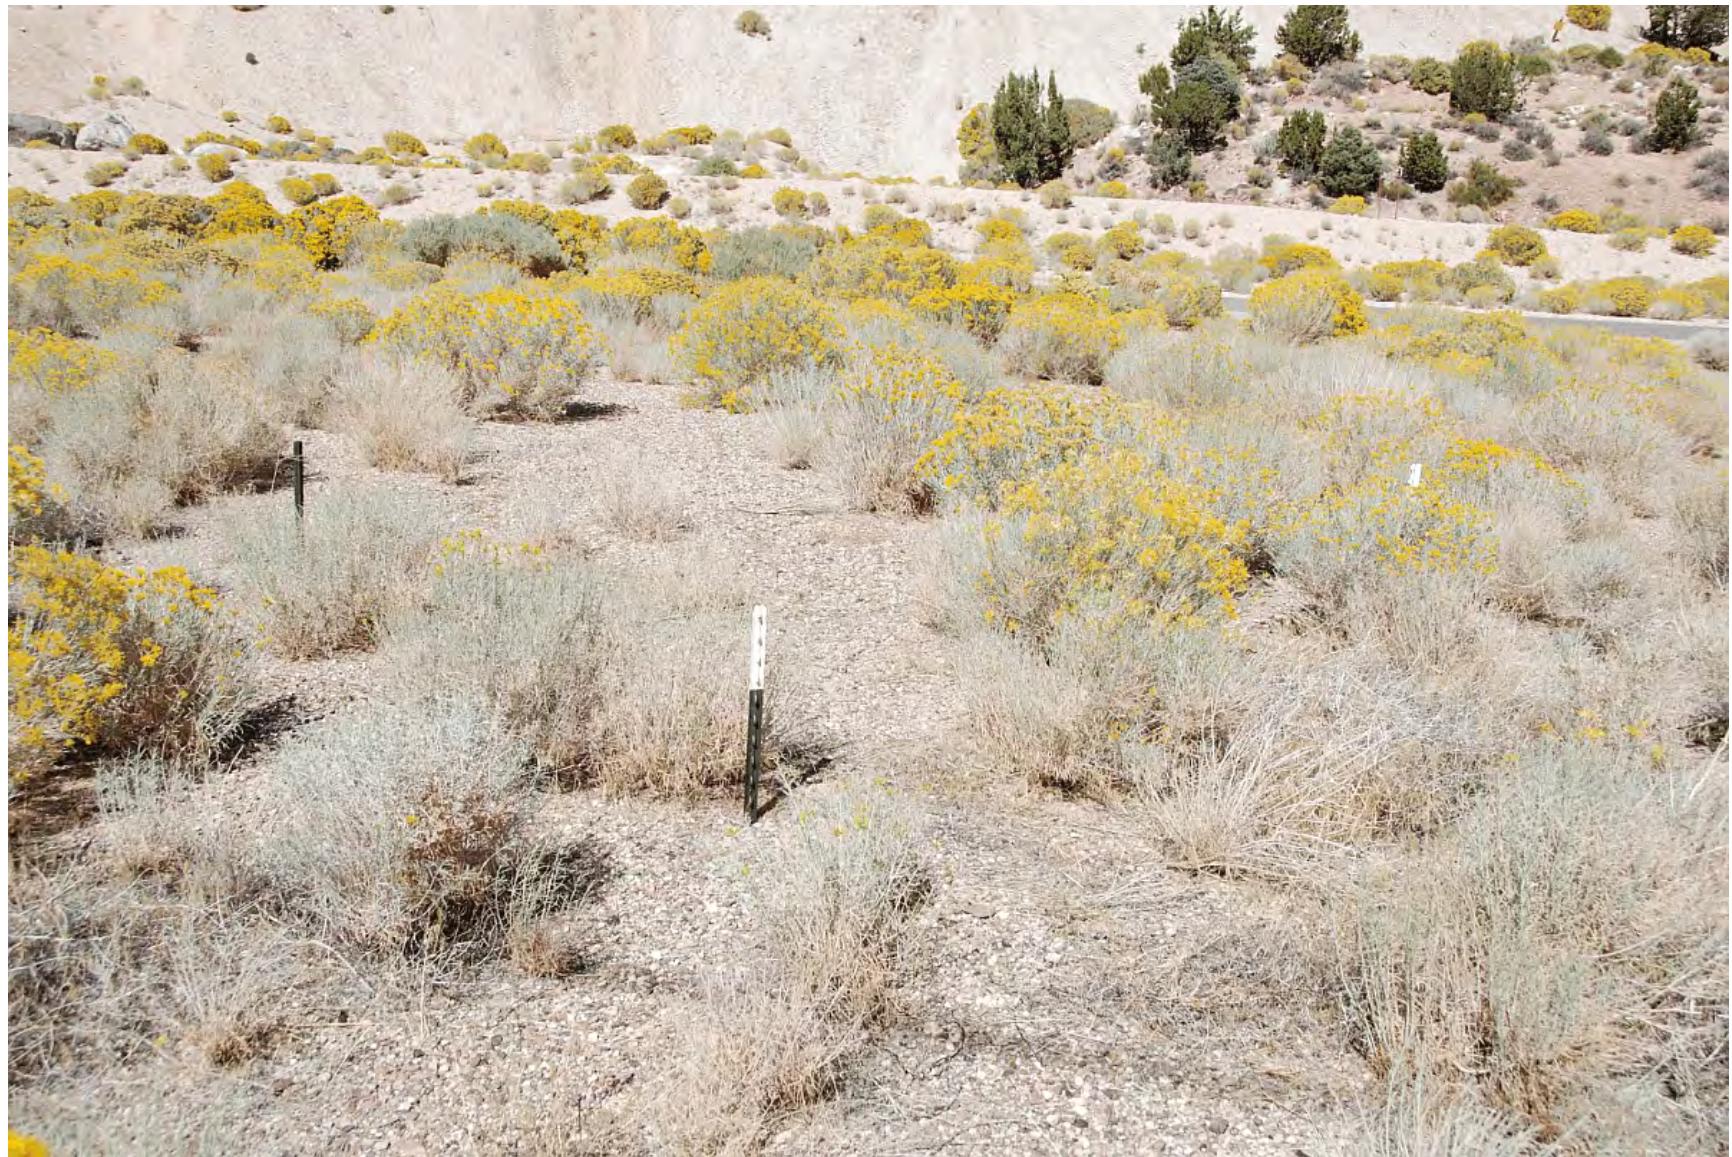
Feature 66 (Figure 220) is three metal T posts at UTM coordinates 572084 E, 4117006 N at the parking area. The T posts extend 2 ft above the surface and are in a triangular pattern 16 ft (4.9 m) on the long side and 10 ft (3 m) on the short side. No function for the posts has been determined at this time.

Figure 220. Feature 66, T posts, U12n Tunnel, view northwest (2008).

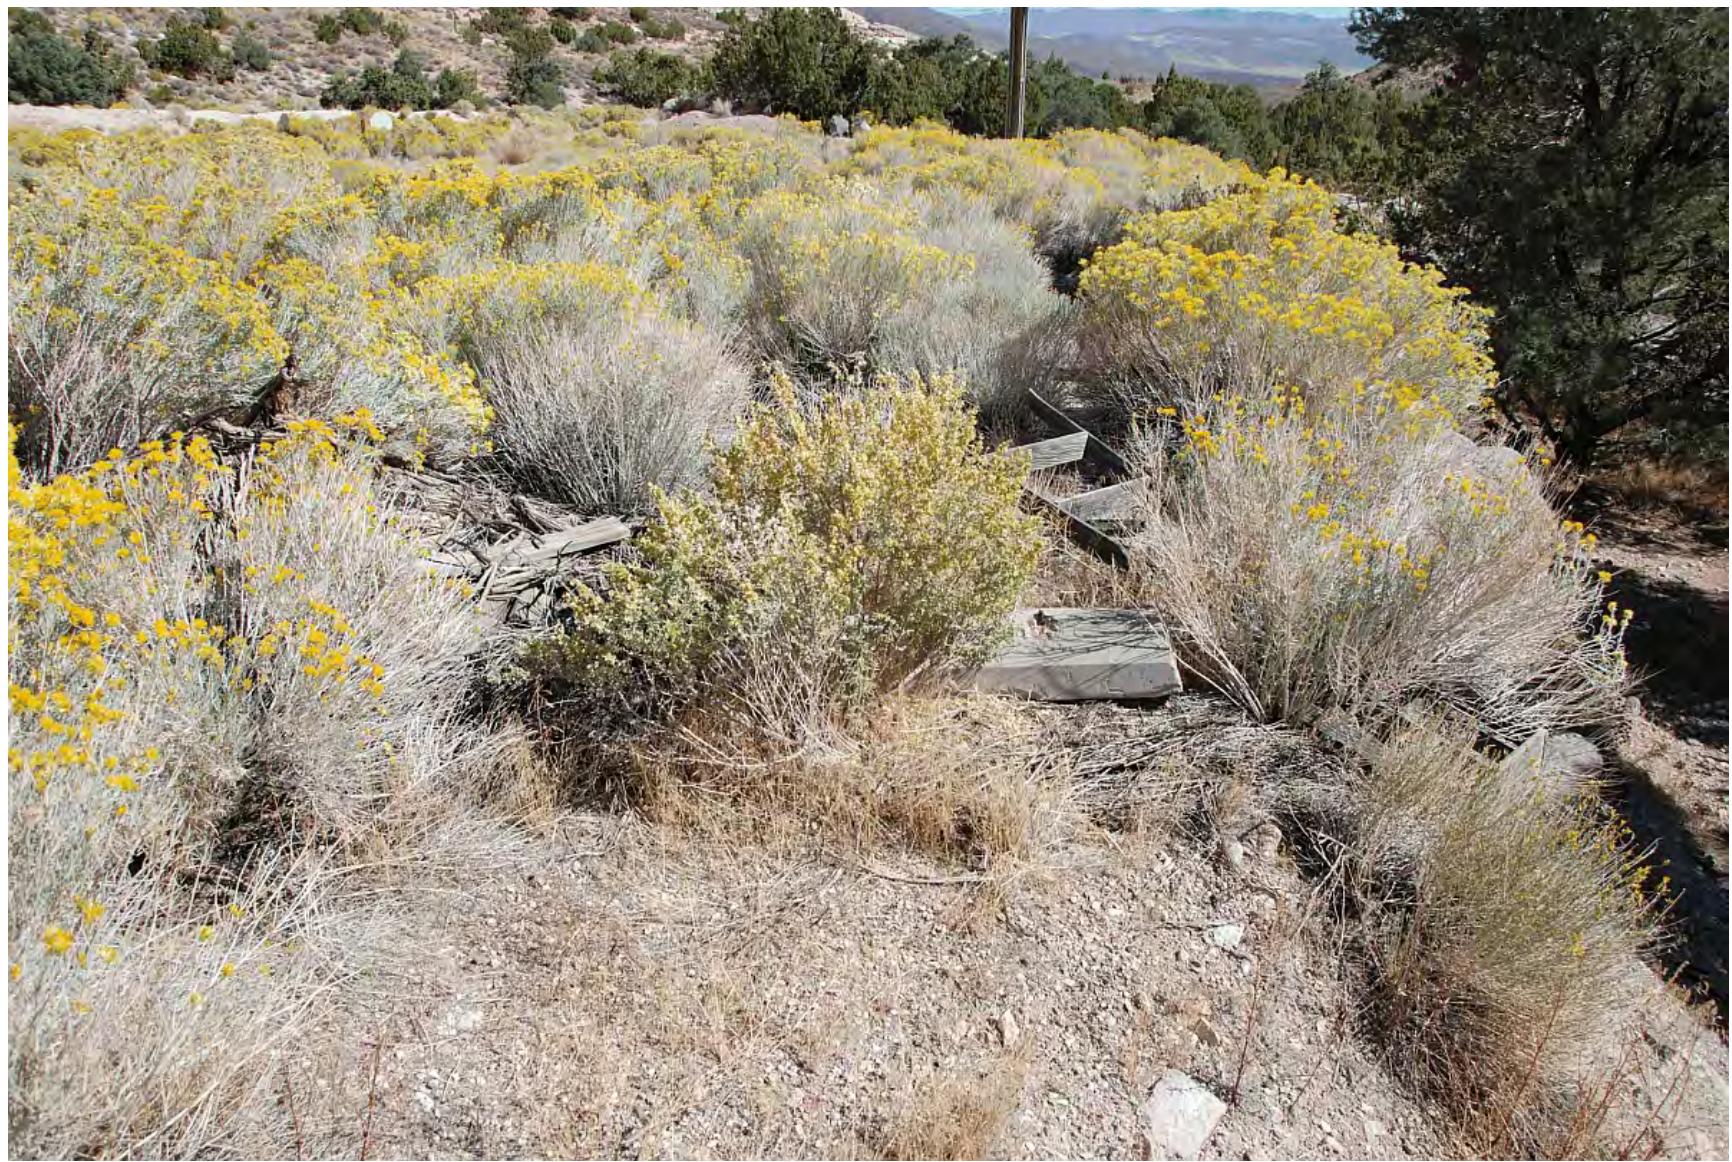
Feature 67 (Figure 221) is concrete barriers (parking curbs) and a ladder at UTM coordinates 572093 E, 4116987 N at the parking area. The 12 barriers are 1 ft wide at the base, 6 inches in height in the center, and 8 ft long and form a trapezoid or triangle in end view. The barriers are not stacked but randomly placed and most are broken. The wood step ladder is 8 ft tall, broken, and appears to have been discarded at this location.

Figure 221. Feature 67, concrete barriers (parking curbs) and ladder, U12n Tunnel, view northeast (2008).

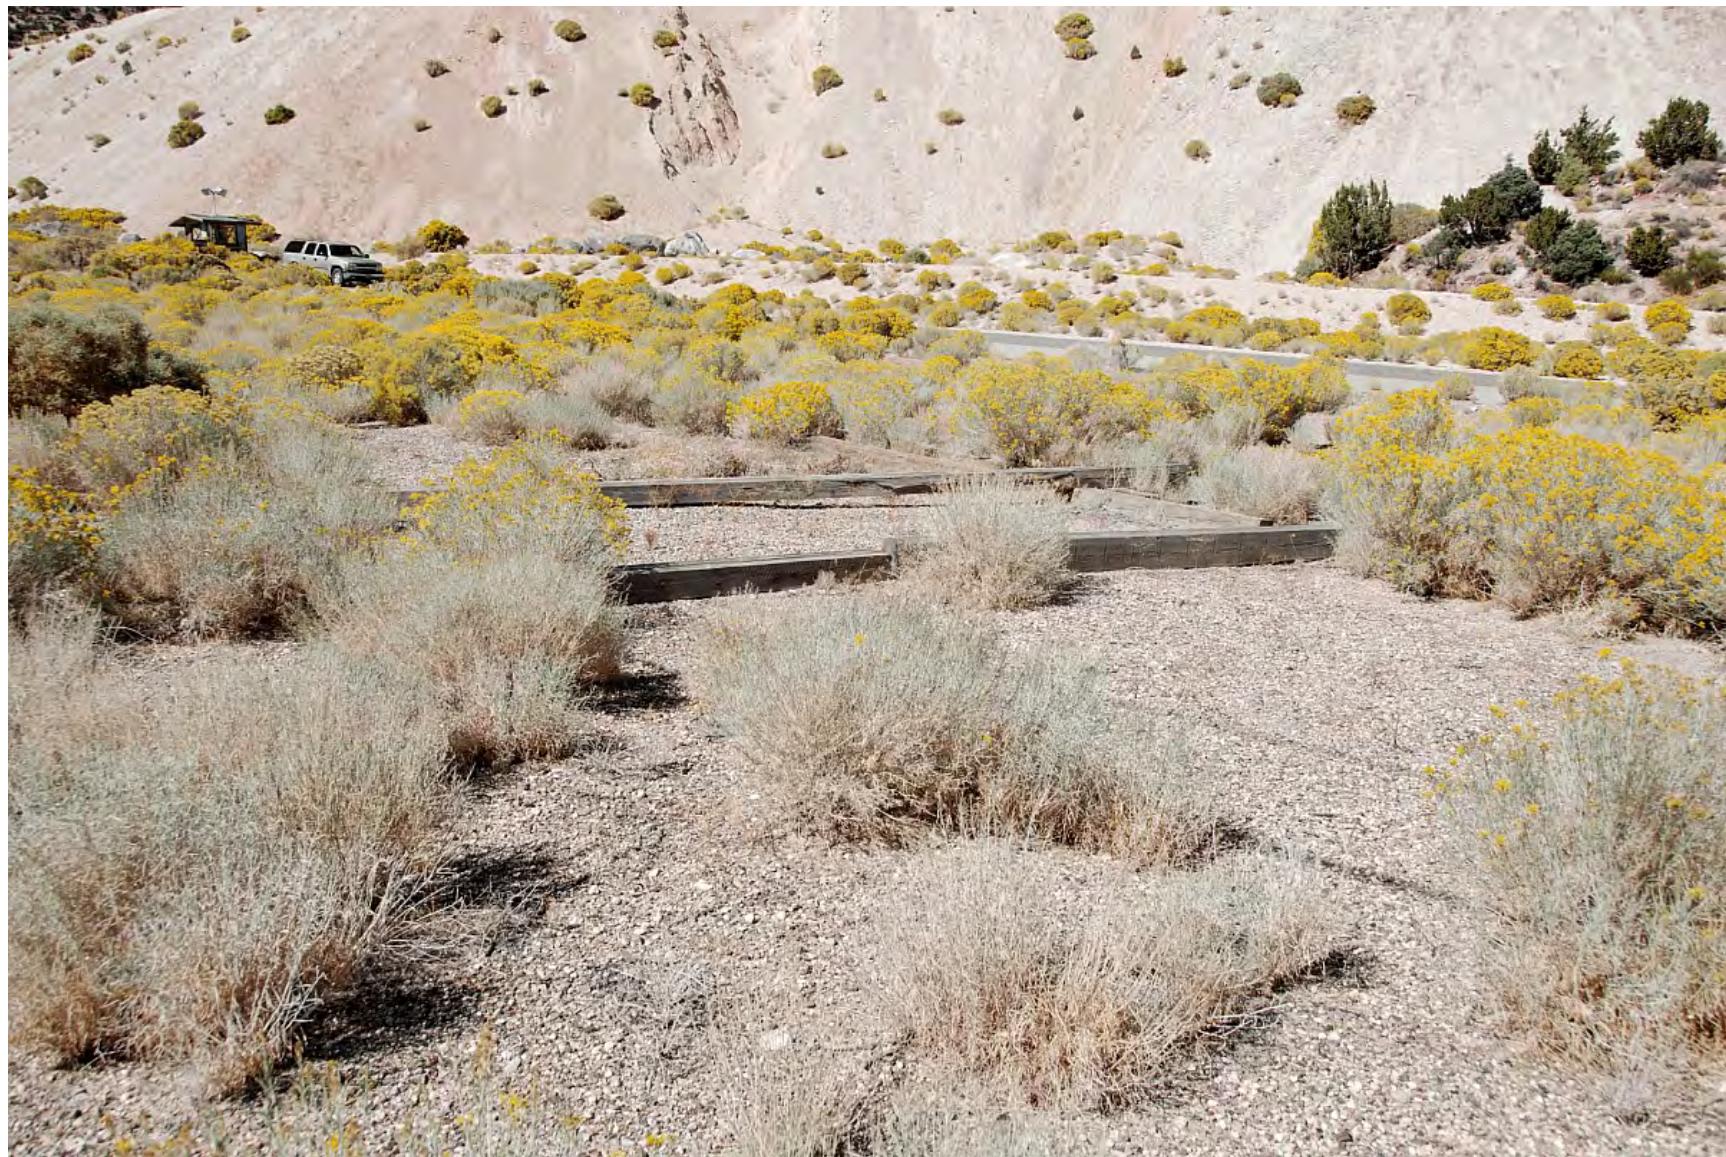
Feature 68 (Figure 222) is milled lumber beams at UTM coordinates 572105 E, 4117005 N at the parking area. The beams form a partial rectangle that measures 20 ft north-south by 20 ft east-west. Two 6 x 8 inch milled lumber beams that are 10 ft long have been placed end to end forming the north, east, and south sides. There are no beams on the west side. A 16 ft long beam has been placed north-south midway on the feature. No use for the feature has been determined at this time.

Figure 222. Feature 68, wood beams, U12n Tunnel, view northwest (2008).

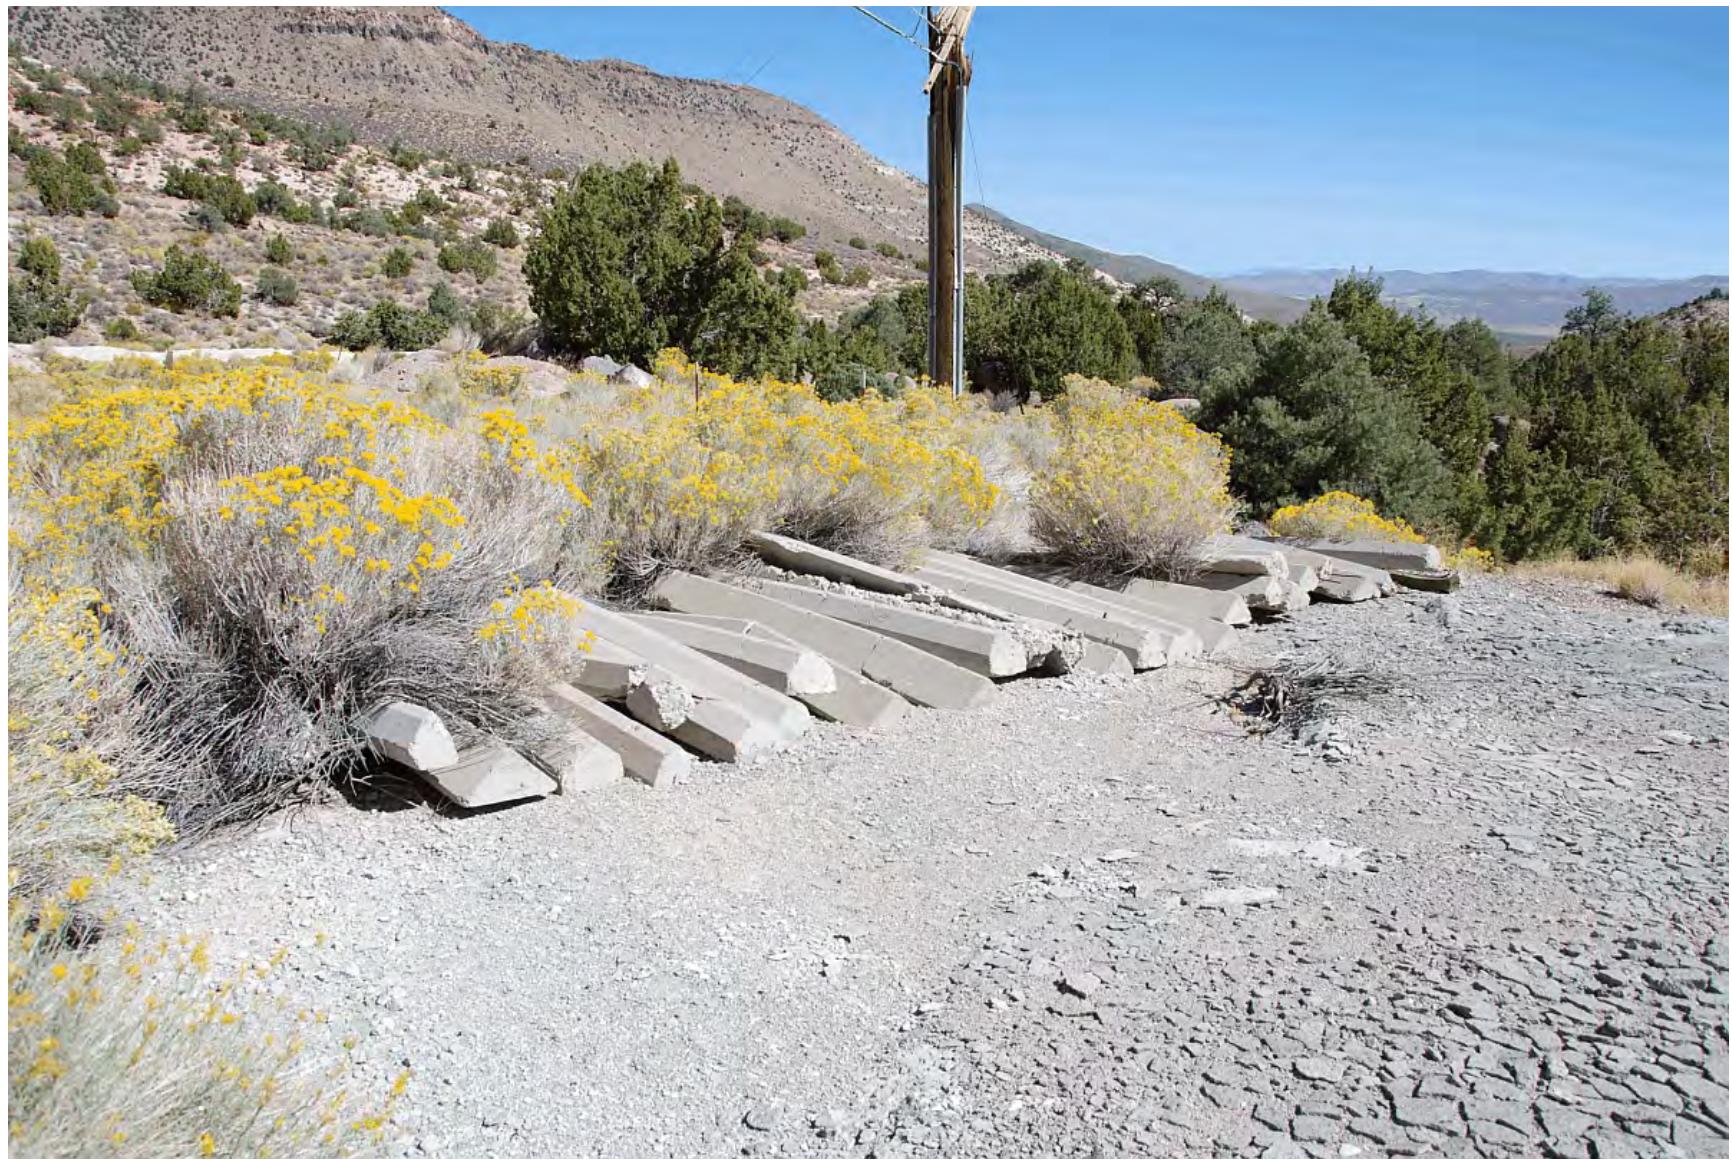
Feature 69 (Figure 223) is a concrete barriers (parking curbs) and a metal sign at UTM coordinates 572127 E, 4116989 N at the parking area. Two types of barriers are present. One type is 1 ft wide at the base, 6 inches in height in the center, 8 ft long, and forms a trapezoid in end view. The second type is 1 ft wide at the base, 6 inches in height, and is triangular in end view. Unlike the barriers at Feature 70, these have been placed side by side. Also, the surface around the barriers has been covered with a thin layer of concrete that is deteriorating. A white metal sign with black lettering, lying on the surface, is labeled NO DUMPING OR WASH OUT. The metal sign was attached to plywood backboard on a 4 x 4 inch post that is 3 ft in height (standing).

Figure 223. Feature 69, concrete barriers (parking curbs), U12n Tunnel, view northeast (2008).

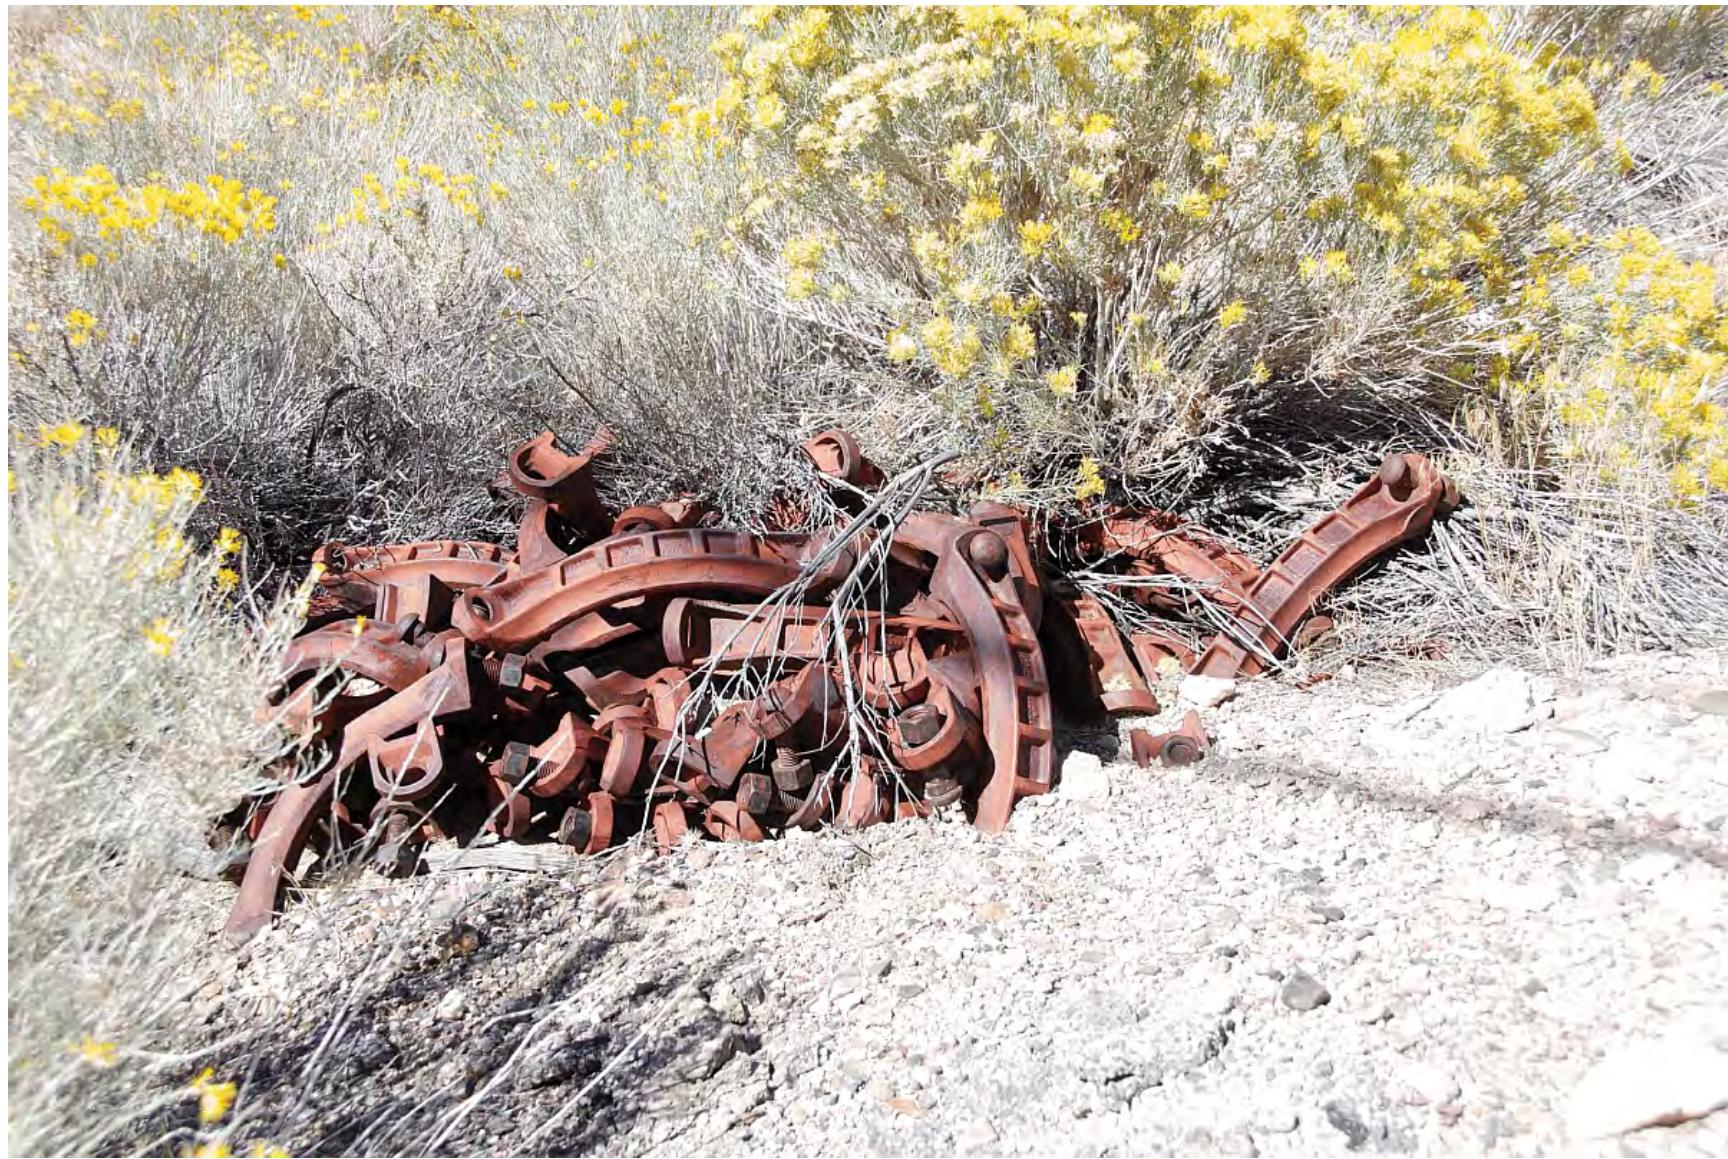
Feature 71 (Figure 225) is pipe clamps at UTM coordinates 572130 E, 4116997 N at the parking area. The clamps are 20 inch Victaulic style and made by Gustin Bacon. The clamps are in a pile and no rubber gaskets were found.

Figure 225. Feature 71, pipe clamps, U12n Tunnel, view northwest (2008).

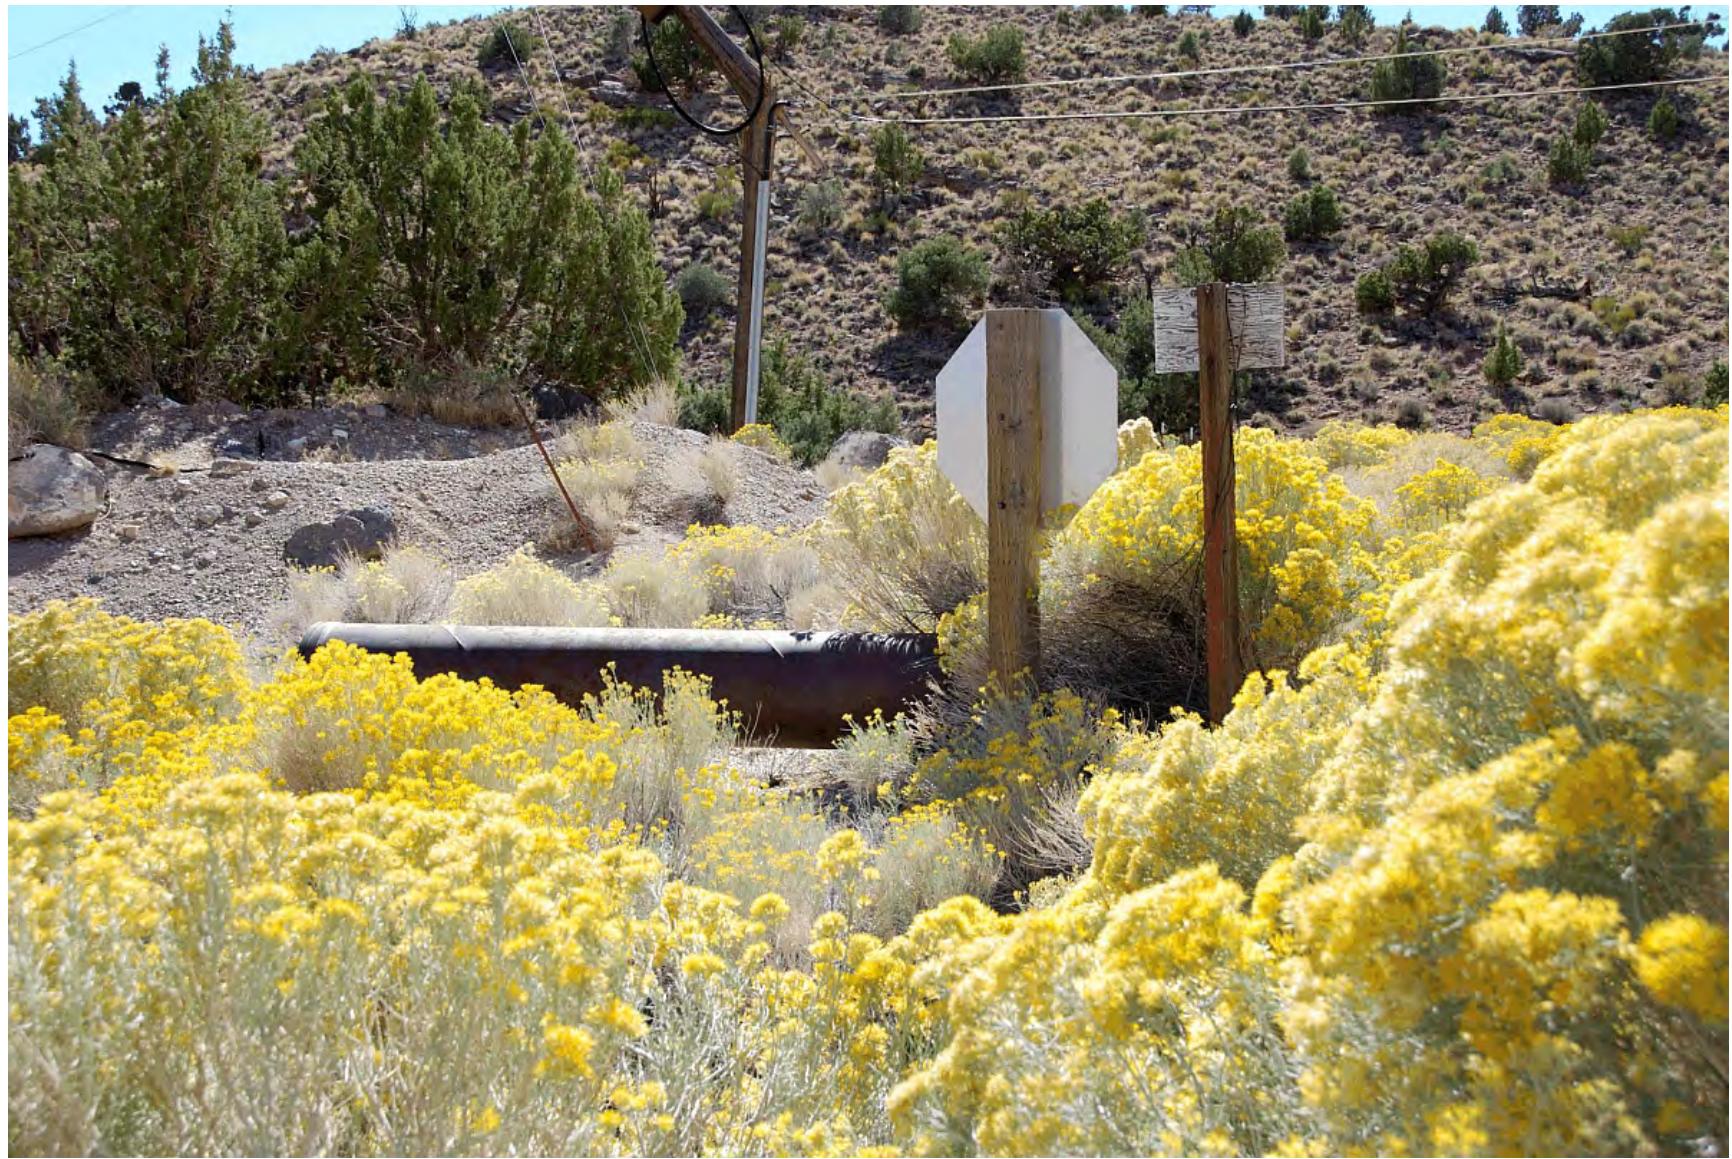
Feature 72 (Figure 226) is two signs and a pipe at UTM coordinates 572137 E, 4117015 N at the parking area. A metal stop sign is mounted to a 6 x 6 inch post that is 5 ft 11 inches (1.8 m) in height. Three feet to the west is a second sign that consists of a 1 ft 6 inch x 11 inch piece of plywood mounted on a 4 x 4 inch post that is 6 ft 1 inch (1.9 m) in height. The black lettering on the white painted plywood has faded and is not legible. On the surface south of the signs is a 10 ft long,

Figure 226. Feature 72, signs and pipe, U12n Tunnel, view southeast (2008).

1 ft 8 inch diameter spiral welded Victaulic style grooved pipe. The pipe is the same diameter as the clamps at Feature 71.

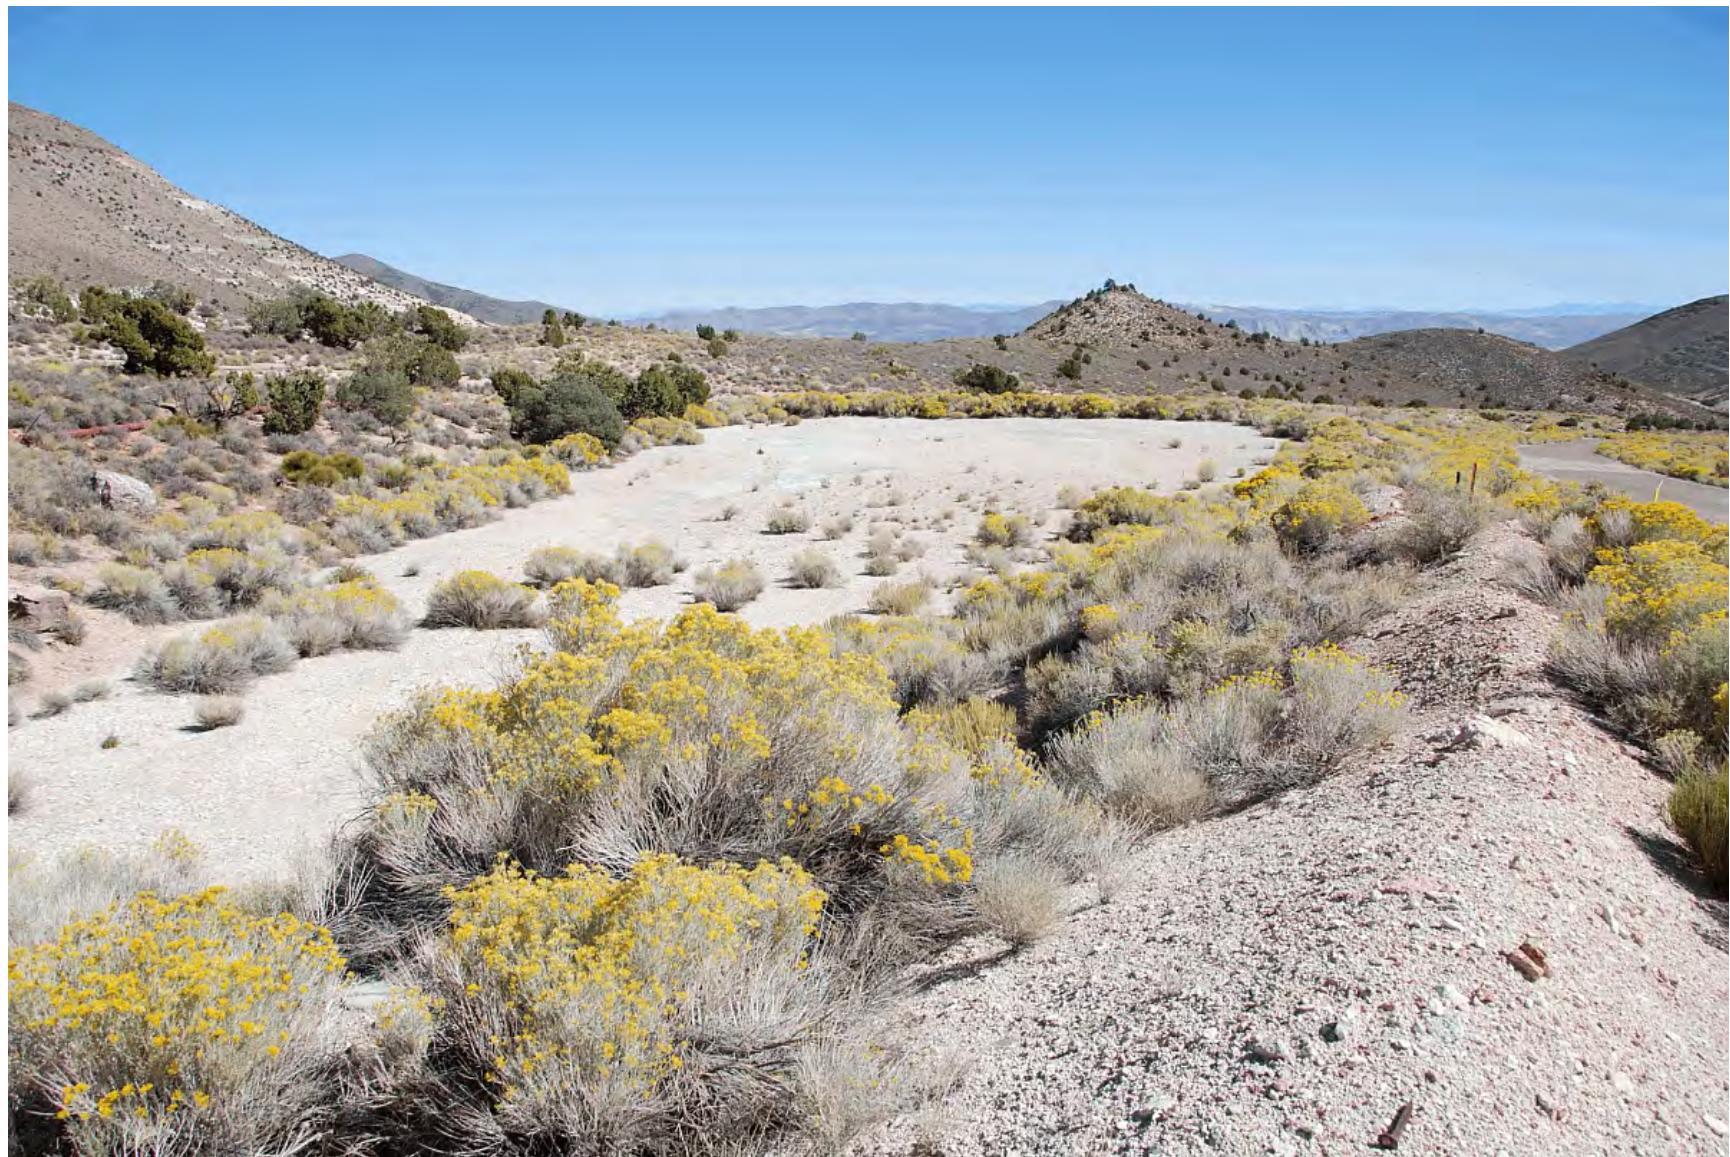
Figure 228. Feature 73, pond 1, U12n Tunnel, view east (2008).

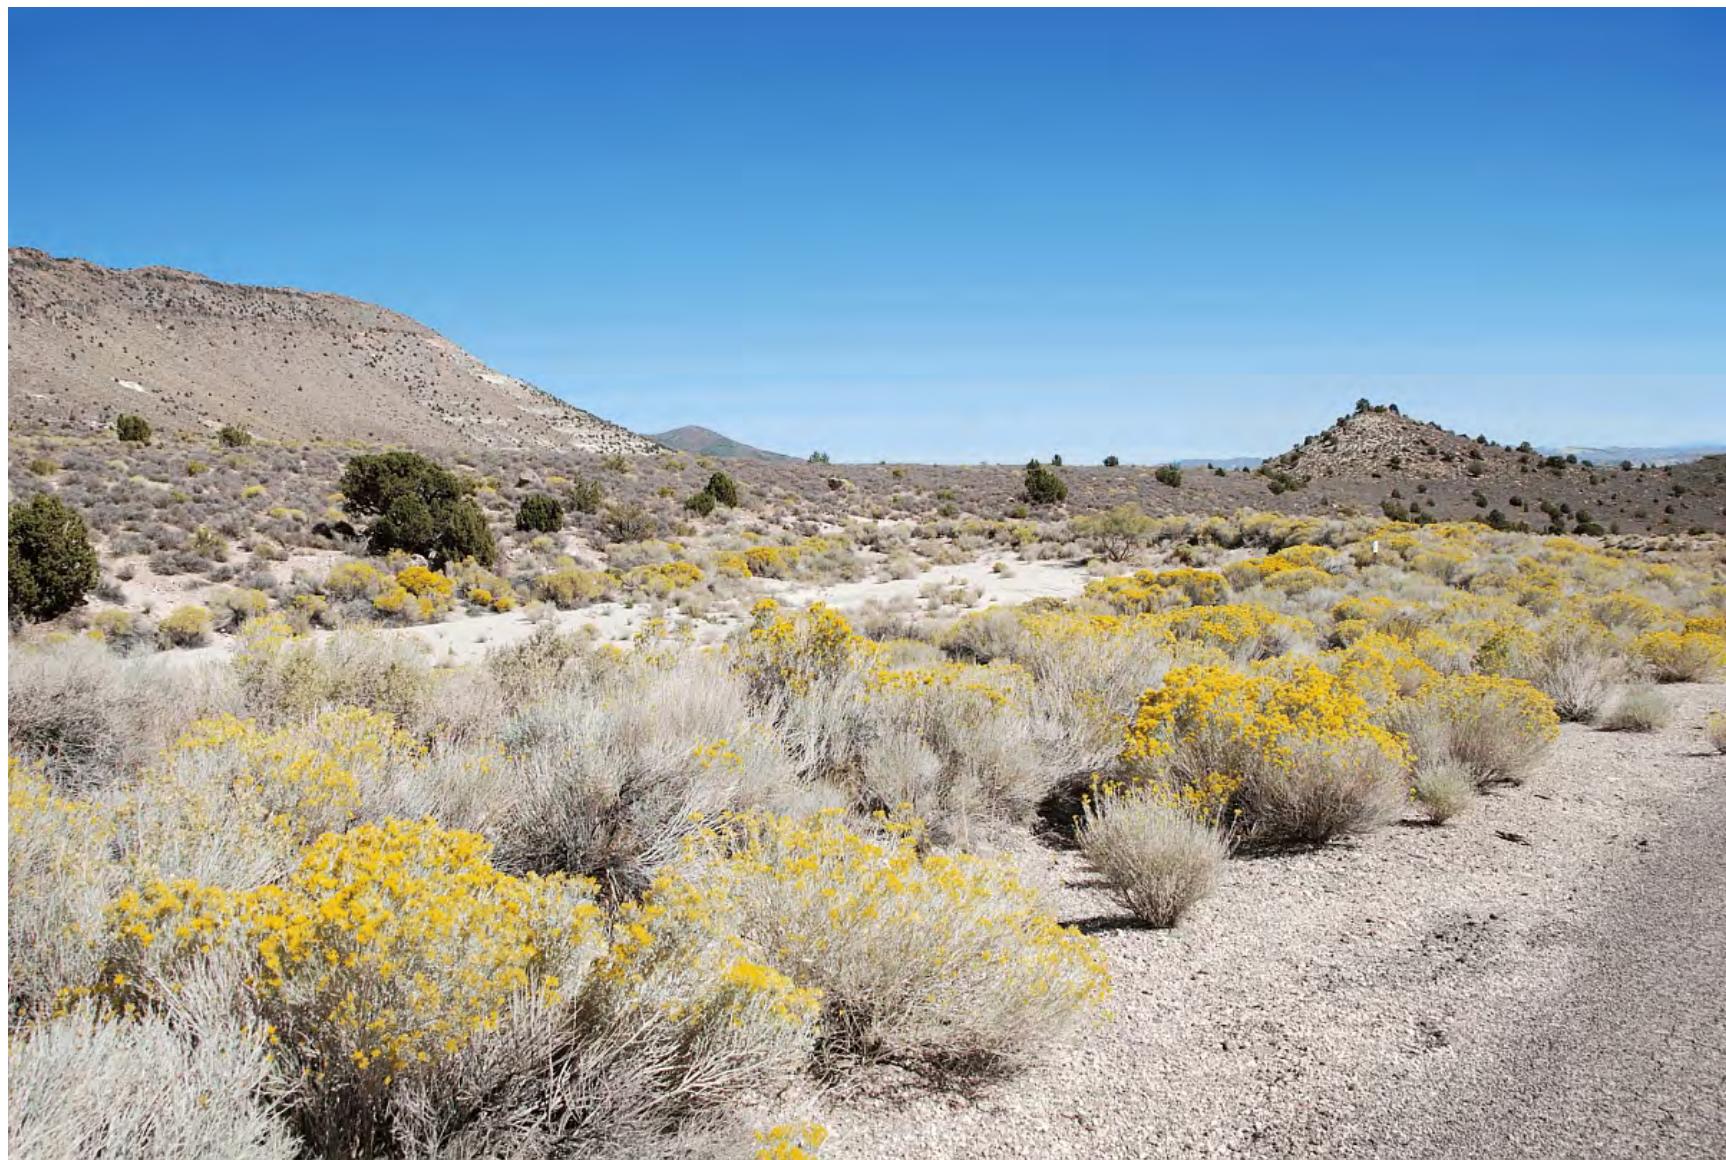
Figure 229. Feature 74, pond 2, U12n Tunnel, view northeast (2008).

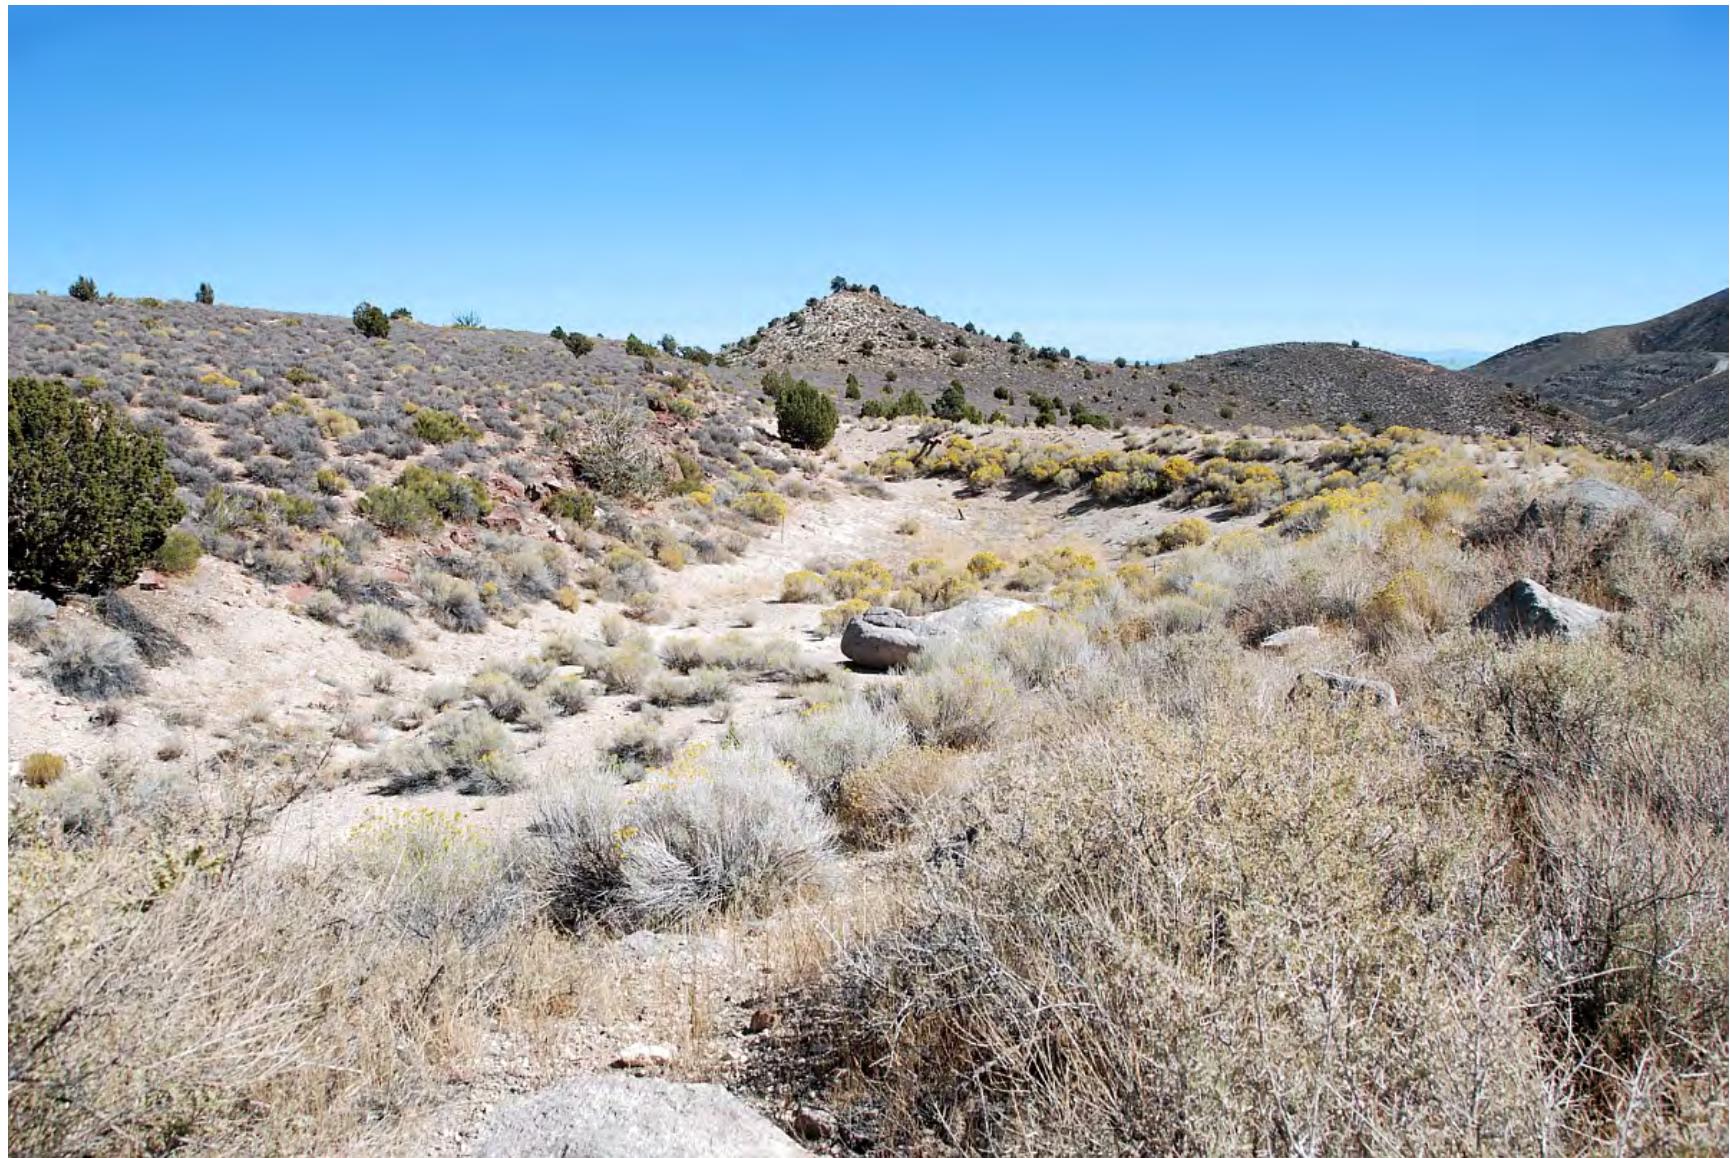
Figure 230. Feature 75, pond 3, U12n Tunnel, view southeast (2008).

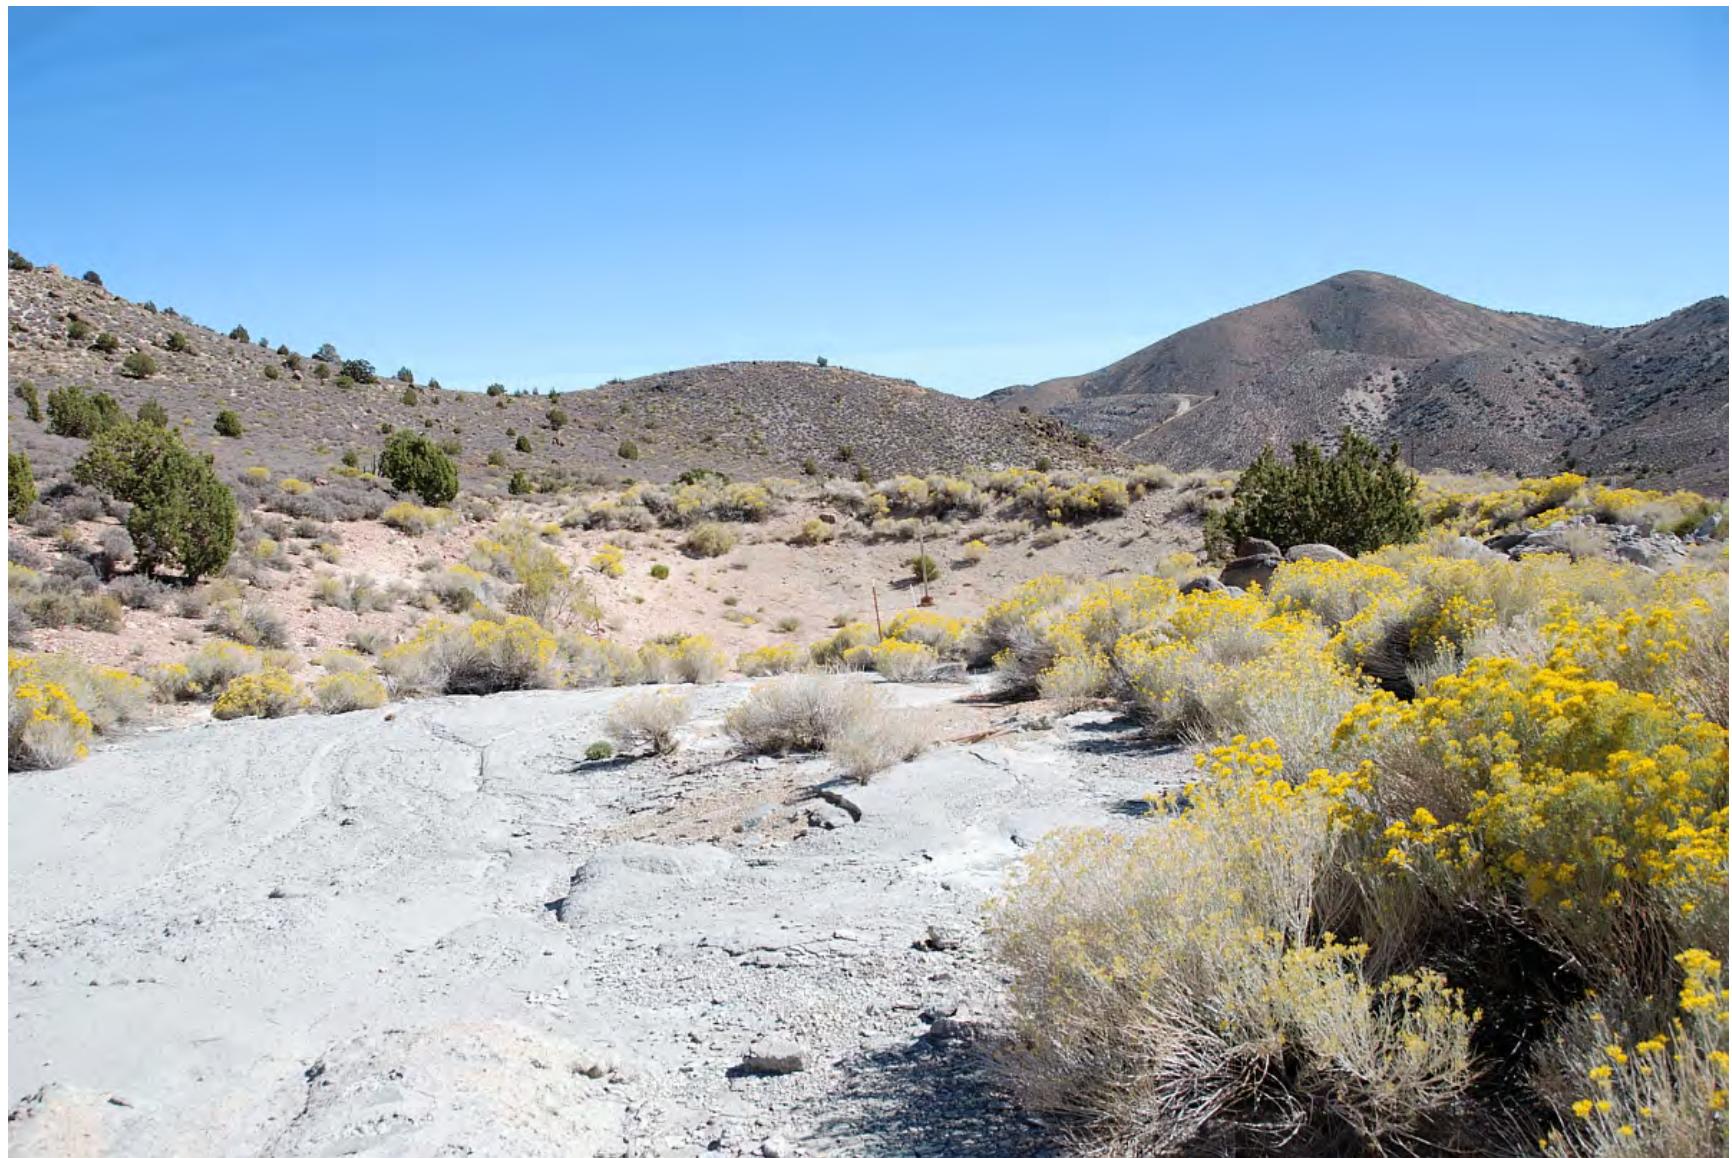
Figure 231. Feature 76, pond 4, U12n Tunnel, view southeast (2008).
