A total of 202 features were recorded, mapped, and photographed for the U12n Tunnel complex. The project area encompassed 600.8 acres (243.1 hectares) at the portal and mesa areas. At the U12n portal area are ten sub-areas containing features related to the construction, testing, and general everyday activities within the tunnel. These include concrete foundations for buildings, communications equipment, mining equipment, rail lines, retention ponds, storage containers, and access control facilities. Only a telephone trailer remains on the telephone pad as all of the other buildings have been removed from the portal area. The microwave tower, portions of the rail lines, the muck car dump, rotary dump, and wash rack are still in place. Also, the traffic control point and powder magazines along N Tunnel Road are intact. At the mesa area are four sub-areas containing features generally related to pre- and post-shot drilling, recording facilities, and ventilation equipment. These include concrete foundations, instrument cable holes, and drill holes. The concrete foundations were for buildings and small equipment. Concrete pads and various equipment remain at the cable hole locations bu

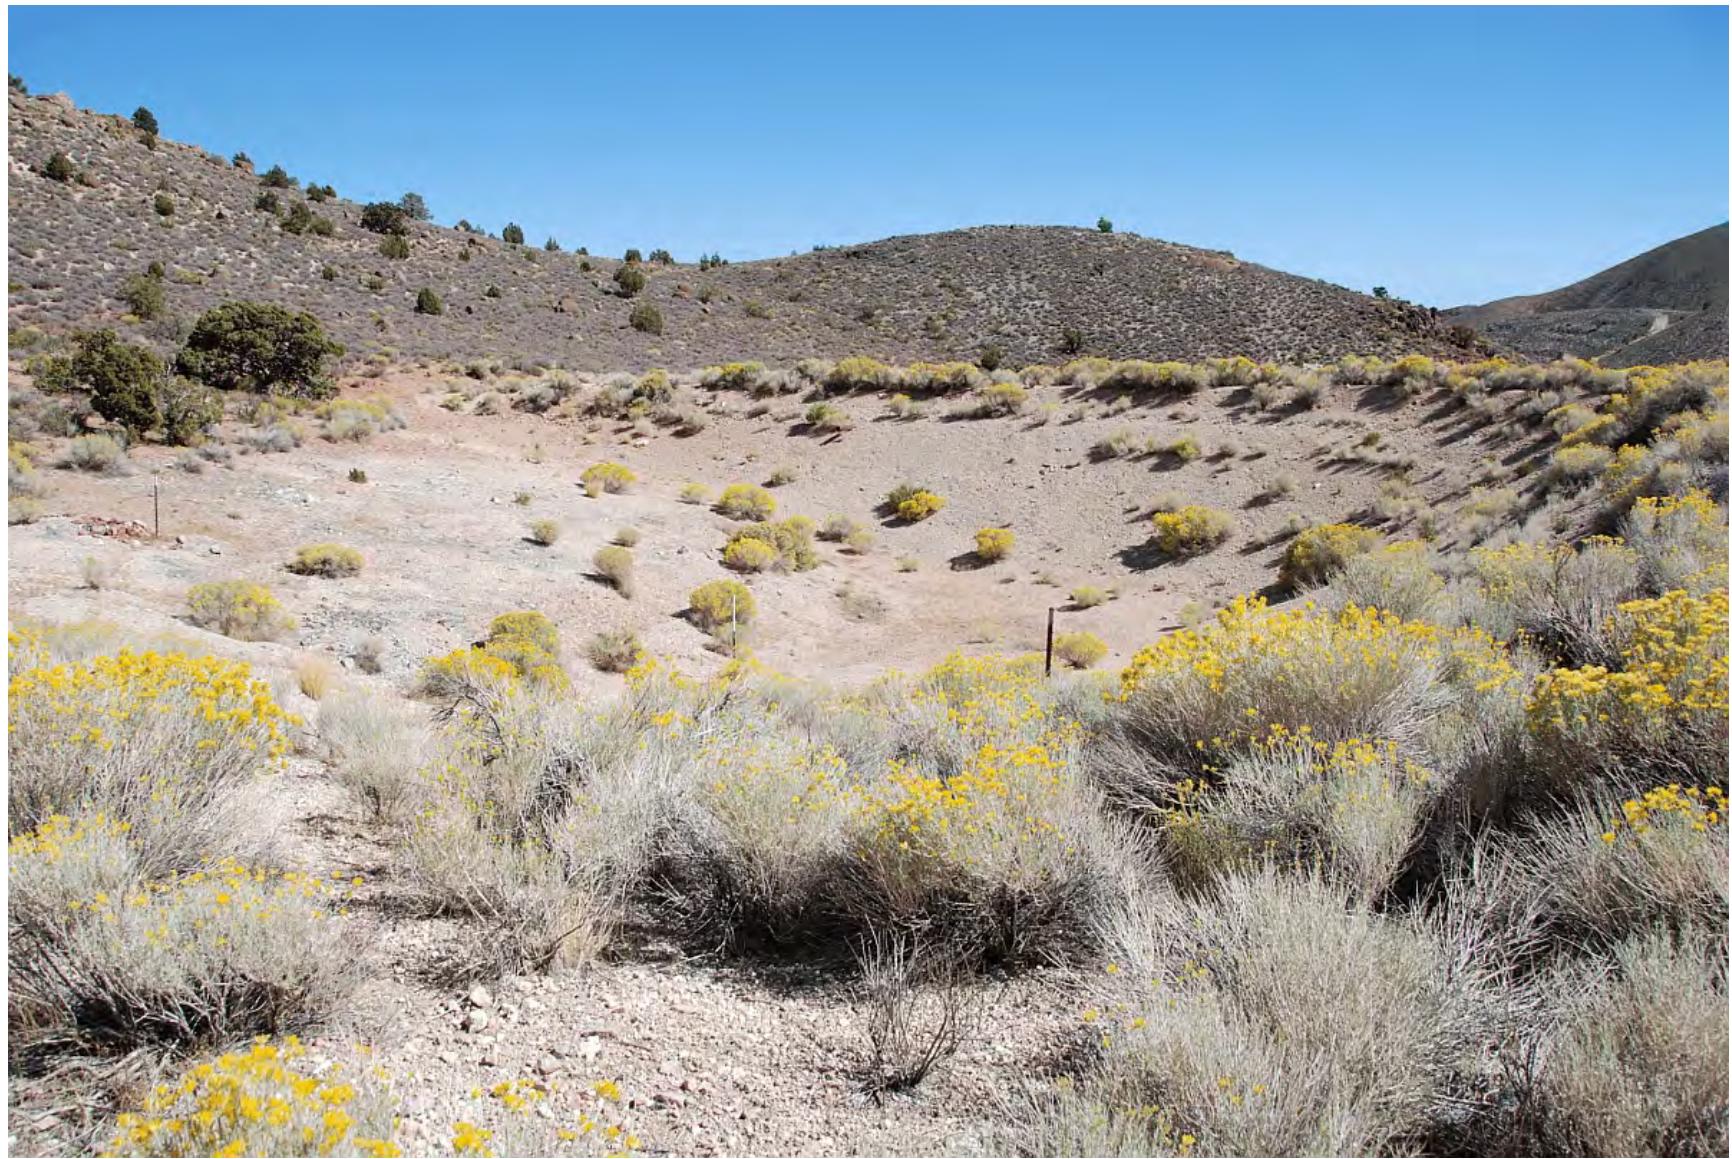
Figure 232. Feature 77, pond 5, U12n Tunnel, view southeast (2008).

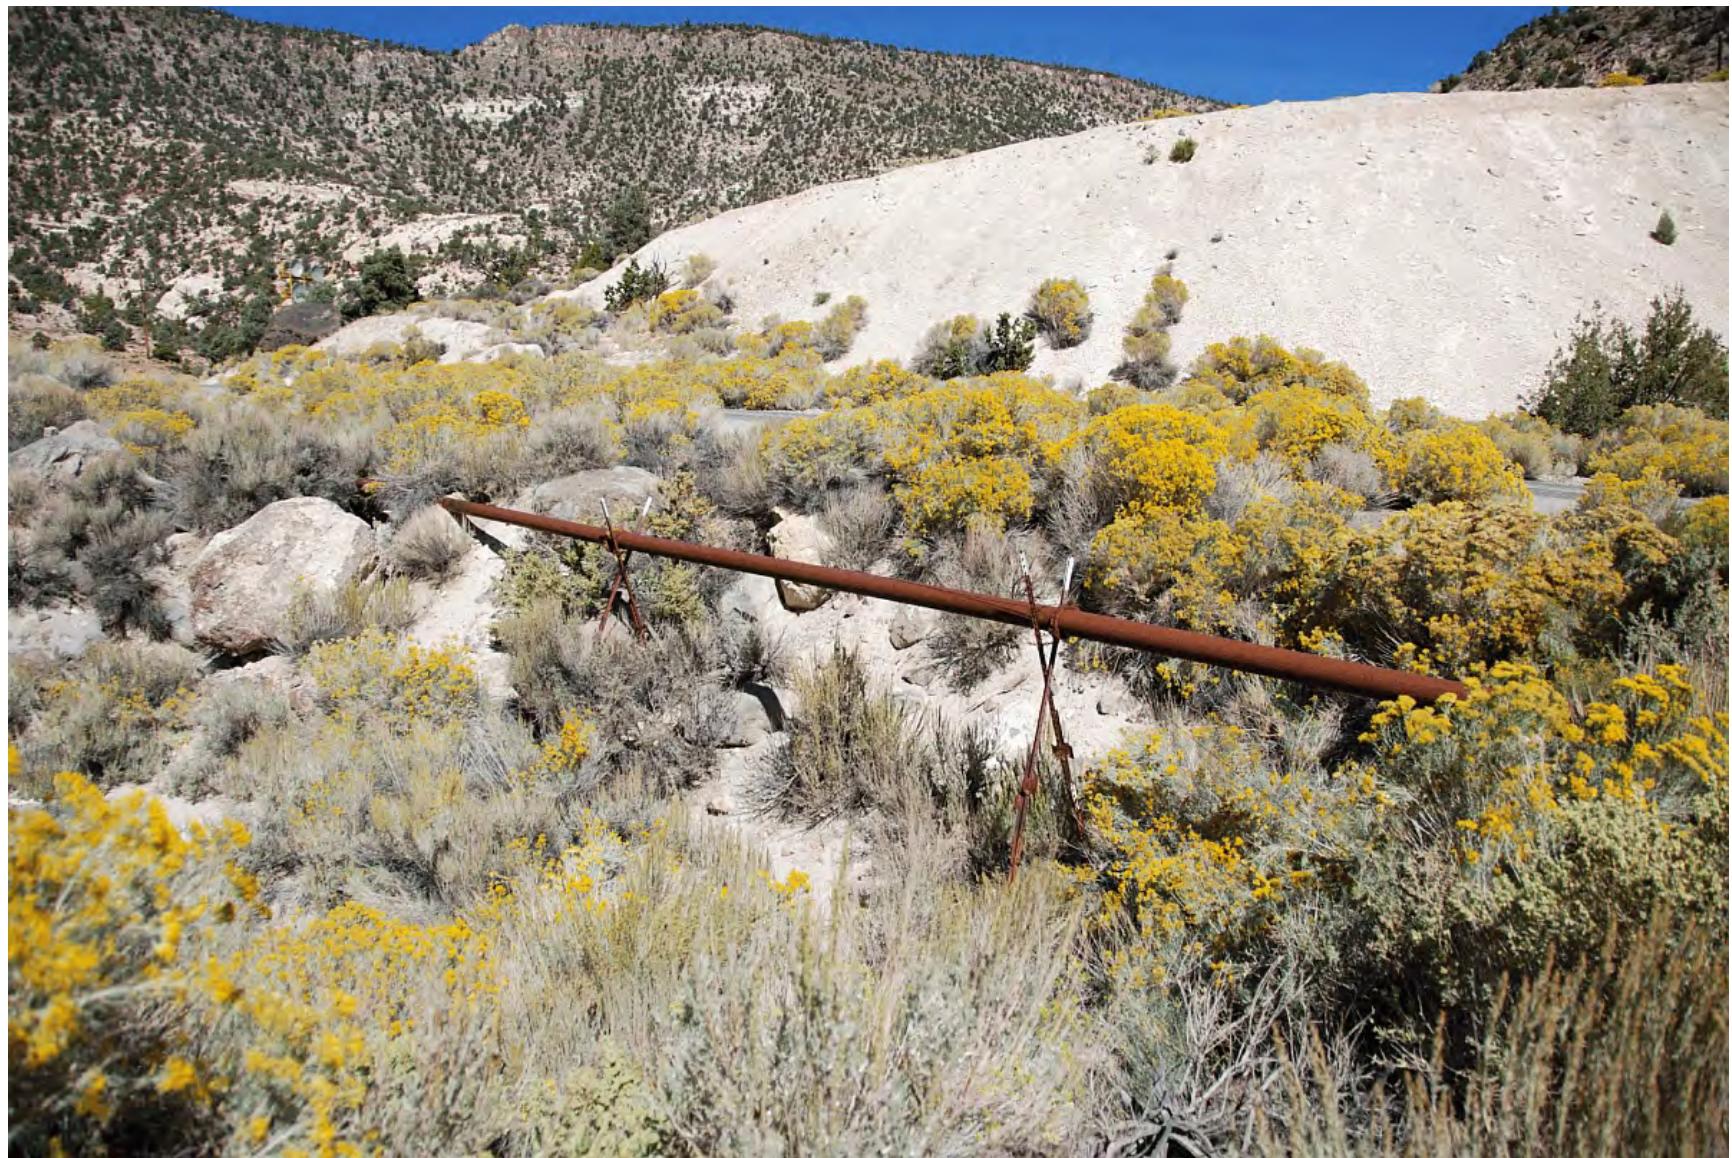
Figure 233. Feature 78, pipeline, U12n Tunnel, view north (2008).

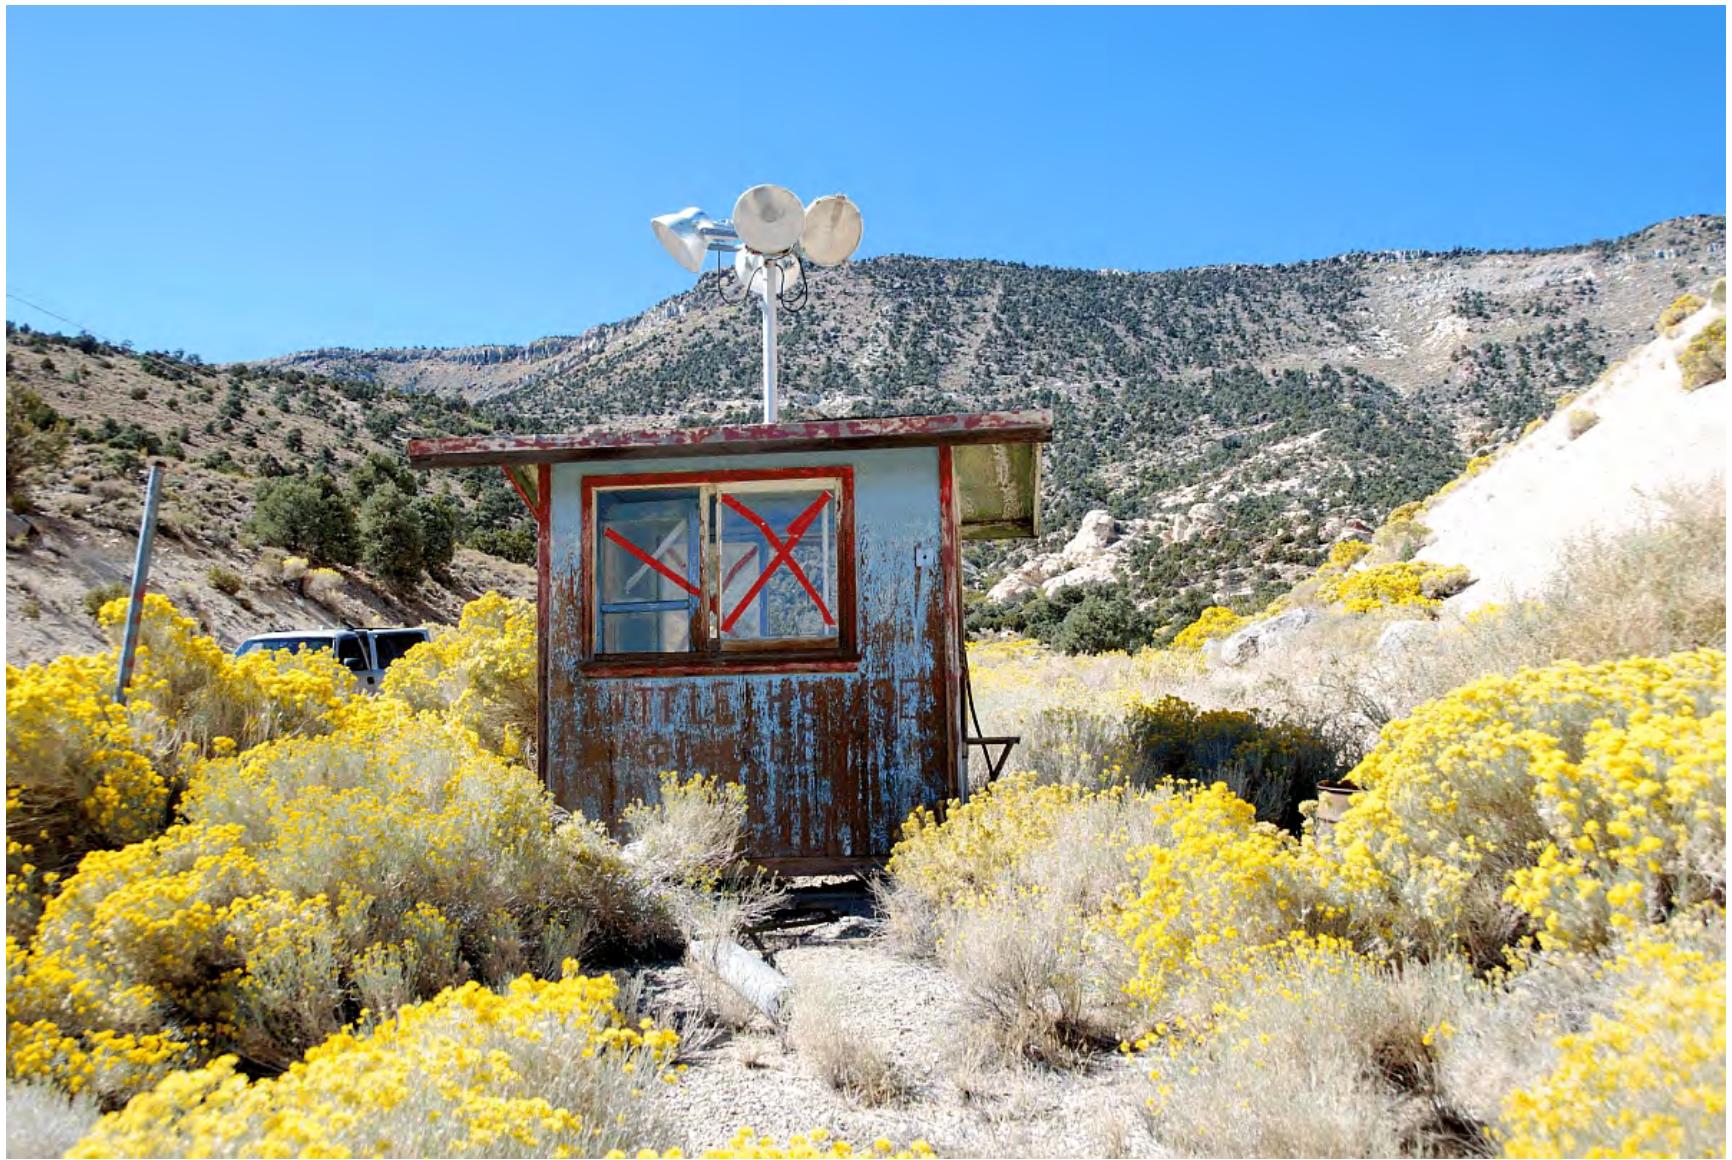
Feature 79 (Figure 234) is a wood building, rock wall, panel box, and barricade along the N Tunnel Road at UTM coordinates 572034 E, 4117037 N and an elevation of 5,860 ft (1,786.1 m). The building served as a traffic control point for access to the U12n Tunnel Complex. It is 8 ft 2 inches north-south, 6 ft 3 inches (1.9 m) east-west, 8 ft in height, and constructed of 2 x 4 inch milled lumber framing and 1/2-inch plywood sheeting. The roof is gabled (north-south) and drops 1 ft 9 inches from the ridge line to the eave. It has 2 x 4 inch rafters, no joists, and plywood decking. The decking is covered with rolled roofing material. The roof extends 2 ft from the exterior facades of the building. Centered on the ridge line is a 2 1/2-inch pipe approximately 4 ft in height. On top of the pipe are four 1 ft 4 inch diameter flood lights. The shack is mounted on 6 x 6 inch skids.

Centered in the south facade is a 2 ft 8 inch wide by 6 ft 8 inch tall door opening. The door has two (vertical) 2 ft 8 inch wide by 1 ft 9 inch tall plexiglass windows in the top section. The bottom of the door has a piece of 1/2-inch plywood nailed to the exterior surface. The west facade has a 5 ft x 3 ft 4 inch horizontal double sliding wood framed window with an aluminum screen. Near the north corner on the west facade is a 1 ft 1/2 inch x 8 1/2 inch x 4 1/2 inch (30.6. x 21.6 x 11.4 cm) electrical switch box. Centered in the north facade is a 5 ft x 3 ft 4 inch fixed wood-framed window

Figure 234. Figure 79, traffic control point building, U12n Tunnel, view west (2008).

opening. Plexiglass for the window is in on the floor below the opening. Centered below the window opening is a 1 ft 9 inch x 1 ft 2 inch plywood shelf. It is braced on each end with 2 x 4's placed diagonally across the corners and attached to the adjacent walls. In the east facade is a 5 ft x 3 ft 4 inch horizontal double sliding wood-framed window. The structure was originally painted blue or green with red trim. Painted in red on the east facade is LITTLE HOUSE ON THE HILL.

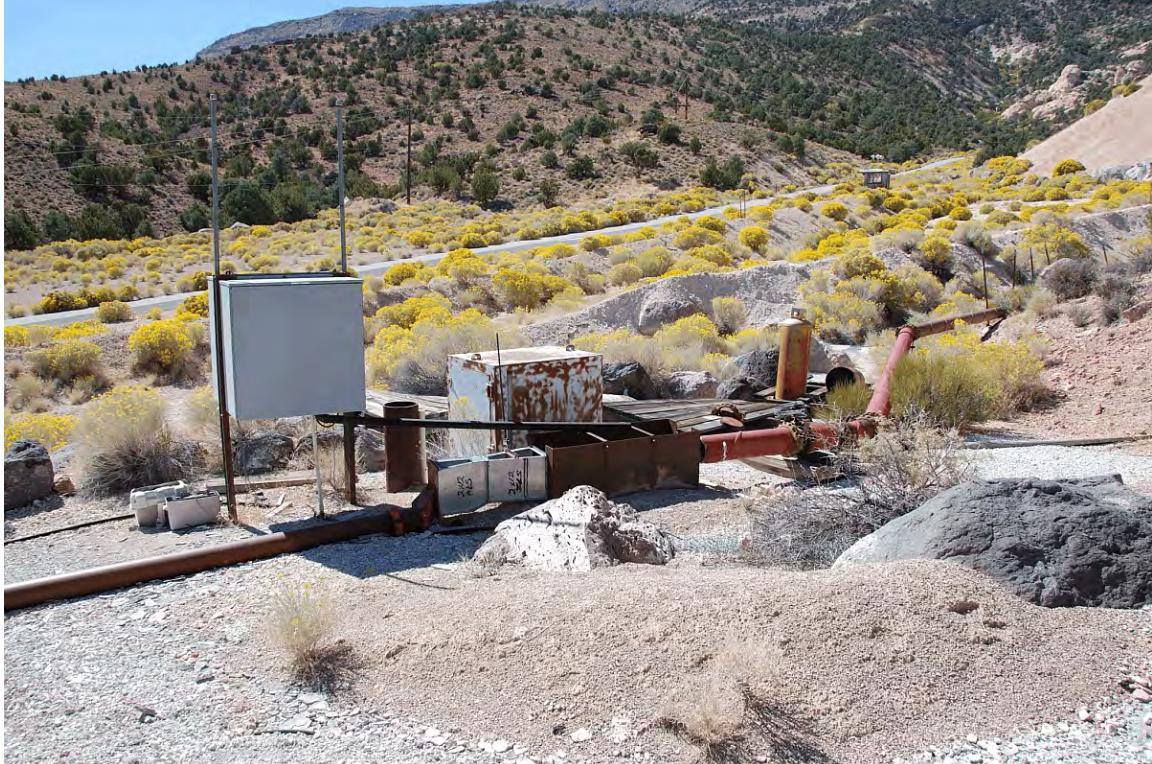
Feature 80 (Figure 235) is the tunnel drain discharge monitoring station on a pipe line at UTM coordinates 572126 E, 4117065 N and an elevation of 5,840 ft (1,780 m). The 6-inch metal Victaulic pipe line is north of the N Tunnel Road and visible above the surface for approximately 395 ft (120.4 m). The sampling station consists of two metering boxes, a possible instrument storage box, an electrical panel, a vertical pipe, two batteries, three wood pallets, and two compressed gas cylinders. The west metering metal box is 4 ft in length, 1 ft 6 inches in width, and 1 ft 6 inches tall. The box has no top and is open to access the flowing water that enters from the pipe on the west end. The second metering box is adjacent to the east edge of the first box and shaped like a bow tie. It is 3 ft long, 1 ft wide (at each end), and 1 ft 2 inches in height. The box reduces down to 3 inches in the center. A third metal box is 3 ft 6 inches east-west, 2 ft 6 inches north-south, south of the metering boxes, and is probably for instrument storage. Labeling on the box is N-Tunnel Pond EFF. Near the box is a 10 inch diameter metal pipe that extends 2 ft above the surface. Southeast of the metering boxes are two electrical panels mounted on two 6-inch channel iron legs that are 6 ft in height. The panels are 3 ft x 3 ft x 1 ft 5 inches and mounted back to back. Below the electrical panels are two 12 volt lead acid batteries. Three 8 ft x 4 ft wood pallets are south and west of the metering boxes and probably were used for decking above a possibly wet surface. At the west end of the pallets are two 4 ft long by 1 ft 2 inch diameter compressed gas cylinders.

Figure 235. Plan map and photograph of Feature 80, tunnel drain discharge monitoring station and waterline, U12n Tunnel, view southwest (2008).

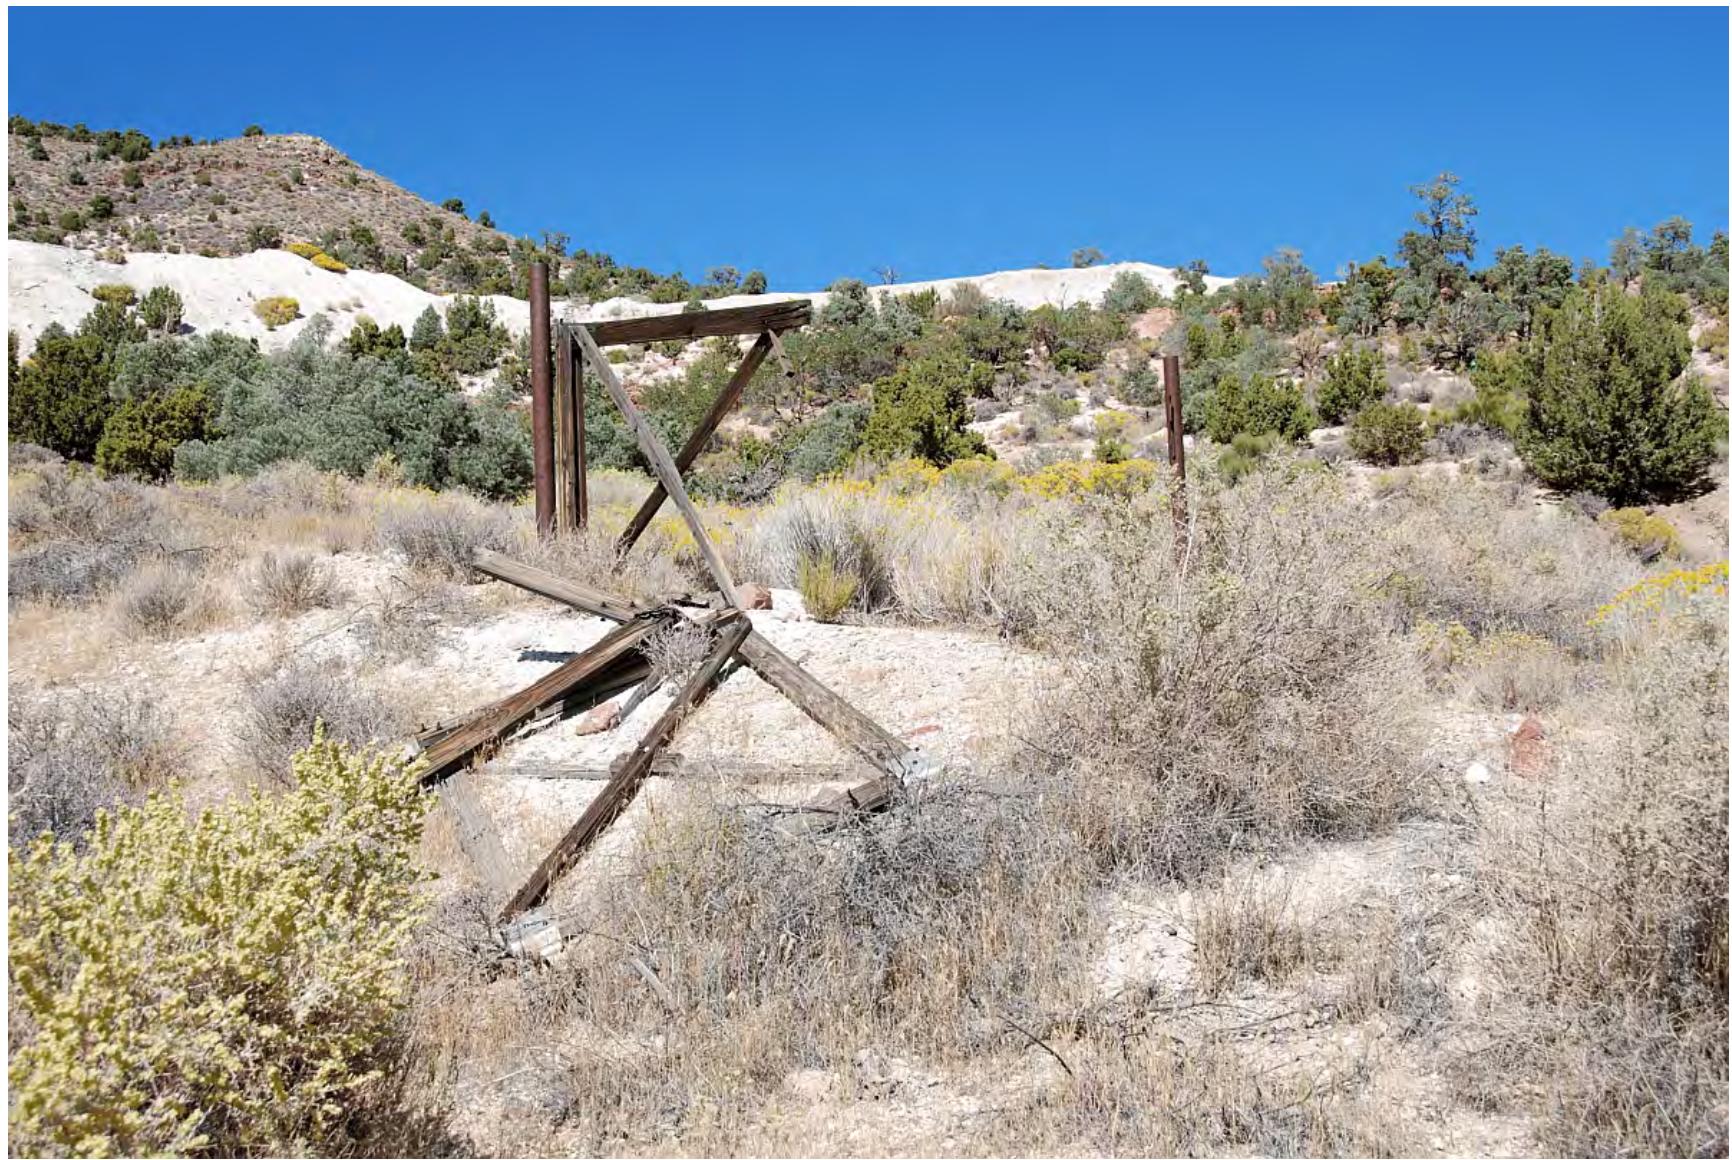
Figure 236. Feature 81, wood gate across original dirt access road, U12n Tunnel, view northwest (2008).

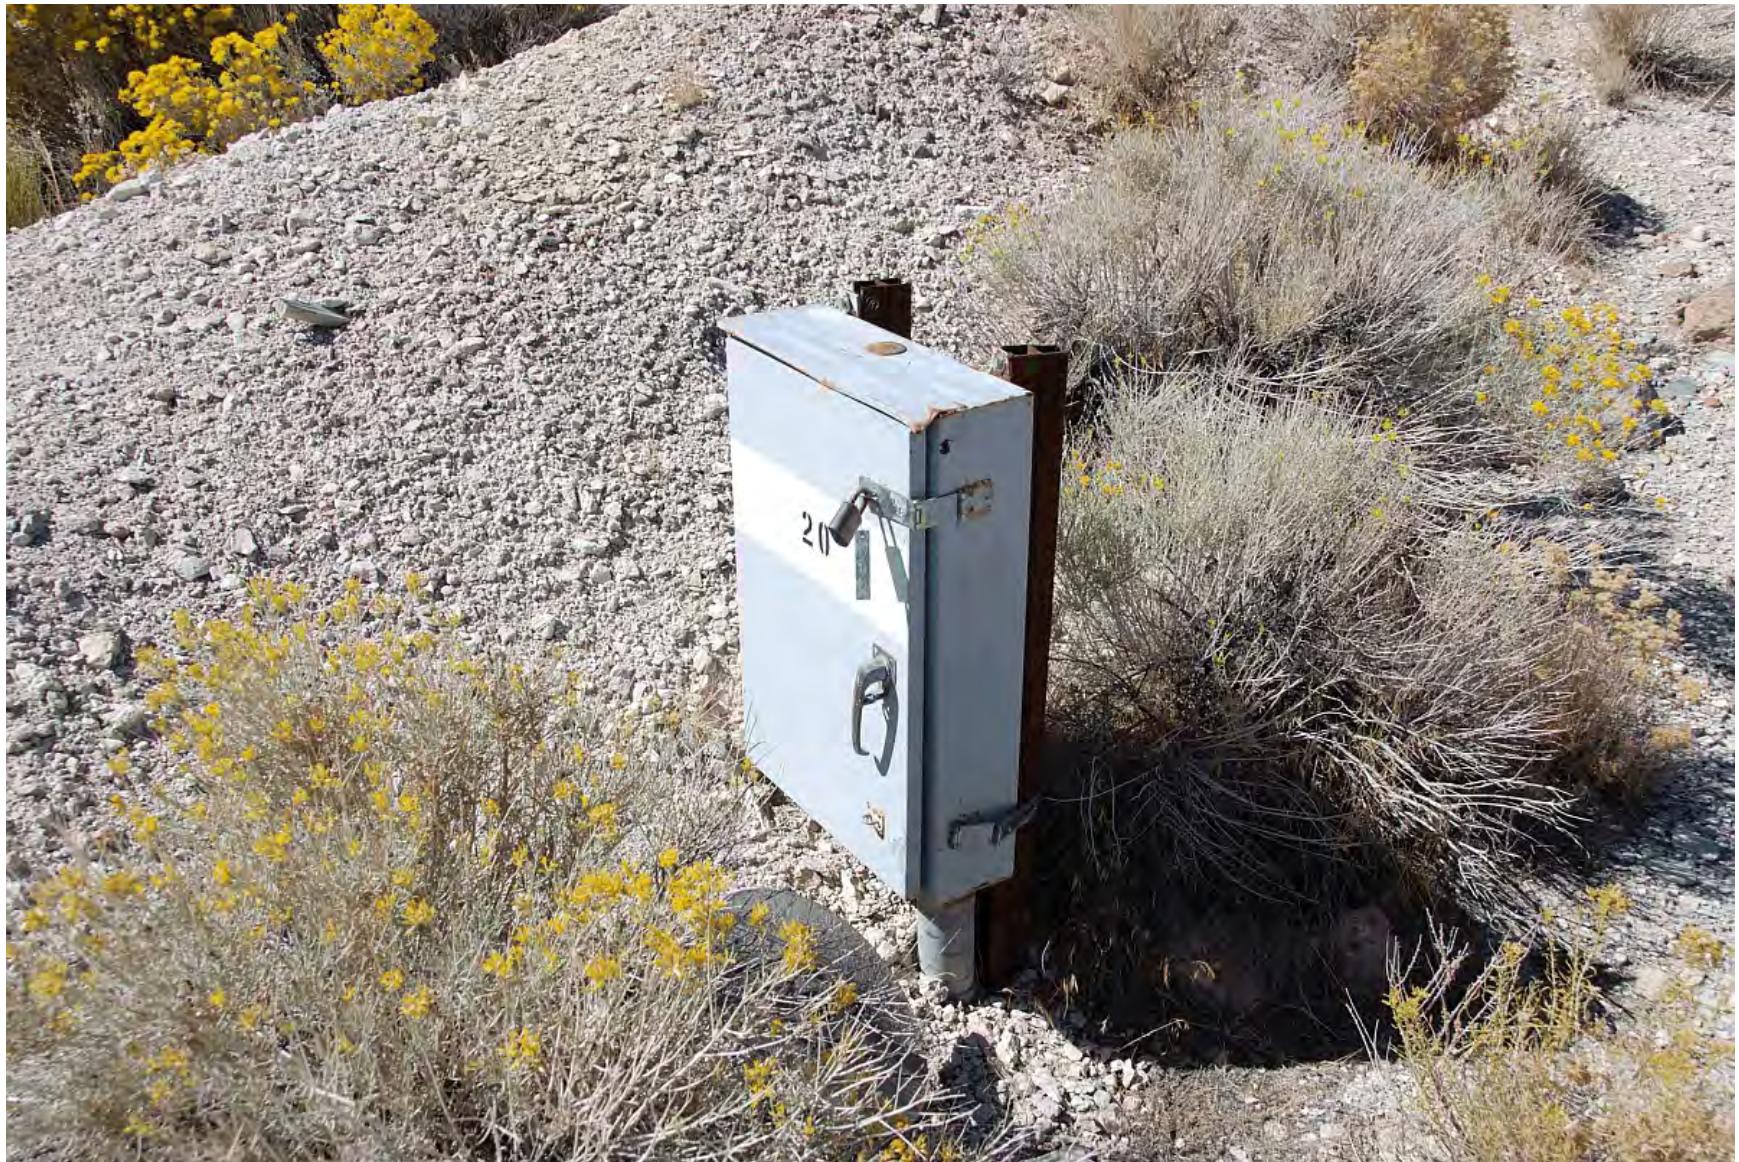
Figure 237. Feature 82, electrical panel, U12n Tunnel, view southwest (2008).

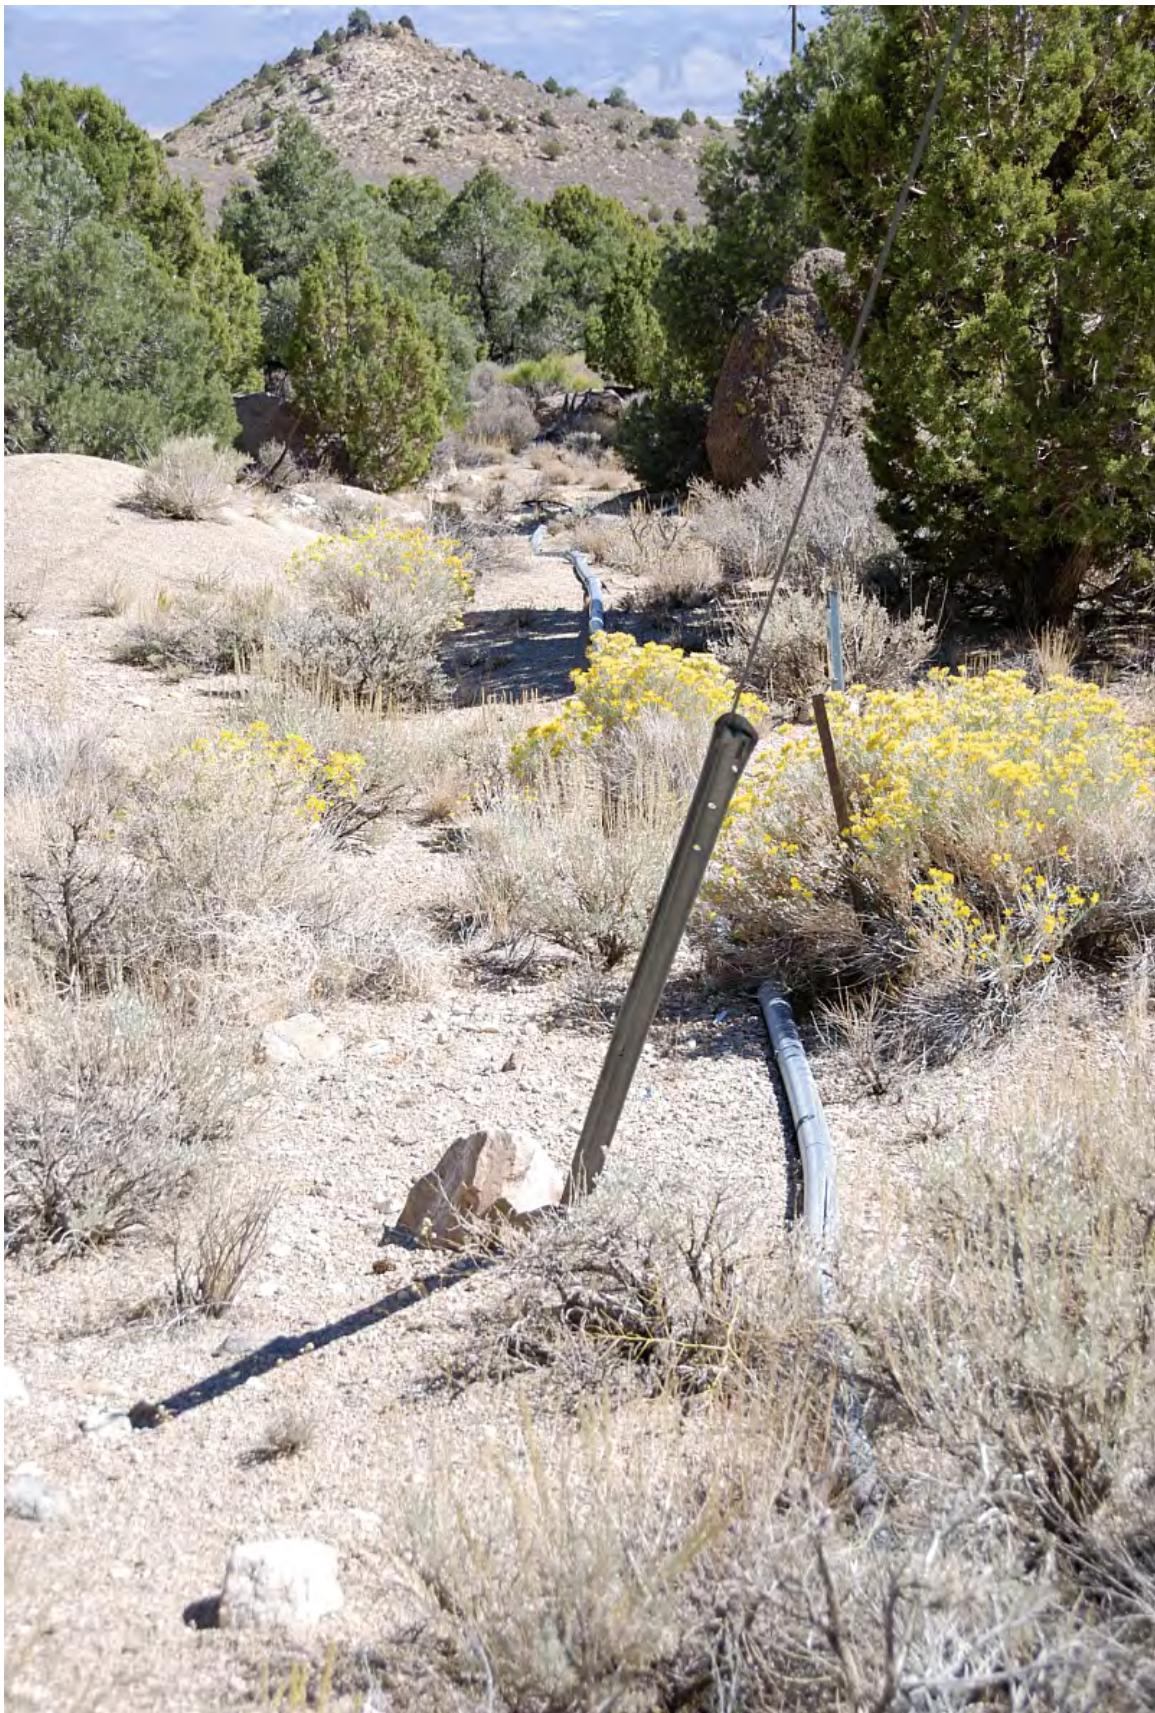
Figure 238. Feature 82, conduit, U12n Tunnel, view east (2008).

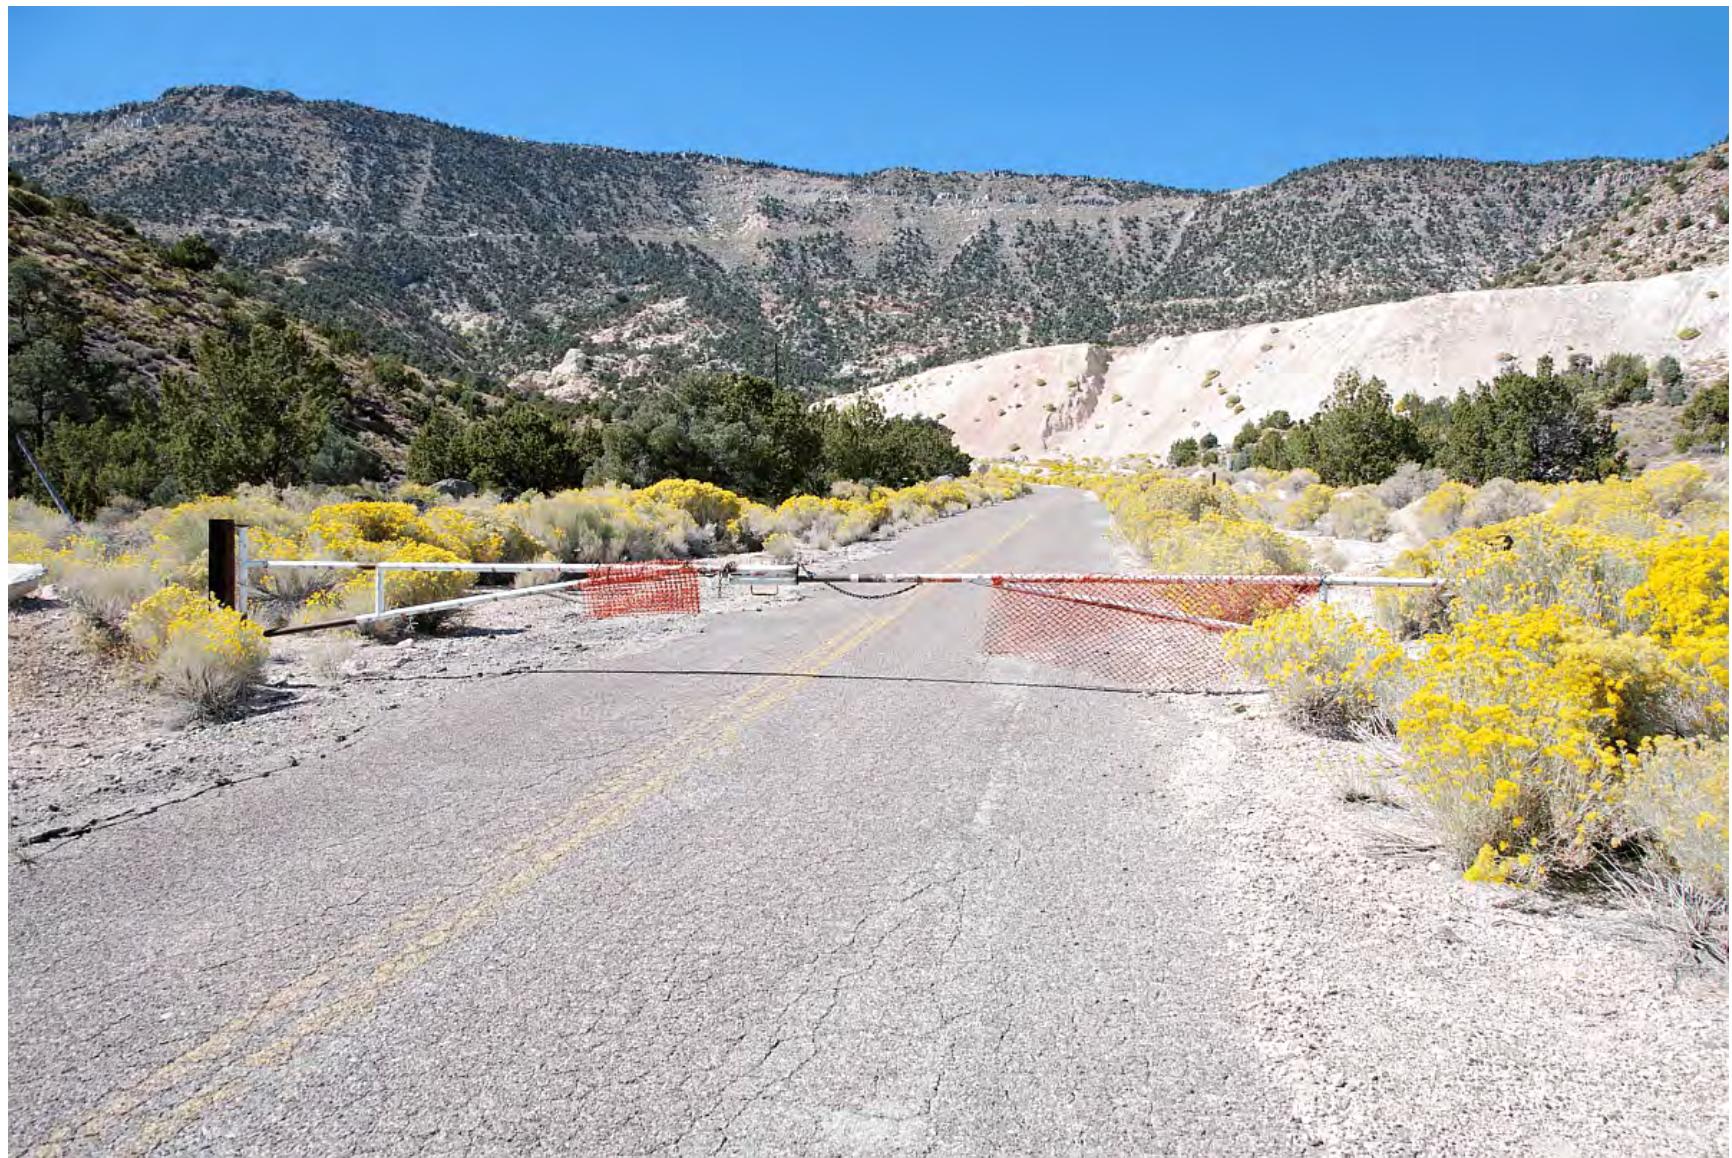
Feature 83 (Figure 239) is a metal barricade across the N Tunnel Road at UTM coordinates 572292 E, 4116965 N and an elevation of 5,800 ft (1,767.8 m). The barricade (presently used) consists of two vertical 6-inch I-beams 4 ft 2 inches tall that are set in concrete on each side of the N Tunnel Road. Attached to each I-beam are two horizontal metal plates that form the top and bottom pivot points for the barricade arms (gate). The arms are roughly triangular in shape and consists of a vertical pivot end pipe, top horizontal pipe, bottom angled pipe, vertical bracing, and a closure pipe. The pivot end of the arms is a vertical 2-inch pipe 3 ft 4 inches in height. The top horizontal pipe is 15 ft in length, the bottom angled pipe is 12 ft in length, and the vertical brace is 1 ft 8 inches in height. The top horizontal pipe extends 3 ft from the intersection of the angled pipe. When closed, the two horizontal pipes are connected by a sliding closure. The closure consists of two stacked and welded pieces of 2 1/2-inch pipe. The 2 1/2-inch pipe is slid over each end of the 2-inch horizontal pipe ends and secured with a chain and lock. Orange plastic netting has been attached to the arms to make the barricade more visible. North and east of the north I-beam are three 4 x 6 inch milled lumber posts that have been cut off 5 inches above the ground surface. The posts are spaced 3 ft apart and appear to have supported a sign that is now missing.

Figure 239. Feature 83, barricade across N Tunnel Road, U12n Tunnel, view west (2008).

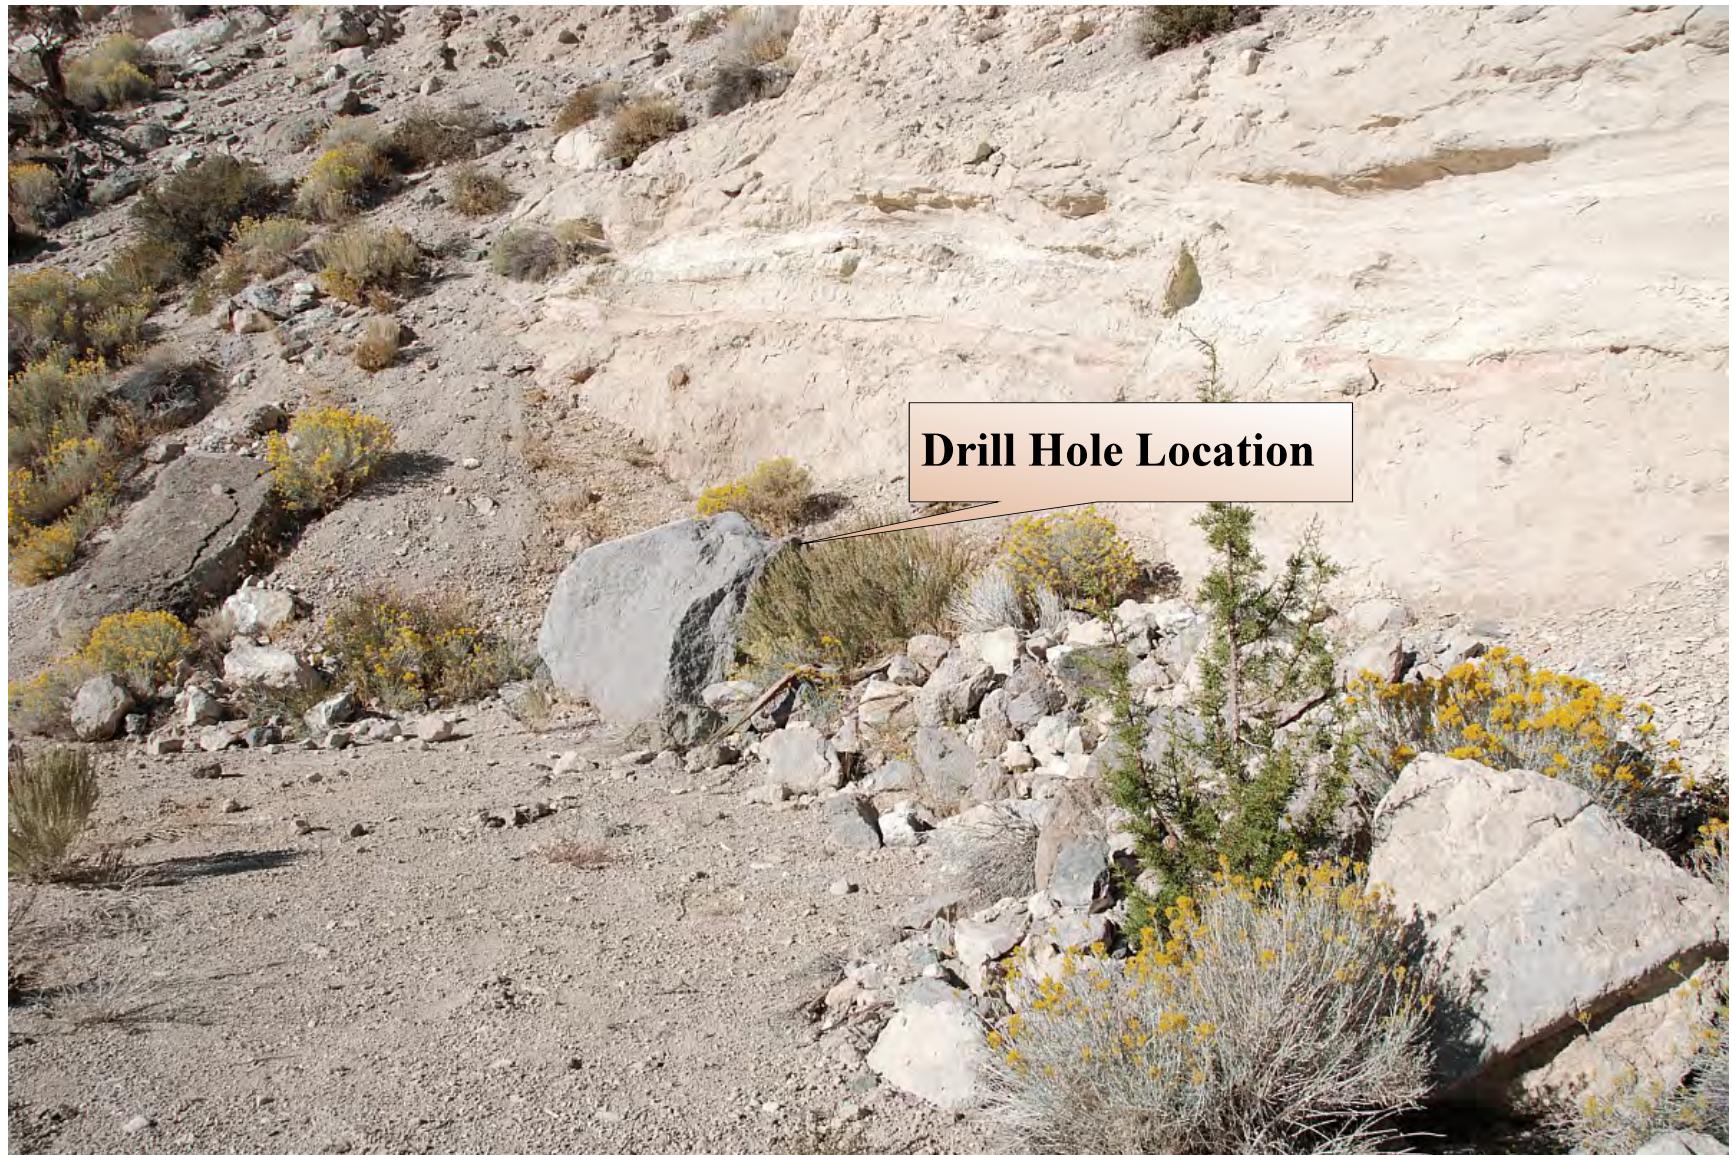
Feature 84 (Figure 241) is the UE-12n #5 exploratory drill hole at UTM coordinates 571125 E, 4116551 N, at an elevation of 6,664 ft (2,031.2 m), and drilled to a depth of 503 ft (153 m) (Bennett 1991). The drill hole is near the intersection of the abandoned Rainier Mesa Road and the north end of the dirt pad for the U12b Tunnel Station 12-304. No pipe or other artifacts related to the drill hole were found at the location. However, the road and dirt pad have been graded to push back rock fall from the mesa slope. The drill hole coordinates are within the rock fall and vegetation that obscures the edge of the road and dirt pad.

Figure 241. Graded area at Feature 84, UE-12n #5 exploratory drill hole, U12n Tunnel, view northwest (2008).

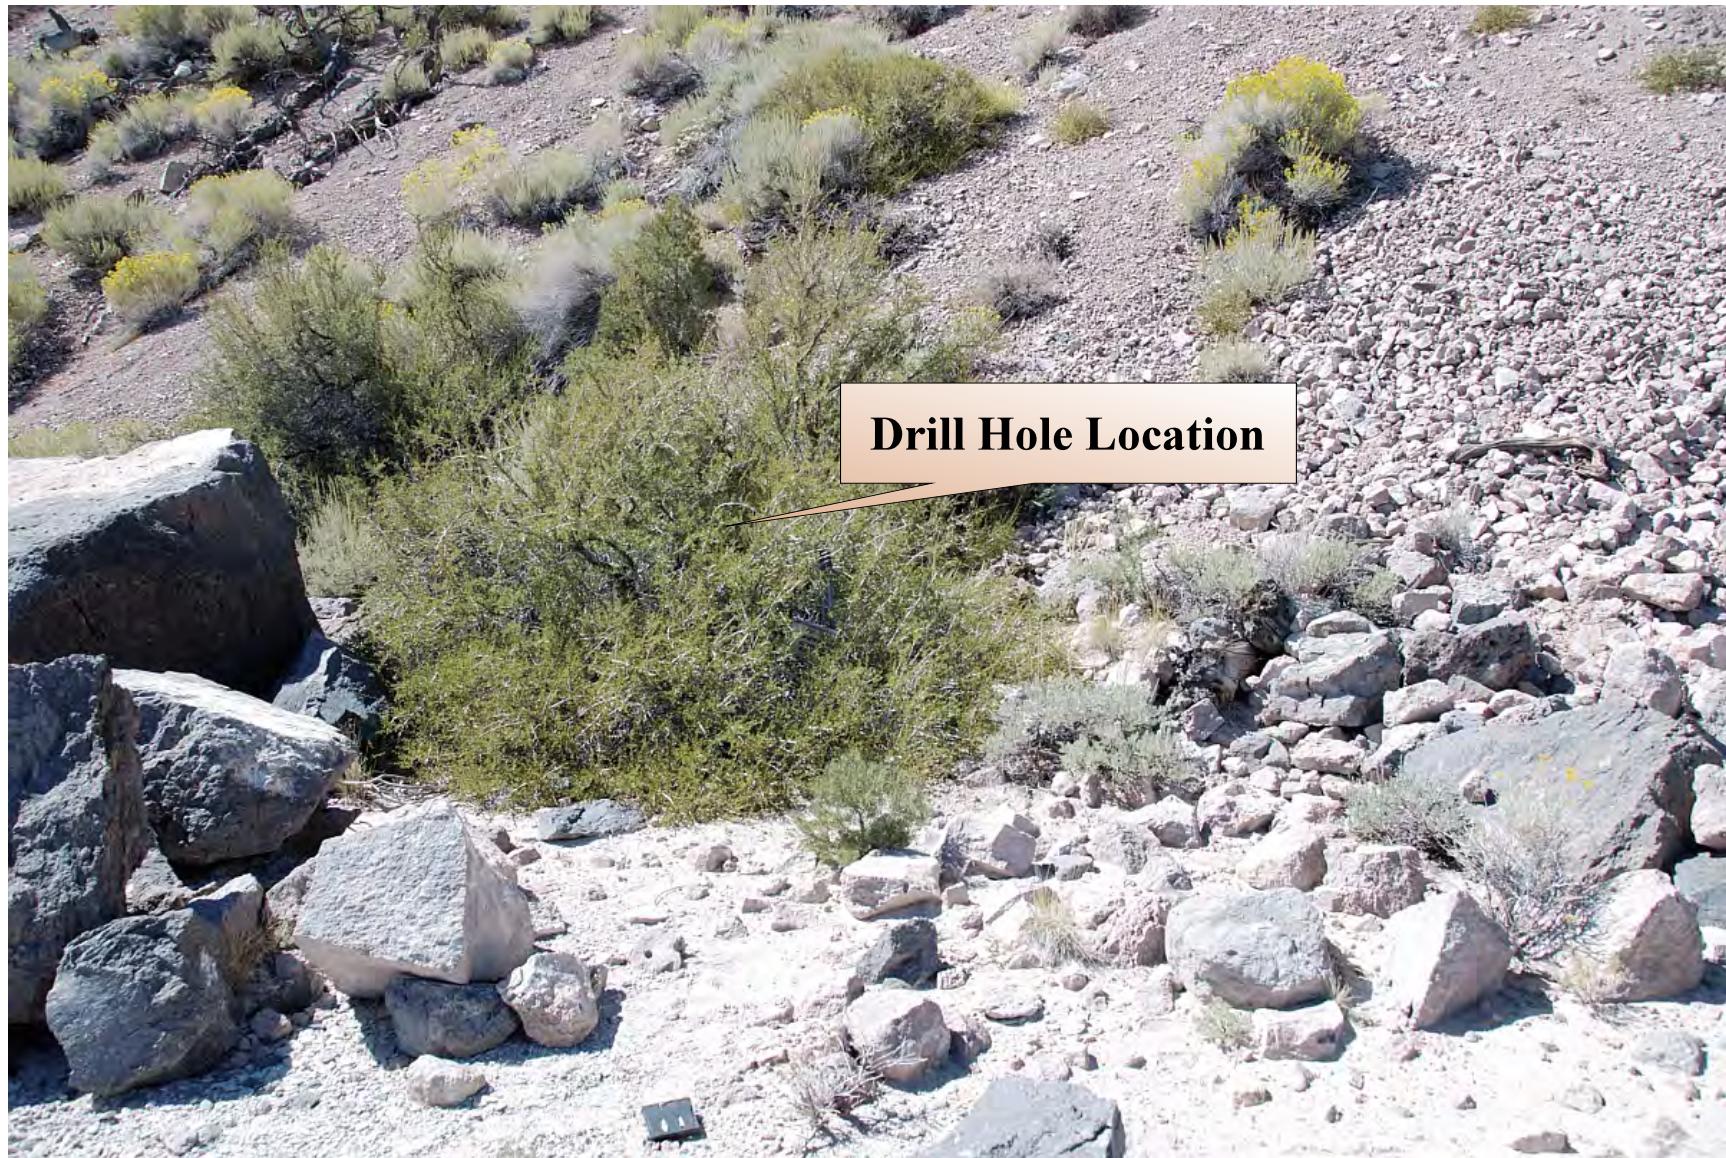
Feature 85 (Figure 242) is the UE-12n #7 exploratory drill hole at UTM coordinates 570948 E, 4117122 N, at an elevation of 6,893 ft (2,101.0 m), and drilled to a depth of 832 ft (254 m) (Bennett 1991). The drill hole pad is part of the abandoned Rainier Mesa Road that has been disturbed by grading of the surface to push back rock fall from the mesa slope. No pipe was found but the sign identifying the drill hole is visible at the location. The drill hole coordinates are within the rock fall and vegetation that obscures the edge of the road.

Figure 242. Graded area at Feature 85, UE-12n #7 exploratory drill hole, U12n Tunnel, view northwest (2008).
