A total of 202 features were recorded, mapped, and photographed for the U12n Tunnel complex. The project area encompassed 600.8 acres (243.1 hectares) at the portal and mesa areas. At the U12n portal area are ten sub-areas containing features related to the construction, testing, and general everyday activities within the tunnel. These include concrete foundations for buildings, communications equipment, mining equipment, rail lines, retention ponds, storage containers, and access control facilities. Only a telephone trailer remains on the telephone pad as all of the other buildings have been removed from the portal area. The microwave tower, portions of the rail lines, the muck car dump, rotary dump, and wash rack are still in place. Also, the traffic control point and powder magazines along N Tunnel Road are intact. At the mesa area are four sub-areas containing features generally related to pre- and post-shot drilling, recording facilities, and ventilation equipment. These include concrete foundations, instrument cable holes, and drill holes. The concrete foundations were for buildings and small equipment. Concrete pads and various equipment remain at the cable hole locations bu

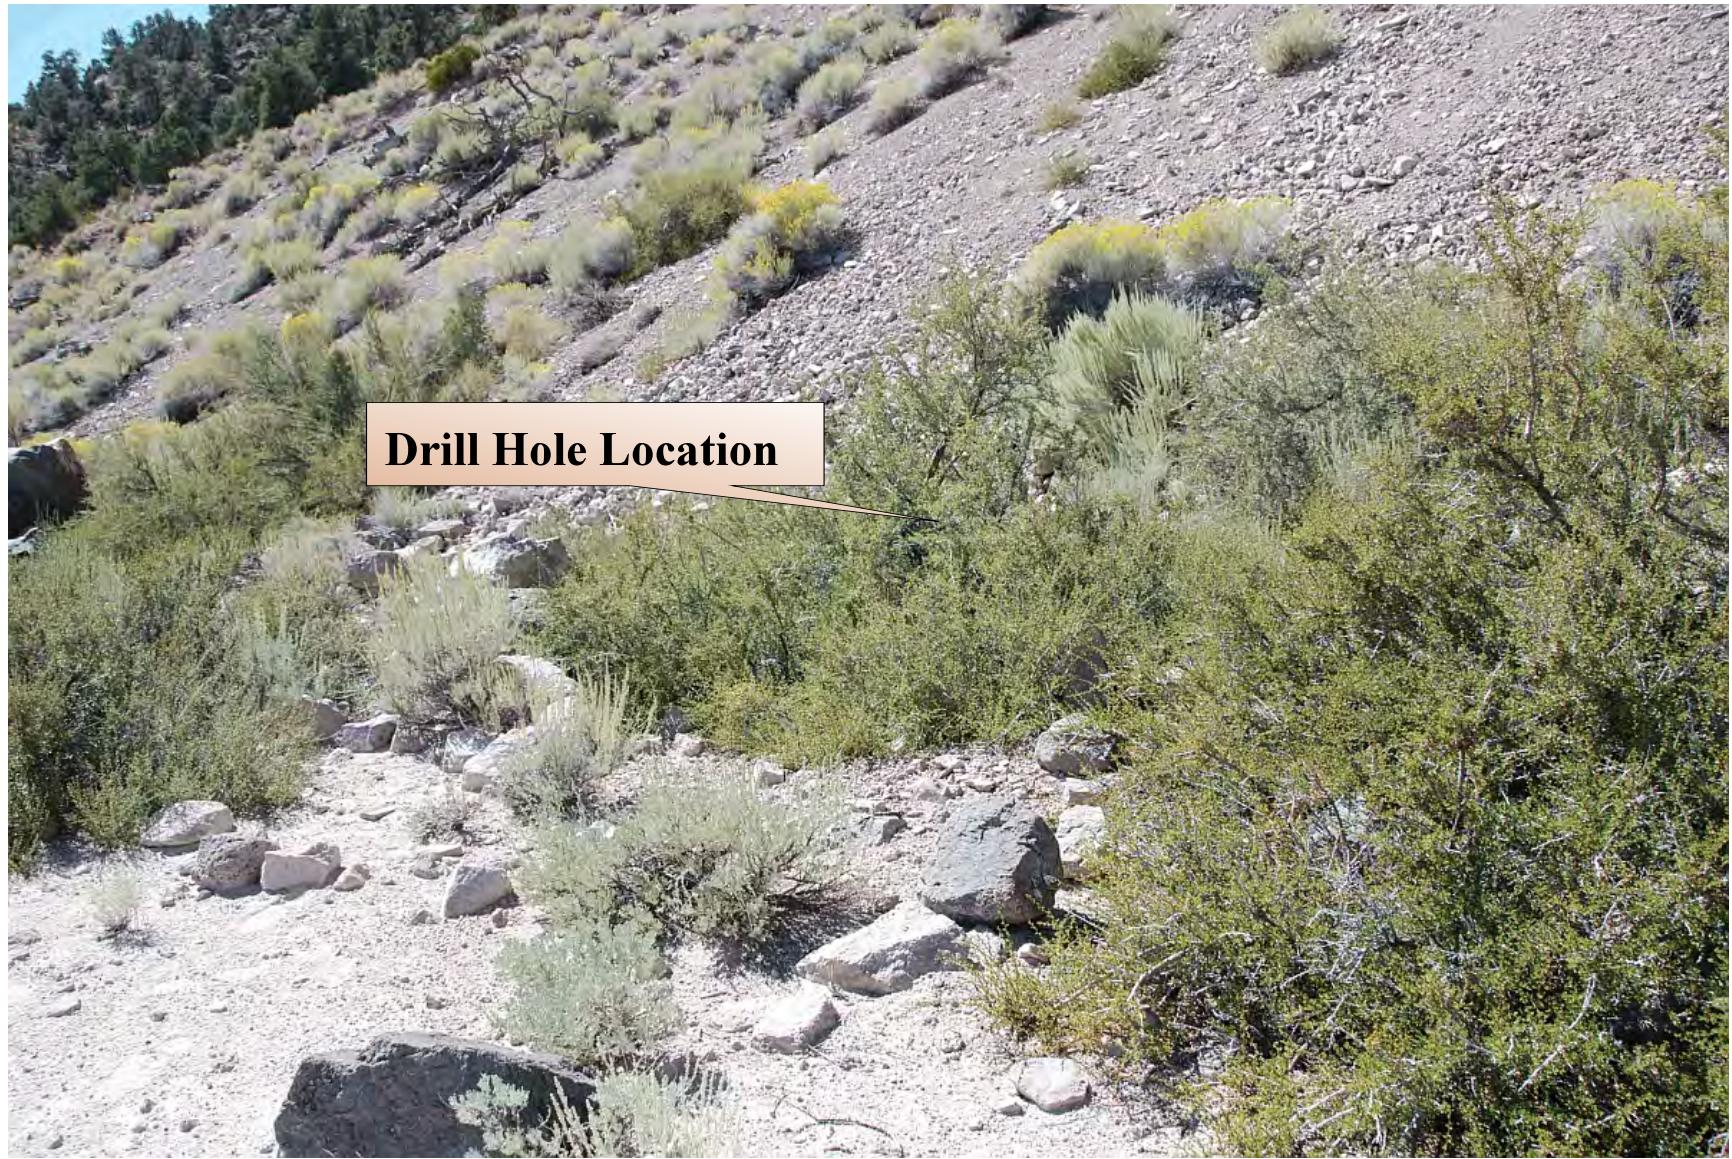
Feature 86 (Figure 243) is the UE-12n #4 exploratory drill hole at UTM coordinates 570947 E, 4117132 N, at an elevation of 6,894 ft (2,101.2 m), and drilled to a depth of 831 ft (253 m) (Bennett 1991). The drill hole pad is part of the abandoned Rainier Mesa Road. No pipe or other artifacts related to the drill hole were found at the location. No pipe or other artifacts related to the drill hole were found at the location. However, the road has been graded to push back rock fall from the mesa slope. The drill hole coordinates are within the rock fall and vegetation that obscures the edge of the road.

Figure 243. Graded area at Feature 86, UE-12n #4 exploratory drill hole, U12n Tunnel, view southwest (2008).

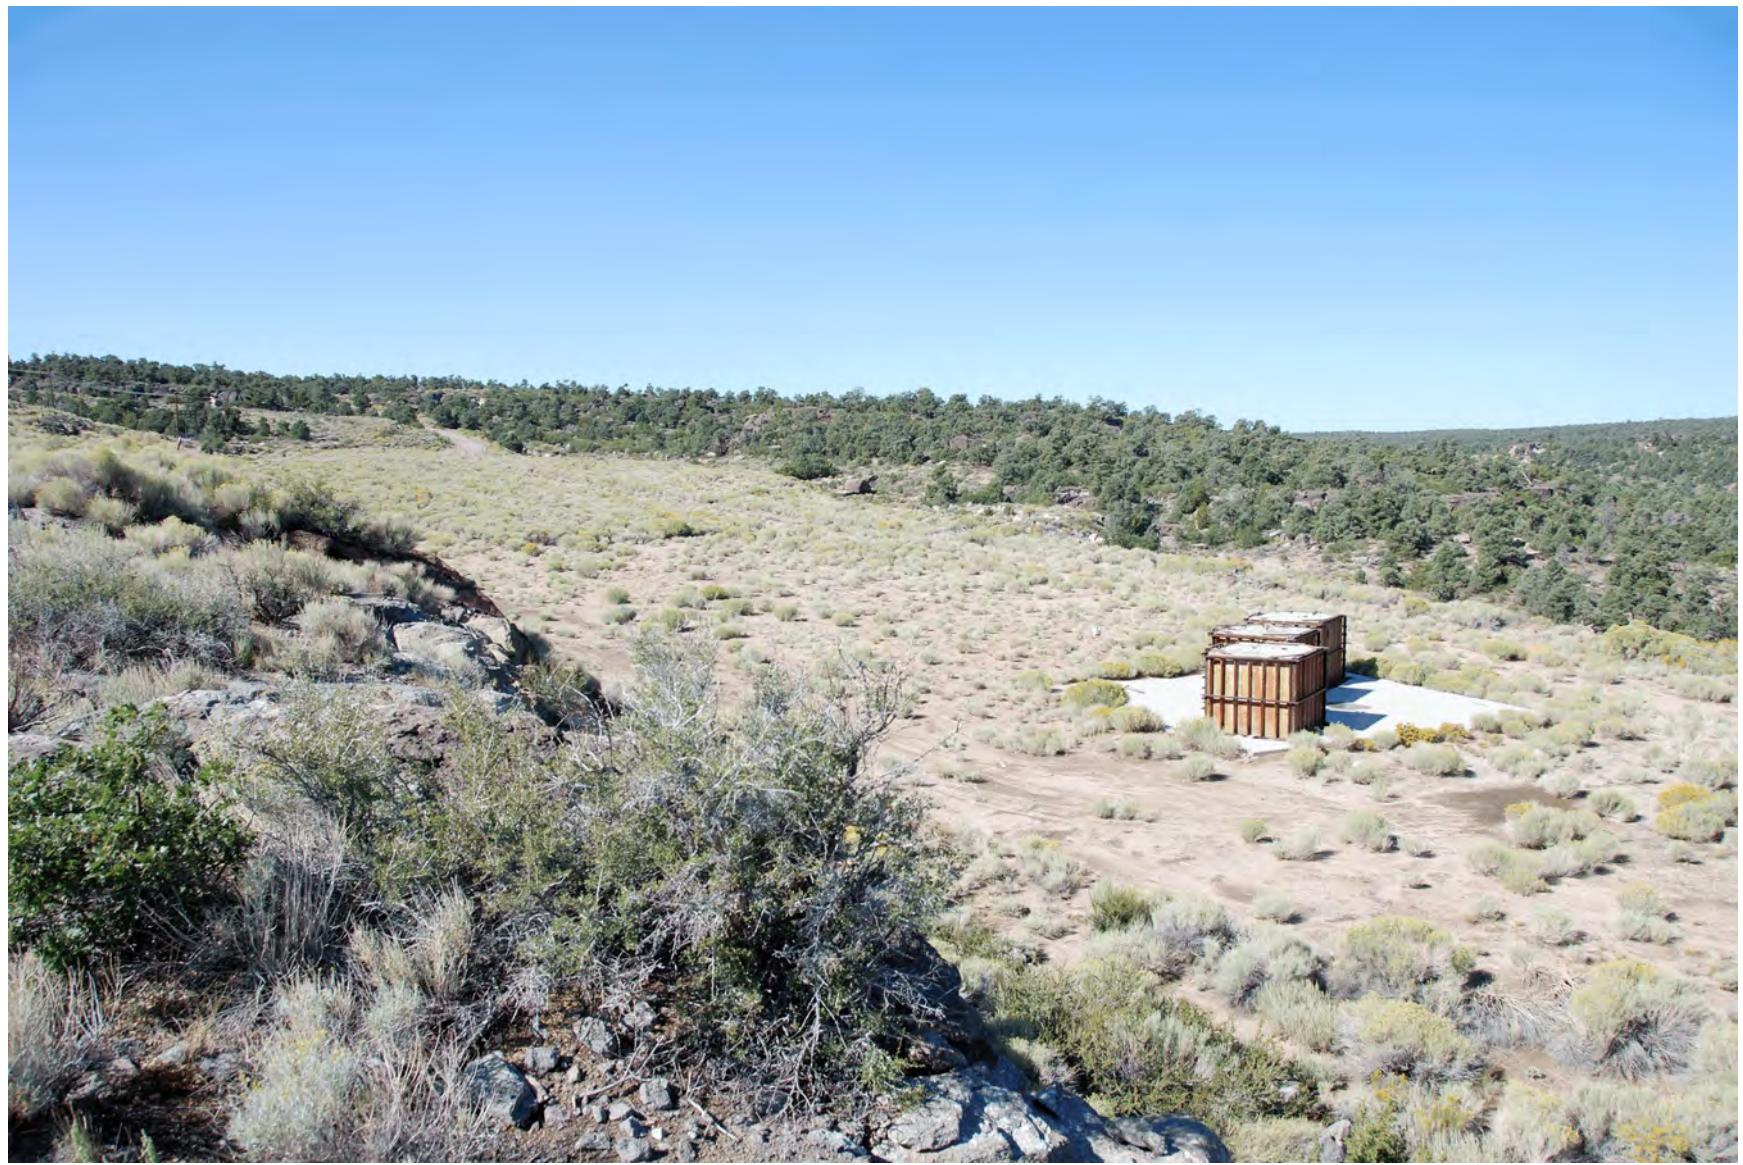
Figure 245. Overview of the U12n Tunnel complex, mesa trailer park lower level, view southwest (2008).

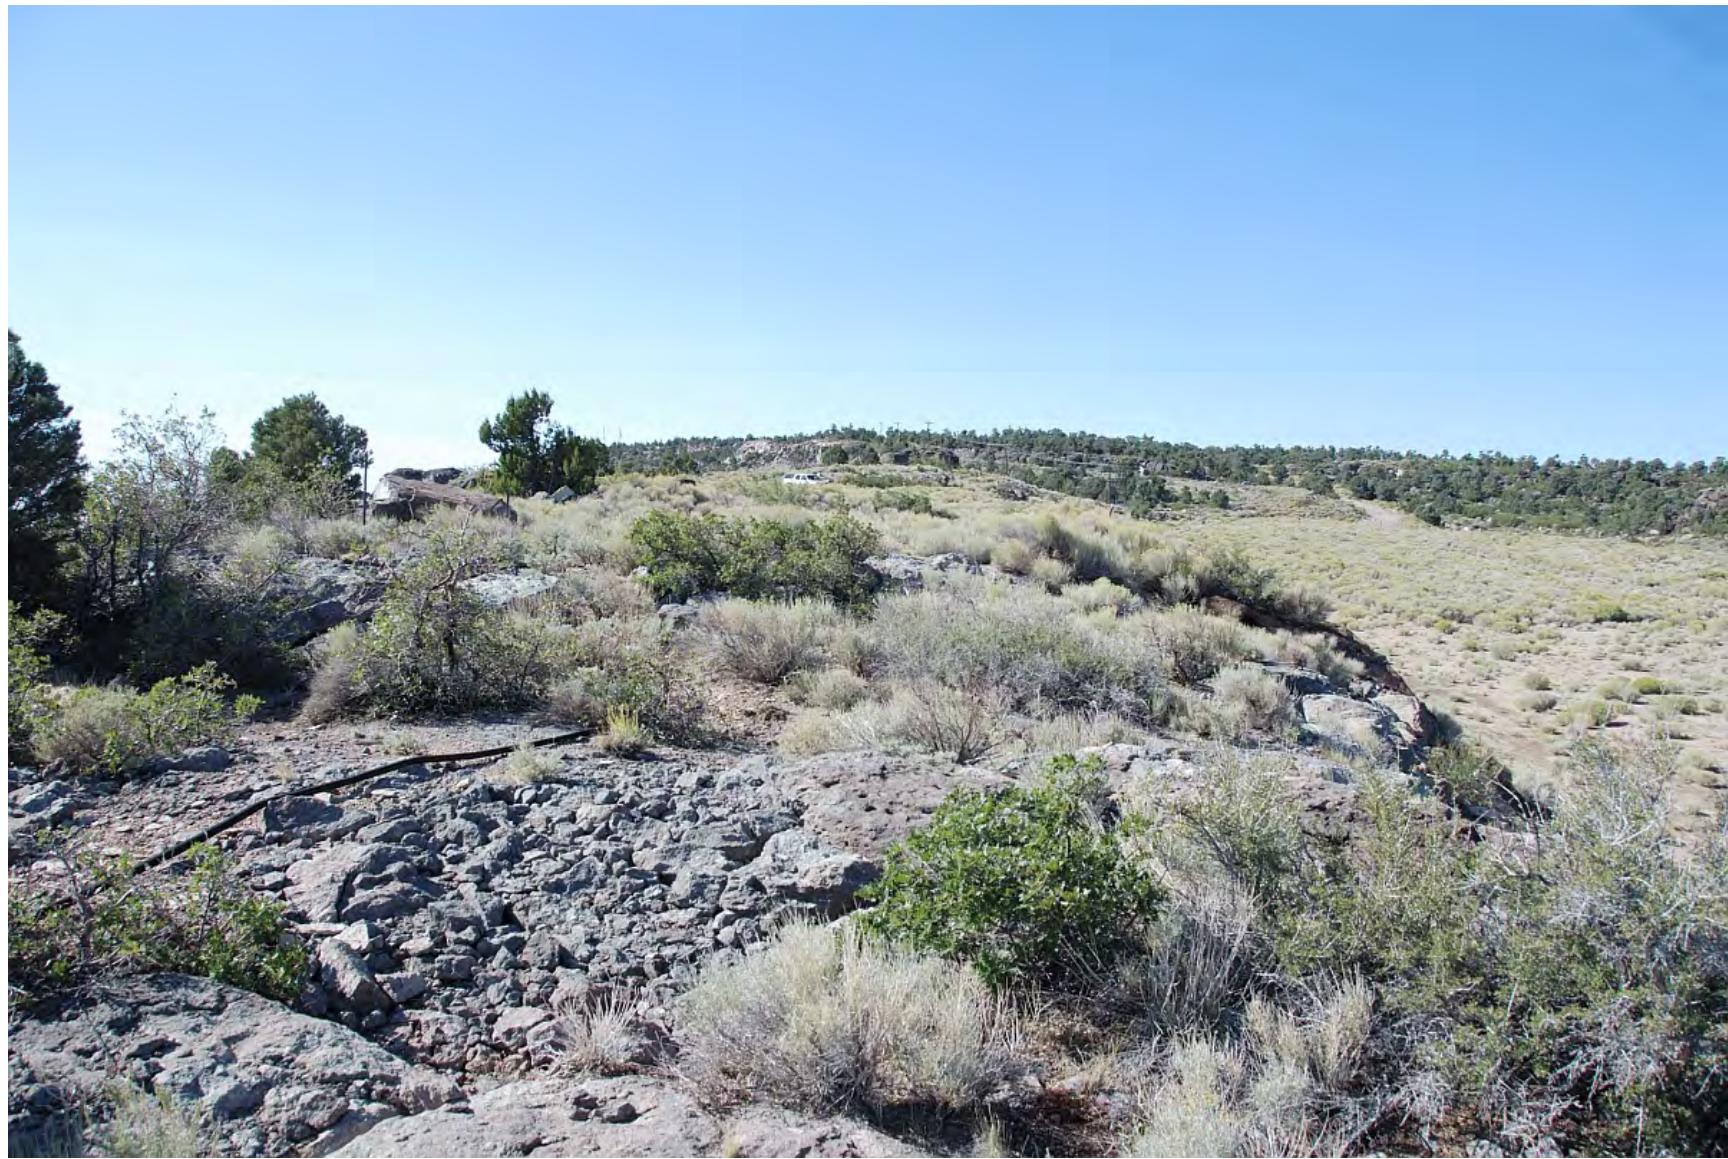
Figure 246. Overview of the U12n Tunnel complex mesa trailer park upper level, view south (2008).

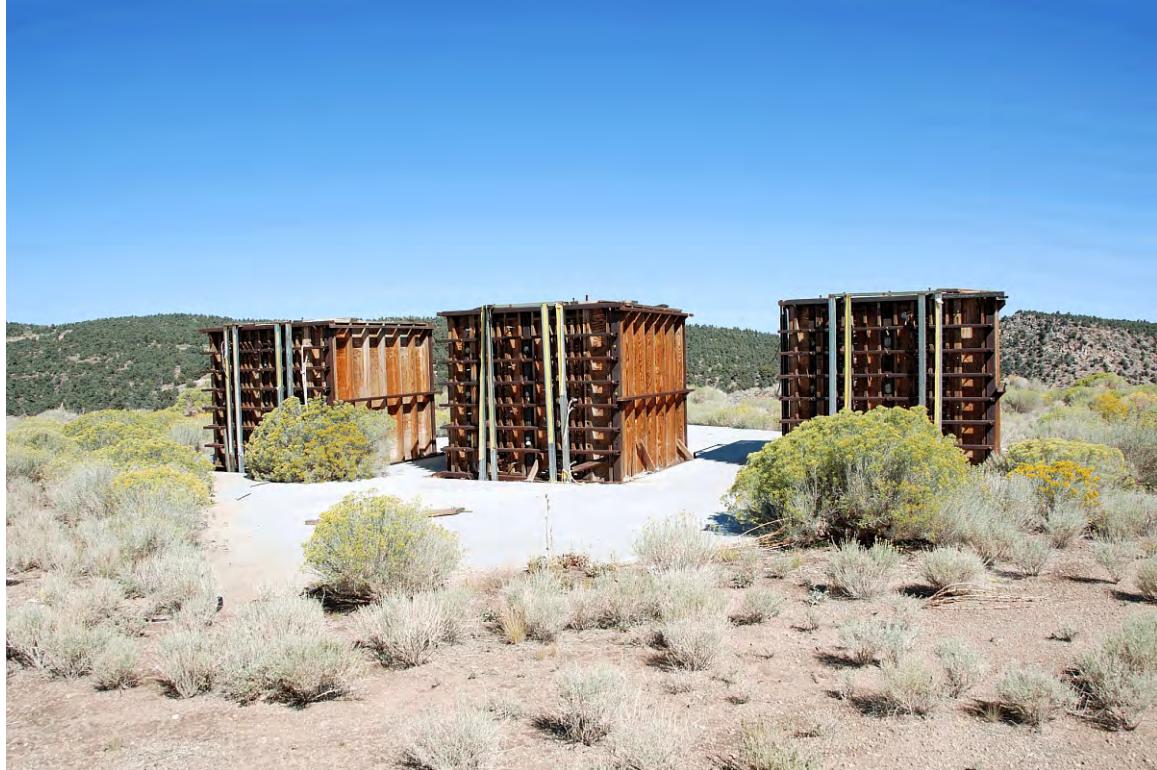
Feature 87 (Figure 247) is the concrete foundation for the U12n mesa cable building, U-12n #1, #2, and #3 Cable Holes, three wood forms with metal frames, and two small concrete pads. UTM coordinates for the cable holes are 570845 E, 4117689 N; 570840 E, 4117646 E; and 570836 E, 4117646 N, respectively. Cable hole #1 was drilled to 1,221 ft (372m), cable hole #2 was drilled to 1,235 ft (374 m), and cable hole #3 was drilled to 1,235 ft (376 m) (Bennett 1991). The concrete foundation for the cable building is 40 x 40 ft, orientated at 23 degrees, and at UTM coordinates 570850 E, 4117649 N. On the foundation are three plywood grout forms that are identical in size but not symmetrically placed. Each form surrounds one of the cable holes. The forms measure 8 ft 10 inches x 8 ft 10 inches x 8 ft (2.6 x 2.6 x 2.4 m) and are recessed 4 inches into the concrete pad. They are constructed of 1-inch plywood and 2 x 6 inch framing with the framing (studs and top and bottom plates) on the exterior of the form. Also, a 4-inch channel iron frame measures 9 ft 5 inches x 9 ft 5 inches x 8 ft (2.8 x 2.8 x 2.4 m) and encloses the form for additional support. The metal frame is along the top, bottom, and side edges of the wood form. On the south and west sides of the forms are Unistrut racks with coaxial fittings for cable attachment. The fittings are numbered for cable identification. All of the joints on the forms and the coaxial fittings are sealed with silicon calking. Along the east and north side of the foundation are two 4 x 4 ft concrete pads. The east pad has a 2 x 2 ft metal plate centered in the surface and the north pad has an impression from a similar plate but the plate is missing. Both pads have bolts that have been cut flush with the surface. Associated artifacts are insulated cable and wire, a brass valve, and wood and plastic fragments.

Figure 247. Plan view and photograph of Feature 87, mesa cable building foundation and U-12n #1, #2, and #3 cable holes, U12n Tunnel, view north (2008).

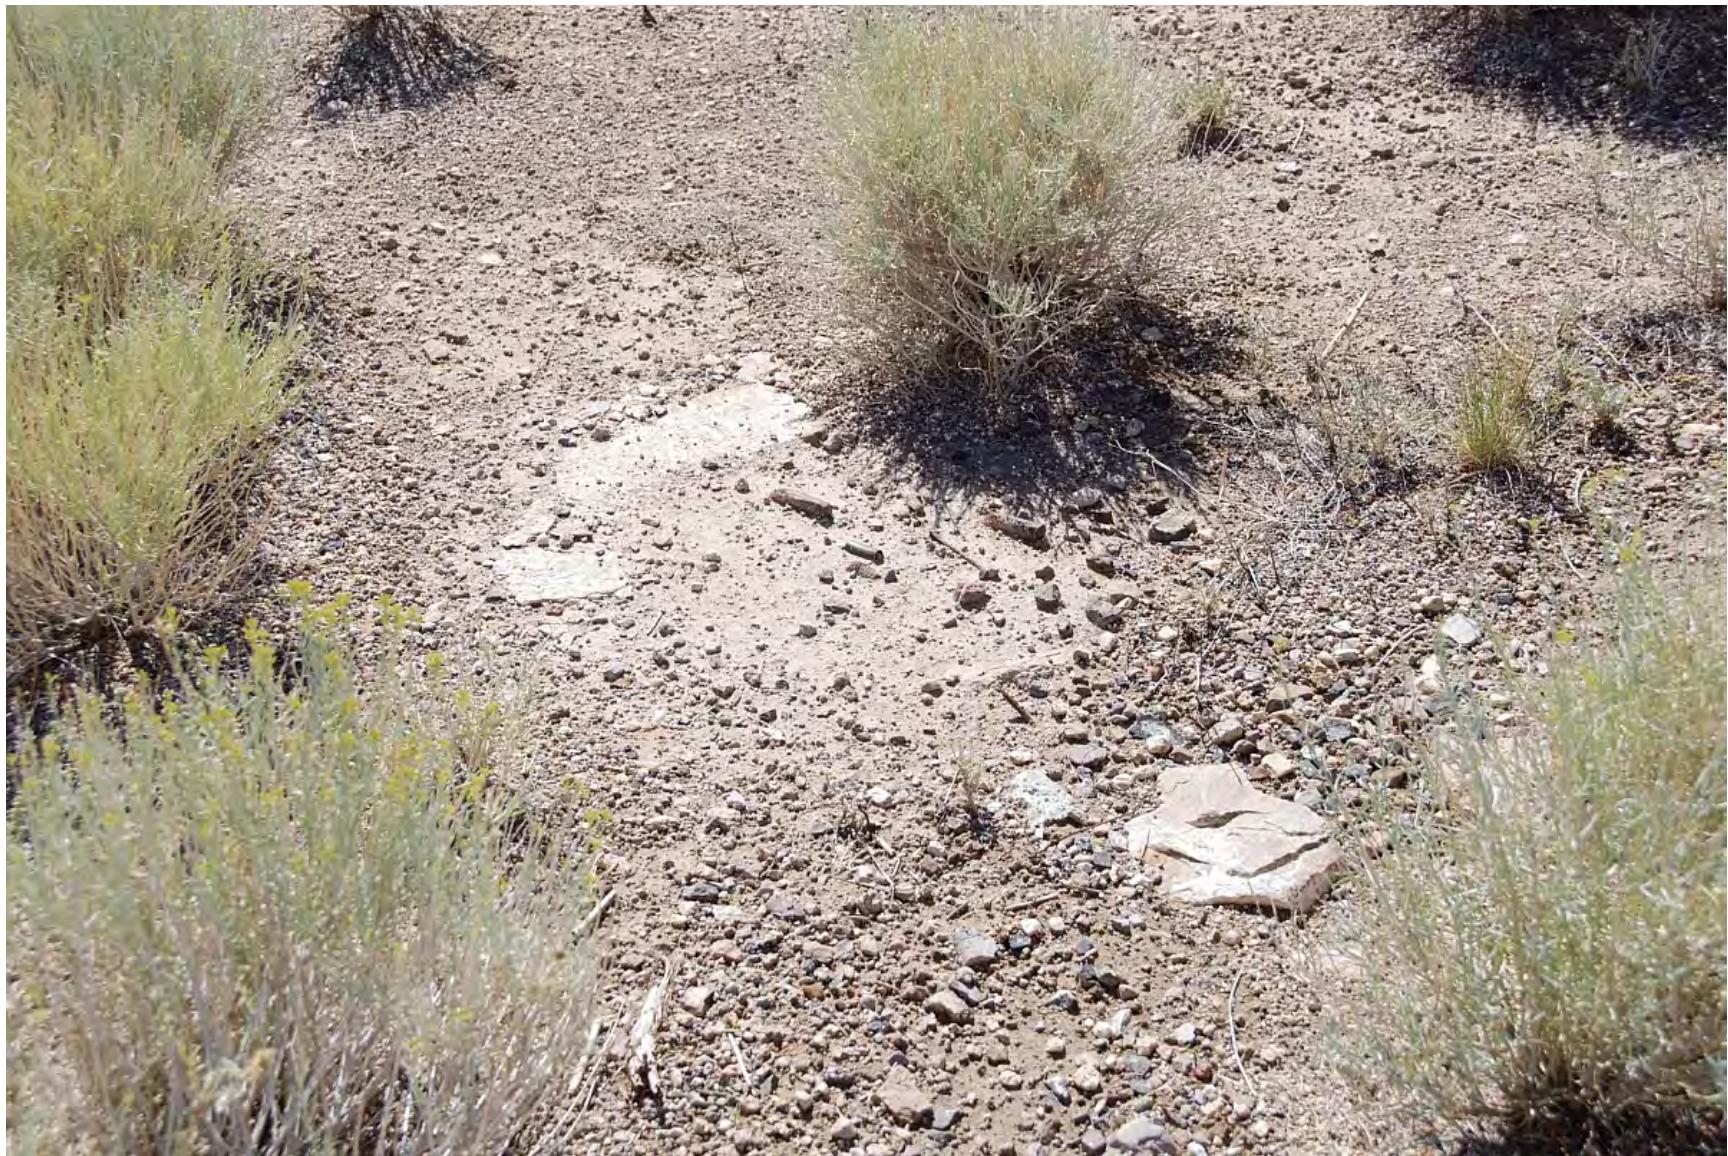
Figure 248. Feature 88, concrete pad, U12n Tunnel, view southeast (2008).

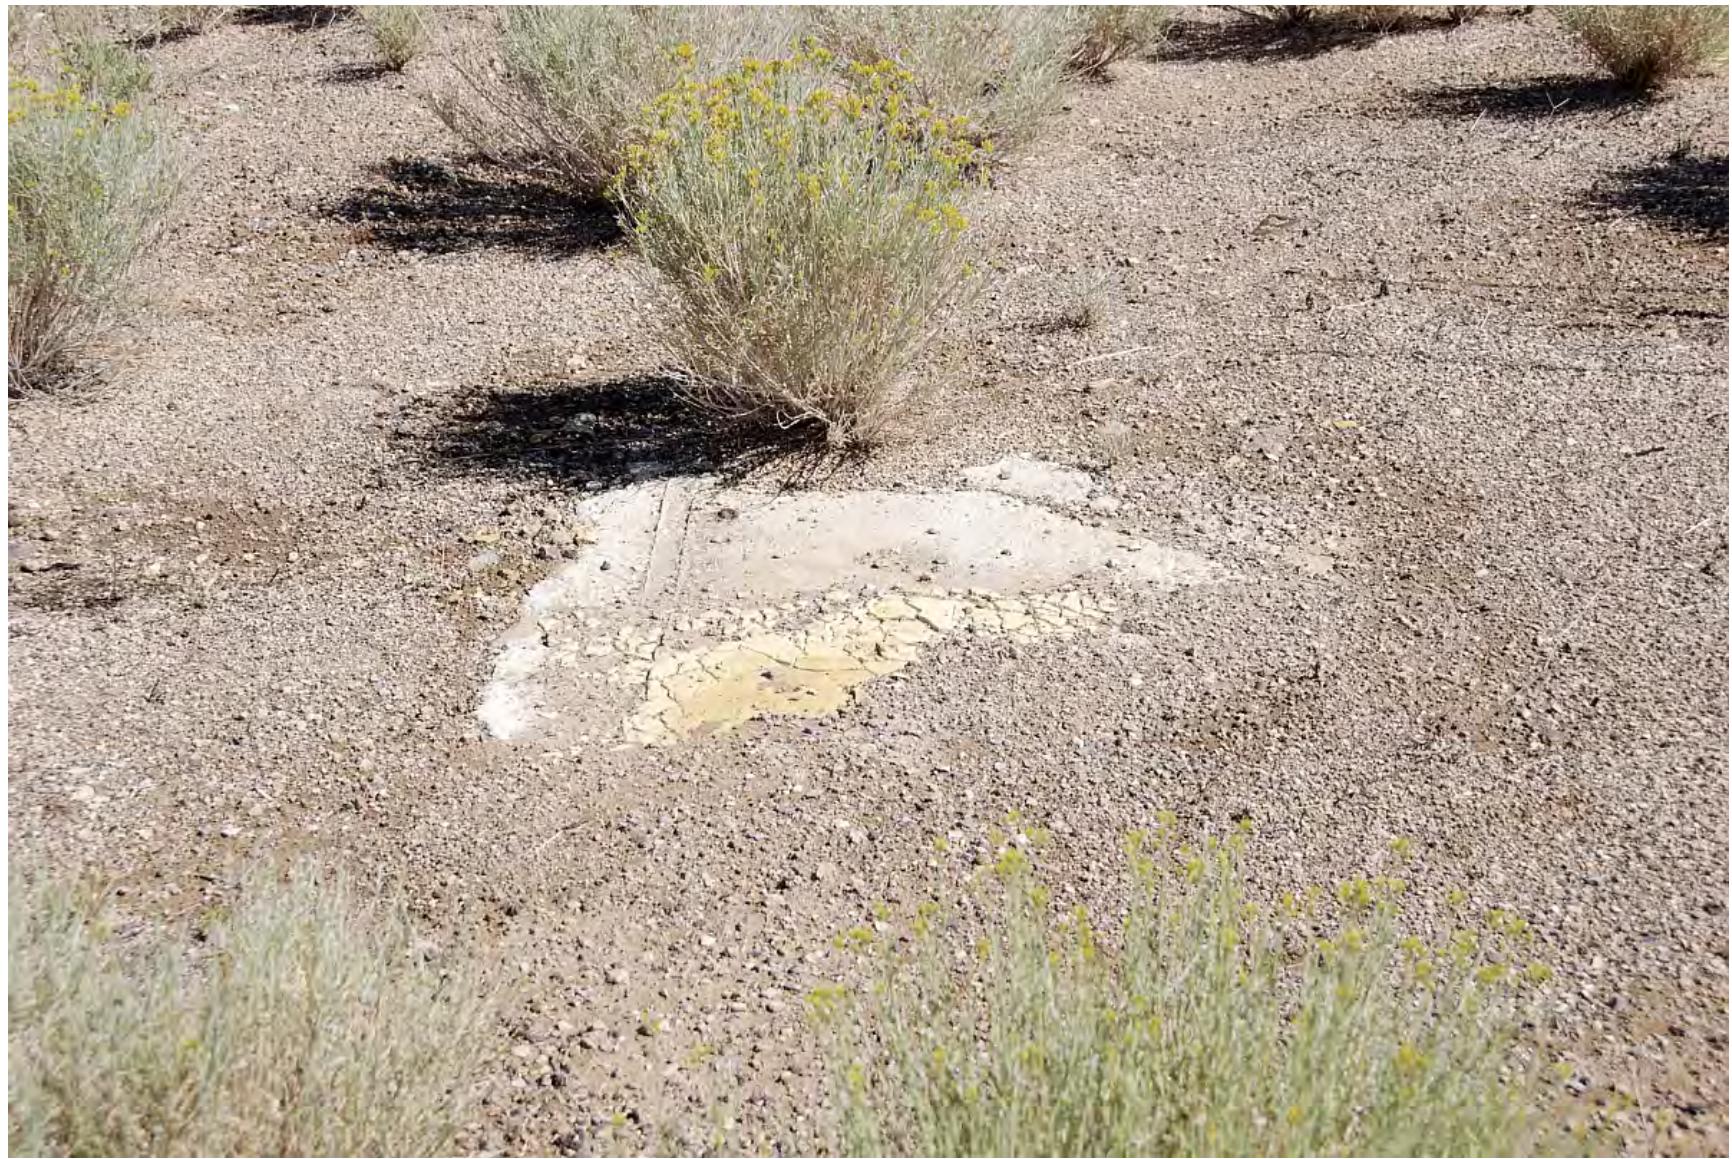
Figure 249. Feature 89, concrete pad, U12n Tunnel, view northwest (2008).

west side from a 2 x 4 laid in the wet concrete. A yellow grout is on the surface of the pad along the southeast side.

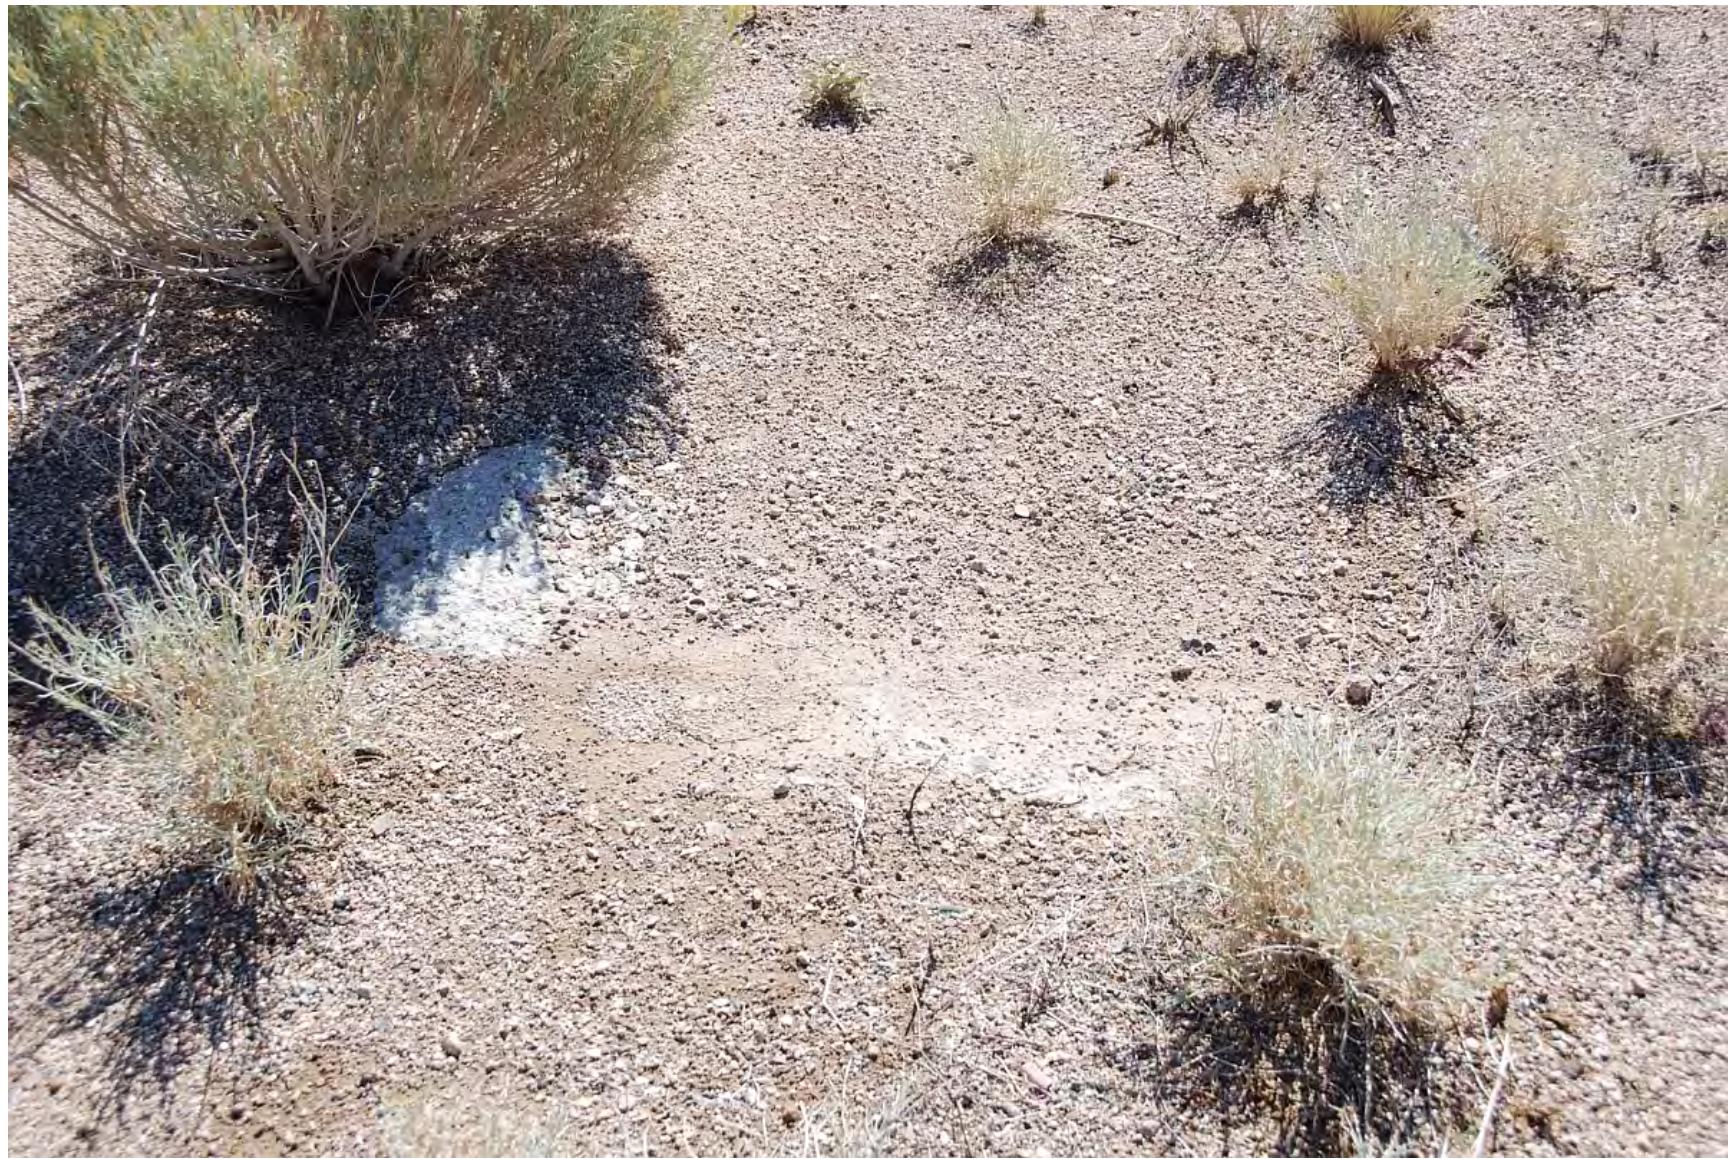
Figure 250. Feature 90, concrete pad, U12n Tunnel, view southeast (2008).

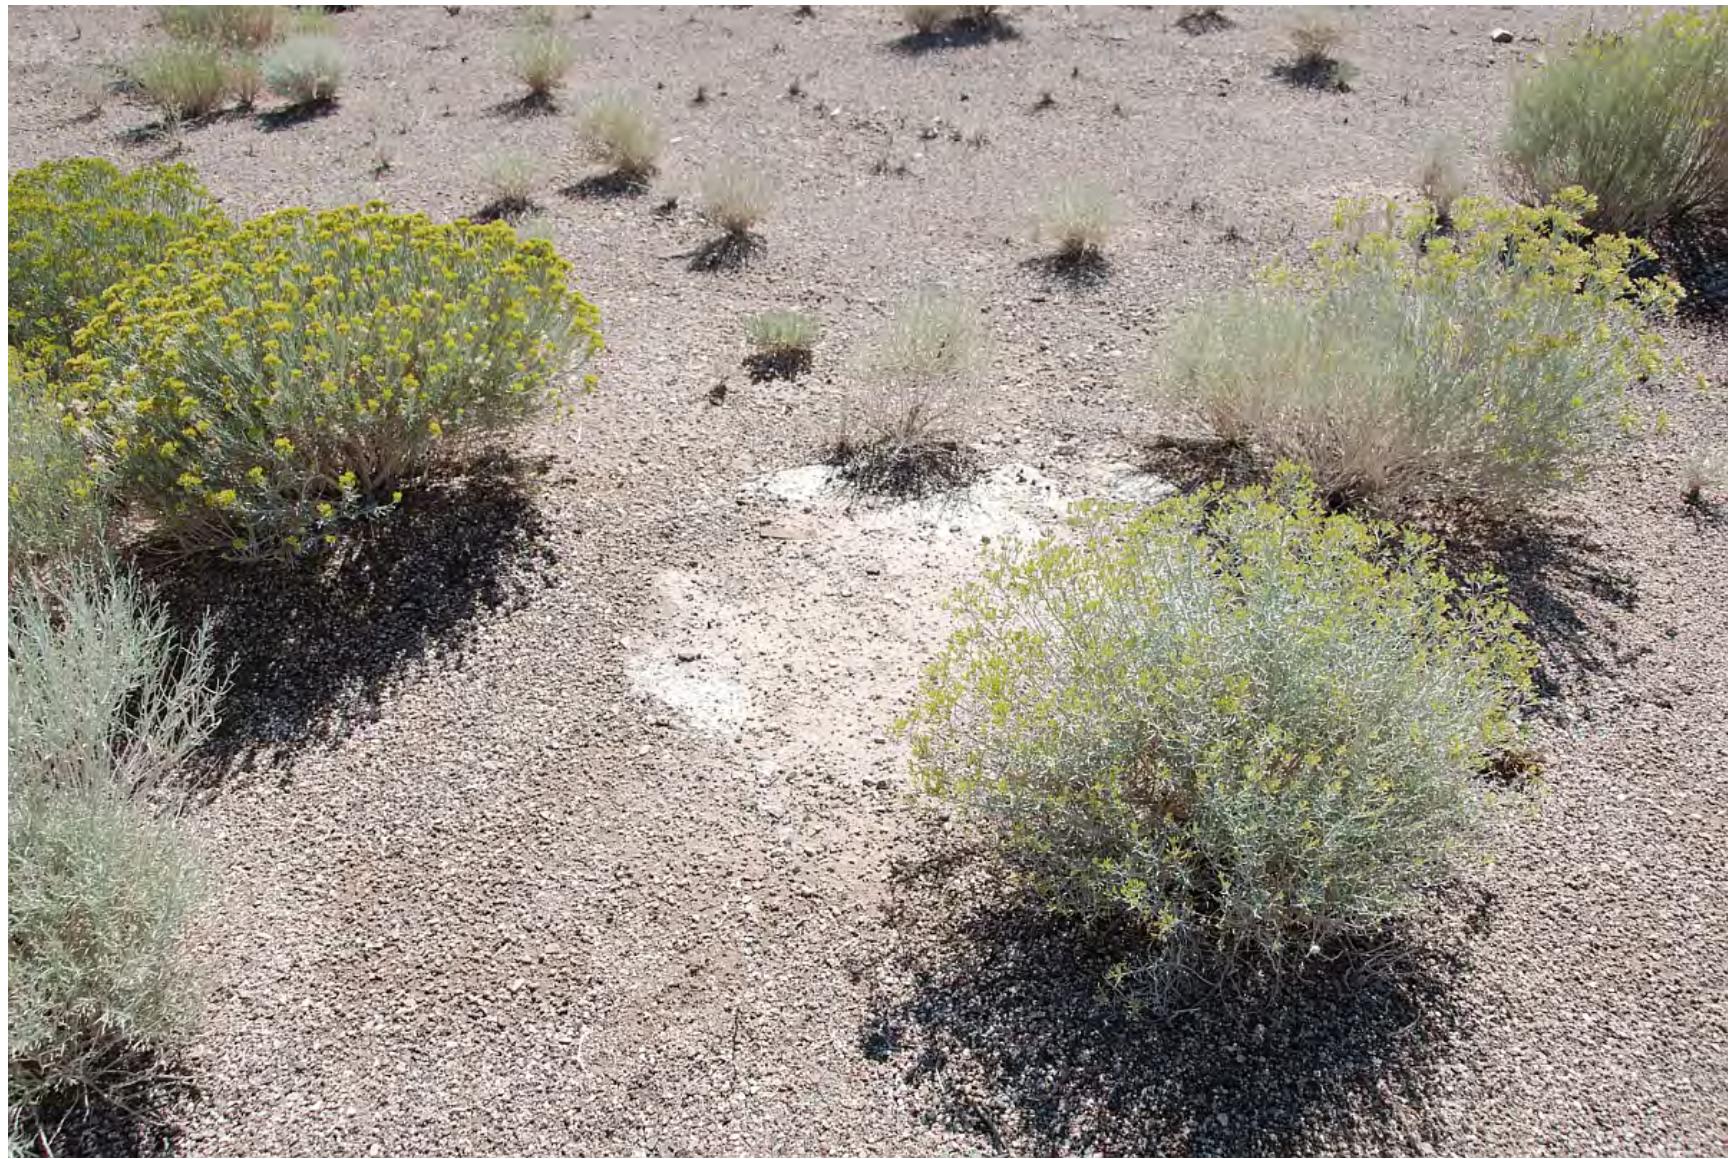
Figure 251. Feature 91, concrete pad, U12n Tunnel, view southeast (2008).

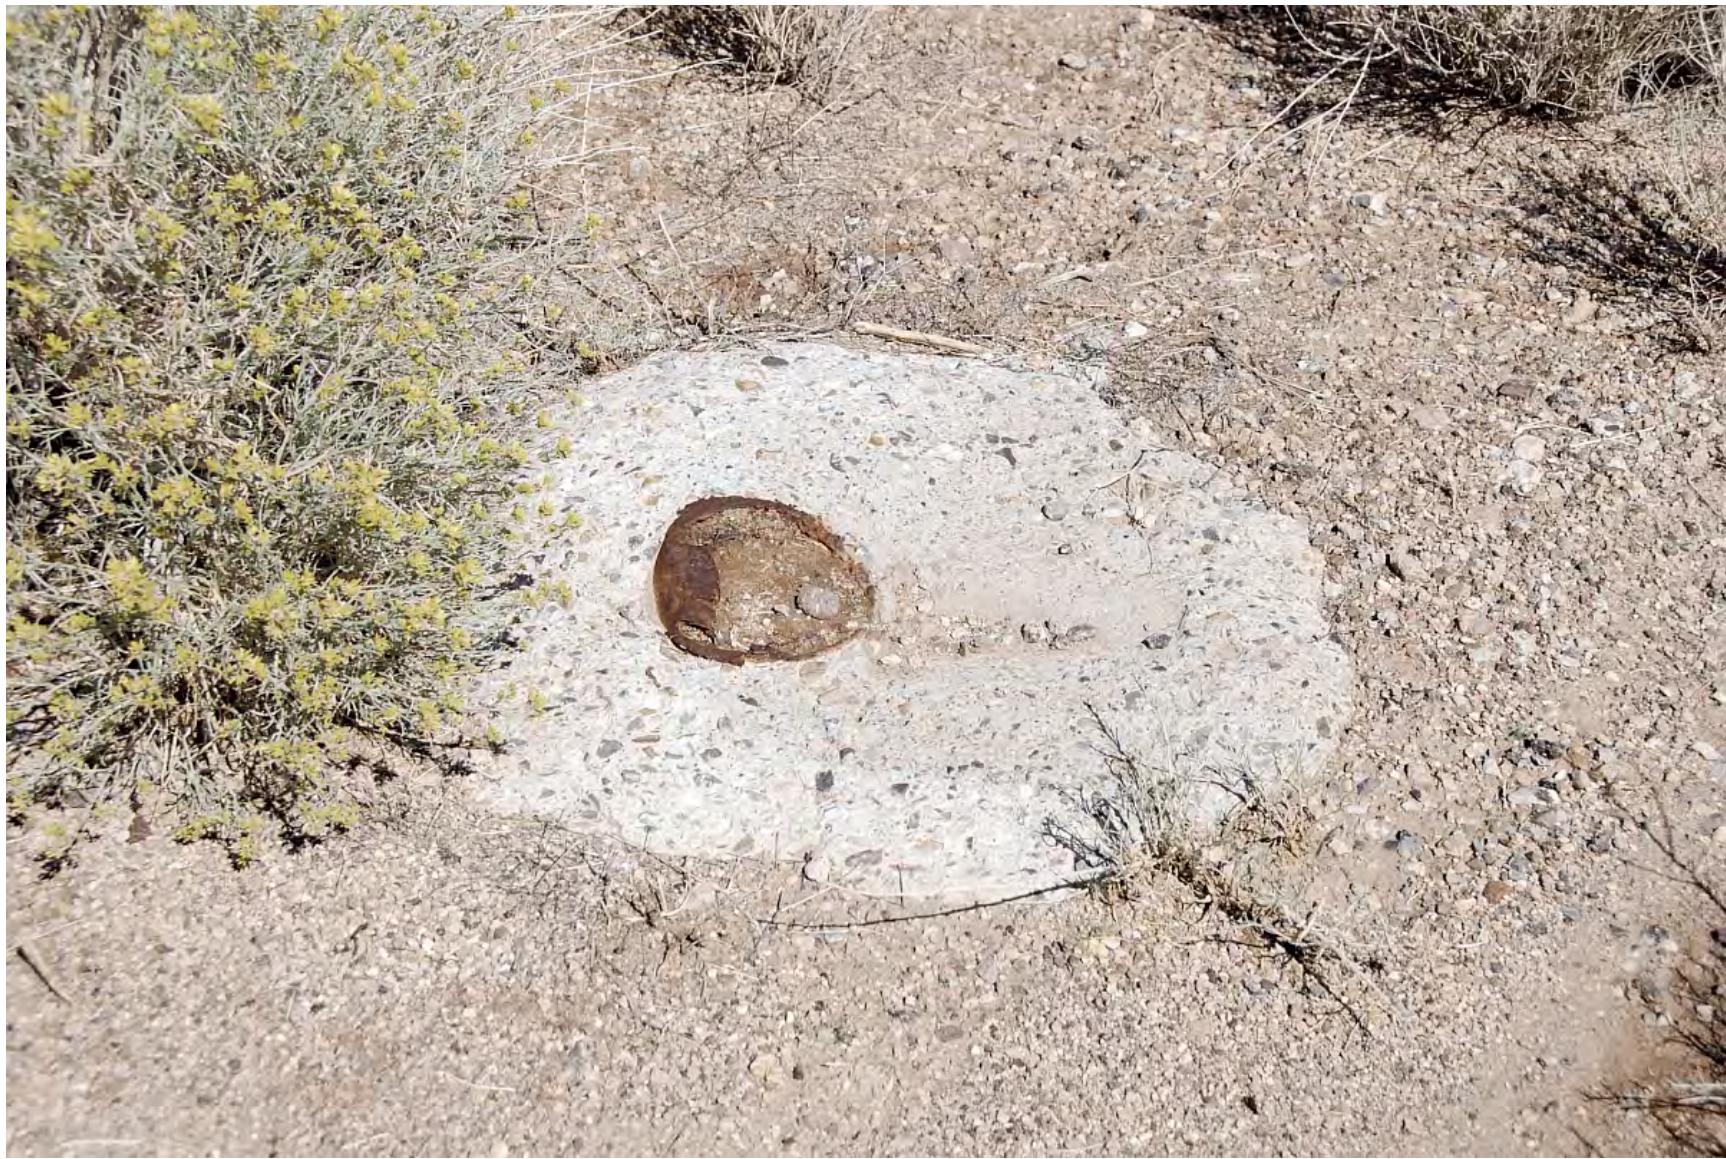
Figure 253. Feature 93, pipe and concrete pad, U12n Tunnel, view north (2008).

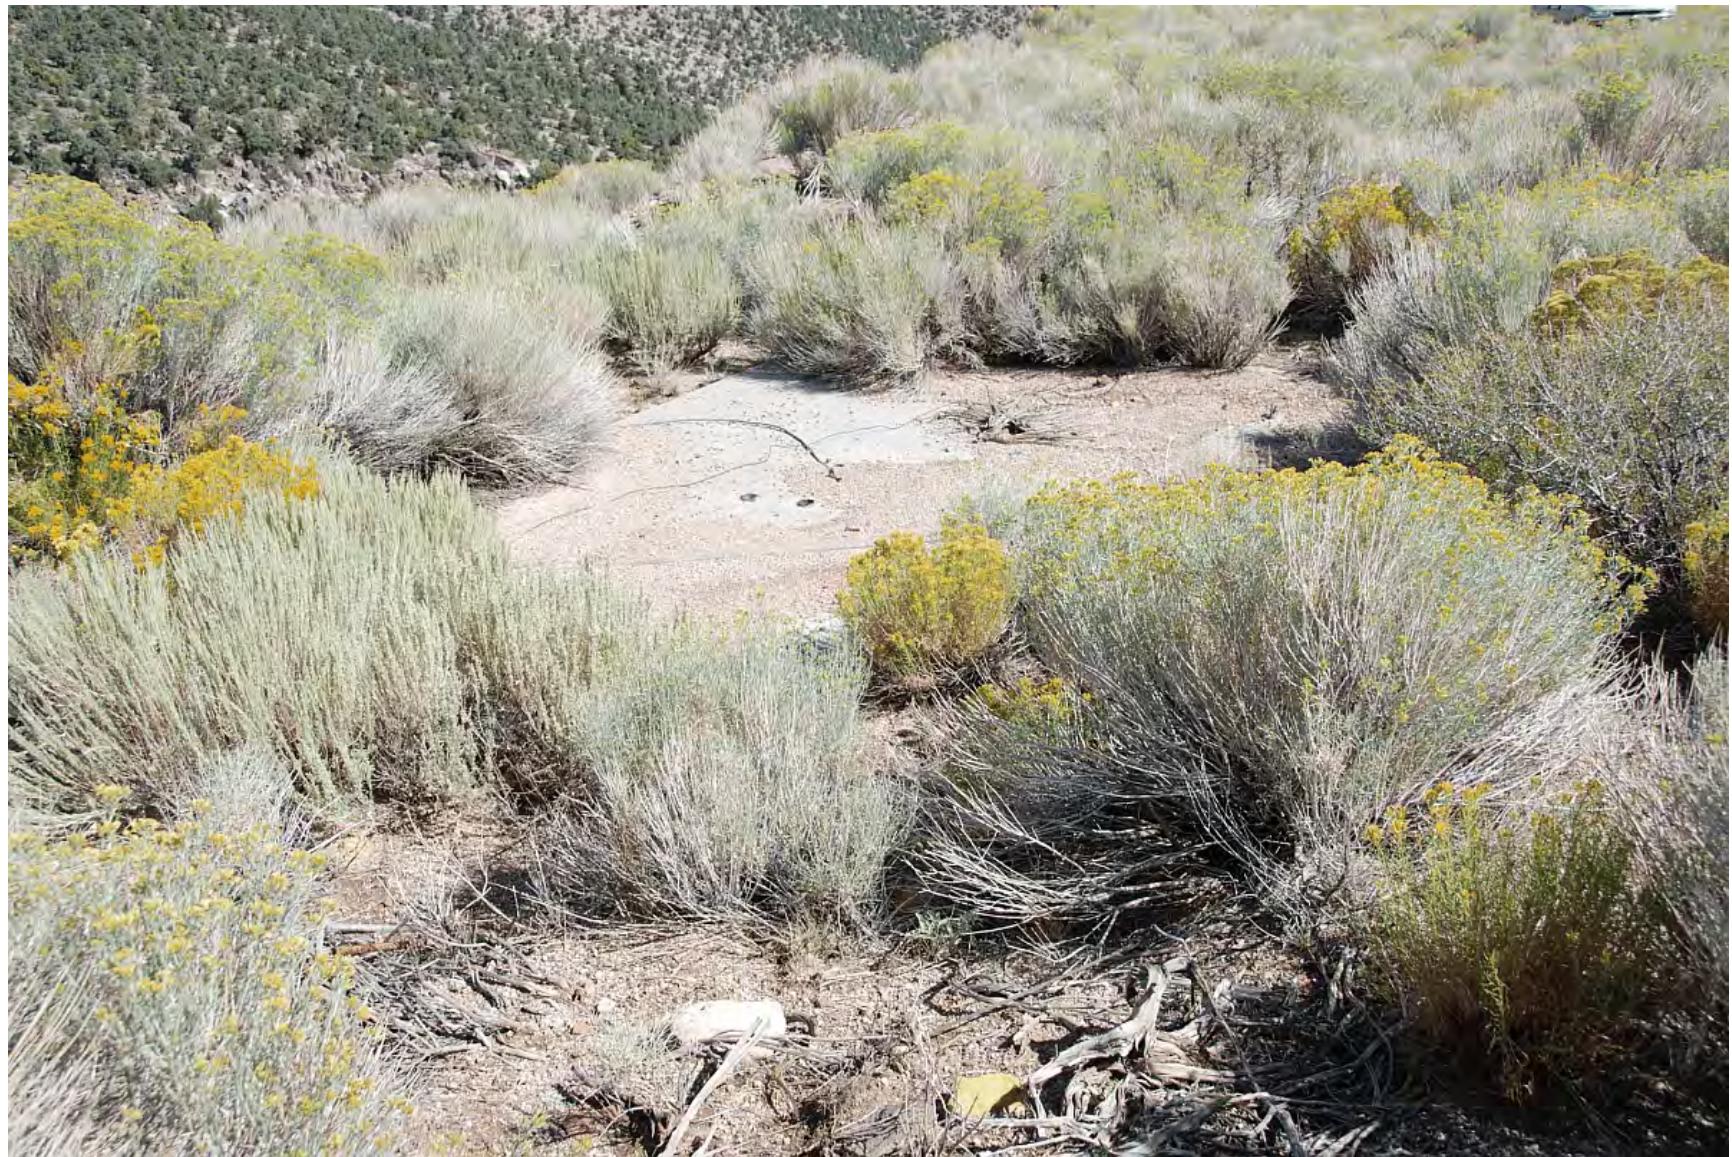
Figure 254. Feature 94, electrical substation concrete pad, U12n Tunnel, view northwest (2008).

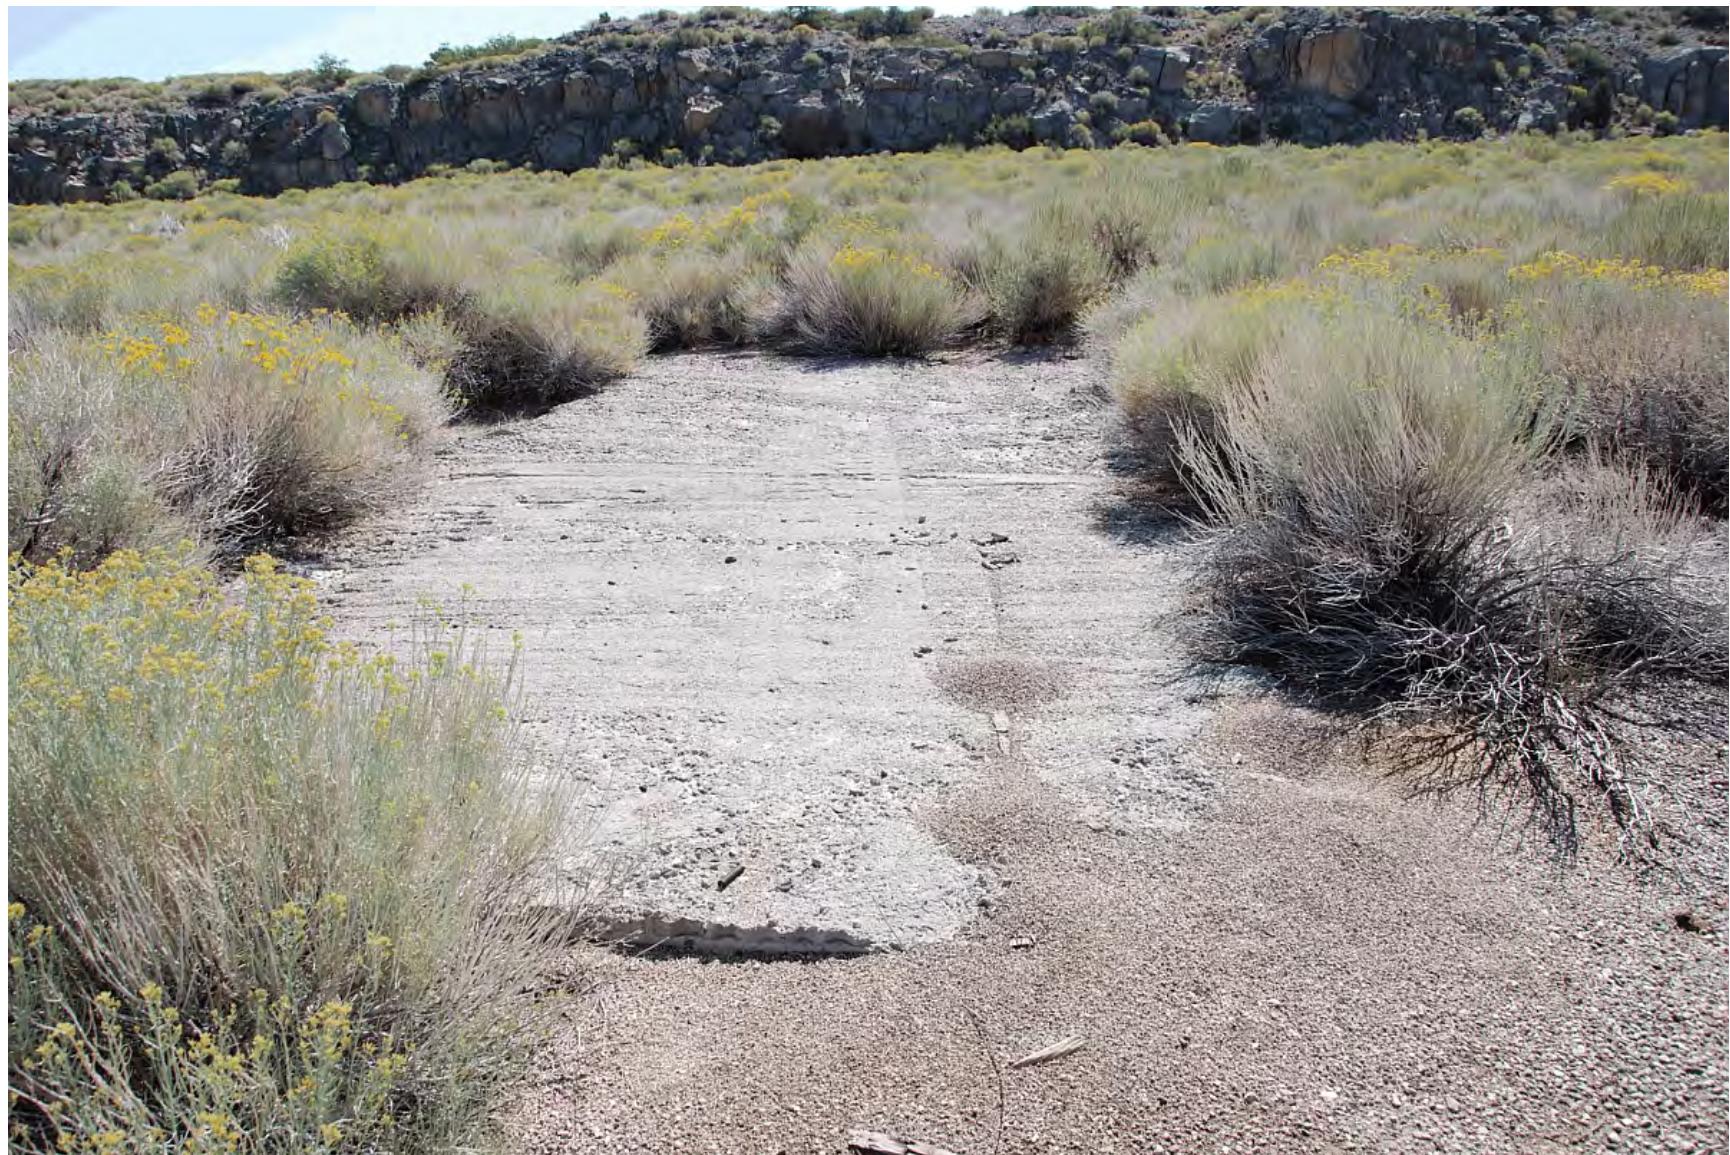
Feature 95 (Figure 255) is a concrete pad at UTM coordinates 570743 E, 4117542 N. The concrete pad is 23 ft east-west by 10 ft north-south and orientated at 30 degrees. The concrete is not level with the north side of the pad which is approximately 3 inches higher than the south side of the pad. The surface of the concrete is highly deteriorated but some areas show a brushed finish. Associated artifacts are insulated wire, nails, light bulbs, a hack saw blade, bolts, and wood fragments.

Figure 255. Feature 95, concrete pad, U12n Tunnel, view northeast (2008).
