A total of 202 features were recorded, mapped, and photographed for the U12n Tunnel complex. The project area encompassed 600.8 acres (243.1 hectares) at the portal and mesa areas. At the U12n portal area are ten sub-areas containing features related to the construction, testing, and general everyday activities within the tunnel. These include concrete foundations for buildings, communications equipment, mining equipment, rail lines, retention ponds, storage containers, and access control facilities. Only a telephone trailer remains on the telephone pad as all of the other buildings have been removed from the portal area. The microwave tower, portions of the rail lines, the muck car dump, rotary dump, and wash rack are still in place. Also, the traffic control point and powder magazines along N Tunnel Road are intact. At the mesa area are four sub-areas containing features generally related to pre- and post-shot drilling, recording facilities, and ventilation equipment. These include concrete foundations, instrument cable holes, and drill holes. The concrete foundations were for buildings and small equipment. Concrete pads and various equipment remain at the cable hole locations bu

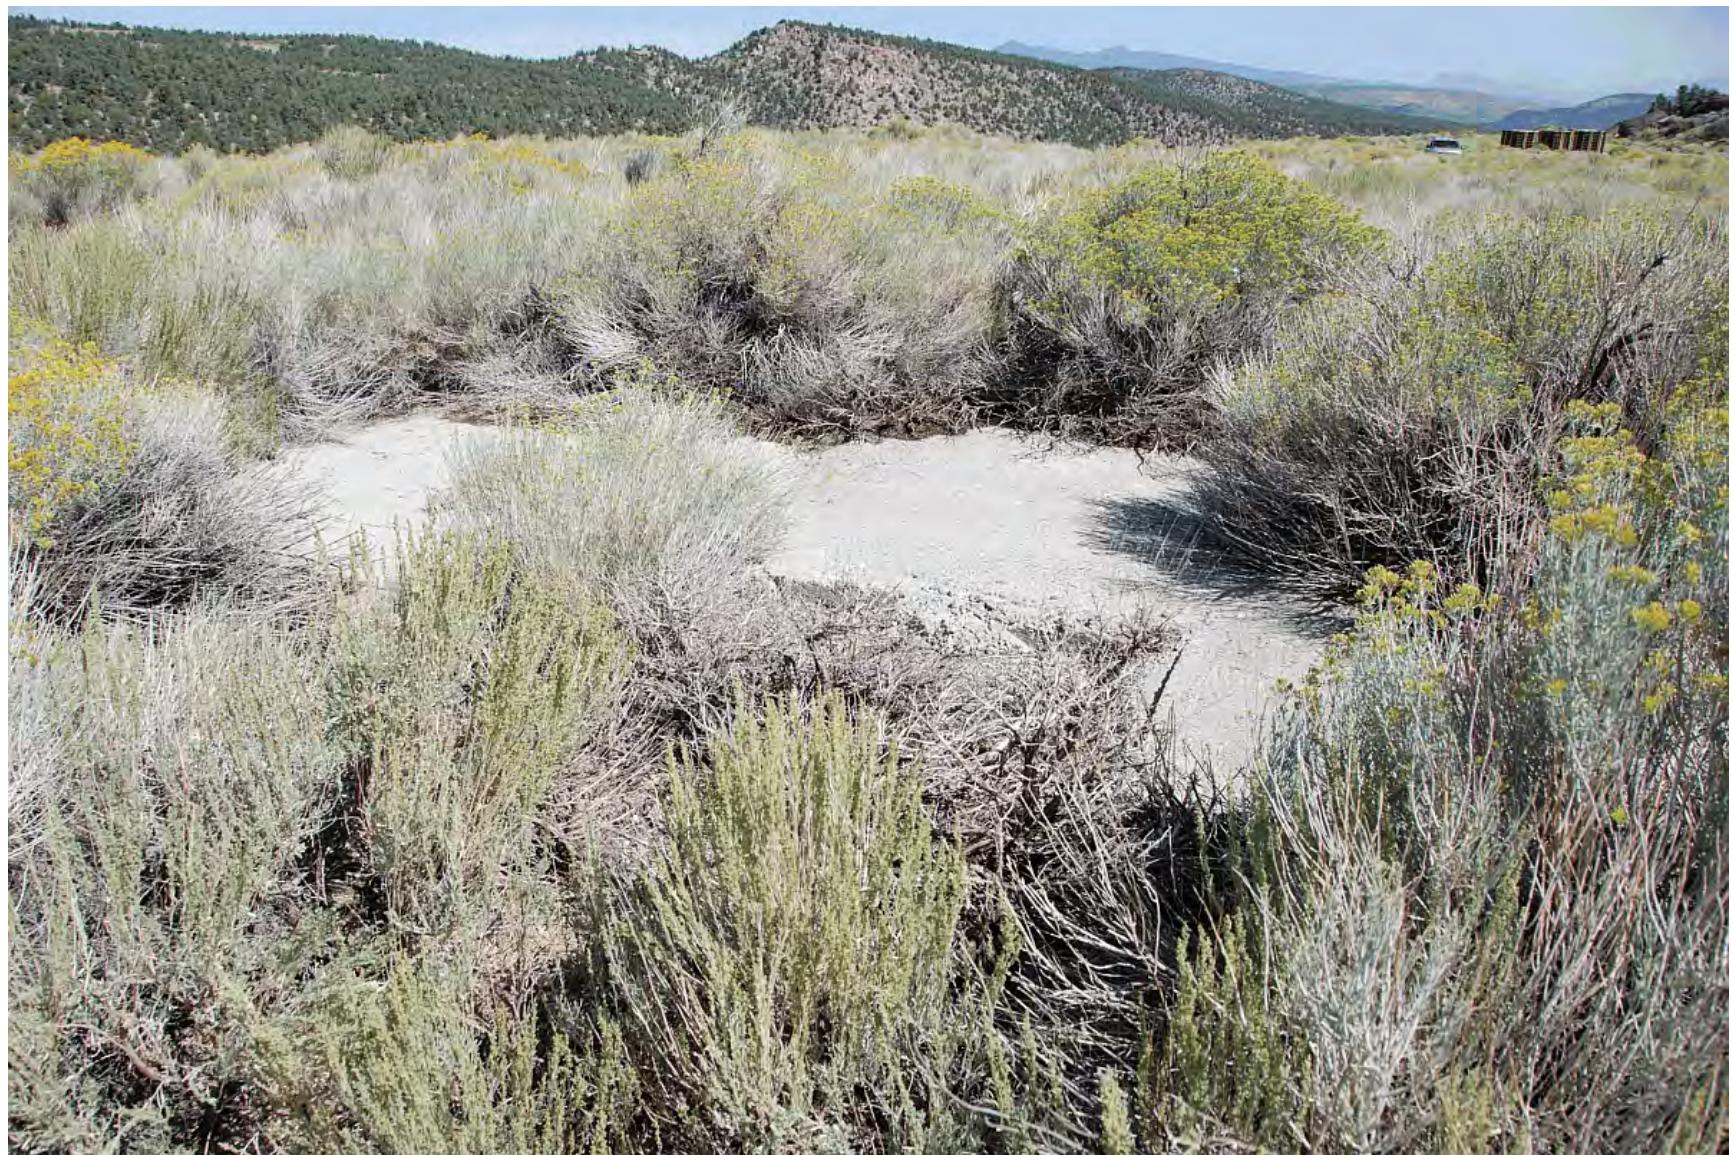
Feature 96 (Figure 256) is a concrete pad at UTM coordinates 570740 E, 4117523 N. The exterior dimensions of the pad are 14 ft east-west by 9 ft north-north and is oriented at 30 degrees. Centered in the south side is a 4 x 4 ft opening giving the pad a U shape. The rough poured concrete was formed with plywood and 2 x 4's which are still lying along the south edge of the pad. Associated artifacts are insulated wire, broken glass, and wood fragments.

Figure 256. Feature 96, concrete pad, U12n Tunnel, view northeast (2008).

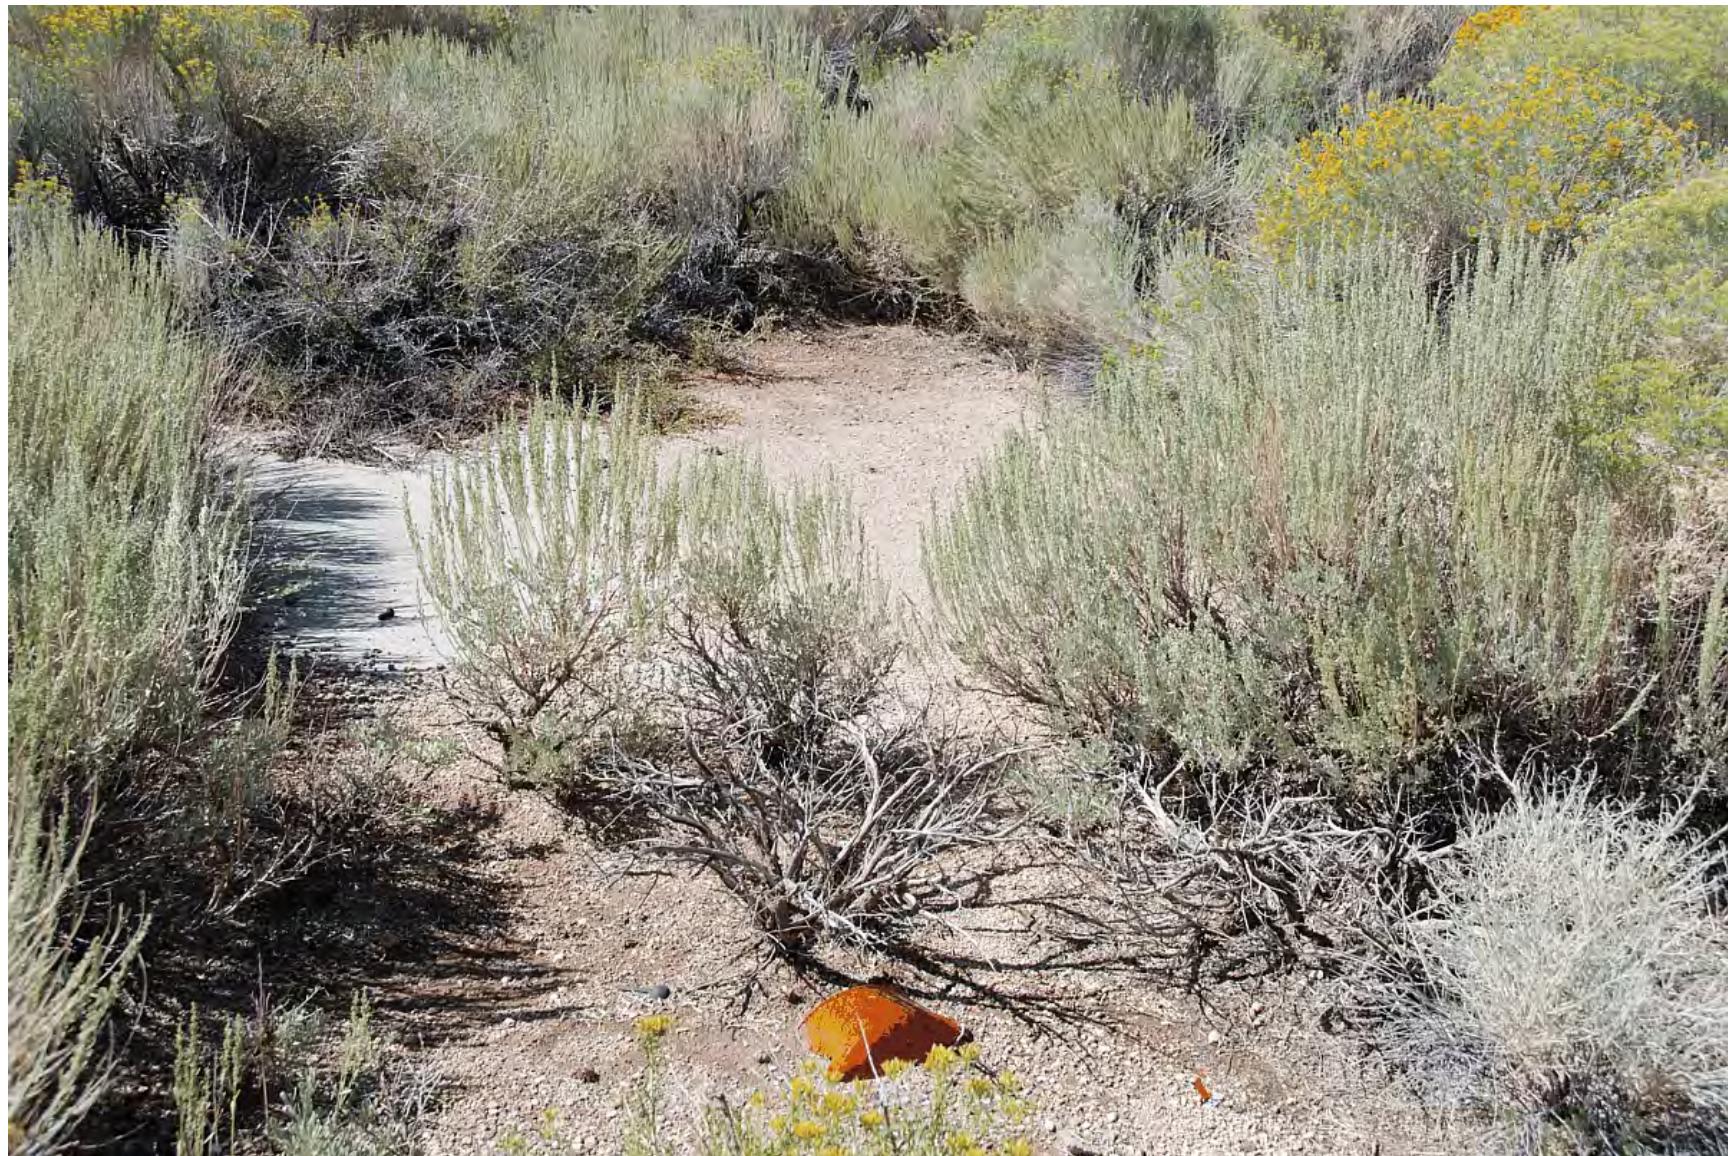
Feature 97 (Figure 257) is a concrete pad at UTM coordinates 570735 E, 4117518 N. The pad is 12 x 12 ft and orientated at 30 degrees. The surface of the concrete has been brushed and there are two 2-inch galvanized conduits near the center of the pad that have been cut flush with the surface. Associated artifacts are bolts, washers, insulated cable, and a yellow lens cover for a light (possibly flashing type).

Figure 257. Feature 97, concrete pad, U12n Tunnel, view south (2008).

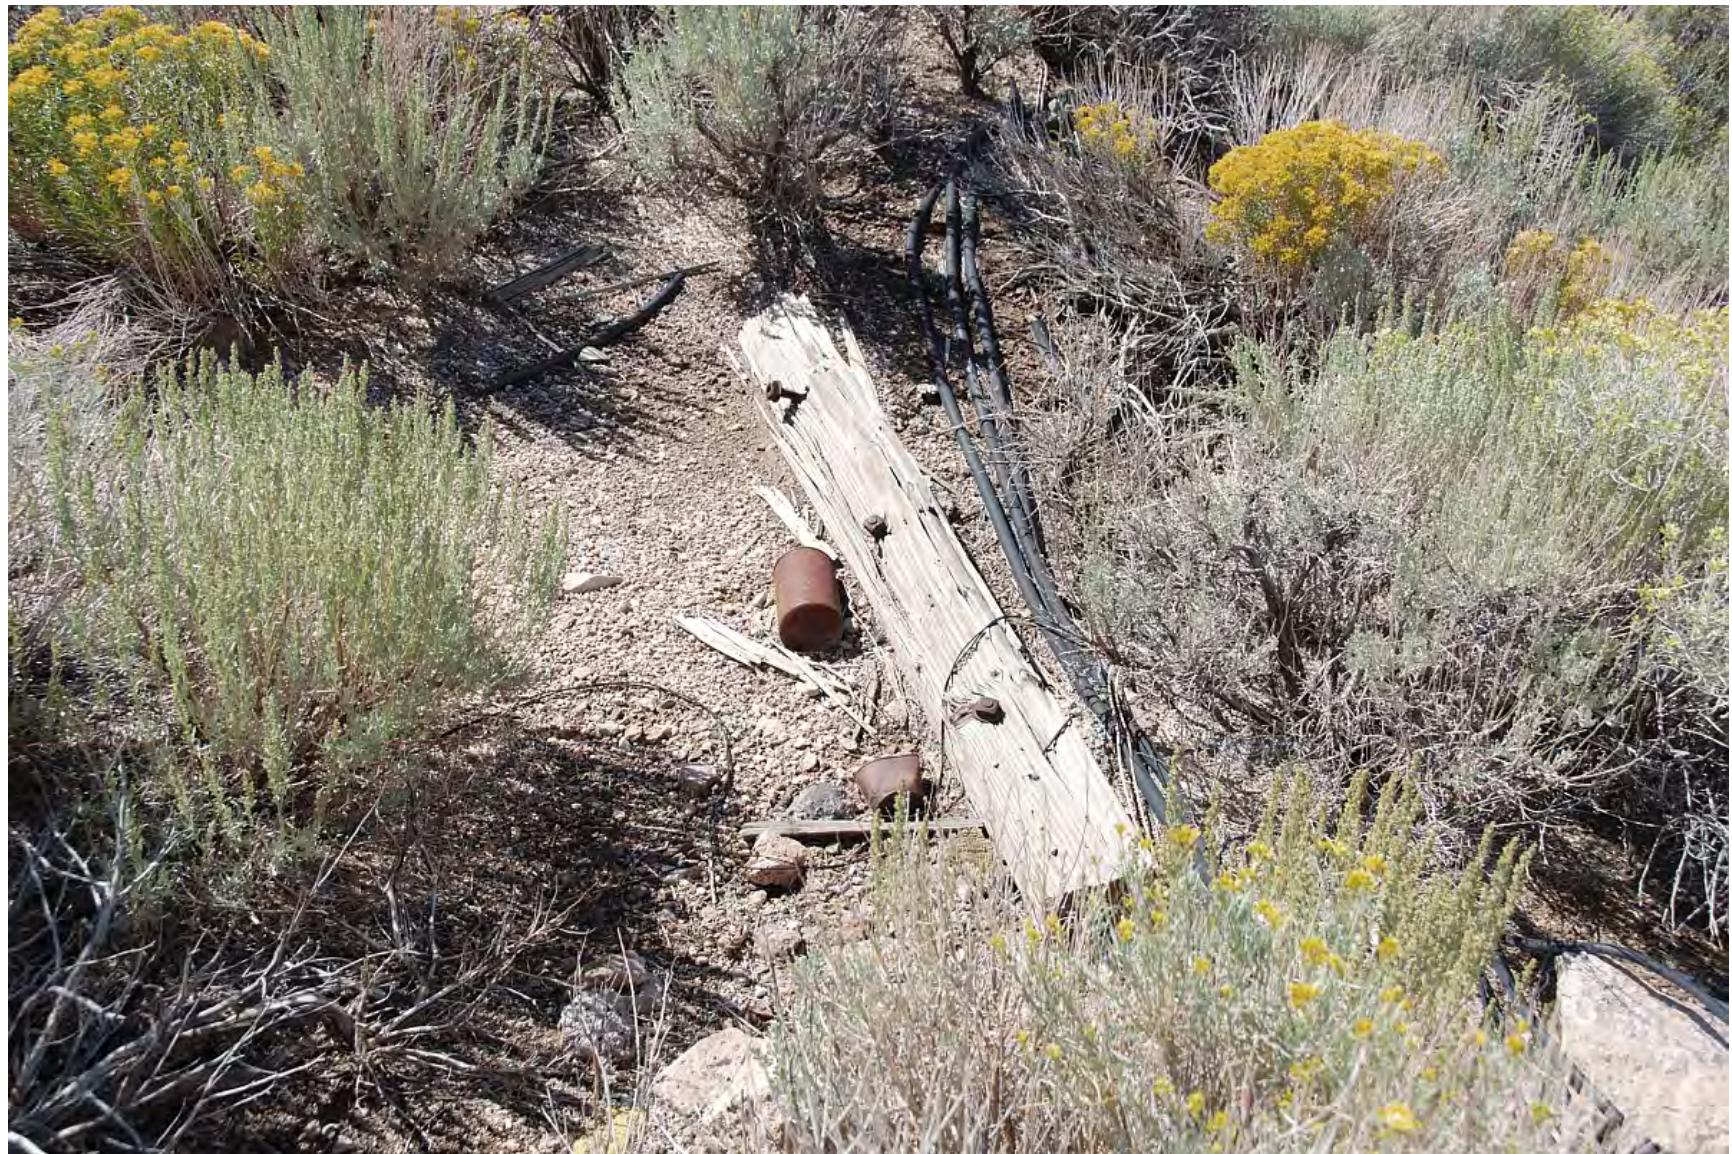
Feature 98 (Figure 258) is stairs or cable access supports between the U12n trailer park and the access road to the west. It is at UTM coordinates 570716 E, 4117478 N and consists of two concrete blocks and milled lumber beams on the slope between the upper and lower levels of the Trailer Park. The upper support consists of a 6 x 6 inch milled lumber beam that is 5 ft 4 inches (1.6 m) long and resting on a concrete block. The block is buried and the exact size is unknown. Three bolts secure the beam to the concrete. Approximately 12 ft downslope at UTM coordinates 570712 E, 4117477 N is the lower support. It consists of 5 ft x 7 ft x 1 ft (1.5 x 2.1 x 0.3 m) concrete block. The access conforms to a stairway shown on the Radiological Sciences Department Field Operations engineering drawing 4-32 dated September 9, 1968. Associated artifacts are insulated cable and wire and cans.

Figure 258. Feature 98, stairs or cable access supports, U12n Tunnel, view southwest (2008).

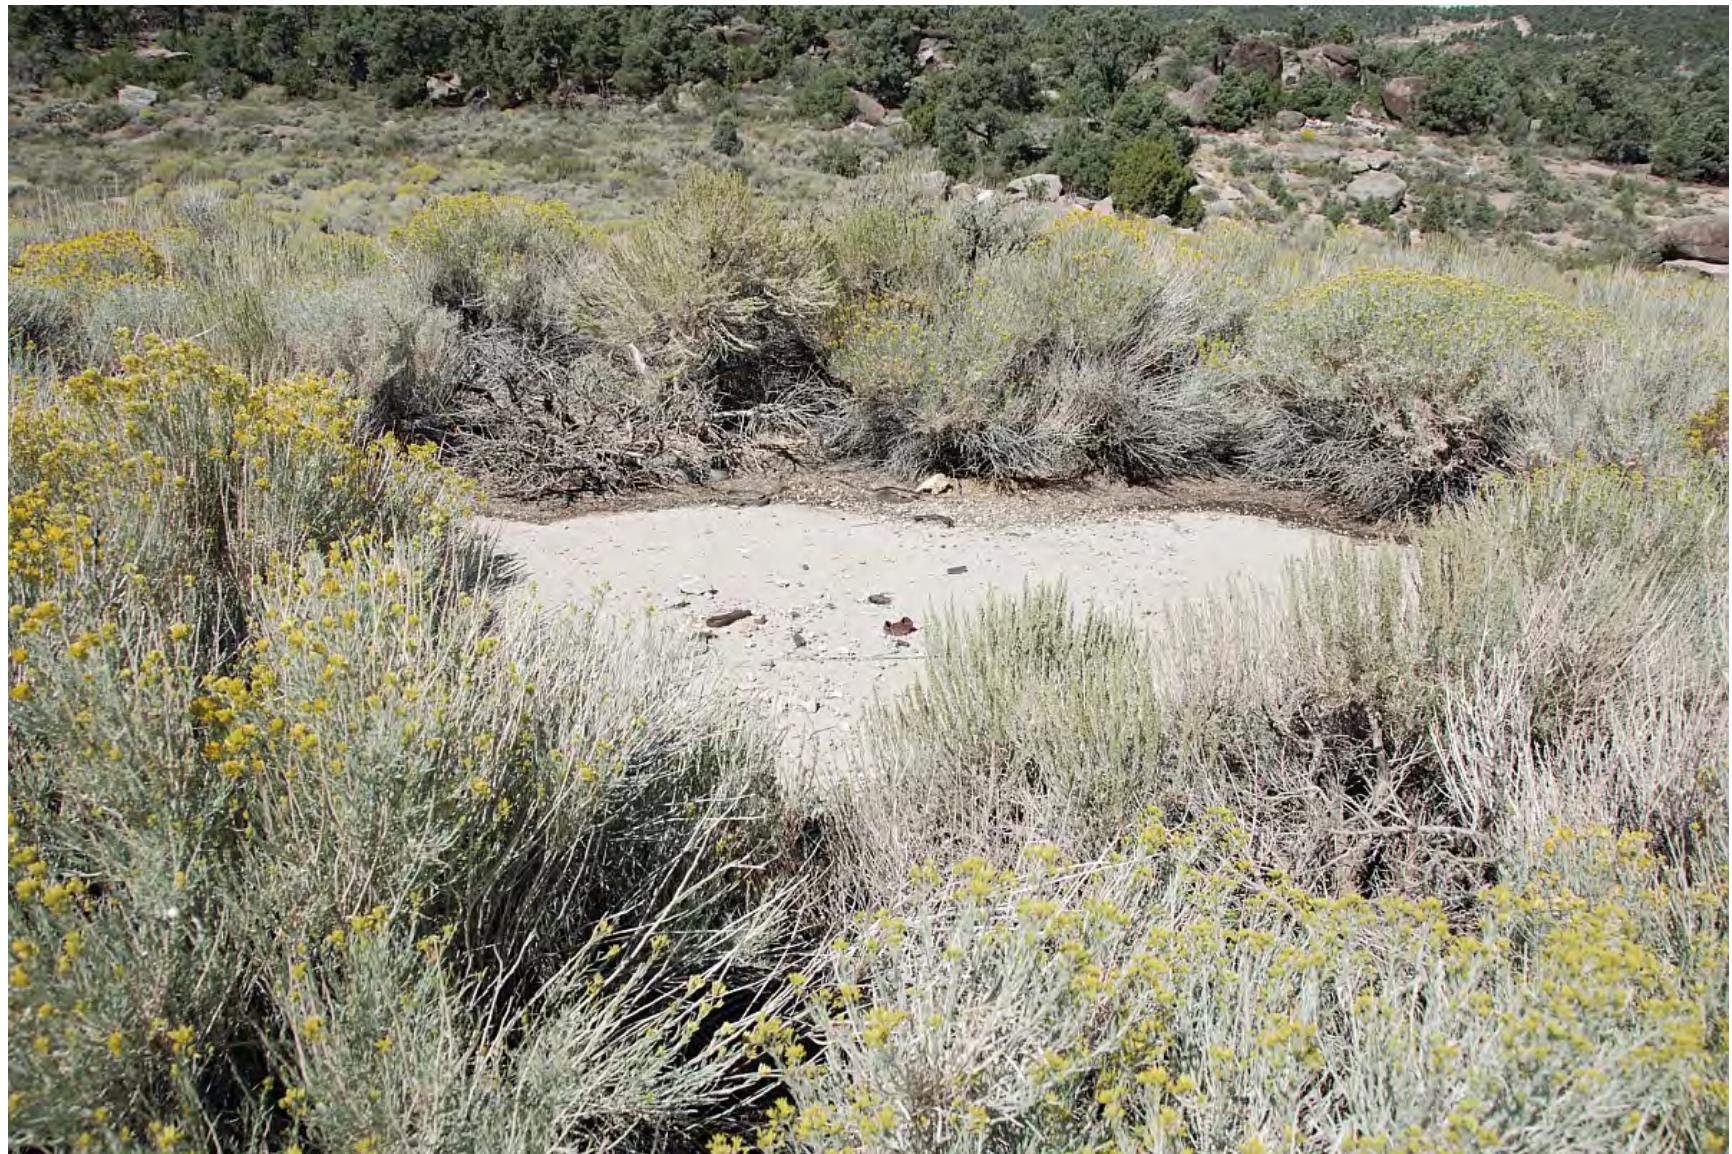
Feature 99 (Figure 259) is a concrete pad for an electrical substation at UTM coordinates 570722 E, 4117472 N. The pad is 13 ft north-south by 10 ft east-west and orientated at 10 degrees. The surface of the concrete has been brushed and there are two 2 inch galvanized conduit in the center of the pad that have been cut flush with the surface. Along the west edge are two 3-inch galvanized conduit that extend above the surface and encase three 7/8-inch (2.2 cm) insulated cables. The pad is shown on Holmes and Narver engineering drawing JS-012-U12n.15-E45.1 and dated March 11, 1982 and is labeled SUB #4 NOT USED.

Figure 259. Feature 99, electrical substation concrete pad, U12n Tunnel, view west (2008).

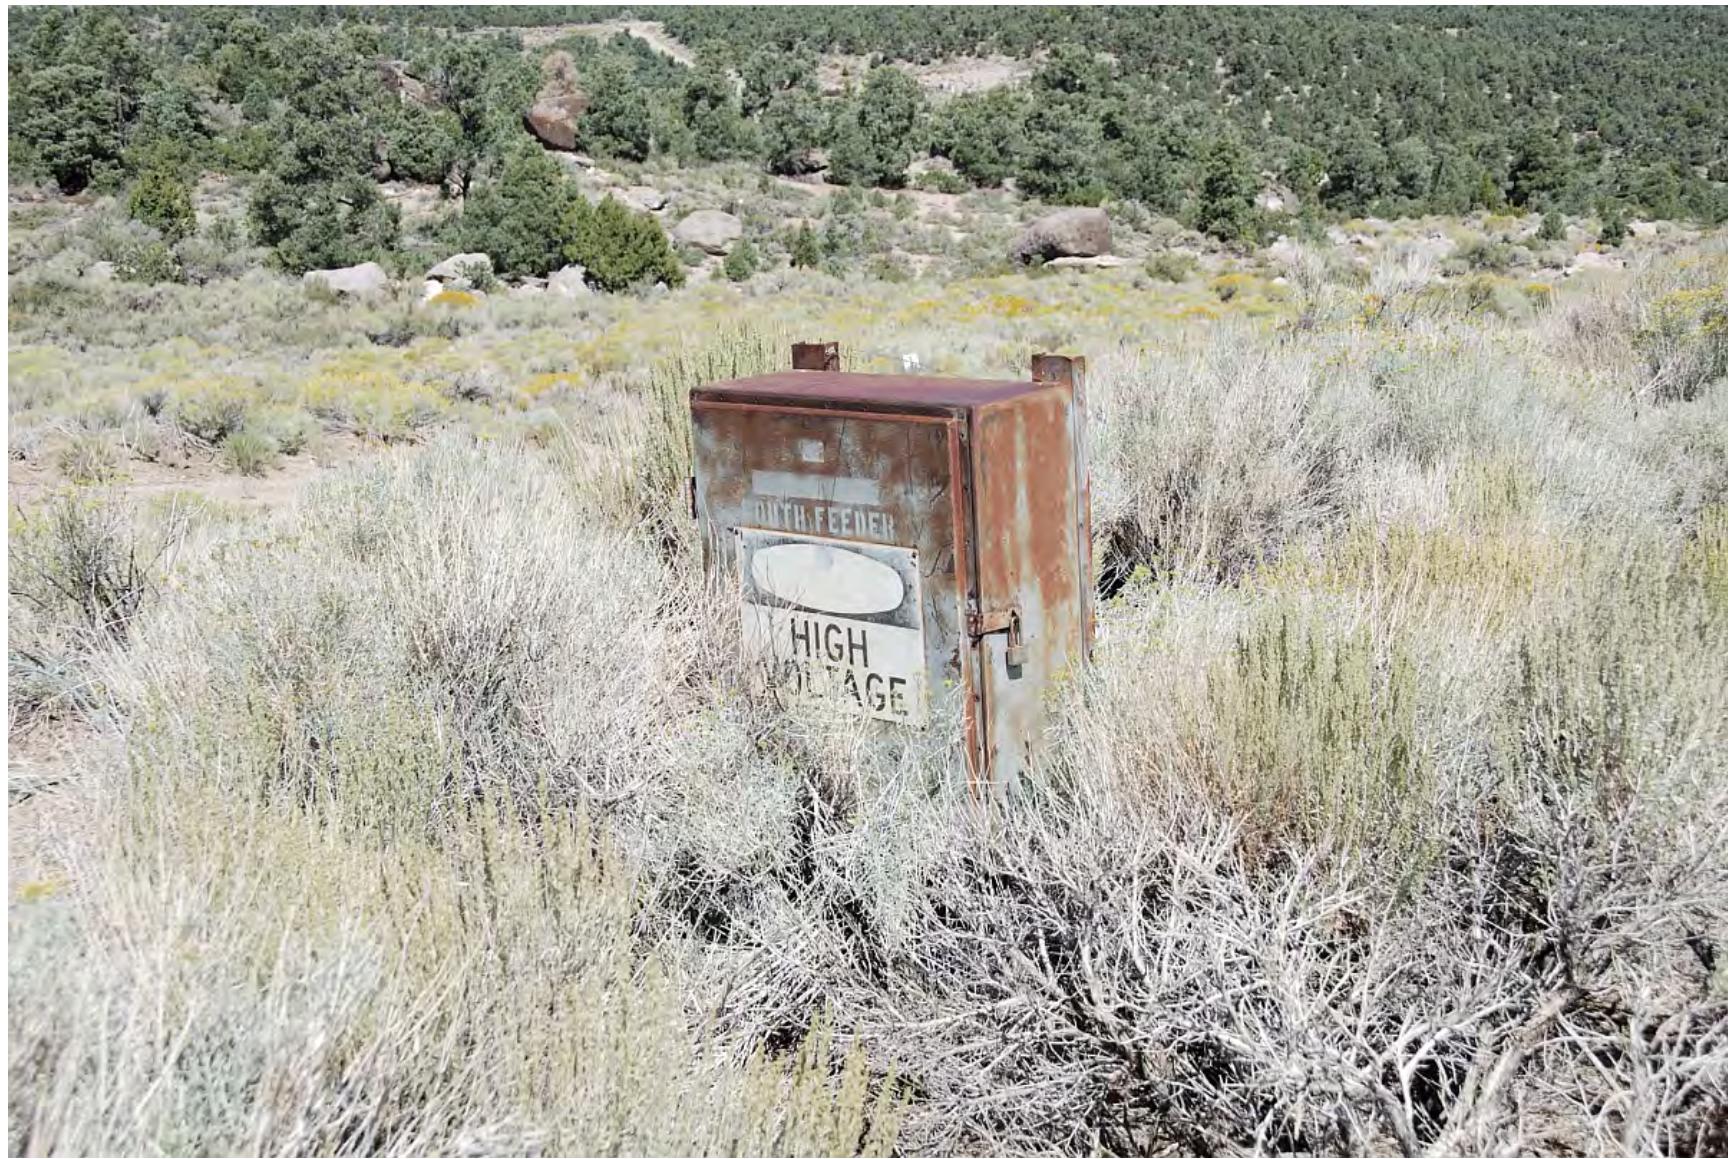
Feature 100 (Figure 260) is an electrical panel at UTM coordinates 570702 E, 4117431 N. The panel is 2 ft 6 inches x 3 ft x 1 ft and supported by two 4-inch channel iron legs that are 5 ft 6 inches (1.4 m) in height. The panel is labeled SOUTH FEEDER, HIGH VOLTAGE, and is locked.

Figure 260. Feature 100, electrical panel, U12n Tunnel, view northeast (2008).

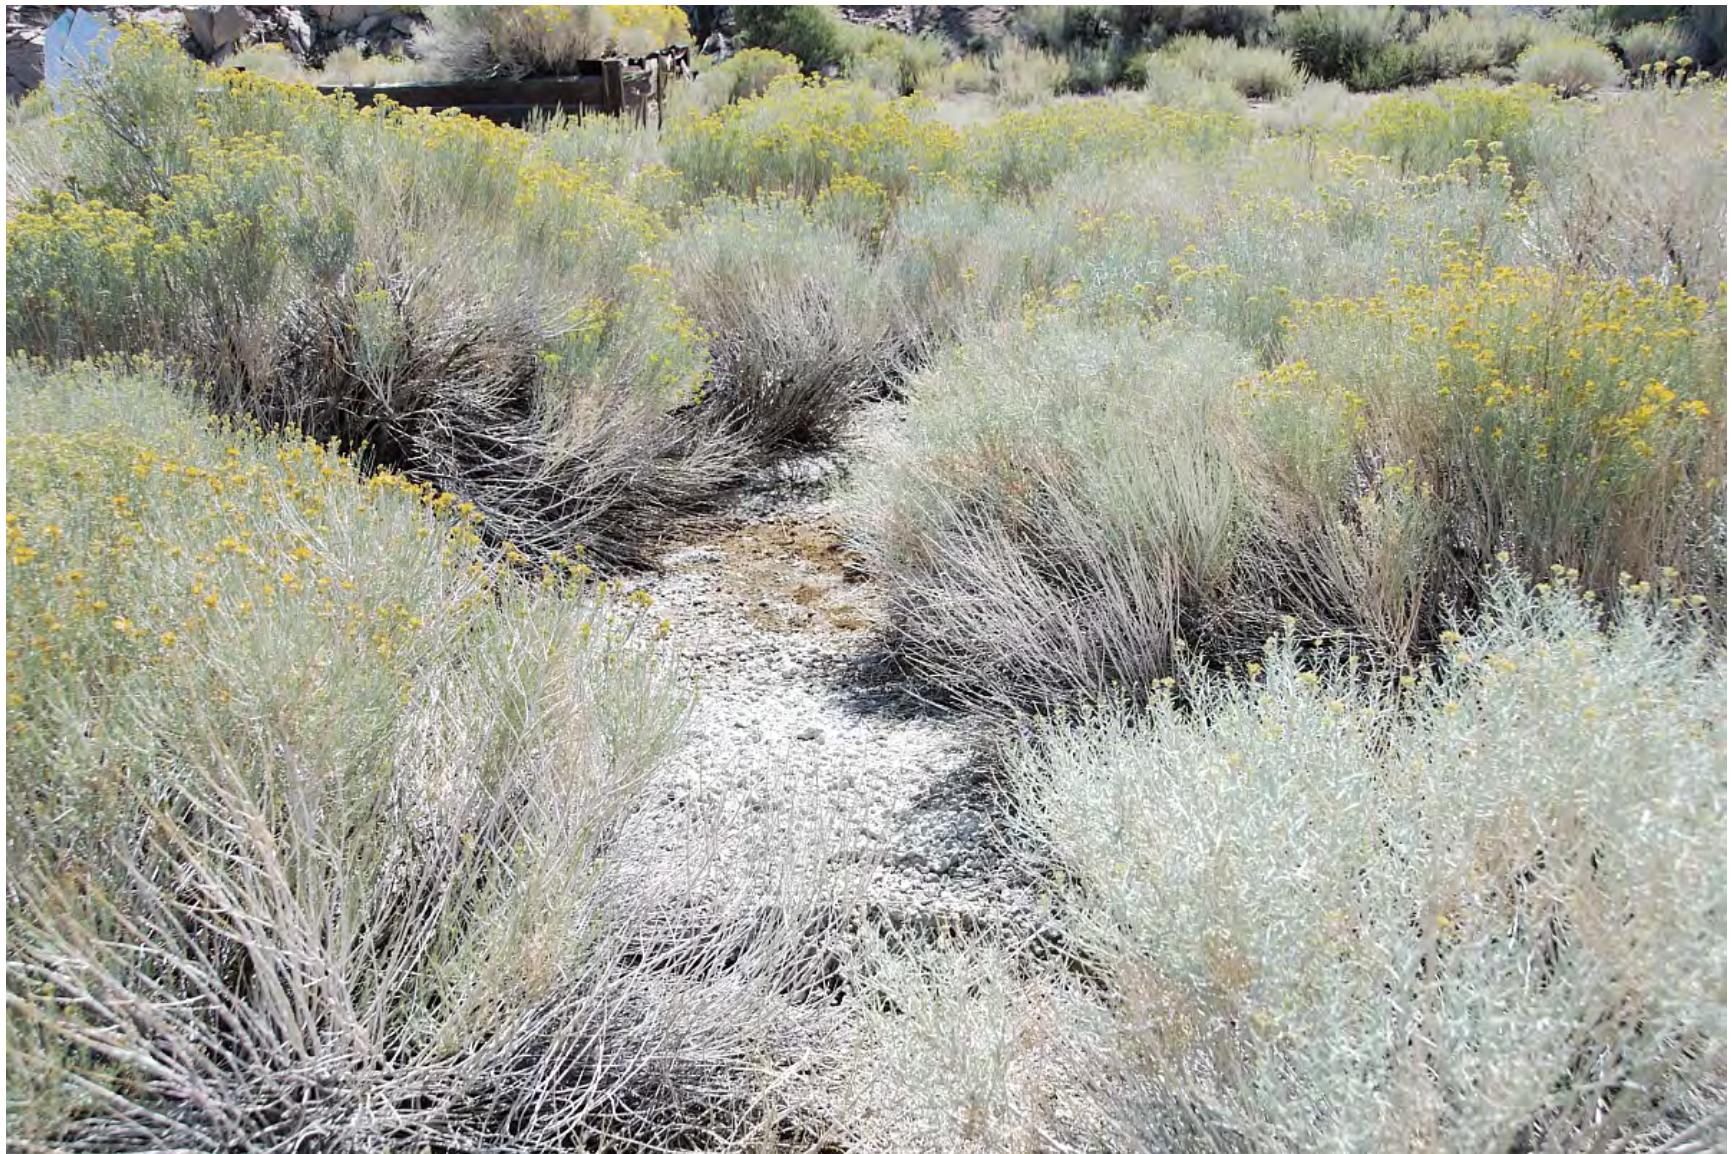
Feature 101 (Figure 261) is an expanse of concrete at UTM coordinates 570720 E, 4117436 N. The concrete measures 10 ft east-west by 5 ft north-south and probably was left over from another pour and disposed at this location. Associated artifacts are a woven hemp mat and asphalt.

Figure 261. Feature 101, excess concrete, U12n Tunnel, view southeast (2008).

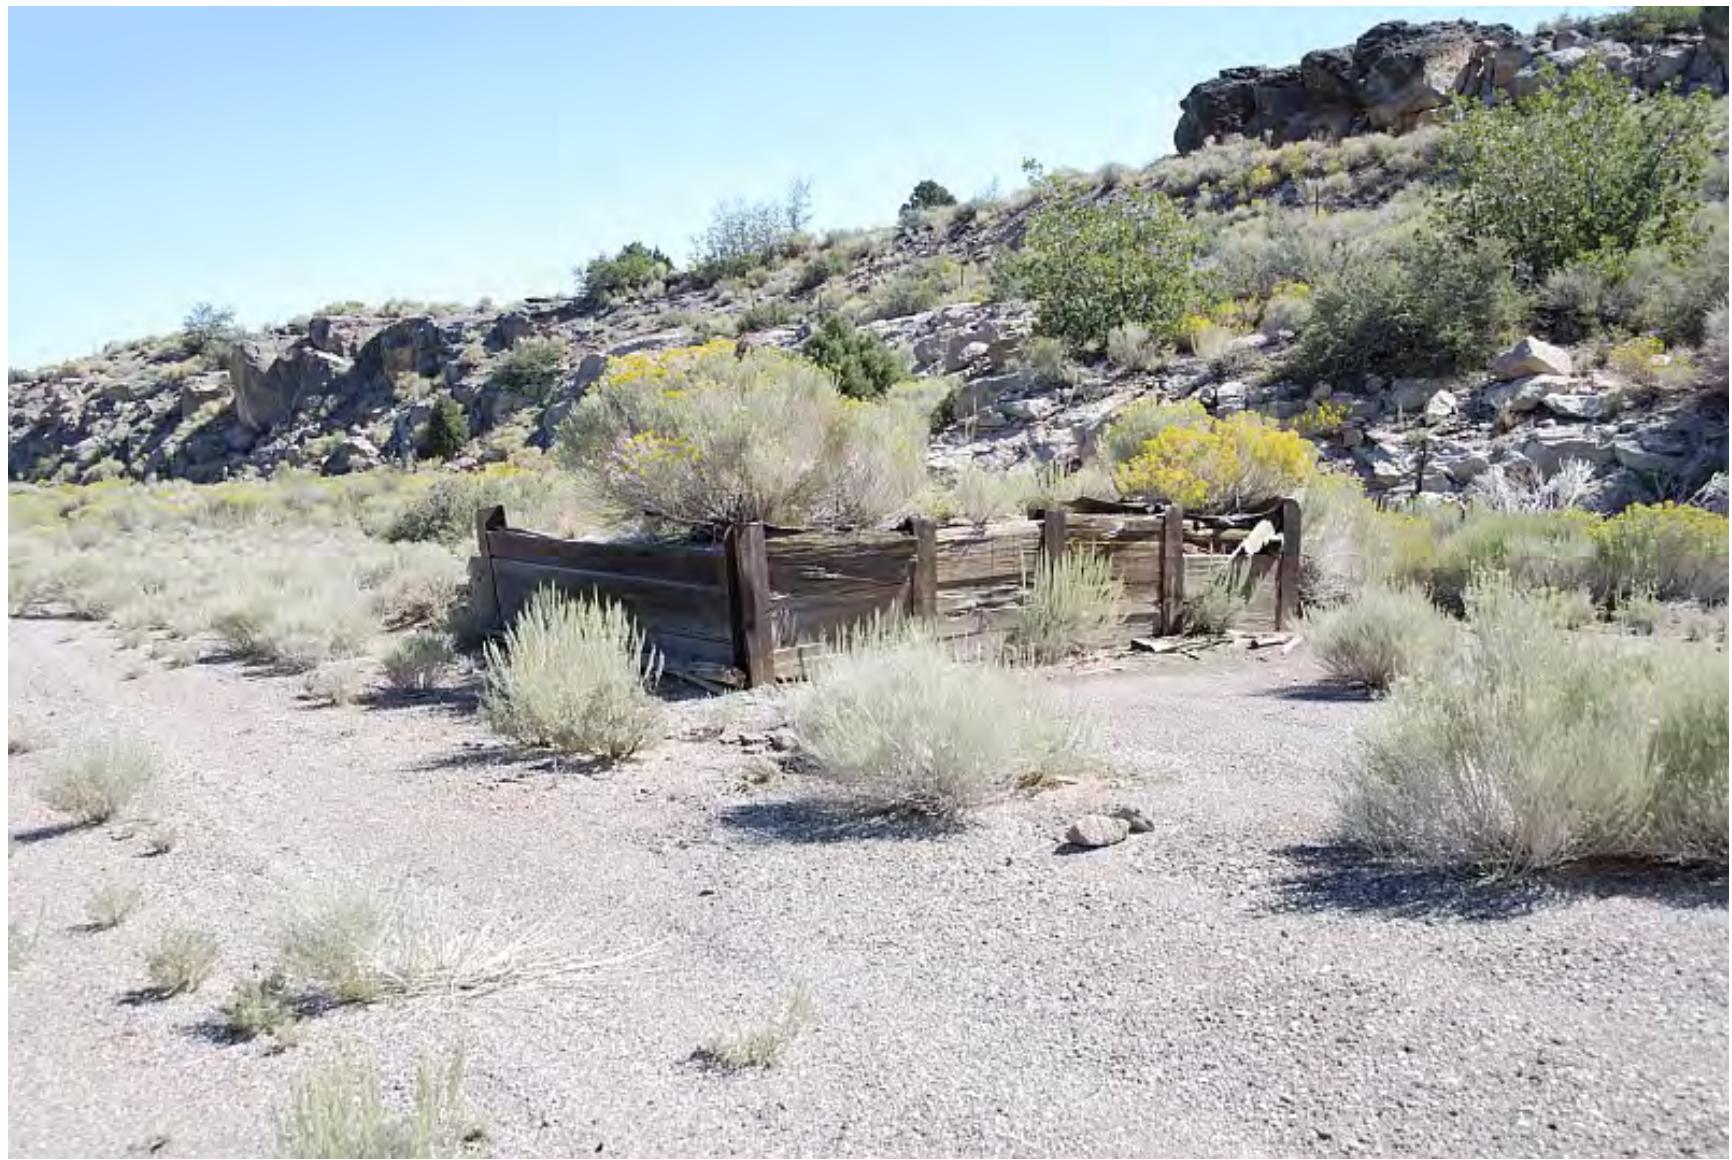
Feature 102 (Figure 262) is a loading ramp at UTM coordinates 570732 E, 4117428 N. The ramp face is constructed of 6-inch I-beam posts spaced 3 ft apart and the gaps filled with 6 x 6 x 3 ft milled lumber lagging. It is 13 ft 5 inches east-west and 2 ft 8 inches in height. A 1 ft 3 inch wide by 1 ft 4 inch long piece of 1/8-inch diamond plate metal extends along the top edge of the ramp. The east and west sides are constructed similar to the face and consist of 6-inch I-beam spaced 6 ft apart and filled with 6 inch x 6inch x 6 ft lagging. The slope section of the ramp is compacted soil and extends 30 ft and is oriented at 20 degrees. The area south of the ramp has been covered with asphalt. Associated artifacts are milled lumber fragments, wire, and metal fragments.

Figure 262. Feature 102, loading ramp, U12n Tunnel, view northeast (2008).

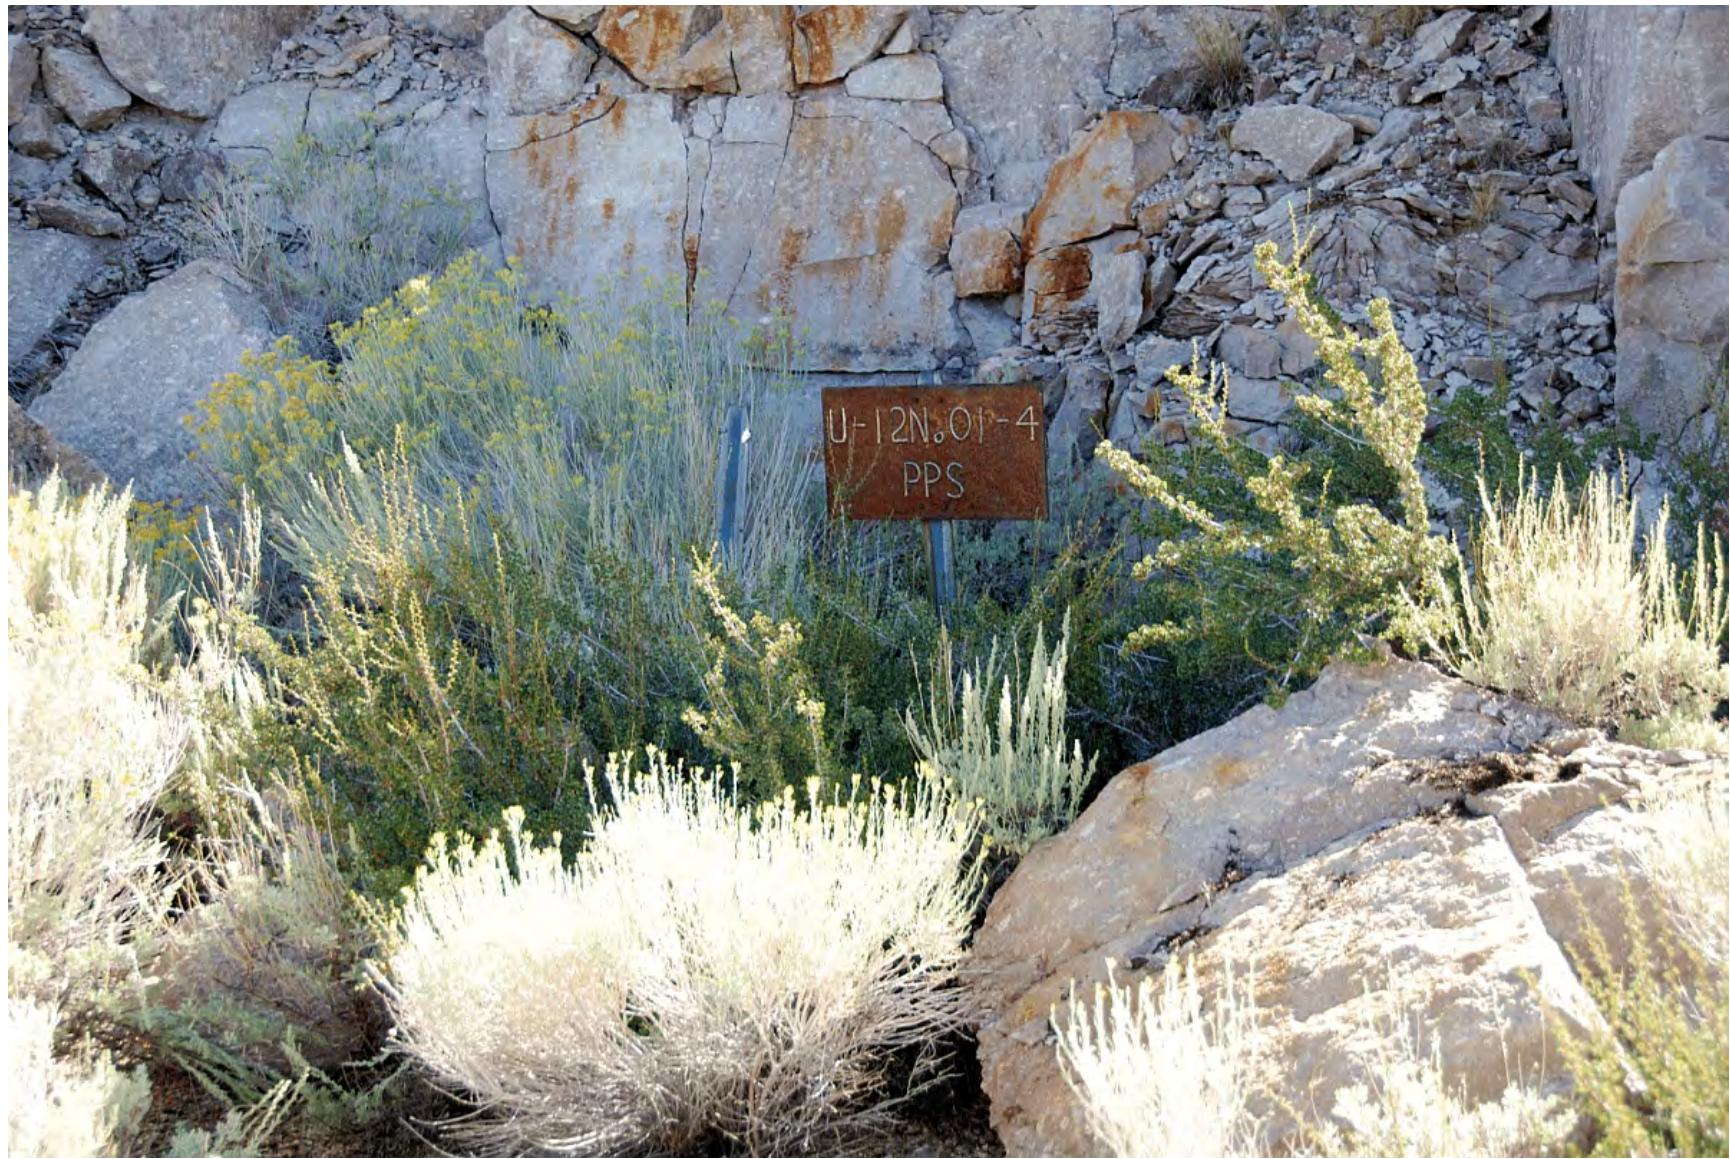
Feature 103 (Figure 263) is the U-12n.01-4 PPS pre-postshot drill hole at UTM coordinates 570782 E, 4117460 N, at an elevation of 7,339 ft (2,236.9 m), and drilled to a depth of 836 ft (255 m) (Bennett 1991). The drill hole is marked by one white sign lying on the surface and one oxidized sign with welded lettering. No pipe is visible above the surface because rock fall and dense vegetation obscure the area.

Figure 263. Feature 103, U-12n.01-4 PPS pre-postshot drill hole, U12n Tunnel, view northeast (2008).

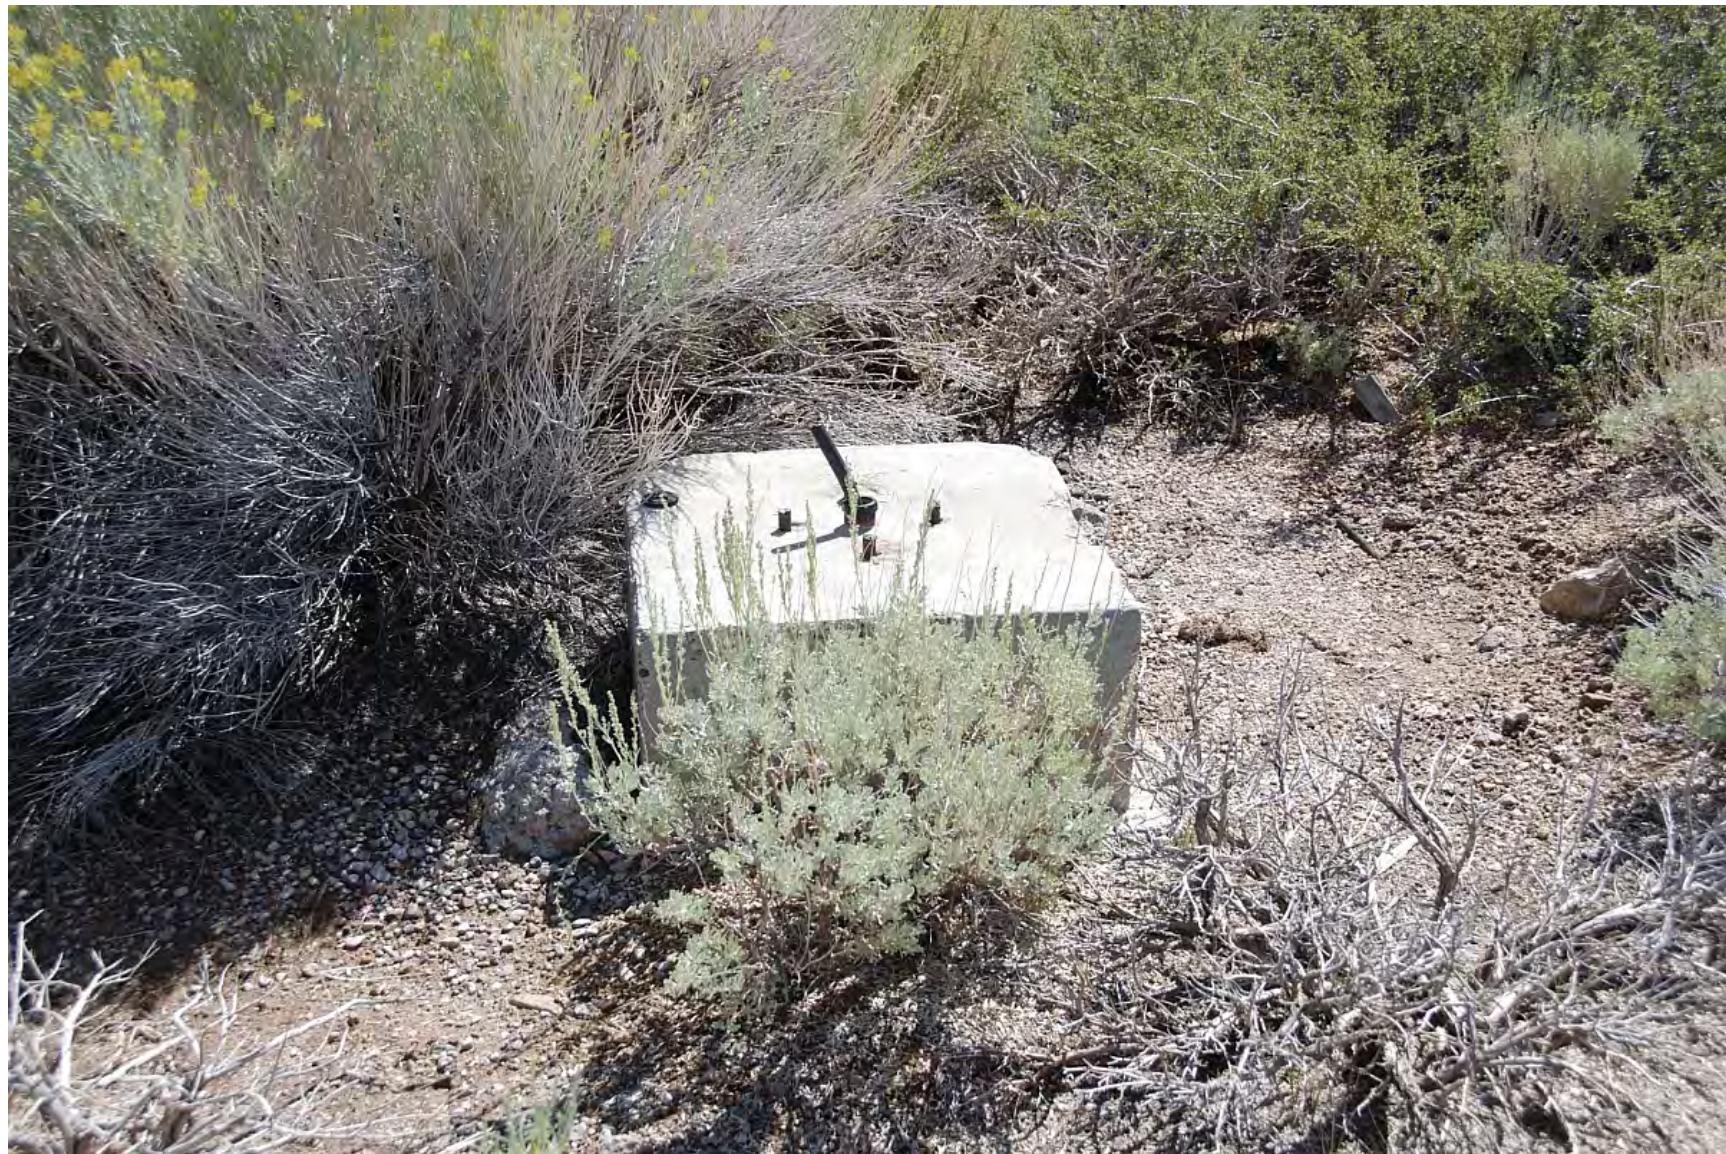
Feature 104 (Figure 264) is a concrete block to support a light pole at UTM coordinates 570780 E, 4117479 N. The block is 2 ft x 2 ft x 1 ft and has 1 1/2-inch galvanized conduit extending through the surface encasing 3/4-inch insulate cable. Four 5/8-inch bolts around the conduit attached the light pole base to the concrete.

Figure 264. Feature 104, concrete block, U12n Tunnel, view northeast (2008).

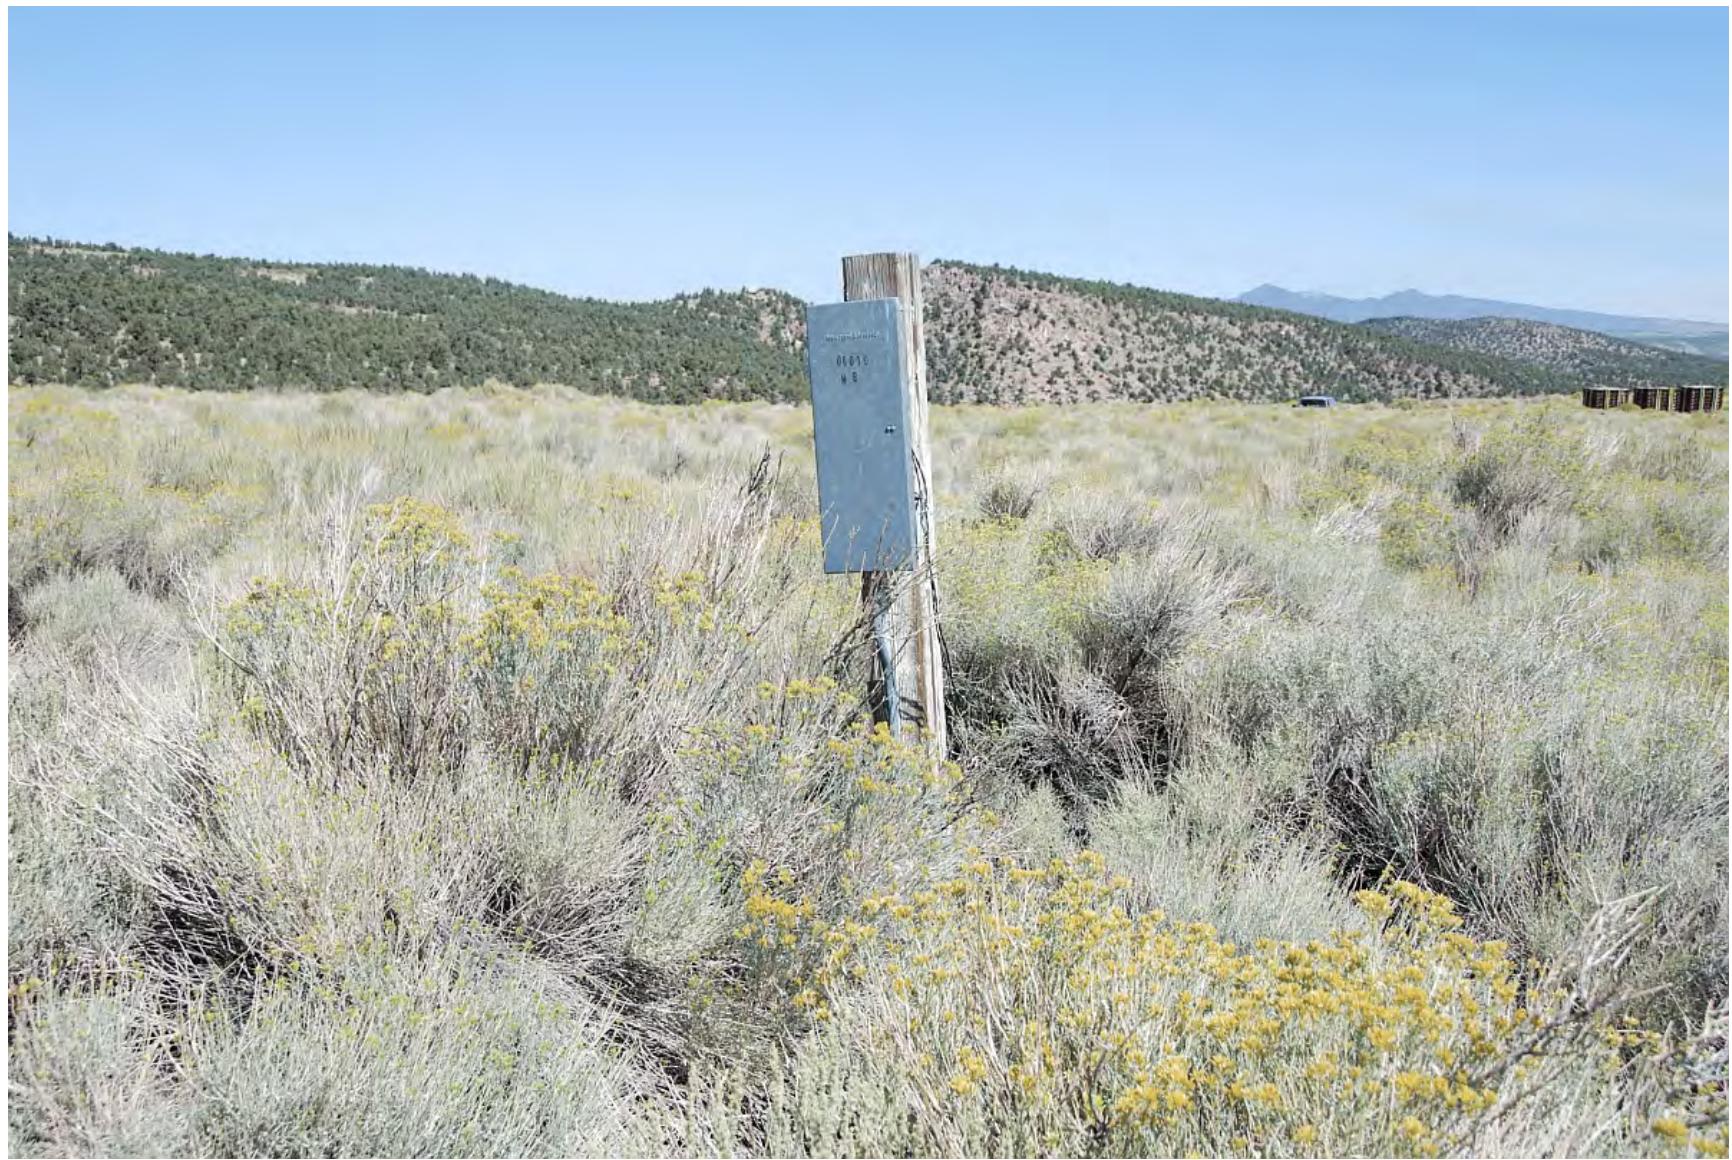
Feature 105 (Figure 265) is a telephone junction box at UTM coordinates 570761 E, 4117499 N. The galvanized box is 1 ft 10 inches x 8 inches x 3 inches and attached to a 6 x 6 milled lumber post that is 6 ft in height. It is a low voltage telephone junction box labeled 0601D.

Figure 265. Feature 105, telephone junction box, U12n Tunnel, view northeast (2008).
