A total of 202 features were recorded, mapped, and photographed for the U12n Tunnel complex. The project area encompassed 600.8 acres (243.1 hectares) at the portal and mesa areas. At the U12n portal area are ten sub-areas containing features related to the construction, testing, and general everyday activities within the tunnel. These include concrete foundations for buildings, communications equipment, mining equipment, rail lines, retention ponds, storage containers, and access control facilities. Only a telephone trailer remains on the telephone pad as all of the other buildings have been removed from the portal area. The microwave tower, portions of the rail lines, the muck car dump, rotary dump, and wash rack are still in place. Also, the traffic control point and powder magazines along N Tunnel Road are intact. At the mesa area are four sub-areas containing features generally related to pre- and post-shot drilling, recording facilities, and ventilation equipment. These include concrete foundations, instrument cable holes, and drill holes. The concrete foundations were for buildings and small equipment. Concrete pads and various equipment remain at the cable hole locations bu

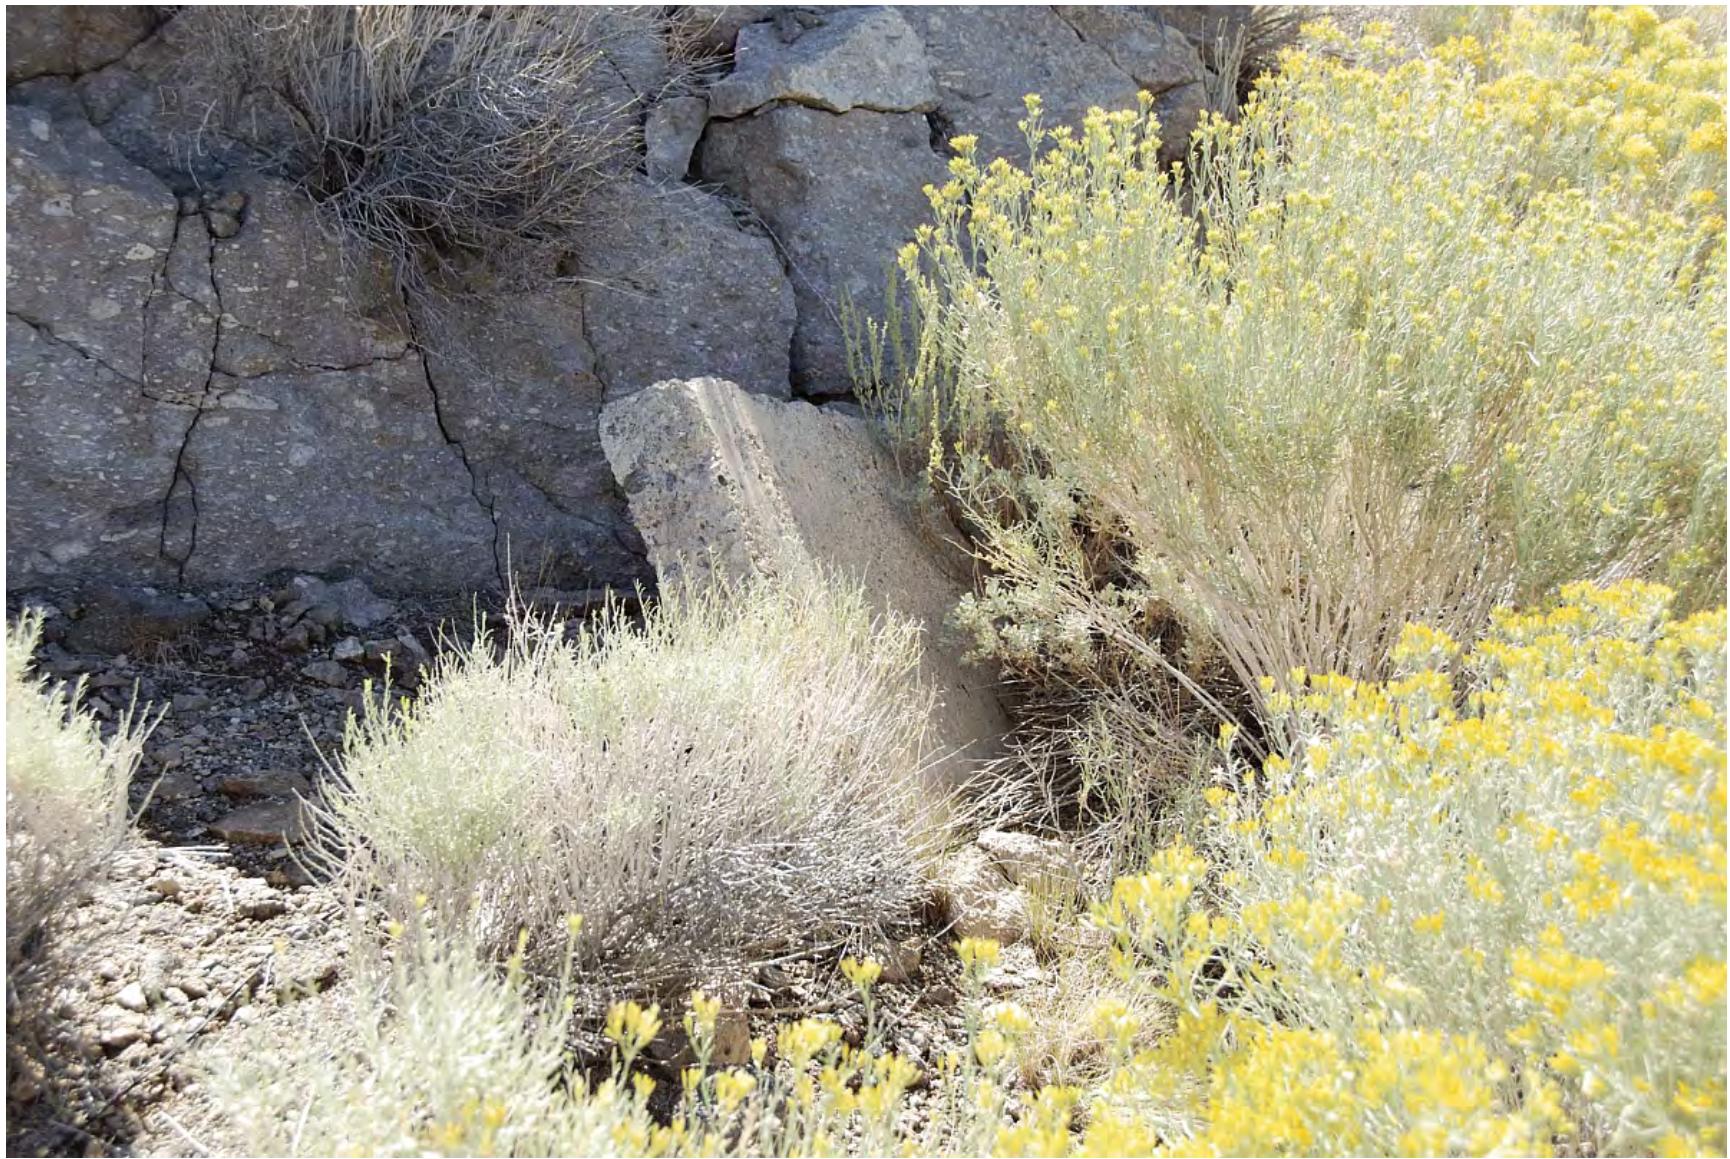
Feature 106 (Figure 266) is a concrete pad at UTM coordinates 570794 E, 4117504 N. The pad is 3 ft 2 inches x 3 ft 2 inches x 5 inches and resting on its edge and does not appear to be in its original location. The pad may be the bottom support section for a stair or cable run support such as Feature 107.

Figure 266. Feature 106, concrete pad, U12n Tunnel, view east (2008).

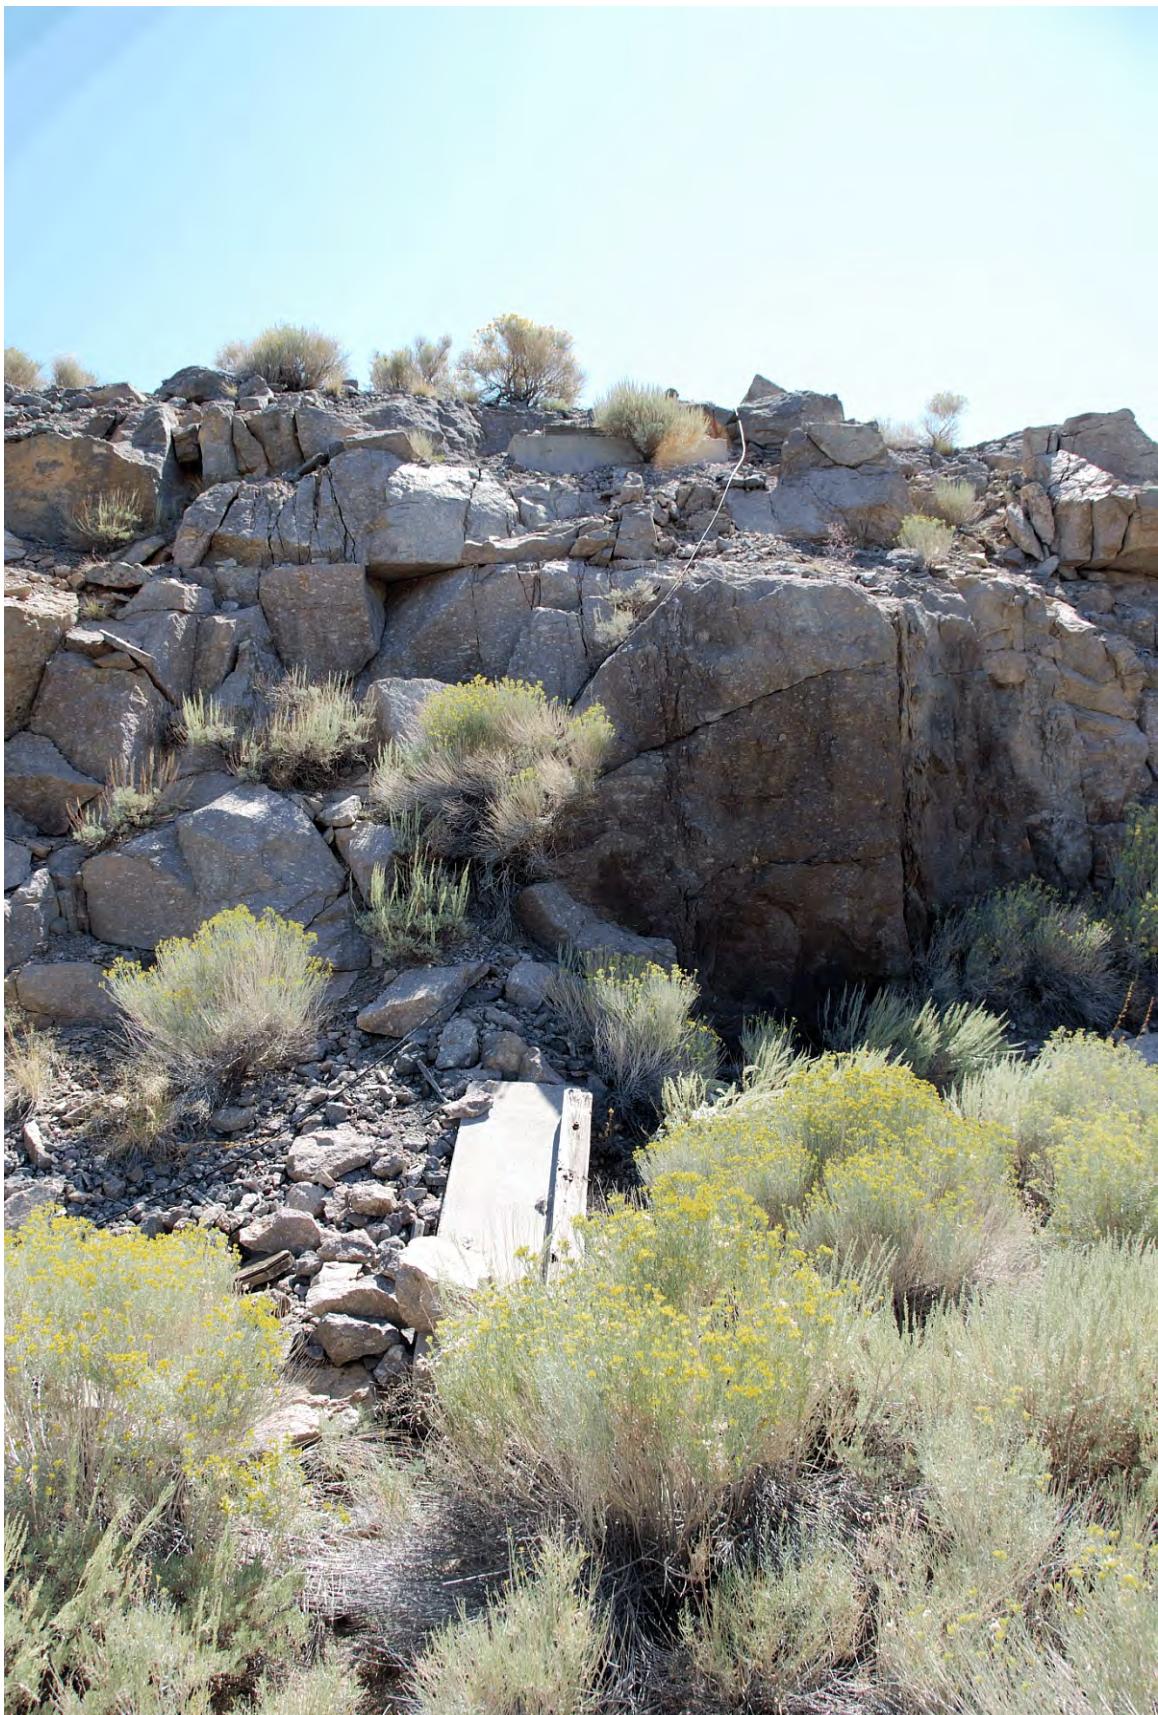
Feature 107 (Figure 267) is a stair or cable run support at UTM coordinates 570836 E, 4117575 N. The feature consists of two concrete blocks with milled lumber beams near the bottom and top of the slope between the upper and lower levels of the U12n trailer park. The lower concrete block is 7 ft x 2 ft x 1 ft 2 inches and has a 4 inch x 6 inch x 62 inch milled lumber beam bolted to the long edge. The block is not in its original position and lying on its side. The upper block is 7 ft x 5 ft x 1 ft with a 4 inch x 6 inch x 5 ft 2 inch milled lumber beam bolted to the west edge. It is at UTM coordinates 570838 E, 4117571 N and is in its original position.

Figure 267. Figure 107, stairs or cable access supports, U12n Tunnel, view east (2008).

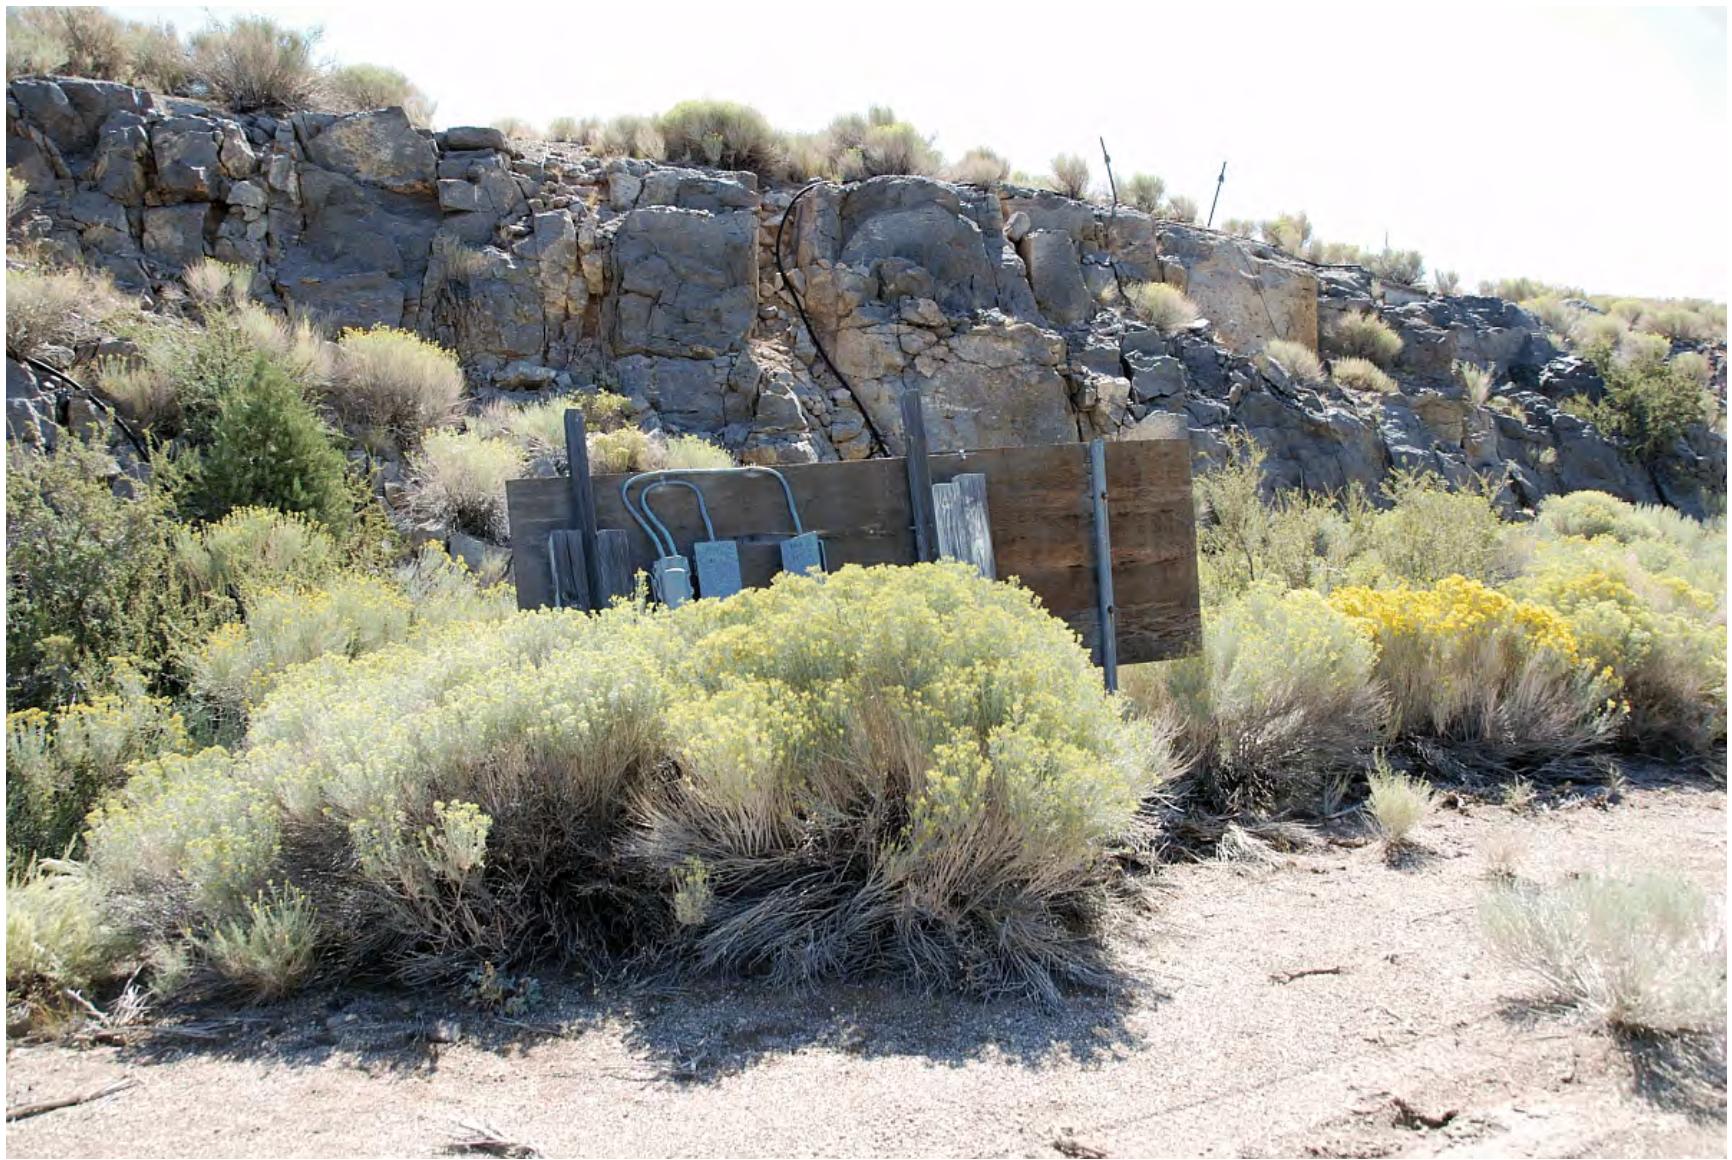
Feature 108 (Figure 268) is an electrical panel backboard at UTM coordinates 570839 E, 4117596 N on the lower level of the mesa trailer park. The backboard is 12 ft north-south and 7 ft 8 inches (2.3 m) in height. It consists of 3/4-inch and 1-inch plywood mounted to two 6 inch x 6 inch x 5 ft 6 inch milled lumber posts, two 4 x 4 x 7 ft 8 inch posts, and one 3 inch diameter by 6 ft 6 inch tall galvanized pipe. There are 10 low voltage electrical junction boxes (communication type) on the east side and 2 on the west side. Labeling on two boxes is 0601A-1 and 0601A-2.

Figure 268. Feature 108, electrical panel backboard, U12n Tunnel, view southeast (2008).

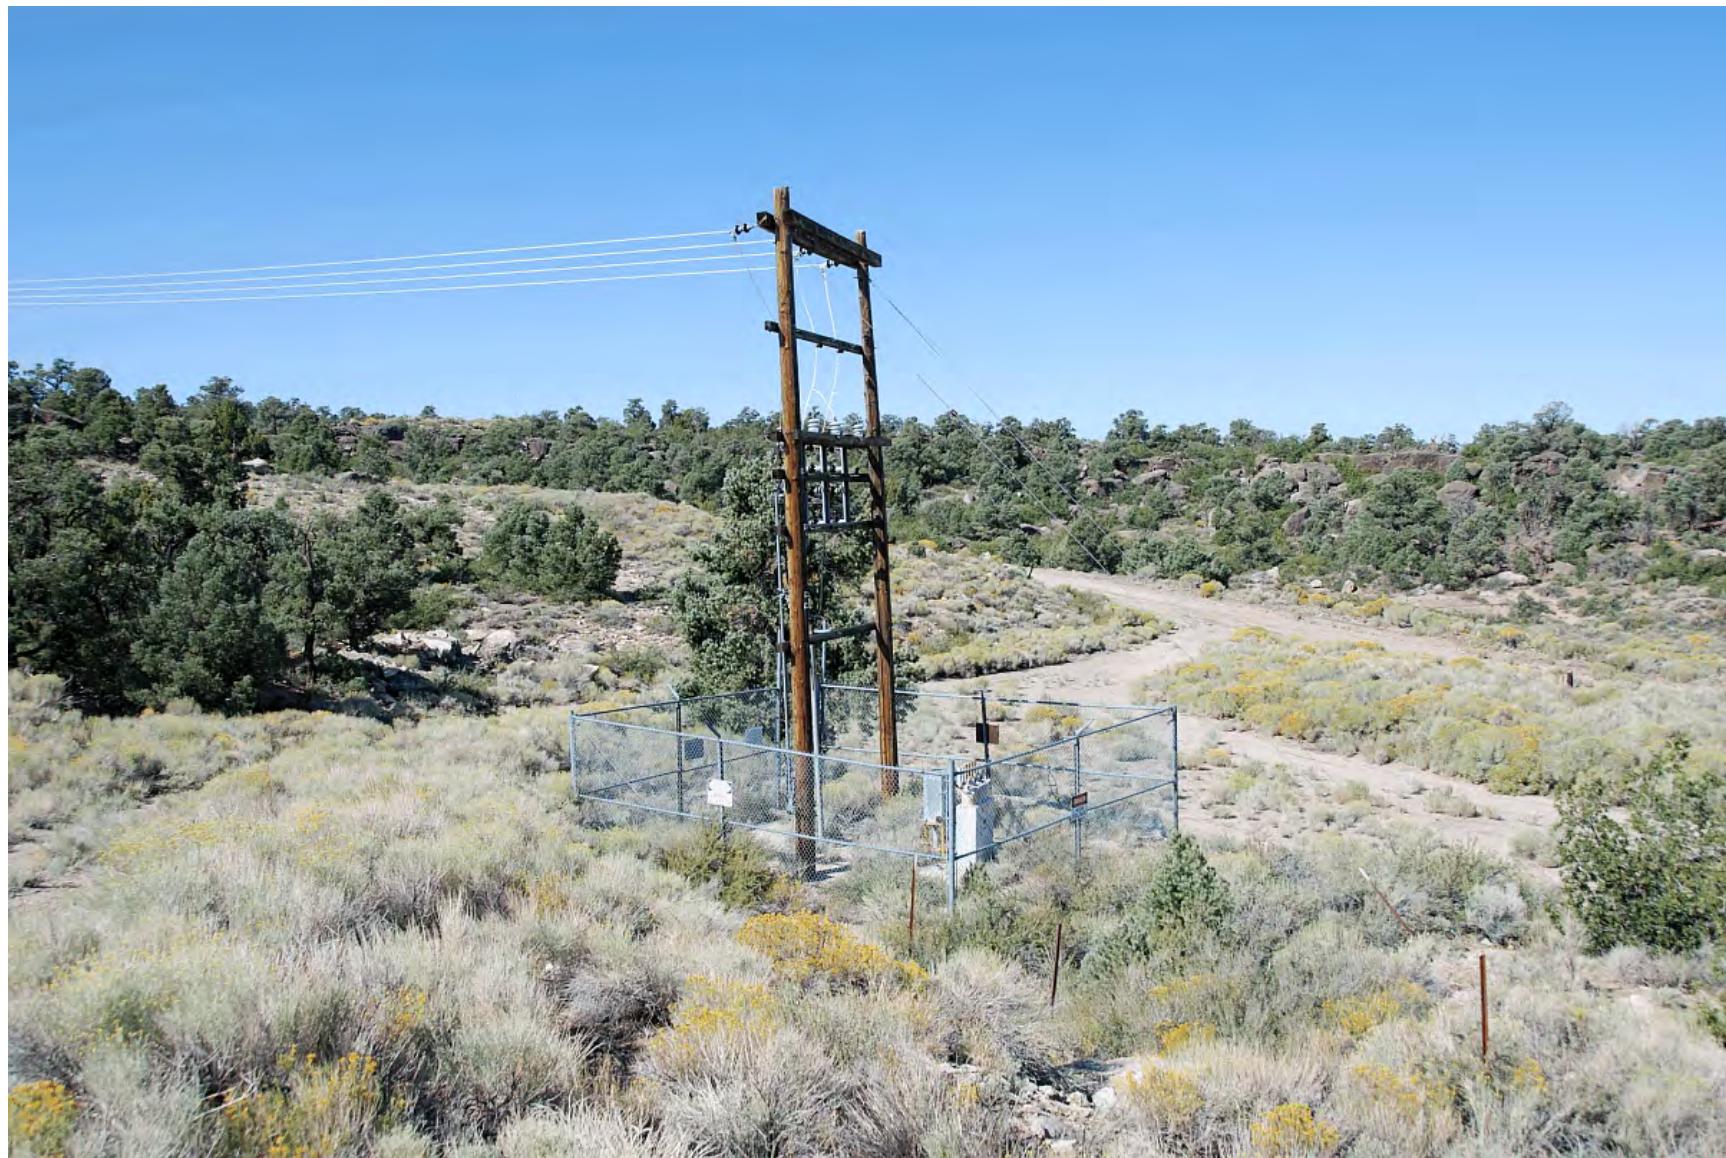
Figure 269. Feature 109, electrical switch station, U12n Tunnel, view southwest (2008).

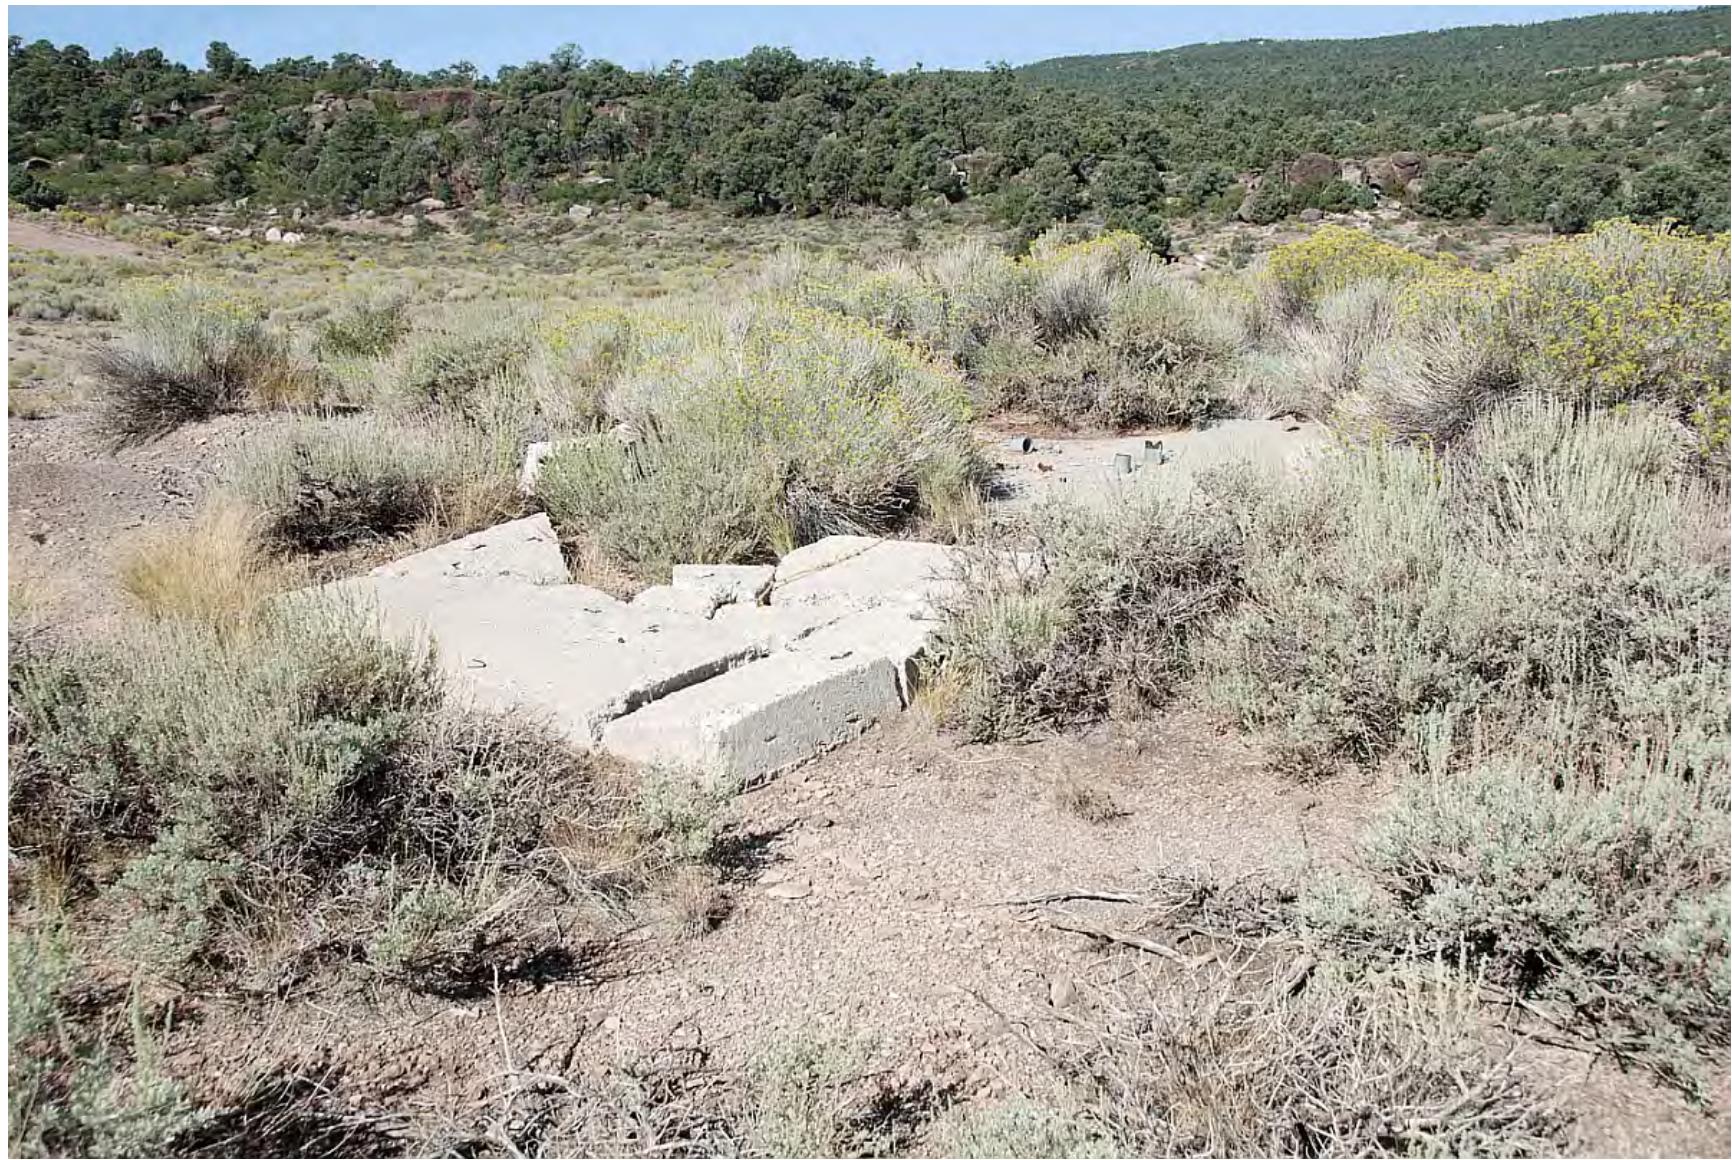
Feature 110 (Figure 270) is two concrete pads for electrical substation #5 at UTM coordinates 570800 E, 4117479 N at an elevation of 7,520 ft (2,292.1 m). The west pad is 10 x 10 ft and has two 3-inch galvanized conduits extending through the center. The east pad is 7 ft north-south by 6 ft 2 inches east-west and has been broken into several pieces and all but one remain in their original location. The pads location conforms to Substation #5 shown on the Holmes and Narver engineering drawing JS 012 N09 E22 dated August 27, 1974.

Figure 270. Feature 110, concrete pad for electrical substation #5, U12n Tunnel, view north (2008).

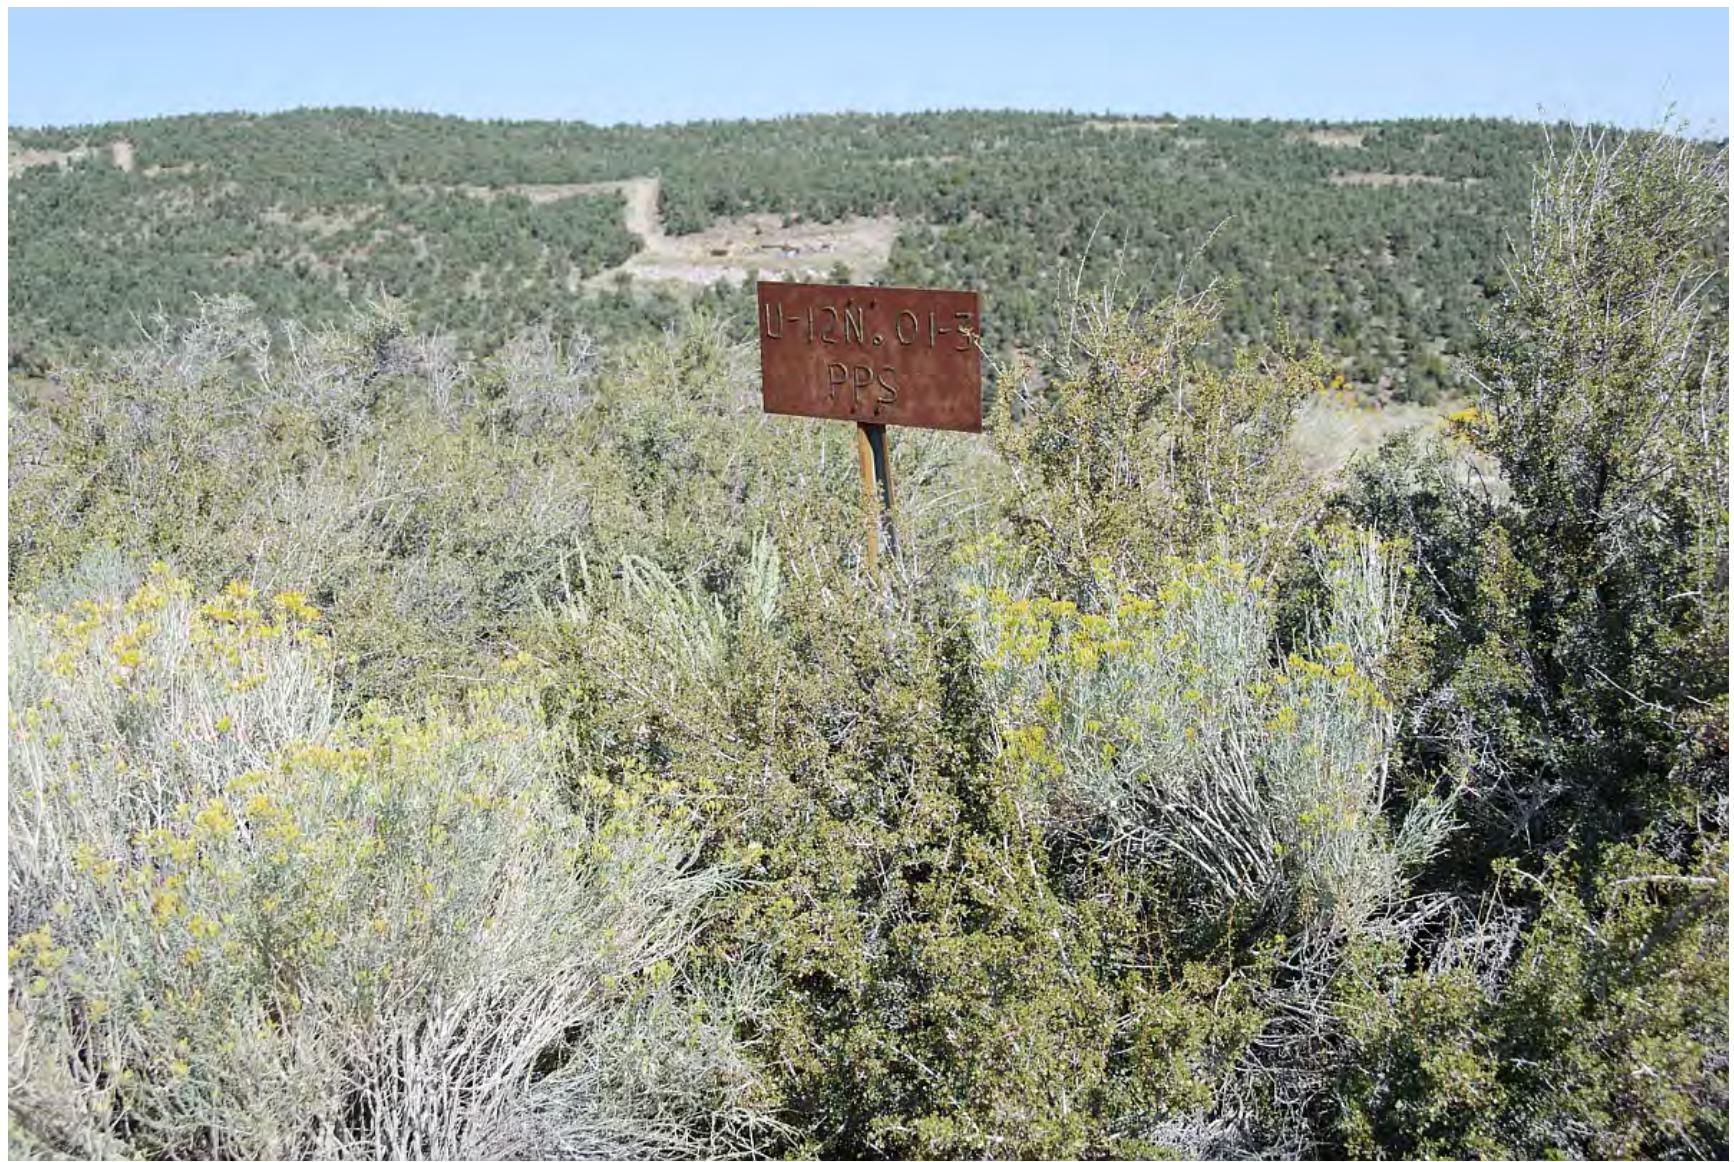
Feature 111 (Figure 271) is the U-12n.01-3 PPS pre-postshot drill hole at UTM coordinates 570815 E, 4117488 N, at an elevation of 7,341 ft (2,237.5 m) and drilled to a depth of 800 ft (244 m) (Bennett 1991). The feature consists of 10 3/4 inch (27.3 cm) casing extending 8 inches above the surface. The top of the pipe is sealed with a welded metal plate. The location is heavily overgrown with vegetation but marked with a welded metal sign 4 ft in height.

Figure 271. Feature 111, U12-n.01-3 PPS pre-postshot drill hole, U12n Tunnel, view northwest (2008).

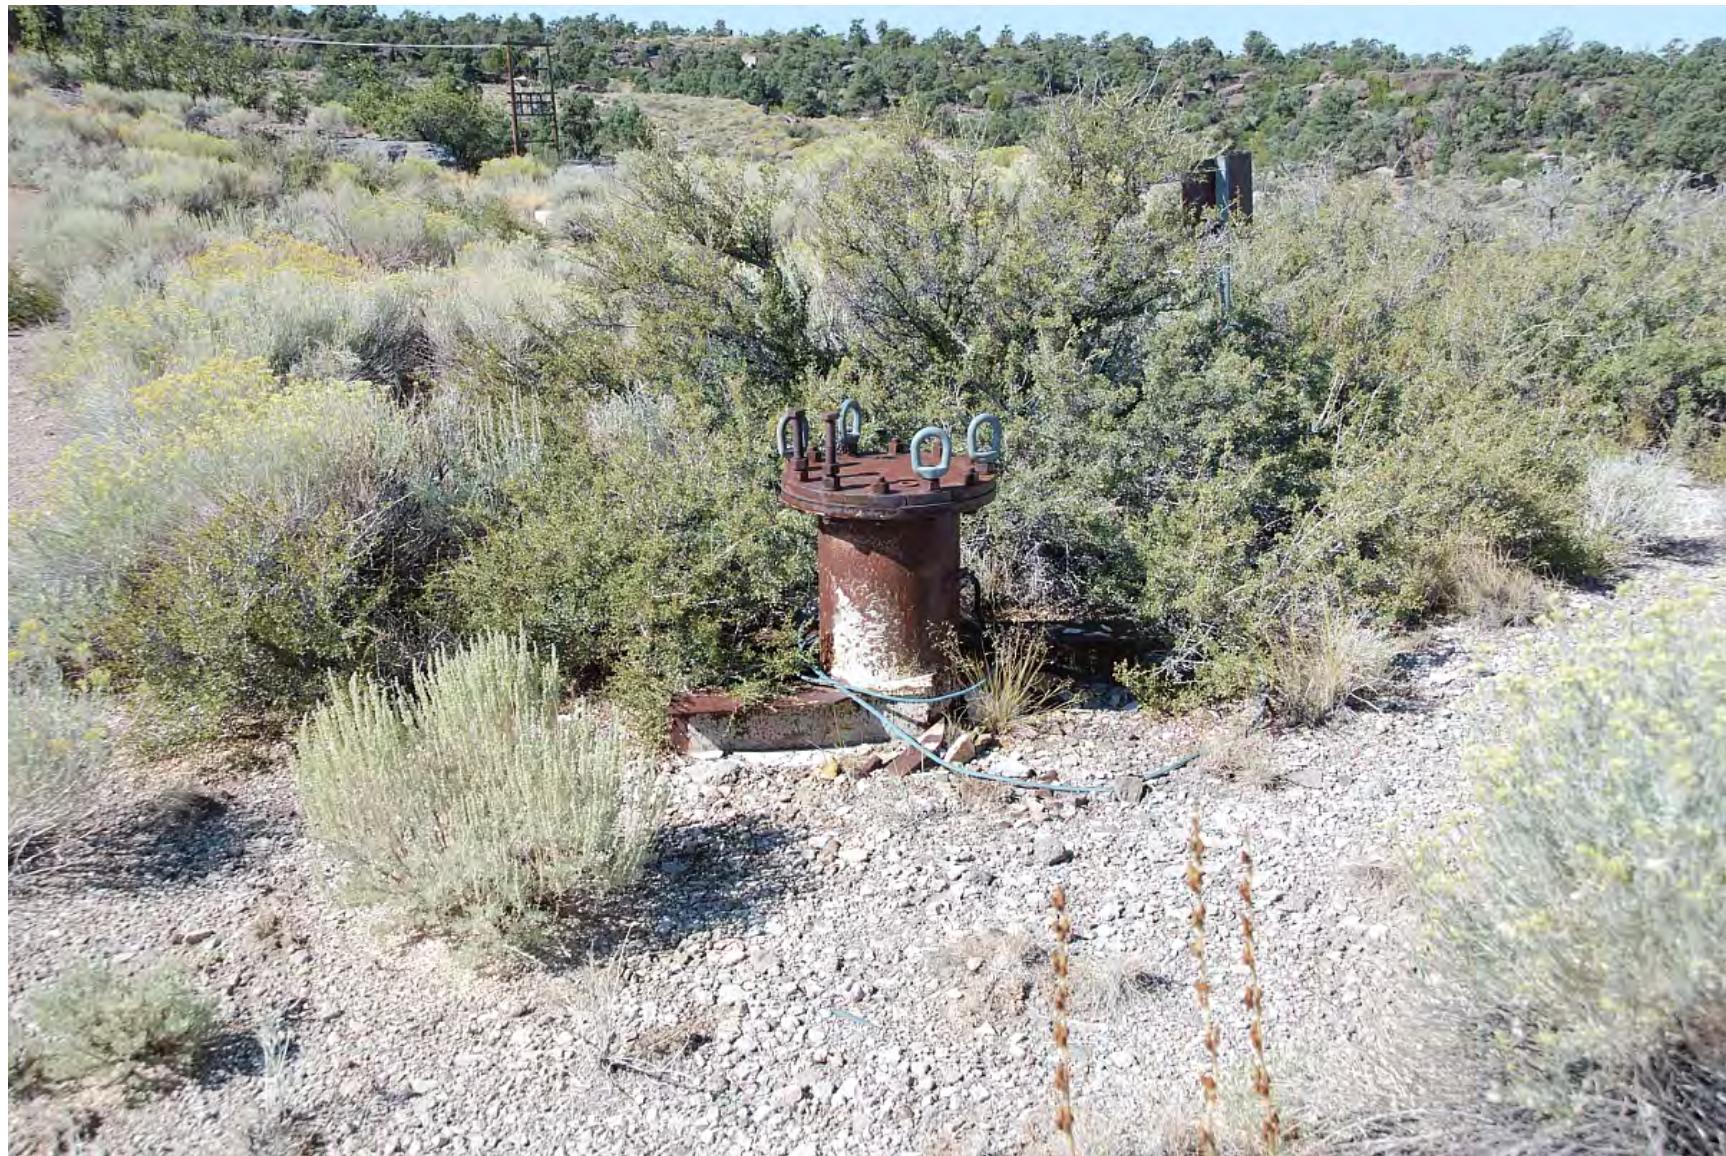
Figure 272. Feature 112, U-12n.01-2 R/C drill hole, U12n Tunnel, view southwest (2008).

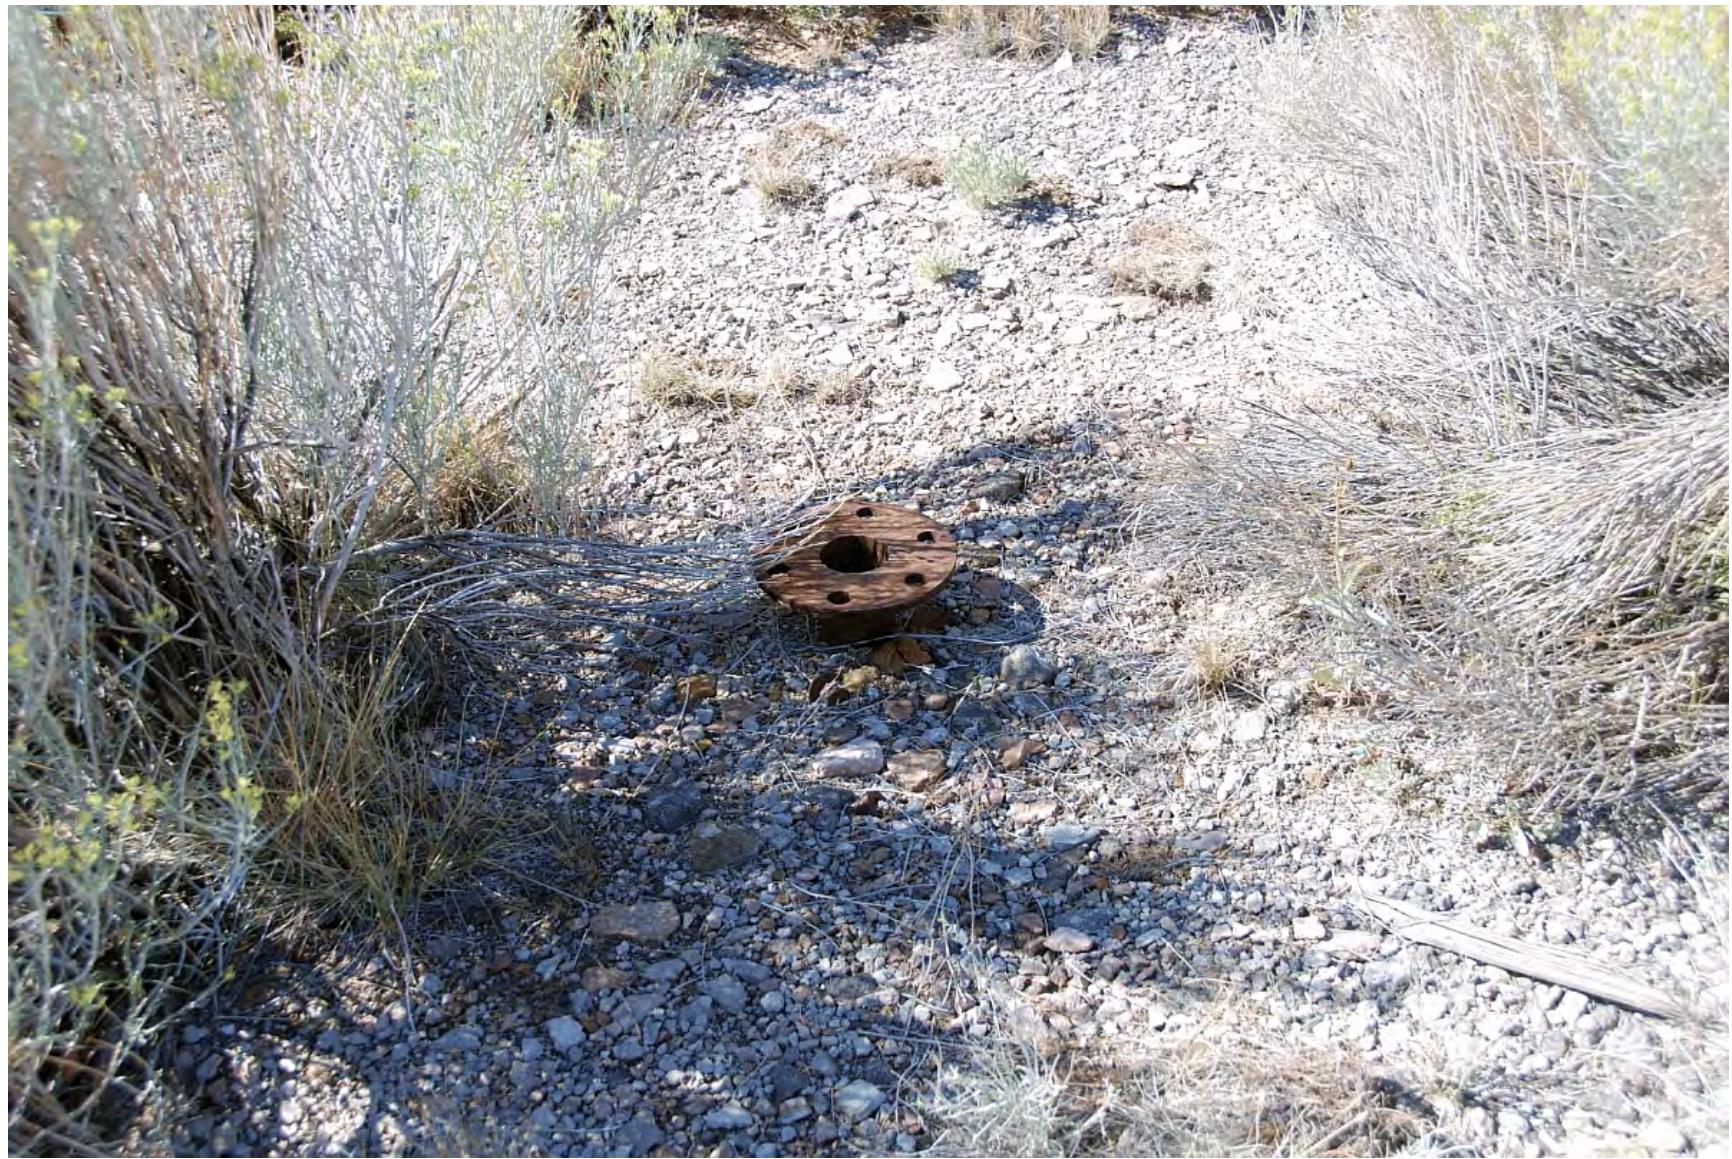
Figure 273. Feature 113, pipe, U12n Tunnel, view southeast (2008).

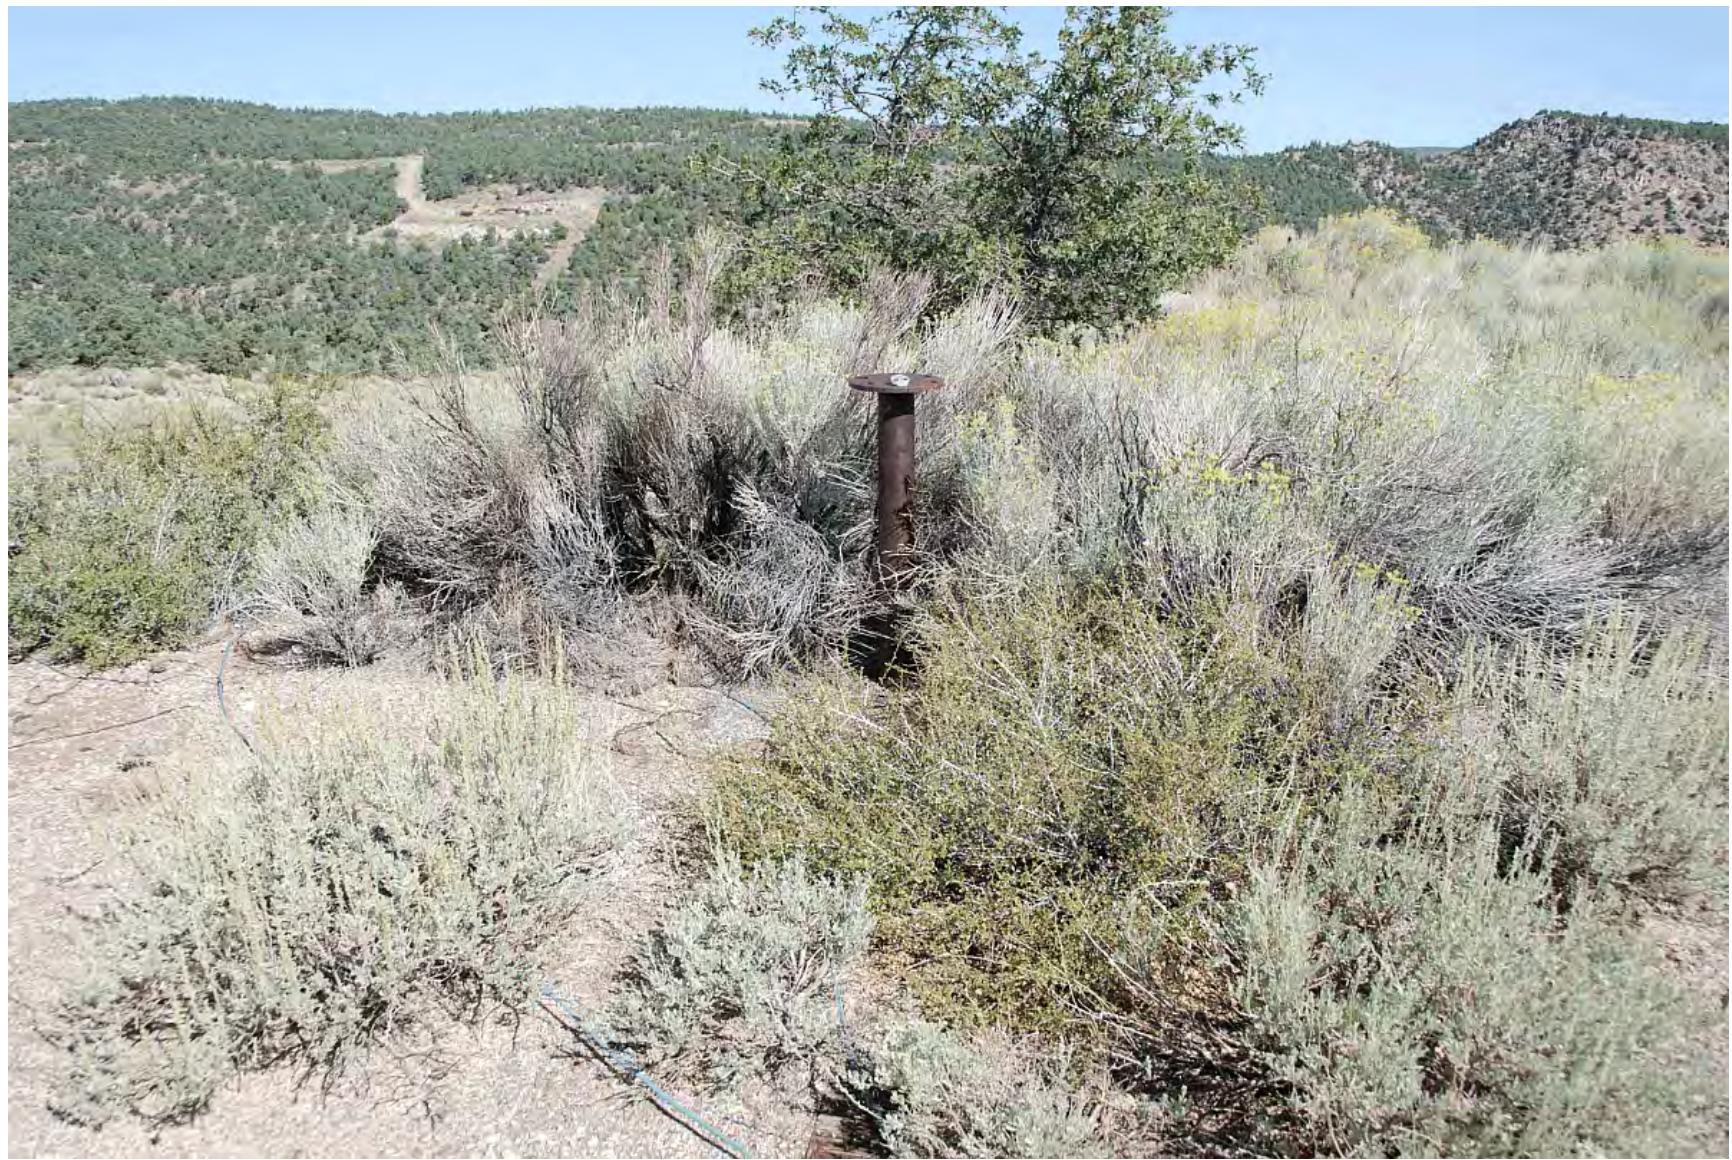
Figure 274. Feature 114, pipe, U12n Tunnel, view north (2008).

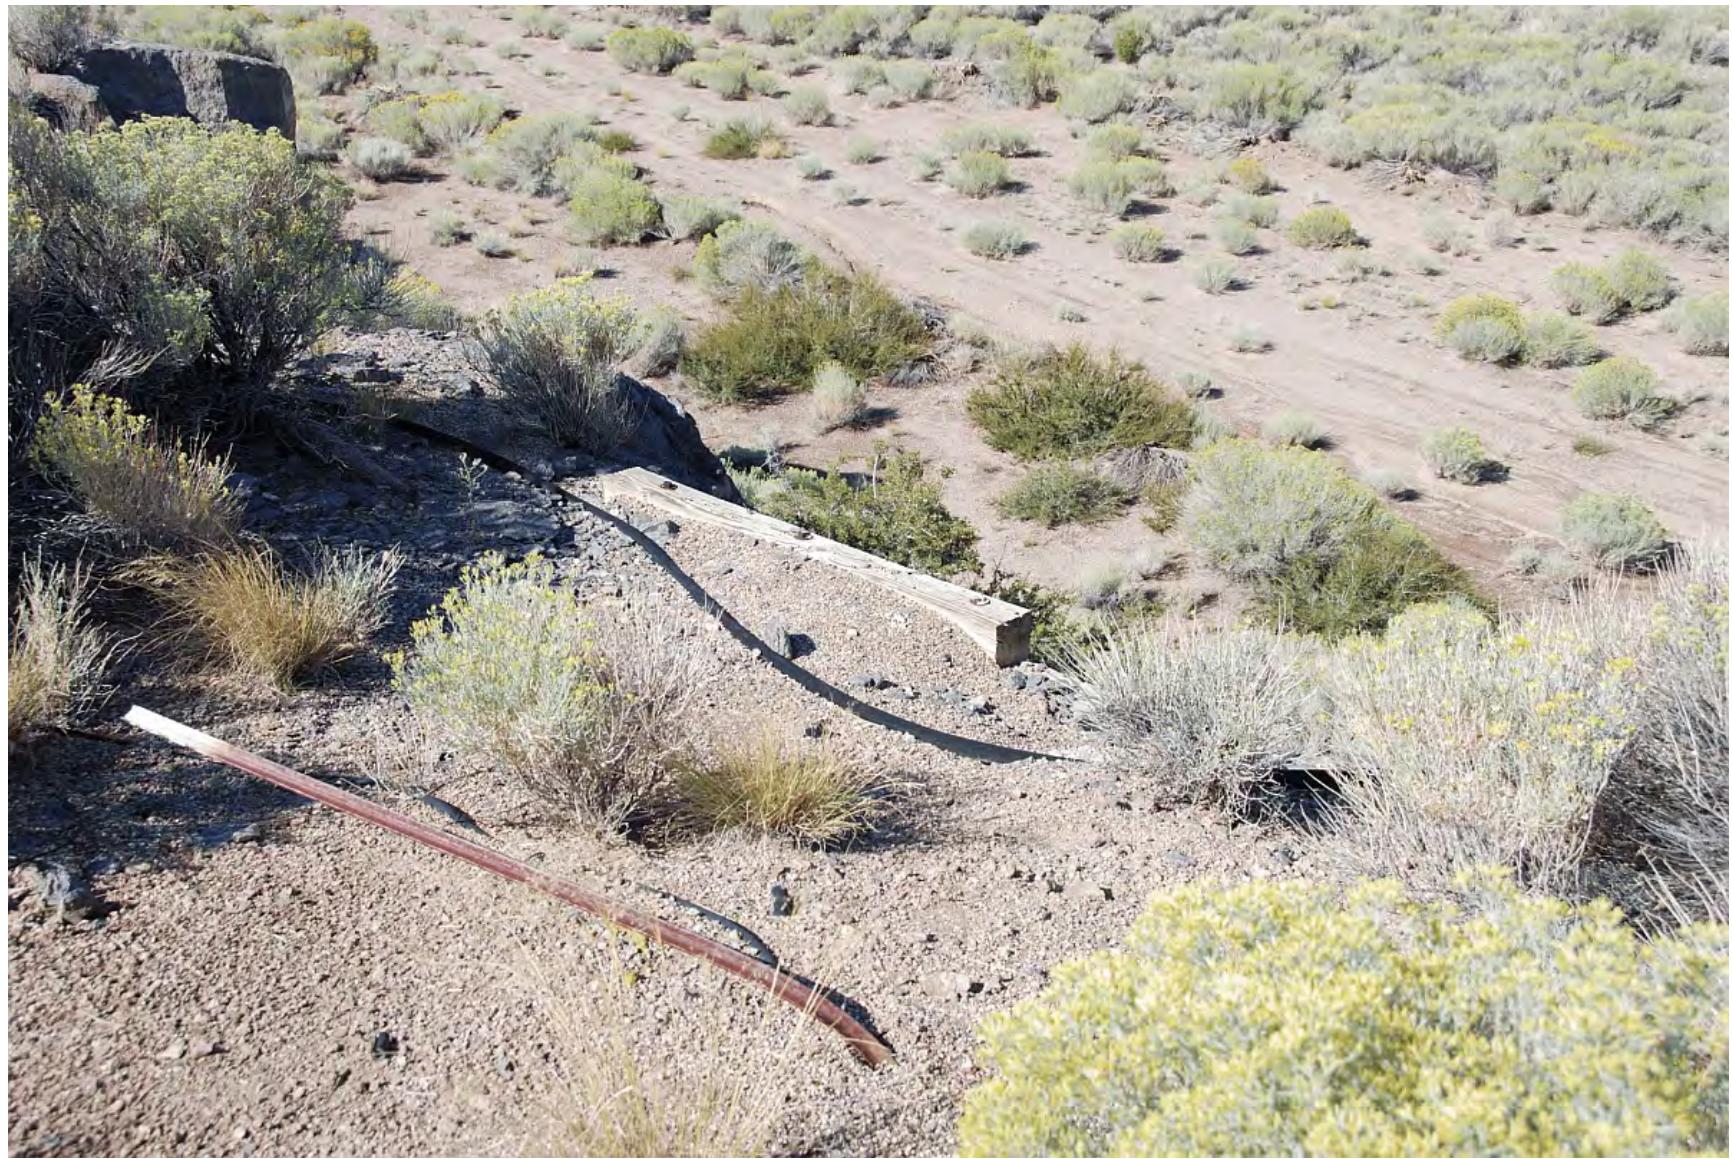
Figure 275. Feature 115, stairs or cable run support, U12n Tunnel, view southwest (2008).
