A total of 202 features were recorded, mapped, and photographed for the U12n Tunnel complex. The project area encompassed 600.8 acres (243.1 hectares) at the portal and mesa areas. At the U12n portal area are ten sub-areas containing features related to the construction, testing, and general everyday activities within the tunnel. These include concrete foundations for buildings, communications equipment, mining equipment, rail lines, retention ponds, storage containers, and access control facilities. Only a telephone trailer remains on the telephone pad as all of the other buildings have been removed from the portal area. The microwave tower, portions of the rail lines, the muck car dump, rotary dump, and wash rack are still in place. Also, the traffic control point and powder magazines along N Tunnel Road are intact. At the mesa area are four sub-areas containing features generally related to pre- and post-shot drilling, recording facilities, and ventilation equipment. These include concrete foundations, instrument cable holes, and drill holes. The concrete foundations were for buildings and small equipment. Concrete pads and various equipment remain at the cable hole locations bu

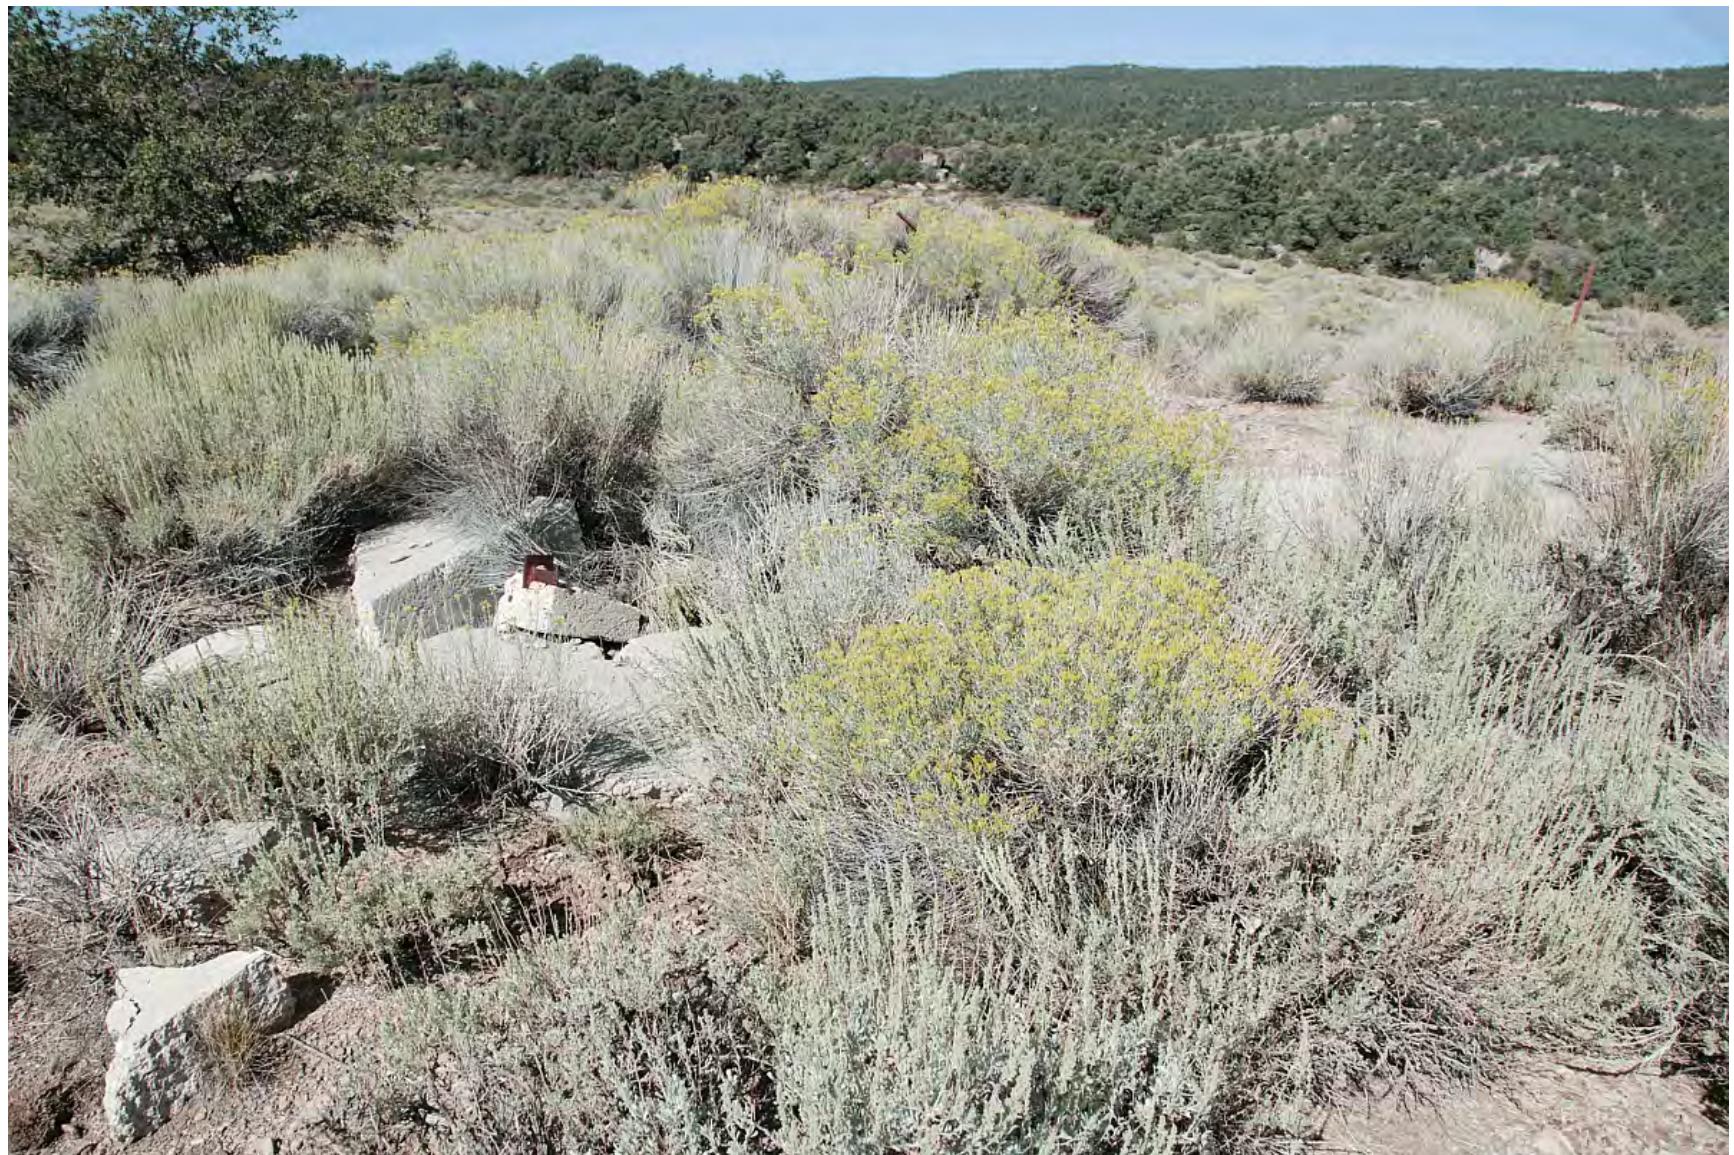
Feature 116 (Figure 276) is two concrete pads at UTM coordinates 570827 E, 4117510 N for electrical substation #2. The west pad is 14 ft north-south by 10 ft east-west and has two 3-inch galvanized conduits extending through the center. The dimensions of the second pad were not determined because it has been broken and stacked near its original location. The pads locations conform to Substation #2 shown on the Holmes and Narver engineering drawing JS 012 N09 E22 dated August 27, 1974.

Figure 276. Feature 116, concrete pads for electrical substation #2, U12n Tunnel, view southwest (2008).

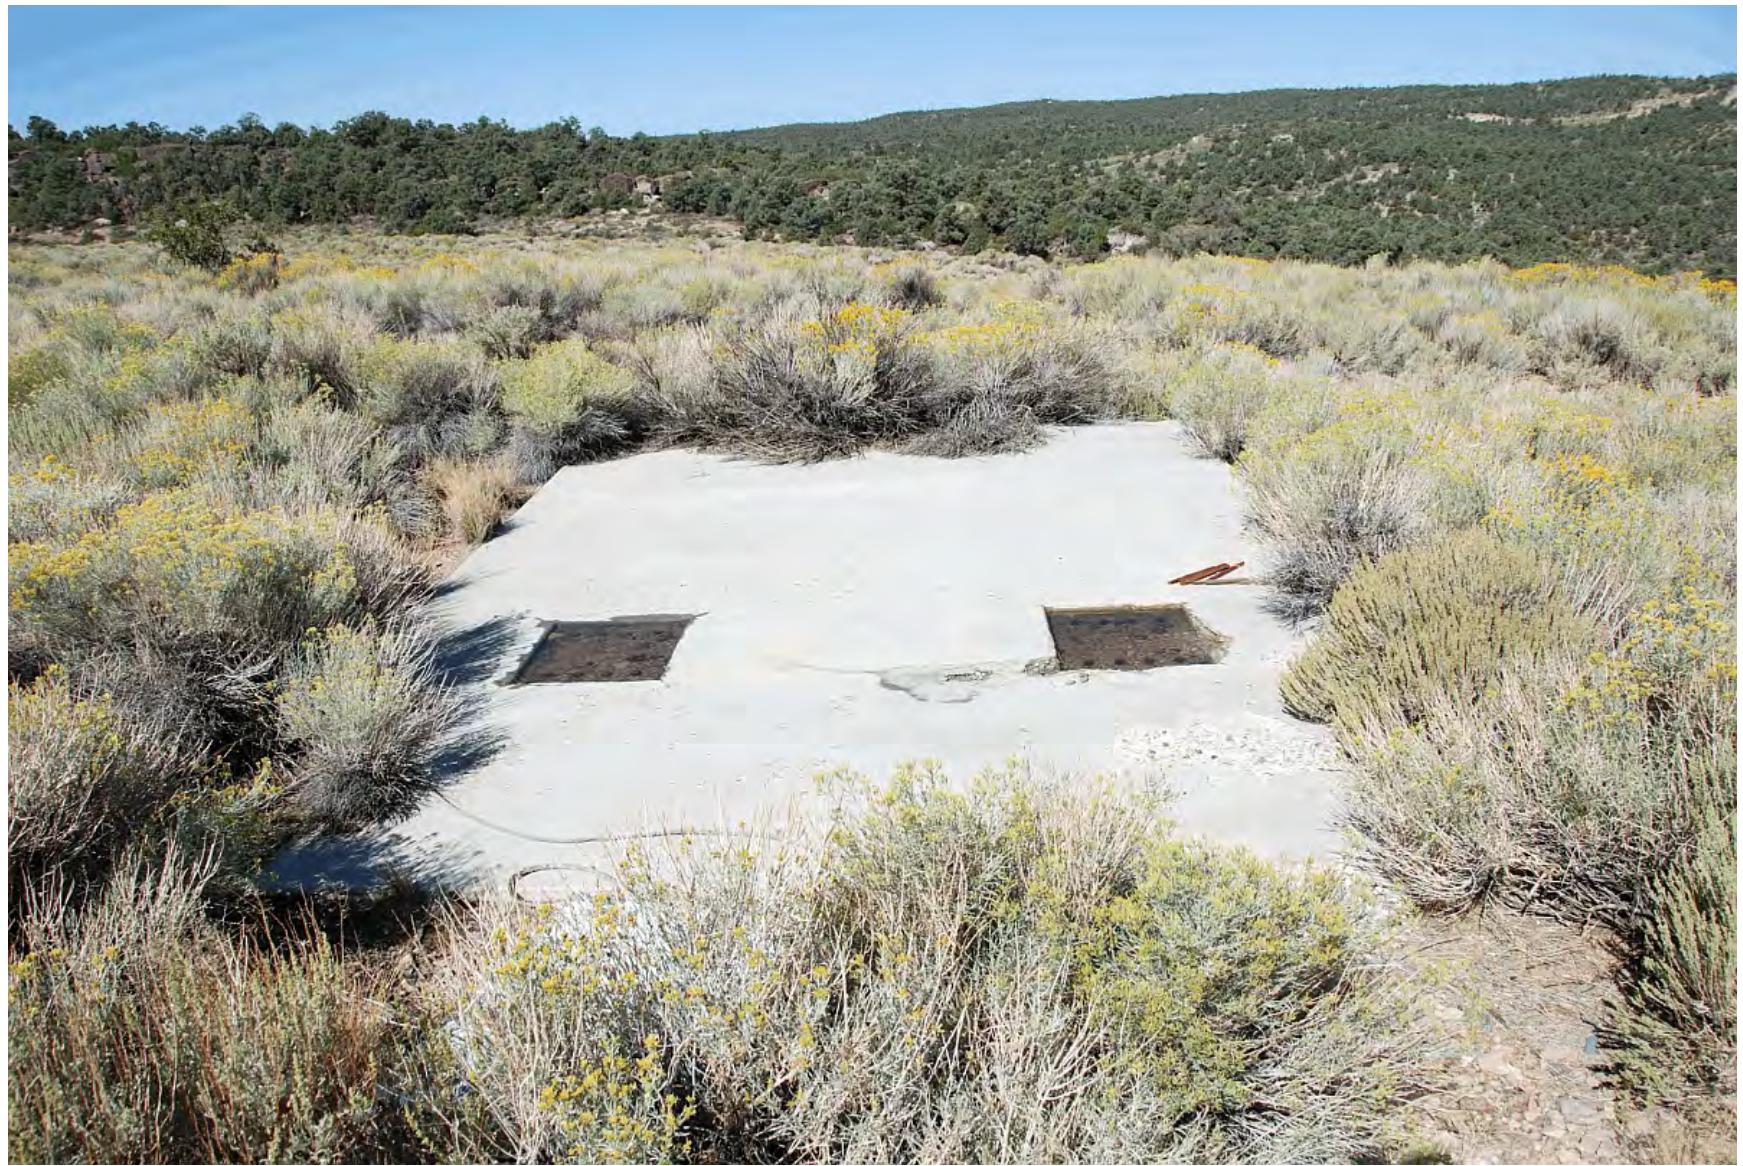
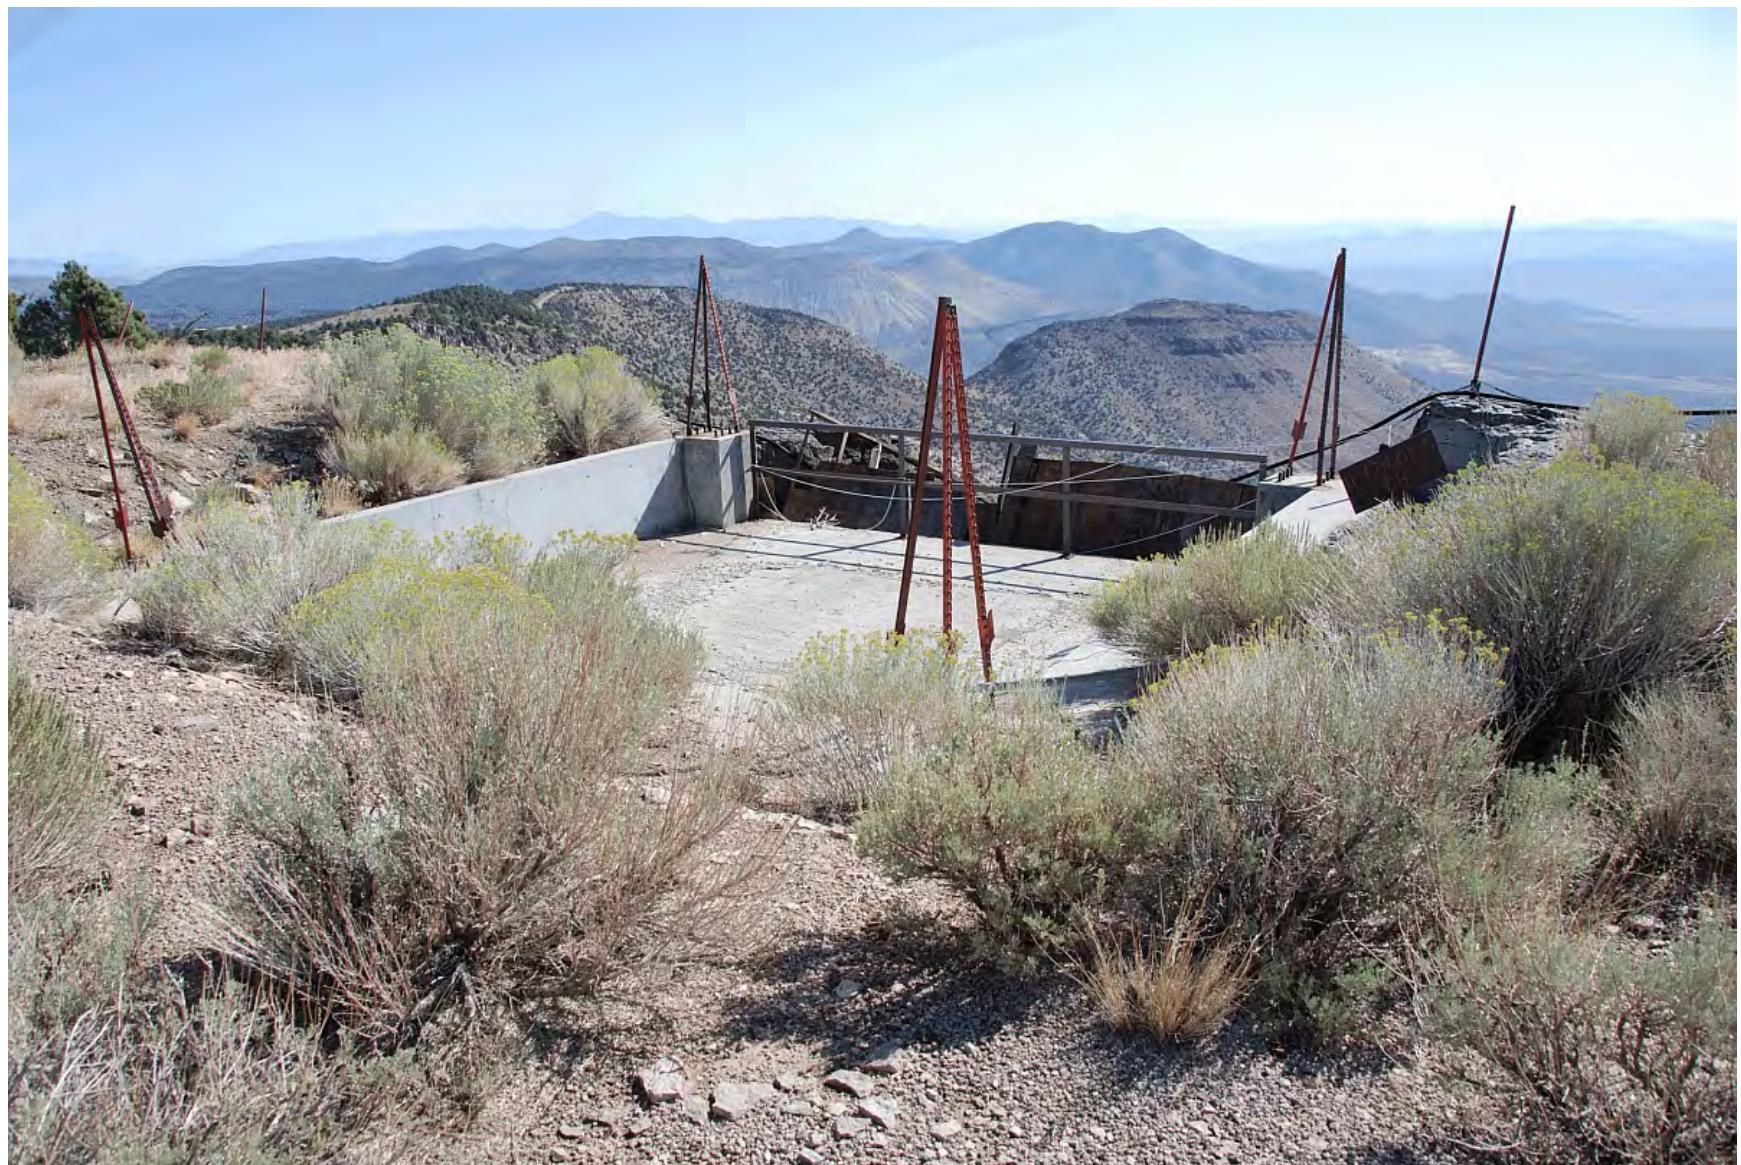
Feature 117 (Figures 277-279) is the U-12.01-5 CH cable hole at UTM coordinates 570858 E, 4117539 N, at an elevation of 7,330 ft (2,234.2 m) and drilled to a depth of 1,290 ft (393 m) (Bennett

Figure 278. Feature 117, concrete pad, U12n Tunnel, view southwest (2008).

Figure 279. Feature 117, concrete pad for the U-12n.01-5 CH, U12n Tunnel, view northeast (2008).

1991). The cable hole consists of two concrete features. The west feature is a 17 ft east-west by 12 ft north-south concrete pad. Two 1 ft 8 inch x 1 ft 8 inch depressions 2 inches deep are 4 ft from the east edge and 2 ft from the north and south edges. Eight 1-inch bolts have been cut flush with the bottom surface of the depressions. These are for the attachment of a metal structure. The east feature is a concrete structure that surrounds the U12.01-5 cable hole. The structure is a recessed foundation with walls along the north, south, and west sides. The east edge of the structure has no wall and is open to the vertically plunging mesa face. The structure is 23 ft north-south by 23 ft east-west and the walls are 2 ft 10 inches in height. The south and west walls are 2 ft thick and the north wall is 6 inch inches thick. The top of the walls are flush with the surface. Inside the walls at each corner are 2ft x 2ft concrete columns 2 ft 10 inches in height. On top of each column are three metal T posts welded together at the top forming a tripod type structure. Protruding through the top surface of each column, along the north and south edges, are four 1-inch bolts. Along the open east side of the structure is a 3 ft 8 inch tall metal railing. Outside of the railing is a barrier (wall) constructed of 2 x 4 inch milled lumber and sheets of 3/4-inch plywood. The barrier has partially collapsed and suspended precariously over the mesa edge. A welded metal sign on the south side of the structure is labeled U12N.01-5 CH. Associated artifacts are plexiglass fragments, braided cable, insulated cable, insulated wire, and wood fragments.

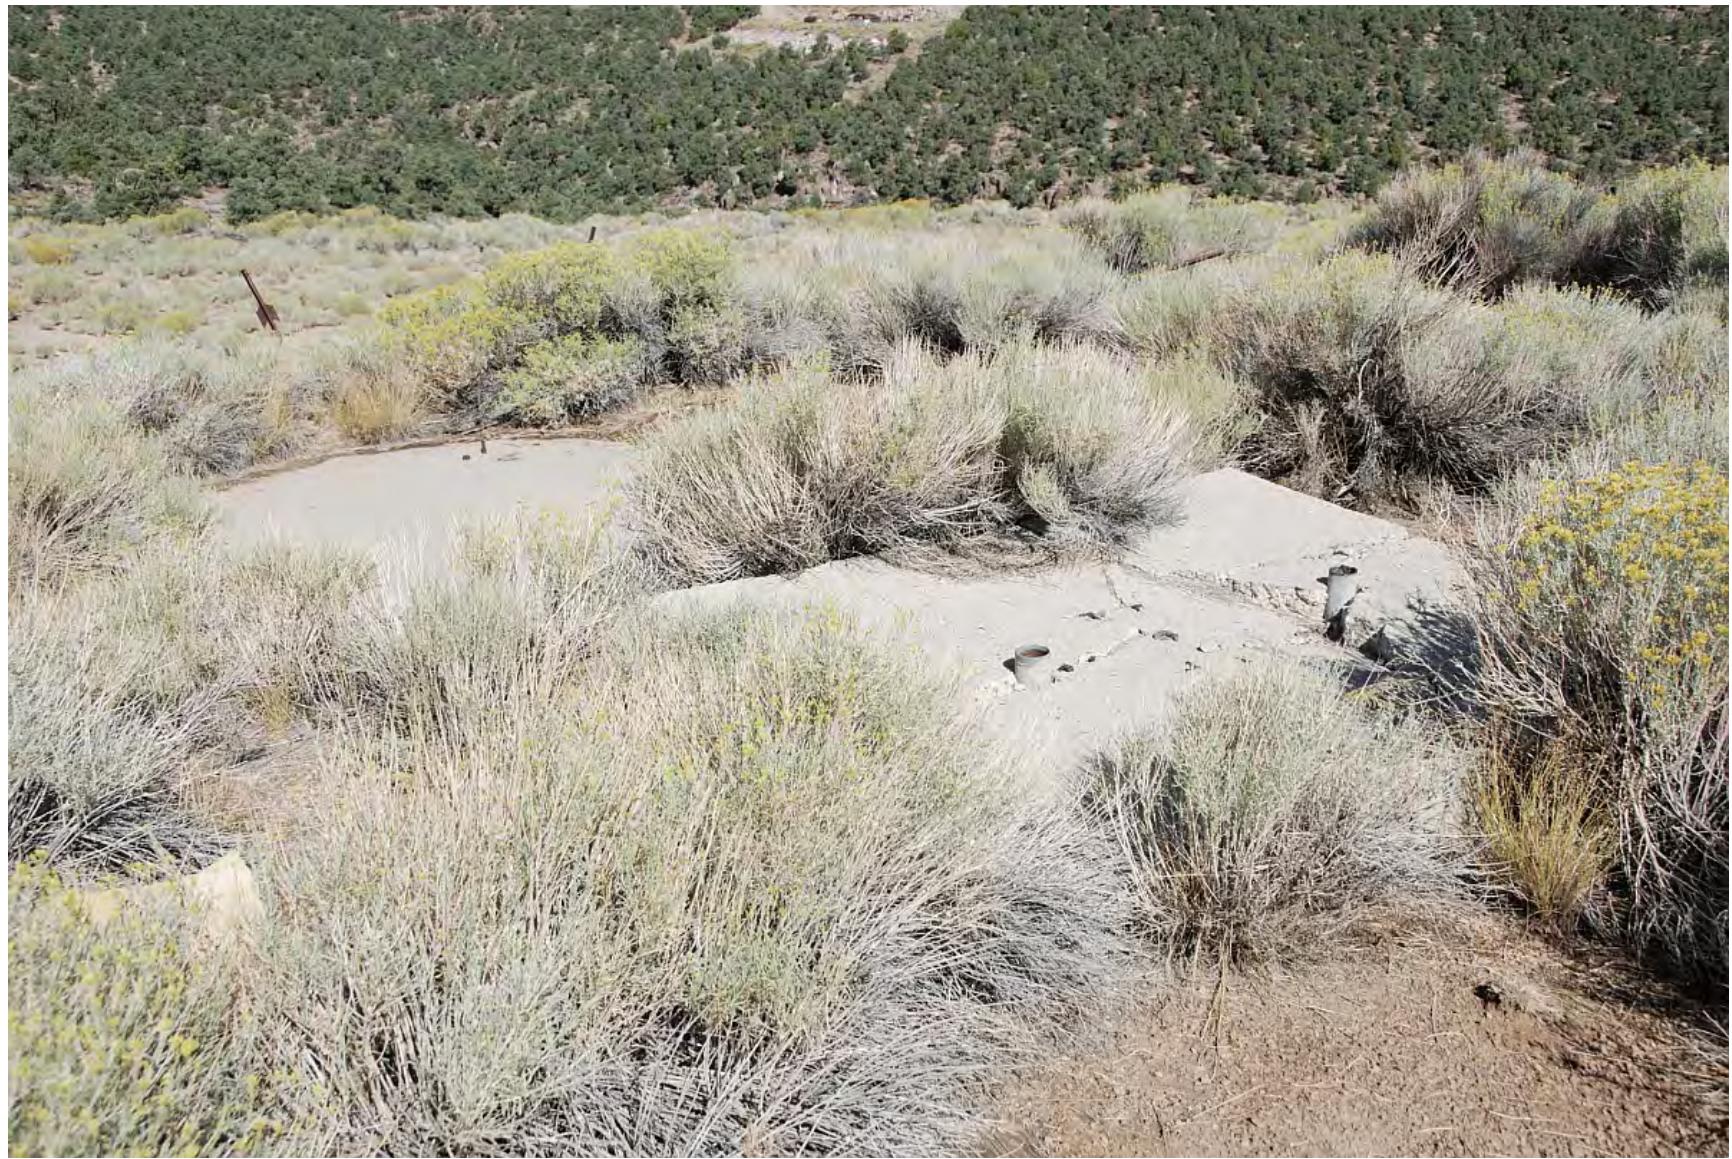
Feature 118 (Figure 280) is two concrete pads at UTM coordinates 570846 E, 4117578 N for electrical substation #1. The west pad is 10 ft north-south by 9 ft east-west and two 3-inch galvanized conduit extending 3 inches above the surface. The pad is cracked in several areas around the conduits. The east pad is 6 ft east-west by 7 ft north-south and has two 3-inch galvanized conduits cut flush with the surface. The pads locations conform to Substation #1 shown on the Holmes and Narver engineering drawing JS 012 N09 E22 dated August 27, 1974.

Figure 280. Feature 118, concrete pads for electrical substation #1, U12n Tunnel, view northwest (2008).

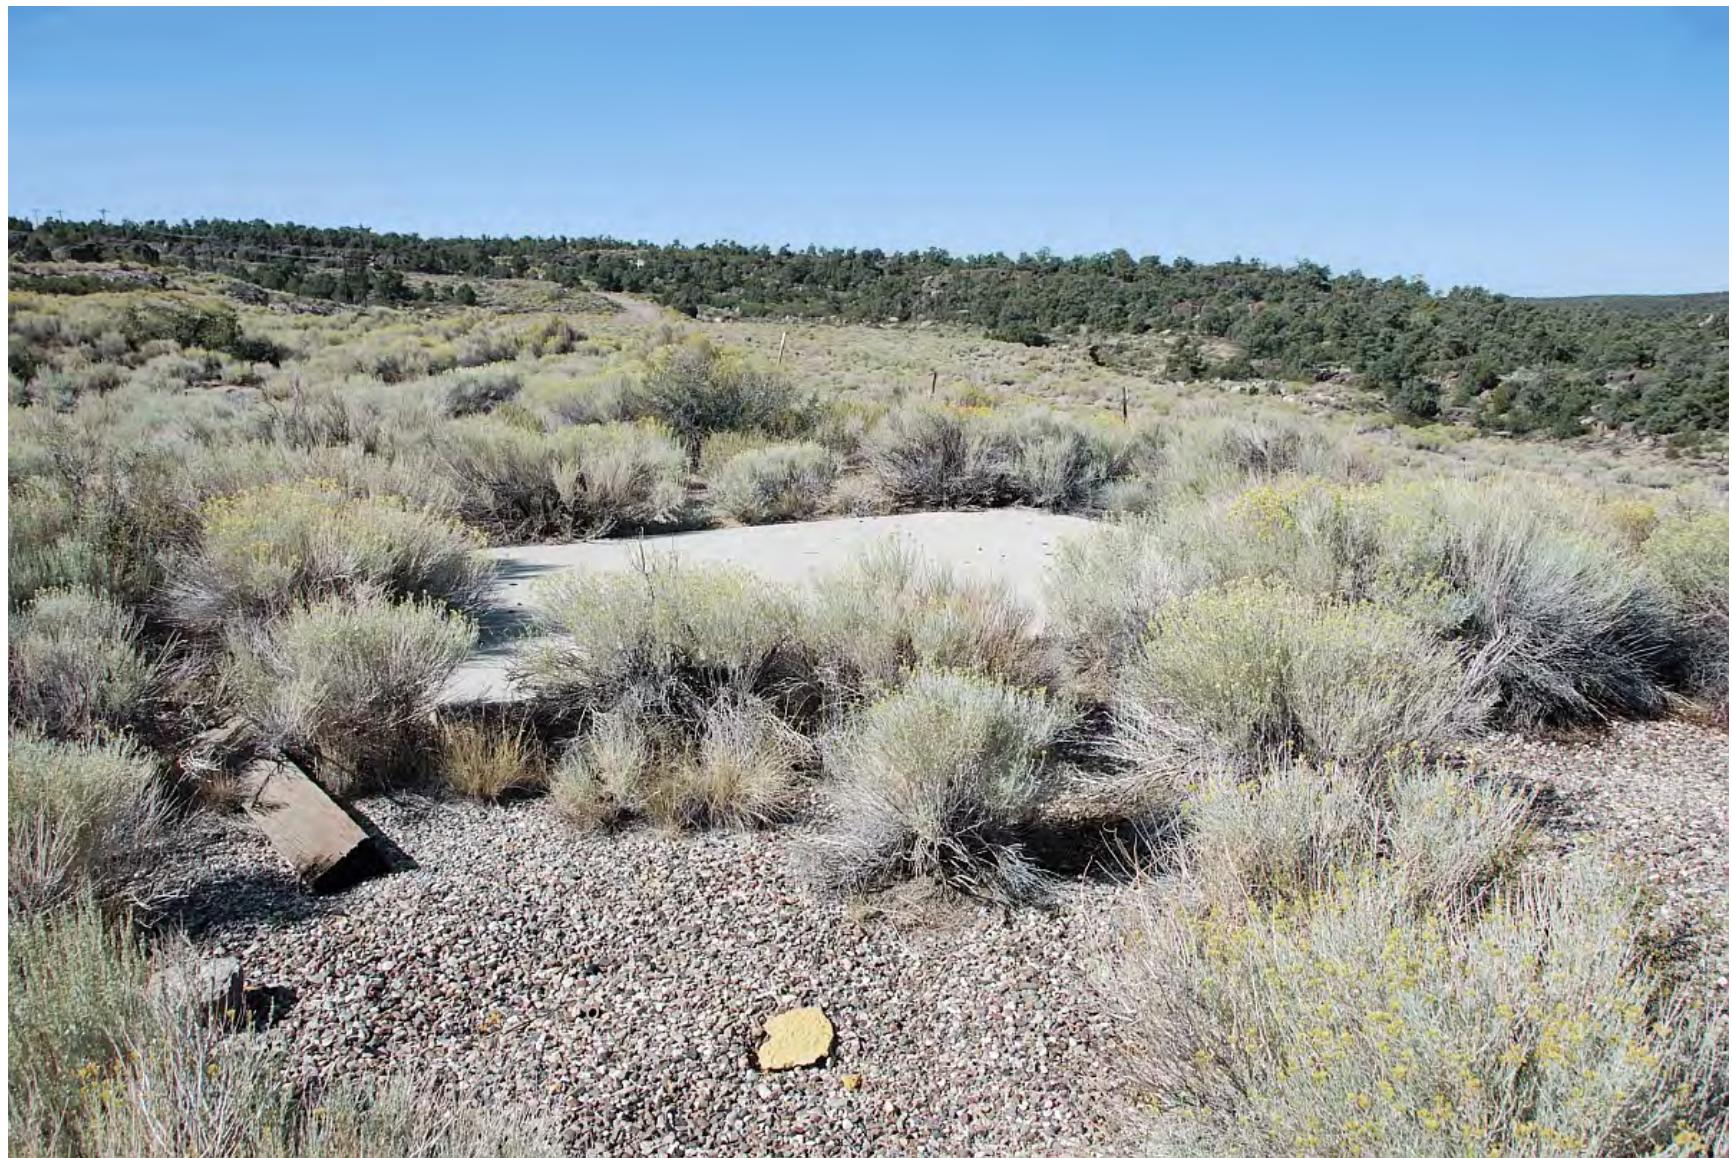
Figure 281. Feature 119, concrete pad for electrical substation #8, U12n Tunnel, view southwest (2008).

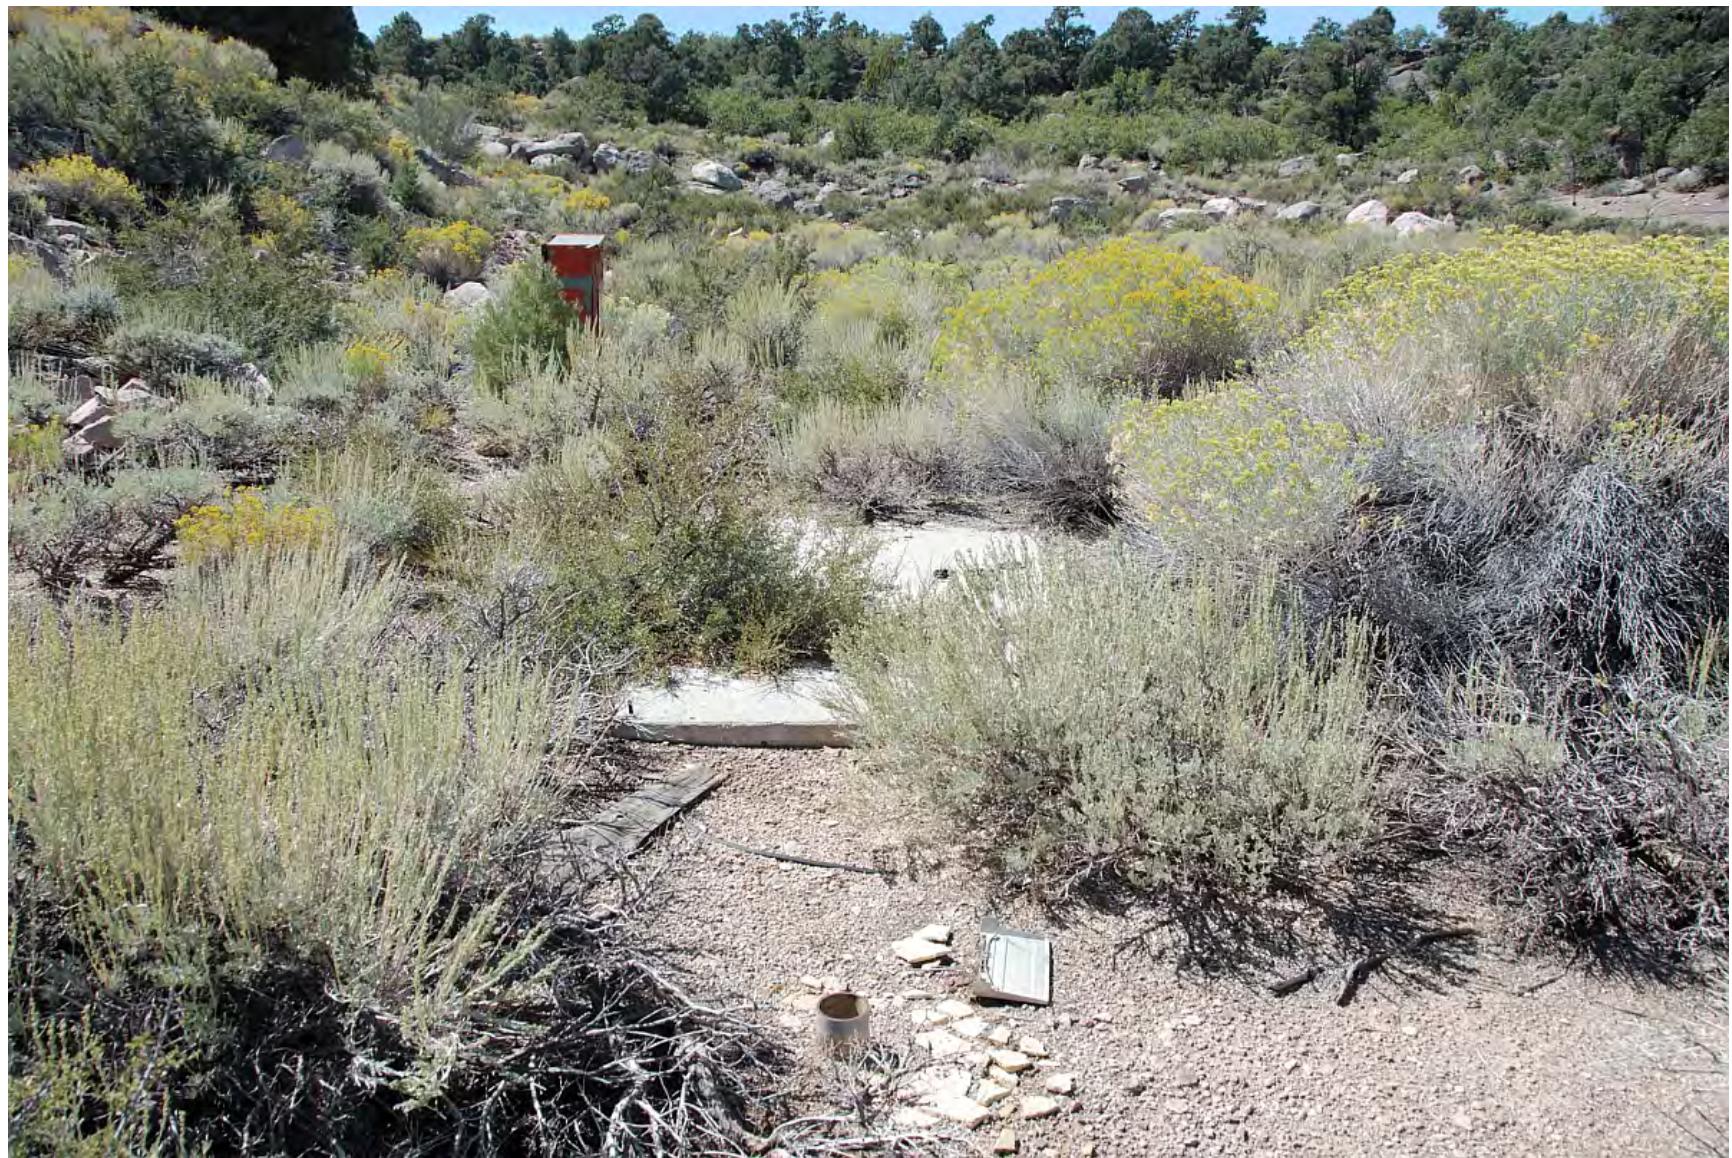
Feature 120 (Figure 283) is a concrete pad, conduit, and electrical panel at UTM coordinates 570662 E, 4117440 N for electrical substation #7. The concrete pad is 5 ft east-west by 10 ft north-south with

Figure 283. Feature 120, concrete pad for electrical substation #7, U12n Tunnel, view south (2008).

bolts protruding through the surface at each corner. Two 3 1/2-inch galvanized conduit 4 inches in height are 5 ft from the north and south edges and centered east-west on the pad. South of the pad is a 3 ft 1 inch x 2 ft 7 inch x 1 ft electrical panel box painted red. The box is supported by two 3-inch channel iron legs. It is labeled SOUTH FEEDER FROM OFC 2 IN SUB 5-3. The location of the pad and feeder box conforms to Substation #7 shown on the Holmes and Narver engineering drawing JS 012-U12n.15-C21 dated June 29, 1981.

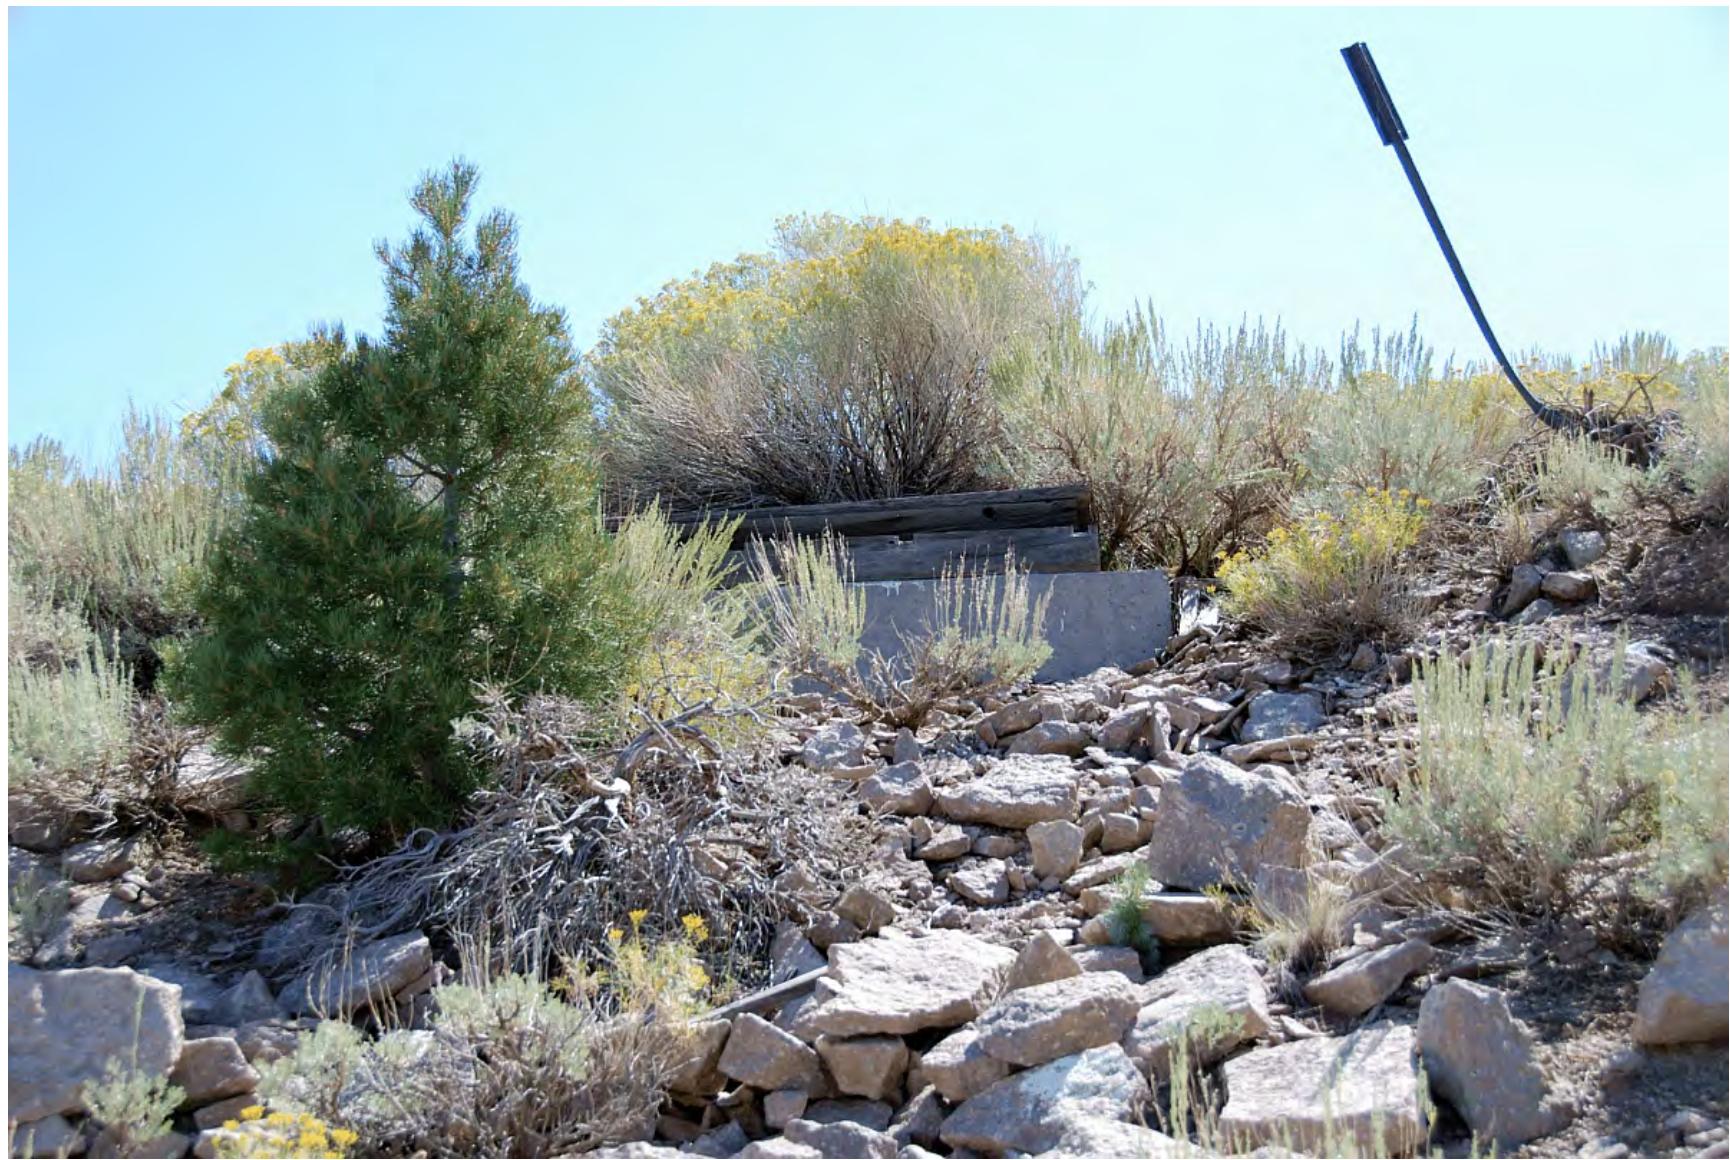
Figure 284. Feature 121, stair or cable access support, U12n Tunnel, view east (2008).

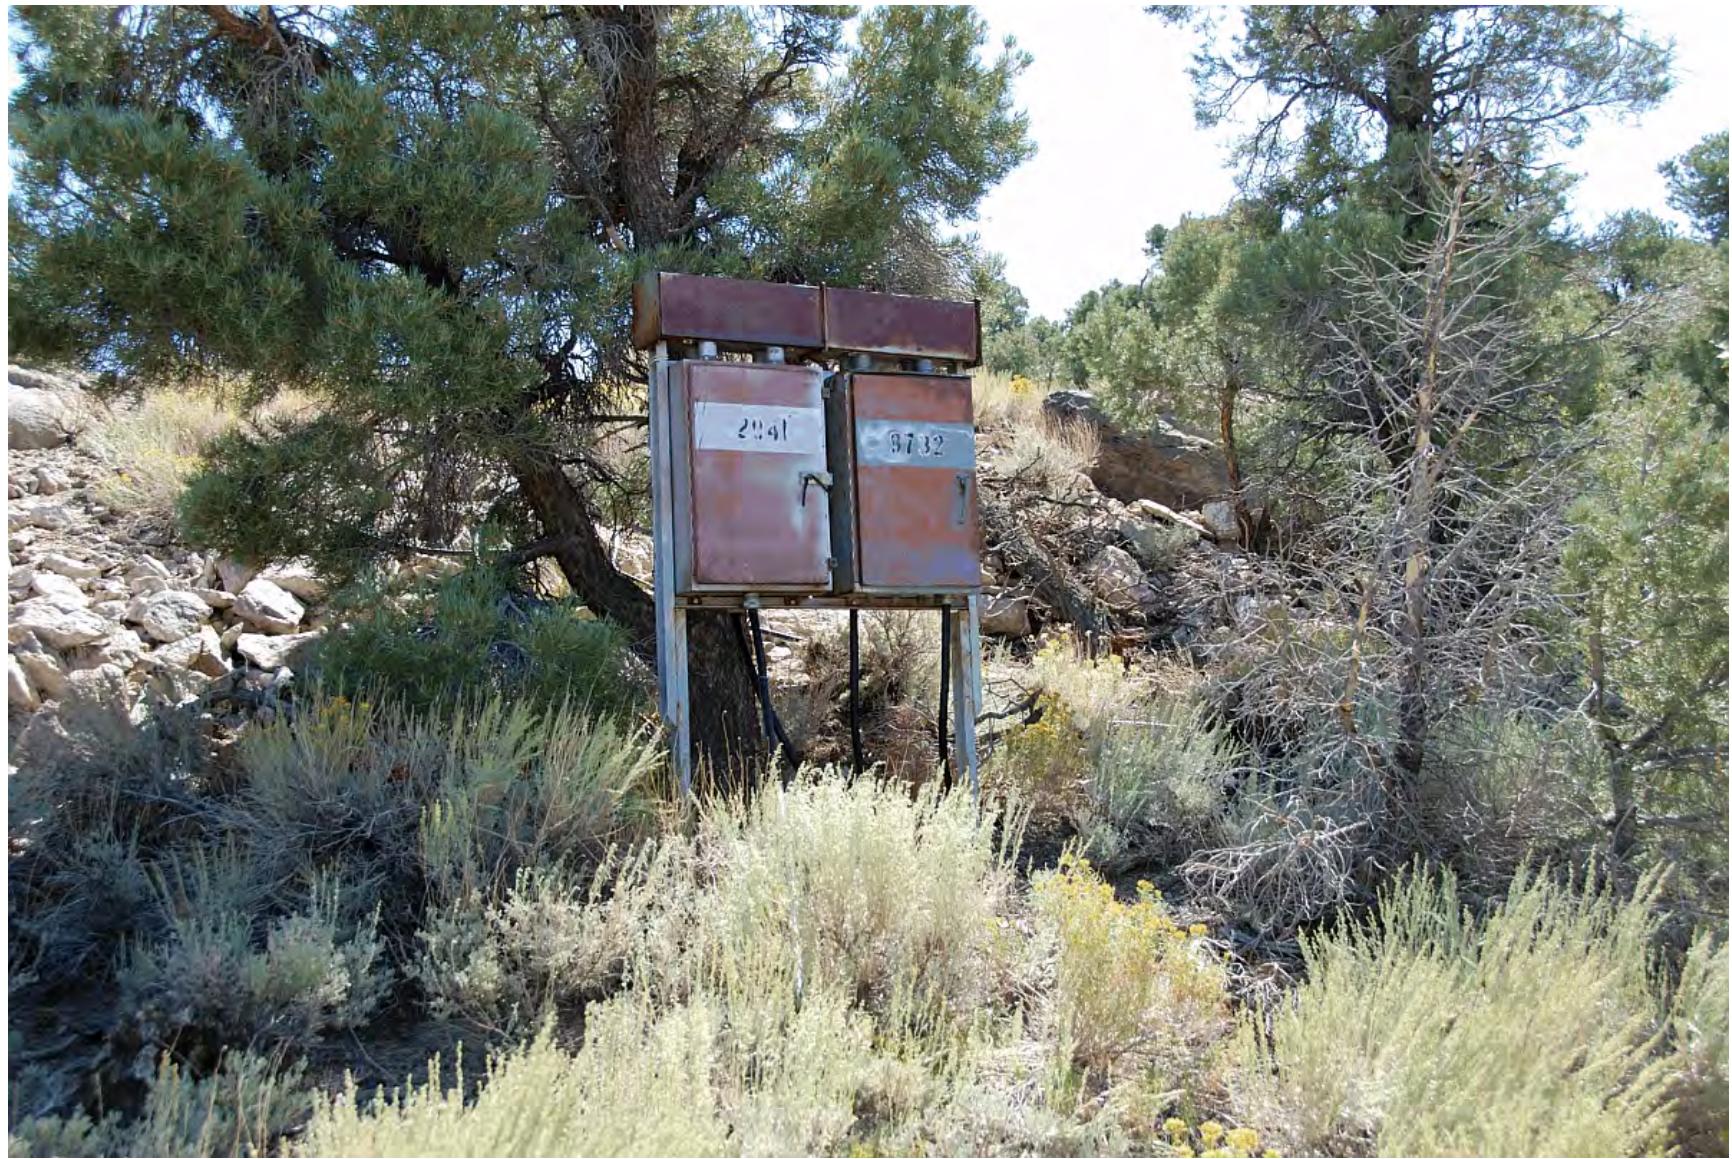
Figure 285. Feature 122, electrical panels, U12n Tunnel, view southeast (2008).

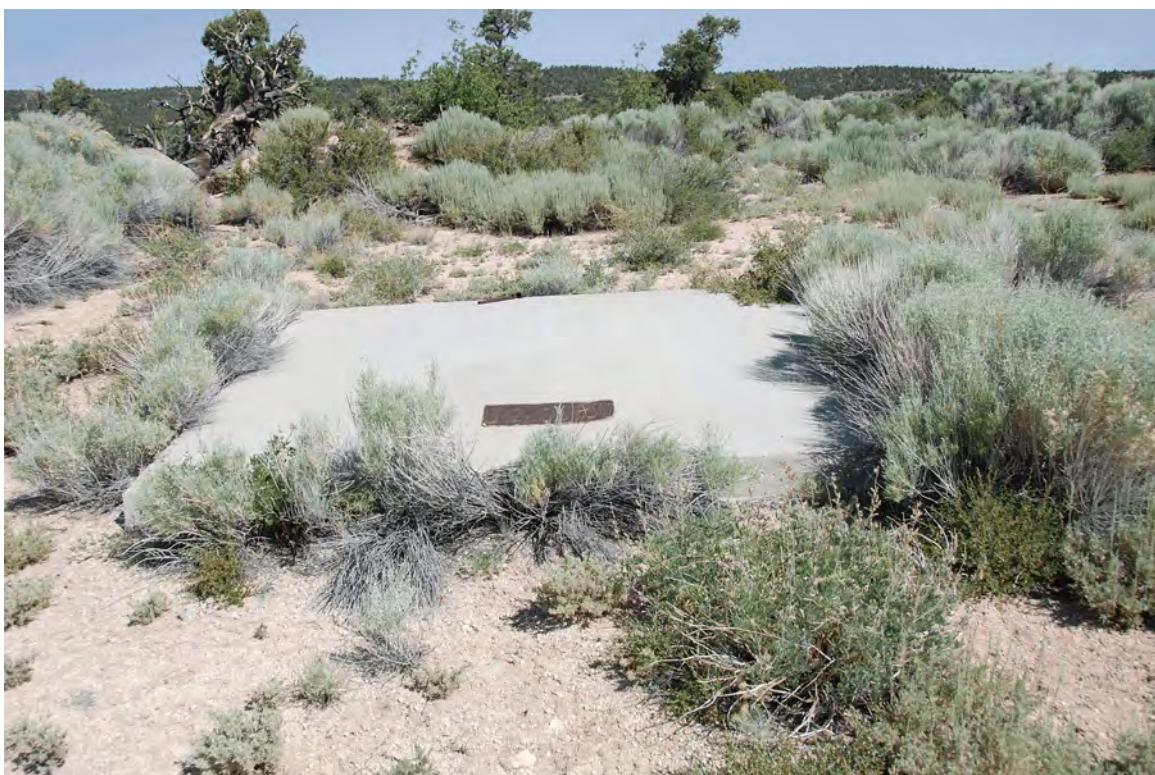
Feature 123 (Figure 286) is a concrete pad at UTM coordinates 570552 E, 4117287 N for the U-12n.06 PS #1 postshot drill hole. The drill hole is at an elevation of 7,408 ft (2,258.0 m) and drilled to a depth of 975 ft (297m) (Bennett 1991). The drill hole is near the center of a roughly square dirt pad that is 100 x 100 ft (30.5 x 30.5 m), encompasses 0.22 acres (0.09 hectare), and accessed by a road that enters the pad from the southeast corner. No pipe is visible above the surface, however a slightly domed, 10 x 10 ft concrete pad, marks the location of the drill hole. Near the south edge of the concrete pad is a 1 ft 8 inch x 7 inch (50.8 x 17.8 cm) metal plate with welded lettering that identifies the drill hole. A handle for an 18 inch (45.7 cm) pipe wrench is on the concrete pad near the north edge. Bennett (1991) lists the abandoned (drilling not attempted or not completed) U12n.06 PS#1D drill hole at UTM coordinates 570532 E, 4117294 N, only a few feet from the PS#1 drill hole. The area was investigated but no indication of the hole being drilled was found. However, PS#1D is a directional drill hole that could have been drilled in the PS#1 drill hole.

Figure 286. Plan map of Feature 123, concrete pad for the U-12n.06 PS #1 drill hole, location of proposed drill hole U-12n.06 PS #1D, location of Feature 124, pole tower, and photograph of Feature 123, view northeast (2008).

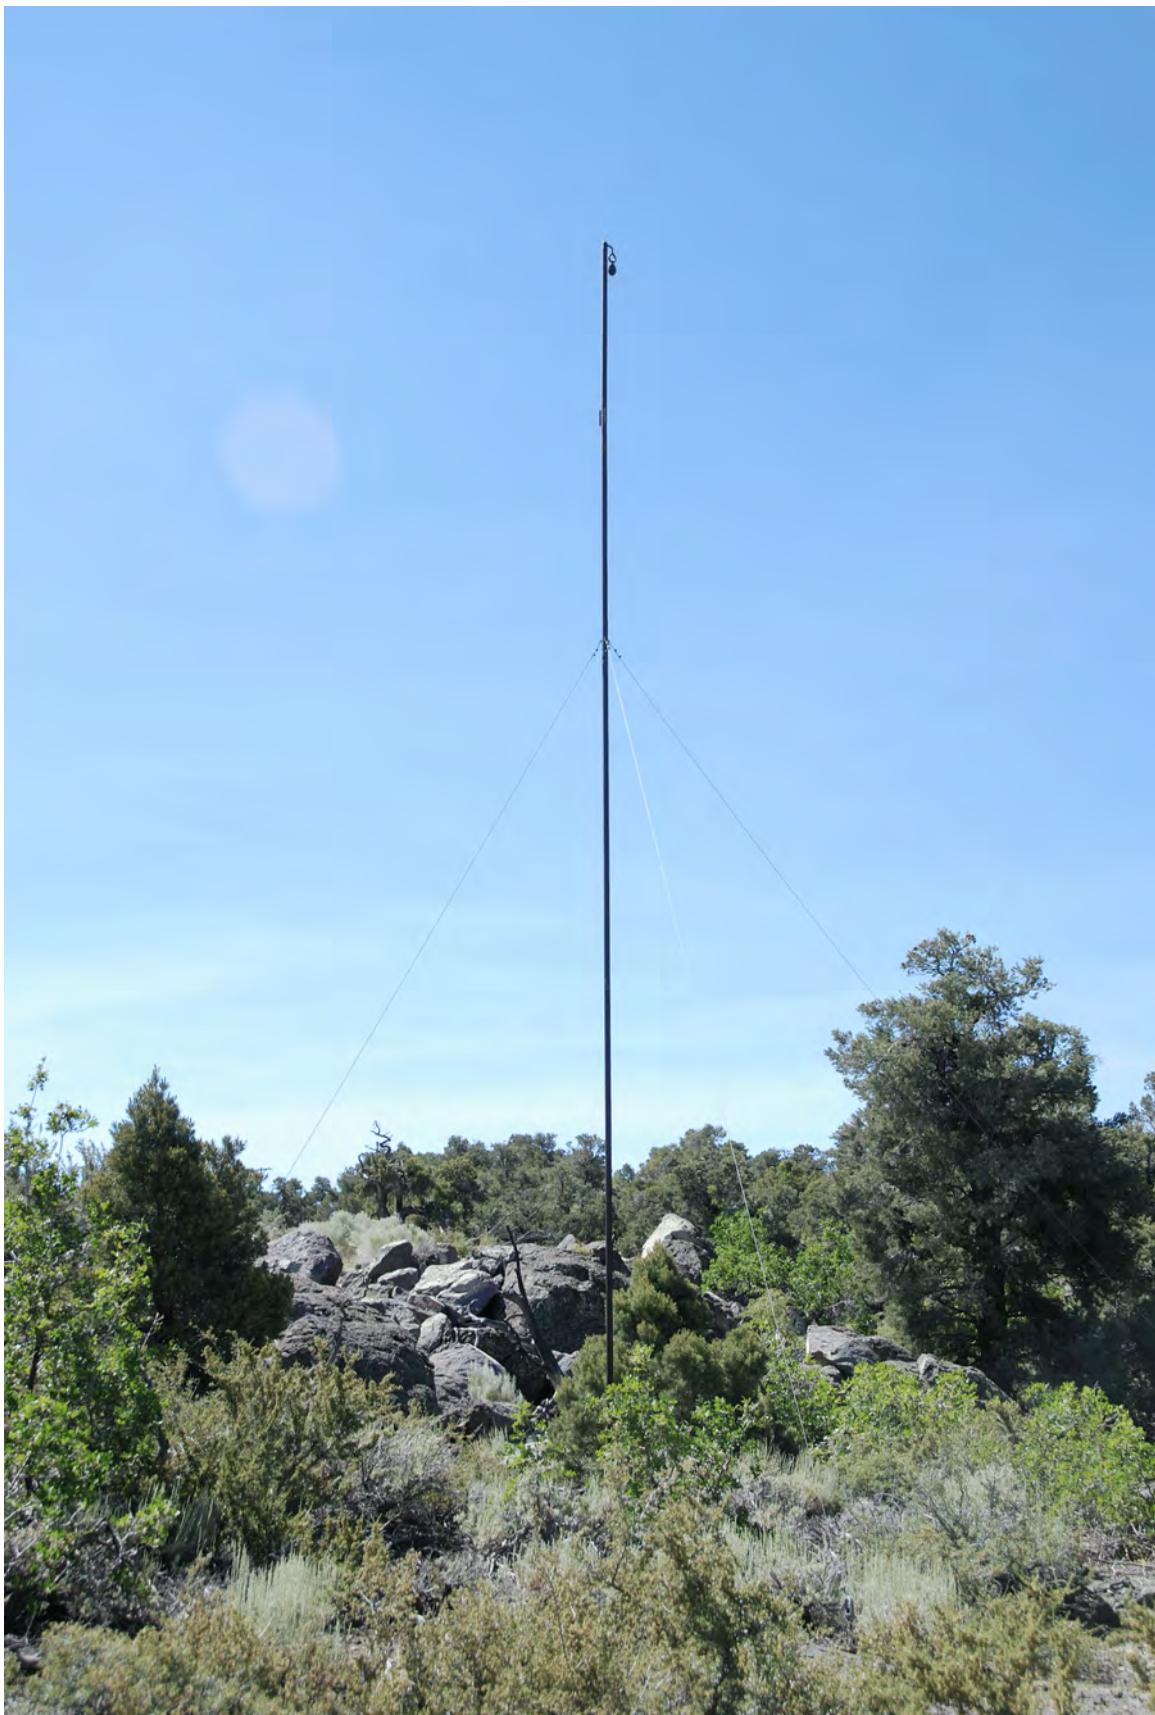
Figure 287. Feature 124, pole tower, U12n Tunnel, view south (2008).

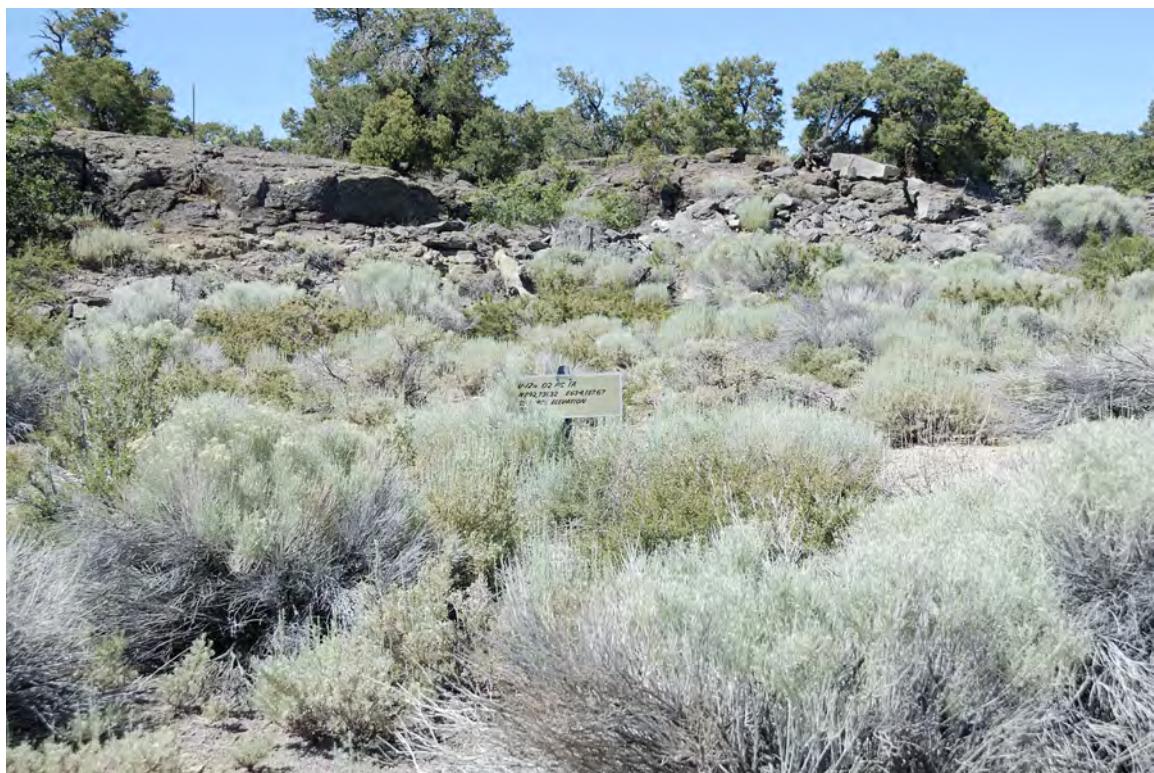
Figure 288. Plan map and photograph of Feature 125, U-12n.02 PS #1 and # 1AS drill hole, U12n Tunnel, view southeast (2008) and U12b.07 #2RC drill hole.
