A total of 202 features were recorded, mapped, and photographed for the U12n Tunnel complex. The project area encompassed 600.8 acres (243.1 hectares) at the portal and mesa areas. At the U12n portal area are ten sub-areas containing features related to the construction, testing, and general everyday activities within the tunnel. These include concrete foundations for buildings, communications equipment, mining equipment, rail lines, retention ponds, storage containers, and access control facilities. Only a telephone trailer remains on the telephone pad as all of the other buildings have been removed from the portal area. The microwave tower, portions of the rail lines, the muck car dump, rotary dump, and wash rack are still in place. Also, the traffic control point and powder magazines along N Tunnel Road are intact. At the mesa area are four sub-areas containing features generally related to pre- and post-shot drilling, recording facilities, and ventilation equipment. These include concrete foundations, instrument cable holes, and drill holes. The concrete foundations were for buildings and small equipment. Concrete pads and various equipment remain at the cable hole locations bu

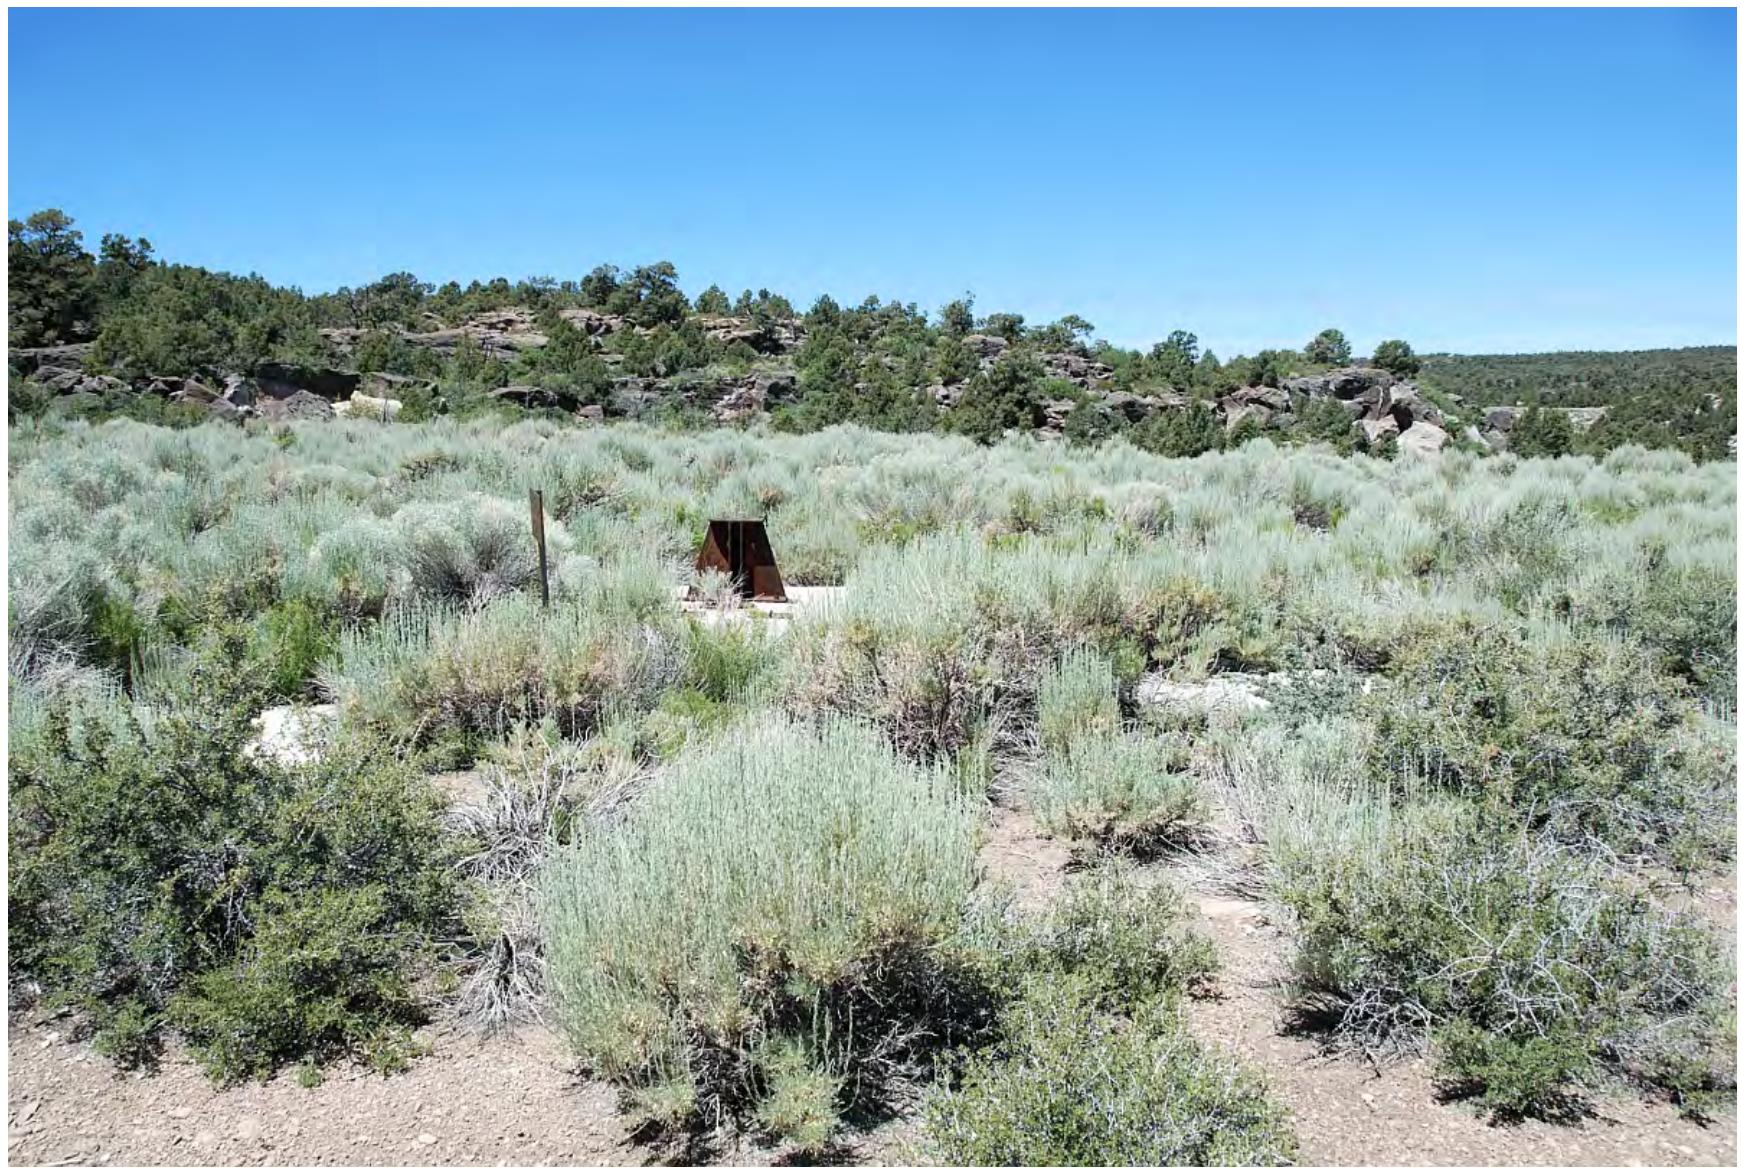
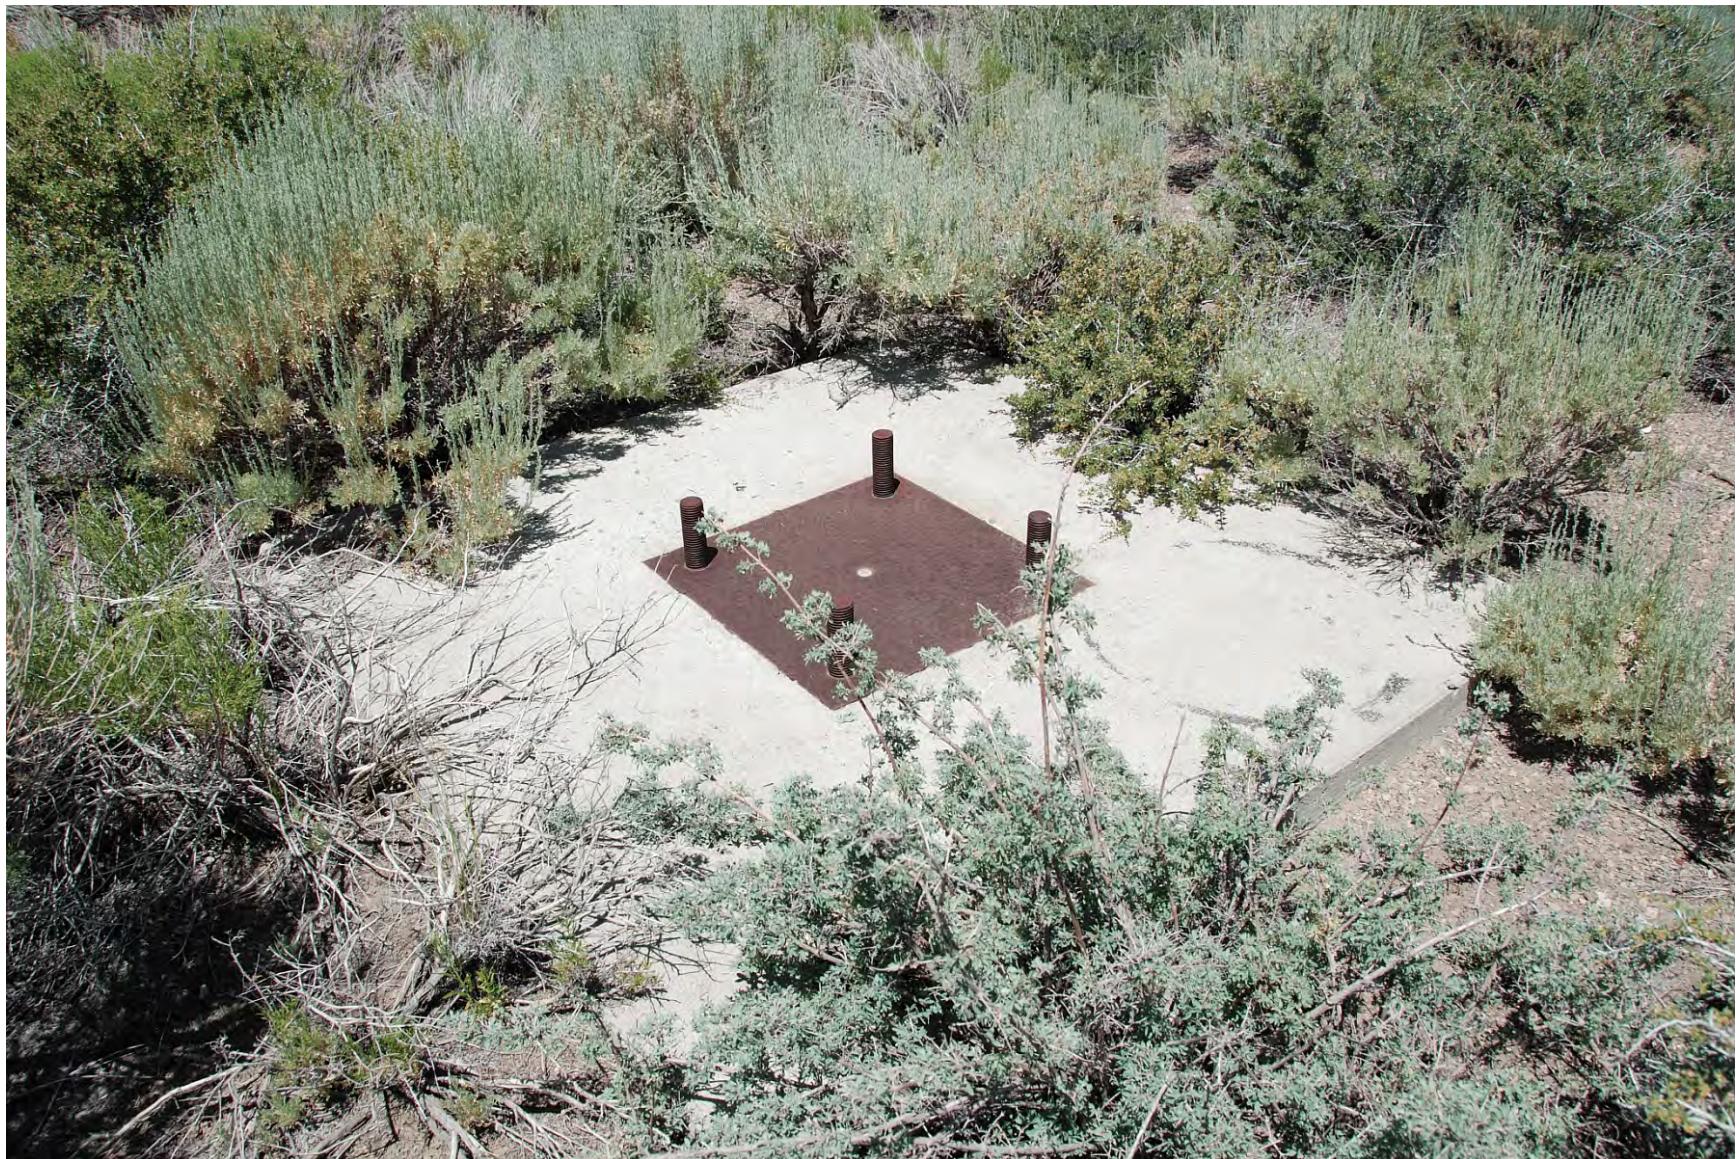
Feature 126 (Figures 289-291) is the U-12n.02 #1 CH cable hole at UTM coordinates 570311 E, 4117354 N, at an elevation of 7,203 ft (2,195.5 m), and drilled to a depth of 1,233 ft (4376 m) (Bennett 1991). The drill hole is near the center of an irregular-shaped dirt pad that is 190 ft (57.9m) east-west by 290 ft (88.4 m) north-south, encompasses 0.8 acres (0.34 hectare), and accessed by a road that enters from the south. The cable hole consists of a 10 3/4 inch (27.3 cm) diameter casing that does not extend above the surface of a 10 x 10 ft concrete slab on which the casing is centered. Adjacent to the casing on the west side is a 2 ft 6 inch long by 9 inch wide by 2 ft tall metal stand. East of the casing are two 1 ft x 9 inch metal plates that possibly supported a metal stand described previously. Near the pad is a metal sign with welded lettering that identifies the cable hole, its location, and elevation. Approximately 18 ft (5.4 m) from each corner of the cable pad are 6 x 6 ft concrete pads (Figure 290). Centered in the small pads are 2 ft x 2 ft metal plates with 1 3/4 inch (4.4 cm) diameter by 6 inch long bolts welded to each corner. The northeast and southeast pads appear to have been moved from their original locations. Associated artifacts are metal fragments, welding rods, communications wire, and rubber fragments.

Figure 290. Photograph of Feature 126, U12-n.02 #1 CH drill hole and metal stand, view northwest (2008).

Figure 291. Photograph of Feature 126, concrete pad and metal plate, U-12n.02 #1 CH, view southwest (2008).

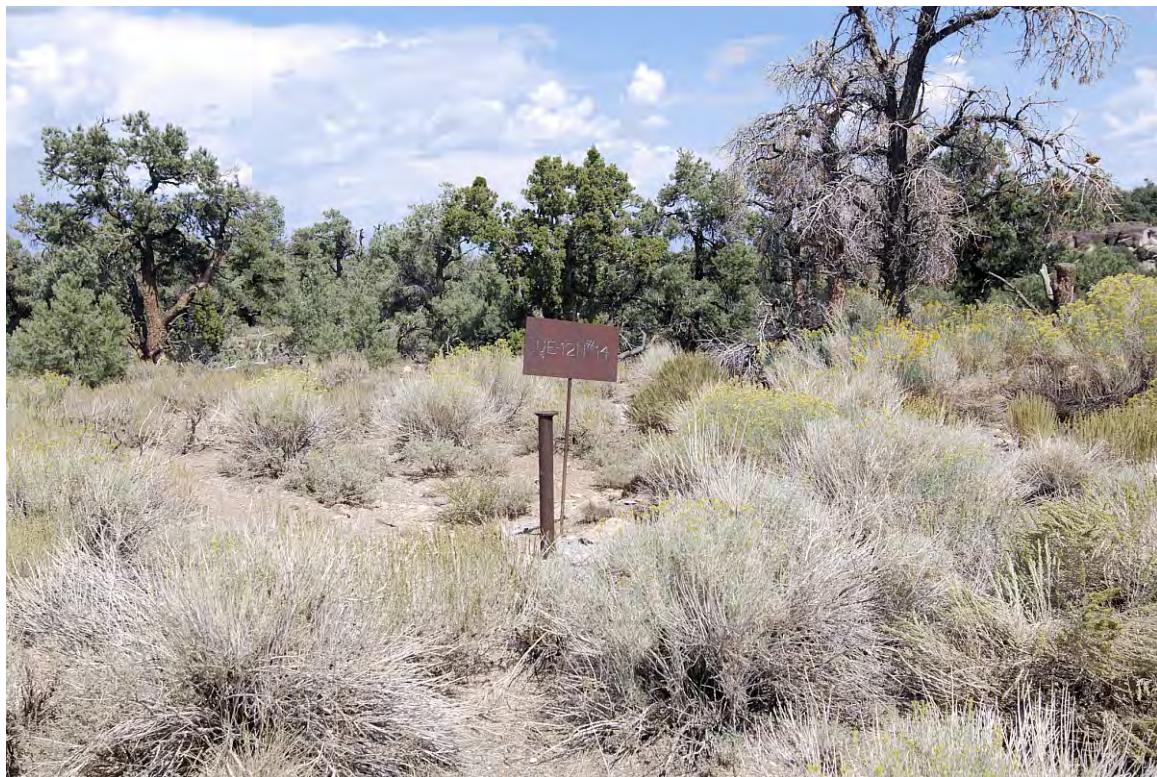
Figure 292. Feature 127, UE-12n #14 exploratory drill hole, U12n Tunnel, view northeast (2008).

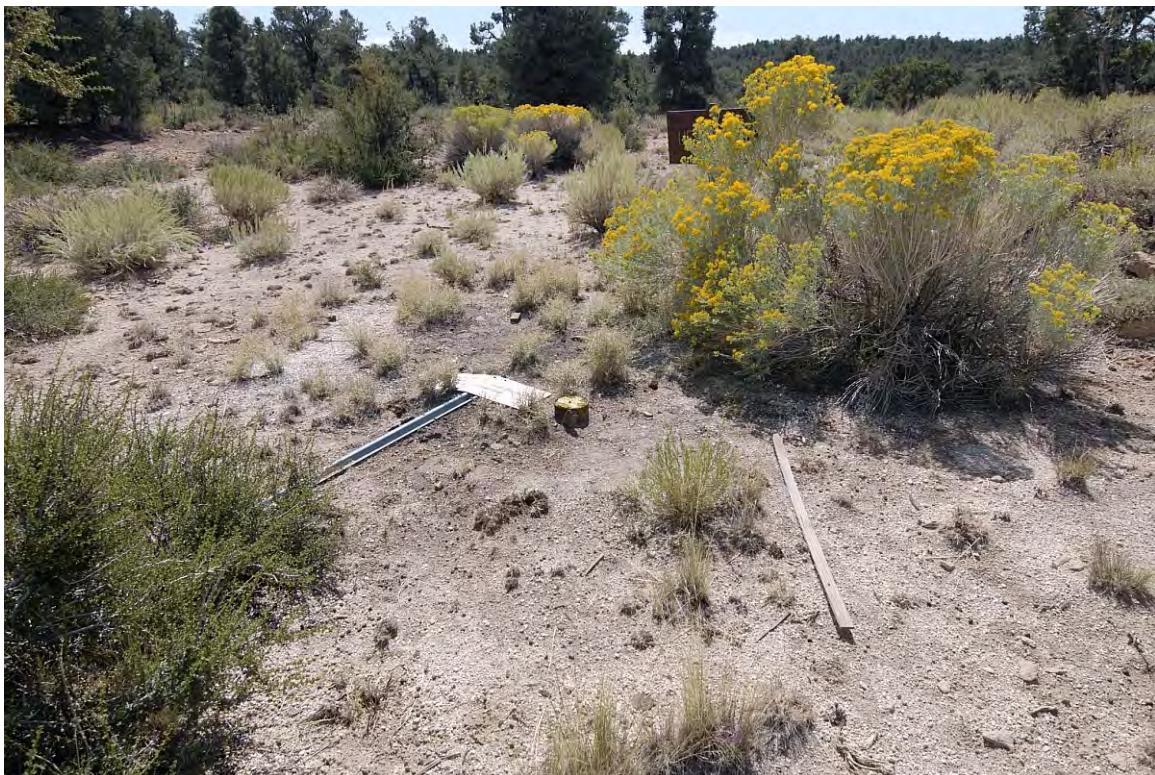
Figure 293. Plan map and photograph of Feature 128, UE-12n #6 exploratory drill hole, and Feature 129, core samples, U12n Tunnel, view northeast (2008).

Feature 128 (Figure 293) is the UE-12n #6 exploratory drill hole at UTM coordinates 569576 E, 4116811 N, at an elevation of 7,527 ft (2,294.2 m), and drilled to a depth of 2,317 ft (706 m) (Bennett 1991). The drill hole is near the center of a rectangular dirt pad that is 210 ft (64 m) north-south by 140 ft (42.7 m) east-west and encompasses 0.41 acres (0.16 hectares) and accessed by a dirt road that enters from the north. It consists of a 6-inch (15.2 cm) casing that extends 3 inches above the surface. The casing has been cemented to the top and two metal signs (one lying on the surface) mark the location of the drill hole. Associated artifacts are a metal paint bucket, insulated wire, pipe fragments, rubber hose fragments, metal fragments, milled lumber fragments, and welding rods.

Feature 129 (Figures 293 and 294) is core samples at UTM coordinates 569580 E, 4116841 N. The samples are at the north end of the UE-12n #6 drill hole (Feature 128) and consist of approximately 100 core sample fragments. The 3 inch diameter samples are of various lengths and are near the access road to the well pad. Associated artifacts are milled lumber fragments and a metal sign with no labeling.

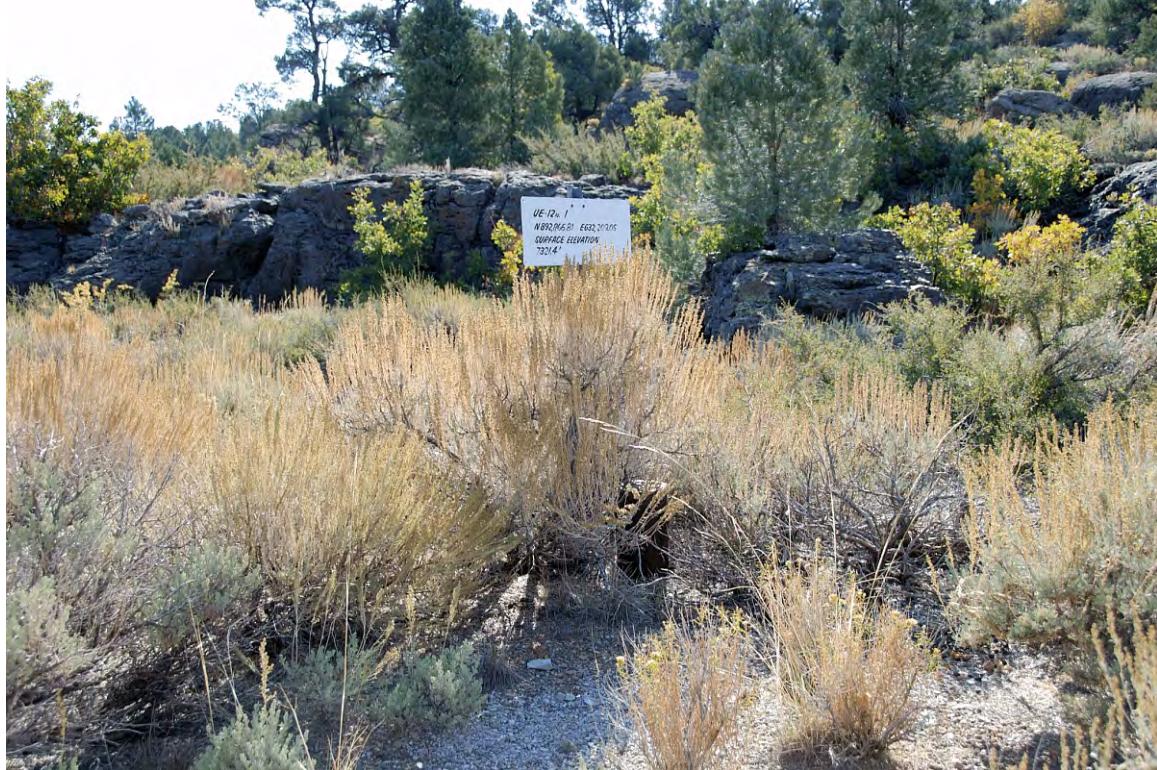
Figure 295. Plan map and photograph of Feature 130, UE-12n #1 exploratory drill hole, U12n Tunnel, view southeast (2008).

Feature 130 (Figure 295) is the UE-12n #1 exploratory drill hole at UTM coordinates 569867 E, 4117381 N, at an elevation of 7,321 ft (2,231.4 m), and drilled to a depth of 2,001 ft (610 m) (Bennett 1991). The drill hole is near the east edge of an irregular-shaped dirt pad that is 188 ft (57.3 m) north-south by 160 ft (48.8 m) east-west and encompasses 0.41 acres (0.17 hectares). It consists of a 6 -inch casing extending 1 ft above the surface. The location is marked by a metal sign with the drill hole number, coordinates, and surface elevation. Along the south side of the drill hole and concealed within vegetation are highly fragmented core samples. Associated artifacts are milled lumber fragments, crushed cans, lath, plastic fragments, and rubber fragments.

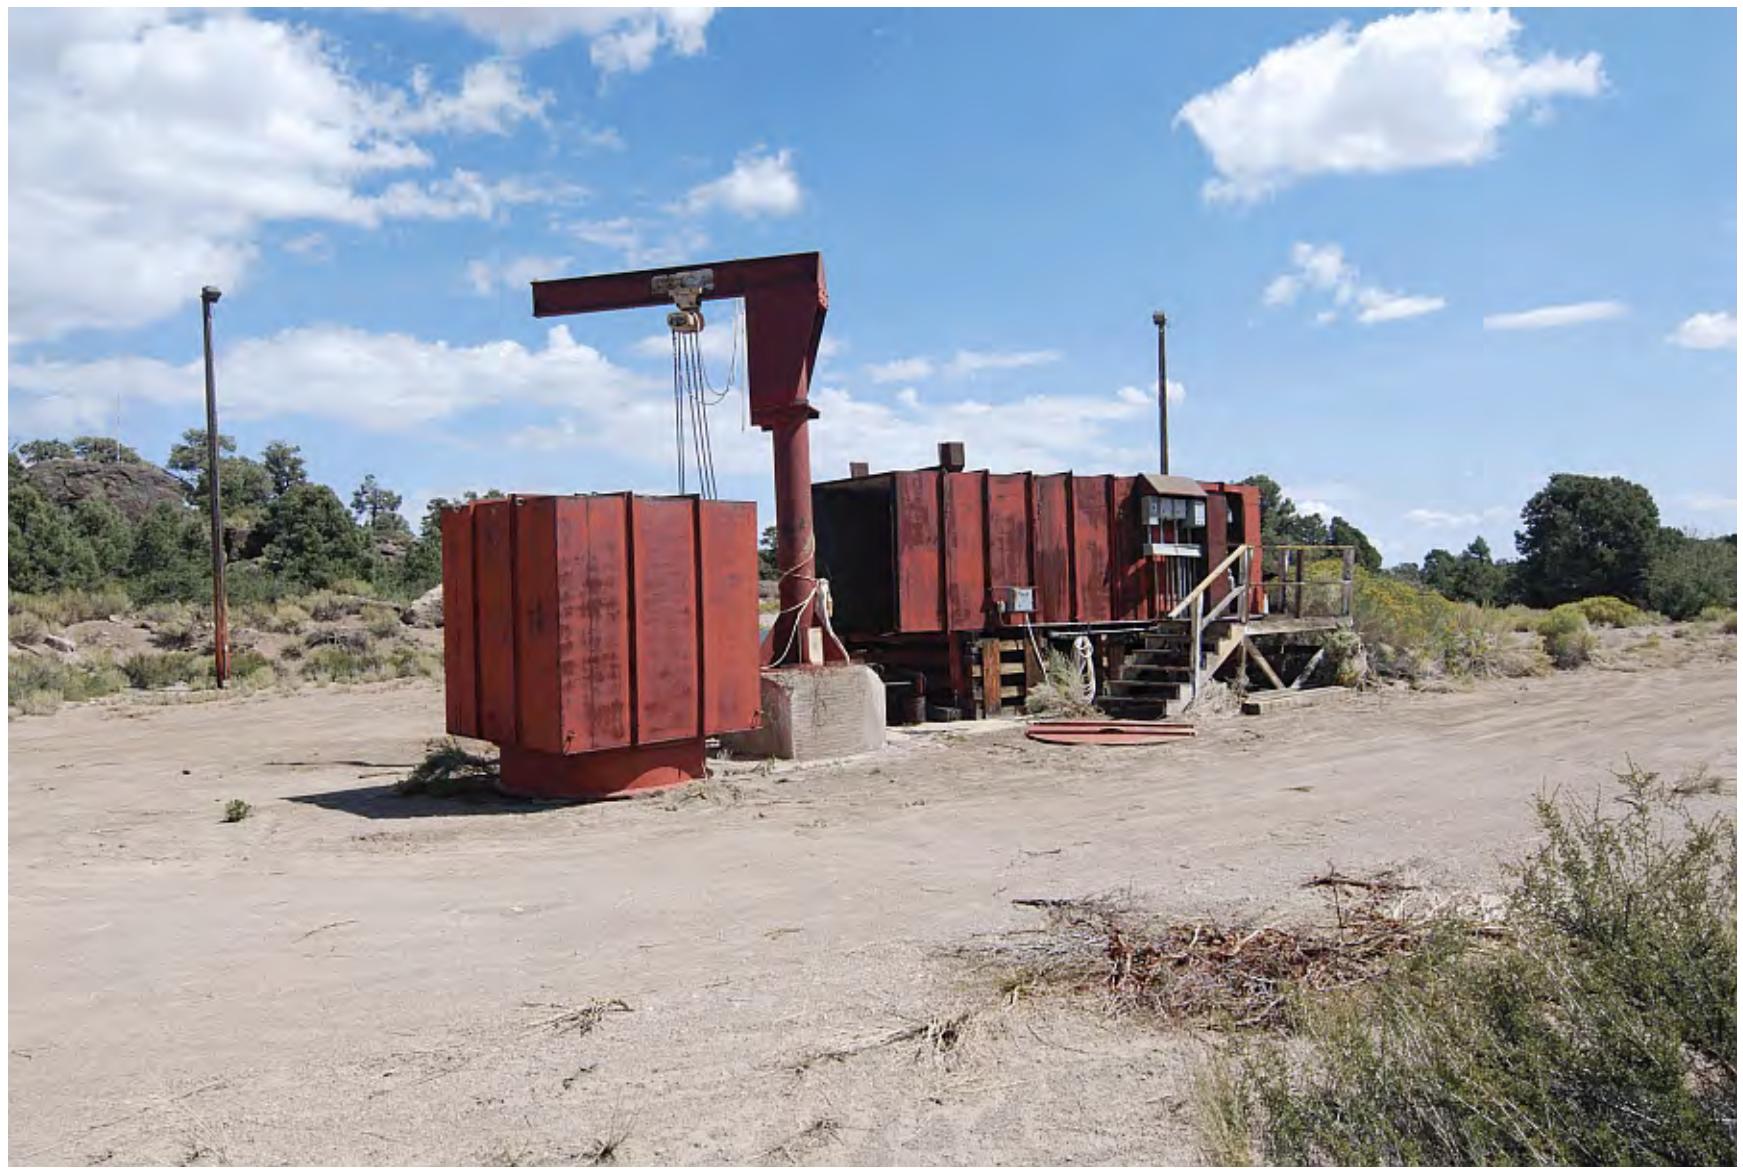
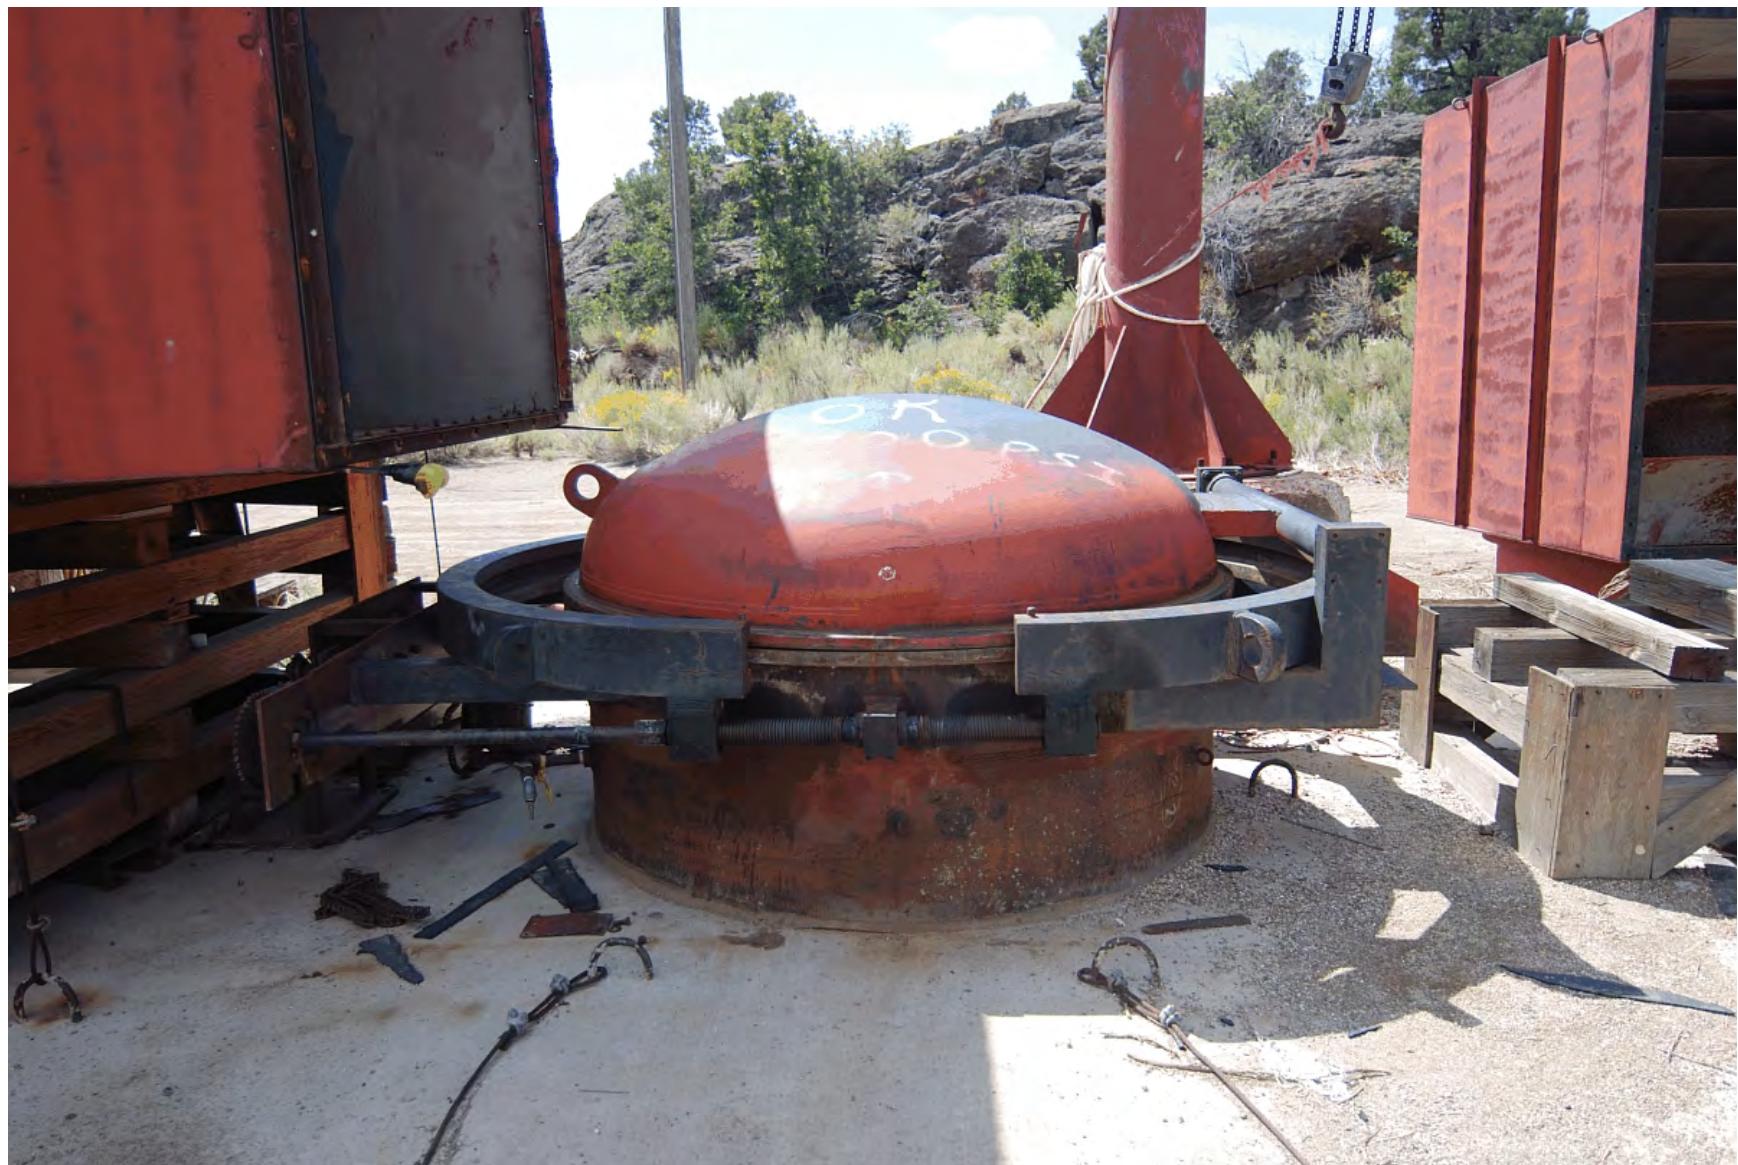
Figure 298. Feature 131, U-12n Vent Hole #2, U12n Tunnel, view southeast (2008).

Figure 299. Feature 131, U-12n Vent Hole #2 and turn-tube containment door, U12n Tunnel, view southwest (2008).

It is on a dirt pad that is 330 ft (100.6 m) north-south by 130 ft east-west and encompasses 0.83 acres (0.33 hectares). Features 132-137 are on the U-12n Vent Hole #2 dirt pad.

Near the northwest corner of the foundation is a pipe and beam crane. The base is a 4 ft 6 inch x 4 ft 6 inch x 3 ft concrete block. On top of the block is a 4 ft diameter 1/2 inch thick metal plate attached to the concrete with 1 1/8-inch bolts. The plate is the base for a 1 ft 3 inch diameter vertical metal pipe that is 12 ft in height. A 1-ft I-beam arm extends horizontally 12 ft from the metal pipe. On the I-beam arm is a 3 ton BUDGIT electric winch. The operating switch for the winch is on an electrical cable on the concrete base.

Outside of the foundation near the northwest corner is a metal box that is 7 x 7 x 7 ft. The east side of the box is open and is the same measurement as the north end of the metal conduit at the vent hole. A 6 ft 8 inch diameter metal pipe exits the bottom of the box and is the same size as the vent

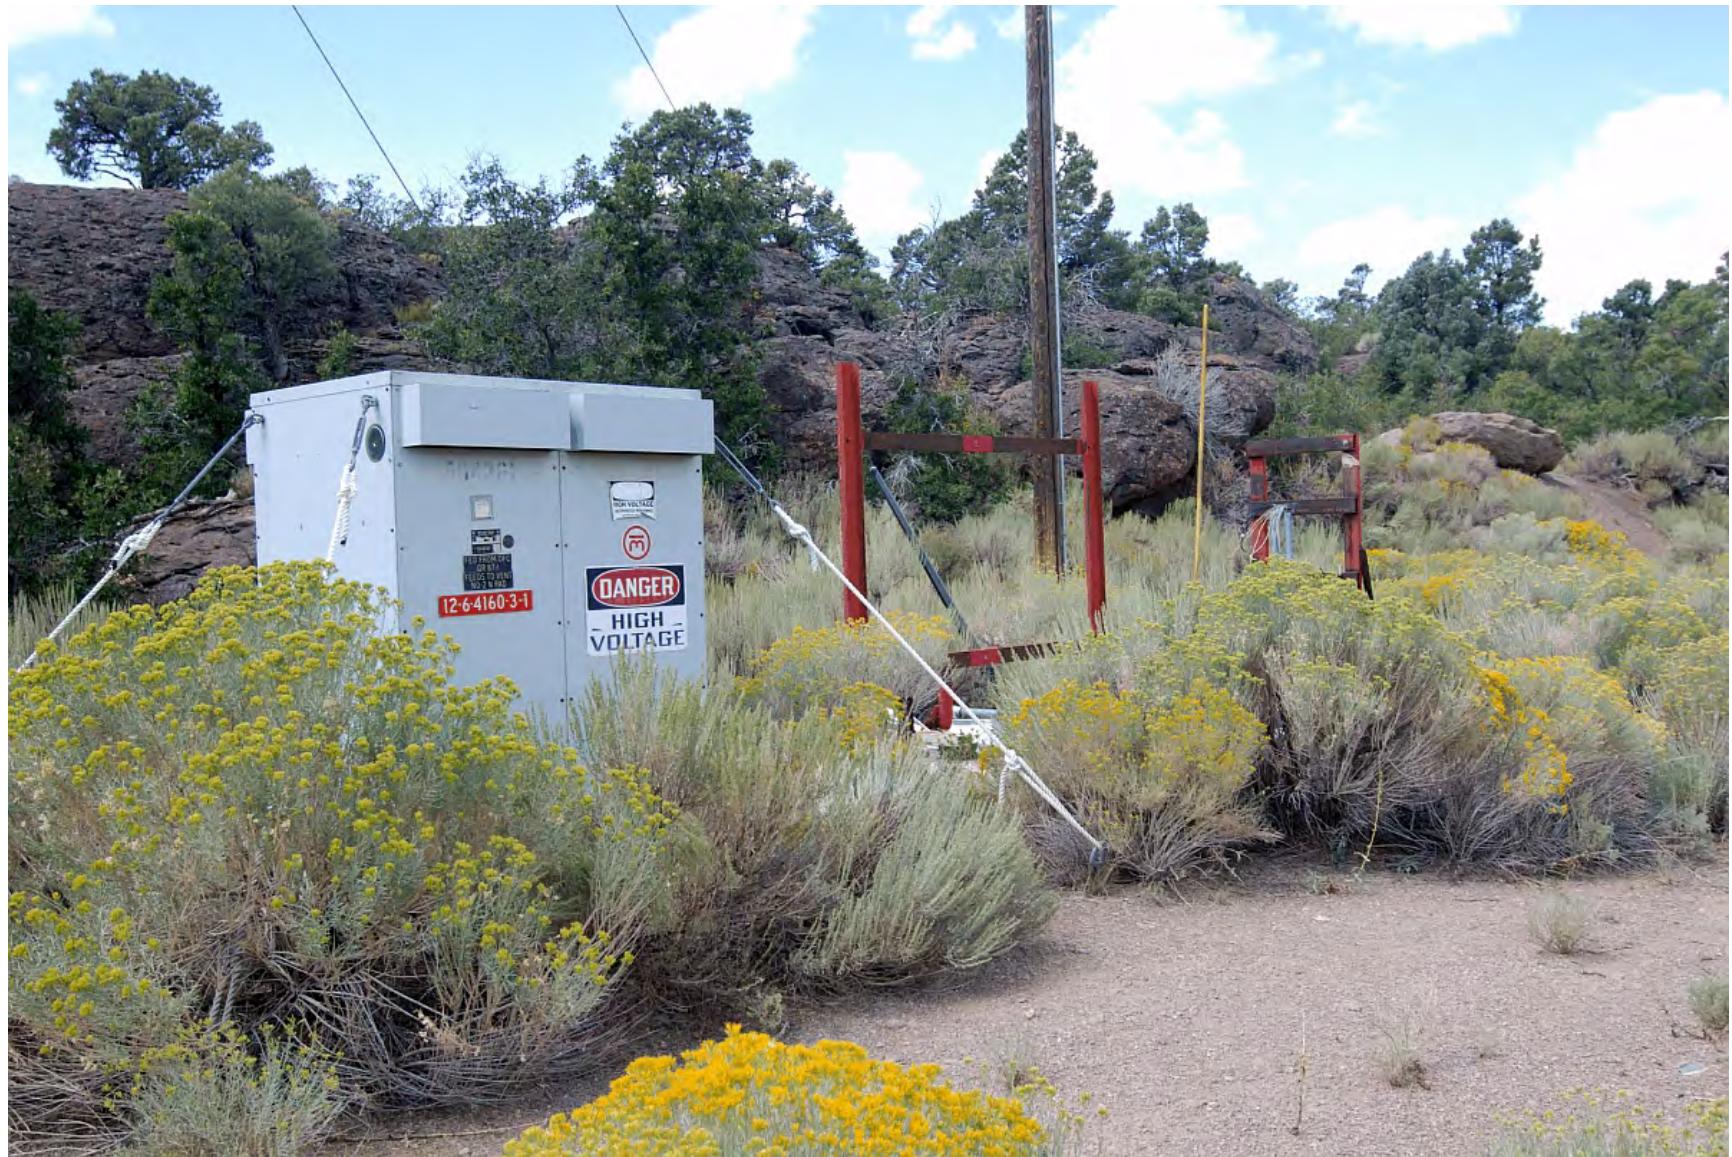
Figure 300. Feature 132, electrical substation at U-12n Vent Hole #2, U12n Tunnel, view northwest (2008).

Feature 132 (Figures 296 and 300) is an electrical substation at UTM coordinates 569394 E, 4117517 N. The substation consists of two concrete pads and a high voltage panel box. The north pad is 17 ft north-south by 7 ft east-west. On each corner of the pad and centered on the north and south edges are 1 ft 5 inch tall by 2 7/8 inch diameter metal jack stands. Each stand consists of a 10 x 10 inch metal base plate with a vertical 2 7/8 inch diameter vertical pipe. A threaded rod inserted in the end of the pipe can be adjusted vertically. On the northeast corner of the pad is a 2 ft 10 inch north-south by 6 ft tall metal frame constructed of 4-inch channel iron. The frame supported electrical panels that are missing; however, conduit with insulated cables extend above the surface below the frame. Along the west edge of the pad is a 8 ft 4 inch north-south by 7 ft 6 inch tall metal electrical panel backboard with no panels. The vertical legs of the frame are 6-inch channel iron and the horizontal members are 4-inch channel iron. Below the frame are 4 1/2-inch, 4-inch, 2 1/4-inch, and 1-inch galvanized conduit. Two metal rails are along the south side of the pad. The first rail is 2 ft 2 inches from the south edge, is a 3 ft long piece of 6 inch channel iron rail, and is mounted on rubber "shock absorbers." A second similar rail is 4 ft 4 inches from the south edge and parallel to the first. A panel box or transformer probably was mounted on the rails. Galvanized conduit is near the east end of the rails. A second 6 ft 8 inch north-south by 1 ft 2 inch east-west concrete pad is 2 ft south of the first pad. On the pad is a high voltage panel box. The panel box is 4 ft 8 inches in length, 3 ft 6 inches wide, and 5 ft 10 inches in height. It is secured with four galvanized stanchions and 3/4-inch rope. The box is labeled FED FROM OFC QR 87-1 and FEEDS TO VENT #2 N PAD #12-6-41160-3-1. Along the east side of the top surface of the pad is a 5 ft north-south by 2 ft east-west trough through which conduit and electrical cables extend from below the pad into the panel box.

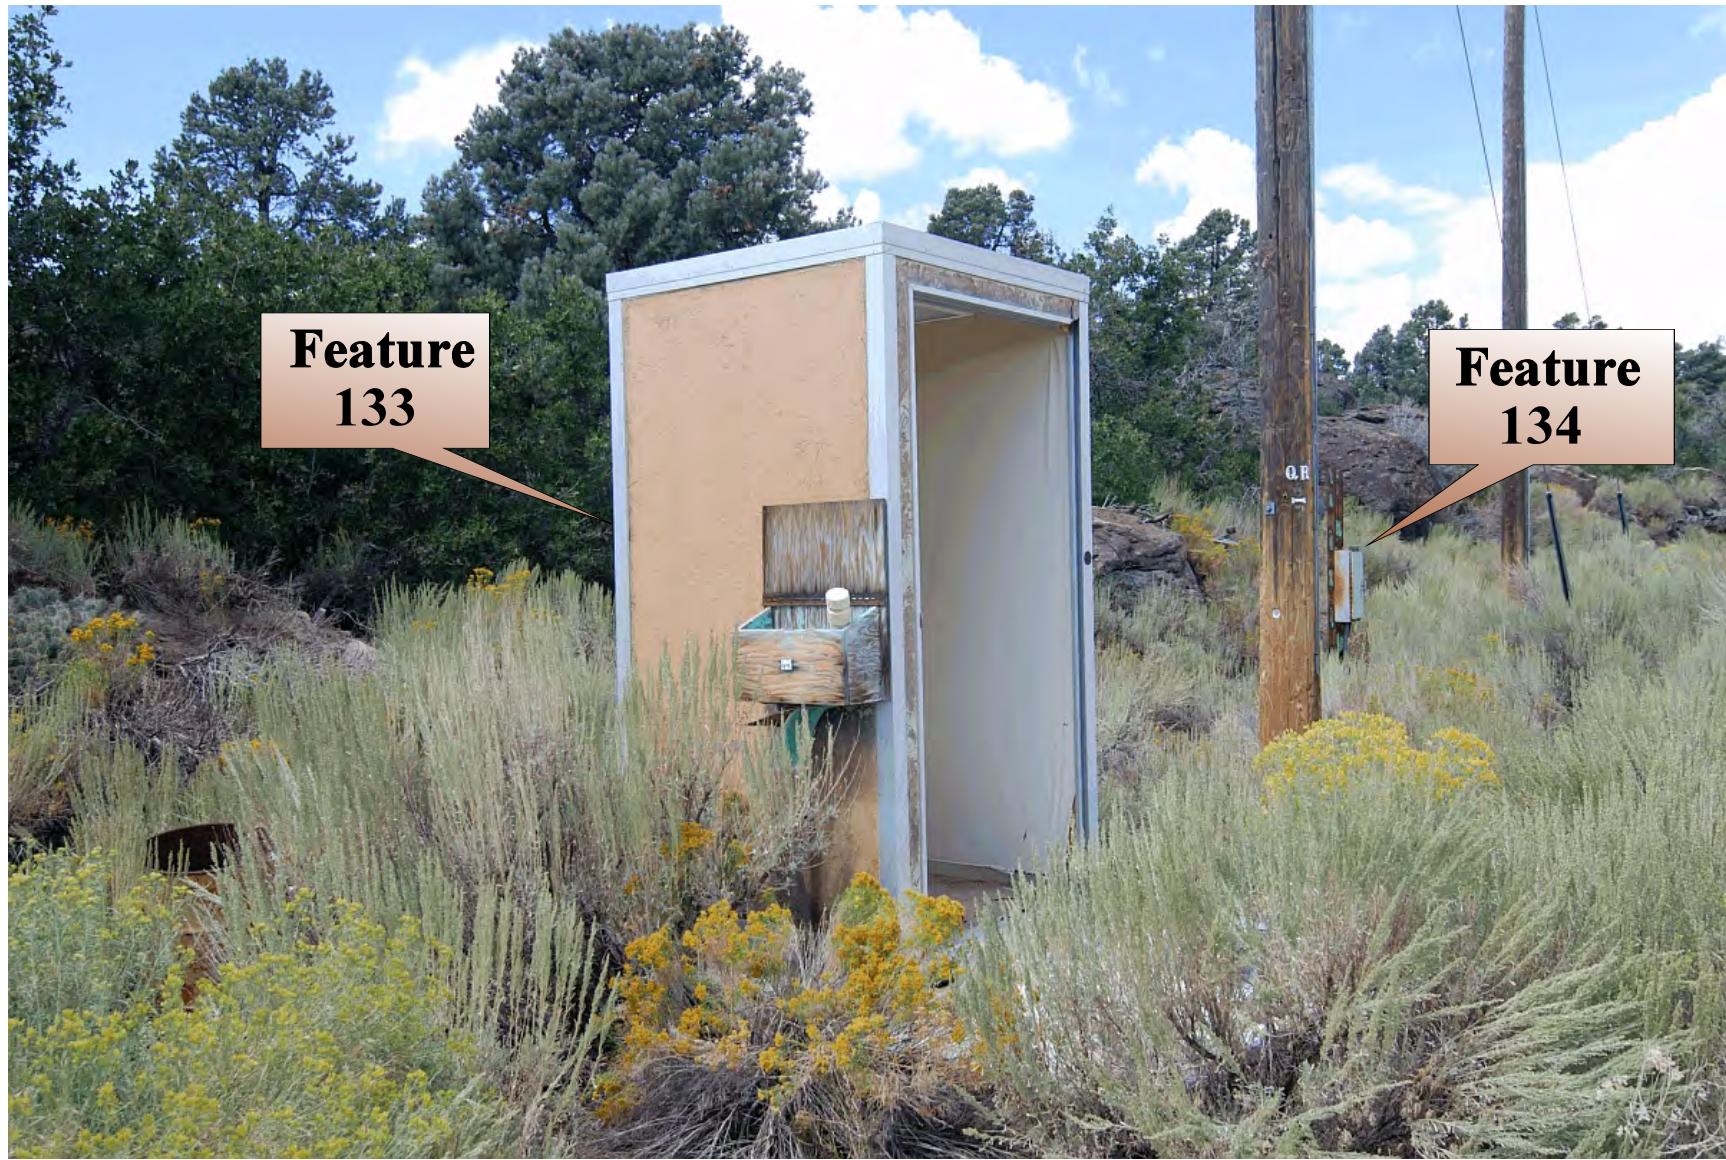
Figure 301. Feature 133, telephone booth, and Feature 134, electrical panel at U-12n Vent Hole #2, U12n Tunnel, view northwest (2008).

Feature 133 (Figures 296 and 301) is a telephone booth at UTM coordinates 569396 E, 4117503 N. The booth is 4 x 4 x 8 ft and needed because of the noise produced at the vent hole when the two 350 horsepower ventilation fans were in operation. The walls of the structure are made of fiberglass, Celetex, and Masonite. The Masonite is sandwiched between the fiberglass and Masonite panels. The door for the structure is on the surface and contains a 2 ft 2 inch square aluminum sliding window. Attached to the west interior wall is a 1 ft wide shelf that extends between the north and south walls. A phone jack is centered above the shelf. A 2 ft square light fixture is mounted to the ceiling and the light switch is on the south wall. On the exterior of the south wall at the east corner is a 1 ft 6 inch x 1 ft x 7 inch wood box.

Feature 134 (Figures 296 and 301) is a electrical panel box at UTM coordinates 569388 E, 4117512 N. The panel box is 2 ft 6 inches x 1 ft 8 inches x 8 inches and attached to two 7 ft 6 inch tall 1 3/4-inch channel iron (Unistrut) legs.

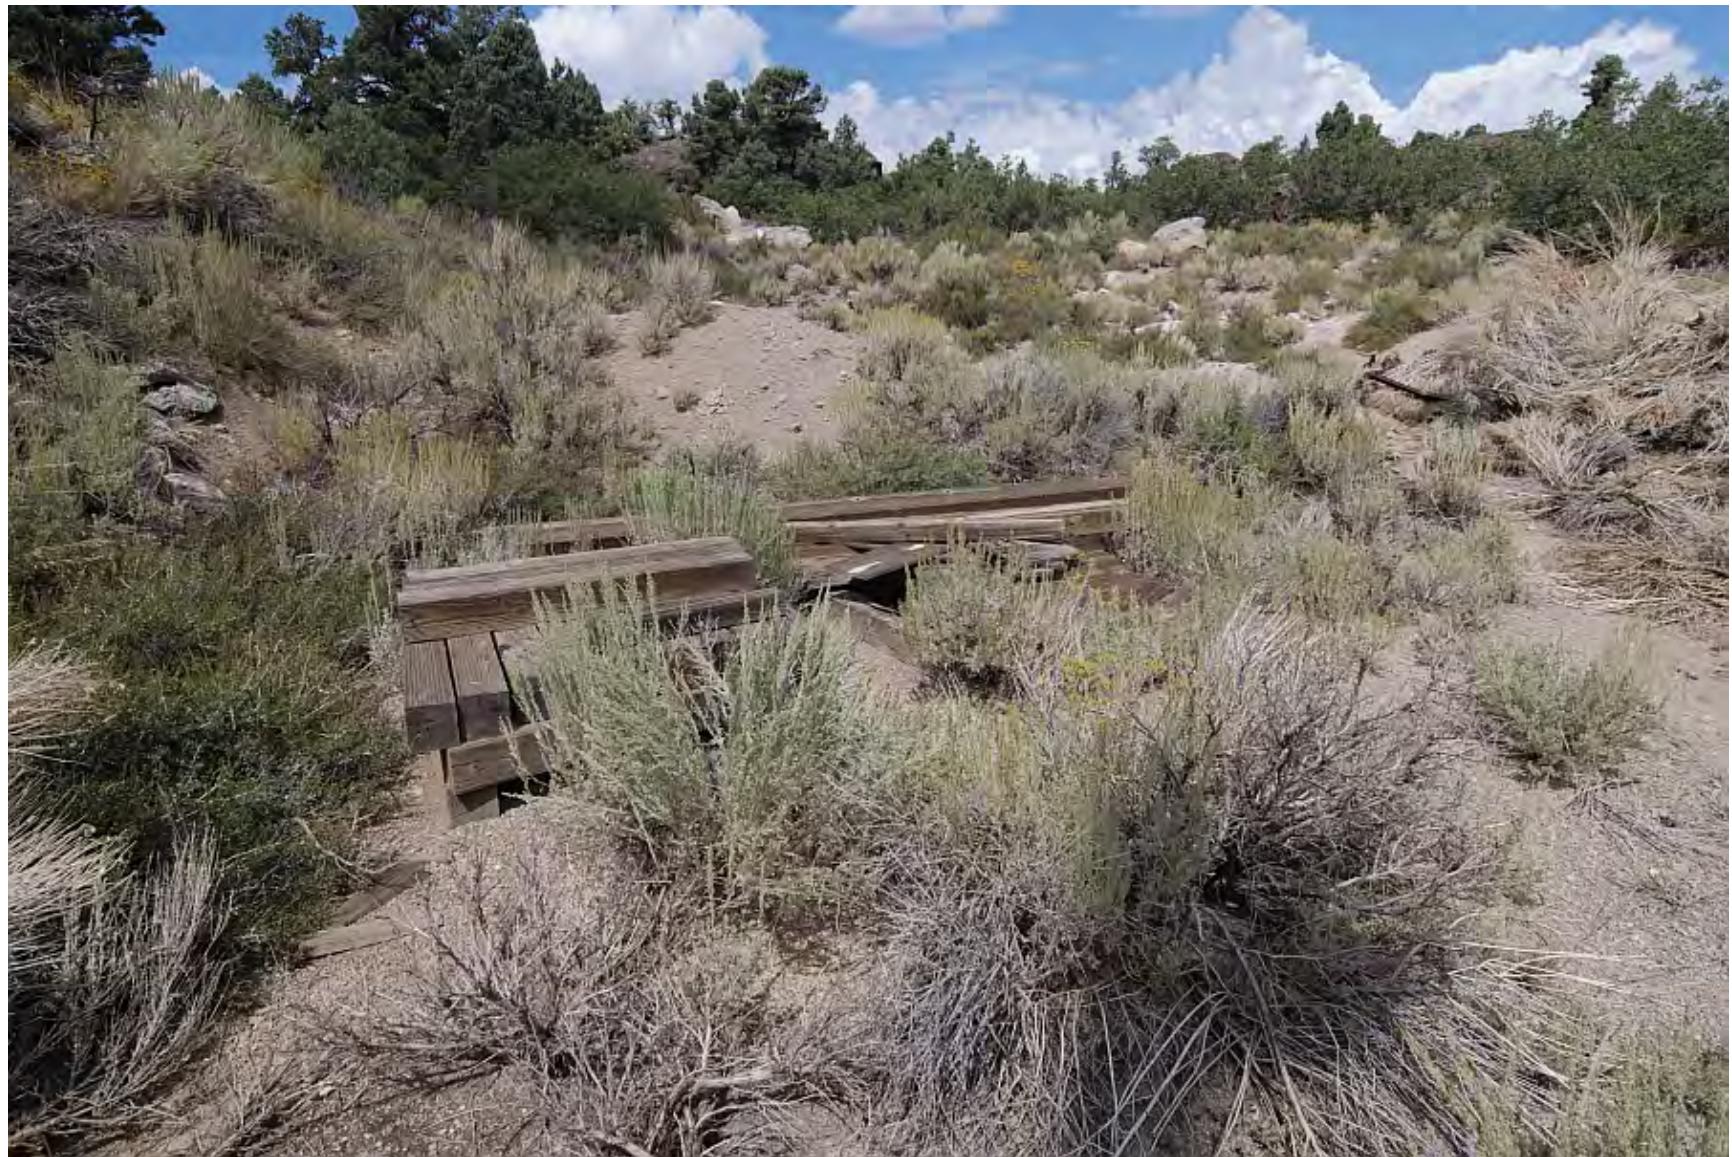
Figure 302. Feature 135, stacked lumber at U-12n Vent Hole #2, U12n Tunnel, view north (2008).

Feature 135 (Figures 296 and 302) is a stack of milled lumber and plywood at UTM coordinates 569367 E, 4117552 N. The stack includes 6 x 6 , 4 x 4, and 2 x 4 inch milled lumber of lengths form 4 to 12 ft. The 1/2-inch plywood is 3 ft 6 inches long by 10 inches wide.

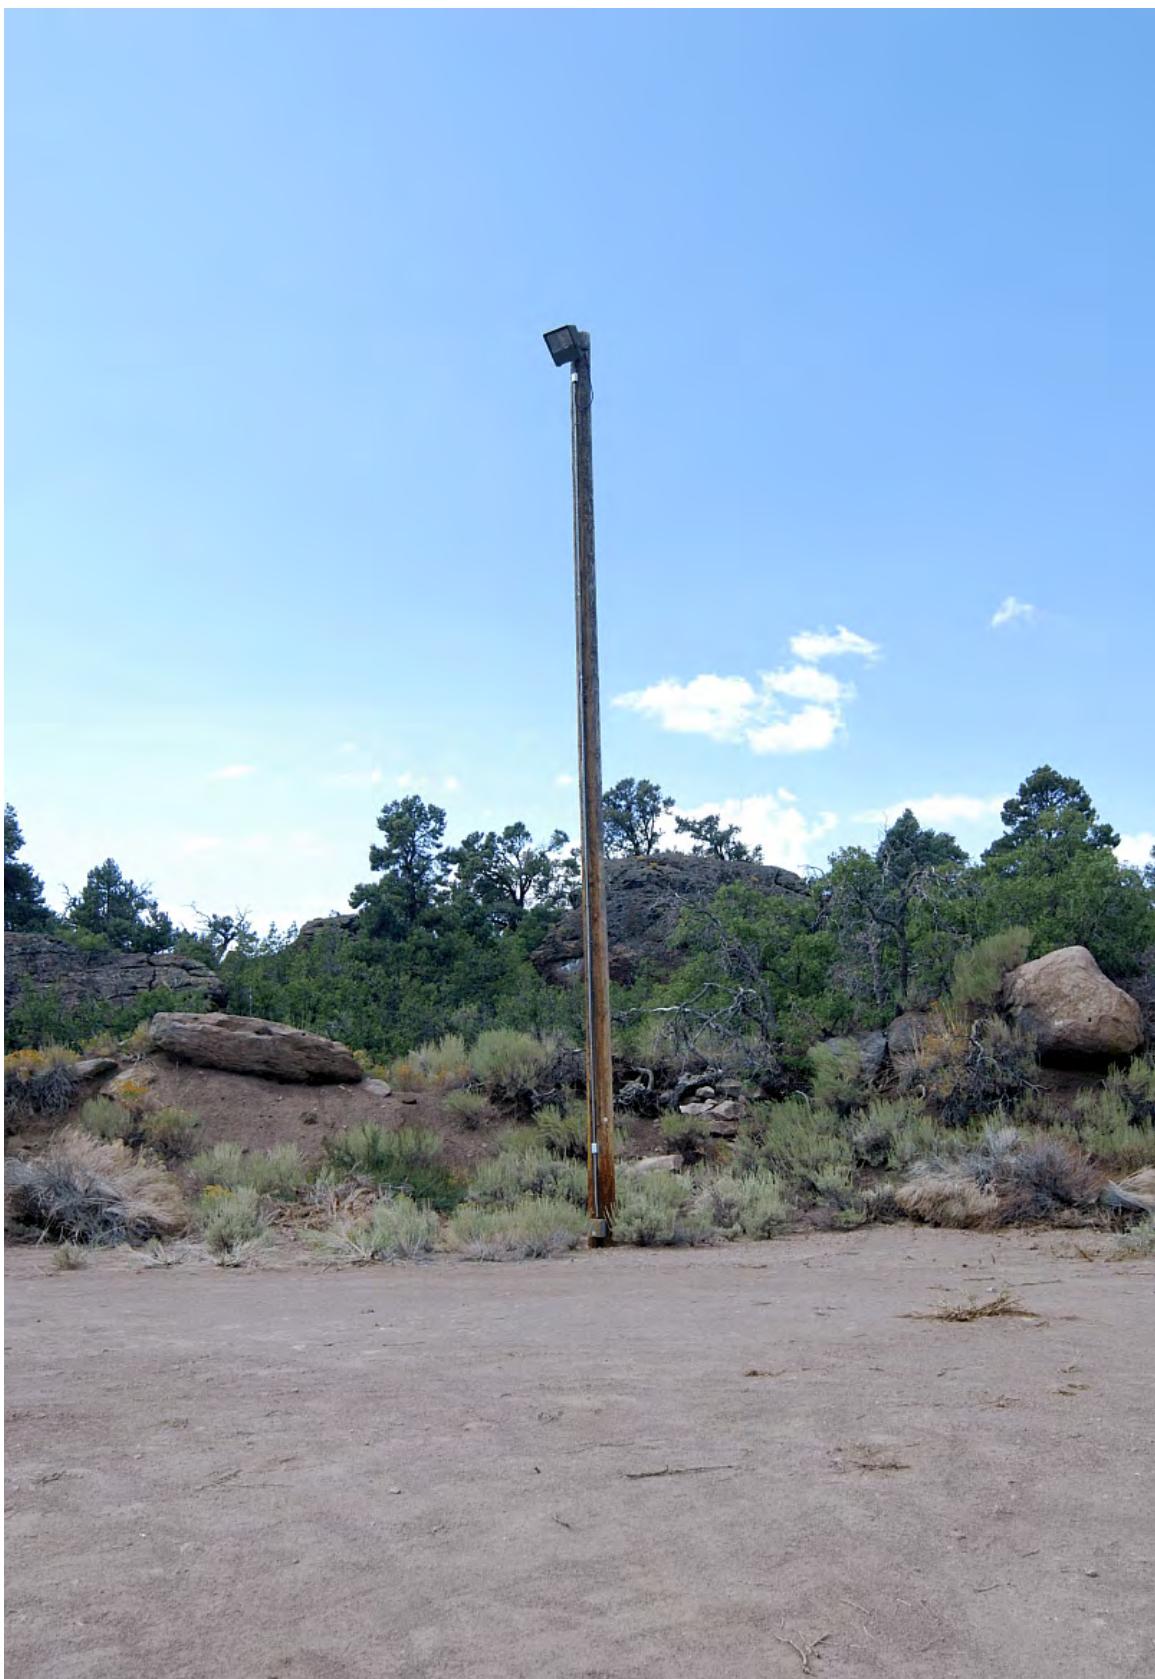
Figure 303. Feature 136, light pole (one of five) at U-12n Vent Hole #2, U12n Tunnel, view southwest (2008).

Feature 136 (Figures 296 and 303) is five wood light poles that surround the U12n Vent Hole #2 dirt pad. There are three poles on the west side of the pad at UTM coordinates 569390 E, 4117504 N; 569378 E, 4117528 N; and 569371 E, 4117545 N. The two poles on the east side of the pad are at UTM coordinates 569400 E, 4117561 N and 569435 E, 4117525 N. They are approximately 8 inches in diameter and 20 ft in height with rectangular light fixtures mounted to the top of the poles. The south pole on the west side of the pad has two light fixtures and the remaining poles have one light fixture.
