A total of 202 features were recorded, mapped, and photographed for the U12n Tunnel complex. The project area encompassed 600.8 acres (243.1 hectares) at the portal and mesa areas. At the U12n portal area are ten sub-areas containing features related to the construction, testing, and general everyday activities within the tunnel. These include concrete foundations for buildings, communications equipment, mining equipment, rail lines, retention ponds, storage containers, and access control facilities. Only a telephone trailer remains on the telephone pad as all of the other buildings have been removed from the portal area. The microwave tower, portions of the rail lines, the muck car dump, rotary dump, and wash rack are still in place. Also, the traffic control point and powder magazines along N Tunnel Road are intact. At the mesa area are four sub-areas containing features generally related to pre- and post-shot drilling, recording facilities, and ventilation equipment. These include concrete foundations, instrument cable holes, and drill holes. The concrete foundations were for buildings and small equipment. Concrete pads and various equipment remain at the cable hole locations bu

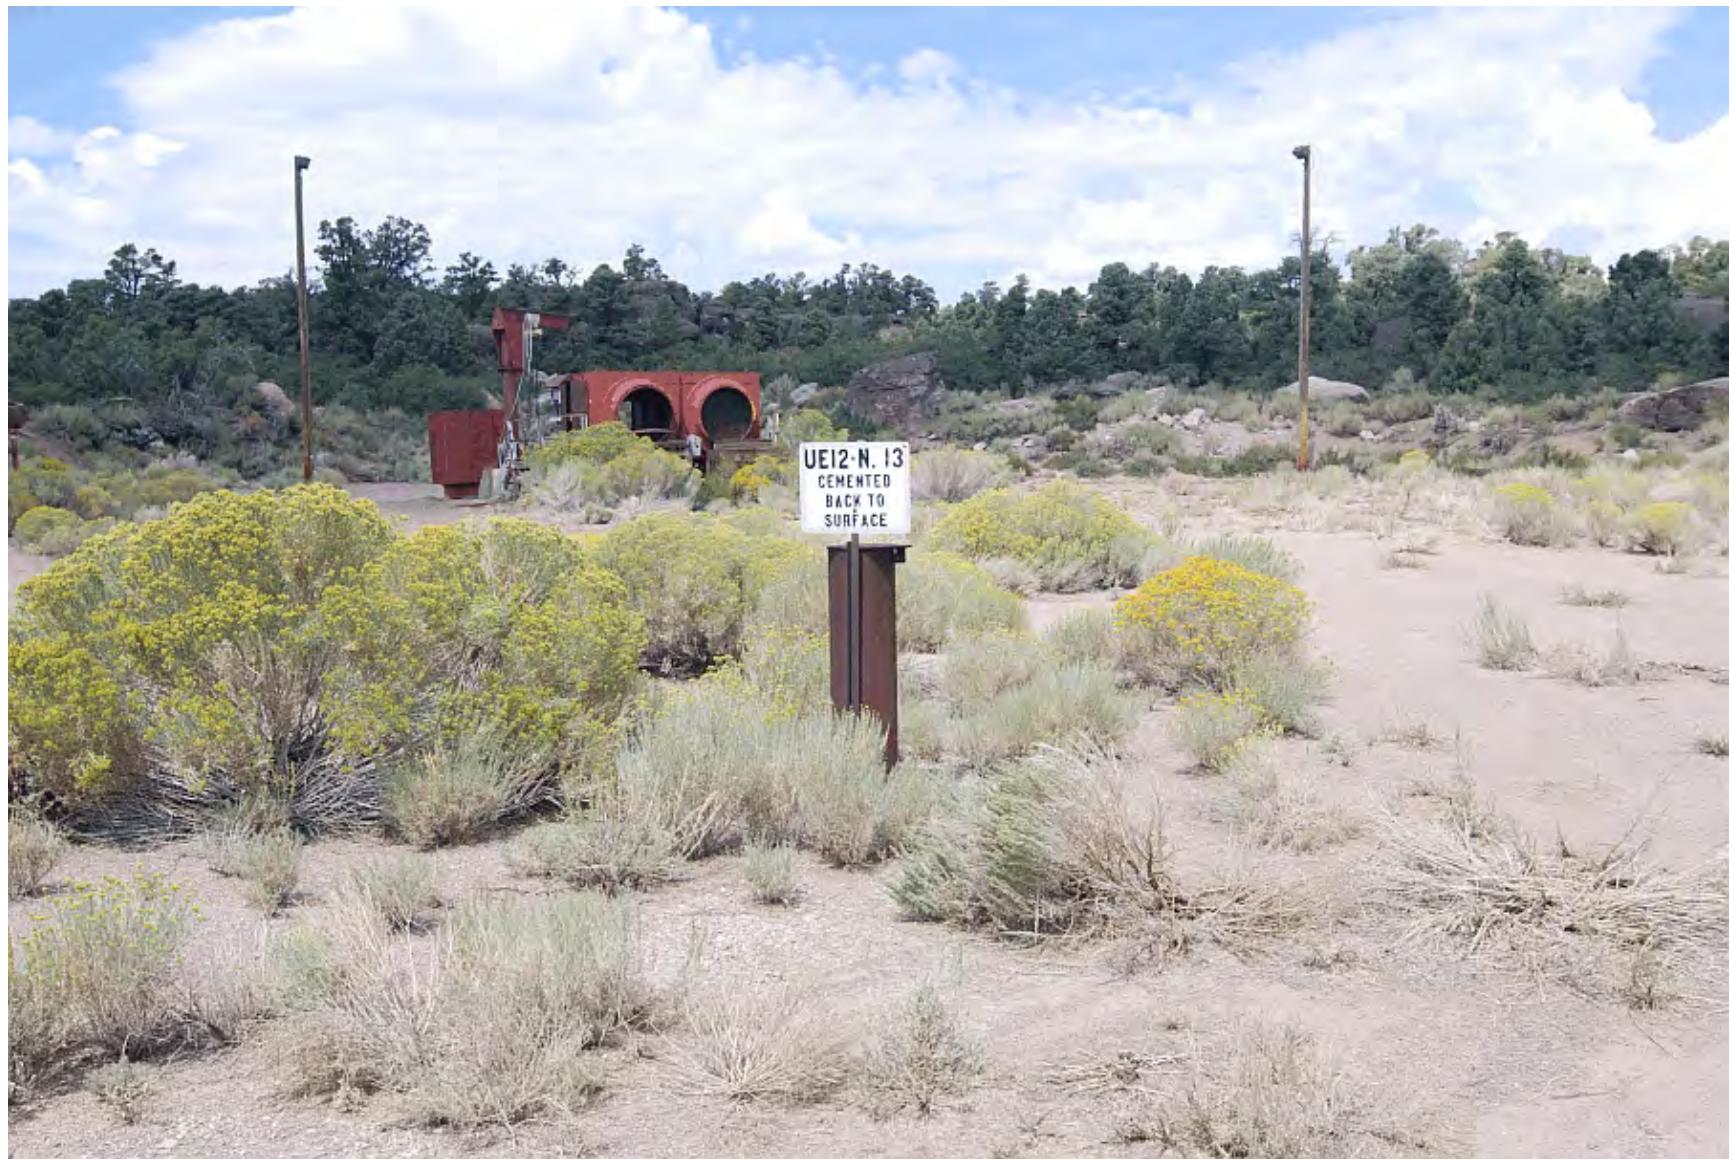
Figure 304. Feature 137, UE-12n #13 exploratory drill hole near the U-12n Vent Hole #2, U12n Tunnel, view north (2008).

Feature 137 (Figures 296 and 304) is the UE-12n #13 exploratory drill hole at UTM coordinates 569349 E, 4118331 N, at elevation 7,355 ft (2,241.8 m), and drilled to a depth of 1,086 ft (331 m) (Bennett 1991). The drill hole is on the south end of the U-12n Vent Hole #2 dirt pad. It consists of a 8-inch (20.3 cm) casing that extends 3 ft 6 inches above the surface and has a 1 ft diameter metal plate hinged to the top. A sign identifies the location and is labeled **UE12-N.13 CEMENTED BACK TO SURFACE**.

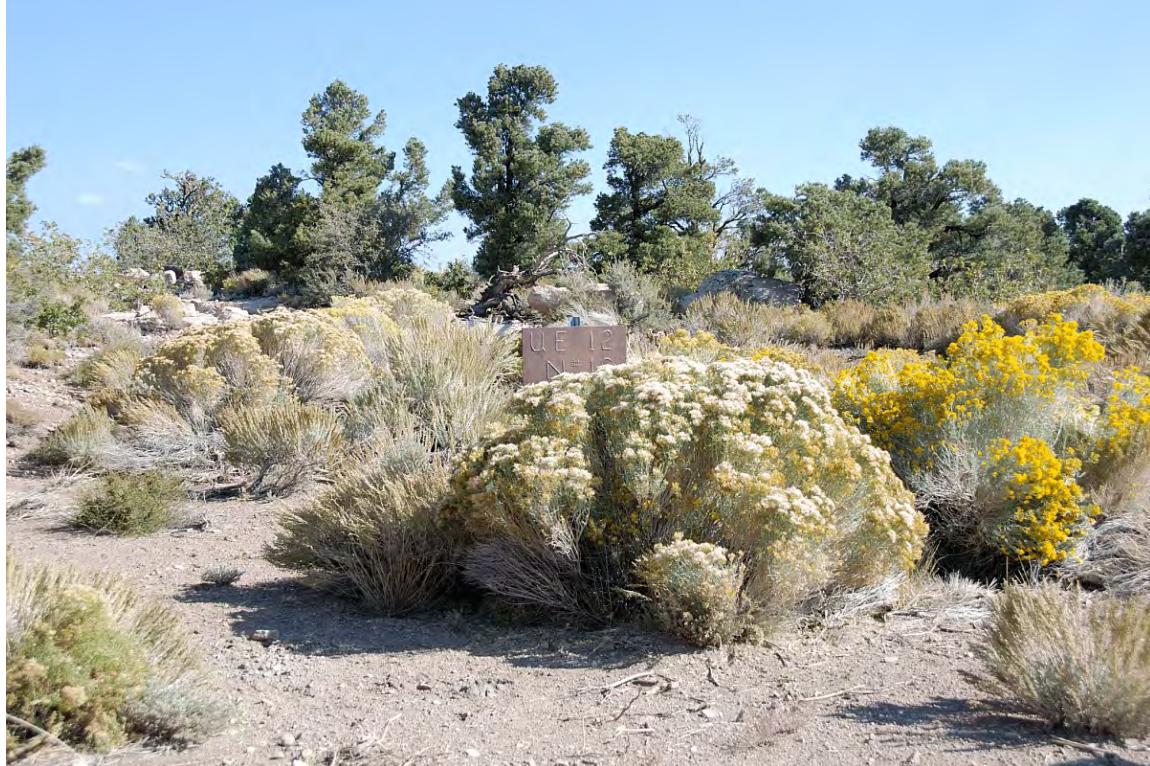
Figure 305. Plan map and photograph of Feature 138, UE-12n #16 exploratory drill hole, U12n Tunnel, view northeast (2008).

Feature 138 (Figure 305) is the UE-12n #16 exploratory drill hole at UTM coordinates 569421 E, 4117506 N, at elevation 7,527 ft (2,294.2 m), and drilled to a depth of 1,086 ft (331 m) (Bennett 1991). It is on the east end of a dirt pad that is 120 ft (34.2 m) east-west by 31 ft (9.4 m) north -south and encompasses 0.08 acres (0.03 hectares). The drill hole consists of 6-inch casing that extends 3 ft 5 inches (1.04 m) above the surface and is capped with welded metal plate. Associated artifacts are wood fragments and insulated wire.

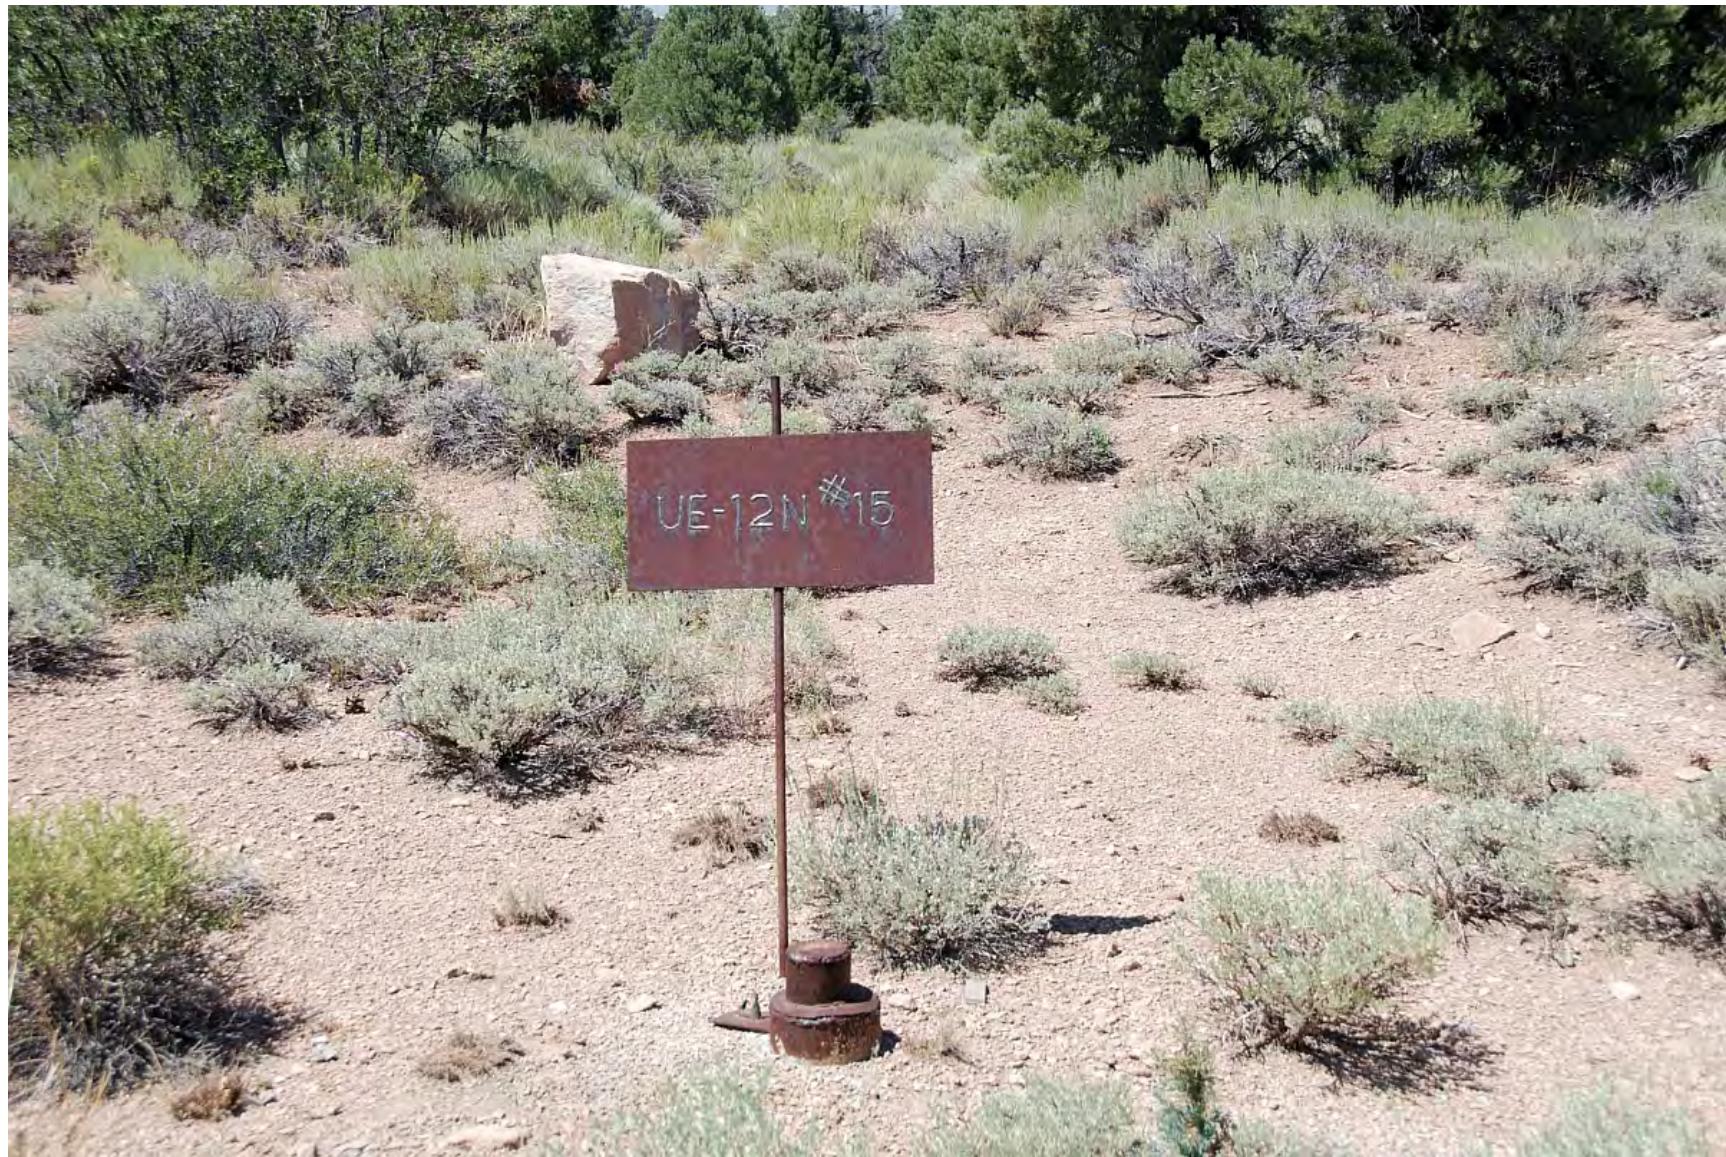
Figure 307. Feature 139, UE-12n #15 exploratory drill hole, U12n Tunnel, view northwest (2008).

Feature 139 (Figures 306 and 307) is the UE-12n #15 exploratory drill hole at UTM coordinates 569702 E, 4117958 N, at an elevation of 7,371 ft (2,2436.7 m), and drilled to a depth of 585 ft (178 m) (Bennett 1991). It is on an irregular-shaped dirt storage pad that is 675 ft (205.7 m) east-west and 165 ft (50.3 m) north-south and encompasses 1.7 acres (0.7 hectares). The pad is labeled Storage Pad

on the JS-12-U12n.19-C1 engineering drawing (1984). The drill hole consists of 7 5/8-inch casing 3 inches in height and capped with a welded metal plate. Extending 3 inches above the plate is a 4-inch nipple that has been sealed with a welded metal plate. Welded to the west side of the casing is a 6 x 4 inch metal plate with a brass grounding clamp. A welded metal sign identifies the drill hole. The UE-12n #15a drill hole is 6 1/2 ft (1.9 m) south of this drill hole. Associated artifacts are insulated wire and concrete fragments.

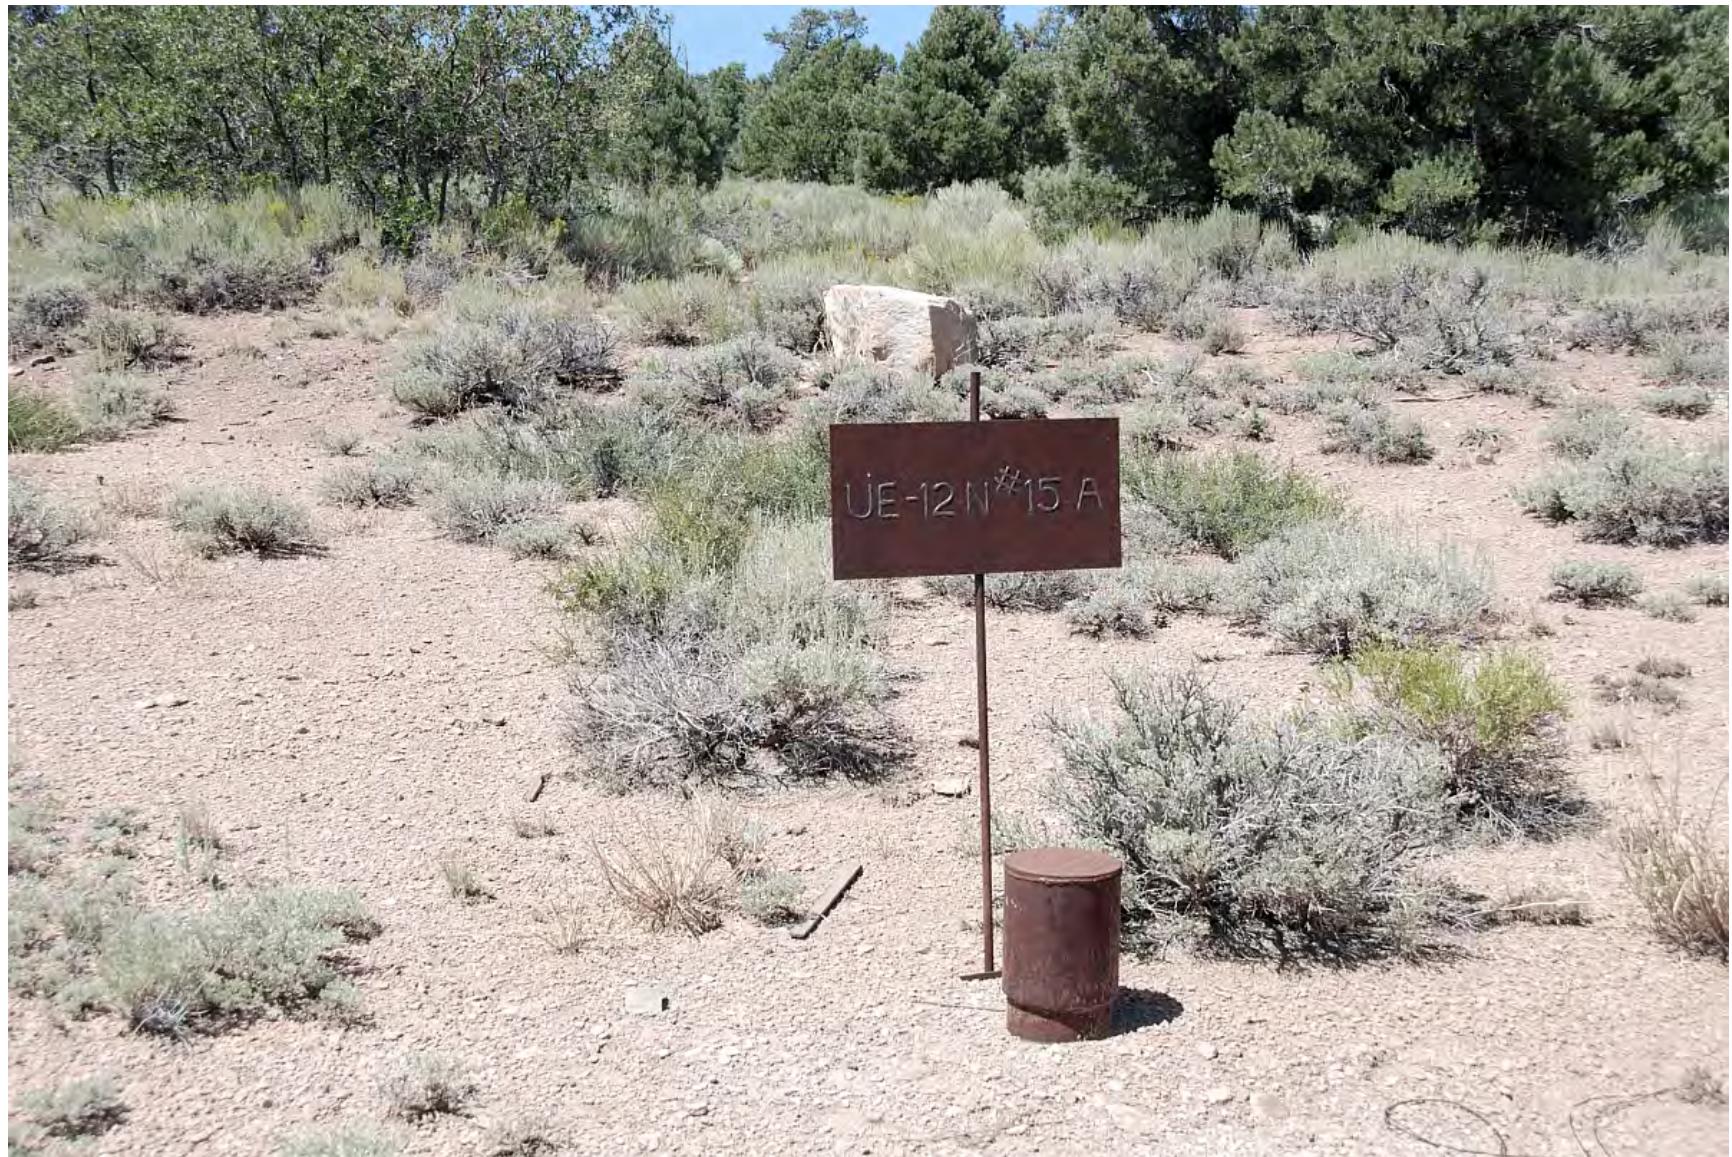
Figure 308. Feature 140, UE-12n #15a exploratory drill hole, U12n Tunnel, view northwest (2008).

Feature 140 (Figures 306 and 308) is the UE-12n #15a exploratory drill hole at UTM coordinates 569703 E, 4117954 N, at an elevation of 7,369 ft (2,246.1 m), and drilled to a depth of 1,934 ft (589 m) (Bennett 1991). It is 6 1/2 ft to the south of UE12n EX#15. The drill hole is 7 5/8-inch casing extending 3 inches above the surface. Screwed to the top of the casing is a 9 inch long collar that has been sealed with a welded metal plate. A welded metal sign identifies the drill hole. Associated artifacts are insulated wire and concrete fragments.

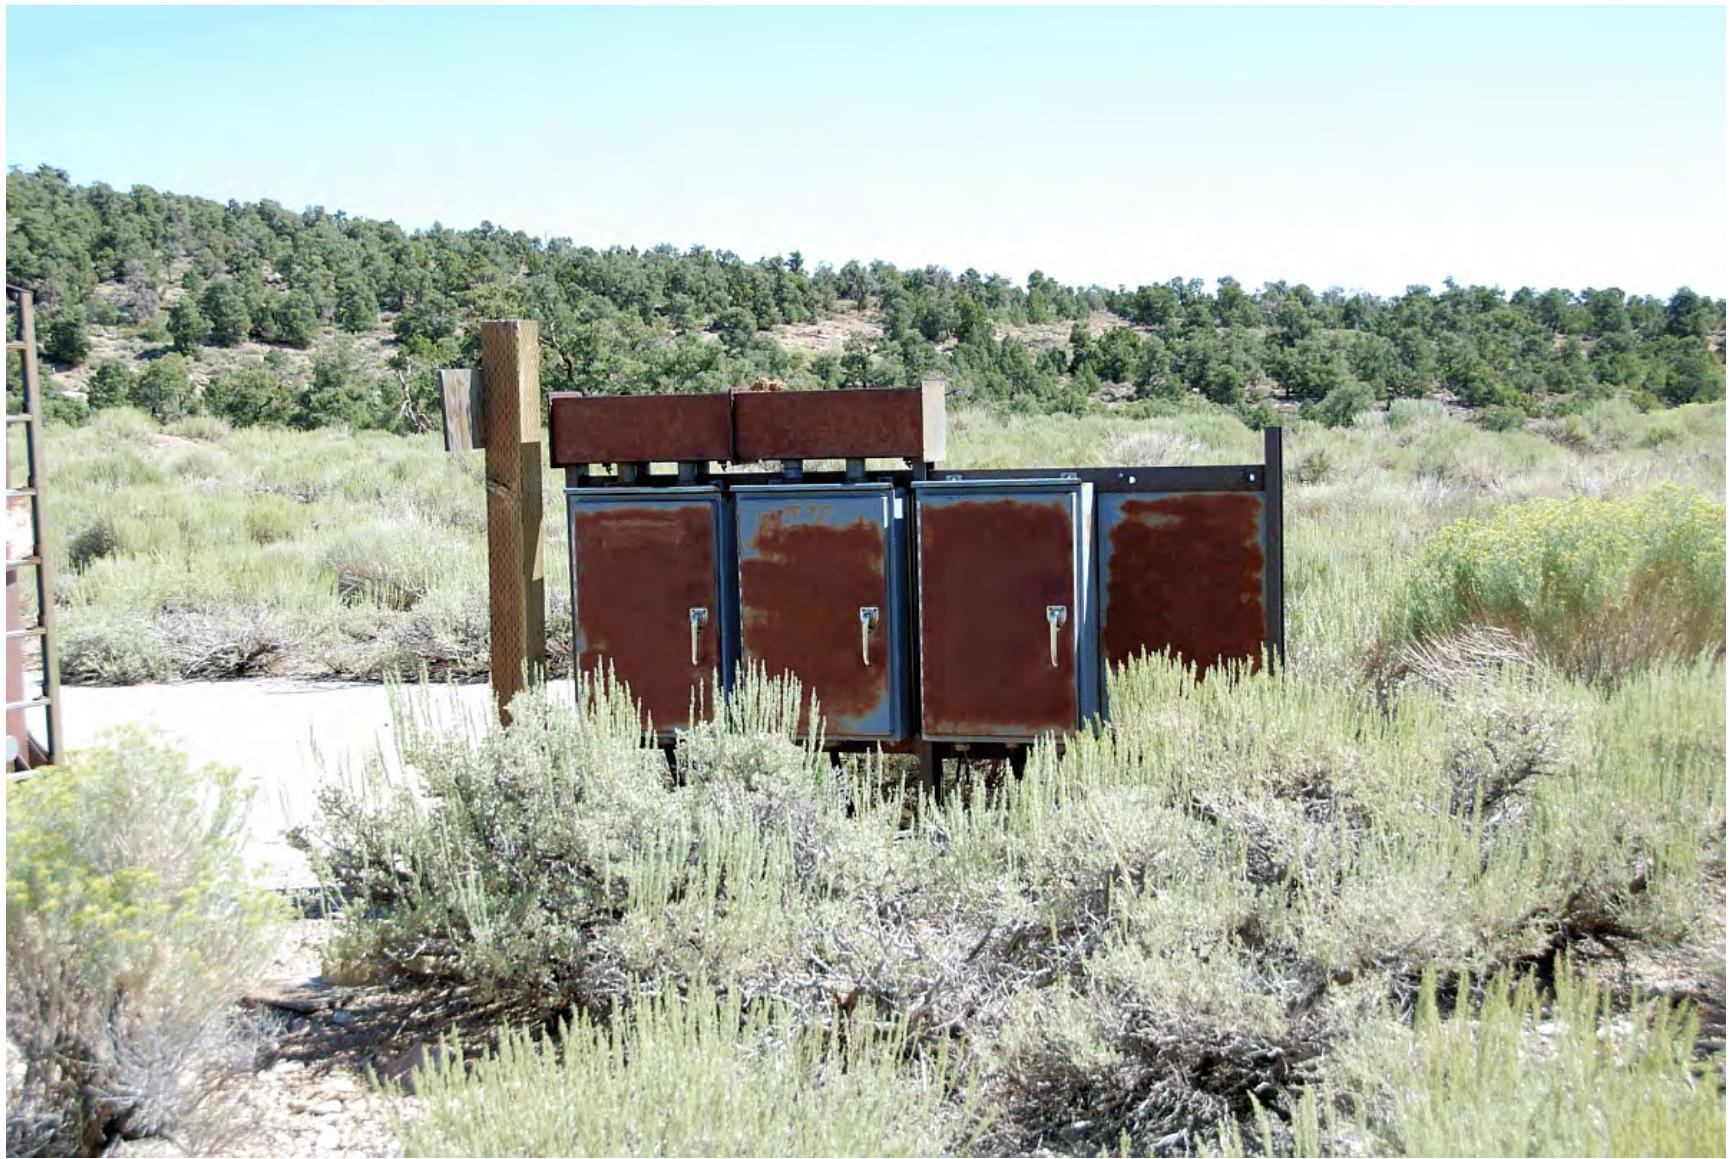
Figure 311. Feature 142, electrical panel backboard at U12n.10 CH, U12n Tunnel, view northeast (2008).

Feature 142 (Figures 309 and 311) is an electrical panel backboard at UTM coordinates 569854 E, 4118005 N. The backboard is constructed of 3-inch channel iron and is 7 ft 6 inches north-south by 5 ft in height. Eight 2 ft 6 inch x 1 ft 8 inch x 6 inch electrical panel boxes are mounted to the backboard, four on the east and four on the west sides. At the north end of the backboard is a 4 x 4 inch milled lumber post 6 ft in height. Nailed to the north side of the post is a blank sign board.

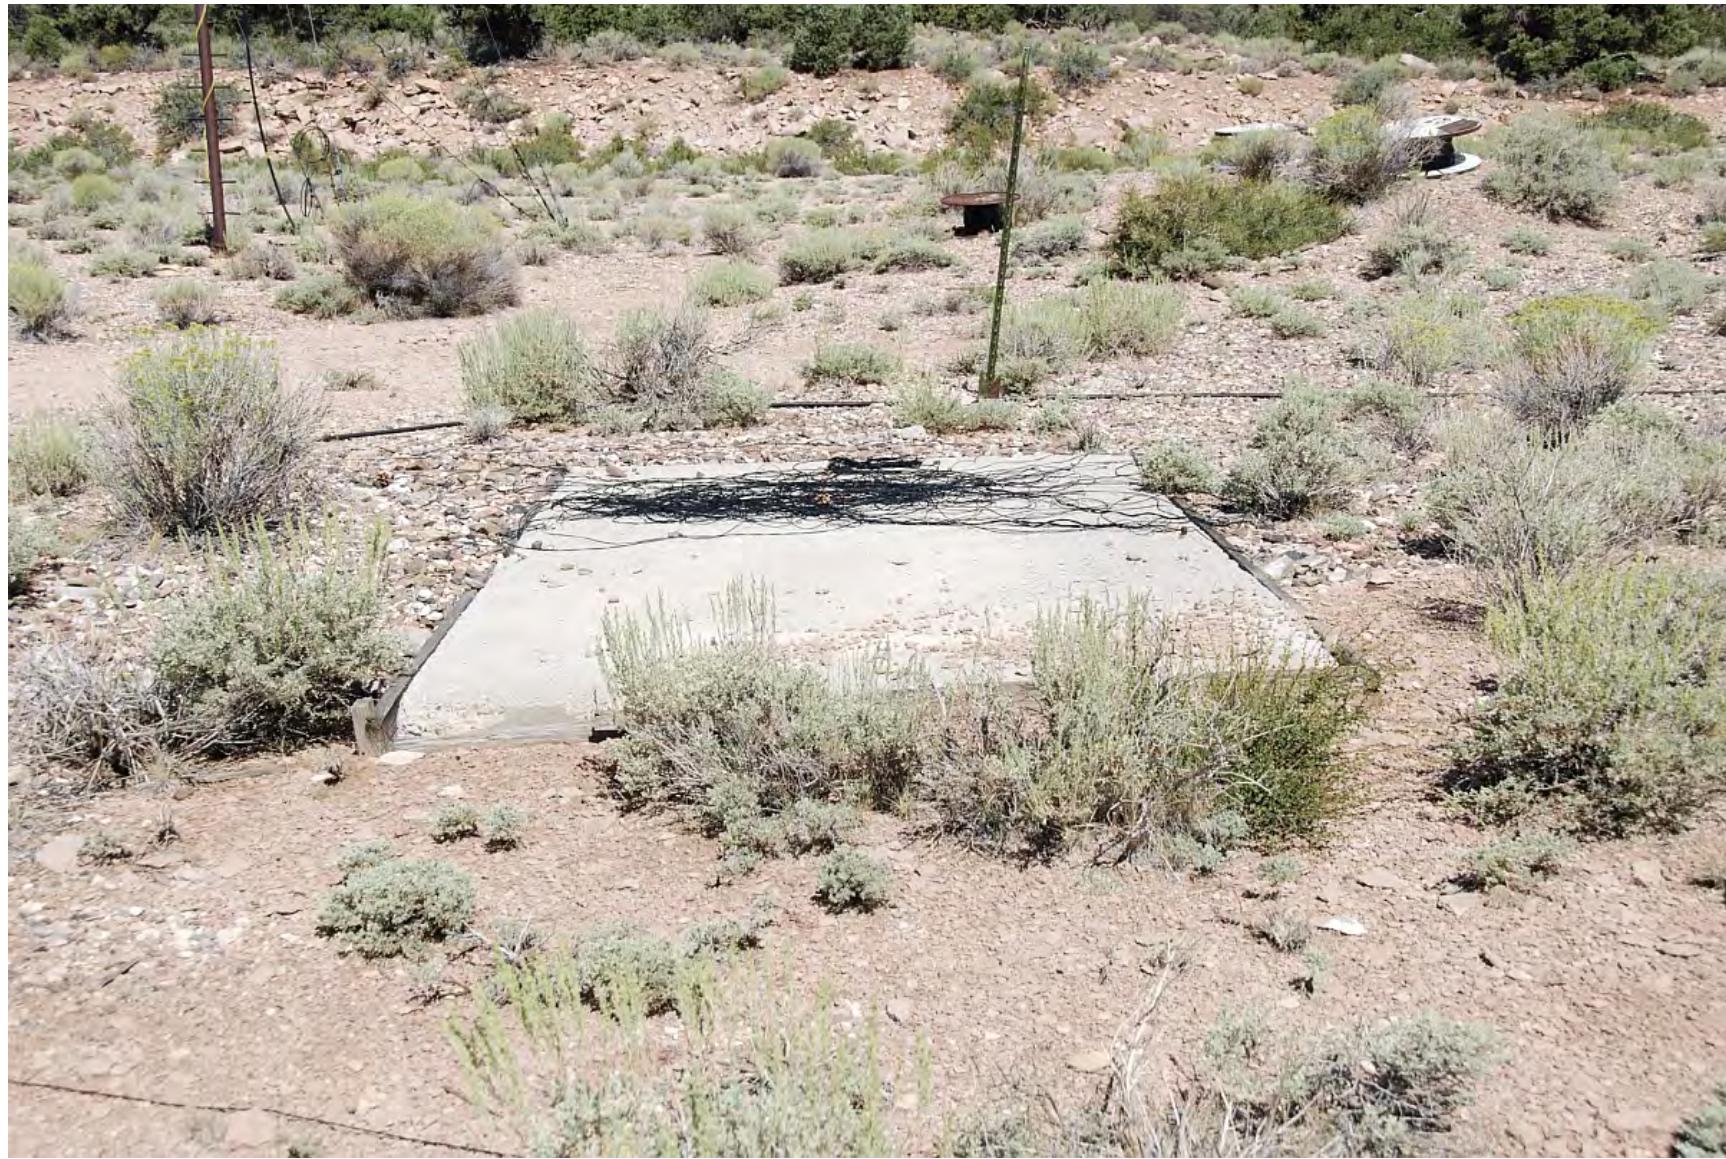
Figure 317. Feature 148, concrete pad at the U-12n.10A Structure CH, U12n Tunnel, view north (2008).

Feature 148 (Figures 309 and 317) is a concrete pad at UTM coordinates 569839 E, 4117980 N. The concrete pad is 13 ft north-south by 7 ft east-west. The concrete has not been smoothed or brushed but left rough and 2 x 4 inch milled lumber used for forming the pad are still present on all sides. Associated artifacts are insulated wire and wood fragments.

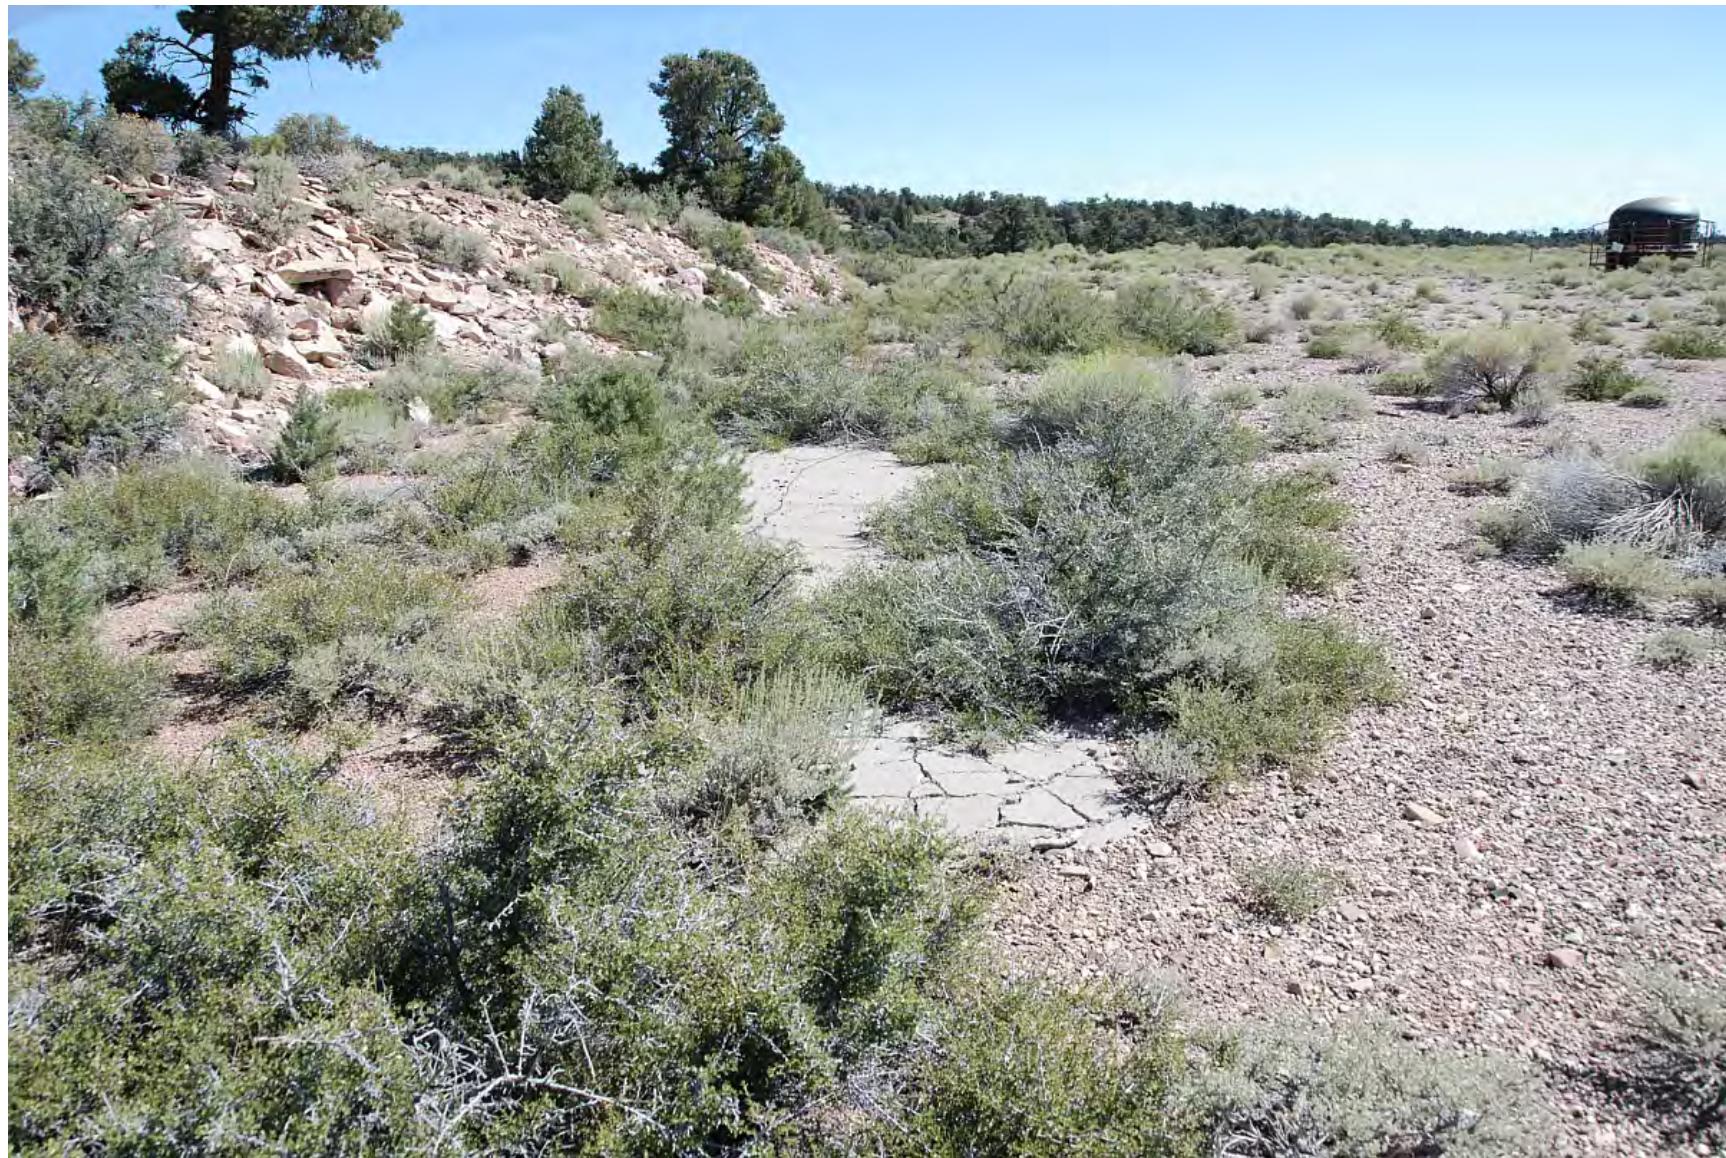
Figure 321. Feature 152, concrete pad at the U-12n.10A Structure CH, U12n Tunnel, view east (2008).

Feature 152 (Figures 309 and 321) is a concrete pad at UTM coordinates 569796 E, 4118008 N. The concrete pad is 24 ft long (east-west), 9 ft wide at the east end, and 5 ft wide at the west end. The pad is approximately 2 inches thick, exhibits no evidence of being constructed with forms, and is now highly deteriorated.

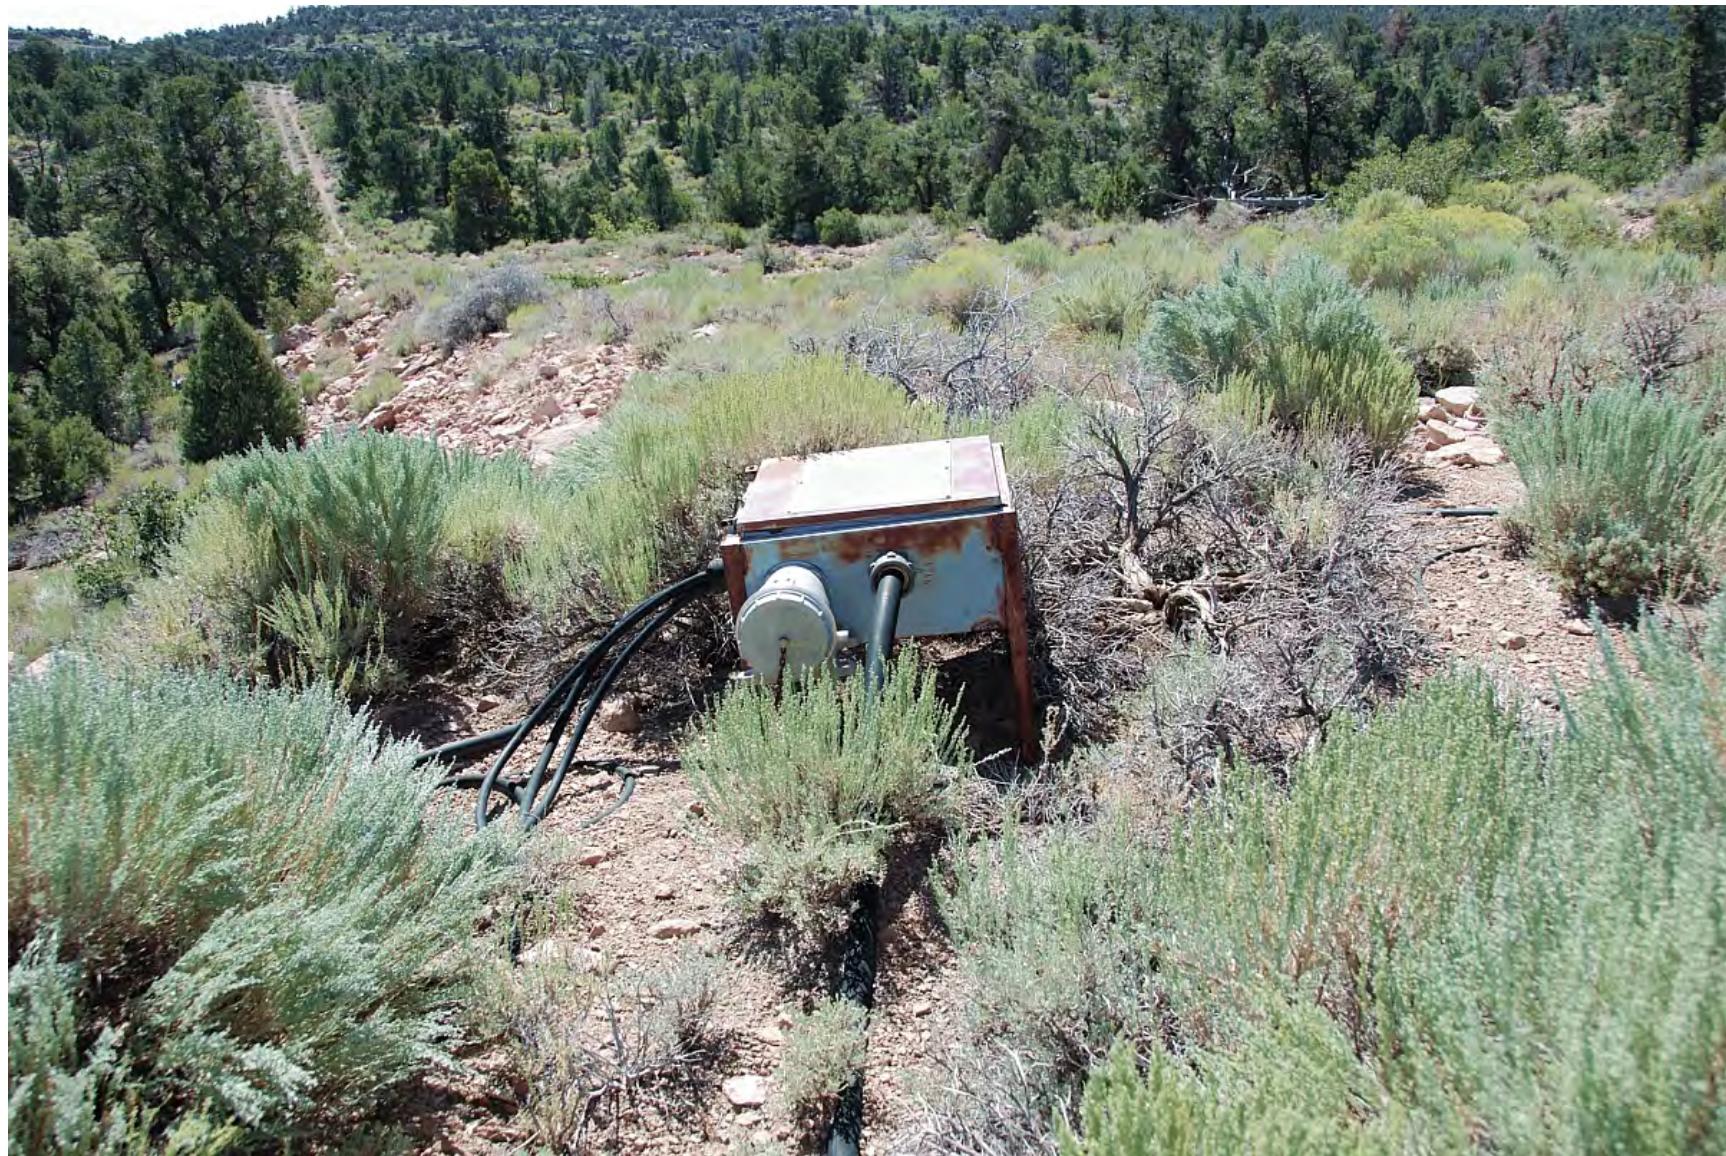
Figure 323. Feature 154, electrical junction box at the U-12n.10A Structure CH, U12n Tunnel, view southwest (2008).

Feature 154 (Figures 309 and 323) is an electrical junction box at UTM coordinates 569894 E, 4118002 N. The box is 2 x 2 x 1 ft and is lying horizontally to the surface and supported by 1 1/2-inch angle iron legs 2 ft in height. Insulated cables enter the box through the east and south sides.

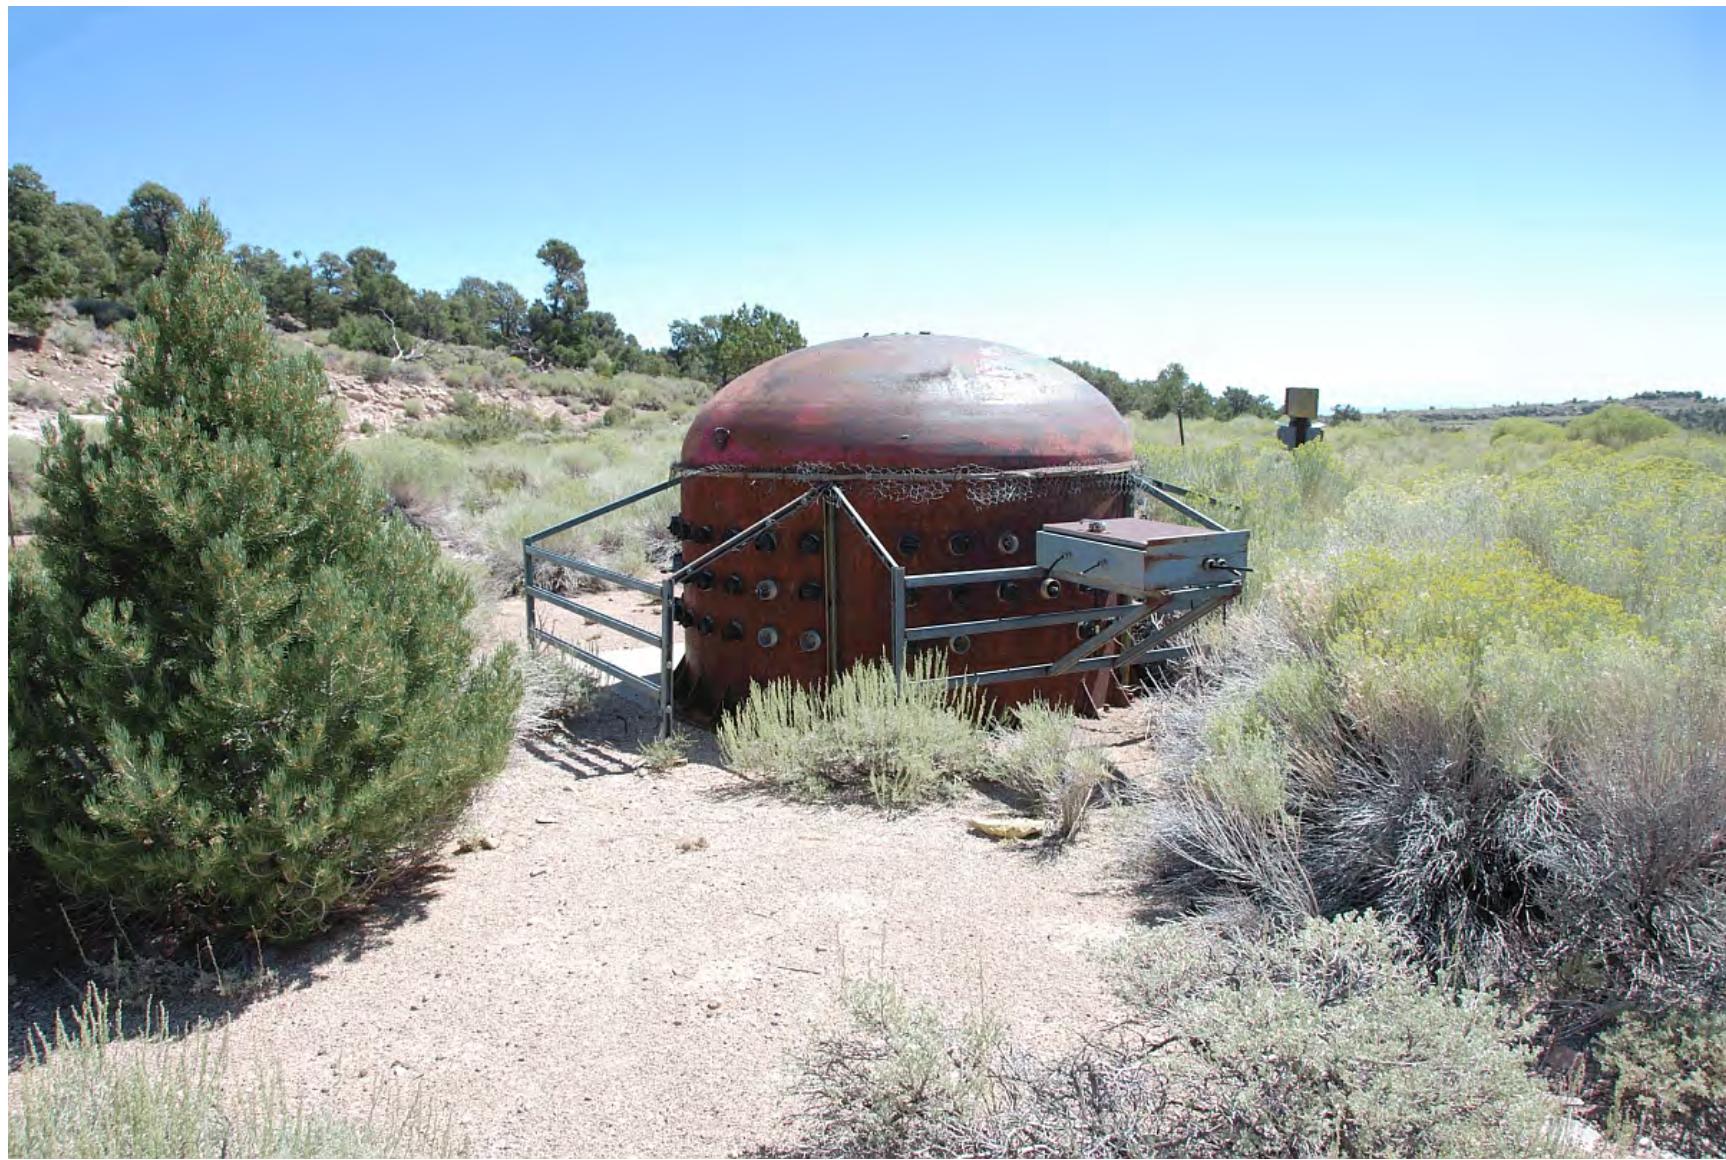
Figure 328. Feature 158, U-12n.10A EMP CH, U12n Tunnel, view northeast (2008).

Feature 158 (Figures 327 and 328) is the U-12n.10a EMP CH cable hole at UTM coordinates 569914 E, 4118215 N, at an elevation of 7,384 ft (2,250.6 m), and drilled to a depth of 1,330 ft (405 m) (Bennett 1991). The drill hole is on a dirt and gravel pad that is 390 ft (118.9 m) north-south by 330 ft east-west and encompasses 2 acres (0.8 hectares). Features 158-168 are on or near the dirt pad. The U12n.10A EMP CH consists of a 12 x 12 ft concrete pad and 9 ft diameter metal dome structure. The dome was designed to be gas tight to contain any radioactive gas that could potentially follow any of the 72 cables from the tunnel to the surface during the test. The dome, 7 ft in height, is centered on the pad and secured to the concrete with 1 1/4-inch bolts spaced 1 ft apart around the perimeter of the dome's flanged base. Welded to the side of the dome in three rectangular patterns are 3-inch nipples spaced 6 inches on center right to left and 3 inches on center top to bottom. There are 32 nipples on the south side, 16 on the west, 24 nipples on the north. The nipples provide both protection and access to the cable gas blocked connectors attached to the end of each instrument cable. A galvanized metal rack is 2 ft from the side of the dome at each set of nipples. The racks are constructed of 1 1/2-inch galvanized channel iron (Unistrut) and are 6 ft wide and 3 ft 4 inches in height. The top of the rack is diagonally braced to a rim that extends around the top side of the dome. On the west side is a locked 2 ft 6 inch x 1 ft 8 inch x 8 inch electrical panel mounted horizontally to the top of the galvanized rack. Chicken wire is attached at several places to the rim on the dome. Associated artifacts on the pad are insulated cable and wire, cans, wood and rubber fragments, bolts, metal plates, chicken and barbed wire, plastic, canvas, I-beam, and a galvanized bucket and trash.

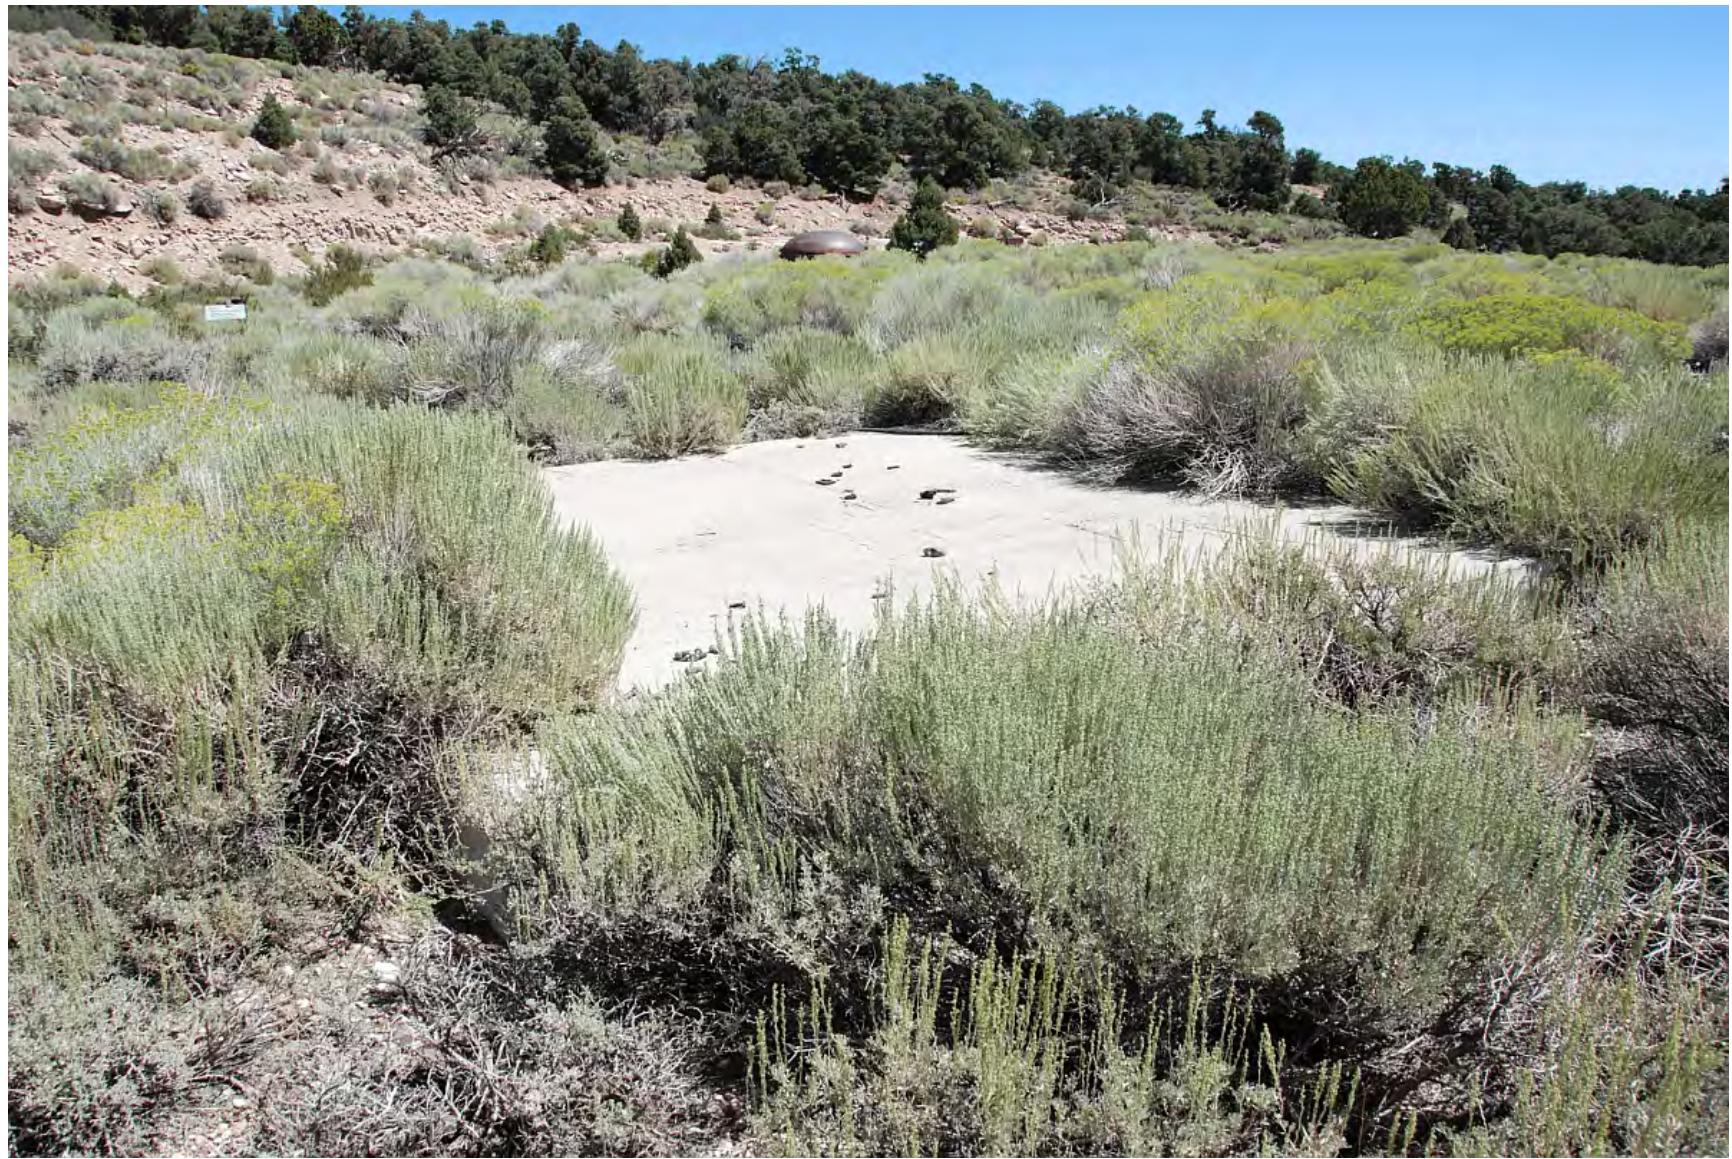
Figure 335. Feature 165, concrete pad a the U-12n.10A EMP CH, U12n Tunnel, view northeast (2008).

Feature 165 (Figures 327 and 335) is a concrete pad at UTM coordinates 569886 E, 4118201 N. The pad is 16 x 16 ft, 1 ft thick, and has a rough surface. Along the south and west edges, 1 1/2-inch bolts have been cut flush with the surface.
