A total of 202 features were recorded, mapped, and photographed for the U12n Tunnel complex. The project area encompassed 600.8 acres (243.1 hectares) at the portal and mesa areas. At the U12n portal area are ten sub-areas containing features related to the construction, testing, and general everyday activities within the tunnel. These include concrete foundations for buildings, communications equipment, mining equipment, rail lines, retention ponds, storage containers, and access control facilities. Only a telephone trailer remains on the telephone pad as all of the other buildings have been removed from the portal area. The microwave tower, portions of the rail lines, the muck car dump, rotary dump, and wash rack are still in place. Also, the traffic control point and powder magazines along N Tunnel Road are intact. At the mesa area are four sub-areas containing features generally related to pre- and post-shot drilling, recording facilities, and ventilation equipment. These include concrete foundations, instrument cable holes, and drill holes. The concrete foundations were for buildings and small equipment. Concrete pads and various equipment remain at the cable hole locations bu

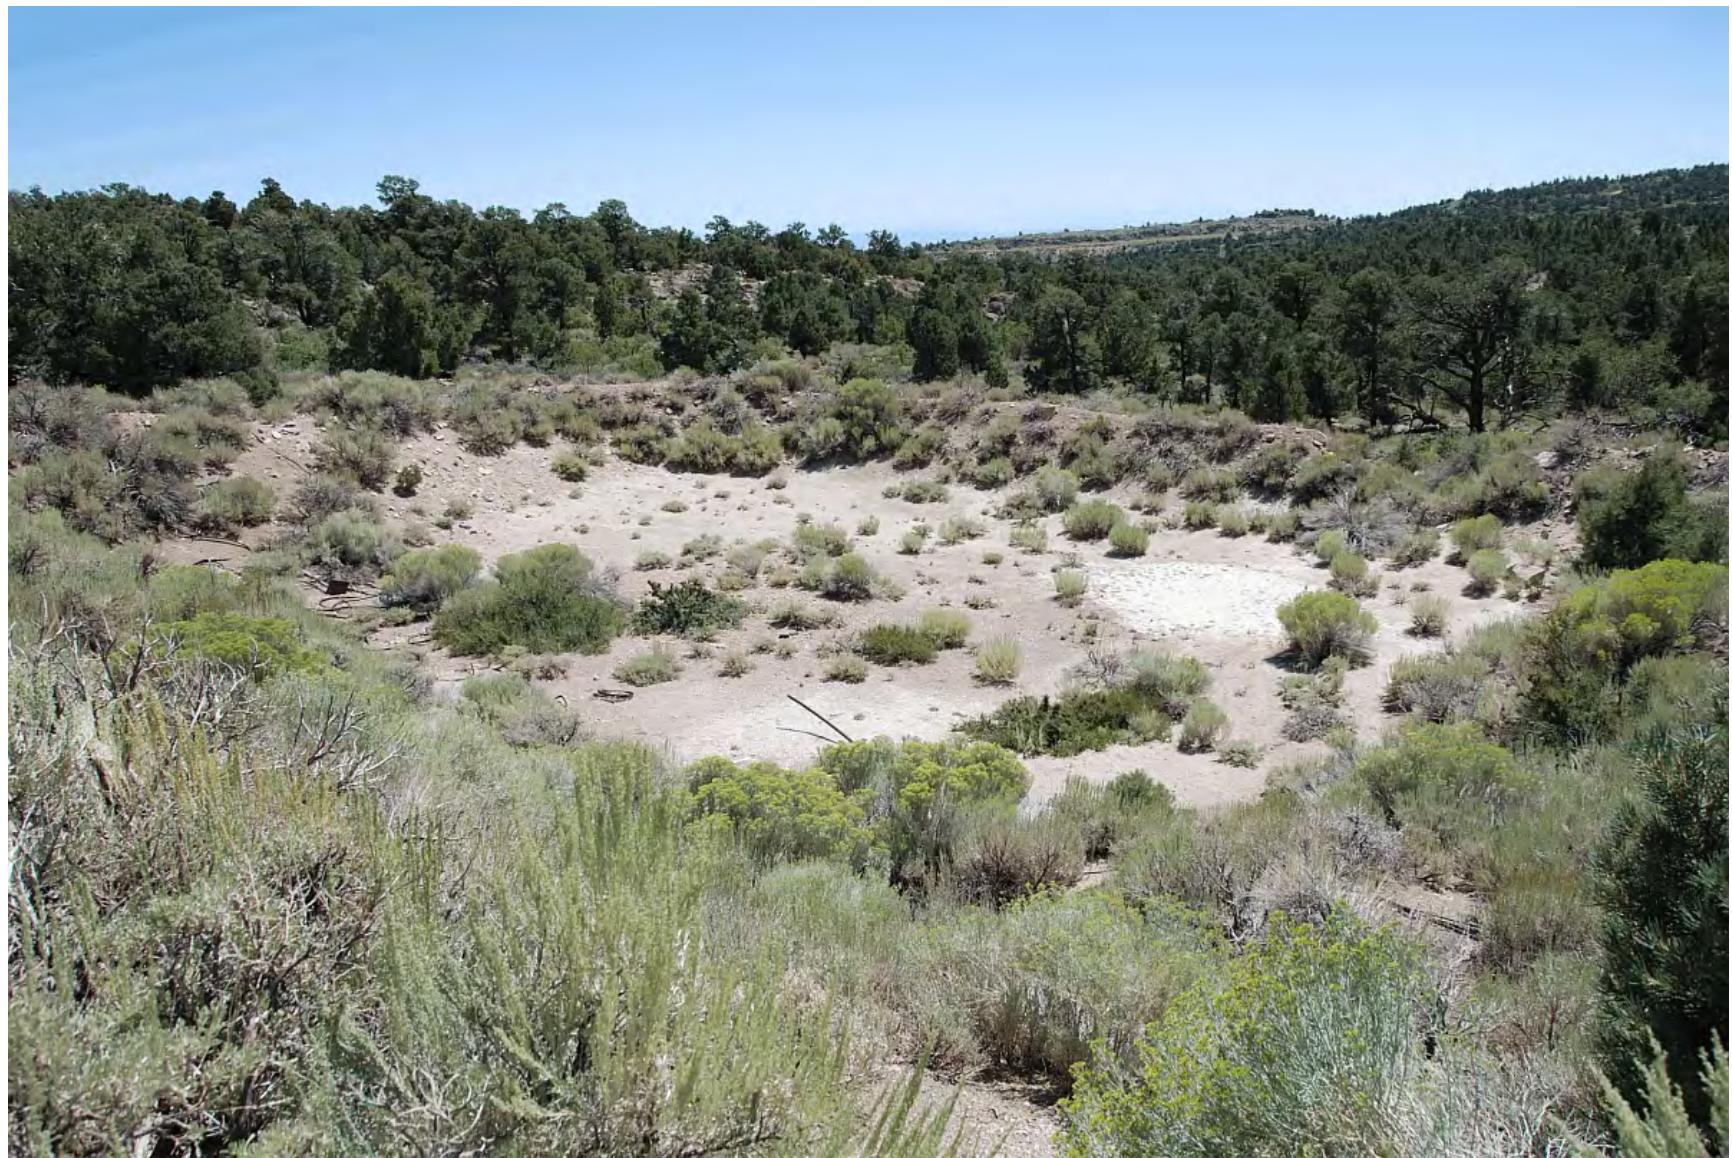
Figure 338. Feature 168, drilling mud pit for the U-12n.10A EMP CH, U12n Tunnel, view southeast (2008).

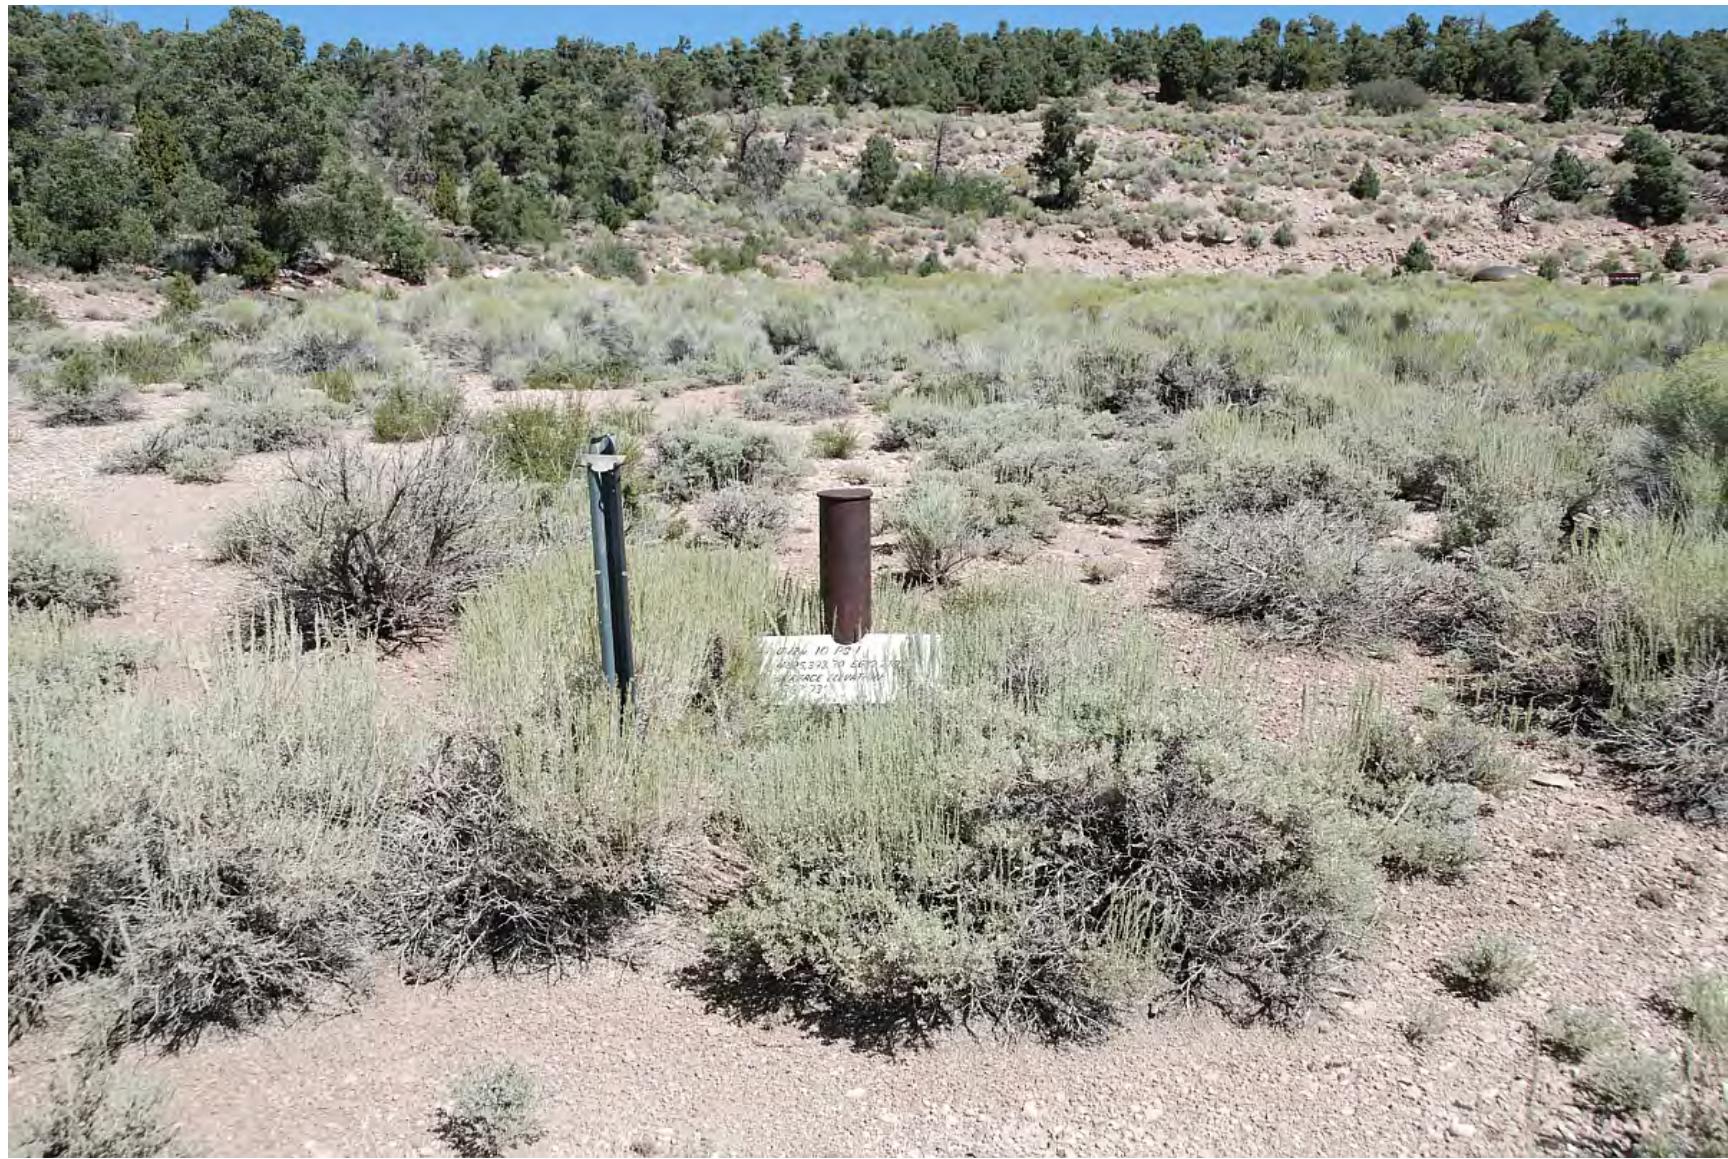
Figure 339. Feature 169, U-12n.10 PS #1 postshot drill hole, U12n Tunnel, view north (2008).

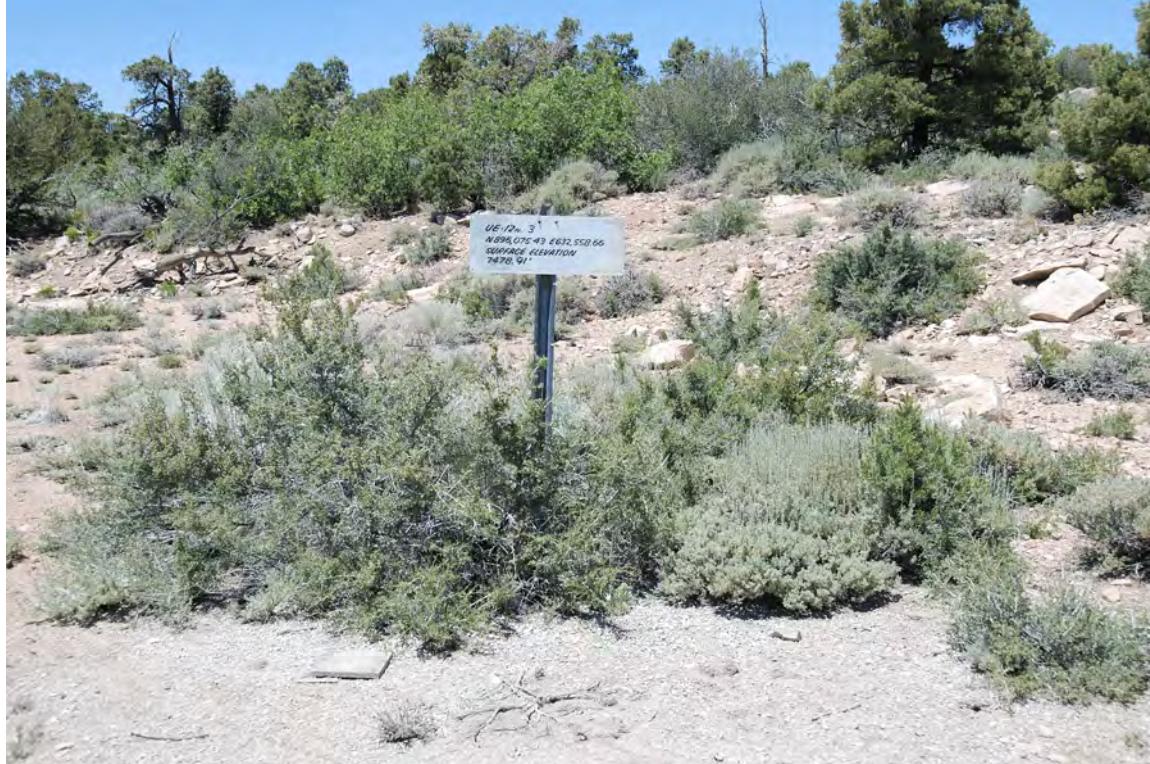
Figure 340. Plan map of Feature 170, UE-12n #3 exploratory drill hole, and Feature 171, antenna, and photograph of Feature 170, view northwest (2008).

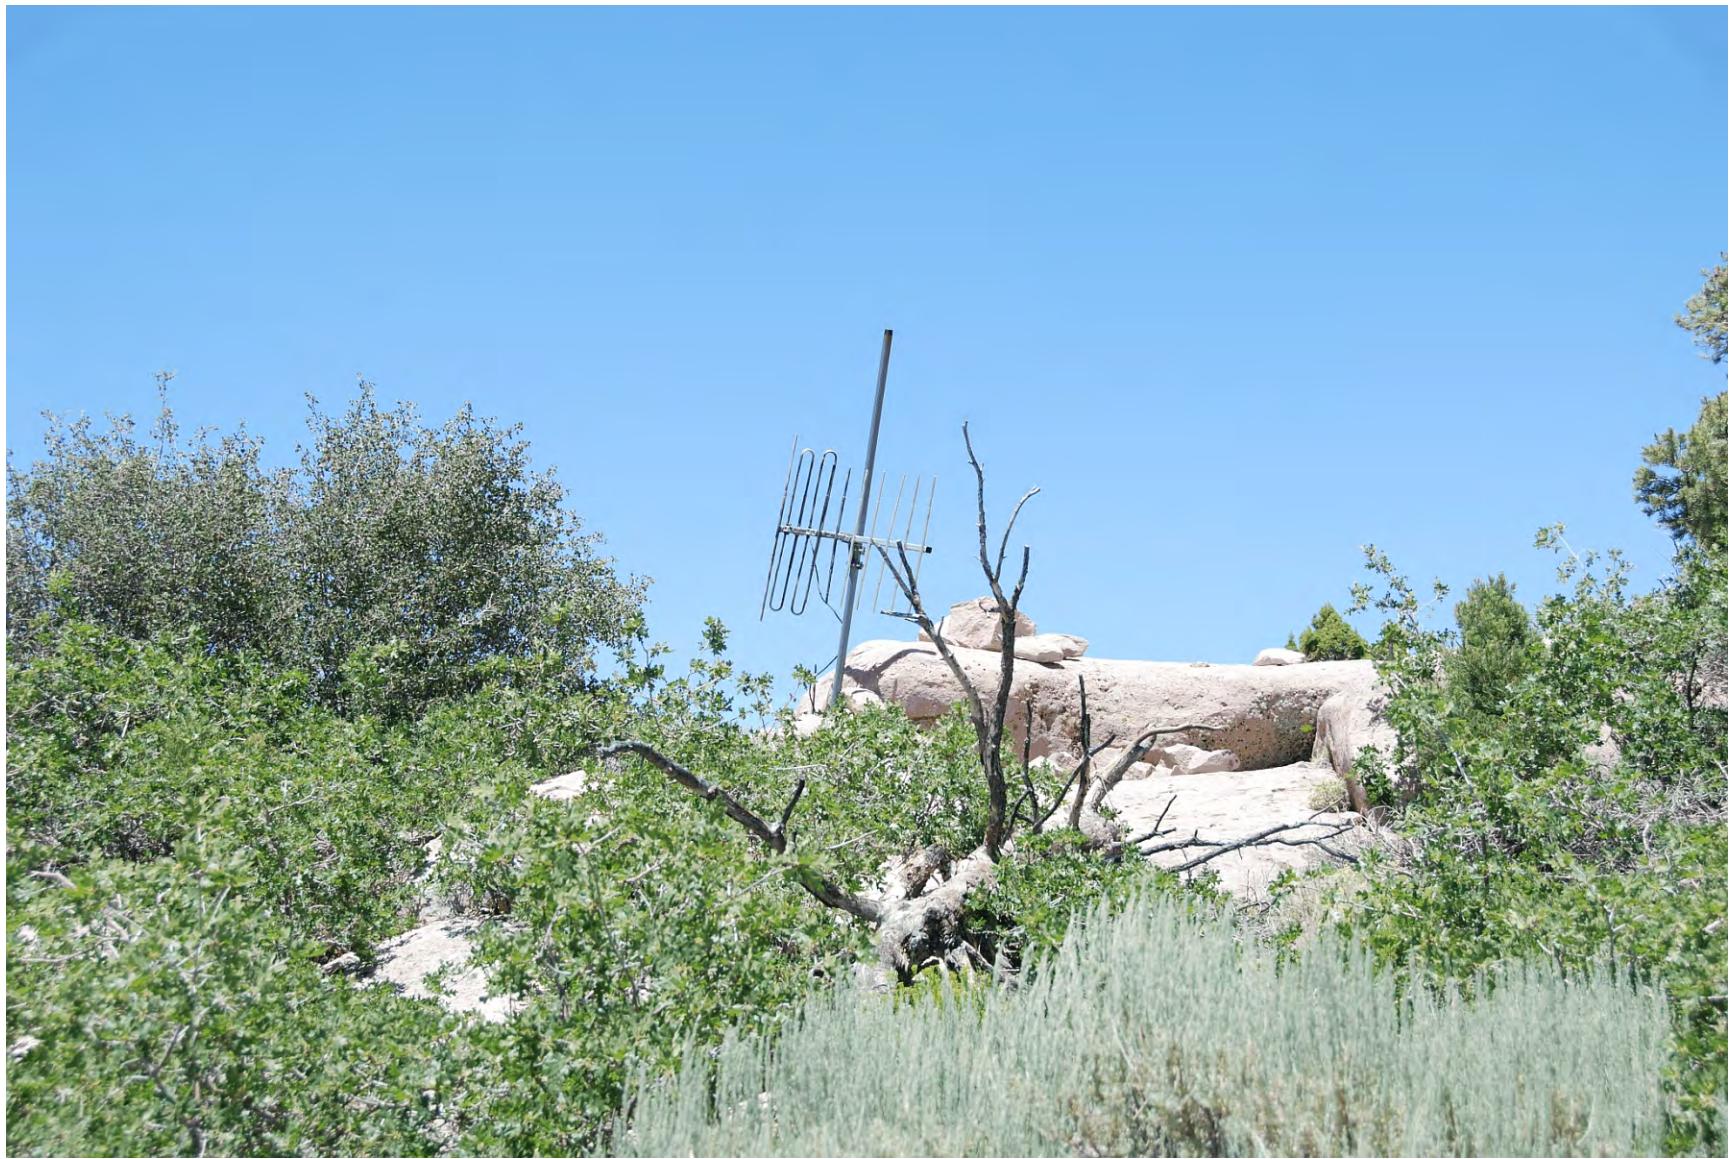
Figure 341. Feature 171, antenna, U12n Tunnel, view northeast (2008).

ft to a 1 1/2-inch galvanized pipe that is 6 ft in height. The pipe is supported by a 1 ft 2 inch triangular metal base attached to the exposed bedrock.

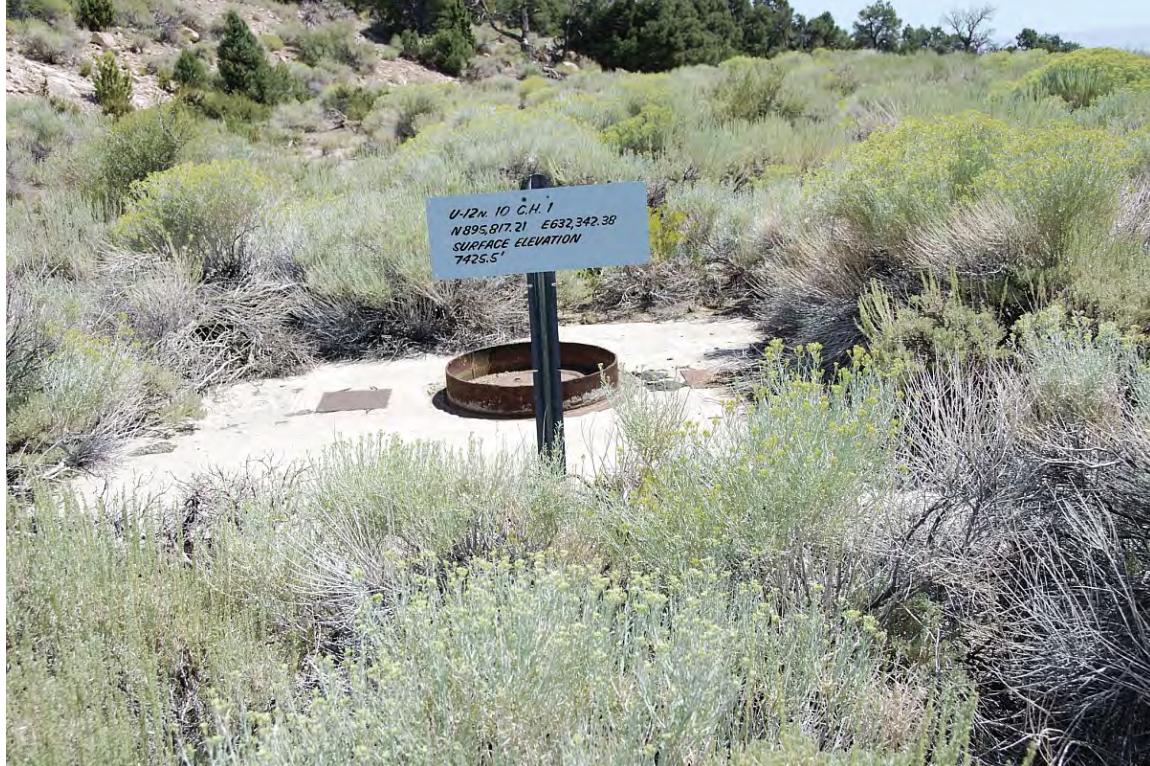
Figure 342. Plan map of Feature 172, the U-12n.10 CH #1 cable hole dirt pad ,and location of Features 172-174, photograph of Feature 172, U12n Tunnel, view east (2008).

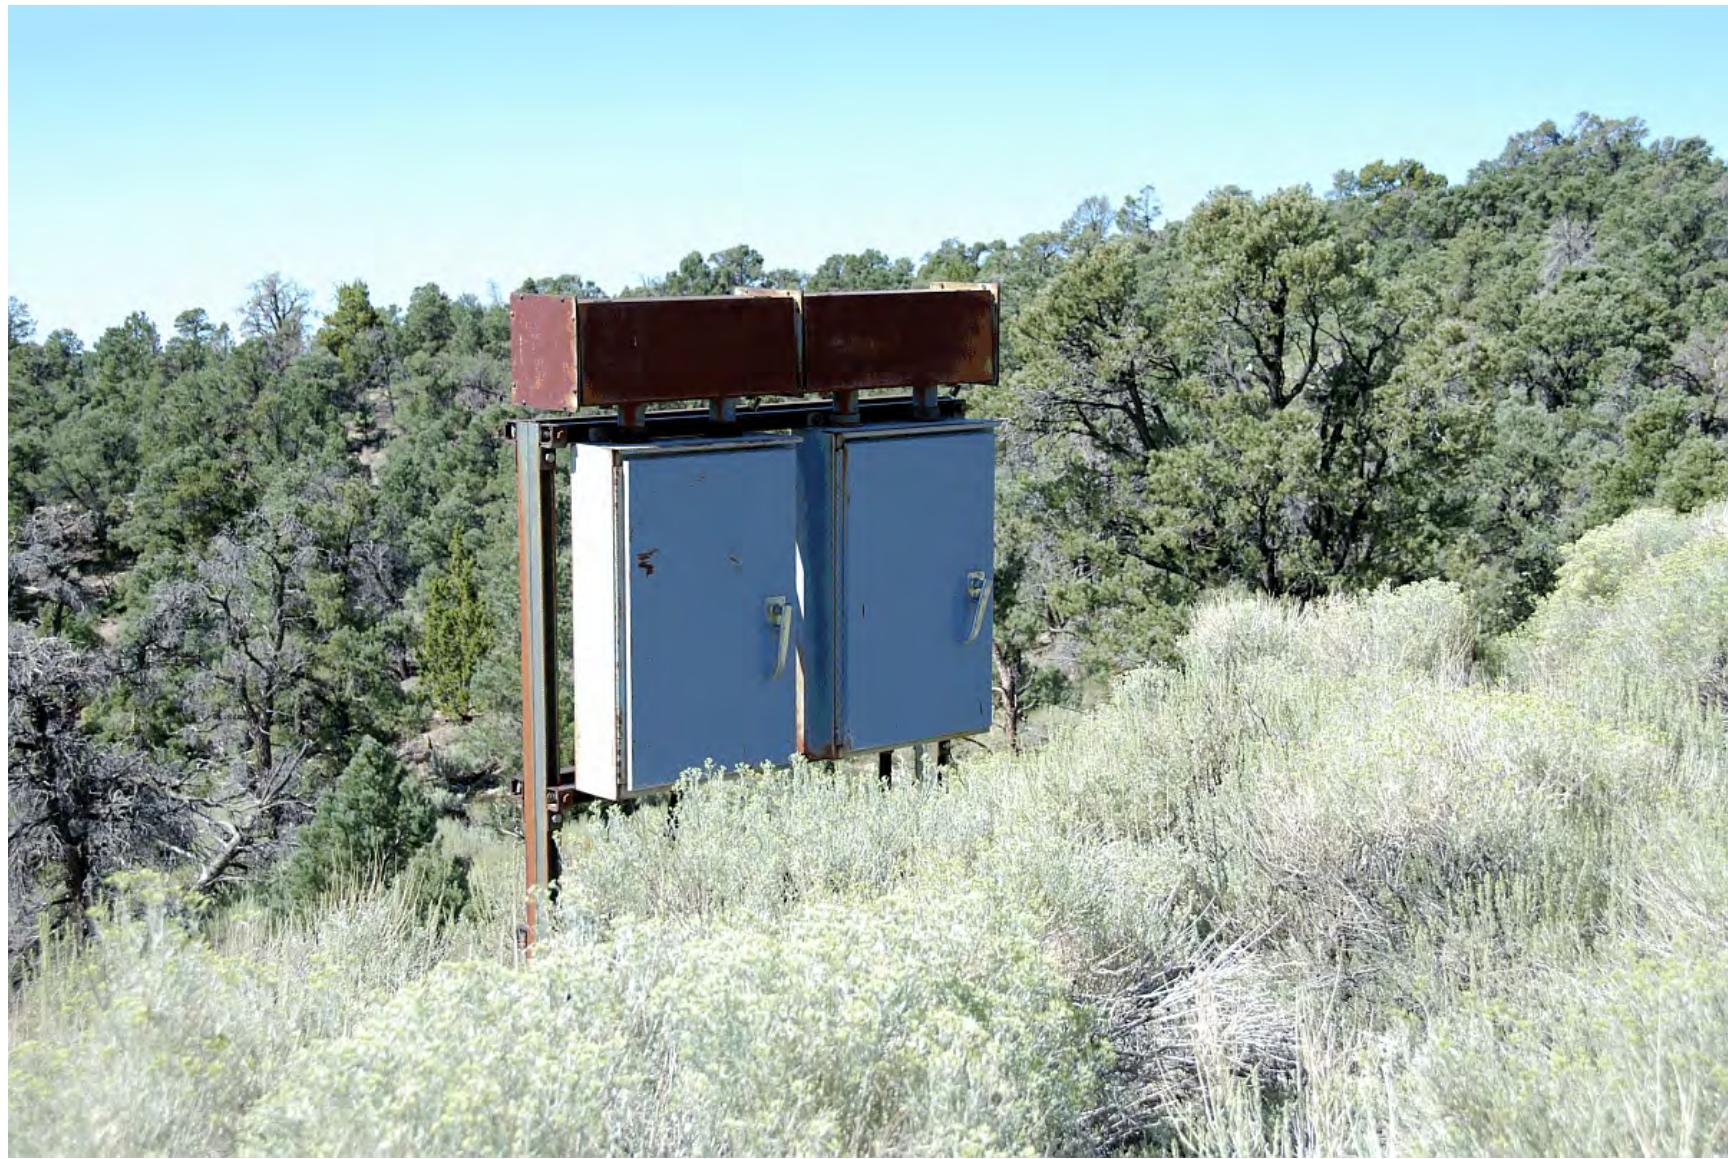
Figure 343. Feature 173, electrical panels at the U12n.10 CH#1, U12n Tunnel, view southwest (2008).

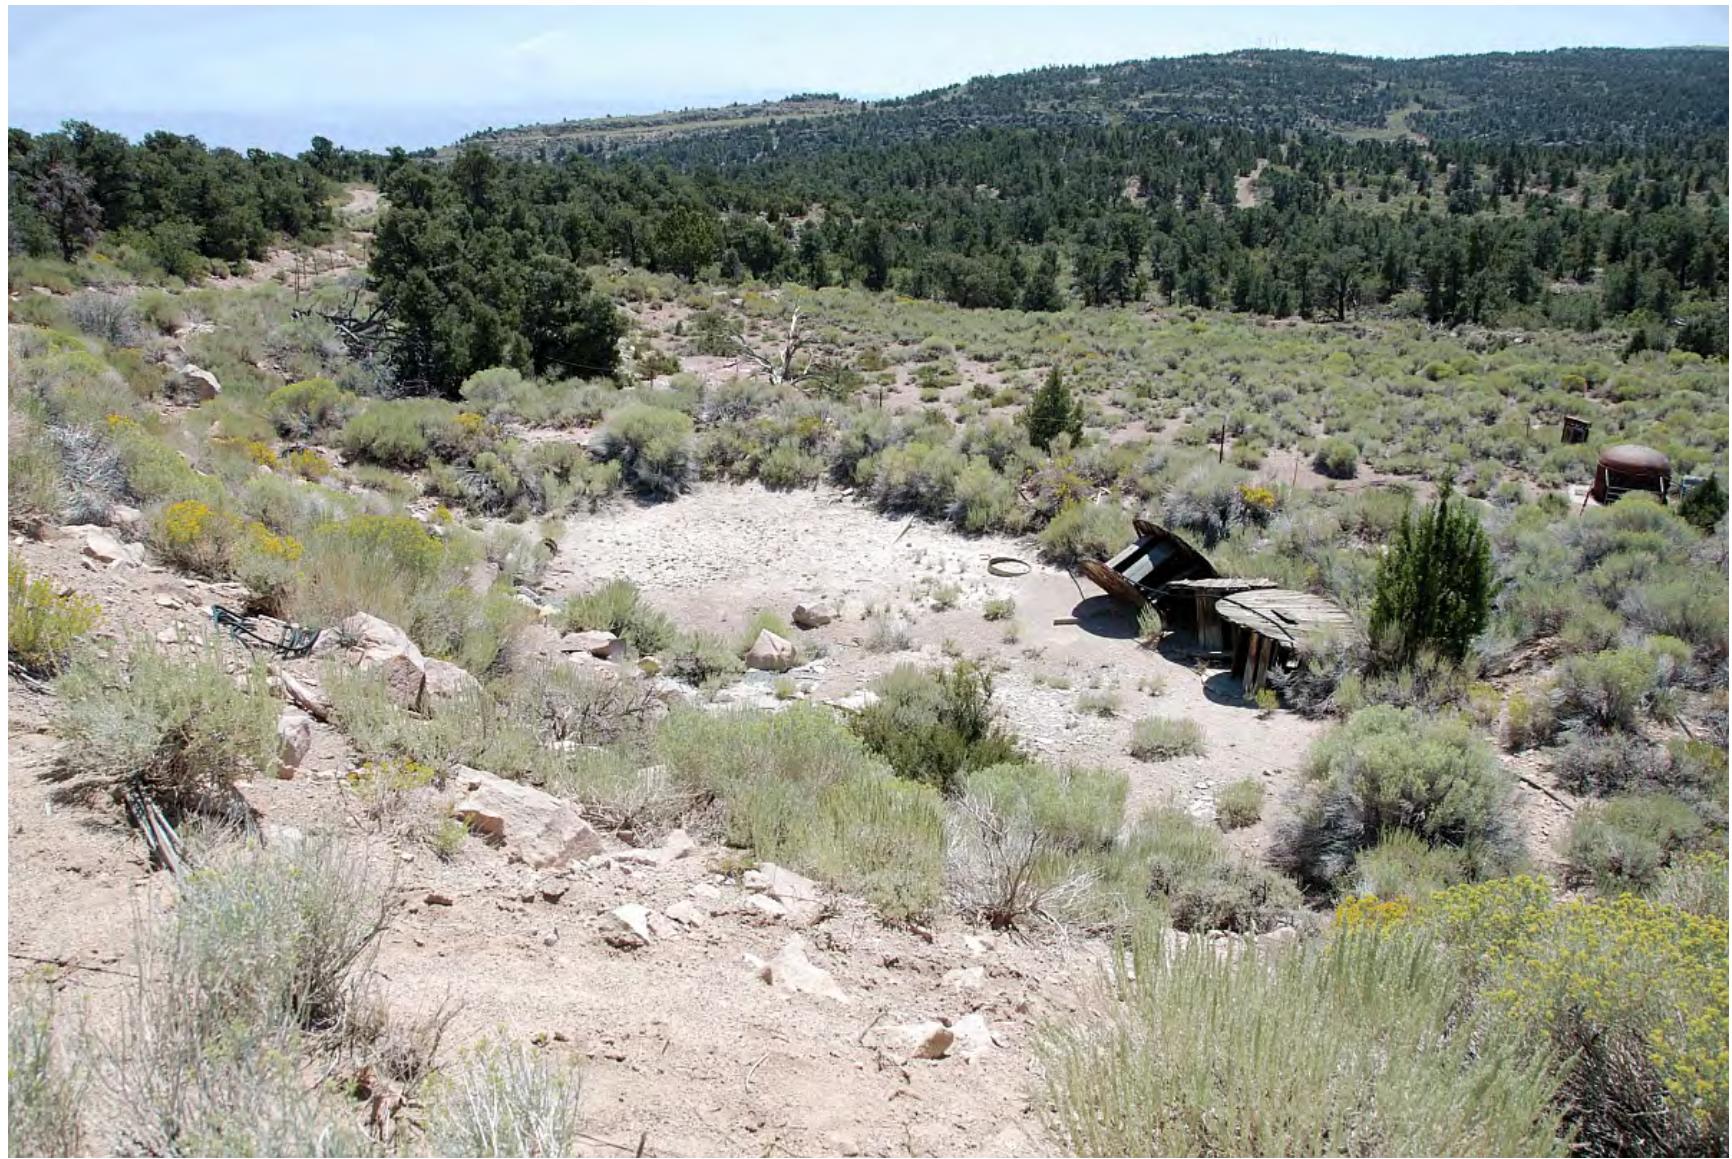
Figure 344. Feature 174, drilling mud pit for the U-12n.10 CH #1, U12n Tunnel, view southeast (2008).

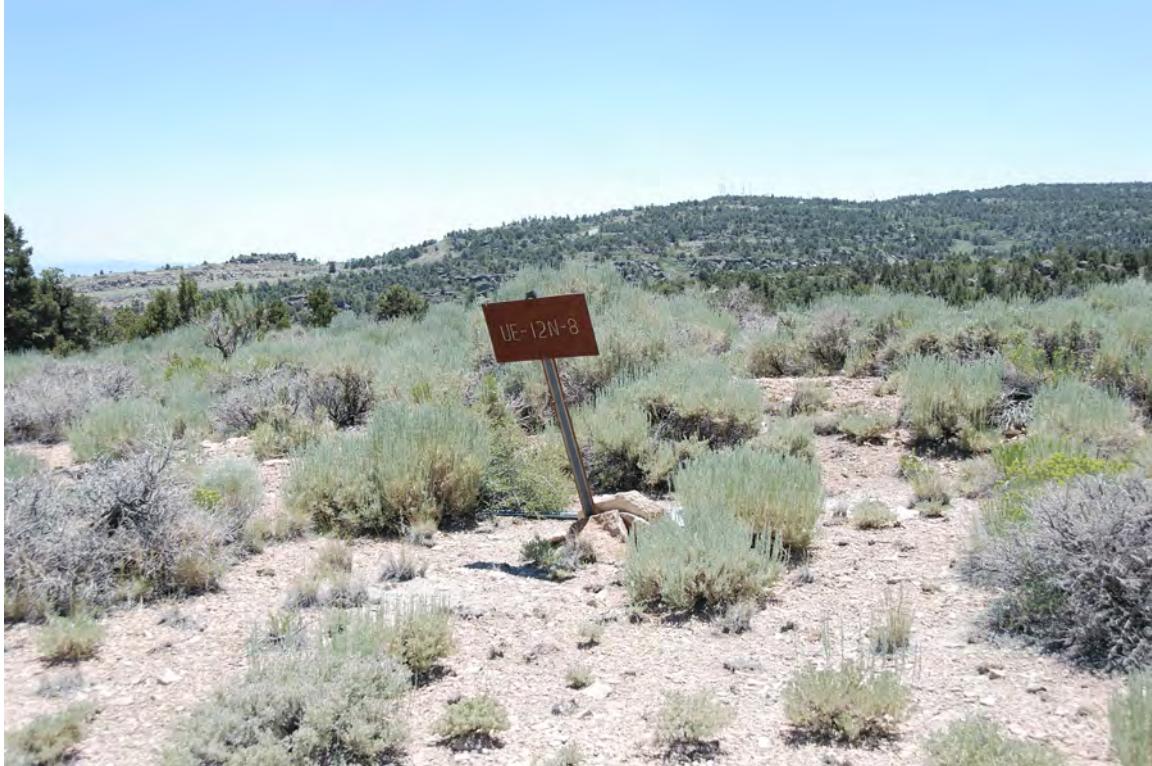
Feature 175 (Figure 345) is the UE-12n #8 exploratory drill hole at UTM coordinates 570080 E, 4118200 N, at an elevation of 7,395 ft (2,254 m), and drilled to a depth of 1,784 ft (544 m) (Bennett 1991). The drill hole is near the south edge of an irregular shaped dirt pad that is 230 ft (70.1 m) east-west by 100 ft (30.5 m) north-south, encompasses 0.38 acres (0.15 hectare), and accessed by a road that enters the pad from both the east and west ends. The drill hole consists of a piece of 6-inch diameter pipe that is 7 inches tall and is collapsed on one side roughly forming a crescent shape. The top of the pipe is sealed with a welded metal plate. A metal sign with welded lettering identifies and marks the drill hole location. Associated artifacts are communication wire, milled lumber fragments, metal fragments, various sized cable, crushed cans, and broken glass.

Figure 345. Plan map and photograph of Feature 175, UE-12n #8 exploratory drill hole, view southeast (2008).

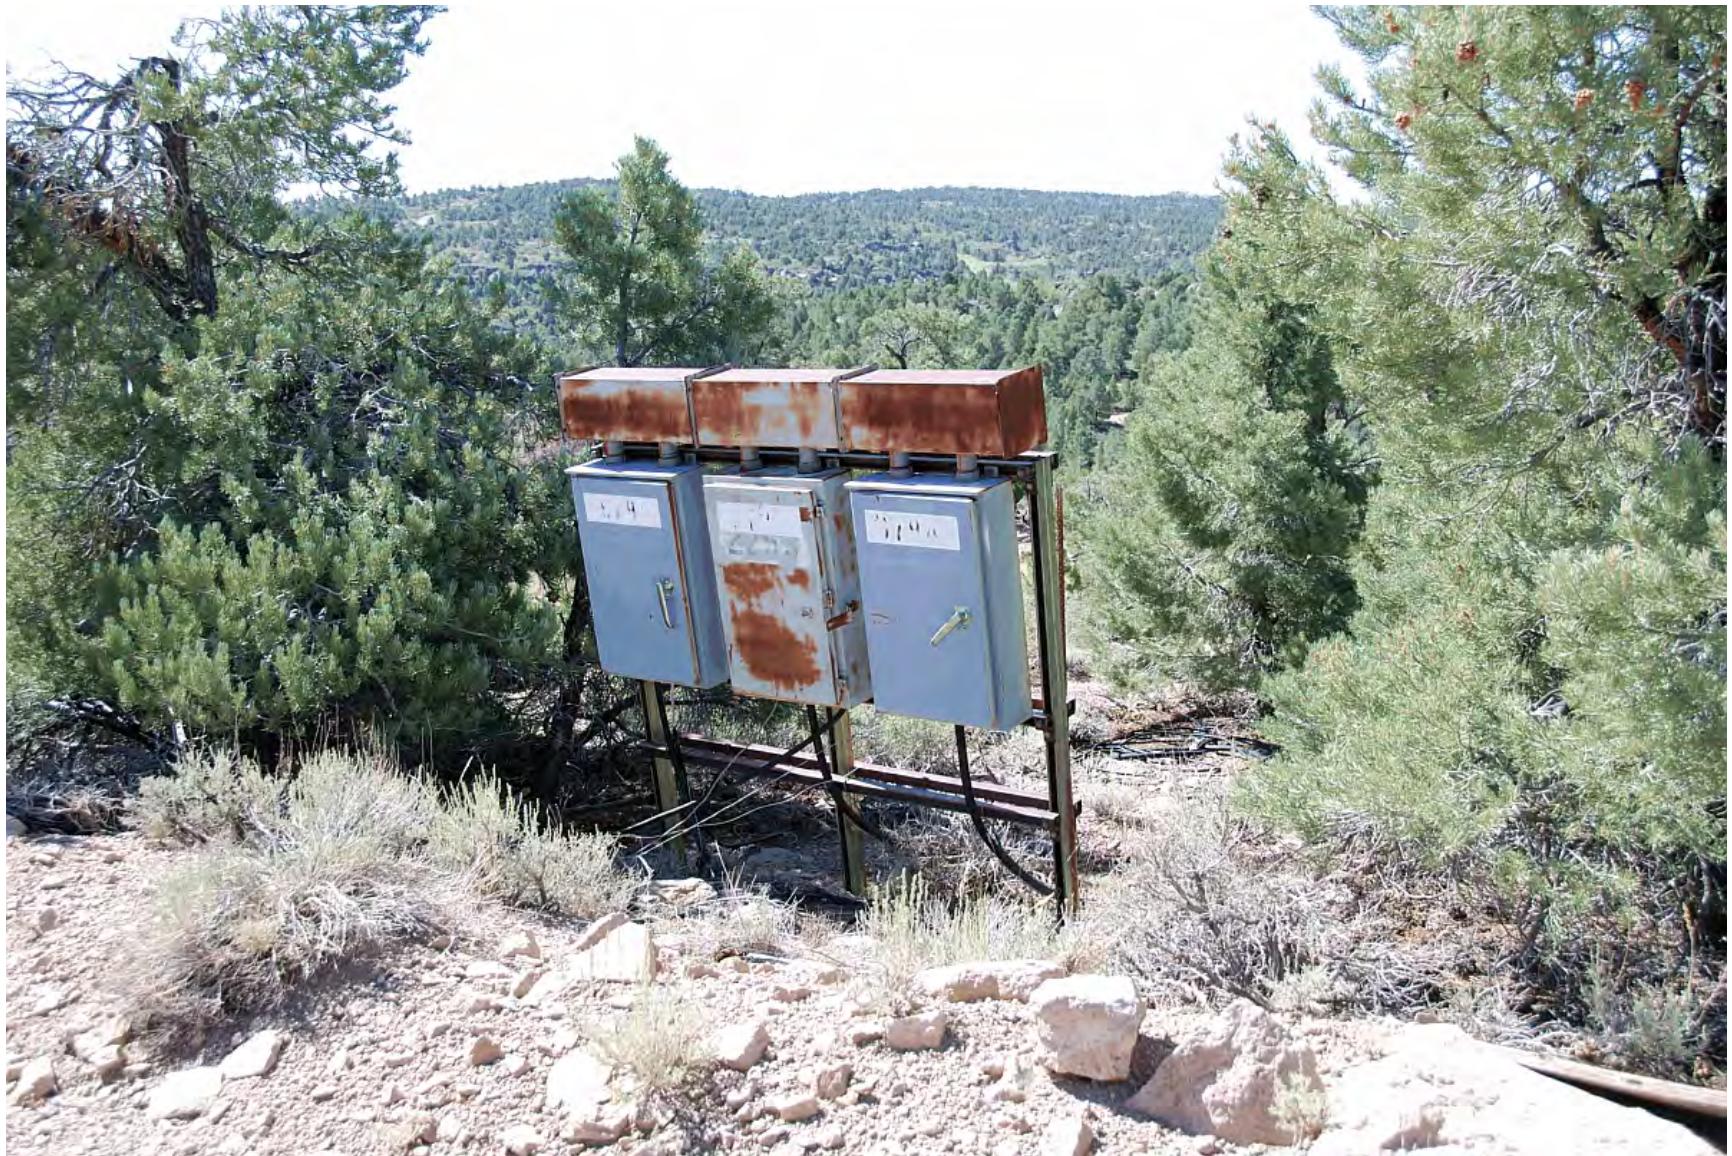
Figure 346. Feature 176, electrical panels, U12n Tunnel, view southeast (2008).

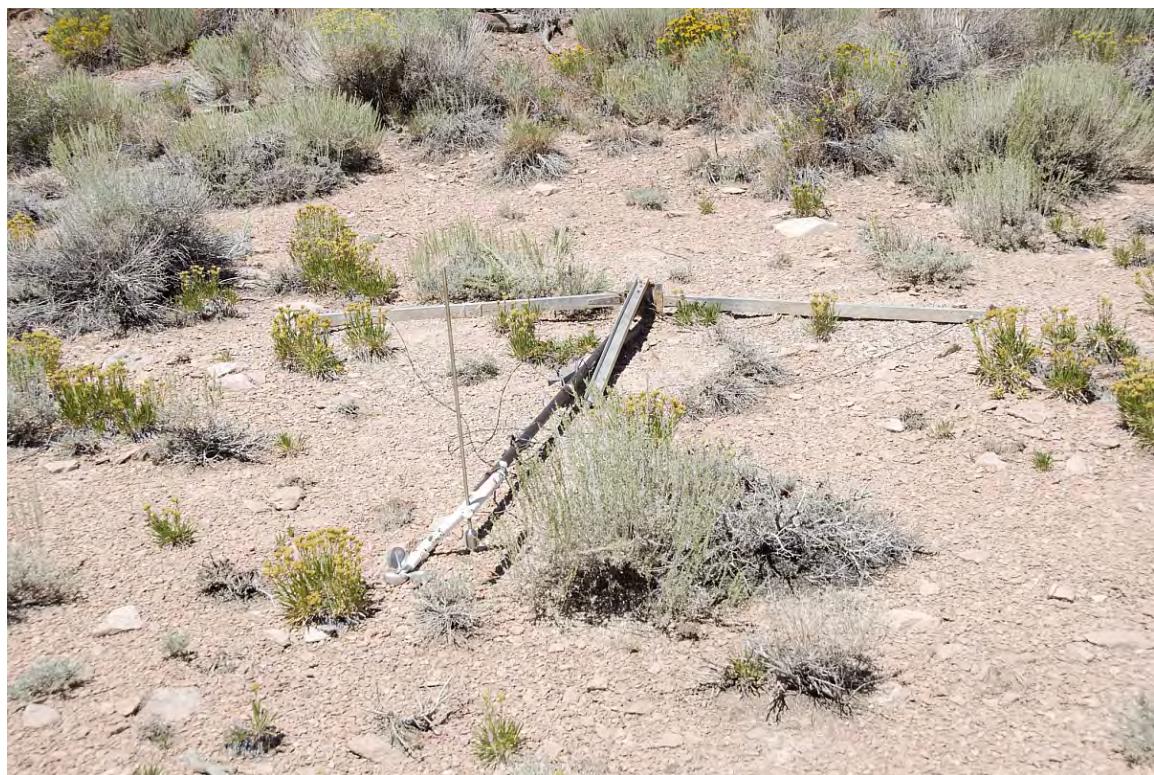
Figure 347. Plan view of dirt pad and photograph of Feature 177, anemometer, U12n Tunnel, view west (2008).

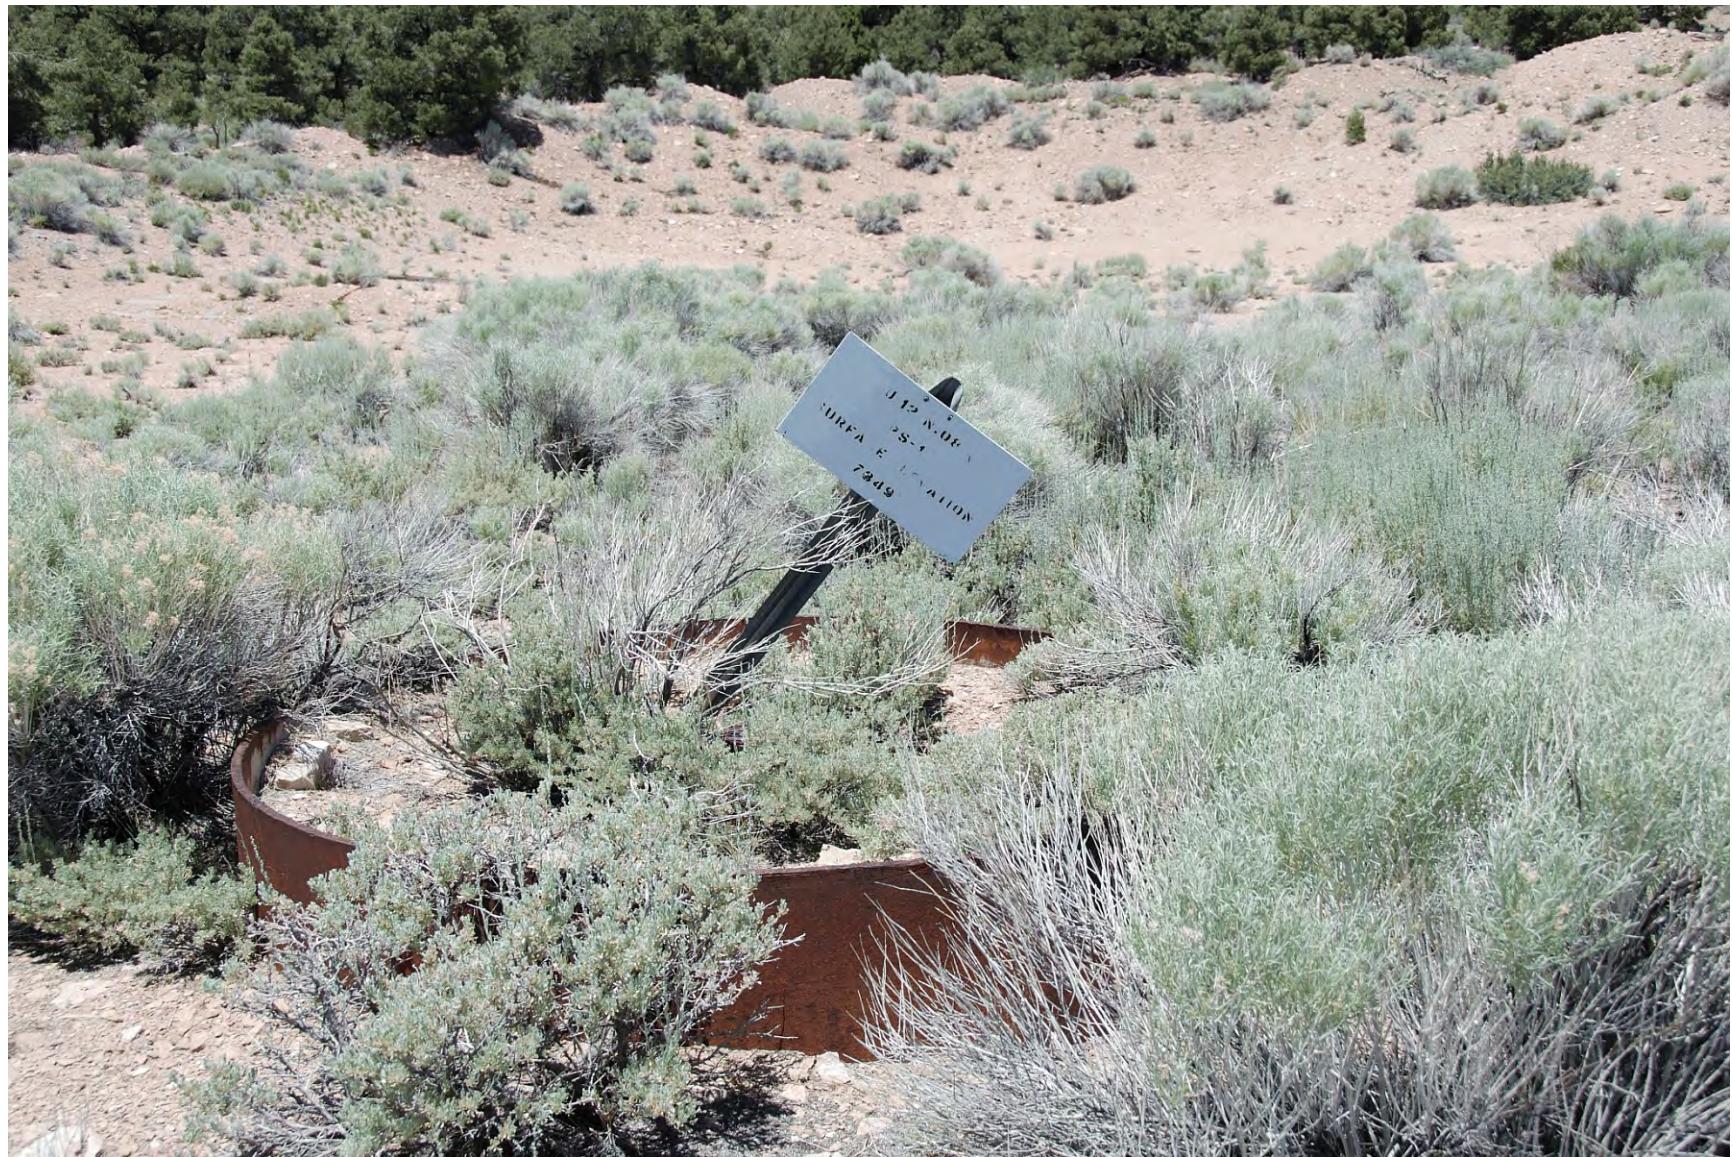
Feature 178 (Figures 348 and 349) is the U-12n.08 PS #1 postshot drill hole on an irregular-shaped dirt pad that is 450 ft (137.2 m) north-south and 300 ft east-west, encompasses 2.1 acres (0.9 hectare), and at an elevation of 7,349 ft (2,240 m). Features 179-182 also are on or near the dirt pad. One access road enters the pad from the south and a second road exists the pad from the northeast corner and provides access to drill holes UE-12n #10, UE-12n #11, and UE-12n #12. Artifacts found on the drill pad are communications wire, broken glass, rubber fragments, milled lumber fragments, metal fragments, and welding rods.

Figure 349. Feature 178, U12-n.08 PS #1 drill hole, U12n Tunnel, view west (2008).

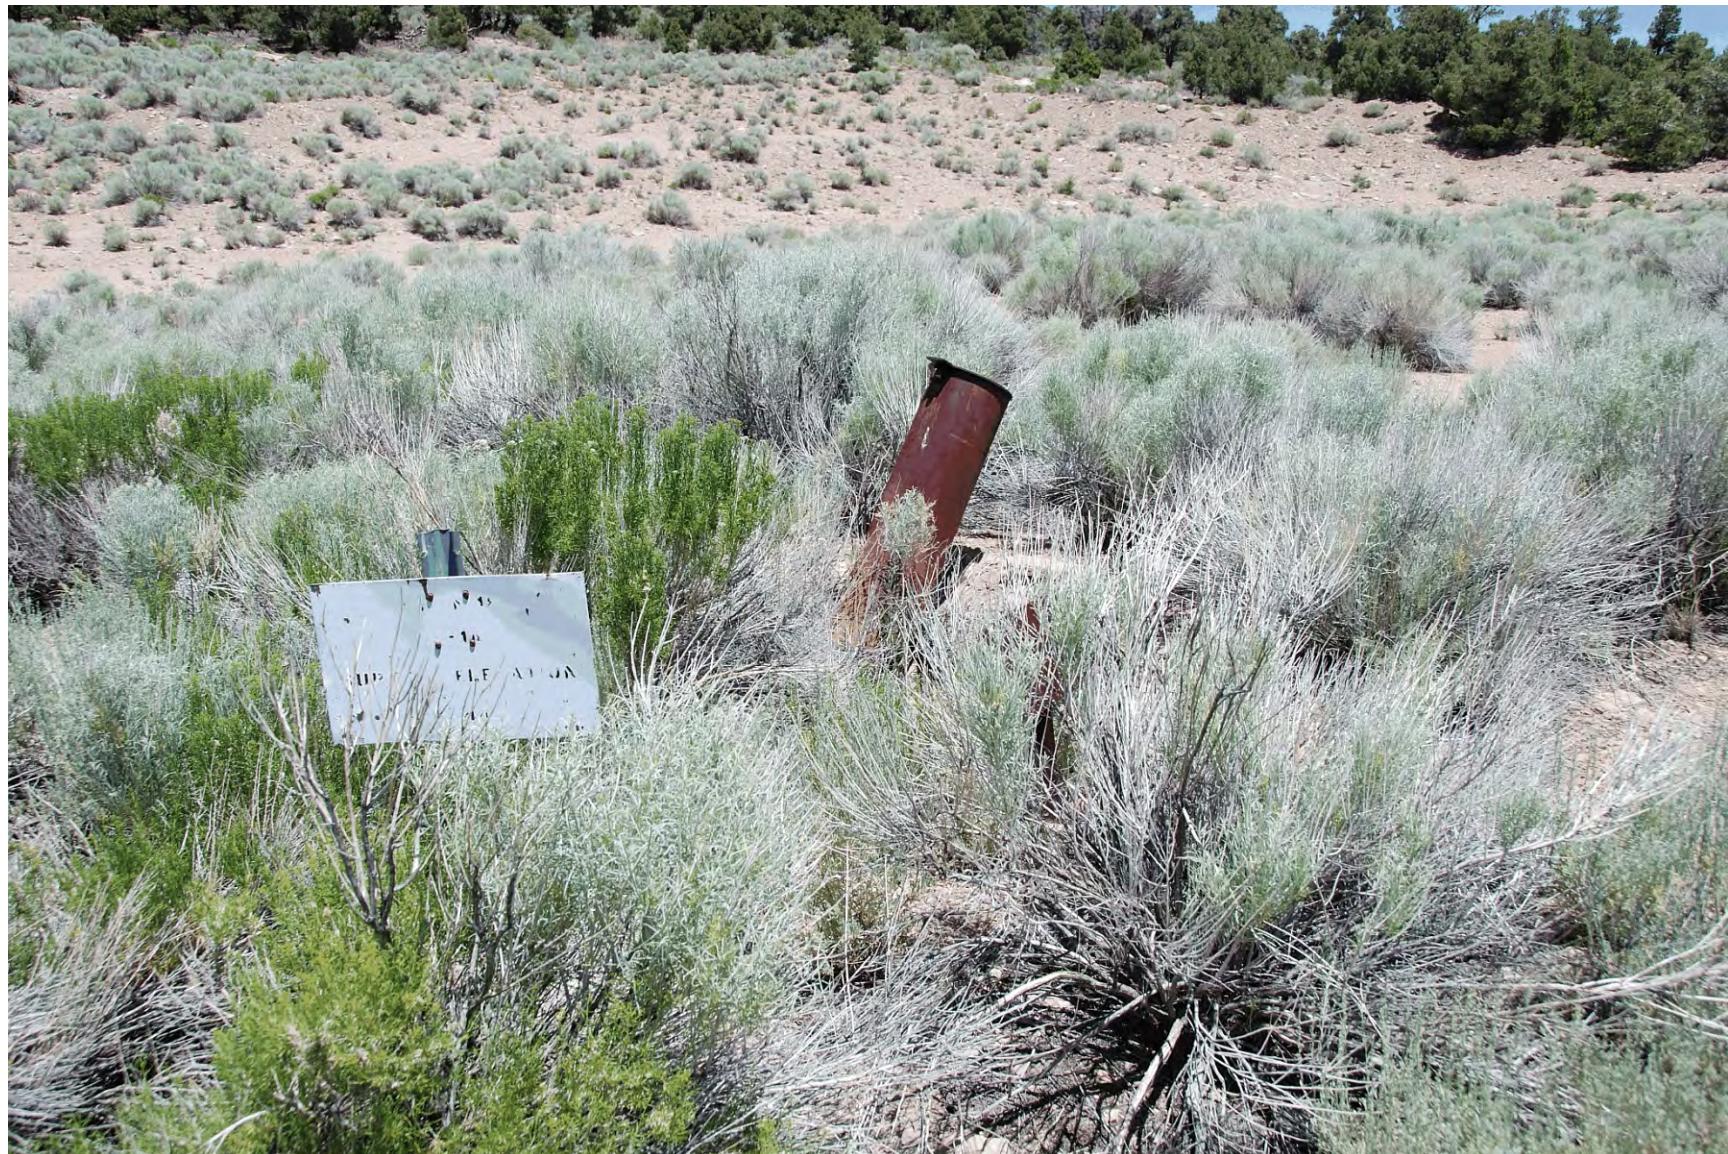
Feature 179 (Figures 348 and 350) is the U-12n.18 PS #1A, #1AA, and #1AAB postshot drill hole at UTM coordinates 570354 E, 4118310 N, at and elevation of 7,344 ft (2,238.5 m) and drilled to a depth of 1,568 ft (478 m) (Bennett 1991). The drill hole consists of a 10 3/4-inch (27.3 cm) diameter pipe extending 3 ft above the surface at approximately 70 degrees. The end of the pipe is covered with a flat metal plate that is hinged to the end of the pipe. An oxidized metal sign with welded lettering (lying on the surface) and a white painted metal sign identify and mark the location of the drill hole.

Figure 350. Feature 179, U-12n.18 PS #1A, #1AA, and #1AAB postshot drill hole, U12n Tunnel, view northeast (2008).

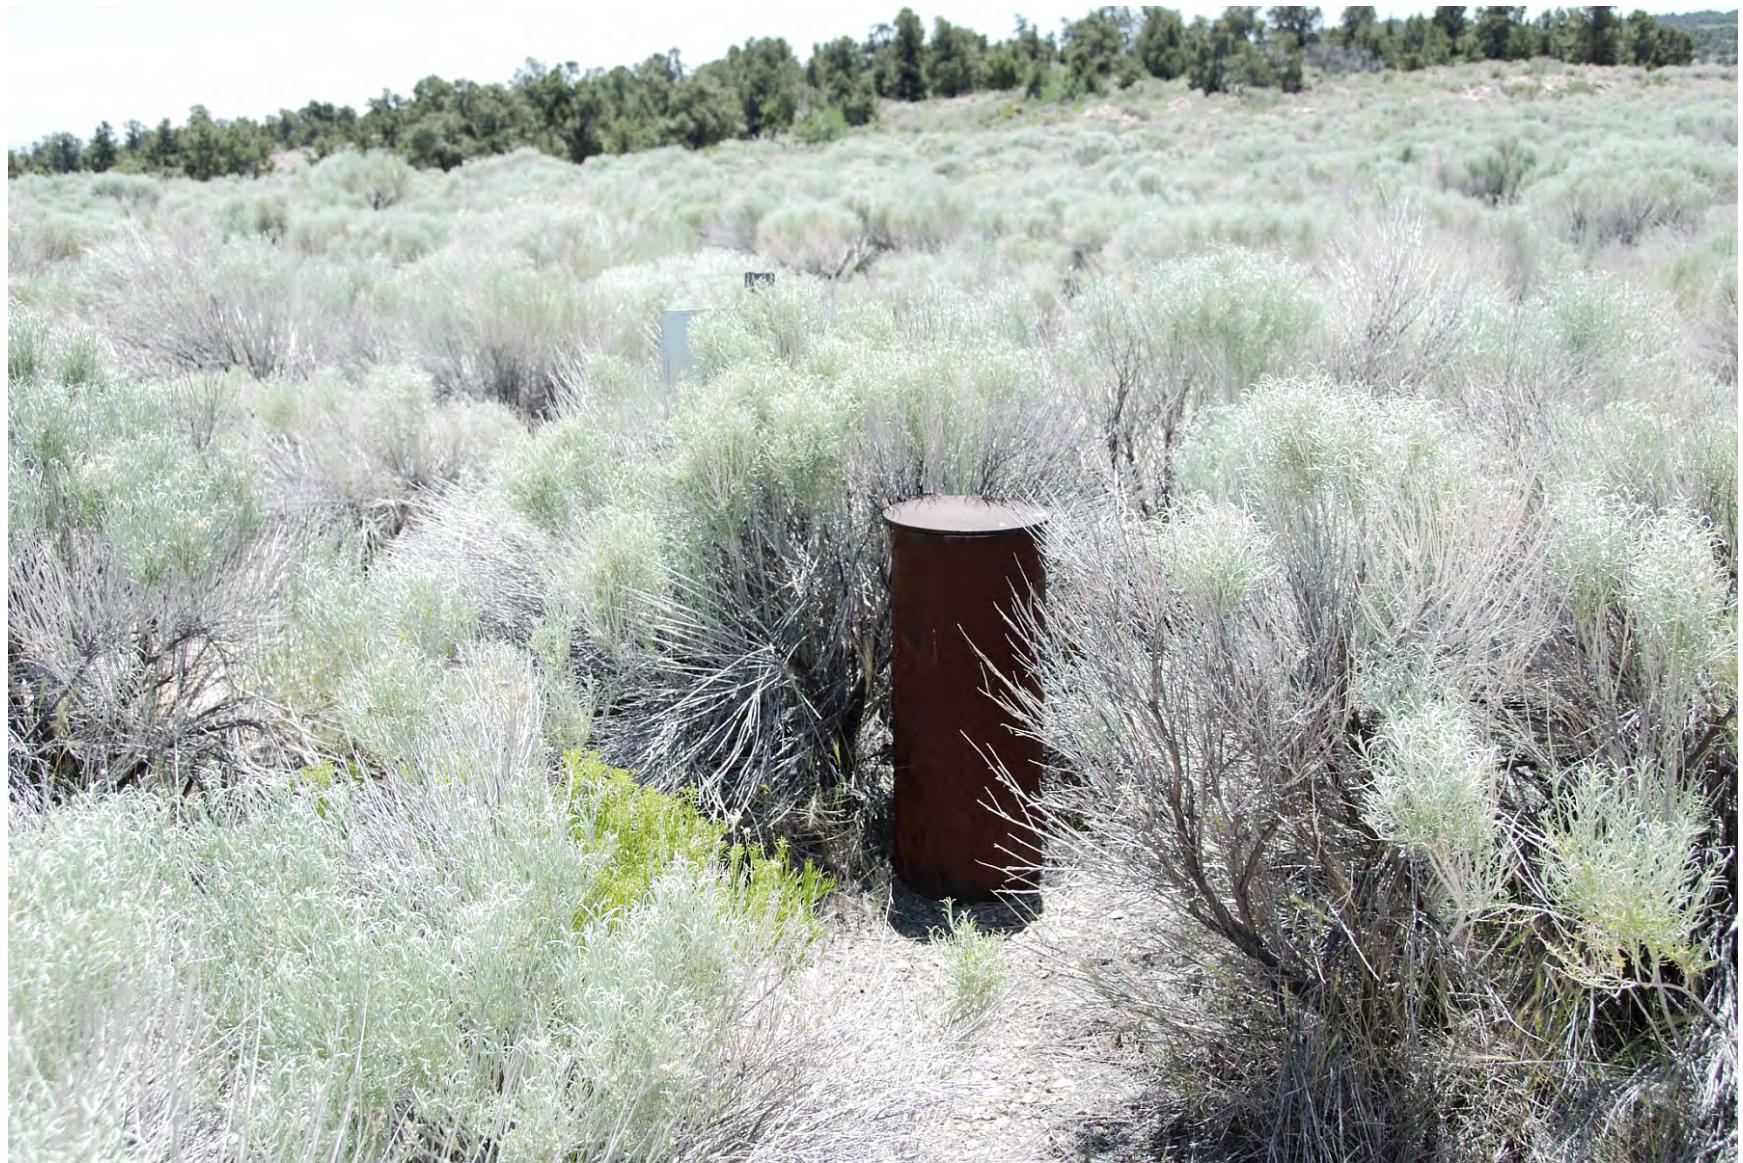
Feature 180 (Figures 348 and 351) is the U-12n.15 PS #1A, PS #1AA, PS# 1AB, PS# 1AC, and #1AD postshot drill hole at UTM coordinates 570345 E, 4118316 N, at an elevation of 7,347 ft (2,239.4 m) drilled to a depth of 1,568 ft (478 m), 1,584 ft (482.8 m), 1,599 ft (487.4 m), 1,631 ft (497.1 m), and 901 ft (274.6 m) respectively (Bennett 1991). U-12n.15 PS# 1A consists of a 10 3/4-inch diameter pipe extending 2 ft 3 inches (0.68 m) from the surface. The end of the pipe is covered with a flat metal plate that is hinged to the end of the pipe. The remaining holes were cased with 9 7/8-inch (25 cm) pipe. A white metal sign identifies the drill hole number, coordinates, and surface elevation. Associated artifacts are broken glass, communications wire, and metal fragments.

Figure 351. Feature 180, U-12n.15 PS #1, PS #1AA, PS #1AB, PS #1AC, and PS #1AD, U12n Tunnel, view southwest (2008).
