A total of 202 features were recorded, mapped, and photographed for the U12n Tunnel complex. The project area encompassed 600.8 acres (243.1 hectares) at the portal and mesa areas. At the U12n portal area are ten sub-areas containing features related to the construction, testing, and general everyday activities within the tunnel. These include concrete foundations for buildings, communications equipment, mining equipment, rail lines, retention ponds, storage containers, and access control facilities. Only a telephone trailer remains on the telephone pad as all of the other buildings have been removed from the portal area. The microwave tower, portions of the rail lines, the muck car dump, rotary dump, and wash rack are still in place. Also, the traffic control point and powder magazines along N Tunnel Road are intact. At the mesa area are four sub-areas containing features generally related to pre- and post-shot drilling, recording facilities, and ventilation equipment. These include concrete foundations, instrument cable holes, and drill holes. The concrete foundations were for buildings and small equipment. Concrete pads and various equipment remain at the cable hole locations bu

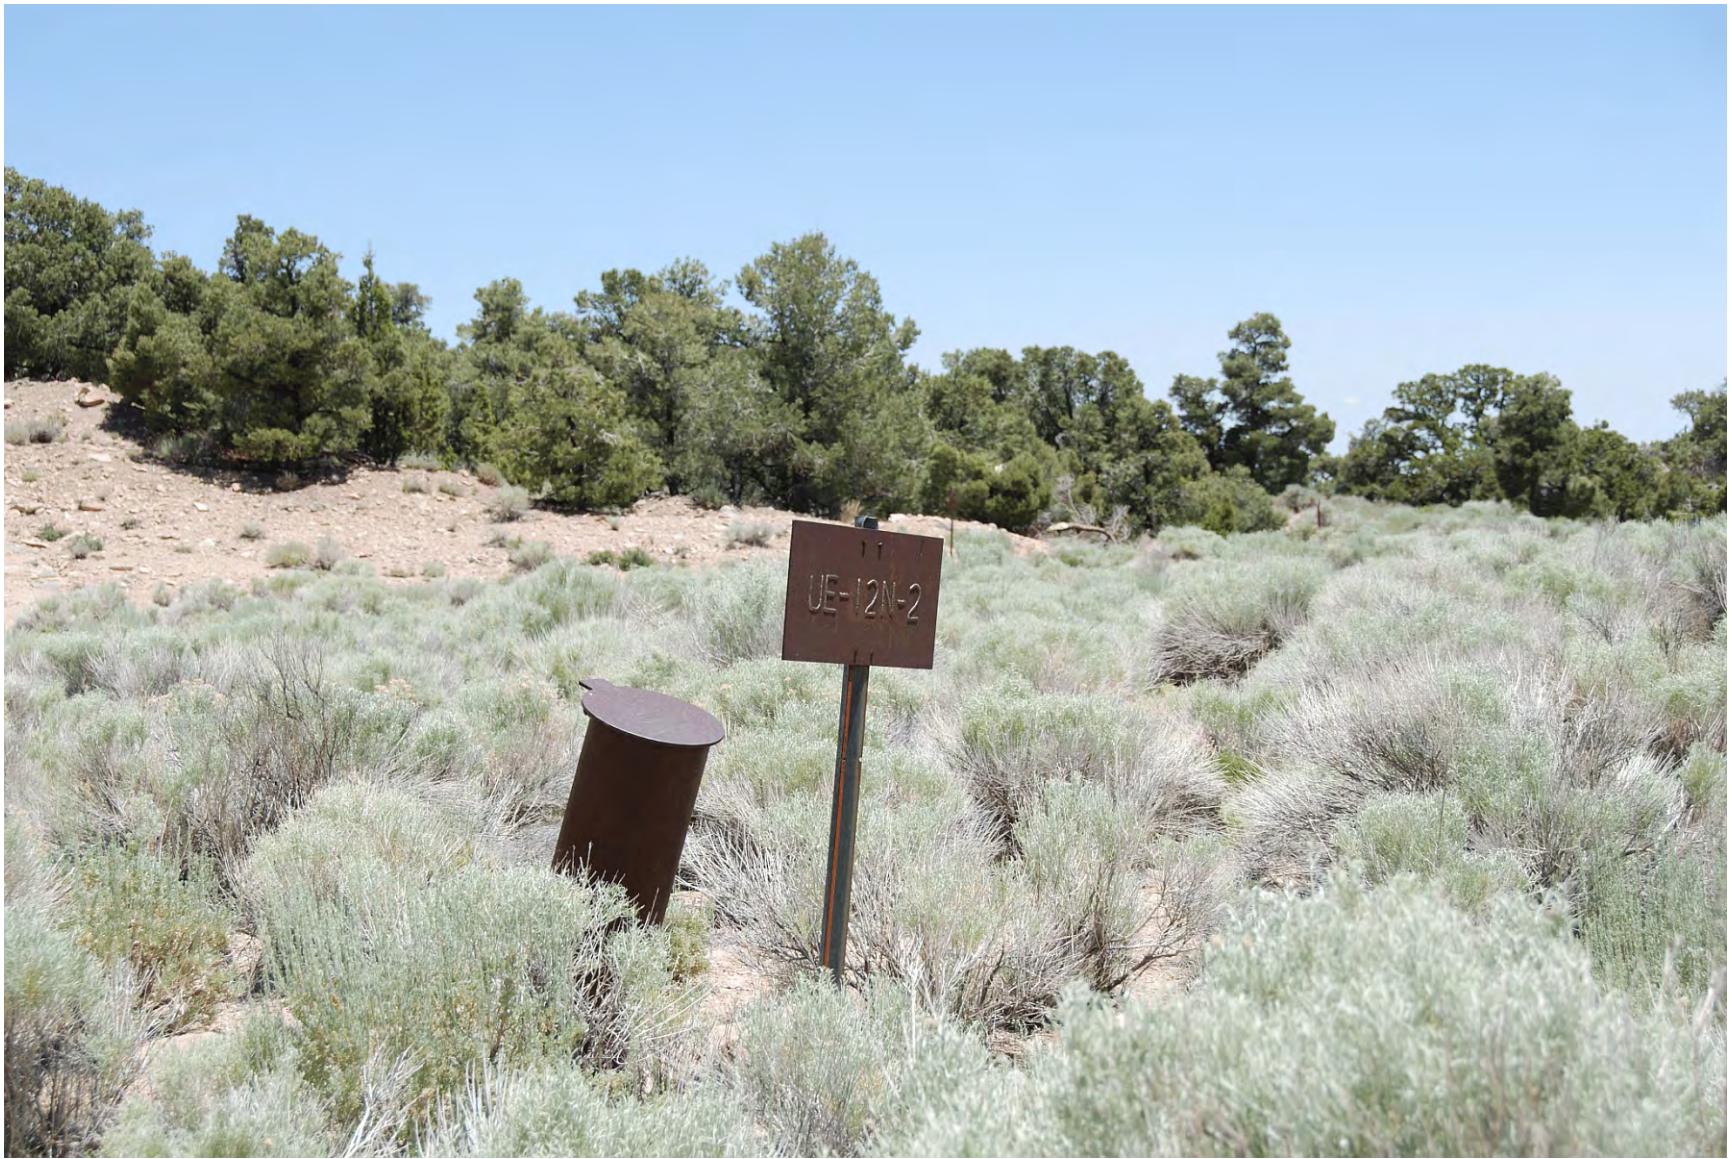
Feature 181 (Figures 348 and 352) is the UE-12n #2 exploratory drill hole at UTM coordinates 570360 E, 4118319 N, at an elevation of 7,344 ft (2,238.5 m) and drilled to a depth of 1,779 ft (542 m) (Bennett 1991). The drill hole consists of a 6-inch diameter pipe extending 3 ft 2 inches above the surface at approximately 75 degrees. The end of the pipe is covered with a flat metal plate that is hinged to the end of the pipe. An oxidized metal sign with welded lettering identifies the drill hole number. No artifacts were found near the drill hole.

Figure 352. Feature 181, UE-12n #2 exploratory drill hole, U12n Tunnel, view northeast (2008).

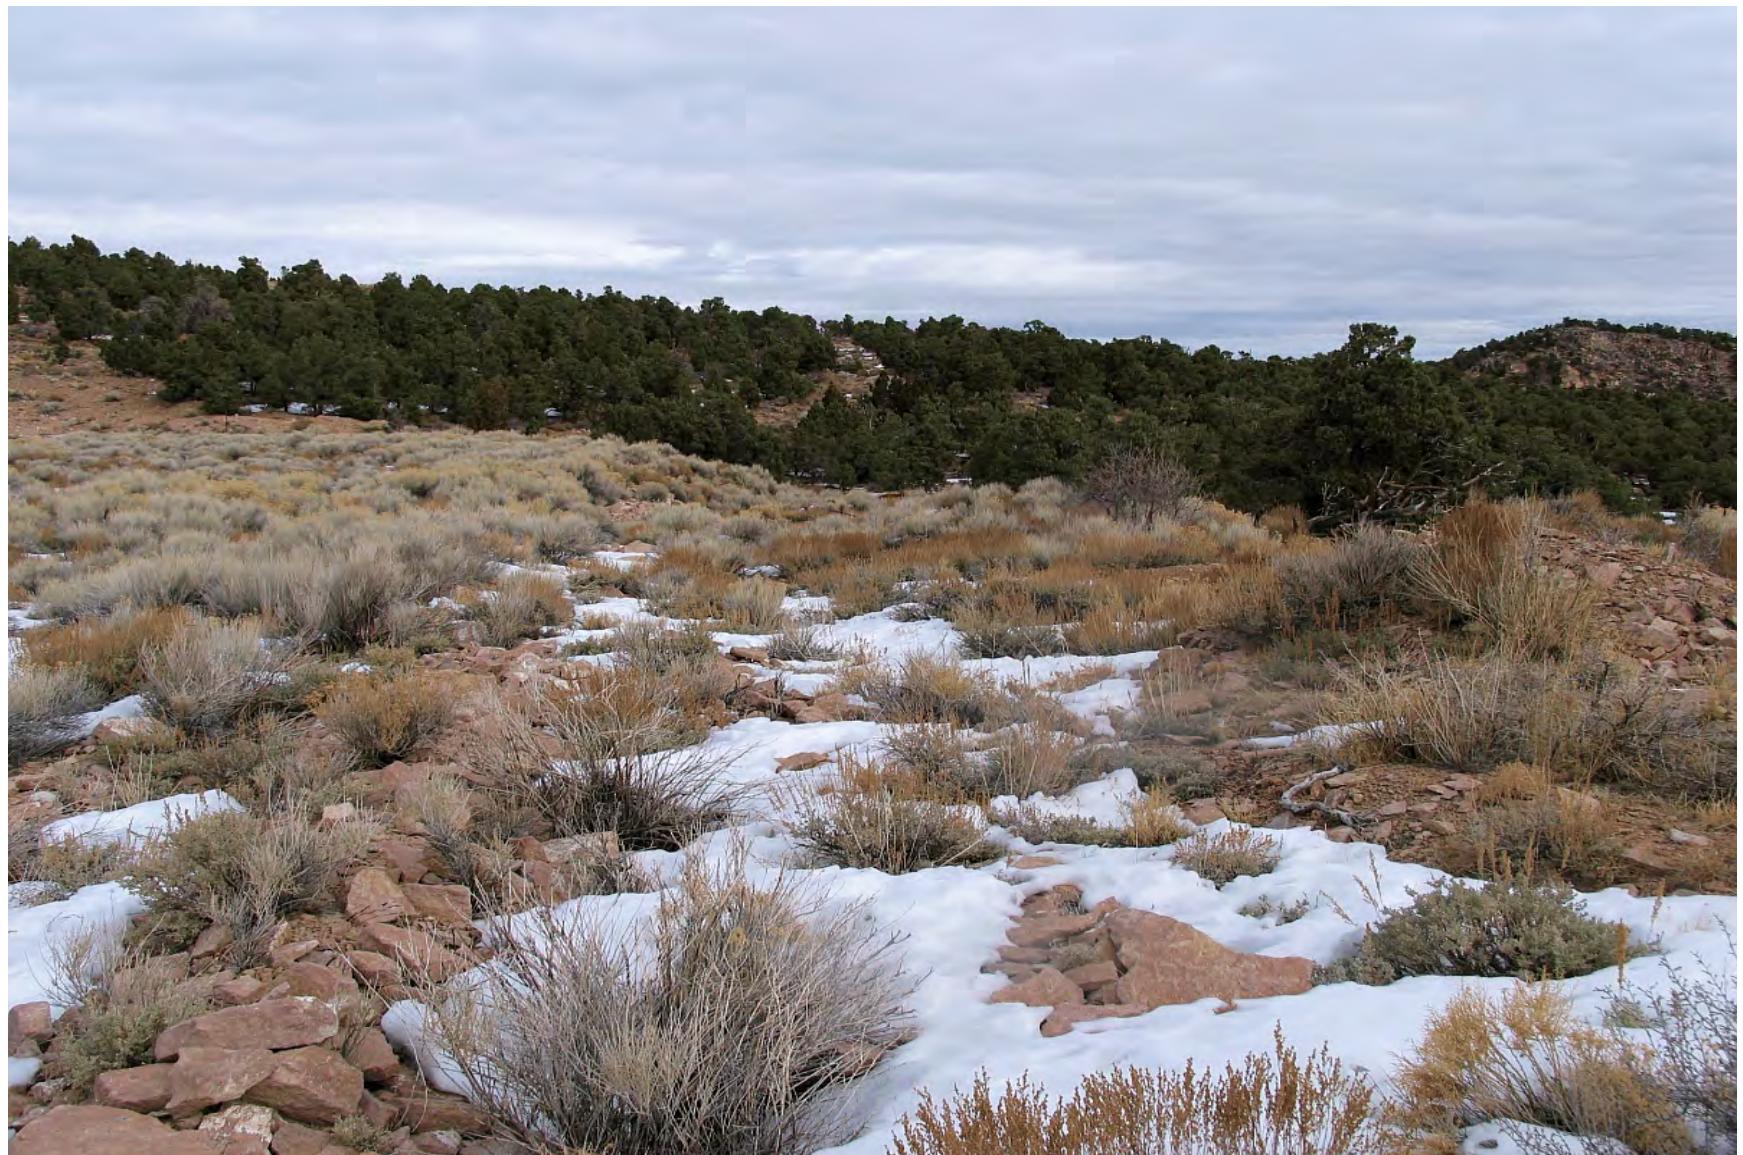
Figure 353. Feature 182, pit, U12n Tunnel, view northeast (2009).

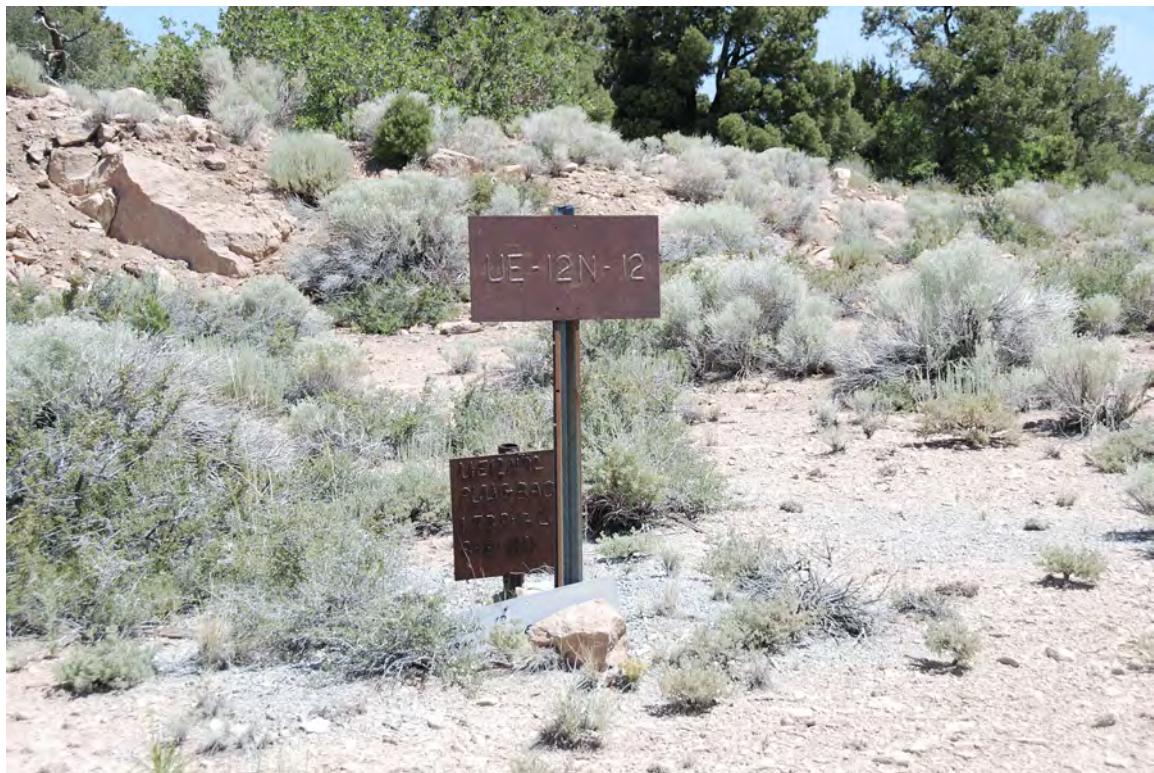
Feature 183 (Figure 354) is the UE-12n #12 exploratory drill hole at UTM coordinates 570408 E, 4118521 N, at an elevation of 7,412 ft (2,259.2 m), and drilled to a depth of 1,733 ft (528 m) (Bennett 1991). The drill hole is on an irregular shaped dirt pad that is 135 ft (41.1 m) north-south by 85 ft east-west and encompasses 0.24 acres (0.1 hectares) with access roads that enters the pad from both the north and south ends. No pipe or casing is visible above the surface, however three metal signs (two welded letters and one white) identify and mark the drill hole location. One welded sign is on a post that is 3 ft 6 inches in height and has welded lettering identifying the drill hole number. The second welded sign has the drill hole number, an August 1980 plug-back date, and the depth of the plug back to the surface. The white metal sign is lying on the surface and identifies the drill hole number, coordinates, and surface elevation. Associated artifacts are milled lumber fragments, plastic fragments, communication wire, broken glass, and metal fragments.

Figure 354. Plan map and photograph of Feature 183, UE-12n #12 exploratory drill hole, view northwest (2008).

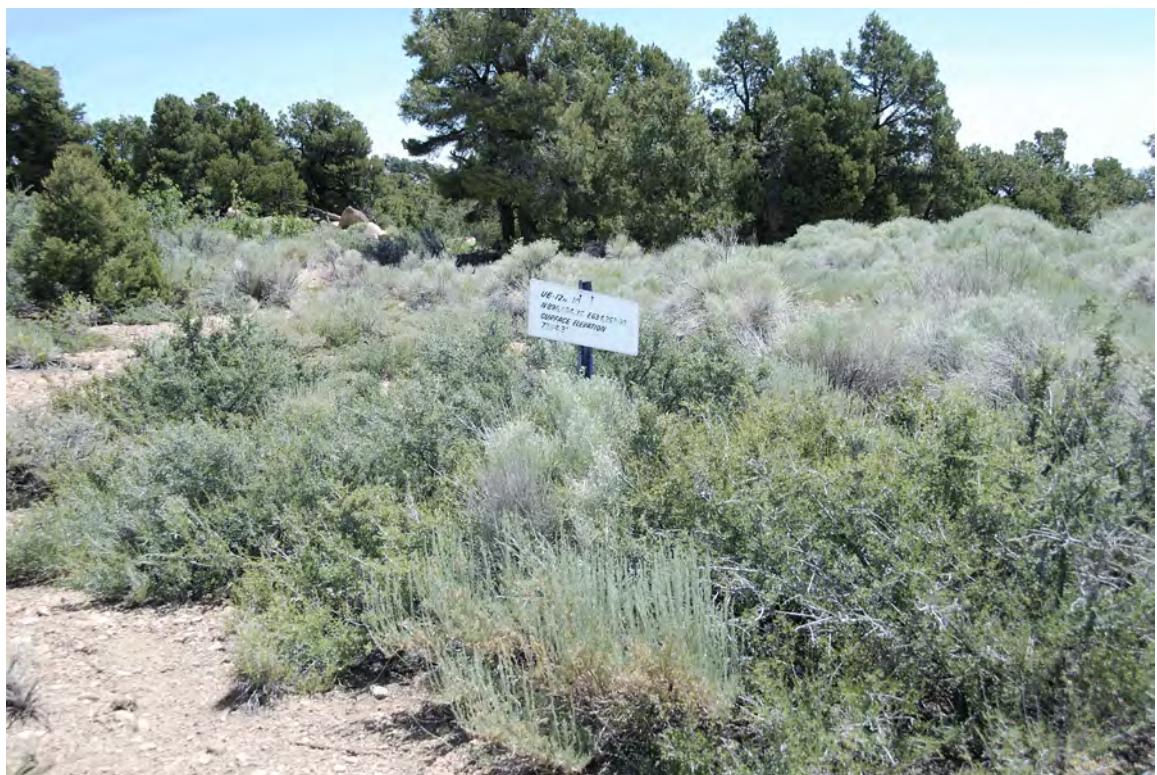
Feature 184 (Figure 355) is the UE-12n #10 exploratory drill hole at UTM coordinates 570516 E, 4118538 N, at an elevation of 7,378 ft (2,248.8 m), and drilled to a depth of 1,877 ft (572 m) (Bennett 1991). The drill hole is on an irregular shaped dirt pad that is 131 ft (39.8 m) east-west and 105 ft north-south and encompasses 0.26 acres (0.11 hectares) with access roads that enters the pad

Figure 355. Plan map and photograph of Feature 184, UE-12n #10 exploratory drill hole, view northeast (2008).

from both the north and south ends. No pipe or casing is visible above the surface; however, a white metal sign marks and identifies the drill hole number, coordinates, and surface elevation. Associated artifacts are milled lumber fragments, welding rods, communication wire, crushed cans, plastic fragments, broken glass, a saw blade, buss fuses, and rubber fragments.

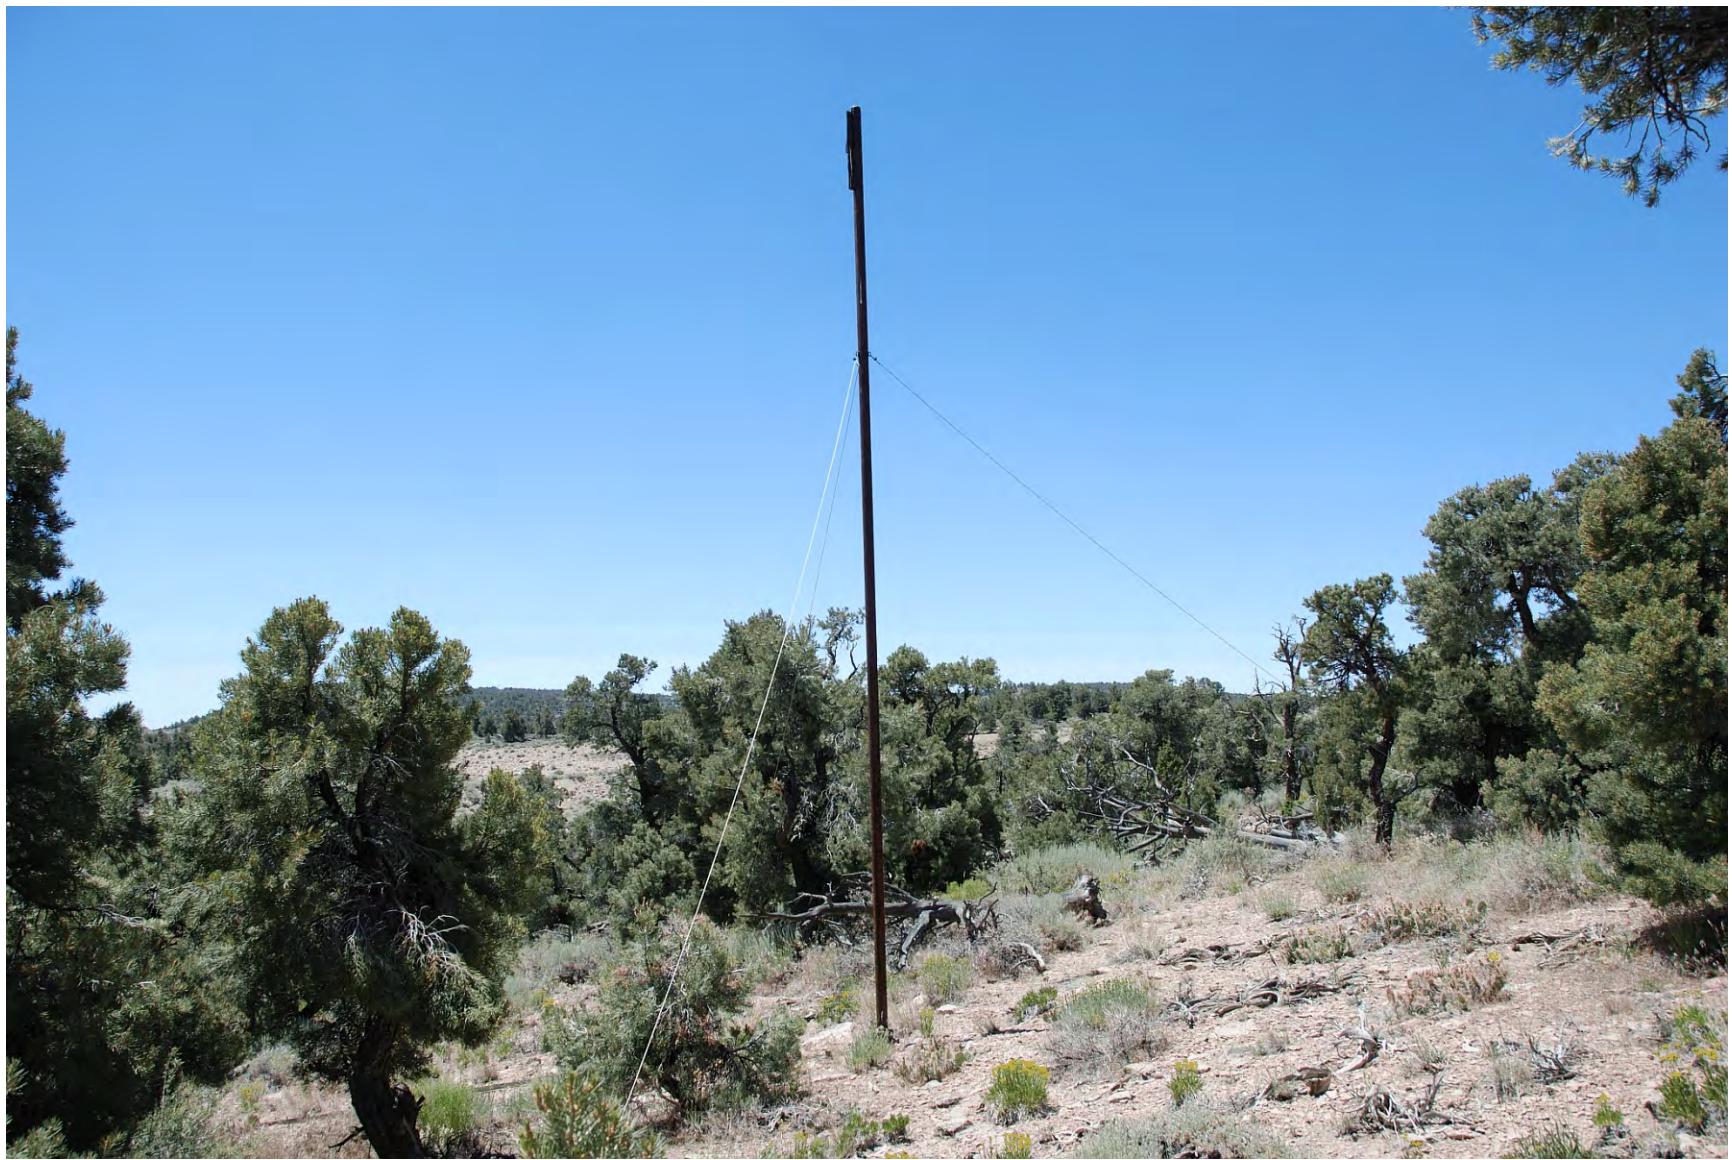
Feature 185 (Figure 356) is a metal pole tower at UTM coordinates 570505E, 4118400N. It is at an elevation of 7,340 ft and near drill holes UE-12n #10 and UE-12n #11. The tower consists of a 6-inch diameter pipe (base) that extends 6 inches above the surface. Centered in the base is a 2 1/2 inch diameter pipe (tower) that is approximately 20 ft tall. The 2 1/2-inch pipe is secured in the base by three bolts (set bolts) screwed through the side of the base and against the exterior of the pipe. Three 1/4-inch braided wire cables are attached approximately 5 ft below the top of the tower and are secured to the surface with metal stanchions. Along the north side near the top of the tower is a 6 inch wide by 2 ft long metal plate. Three bolts are welded to the side of the plate probably for attachment of equipment. Associated artifacts are 2x2 milled lumber and a piece of 3/4-inch plywood that may have been a sign (no lettering remains).

Figure 356. Feature 185, pole tower, U12n Tunnel, view southeast (2008).

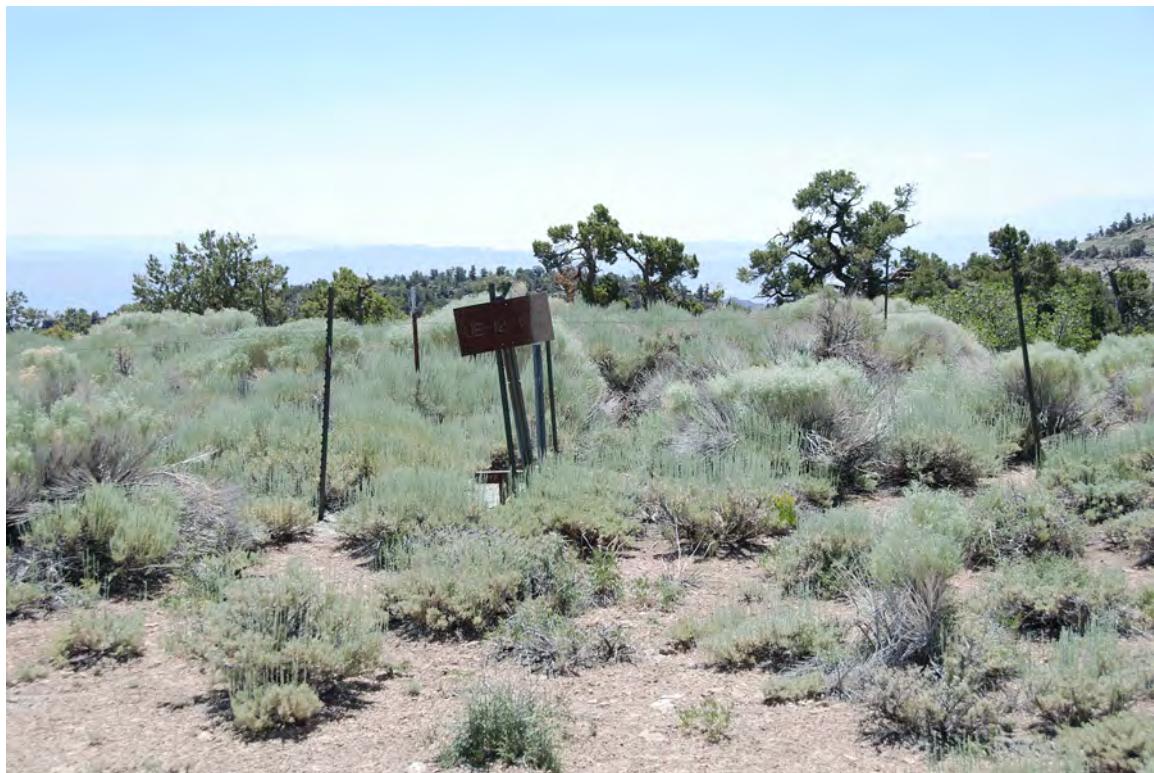
Feature 186 (Figure 357) is the UE-12n #11 exploratory drill hole at UTM coordinates 570586 E, 4118361N, at an elevation of 7,309 ft (2,227.8 m), and drilled to a depth of 1,882 ft (574 m) (Bennett 1991). The drill hole is near the east edge of a roughly rectangular-shaped dirt pad that is 150 ft north-south by 125 ft (38.1 m) east-west and encompasses 0.37 acres (0.15 hectares) with an access road that enters from the west. The drill hole consists of a 4 1/2-inch diameter pipe that extends 1 ft above the surface and is capped with a metal plate. A piece of 1 1/2-inch angle iron is welded across the top of the pipe with lettering CMT 1882 TO GL (cemented 1,882 ft to ground level). Near the pipe is an oxidized metal sign that identifies the drill hole number. Extending south from the drill hole is a 70 ft long by 10 ft wide trench that empties into an area south of the pad. Along the edge of the trench are metal T posts and a single yellow coated wire. Associated artifacts are metal fragments, plastic fragments, communication wire, crushed cans, and a 55 gal metal barrel.

Figure 357. Plan map and photograph of Feature 186, UE-12n #11 exploratory drill hole, U12n Tunnel, view southeast (2008).

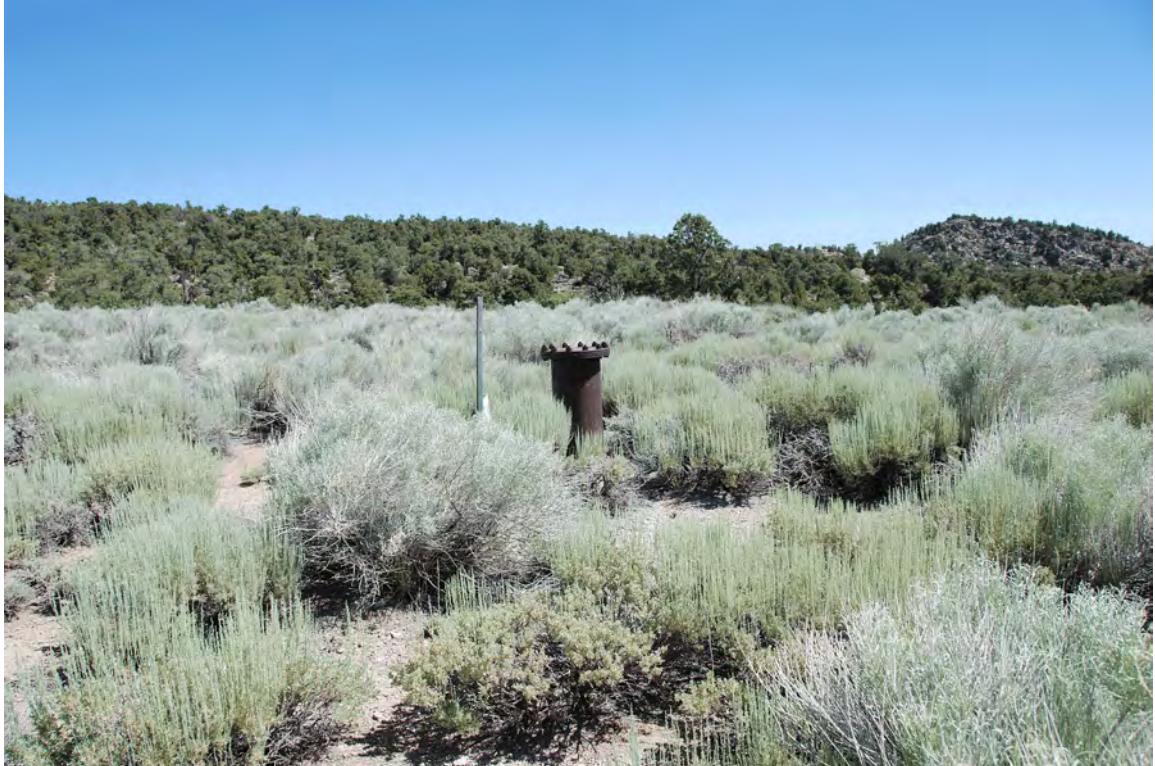
Feature 187 (Figure 358) is the U-12n.03 #1 CH cable hole at UTM coordinates 570521 E, 4118215 N, at an elevation of 7,304 ft (2,226.3), and drilled to a depth of 1,248 ft (380 m) (Bennett 1991). The drill hole is near the south edge of an irregular-shaped dirt pad that is 233 ft (71 m) east-west by 141 ft (43 m) north-south and encompasses 0.46 acres (0.19 hectares) with an access road that enters from the west. Level with the surface is the top edge of a 20 3/8-inch (51.8 cm) diameter pipe (surface casing). A 13 3/8-inch (34 cm) diameter casing, centered inside the 20 3/8-inch pipe, extends 2 ft 9 inches above the surface and is capped with a 1 ft 7 inch diameter, 12 bolt flange and plate. Near the pipe and casing is a galvanized metal post and white sign that identifies cable hole number, coordinates, and surface elevation.

Figure 358. Plan map of Features 187 and 188 and photograph of Feature 187, U-12n.03 #1 CH cable hole, view north (2008).

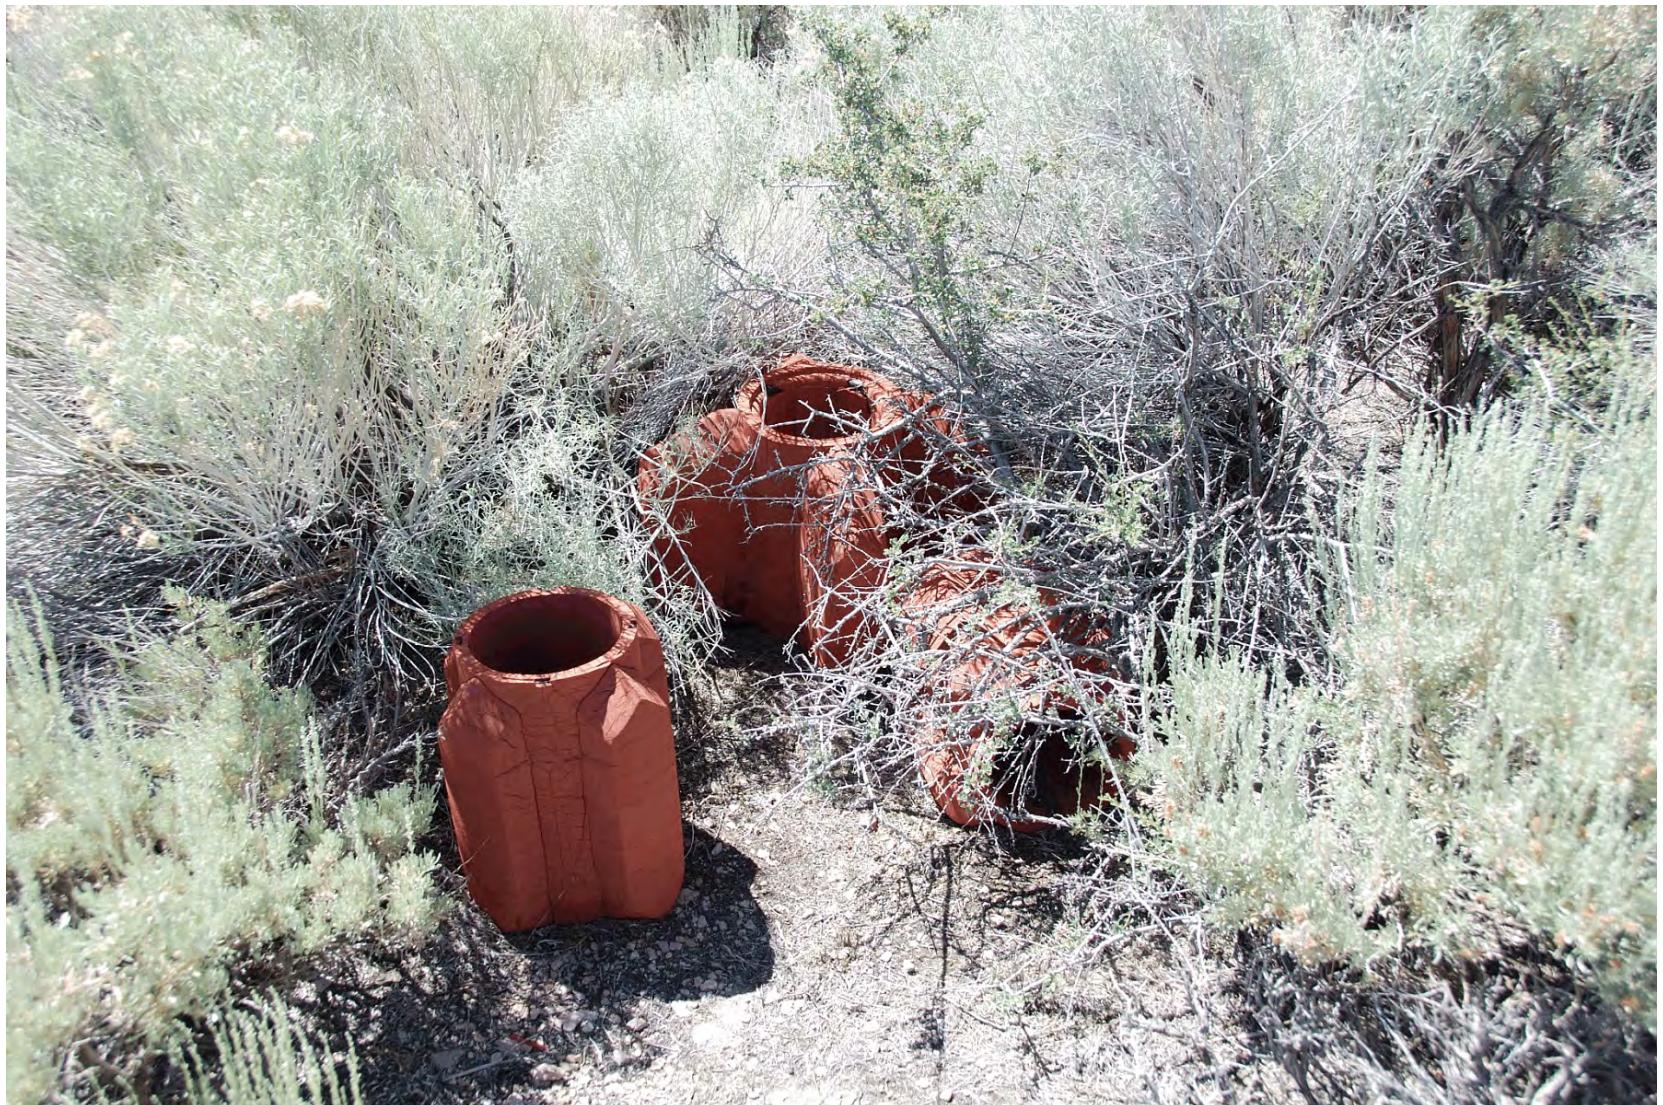
Feature 188 (Figure 359) is four casing centering sleeves at UTM coordinates 570561 E, 4118218 N. The feature is along the northeast edge of the U-12n.03 #1 CH dirt pad. The sleeves (insulators or centralizers) are cylindrical and measure 13 3/8 inches (33 cm) outside diameter, 7 5/8 inches (19.4 cm) inside diameter, and 1 ft 4 inches tall. One sleeve is 20 3/8 inches in outside diameter, 7 5/8 inches inside diameter, and 1 ft 4 inches tall. There are four longitudinal ridges approximately 3 inches wide, spaced 90 degrees, and tapered to a point on each end that extend the length of the sleeve. The sleeves are an orange (probably red faded by sunlight) rubberized material and are significantly weathered. Other associated artifacts are rope, milled lumber fragments, crushed cans, and broken bottles.

Figure 359. Feature 188, casing centering sleeves (insulators) at the U-12n.03 #1 CH, U12n Tunnel, view east (2008).

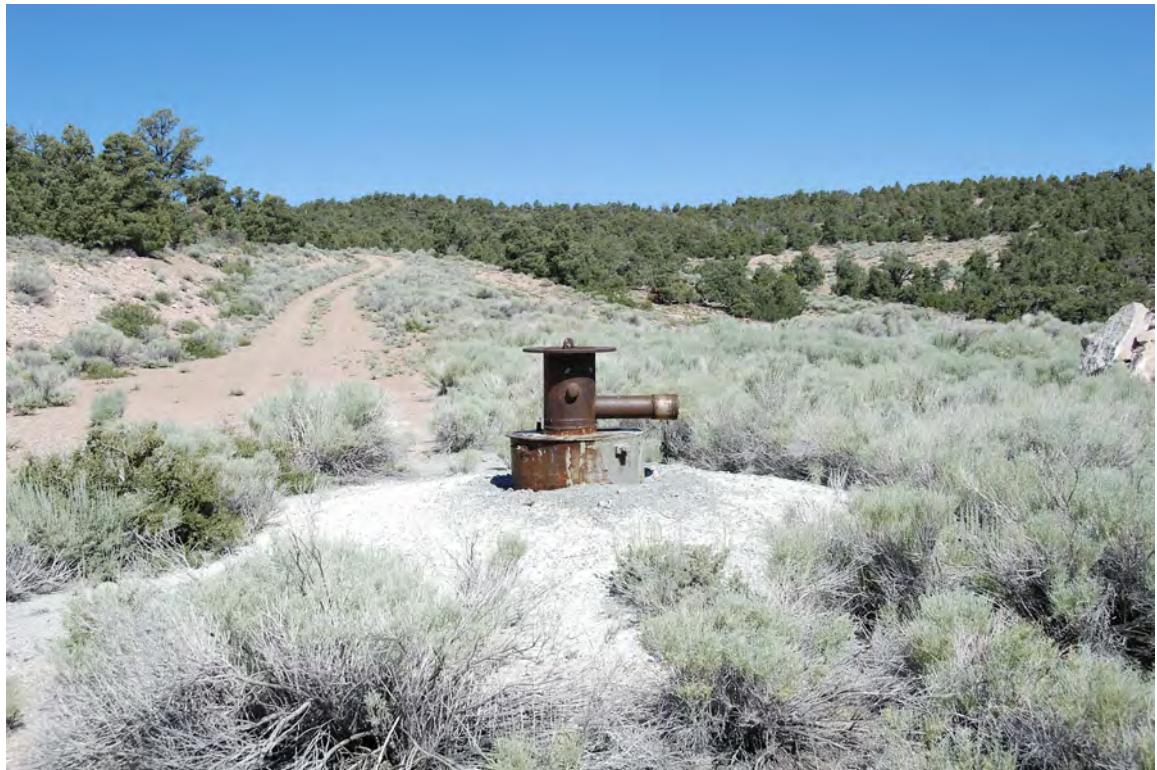
Feature 189 (Figure 360) is the U-12n.20 PH #1 peep hole at UTM coordinates 570534 E, 4118168 N, at an elevation of 7,317 ft (2,230.2 m), and drilled to a depth of 1,250 ft (381 m) (Bennett 1991). The drill hole is near the center of a square dirt pad that is 180 x 180 ft and encompasses 0.73 acres (0.29 hectares) with an access road that enters from the west. Features 190 and 191 are on or near the dirt pad. The drill hole consists of a 33 inch diameter pipe (surface casing) that extends 1 ft 2 inches above the surface and is capped with a welded metal plate (slightly larger in diameter than the pipe). Welded to the top of the plate are two 1-inch nipples sealed with 1-inch threaded plugs. Four 3-inch (7.6 cm) rectangular metal lugs are welded to the exterior sides of the pipe at 90 degree intervals. Extending through and slightly off-center of the plate is a piece of 13 3/8 inch casing that is 1 ft 9 inches long. The casing is capped by a 2 ft diameter, 3/4-inch (1.9 cm) thick, flange with 10 holes around the perimeter that is welded to the casing. A second metal plate has been welded to the interior of the flange sealing the end of the casing. Extending through the interior plate are two 1 1/2-inch nipples 2 inches (5.1 cm) in length and plugged. Between the two nipples is a 2 1/2-inch wide by 4 inch tall metal plate with a 1-inch diameter hole. Extending out the east side of the casing is a 2 1/2-inch nipple that is 1 1/2 inches in length and sealed with a welded metal plate. Extending out the north side of the casing is a 6-inch pipe, 1 ft 3 inches in length, and ending with a Victaulic grooved connection. The end of the pipe is sealed with a welded metal plate. Associated artifacts are communications wire, crushed and oxidized cans, milled lumber fragments, welding rods, and broken glass. Also, near the southwest corner of the pad (near pipe) are several fragments of white concrete (grout) that was probably used to cement the large diameter pipe to the subsurface rock strata.

Figure 360. Plan map of Features 189-191, and photograph of Feature 189, U-12n.20 PH #1 peep hole, view west (2008).

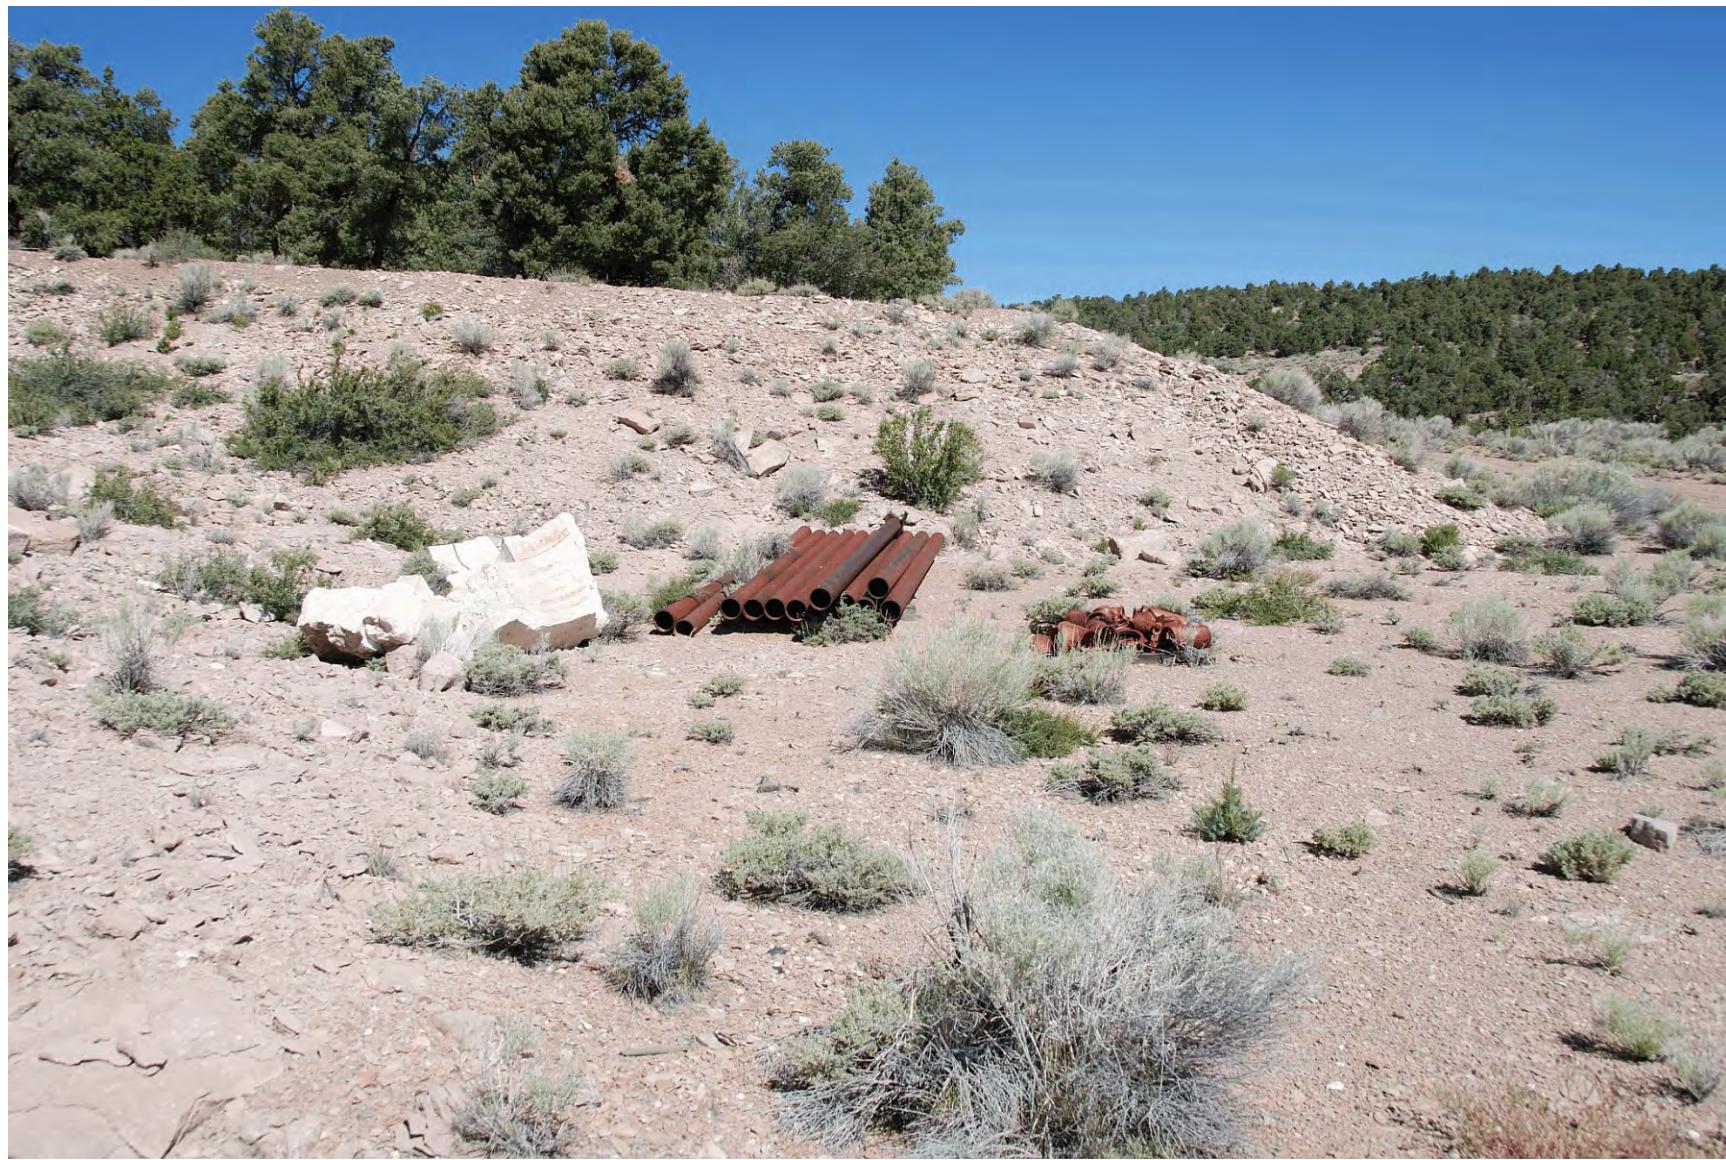
Feature 190 (Figures 360 and 361) is pipe, pipe fittings, and concrete at UTM coordinates 570512 E, 4118154 N at the U-12n.20 PH #1. The feature consists of 12 joints of 6-inch diameter by 20 ft long Victaulic pipe stacked on two pieces of 4 x 4 inch milled lumber. A 6-inch butterfly valve is attached to the end of one pipe. Near the pipe on a wood pallet are three 90 degree, two 45 degree, four T connections, and twelve clamps and rubber gaskets (all 6 inch Victaulic). Near the pipe is concrete that was used to grout pipe to the surface or within a larger pipe.

Figure 361. Feature 190, Victaulic pipe, fittings, and concrete at the U-12n.20 PH #1, U12n Tunnel, view west (2008).

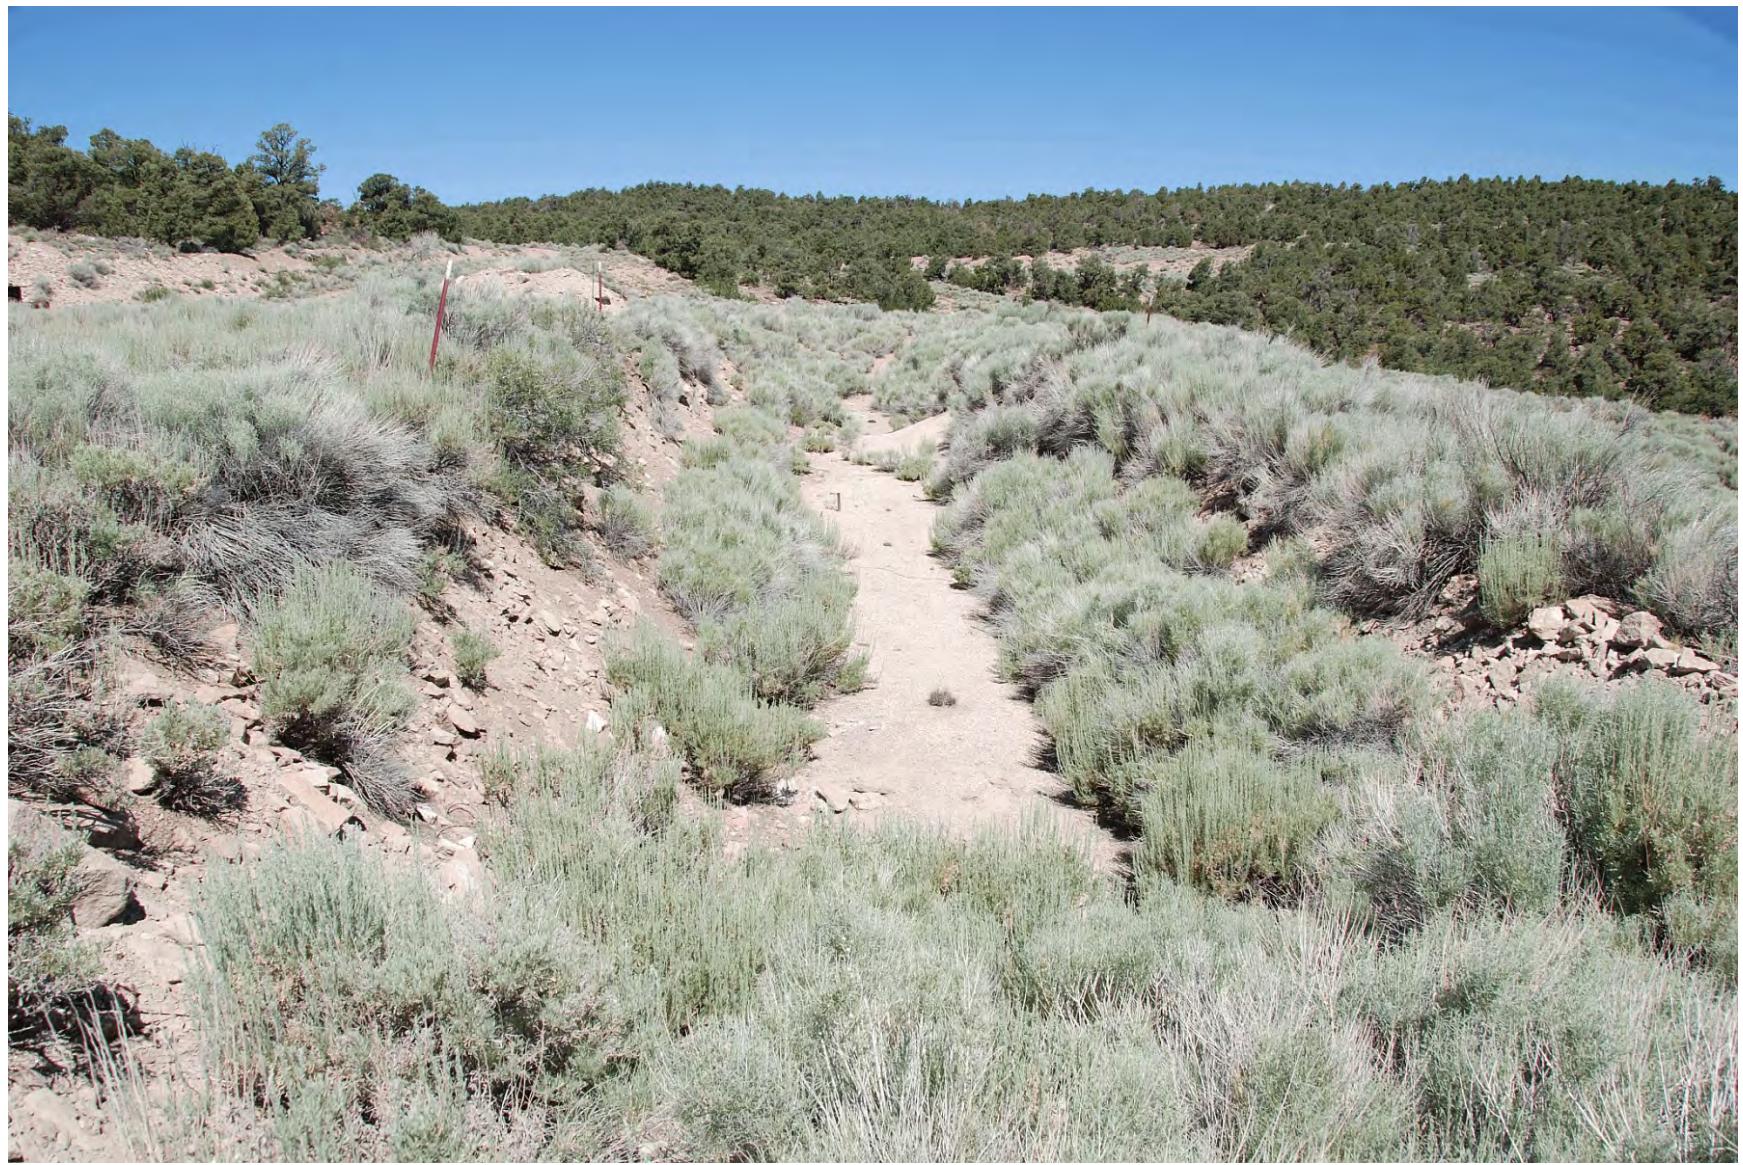
Feature 191 (Figures 360 and 362) is a drill hole mud pit at UTM coordinates 570566 E, 4118175 N. The feature is 125 ft east-west by 26 ft north-south and is 4 ft deep with three metal T posts that once supported a fence.

Figure 362. Feature 191, drill hole mud pit at U-12n.20 PH #1, view west, (2008).

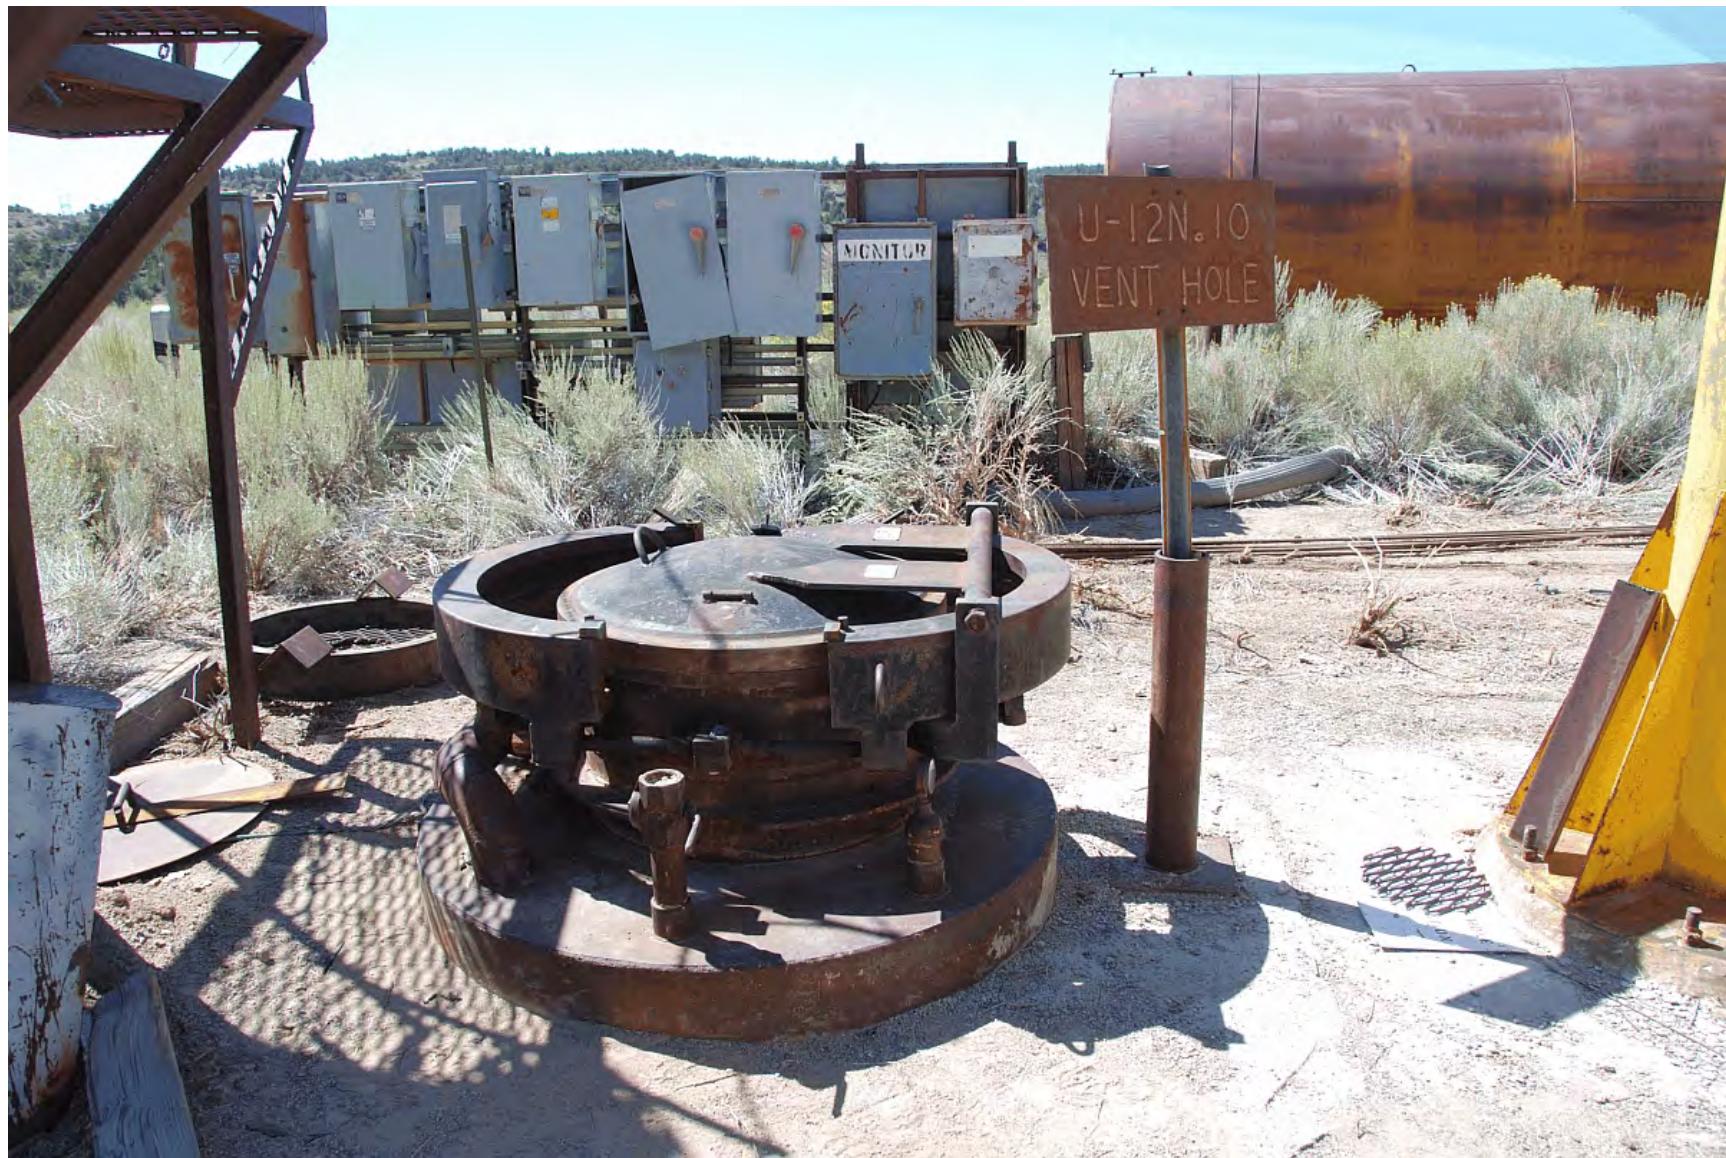
Figure 366. Feature 192, U-12n.10 Vent Hole, U12n Tunnel, view south (2008).
