A total of 202 features were recorded, mapped, and photographed for the U12n Tunnel complex. The project area encompassed 600.8 acres (243.1 hectares) at the portal and mesa areas. At the U12n portal area are ten sub-areas containing features related to the construction, testing, and general everyday activities within the tunnel. These include concrete foundations for buildings, communications equipment, mining equipment, rail lines, retention ponds, storage containers, and access control facilities. Only a telephone trailer remains on the telephone pad as all of the other buildings have been removed from the portal area. The microwave tower, portions of the rail lines, the muck car dump, rotary dump, and wash rack are still in place. Also, the traffic control point and powder magazines along N Tunnel Road are intact. At the mesa area are four sub-areas containing features generally related to pre- and post-shot drilling, recording facilities, and ventilation equipment. These include concrete foundations, instrument cable holes, and drill holes. The concrete foundations were for buildings and small equipment. Concrete pads and various equipment remain at the cable hole locations bu

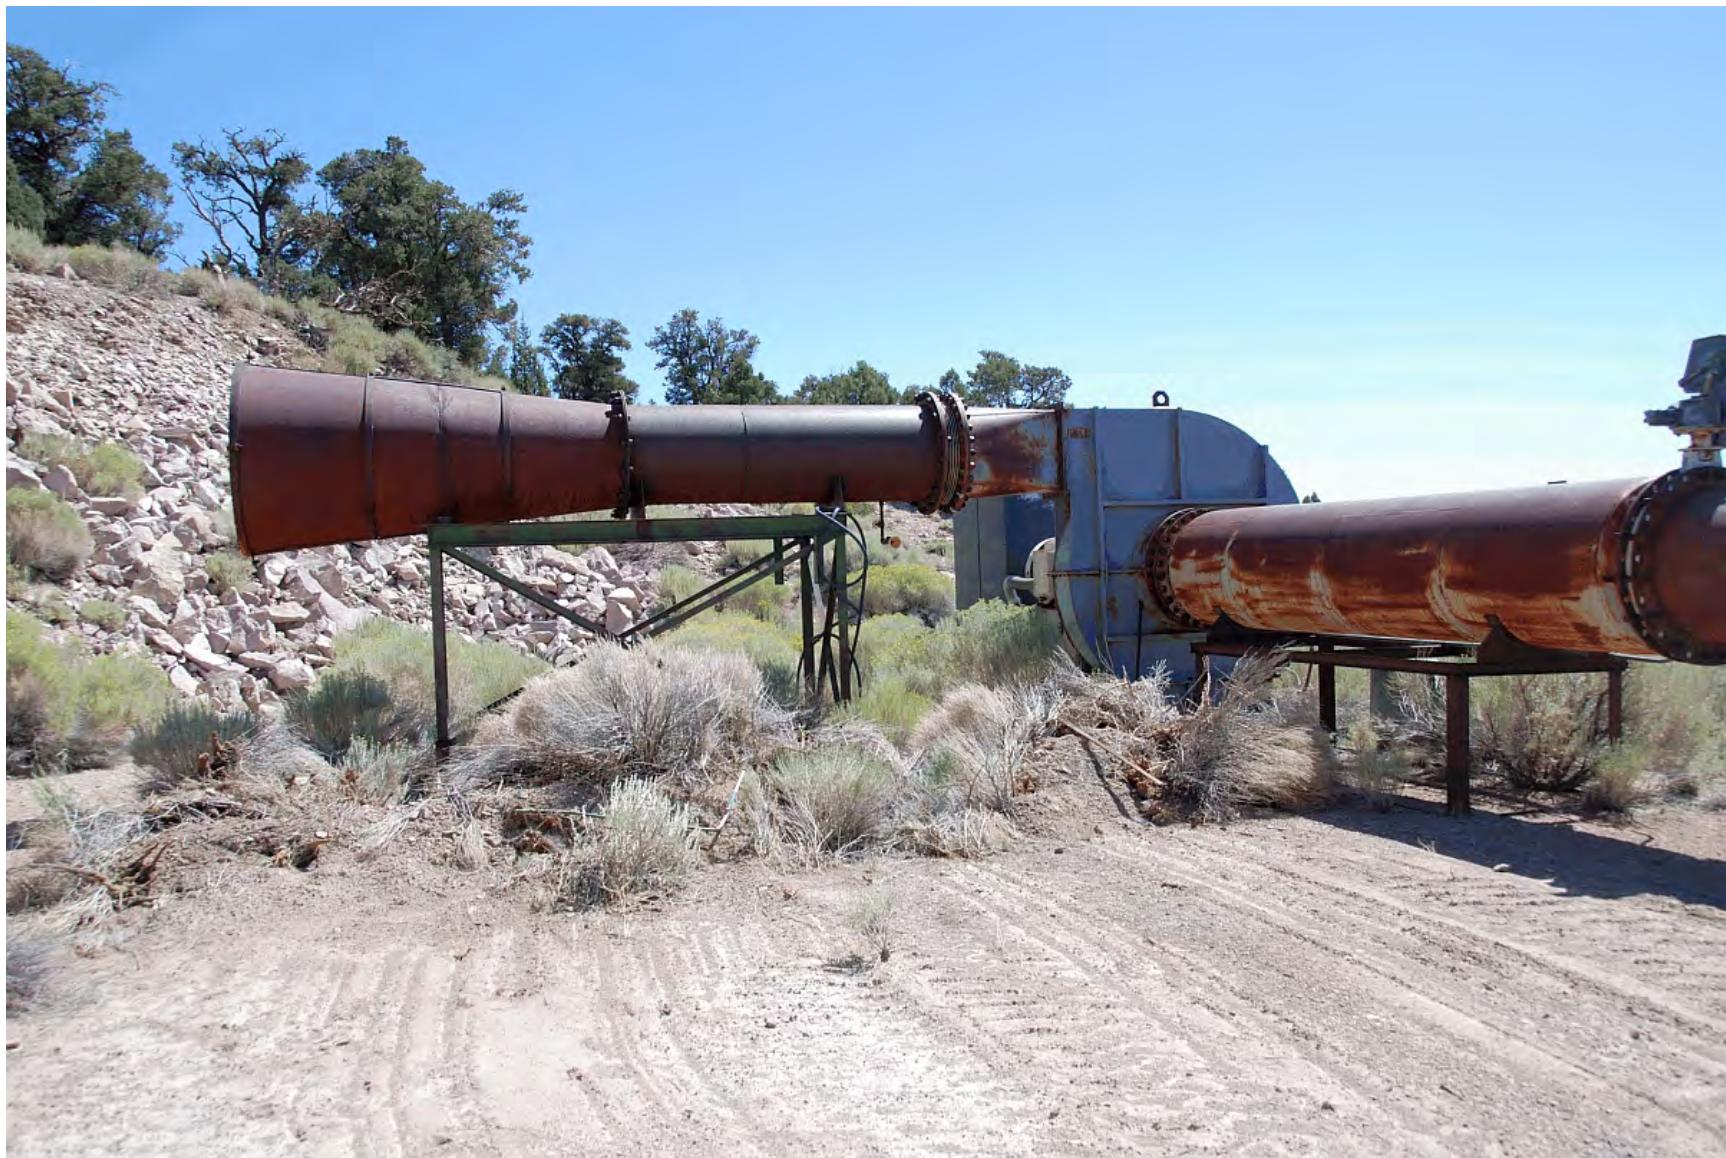
Figure 367. Feature 192, Buffalo Blower and vent lines at the U-12n.10 Vent Hole, U12n Tunnel, view east (2008).

remote controlled dampers used to control the cubic feet per minute of tunnel ventilation. The 3-ft vent lines extends 17 ft east and is attached to Buffalo Blowers. Exiting the top of the blowers are rectangular to round couplings that are attached to flexible 3 ft diameter vibration dampeners and then to 3 ft diameter vent lines that are 9 ft in length. The vent lines then expand to 4 ft 8 inches in diameter over the last 10 ft. The ends are sealed with expanded metal. The vent lines exiting the blowers are supported by rectangular metal frames that are 10 ft long, 4 ft wide, and 6 ft 4 inches in height. The legs of the frames are set in 3 ft square concrete pads.

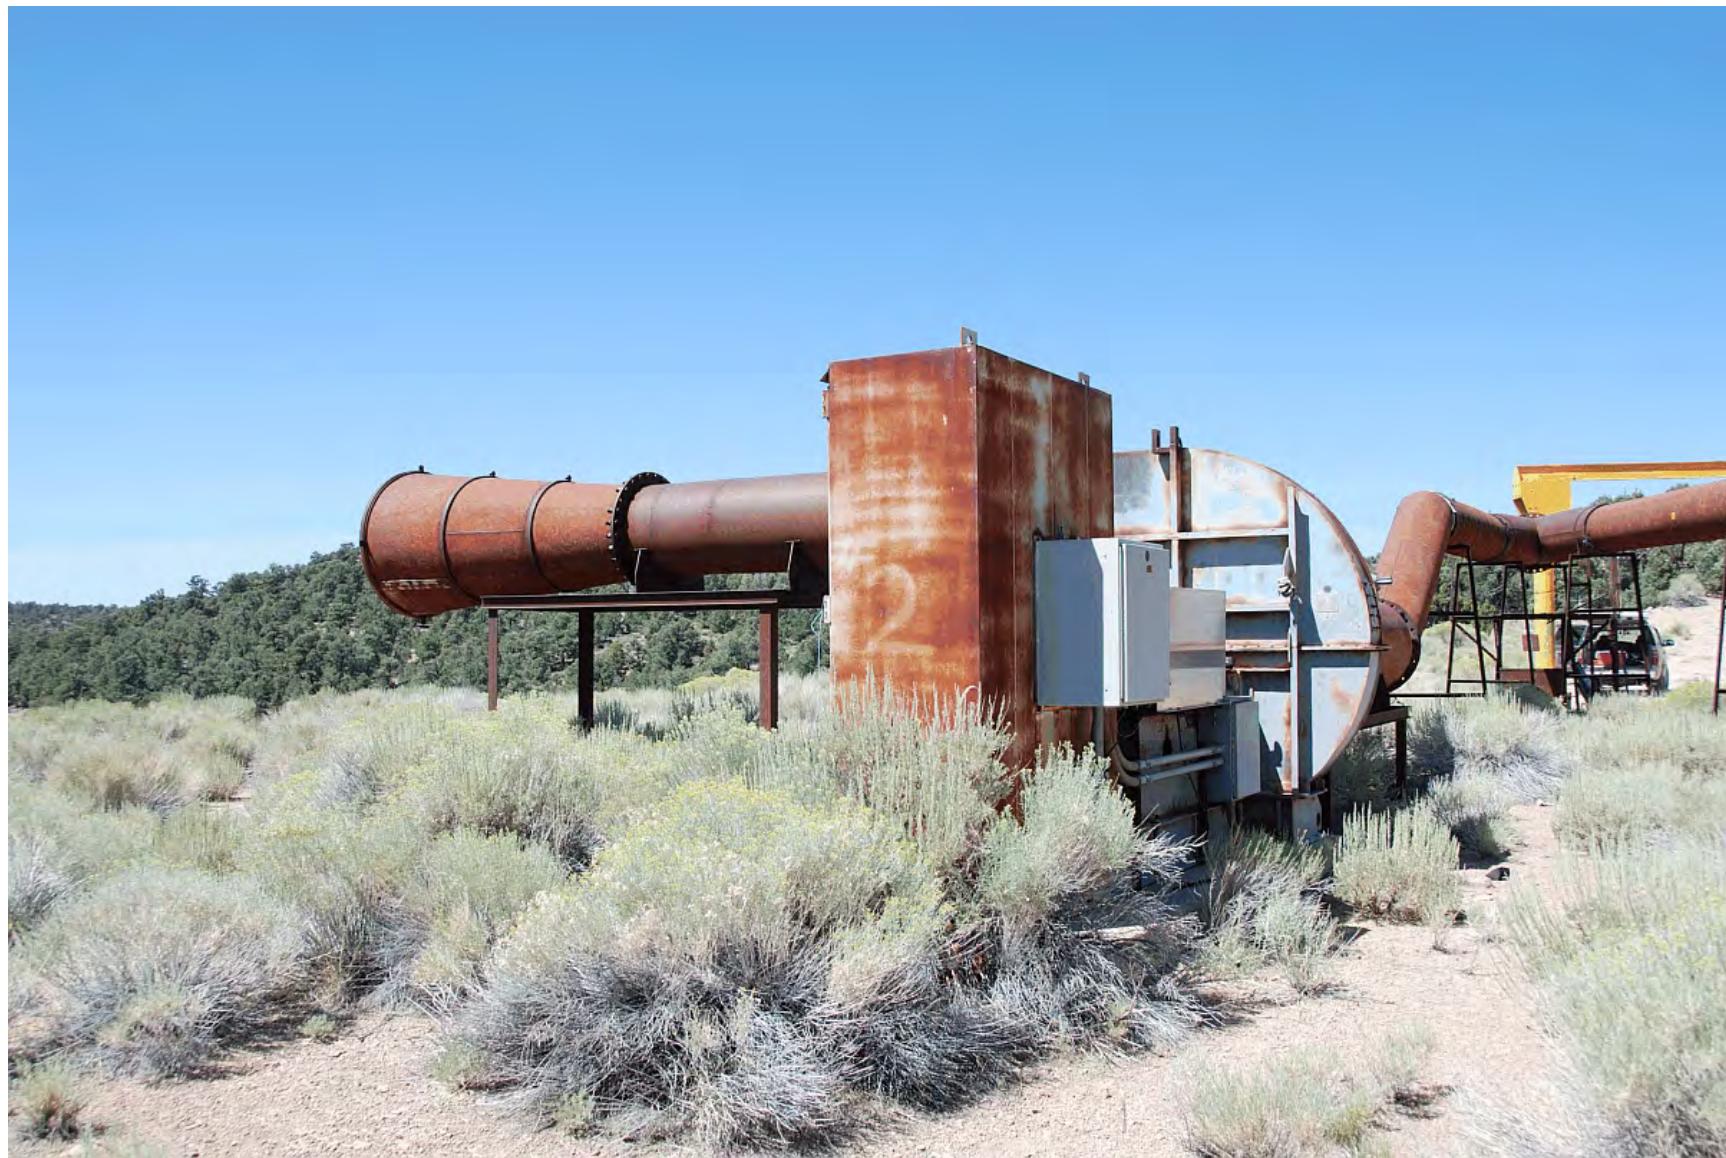
Figure 368. Feature 192, electrical panel and Buffalo Blower at the U-12n.10 Vent Hole, U12n Tunnel, view southwest (2008).

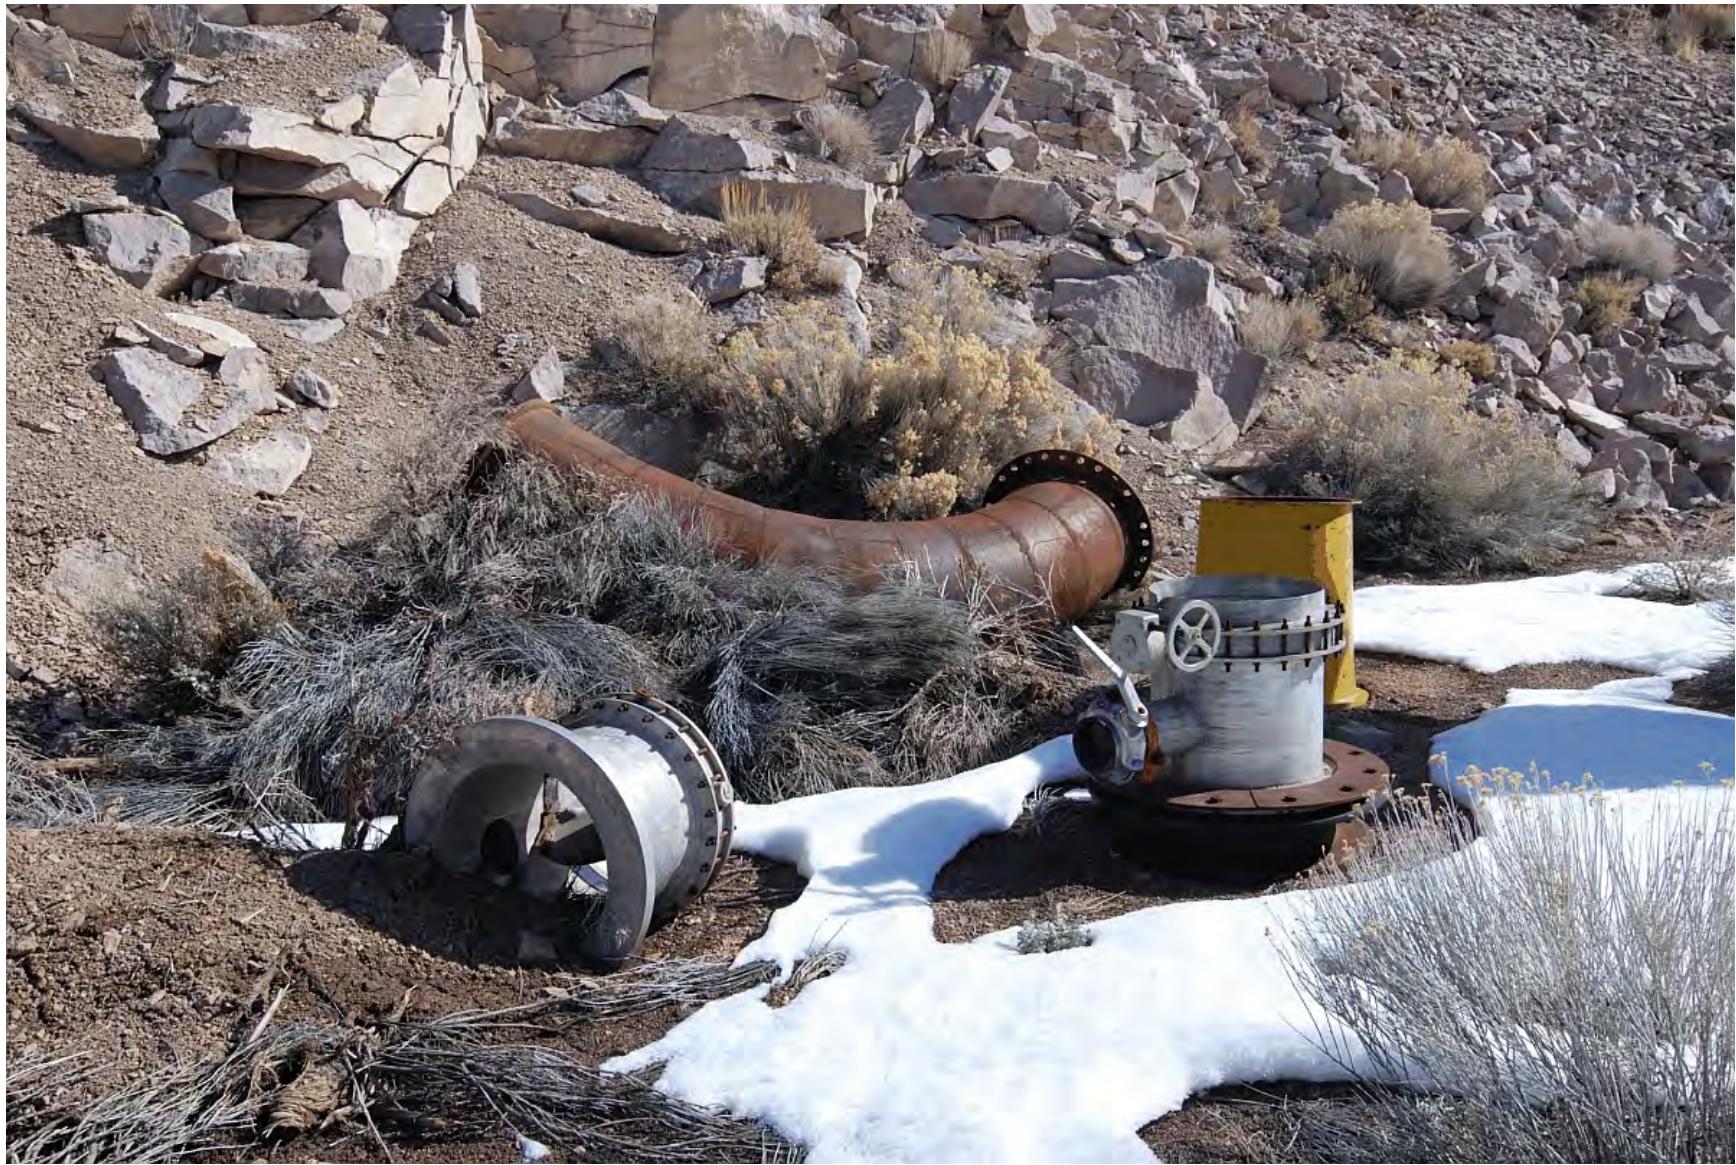
Feature 193 (Figures 363 and 369) is equipment at UTM coordinates 570524 E, 4118011 N. The equipment is two pieces of vent line and two butterfly valves. The vent line is a 2 ft 6 inch diameter 90 degree elbow that is 9 ft in length and a 2 ft 6 inch to 2 ft (end diameter) straight reducer vent line that is 2 ft 10 inches in length. Both were attached to the west end of the vent line and to the vent hole casing during normal operations. The butterfly valves are 1 ft 8 in diameter and manually operated. After removal of the 90 degree elbow, a butterfly valve was connected to the vent hole casing to facilitate pressurization, leak checking, and depressurization of the tunnel prior to each nuclear test.

Figure 369. Feature 193, stored equipment at the U-12n.10 Vent Hole, U12n Tunnel, view northeast (2009).

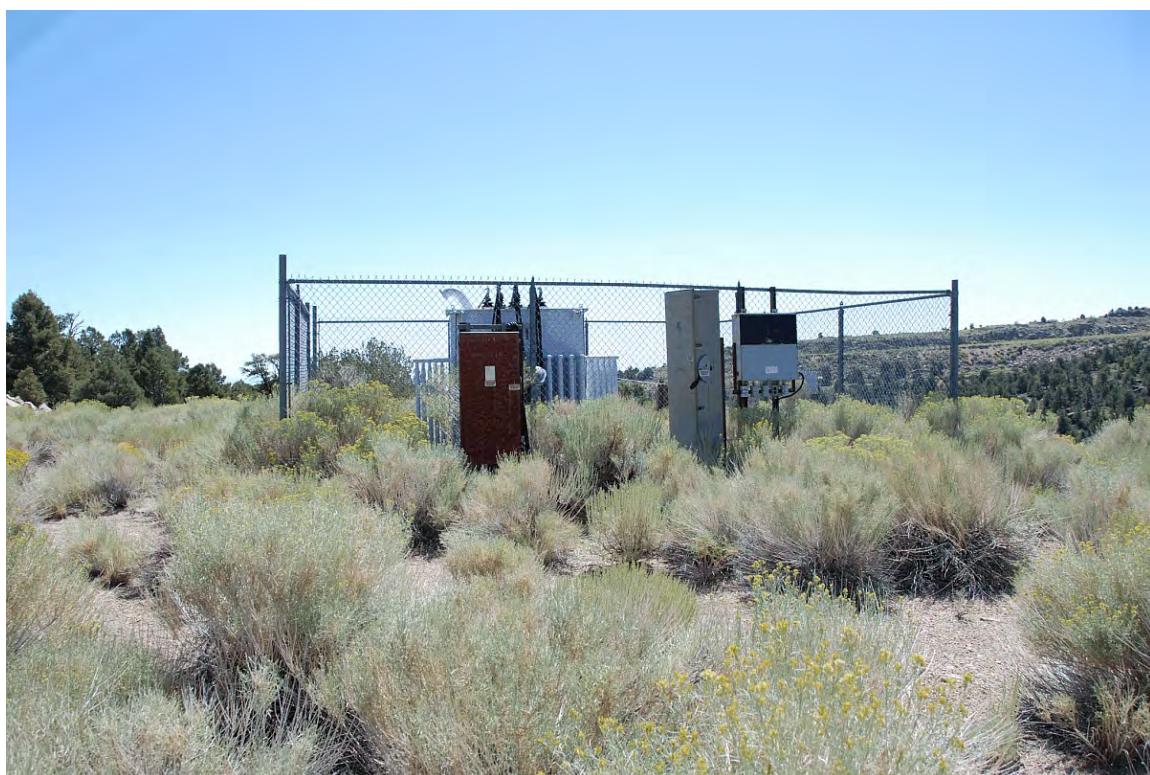
Feature 194 (Figures 363 and 370) is the electrical substation for the U12.10 Vent Hole at UTM coordinates 570526 E, 4117992 N. It consists of a chain link fence, electrical transformer, automatic switches, and electrical panel. The chain link fence is 24 ft east-west by 24 ft north-south by 7 ft 8 inches in height. On the north side at the east corner is a 5 ft wide locked gate. Entry into the fenced area is not allowed. Inside is an electrical transformer 5 ft from the north fence and 3 ft 4 inches from the west fence. It is approximately 5 x 3 x 6 ft and supported by a concrete pad. Two feet east of the transformer is a set of 2 x 3 ft automatic oil filled switches. On the exterior of the west fence 5 ft from the north corner is a 4 ft x 1 ft 10 inch x 2 inch electrical panel box supported by two 3-inch angle iron legs that are 6 ft in height. A second panel box is 5 ft 6 inches x 1 ft 10 inches x 1 ft and is 5 ft 4 inches to the south of the first box. It is supported by two pieces of 2-inch channel iron 5 ft 8 inches in length. A third panel box is 2 ft 3 inches x 2 ft 1 inch x 8 inches and is 1 ft 4 inches south of the second box. The panel box is 4 ft above the surface attached to two 1 1/2-inch angle iron legs that are 6 ft in height. Attached to the bottom of the box are five 110 v electrical plug boxes.

Figure 370. Plan map and photograph of Feature 194, electrical substation for the U12n.10 Vent Hole, U12n Tunnel, view east (2008).

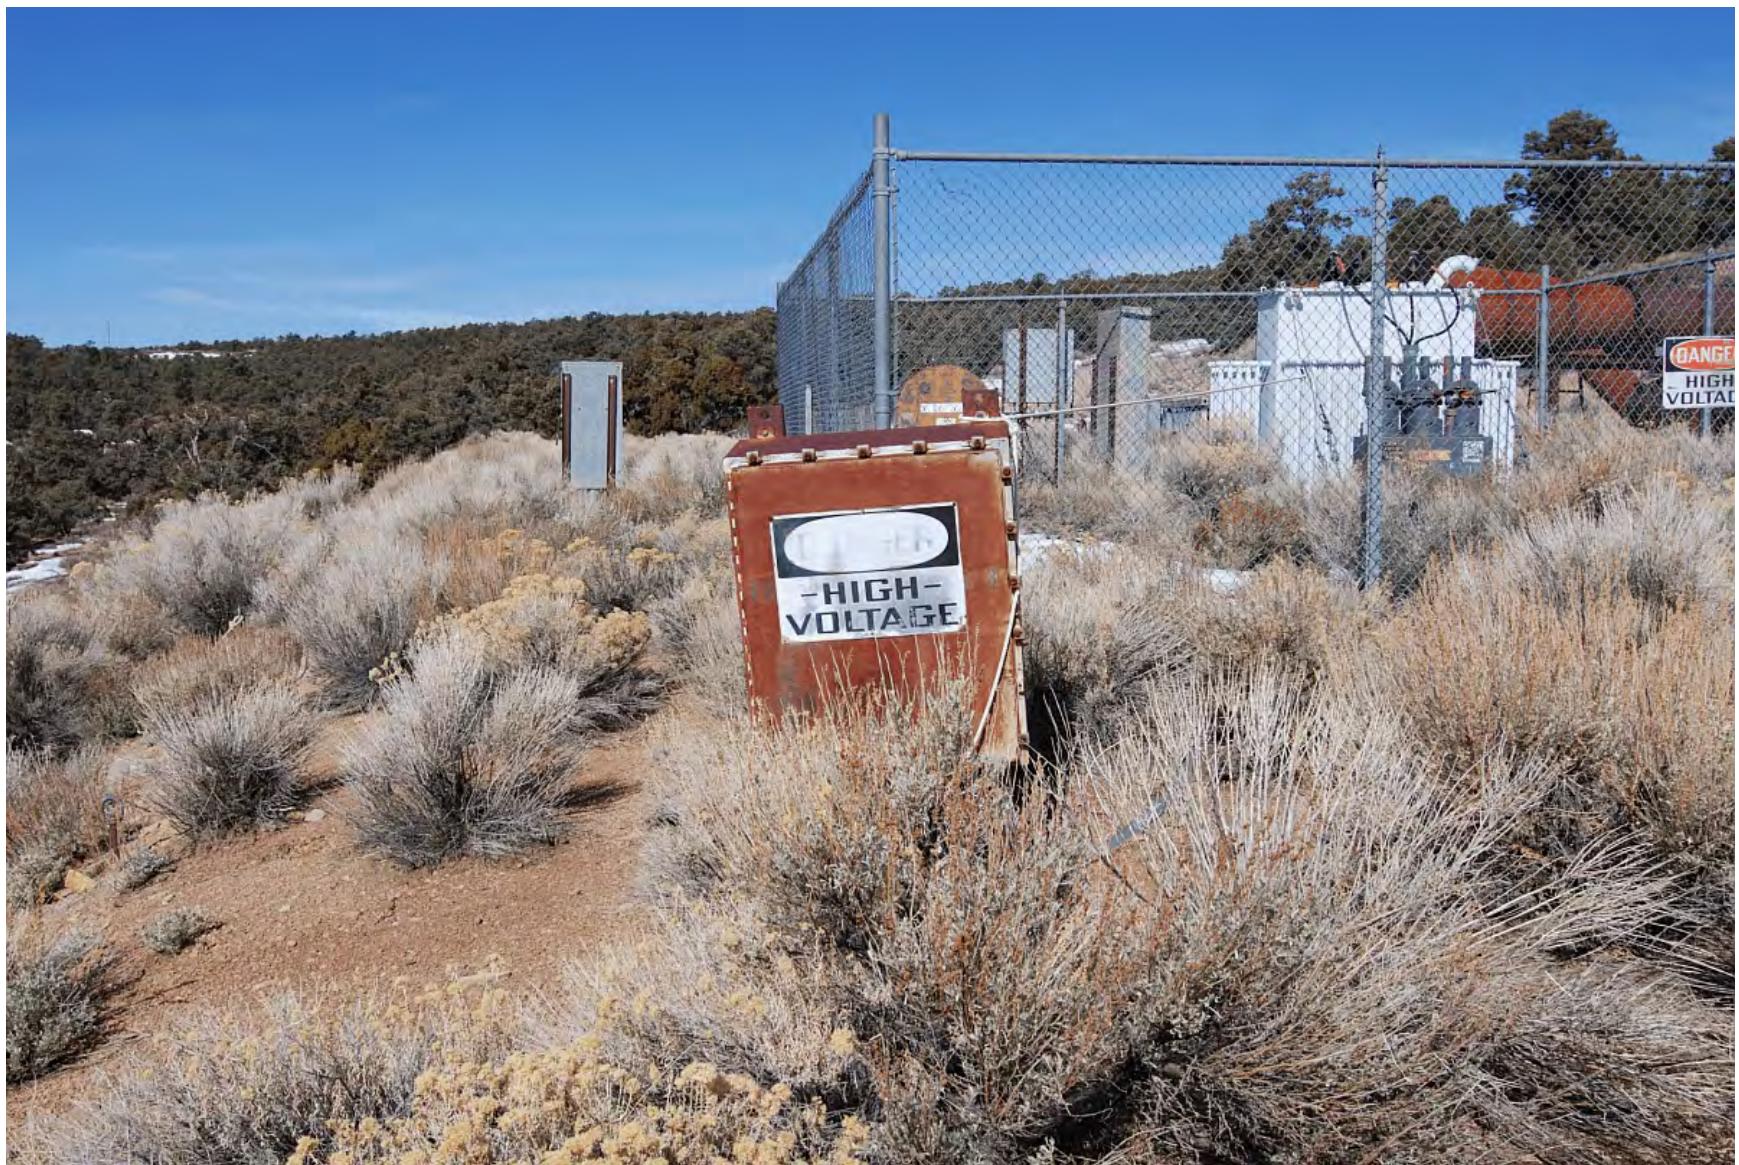
Feature 195 (Figures 363 and 371) is an electrical panel at UTM coordinates 570530 E, 4117983 N. The panel is 2 ft 6 inches x 1 ft x 3 ft and attached to two 4-inch channel iron legs that are 4 ft 8 inches in height. It is labeled DANGER HIGH VOLTAGE on the door panel.

Figure 371. Feature 195, electrical panel for the U12n.10 Vent Hole, U12n Tunnel, view northwest (2009).

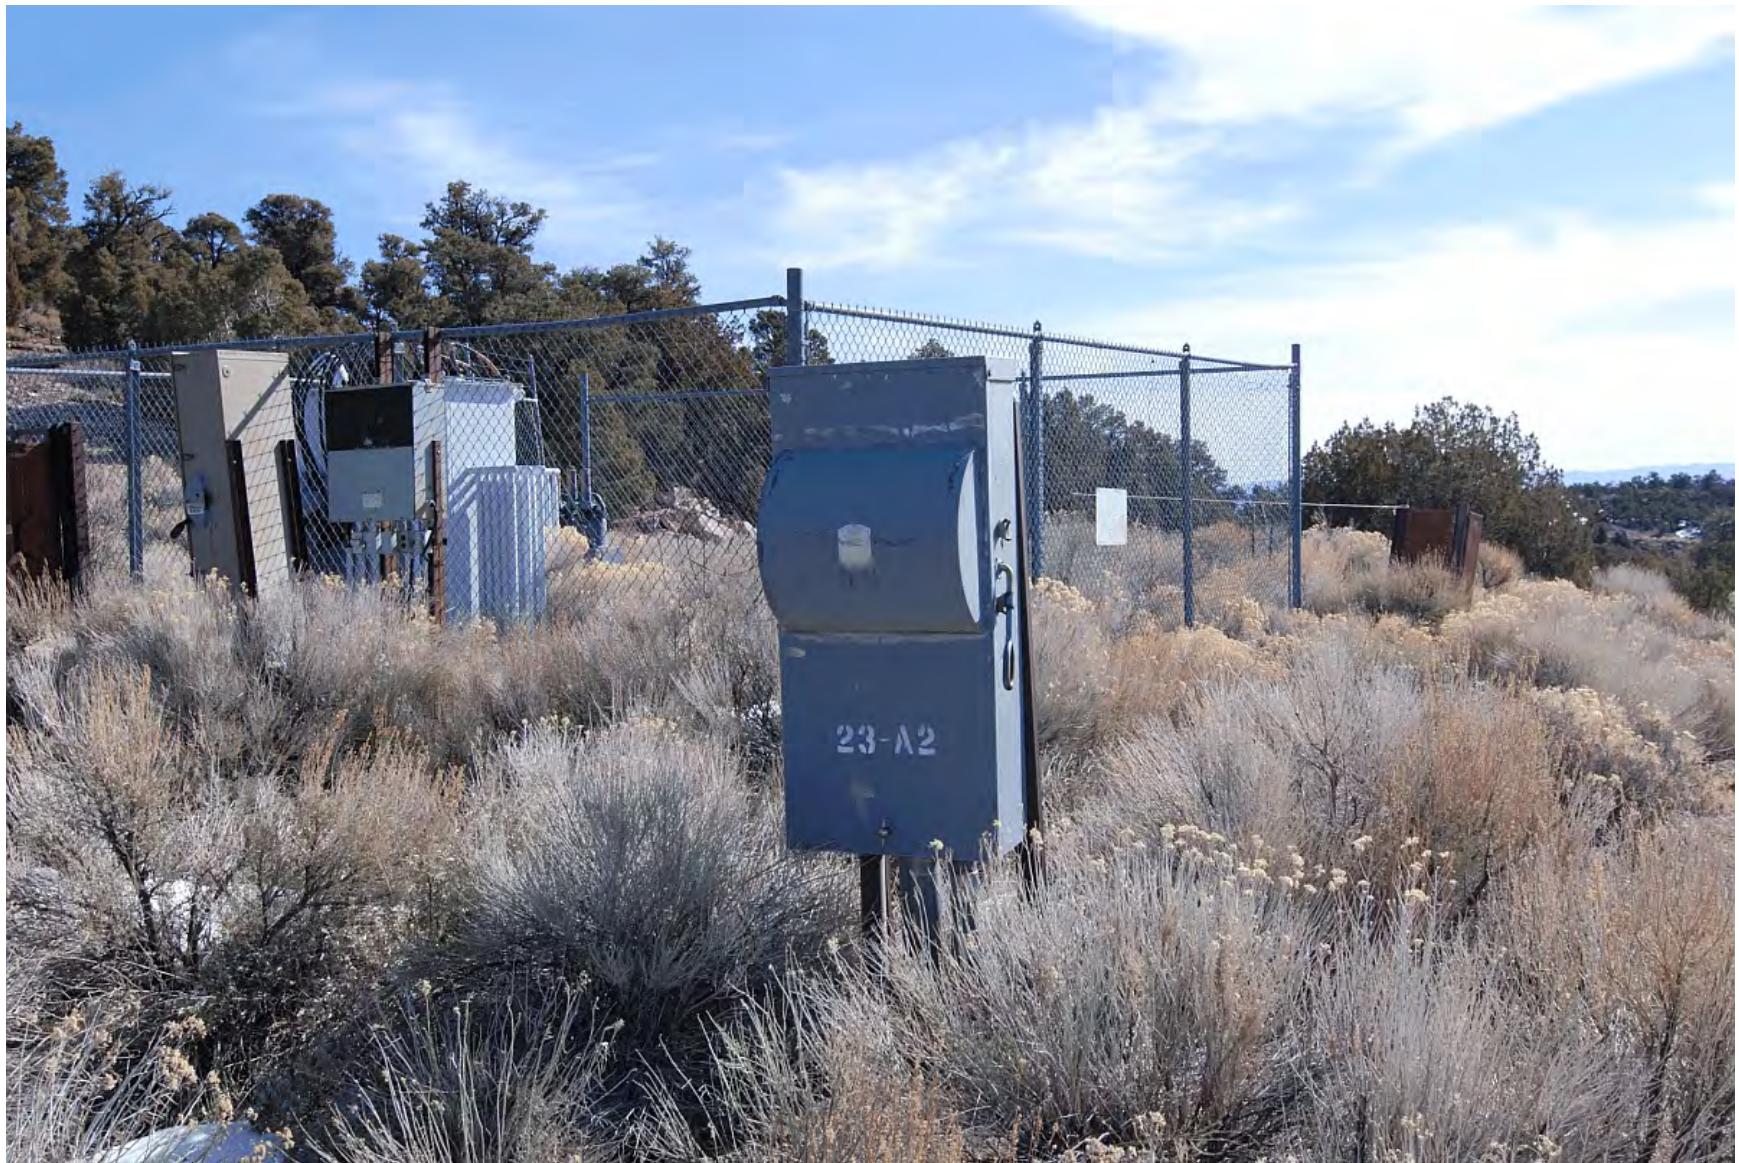
Feature 196 (Figures 363 and 372) is an electrical panel at UTM coordinates 570515 E, 4117989 N. The panel is 2 ft x 10 inches x 54 inches and supported by two 3-inch channel iron legs that are 6 ft in height. Two 3-inch and one 4- inch conduits extends from the bottom of the panel to the substation (Feature 194). It is labeled 23-A2 on the door panel.

Figure 372. Feature 196, electrical panel, U12n Tunnel, view northeast (2009).

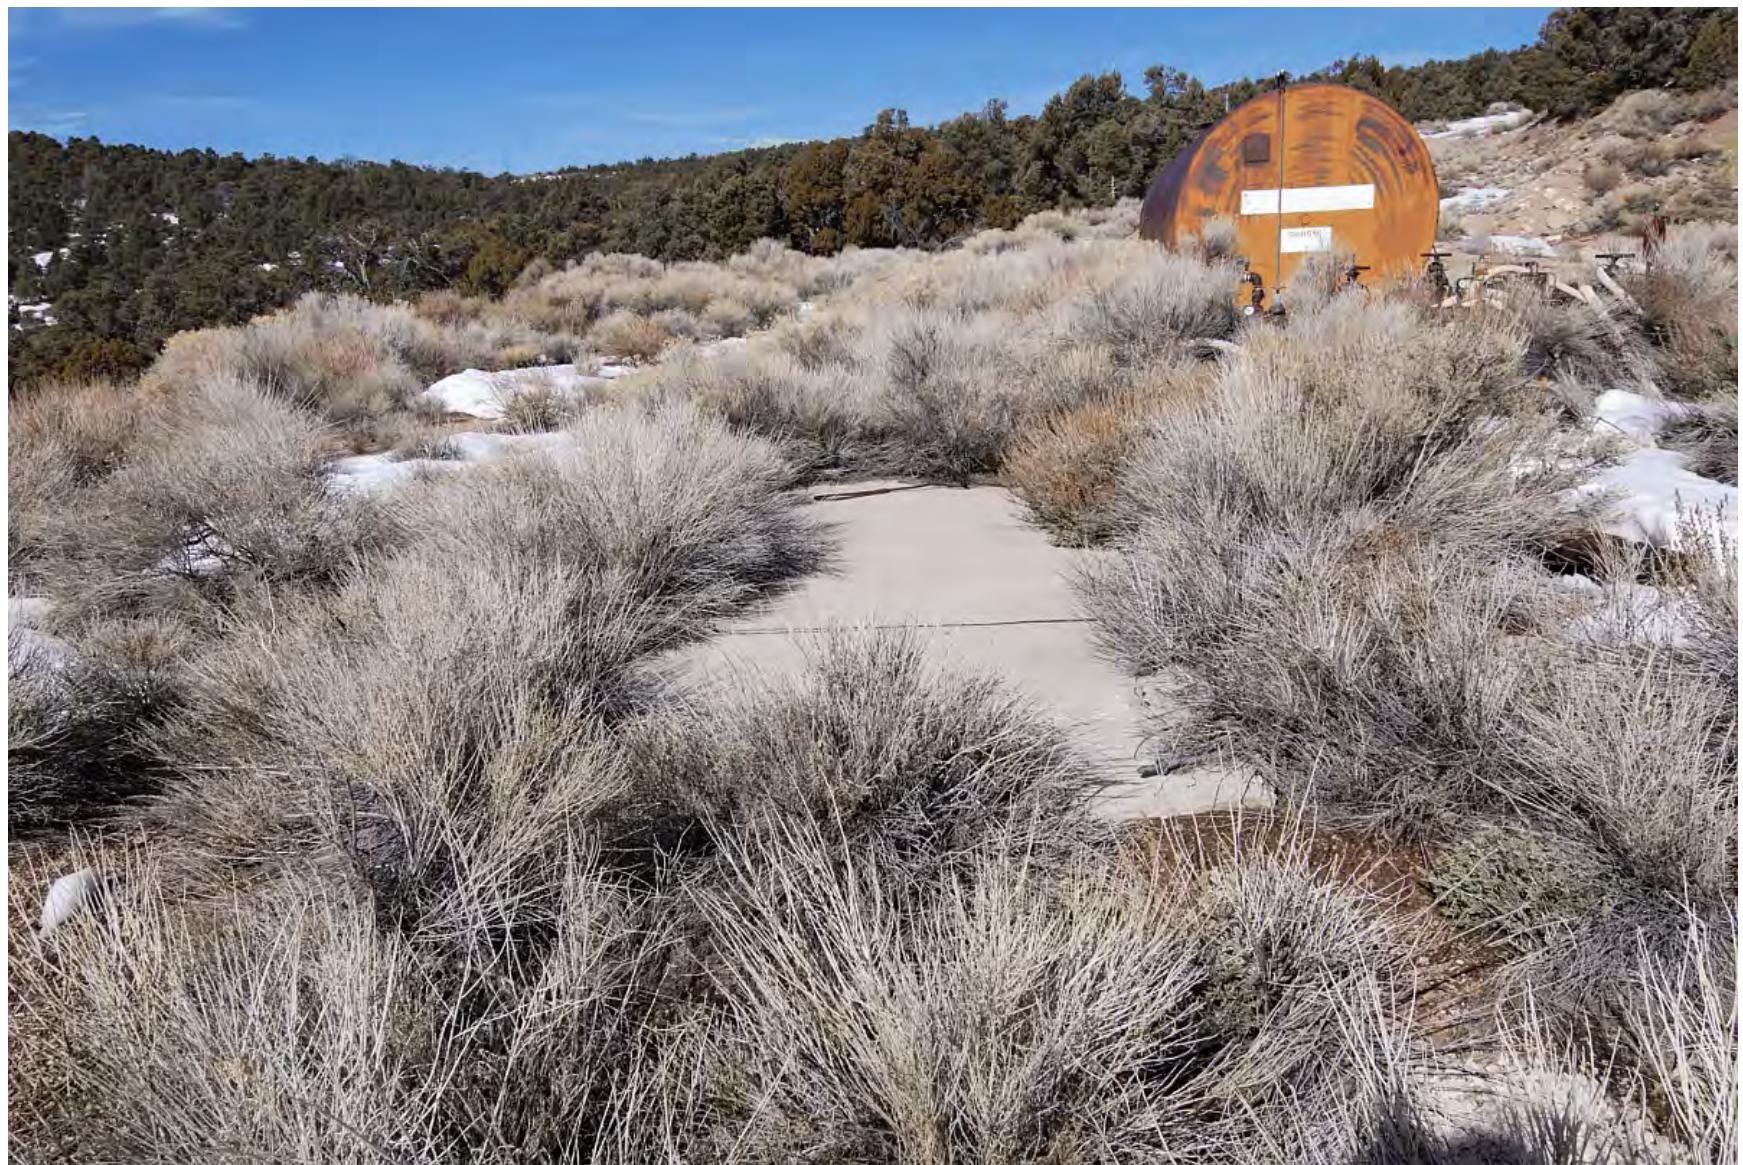
Figure 373. Feature 197, concrete pad at the U-12n.10 Vent Hole, U12n Tunnel, view northwest (2009).

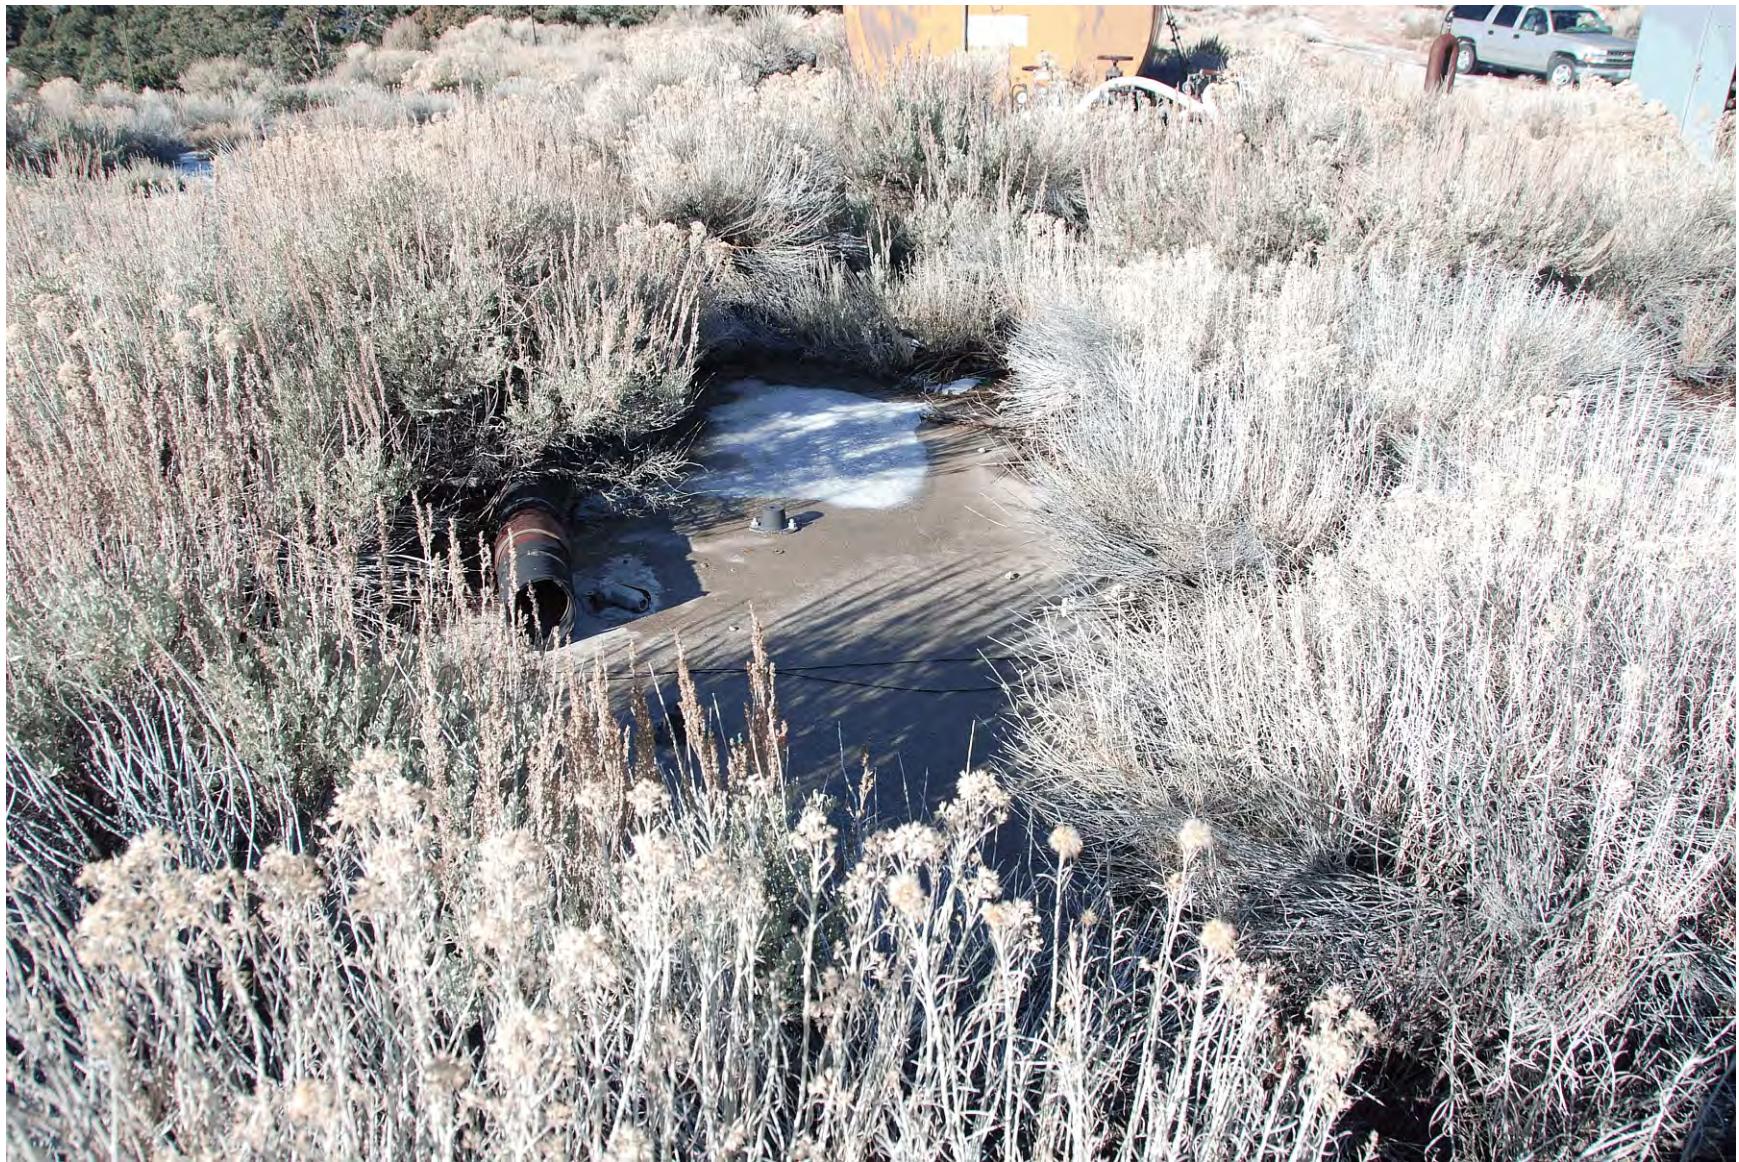
Figure 374. Feature 198, concrete pad at the U-12n.10 Vent Hole, U12n Tunnel, view northwest (2010).

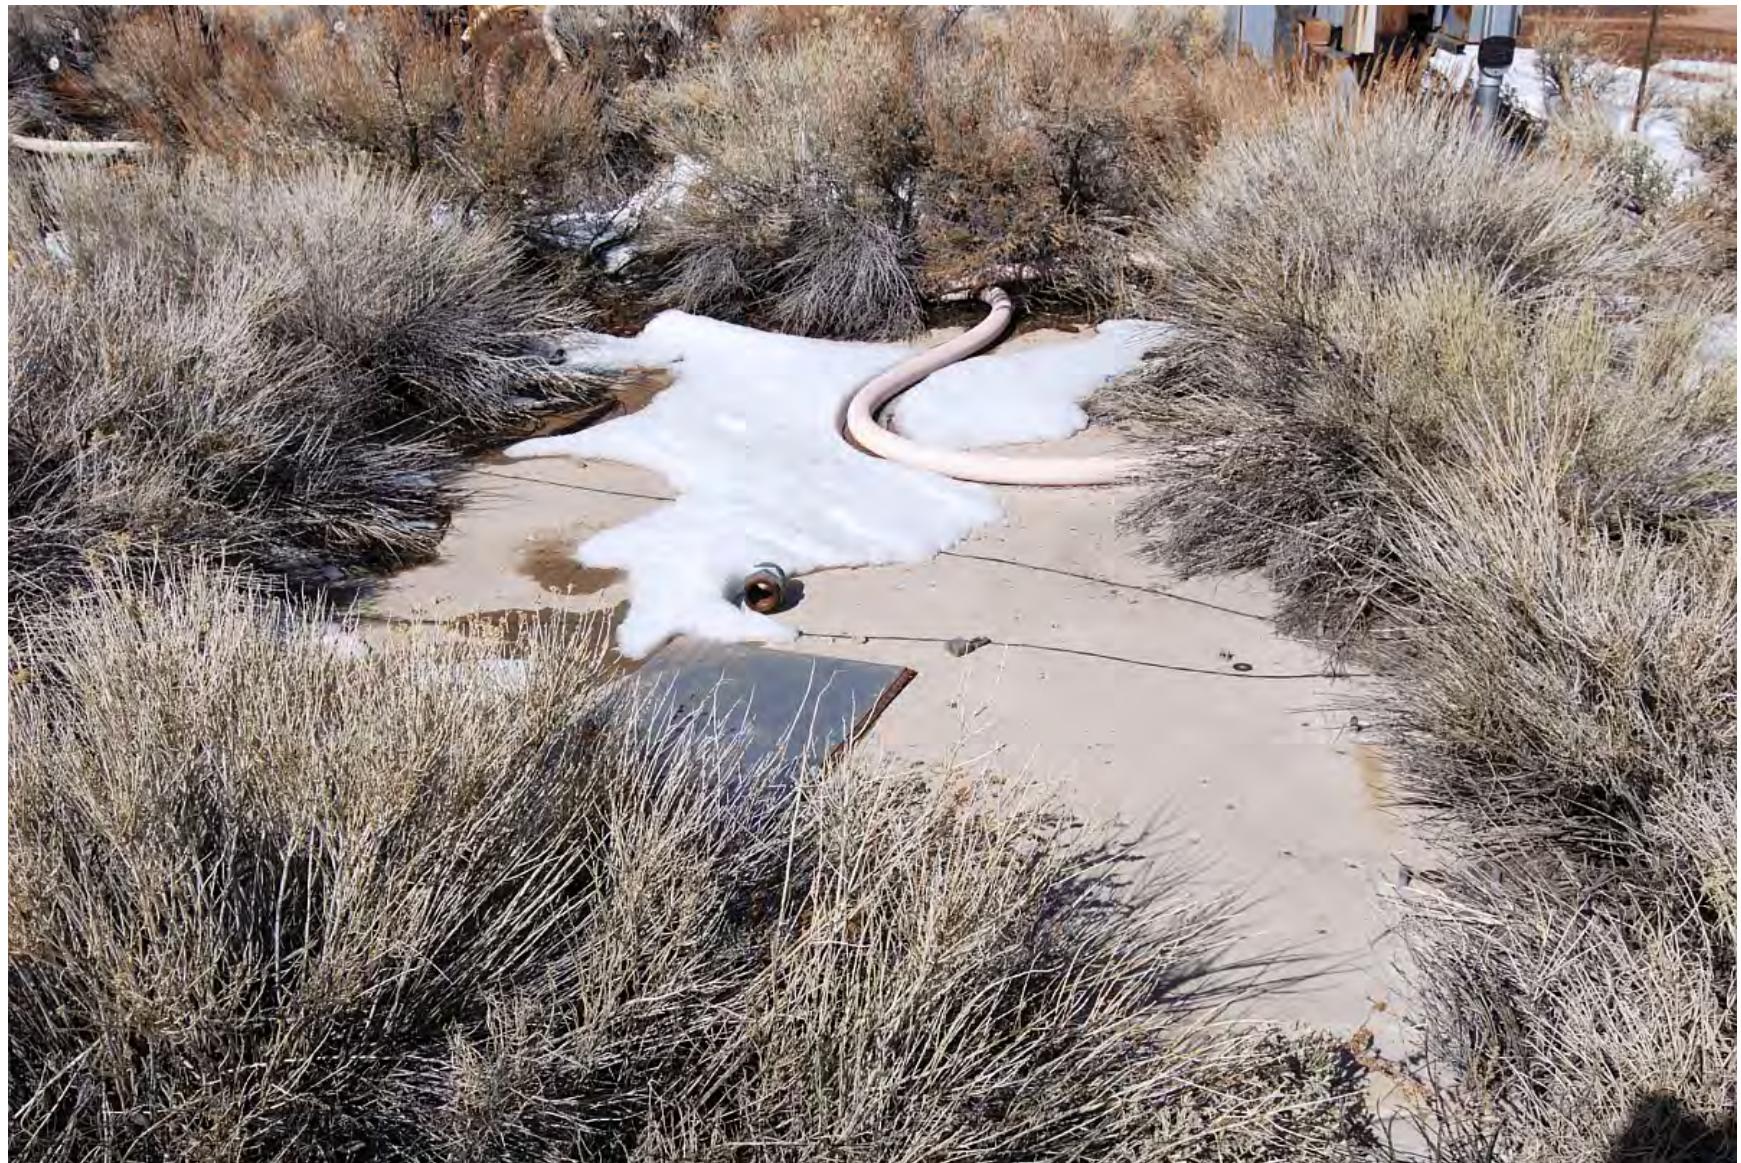
Figure 375. Feature 199, concrete pad at the U-12n.10 Vent Hole, U12n Tunnel, view northwest (2009).

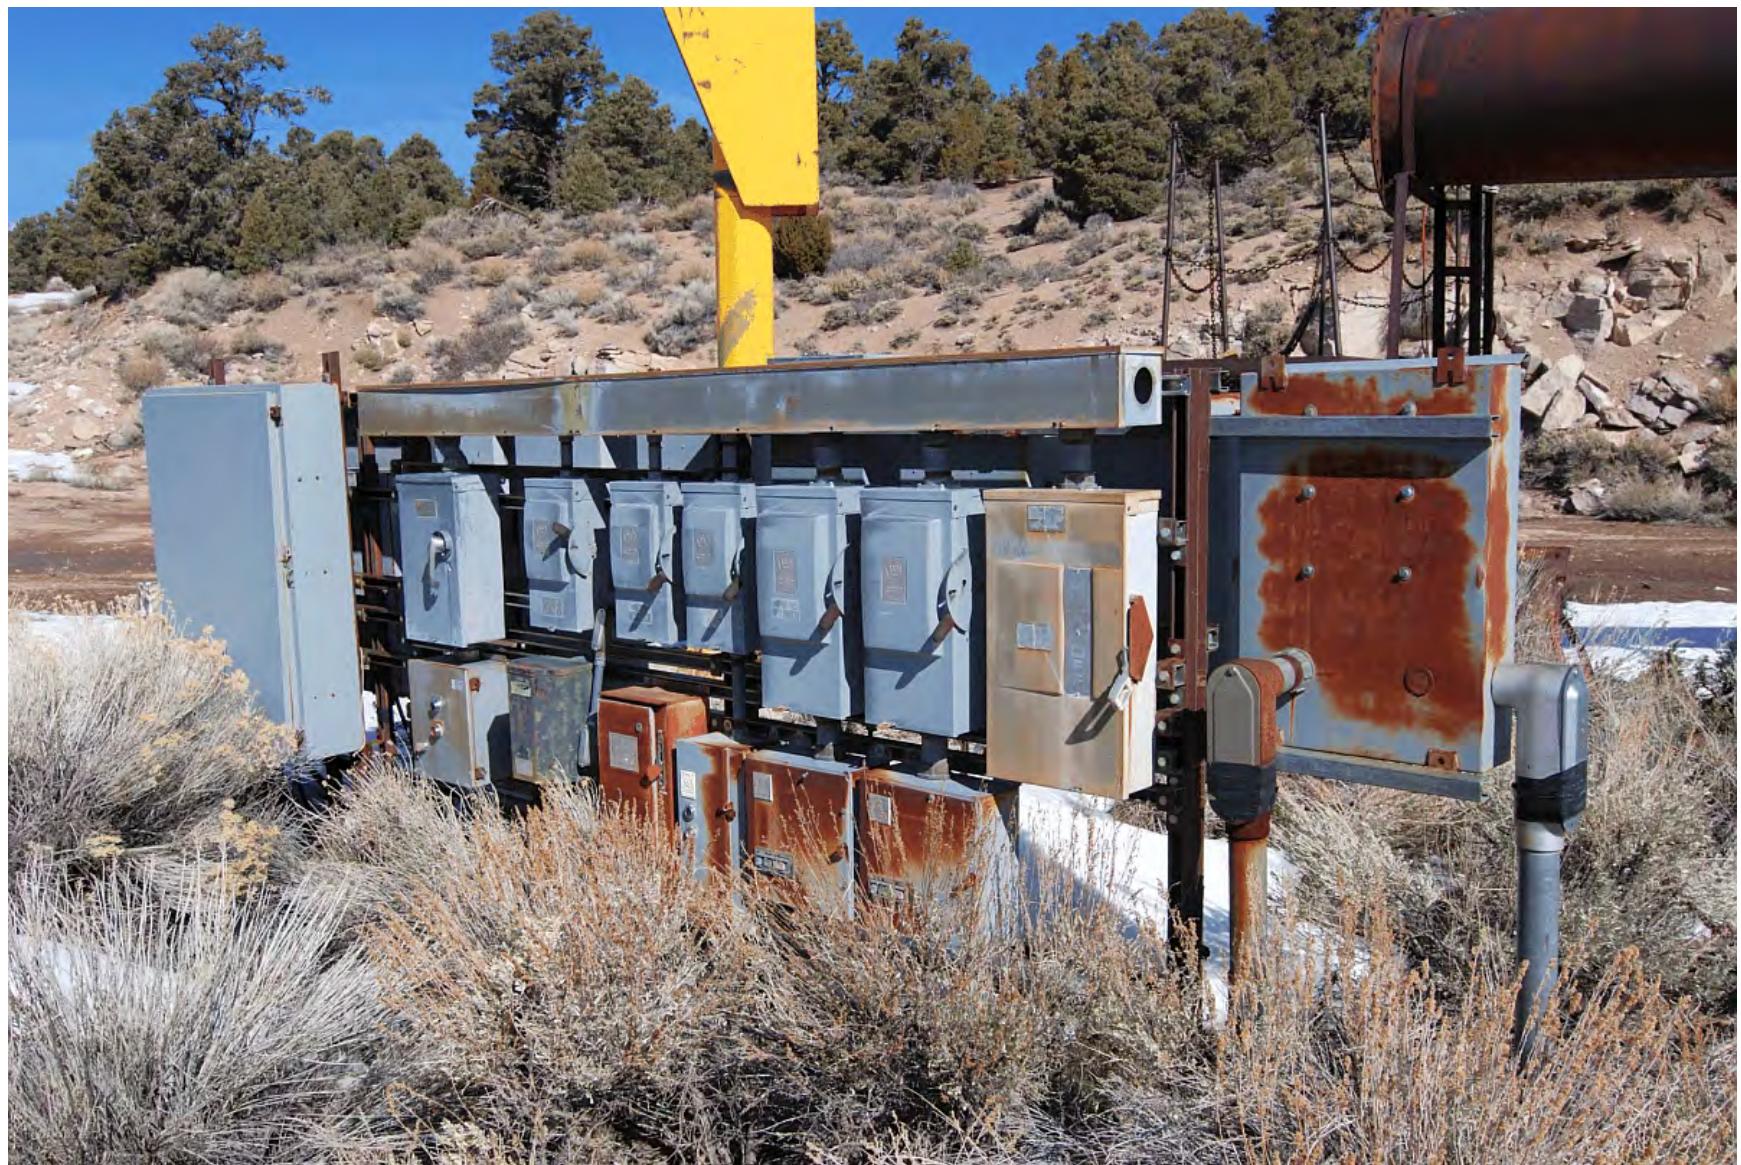
Figure 376. Feature 200, electrical panel backboard at the U-12n.10 Vent Hole, U12n Tunnel, view north (2009).

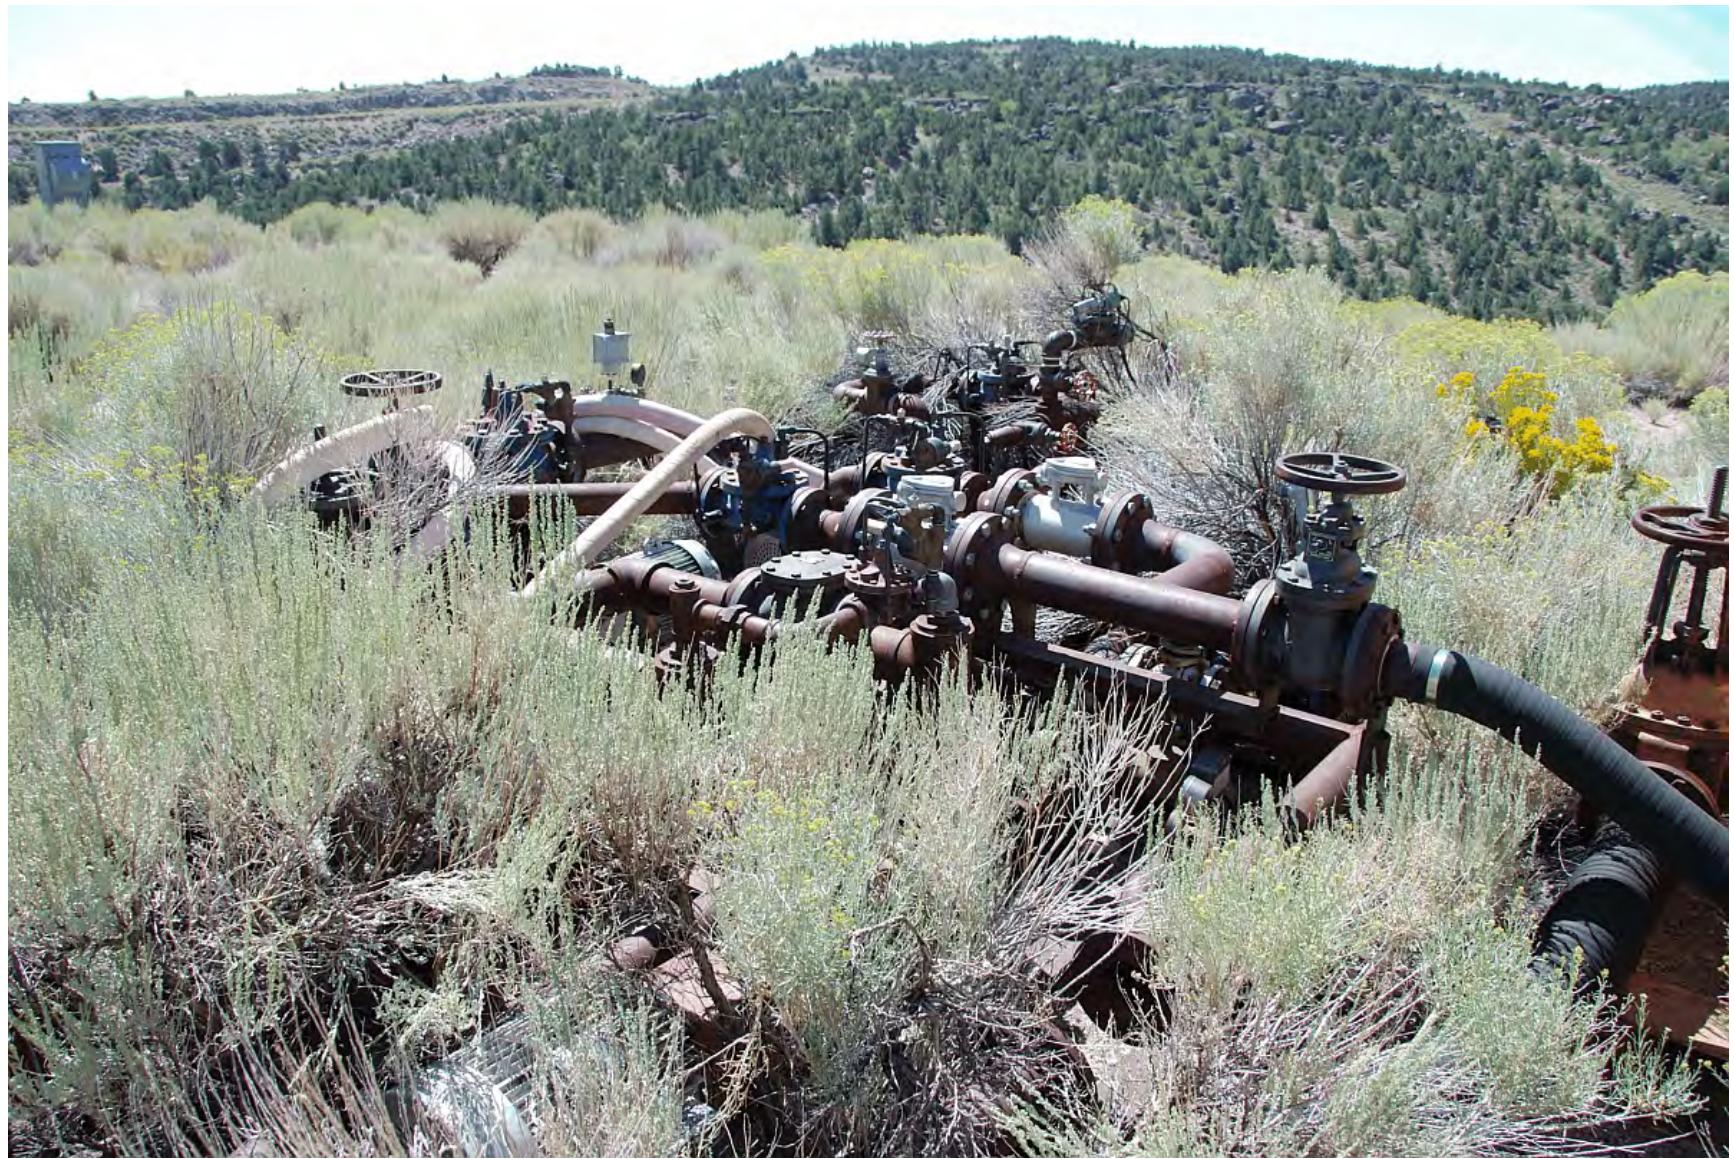
Feature 201 (Figures 363 and 377) is the tunnel chill water system pump skid at UTM coordinates 570502 E, 4118002 N. The chiller has been removed. The skid consists of various sized pipes, hoses, valves, three pumps, and three electric motors. The pump skid is at the east end of the metal tank (Feature 202).

Figure 377. Feature 201, chill water pump skid at the U-12n.10 Vent Hole, U12n Tunnel, view southeast (2008).
