A total of 202 features were recorded, mapped, and photographed for the U12n Tunnel complex. The project area encompassed 600.8 acres (243.1 hectares) at the portal and mesa areas. At the U12n portal area are ten sub-areas containing features related to the construction, testing, and general everyday activities within the tunnel. These include concrete foundations for buildings, communications equipment, mining equipment, rail lines, retention ponds, storage containers, and access control facilities. Only a telephone trailer remains on the telephone pad as all of the other buildings have been removed from the portal area. The microwave tower, portions of the rail lines, the muck car dump, rotary dump, and wash rack are still in place. Also, the traffic control point and powder magazines along N Tunnel Road are intact. At the mesa area are four sub-areas containing features generally related to pre- and post-shot drilling, recording facilities, and ventilation equipment. These include concrete foundations, instrument cable holes, and drill holes. The concrete foundations were for buildings and small equipment. Concrete pads and various equipment remain at the cable hole locations bu

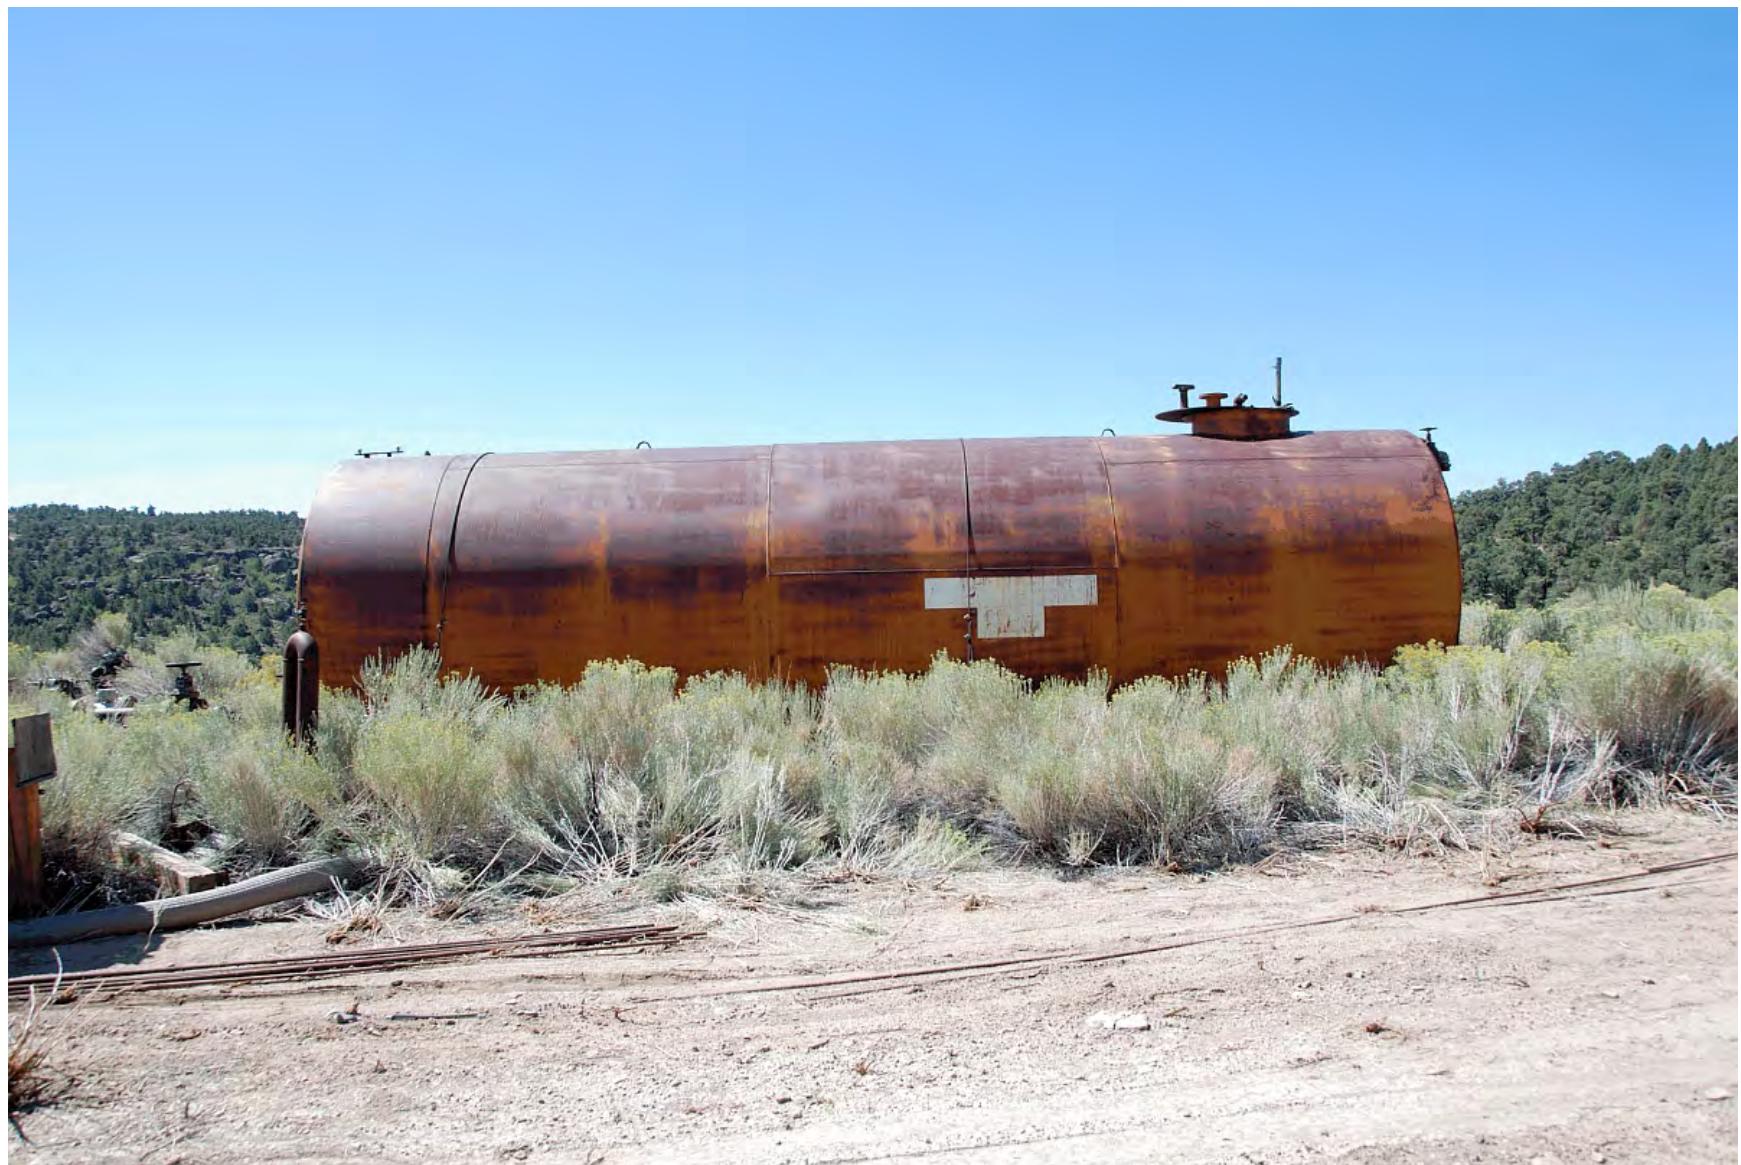
Figure 378. Feature 202, water tank at the U-12n.10 Vent Hole, view south, (2009).
