# Evaluation of Aluminum-Boron Carbide Neutron Absorbing Materials for Interim Storage of Used Nuclear Fuel

# **Evaluation of Aluminum-Boron Carbide Neutron Absorbing Materials for Interim Storage of Used Nuclear Fuel**

The final technical report for NEUP project 10-603

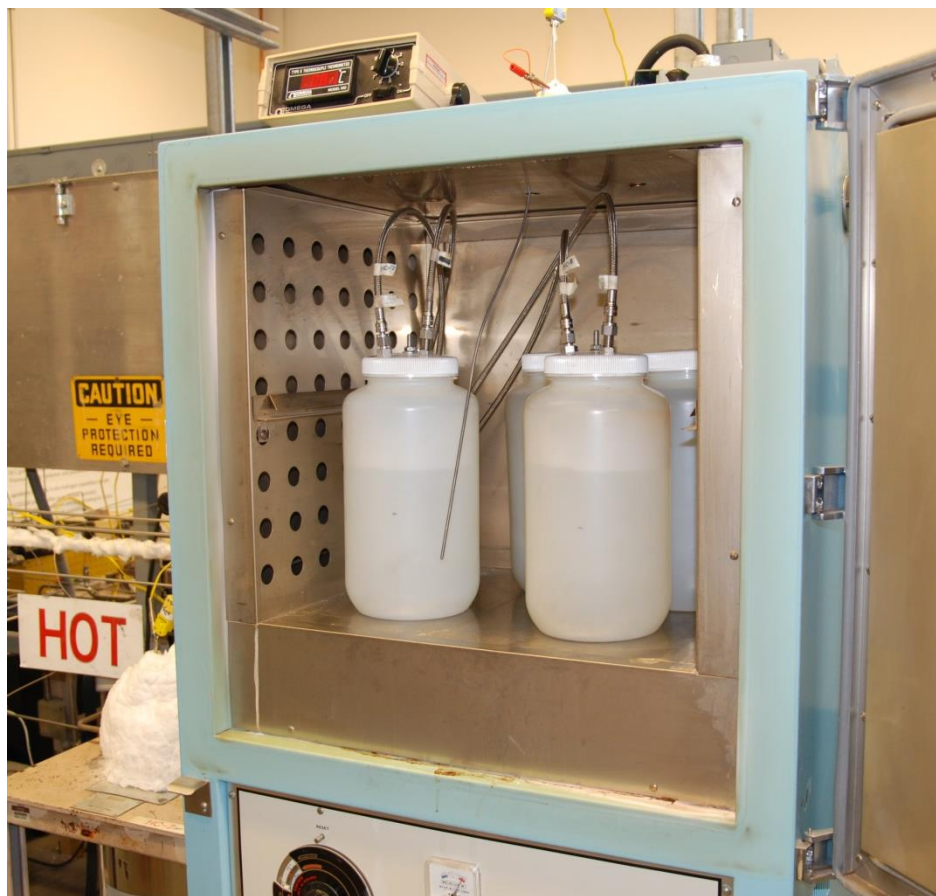
Figure 22 Humidification system for autoclave corrosion

The humidity level of the gas was controlled by the temperature of the water. The Nalgene bottles placed in a large oven to maintain an even temperature environment around the bottle. A refill bottle was kept inside the furnace so that there was not a temperature spike in the system when a bottle had to be refilled. The outlet lines coming out of the furnace were wrapped in heat tape to prevent condensation inside the lines. The outlet was then connected to the inlet of the autoclave.
