# Monitoring Microstructural Evolution of Alloy 617 with Non-Linear Acoustics for Remaining Useful Life Prediction; Multiaxial Creep-Fatigue and Creep-Ratcheting

**Project Title:** Monitoring microstructural evolution of Alloy 617 with nonlinear acoustics for remaining useful life prediction; multiaxial creep-fatigue and creep-ratcheting 10-915

**Period:** January 1, 2010 through August 30, 2014

**Report Date:** October 30, 2014

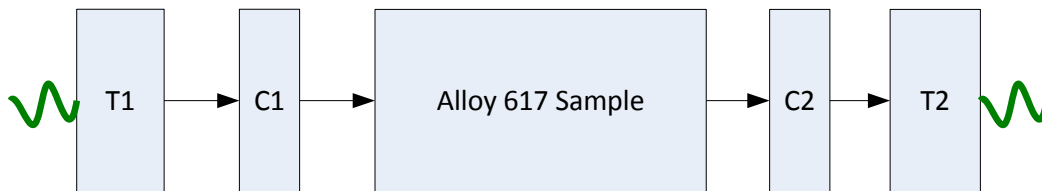
**Figure 2.2.1.14.** Schematic of nonlinearity measurement.

$$A_n(L) = \beta_n (A_1(0))^n f_n(\alpha_1, \alpha_2, \dots, \alpha_n, L) \quad (4)$$

where  $\beta_n$  is the nonlinear parameter and  $f_n(\alpha_1, \alpha_2, \dots, \alpha_n, L)$  is the factor that accounts for the attenuation at different harmonics.

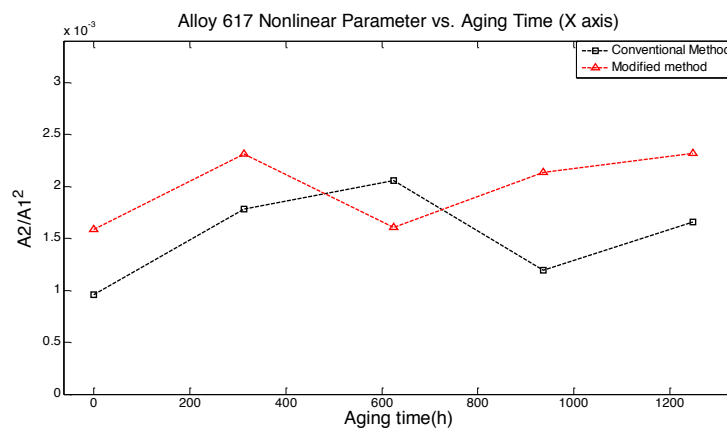
**Figure 2.2.1.17.** Alloy 617 nonlinear parameter as a function of exposure time for X direction (comparison between conventional method and modified method).

Figure 2.2.1.17 shows the qualitative nonlinear parameter of the aged samples by the conventional and modified methods. Experimental results from these two methods show good consistency. However, if we examine the standard error of the results for the two measurement methods shown in Table 2.2.1.2 we find that the standard error for the modified measurement method is much smaller than that from the conventional method. Which means the modified measurement can give us a more converged and accurate qualitative nonlinear parameter.

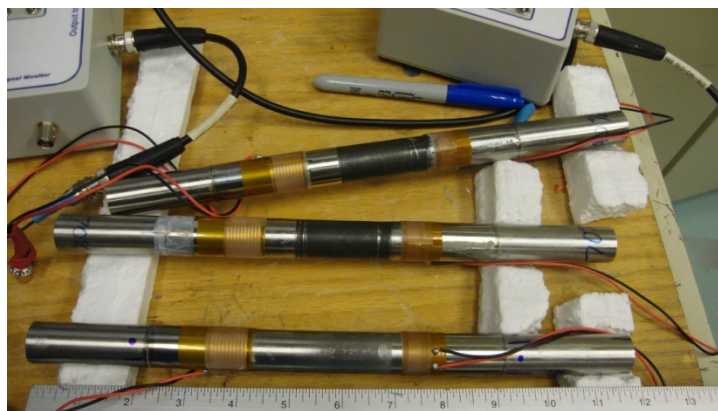
**Figure 2.2.2.12.** Photographs of experimental setup and specimens (as received, 71% ad 58%).

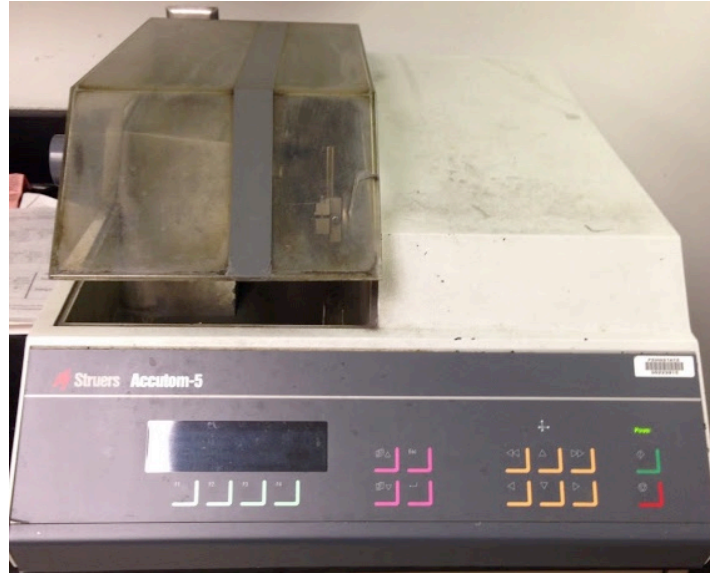
**Figure 2.3.1.1.** Struers Accutom-5 sample cut-off saw

The process begins with a saw specially designed for sample preparation purposes to remove a small portion of tested samples to be observed with the optical microscope. Also, when using the saw, specific blades and machine settings must be used depending on the sample material. All equipment and materials used for the entirety of the sample preparation are purchased from Struers. Saw machinery being used is an Accutom-5 cut-off saw, with a silicon carbide cut-off wheel. The speed of the cut-off wheel during sample cutting is 3000 rpm, with a feed of 0.015 mm/s. Through the duration of cutting, water is applied to the blade in order to maintain low temperature of the blade and limit the opportunity for failure. Figure 2.3.1.1 is a photograph of the saw. The sample is placed in a holder underneath the plastic hood to protect the operator from any projected fragments.

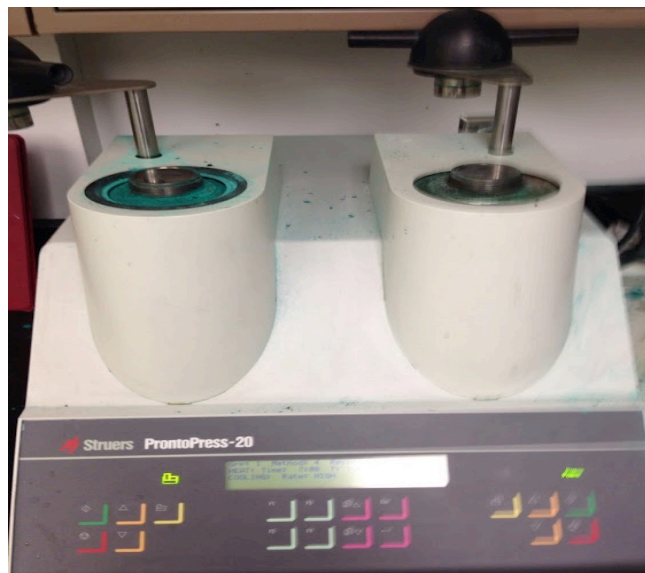
**Figure 2.3.1.2.** Struers ProntoPress-20 sample mounting machine

Once the sample has been cut from the tested specimen, it must be mounted in a fast-curing resin, allowing the sample to be ground, polished, etc. without having to touch the surface to be examined, which could potentially jeopardize the final results. The mechanism used to mount the samples is a ProntoPress-20 as seen in Figure 2.3.1.2, which melts the powdery resin material, then cures it by rapid cooling.

Resin used for mounting samples of Alloy 617 is Isofast, which is a diallyl phthalate hot mounting resin with glass fibers in it. The complete mounting process takes 11 min., 7 of which are for heating at 180°C, the other 4 are for high-rate cooling. The final result of sample mounting is the formation of a green puck made of the cured resin, with the mounted sample visible within the puck's cross-section as within the examples in Figure 2.3.1.3.

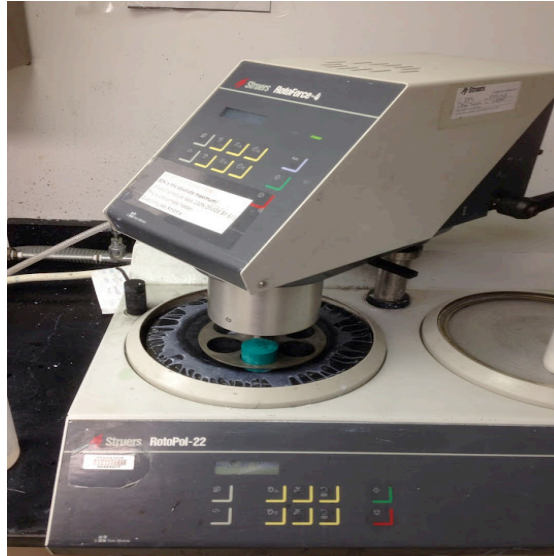
**Figure 2.3.1.5.** Alloy 617 sample being polished

Following sample grinding is sample polishing. Each sample undergoes three rounds of polishing, two of which are using the same polishing materials. The machine used for polishing is the same used for grinding. However, for polishing, a mechanical sample holder is used which, in addition to the spinning polishing pad, also spins and applies a user-specified amount of force to the sample being polished. Figure 2.3.1.5 shows a sample undergoing the process of polishing. It is worth noting that for polishing, only one sample is prepared at a time.
