# National Grid Deep Energy Retrofit Pilot

K. Neuhauser  
*Building Science Corporation*

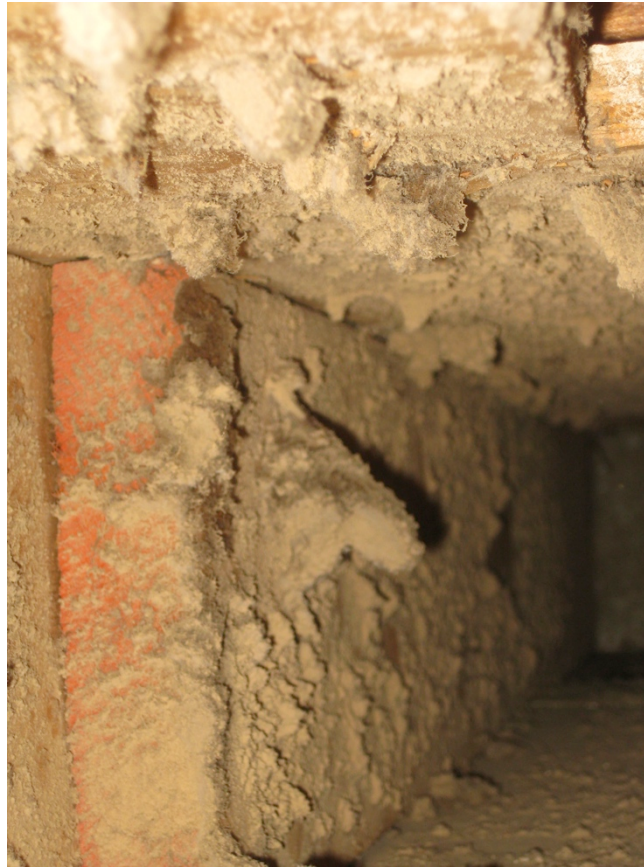
**Figure 4. View inside framing cavity forced-air duct return at Test Home 1**

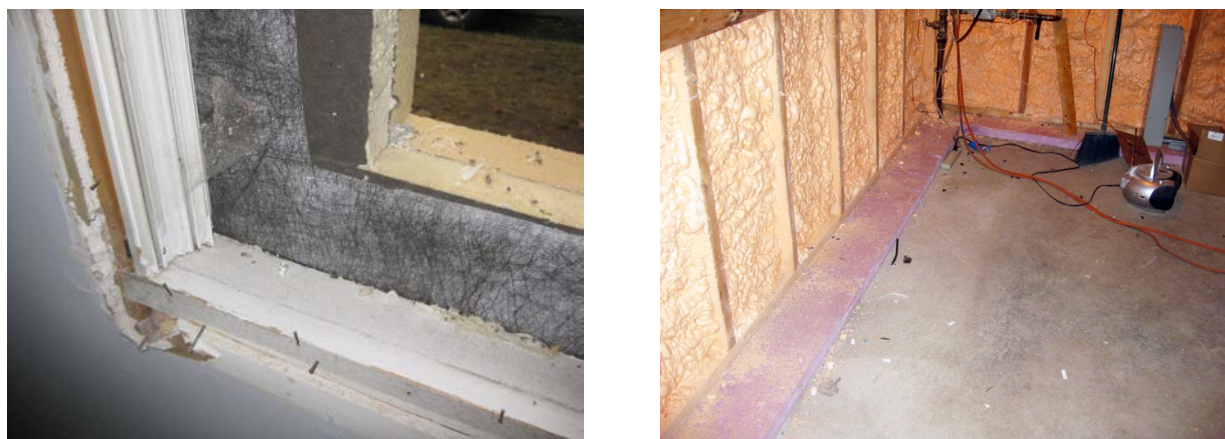
**Figure 7. Left: Window opening at Test Home 1 with existing window still in place. Note exterior insulation and house wrap airflow control layers installed to exterior; Right: Basement slab perimeter insulation at Test Home 1.**

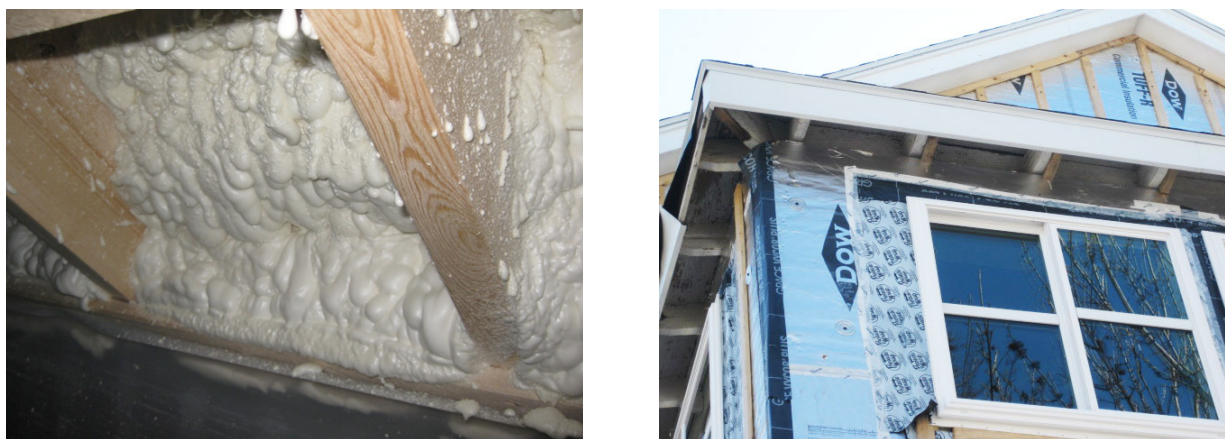
**Figure 14. Left: ccSPF providing transition of airflow control at new roof to new wall transition; Right: Rigid exterior insulation notched around projecting rafters.**

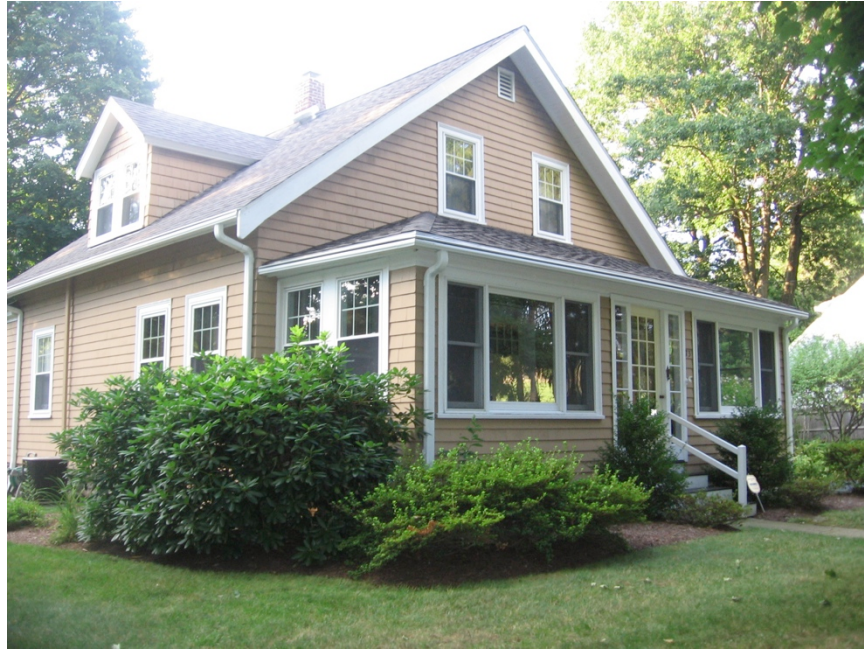
**Figure 15. Pre-retrofit Cape located in Newton, Massachusetts**

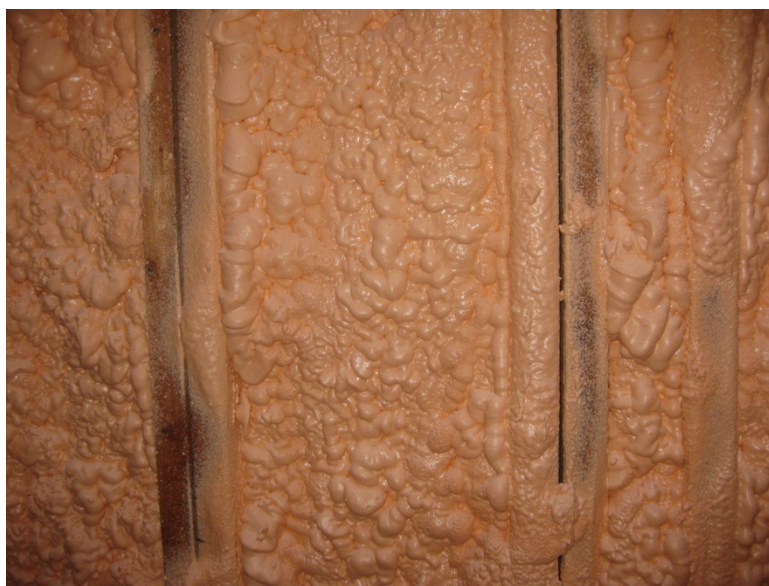
**Figure 21. Airflow channels between double roof rafters at Test Home 1**

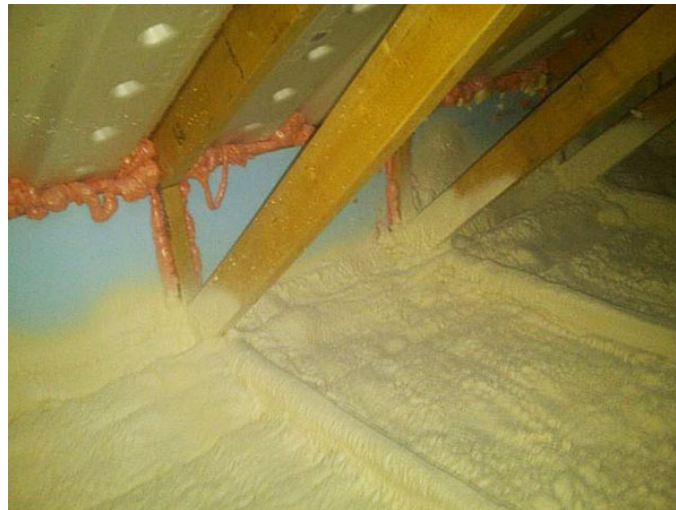
**Figure 29. ccSPF airflow control layer in vented attic at Test Home 5**

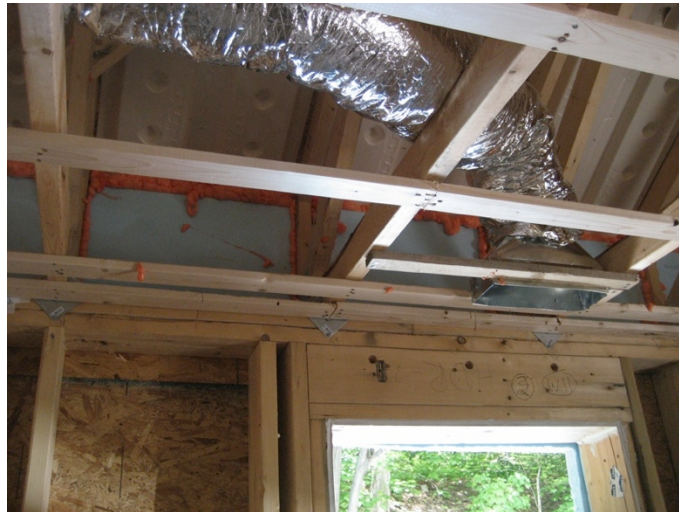
**Figure 30. Ventilation duct initially located above airflow control layer in vented attic at Test Home 5**

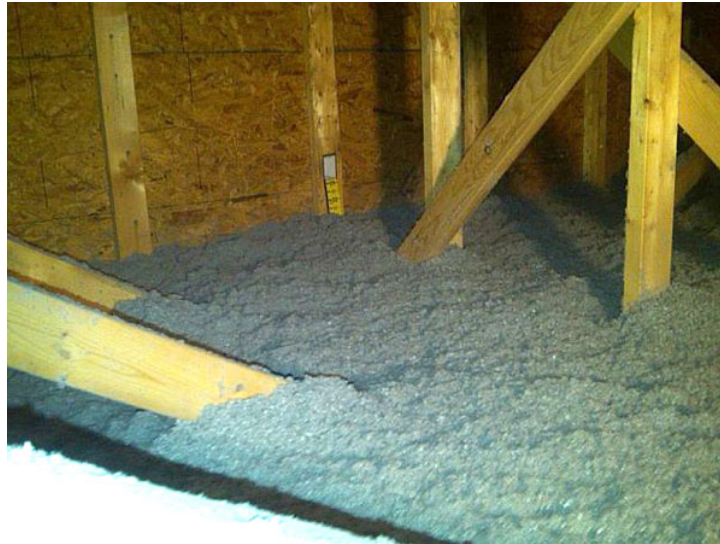
**Figure 33. Loose-blown insulation in vented attic at Test Home 5**

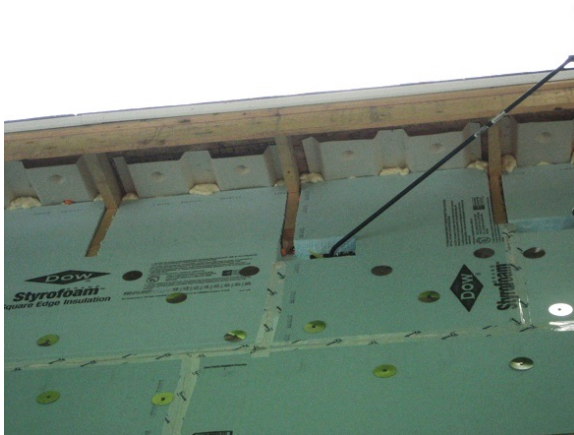
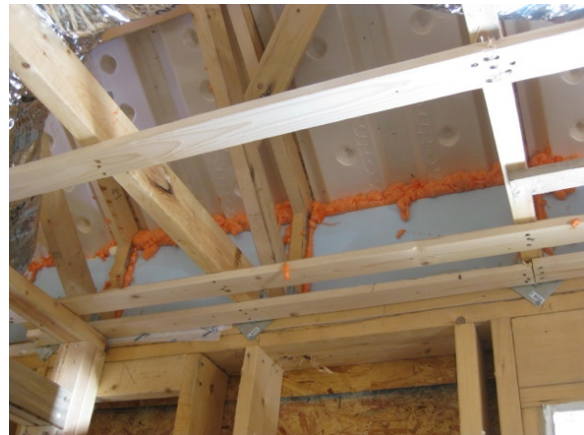
**Figure 34: Left: Rigid insulation blocking between roof trusses at Test Home 5 exterior; Right: Rigid insulation blocking between roof trusses at Test Home 5 interior**

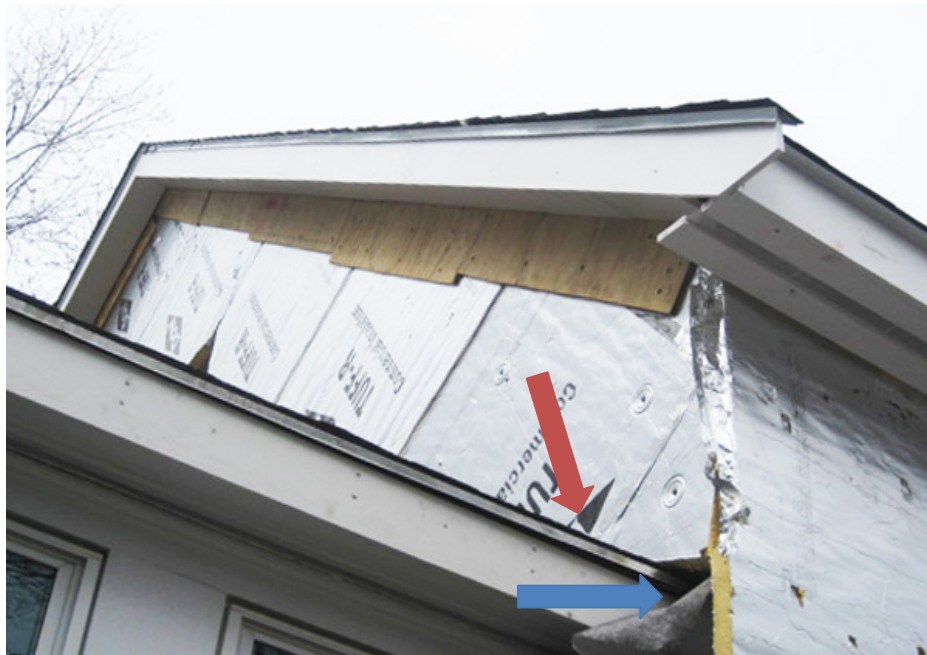
**Figure 35. Wall-roof interface at Test Home 4 showing two common flashing errors: 1) step flashing is not located at plane of water control, and 2) drip edge of lower roof creates a condition where water may be directed in behind the drainage plane. Note that both of these conditions were corrected at this test home.**

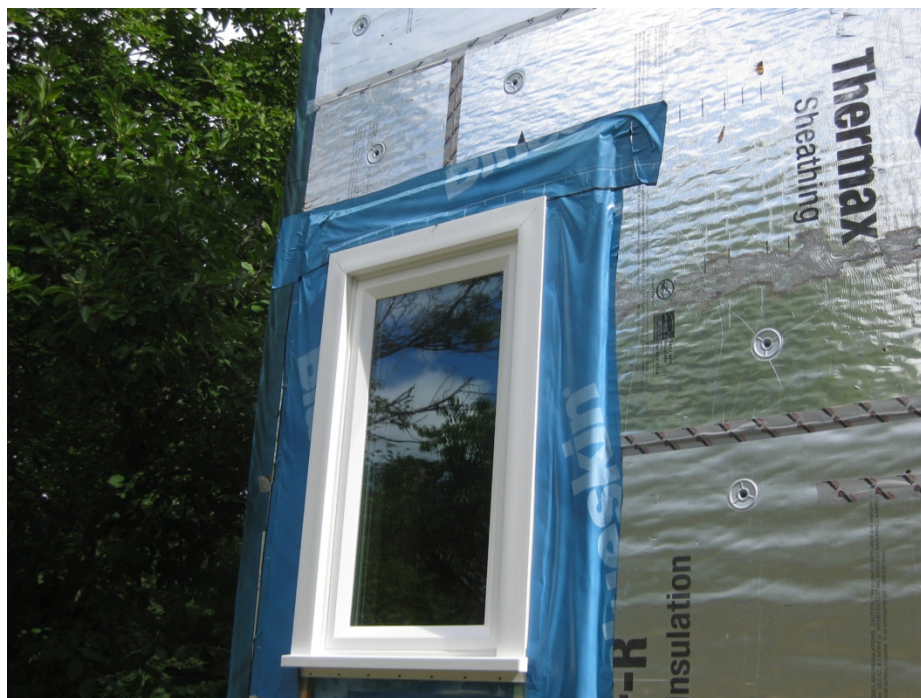
**Figure 36. Nonterminated flashing membrane presents risk of collecting water**

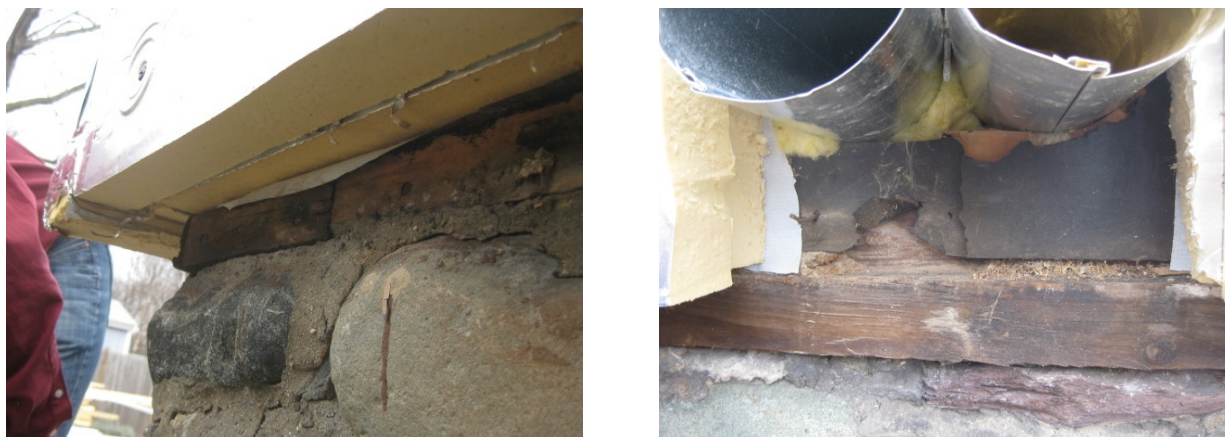
**Figure 38. Left: Exterior insulation installed prior to sealing house wrap to base of wall for airflow control transition; Right: Portions of exterior insulation must be removed to allow air sealing of the house wrap at these pipe penetrations.**

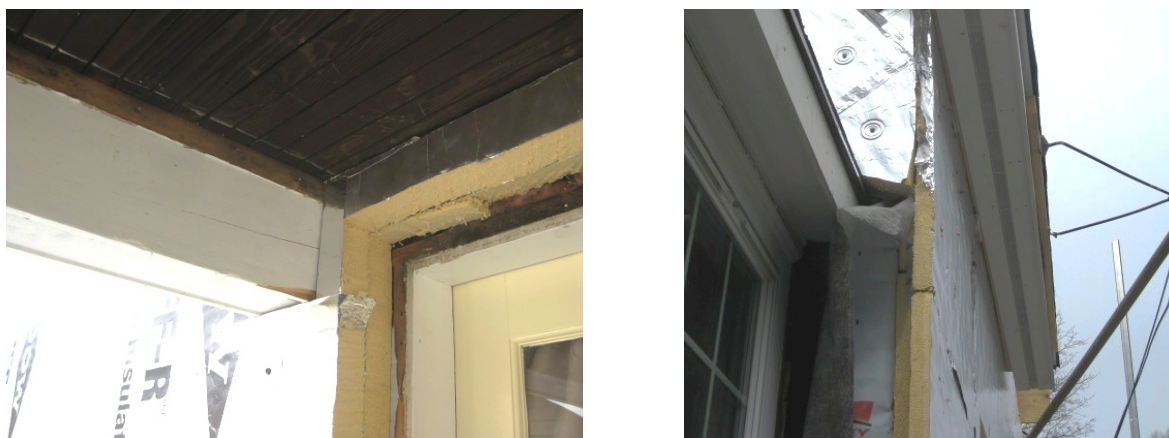
**Figure 39. Left: Porch roof support beam with trim and porch ceiling void airflow control where they connect to the wall and penetrate exterior insulation; Right: A porch roof return that connects to the existing wall challenges continuity of airflow control.**

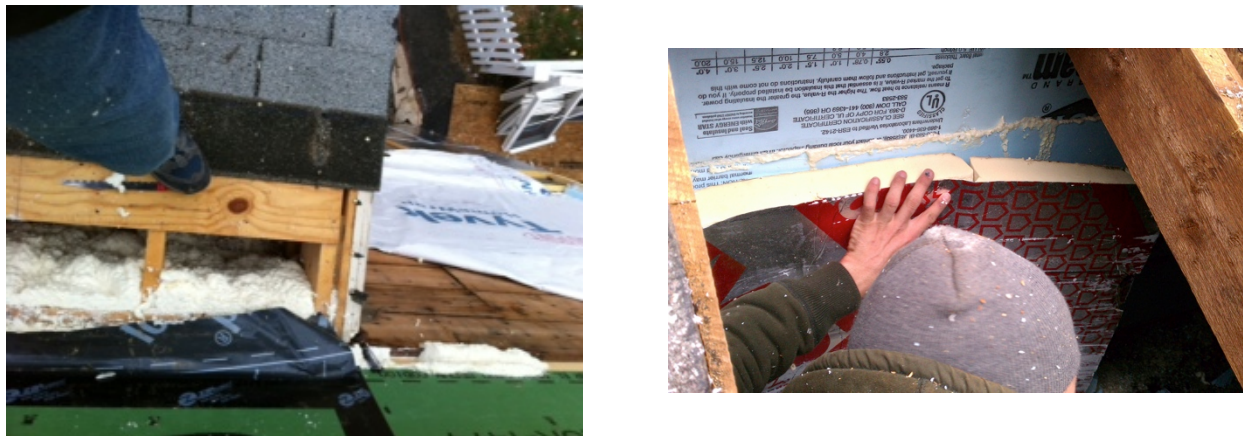
**Figure 40. Left: ccSPF airflow control around porch roof framing at Test Home 3; Right: Worker applying rigid foam and foam sealant between attached porch roof and porch ceiling, Test Home 4**

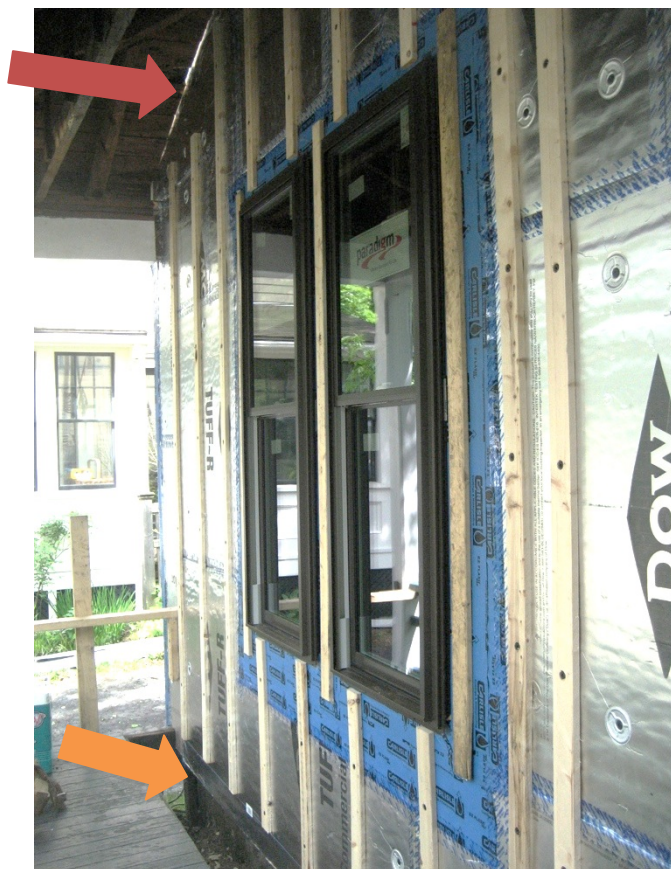
**Figure 41. Porch deck, ceiling, and roof cut away from wall to allow continuous air, thermal, and water control, Test Home 2**

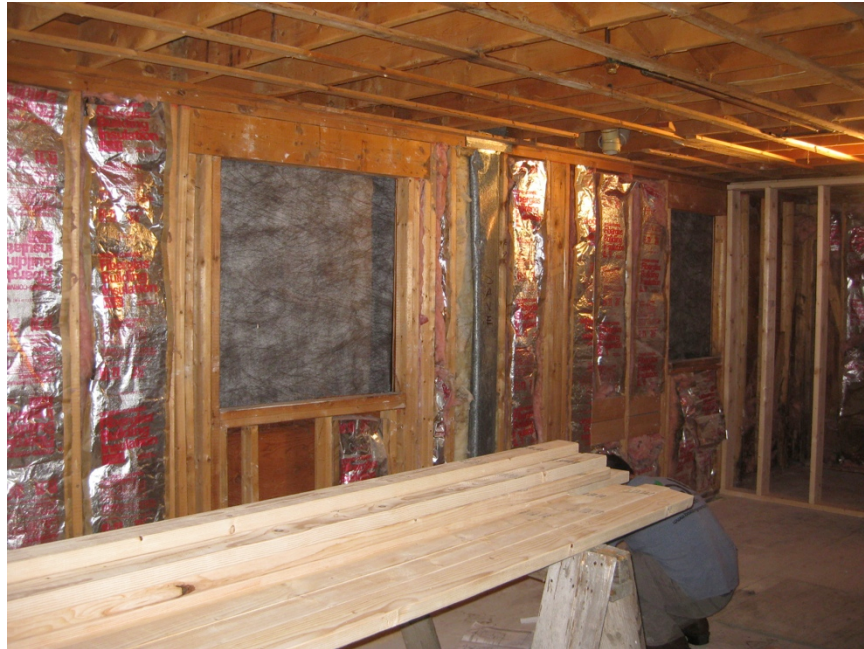
**Figure 42. Foil-faced cavity insulation representing a second vapor retarder, Test Home 1**

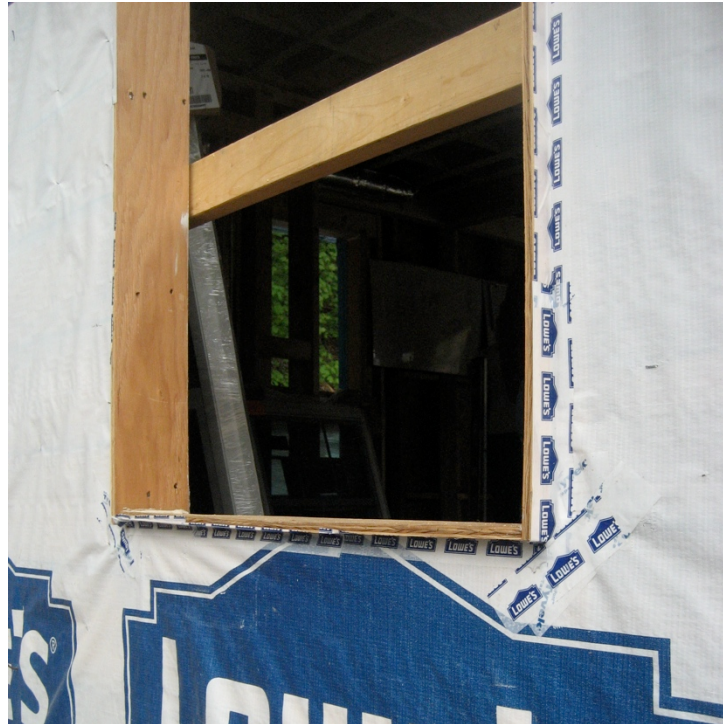
**Figure 43. House wrap airflow control layer sealed to window extension box at Test Home 5**

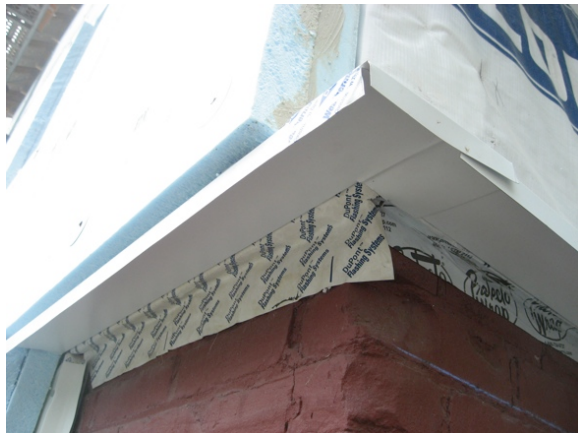
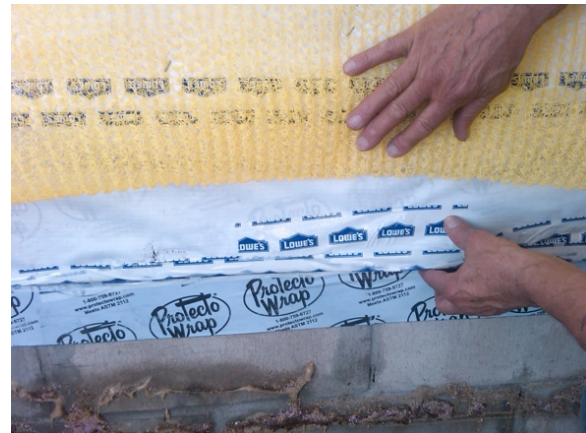
**Figure 44. Left: Airflow control transition at existing brick foundation wall, Test Home 5; Right: Airflow control transition at new CMU foundation wall section, Test Home 5**

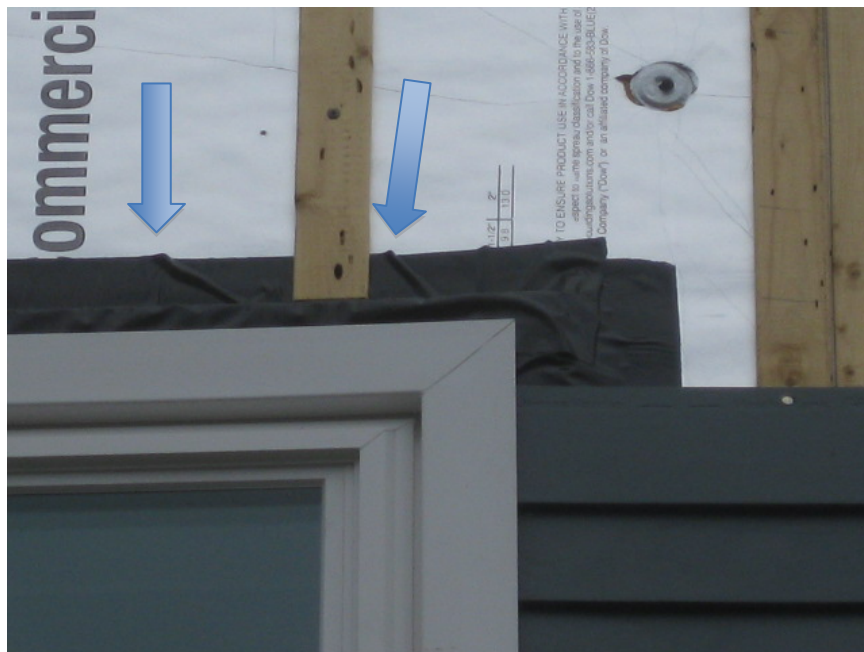
**Figure 49. Wrinkles in flashing membrane wrapped over strapping and back to drainage plane. Note how this window head flashing requires flashing of its own.**

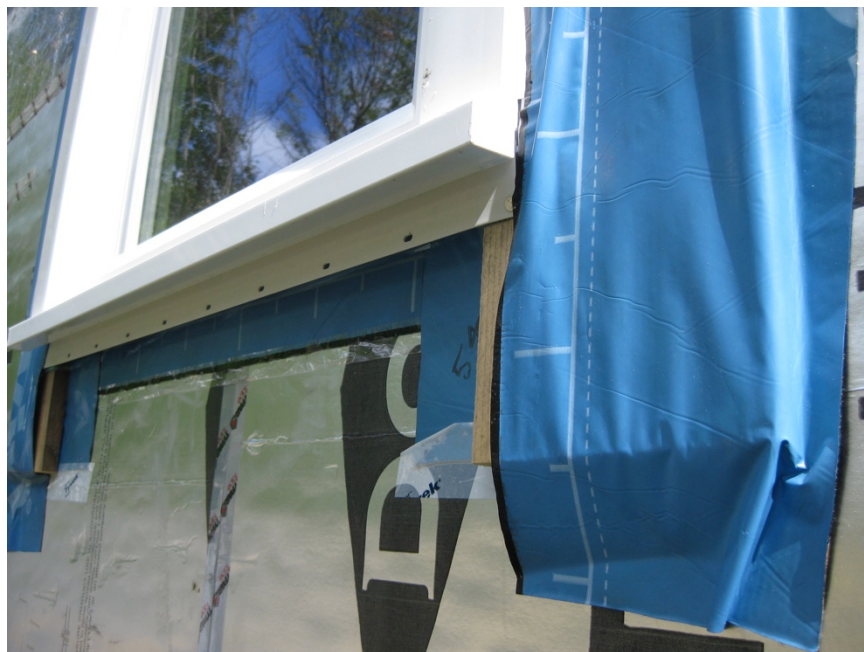
**Figure 50. Installation of the window over strapping provides a generous drainage gap for the sill pan flashing.**

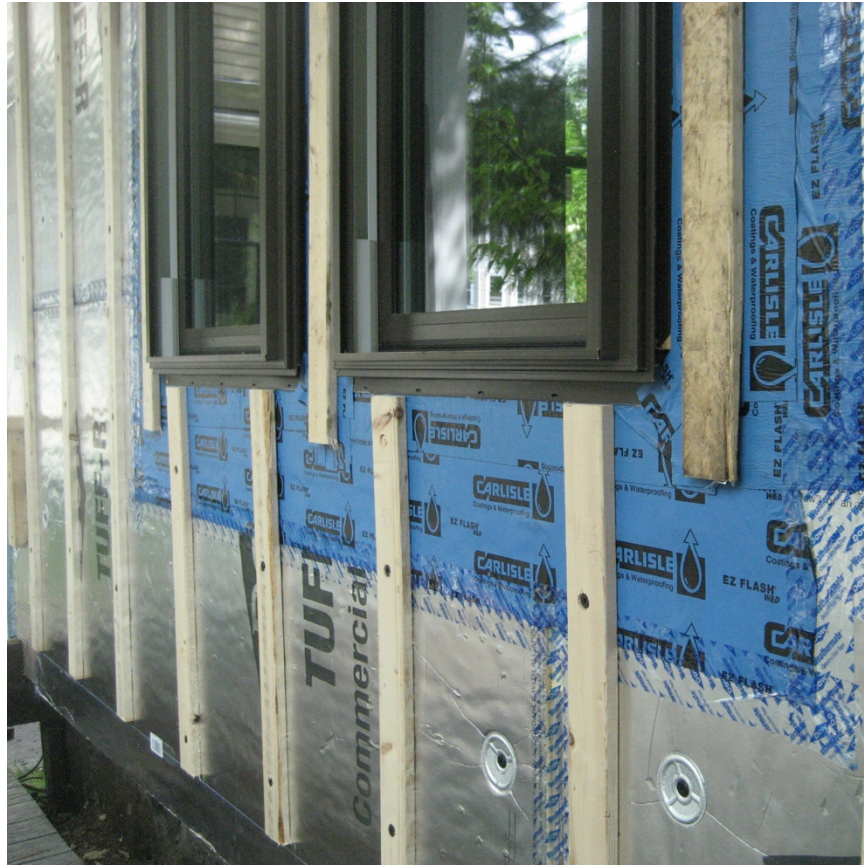
**Figure 51. Window installed with flanges aligned with drainage plane at Test Home 2. Note strapping run up to, but not over, bottom flange of window. A single piece of strapping at the side of the window is sufficient to support both trim and cladding attachment.**

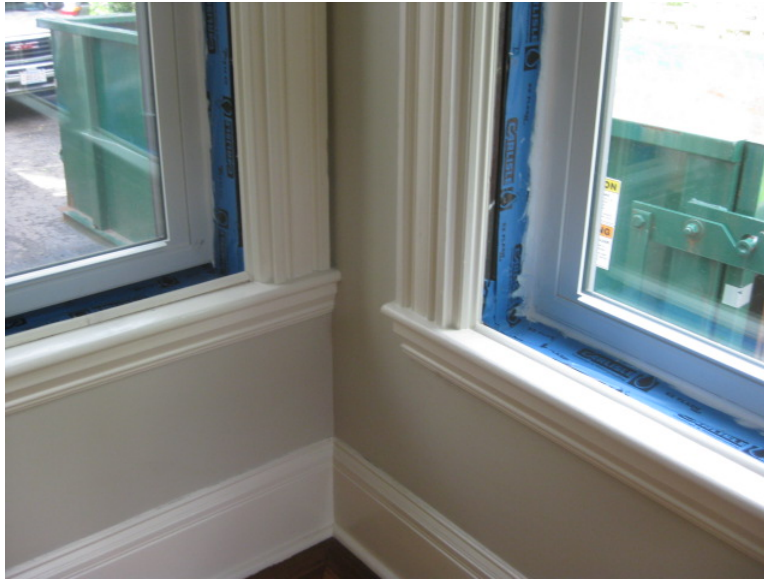
**Figure 52. Window sealed to membrane at inside perimeter of window at Test Home 2. Note how the window frame is slightly larger than the finished opening.**

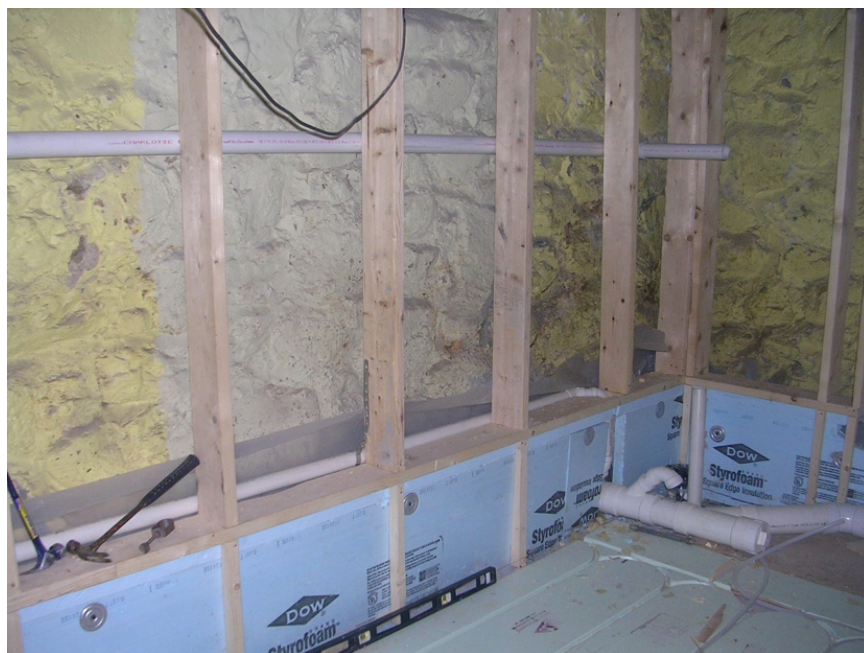
**Figure 53. Thermal break between wood stud wall and concrete underpinning wall at Test Home 4**

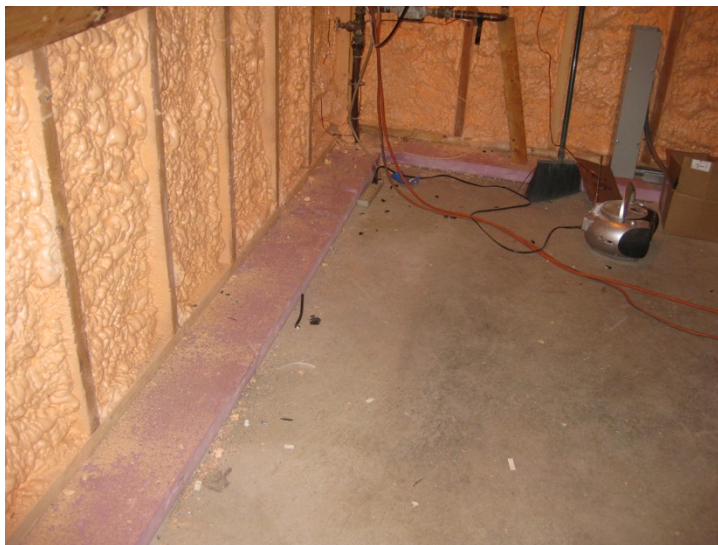
**Figure 54. Thermal break between wood stud wall and existing concrete slab at Test Home 1**

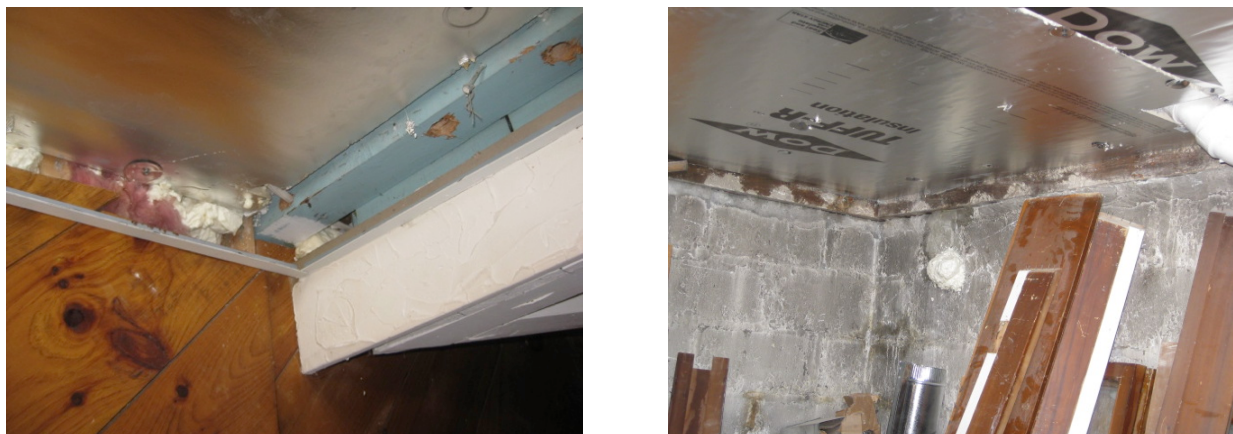
**Figure 55. Left: Structural beam exposed to basement; Right: Framed wall sill exposed to basement**

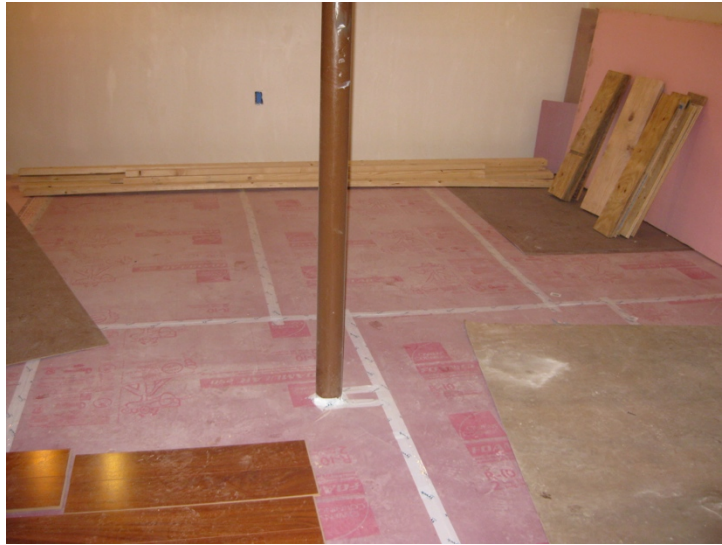
**Figure 56. Basement floor insulation at Test Home 1 installed near end of project to prevent damage to insulation**

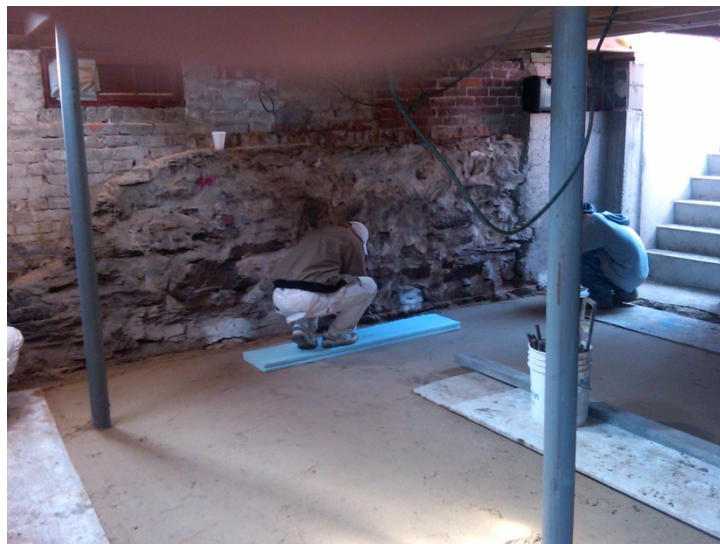
**Figure 57. New basement slab and structural support at Test Home 5**

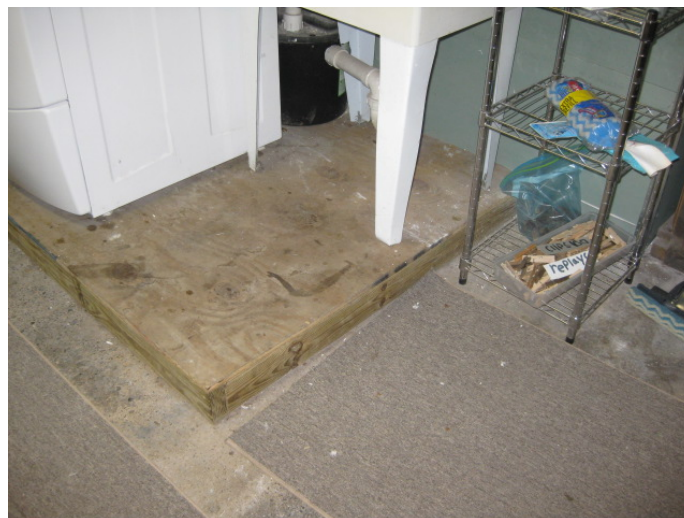
**Figure 58. Equipment platform and shelving in basement of Test Home 2**

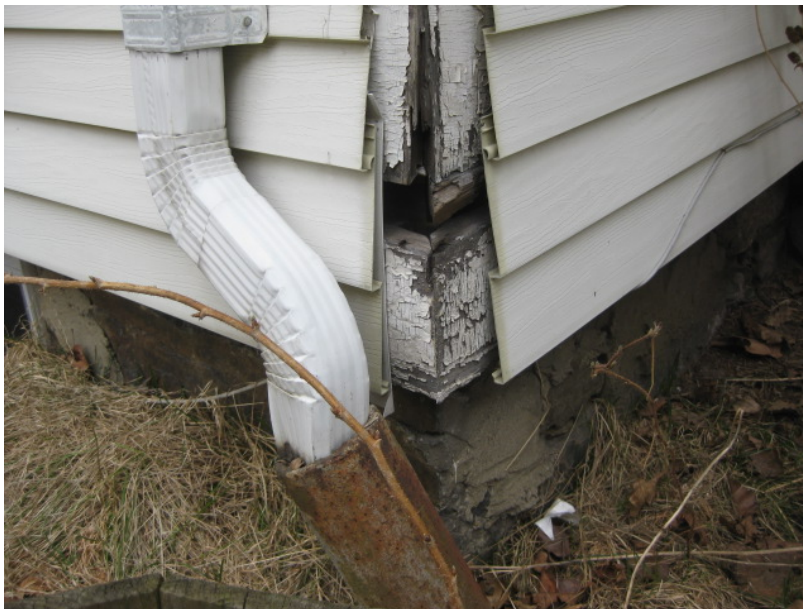
**Figure 65. Vinyl siding and deteriorated wood cladding at Test Home 2**

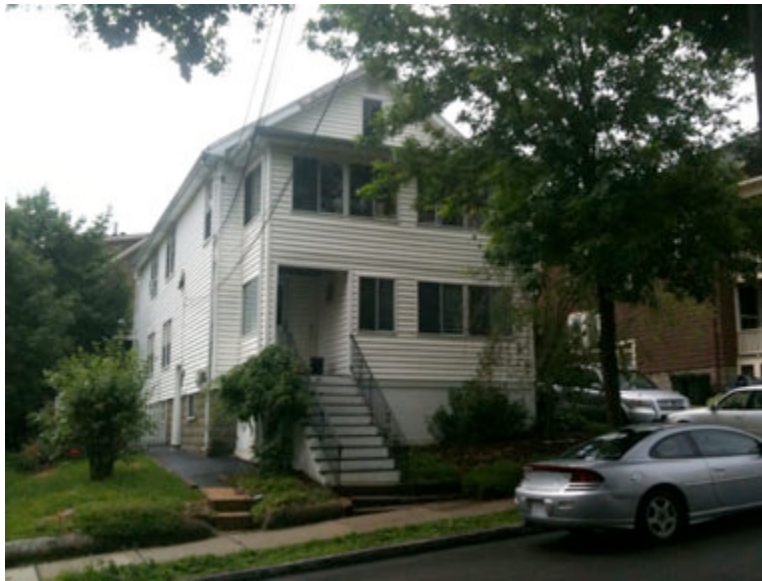
I find it curious that the project would insulate to the interior with closed cell spray foam when the application indicates that the roof is to be replaced. The depth of foam that would be required to meet the target R-value would represent a significant material cost per unit area, probably somewhere in the range of \$3.75-7/s.f. To reach a comparable R-value with polyisocyanurate above the roof and fiberglass batt insulation within the roof framing cavities would entail a material cost in the neighborhood of \$3.60/s.f. (including ½ plywood for nailbase and 6" screws). It will be interesting to learn from the builder about the labor costs and how these affect the relative costs of different roof insulation strategies.

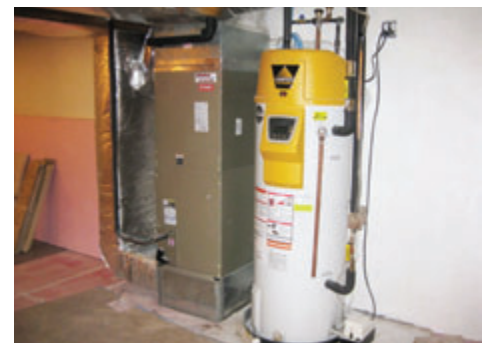
The mechanical system plan included forced-air heating and cooling distribution and balanced ventilation. The equipment selection for this system as well as the water heating system and configuration of the attic/roof insulation were dictated by the availability of donated products.

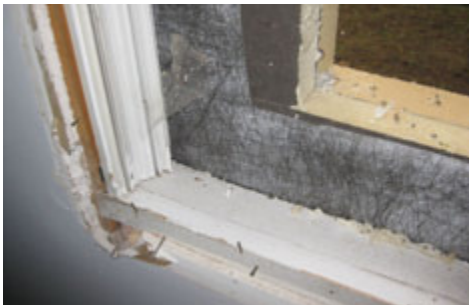
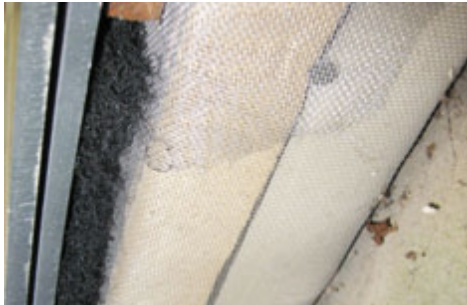
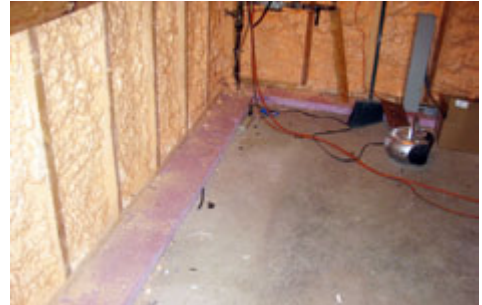
## TESTING AND ON-SITE TECHNICAL SUPPORT

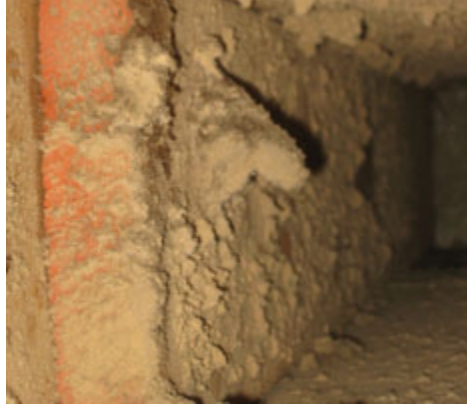
age at 1695 cfm at 50 Pascals or near 4 ACH50. BSC measured the post-retrofit air leakage to be 584 cfm50 or 1.6 ACH50.

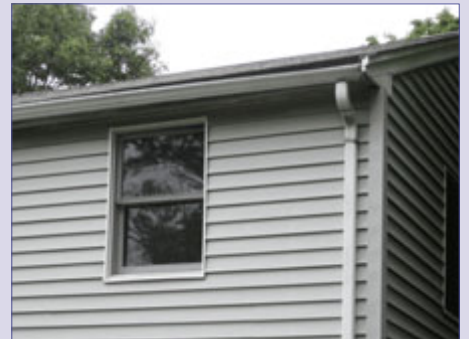
**Building Science Corporation**  
30 Forest Street  
Somerville, MA 02143  
[www.buildingscience.com](http://www.buildingscience.com)

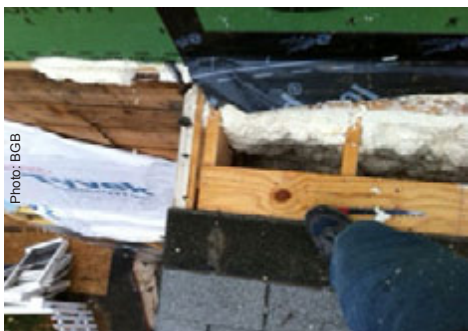
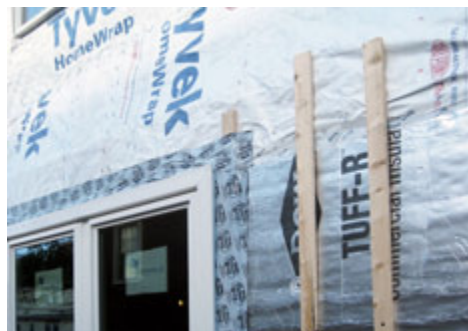
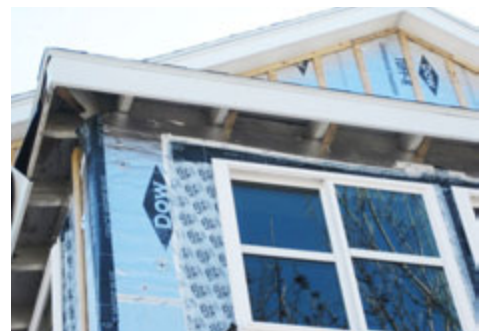
## TESTING AND ON-SITE TECHNICAL SUPPORT

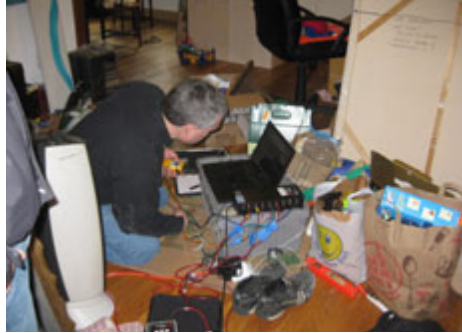
The pre-retrofit fully unguarded test of the apartment space found it to be rather air leaky at 8730 cfm50 or 26 ACH50. Comparison to guarded testing of the apartment space and basement suggests that about 45% of the combined apartment leakage is at the basement-apartment separation. After substantial completion of the retrofit

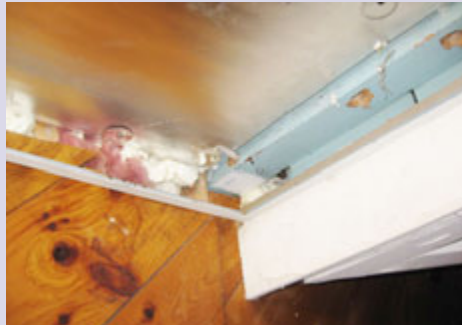
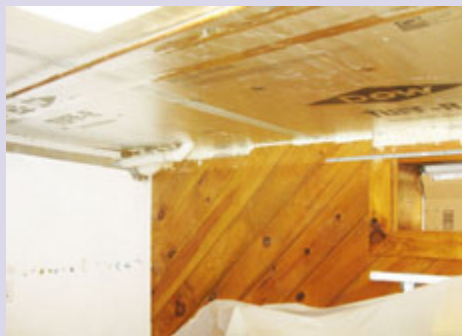
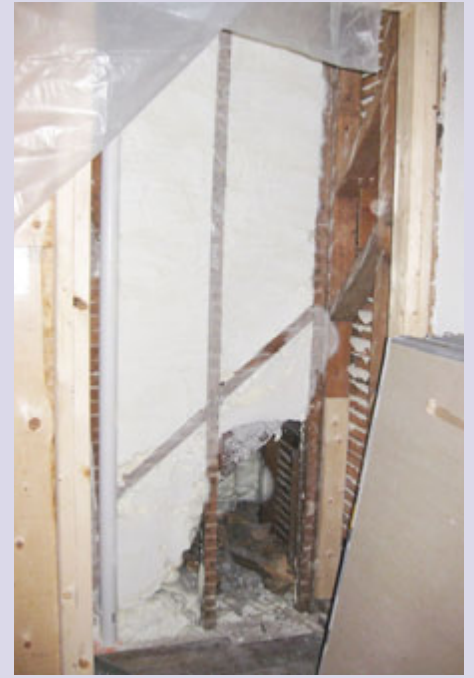
**Building Science Corporation**  
30 Forest Street  
Somerville, MA 02143  
[www.buildingscience.com](http://www.buildingscience.com)

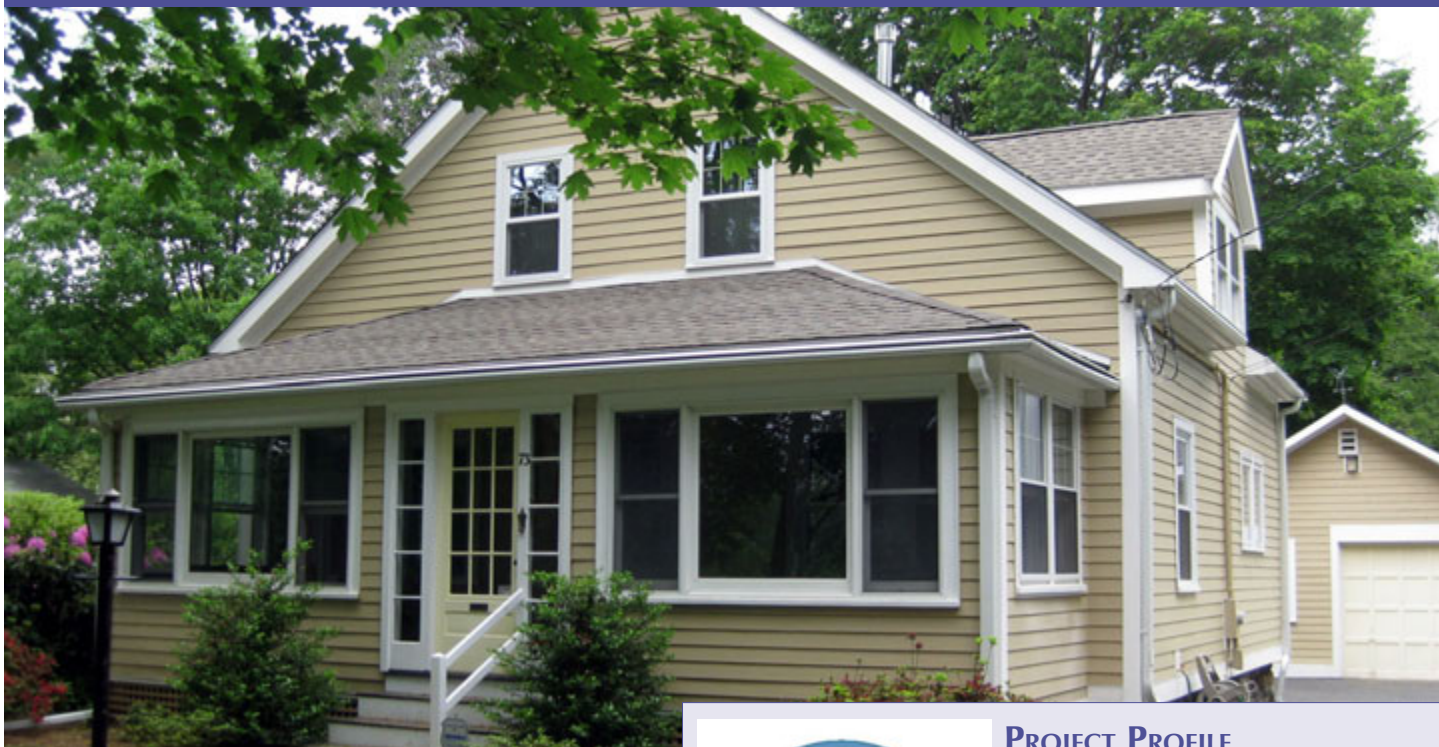
Newton, Massachusetts

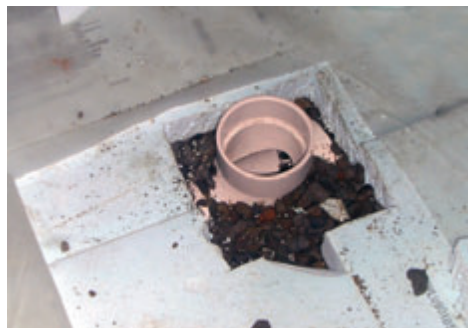
The wall assembly for this project establishes the exterior face of the insulating sheathing as the drainage plane while the housewrap serves as the primary air control layer. The multiple layers of materials in this system provide additional control. The thickness of exterior insulation also places the rain shedding layer further from water sensitive structure.

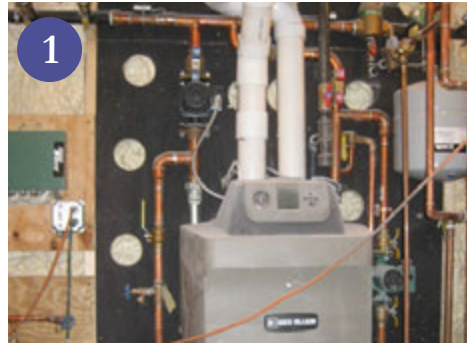
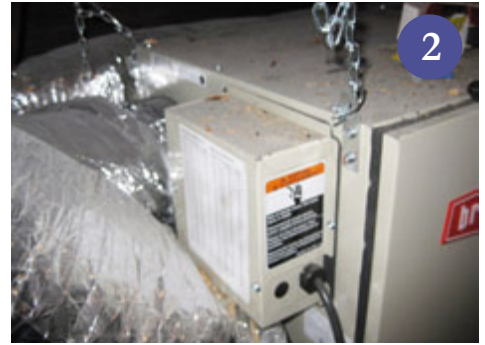
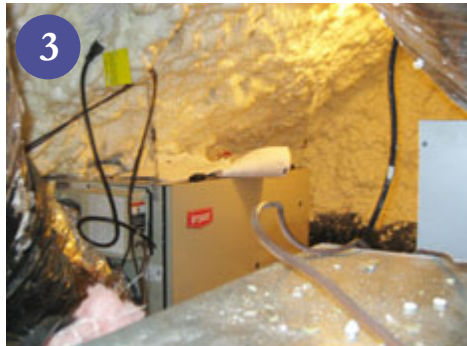
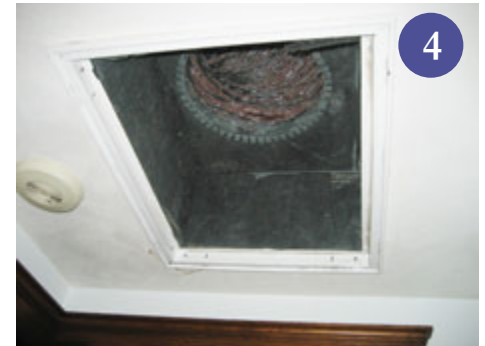
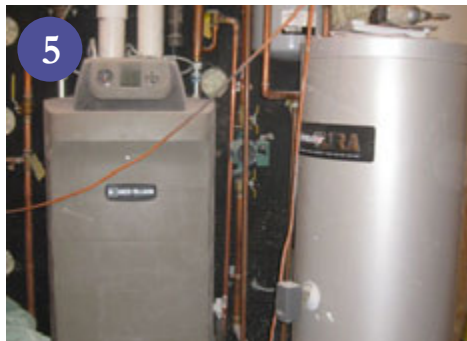
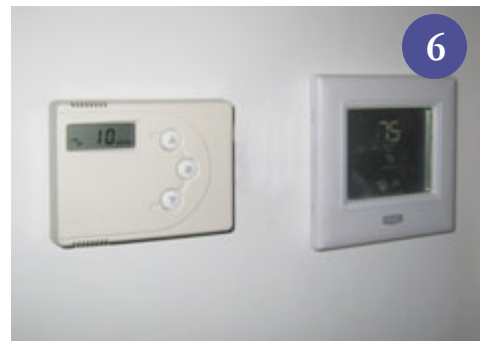
**Appliances:** ENERGY STAR® appliances.

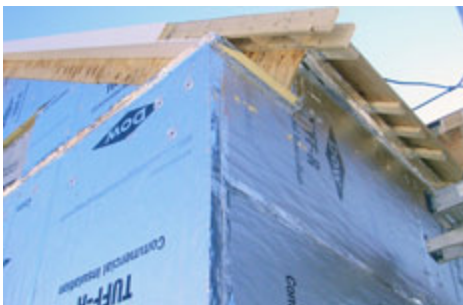
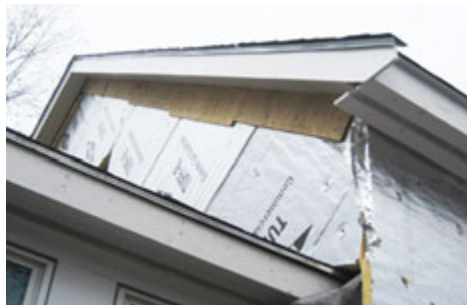
## TESTING AND ON-SITE TECHNICAL SUPPORT

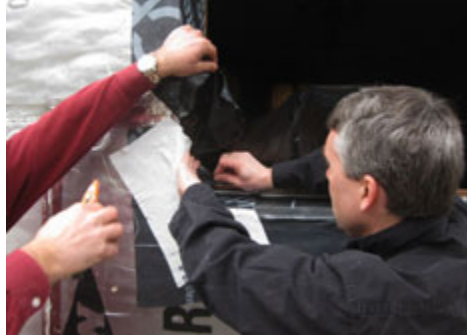
additional site visit to identify major sources of air leakage. With the house alternately depressurized and pressurized, BSC inspected the enclosure with a both a small handheld smoke generator and a larger theatrical smoke machine. While no significant problems were observed in the enclosure construction, BSC did find a problem with outside air dampers on the ERV that requires remediation.

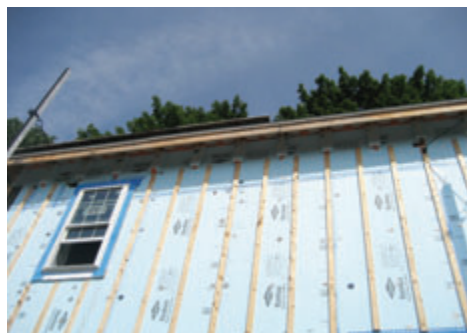
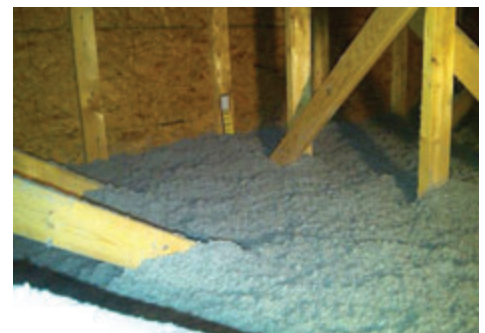
Air flow control at the top of the building is achieved by sealing the perimeter and sealing penetrations at the top floor ceiling. Careful detailing is needed to transition the ceiling air flow control to that of the wall system. A raised heel truss allows the full depth of insulation to continue to the perimeter of the attic. Rigid foam installed up the height of the raised heel protects the ceiling insulation from windwashing or displacement. This approach accommodates very high levels of insulation at a low marginal cost. Mechanical systems and ventilation distribution are located entirely within the conditioned space and not in the vented attic.

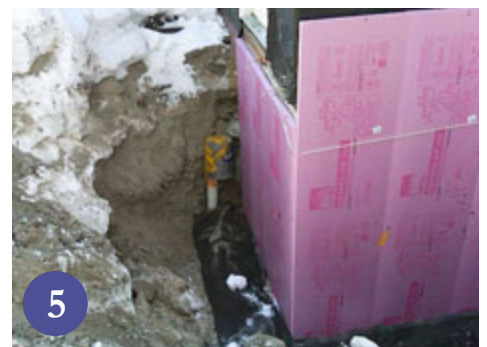
\* BSC does not recommend installing a sand layer under new slabs.

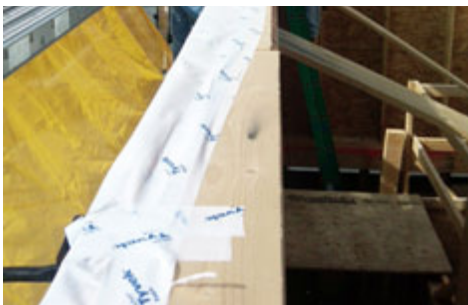
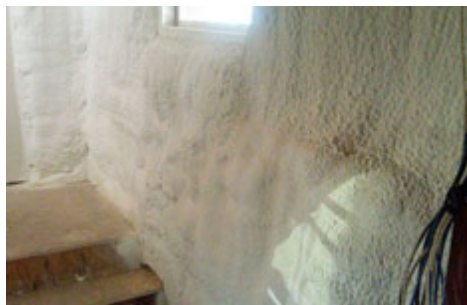
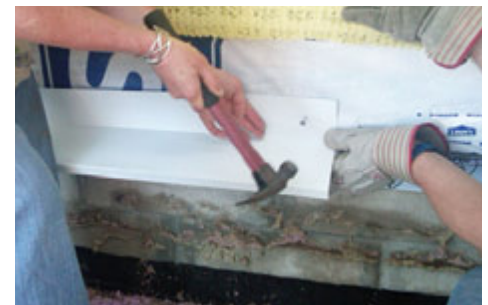
## TESTING AND ON-SITE TECHNICAL SUPPORT

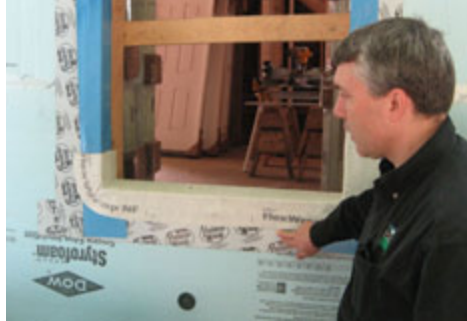
around the house in order to meet the airtightness goal set by the National Grid DER pilot program. The final measurement came in at 1.6 ACH 50!
