# National Grid Deep Energy Retrofit Pilot

K. Neuhauser  
*Building Science Corporation*

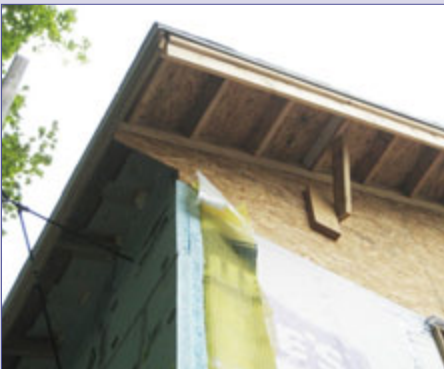
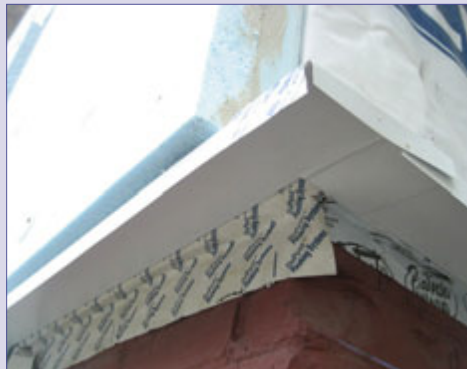
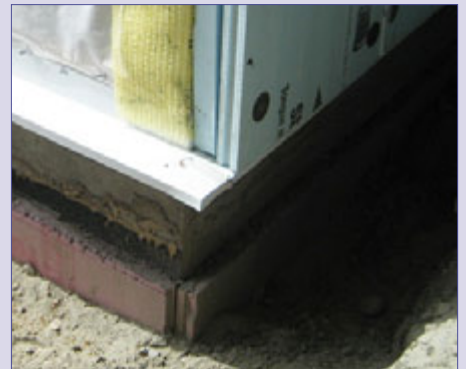
**Building Science Corporation**  
30 Forest Street  
Somerville, MA 02143  
[www.buildingscience.com](http://www.buildingscience.com)
