Title: ANALYSIS OF POTENTIAL HAZARDS ASSOCIATED WITH 241Am LOADED RESINS FROM NITRATE MEDIA

Intended for: Supporting Documentation requested by DNFSB in support of Technology Transfer Contract NFE-12-0047

ANALYSIS OF POTENTIAL HAZARDS ASSOCIATED WITH ^{241}Am LOADED RESINS FROM NITRATE MEDIA

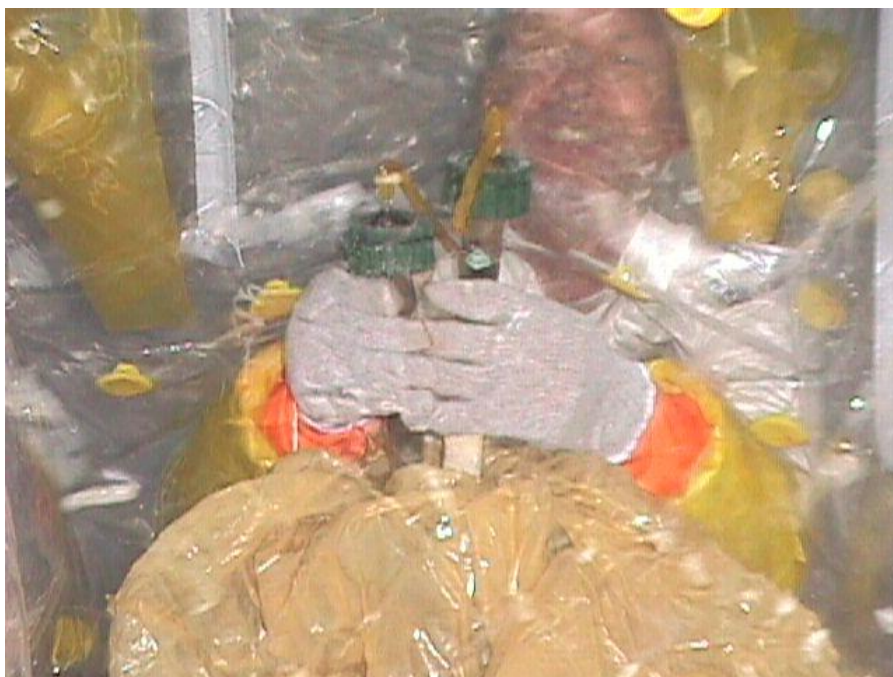
Figure Caption. Photograph of a worker handling two items, believed to be ion exchange columns. The side-by-side arrangement would be consistent with the description, which suggests that each column is actually a pair of columns connected in parallel joined at the bottom by a “rigid connection”.

Use of a series of five ion exchange columns are noted in the source document.¹⁴ Separate notation above shows two resin columns in “container 2” and three resin columns in “container 3”. A more detailed description of a single resin column describes the arrangement as consisting of 2 columns joined at the bottom (each of 50 mm diameter and 215 mm length). Looking at the photo of the “joined column” (see Figure below) there is clearly something wrong with the dimensions discussed in the reference document. The photos show columns that are about 1" diameter. The green column caps in the photo are significantly oversized relative to the columns, appearing to be ~2" diameter, and are the probable source of the size discrepancy in the reference document.

Volume for a right circular cylinder may be readily calculated by $V = \pi r^2 h$. Assuming column segments of 25 mm diameter and 215 mm length volume for each column segment is about 106 mL. With five columns total, each consisting of two joined column segments of the specified dimension, a total volume of about 1.06 L is possible in the described columns.
