Bennett College

Ida H. Goode Gymnasium Energy Efficiency/Sustainable Energy Project

Final Report to the U.S. Department of Energy

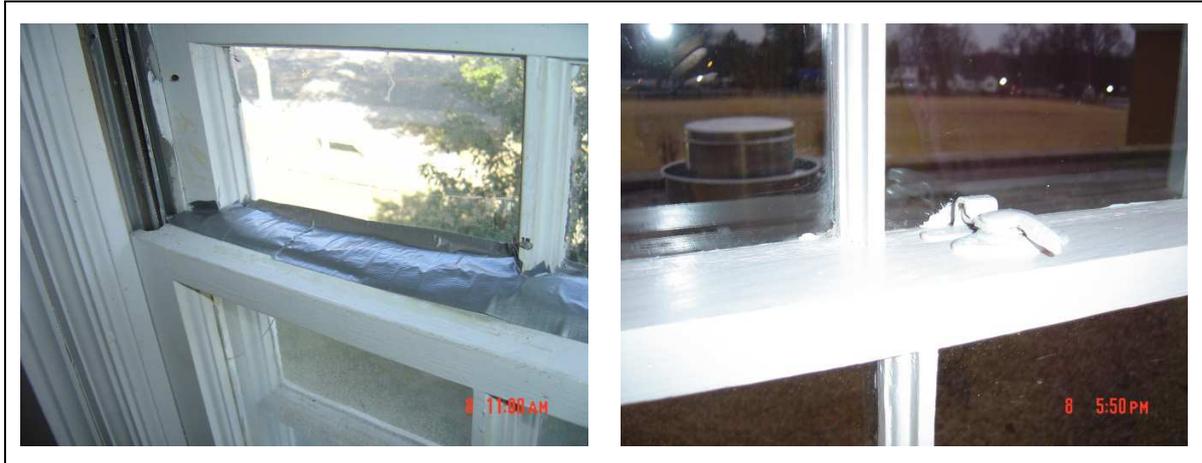
Phase II Subtask 4.3 - Window & Door restoration

- Prior to the renovation, there was a significant amount of air infiltration coming through the windows or doors. The existing window were restored to significantly reduce air infiltration and to protect the historic preservation status of the building.

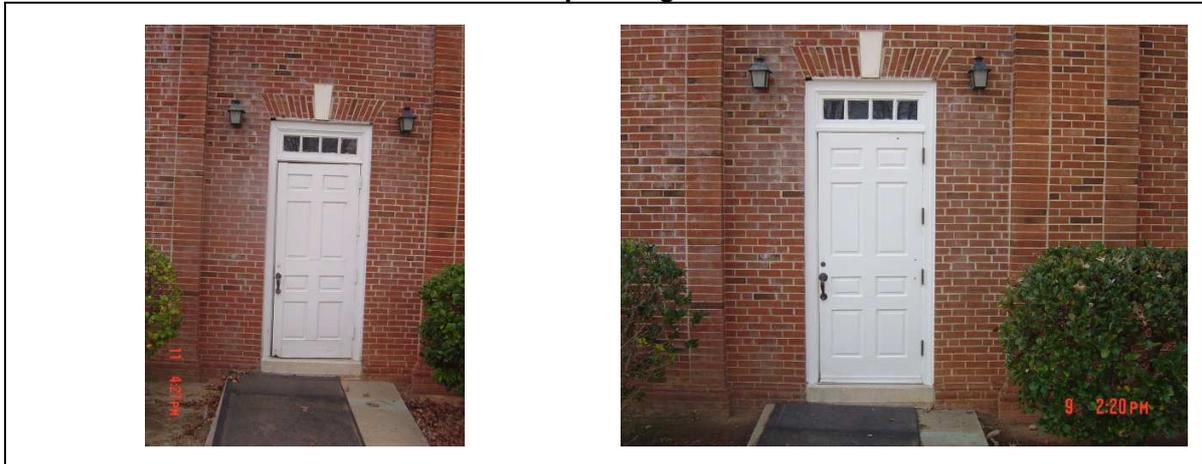
Phase II Subtask 4.4 - Window & Door painting

- Since the historic preservation requirements prevent replacement of exterior doors and windows, all restored windows and door were painted to reflect the buildings original look.

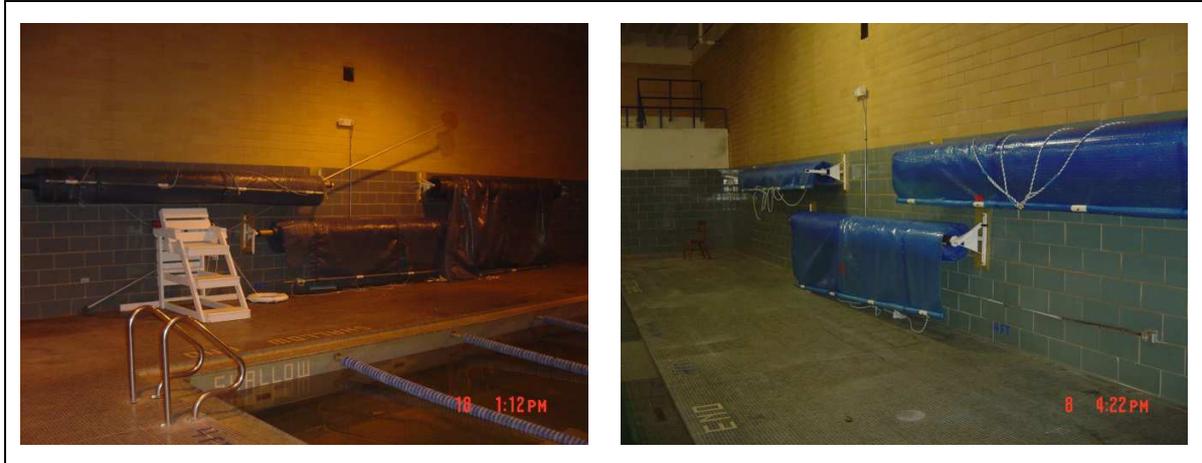
Phase II Subtask 5.6 - Pool Cover

- The existing pool cover was replaced with a new pool cover. The use of the pool cover will reduce the amount of energy it takes to heat the pool.

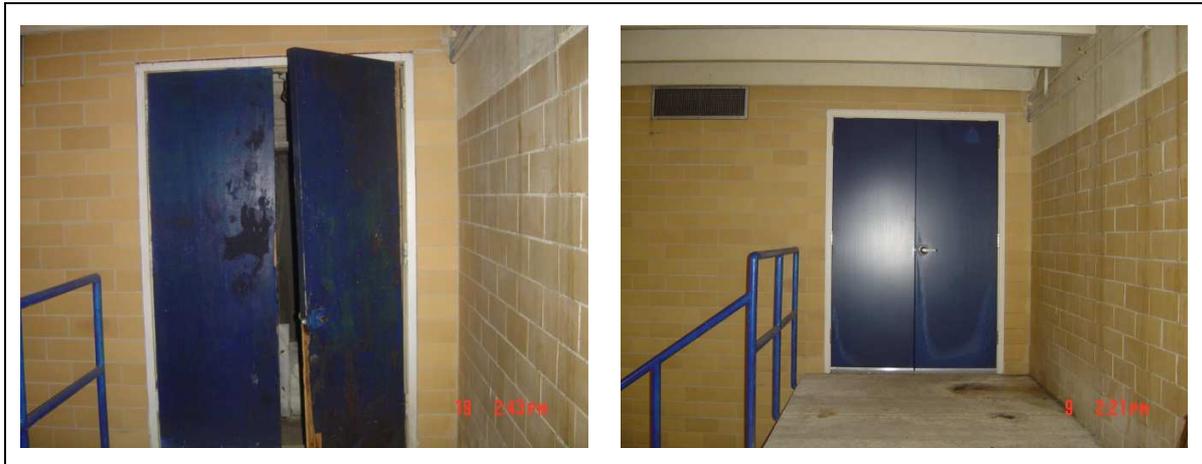
Phase II Subtask 10.4 - Pool Filtration Room Door

- The gallery door leads to an unconditioned mechanical room. The existing door did not seal properly and was not properly weather stripped. The new weather-stripped door will reduce the amount of heat loss in the pool gallery.

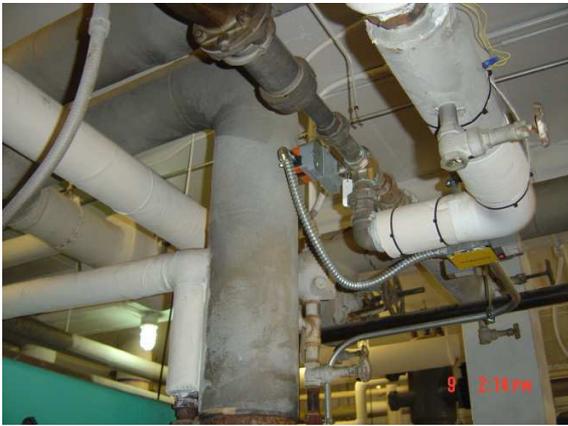
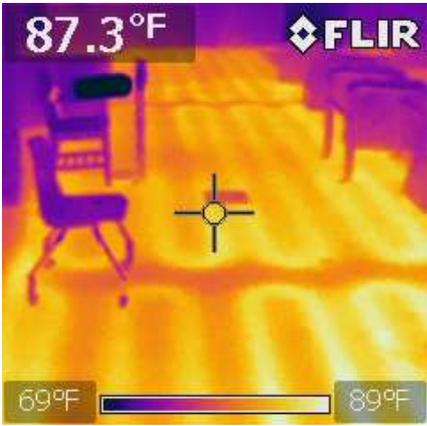
Phase II Subtask 5.5 - Floor Radiant Heating

<p>01. Must block car port and porch area from insulation</p>	<p>02. Example of air sealing needs to stop attic infiltration of conditioned air.</p>

- A three way control valve was installed on the floor radiant heating loop. Previously there was no way to control the temperature of the hot water flowing through this loop. The controls valve will allow the college to control the temperature of the loop which reduces the amount of wasted heat.

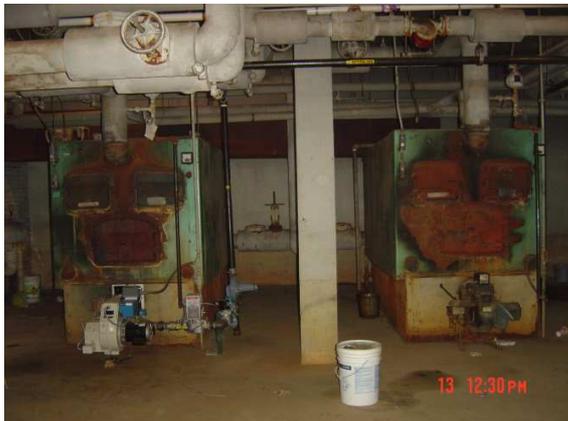
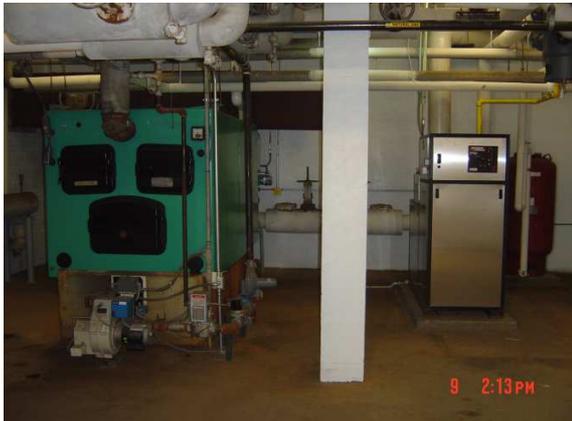
Phase II Subtask 7.4 - HVAC – Boilers

- The existing primary boiler was replaced with a new high efficient condensing boiler. The new boiler is 97% efficiency and will energy cost tremendously.

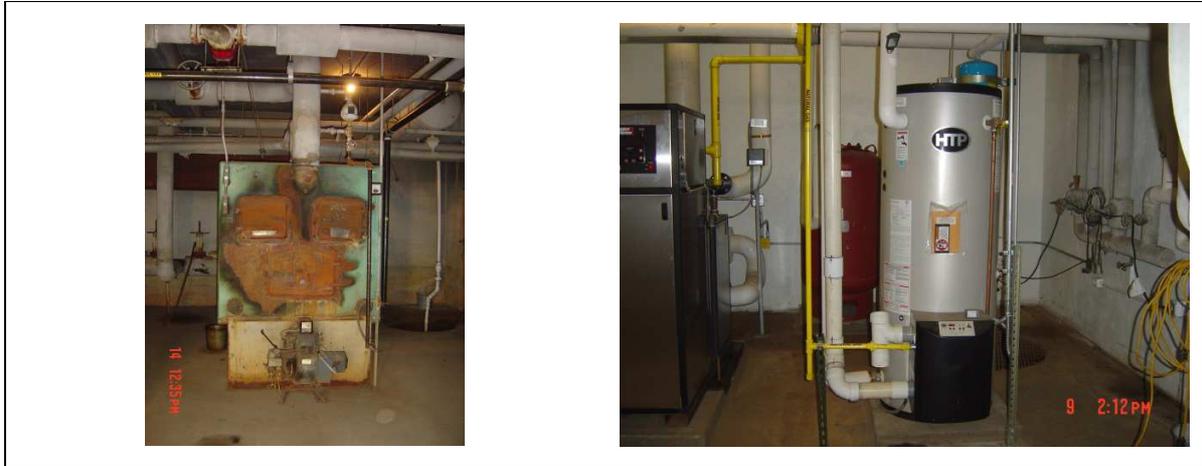
Phase II Subtask 7.5 - HVAC - Domestic Hot Water

- A domestic hot water heater was installed to provide hot water to the building. Prior to the renovation hot water was produced by the existing boiler. The new efficient water heater will prevent year round usage of the old hot water boiler.

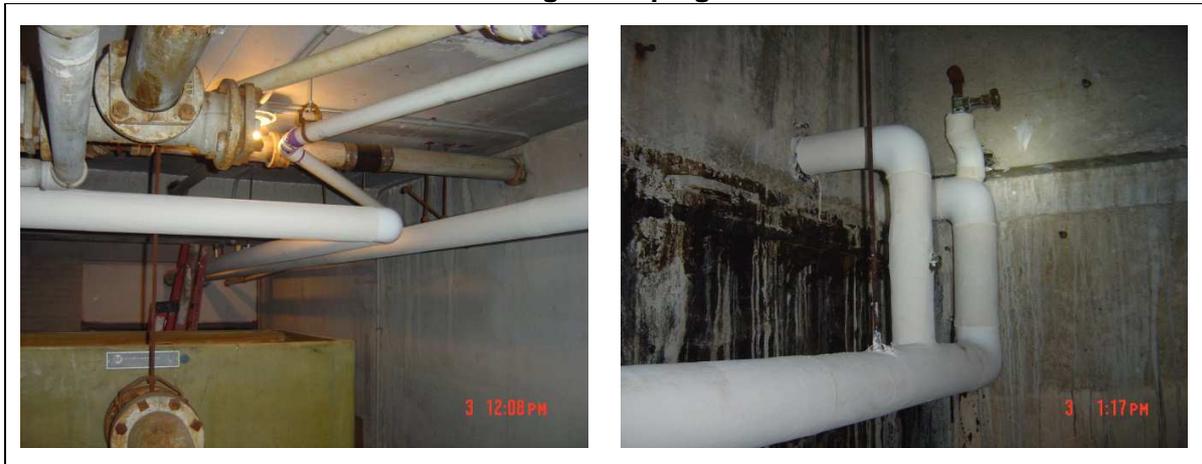
Phase II Subtask 7.12 HVAC - Existing HW Piping Insulation

- New piping insulation was installed on existing hot water piping. This will reduce heat loss as hot water travels through the system.

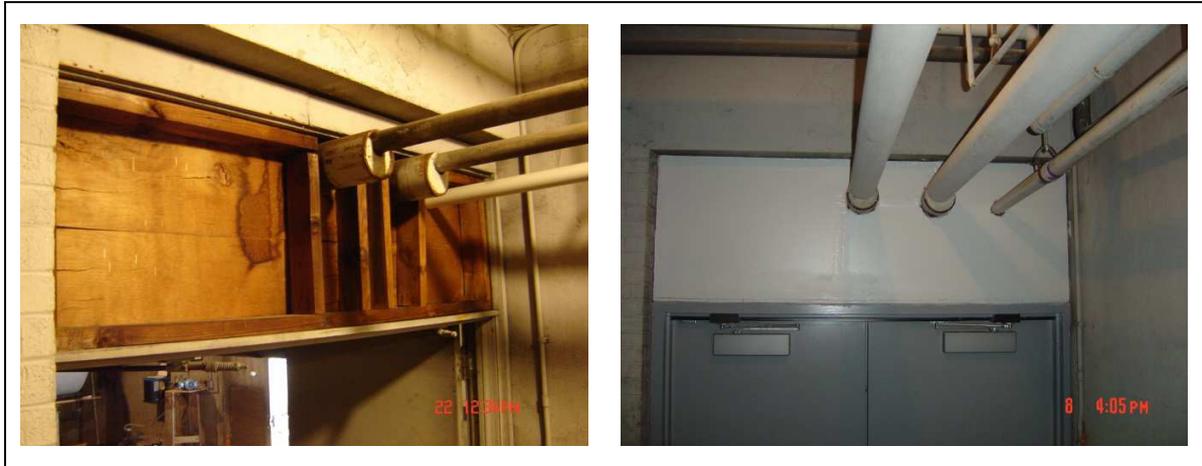
Phase II Subtask 7.14 - Fire Protection

- The existing piping penetrations were fire-caulked and new fire rated doors were installed in the mechanical room. This provides a safer mechanical room.

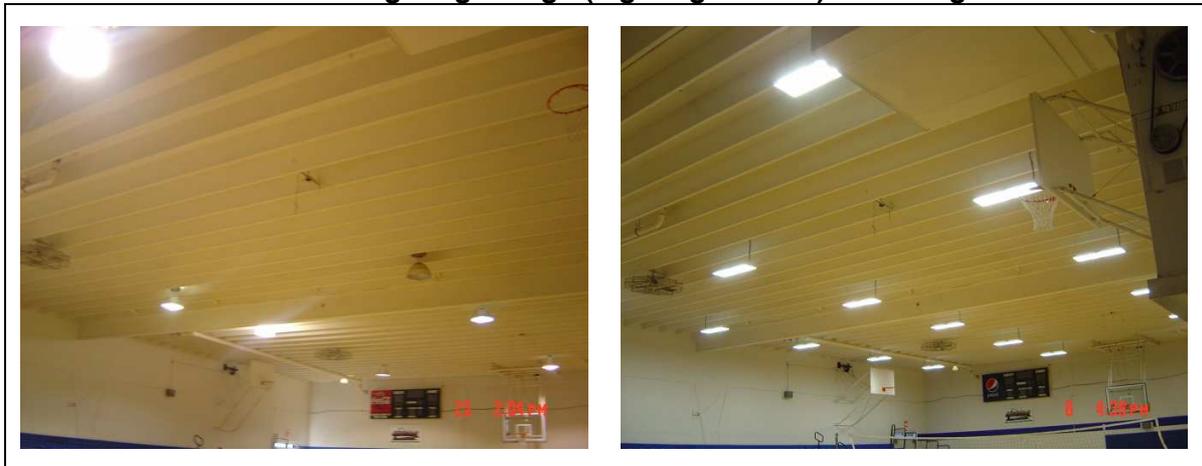
Phase II Subtask 11.4 - Lighting Design (Lighting Retrofit) - Building

- New LED light fixtures were installed in the gymnasium. Also T8 fixtures were installed to replace existing T12 fixtures. Occupancy sensors were installed in applicable areas. Not only will the new lights reduce energy costs, but they are providing addition light in most areas.

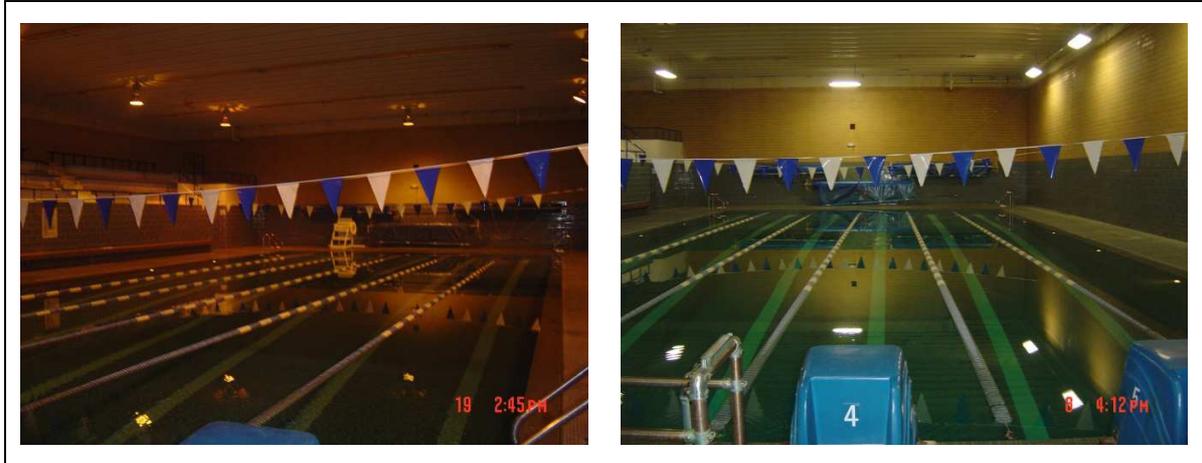
Phase II Subtask 11.5 - Lighting Design (Lighting Retrofit) - Pool

- The existing pool lights were replaced with new energy efficient lights, similar to the rest of the building.
