**WSRC-MS-99-00078**

# Microstructural Characterization of 6061 Aluminum to 304L Stainless Steel Inertia Welds

K. A. Dunn, M. R. Louthan, and M. H. Tosten  
Westinghouse Savannah River Company  
Aiken, SC 29808

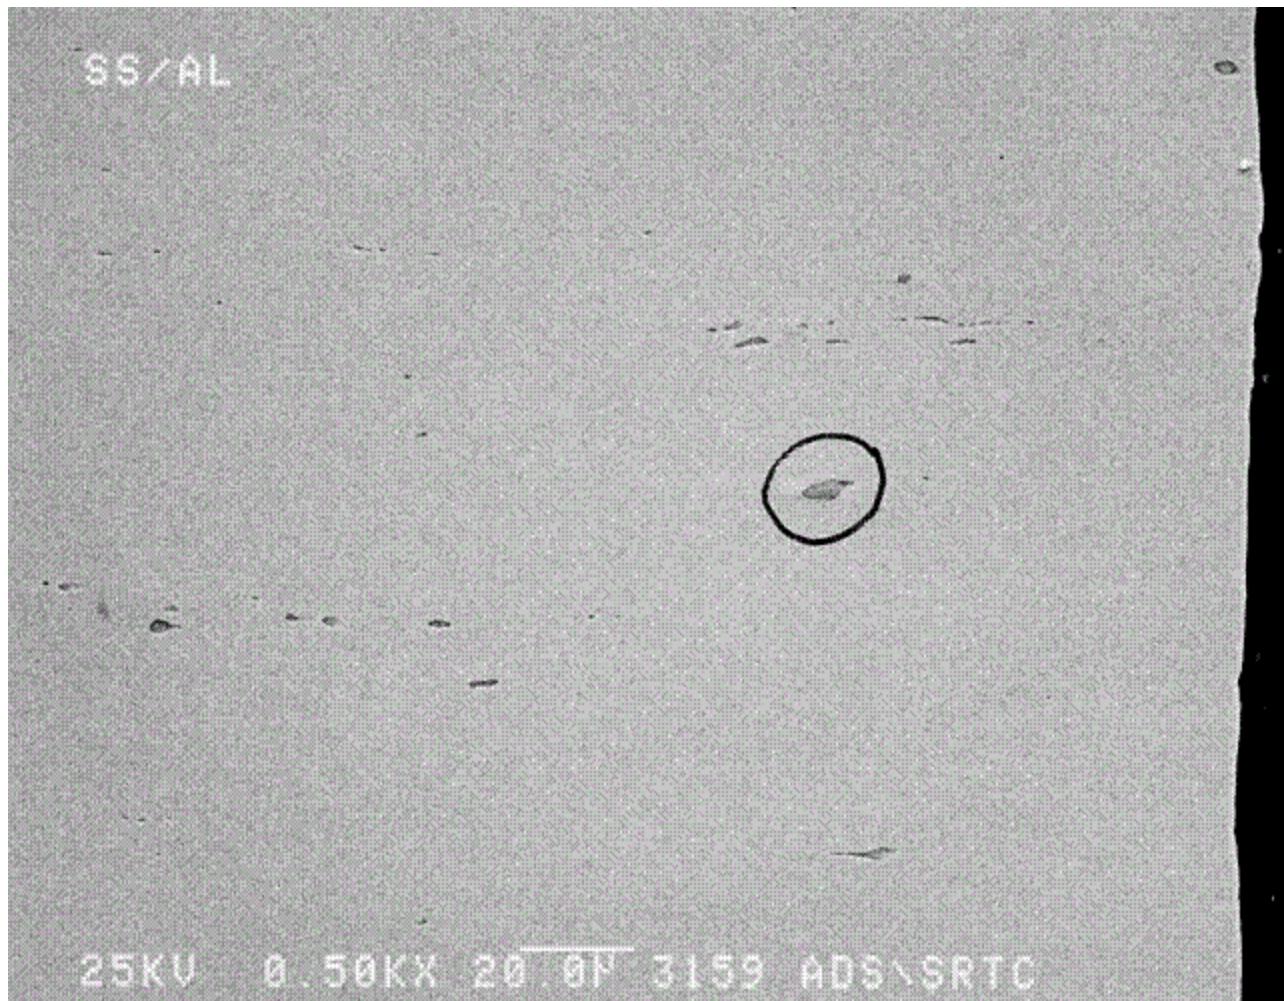
**Figure 14. SEM photograph of stainless steel portion of inertia welded specimen in the unetched condition. Page 28 bottom**

SEM examination, using the backscattered electron detector, did not indicate a pattern of particles along the grain boundaries in the SS material. However, a small number of particles were observed in the matrix aligned with the rolling direction, Figure 14. EDS examination of a particle in the matrix revealed the presence of C, Cr, and Mn with trace amounts of O<sub>2</sub> and Al, Figure 15. No impurities in the Al alloy were observed. An EDS analysis across the unetched Al/SS interface is shown in Figures 16 and 17. A distinct separation between the Al and SS was seen and no oxides were detected at the interface.

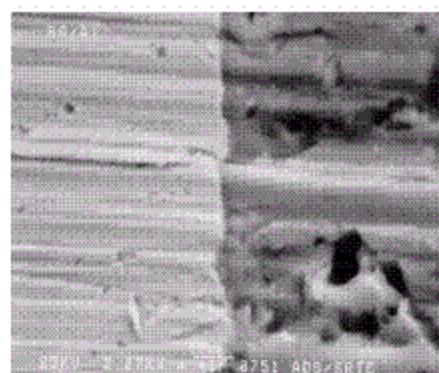
**Figure 16. "SEM photograph of mounted and unetched Al/SS inertia weld.**
