FERNALD PRESERVE

2015 Site Environmental Report

U.S. Department of Energy
Office of Legacy Management
Issued May 2016

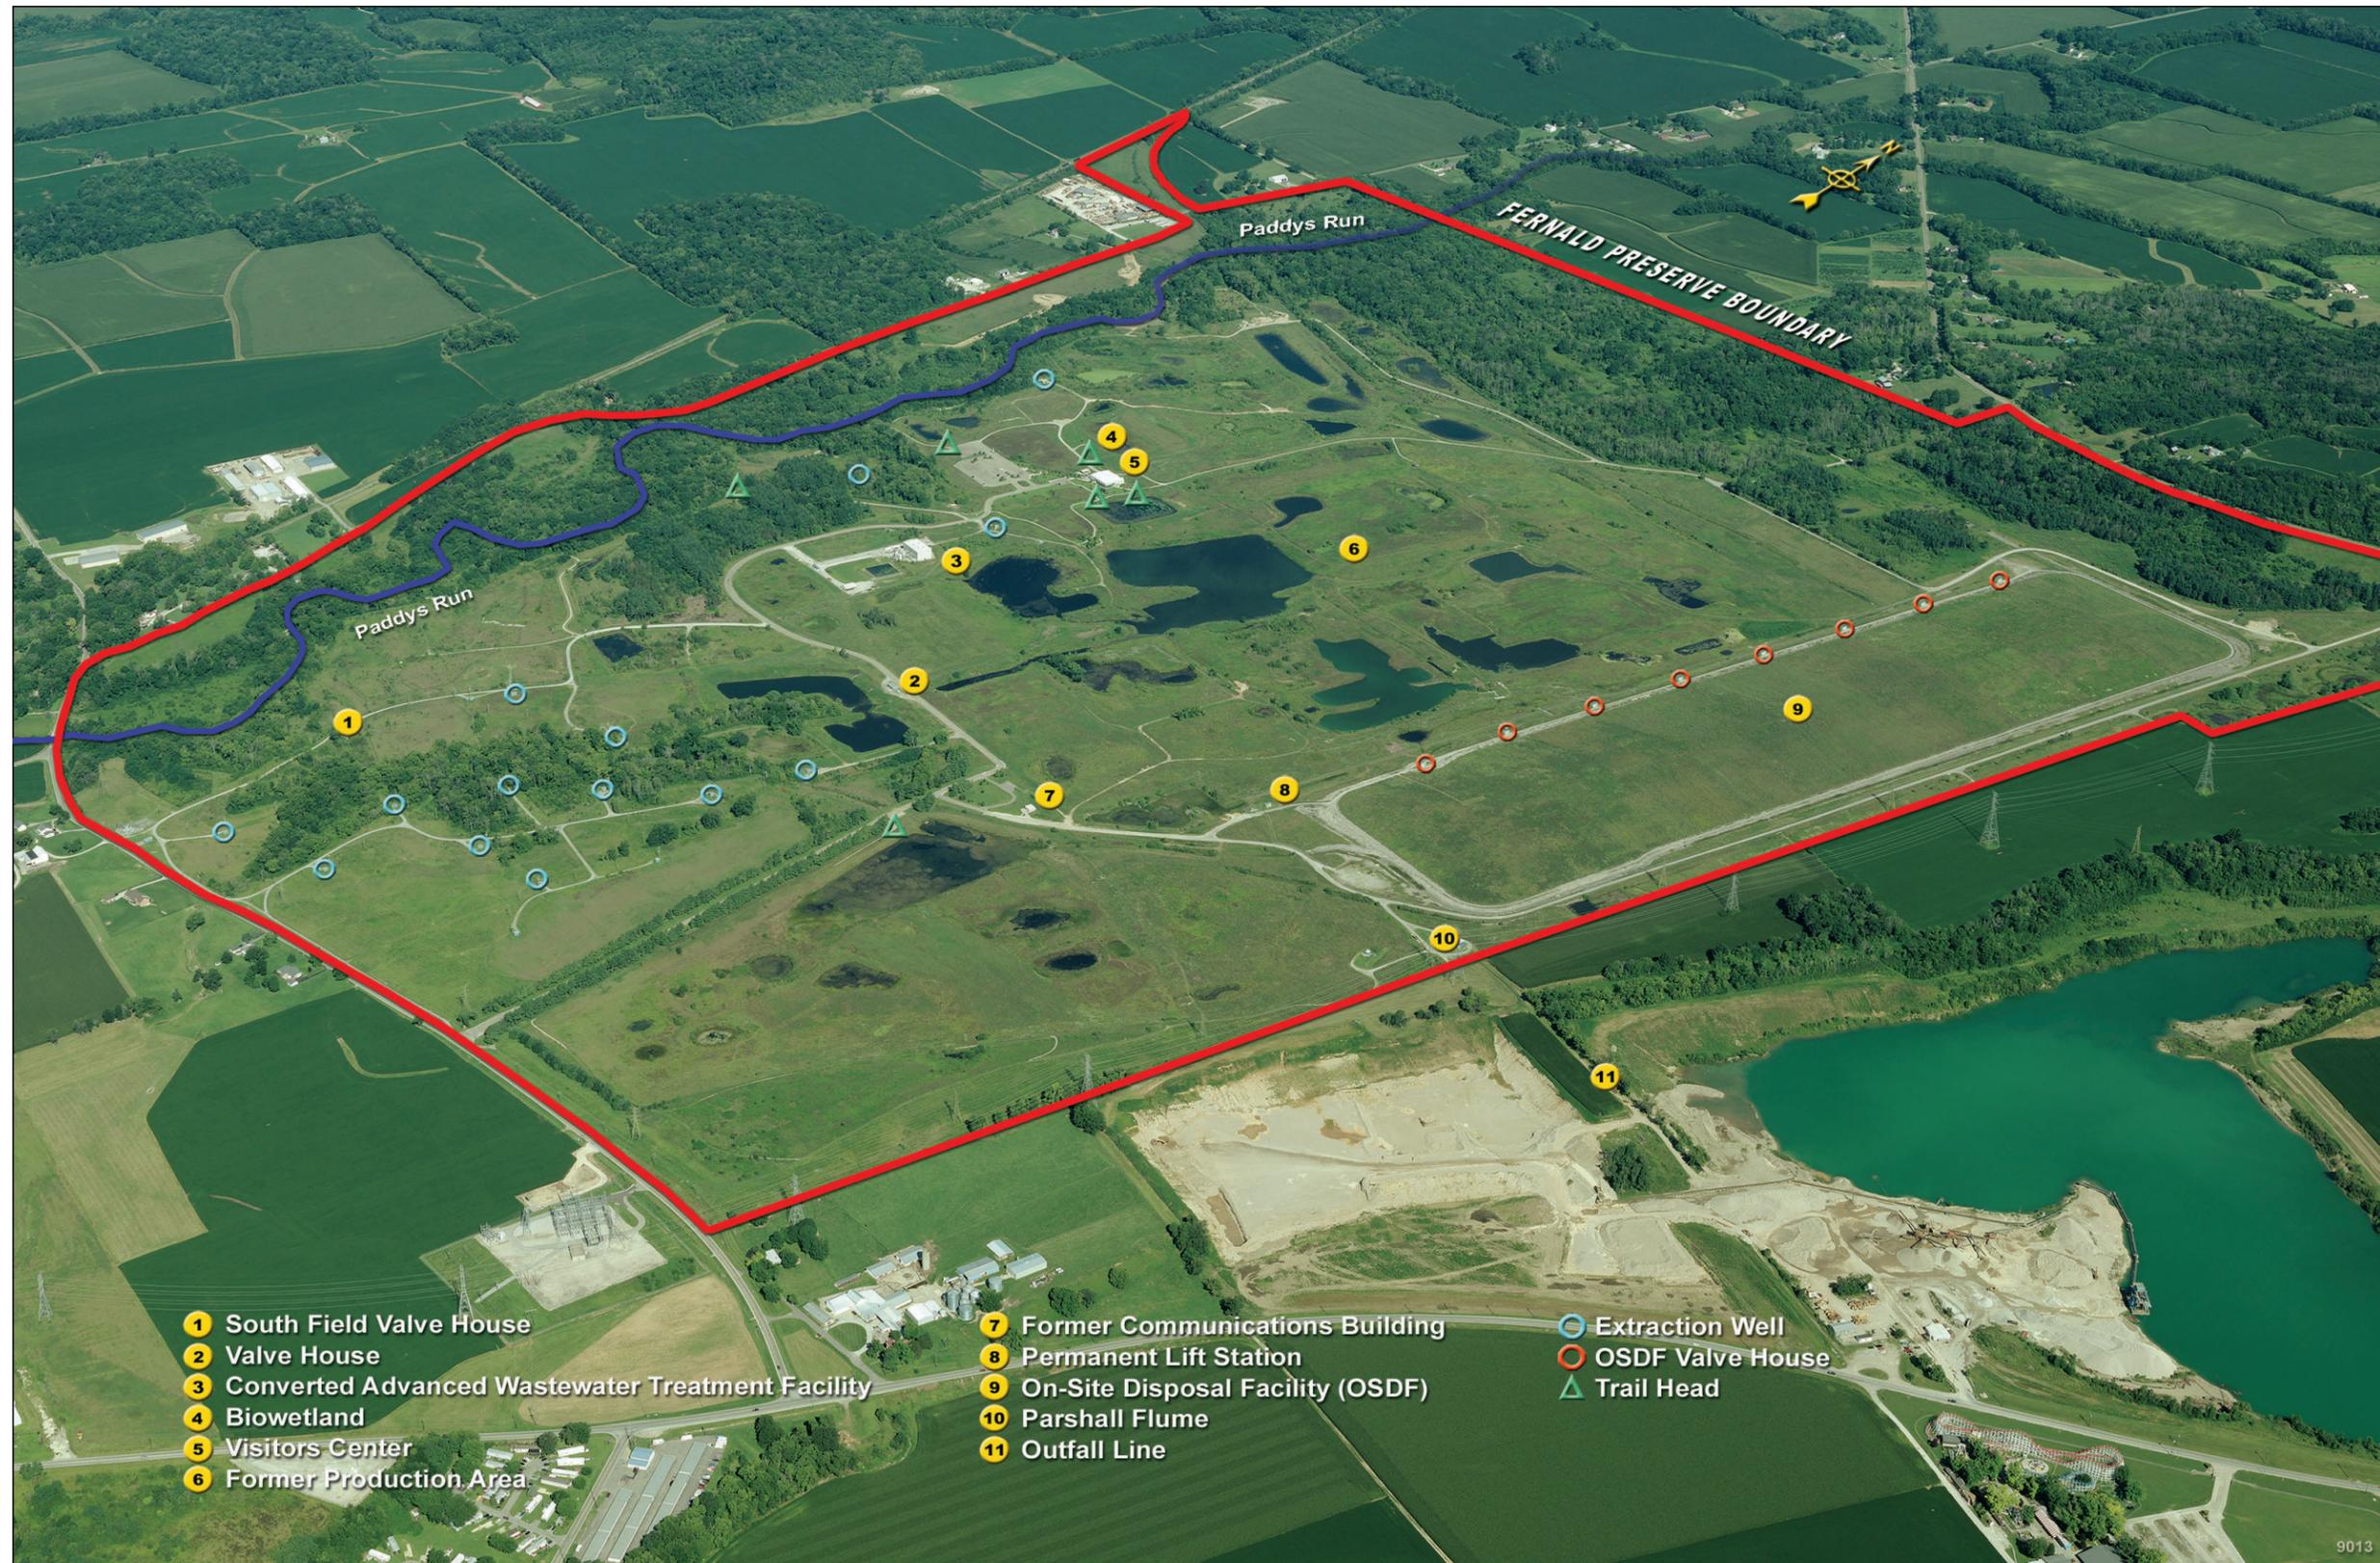
Figure 3. Fernald Preserve Perspective

Figure 3 depicts the location of the major physical features of the site, such as the buildings and supporting infrastructure. The Former Production Area and the OSDF dominate this view. The Former Production Area occupies approximately 136 acres (55 hectares) in the center of the site, and the OSDF occupies approximately 120 acres (48.6 hectares). The Great Miami River cuts a terraced valley to the east of the site, and Paddys Run (an intermittent stream) flows from north to south along the site's western boundary. In general, the site lies on a terrace that slopes gently among vegetated bedrock outcrops to the north, southeast, and southwest.

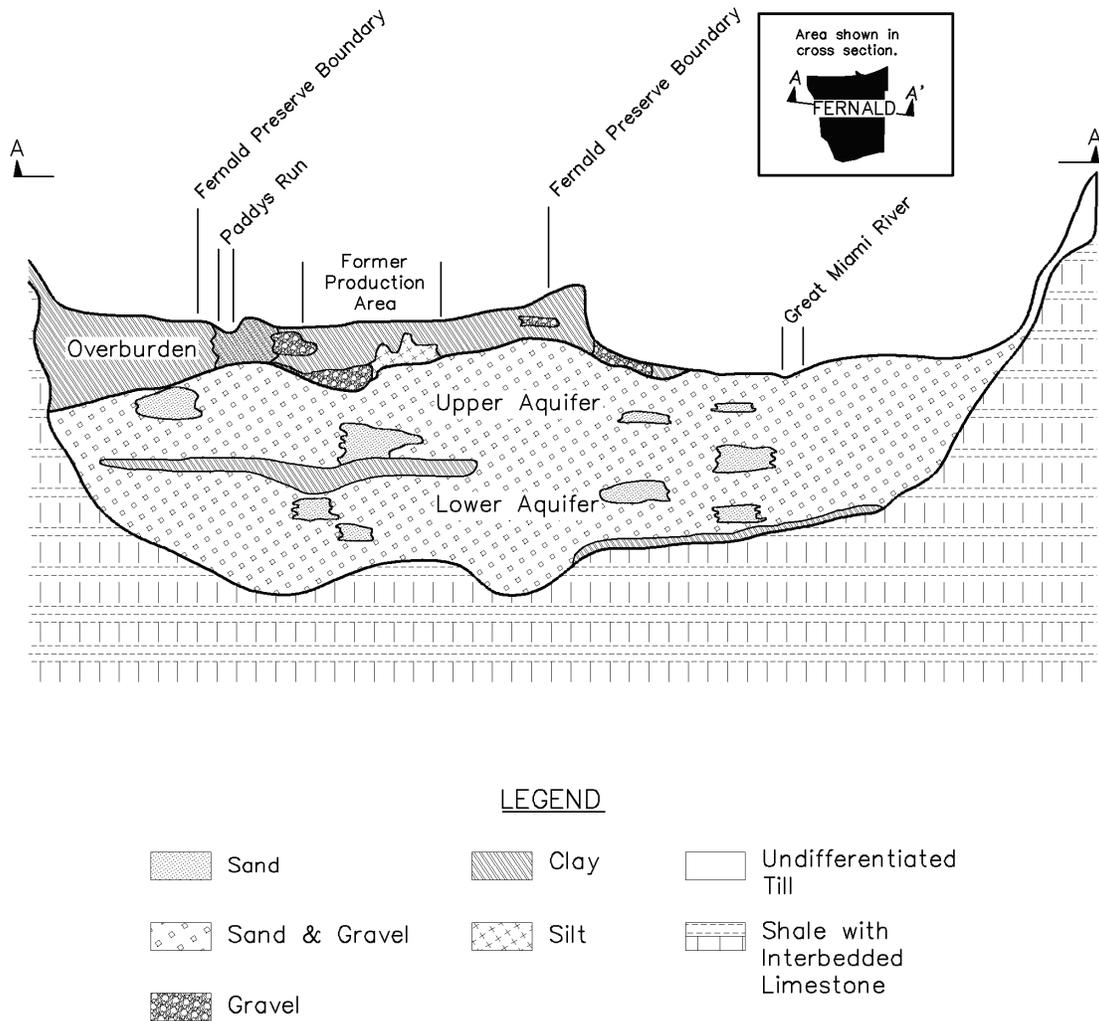
Figure 4. Schematic Cross Section of the New Haven Trough, Looking North

The last glacier to reach the area left a glacial overburden—a low-permeability mixture of clay and silt with minor amounts of sand and gravel—deposited across the land surface. The site is situated on a layer of glacial overburden that overlies portions of a 2- to 3-mile-wide (3 to 5 km wide) buried valley. This valley, known as the New Haven Trough, makes up part of the Great Miami Aquifer. The impermeable shale and limestone bedrock that defines the edges and bottom of the New Haven Trough restricts the groundwater to the sand and gravel within the buried valley. Where present, the glacial overburden limits the downward movement of precipitation and surface water runoff into the underlying sand and gravel of the Great Miami Aquifer.

The Great Miami River and its tributaries have eroded considerable portions of the glacial overburden and exposed the underlying sand and gravel of the Great Miami Aquifer. Thus, in some areas, precipitation and surface water runoff can easily migrate into the underlying Great Miami Aquifer and transport contaminants to the aquifer as well. Natural and man-made breaches of the glacial overburden were key pathways where contaminated water entered the aquifer, causing the groundwater plumes that are being addressed by aquifer restoration activities. Figure 4 provides a view of the structure of subsurface deposits in the region along an east-west cross section beneath the site and through the New Haven Trough, and Figure 5 presents the regional groundwater flow patterns in the Great Miami Aquifer.

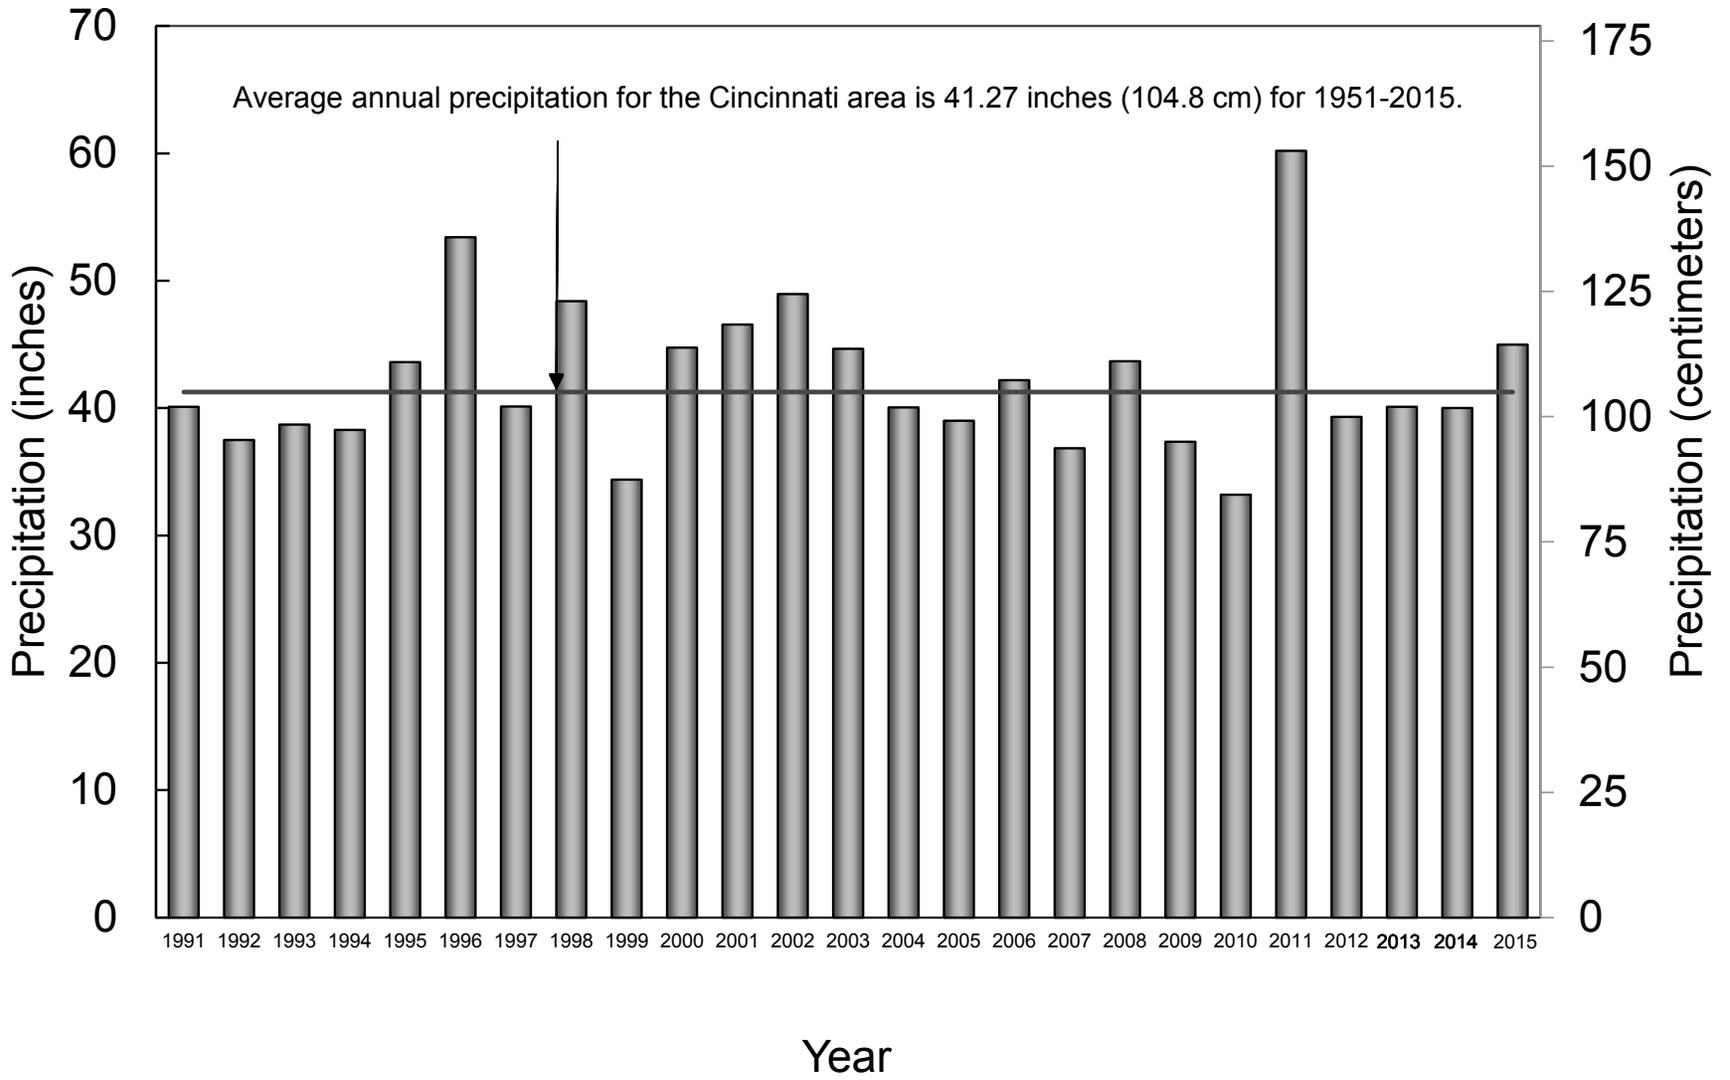
Figure 7. Annual Precipitation, 1991–2015

In 2015, 44.98 inches (114.2 centimeters [cm]) of precipitation were measured at the Butler County Regional Airport. This measurement, which represents precipitation at the site, is higher than the average annual precipitation of 41.27 inches (104.8 cm) for 1951 through 2015. Figure 7 shows the total annual precipitation recorded at the Fernald Preserve for each year from 1991 through 2015 and the annual precipitation for the Cincinnati area from 1951 through 2015. Figure 8 shows monthly precipitation at the site for 2015 compared to the Cincinnati area average monthly precipitation from 1951 through 2015.

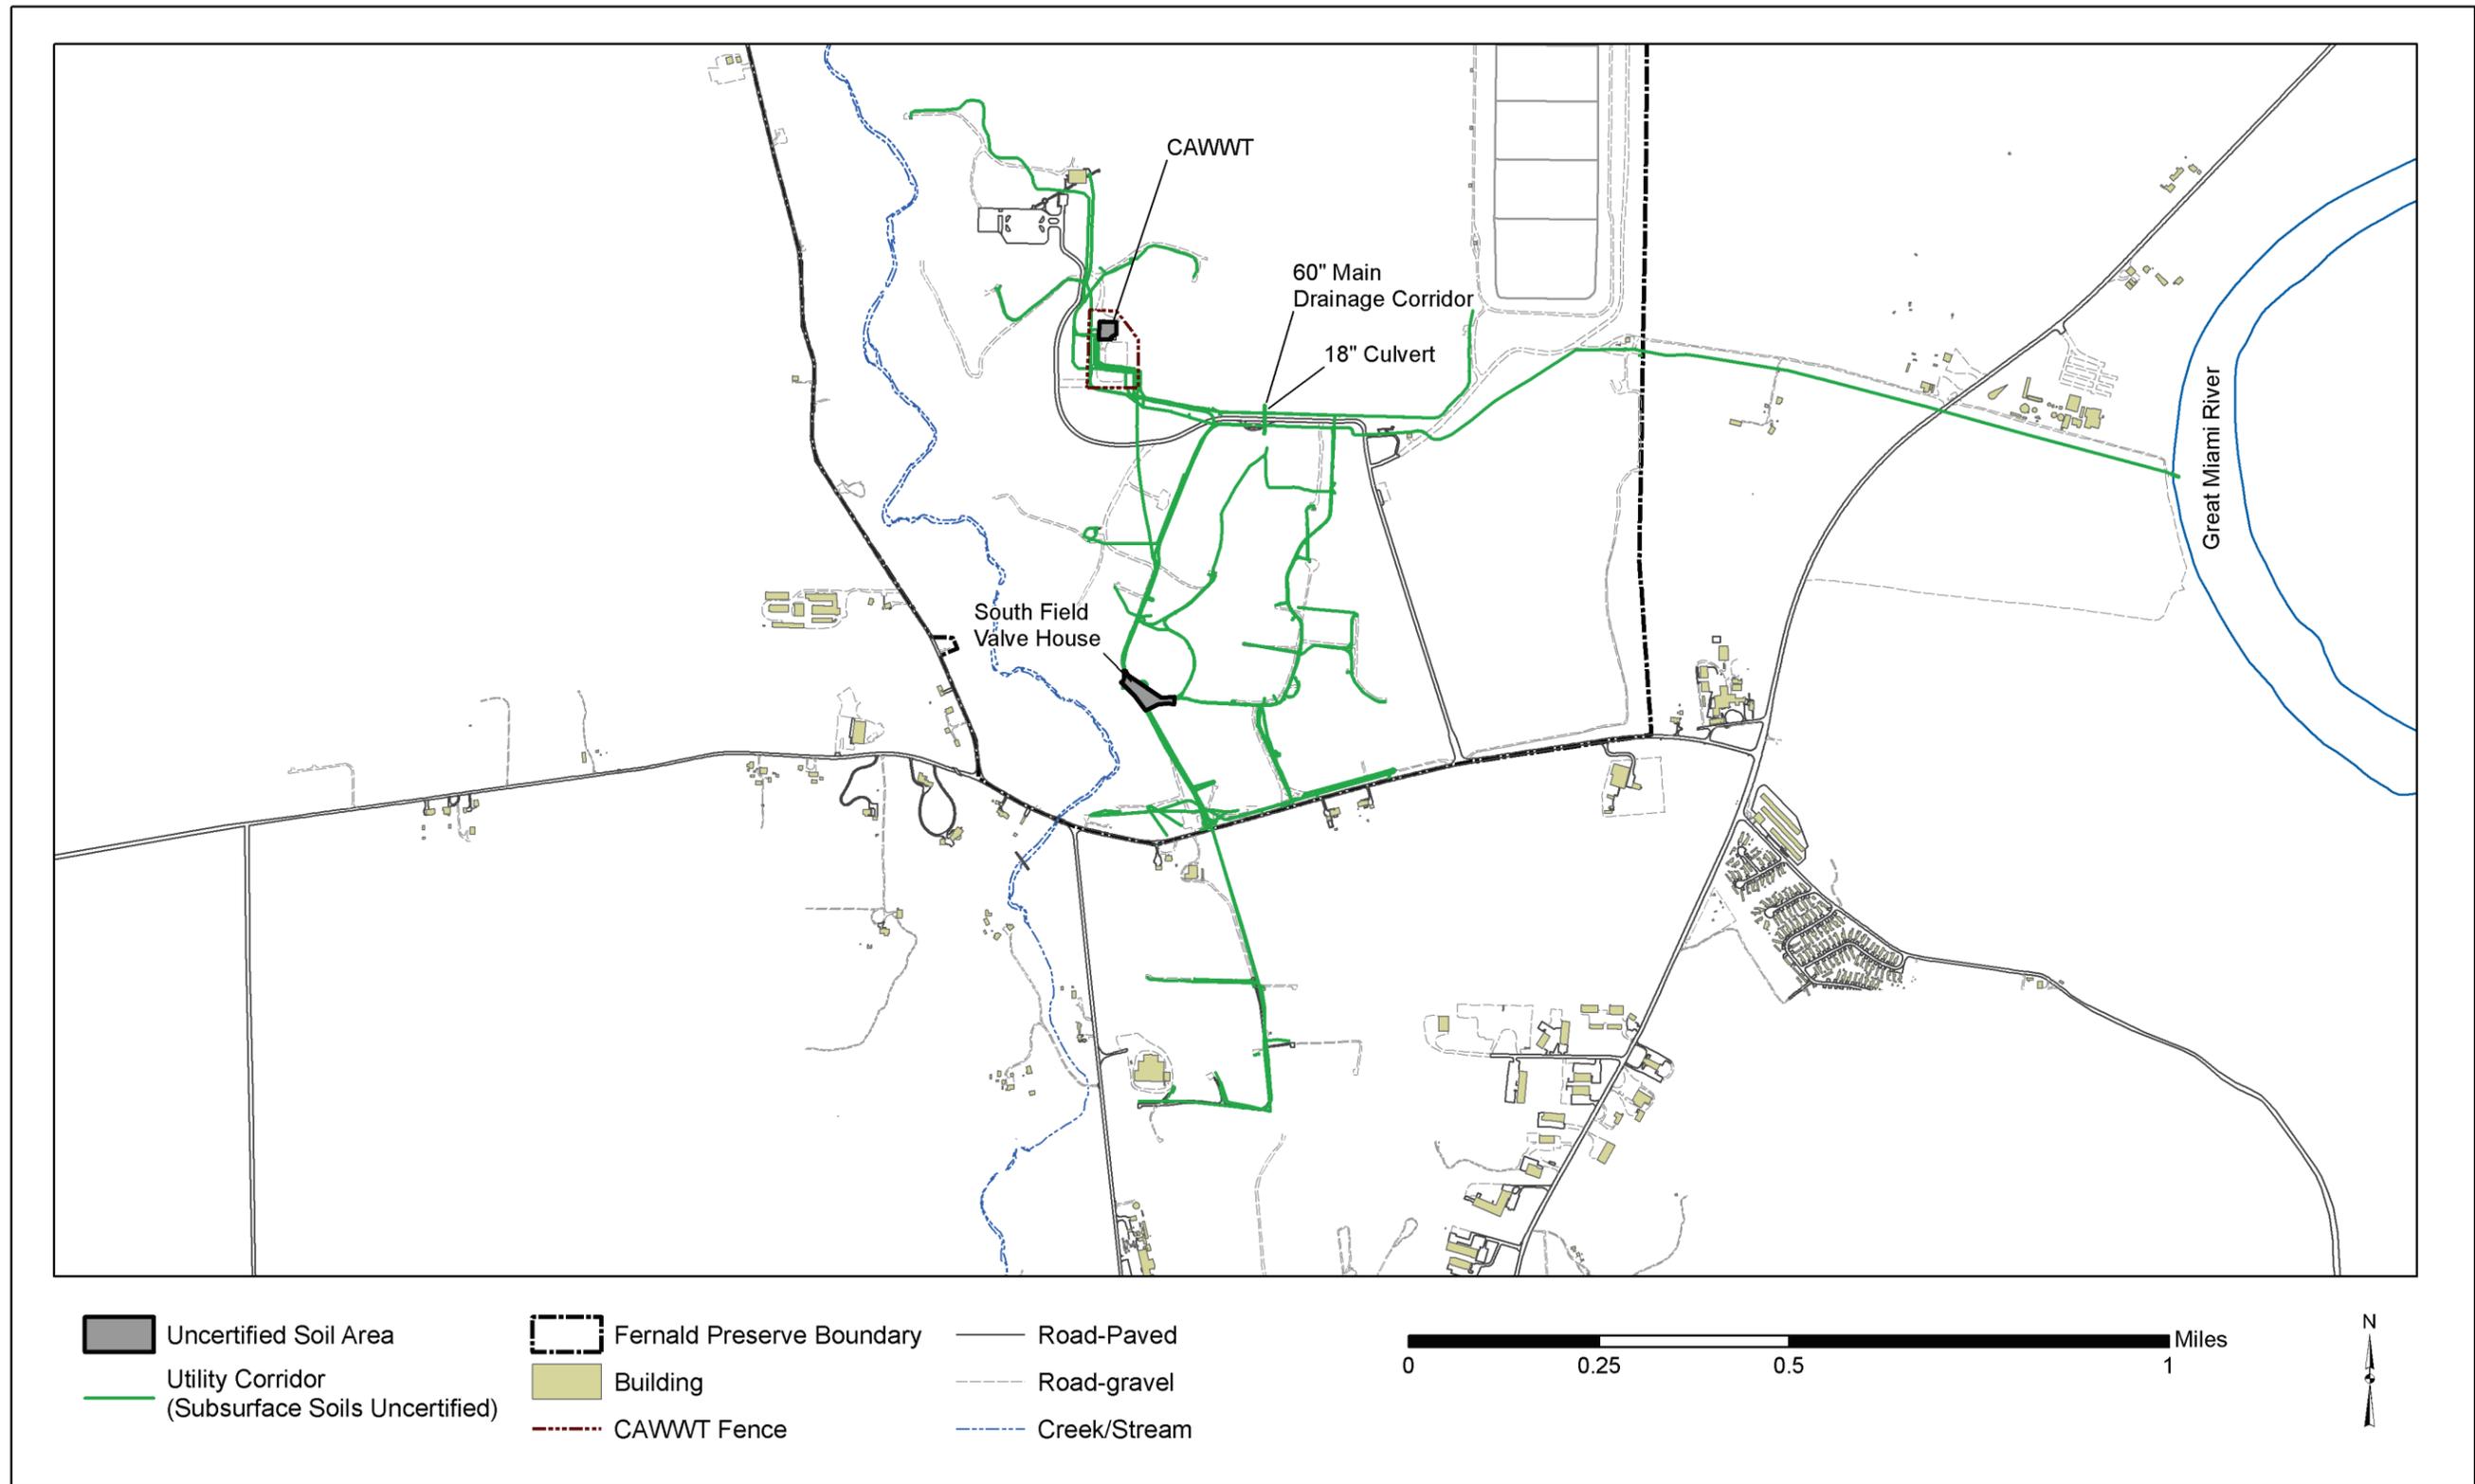
Figure 9. Uncertified Areas and Subgrade Utility Corridors

- Figure 9 indicates soil areas that remain uncertified pending the end of the groundwater remedy and the decontamination and decommissioning of the related facilities and the associated utilities.

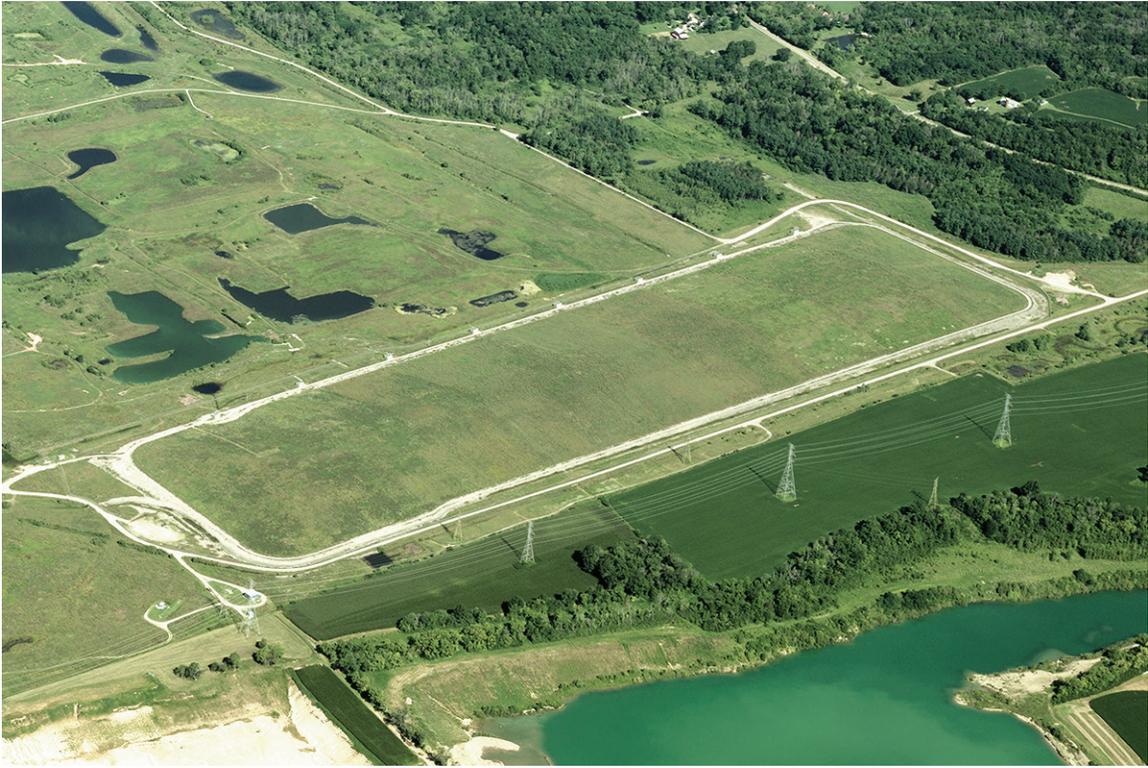
Aerial Photograph of OSDF, June 2015

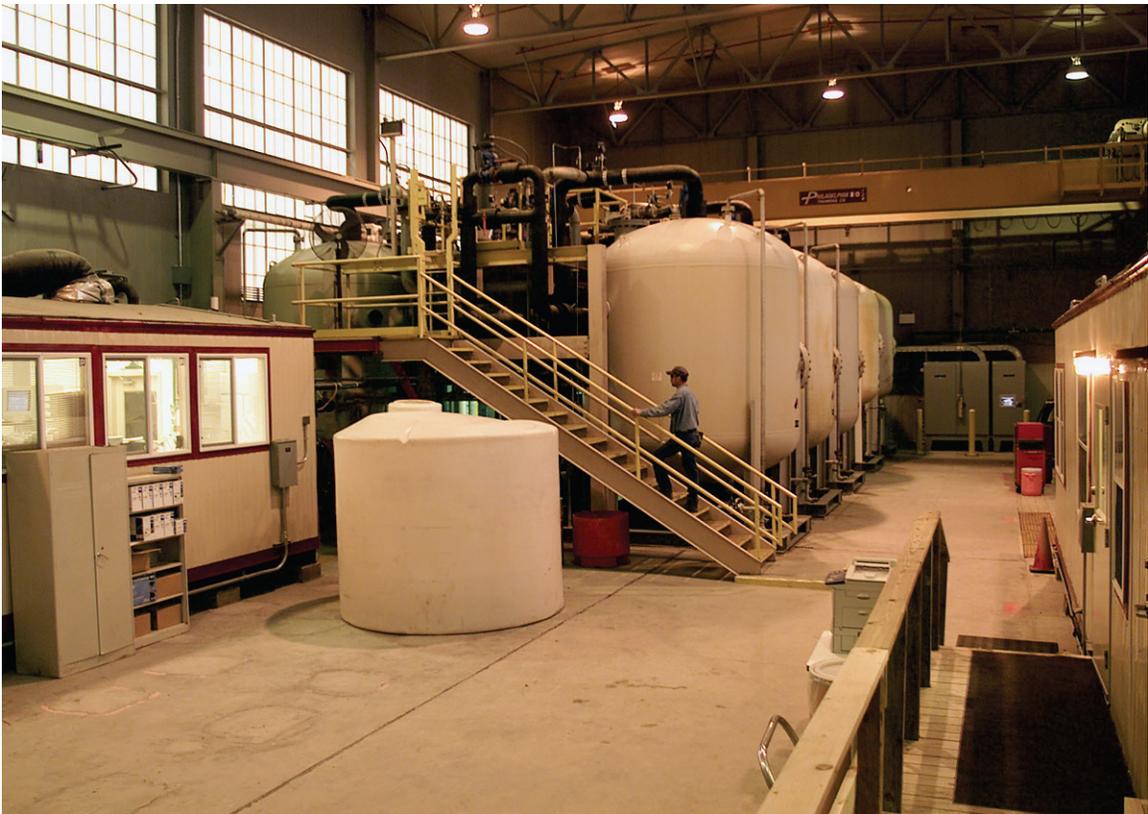
The Converted Advanced Wastewater Treatment Facility

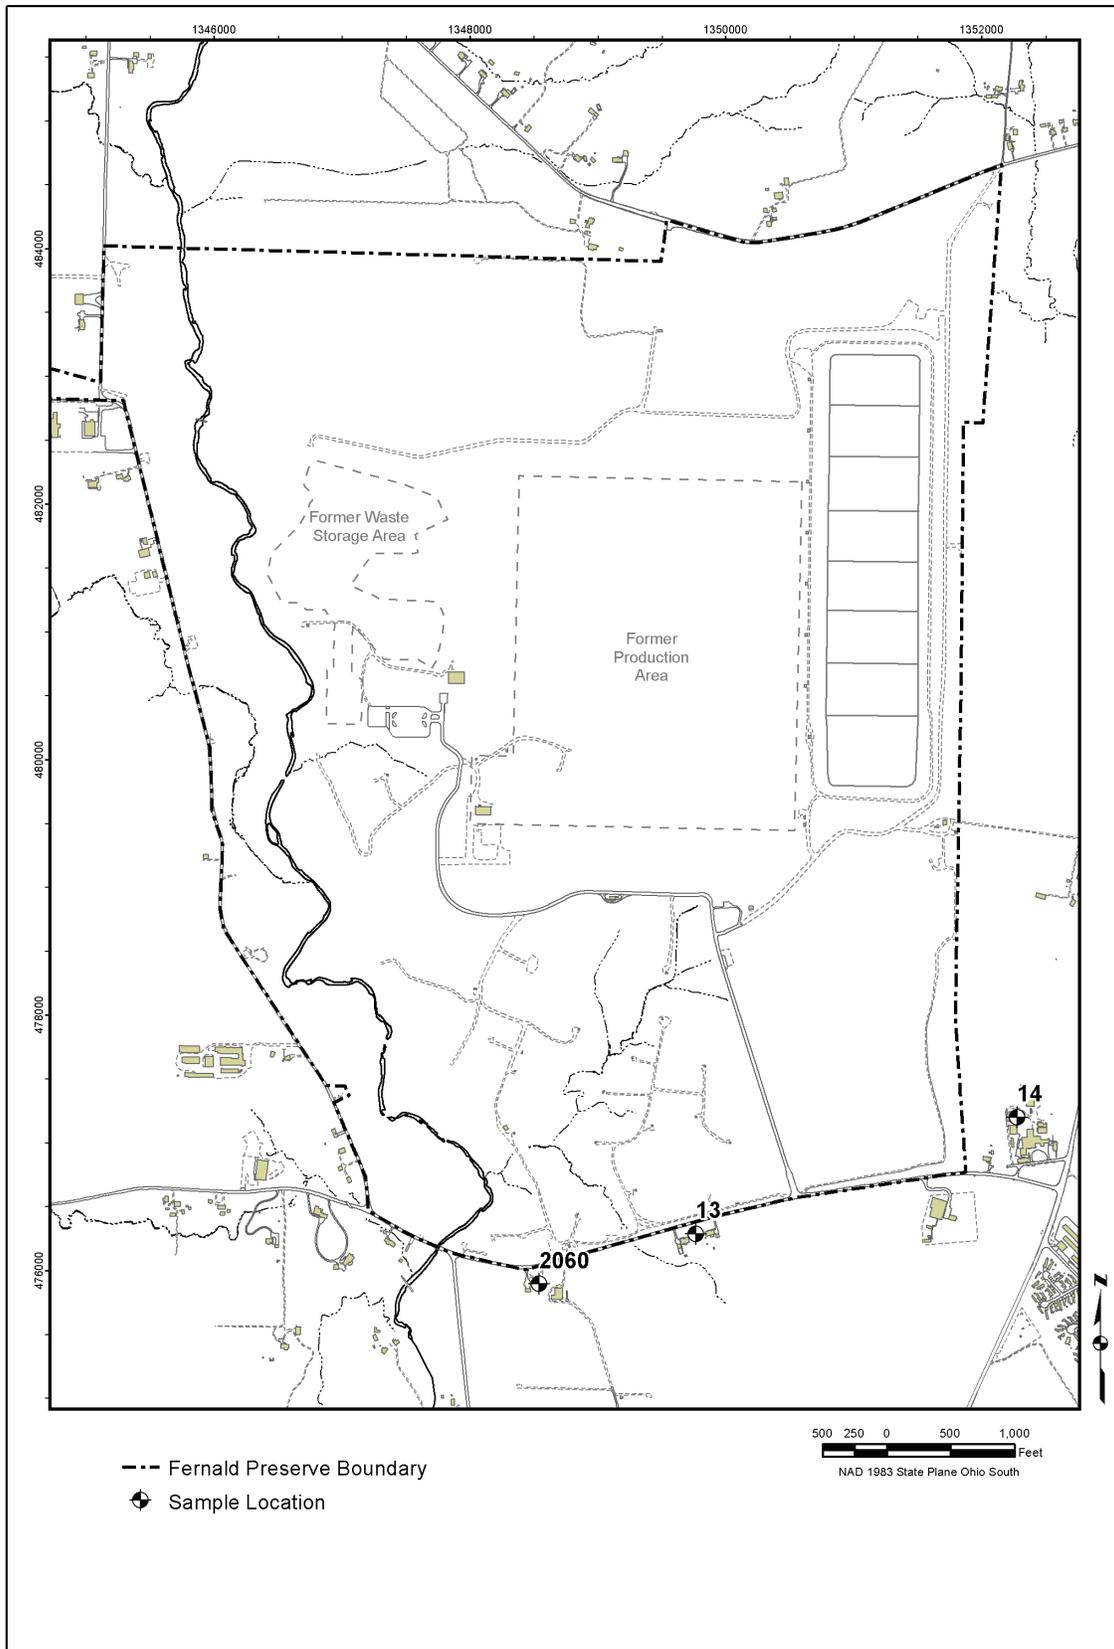
Figure 10. DOE and Ohio EPA Groundwater Split Sample Locations

In 2015, DOE and Ohio EPA cooperated in the split sampling program. Table 3 provides the analytical results of split groundwater samples, and Figure 10 shows the split sample locations.

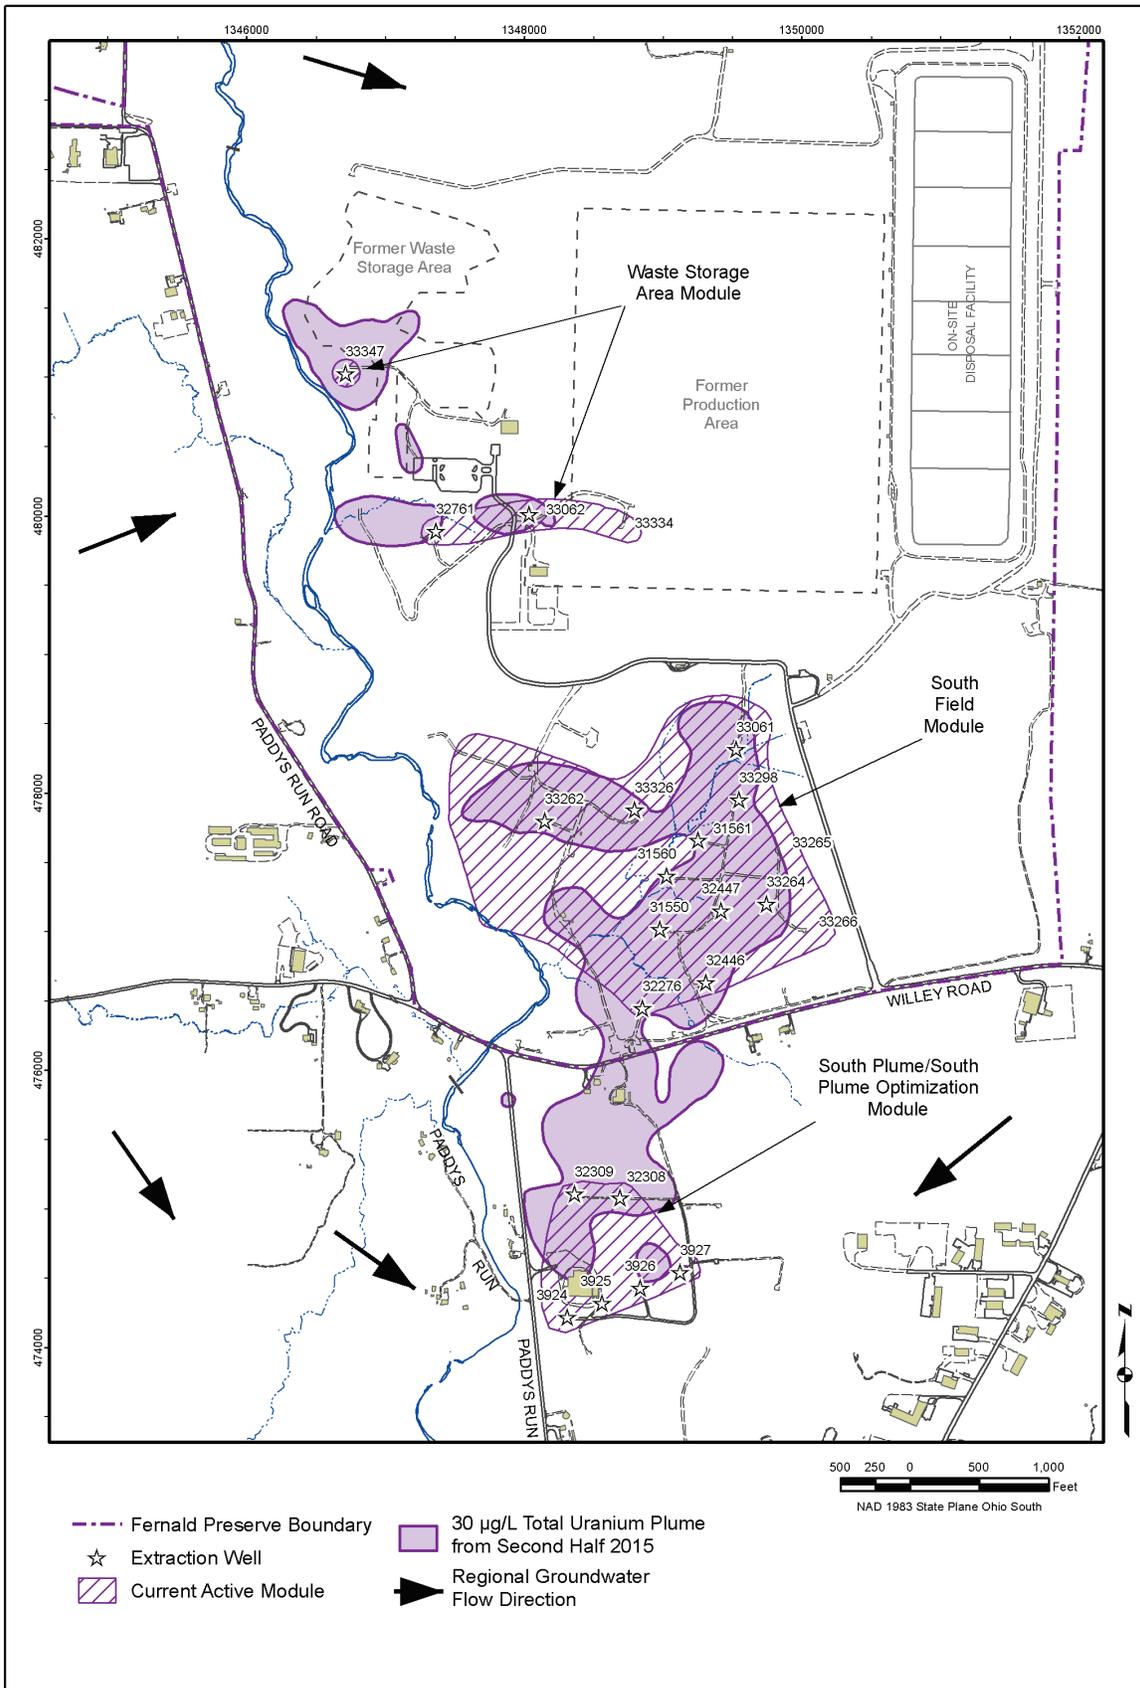
Figure 11. Extraction Wells Active in 2015

surface water through the bed of Paddys Run, the storm sewer outfall ditch (SSOD), the Pilot Plant Drainage Ditch (PPDD), and the Old Drainage Ditch from the Plant 1 Pad. Figure 11 shows the footprint of the 30 micrograms per liter (µg/L) uranium plume within the aquifer from the second half of 2015.

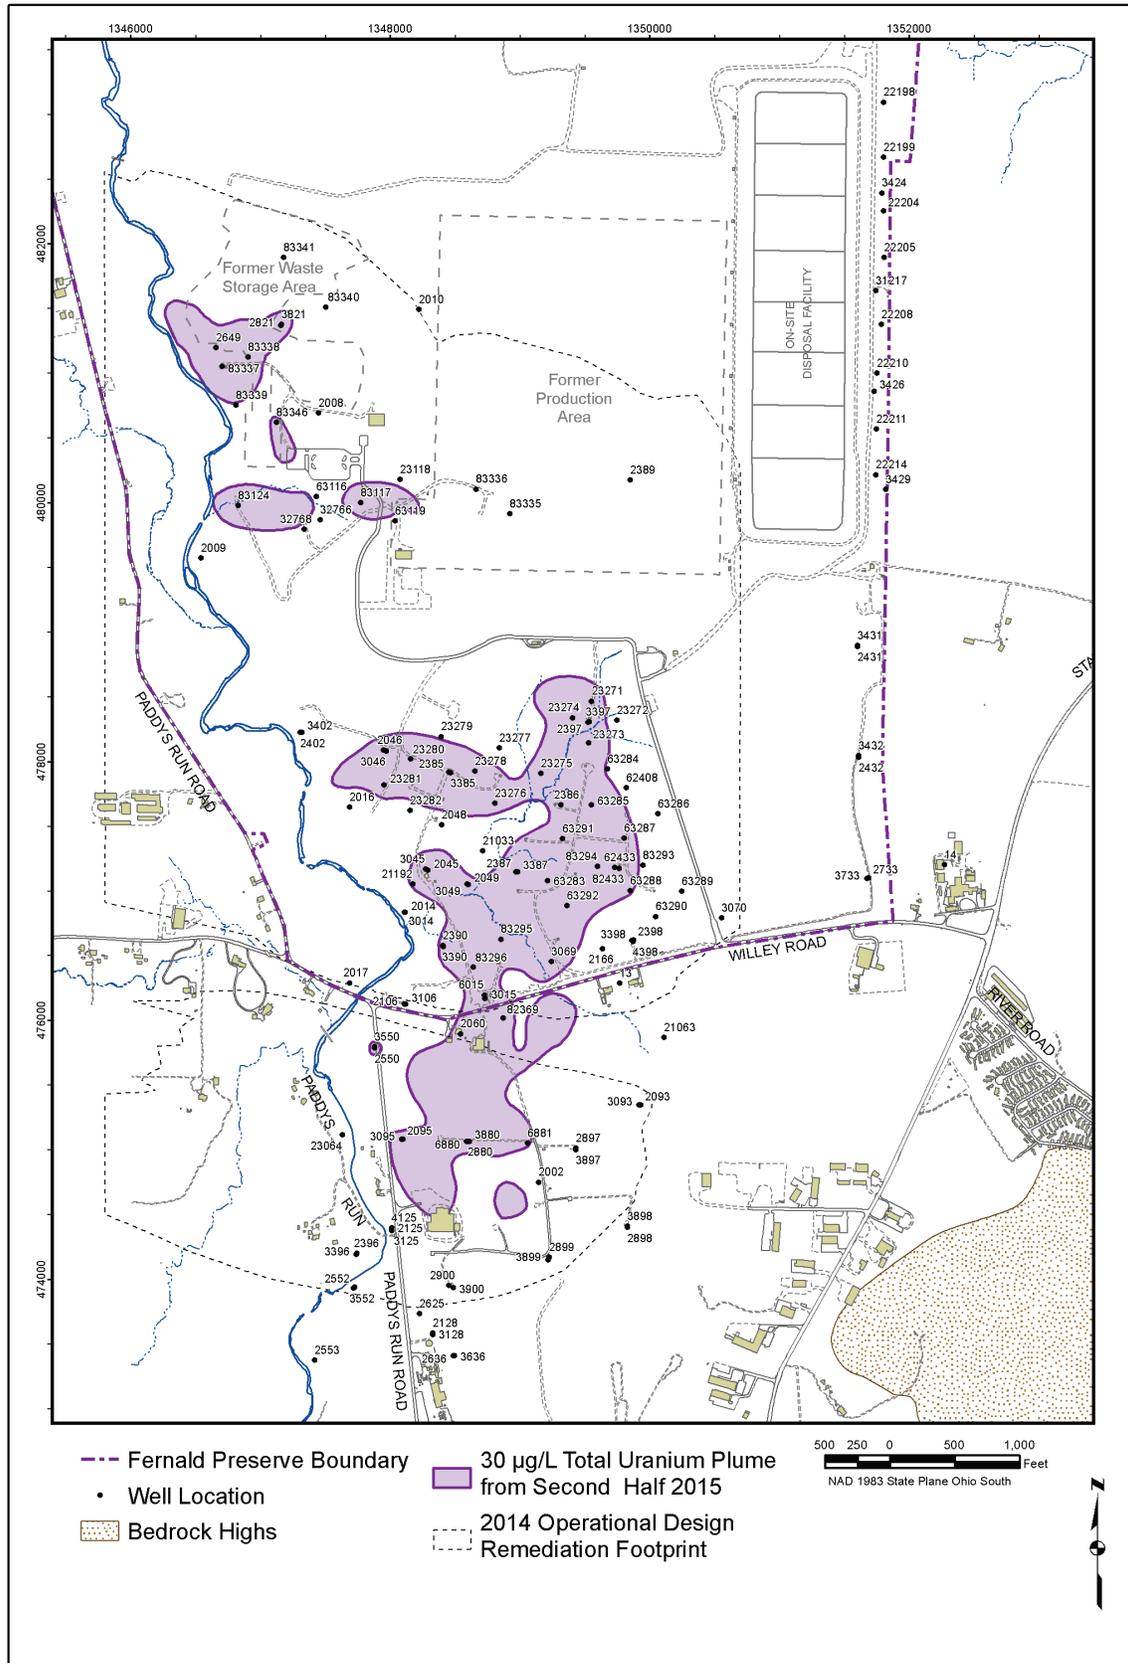
Figure 12. Locations for Semiannual Total Uranium Monitoring

The *Design for Remediation of the Great Miami Aquifer in the Waste Storage and Plant 6 Areas* (DOE 2001a) also provided data indicating that the uranium plume in the former Plant 6 Area was no longer present. It was believed that the uranium concentrations in the plume had decreased to levels below the FRL as a result of plant operations shutting down in the late 1980s and the pumping of highly contaminated perched water as part of the Perched Water Removal Action No. 1 in the early 1990s. Because a uranium plume with concentrations above the groundwater FRL was no longer present in the former Plant 6 Area at the time of the design, a restoration module for the area was determined to be unnecessary. Groundwater monitoring continues in the former Plant 6 Area with one well (well 2389) in the area having sporadic total uranium FRL exceedances. Figure 12 shows the location of monitoring well 2389.

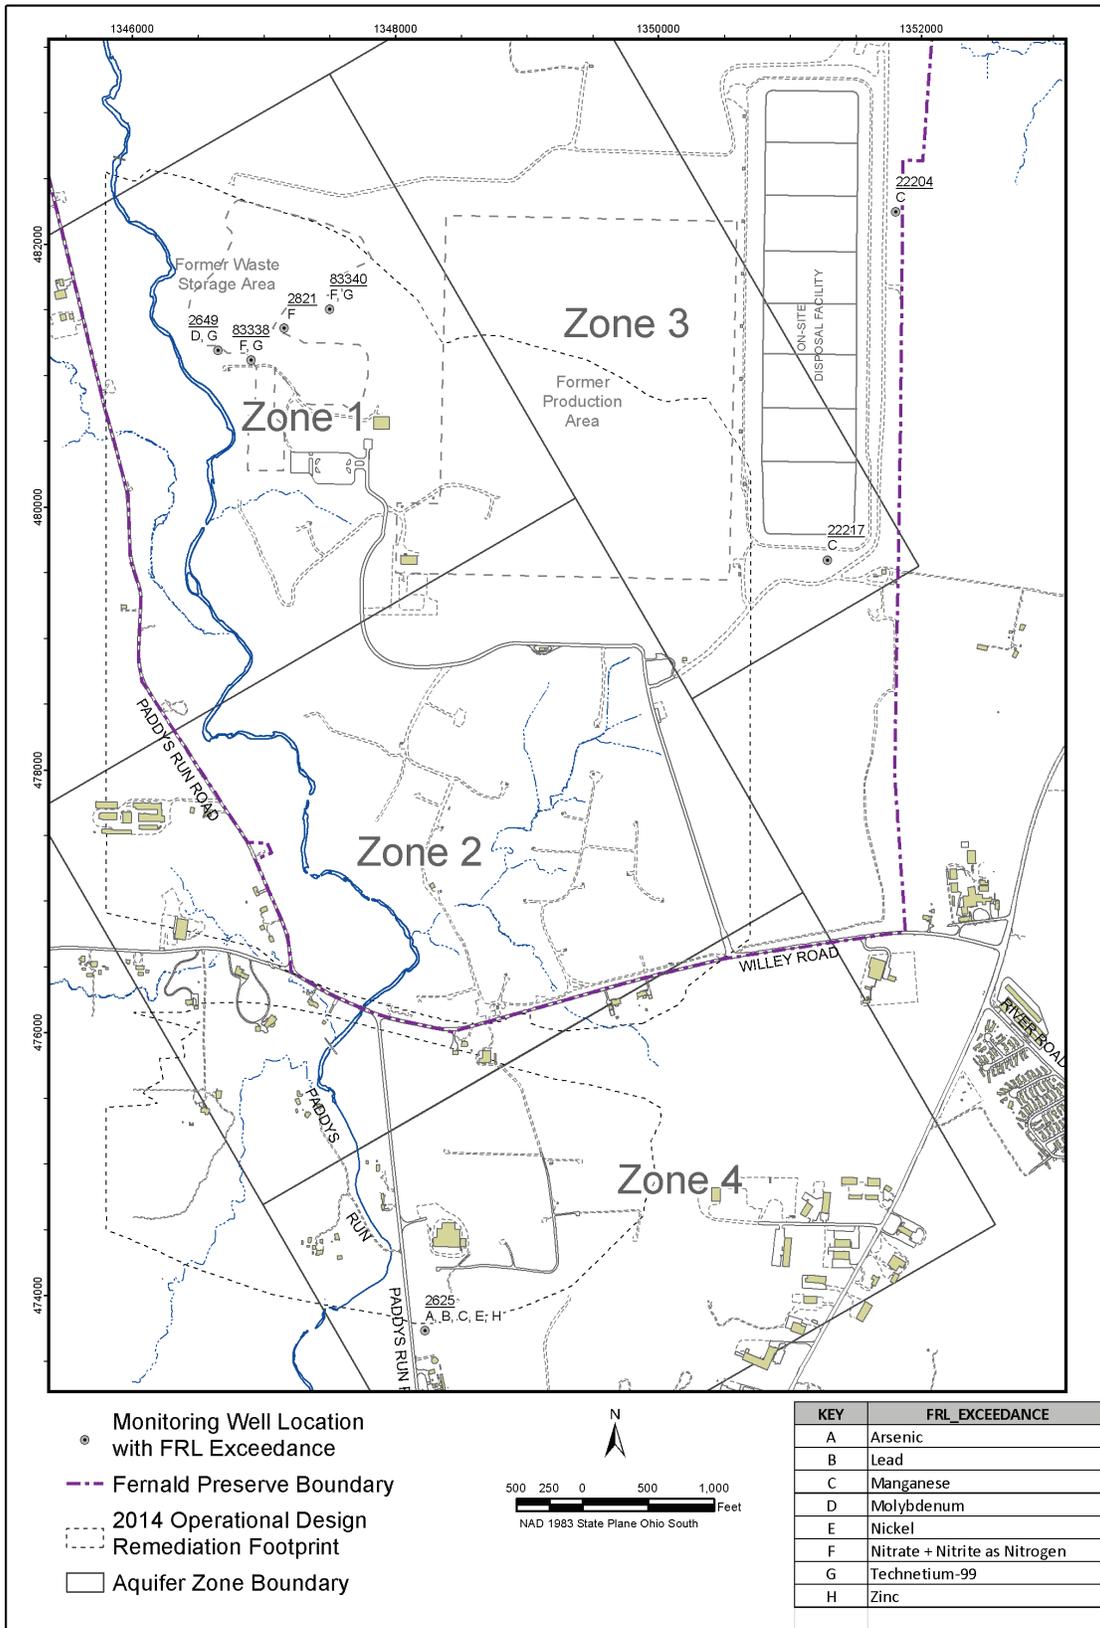
Figure 19. Non-Uranium Constituents with 2015 Results Above FRLs

During 2015, eight non-uranium constituents had FRL exceedances. Several of the locations are outside the 2014 Operational Design Remediation Footprint. No plumes were identified for the non-uranium constituents above FRLs at the locations outside the 2014 Operational Design Remediation Footprint in the extensive groundwater characterization efforts evaluated as part of the *Remedial Investigation Report for Operable Unit 5* (DOE 1995d).

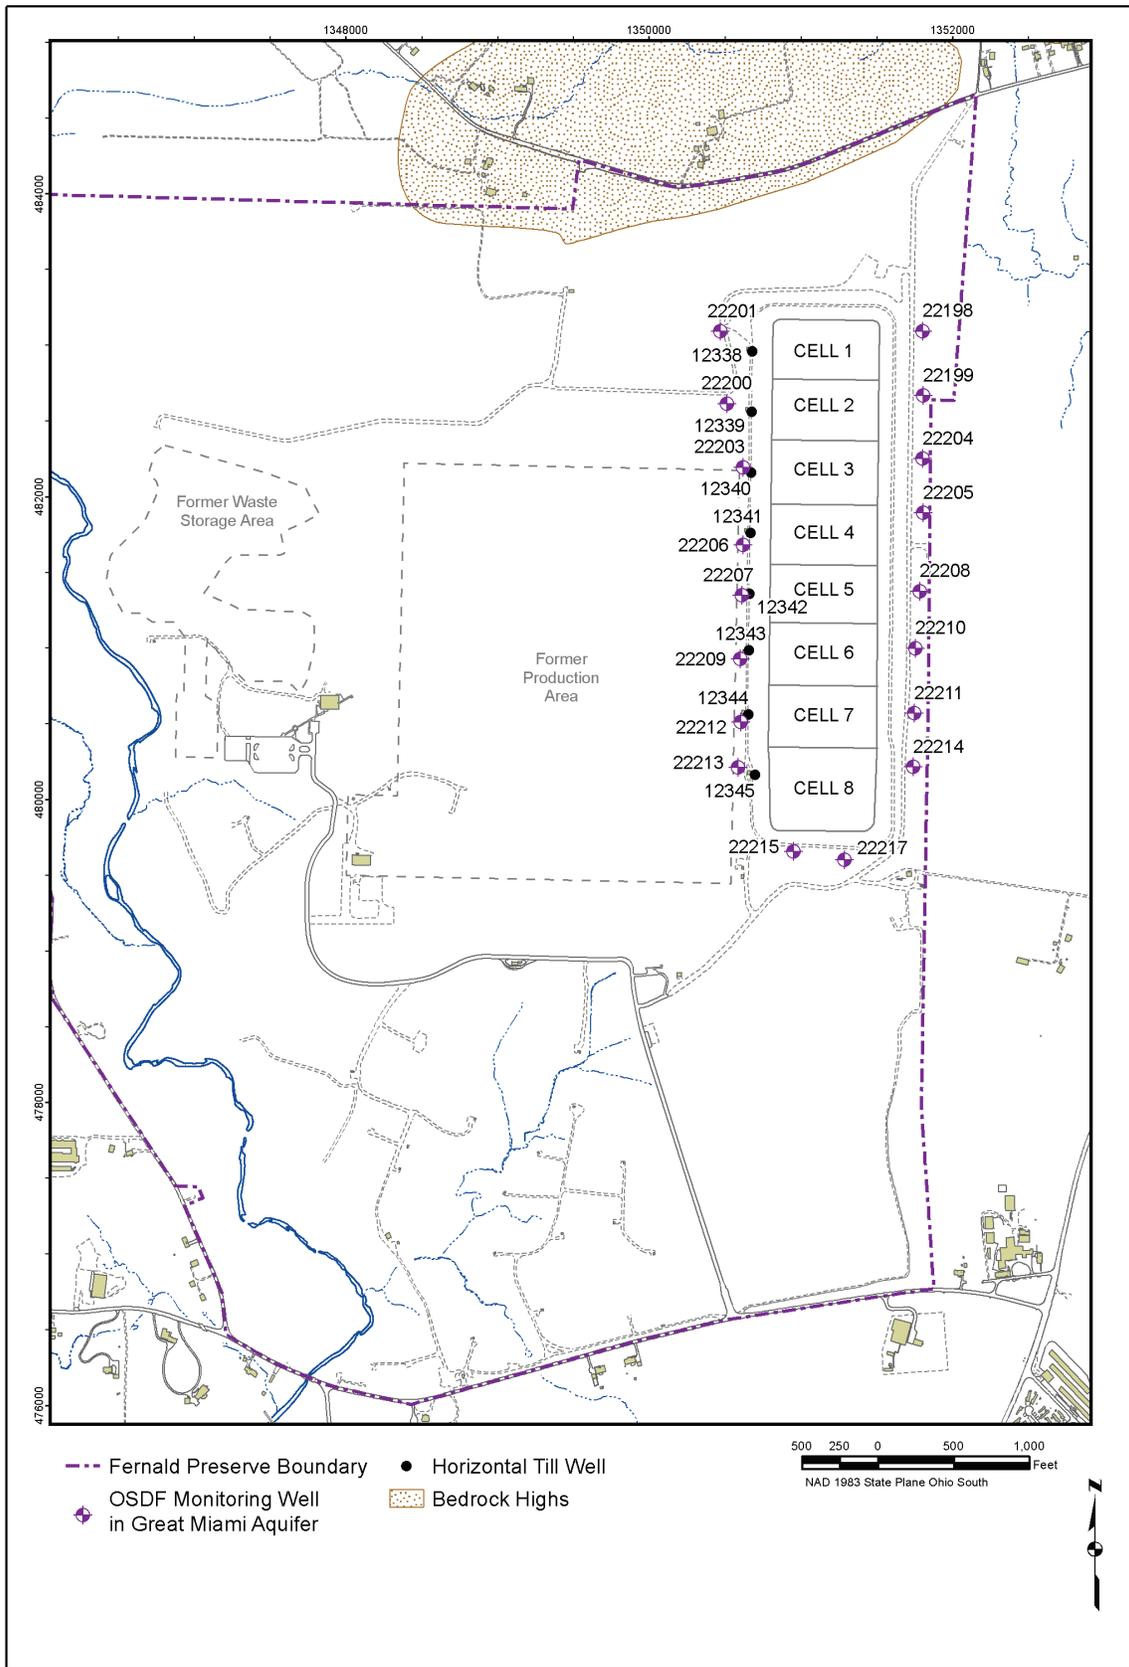
Figure 20. OSDF Footprint and Monitoring Well Locations

Monitoring of the OSDF is conducted in the leachate collection system (LCS), leak detection system (LDS), glacial till (perched water), and the Great Miami Aquifer. Figure 20 identifies the OSDF footprint and monitoring well locations for Cells 1 through 8. Flow is being monitored within the LCS and LDS to determine if the facility is operating as designed. Water

quality is being monitored in the LCS, LDS, glacial till, and the Great Miami Aquifer to identify any potential leakage from the facility.
