FERNALD PRESERVE

2015 Site Environmental Report

U.S. Department of Energy
Office of Legacy Management
Issued May 2016

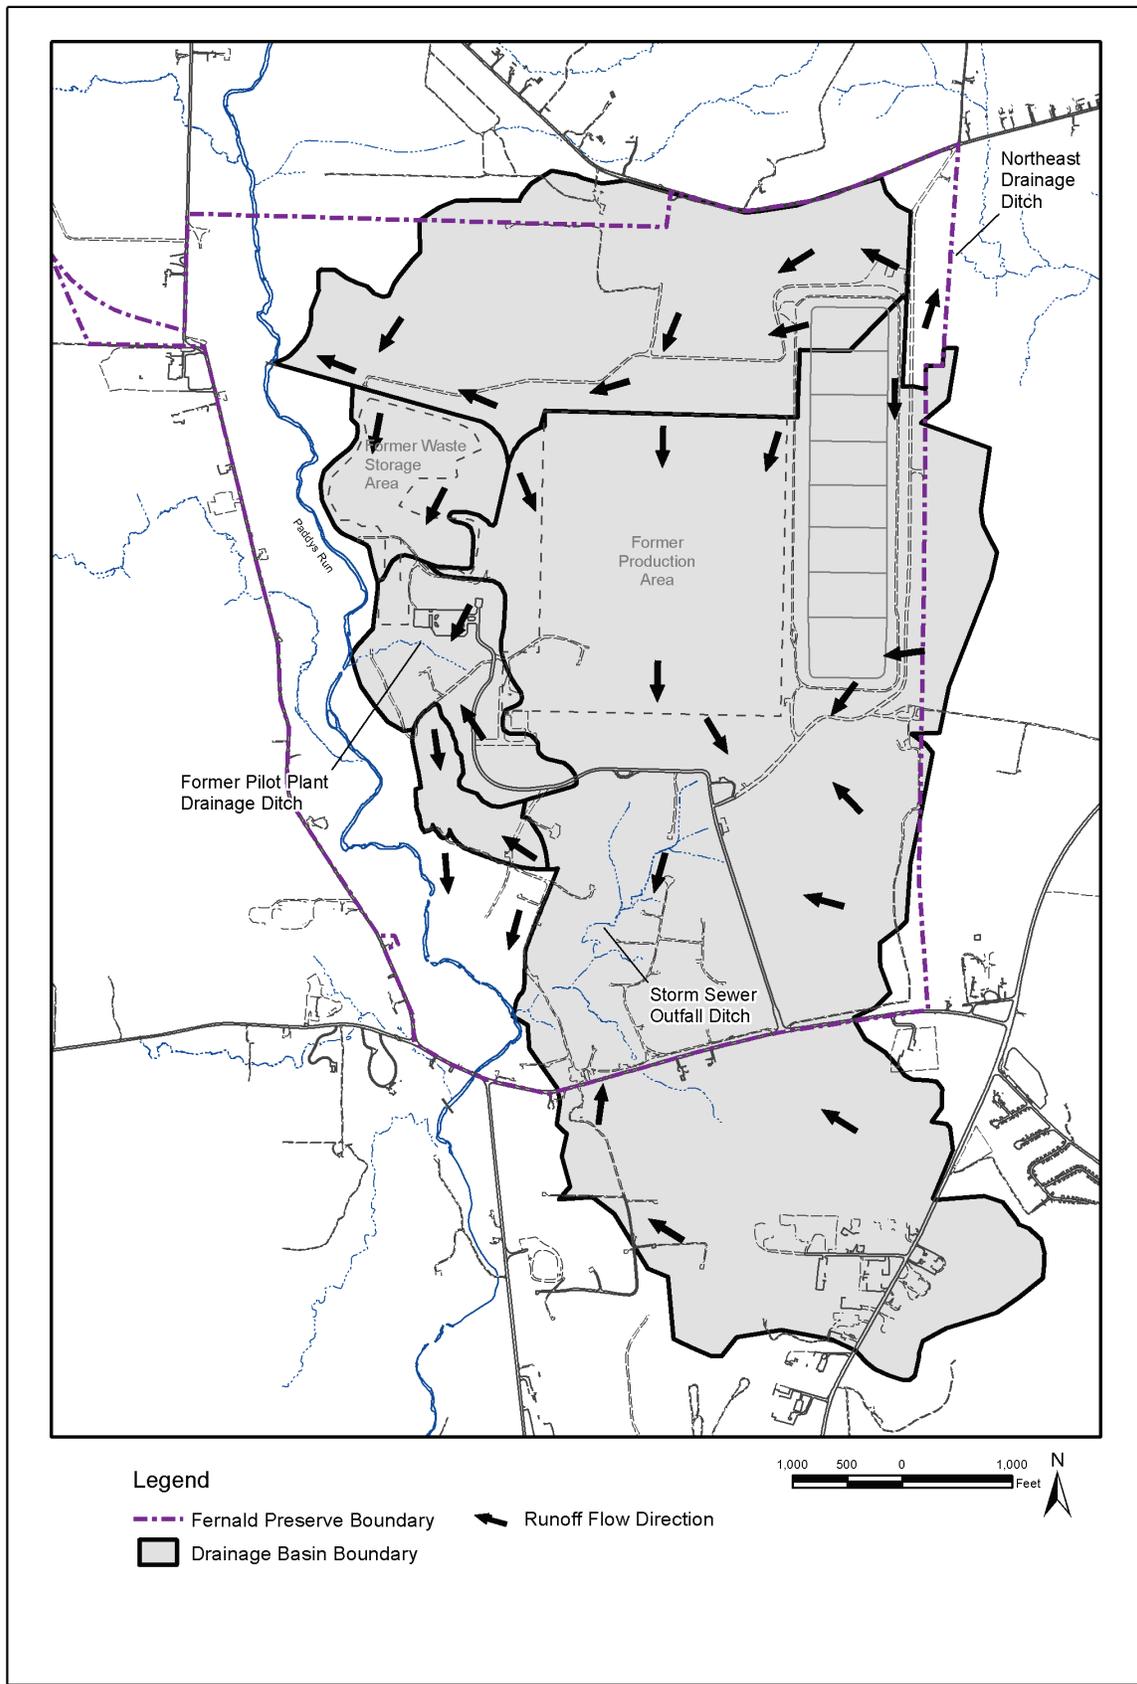
Figure 21. Uncontrolled Surface Water Areas and Runoff Flow Directions

Paddys Run (e.g., SSOD) as well as the northeast drainage that flows to the Great Miami River. The arrows on Figure 21 indicate the general flow direction of uncontrolled runoff as determined from the topography. Uncontrolled runoff from the Fernald Preserve leaves the property via two drainage pathways: Paddys Run and the northeast drainage ditch.

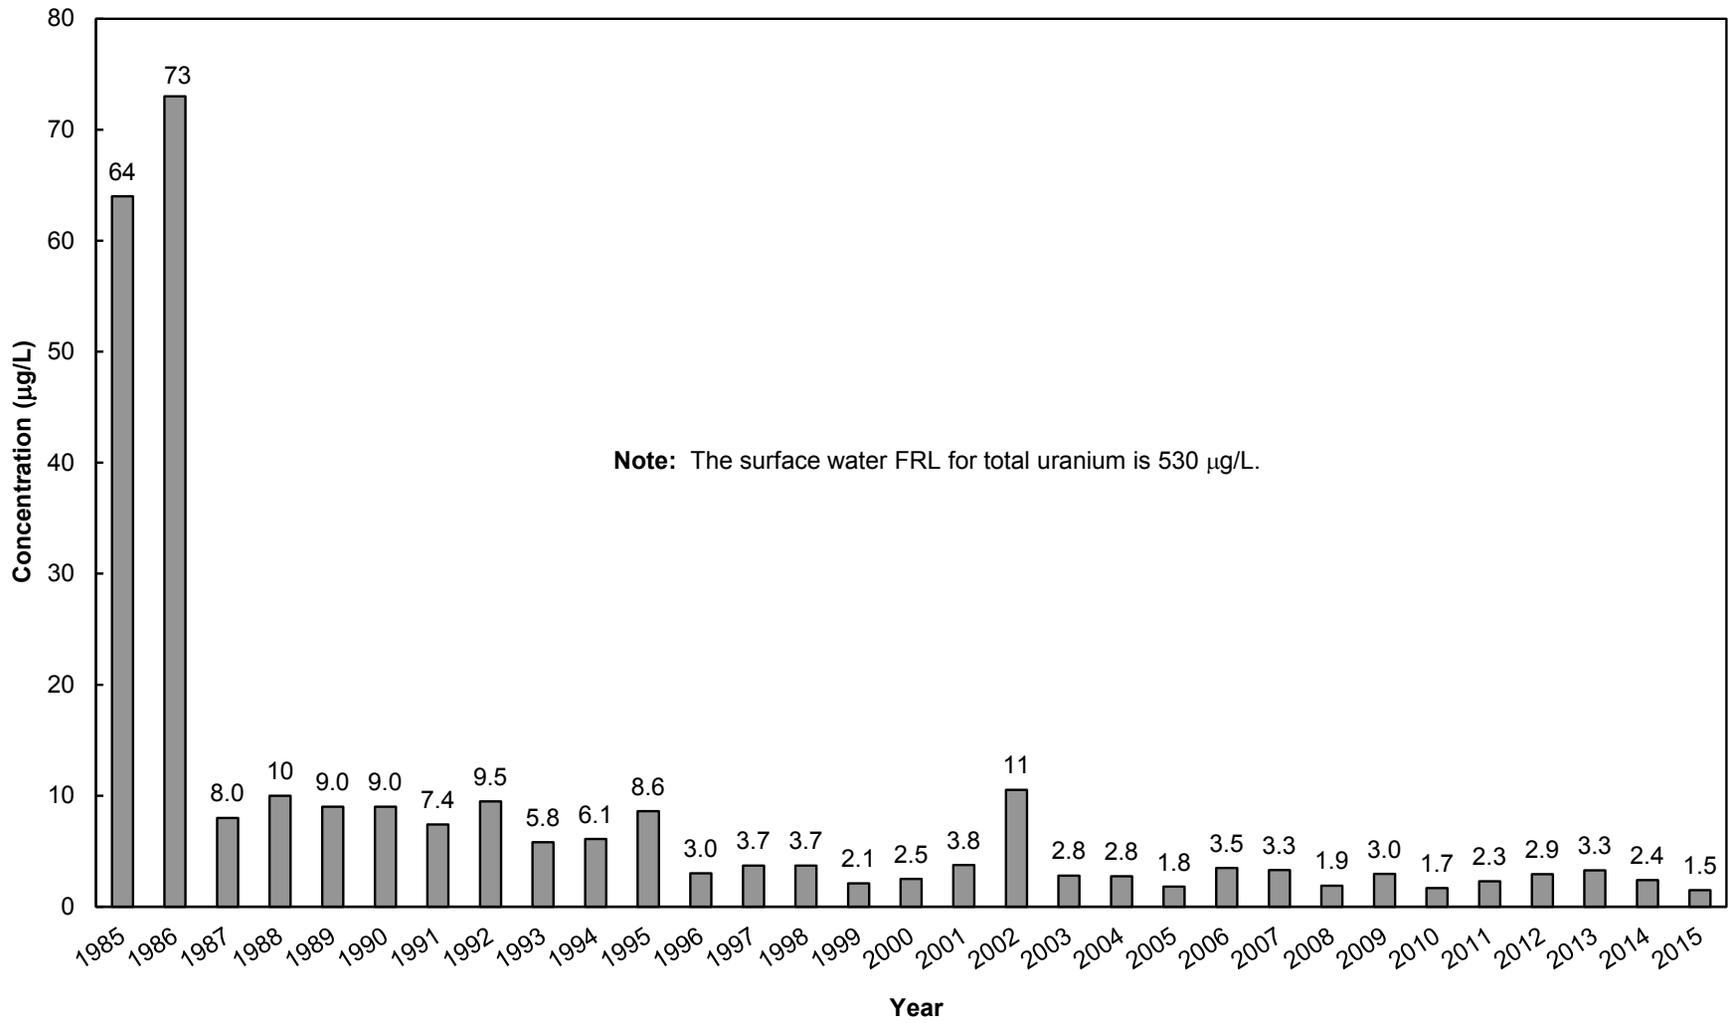
Figure 24. Annual Average Total Uranium Concentrations in Paddys Run at Willey Road (SWP-03) Sample Location, 1985-2015

The maximum total uranium concentration at SWP-03 during 2015 was 2.26 µg/L, well below the surface water total uranium FRL of 530 µg/L. Figure 24 shows the annual average total uranium concentration in Paddys Run at Willey Road for the period 1985 through 2015. This figure illustrates the decrease of the total uranium concentration in Paddys Run from 1986.

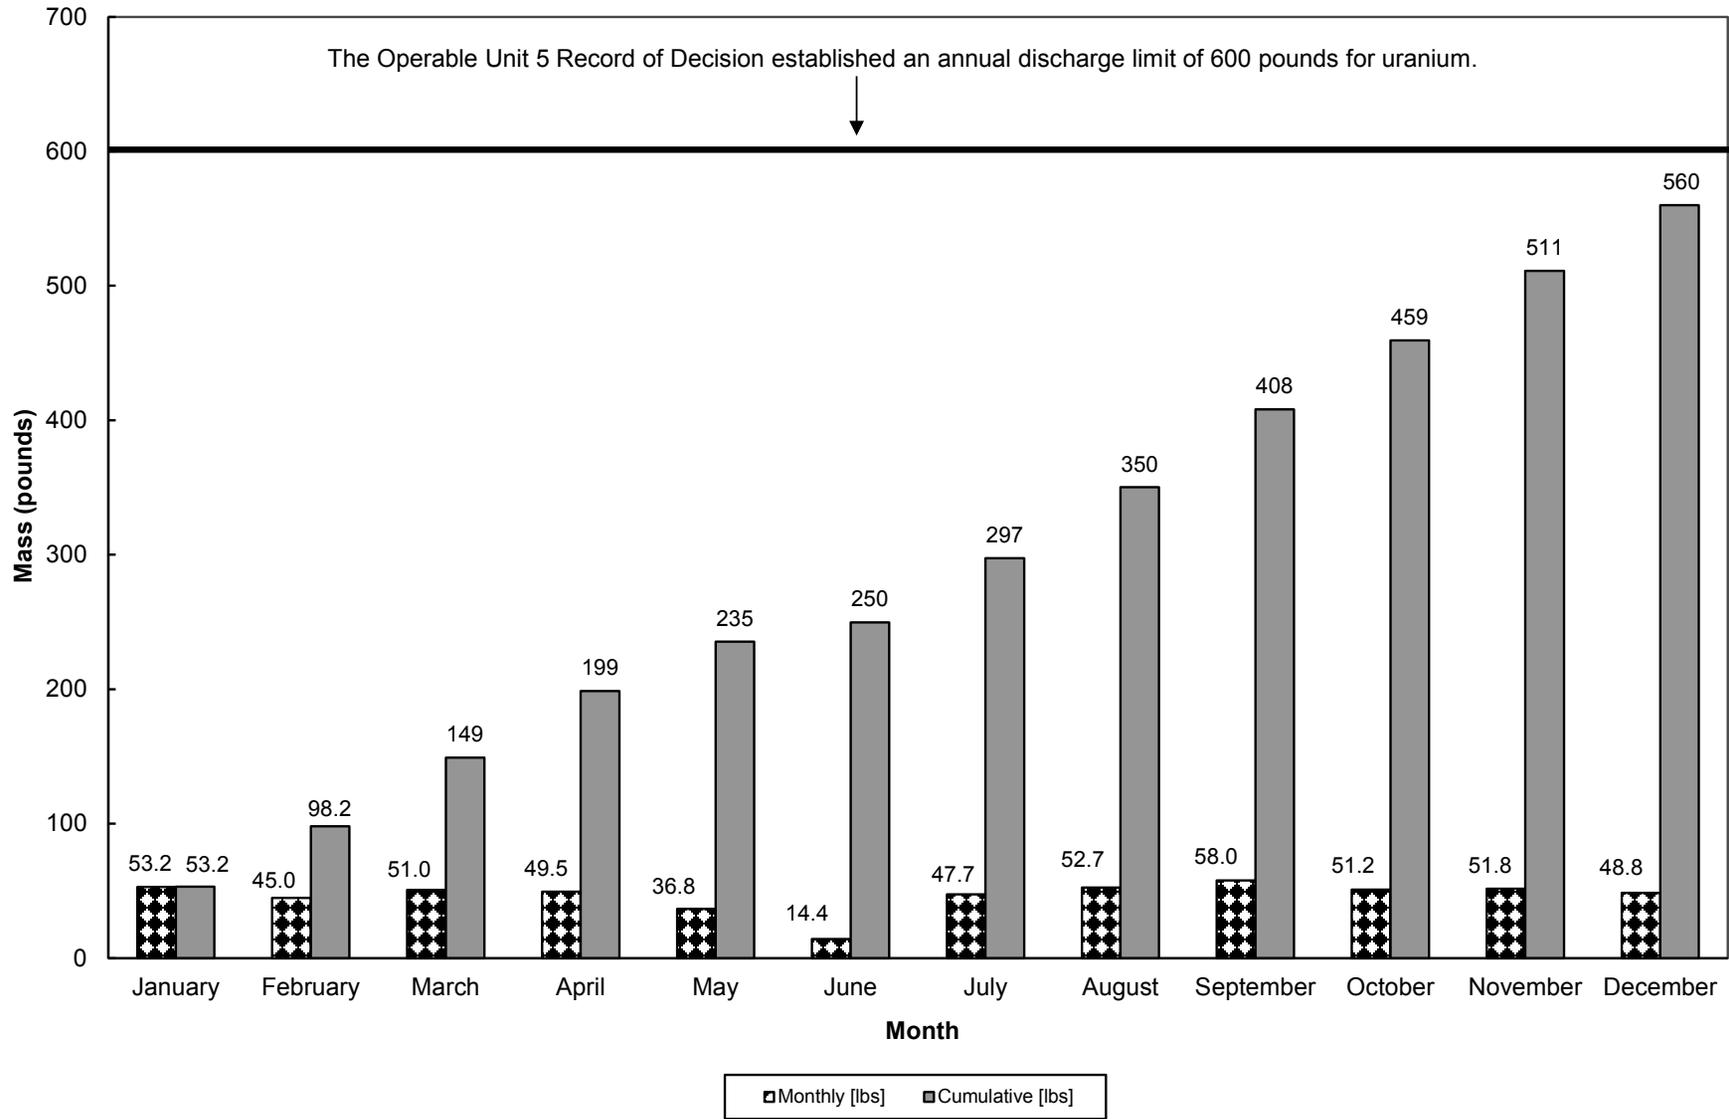
Figure 25. Mass of Uranium Discharged to the Great Miami River Through the Parshall Flume (PF 4001) in 2015

The estimated total amount of uranium discharged to the surface water pathway for the year, including controlled treated effluent discharges and uncontrolled runoff, was approximately 654 lb (297 kg).

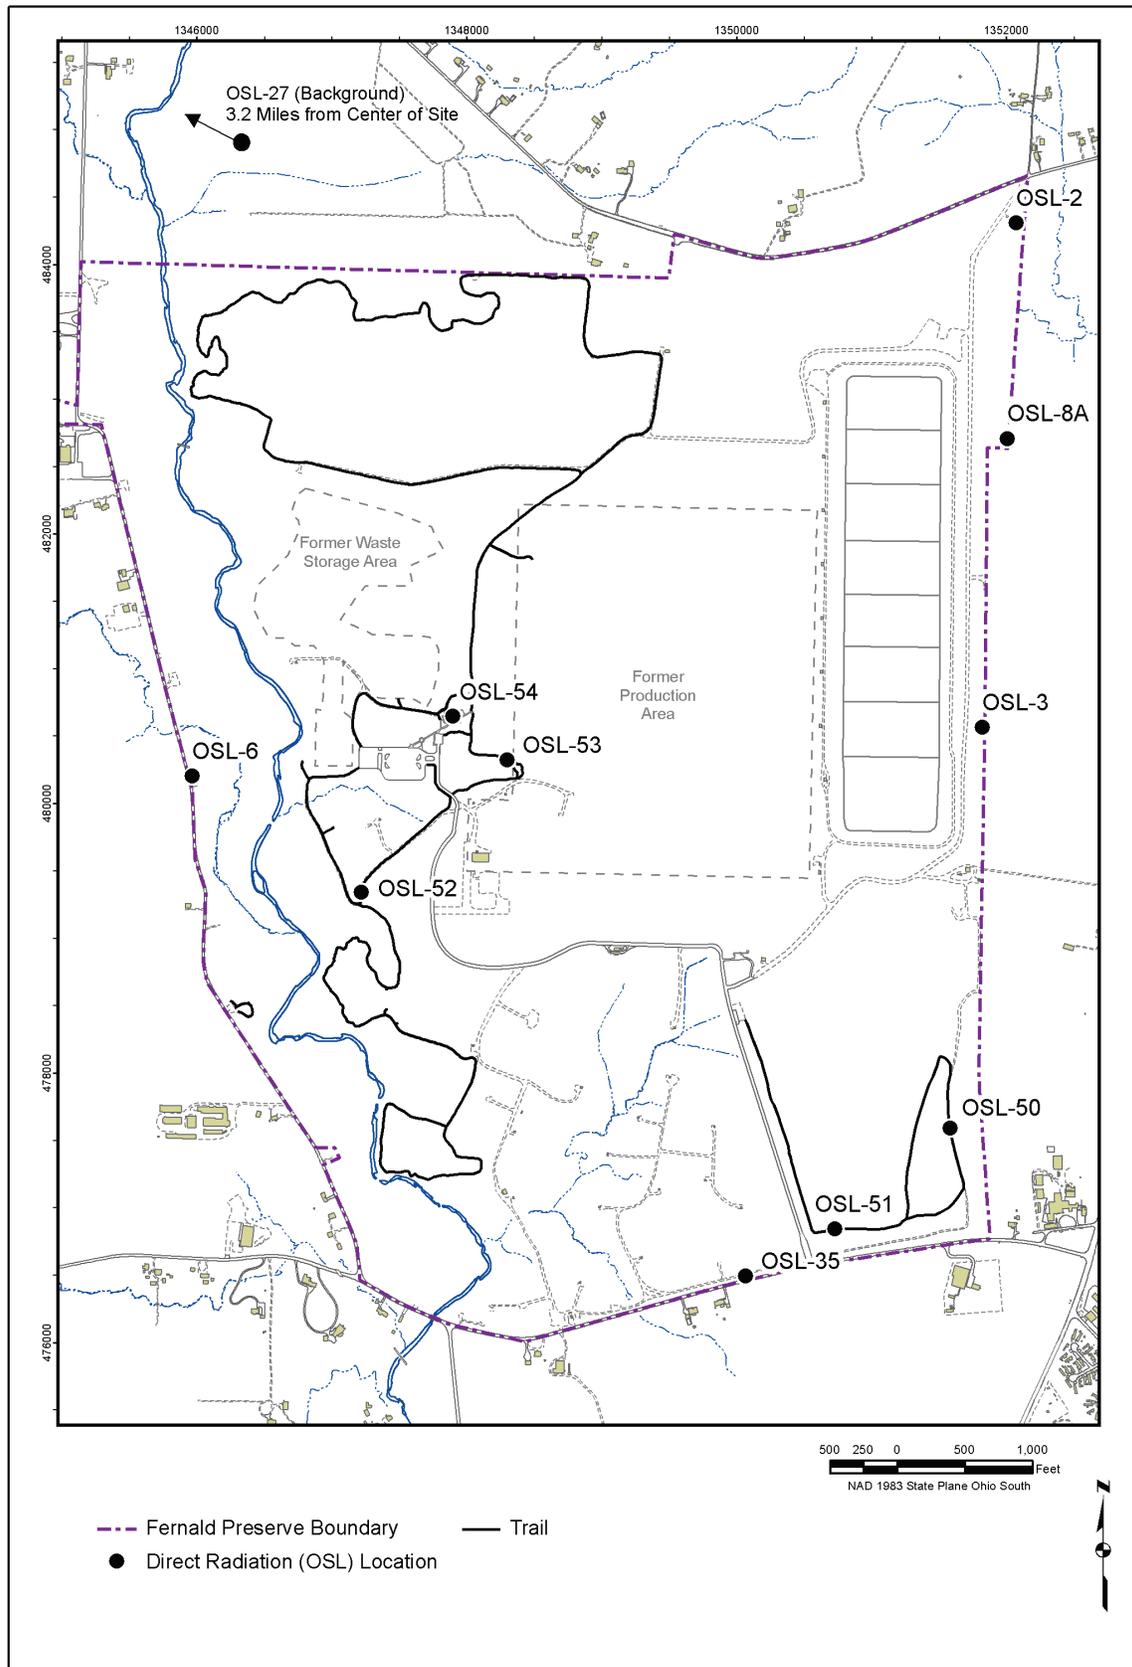
Figure 28. Direct Radiation (OSL) Monitoring Locations

Direct radiation originates from sources such as cosmic radiation, naturally occurring radionuclides in soil and food, and anthropogenic radioactive materials. Gamma rays and X-rays are the dominant types of radiation that create a public exposure concern because they penetrate into the deep tissues of the body. The largest historical source of direct radiation at the Fernald Preserve was waste material associated with the Silos Project. The last waste material associated with the Silos Project was removed from the site in 2006. Presently, there are no significant sources for direct radiation at the Fernald Preserve. During 2015, direct radiation levels at the Fernald Preserve were continuously measured at four trail locations, the Visitors Center, five boundary locations, and one background location with optically stimulated luminescence (OSL) dosimeters. The background location is 3.2 miles from the center of the Fernald Preserve (Figure 28).

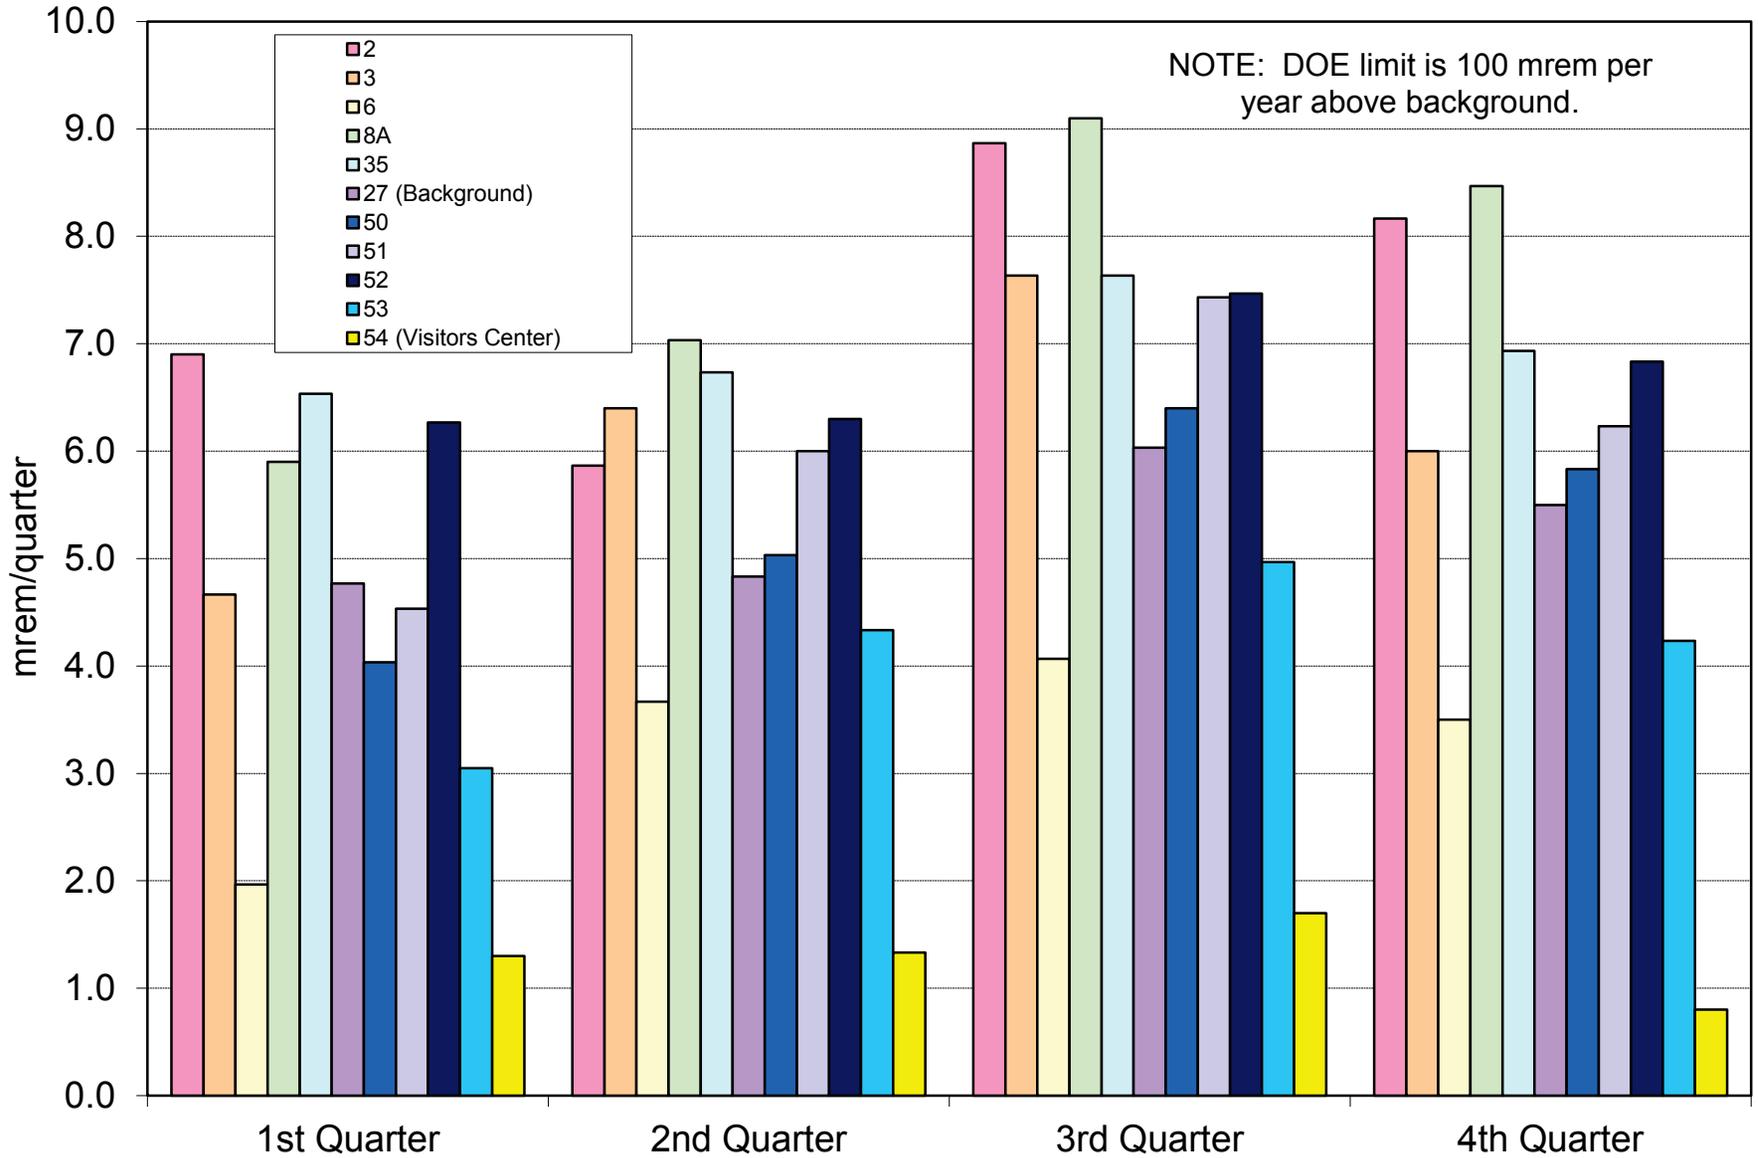
Figure 29. 2015 Quarterly Results for OSL Monitoring Locations

Table 8 provides the annual range of direct radiation measurements for 2014 and 2015, and Figure 29 illustrates the quarterly results for 2015. Each quarterly result is the average of three measurements obtained from three dosimeters placed at each location. In general, the first- and second-quarter results are less than other quarters because they had fewer exposure days, and the winter months may hold more moisture in the ground, which can attenuate radiation emitted from soil particles.

From the data in Table 8, the maximum measurement is 31 mrem/yr (0.31 mSv/yr) at OSL-8A (Figure 29) and the background dose is 21 mrem/yr (0.21 mSv/yr). The difference in the OSL dose between OSL-8A and the background dosimeters is 10 mrem/yr (0.10 mSv/yr), which is assumed to be the direct radiation dose for a hypothetical individual who stands at the OSL-8A location for 1 year. This is a very conservative estimate of the dose, as an individual would not spend an entire year at OSL-8A. Additionally, Appendix C shows that the present quarterly measurements at the boundary are indistinguishable from background results when statistical variability is considered.

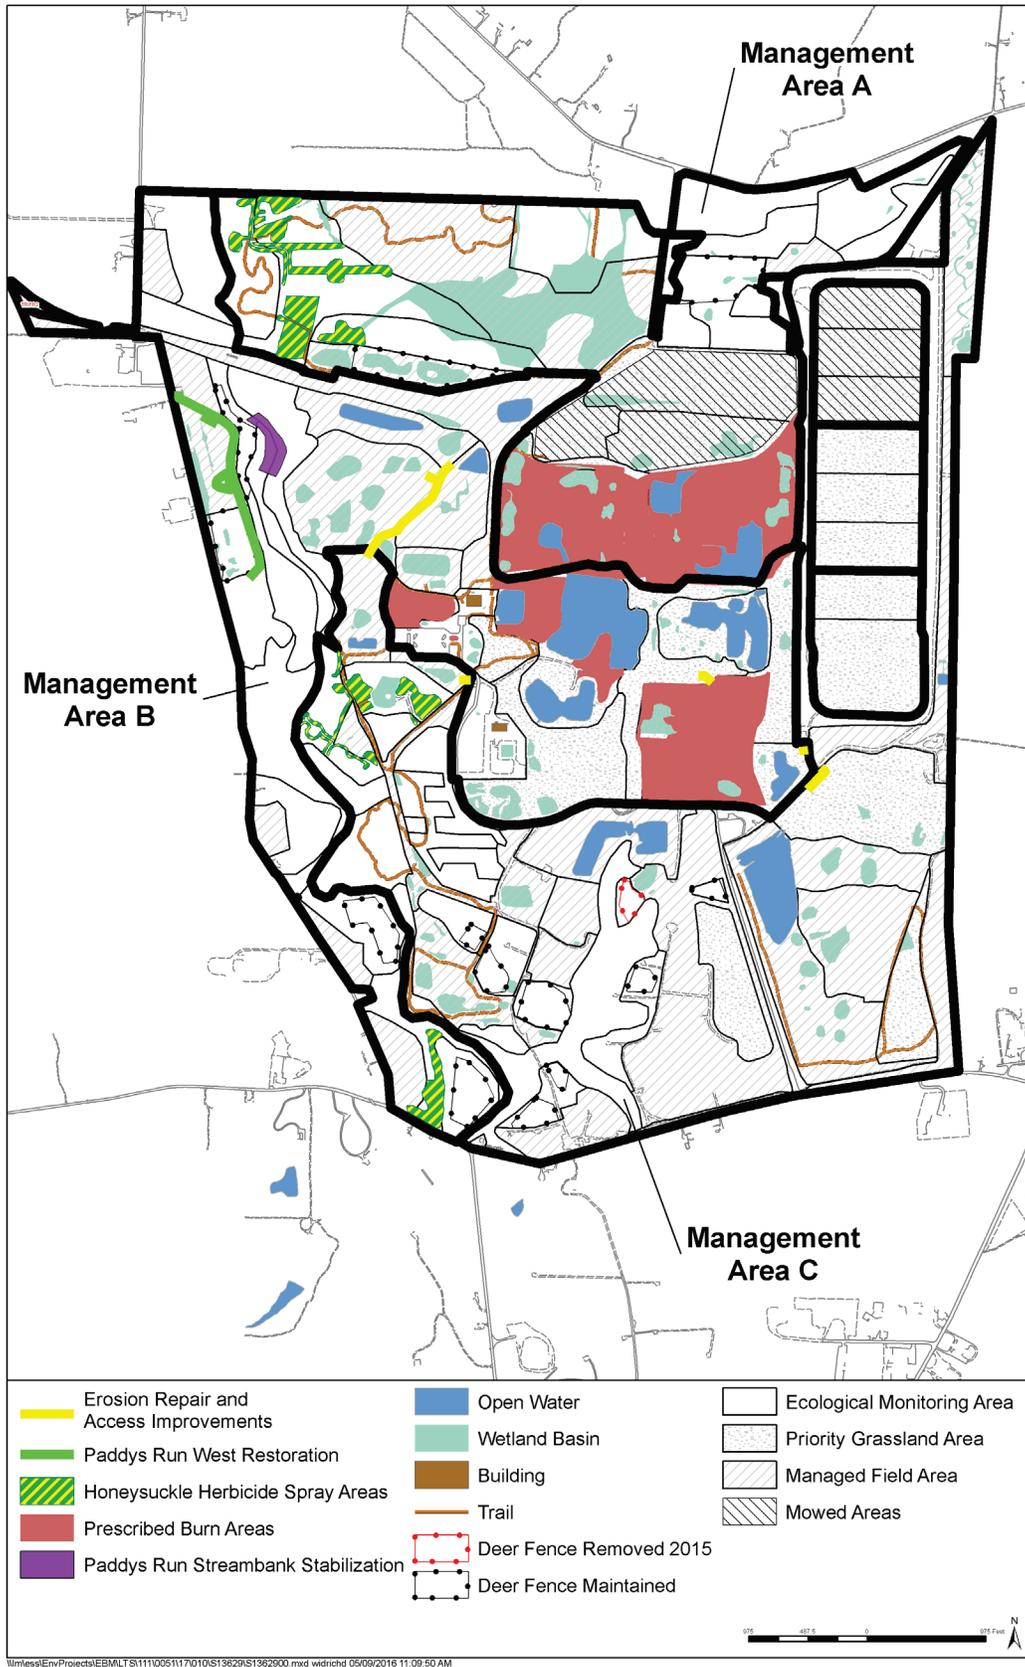
Figure 32. 2015 Ecological Restoration Activities

The Paddys Run streambank stabilization project began in 2014 and was completed in 2015. Installation of the soil encapsulated lifts and plants were completed in the spring, and the downstream crossvane was constructed in October.

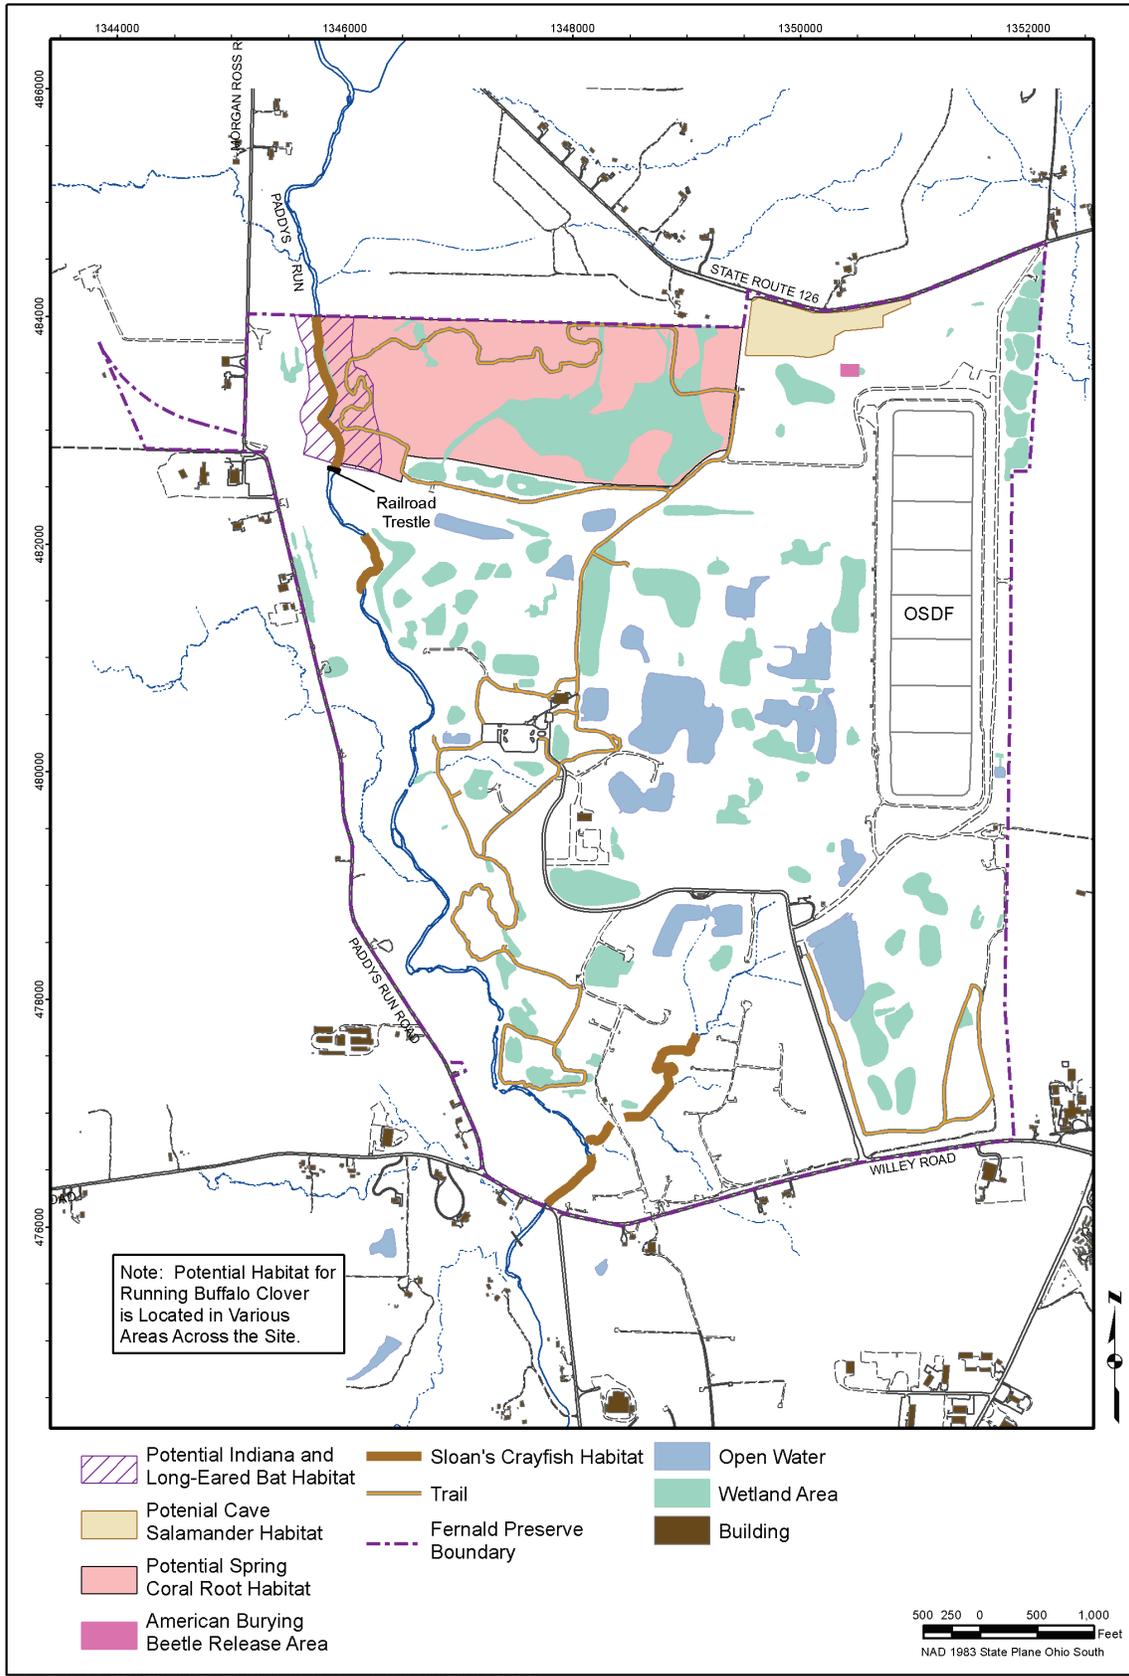
Figure 34. Threatened and Endangered Species Habitat Areas

cave salamander. None of these species have been found on the site, but their habitat ranges encompass the Fernald Preserve. The state-threatened cobblestone tiger beetle has been considered a possible species in the past, but its habitat is limited to the Great Miami River. Figure 34 shows the potential habitats for these species. According to provisions in the LMICP, Section 6, "Natural Resource Monitoring Plan," threatened or endangered species habitat will be surveyed as needed prior to any construction activities. If threatened or endangered species are identified, appropriate avoidance or mitigation efforts will be taken.

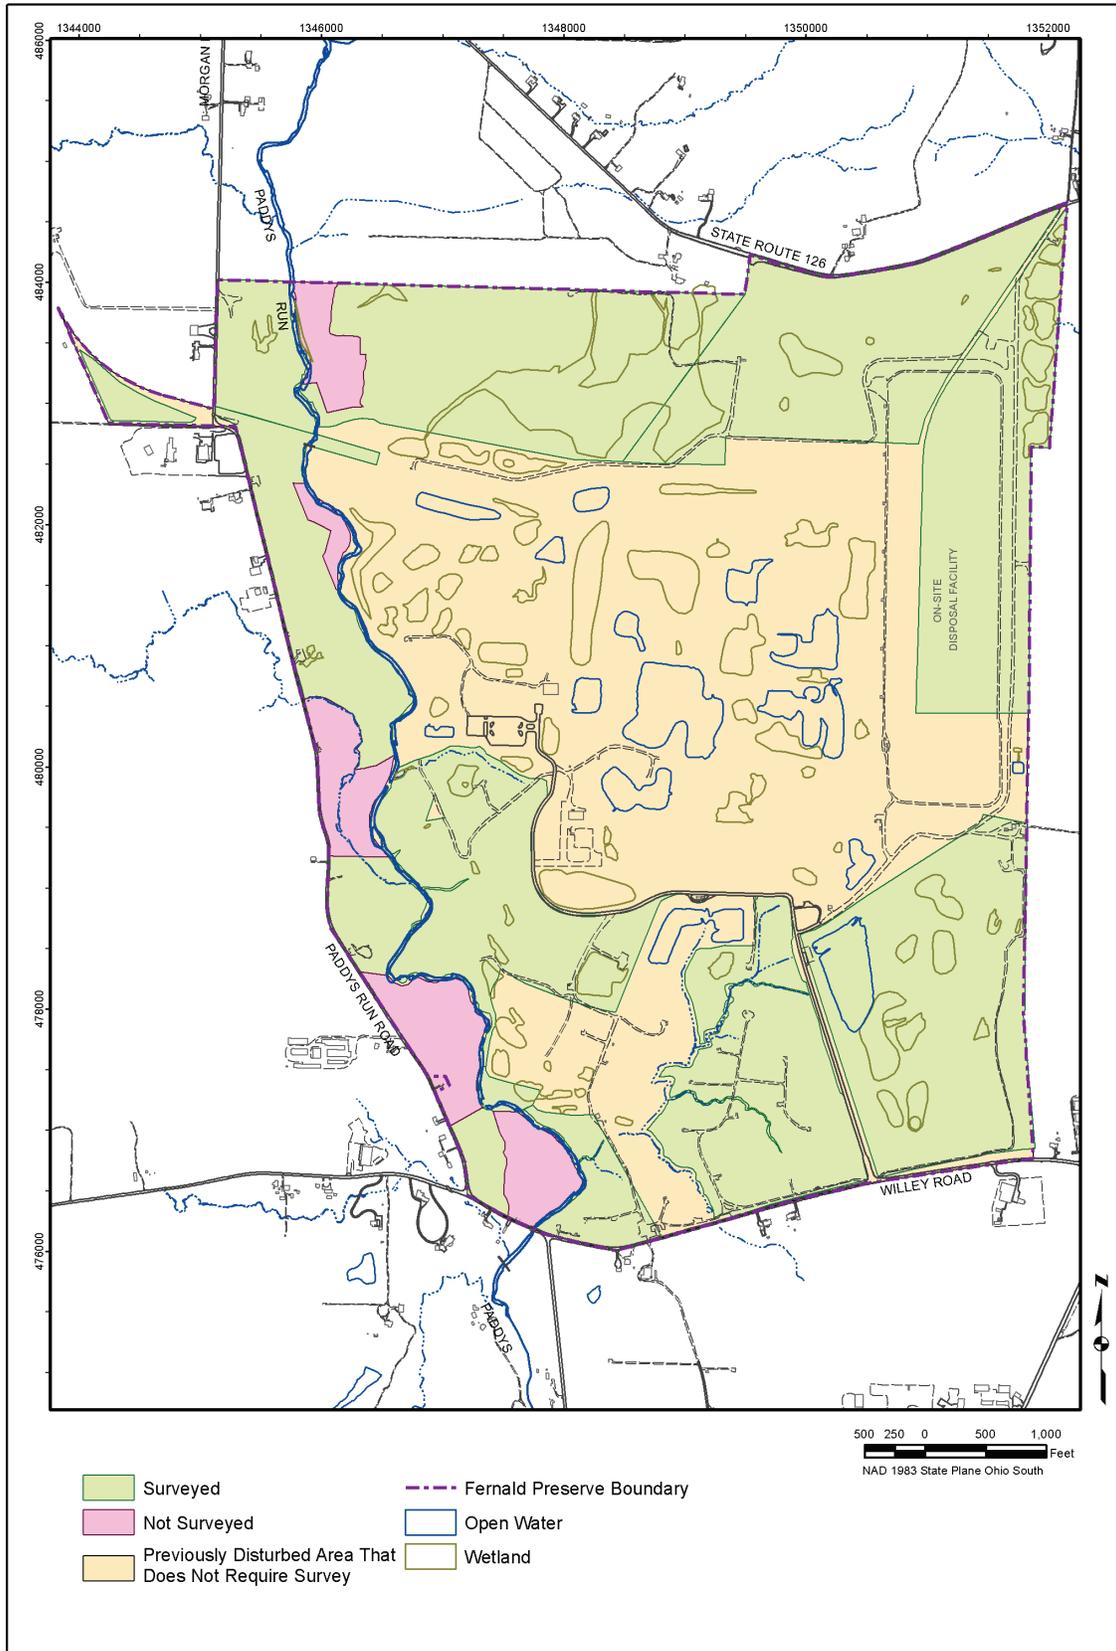
Figure 35. Cultural Resource Survey Areas

To comply with these laws and the Programmatic Agreement, DOE conducted archaeological surveys prior to remediation activities in undeveloped areas of the Fernald Preserve. Figure 35 shows the areas of the Fernald Preserve that have been surveyed. These surveys have resulted in the identification of five sites that may be eligible for listing on the National Register of Historic Places (NRHP). None of these sites were affected by construction activities.
