Balloon at Night

Tony Ohlhausen
Sandia National Laboratories[†]

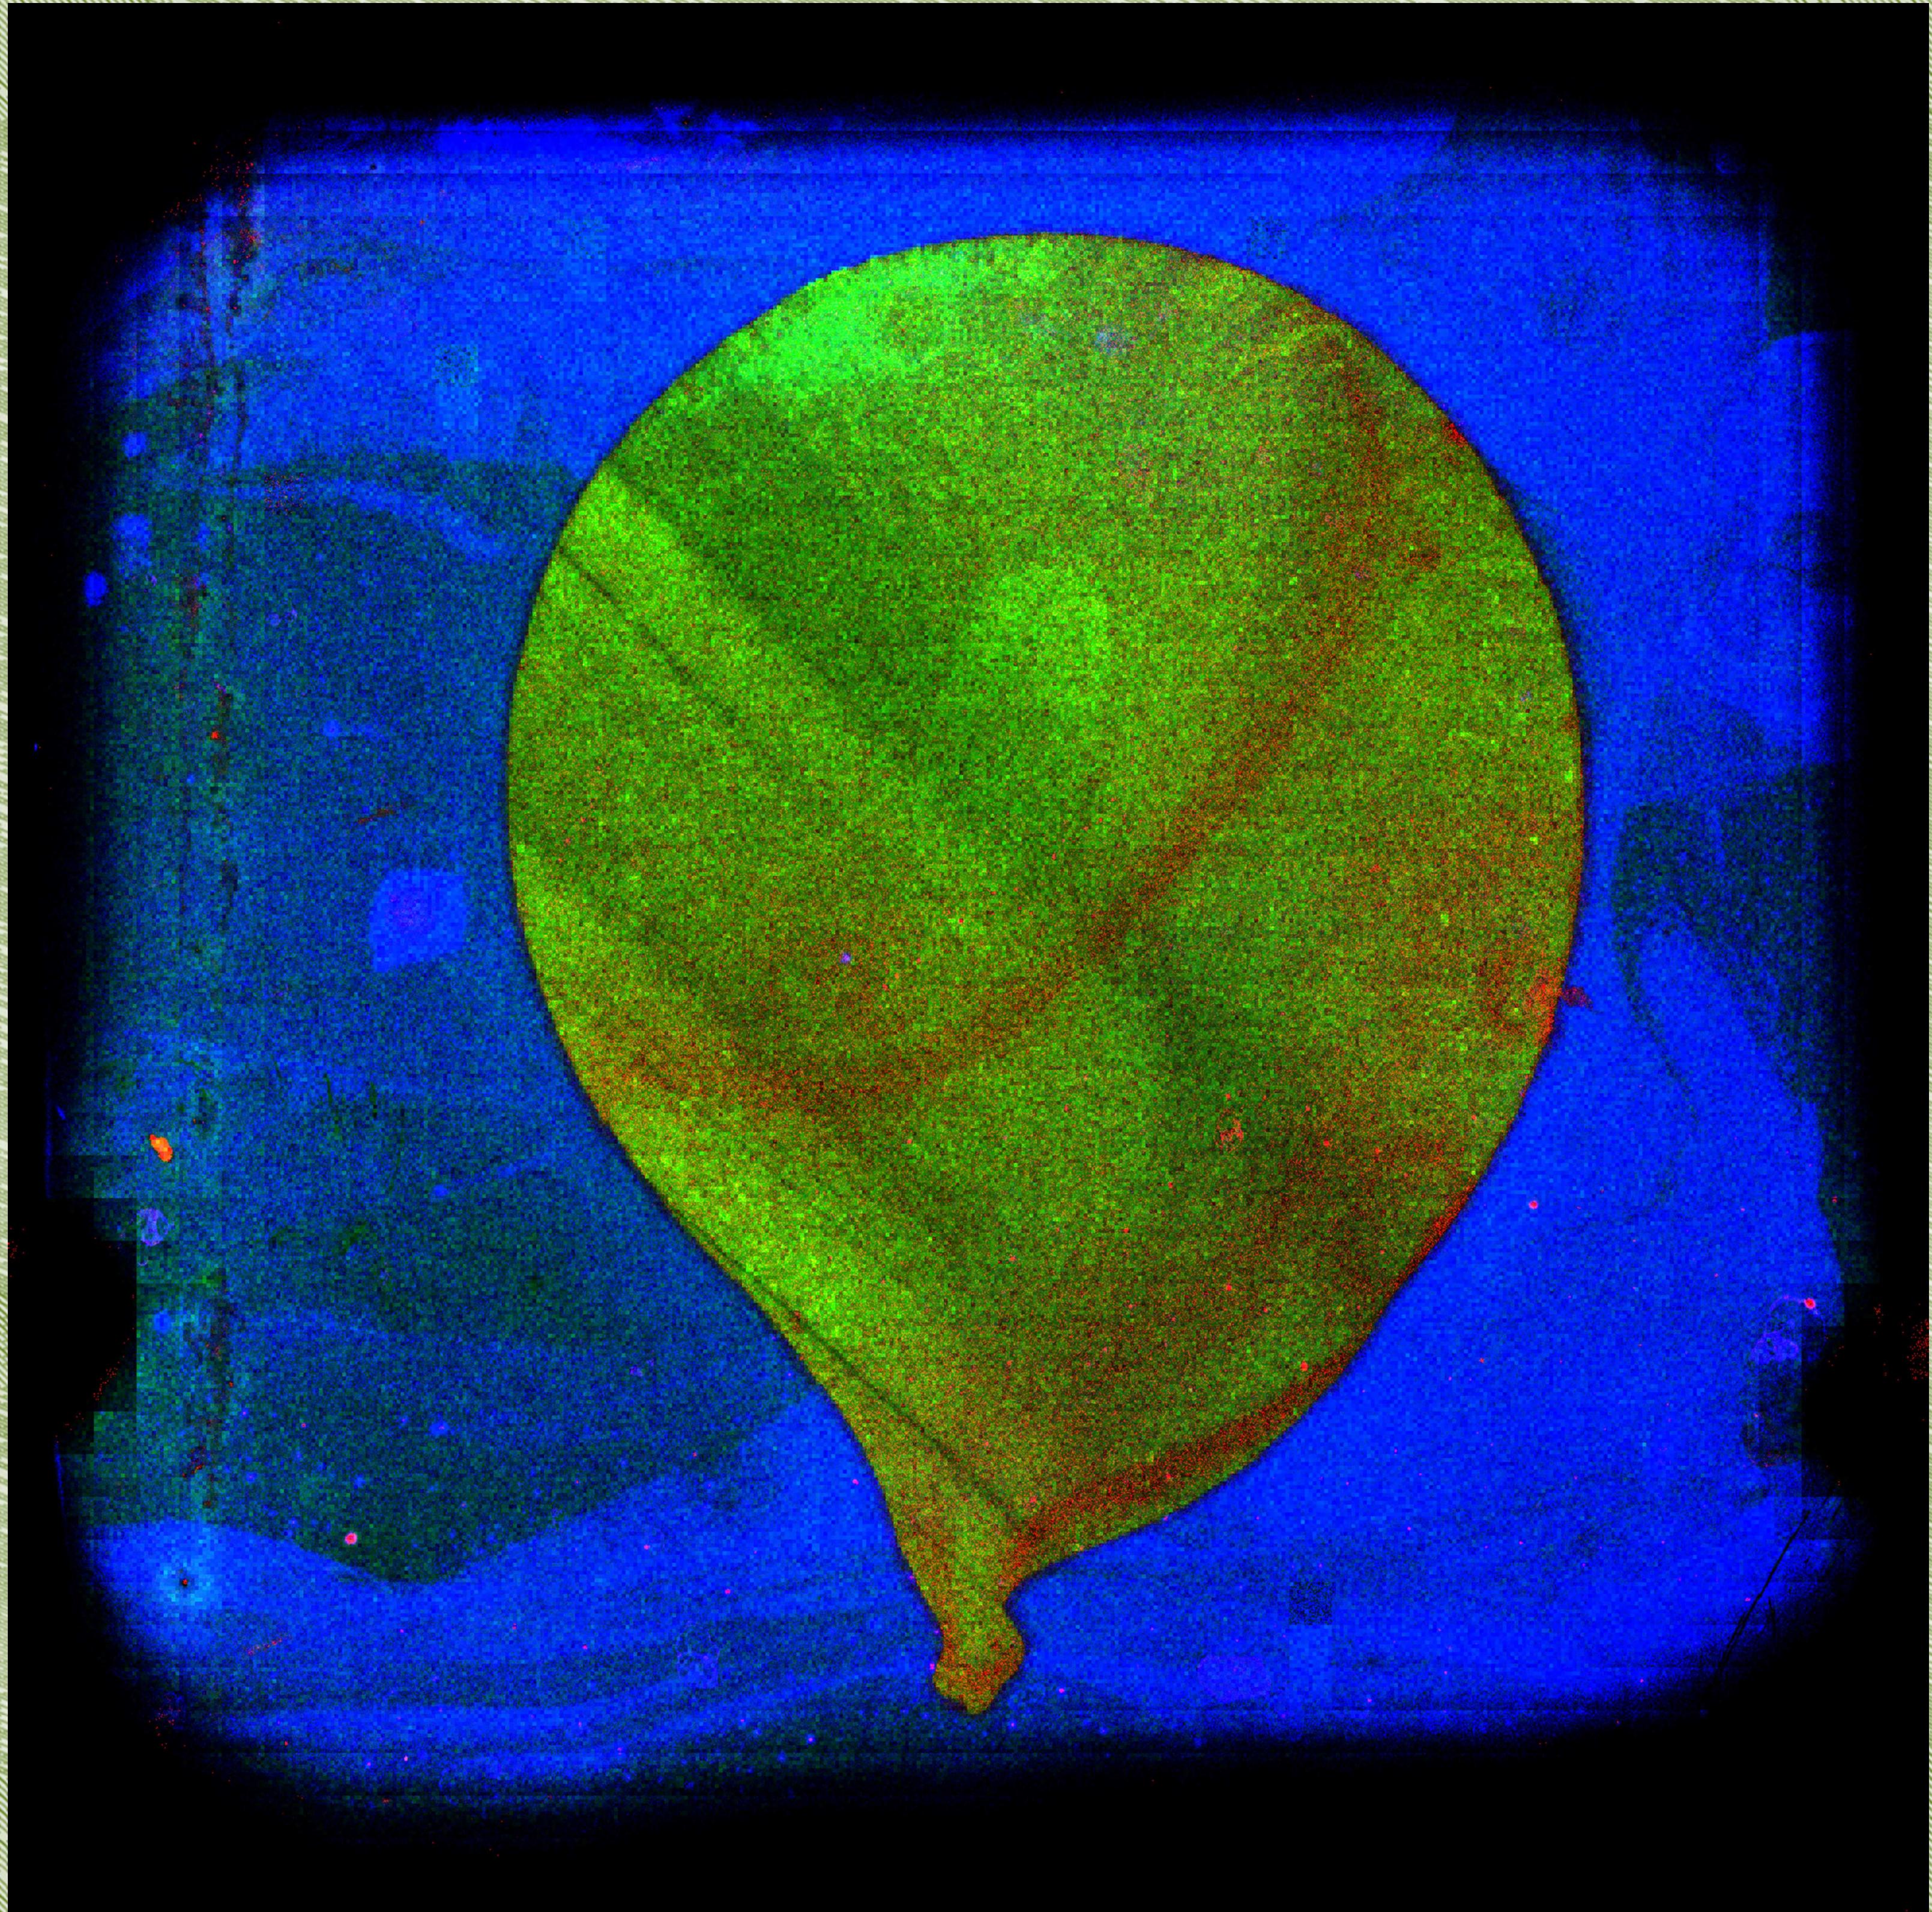
This picture was created by performing a positive secondary ion stage-scanned ToF-SIMS image acquisition of the residue of a silicone-based replicating compound on a polished Al coupon. Shown above are the actual, untouched, multivariate analysis results which consist of the substrate (blue), silicones (green) and other surface contamination (red).
