# **SANDIA REPORT**

SAND2017-4612

# **Advanced Percussive Drilling Technology for Geothermal Exploration and Development**

## **Phase II Report**

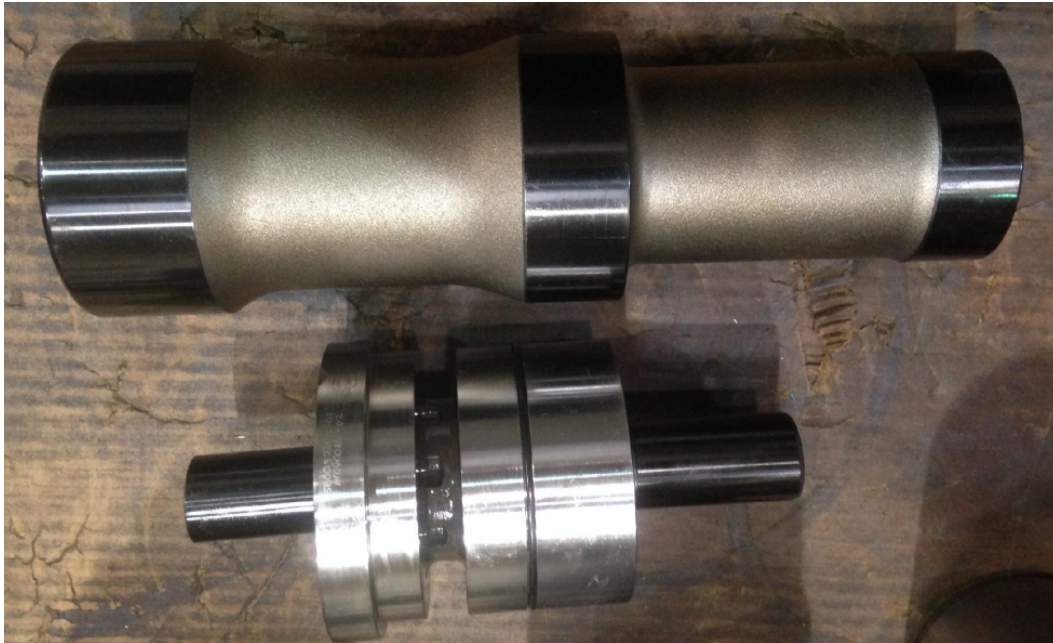
**Figure 16. High-temperature prototype after first run**

The appearance of the high temperature prototype piston and air distributor are shown in the photos below:

The photos clearly show a developing wear pattern in the lubricious coating on the piston OD, adjacent to the striking end. Barely visible after the first test, this wear pattern progressed into a wear band approximately .125" (3 mm) wide. A very faint wear ring was visible in the middle piston land after the third run. The top piston land and Air Distributor stem showed no visible wear or damage.

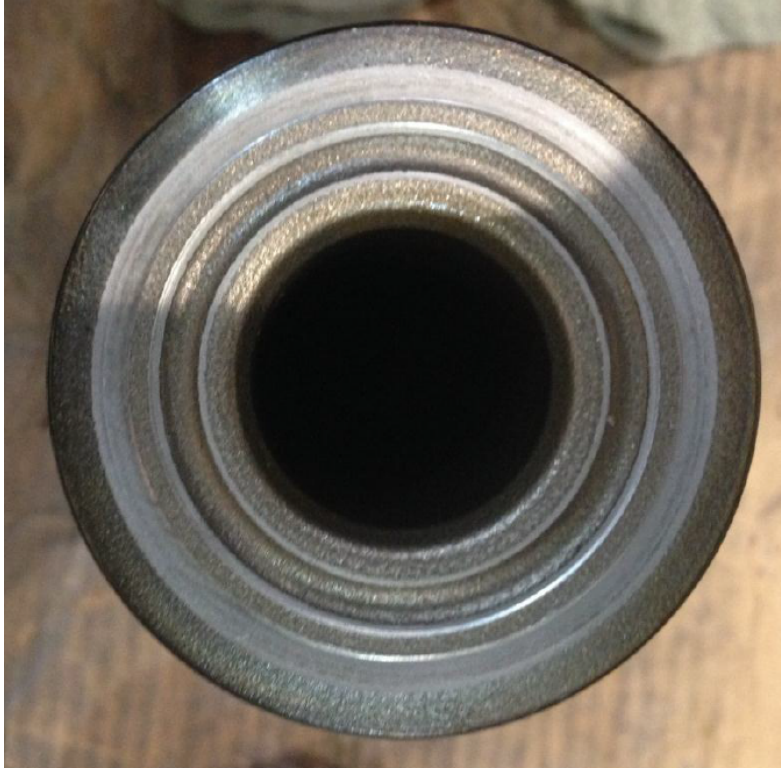
**Figure 19. Striking face of piston**

After the third run, an embossed wear pattern was visible on the piston striking face corresponding to the impact surface of the bit. It is believed the relatively soft surface hardness of the stainless steel piston contributed to this deformation, shown below.

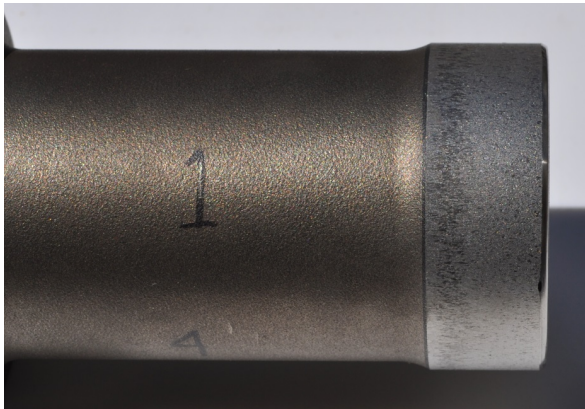
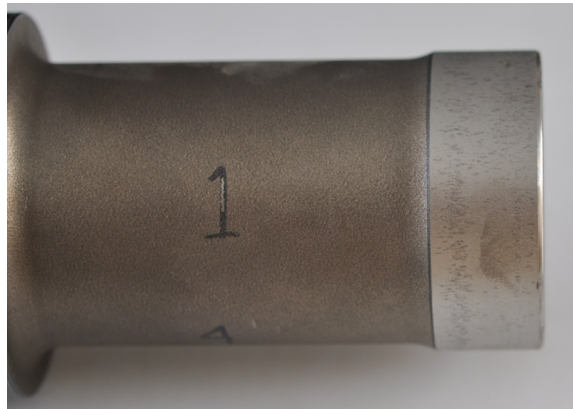
Figure 31. HT piston wear progression (stem end)

Subsequent inspections were conducted at longer intervals after the initial inspection to allow more footage to be drilled. The coating on the stem was completely worn away after 27 feet. Additional wear patterns began to develop on the mid-section of the piston.

Slight change in texture. Coating removed from stem end

As the previous figures illustrate, the high-temperature piston showed signs of galling and excessive wear early on. The lower hardness of the material (~HRC 46) compared to the conventional material selection was the cause of the high levels of wear. Test of the high-temperature piston was abandoned in favor of coating the low-temperature piston with the same coating.

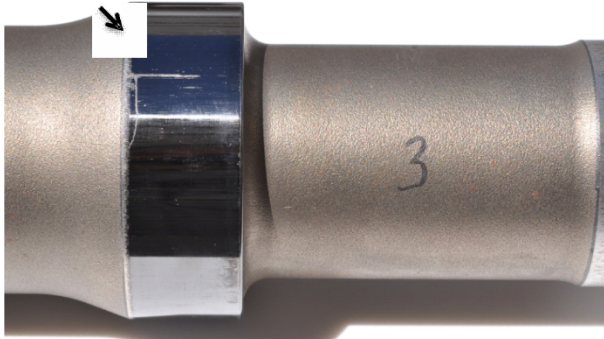
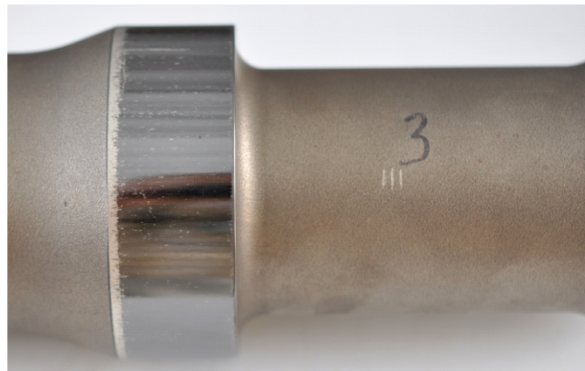
Figure 32. HT piston wear progression (mid-section)

Minimal additional wear on leading edge

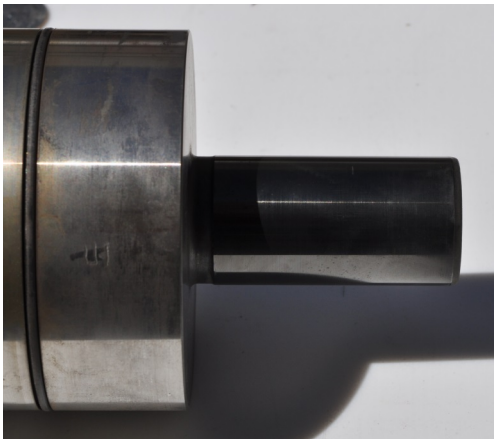
**Figure 34. HT distributor wear progression**

No visible signs of wear

The distributor showed no visible signs of wear throughout the tests with the high-temperature piston. Because of its performance in those tests, it was used in subsequent tests with the alternative piston.

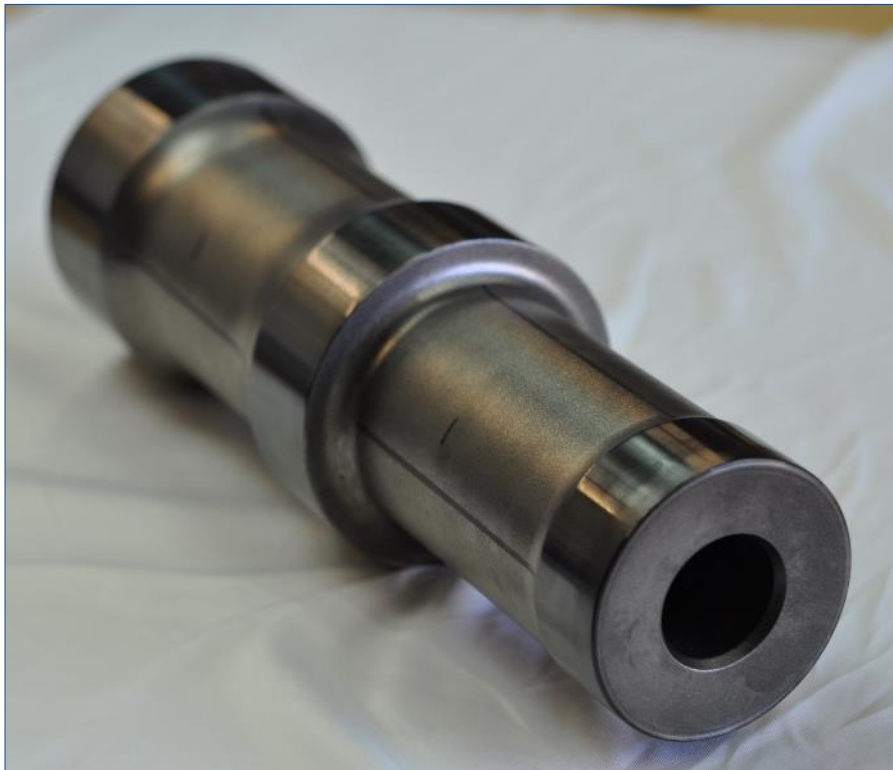
**Figure 35. LT piston with DLC coating applied**

In addition to addressing the material hardness, several geometric changes were made to the piston to reduce contact stresses along sliding surfaces. A chamfer was added to the leading edge of the piston. A radius was added to the leading edge of the mid-section of the piston where it enters the air cylinder. The same hammer components were used from the previous tests. A picture of the coated LT piston is shown in Figure 35.

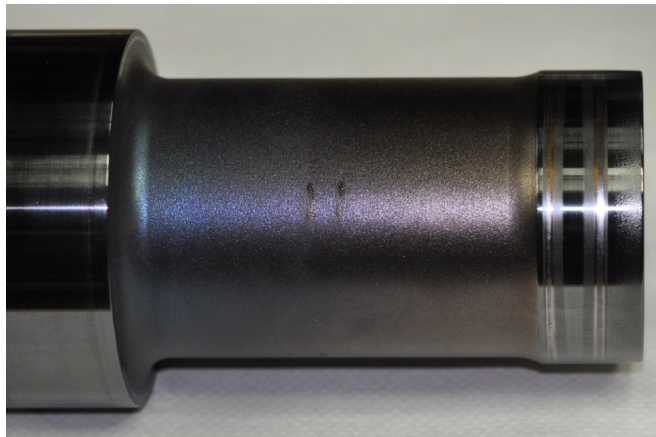
The next internal inspection was conducted after 79.5 ft of total footage as shown Figure 43. The wear ring on the struck end has grown. There are also visible wear patterns developing on the mid-section and far-end of the piston.

- Additional bluin
- 2 wear rings developing
- Due to piston rotation?

Visible ring near end

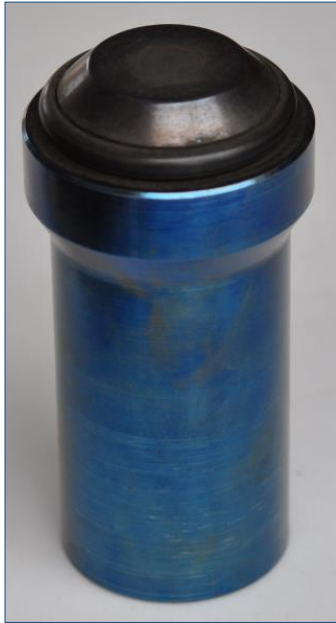
**Figure 47. Check valve tempering temperature color change**

gas air. The deep blue color indicates sustained temperatures in the range of approximately 550°F-600°F.

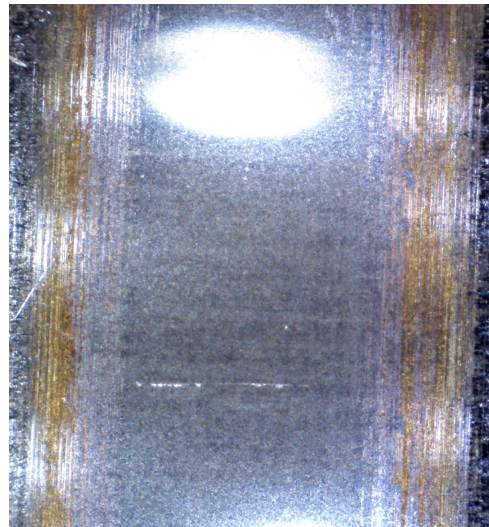
The next inspection shows a steady progression of wear that was seen in the previous interval. The tempered region continued to expand towards the struck end. The wear bands on the stem appear more polished. The transverse wear pattern visible on the far end in the previous interval is now visible in the mid-section.

Expanded tempered region

Wear ring wider

Wear appears to have reached steady condition

Visible wear  
ring

Original  
machining  
marks

Consistent with After 119 ft

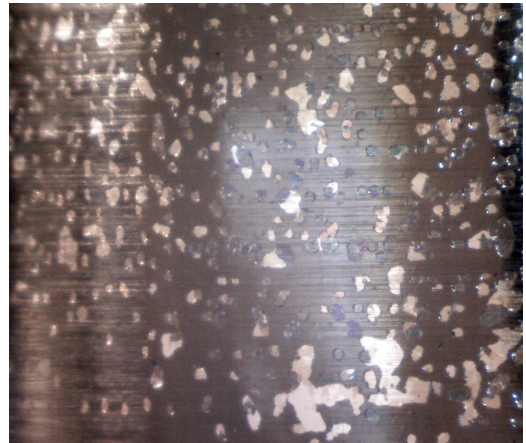
**Figure 49. HT distributor with DLC after 196.25 feet cumulative.**

Close-up view of "pits" on distributor surface(50x zoom)

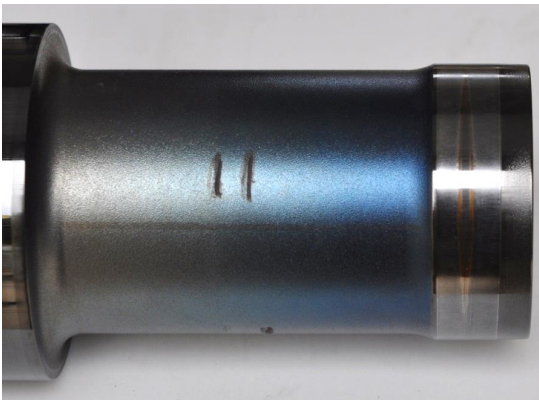
**Figure 50. LT piston with DLC after 201.75 ft.**

The final inspection revealed additional wear on the stem end. The two wear rings have nearly coalesced. A band of the original coating remains in place. The transverse wear patterns in the mid-section and the far end have expanded. There is a visible ring on the far end of the piston indicating material transfer between the air cylinder and piston.

Overall, the hammer configuration with the LT material piston and HT material distributor drilled more than 200 ft. in 24 ksi Sierra White granite at temperatures up to 572°F without liquid lubricants. During this time, it went through multiple thermal cycles and was able to maintain performance with rates of penetration exceeding 100 ft/hr. Although wear patterns developed on the moving parts, the performance of the hammer was quite remarkable when considering the operating environment.
