**Paper No. 5007**

## **Fuel Assembly Tests under Normal Conditions of Transport**

Sandia National Laboratories\*  
Albuquerque, New Mexico USA

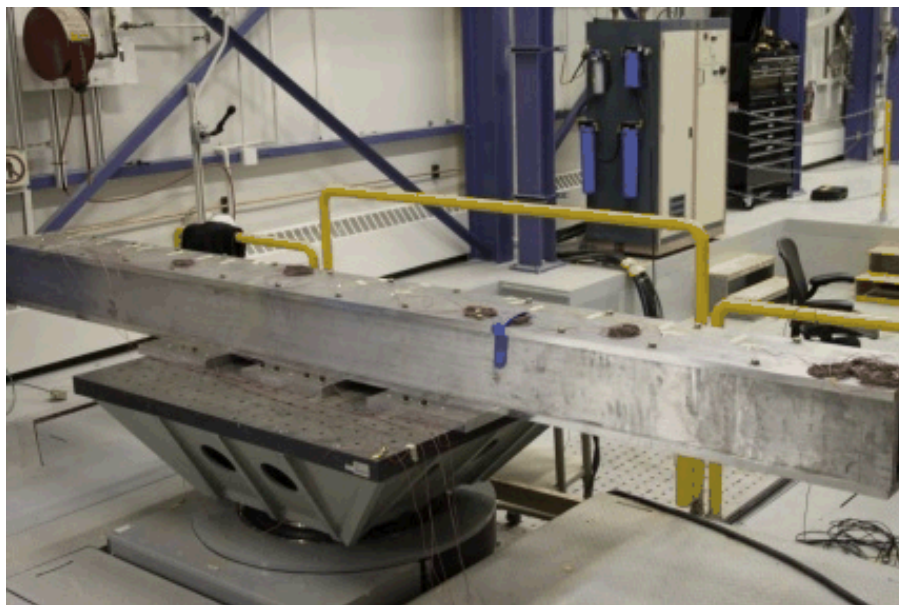
Three sets of NCT tests were performed using the assembly/basket unit [1 -3]. The first set of tests used a uniaxial (vertical direction) shaker at Sandia National Laboratories (Figure 2). The inputs to the shaker for this series of tests simulated normal conditions of truck transport. Truck transport is widely regarded as a more severe vibration and shock environment than rail transport. And, accelerations in the vertical direction tend to exceed those for the other axes and are potentially most damaging to a rod within an assembly. The truck NCT accelerations used as input to the shaker were based upon data in [4].

**Figure 2 Sandia uniaxial shaker**

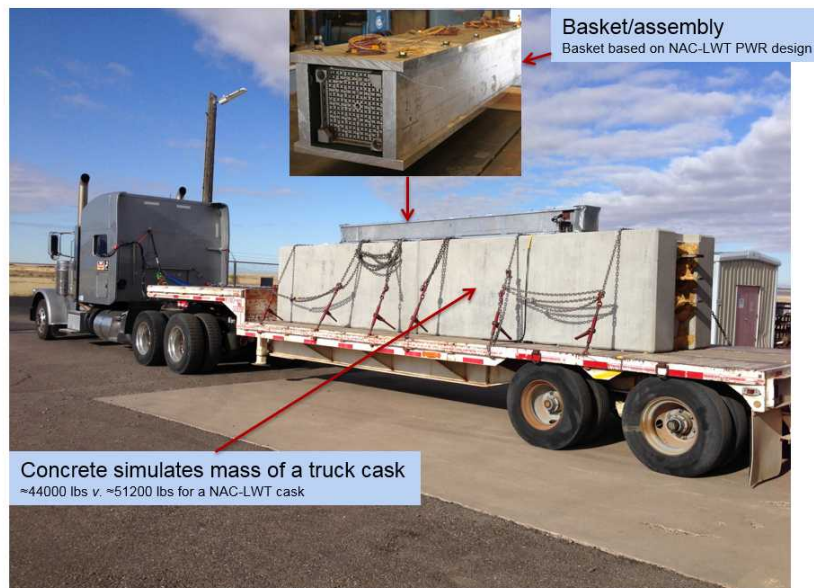
The second test was an actual truck over-the-road test. The assembly/basket was placed upon a trailer upon concrete blocks whose mass simulated that of a truck cask (Figure 3). The truck was driven over a variety of road conditions and velocities (Figure 4).

**Figure 3 Over-the-road truck test configuration**

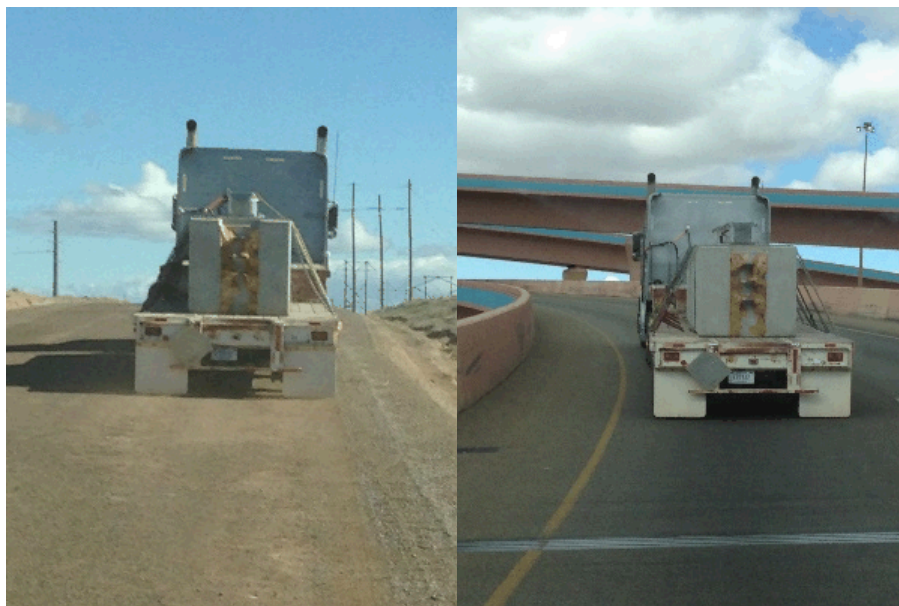
**Figure 4 Typical roads for truck test**

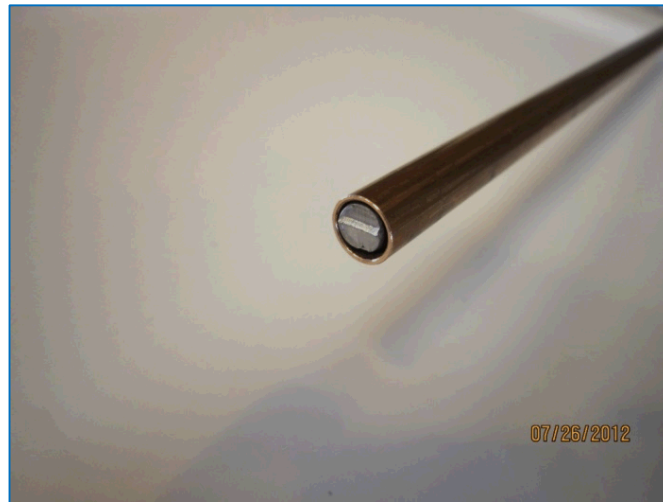
For both sets of these tests, all of the tubes were filled with lead “rope” (lead rod) to simulate the mass of actual uranium oxide fuel (Figure 5). The Zircaoly-4 tubes were instrumented with strain gauges and uniaxial accelerometers (Figure 6).

**Figure 5 Lead “rope” with in copper surrogate fuel tube**

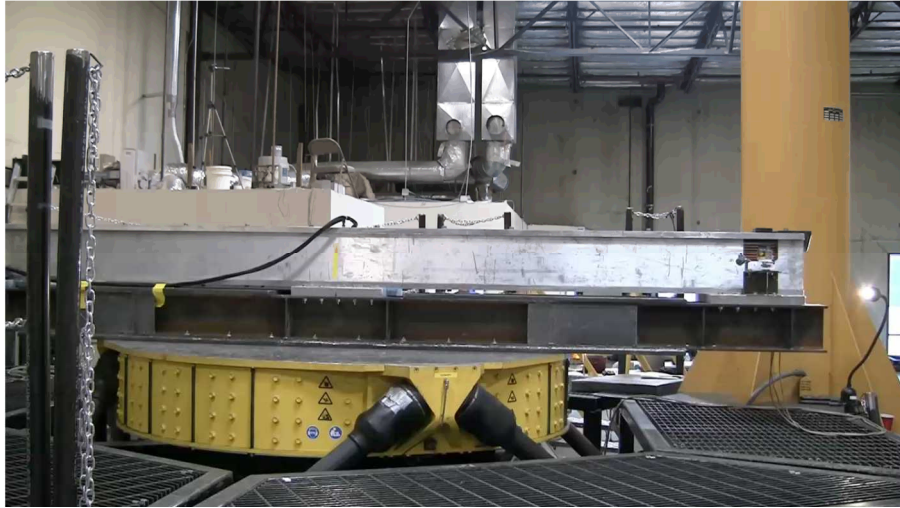
The third set of tests were conducted at the Dynamic Certification Laboratories using a six-degrees-of-freedom multi-axis shaker (Figure 7). These tests simulated both truck and rail NCT. The truck NCT input was the same as used for the Sandia shaker tests. The rail NCT inputs were derived from [5].

**Figure 7 Multi-axis shaker used for rail and truck NCT tests**

For the multi-axis truck and rail NCT tests, three Zircaloy-4 rods were instrumented. One of the tubes was filled with lead “rope” as with the other tests; one was filled with lead pellets; and the third was filled with molybdenum pellets.
