Stress-Corrosion-Cracking Studies on Candidate Container Alloys for the Tuff Repository

NUREG/CR-5710
JUN 15 1992
331

Prepared by
J. A. Beavers, C. L. Durr

Cortest Columbus Technologies, Inc.

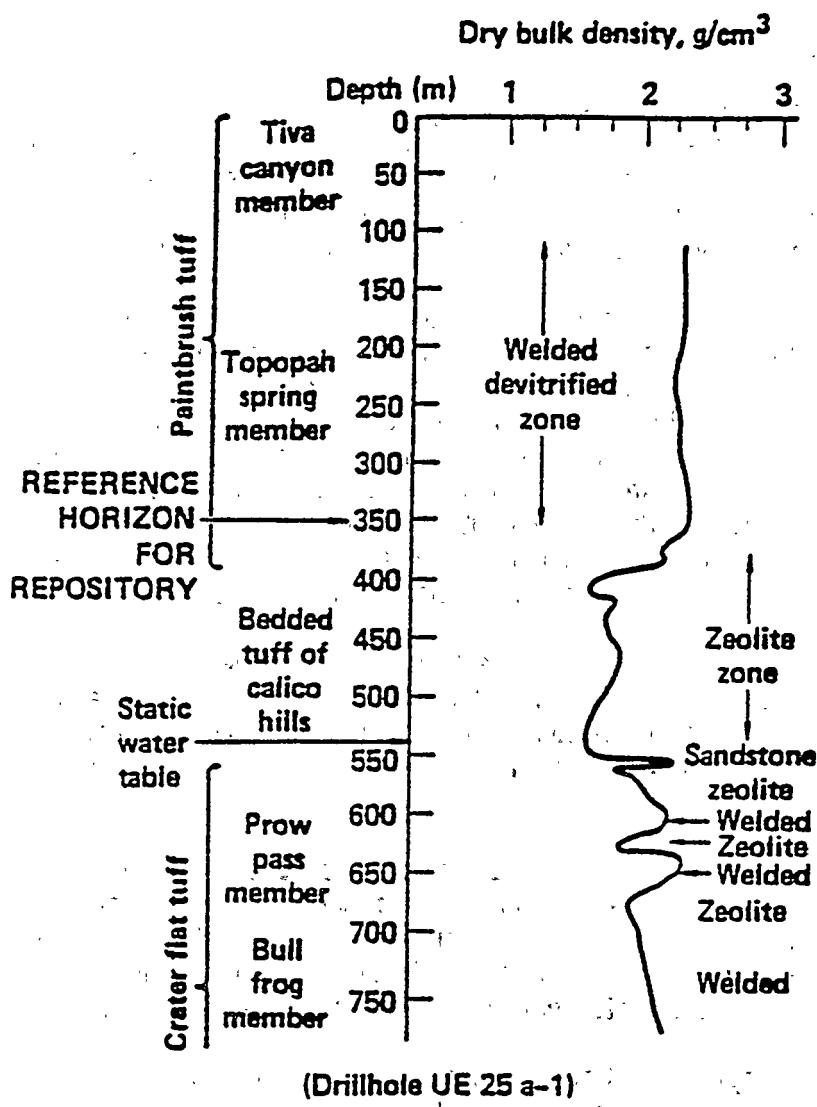
Figure 2.1 Representative Stratigraphic Section in Nevada Tuff (Drillhole UE25 a-1) (McCright-1984).

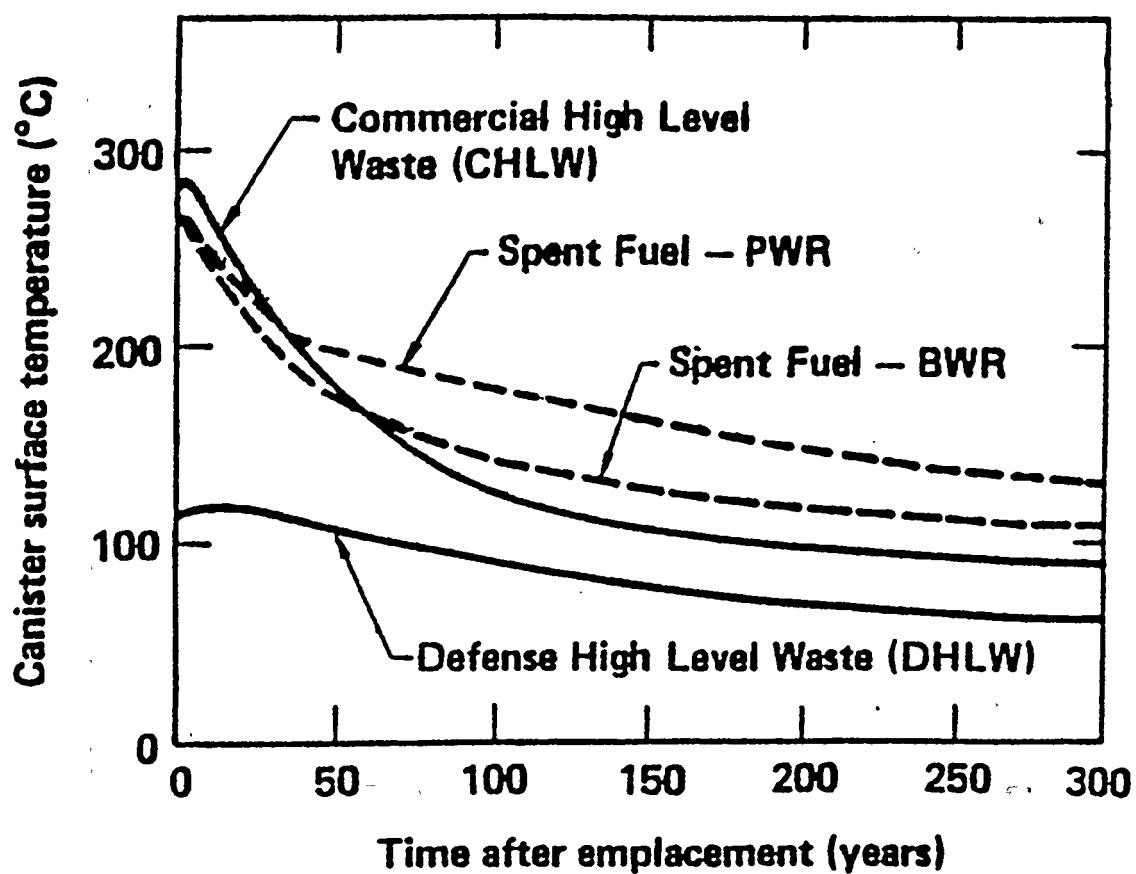
Figure 2.2 Comparative Canister Surface Temperature-Time Profiles For Different Waste Packages In A Tuff Repository (Vertical Emplacement, 50 kW/acre Areal Loading) (McCright-1984).

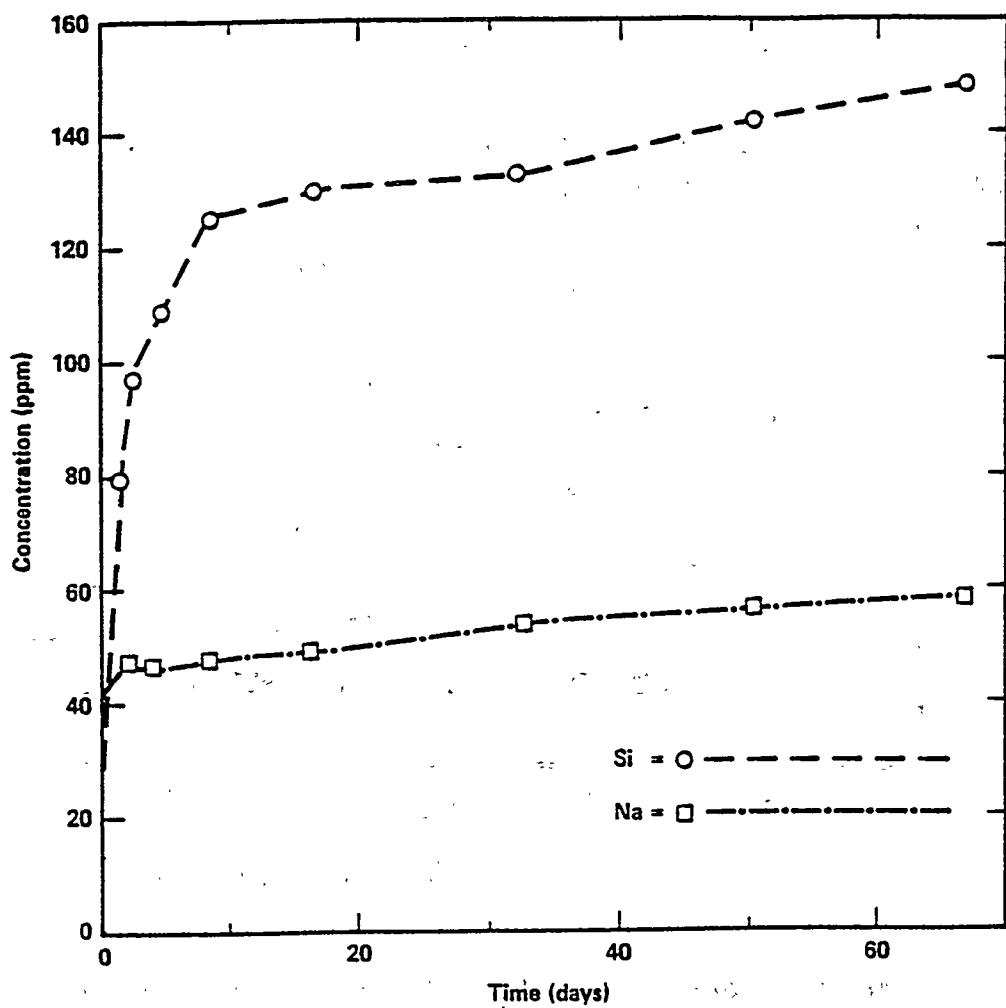
Figure 2.3 Silicon And Sodium Concentrations In J-13 Well Water Reacted With Crushed G-1 Material At 150°C As A Function Of Time In Days (Knauss-1985a).

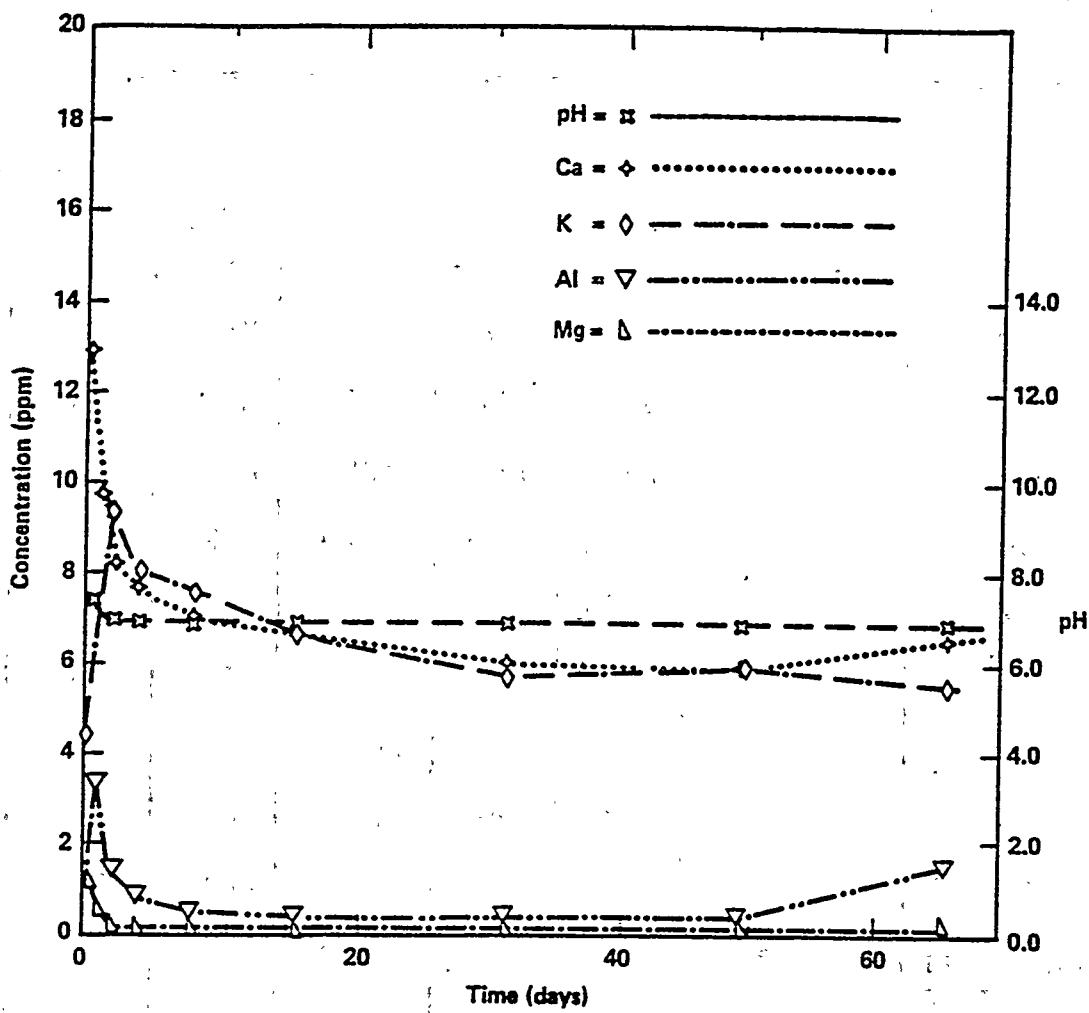
Figure 2.4
Aluminum, Potassium, Calcium, Magnesium, And pH Analyses From J-13 Well Water Reacted With Crushed G-1 Material At 150°C As A Function Of Time In Days (Knauss-1985a).

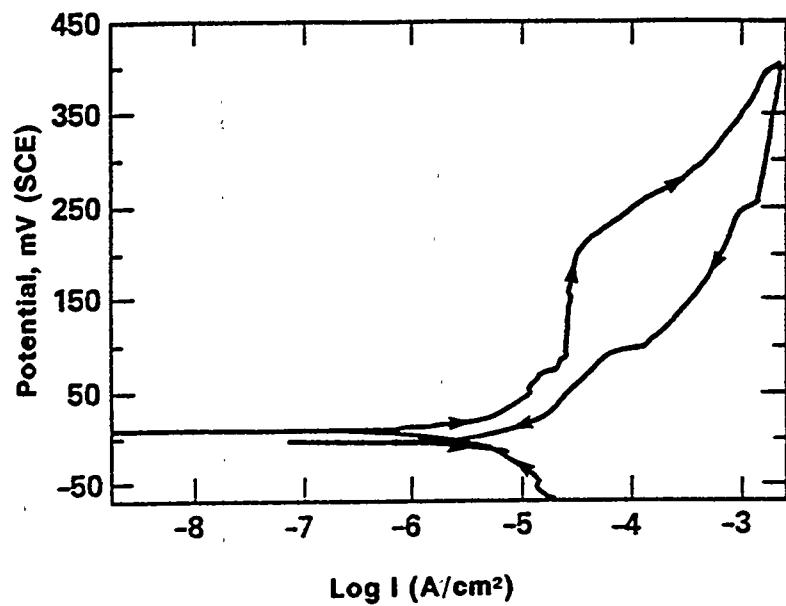
Figure 2.5 · CPP Curve For Alloy CDA 102 In Actual J-13 Well Water At 80°C (Scan Rate: 1 mV/s) (McCright-1985).

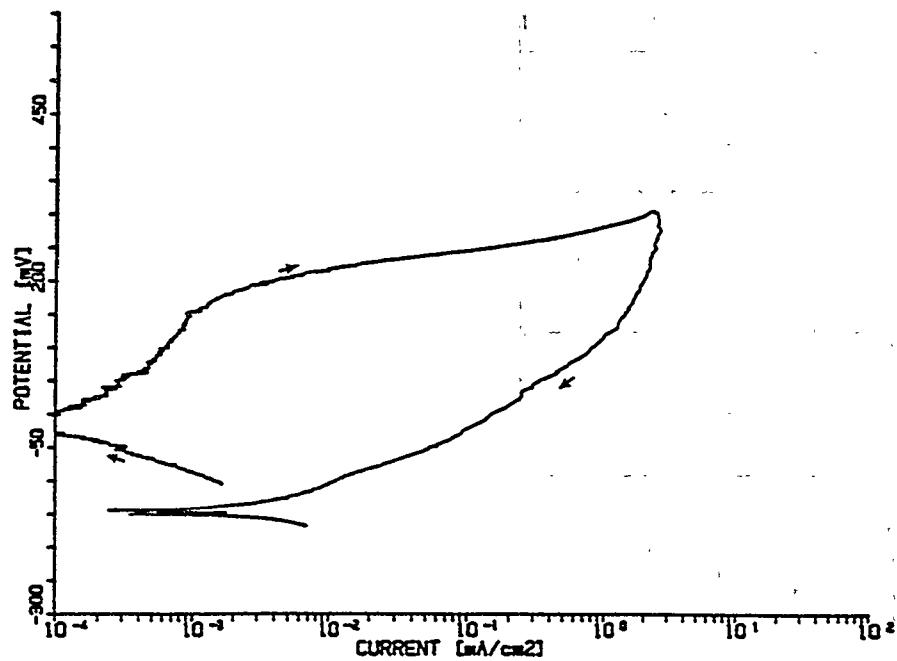
Figure 2.6 CPP Curve For Alloy CDA 102 In Simulated J-13 Well Water At 80°C Following A One Hour Initial Exposure (Beavers-1991b).

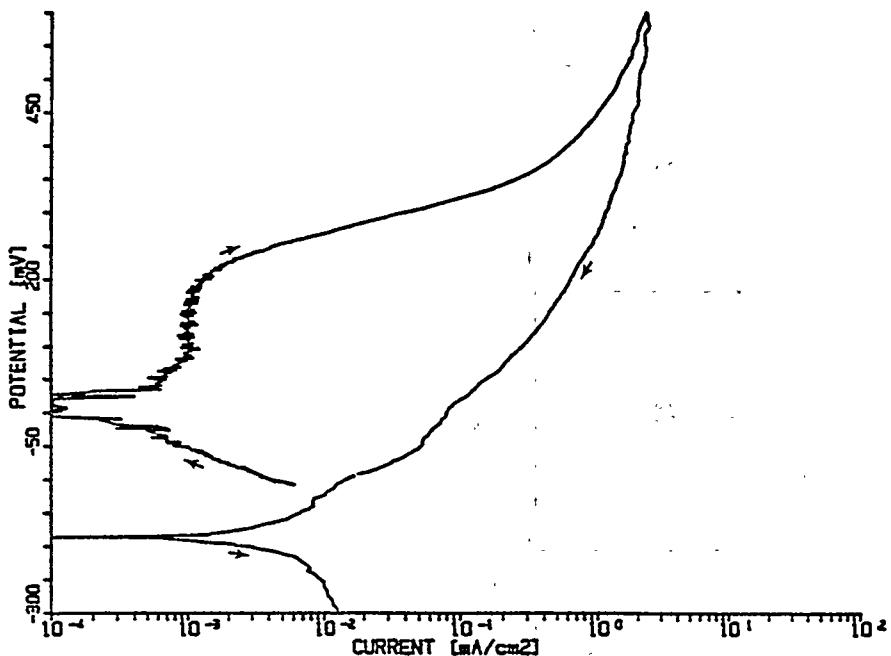
Figure 2.7 CPP Curve For Alloy CDA 102 In Actual J-13 Well Water At 80°C Following A One Hour Initial Exposure (Beavers-1991b).

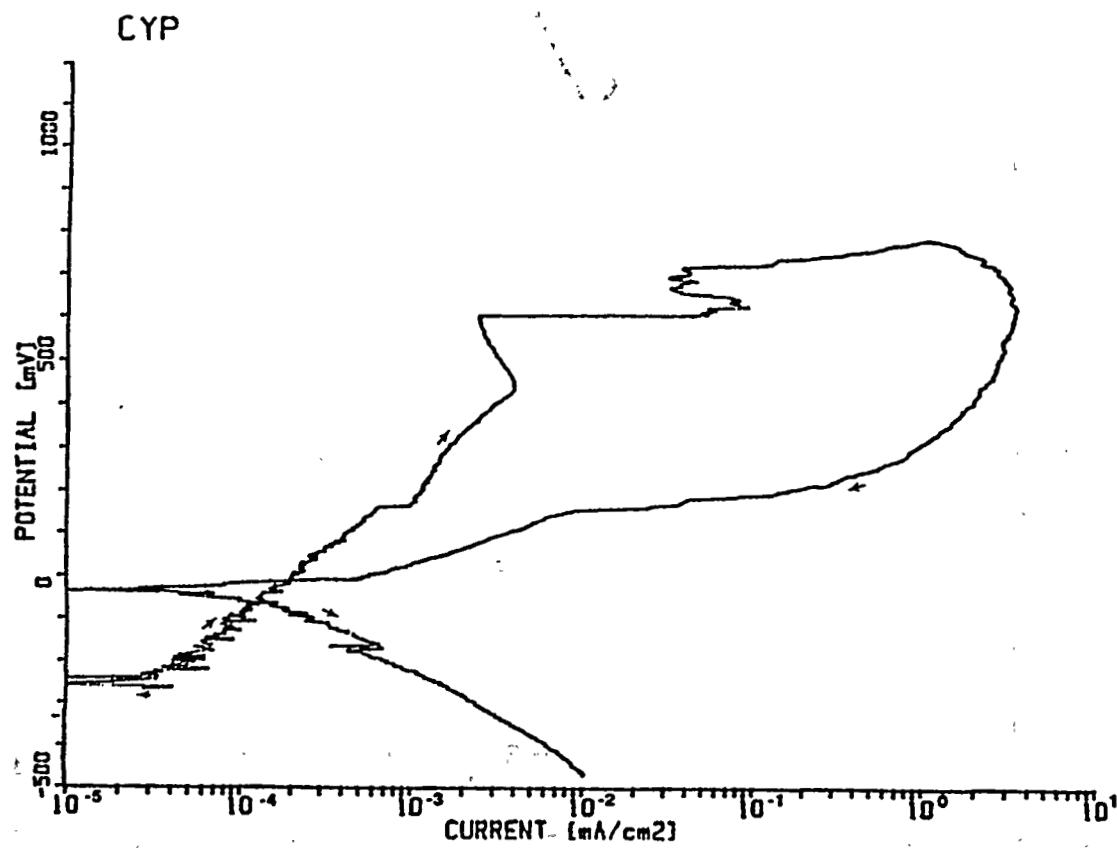
Figure 2.8 CPP Curve For Alloy 825 In Test Solution Number 20 At 90°C (Beavers-1991b).

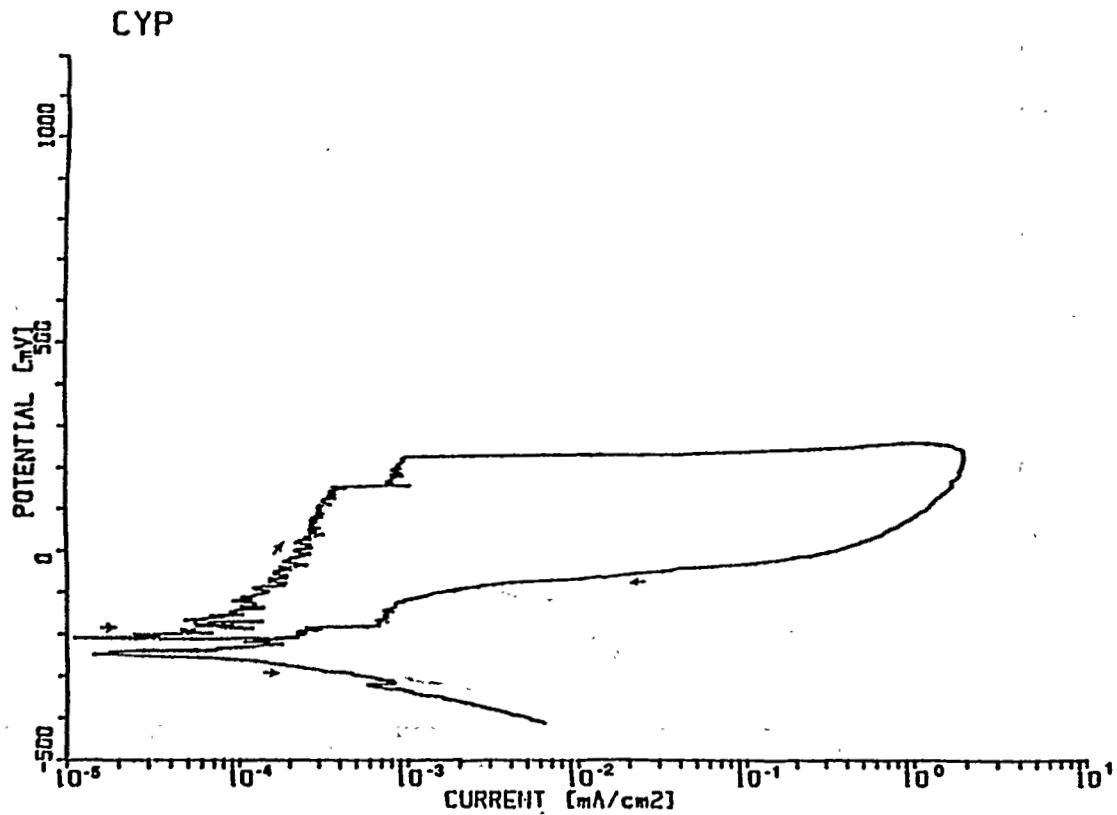
Figure 2.9 CPP Curve For Alloy 304L In Test Solution Number 20 At 90°C (Beavers-1991b).

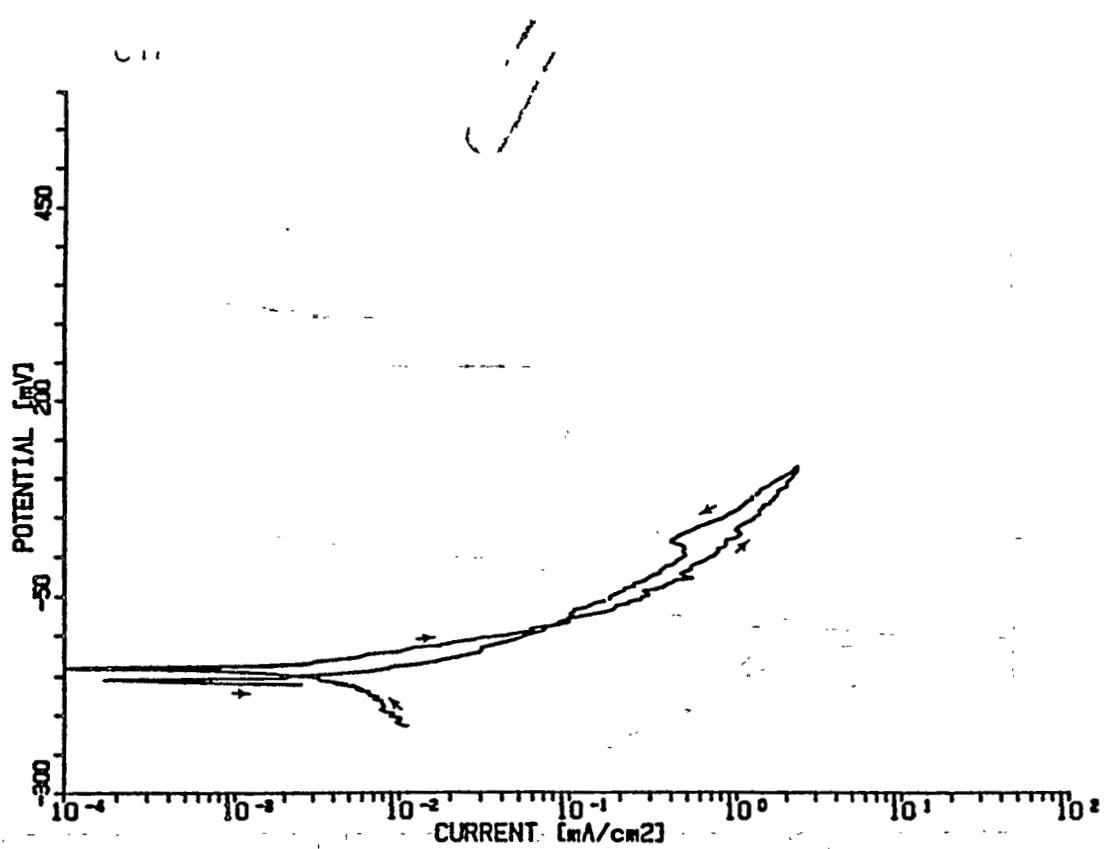
Figure 2.10 CPP Curve For Alloy CDA 102 In Test Solution Number 7 At 90°C (Beavers-1991b).

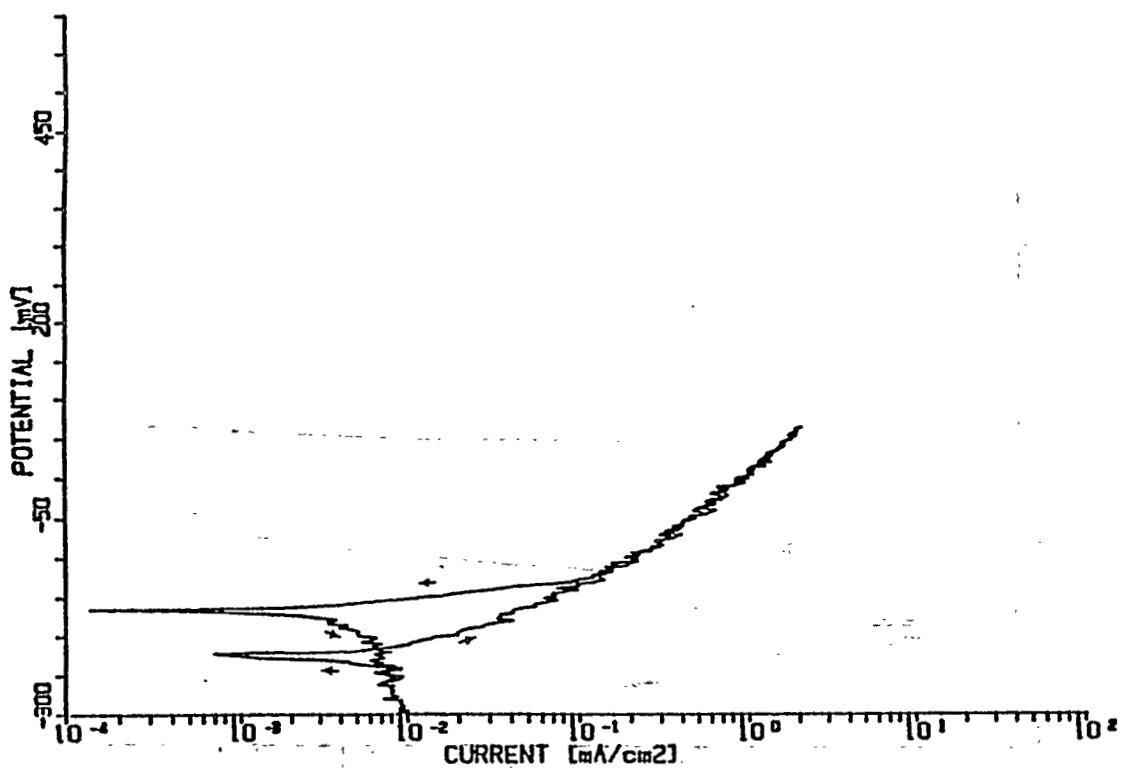
Figure 2.11 CPP Curve For Alloy CDA 715 In Test Solution Number 7 At 90°C (Beavers-1991b).

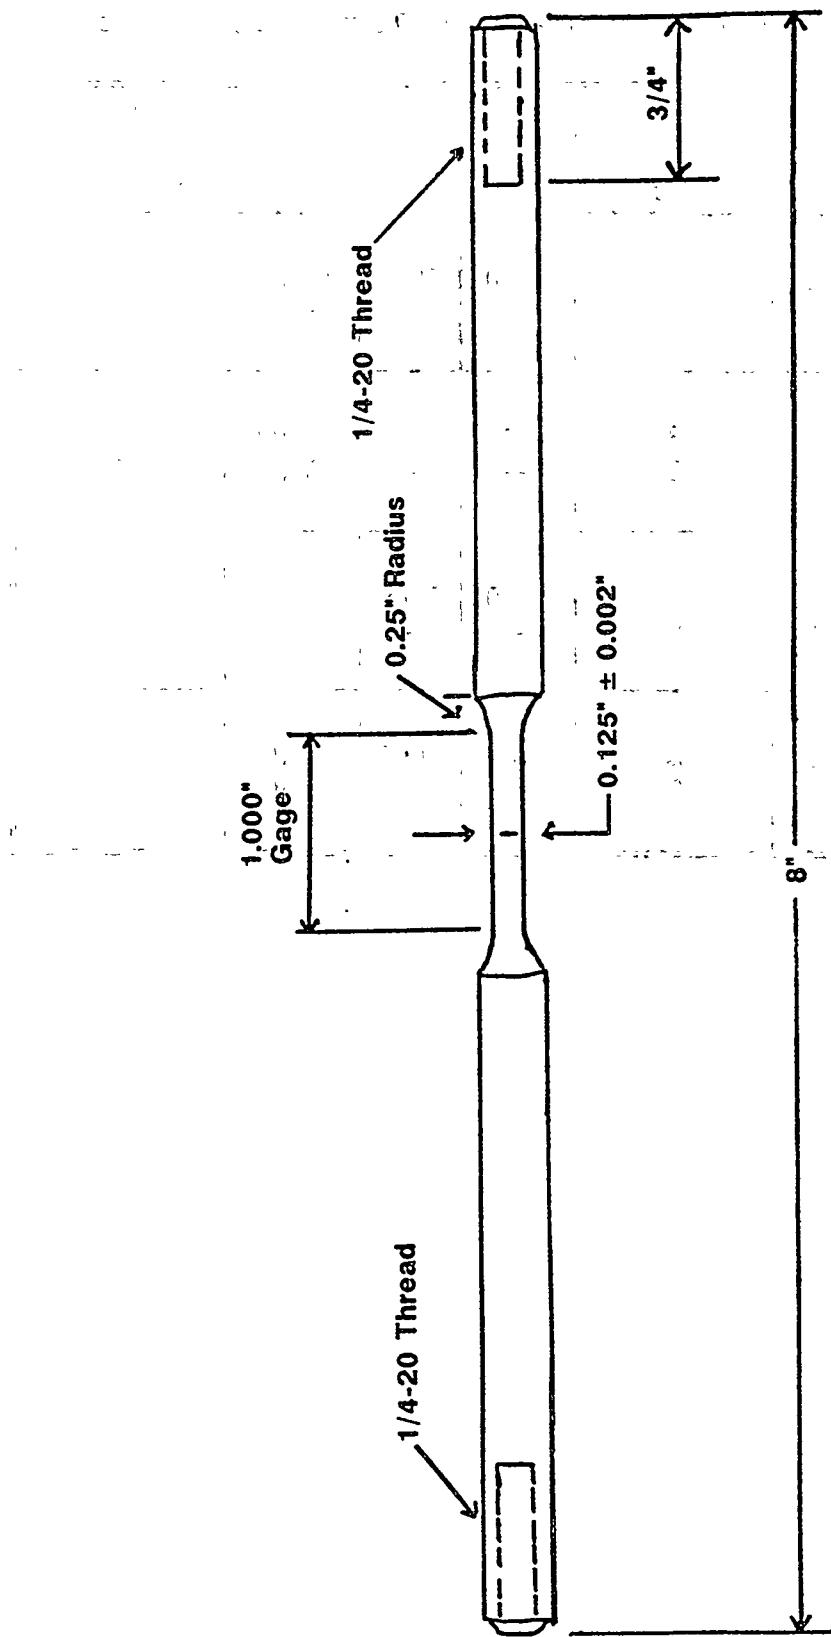
Figure 3.2 Schematic Of The Slow-Strain-Rate Specimen Used In Task 5.

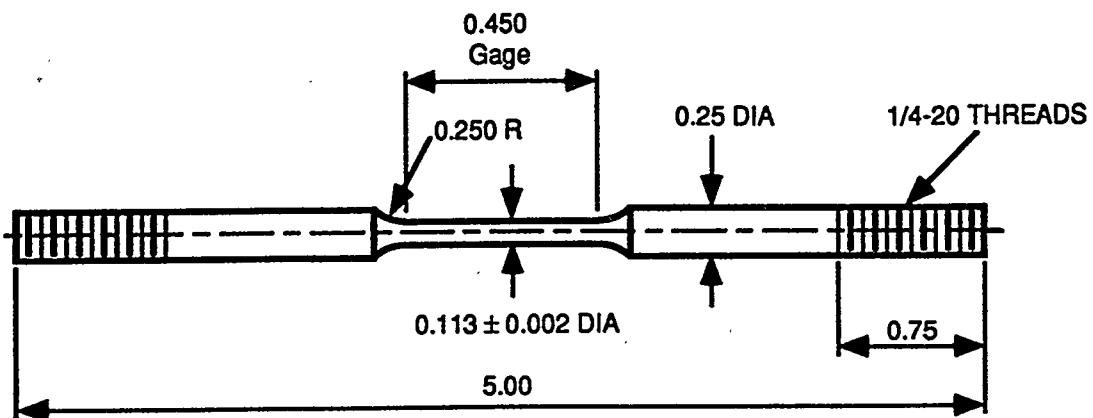
Figure 3.3 Schematic Of The Alternate Slow-Strain-Rate Specimen Used In Task 5.

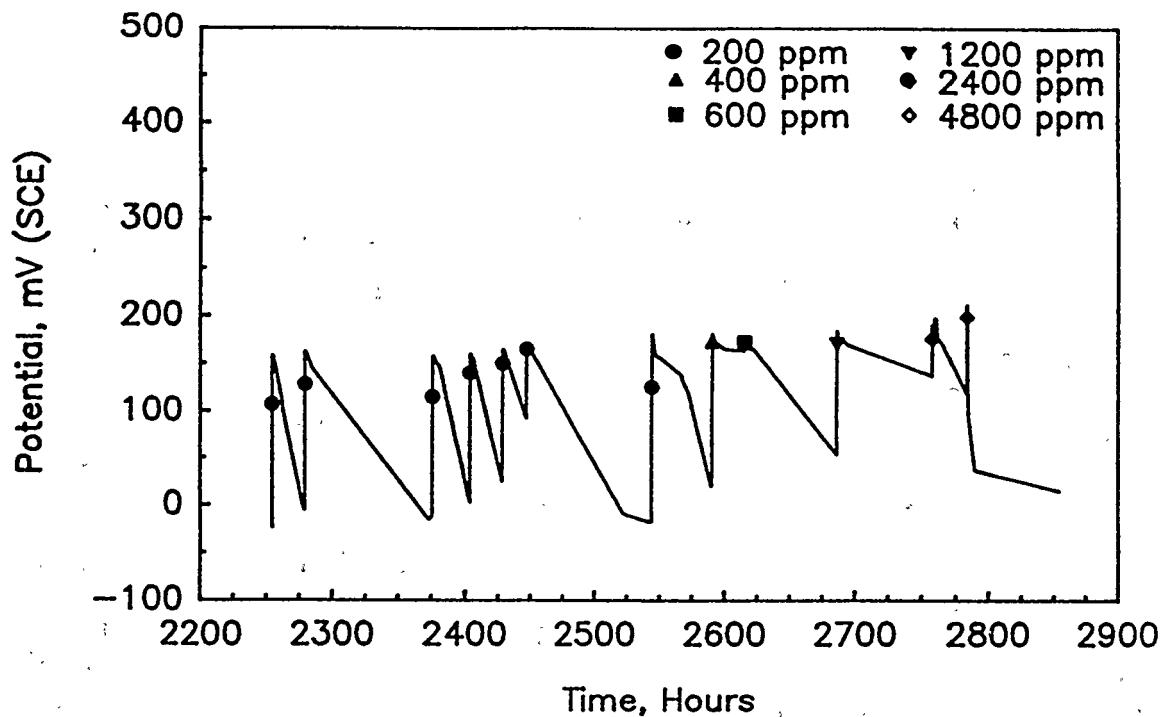
Figure 4.1 Corrosion Potential As A Function Of Test Time For Alloy 304L In Solution Number 20 At 90°C, Showing The Effects Of H_2O_2 Additions.

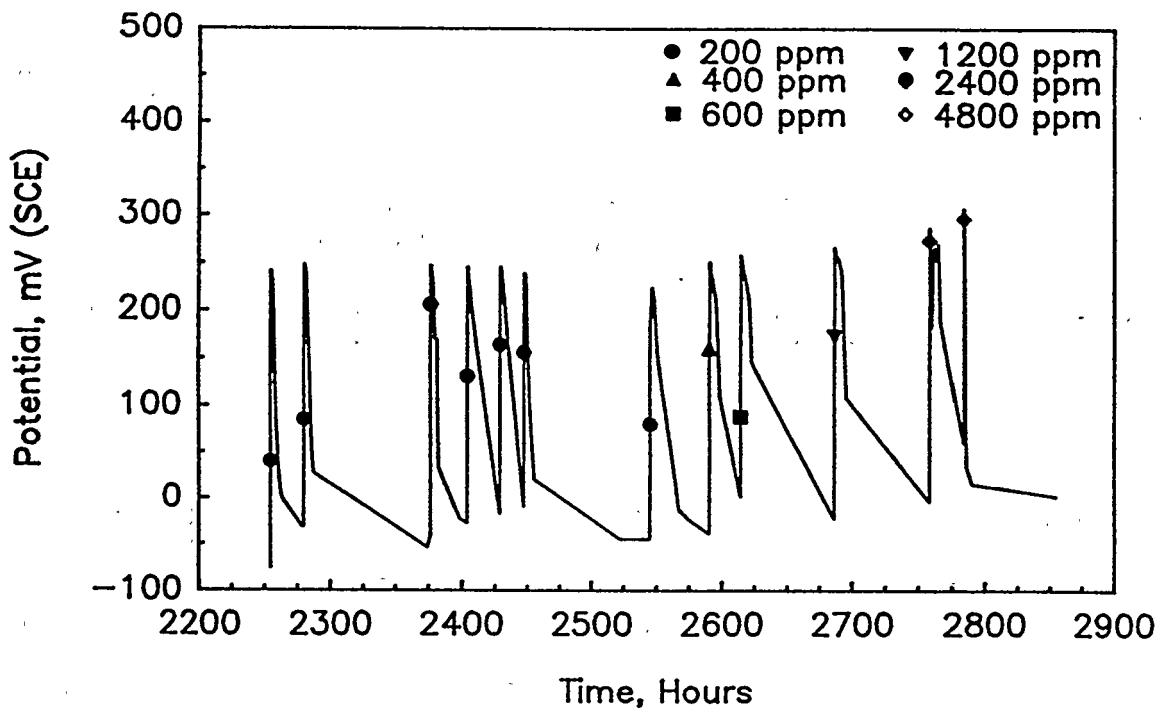
Figure 4.2 Corrosion Potential As A Function Of Test Time For Alloy 825 In Solution Number 20 At 90°C, Showing The Effects Of H_2O_2 Additions.

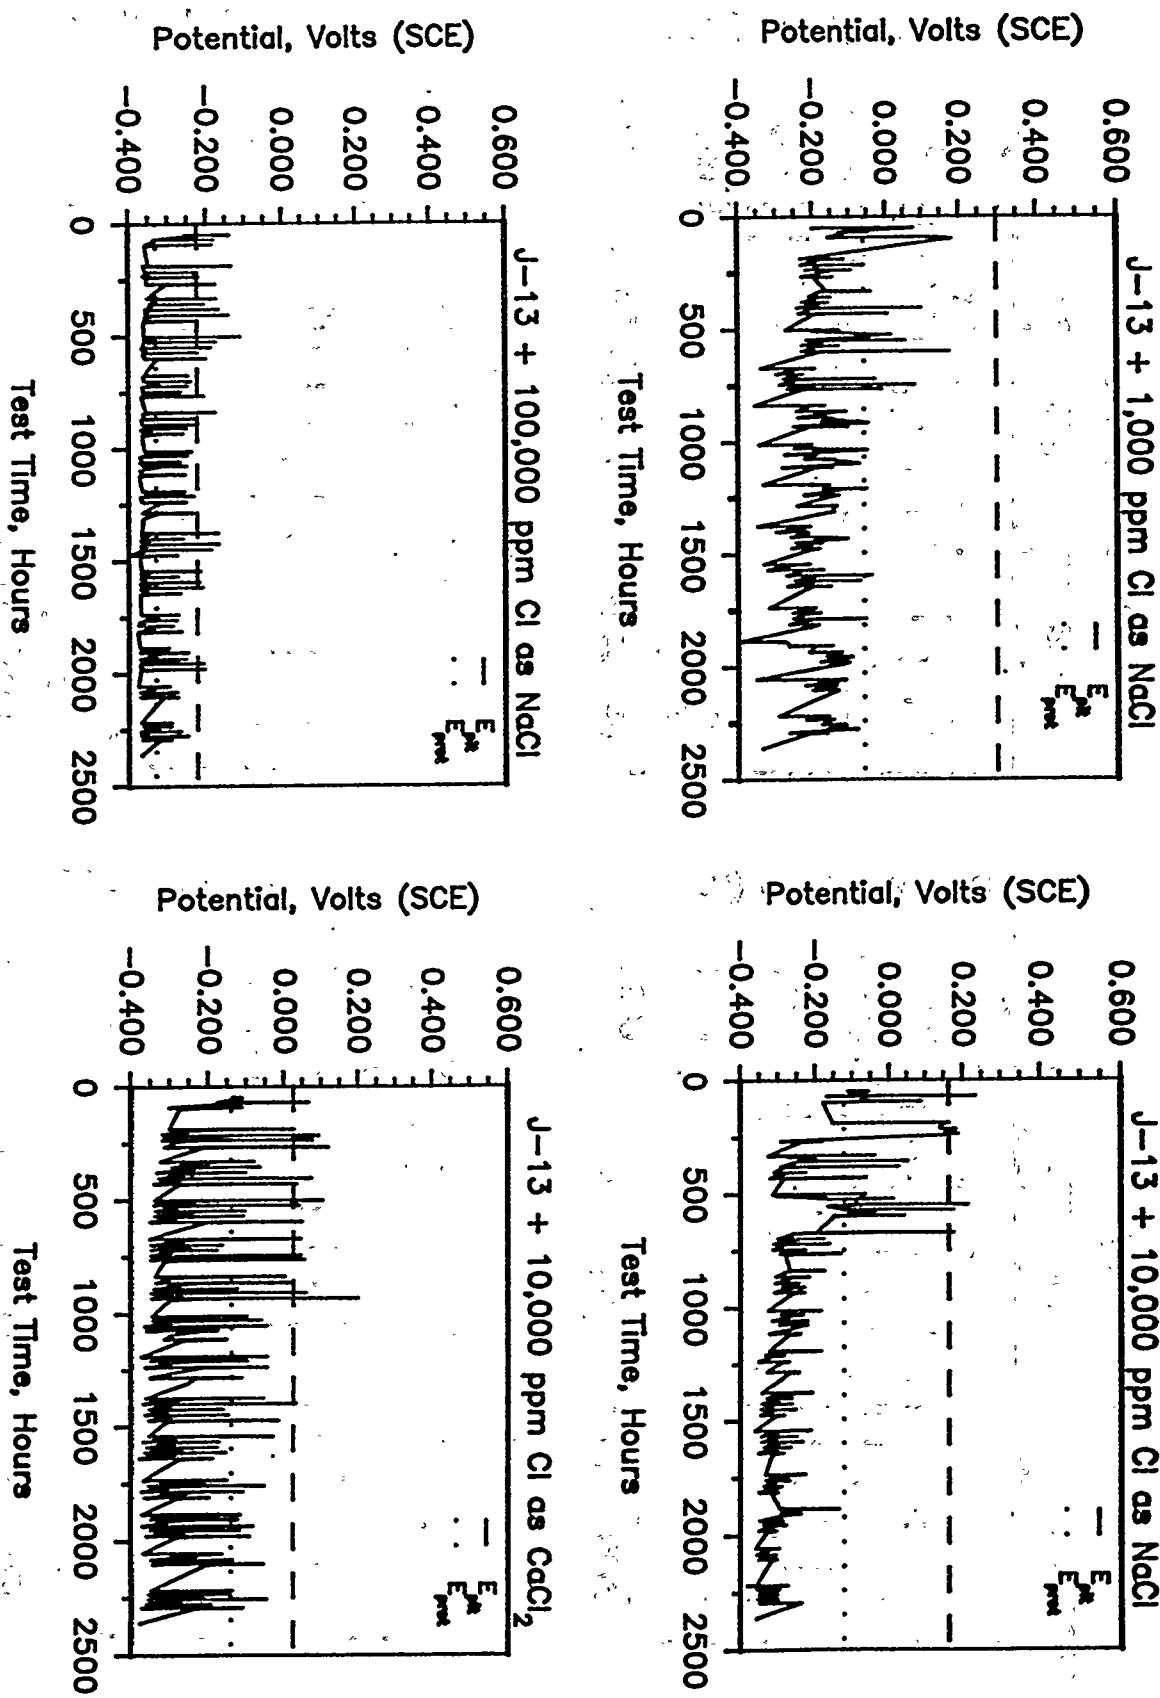
Figure 4.3 Corrosion Potential As A Function Of Test Time For U-Bend Specimens Of Alloy 304L Exposed To The Liquid Phase Of 90°C Aerated Simulated J-13 Well Water Containing Various Types And Concentrations Of Salt. Noble Spikes Indicate 200 ppm H_2O_2 Additions.

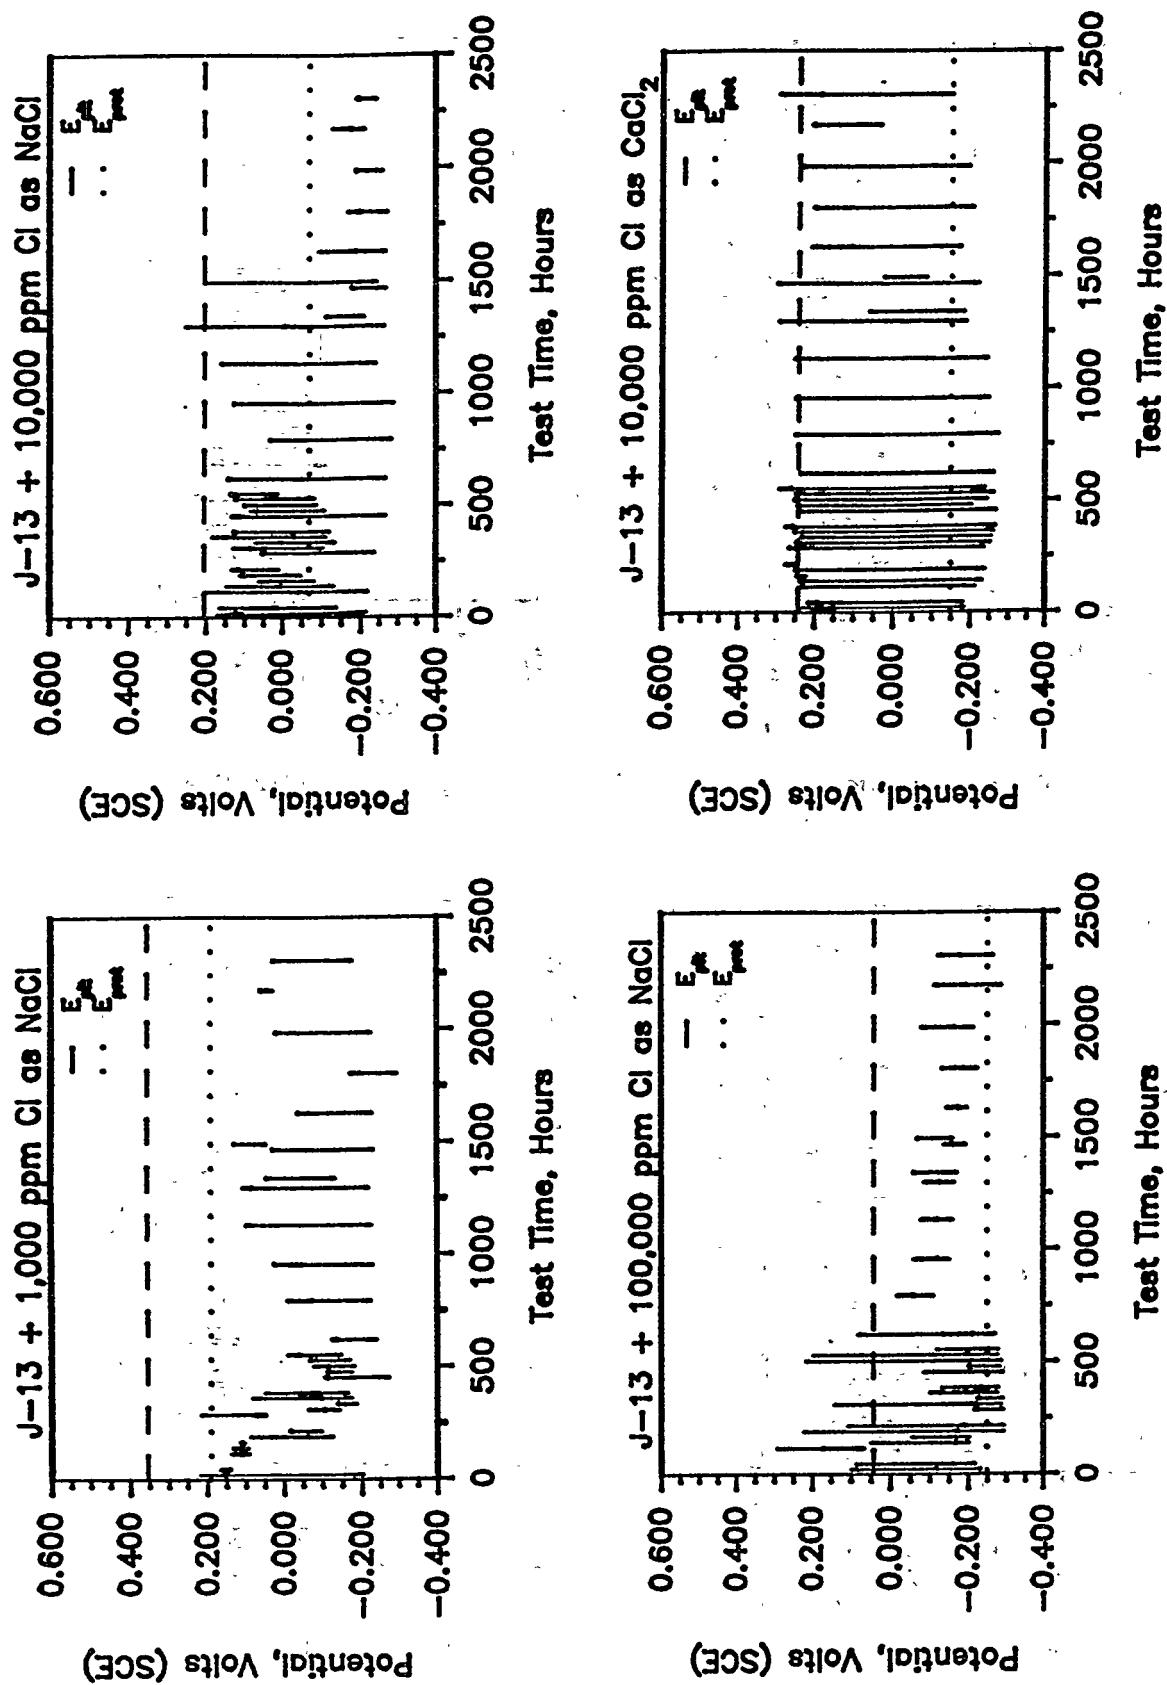
Figure 4.4 Corrosion Potential As A Function Of Test Time For U-Bend Specimens Of Alloy 825 Exposed To The Liquid Phase Of 90°C Aerated Simulated J-13 Well Water Containing Various Types And Concentrations Of Salt. Noble Spikes Indicate 200 ppm H_2O_2 Additions.

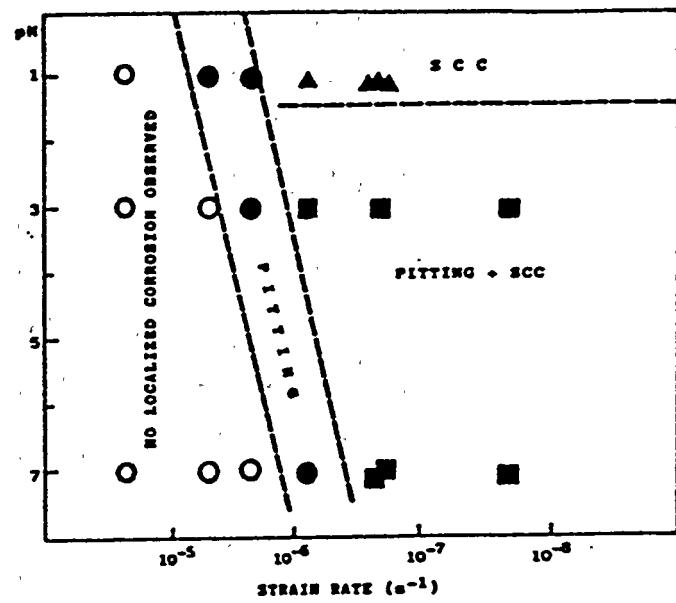
Figure 4.5 Effect Of Strain Rate And pH On The Localized Corrosion Morphology For Type 304 Stainless Steel In Aqueous 5M NaCl At 110°C (Mancia-1986).

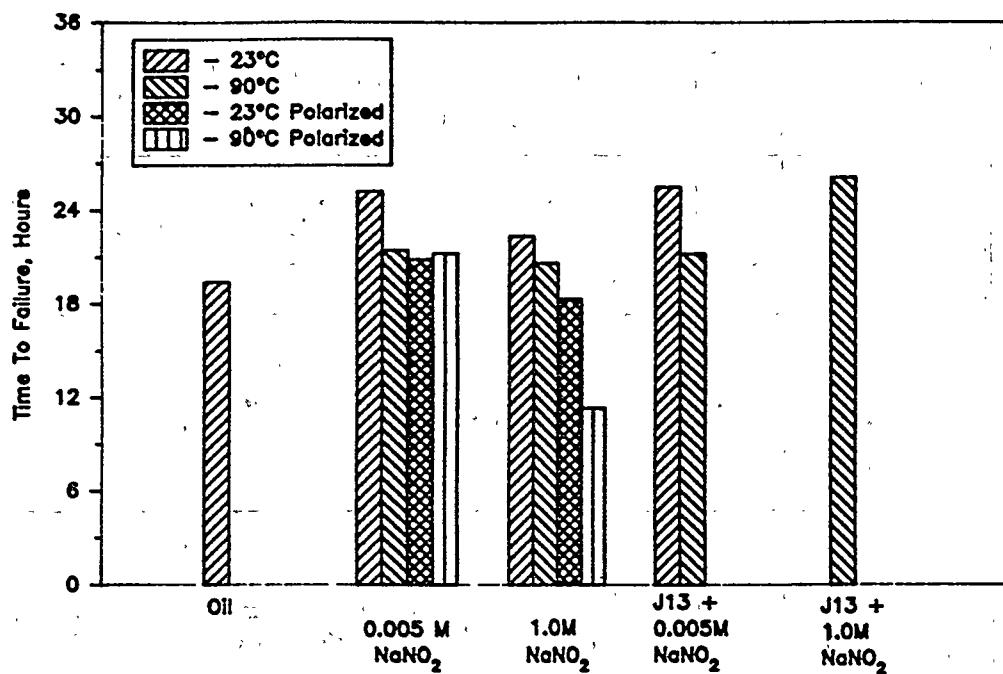
Figure 4.6 Time To Failure As A Function Of Environment, Temperature, And Polarization For Tensile Specimens Of Alloy CDA 102.

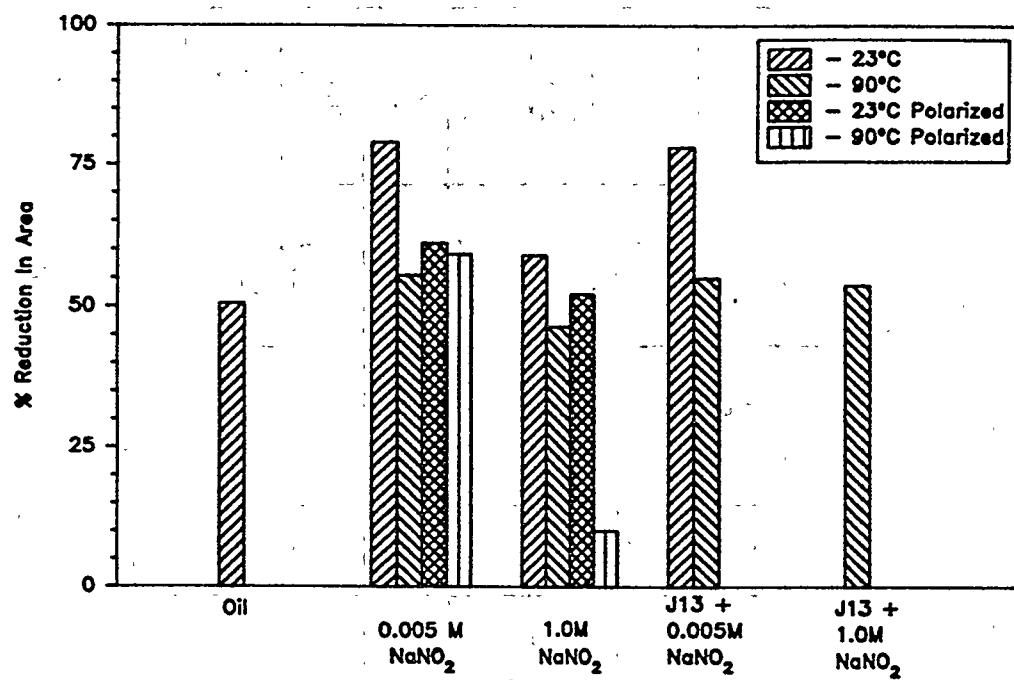
Figure 4.7 Percent Reduction In Area As A Function Of Environment, Temperature, And Polarization For Tensile Specimens Of Alloy CDA 102.

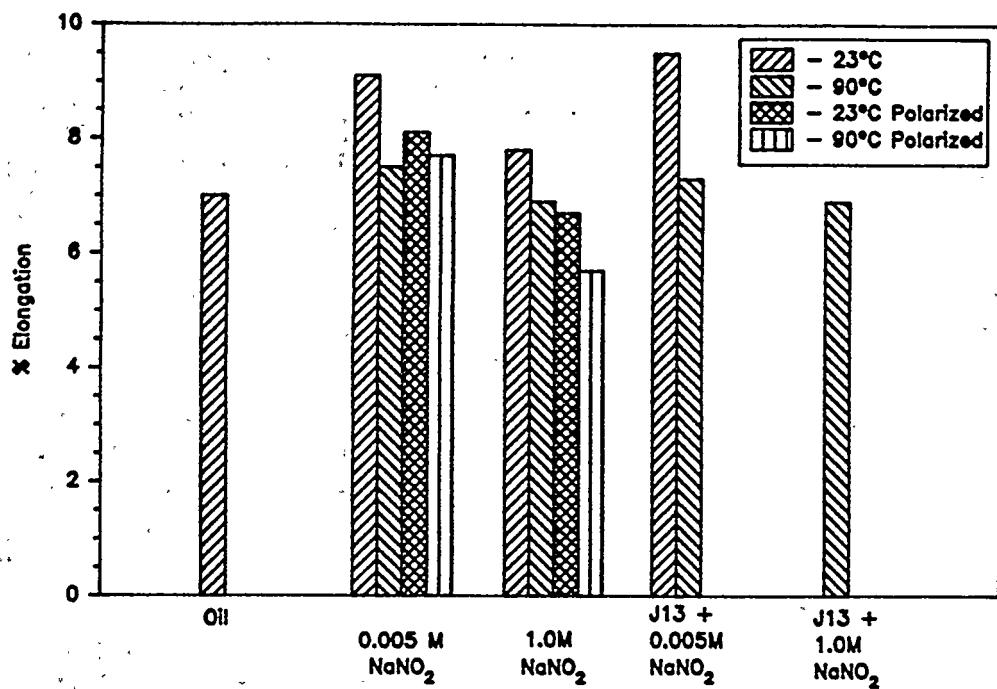
Figure 4.8 Percent Elongation As A Function Of Environment, Temperature, And Polarization For Tensile Specimens Of Alloy CDA 102.

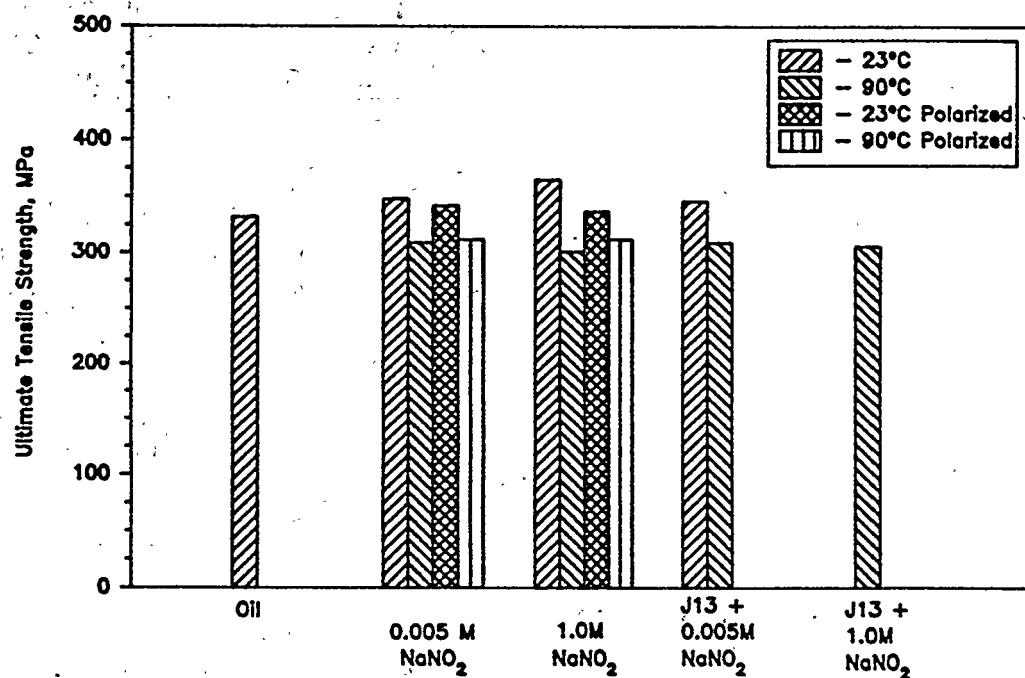
Figure 4.9 Ultimate Tensile Strength As A Function Of Environment, Temperature, And Polarization For Tensile Specimens Of Alloy CDA 102.

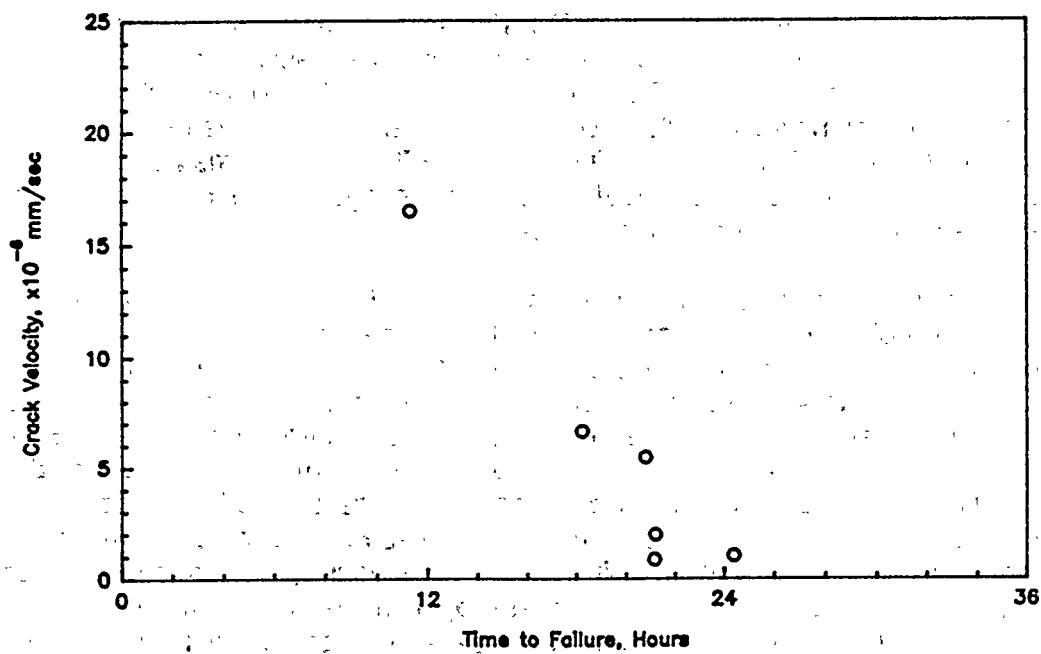
Figure 5.1 Crack Velocity As A Function Of Time To Failure For Tensile Specimens Of Alloy CDA 102 In NaNO_2 Environments.

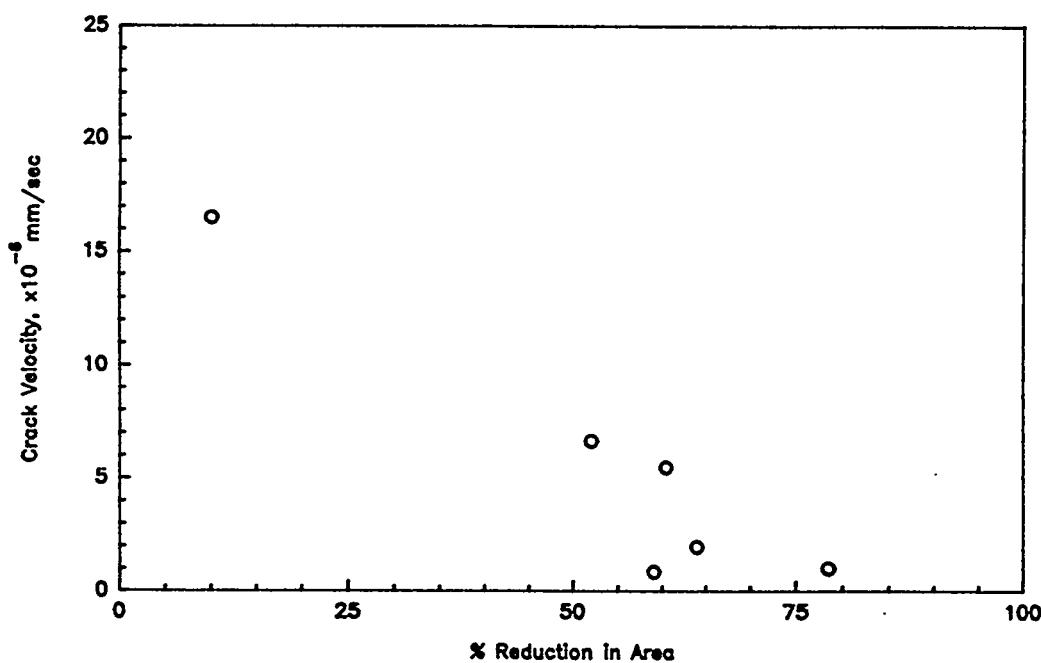
Figure 5.2 Crack Velocity As A Function Of Percent Reduction In Area For Tensile Specimens Of Alloy CDA 102 In NaNO_2 Environments.

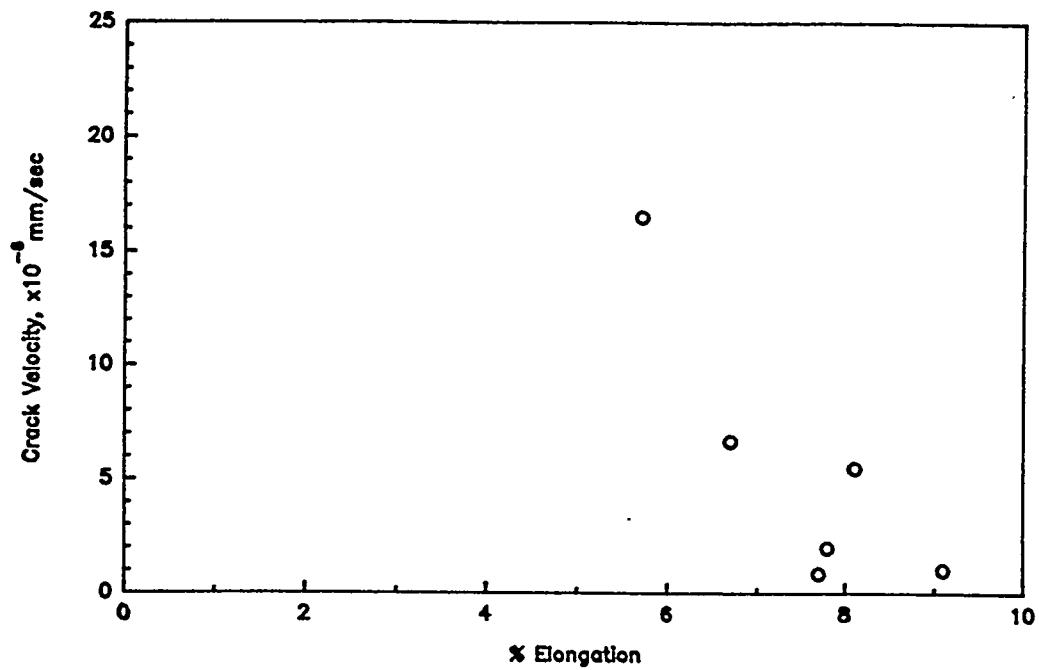
Figure 5.3 Crack Velocity As A Function Of Percent Elongation For Tensile Specimens Of Alloy CDA 102 In NaNO_2 Environments.
