Stress-Corrosion-Cracking Studies on Candidate Container Alloys for the Tuff Repository

NUREG/CR-5710
JUN 15 1992
331

Prepared by
J. A. Beavers, C. L. Durr

Cortest Columbus Technologies, Inc.

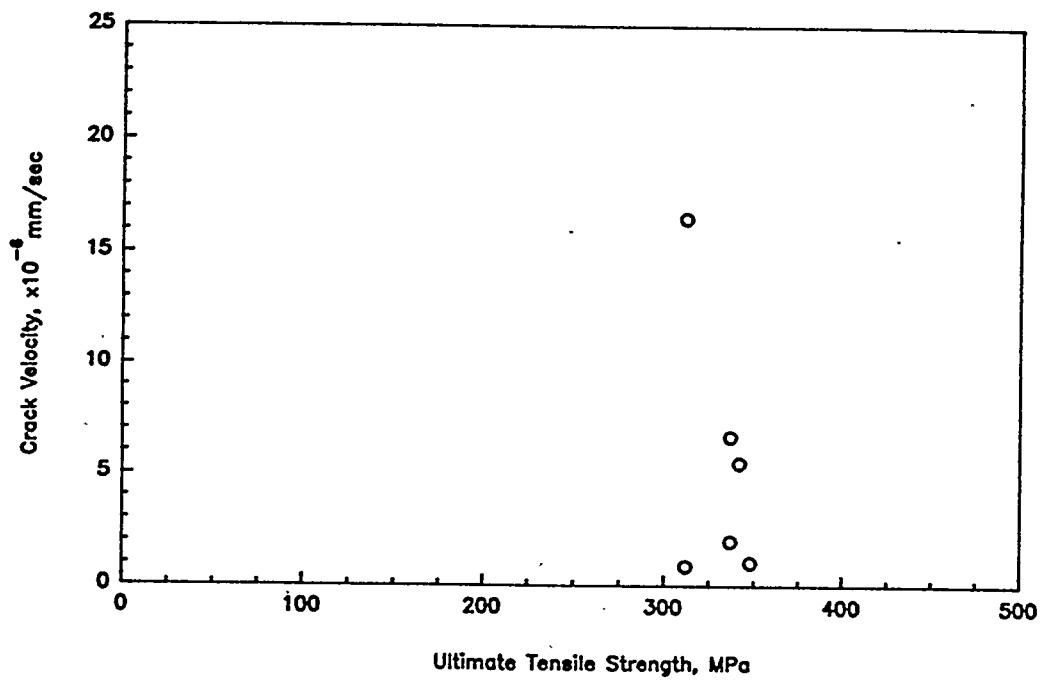
Figure 5.4 Crack Velocity As A Function Of Ultimate Tensile Strength For Tensile Specimens Of Alloy CDA 102 In NaNO_2 Environments.

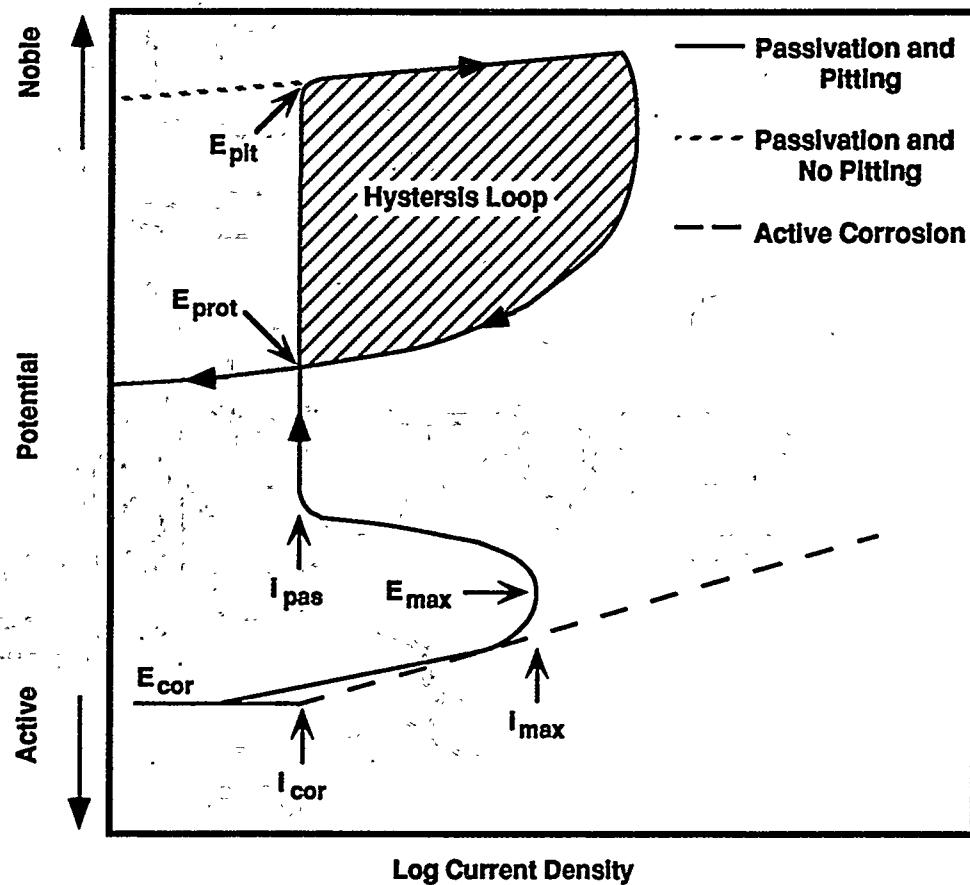
Figure A.1 Schematic Of Typical Anodic Potentiodynamic Polarization Curves.

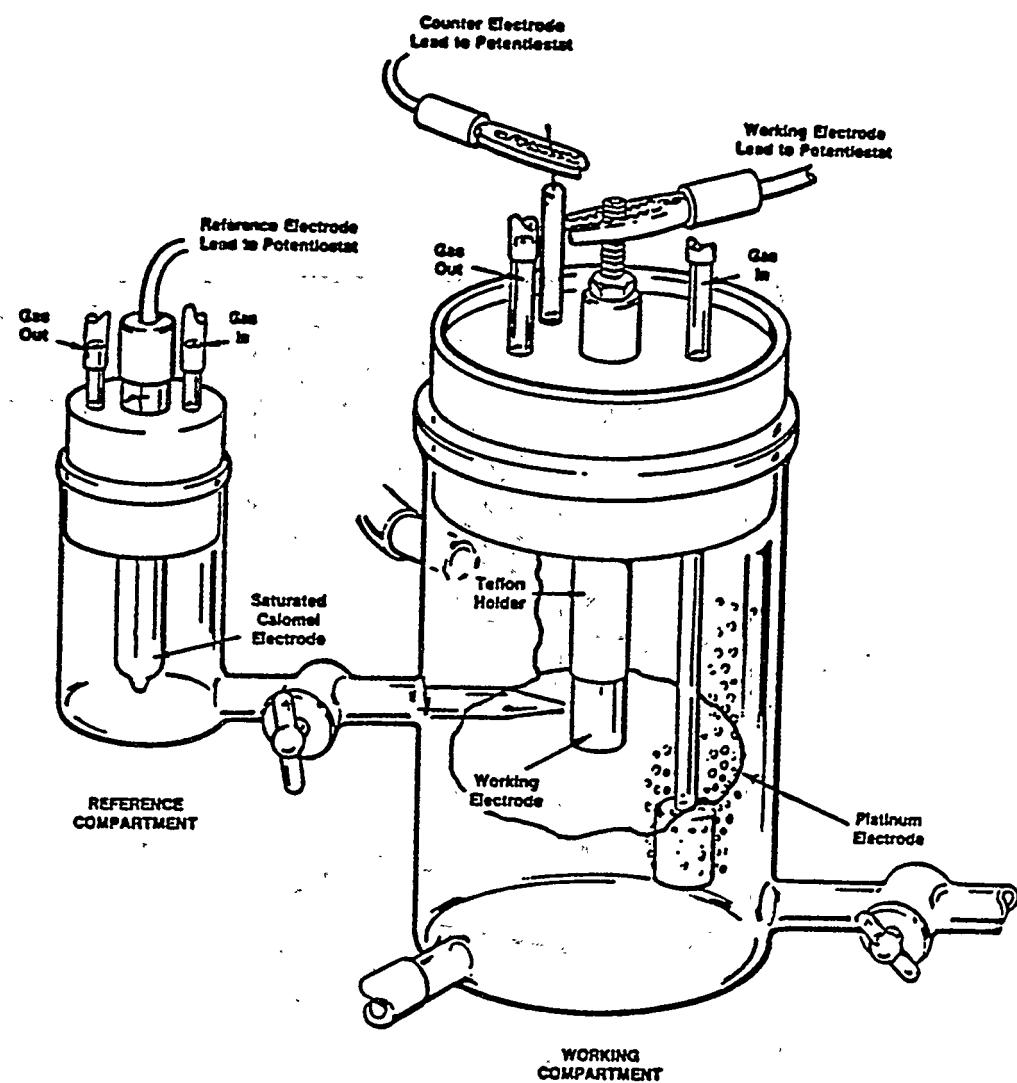
Figure A.2 Electrochemical Cell Used For Ambient Pressure Potentiodynamic Polarization Experiments.

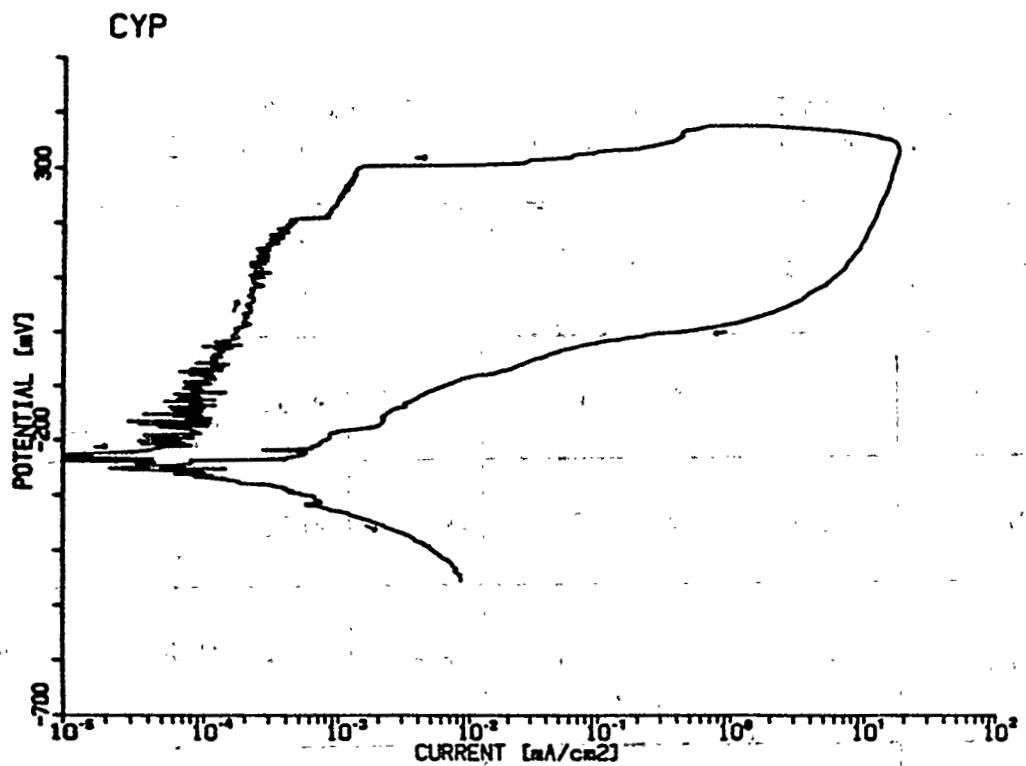
Figure B.1 Polarization Curve For Alloy 304L In 90°C Simulated J-13 Well Water
Containing 1000 ppm Chlorides As NaCl.

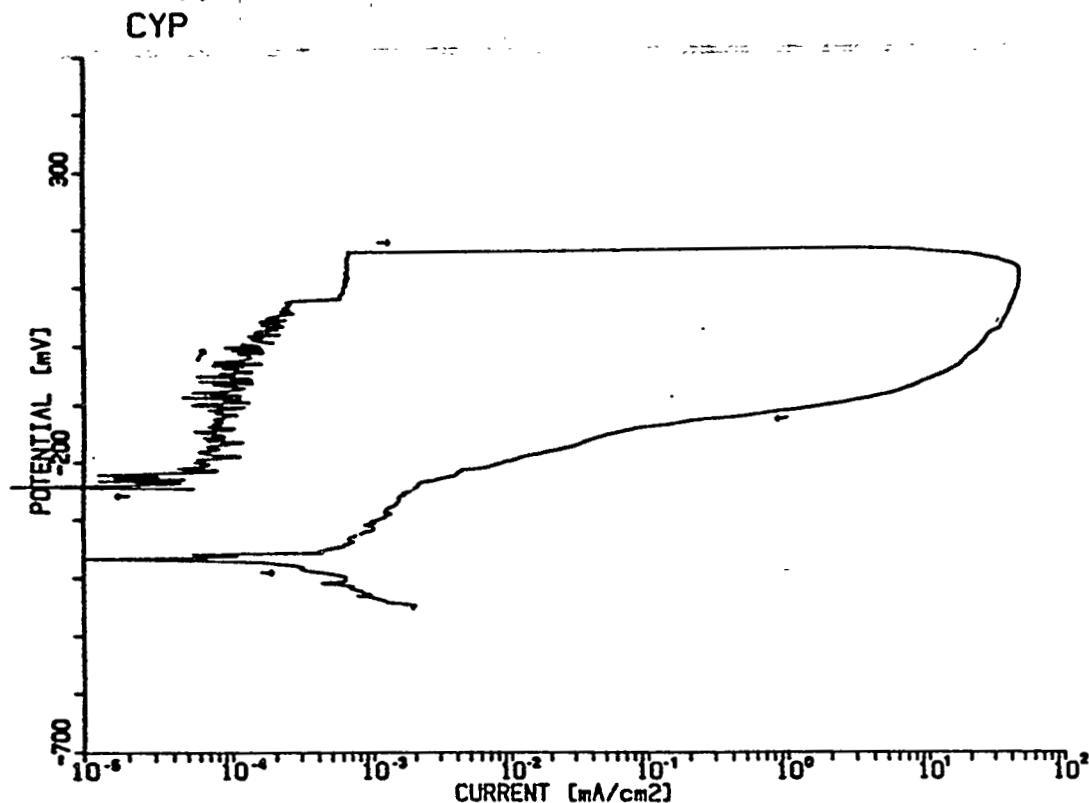
Figure B.2 Polarization Curve For Alloy 304L In 90°C Simulated J-13 Well Water
Containing 10 000 ppm Chlorides As NaCl.

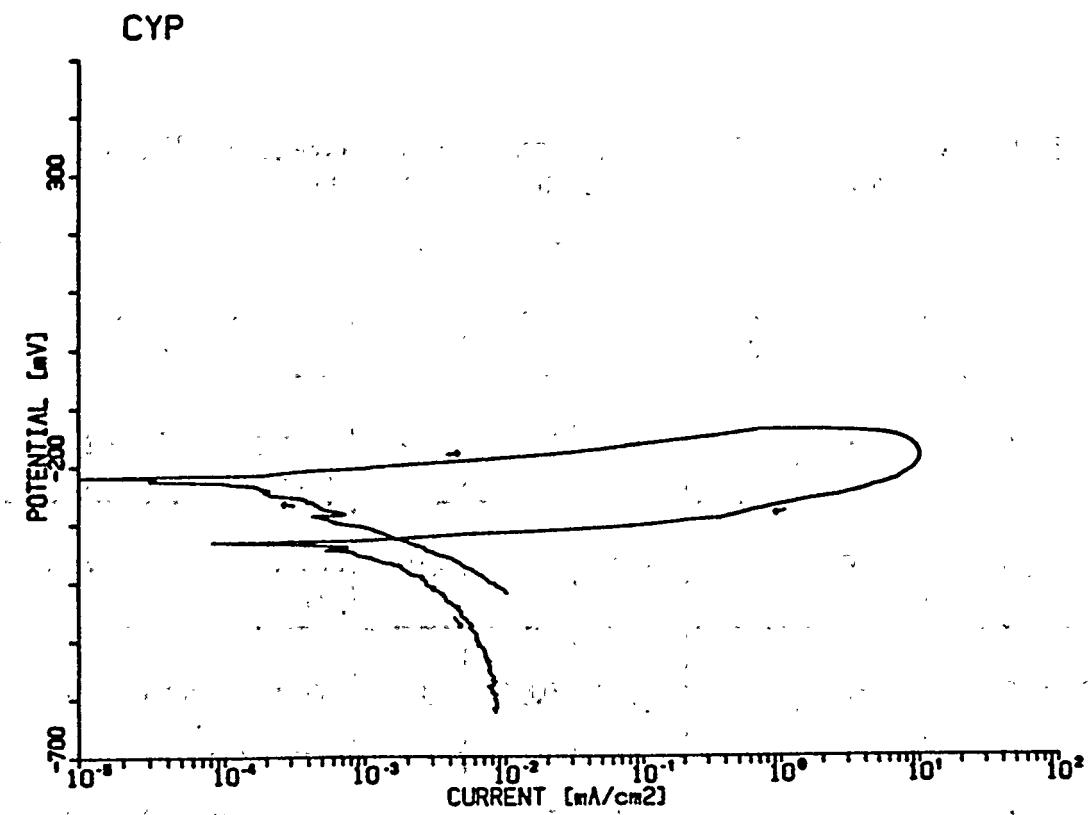
Figure B.3 Polarization Curve For Alloy 304L In 90°C Simulated J-13 Well Water
Containing 100,000 ppm Chlorides As NaCl .

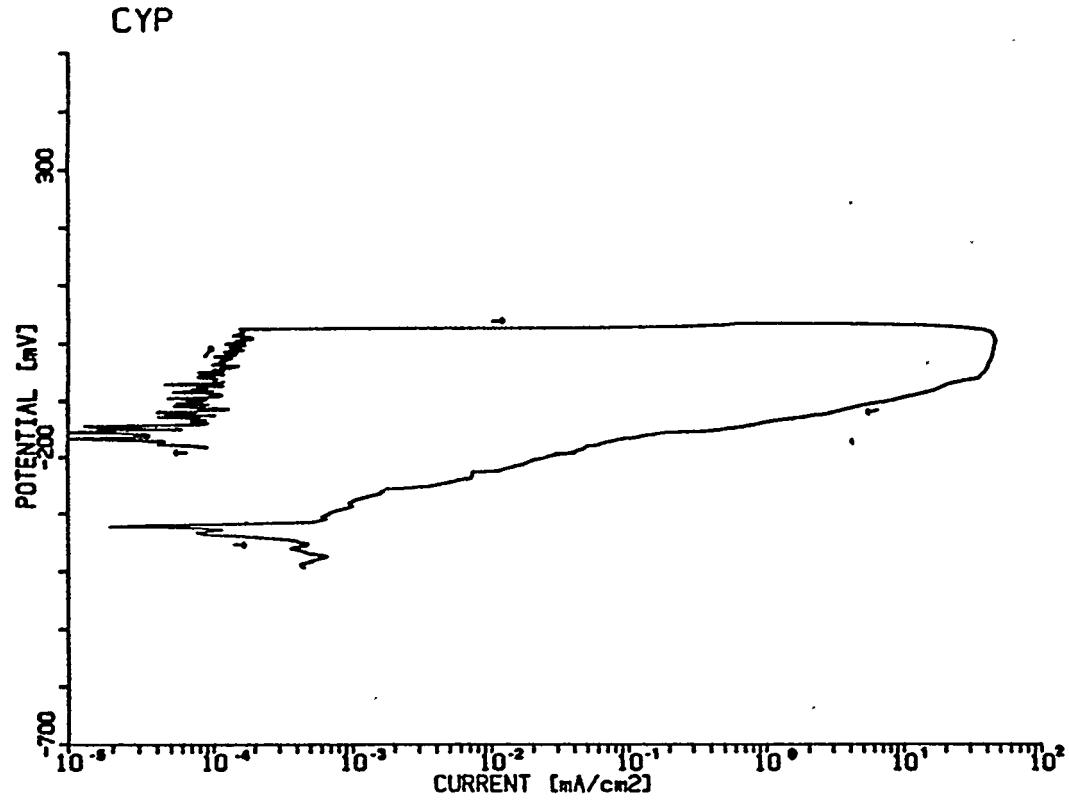
Figure B.4 Polarization Curve For Alloy 304L In 90°C Simulated J-13 Well Water
Containing 10,000 ppm Chlorides As CaCl_2

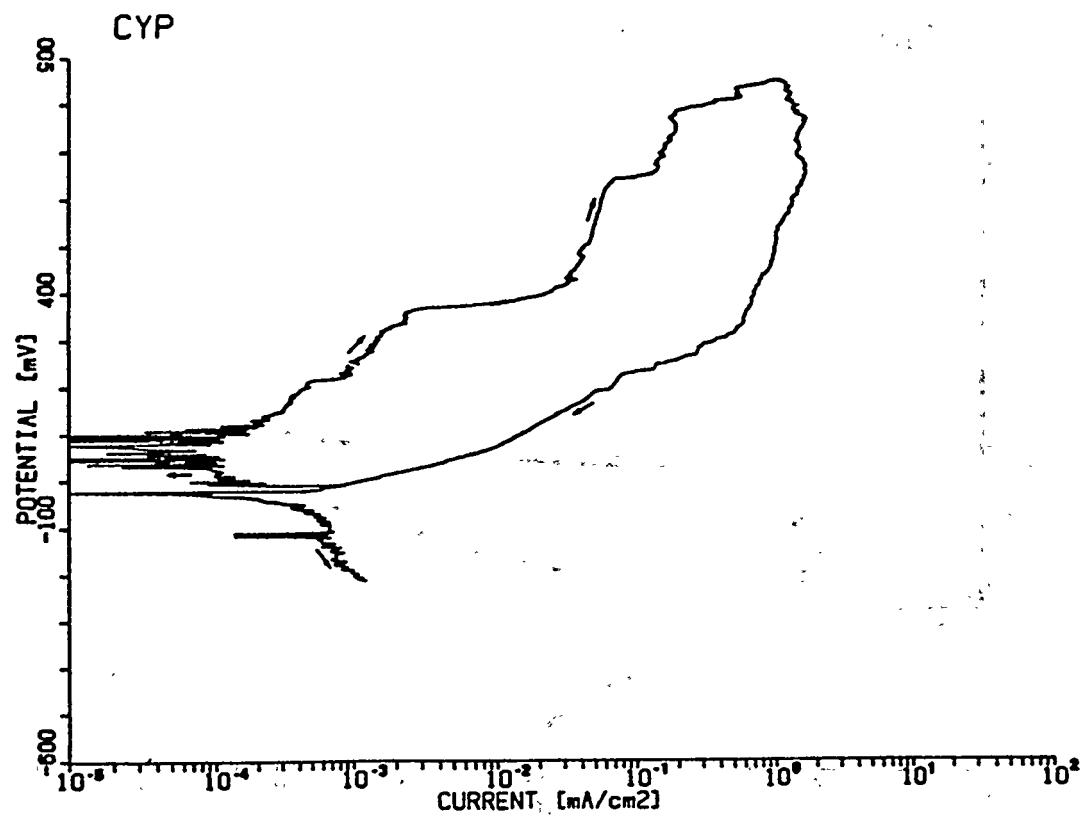
Figure B.5 Polarization Curve For Alloy 825 In 90°C Simulated J-13 Well Water
Containing 1000 ppm Chlorides As NaCl.

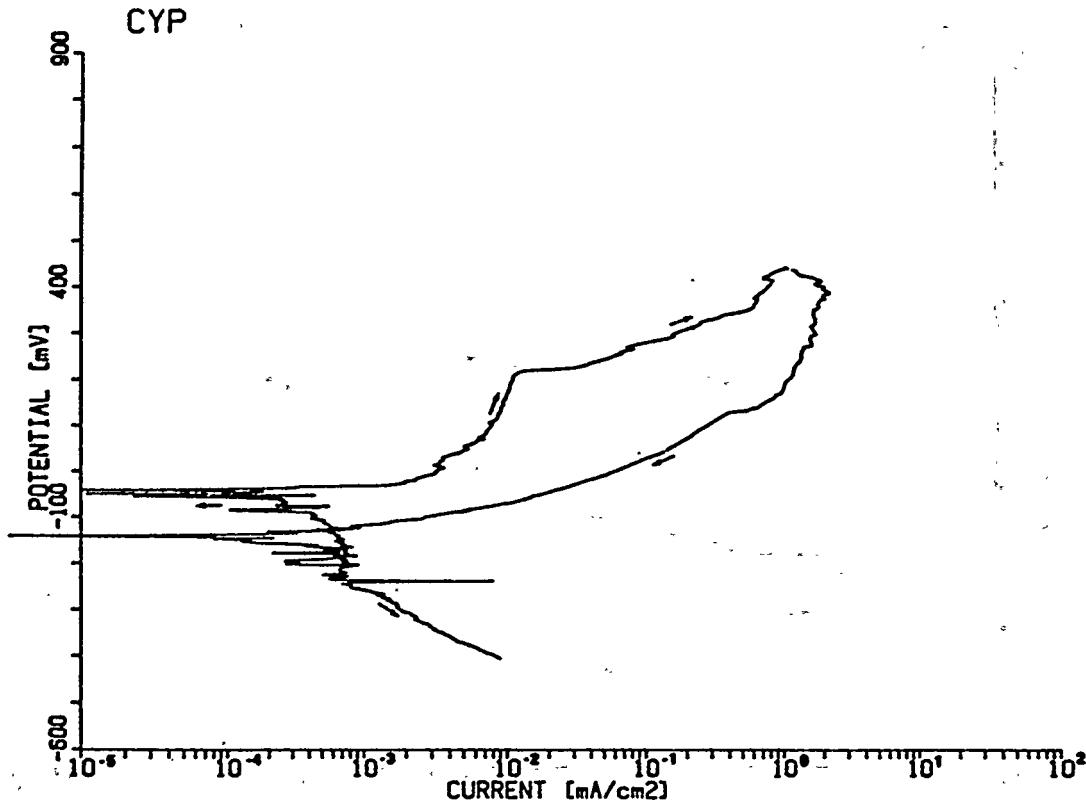
Figure B.6 Polarization Curve For Alloy 825 In 90°C Simulated J-13 Well Water
Containing 10 000 ppm Chlorides As NaCl.

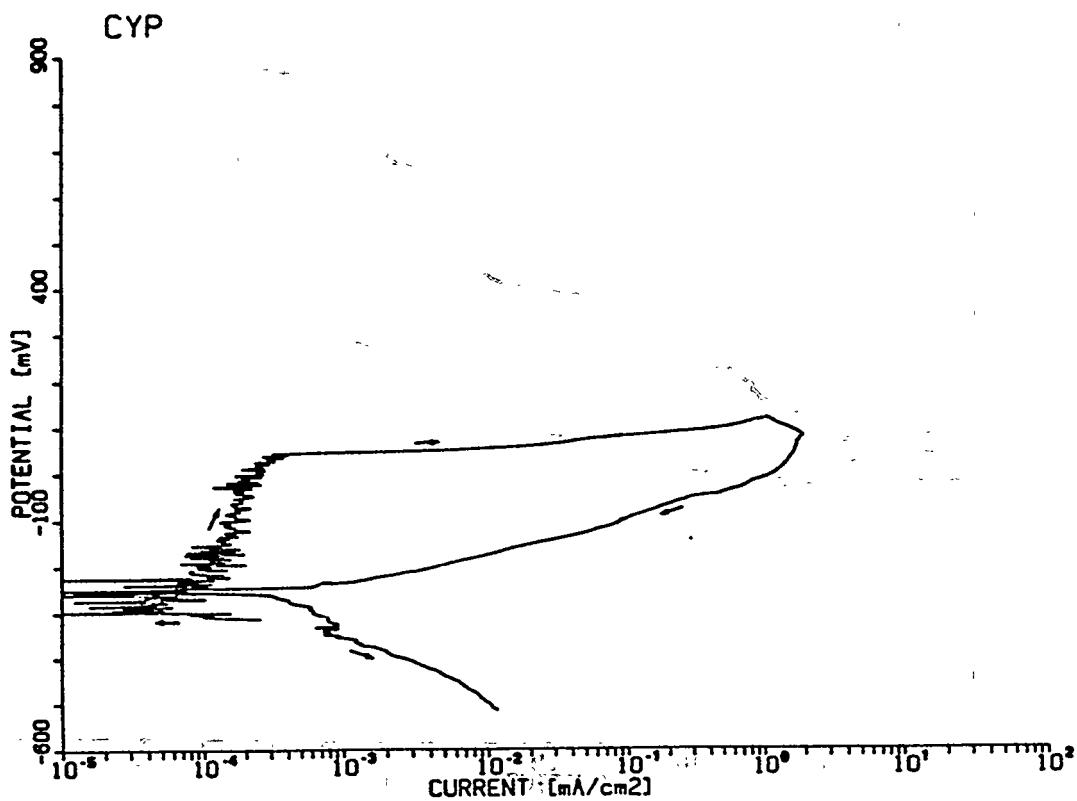
Figure B.7 Polarization Curve For Alloy 825 In 90°C Simulated J-13 Well Water
Containing 100 000 ppm Chlorides As NaCl.

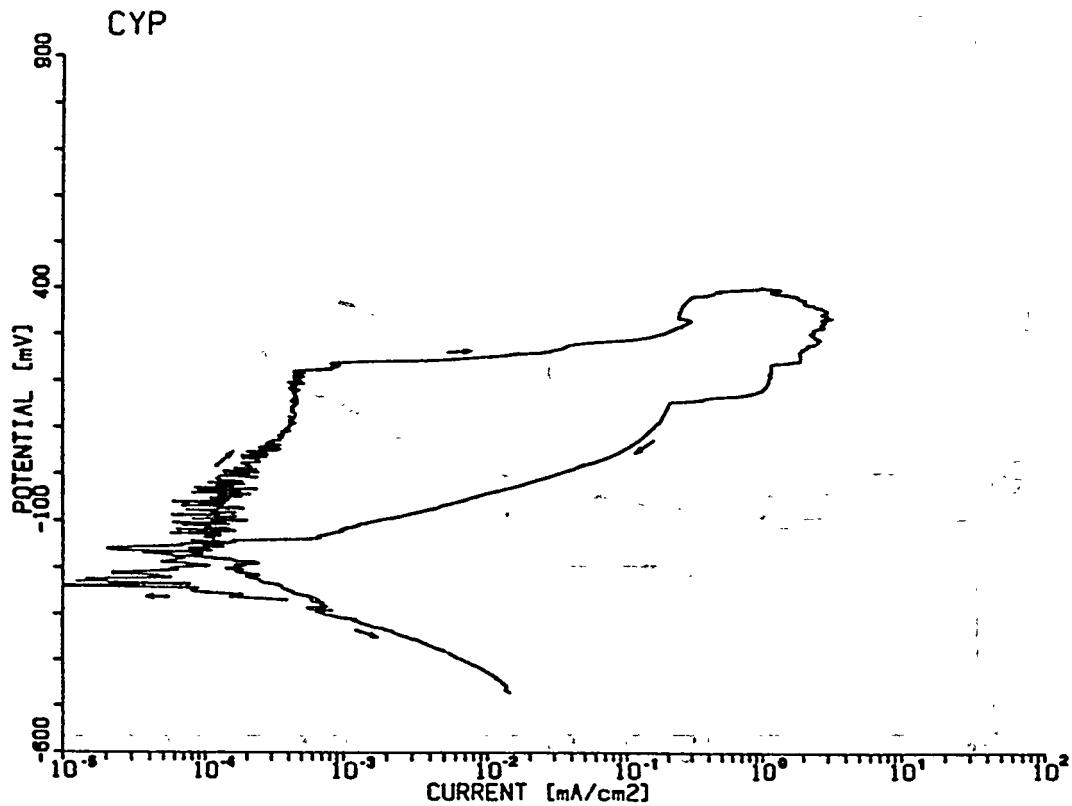
Figure B.8 Polarization Curve For Alloy 825 In 90°C Simulated J-13 Well Water
Containing 10 000 ppm Chlorides As CaCl₂.

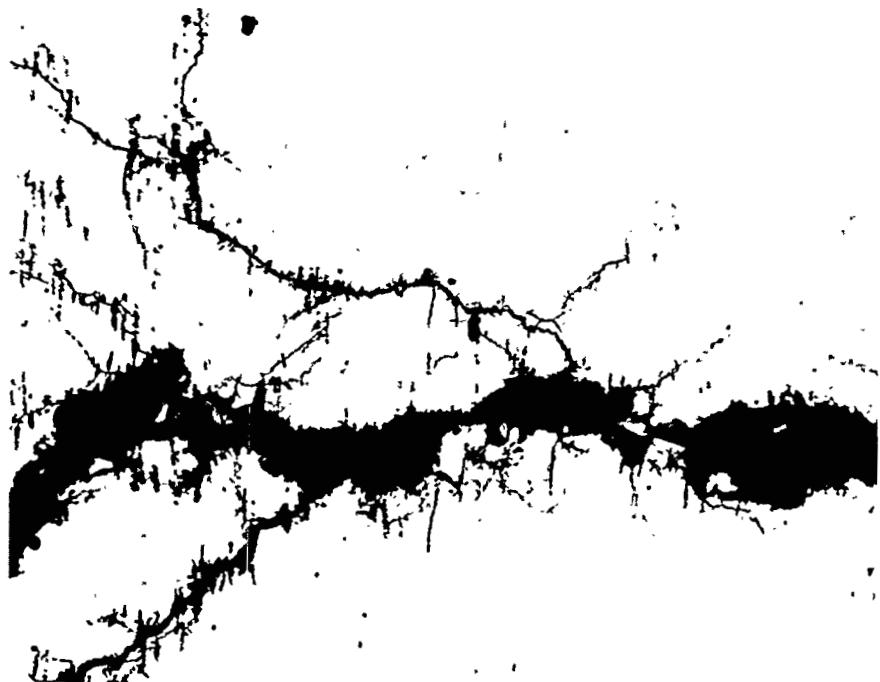
Figure D.1 Photomicrograph Of U-Bend Specimen Of Alloy 304L Following 2855 Hours Of Exposure To Solution No. 20 (With H_2O_2 Additions) At 90°C Showing Transgranular Stress-Corrosion Cracking; 250X Magnification.

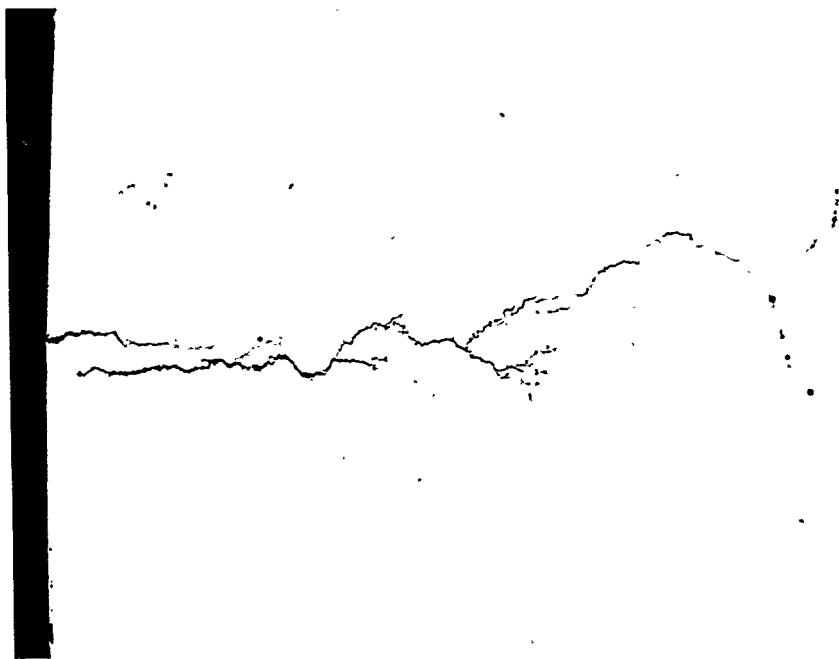
Figure D.3 Photomicrograph Of U-Bend Specimen Of Alloy 304L Exposed In The Vapor Above Simulated J-13 Well Water Containing 1000 ppm Chloride (As NaCl) For 100 Days at 90°C. H₂O₂ Added Daily; 100X Magnification.

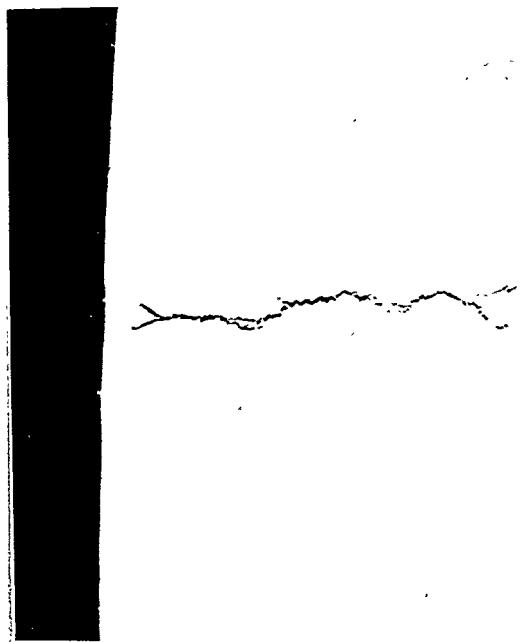
Figure D.4 Photomicrograph Of U-Bend Specimen Of Alloy 304L Exposed In The Vapor Above Simulated J-13 Well Water Containing 10 000 ppm Chloride (As NaCl) For 100 Days at 90°C. H₂O₂ Added Daily; 100X Magnification.

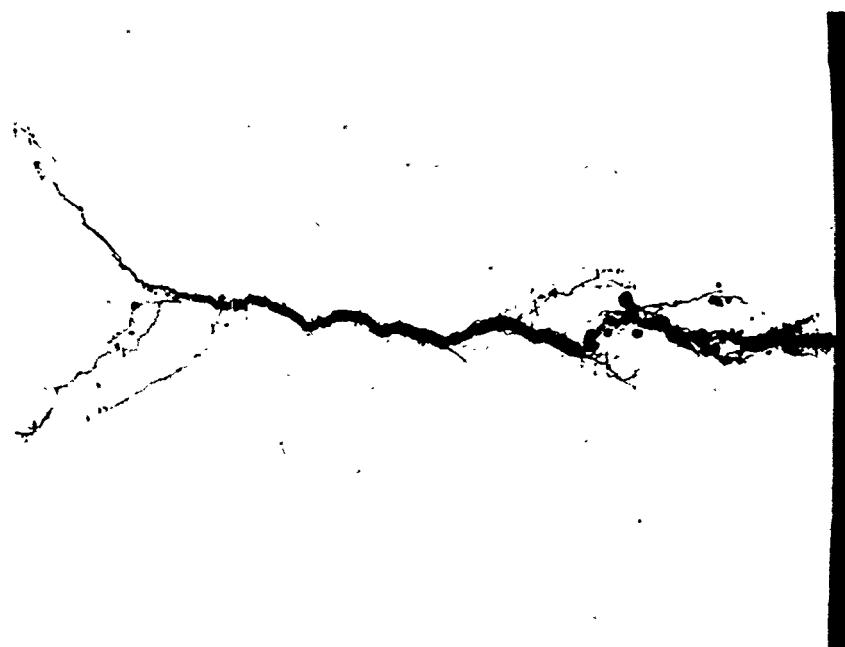
Figure D.5 Photomicrograph Of U-Bend Specimen Of Alloy 304L Exposed In The Vapor Above Simulated J-13 Well Water Containing 10 000 ppm Chloride (As CaCl_2) For 100 Days at 90°C. H_2O_2 Added Daily; 100X Magnification.

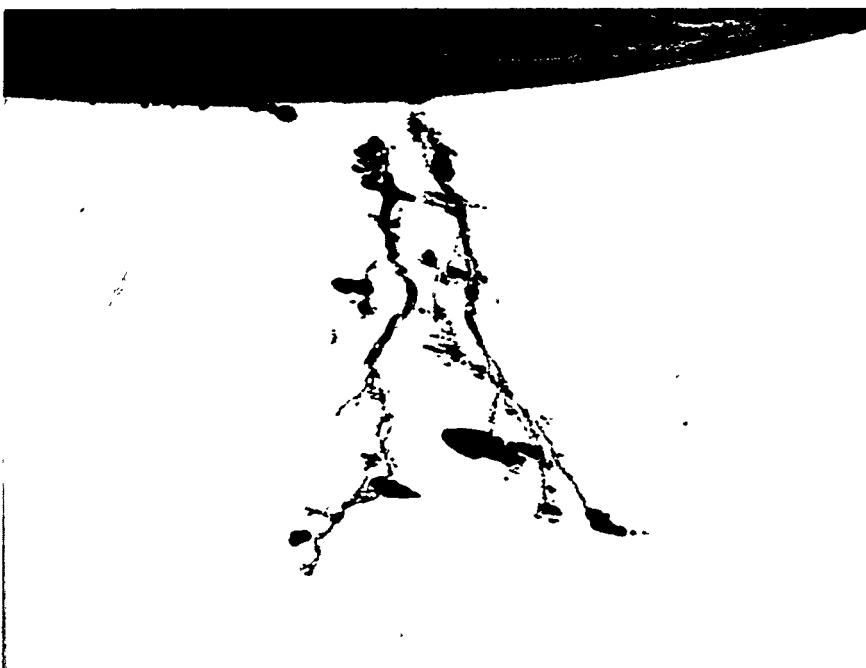
Figure D.7 Photomicrograph Of SSR Specimen Of Alloy 304L Exposed To The Vapor Phase Of Solution Number 20 At 90°C. H₂O₂ Added Daily. Specimen Strained To Failure At 1×10^{-7} sec⁻¹; 50X Magnification (Test No. 34).

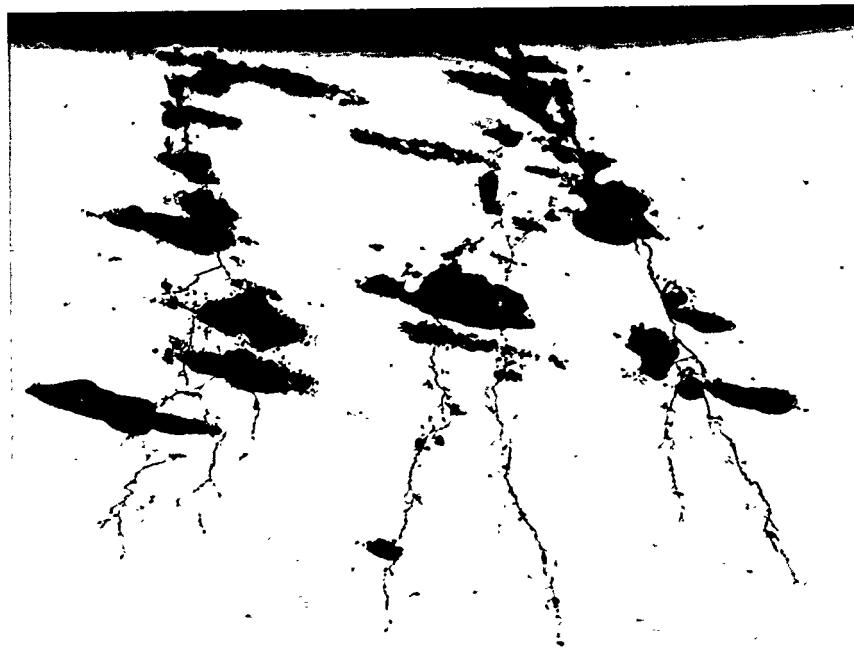
Figure D.10 Photomicrograph Of SSR Specimen Of Alloy 304L Exposed To The Vapor Phase Of 90°C Simulated J-13 Well Water Containing 10 000 ppm Chloride As NaCl. H₂O₂ Added Daily. Specimen Strained To Failure At 1 x 10⁻⁶ sec⁻¹; 100X Magnification (Test No. 39).

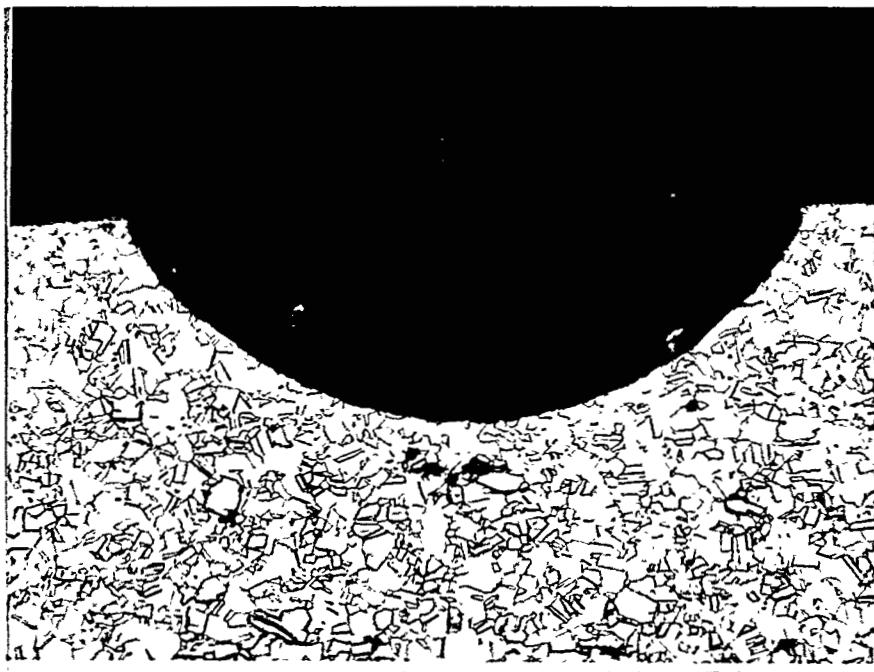
Figure E.1 Photomicrograph Of U-Bend Specimen Of Alloy 825 Exposed In The Vapor Above Simulated J-13 Well Water Containing 10 000 ppm Chloride (As CaCl_2) For 103 Days at 90°C. H_2O_2 Added Daily.

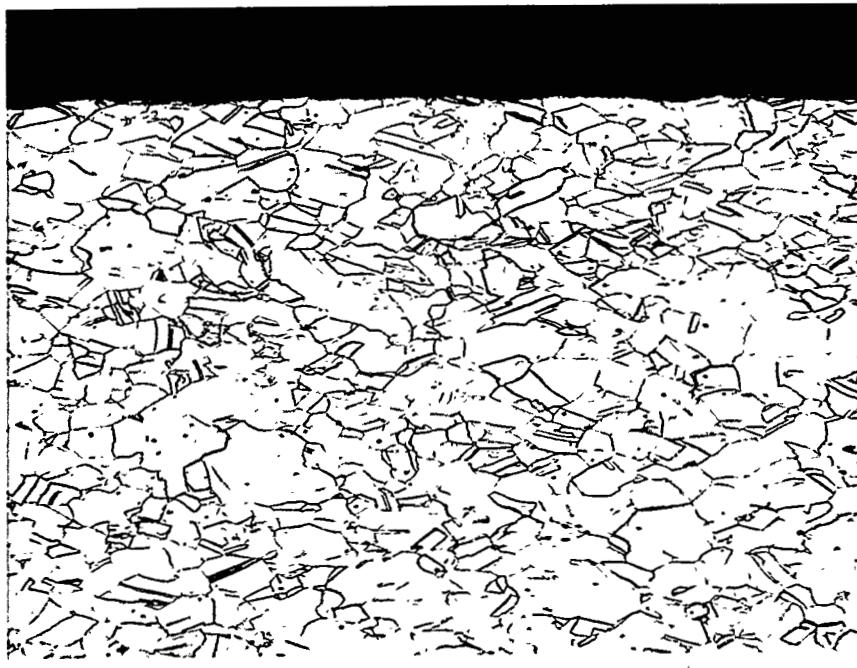
Figure E.2 Photomicrograph Of The Reduced Gage Section Of A Specimen Of Alloy 825 Exposed To The Vapor Phase Of Simulated J-13 Water Containing 100 000 ppm Chloride As Sodium Chloride. Specimen Strained To Failure At $1 \times 10^{-6} \text{ sec}^{-1}$; 100X Magnification (Test No. 50).

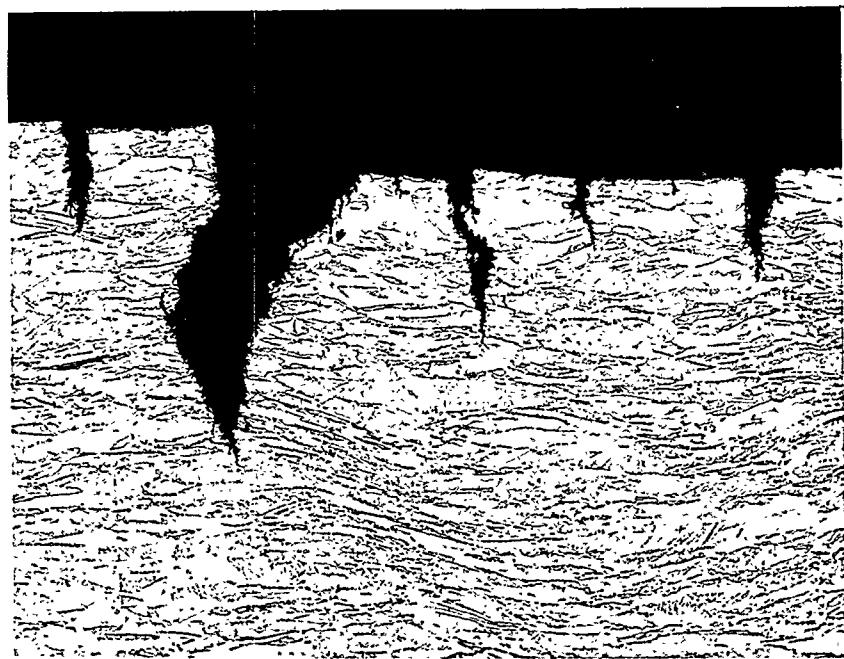
Figure F.3 Photomicrograph Of SSR Specimen Of Alloy CDA 102 Exposed To 0.005M NaNO_2 At 23°C And Polarized To +0.200 Volts (SCE). Specimen Strained To Failure At $1 \times 10^{-6} \text{ sec}^{-1}$; 100X Magnification (Test No. 19).

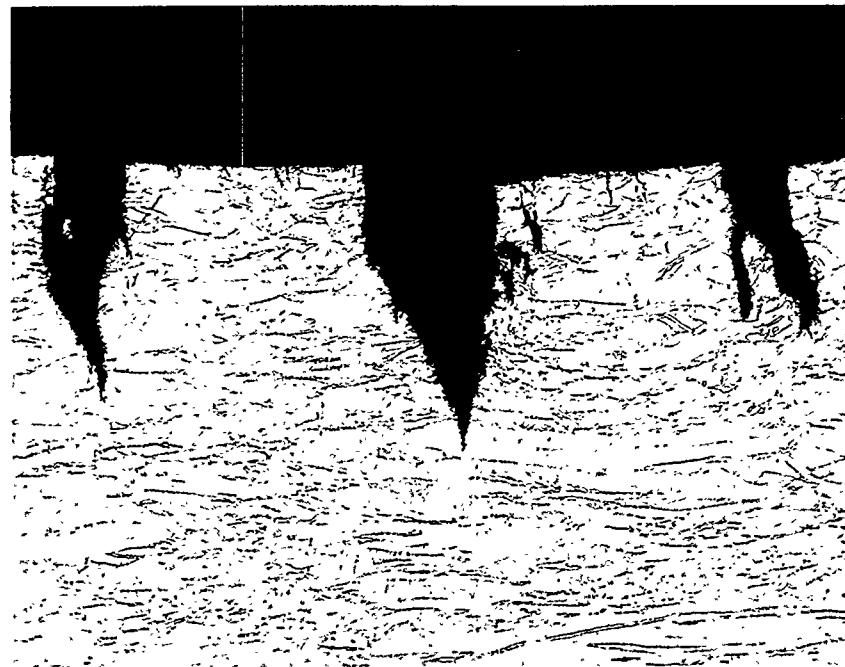
Figure F.4 Photomicrograph Of SSR Specimen Of Alloy CDA 102 Exposed To 0.005M NaNO_2 At 23°C And Polarized To 0.174 Volts (SCE). Specimen Strained To Failure At $1 \times 10^{-6} \text{ sec}^{-1}$; 100X Magnification (Test No. 20).

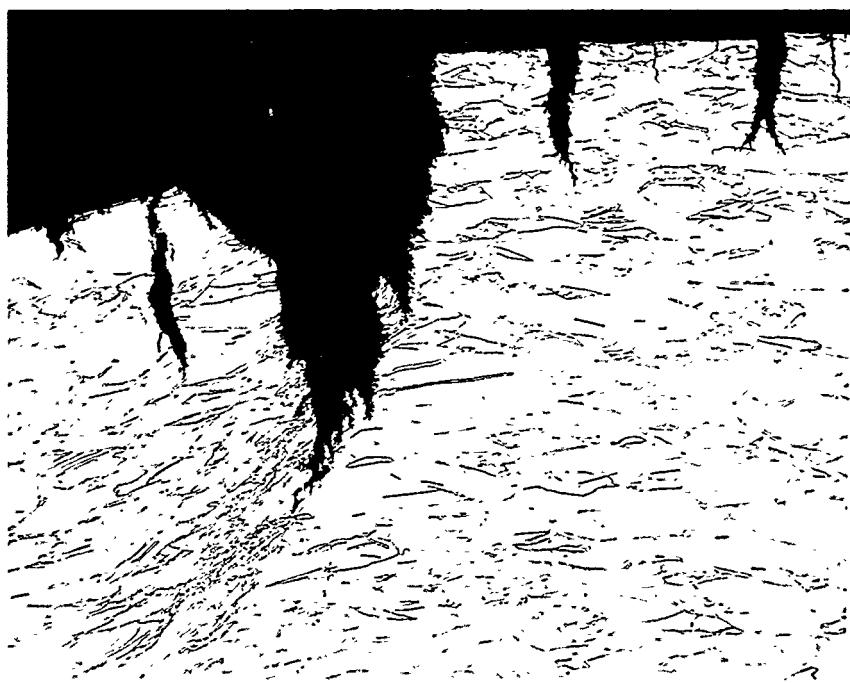
Figure F.5 Photomicrograph Of SSR Specimen Of Alloy CDA 102 Exposed To 1M NaNO_2 At 23°C And Polarized To +0.061 Volts (SCE). Specimen Strained To Failure At $1 \times 10^{-6} \text{ sec}^{-1}$; 100X Magnification (Test No. 17).

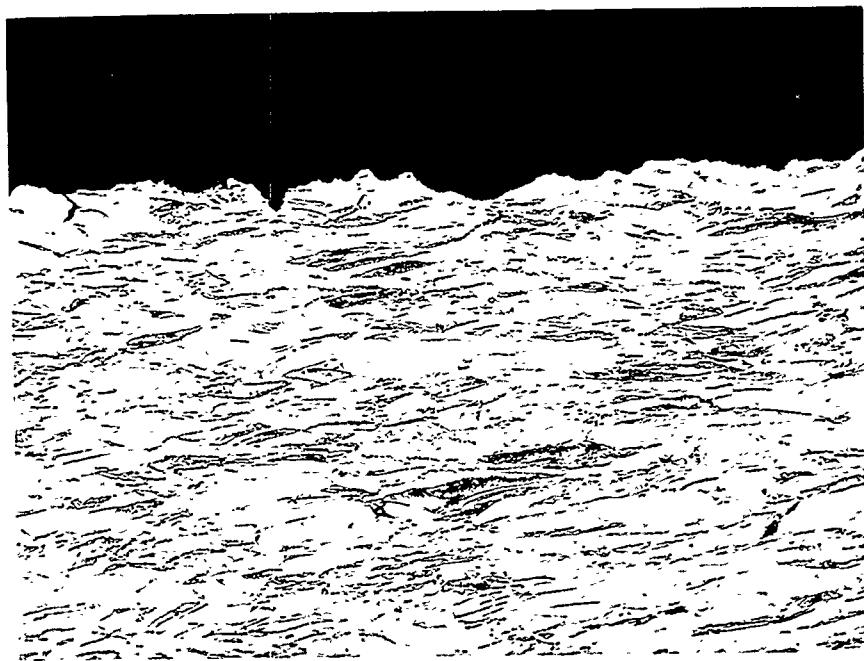
Figure F.7 Photomicrograph Of SSR Specimen Of Alloy CDA 102 Exposed To 0.005M NaNO_2 At 90°C And Polarized To +0.234 Volts (SCE). Specimen Strained To Failure At $1 \times 10^{-6} \text{ sec}^{-1}$; 100X Magnification (Test No. 29).

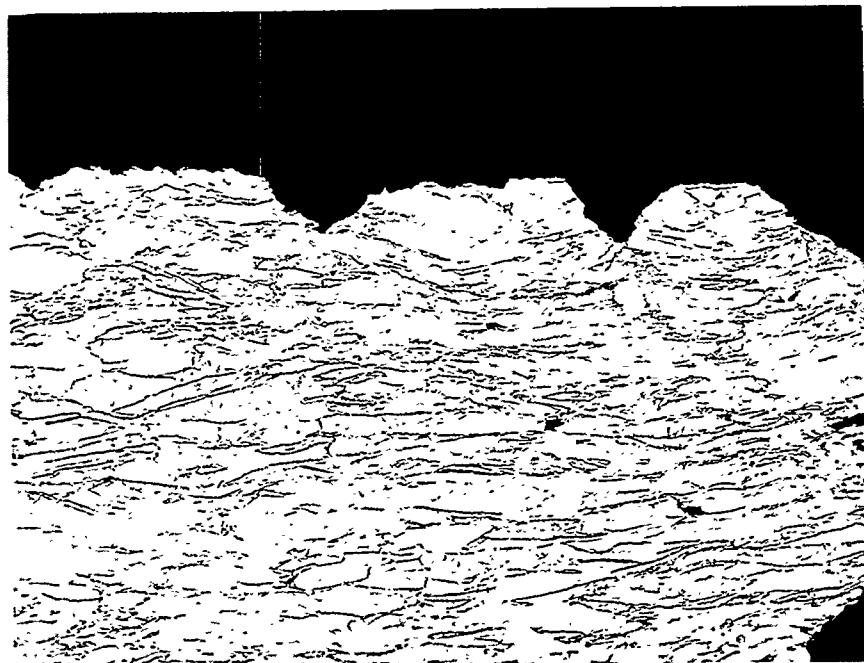
Figure F.8 Photomicrograph Of SSR Specimen Of Alloy CDA 102 Exposed To 0.005M NaNO_2 At 90°C And Polarized To +0.246 Volts (SCE). Specimen Strained To Failure At $1 \times 10^{-6} \text{ sec}^{-1}$; 100X Magnification (Test No. 31).

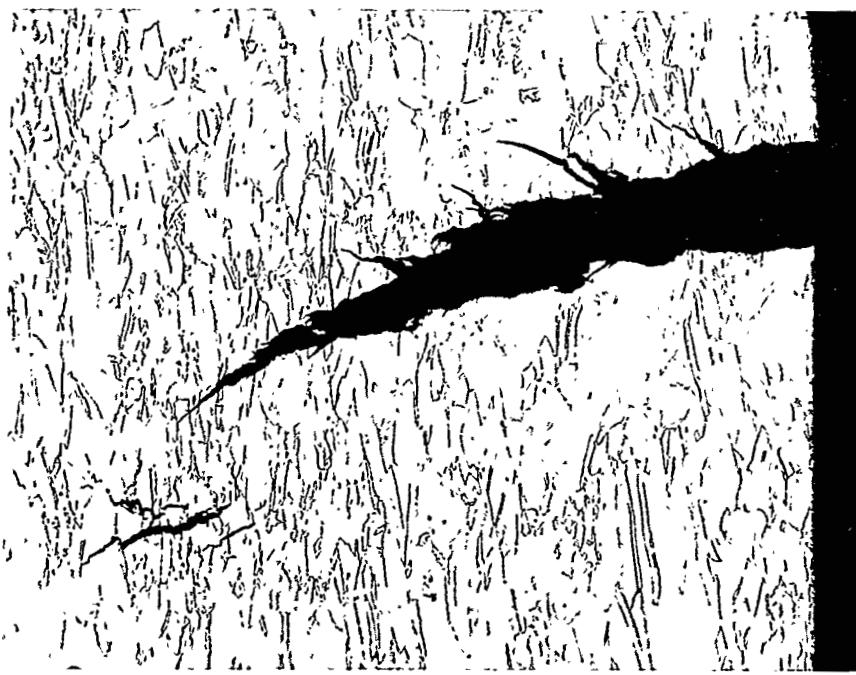
Figure F.9 Photomicrograph Of SSR Specimen Of Alloy CDA 102 Exposed To 1M NaNO₂ At 90°C And Polarized To +0.122 Volts (SCE). Specimen Strained To Failure At 1 X 10⁻⁶ sec⁻¹; 100X Magnification (Test No. 23).

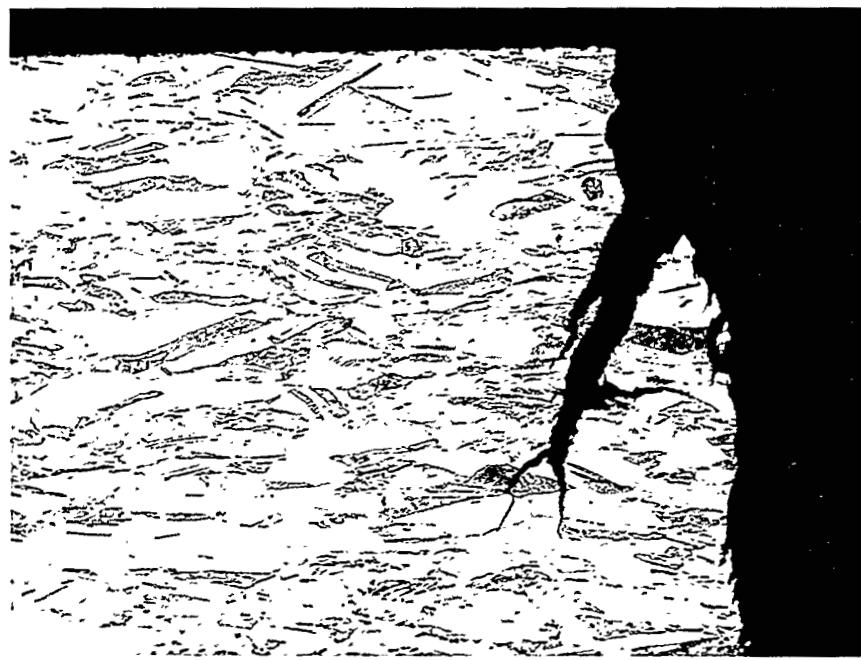
Figure F.10 Photomicrograph Of SSR Specimen Of Alloy CDA 102 Exposed To 1M NaNO₂ At 90°C And Polarized To +0.021 Volts (SCE). Specimen Strained To Failure At 1 X 10⁻⁶ sec⁻¹; 100X Magnification (Test No. 24).

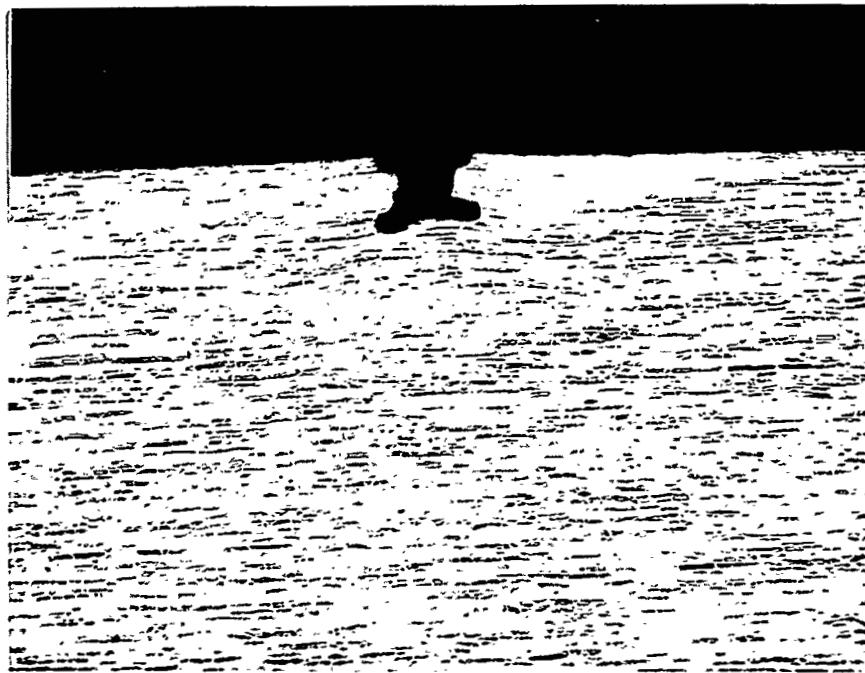
Figure G.1 Photomicrograph Of SSR Specimen Of Alloy CDA 715 Exposed To 1M NaNO₂ At 23°C And Polarized To +0.033 Volts (SCE). Specimen Strained To Failure At 1 X 10⁻⁶ sec⁻¹; 250X Magnification (Test No. 28).

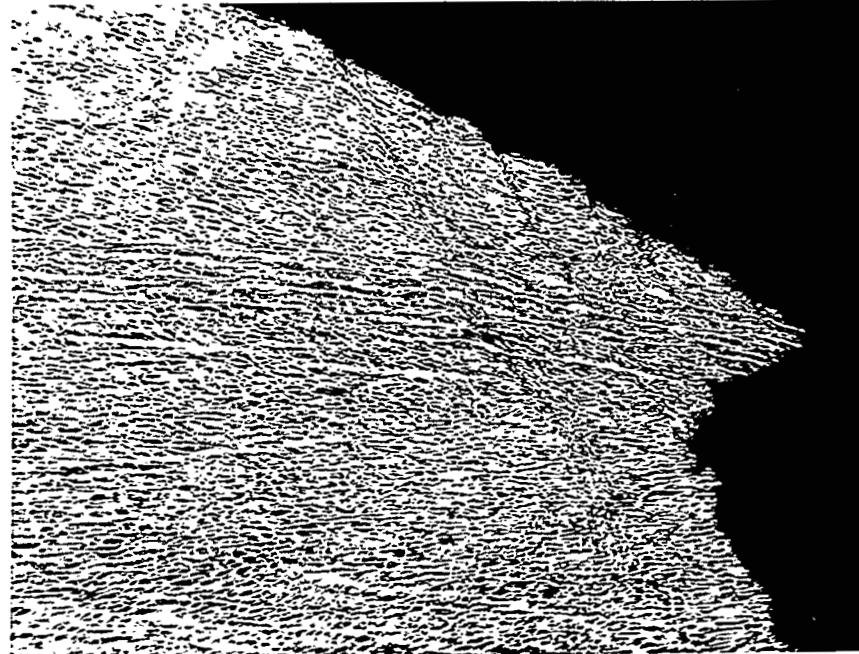
Figure G.2 Photomicrograph Of SSR Specimen Of Alloy CDA 715 Exposed To 1M NaNO₂ At 23°C And Polarized To +0.127 Volts (SCE). Specimen Strained To Failure At 1 X 10⁻⁶ sec⁻¹; 100X Magnification (Test No. 30).
