STABILITY OF ELASTOMERS SUBJECTED TO GEOTHERMAL WELL-LIKE CONDITIONS

SAND2014-16488D

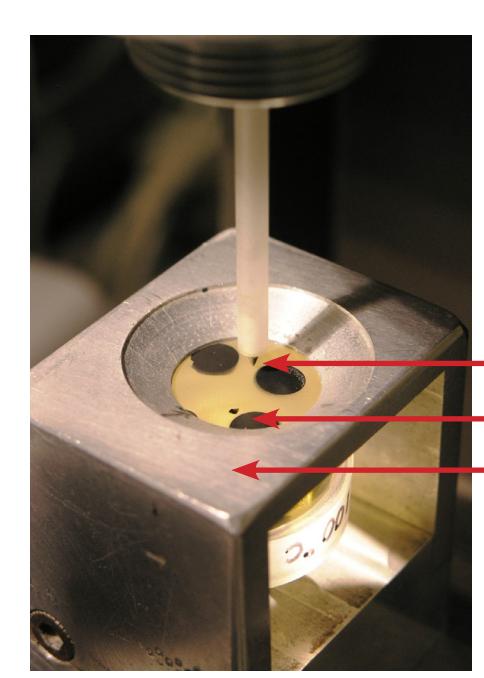
Figure 1. Close-up view of modulus profiler set-up.

Modulus profiles were taken using a home-built instrument. The machine operates by scanning the surface with a parabolic tip at user-defined intervals (0.2 mm) and using displacement from a known force applied to each point on sample to calculate modulus. Samples are cross-sectioned and embedded in epoxy prior to running the experiment.

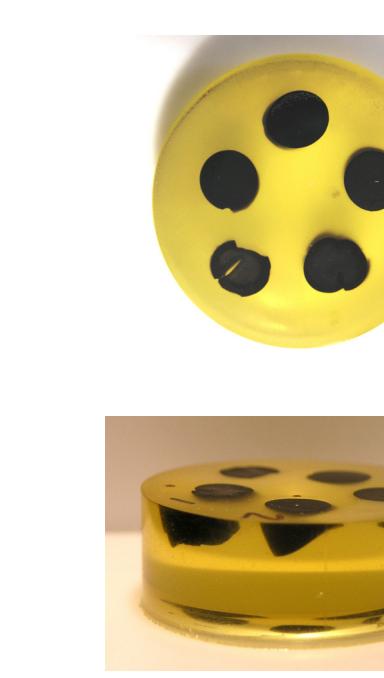
Figure 2. Top: cross-sectioned o-rings embedded in epoxy.
