**Proceedings of the 19th International Symposium on the
Packaging and Transportation of Radioactive Materials
PATRAM 2019**
August 4-9, 2019, New Orleans, LA, USA

**Shock Environments for the Nuclear Fuel Transportation System (Transportation
Platform, Cask, Basket, and Surrogate Assemblies) during Heavy-Haul Transport and
Handling**

Paper # 1282

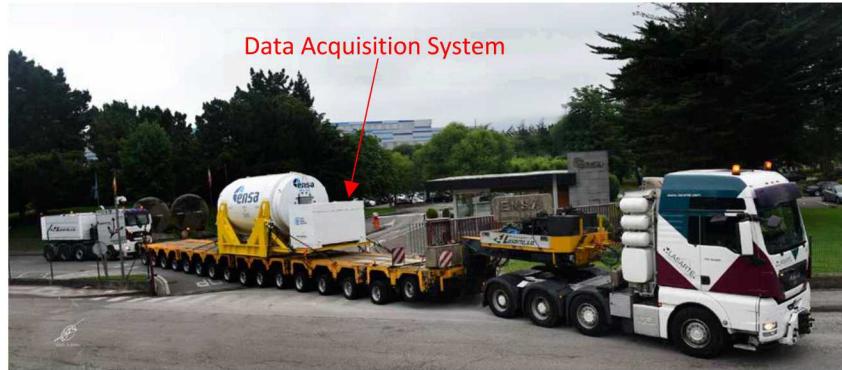
Figure 5. ENUN 32P cask on the trailer used in heavy-haul transport. Google Earth Pro was used to analyze and compare the collected GPS and acceleration and strain data. Latitude and longitude data were collected at 200 Hz. Data were filtered to contain GPS location every 5 seconds and imported into Google Earth. Figure 66 shows the route taken by the heavy-haul truck through Spain, with icons representing places where the truck stopped. GPS data were also used to calculate the train speed with the Google Earth Ruler tool.

The trailer used in testing is pictured in Figure 65 and may vary from trailers used in heavy-haul transport in the US. Like railcars used in the US, most heavy-haul trailers have span bolsters that better divide the wheel reactions to the overall vertical load. The trailer shown below does not have span bolsters, and therefore most likely experienced lower vertical loads on the first few and last few trailer axles.

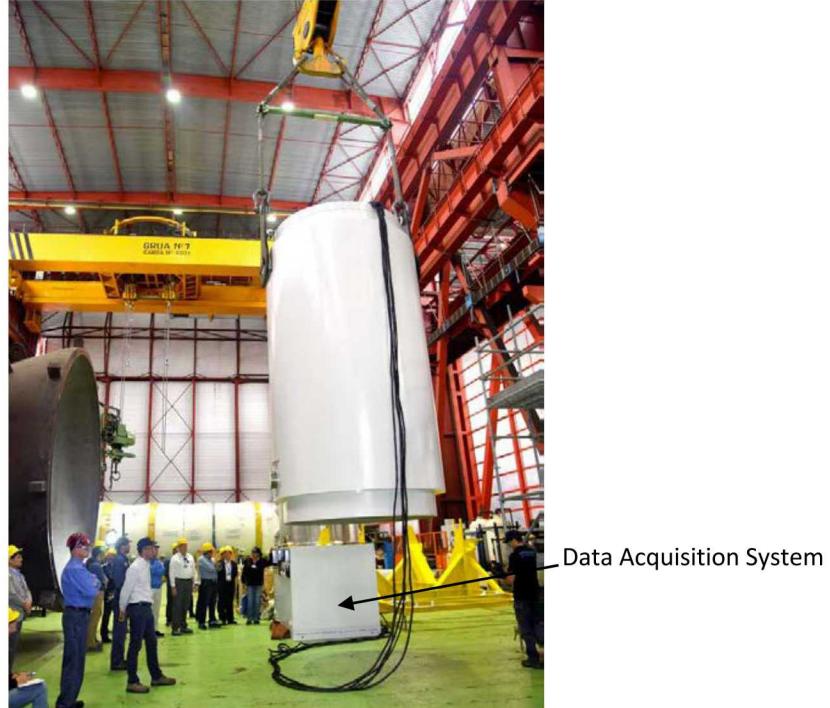
Figure 7. Dry storage cask handling test.

Dry storage cask handling tests and heavy-haul handling tests were conducted to understand the fuel rod environment during handling. To obtain a useful representation of cask handling, a range of cask impacts was performed. The Dry Storage Cask Handling Test involved three ENSA crane operators raising and lowering the cask three times, where varying degrees of crane

handling “aggressiveness” were used by each operator for their three respective tests. Figure 7 shows an operator (right) performing one of the dry storage handling simulation tests.

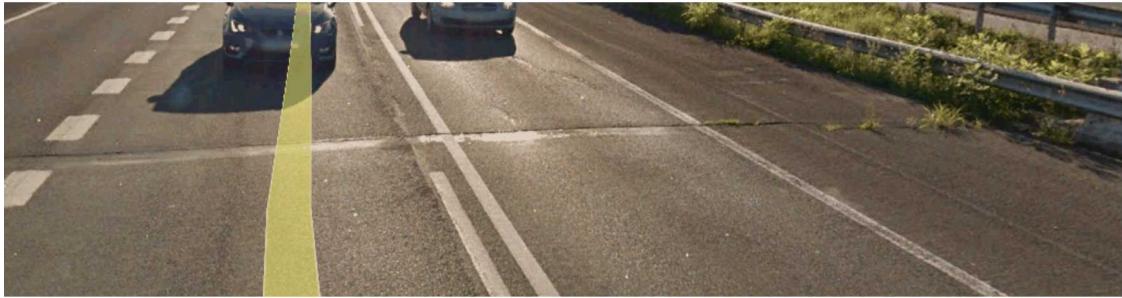
Figure 9. Location of the heavy-haul transport maximum SNL assembly acceleration and strain event.

The highest platform acceleration recorded during heavy-haul transport occurred at 7,890 seconds in the third hour of transport. The maximum acceleration was 4.53 g in accelerometer A19Z located on the back end of the transportation platform, putting this event in the 97th percentile. The maximum SNL assembly acceleration was 0.42 g in accelerometer A5Z (assembly back end). The maximum strain reached during this event was 15.9 μE , making this shock event the cause of both the highest recorded assembly acceleration and highest recorded assembly strain during the heavy-haul transport. This event occurred while the truck was traveling 24 mph and was caused by the bridge abutment shown in Figure 9.
