## Making the Case: Demonstrating the Integrity of PWR Spent Nuclear Fuel During Long-term Storage and Subsequent Transportation

Ned Larson      DOE Office of Nuclear Energy  
Sylvia Saltzstein      Sandia National Laboratories  
Brady Hanson      Pacific Northwest National Laboratory

## EPRI ESCP Fall Workshop

November 5, 2019

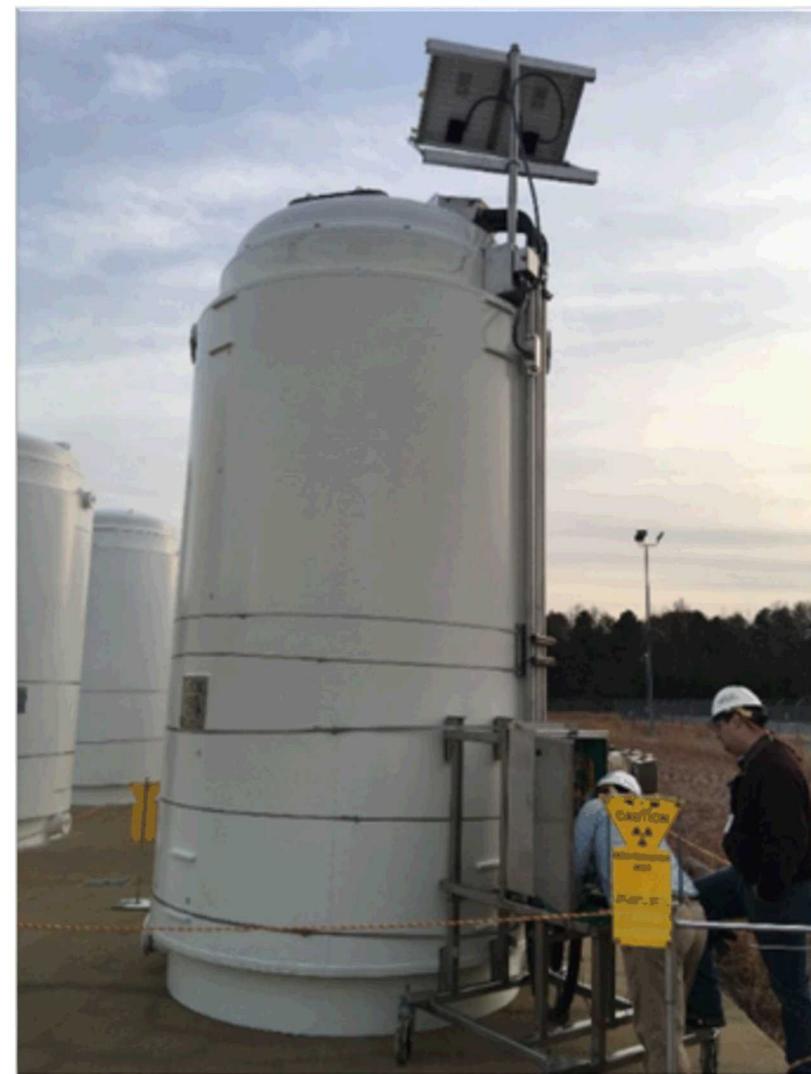
The Research Project Cask stored at North Anna with a solar panel to power the internal thermocouple data acquisition system.

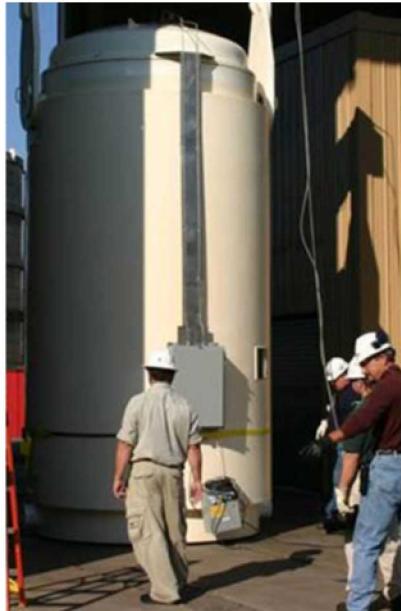
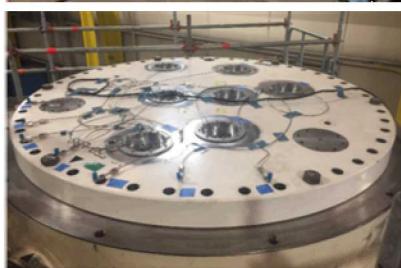
- Steady state PCTs from all models and measurements significantly lower than the design licensing basis:

Parameter	FSAR	LAR	Best-Estimate	HBU Cask Measurements
PCT (model vs data)	348°C	318°C	254-288°C	229°C
Heat Loadouts	36.96kW	32.934kW	30.456kW	30.456kW
Ambient Temperature	100°F	93.5°F	75°F	75°F
Design Specifics	Gaps	Gaps	Gaps	No Gaps?

The aluminum basket expands and closes the gaps, but we don't know by how much.

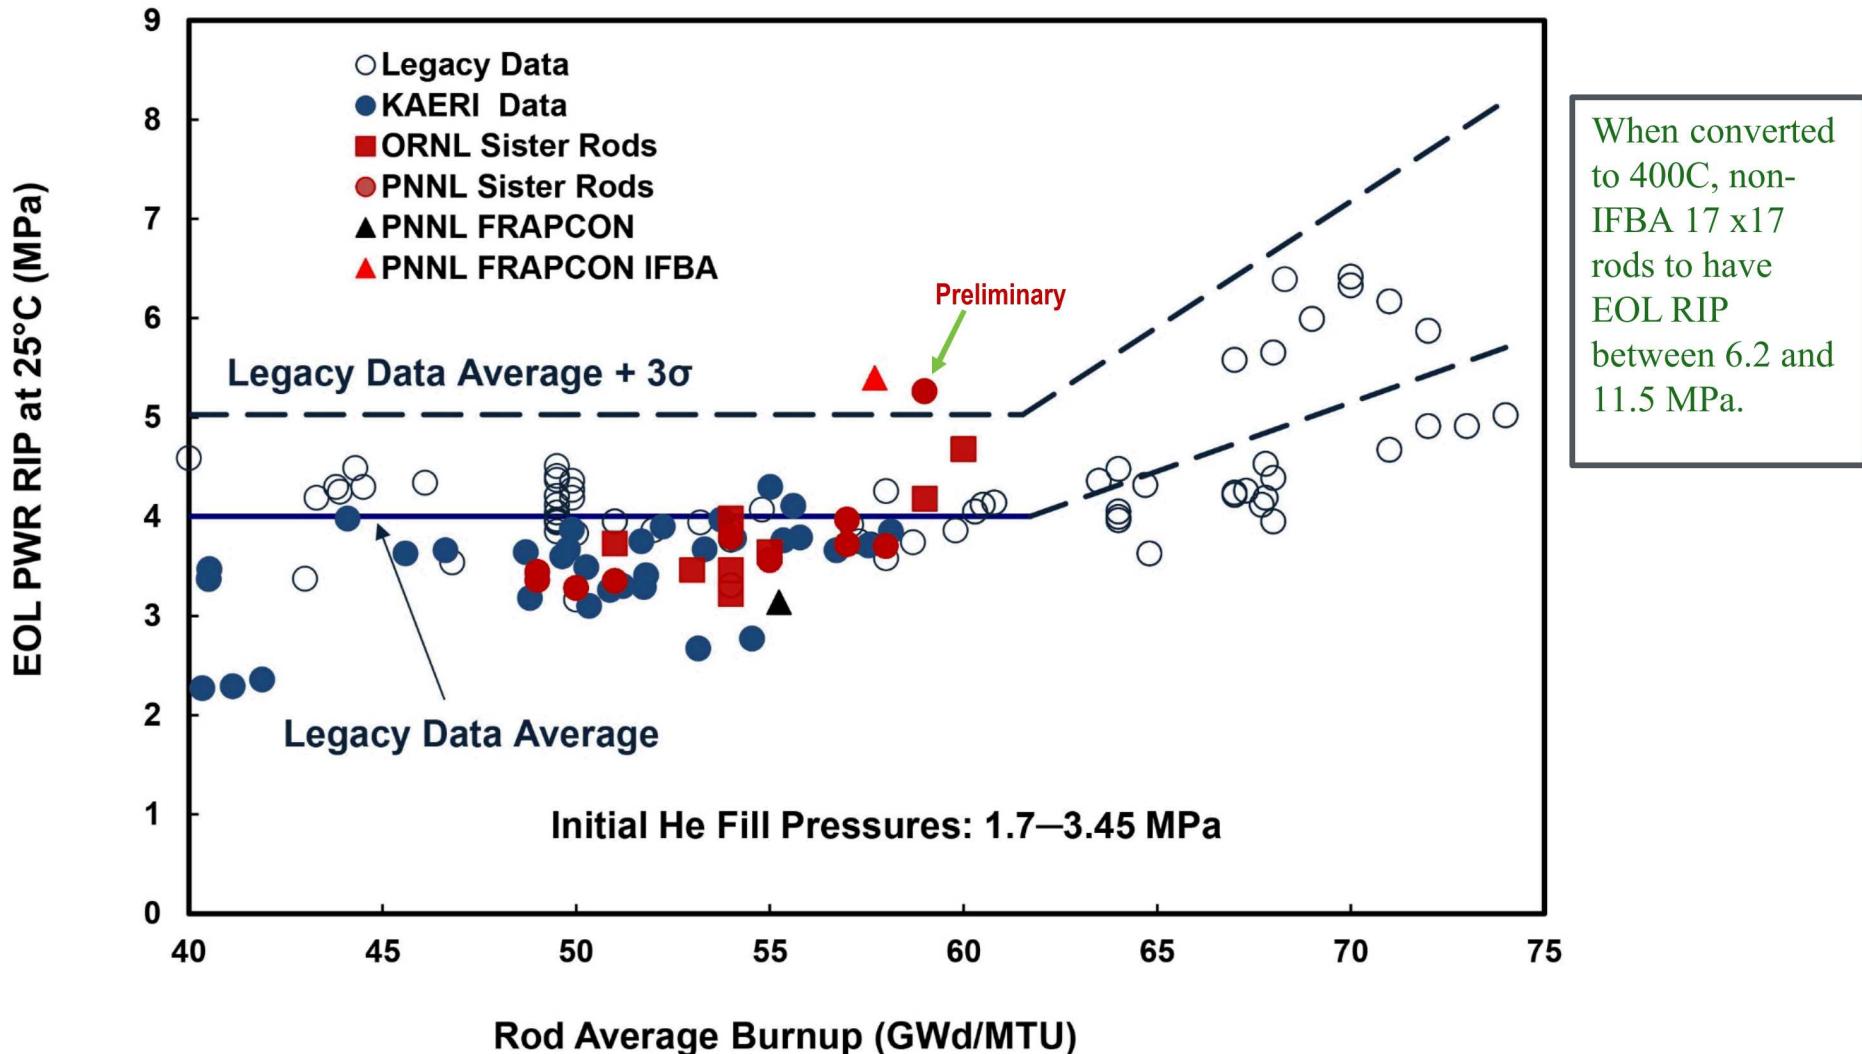
When Temperature is Lower, Rod Internal Pressure is Lower (< 5 MPa at 25° C)

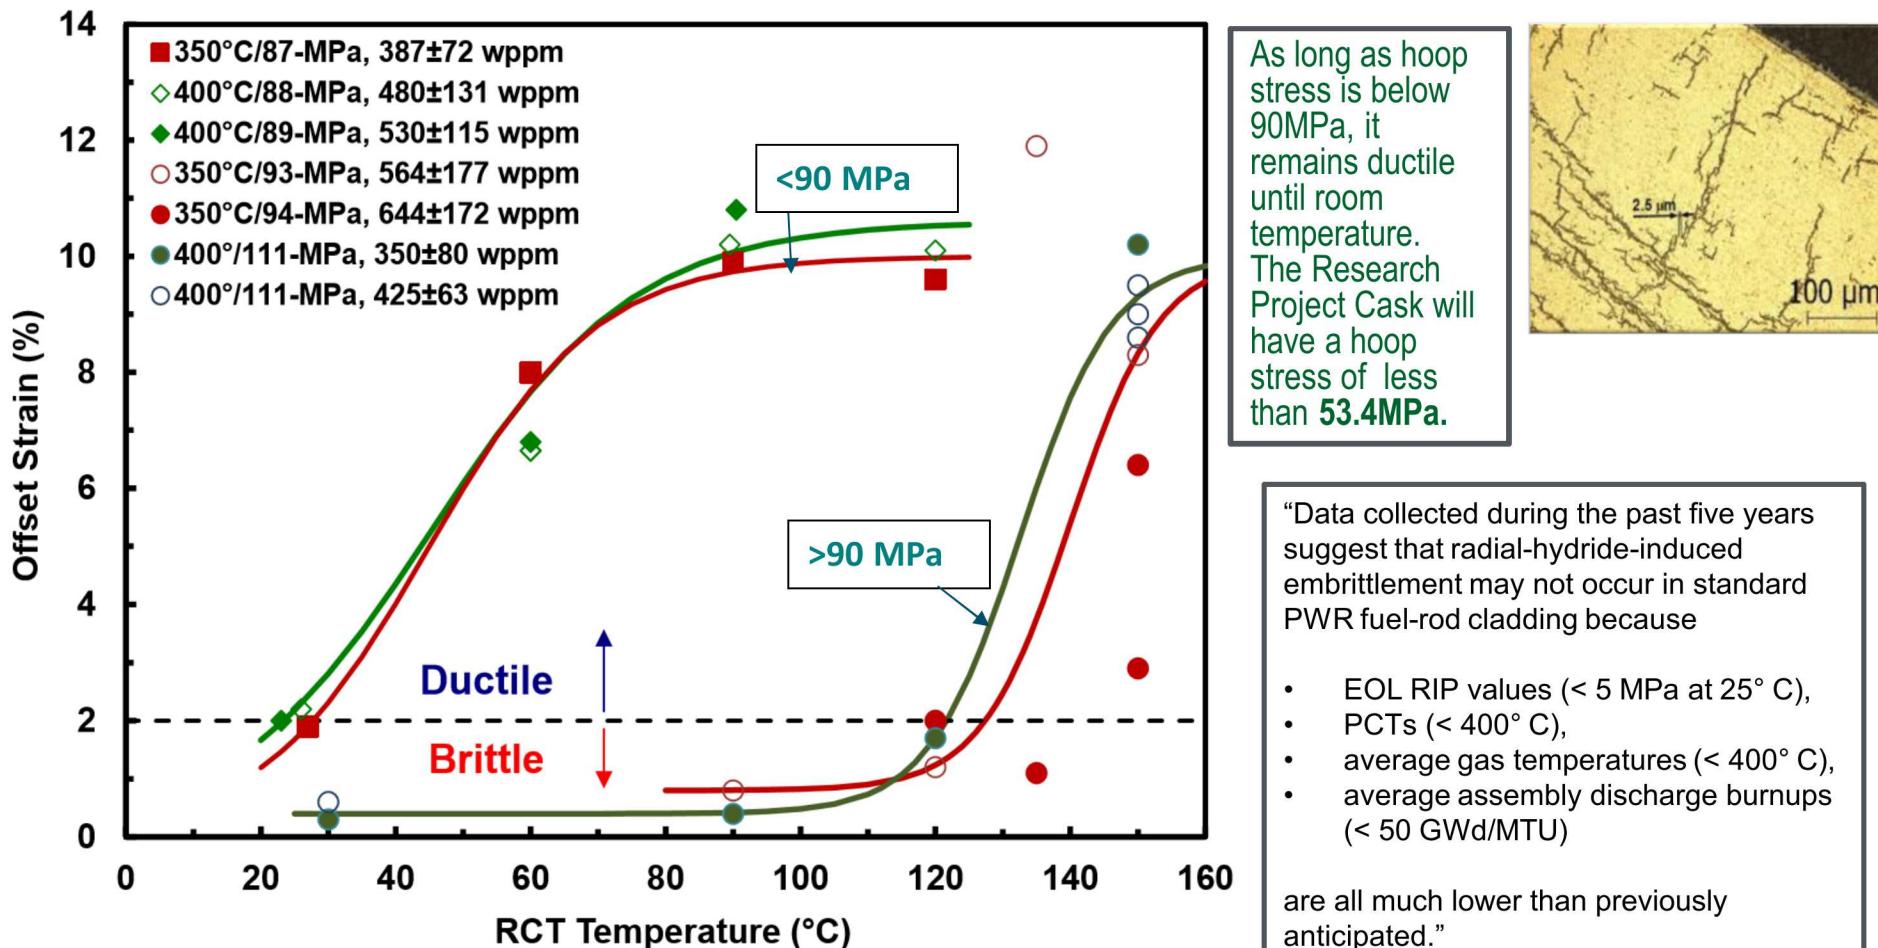
## Ductile-Brittle Transition Temperature using Ring Compression Tests (RCT)

Apparent threshold for reduced ductility with radial hydride treatment at >90MPa Hoop Stress.

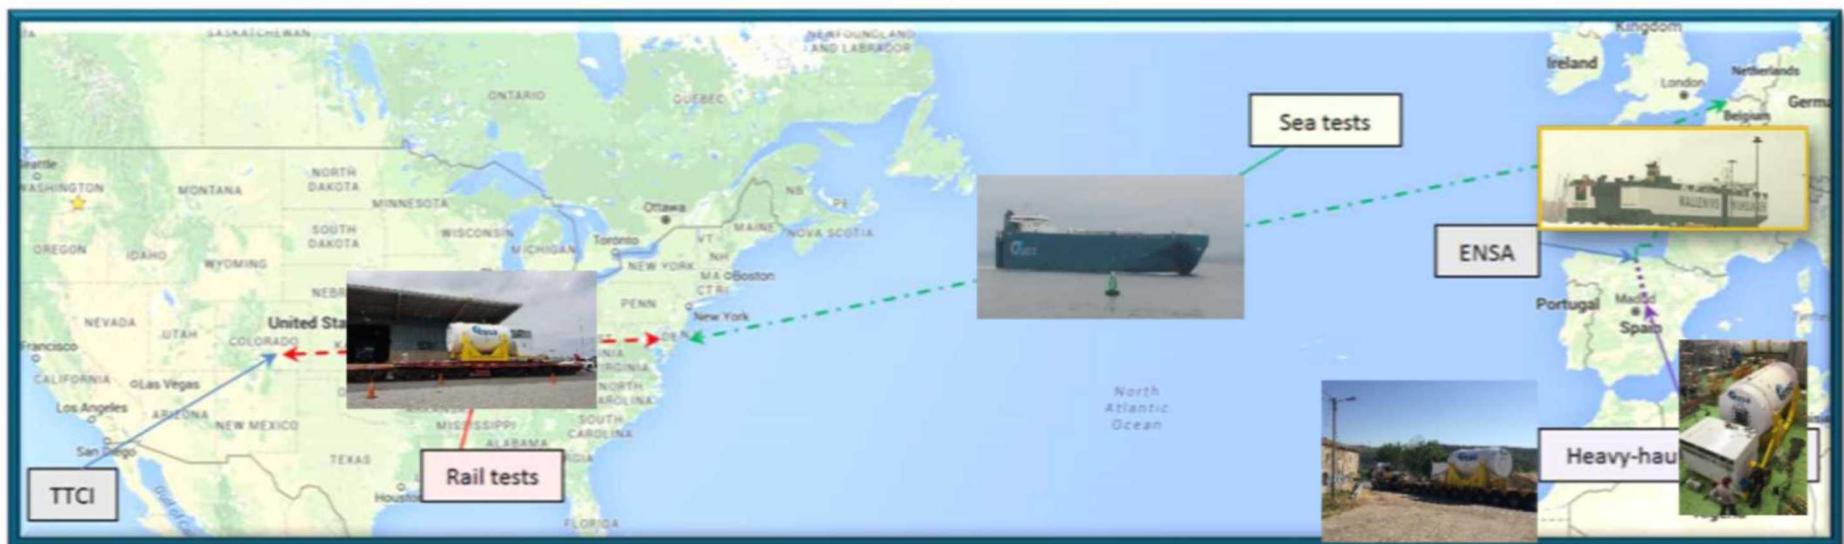
- 1) Heavy-haul truck from within Spain ~ June 14, 2017
- 2) Coastal sea shipment from Santander to large northern European port ~ June 27, 2017
- 3) Ocean transport from Europe to Baltimore
- 4) Commercial rail shipment from Baltimore to Pueblo, Colorado ~ Aug 3, 2017
- 5) Testing completed at the Transportation Technology Center, Inc.
- 6) Return trip to ENSA, September 5, 2017

Data was collected throughout all legs of the transport as well as the transfers between legs.

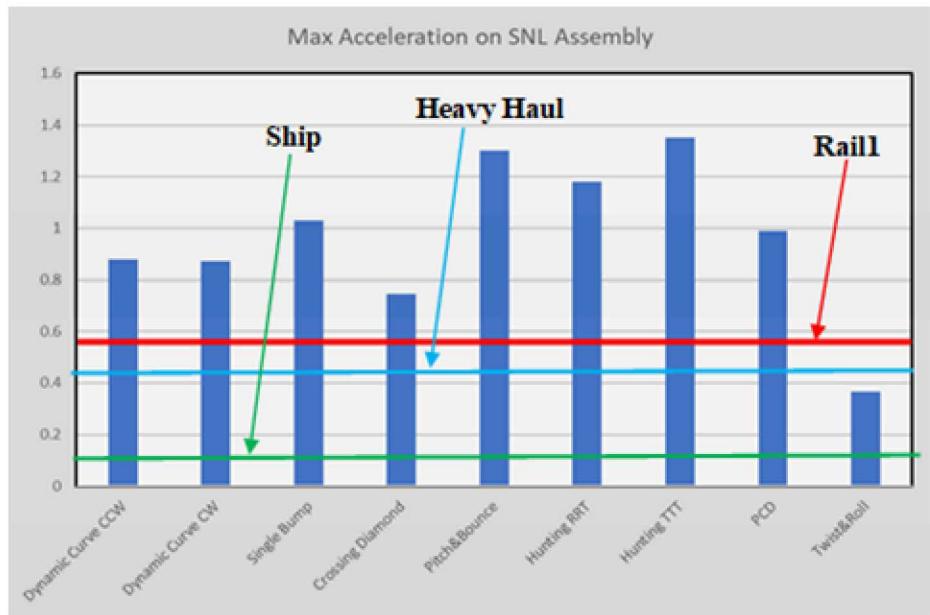
Measured in g

*Maximum Strains and Accelerations from all Transportation Tests*

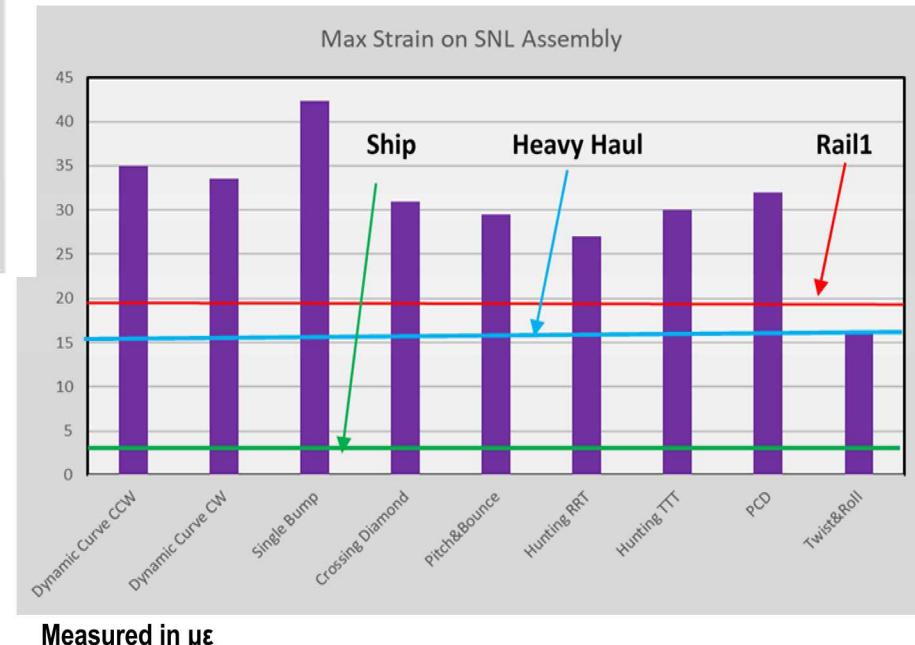
Measured in  $\mu\epsilon$

Measured yield stress levels for irradiated SNF cladding is  $\sim 7000 - 9000 \mu\epsilon$

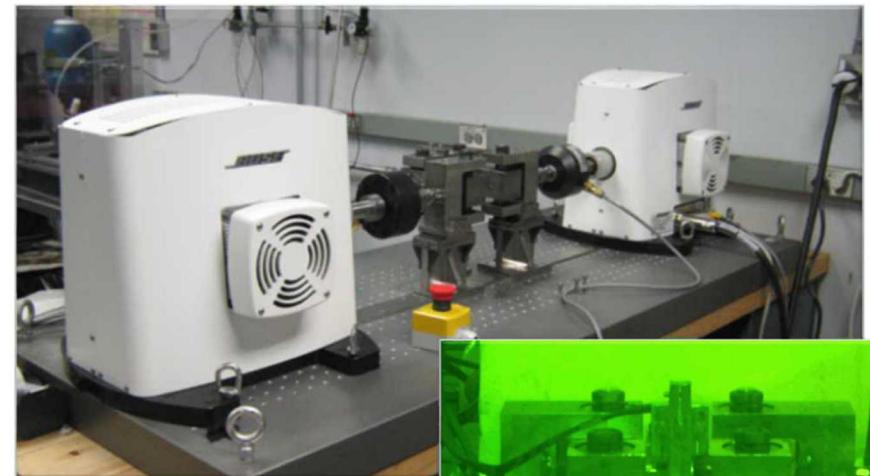
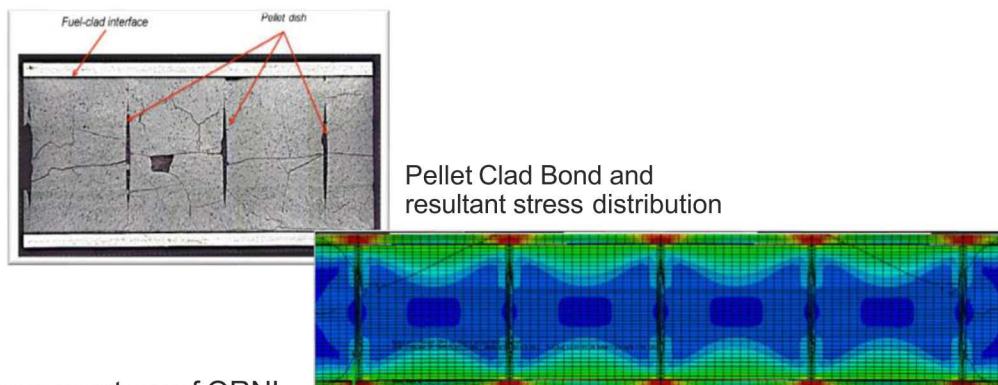
- Both static bending and cyclic fatigue
  - Developed at ORNL under an NRC program and continued with DOE:NE.
- Fatigue life depends on the level of loading
- Pellet-clad and pellet-pellet bonding provides additional stiffness

CIRFT tester out of the hot cell (above) and in the hot cell (right) testing High-Burnup Fuel samples.

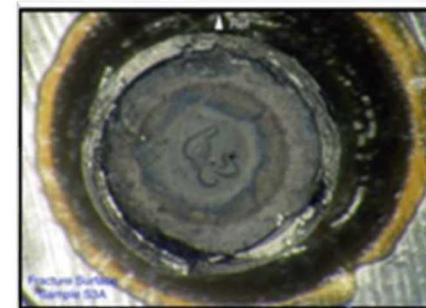
Most rods break cleanly between two pellets.

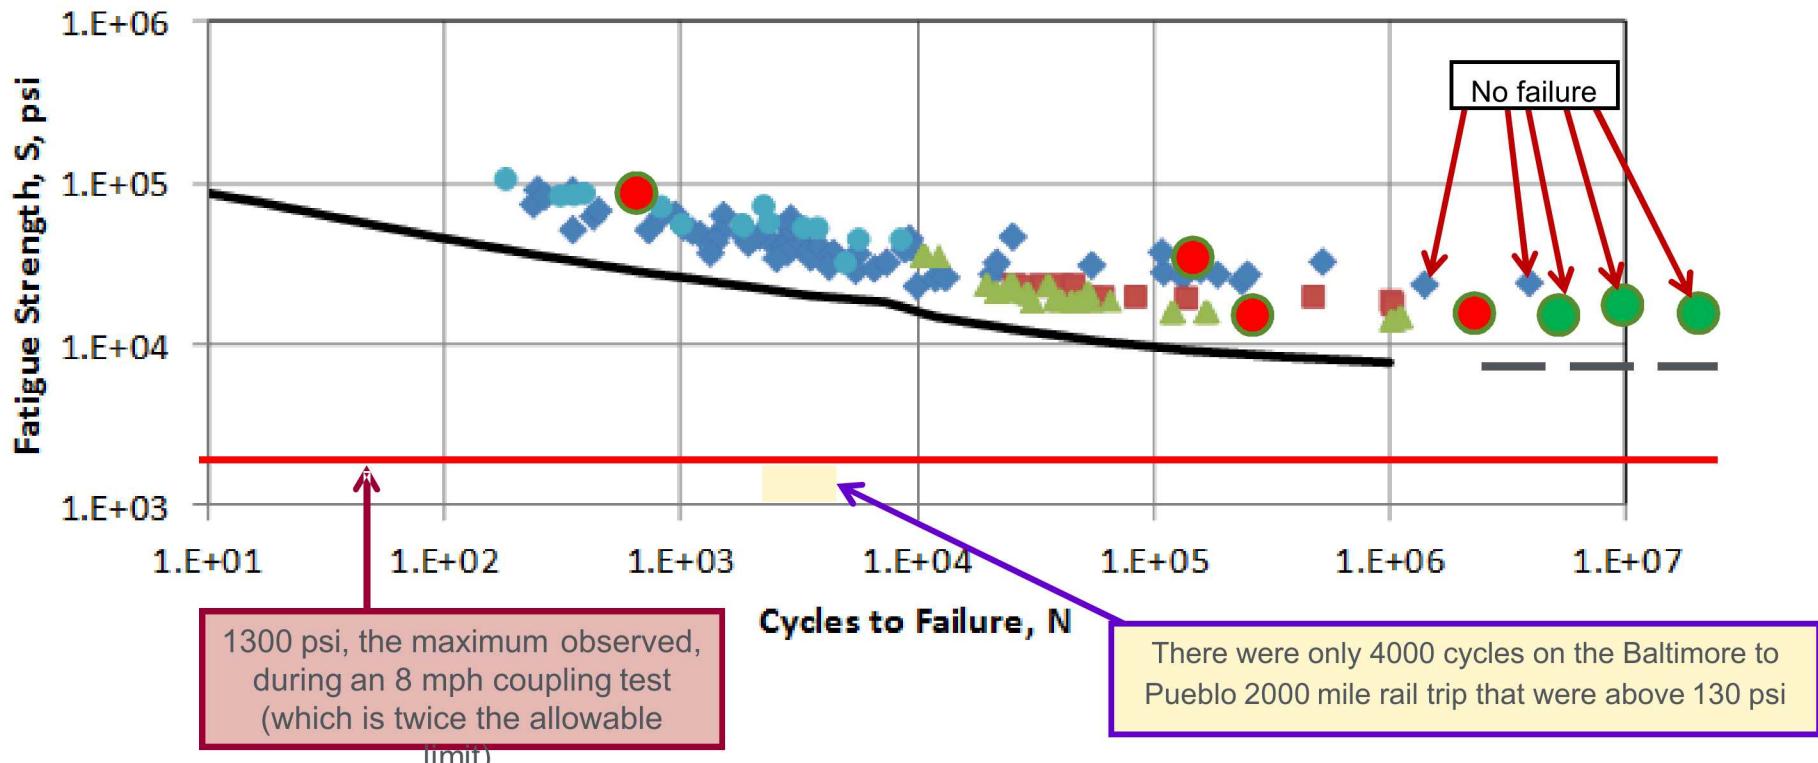
Data plot courtesy of Ken Geelhood, PNNL  
The large circles are ORNL HBR data

- Large red and green circles represent CIRFT data.
- Horizontal red line represents highest recorded stress value from the multimodal tests.
- Bold black line represents failure criteria above which failure may occur. Stress levels and the number of fatigue cycles from the multimodal tests are well below the failure limits.

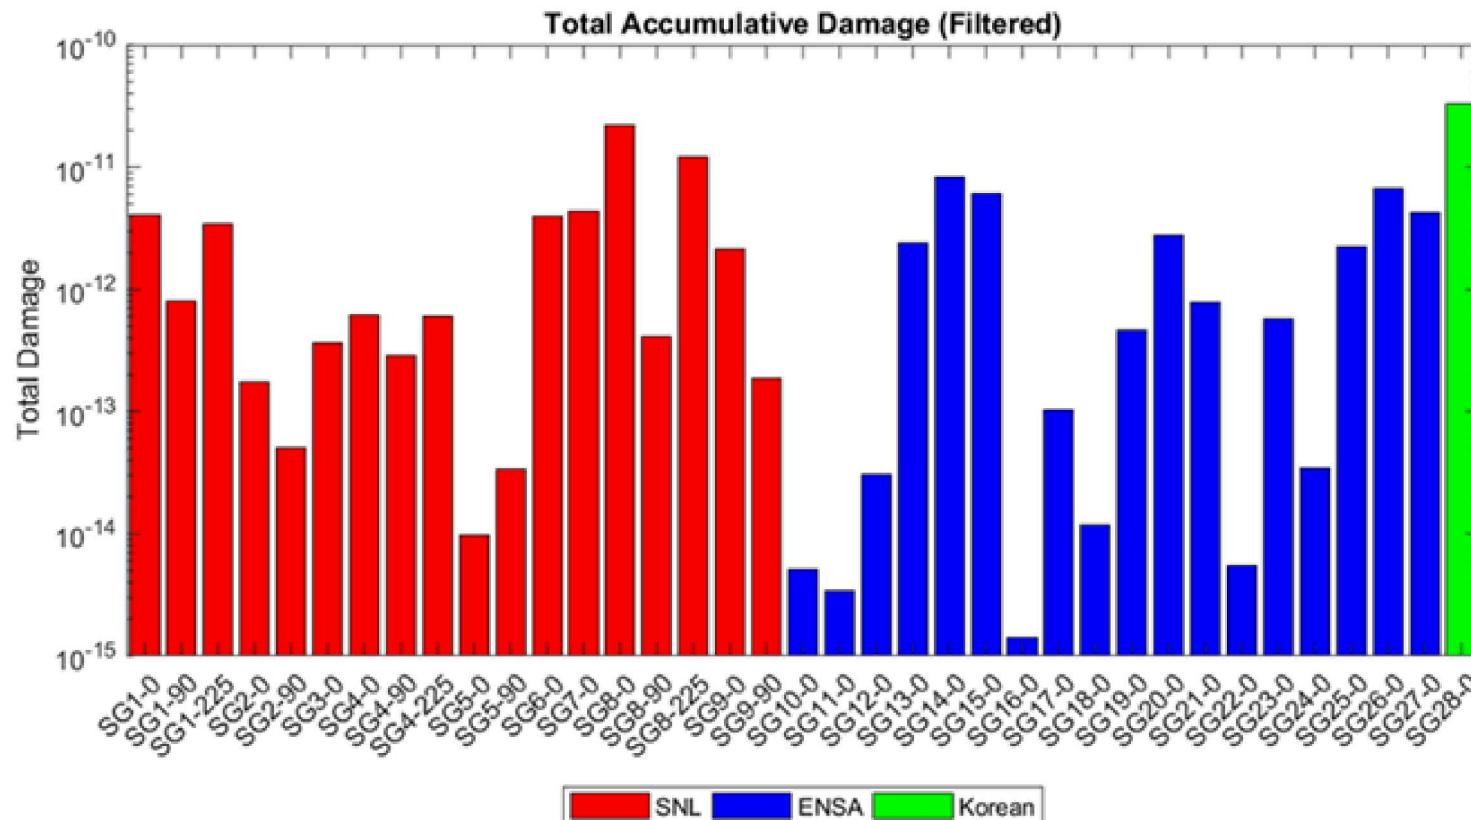
Damage Fraction of 1 represents failure. Strain data is 12 orders of magnitude below fatigue failure. Accumulated fatigue damage is approximately zero.

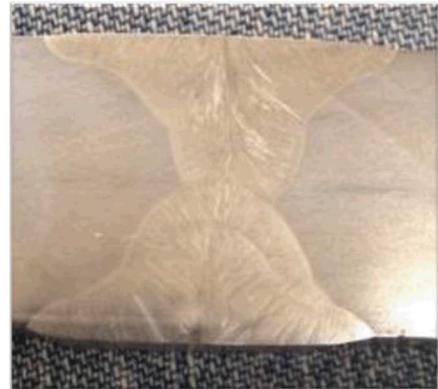
Photo of canister weld. Photo: SNL

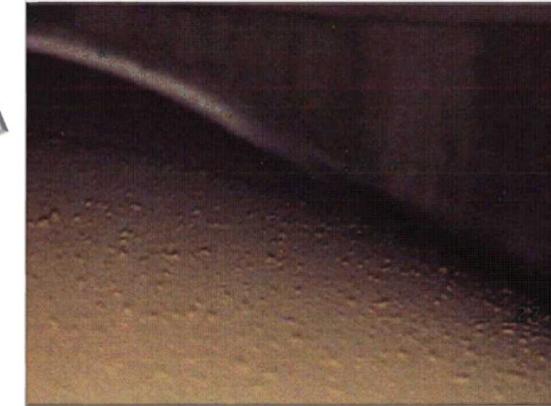
Dust on canister surface at Calvert Cliffs (EPRI 2014)

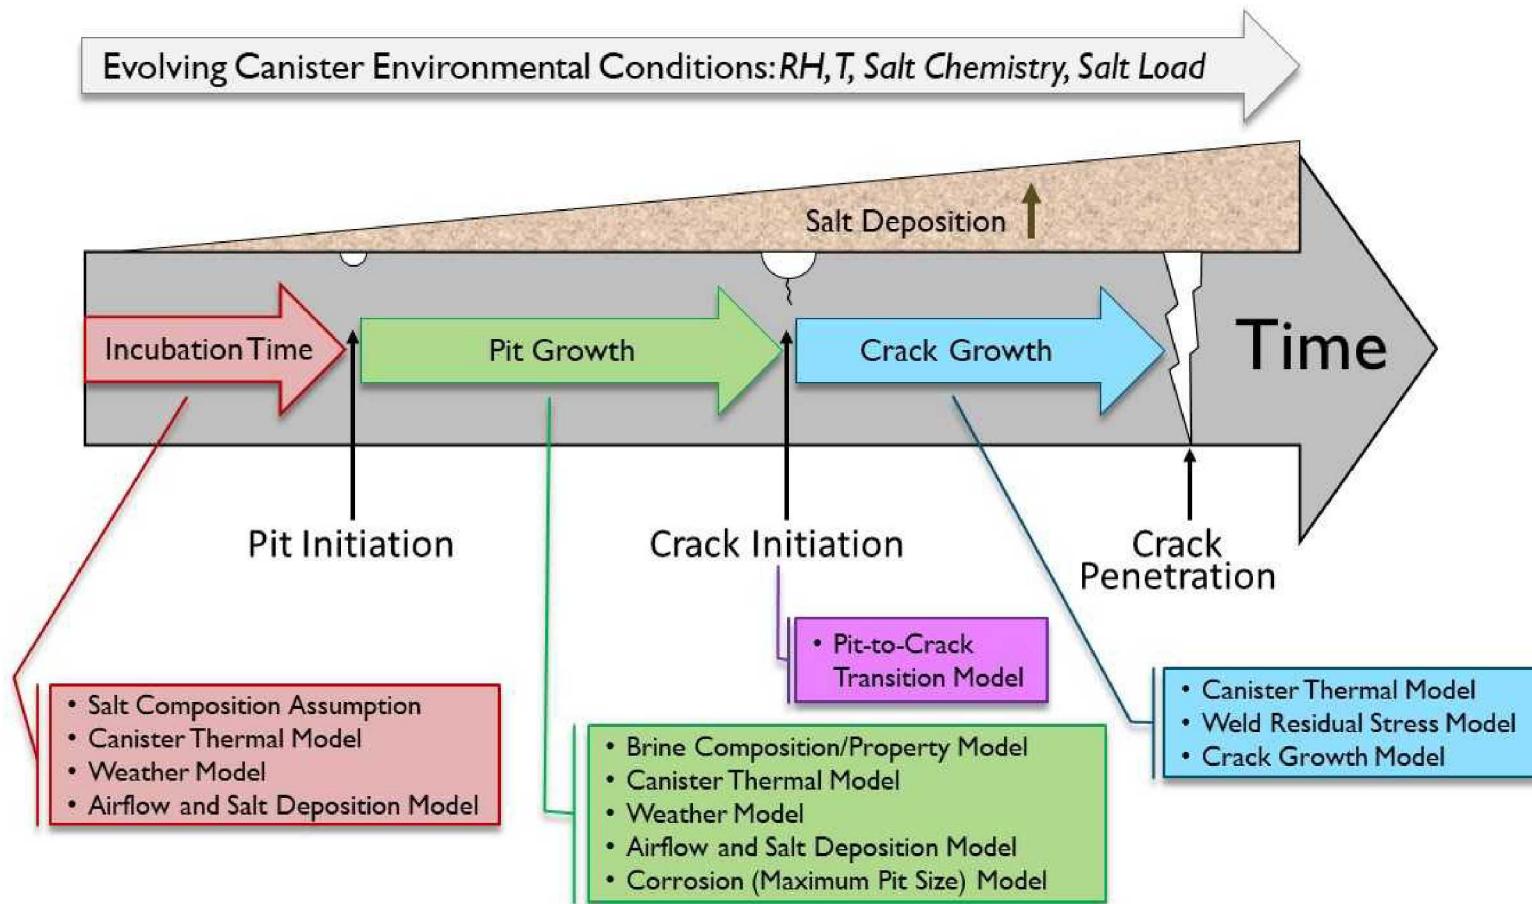
## SNL INTEGRATED MECHANISTIC/PROBABILISTIC MODEL FOR CANISTER SCC

**Goal:** Improve ability to predict timing and location of potential canister penetration by SCC cracks

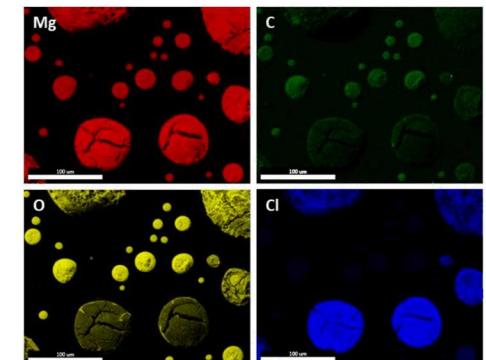
*EDS element maps: depletion of Cl<sup>-</sup> in MgCl<sub>2</sub> droplets with exposure time*

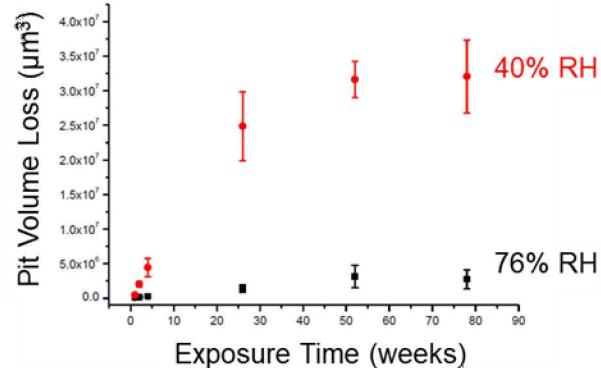
Statistical Pitting Damage Sets

- Generating statistical pitting damage sets as a function of environment and material properties

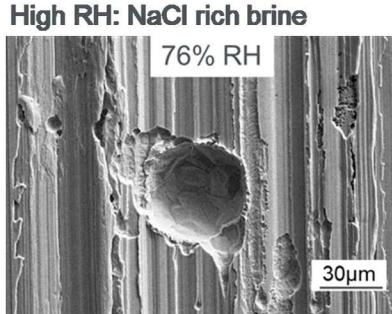
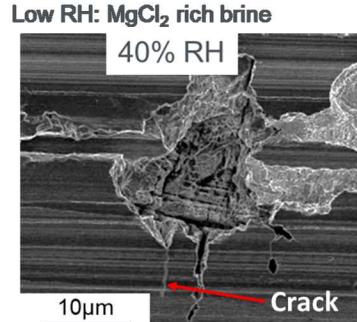
Pitting *f*(environment)

- Material condition and environment govern pit morphology, possibly increasing cracking susceptibility

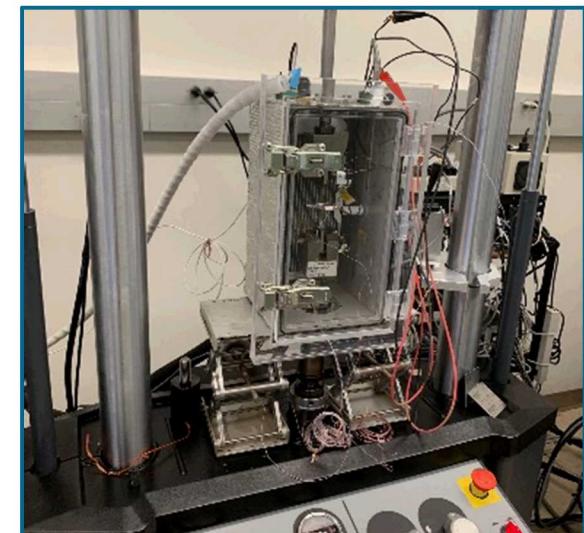
- High-fidelity fracture mechanics testing of pit-to-crack transition and crack growth rate
- Development and interpretation requires knowledge of:
  - Brine Evolution
  - Corrosion damage *f*(environment and material condition)

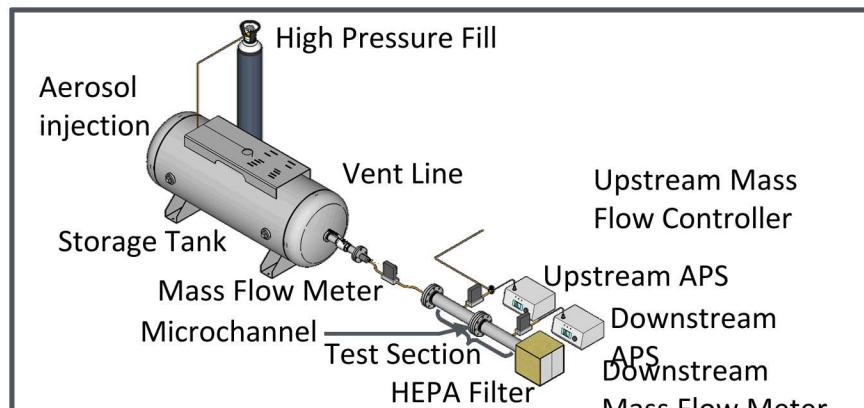
- Start with slot orifices with SCC-like dimensions
- Non-radioactive surrogates ( $\text{CeO}_2$ )
- Measure flow rates and pressure drop during blowdown
- Quantify particle density and size distribution both upstream and downstream of “crack”
- *Incorporate knowledge from mechanical testing, such as respirable fraction, overall robustness of fuel rods, and external loads.*

SCC flow test setup

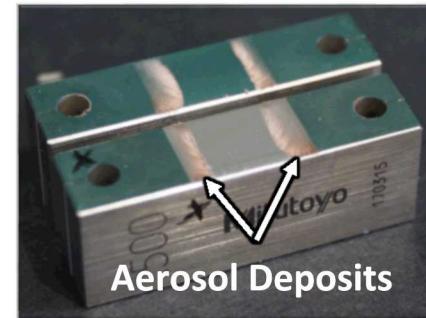
Slot orifice constructed from modified gage blocks after aerosol flow test
