Arc-Fault Unwanted Tripping Survey with UL 1699B-Listed Products

Jay Johnson¹, Kenneth M. Armijo¹, Modi Avrutsky², Daniel Eizips², Sergey Kondrashov²

Abstract — Since adoption of the 2011 *National Electrical Code*®, many photovoltaic (PV) direct current (DC) arc-fault circuit interrupters (AFCIs) and arc-fault detectors (AFDs) have been introduced into the PV market. To meet the *Code* requirements, these products must be listed to Underwriters Laboratories (UL) 1699B Outline of Investigation. The UL 1699B test sequence was designed to ensure basic arc-fault detection capabilities with resistance to unwanted tripping; however, field experiences with AFCI/AFD devices have shown mixed results. In this investigation, independent laboratory tests were performed with listed, recognized, and prototype AFCIs/AFDs to demonstrate limitations with state-of-the-art arc-fault detection products. By running inverter-integral AFCIs, combiner box AFCIs, and stand-alone AFDs through realistic tests beyond the UL 1699B requirements, all products were found to either cause unwanted tripping or were ineffective at detecting harmful arc-fault events. Based on these findings, AFD/AFCI manufacturers

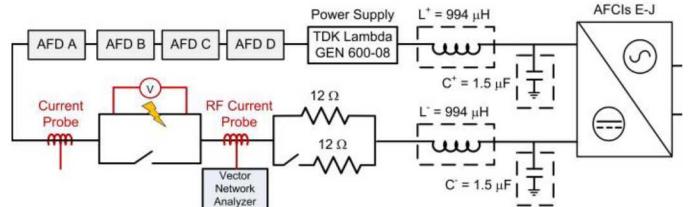
Fig. 1. Arc-fault test circuit using a power supply.

Arc-fault experiments were performed using the test configurations in Figs. 1 and 2 without the inductors and capacitors. The stand-alone AFD products did not contain interrupting devices (IDs) so they were connected in series in the DC test circuit while each of the inverter-integral AFCIs was evaluated. The AFCI in the combiner box was removed from the enclosure and disconnected from the ID for the experiments. To perform arc-fault tests in a controlled environment, a TDK Lambda GEN 600-08 power supply, with a 6 or 12 Ω resistor was used to simulate a PV supply. During the high-irradiance periods of the day, or in the case of AFCIs that tripped on the power supply, real PV power was used using two strings of Sanyo HIT-N225A01 modules with Tigo Optimizers shown in Fig. 2. The arc-fault current was measured with an Agilent 1146A probe and the voltage was measured with an Agilent N2791A differential probe connected to an Agilent DSO-X 2024A oscilloscope. The conducted RF noise on the DC system was separately monitored with an Anritsu MS2034B Spectrum Analyzer and Solar Electronics Co. Type 6741-1 PF current probe. In this paper, the high frequency spectral content is converted from power (dBmW) measured by the Anritsu to current (dB μ A)—including a 3 dB μ A probe attenuation correction.

The masking tests were conducted with 300 W arc-faults on test configurations in either Fig. 1 or Fig. 2 with the L^+ , L^- , C^+ , or C^- parasitic impedance installed sequentially. The inductor was installed between the PV output circuit, while the inverter and the capacitor were connected from the positive or negative PV output circuit to the inverter chassis ground. Multiple inductance and capacitance values were tested, but all devices were tested with a 994 μ H series inductor and a 1.5 μ F capacitor to ground. It should be noted that the current draft of UL 1699B includes a masking test with line impedance created with 200 ft of wire arranged with four 180 degree bends of six-inch radius. The inductor in these tests was also created from hundreds of feet of PV wire but, in this case, tightly wrapped into an air inductor with approximately a 10 inch radius. Depending on the installation, high inductance scenarios are certainly possible if there is coiled PV wire. The capacitance to ground was designed to replicate the array capacitance. This property can vary significantly with module technology and design. SMA estimated the parasitic capacitance of wet silicon PV arrays to be 60-110 nF per kW and wet thin film arrays to be 100-160 nF per kW [20]. Therefore, a wet 9.4 kW thin film array could produce 1.5 μ F to ground and potentially render the arc-fault protection system ineffective.

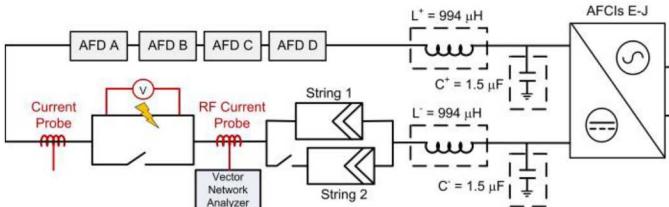
Fig. 2. Arc-fault test circuit using rooftop PV.

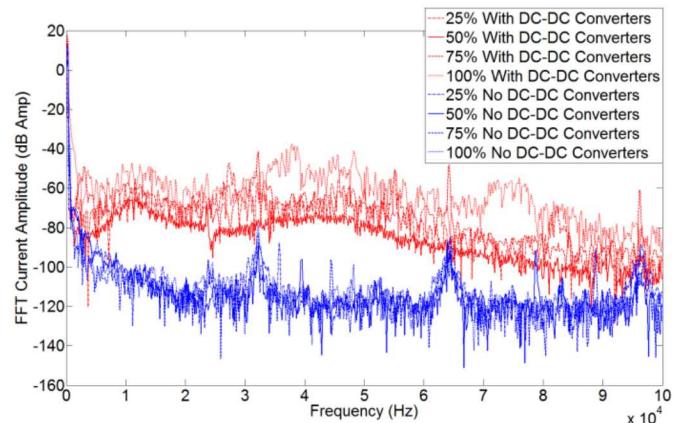
Fig. 3. Additional noise floor from DC/DC converters.

Power supplies, DC/DC converters, power optimizers, inverters, and other power electronics devices generate noise on the DC system [17]. The majority of this noise is generated with respect to device switching frequency and harmonics, but depending on the spectral content, PV AFCIs could trip because of the heightened noise floor. As an example, the frequency with and without module-level DC/DC converters is shown in Fig. 3 at four different inverter power levels. In the case of this 2-string PV system at Sandia's Distributed Energy Technologies Laboratory (DETL), the conducted noise in the DC system was significantly higher when the module-level converters were operating.

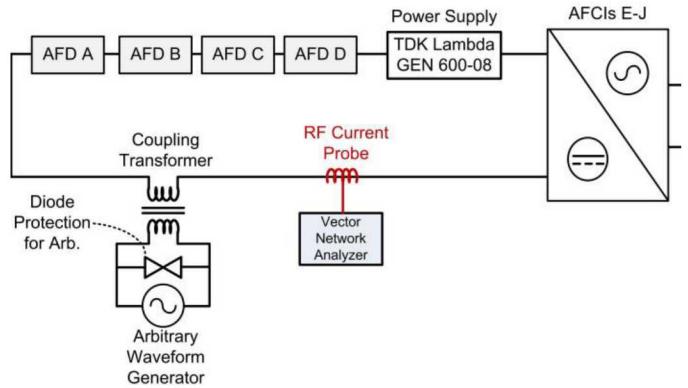
Fig. 4. Test circuit for the frequency sweep experiments.

Many AFD/AFCI products analyze the spectral content of the DC system with a Fast Fourier Transform (FFT) or similar analysis of string/array current. Since arc-faults generate 1/f “pink” noise [11], these devices analyze one or more frequencies to determine when the arc-fault exists. In the case of monotone detection, conducted noise from other power electronics devices on the system or capacitive, inductive, or radiated coupling can cause unwanted tripping. To verify the AFD/AFCIs are resistant in those environments, a coupling circuit was created with an arbitrary waveform generator, shown in Fig. 4. The number of windings on the coupling transformer was adjusted to produce approximately 100 dB μ A (100 mA_{rms}) of noise on the DC system, similar to the switching frequency of most of the PV inverters. This injected

noise signal was adjusted from 1 to 500 kHz in 1 kHz steps at roughly 1 kHz/sec to determine if the AFCI/AFDs were sensitive to single frequency excitation. Experiments with sine and square waves were conducted, but square waves were ultimately selected because they produced the largest superharmonic content and caused more unwanted tripping. As shown in Table 2, multiple AFDs and the charge controller AFCI tripped with square wave injection. These nuisance trips show potential weaknesses in the AFCI/AFD algorithm and could manifest themselves in the field when installed with other power electronics equipment.

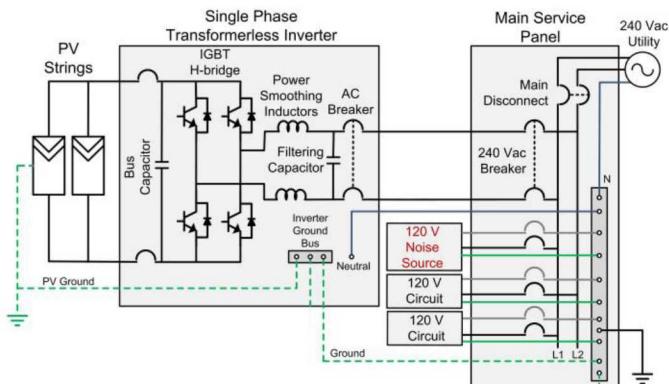
Fig. 5. AC-to-DC noise coupling test configuration.

There are reports of elevator operation and fluorescent light (low-pressure mercury arc lamp) startup tripping AFDs. In these cases, noise—likely from arcing—on the AC system reaches the DC side of the PV system. This is more of a problem for transformerless inverters because there is no galvanic isolation between the AC and DC sides of the inverter. In the lab, a paper shredder, bench grinder, and shop vacuum were connected to an AC outlet directly connected to the service panel for the PV inverter, shown in Fig. 5. In all

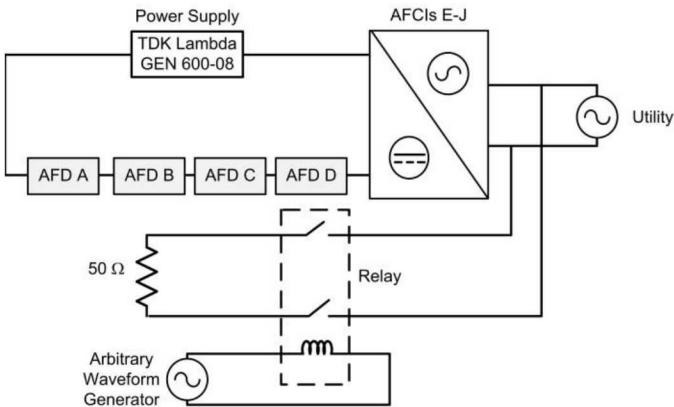
Fig. 6. AC-to-DC noise coupling with a relay connected to a load.

cases, the AFD/AFCI did not trip. Then, to ensure that arcing noise was being produced on the AC side of the inverter, a relay connected to a 50Ω load was paralleled with the inverter, as shown in Fig. 6. This relay was actuated at 10-20 Hz to generate relay-driven arcing noise on the AC side to simulate brushed motors and other devices that produce non-hazardous AC arc-faults. As shown in Table 2, two of the unrecognized AFDs tripped when the AC arc-noise was produced.
