# Corrective Action Management Unit (CAMU)

SAND2008-6344P

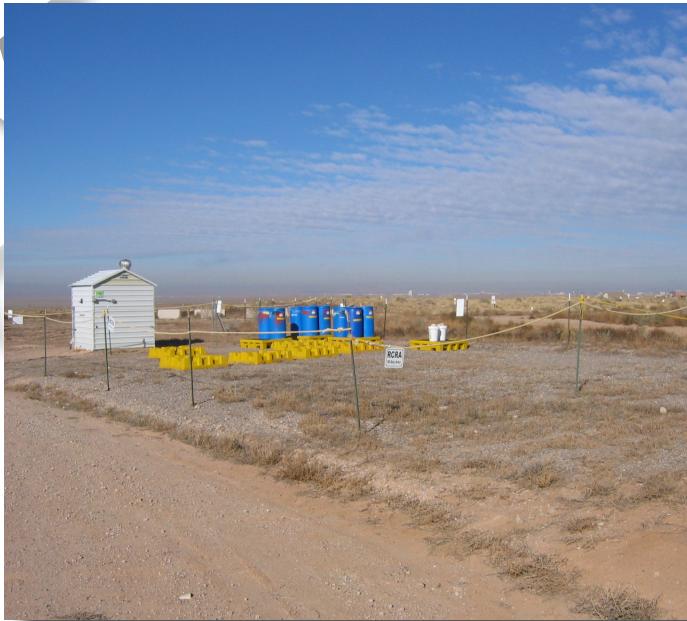
*CAMU's Less Than 90 -Day Accumulation Area*

With the completion of treatment operations in January 2003 and formal closure of the CAMU in October 2003 activities are limited to post closure care operations. Post closure care of the CAMU began on October 7, 2003. Waste generated during post closure care includes leachate from the cell and personal protective equipment (PPE) used during leachate handling activities. A Leachate Collection and Removal System (LCRS) is designed to collect and withdraw

leachate from the CAMU cell during the post closure care period. The LCRS includes a lined sump in the north end of the cell, a collection pipe in a central trench located above a primary subliner, and a dedicated pump that is manually turned on to remove liquids that collect in the sump. The leachate and PPE waste are stored temporarily in a less than 90-day accumulation area prior to removal by the SNL Hazardous Waste Management Facility for proper off-site disposal.

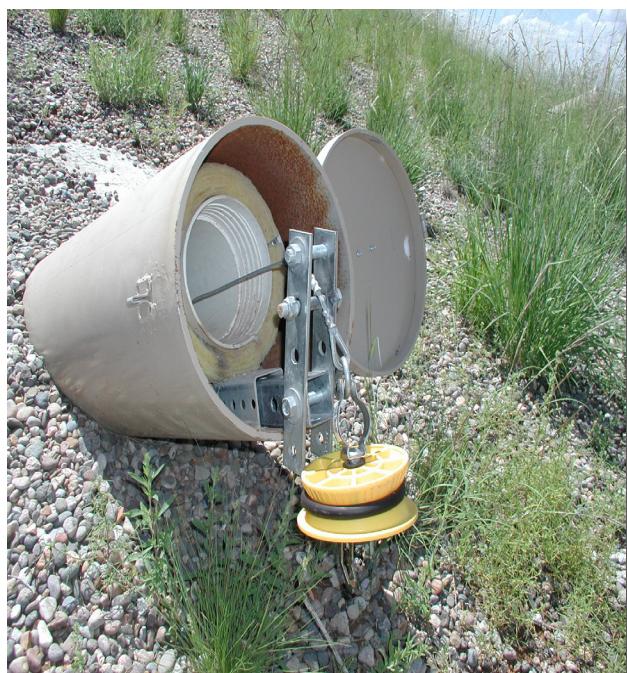
*PSL Access Tube on CAMU's North Side*

**The Primary Subliner (PSL) Monitoring Subsystem** consists of five horizontal tubes that extend the length of the cell directly under the primary subliner. The tubes allow access beneath the cell to measure soil moisture and soil-gas concentrations.
