Sandia National Laboratories, New Mexico

Environmental Restoration Operations

Consolidated Quarterly Report

January – March 2019

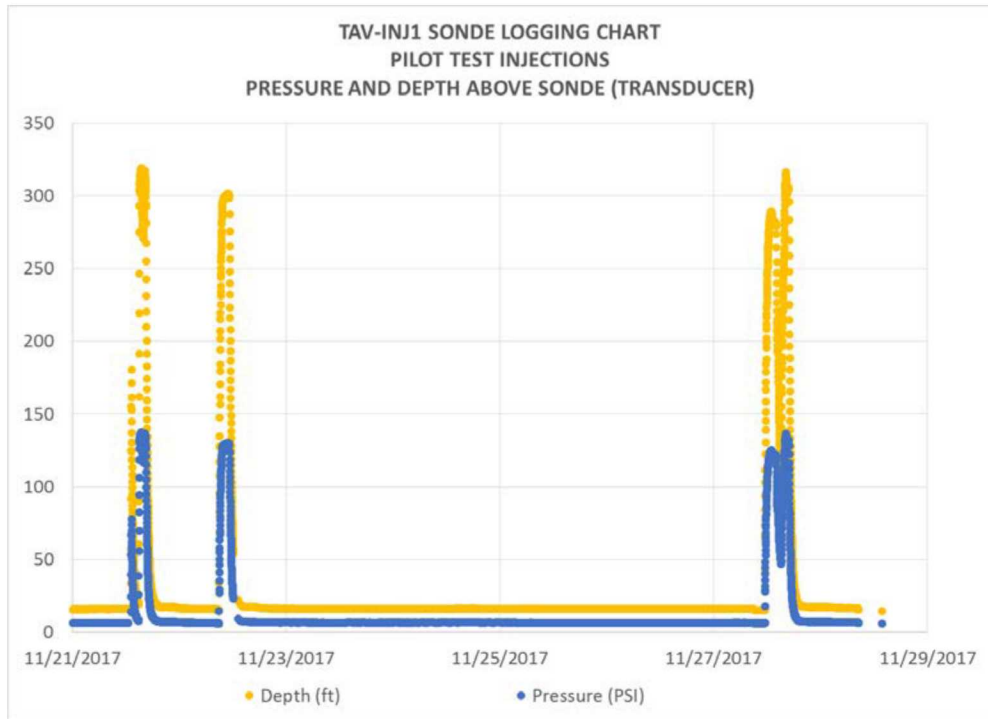
Figure 1a
Pressure and Water Column Height in well TAV-INJ1 during Injections

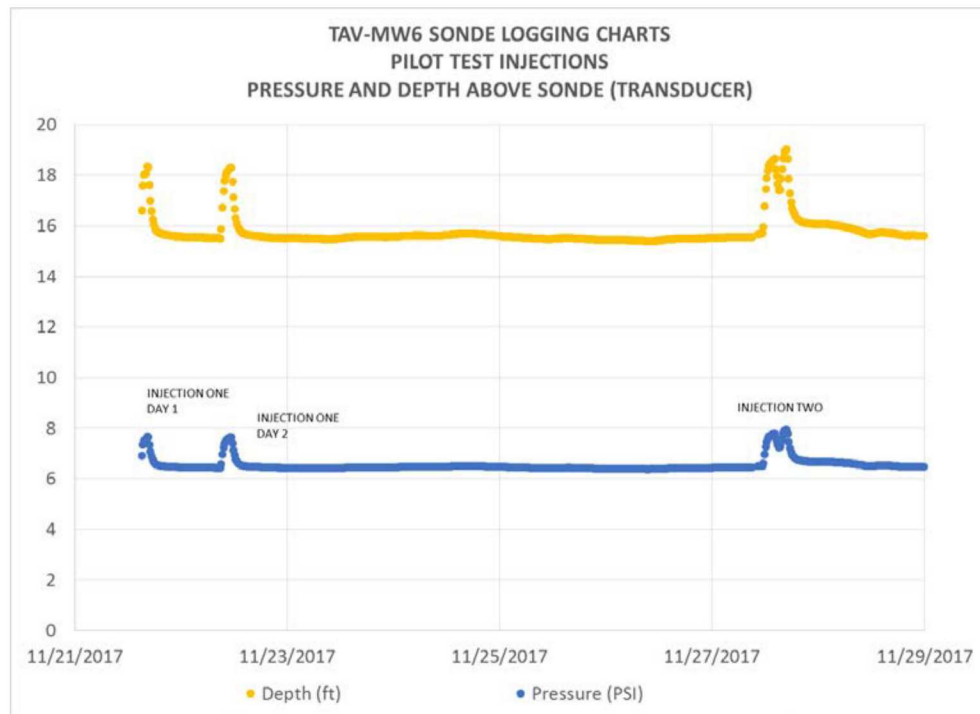
Figure 1b
Pressure and Water Column Height in well TAV-MW6 in
Response to Injections at well TAV-INJ1

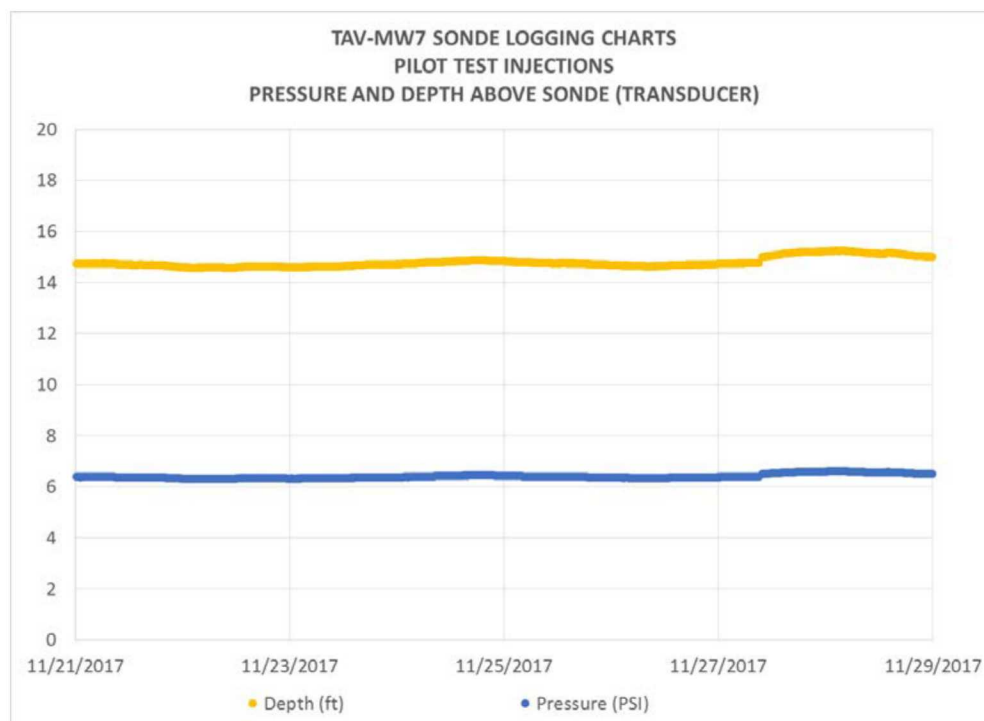
Figure 1c
Pressure and Water Column Height in well TAV-MW7 in
Response to Injections at well TAV-INJ1

In the unlikely event that the sonde readings or the analytical results from well TAV-MW7 show any variation from the baseline, it will be reinstated into the ISB performance monitoring campaign as soon as possible.

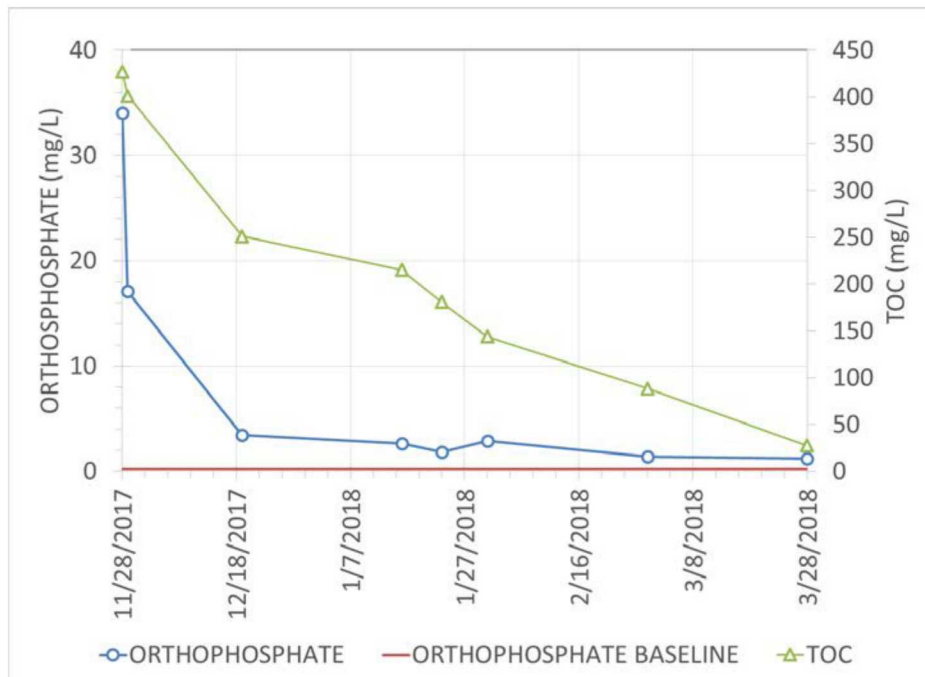
Figure 2
Orthophosphate and TOC Concentrations at TAV-INJ1 following Pilot Test Injections

- Calcium, magnesium, potassium, and sodium – These analytes are not indicative of the performance of the ISB; therefore, are not useful to monitor.
- Orthophosphate as P – Diammonium phosphate (DAP) is an ingredient of the substrate solution. It acts as a pH buffer and provides phosphorous to support microbial cell generation. Figure 2 presents the orthophosphate concentrations in well TAV-INJ1 during the pilot test performance monitoring. It shows that phosphorous was rapidly utilized by microbes. Figure 2 also presents the concentrations of Total Organic Carbon (TOC), which is the main source for microbial growth. Figure 2 shows the more gradual consumption of TOC compared to the exponential utilization of orthophosphate. It is expected that phosphorous will be completely consumed prior to the depletion of TOC. Therefore, TOC is a more robust and reliable indicator for microbial respiration and growth in the treatment zone. Based on this understanding, orthophosphate will be eliminated from the analyte list in full-scale operation. Analysis for TOC will remain.
