SAND93-1000 • UC-721
Unlimited Release
Printed March 1996

Data Report on the Waste Isolation Pilot Plant Small-Scale Seal Performance Test, Series F Grouting Experiment

E. H. Ahrens, T. F. Dale

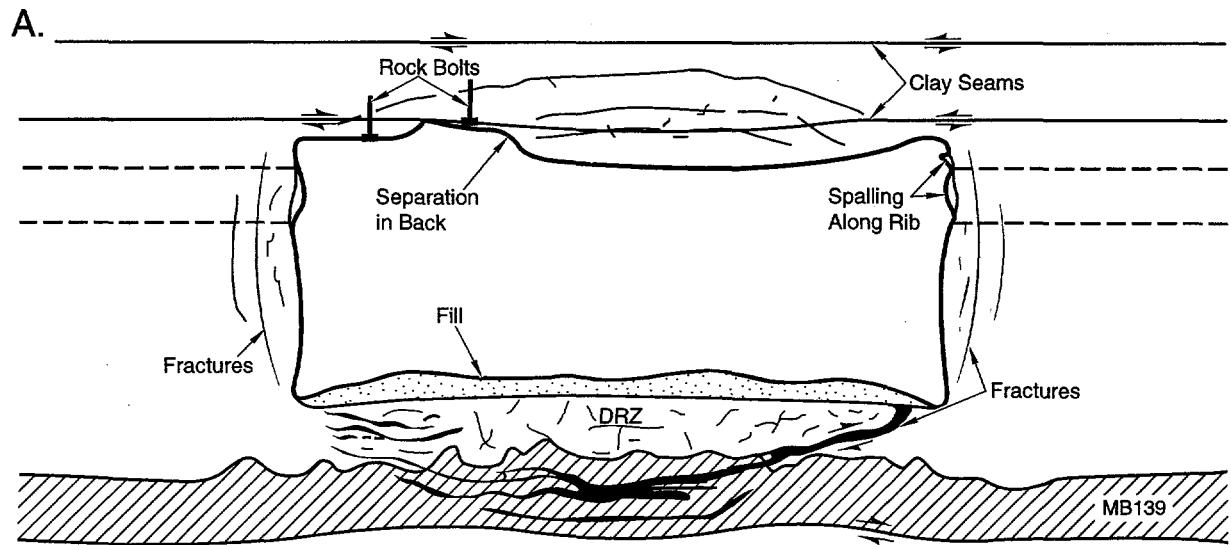
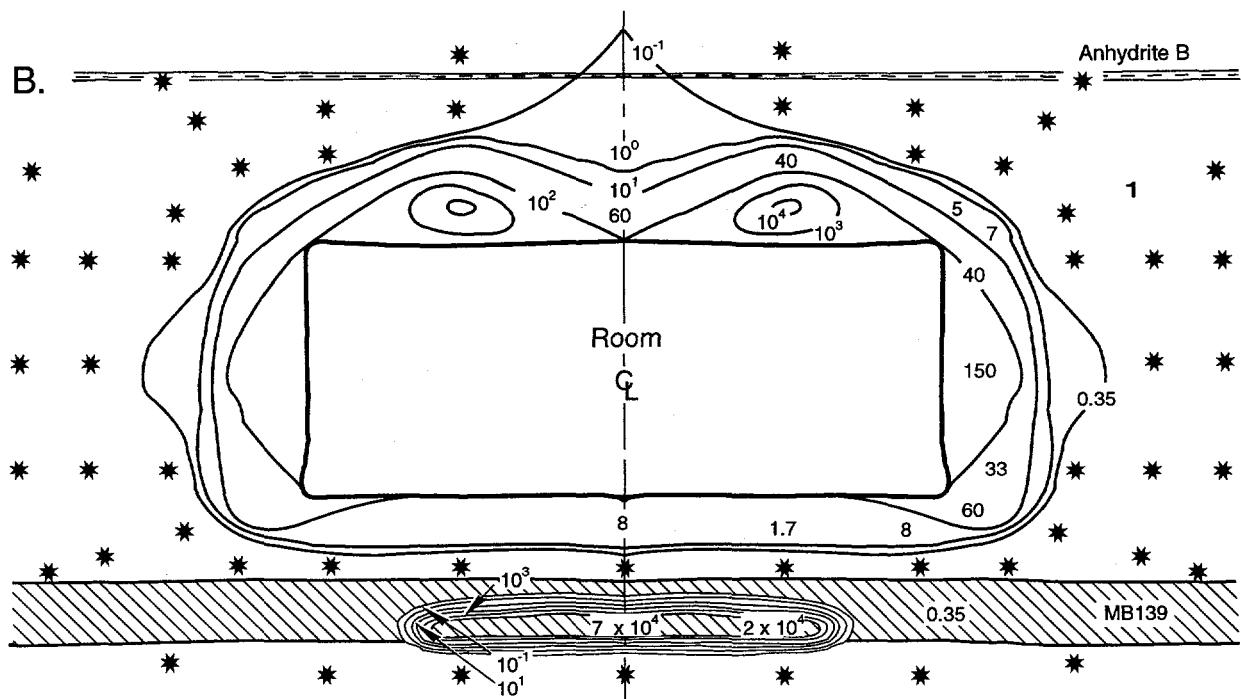
★ = Reading below Resolution
of Equipment (less than 0.1 SCCM)

Units are in Standard cm^3/min (SCCM)

Figure 1-2. Disturbed rock zone adjacent to WIPP underground excavations.
(A) fracture patterns; (B) contours of gas-flow rate for gas injected at less than 1 MPa (adapted from Borns and Stormont, 1988).

Within the disturbed rock zone (DRZ), fractures can increase the permeability of the rock by a few orders of magnitude (Borns and Stormont, 1988). Although the DRZ in halite will eventually heal by creep closure, the local stratigraphy at the repository horizon contains several, almost horizontal layers of anhydrite, polyhalite, and halite, as well as thin clay seams. Of particular note are (1) Marker Bed 139 (MB139), the heterogeneous interbed approximately 2 m below the floor of the repository horizon, and (2) the intervening halite, which commonly exhibits fracturing (Stormont et al., 1987). MB139 is nominally a multilithologic unit consisting of laterally discontinuous lenses of halite, polyhalite, anhydrite, minor gypsum, and thin clay seams. This interbed is approximately 1 m thick and is parallel to the repository floor at depths varying between 2 and 3 m.

Stress redistribution around all excavations induces movement that results in dilation, primarily along depositional interfaces and/or existing flat-lying fractures in relatively hard and brittle units like MB139, as represented in Figure 1-2. Current evidence suggests that continued closure of WIPP excavations over time may result in separations or fractures along the marker-bed/salt interface or within the marker bed (Stormont, 1990). DRZ development has been observed around all excavations, but is more extensive around the wider (>7 m) underground openings within 5 years after excavation (Borns and Stormont, 1988). Additionally, fractures have been observed in interbed layers surrounding the WIPP facility horizon (principally MB139). Bechtel National, Inc. investigated the presence of fractures above and below repository horizon excavations (US DOE, 1986) and found horizontal fractures and separations ranging from microfractures of less than 100 microns to fractures as large as 1 cm in both MB139 and the intervening halite below all test rooms. Similar fracturing was observed in diamond drill core obtained at the test site. Dilation and separations occur in MB139 when it deforms upward into the excavations. Fractures in the DRZ provide potential gas pathways for gas flow from waste emplacement areas and for brine flow to or from these areas (Deal et al., 1987). Grouting may be necessary to control increased permeability resulting from creation of strain-induced fractures in the DRZ around WIPP seals. To demonstrate the ability to control gas and fluid movement within the DRZ, the SSSPT-F experiment included tracer-gas testing, using gas of known density and viscosity, to provide data for determining estimated permeability. For evaluation of grouting effectiveness, tracer-gas testing was conducted before and after grout injection. The pre- and post-grouting permeability measurements were compared to demonstrate the effectiveness of grout injection for sealing the strain-induced fracture permeability within the DRZ.

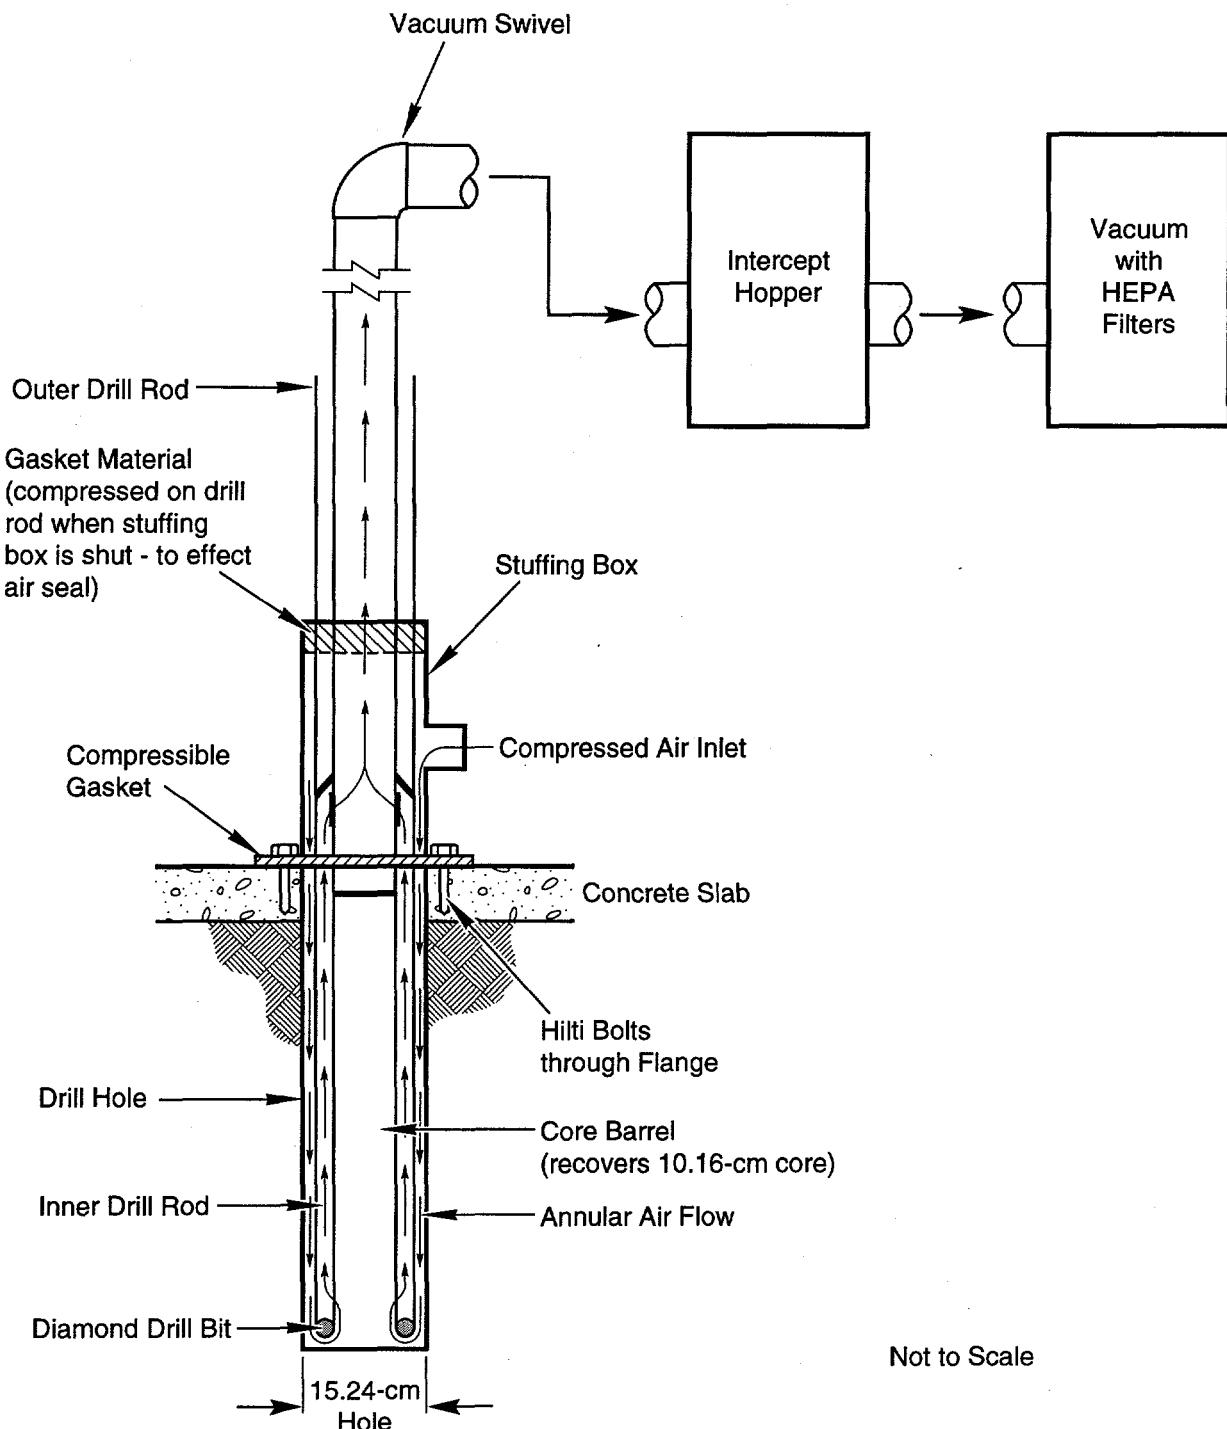
Figure 2-2. Diagram of reverse circulation drilling system.

Diamond drill cuttings are very fine-grained. Standard drilling systems use a configuration that blows compressed air down a single hollow drill rod and outward across the diamond bit, cooling the bit (to prevent fusing the salt, which then adheres to the bit and reduces drilling efficiency) but then driving the cuttings up the annular space between the drill rod and the hole wall, where they can plug fractures and block the entrance of grout. Cuttings that do not lodge in fractures are forcibly ejected from the hole collar and dispersed into the drilling area, creating a very dusty work environment. Drillers must wear protective masks, and salt dust is detrimental to electronic equipment. To overcome these drawbacks, special drilling equipment was developed for SSSPT-F. The equipment incorporates a reverse-circulation air-flow system (shown schematically in Figure 2-2) that leaves fractures open in the hole wall. During drilling, compressed air is passed down the annulus between the outer rod and the drillhole wall and then swept inward across the drill bit, carrying the cuttings between the inner and outer drill rods for approximately 1.2 m (the length of the core barrel). The cuttings are then deflected into the center rod and carried to the swivel above the drill where a hose connects the drill to a powerful vacuum. The vacuum promotes movement of the cuttings from the swivel to an intercept hopper where the coarser particles are retained; the finer particles then pass through multiple high-efficiency particulate air (HEPA) filters. The discharge is relatively clean air, which benefits both the workers and the sensitive electronic equipment used in the experiment.

The SSSPT-F experiment made use of diamond drilling equipment specifically invented for this test. This equipment allowed operators to recover core while drilling a "clean" hole (i.e. one in which the microfractures remain unplugged by drill cuttings). Clean holes were necessary because one objective of SSSPT-F was to determine the effectiveness of grout for sealing microfractures.

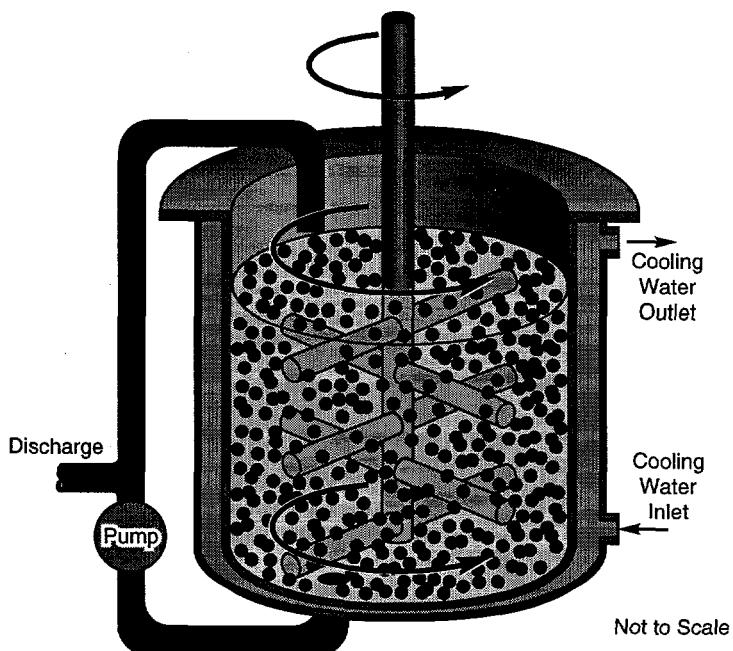
Figure 3-1. Attritor tank principle.

The grouting equipment was selected and developed specifically for SSSPT-F. Grout was pulverized on site and then pumped into the formation below Room L3 through the grout boreholes. A Szegvari 50S Attritor was set up in Room L3 and used to simultaneously pulverize and mix the grout. The attritor was purchased after laboratory work and pilot tests showed that it would efficiently accomplish the required particle size reduction. The 50S pulverized and mixed grout wet by grinding the grout components in a stationary tank together with 681 kg of grinding media (3-mm-diameter, #316 stainless-steel spheres). Six tungsten carbide cross-arms attached to a vertical shaft stirred the contents, imparting random motion to the grinding media. Pulverization resulted from impact and shear between the spheres, and size reduction was accomplished in about 85 minutes. The attritor pulverization principle is shown in Figure 3-1. During mixing, the tank is cooled by chilled water to prevent premature setting of the grout.

Constant agitation of the mix was required because the thixotropic grout must be kept in motion to remain fluid. After pulverization, the grout was transferred from the attritor to a water-cooled agitation tank where it was stirred constantly until injection.

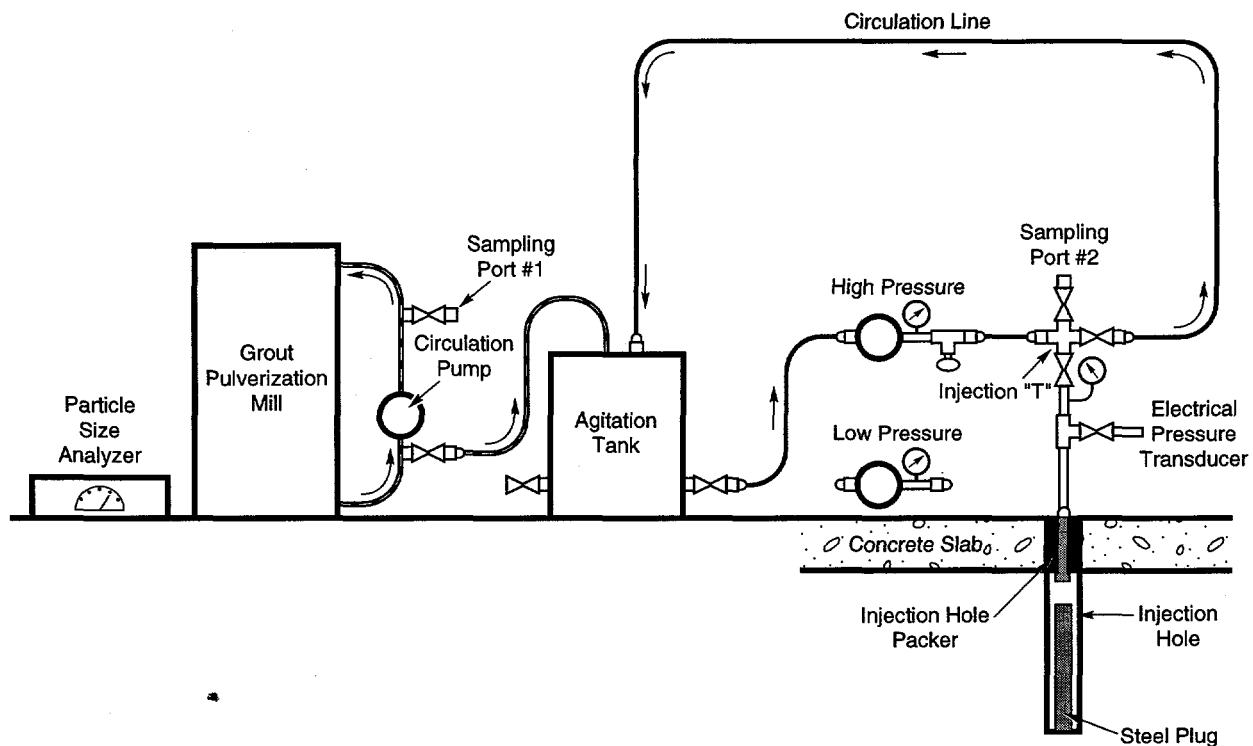
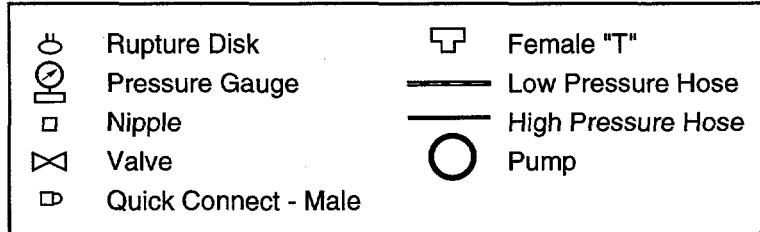
Figure 3-2. Grout pulverization and injection system.

- Inflation pressure in the central injection hole guard packer was checked and adjusted if necessary.
- A hermetically sealed steel plug (shown in Figure 3-2 and described below) was placed in the hole to be grouted. The sliding-end injection packer was positioned above the plug and inflated, and a mechanical restraint was attached to anchor the packer to the slab.

- The injection "T" was inserted into the top of the packer and all grout hoses were connected via quick-connect fittings.
- Five gallons of water containing superplasticizer were placed in the agitation tank, pumped through the grout hoses, and then drained. This flush "lubricated" the system and aided grout flow. Note: Water was used throughout the experiment rather than brine (as stated in the SOP) because laboratory tests prior to the field experiment indicated that brine was unacceptable. Additionally, the Moyno pump was found to generate heat during grouting of the first hole. Use of the Moyno was immediately discontinued because heat greatly reduces the period during which the grout remains injectable.

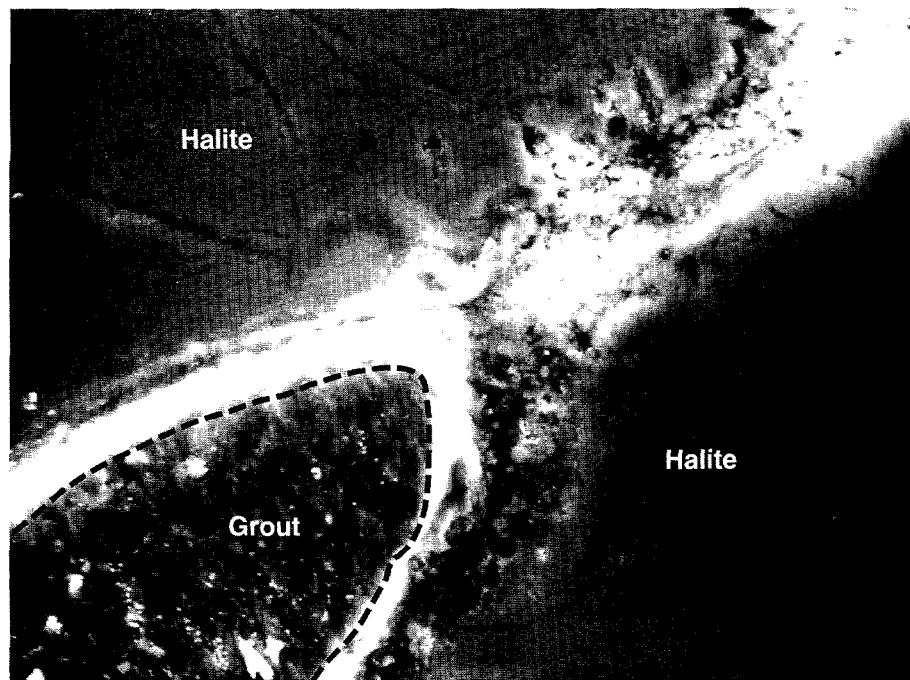
Photo 5-1. Electron microphotograph showing grout "pinch out" at ± 10 microns.

The grouting results can be seen in Photos 5-1 through 5-4, which are scanning electron microphotographs showing fracture widths from 3 to 10 microns completely filled with grout. The graphical scale bar on each photo varies in length with the magnification. Bar length in microns is denoted by the number at the lower left of the scale.

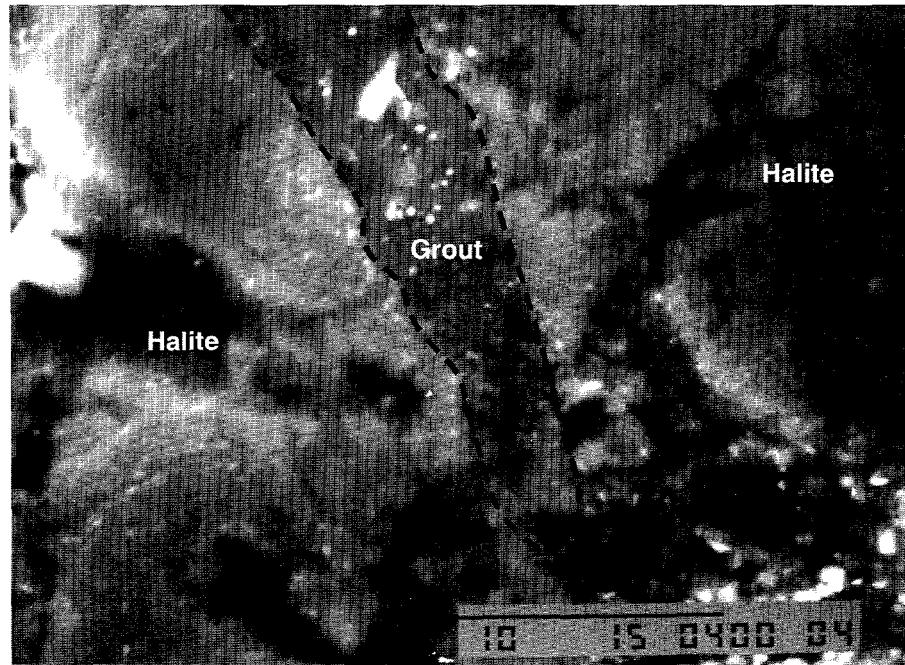
Photo 5-4. Electron microphotograph showing a grout-filled fracture 3 microns wide.

Photo 5-4 shows a 3-micron microfracture in hole L3X43, at a depth of 3.61 m, filled with grout injected through hole L3421. The accompanying spectral analysis graph (Figure 5-1, following page), made with the EDX, confirms that the material filling the fracture is grout. Similar graphs were obtained for all SEM specimens shown. Additional information on grout distribution is presented in Appendix H.

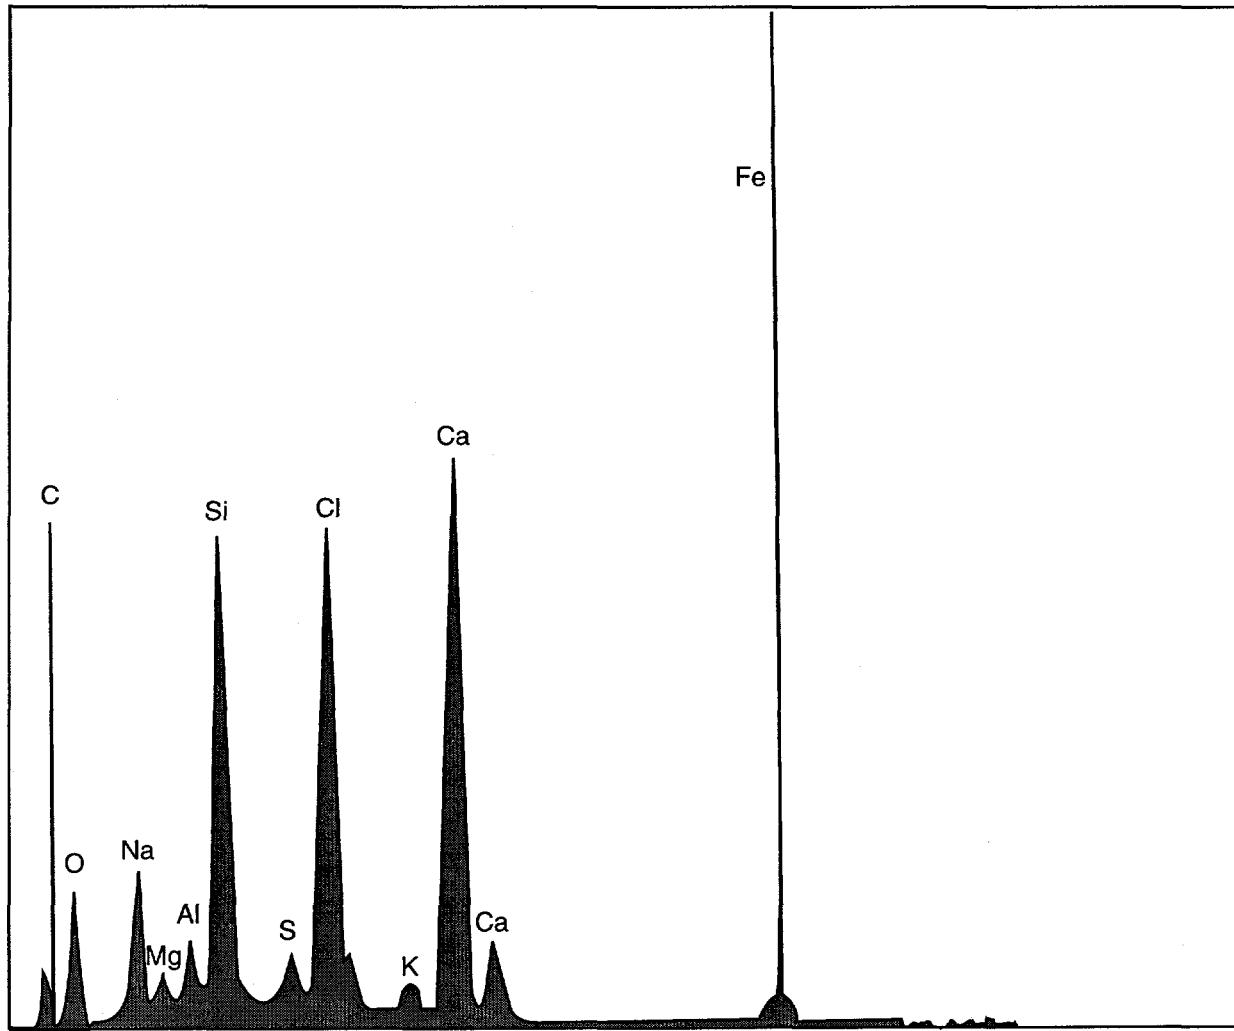
Figure 5-1. Qualitative spectral peaks produced by energy dispersive x-ray, verifying that material in fracture is grout.

- down-the-hole televiwer,
- megascopic (hand lens) observation,
- optical microscopy,
- scanning electron microscopy (SEM) in conjunction with energy dispersive x-ray (EDX). EDX was used to verify that the material sealing the fracture was grout. The EDX technique produces a qualitative spectral graph in which a high peak for silica and calcium verifies that the examined material is grout.

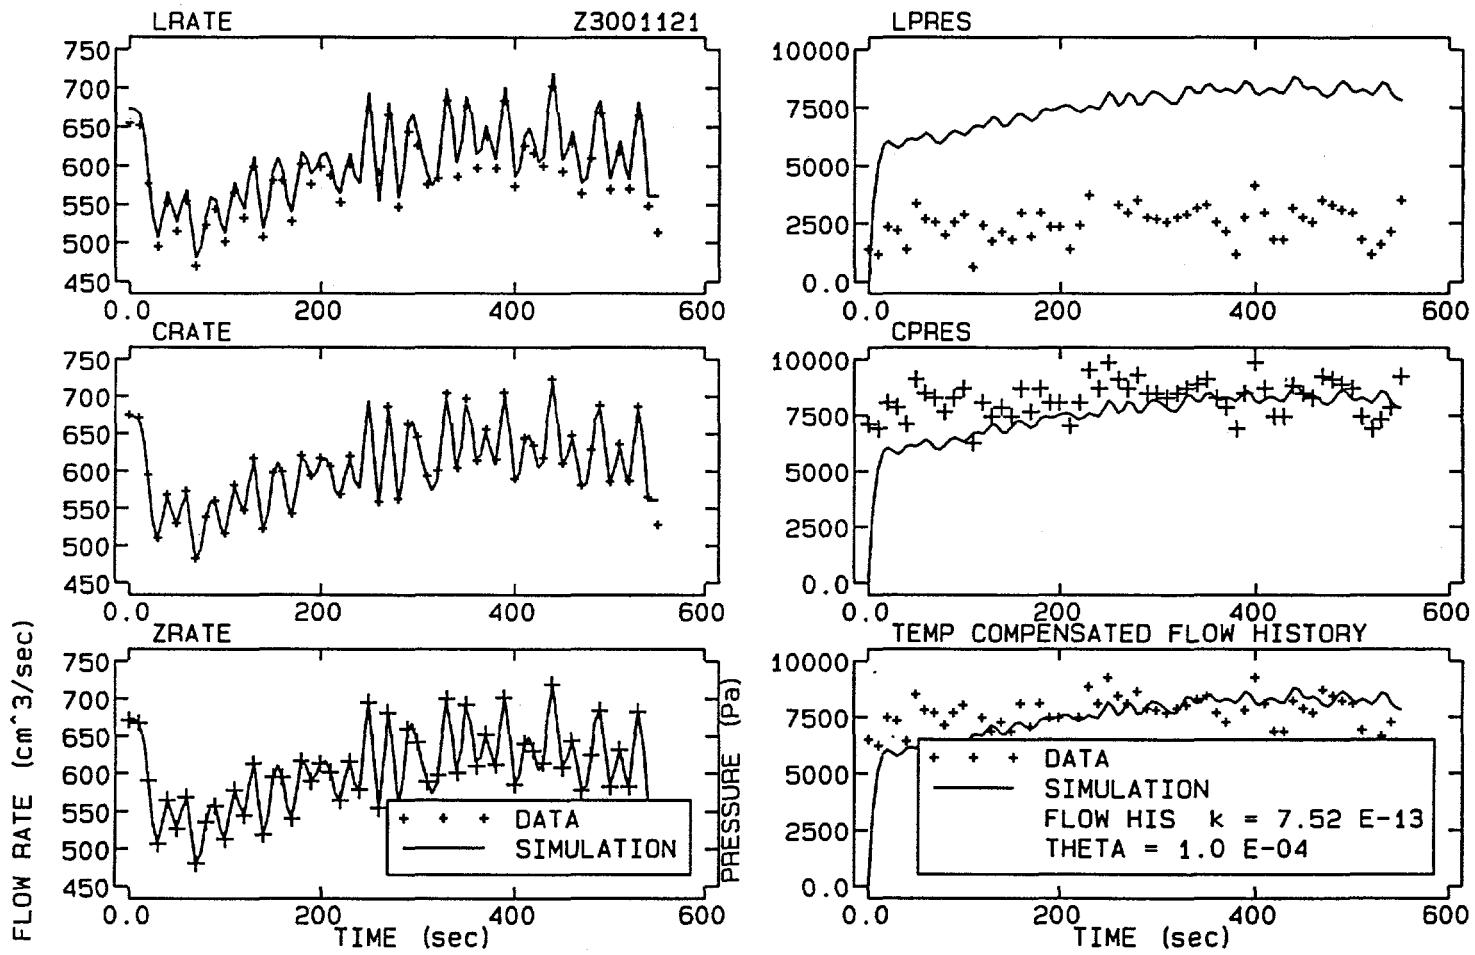
Figure 1. Comparison of as-observed data (LRATE, LPRESS), non-voltage-compensated data (CRATE, CPRESS) and temperature/non-voltage compensated data (ZRATE, ZPRESS) for test L3001121.

Figure 1 shows the pressure and injection-rate data from the three sets of data from the L3001121 test and the simulated test-zone pressure developed from the analysis of the data set including both voltage and temperature compensation. The plots show that the test data have the same form but are offset along the y-axis of the plots. The greatest difference in the observed transducers responses are observed to have been generated from the voltage compensation and only a slight difference is noted due to the temperature compensation. The analyses of the different data sets are summarized in Table 3 and the tabulated data indicating the differences in permeabilities determined from the as-recorded data and those estimated using the compensated data. The results are within one-half order of magnitude for the L3001121 data and very similar for the L3001326 data.

Because the original transducer calibrations for these transducers cannot be repeated and because the transducers are now inoperable and cannot be reevaluated, performing reanalyses on voltage- and temperature-compensated data for the entire series of gas-
