**Sandia National  
Laboratories/CA**

**June 2023**

**Yorke  
ENGINEERING, LLC**

**Exceedance Response Action (ERA)  
Level 2 Technical Report Update**

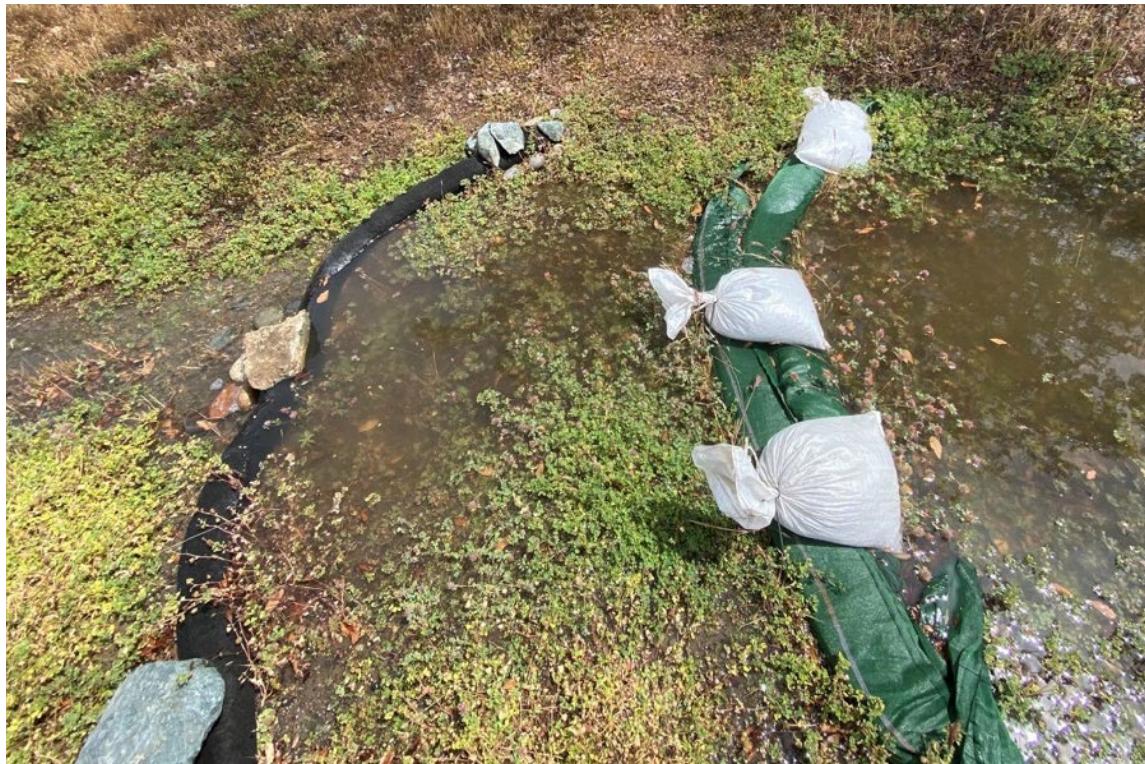
**Figure 6-1: DA-11 Sampling Area with Filter Socks Installed**

Ultratech Filter Socks with Heavy Metal Removal Media were installed in DA-11 and DA-13 in October 2021 before the rainy season commenced. These are shown in Figures 6-1 and 6-2 below. Also as shown in Figure 6-2, before the 2022-2023 Stormwater Year, Fabric was placed on the DA-13 impoundment walls to minimize soil erosion.
