Prospects of Full-scale Device Characterization via Ultra Short Pulsed Lasers with Dual Focused Ion Beams

International Union Of Microbeam Analysis Societies (IUMAS) Conference

June 13th, 2023

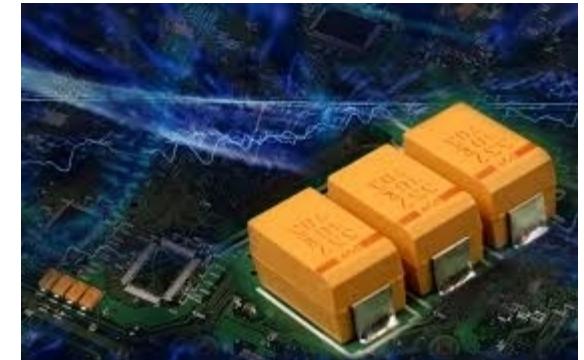
Capacitors

Requires cryogenic capabilities

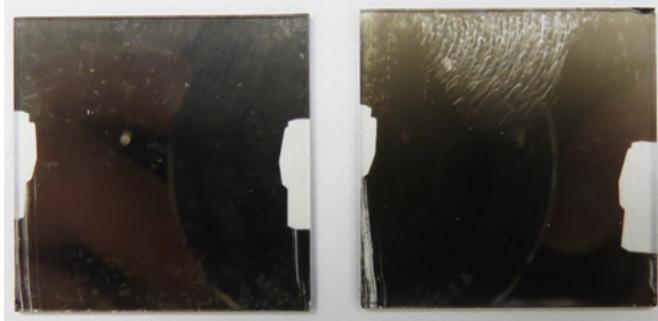
Glass slip after laser milling

Glass slip between laser and chamber prevents ablated material going back into the laser column

Must be changed periodically through cross-sectioning milling

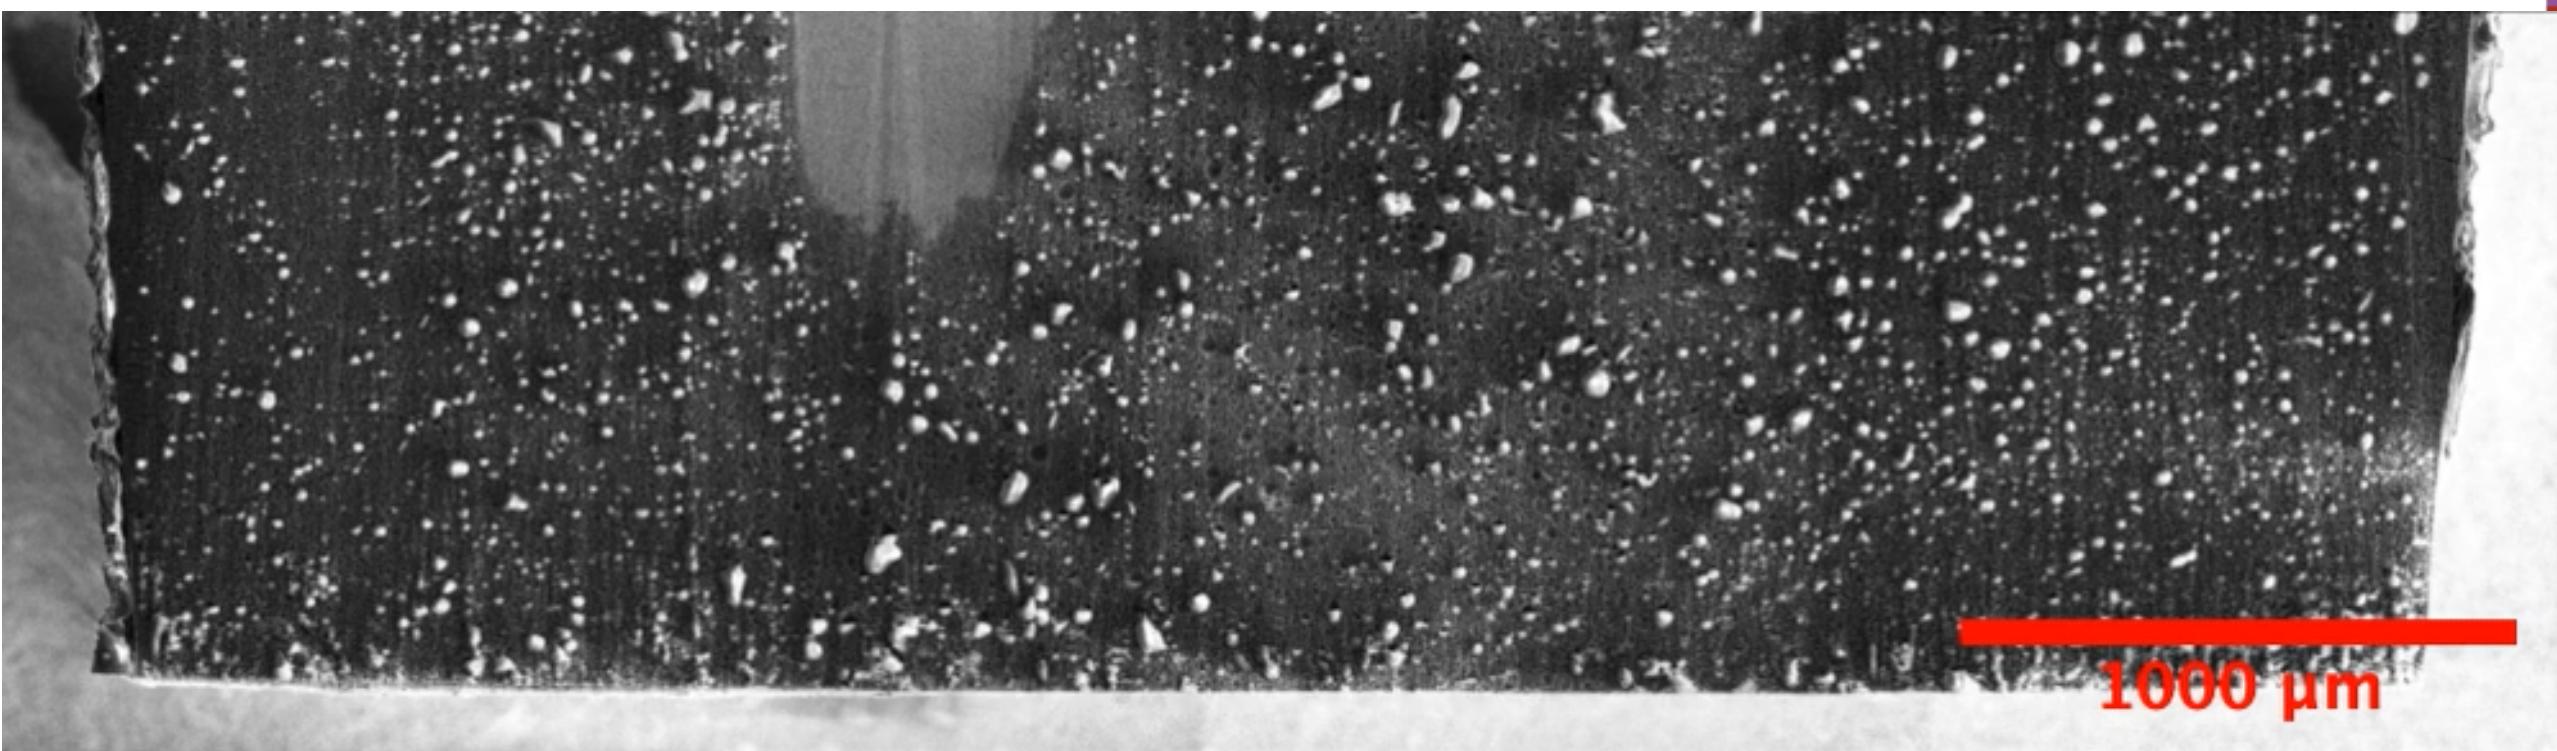
Ta Capacitor Failure

- Automated routine developed using iFAST scripting on laser PFIB
- Max width approx. 1.5 mm, so multiple slices were taken and resulting images stitched together to obtain large field of view
- 2 micron slice thickness, ~400 nm resolution in plane, 720 μm total sectioning depth, 360 slices, 12 min. slice time, 3 days of collection time
