ORNL/TM-13534

**X-231A Demonstration of
In Situ Remediation of
DNAPL Compounds in Low
Permeability Media by
Soil Fracturing with Thermally
Enhanced Mass Recovery
or Reactive Barrier Destruction**

March 1998

Prepared by
OAK RIDGE NATIONAL LABORATORY, AND COLLABORATORS FROM
FRx, Inc., AND COLORADO SCHOOL OF MINES

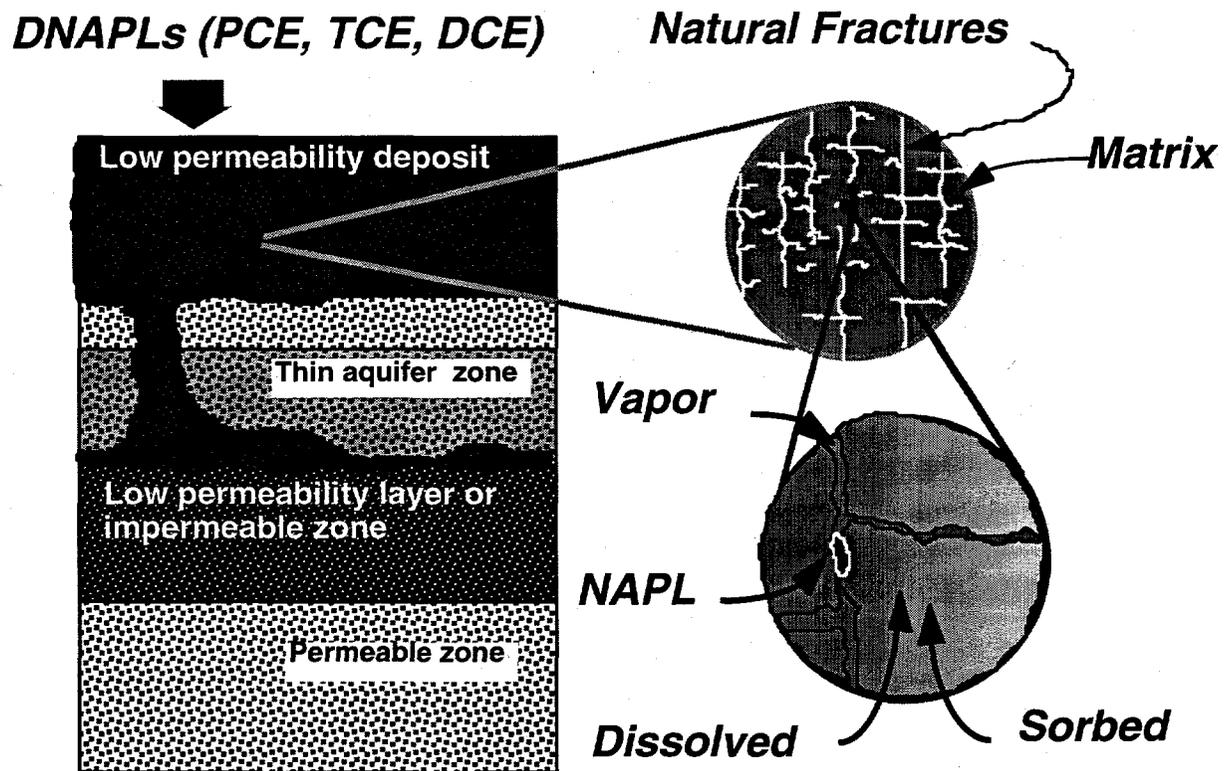
Figure 1.1. Illustration of the remediation problem posed by DNAPL compounds in low permeability media.

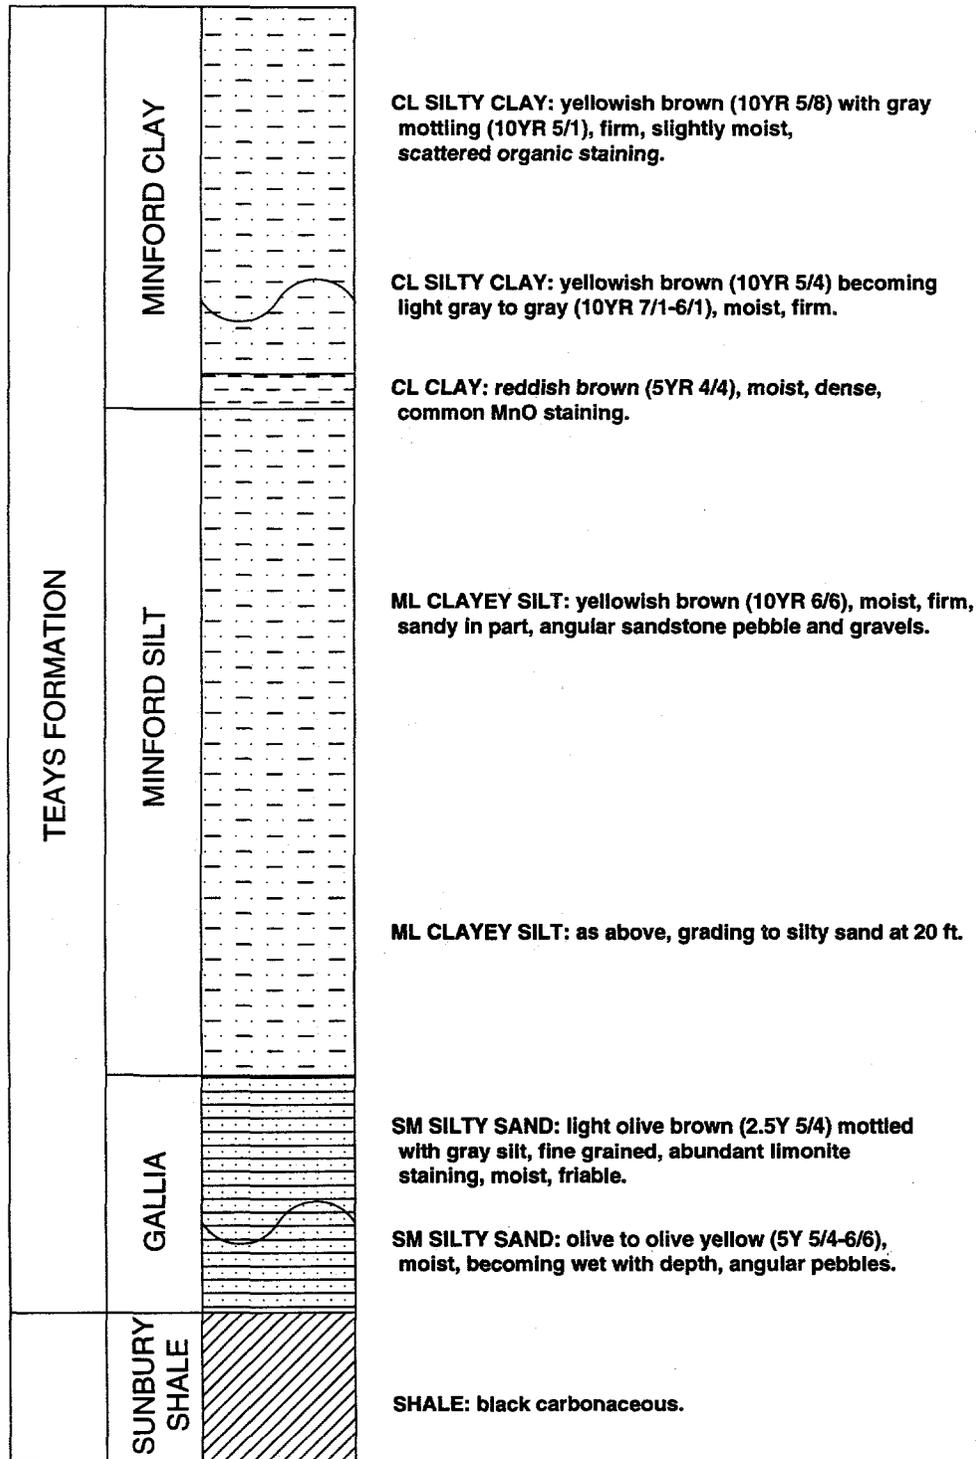
Figure 2.3. Representative lithology of the shallow subsurface at the DOE Portsmouth Plant.

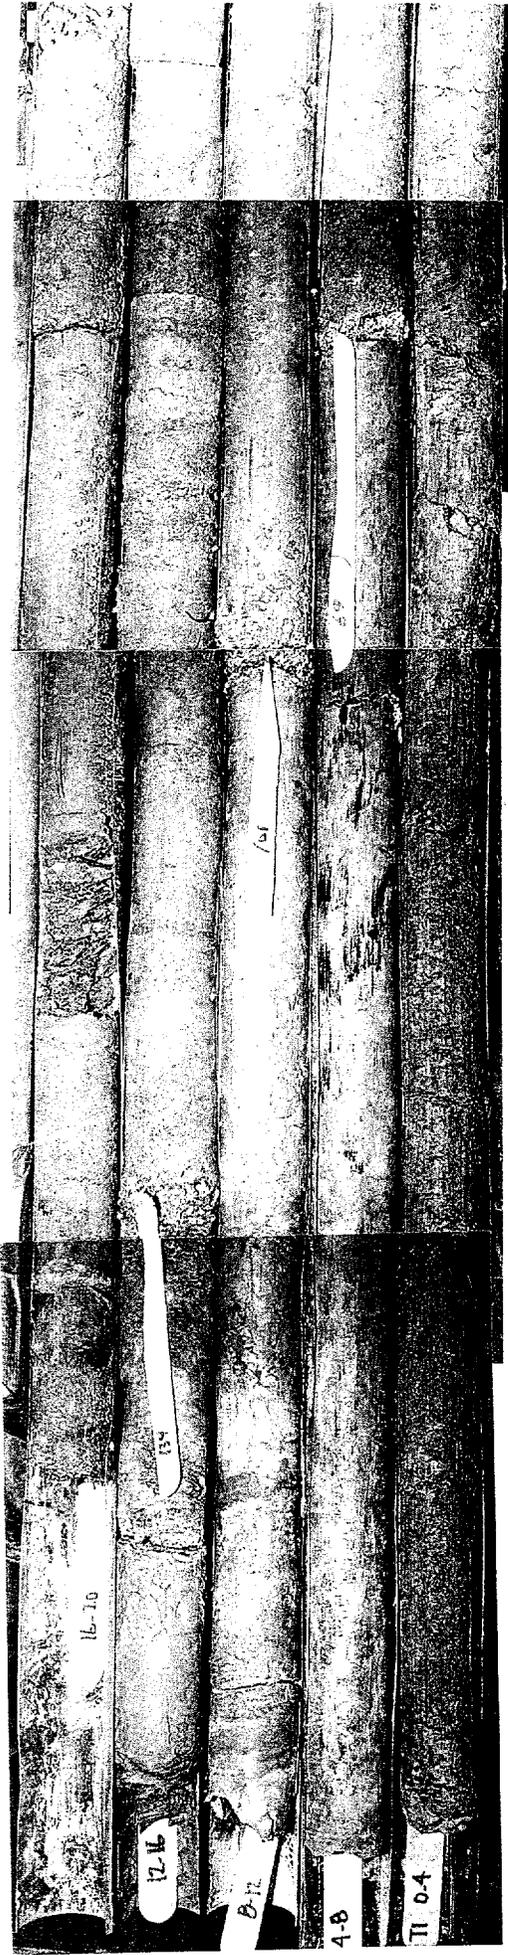
Figure 2.4. Photograph of the lithology of the DOE Portsmouth Plant as observed in a core sequence collected from the Clean Test Site during May 1996.

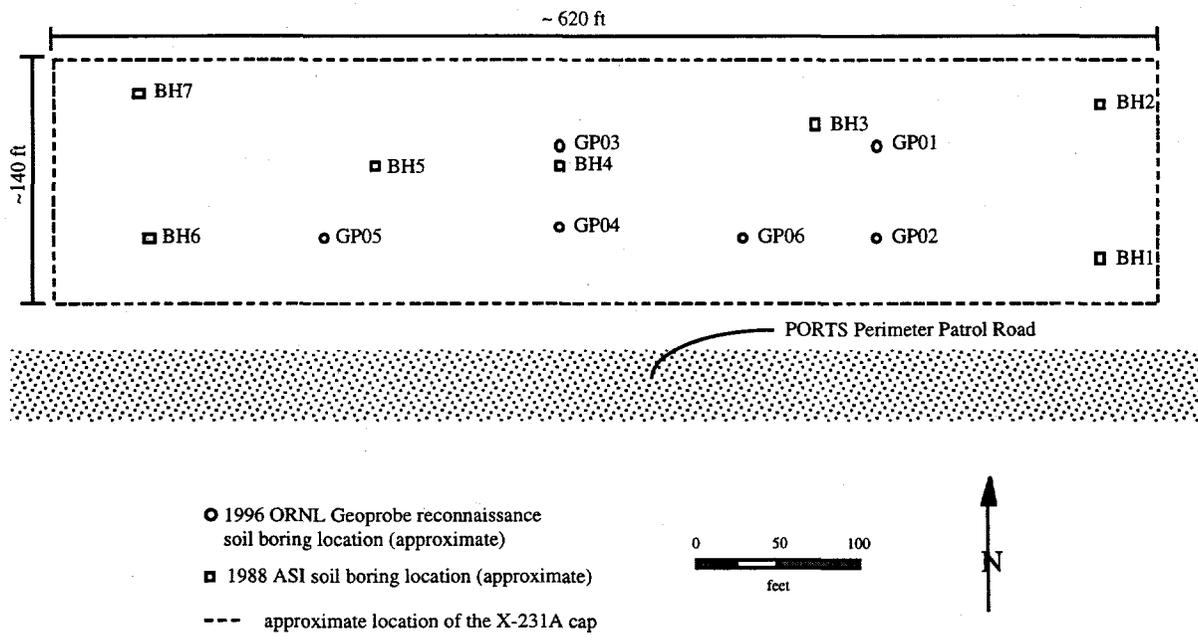
Figure 2.6. Location of May 1996 reconnaissance probe holes and historical borings within the X-231A site.

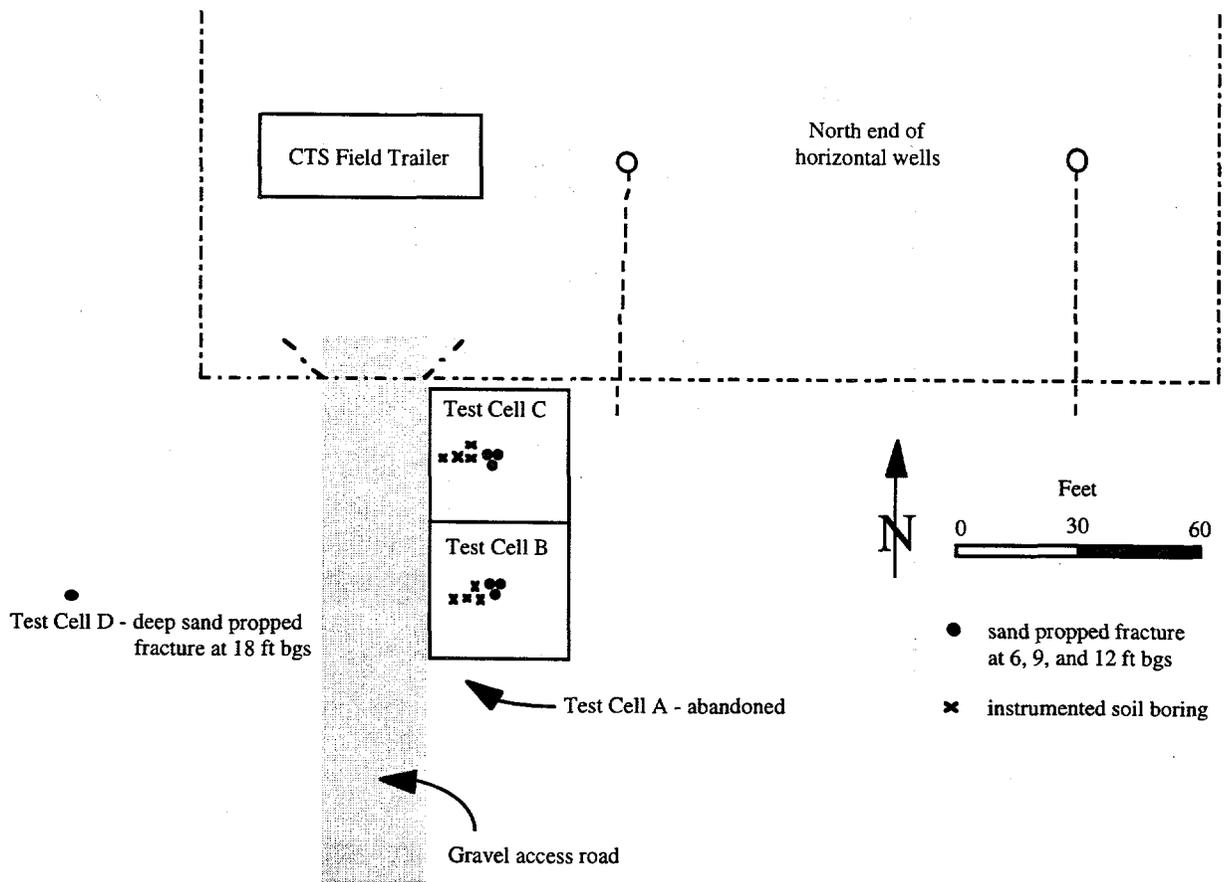
Figure 2.7. Location of the pilot-test fracture cells at the PORTS CTS.

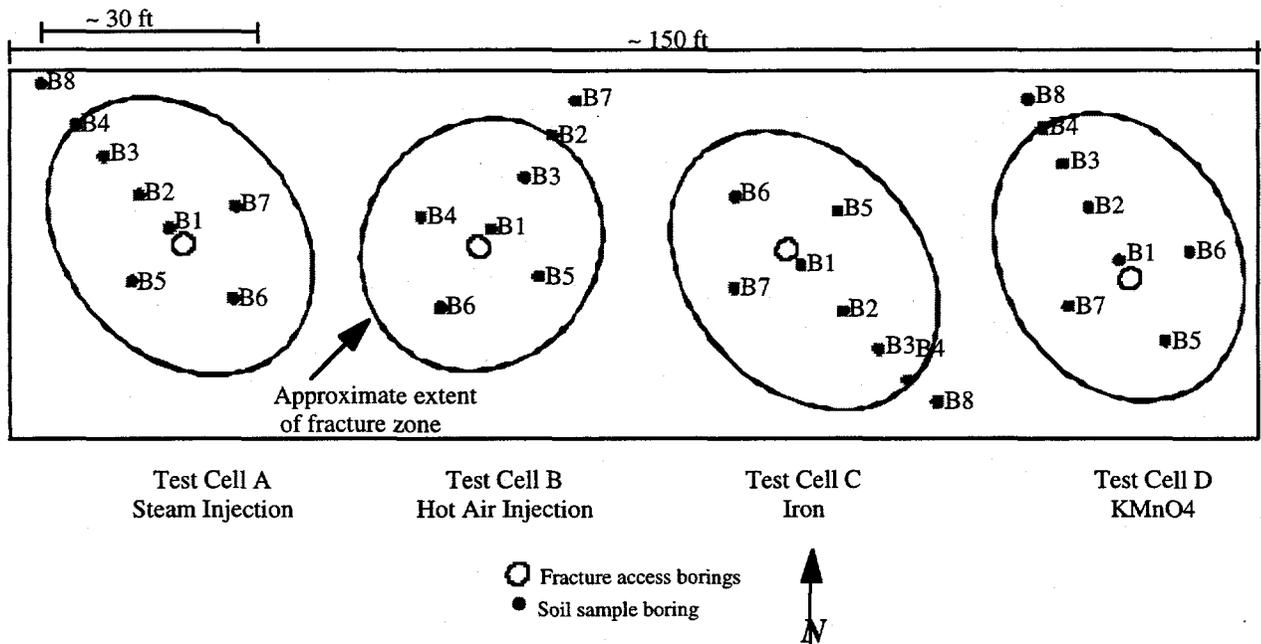
Figure 2.8. X-231A test cell layout and baseline characterization soil boring locations.

(b) Test cells A to D and the initial borings made after fracture emplacement.

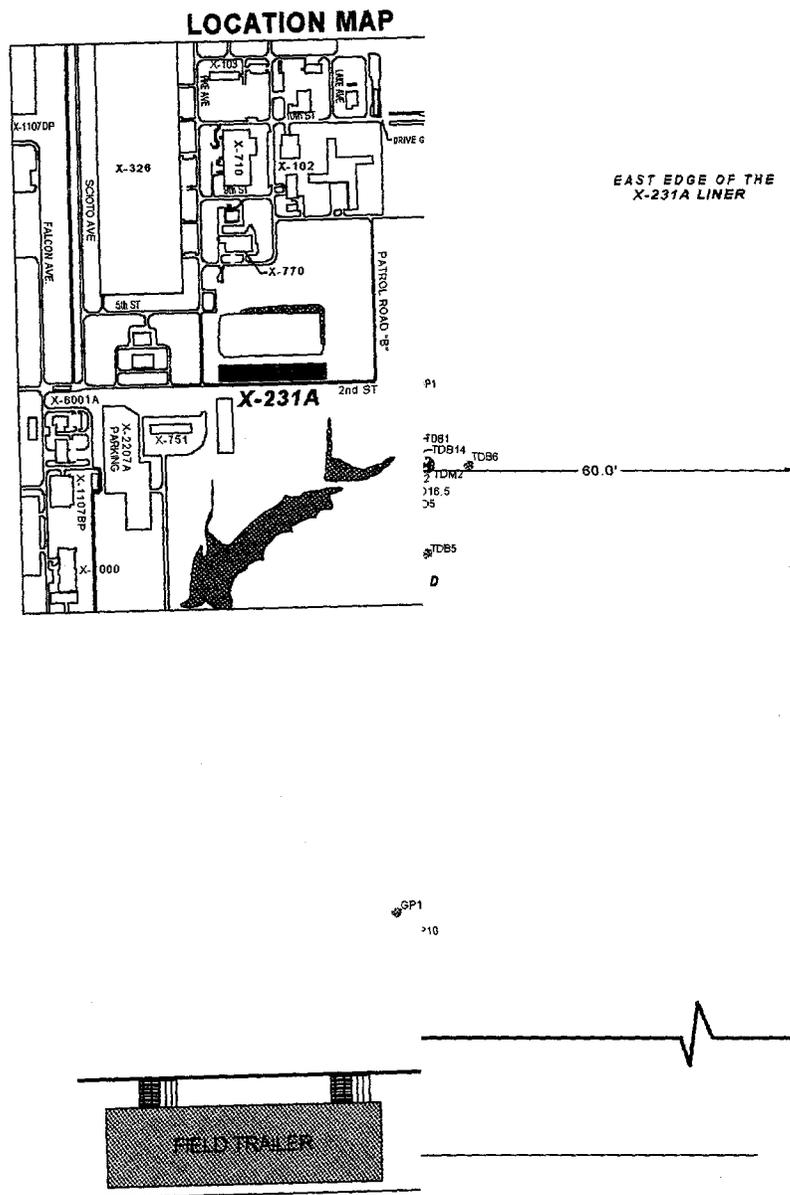
Figure 2.10. X-231A demonstration site plan via monitoring locations.

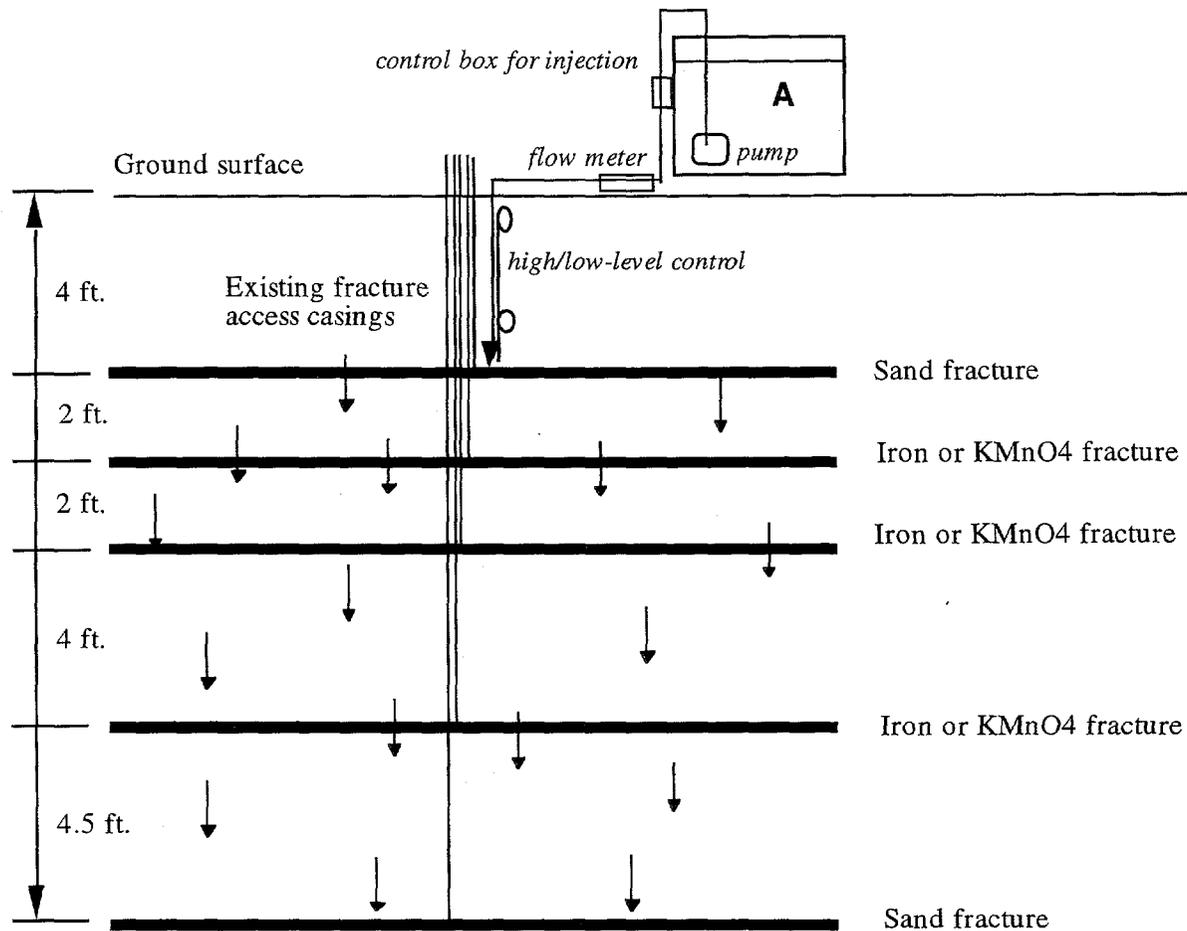
Figure 2.11. Illustration of the water infiltration/percolation system used for test cells C and D during summer 1997.

Notes: Basin A is a 500 gal tank filled with potable water supplemented by a 100 mg/L NaBr tracer solution for injection into either test cell C or D. The discharge from Basin A was controlled by a set of high and low-level float switches installed in the shallow fracture access casing. The float switches provided a constant head of 1 to 3 ft. in the shallow sand-filled fracture. The delivery pump in Basin A was operated continuously or intermittently depending on the acceptance rate of the shallow fracture. Basin A fed both test cells C and D via two independent high and low-level switches in the fractures and the associated control boxes and flow meters located at the feed basin.

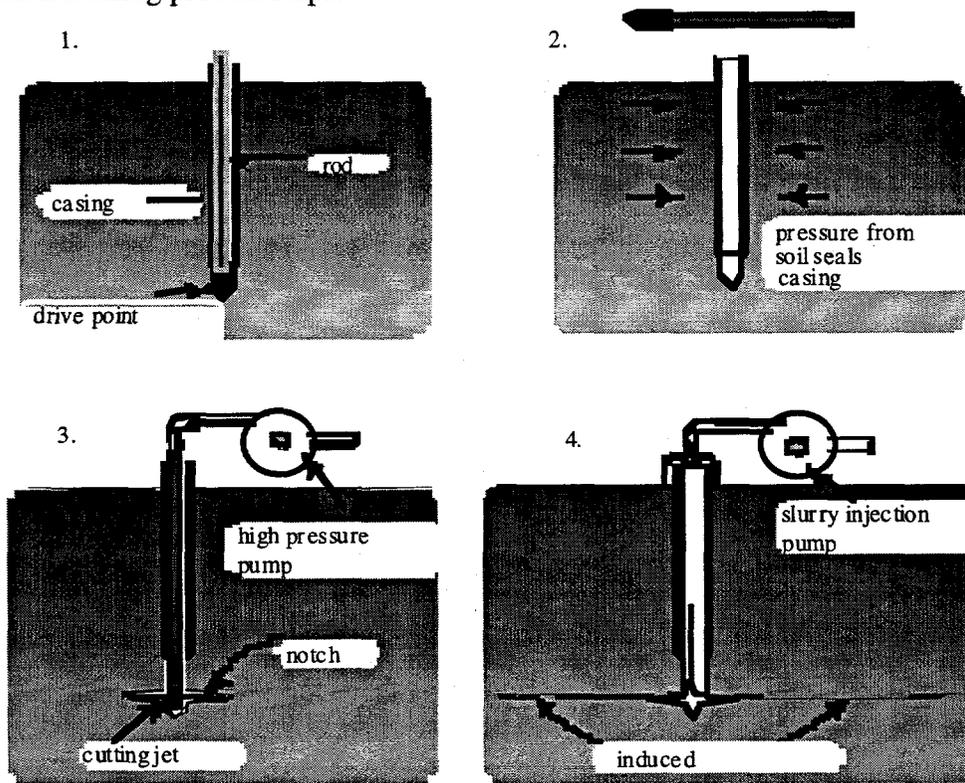
Figure 2.12. Illustration of the hydraulic fracturing process.
 (a) General fracturing process steps.

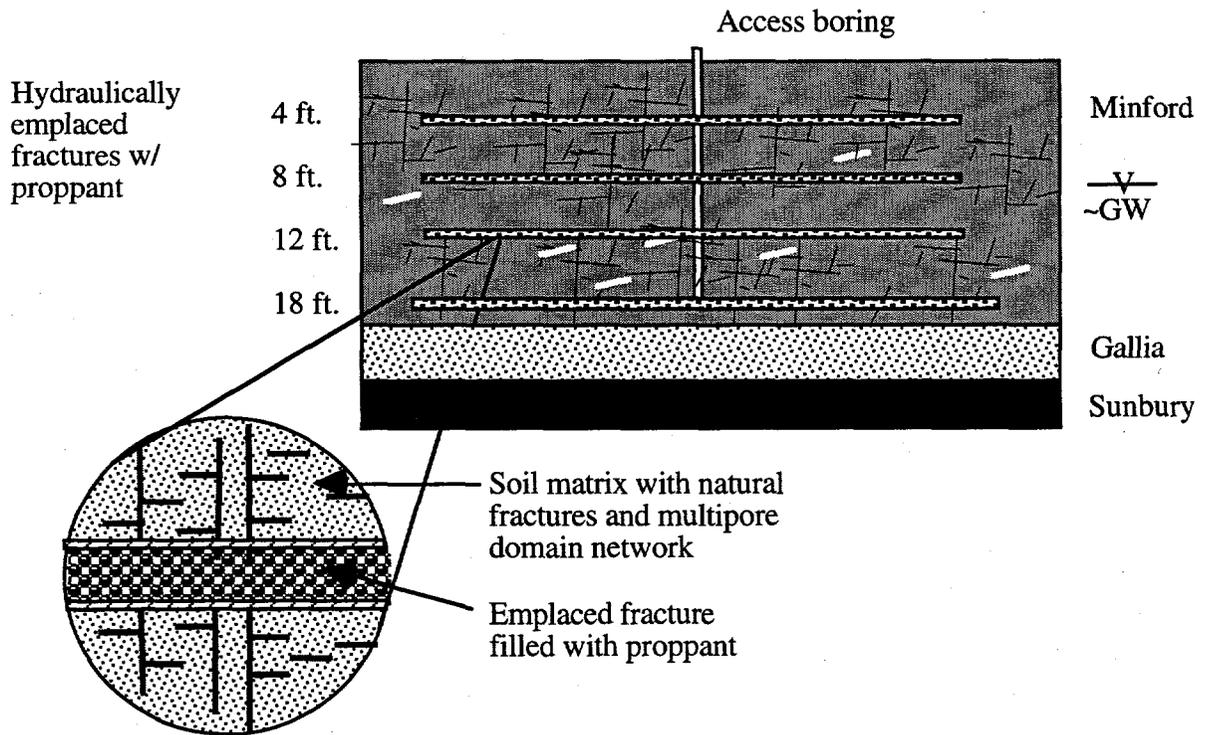
(b) Cross-section illustrating the features of a fracture-enhanced test cell.

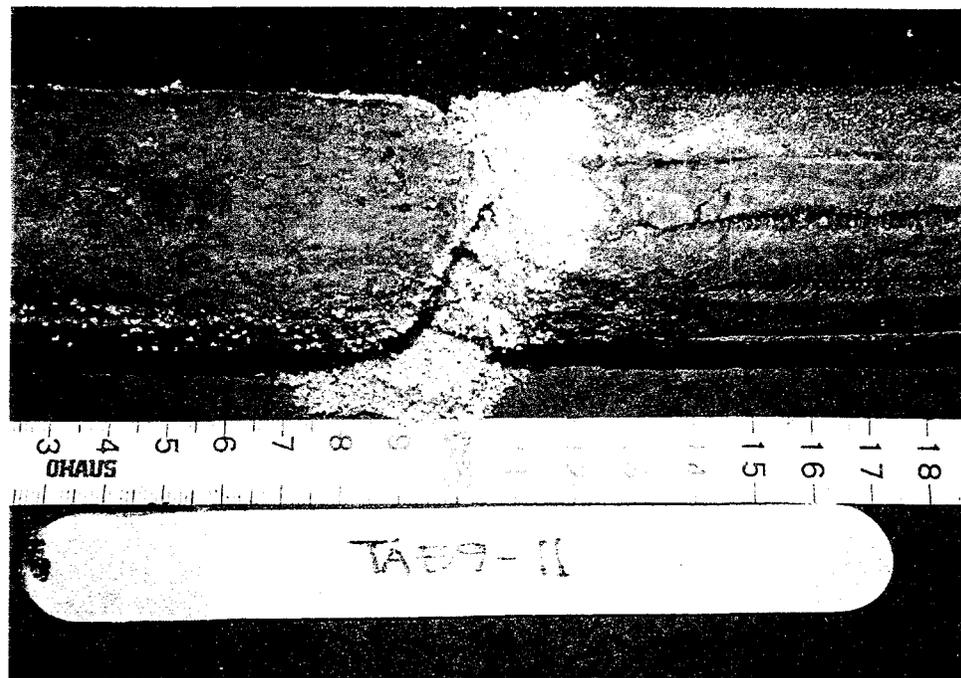
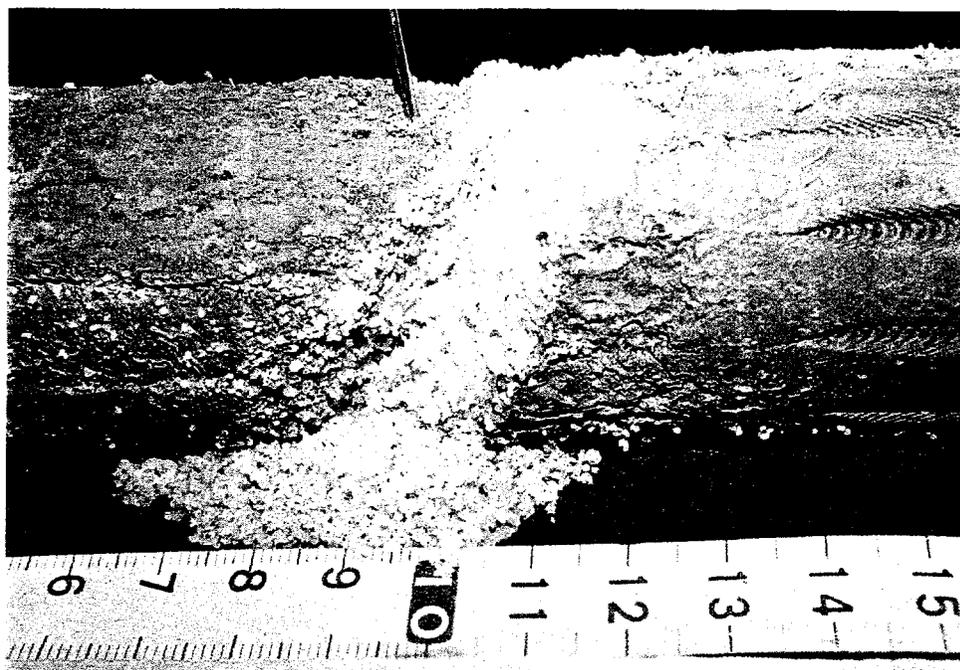
Figure 3.1. Photograph of a sand propped fracture.

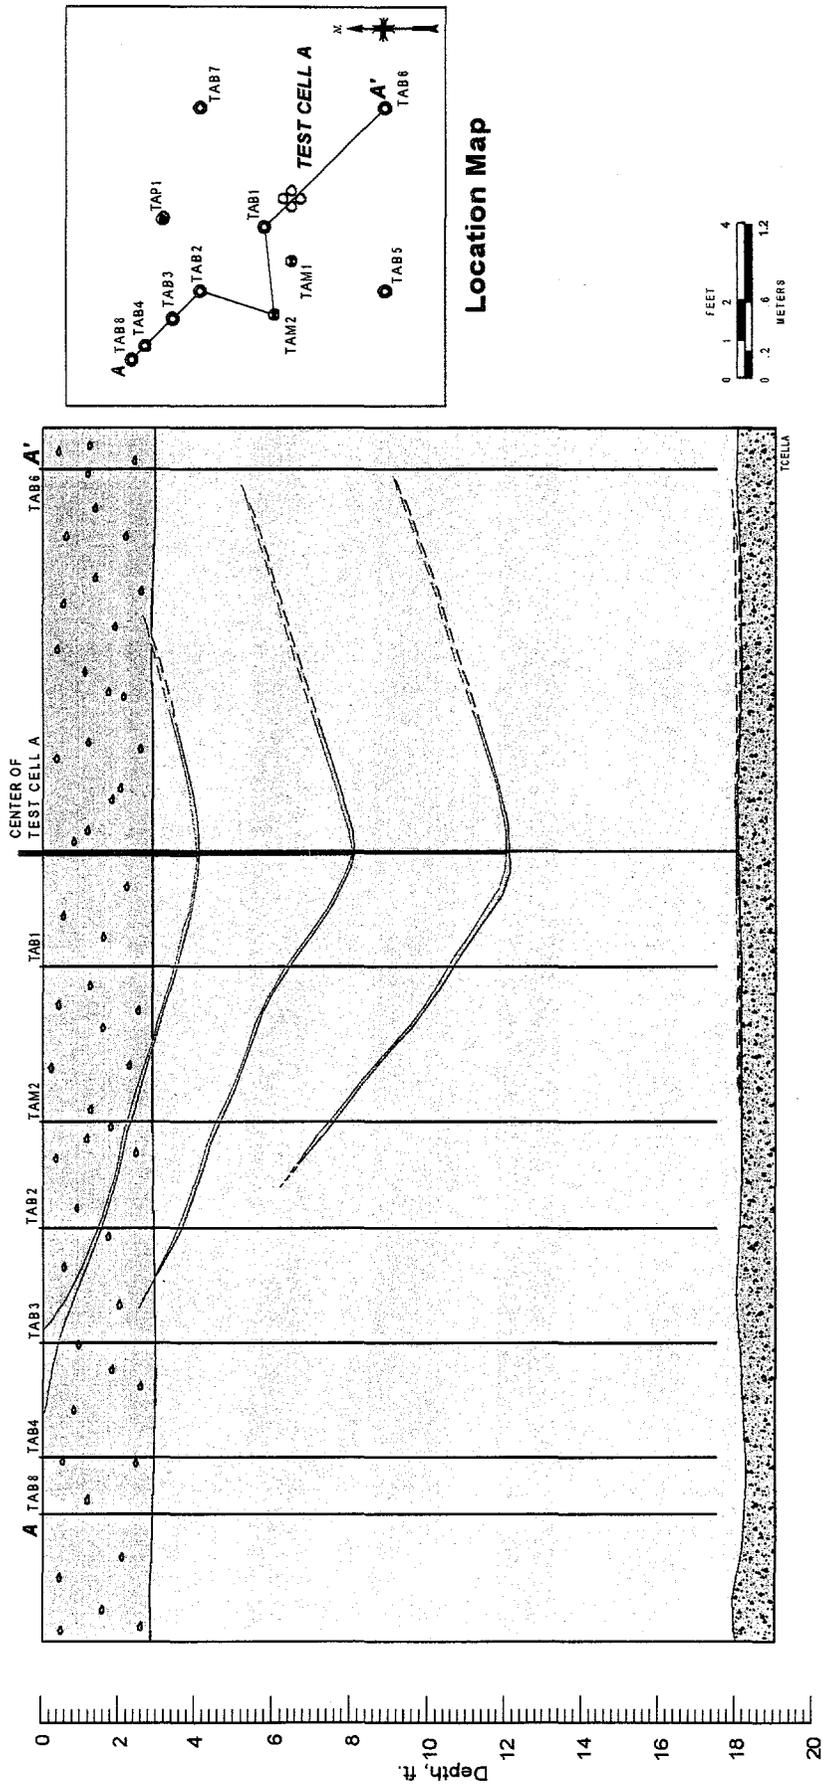
Figure 3.2. Test cell A fracture profile.

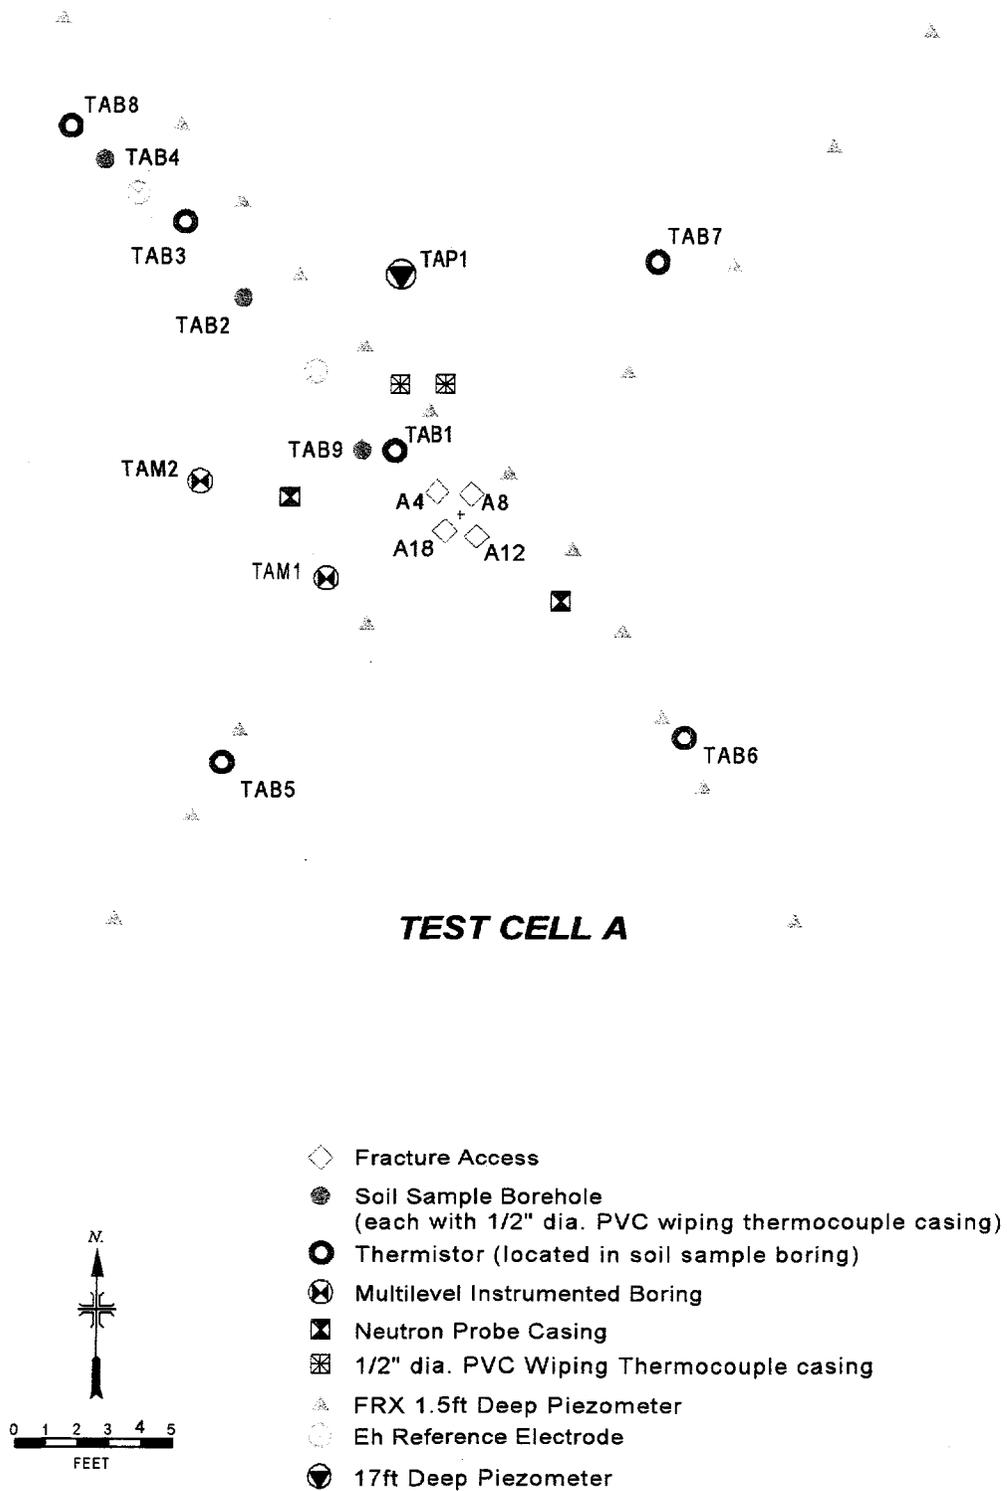
Figure 3.3. Test cell A monitoring locations.

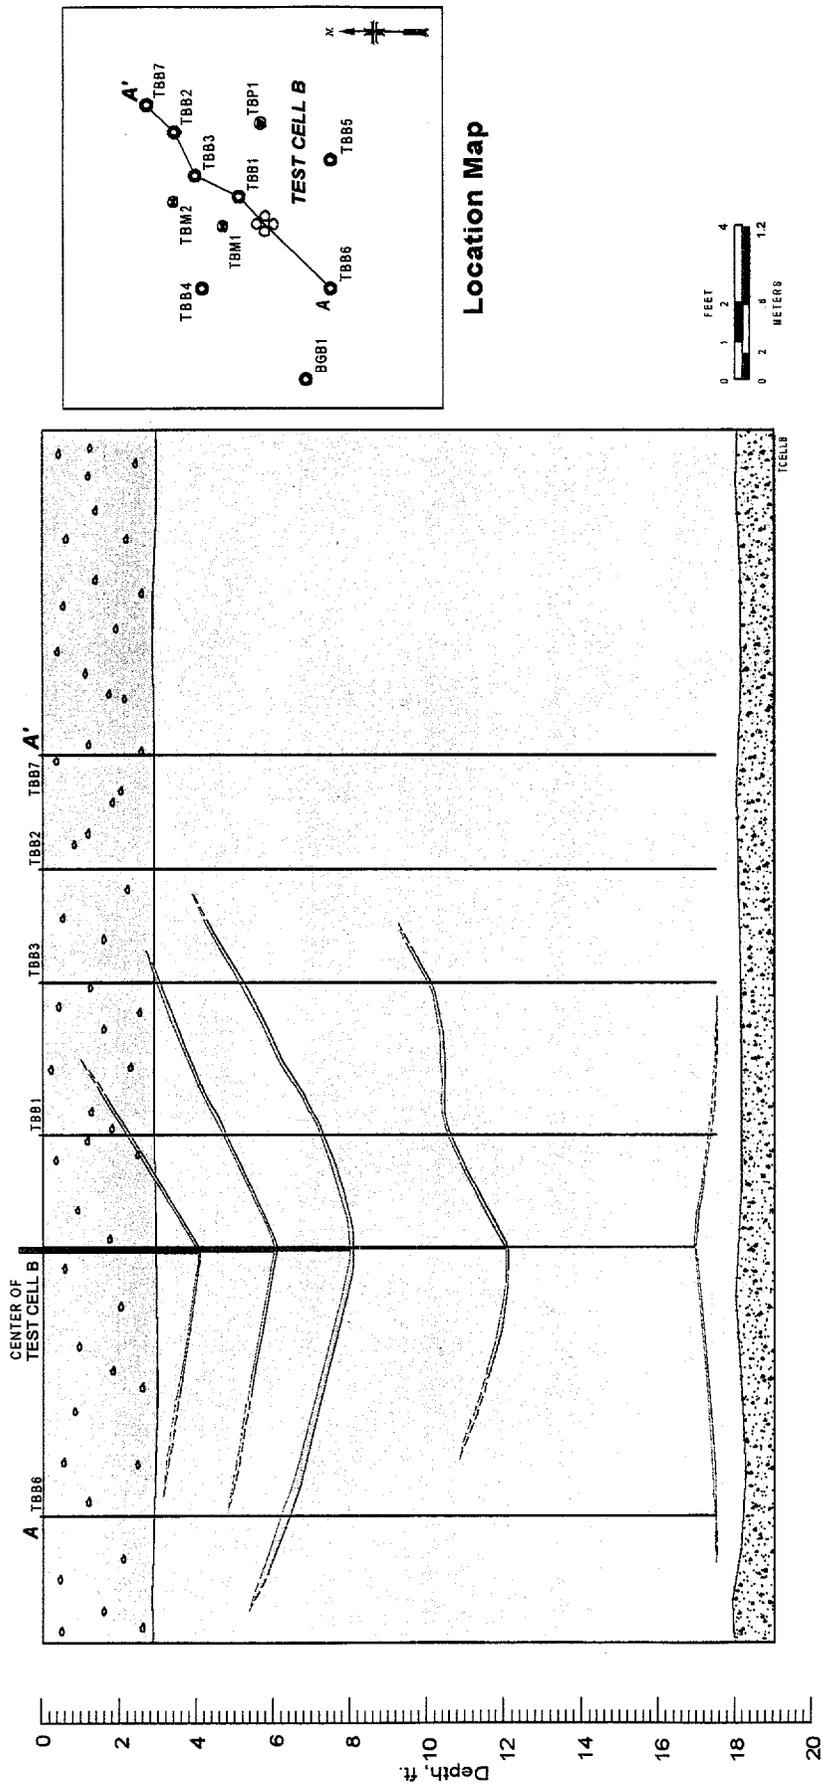
Figure 3.4. Test cell B fracture profiles.

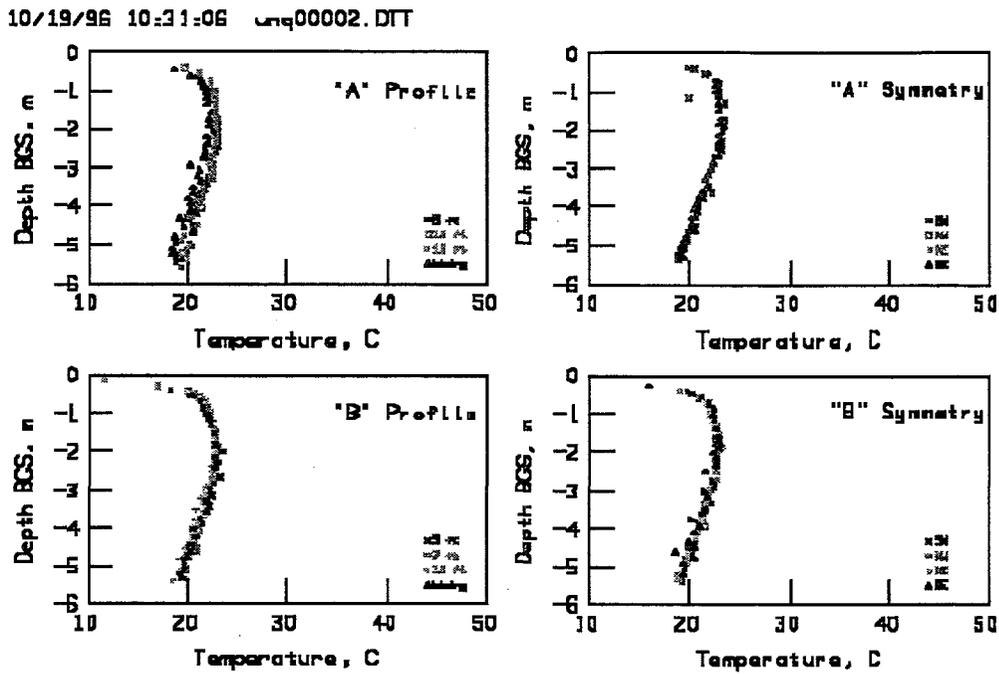
Figure 3.6 Initial temperature profile, 1996.

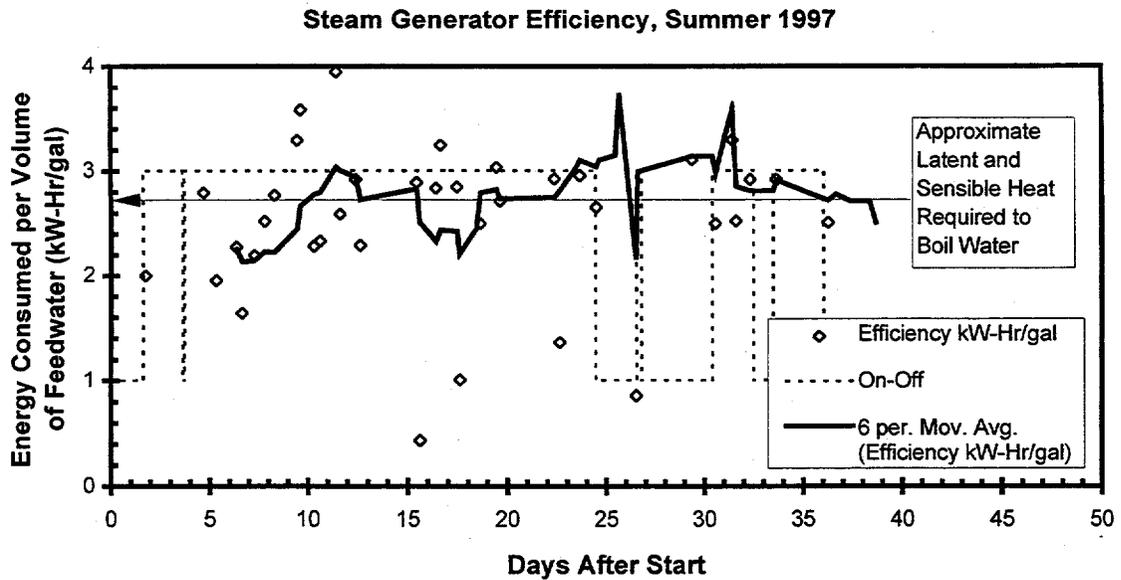
Figure 3.21 Steam generator efficiency, summer 1997. Effectiveness computed as the ratio of incremental water consumed to incremental energy consumed. The on/off state of the generator indicated by the upper/lower level of the dashed line.

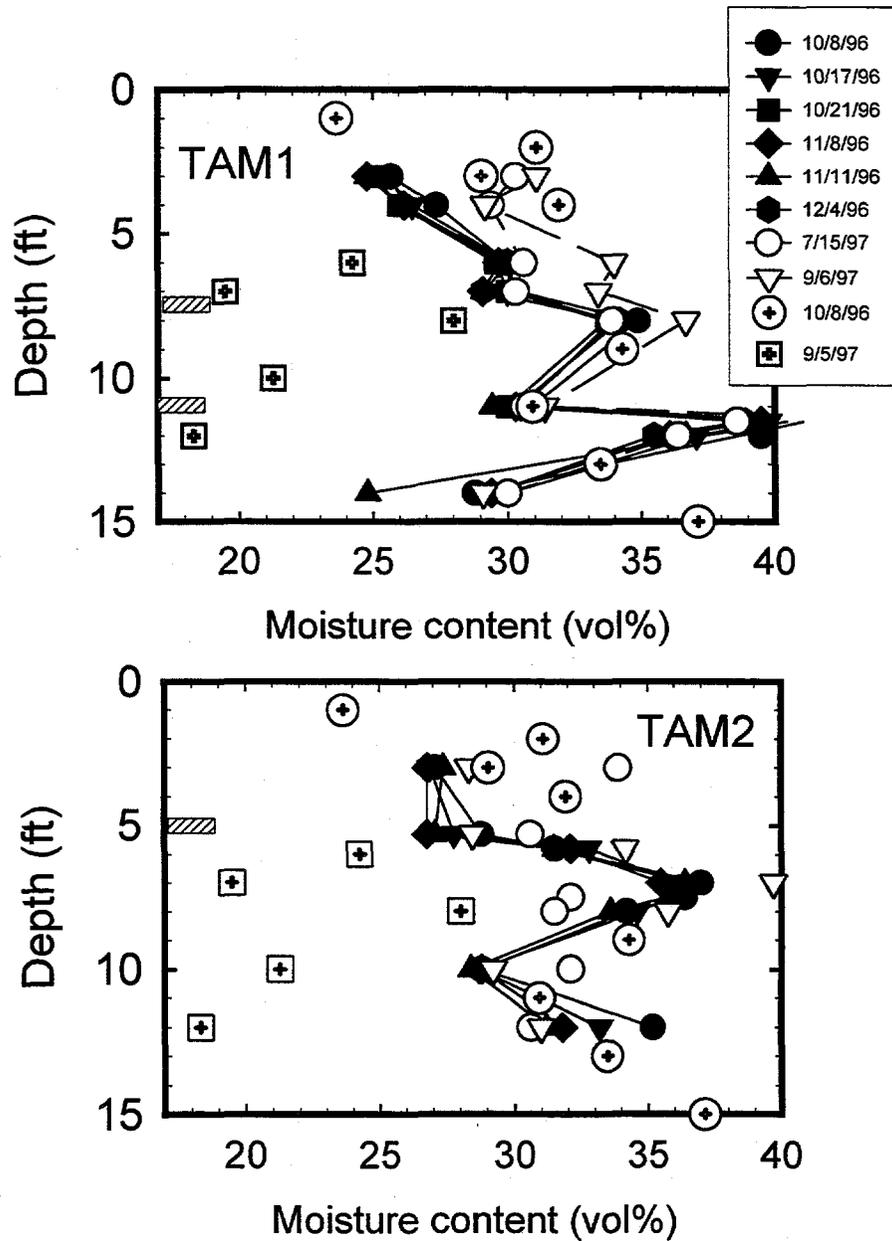
Figure 3.22 Volumetric moisture content as a function of depth and time in Cell A. Boring M1 (upper) and M2 (lower). Open symbols are from Fall, 1996, filled symbols from Summer, 1997, measured using TDR. Circles with internal cross measured in lab before testing (Fall 1996), squares with internal cross measured in lab after testing (Fall, 1997).

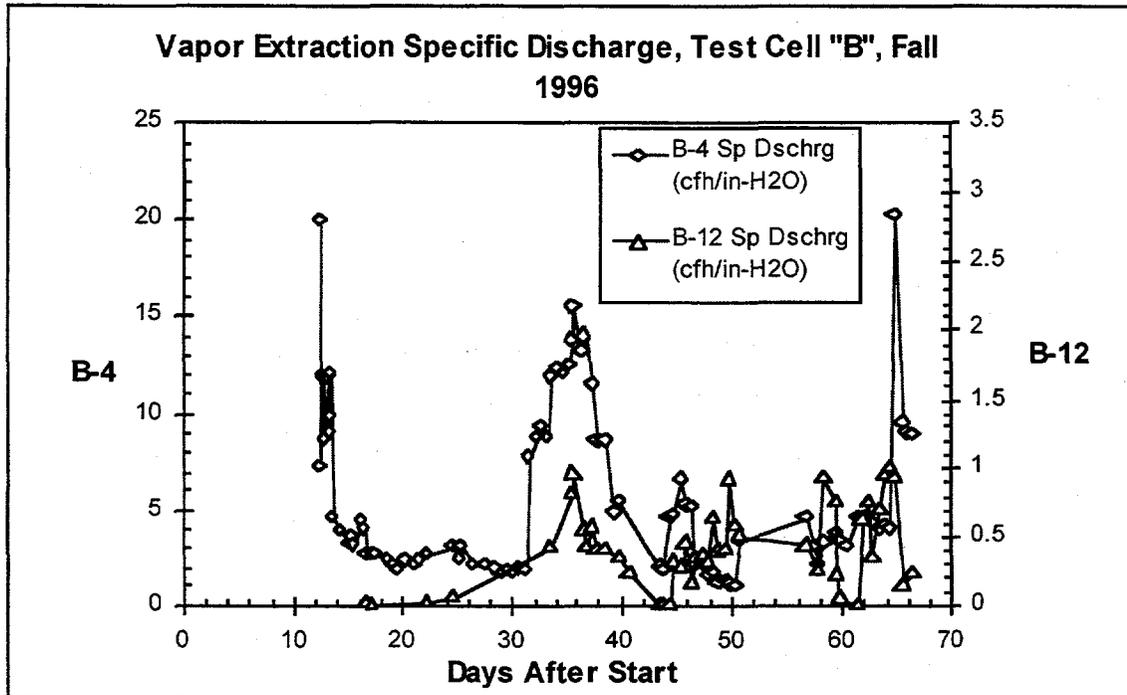
Figure 3.35 Specific discharge of test cell B vapor extraction during fall 1996 tests.

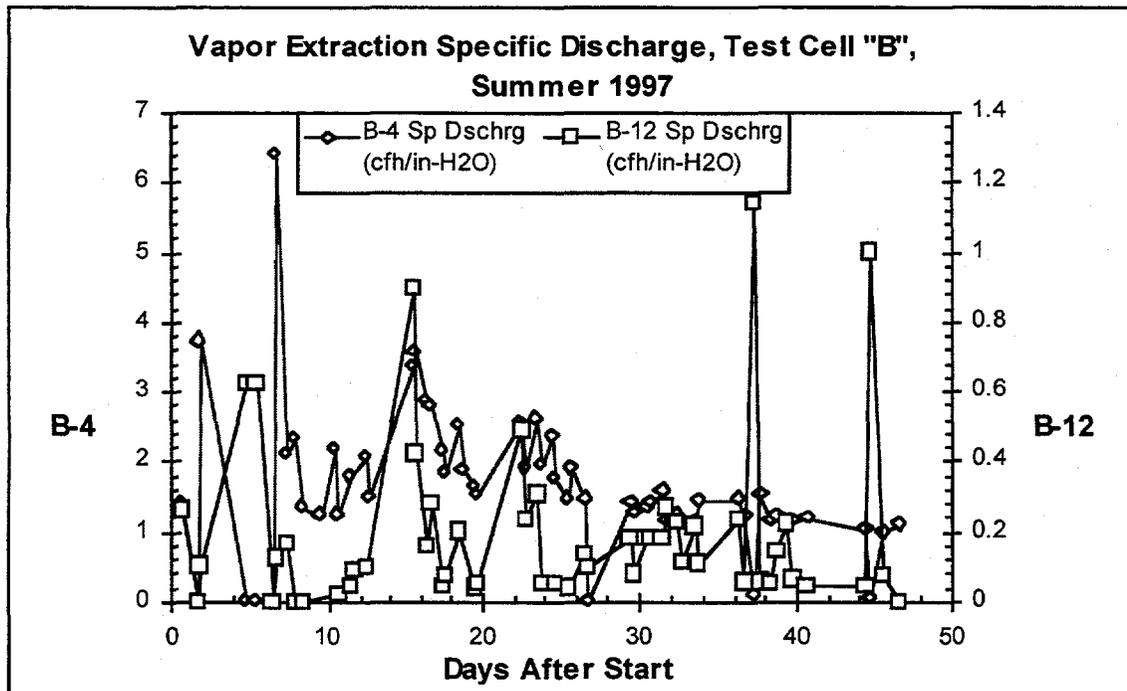
Figure 3.36 Specific discharge of test cell B vapor extraction during summer 1997 tests. Specific discharge calculated as the ratio of measured flow rates and observed pressures.

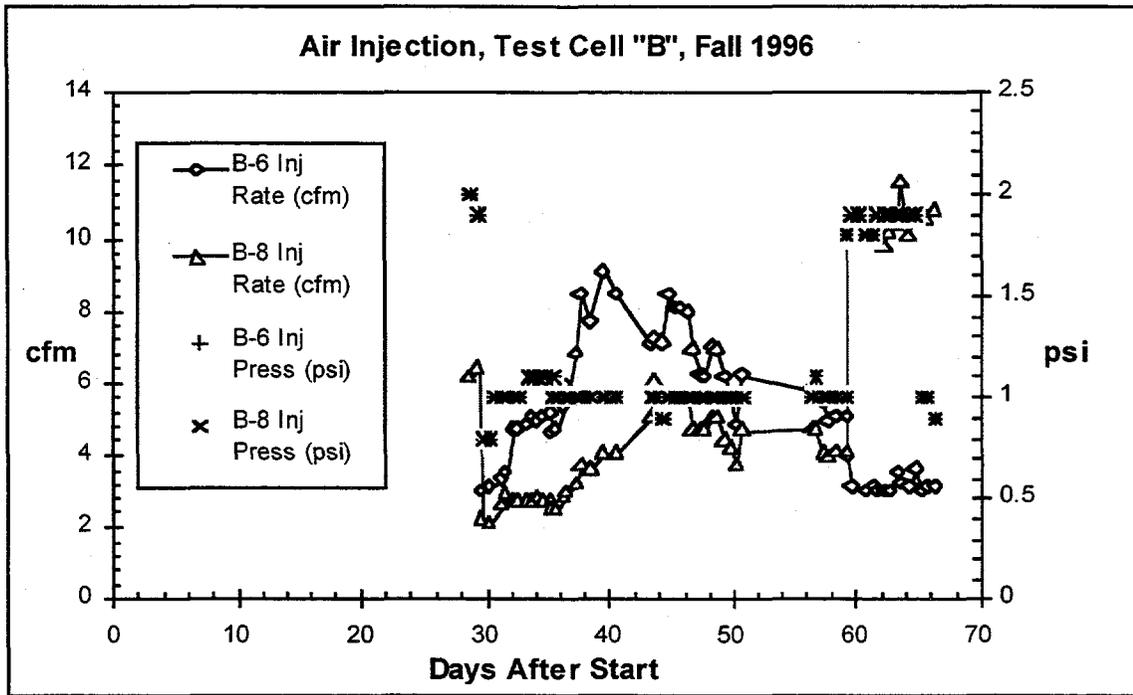
Figure 3.37 Air injection rate and pressure, fall 1996.
 Flow rates measured by variable are flow meters and pressure by dial gage.
 Injection stream of a single compressor was delivered to both B-6 and B-8, so
 injection pressures into the two fractures were identical.

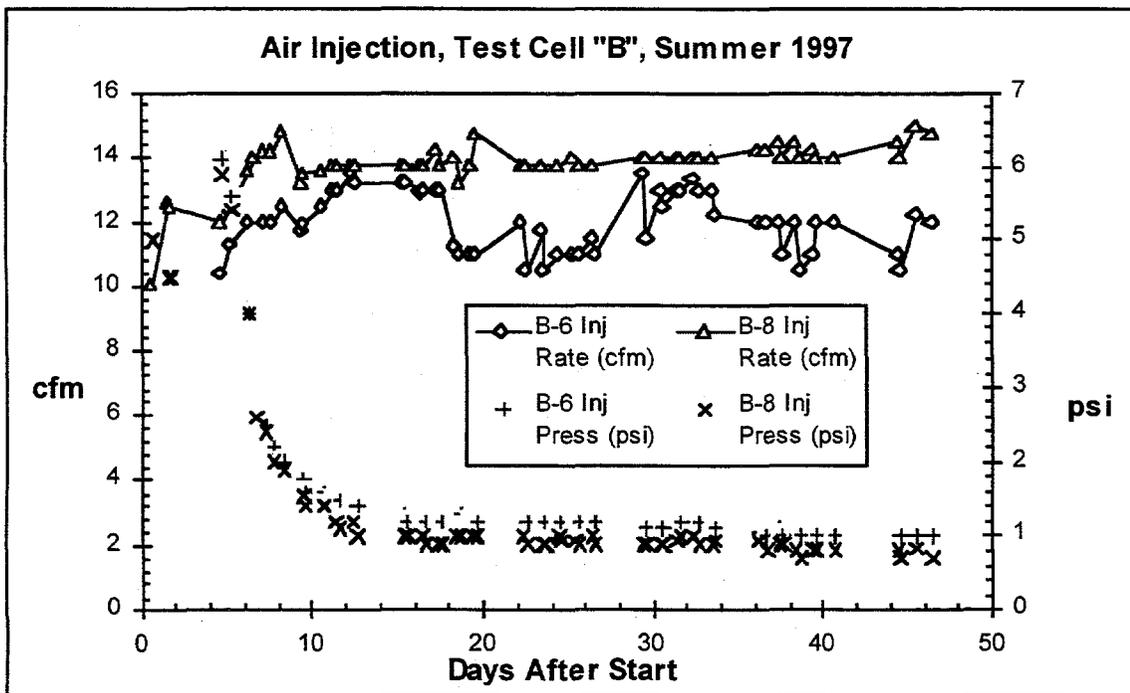
Figure 3.38 Air injection rate and pressure, summer 1997.
 Flow rates measured by variable are flow meters and pressure by dial gage. A
 separate compressor was used for each fracture.
