ORNL/TM-13534

**X-231A Demonstration of
In Situ Remediation of
DNAPL Compounds in Low
Permeability Media by
Soil Fracturing with Thermally
Enhanced Mass Recovery
or Reactive Barrier Destruction**

March 1998

Prepared by
OAK RIDGE NATIONAL LABORATORY, AND COLLABORATORS FROM
FRx, Inc., AND COLORADO SCHOOL OF MINES

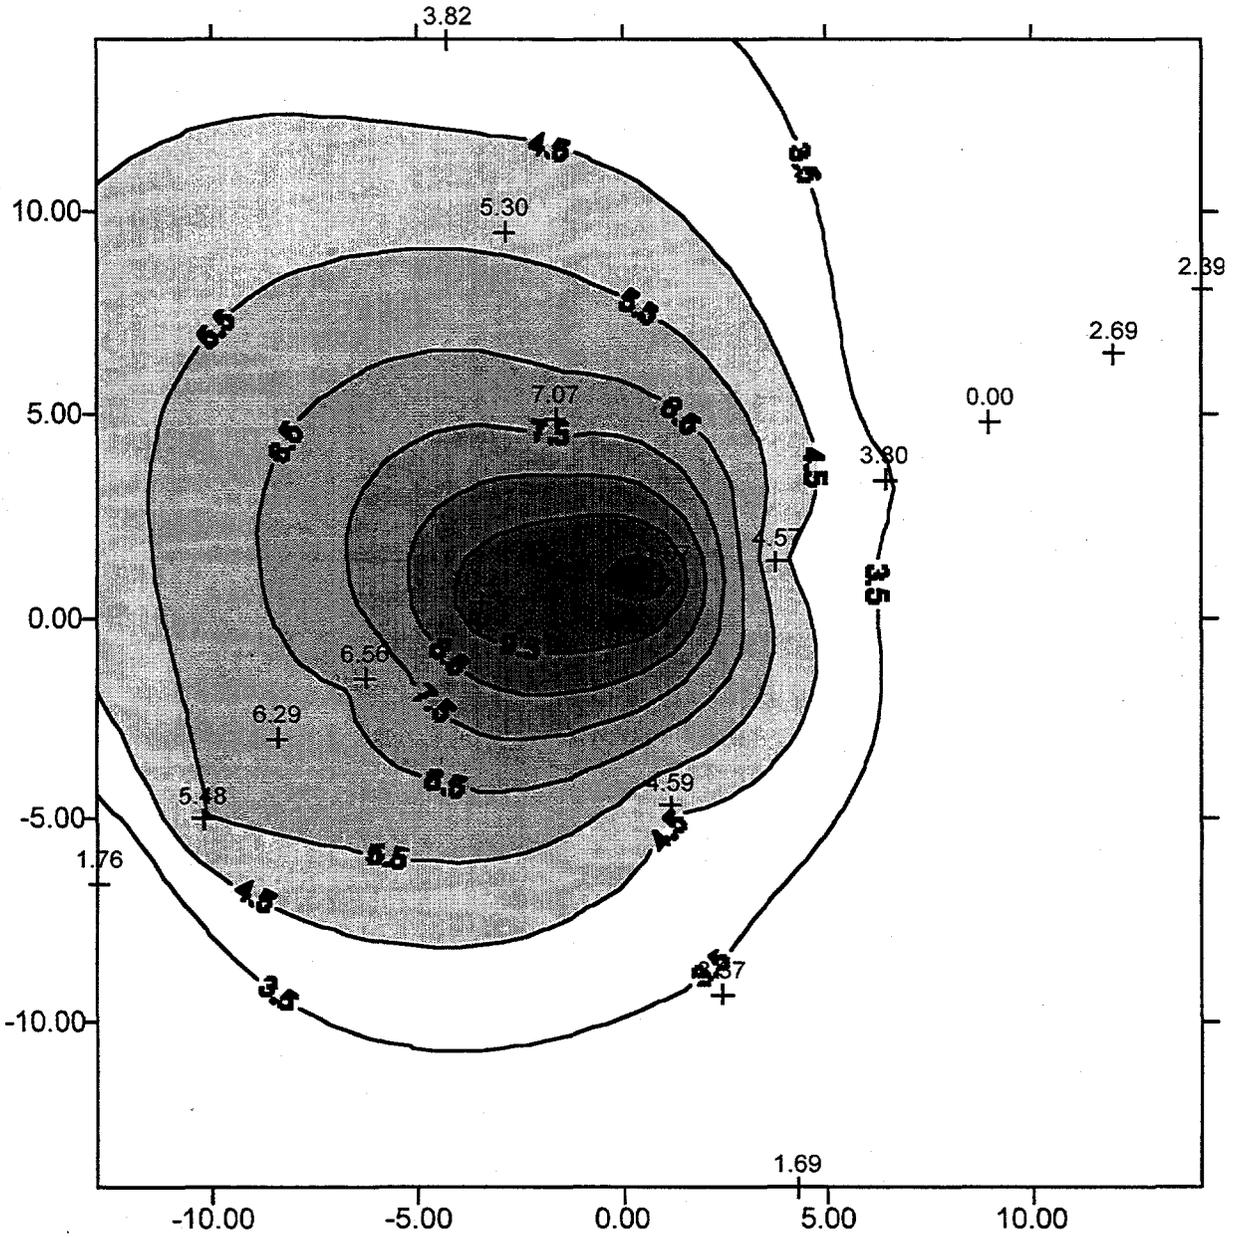
Figure 3.43 Near surface pressures in test cell B.
 Air pressures at shallow depth (1.5 ft) in test cell B during hot air injection and vapor extraction at the end of the summer 1997 test. Contours are in inches-H₂O pressure relative to atm.

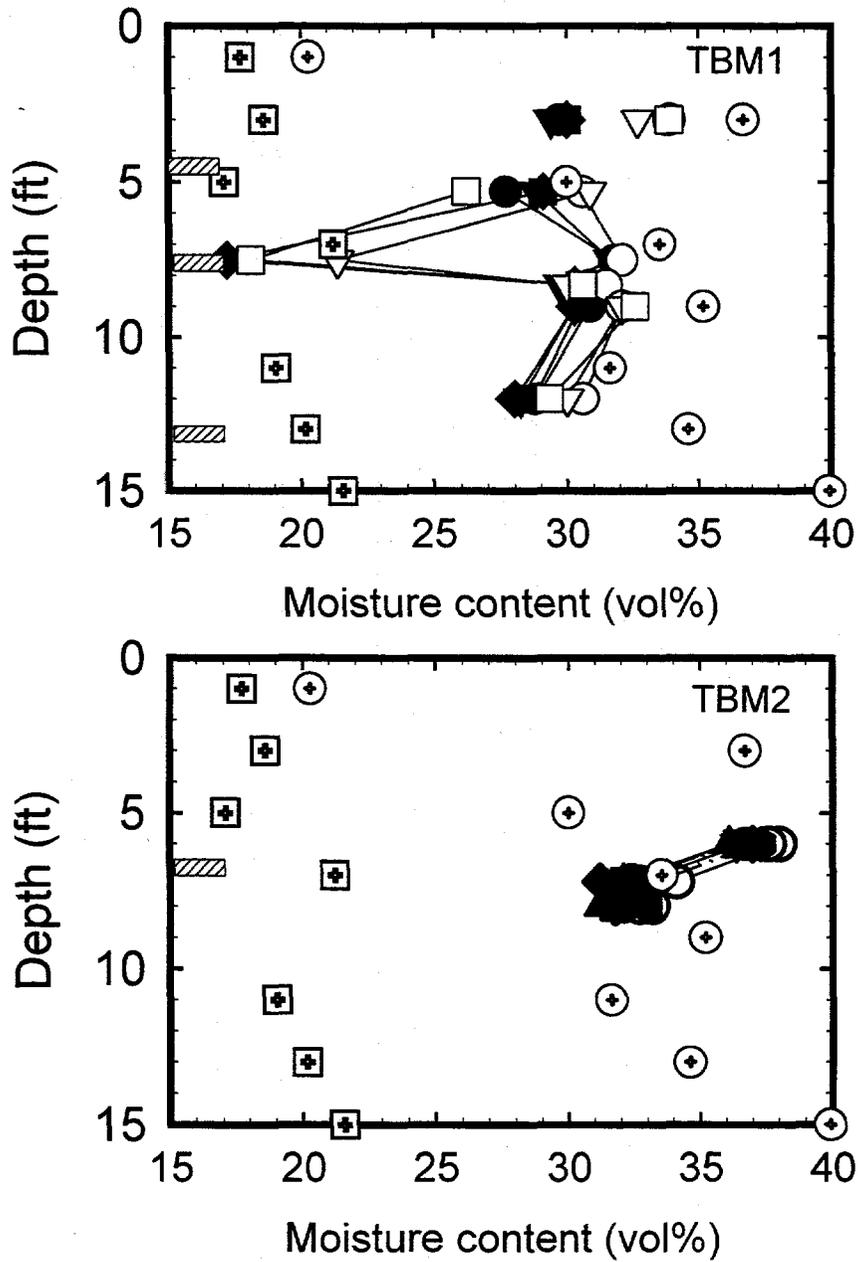
Figure 3.44 Volumetric moisture content as a function of depth and time in Cell B. M1 (upper) and M2 (lower). Open symbols are from Fall, 1996, filled symbols from Summer (1997) measured using TDR. Circles with internal cross measured in lab before testing (Fall 1996), squares with internal cross measured in lab after testing (Fall, 1997)

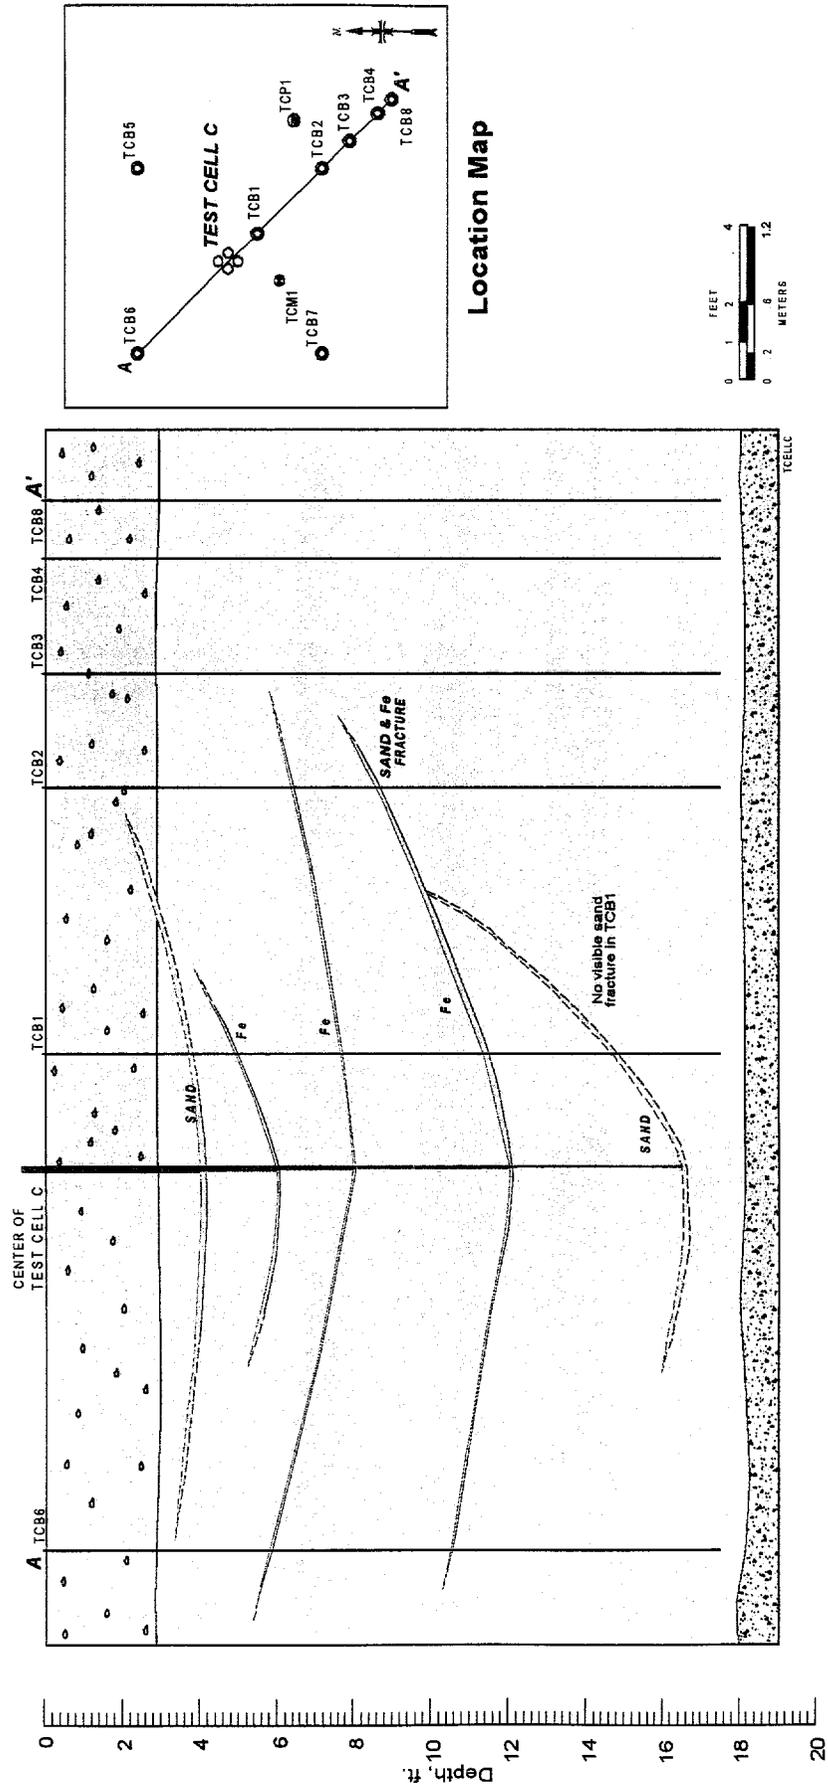
Figure 4.2. Profile view of the fractures emplaced in iron metal test cell C.

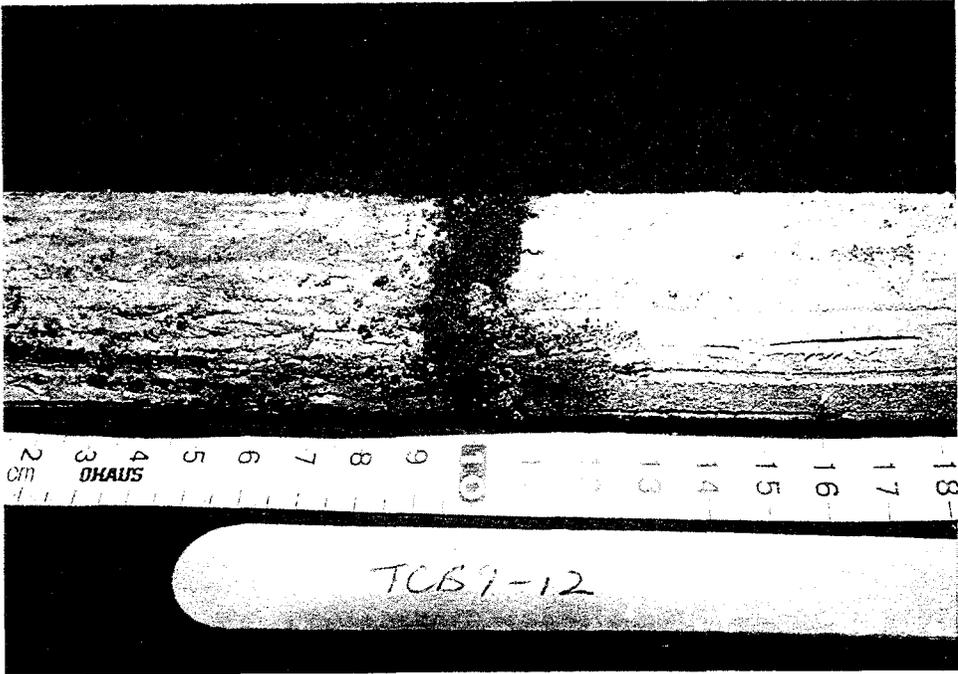
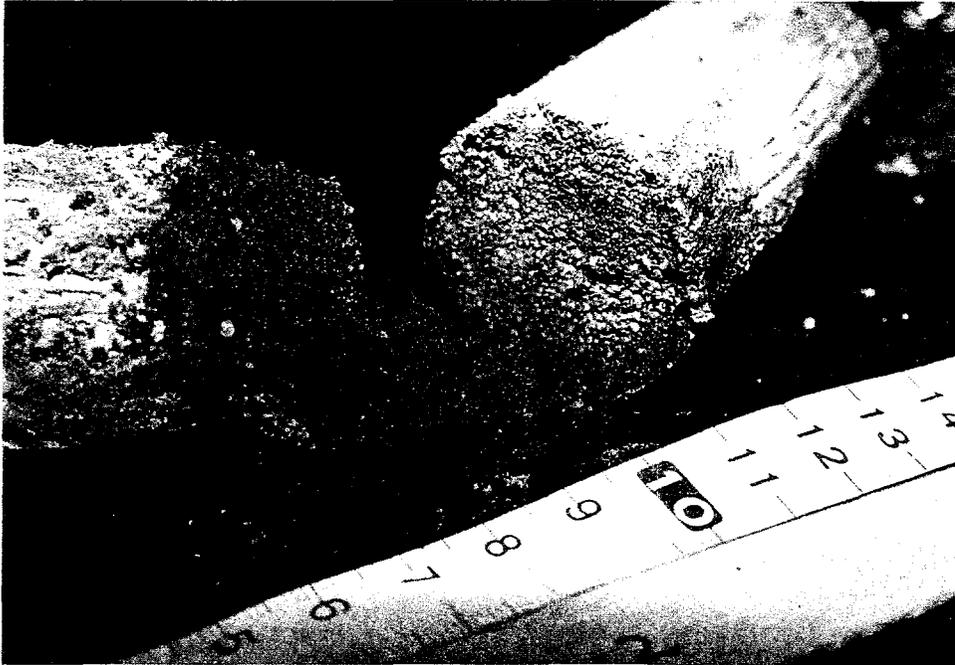
Figure 4.3. Photograph made during December 1996 illustrating the morphology of the iron metal propped fracture and the formation above and below it.

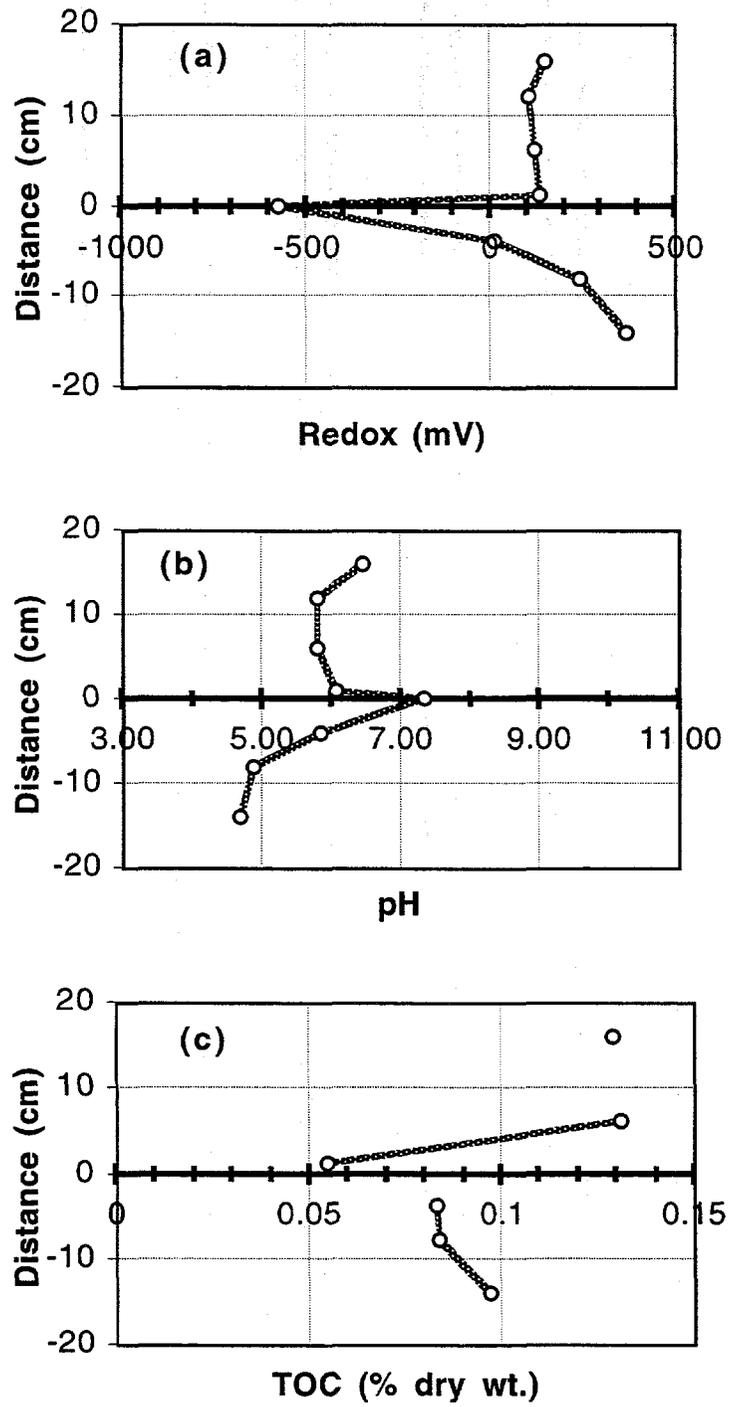
Figure 4.6. Properties in the vicinity of an iron filled fracture 10 months after emplacement.

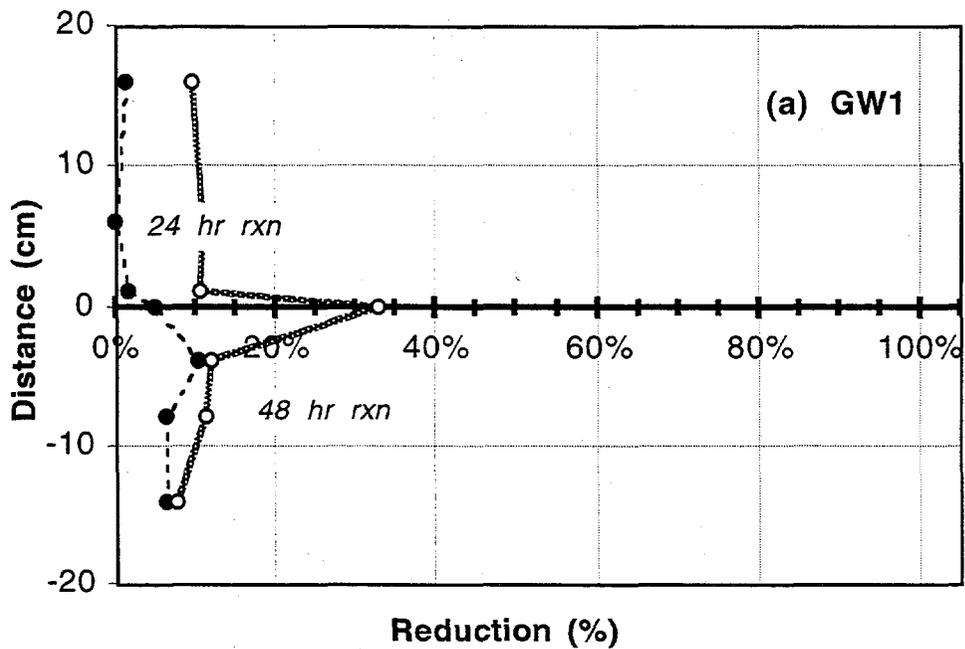
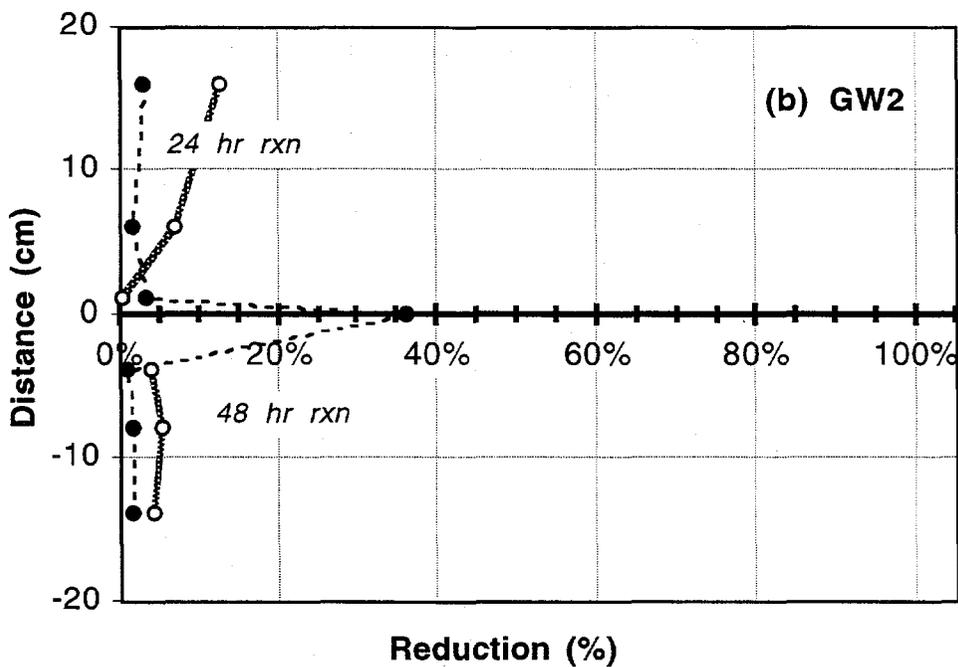
Figure 4.8. TCE degradation in ground water after 24- or 48-hr reactive times versus distance from an iron filled fracture 10 months after emplacement. (a) GW1 initial TCE = 480 mg/L; (b) GW2 initial TCE = 54 mg/L.

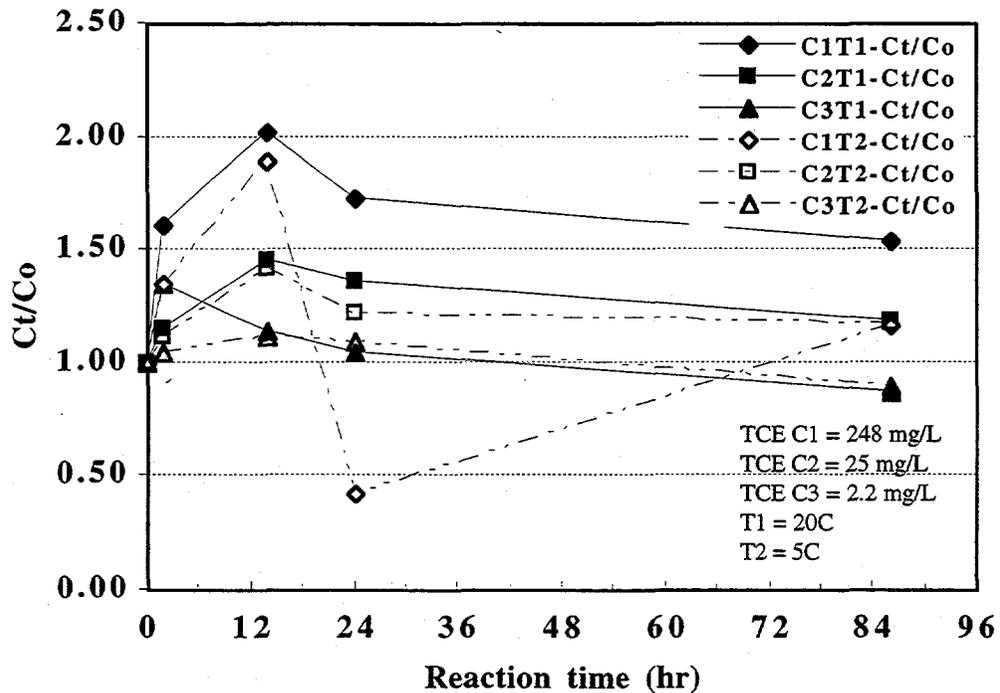
Figure 4.10. TCE degradation with unused iron metal from the same batch that was used for fracture emplacement during September 1996.

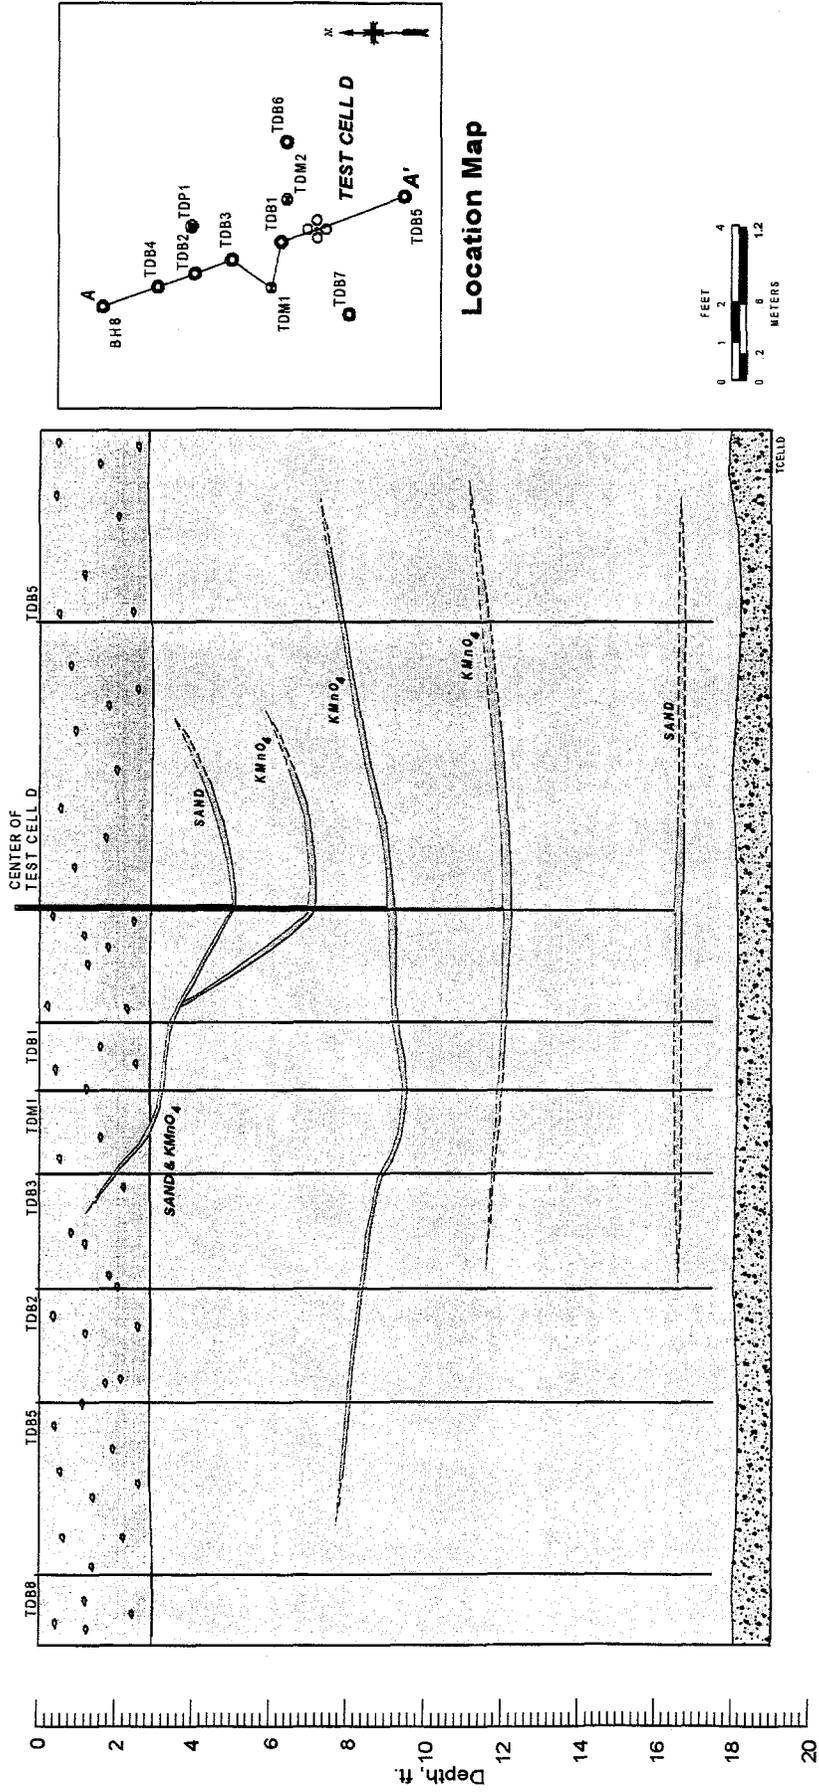
Figure 4.21. Profile view of the fractures emplaced in the permanganate test cell D.

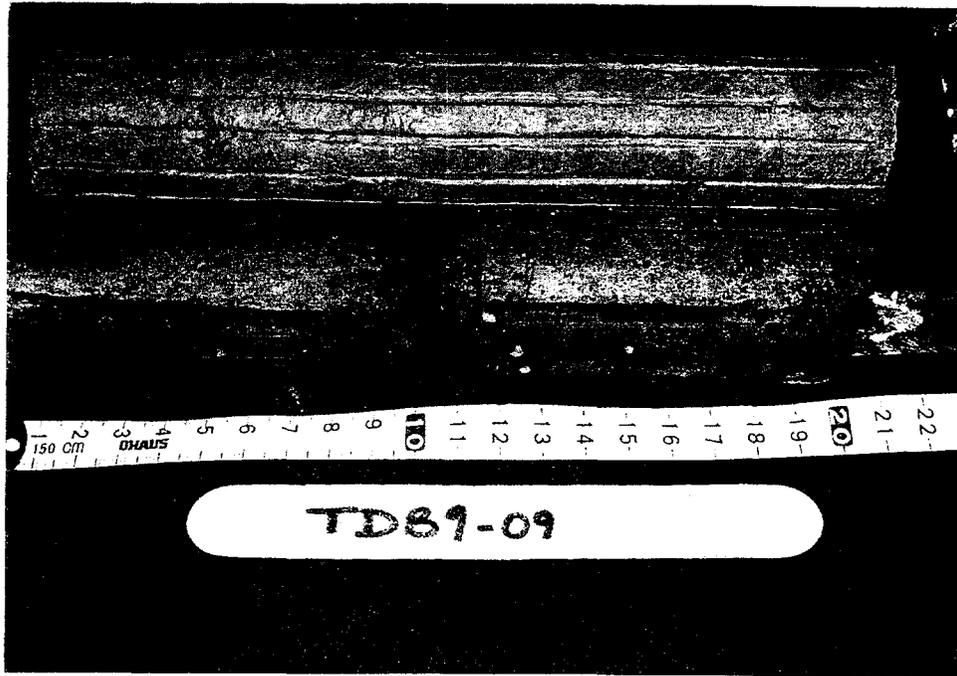
Figure 4.22. Photograph made during December 1996 illustrating the morphology of the permanganate grout fracture and the soil above and below it.

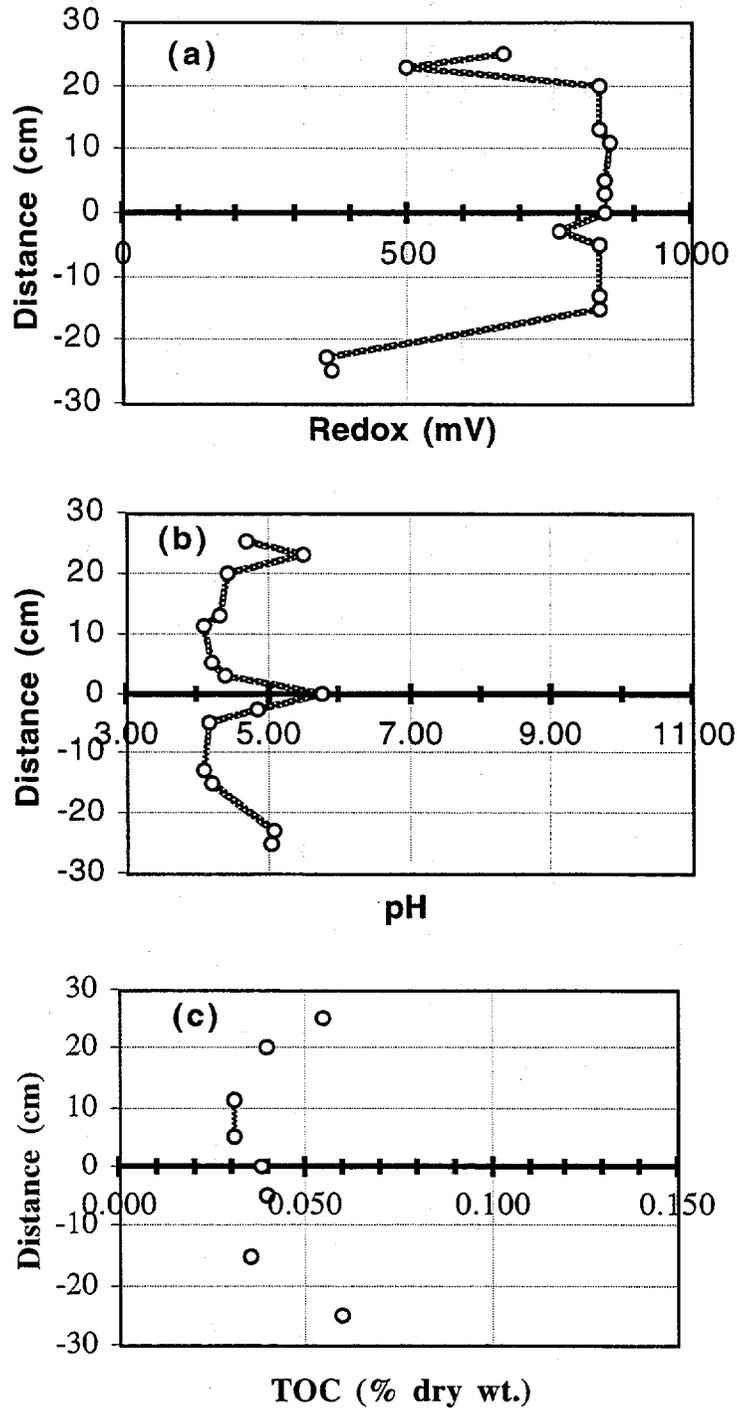
Figure 4.24. Properties in the vicinity of a permanganate filled fracture 10 months after emplacement.

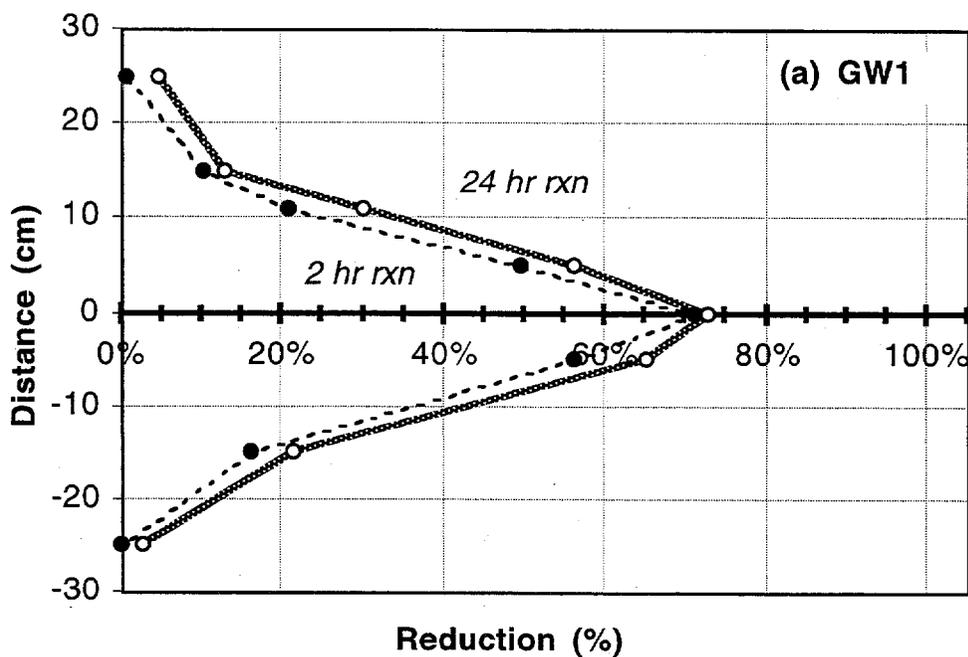
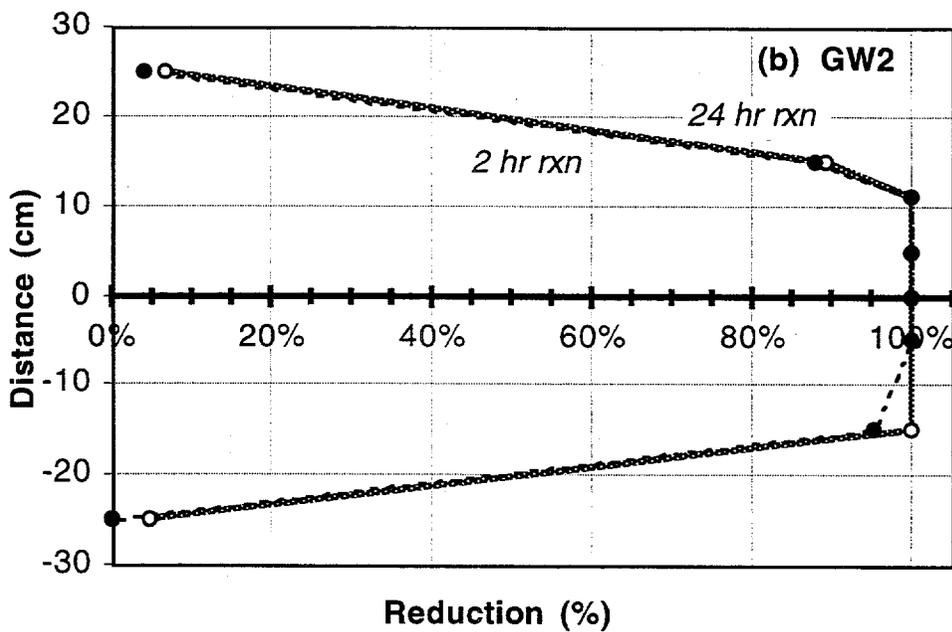
Figure 4.26. TCE degradation in ground water after 2- and 24-hr reaction times versus distance from a permanganate filled fracture 10 months after emplacement. (a) GW1 initial TCE = 480 mg/L; (b) GW2 initial TCE = 54 mg/L.

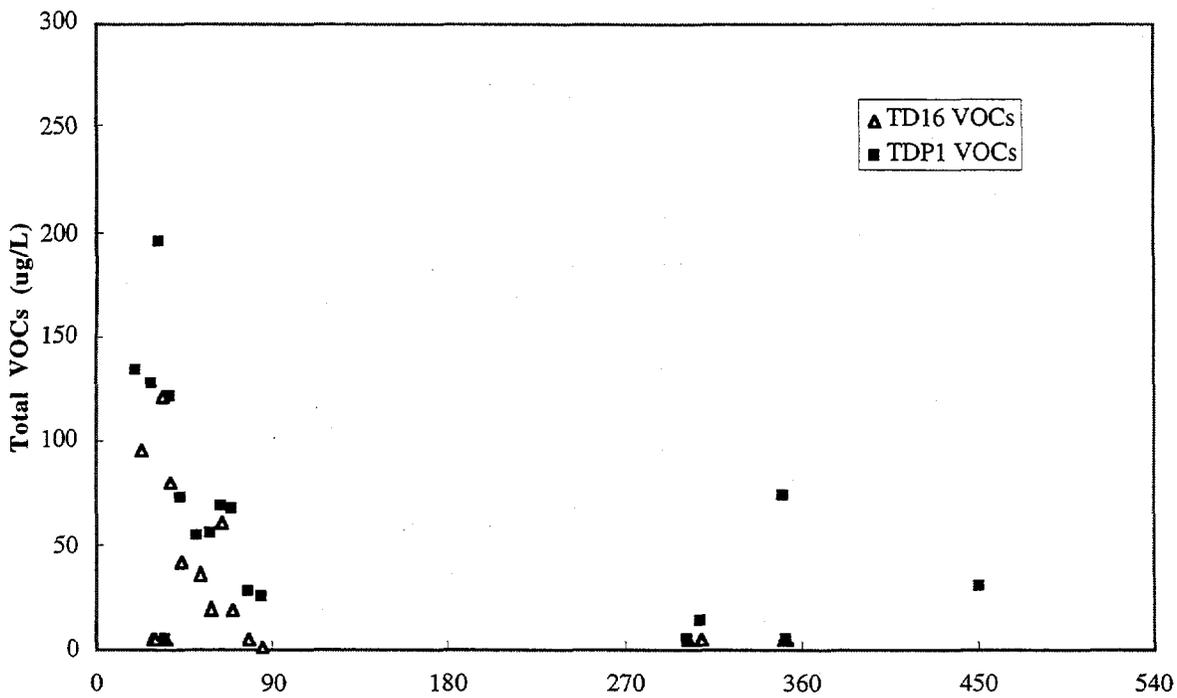
Figure 4.33. Ground water concentrations of DNAPL VOCs beneath the permanganate cell.

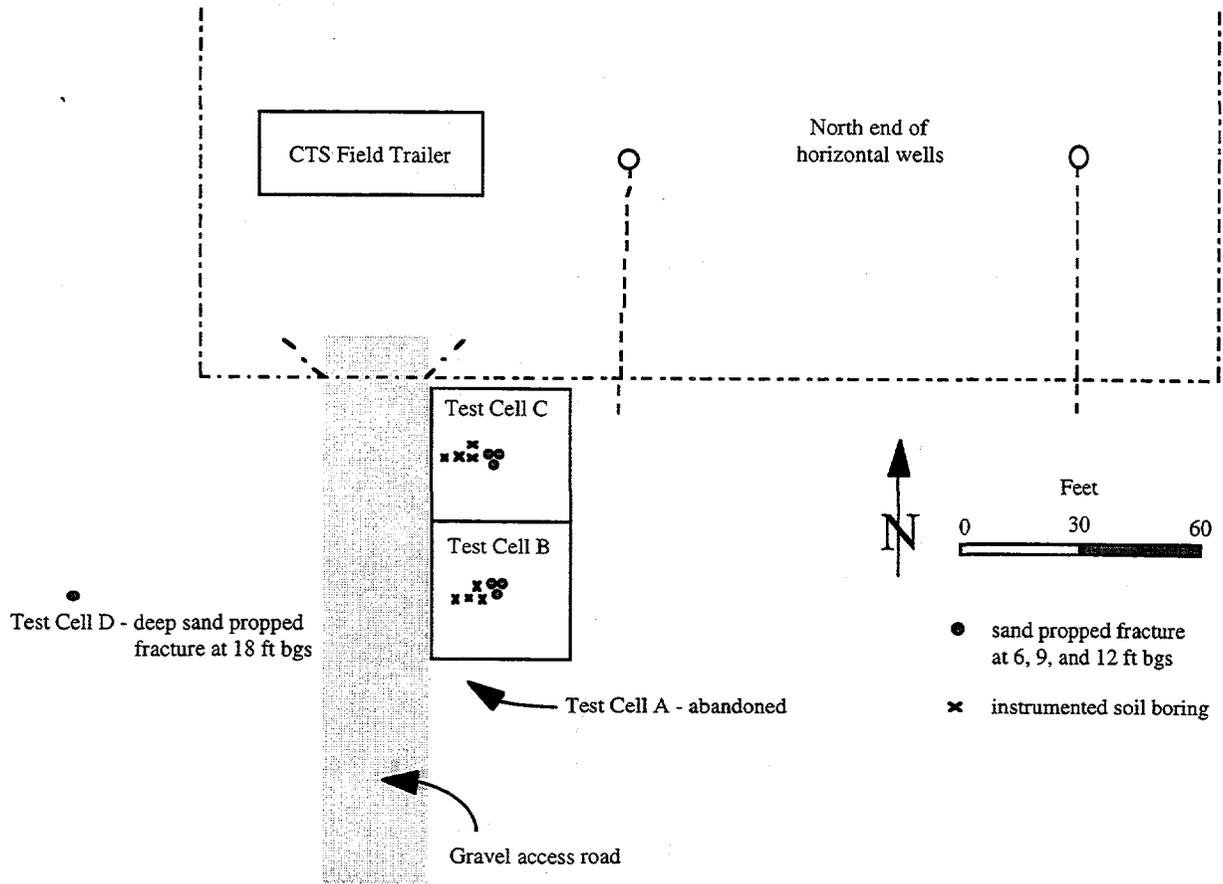
Figure A.3 Location of fracture test cells at the CTS.

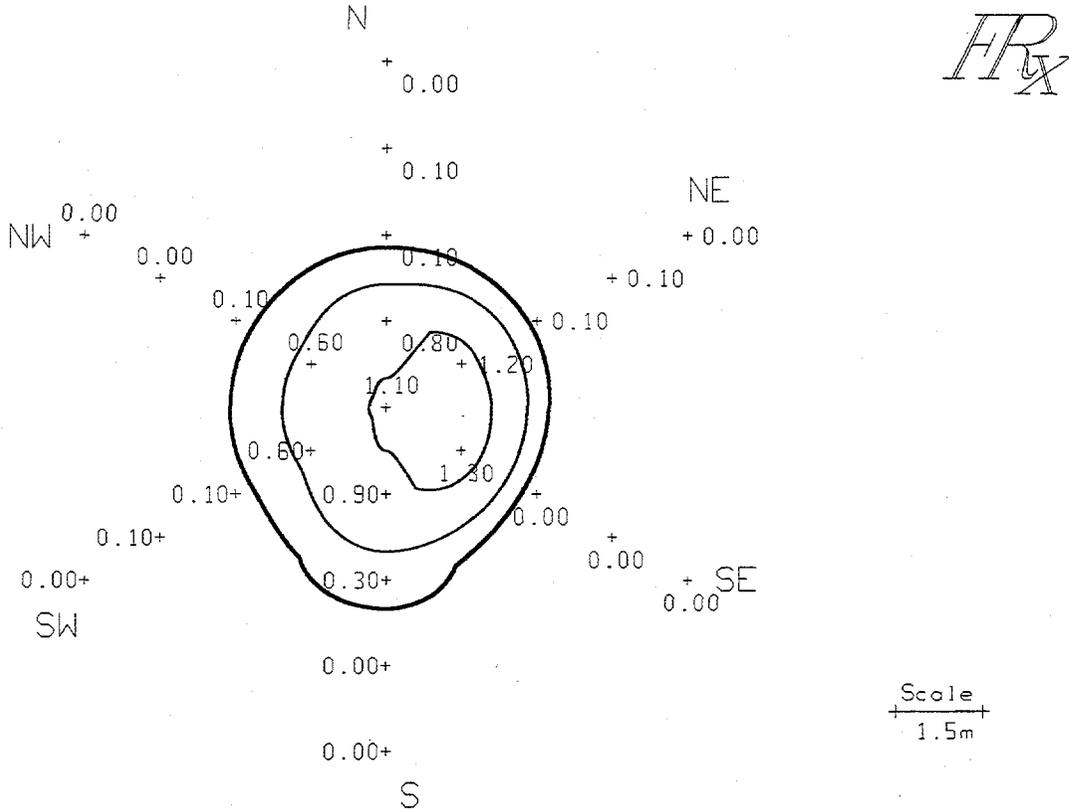
Figure A.4 Hydraulic Fracturing Uplift, Clean Test Site Cell A, 2 m fracture.

Uplift control points spaced 1.5 m apart along rays oriented to "plant" north.

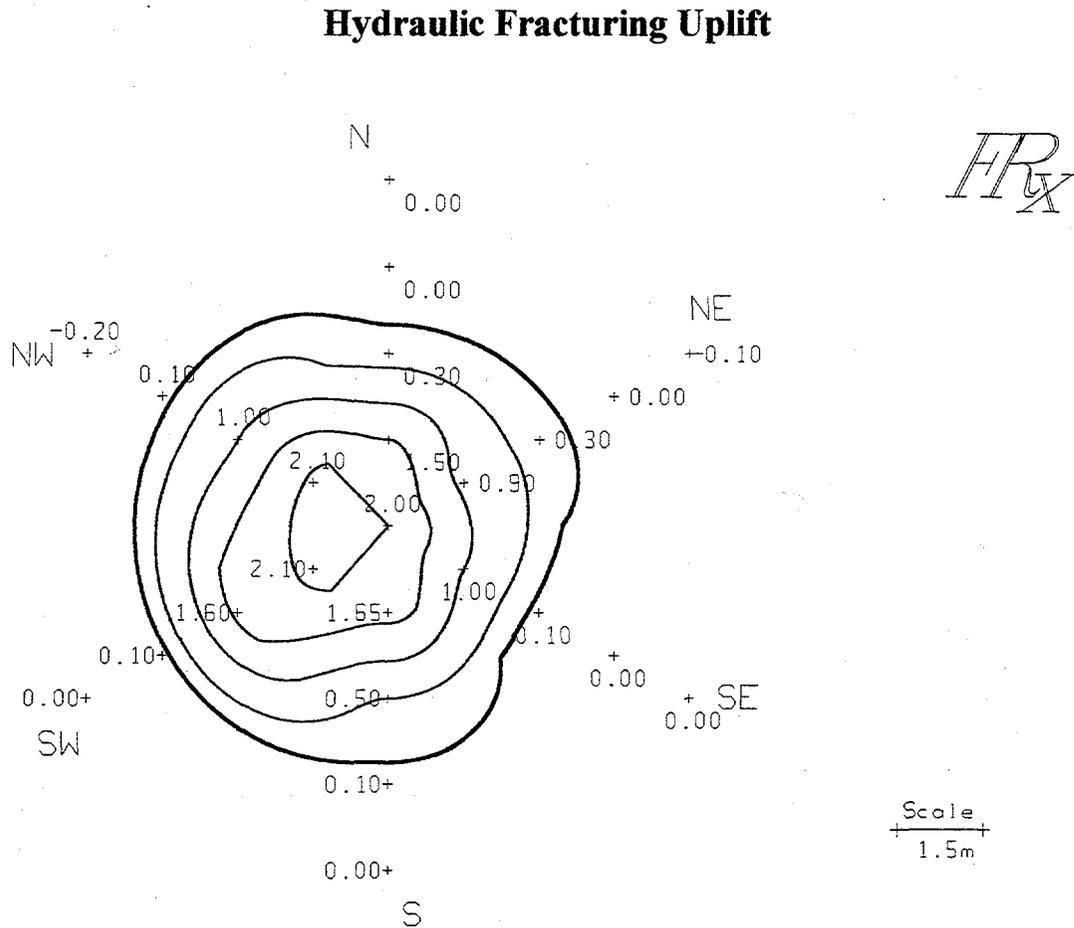
Figure A.8 Hydraulic Fracturing Uplift, Clean Test Site Cell C, 2 m fracture.

Uplift control points spaced 1.5 m apart along rays oriented to "plant" north.

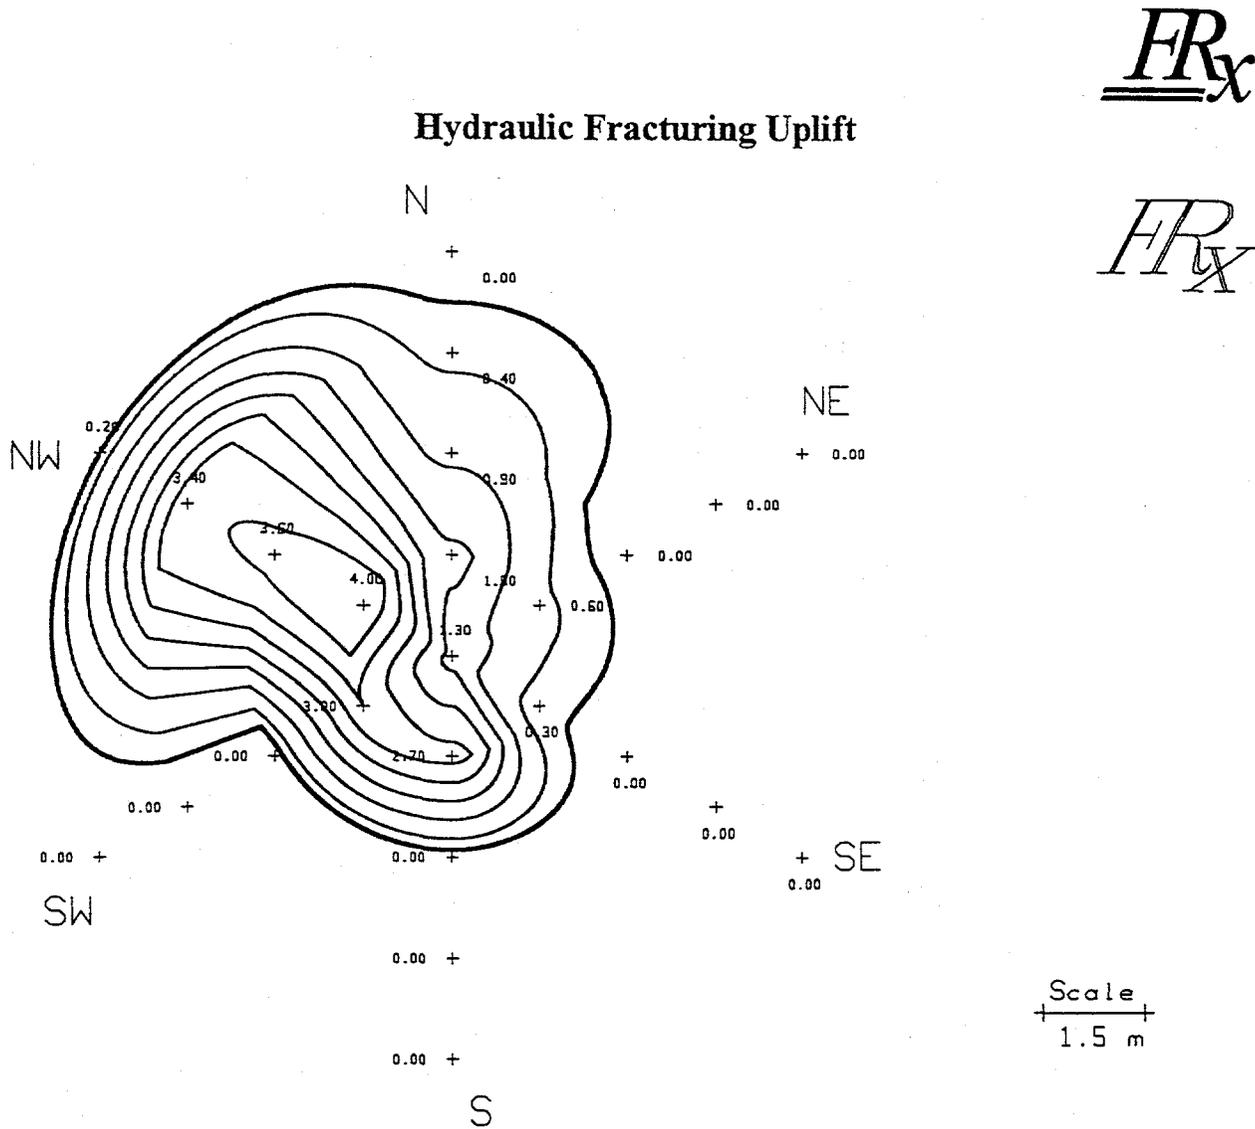
Figure B.1 Hydraulic fracturing uplift, test cell A, 4 ft fracture (8/24/96).

Uplift control points spaced 1.5 m apart along rays oriented to "plant" north.

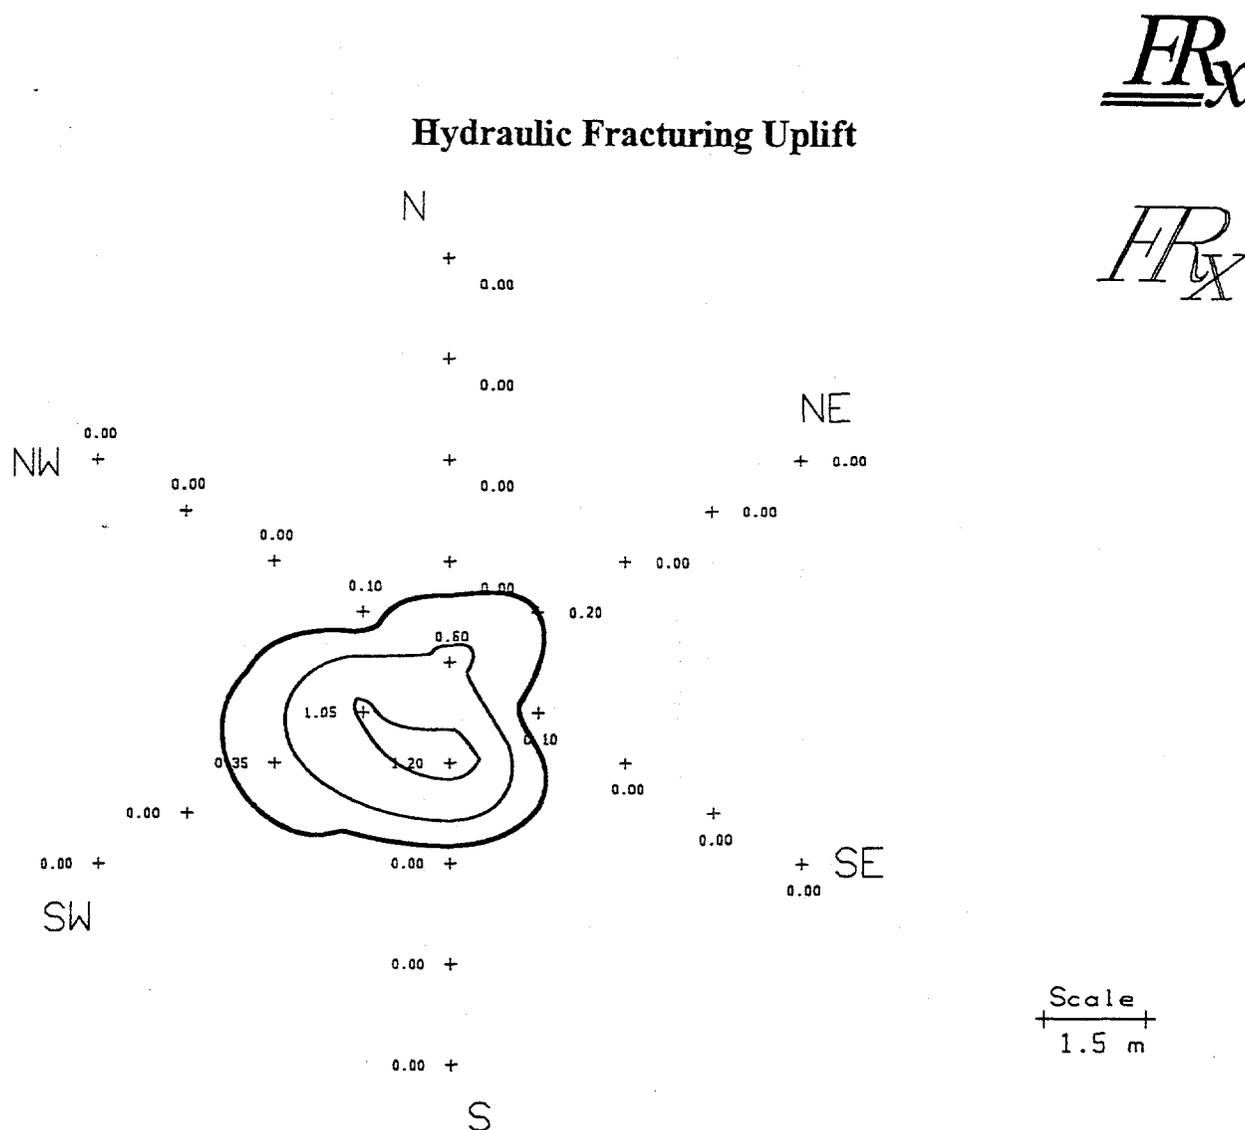
Figure B.2 Hydraulic Fracturing Uplift, Test Cell A, 4 ft fracture (8/25/96).

Uplift control points spaced 1.5 m apart along rays oriented to "plant" north.

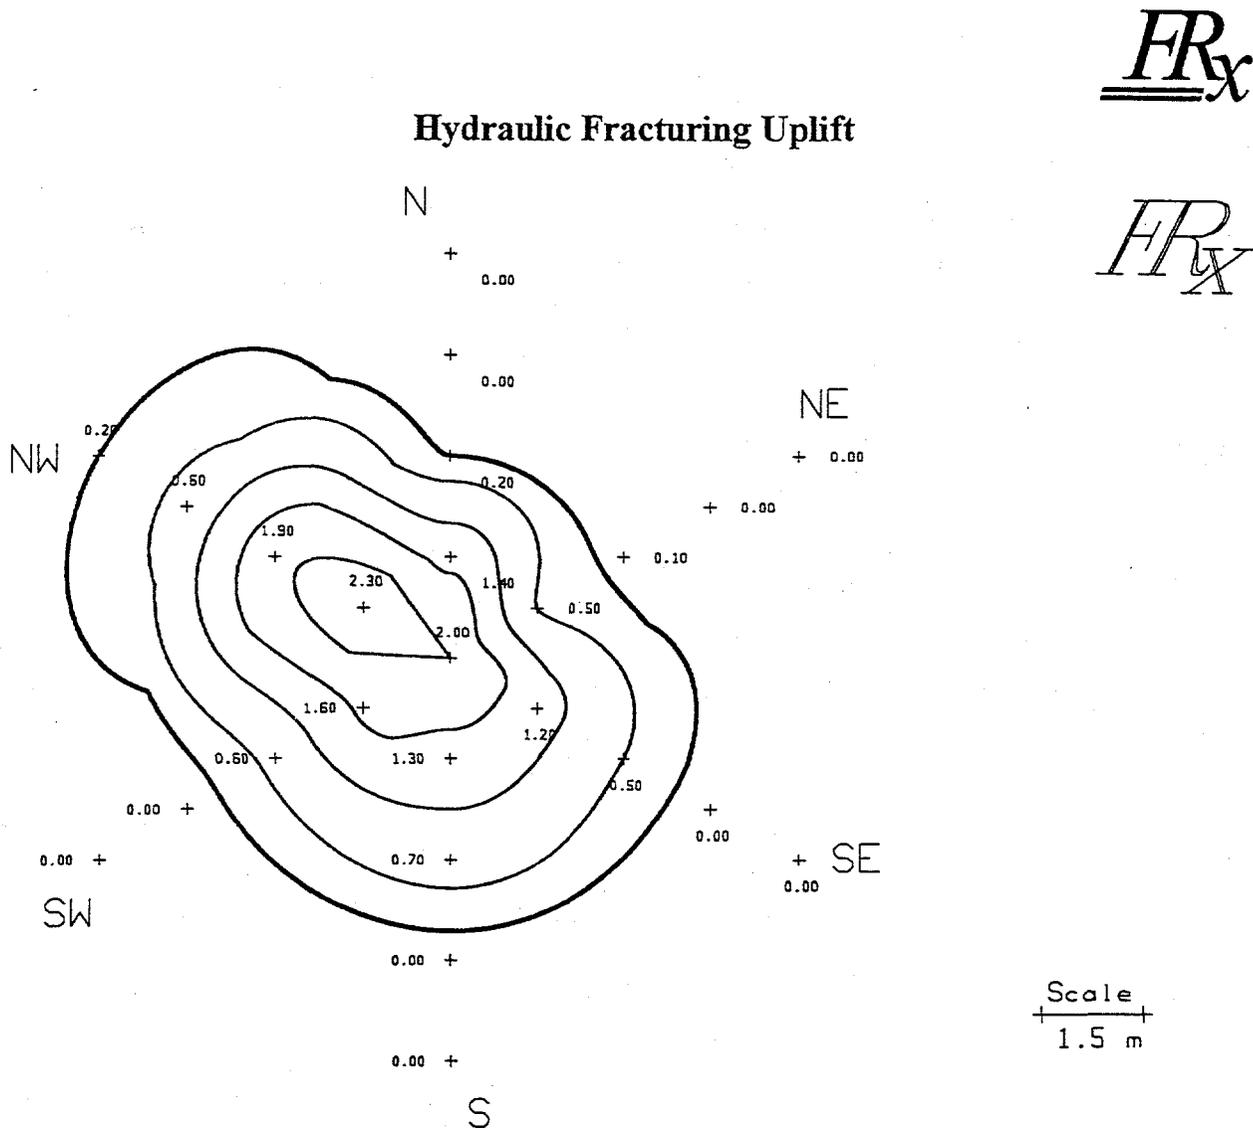
Figure B.3 Hydraulic Fracturing Uplift, Test Cell A, 8 ft fracture.

Uplift control points spaced 1.5 m apart along rays oriented to "plant" north.

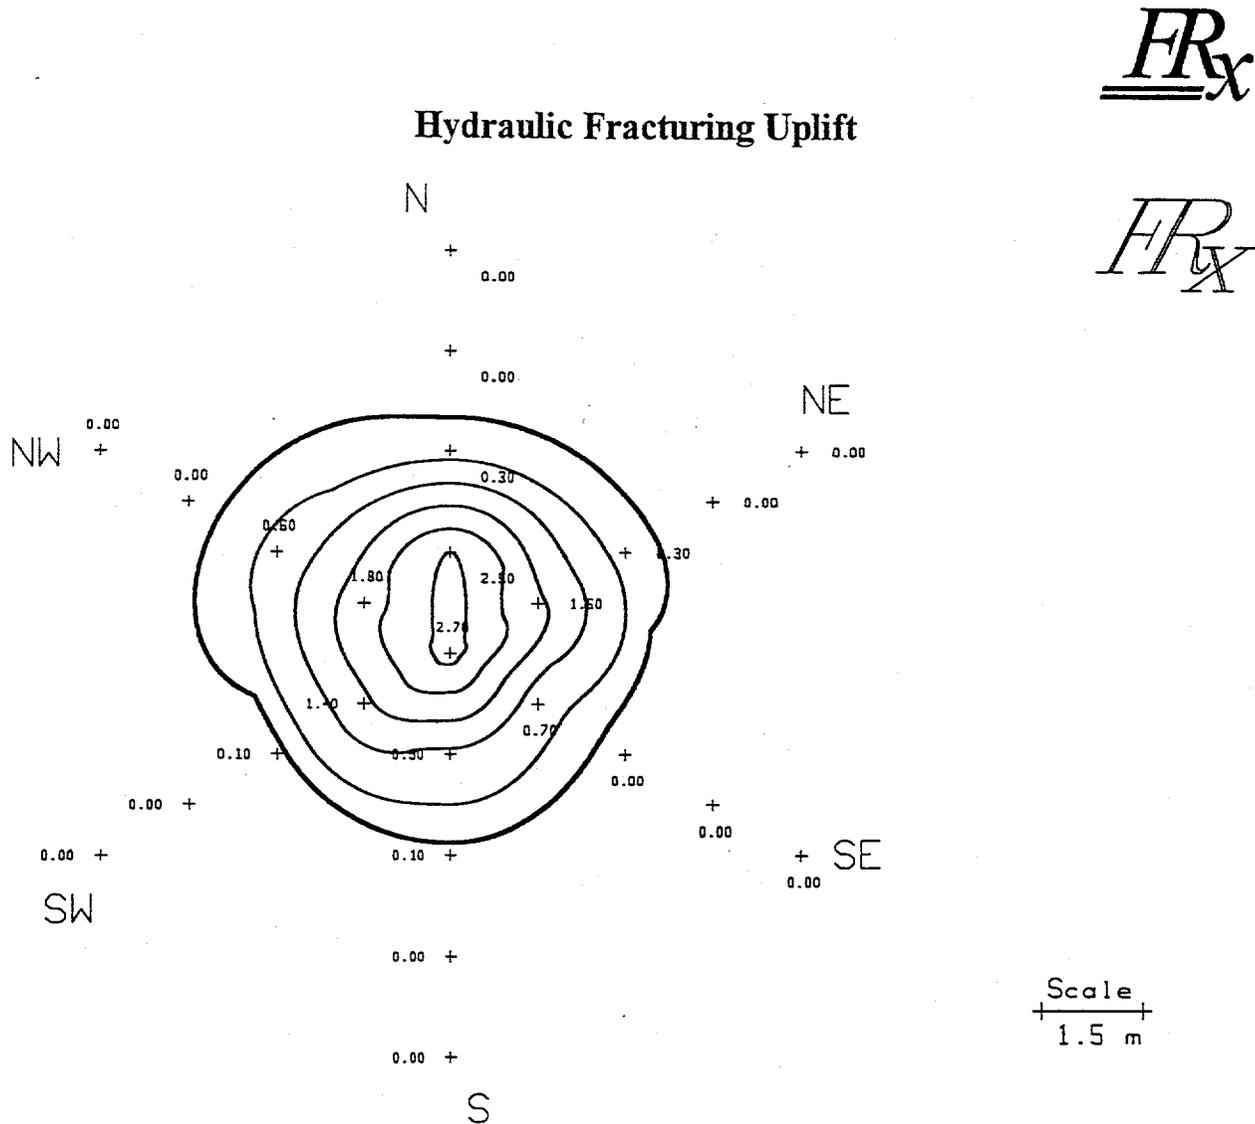
Figure B.7 Hydraulic Fracturing Uplift, Test Cell B, 6 ft fracture.

Uplift control points spaced 1.5 m apart along rays oriented to "plant" north.
