ORNL/TM-13534

**X-231A Demonstration of
In Situ Remediation of
DNAPL Compounds in Low
Permeability Media by
Soil Fracturing with Thermally
Enhanced Mass Recovery
or Reactive Barrier Destruction**

March 1998

Prepared by
OAK RIDGE NATIONAL LABORATORY, AND COLLABORATORS FROM
FRx, Inc., AND COLORADO SCHOOL OF MINES

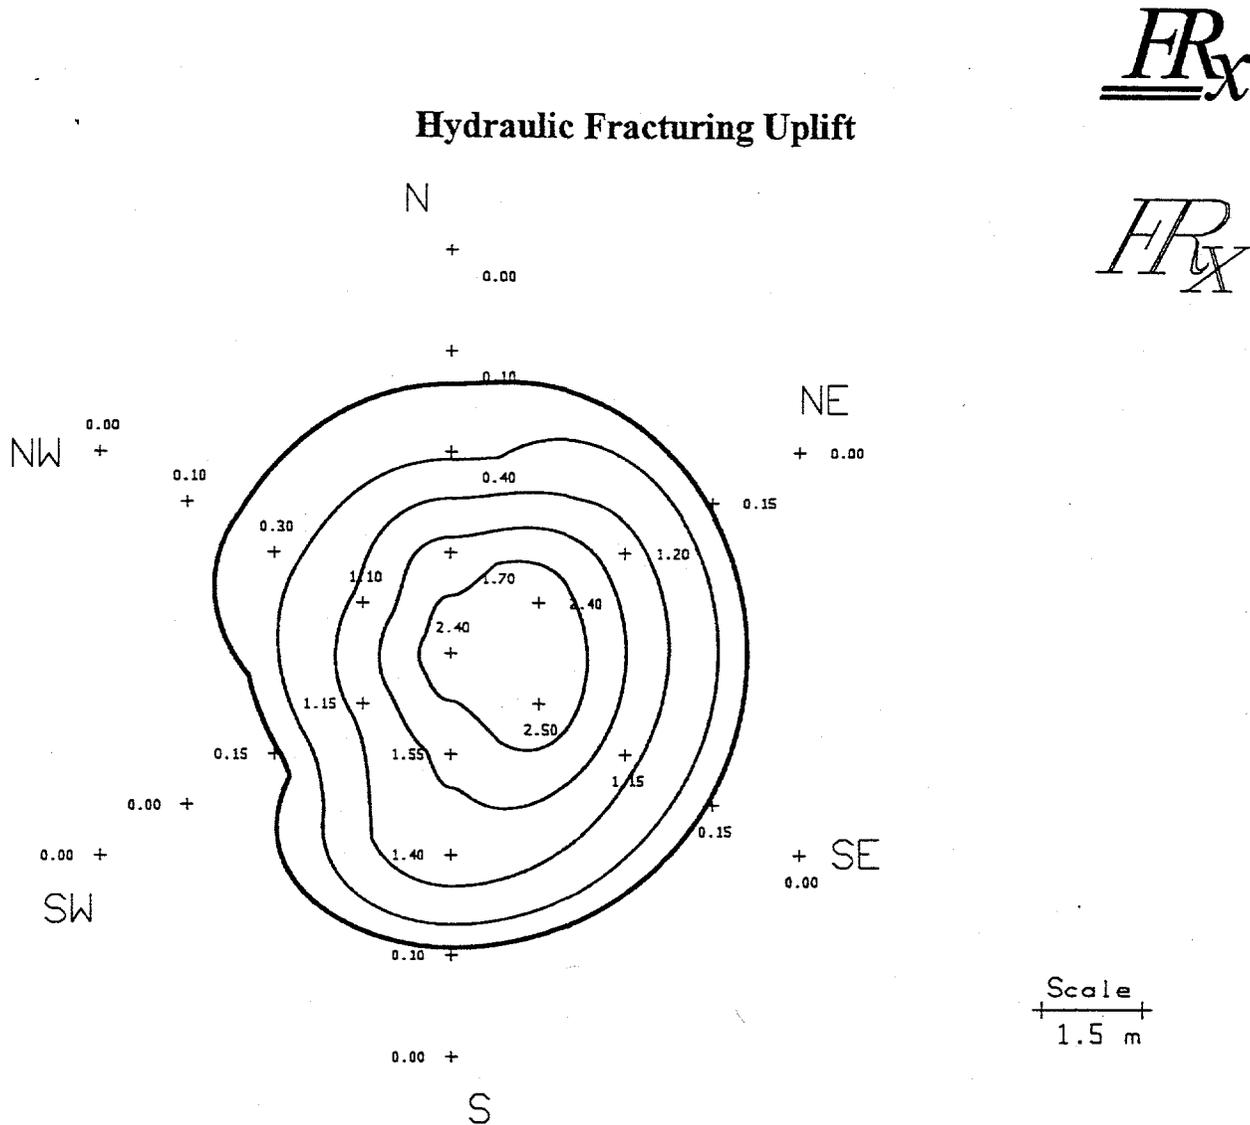
Figure B.9 Hydraulic Fracturing Uplift, Test Cell B, 12 ft fracture.

Uplift control points spaced 1.5 m apart along rays oriented to "plant" north.

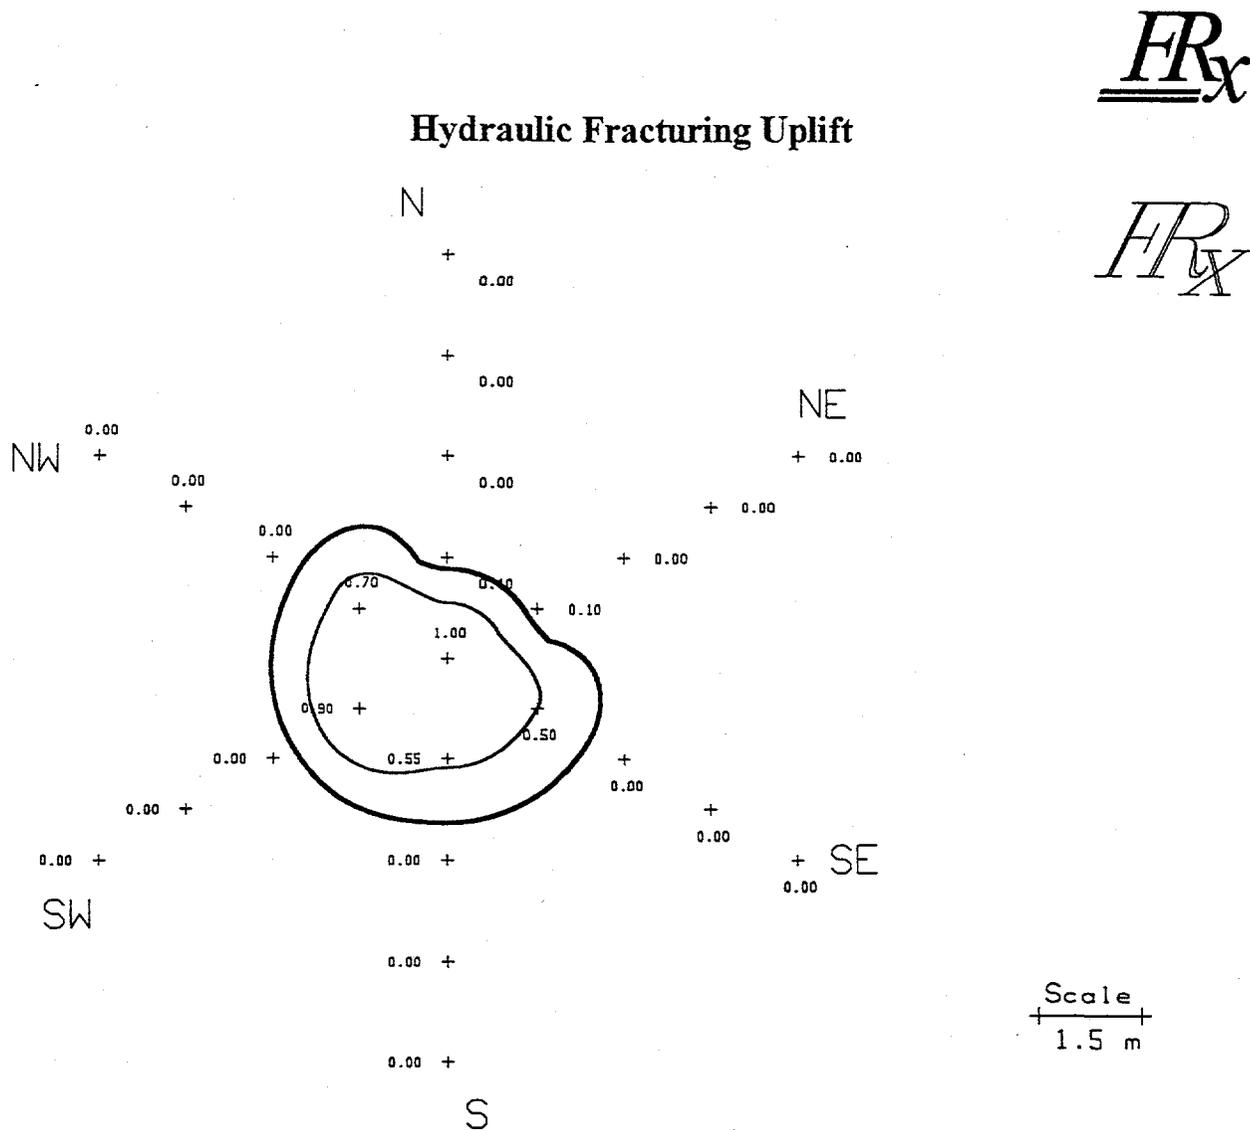
Figure B.11 Hydraulic Fracturing Uplift, Test Cell C, 4 ft fracture.

Uplift control points spaced 1.5 m apart along rays oriented to "plant" north.

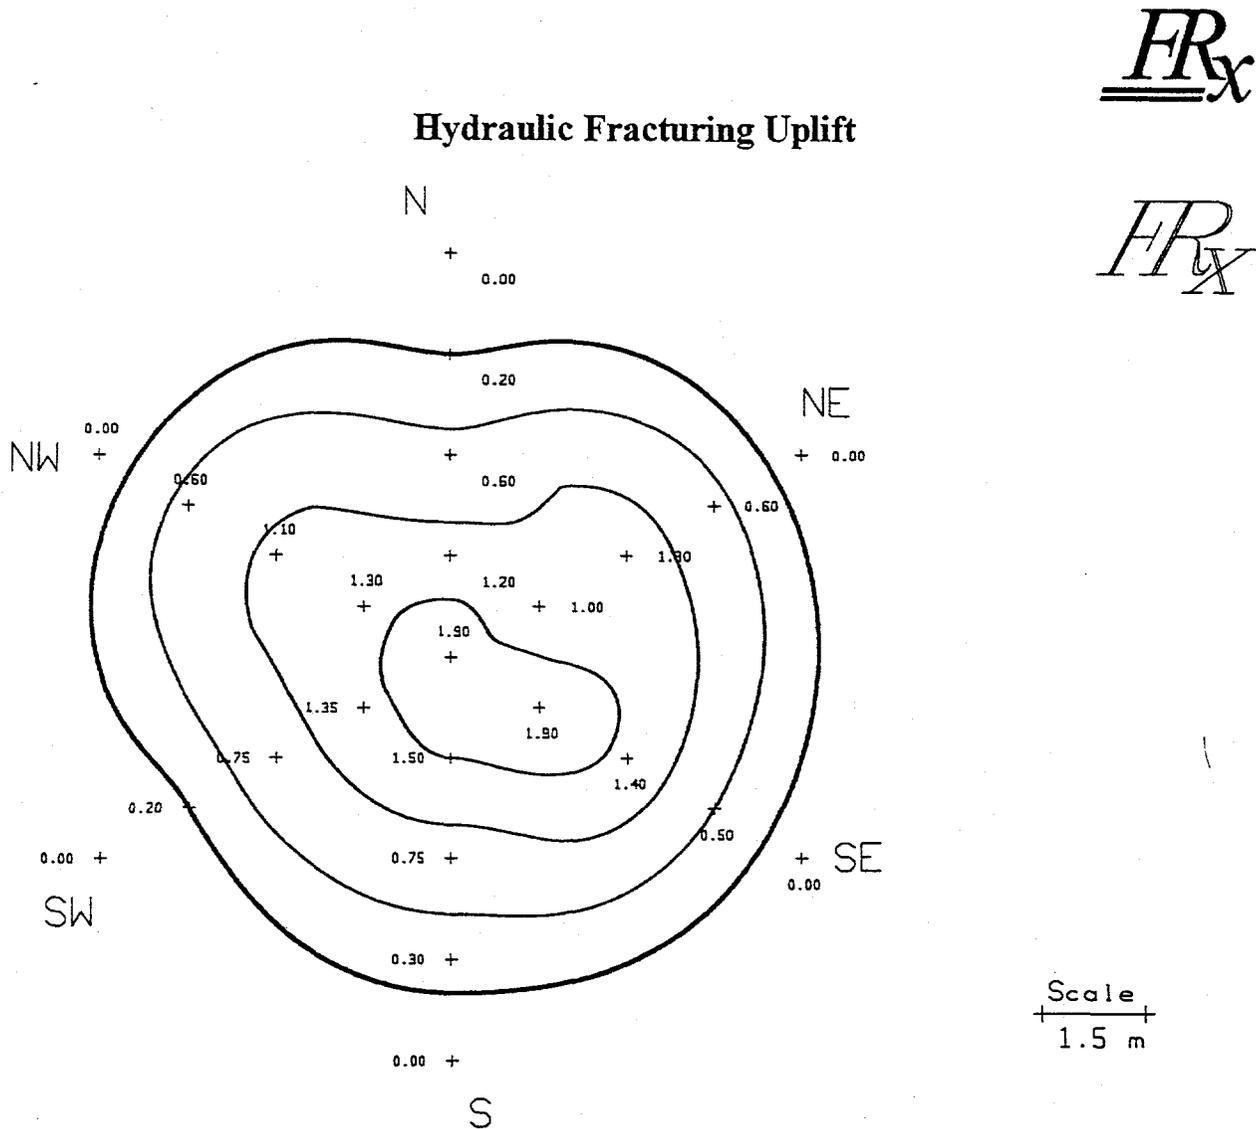
Figure B.13 Hydraulic Fracturing Uplift, Test Cell C, 8 ft fracture.

Uplift control points spaced 1.5 m apart along rays oriented to "plant" north.

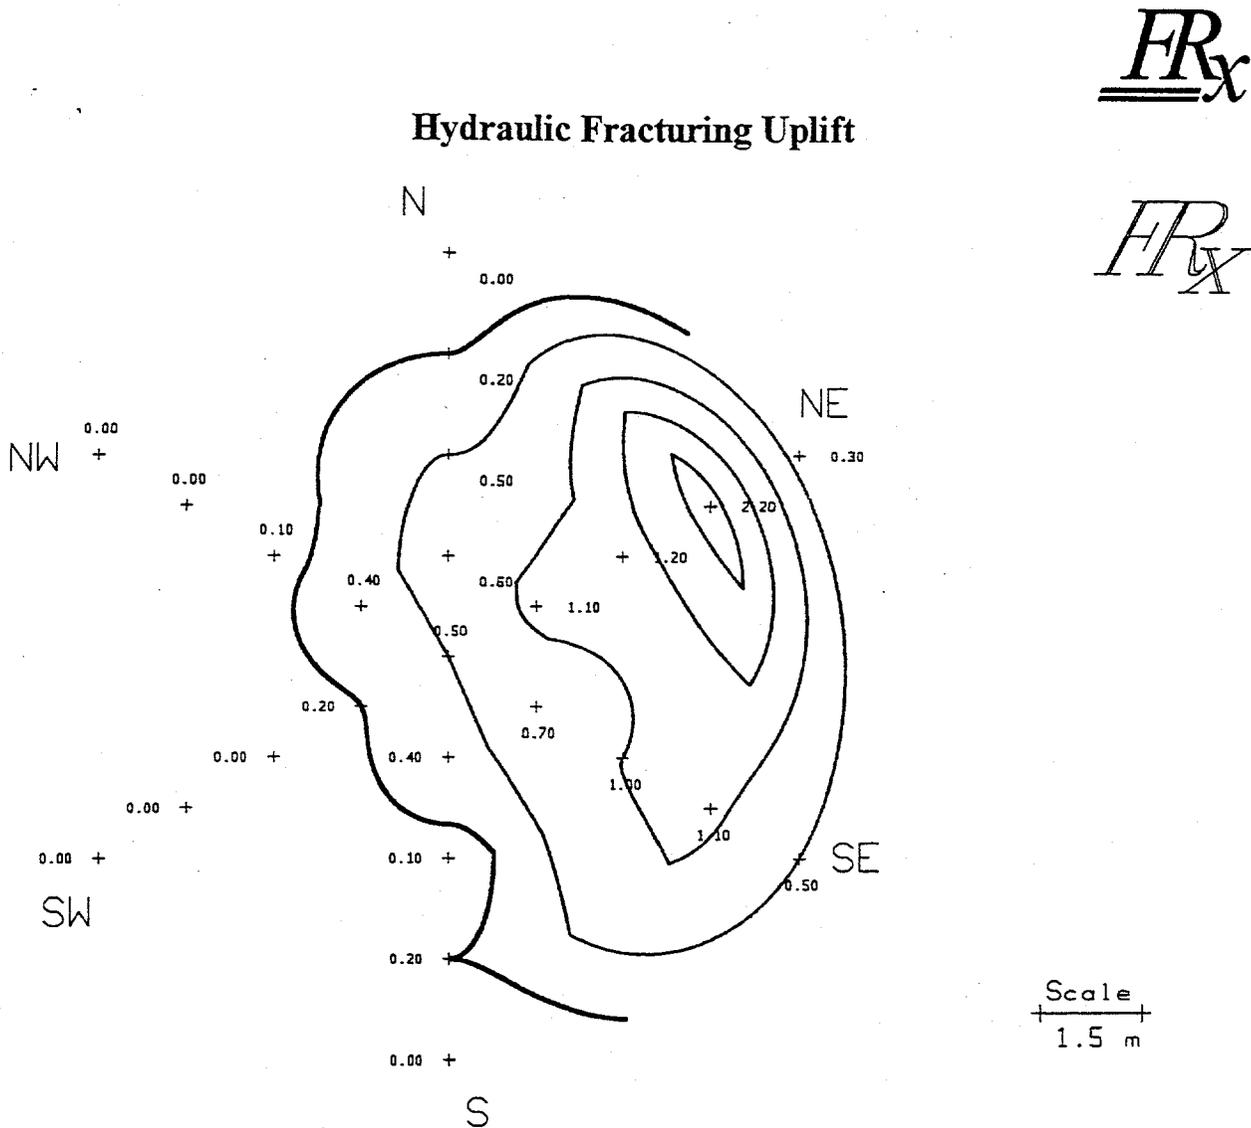
Figure B.15 Hydraulic Fracturing Uplift, Test Cell C, 16.5 ft fracture.

Uplift control points spaced 1.5 m apart along rays oriented to "plant" north.

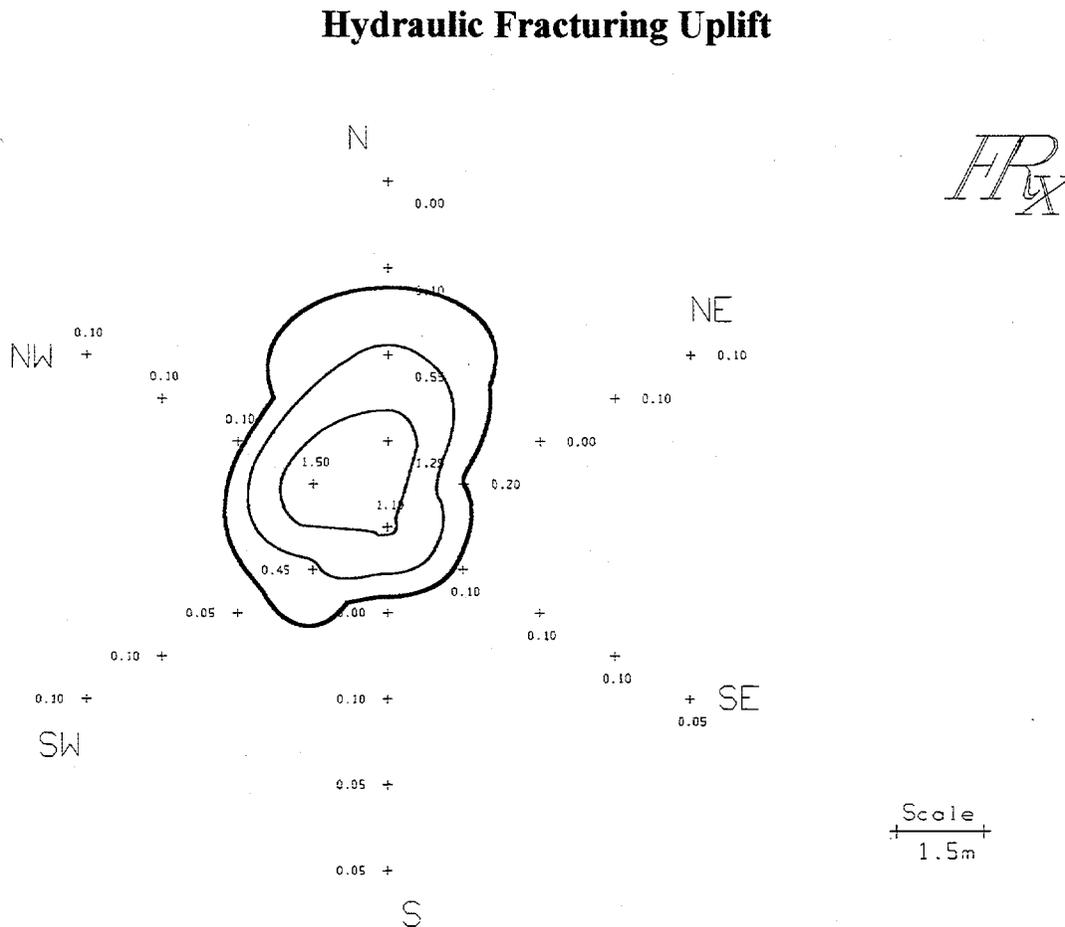
Figure B.16 Hydraulic Fracturing Uplift, Test Cell D, 4 ft fracture.

Uplift control points spaced 1.5 m apart along rays oriented to "plant" north.

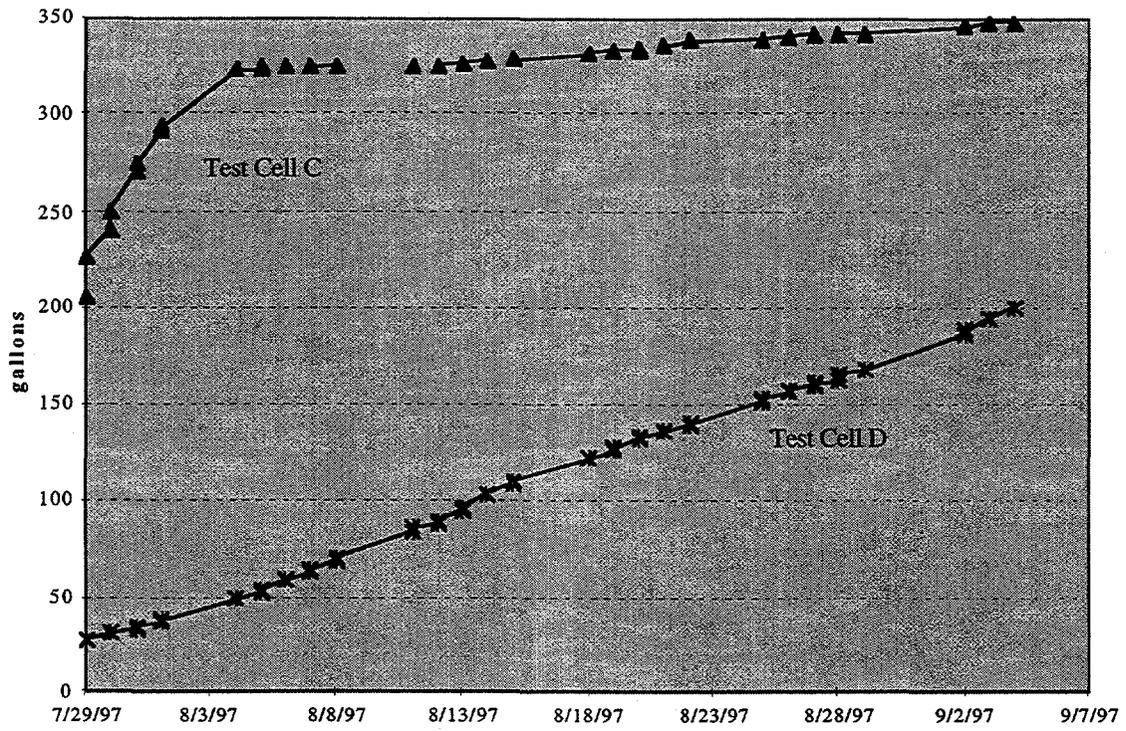
Figure B.21 Rates and volumes injected at Test Cell C and D (summer 1997).

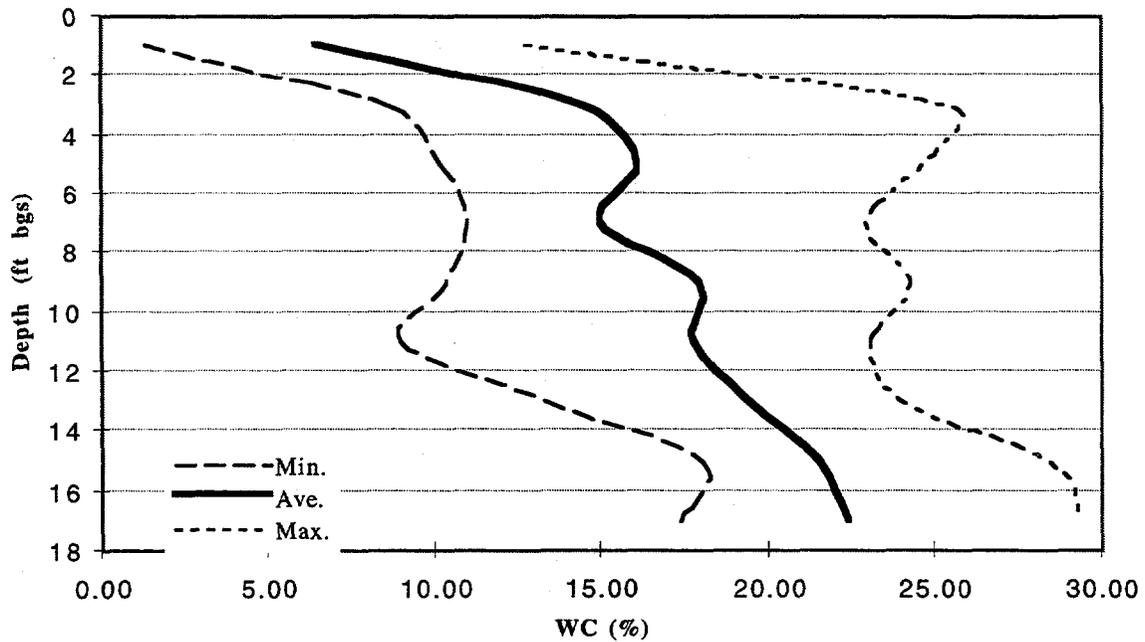
Figure C.4 Test cell D baseline water content profile based on August 1996 soil samples.

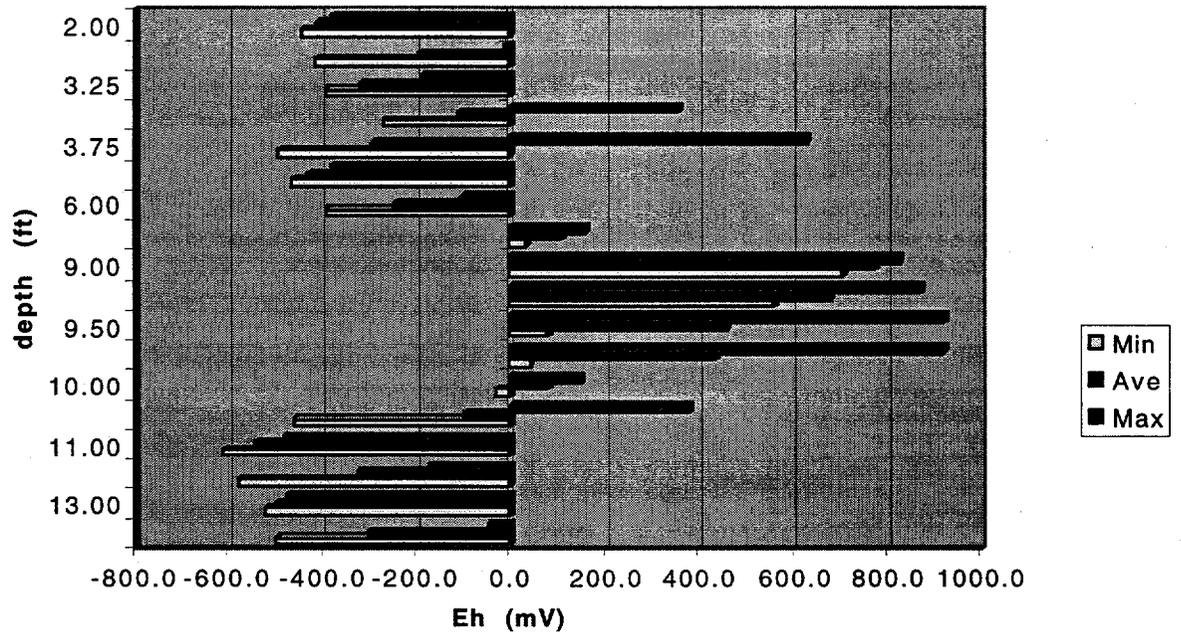
Figure E.1 Test Cell D, Representative Eh Profile (location TDM2).
