Proceedings of the 13th International Acoustic Emission Symposium
Nov. 27-30, 1996 Nara, Japan

A NONDESTRUCTIVE TEST FOR AIRCRAFT HALON BOTTLES,
THE DEVELOPMENT OF AN ACOUSTIC EMISSION APPLICATION

ALAN G. BEATTIE

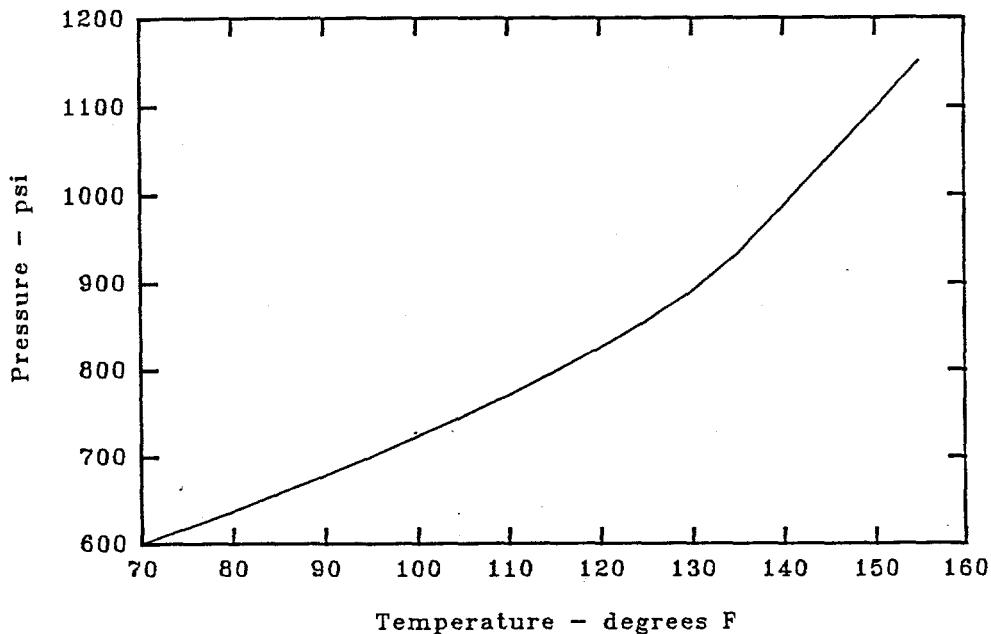
Fig. 1 Temperature - Pressure curve for a Halon Bottle

Initially a rough estimate of the pressure temperature curve of the Halon 1301-Nitrogen mixture was obtained by heating a Halon bottle equipped with a small pressure gauge. The resulting data showed that sufficient pressure could be generated for an acoustic emission test. Later, theoretical curves were obtained from Walter Kidde Co. for a variety of bottles. A typical curve is shown in Figure 1. From these curves, it is seen that a temperature of 145°F will produce a pressure in most Halon bottles about 30% above the bottle pressure at 110°F . 110°F is a temperature which the industry estimates will seldom be exceeded in normal service. Therefore heating a Halon bottle to 145°F exceeds the 110% overpressure criteria and will provide a valid acoustic emission test.

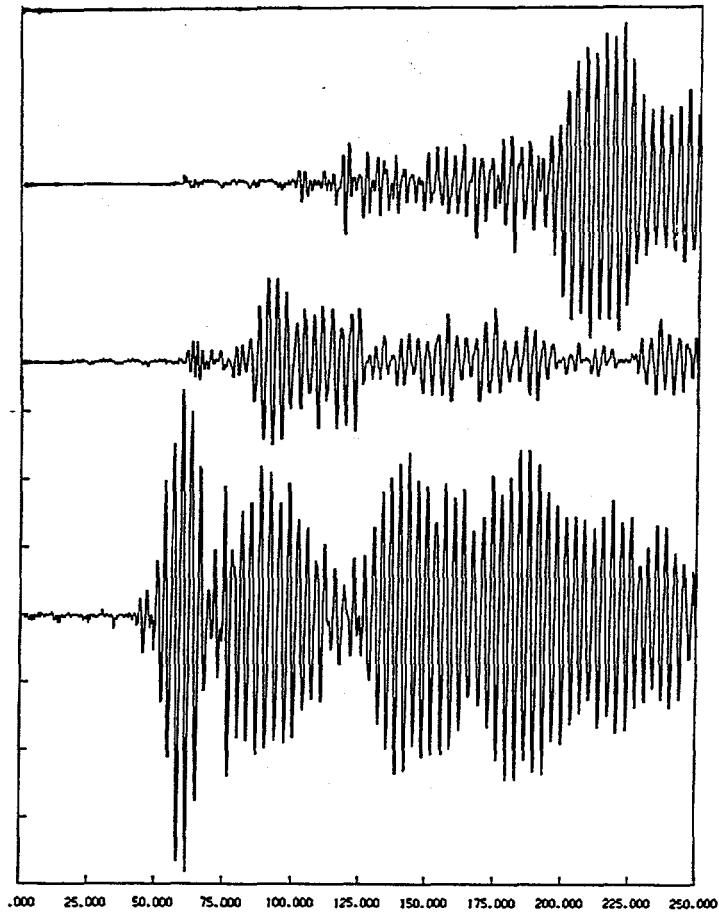
Fig. 2 Three waveforms from the same event. Time is microseconds

tude. Studies of the propagated waves in the bottle wall were then conducted by breaking pencil leads on the bottle and digitizing the received signals from sensors on the bottle. Several facts became apparent. First, the waves contained frequencies at least from 20 to 400 KHz. Second, the wave forms were consistent with transmission of both extensional and flexural modes. Two possible problems were seen. The predominate mode generated by the lead break was the flexural mode. This mode was highly susceptible to scattering and/or distortion by lugs and plates welded to the bottle walls. Examples of waveforms from three sensors excited by the same event are shown in Figure 2. The other problem was that at frequencies below 100 KHz, waves traveled in the liquid Halon as well as the wall. The spherical geometry of the cavity produced focusing and random wave superpositions. Occasionally a lead break would produce a huge signal at a sensor long after the wave appeared to have decayed. These appeared at various sensor locations and the arrival times suggested 10 to 15 round trips of the waves in the Halon. It was found that signals from these waves were eliminated when 300 KHz sensors were used with 250 KHz high pass filters. After extensive testing of several sensors at temperatures up to 300°F, the PAC Nanno 30 was chosen.

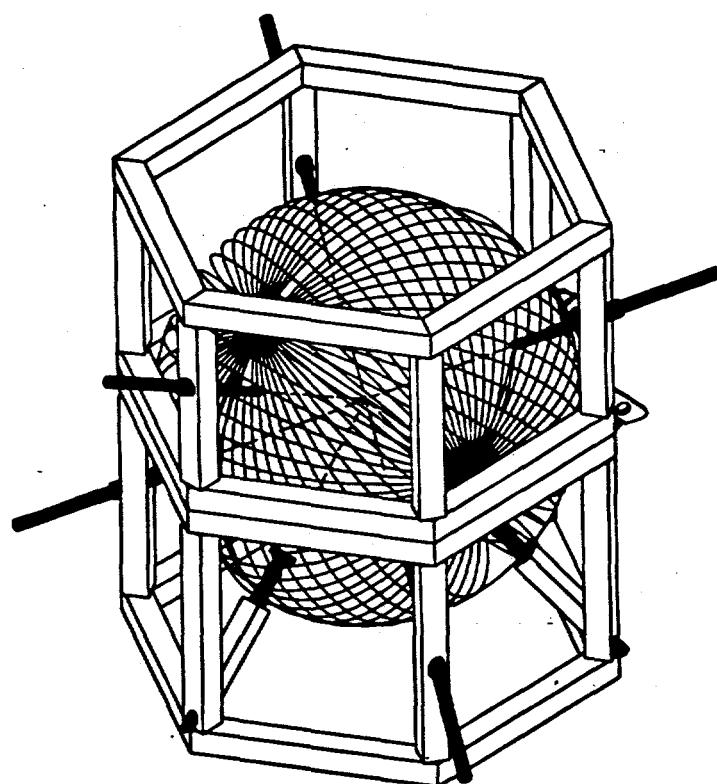
Fig. 3 Drawing of the fixture

The choice of source location led to the design of a fixture. Most airline Halon bottles are spheres and most are between 5 and 16 inches in diameter. The ideal sensor layout on a sphere is six sensors at the ends of the x, y and z axes i.e. the six arbitrary poles of a sphere. By rotating the coordinate system, one can locate the sensors on two parallel planes. As long as two sensors are at the ends of a diameter of a sphere, they can be moved in or out and retain their angular relationship with the other sensors, also located at the ends of diameters. Thus the fixture could accommodate a range of sphere sizes and the only variable that would have to change in a location program would be the radius of the sphere. Figure 3 shows a fixture designed in this way.

The six sensors are positioned at the end of rods which lie along diameters of the bottle. The sensors are spring loaded against the surface. Hard rubber pads glued to the sensor wear plates act as the couplant. Adjusting the distance of the sensors from the center allows the fixture to accommodate spheres from 5 to 16 inches in diameter. The fixture opens like a clam shell to allow easy loading of the bottles. Fixture and bottle sit on a sliding shelf of an industrial oven.

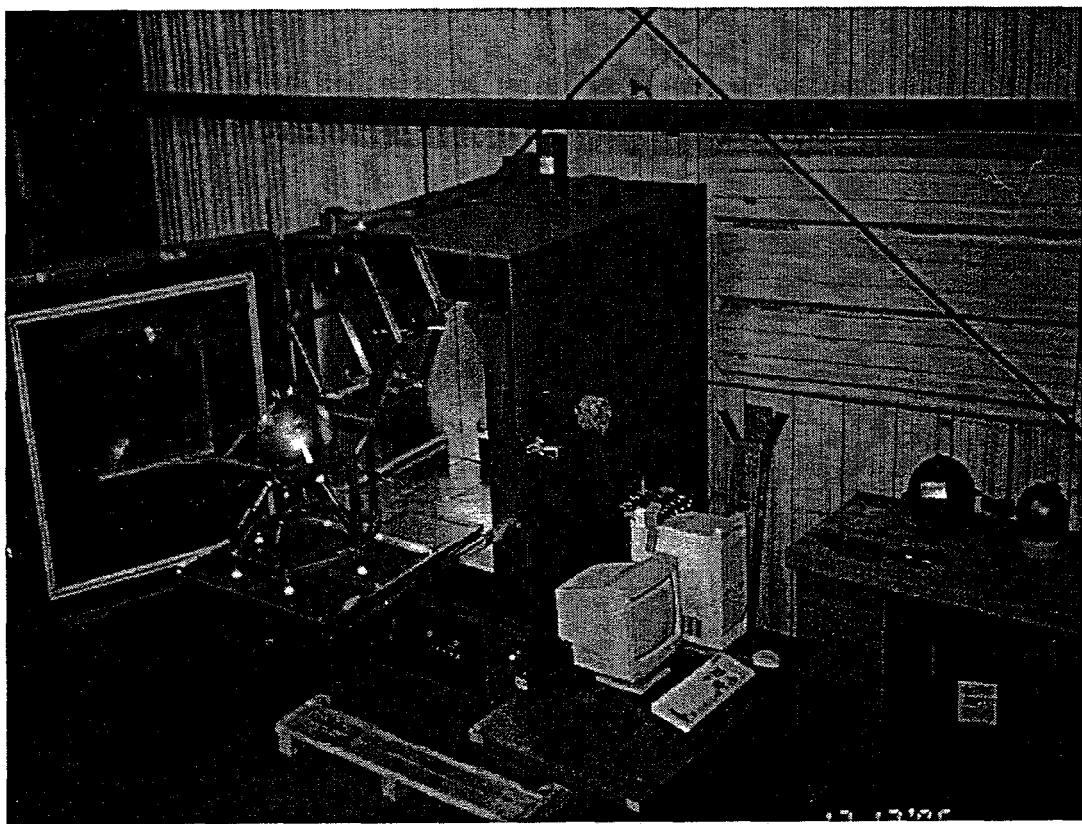
Fig. 4 The prototype system

The prototype incorporates three PAC AEDSP cards mounted in a personal computer case as the acoustic emission system and a Russell industrial oven to heat the bottles. The fixture with the sensors is mounted on a sliding shelf in the oven. This shelf allows the fixture to open and the bottle to be loaded outside the oven. The coils of the heating elements are encased in a sheath and the surface temperature of the sheath is limited to a maximum temperature of 800°F. This is to prevent thermal decomposition of the Halon 1301 in the event of an accidental release. The oven air temperature is limited to a maximum of 200°F. Relays are installed in the oven to allow the computer to operate the heaters and circulation fan. The computer reads the skin temperature of the bottle with a thermocouple taped to the lower surface. Also incorporated in this system is an auto sensor test in which each sensor is pulsed and the amplitude of that signal is measured at all the other sensors. This test checks both the electronics and the acoustic coupling. Figure 4 is a photograph of the prototype.
