VARIABILITY OF MODAL PARAMETERS MEASURED
ON THE ALAMOSA CANYON BRIDGE

Charles R. Farrar, ESA-EA, LANL
Scott W. Doebling, ESA-EA, LANL
Erik G. Straser, ESA-EA, LANL
Phillip Cornwell, Rose-Holman Institute of Technology*

XV International Modal Analysis Conference
Orlando, Fl
February 1997

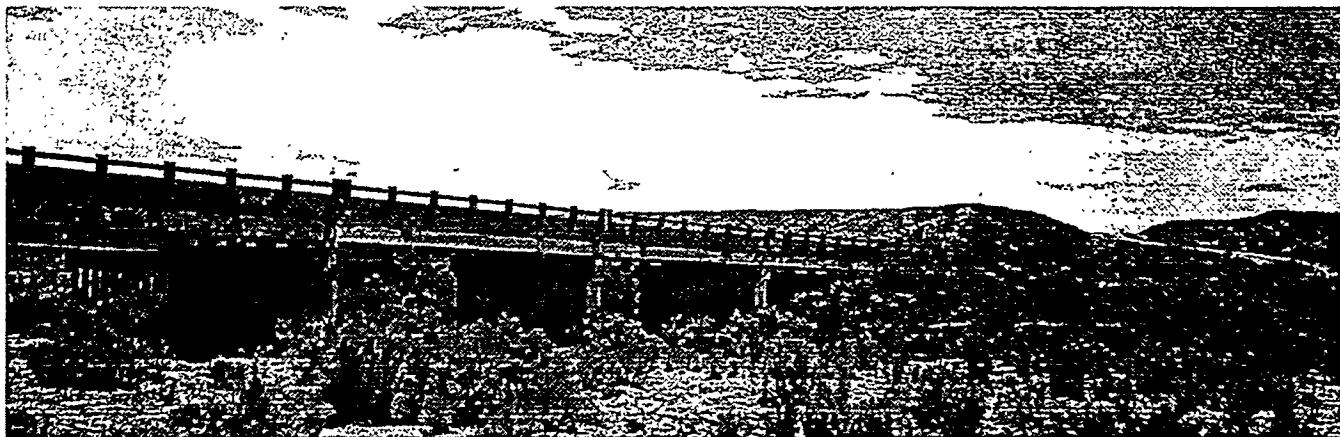
Figure 1. Elevation View of the Alamosa Canyon Bridge

The Alamosa Canyon Bridge has seven independent spans with a common pier between successive spans. An elevation

view of the bridge is shown in Fig.1. Each span consists of a concrete deck supported by six W30x116 steel girders. The roadway in each span is approximately 7.3 m (24 ft) wide and 15.2 (50 ft) long. A concrete curb and guard rail are integrally attached to the deck. Plans for the bridge do not show shear studs on the top flanges of the girders. Inspection of the bridge showed that the upper flanges of the girders are imbedded in the concrete. Four sets of cross braces are equally spaced along the length of the span between adjacent girders. The cross braces are channel sections (C12x25). A cross section of the span at a location showing the interior cross braces is shown in Fig. 2. At the pier the girders rest on rollers as shown in Fig. 3. Also shown in Fig. 3 is the connection detail at the abutment where the beams are bolted to a half-roller to simulate a pinned connection. The bridge is aligned primarily in a north-south direction.
