FIELD VERIFICATION OF A NONDESTRUCTIVE
DAMAGE LOCATION ALGORITHM

Charles R. Farrar, ESA-EA, LANL
Norris Stubbs, Texas A & M, College Station, Texas

Structures Congress
Portland, OR.
April, 1997

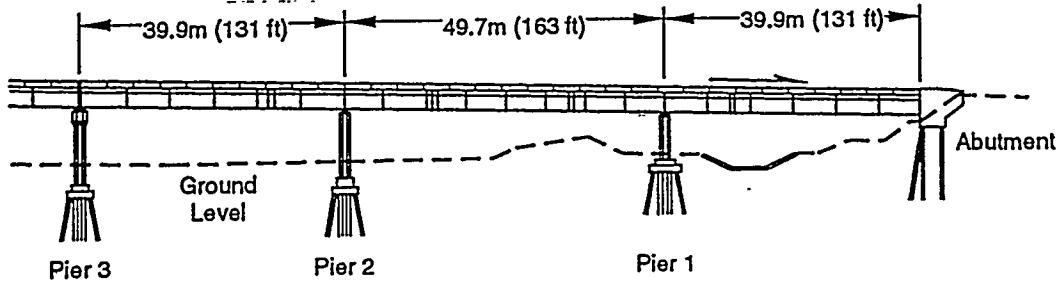
Figure 1. Elevation view of the portion of the eastbound bridge that was tested.

Loads from the stringers are transferred to the plate girders by floor beams. Figure 1 shows an elevation view of the portion of the bridge that was tested. The cross-section geometry of each bridge is shown in Fig. 2.

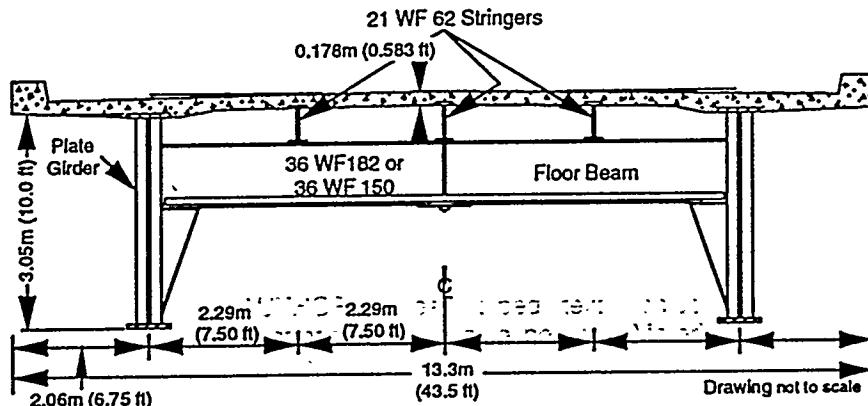
Figure 2. Typical cross-section geometry of the bridge.

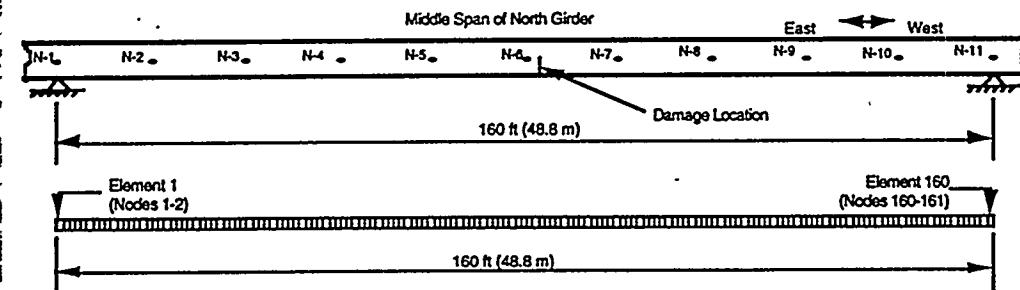
Figure 3. Refined accelerometer locations.

Mode shapes were obtained using two sets of accelerometers. For the refined set of sensors (denoted SET1) shown in Fig. 3 eleven accelerometers were placed along the span where the damage was introduced. Experimental modal data were obtained from the cross-power spectra where sensor N-3 was used as a reference. A coarse set of accelerometer data (denoted SET2) shown in Fig. 4 was also used. Modal data were determined from frequency response functions obtained during measured input, random, forced-vibration tests. An input applied directly above the south girder, midway between the abutment and first pier, was used to excite the structure when data were acquired with either SET1 or SET2. A summary of the experimental methods can be found in Farrar, et al., (1994).

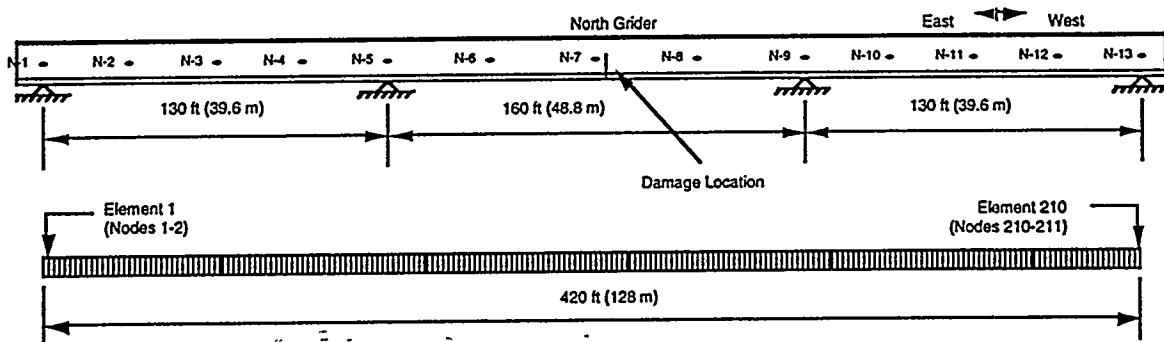
Figure 4. Coarse accelerometer locations.

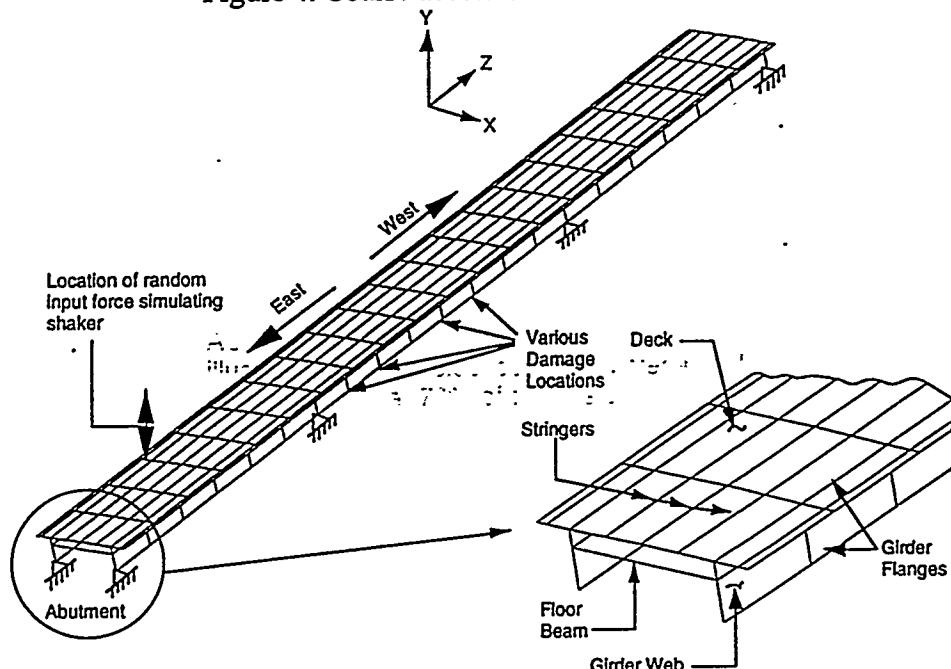
Fig. 5 Finite Element Model of the I-40 Bridge (Piers Neglected).

Using benchmarked finite element models as described in Farrar, et al. (1996), forced vibration tests similar to the ones conducted on the I-40 Bridge were simulated numerically. The finite element model of the bridge is shown in Fig. 5. A random force was applied to the finite element model to simulate the input force applied by the shaker during the experiments. Using the random force input, a dynamic time history analysis was conducted and the responses (i.e., vertical acceleration-time histories) at the nine monitored nodal points were recorded. A forced vibration dynamic analysis was initially done with the bridge in its undamaged state and then repeated for each damaged case A-1 through A-8 and the second undamaged case, Case A-9. Results from these analyses (node point accelerations) were then analyzed using similar signal processing techniques as those applied to the refined set of accelerometer data discussed in Farrar and Jauregui (1996).
