Development of a surface-specific, anti-weathering stone preservative treatment

Sudeep M. Rao^{1,2}, Cathy S. Scotto³, C. Jeffrey Brinker^{1,4}, Timothy J. Ross²

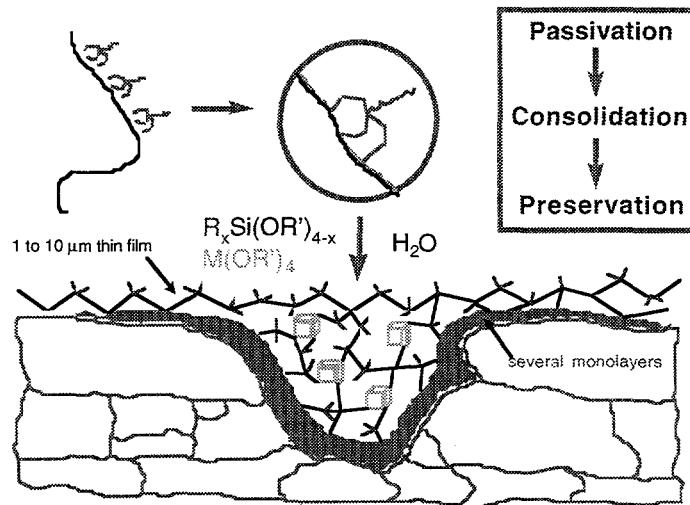
Figure 1. Schematic diagram of treatment for weathered limestone surface on a sculpted "nose". The gray area is the passivant that couples the limestone to the SiO_2 -based consolidant above it. The R_x and M groups shown in the schematic can be tailored to increase the consolidant's hydrophobicity and strength respectively.

Our strategy to protect limestone is a surface-specific treatment that is designed to retard any further chemical or physical weathering by first rendering the limestone surface passive toward hydrolysis and second by strengthening or consolidating the already weathered structure (Rao [7,8], Cygan [9], Nagy [10]). A mineral-specific passivant molecule energetically binds to the calcite surface and also acts as a coupling agent for the consolidant (see Figure 1). The coupling is achieved by a polymerizable “tail” on the passivant that enables sol-gel condensation reactions with the consolidant. The consolidant offers strength to the weathered stone by forming an inorganic framework within the pore system. The sol-gel based consolidation process is amenable to the introduction of strengthening metal oxides and water repelling agents.

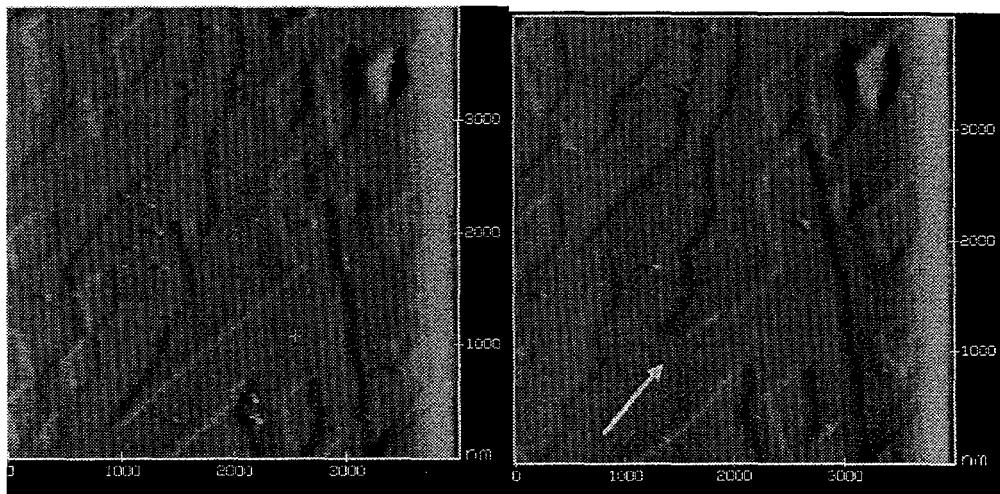
Figure 2a & b. SPM image (left) of single crystal calcite upon addition of simulated acid rain. The appearance of etch pits confirms rapid dissolution of calcite. The etch pits are diamond shaped (<1 nm deep). Figure 2b shows the same location after 3 more minutes of exposure to the weathering solution. Note the enlargement of the etch pits and retreat of steps (esp. peninsular region in the center of the images).

Optically clear calcite samples from Chihuahua, Mexico were cleaved to expose the {104} surface. These were used directly to observe dissolution of calcite characterized by etch pit formation and step retreat on the surface, when exposed to corrosive solutions (see Figure 2). Samples to be treated were placed in the passivant solution for 30 min., rinsed with methanol and then placed in the consolidant for another 30 min. Following rinsing with ethanol they were dried in an oven at 60°C. We used a 12 μm SPM piezoelectric scanner (Model-E) and Si_3N_4 probes. The scan size was kept between 4-10 μm^2 , the Z-range at less than 25 nm, and the scanning rate was 4-8 Hz which results in an image-acquisition time of less than 90 seconds. To simulate acid rain weathering we used freshly deionized water (18 $M\Omega$) which was allowed

Dissolution of untreated calcite was observed immediately upon addition of deionized water by the formation of etch pits approximately 200 nm along the diagonal and about 100 nm along the shorter diagonal (Figure 2a & b). The depth of the etch pits was about 0.5 nm which indicates that dissolution is occurring in monomolecular steps. The rate of surface loss was 4-7 nm²/sec. Further dissolution resulted in the retreat of steps and merging of adjoining pits (Figure 2b). This dissolution of calcite in the presence of an acidic undersaturated solution continues until equilibrium is reached in the fluid cell volume of the microscope. The etching of the surface re-commences after

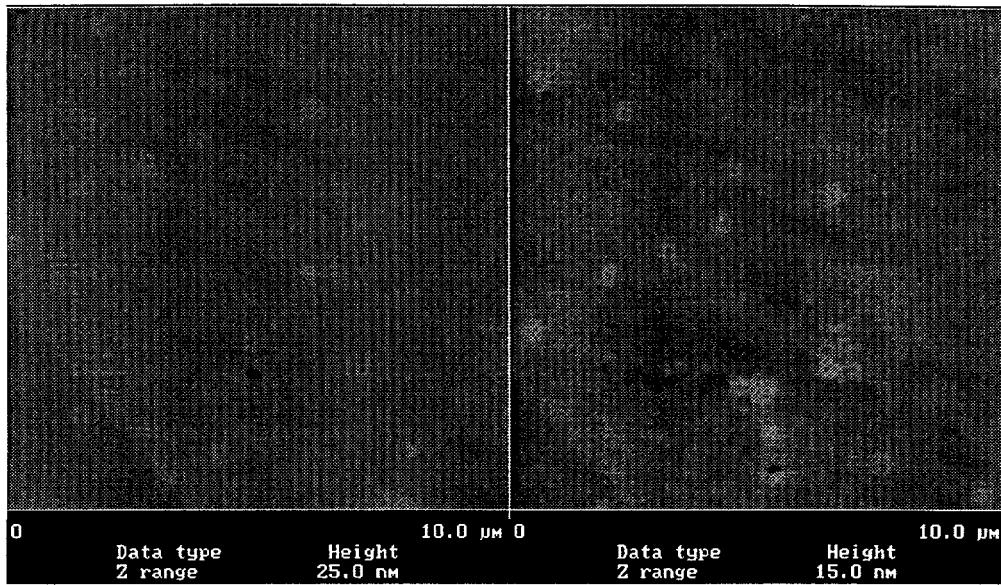
Figure 3a & b. SPM images of single crystal calcite treated with the SAAC passivant and silica based A2** consolidant, before (left) and after (right) addition of simulated acid rain. Time elapsed between the two images is one hour. With the exception of increased contrast due to a change in the Z-axis scale, the surface remains unchanged. No etch pit formation or step retreat is seen.

Calcite crystals treated with the 3% SAAC passivant and A2** consolidant (15% w/w) show no etch pit formation or step retreat upon addition of the weathering solution (Figure 3a & b). The steps are no longer visible and the surface appears rough. A triangular pattern of coating defects seen as bright circles with dark spots in them can also be identified in both the images. The increased contrast in Figure 3b is due to a deliberate decrease in the z-axis scale from 25 nm to 15 nm to highlight surface features. However, we note that calcite treated with just the 15% silica consolidant also showed no etch pits or step movement and the contrast between these two samples can be heightened, for example, by using a more corrosive solution. Thus the protection of the calcite may be due to the inorganic framework on the surface. Calcite treated similarly with a commercial consolidant, Wacker OH containing 75 % silica (not recommended for limestones), resulted in a film that cracked and peeled away.

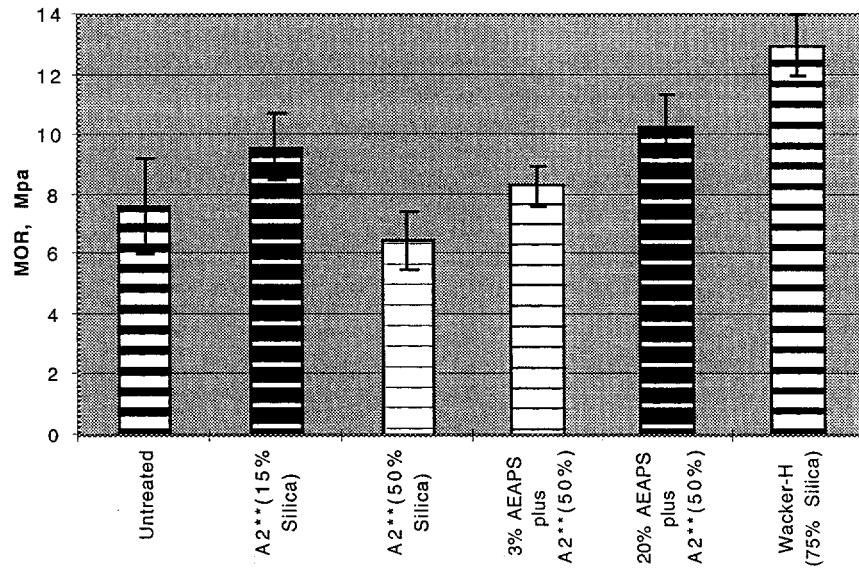
Mod. of Rupture

Figure 4. Plot of modulus of rupture for different treatments.

The effect of the different treatments on the modulus of rupture of the limestone cores as determined from the three-point bend tests is seen in Figure 4. Due to the heterogeneous nature of the stone, the standard deviations were large. The commercial consolidant Wacker-H with 75% silica gave the highest increase in flexural strength. The A2** consolidant alone (without a passivant) with 15% silica, strengthened the stone compared with the more concentrated A2** (50%). This counter-intuitive disparity is due to the processing conditions: the

A2** 15% sol is subjected to two acid-catalyzed steps, aged and then diluted while the 50% A2** sol is hydrolyzed by acid only once. The increased acid concentration and greater H₂O:Si ratio in the A2** 15% sol enhance the hydrolysis rate (Brinker [15]).

This combined with the aging of the sol ultimately forms a stronger gel. The increase in the concentration of the AEAPS passivant from 3 to 20% results in a 25% increase in strength and a 35% increase compared to the untreated stone. Other researchers have also observed that the incorporation of AEAPS into silica aerogels showed reductions in gel times and increases in the bulk density (from reductions in surface area) (Husing [16]). The amino group may be helping to catalyze the condensation reaction due to its basic nature. Cores treated with the 20% AEAPS sol and the 15% A2** sol were not tested due to the rapid gelation on the surface that prevents effective penetration and also leads to excess gelled material on the surface of the stone. The trisilanol form of the SAAC passivant was eliminated in preliminary experiments as it weakened the stone by binding too strongly to calcite and actually leached Ca^{2+} out of the samples.

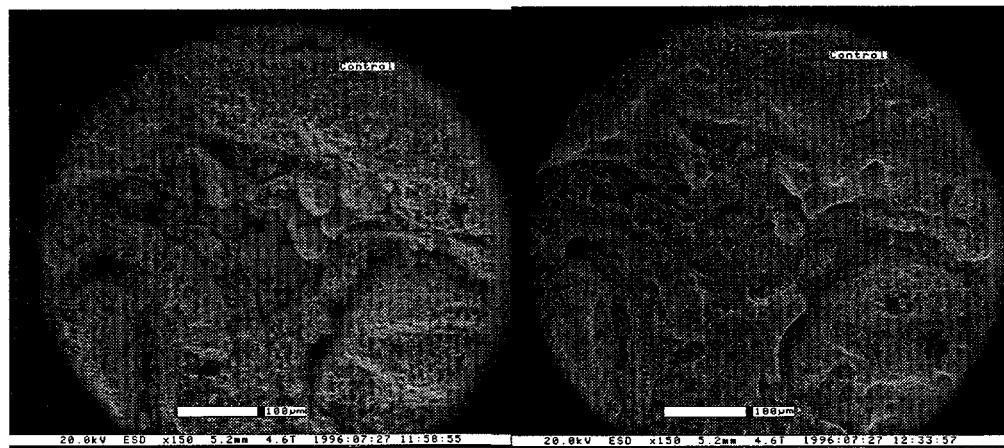
Figure 5a & b. Surface of untreated limestone shows ooids (concentric structures to the bottom left and right of Figure 5a) and polycrystalline regions (centre). Figure 5b shows the same region after addition of acid. Micron bar=100 μm .

The untreated limestone is filled with ooids (concentric spherical structures) and consists of amorphous regions and polycrystalline phases of calcite (Figure 5a). Large voids amidst clusters of fine grained calcite in the limestone are seen. Figure 5b shows the same region after introduction of concentrated acid. Figure 6a shows limestone passivated with SAAC and consolidated with A2**. the composite coating has cracked and retracted exposing bare calcite. Upon exposure to acid, the bare areas exhibit corrosive attack, but the coated areas do not, suggesting that the protective treatment, if continuous, would retard acid-rain attack. We believe that cracking results because the SAAC passivation layer does not bind effectively to the calcite surface, allowing the biaxial tensile stress developed upon curing to cause cracking and delamination (Chapters 7, 8 in Brinker [15]). Improved coupling chemistry combined with a reduction in the coating thickness should remedy this behavior.

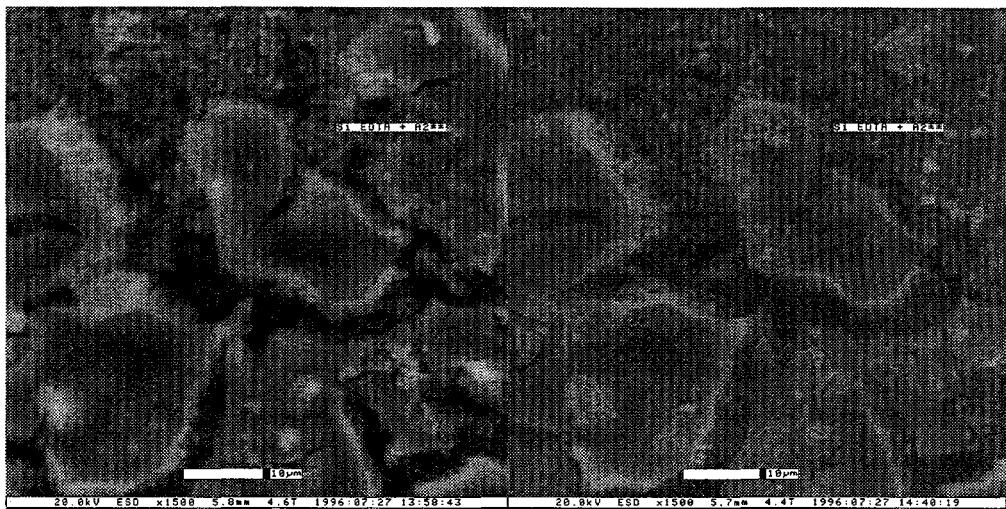
Figure 6a & b. Treated limestone before addition of concentrated sulfuric acid (Figure 6a). Inadequate coupling by the SAAC passivant led to shrinkage of the consolidant. Micron bar=10 μ m. Figure 6b shows the same region after addition of acid. The consolidated areas remain unaffected although the layer is cracked. Better coupling passivants and thinner consolidating layers can prevent the cracking.
