SNAP 7 PROGRAM QUARTERLY PROGRESS REPORT NO. 5

Task 8--Strontium-90 Fueled
Thermoelectric Generator Development

November 1, 1961 to January 31, 1962

MND-P-2483-5

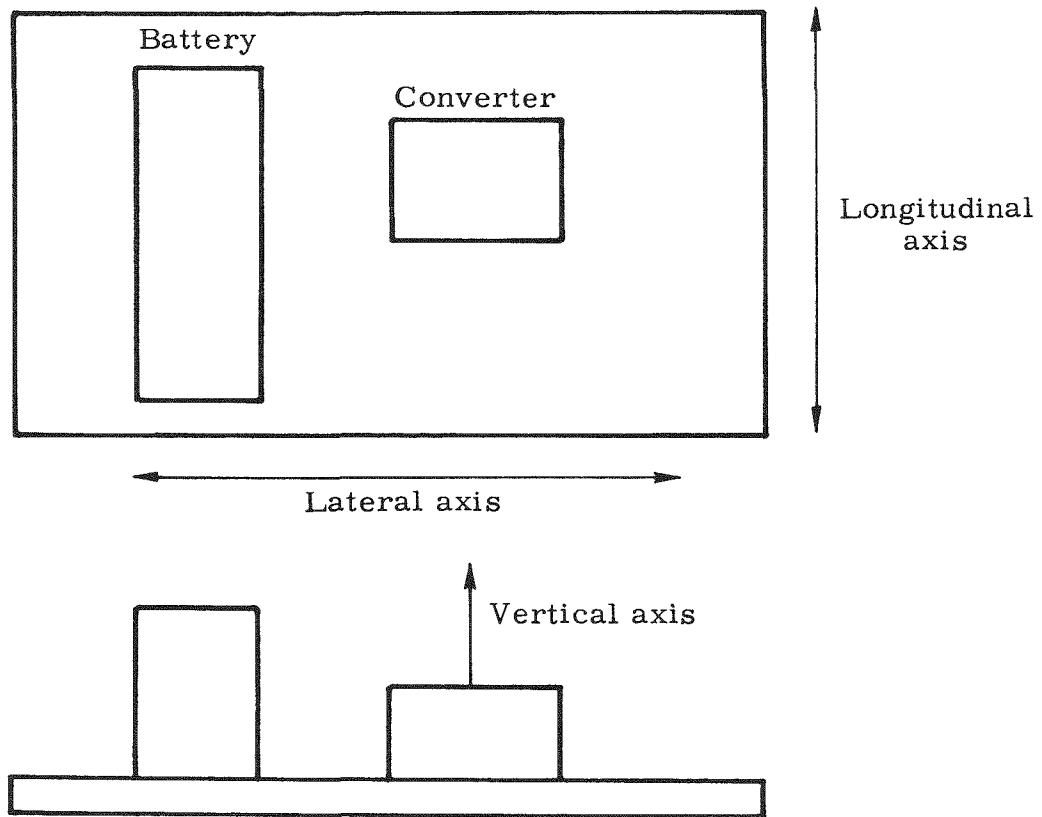
Fig. 1. Reference Axes for Vibration and Shock Testing of SNAP 7A Battery and Converter

Figure 1 shows the reference axes used during the shock and vibration testing of the battery and converter. Figure 2 shows the instrumentation circuitry used during the tests.

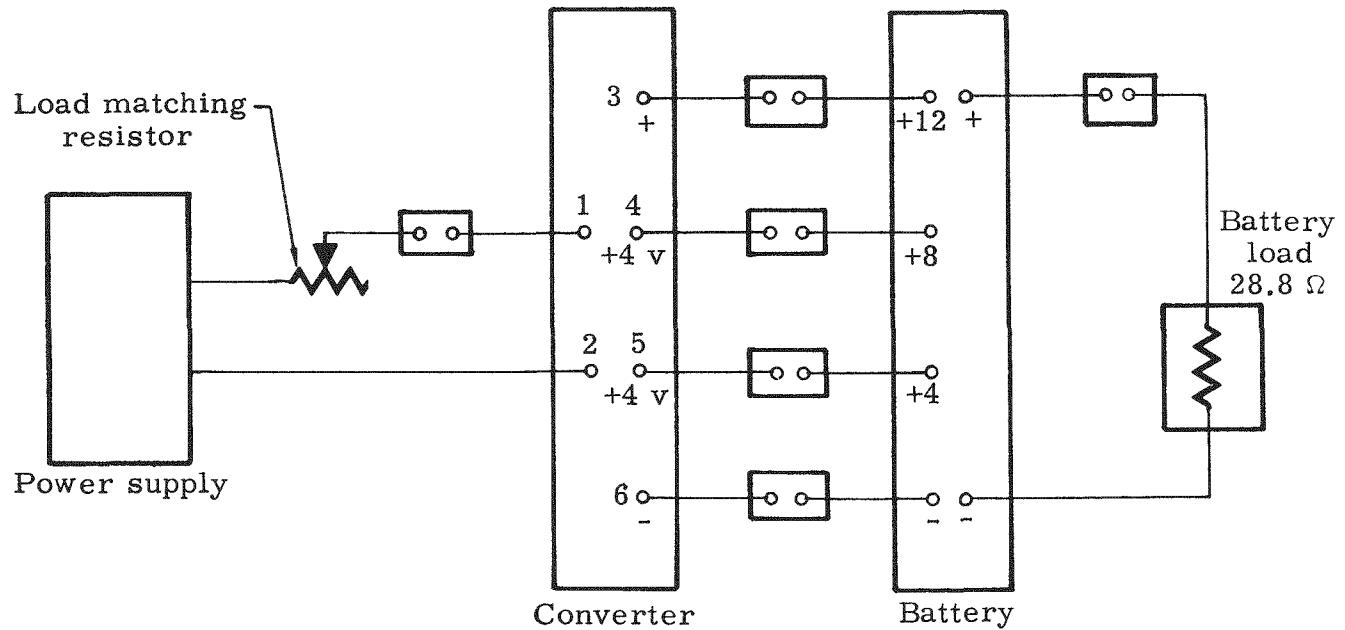
Fig. 2. SNAP 7A Battery and Converter Test Instrumentation Circuitry

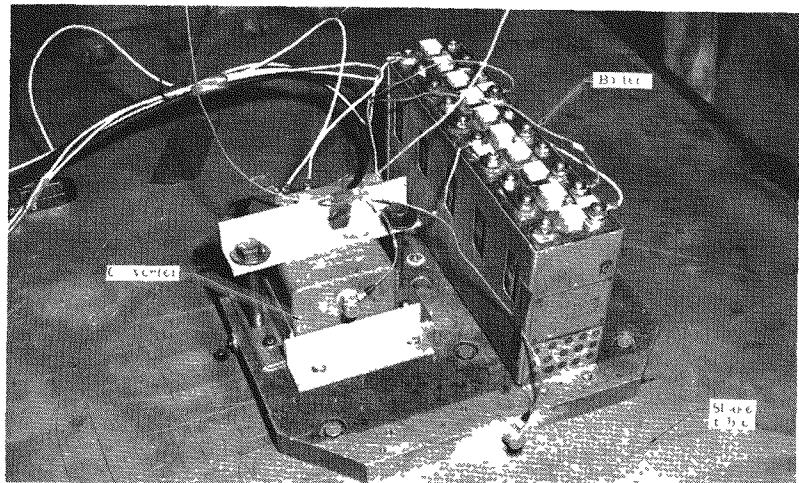
Fig. 3. SNAP 7A Battery and Converter Positioned on the Vibration Slide Table for Excitation in the Longitudinal Axis

- (1) Dwell at 5 to 33 cps in discrete frequency intervals of 1 cps; dwell for 3 minutes at each frequency (3-g level or 0.060 ± 0.006 inch displacement, whichever is less).
- (2) Repeat (1) for the two remaining principal orthogonal axes.
- (3) Dwell at the most severe resonant condition, at the input level consistent with the frequency, for a period of 2 hours.

Figure 3 shows the mounting arrangement for the vibration test in the longitudinal direction.

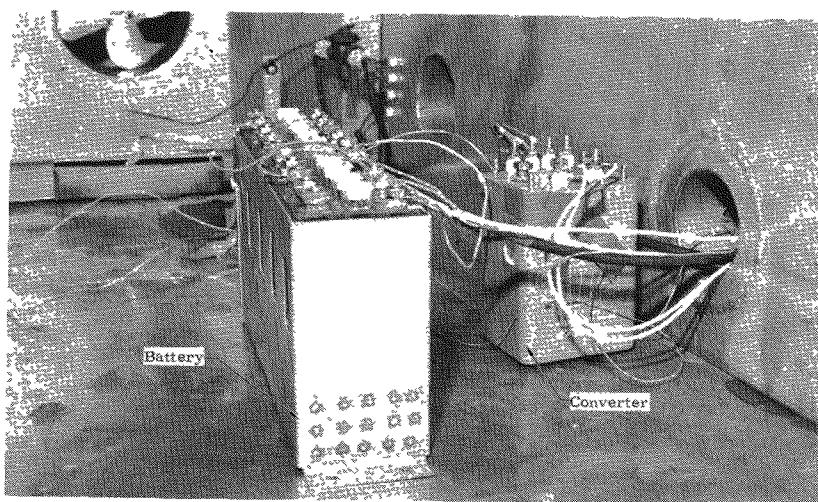
Fig. 5. SNAP 7A Battery and Converter Positioned in Temperature Chamber and Subjected to Various Ambient Temperatures

The battery and converter were positioned in a small temperature chamber, as shown in Fig. 5, and subjected to the following ambient temperatures:

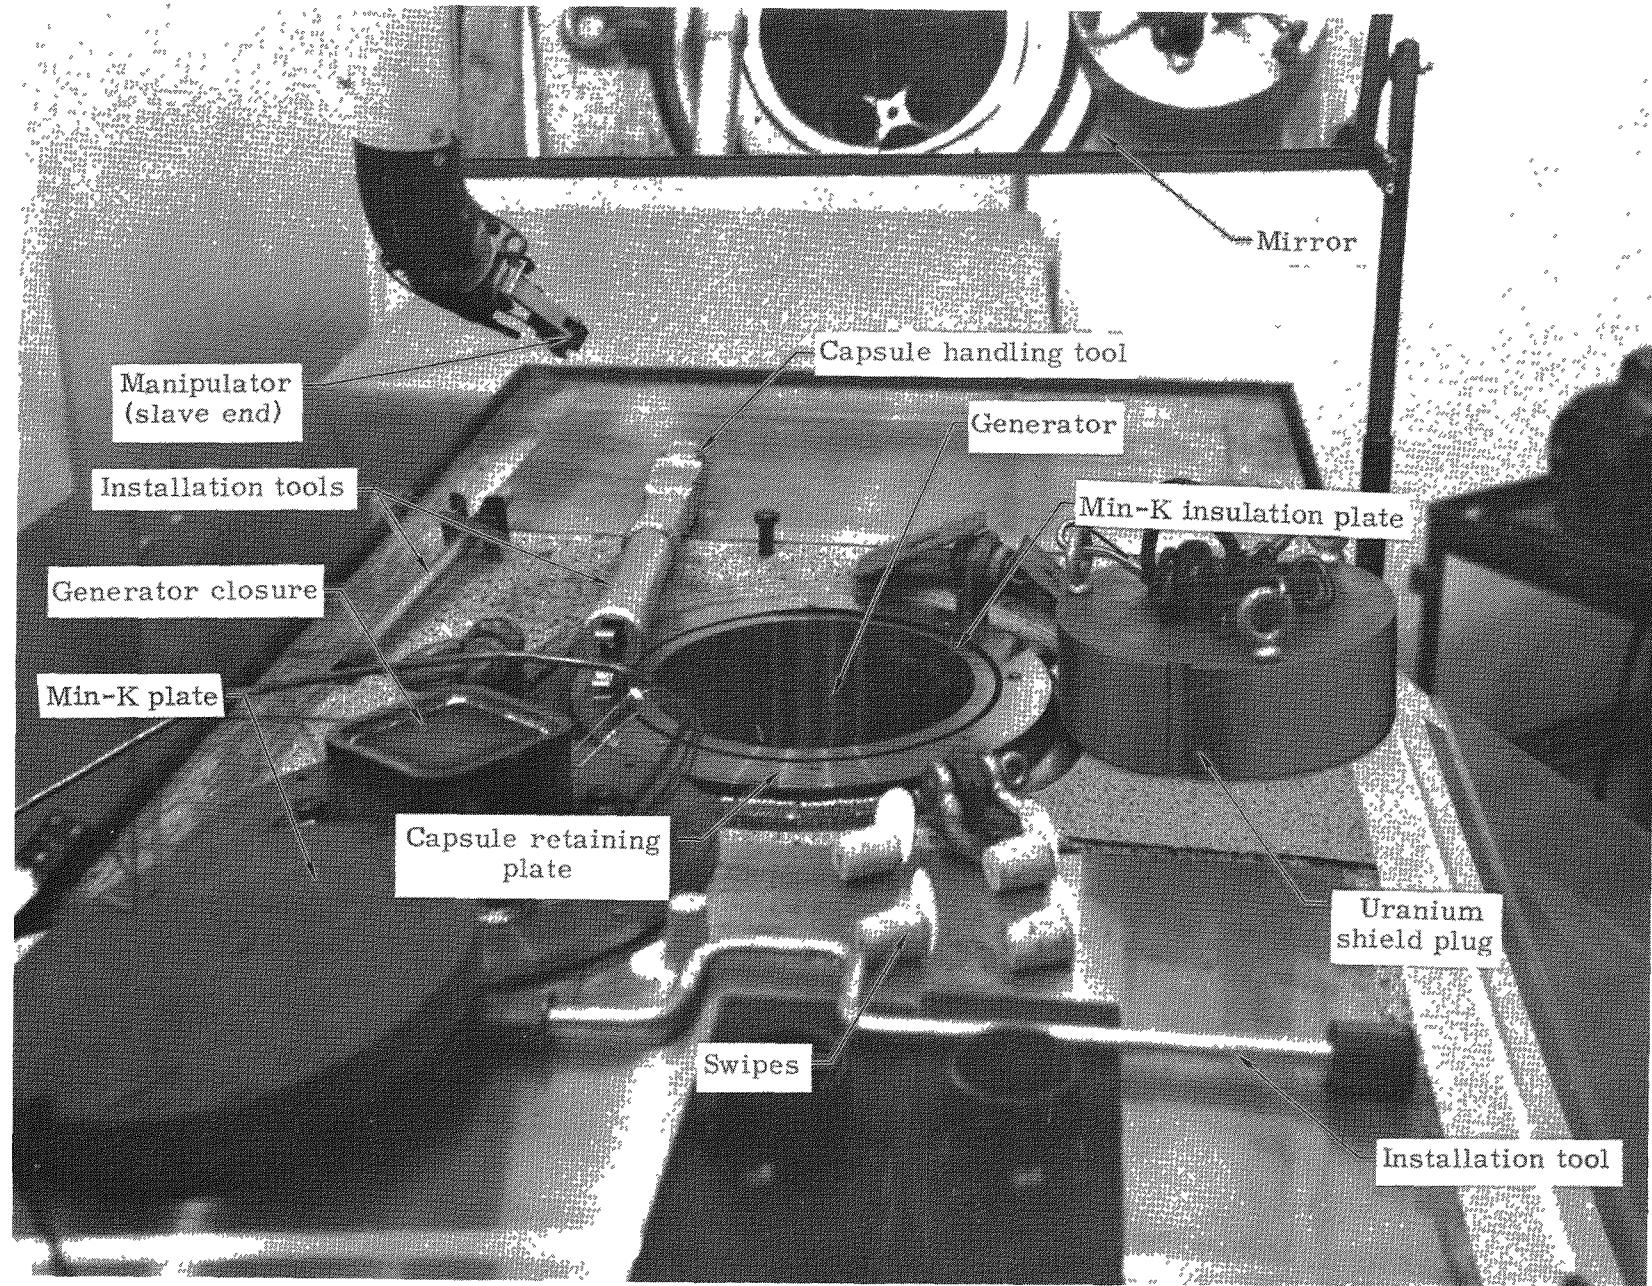
Fig. 6. Fueling of SNAP 7A Generator in Hot Cell at Martin Quehanna Facility

These values are well within the ICC regulations for unescorted shipments (10 mr/hr maximum at one meter and 200 mr/hr maximum at the surface). The fueling was accomplished on November 21, 1961. Approximately 30 minutes were required to install the capsules and close the generator. During the fueling, an argon purge was used. After sealing the generator, it was purged with hydrogen and filled with helium to assure the desired thermal conductivity through the insulation for the first two years of operation.

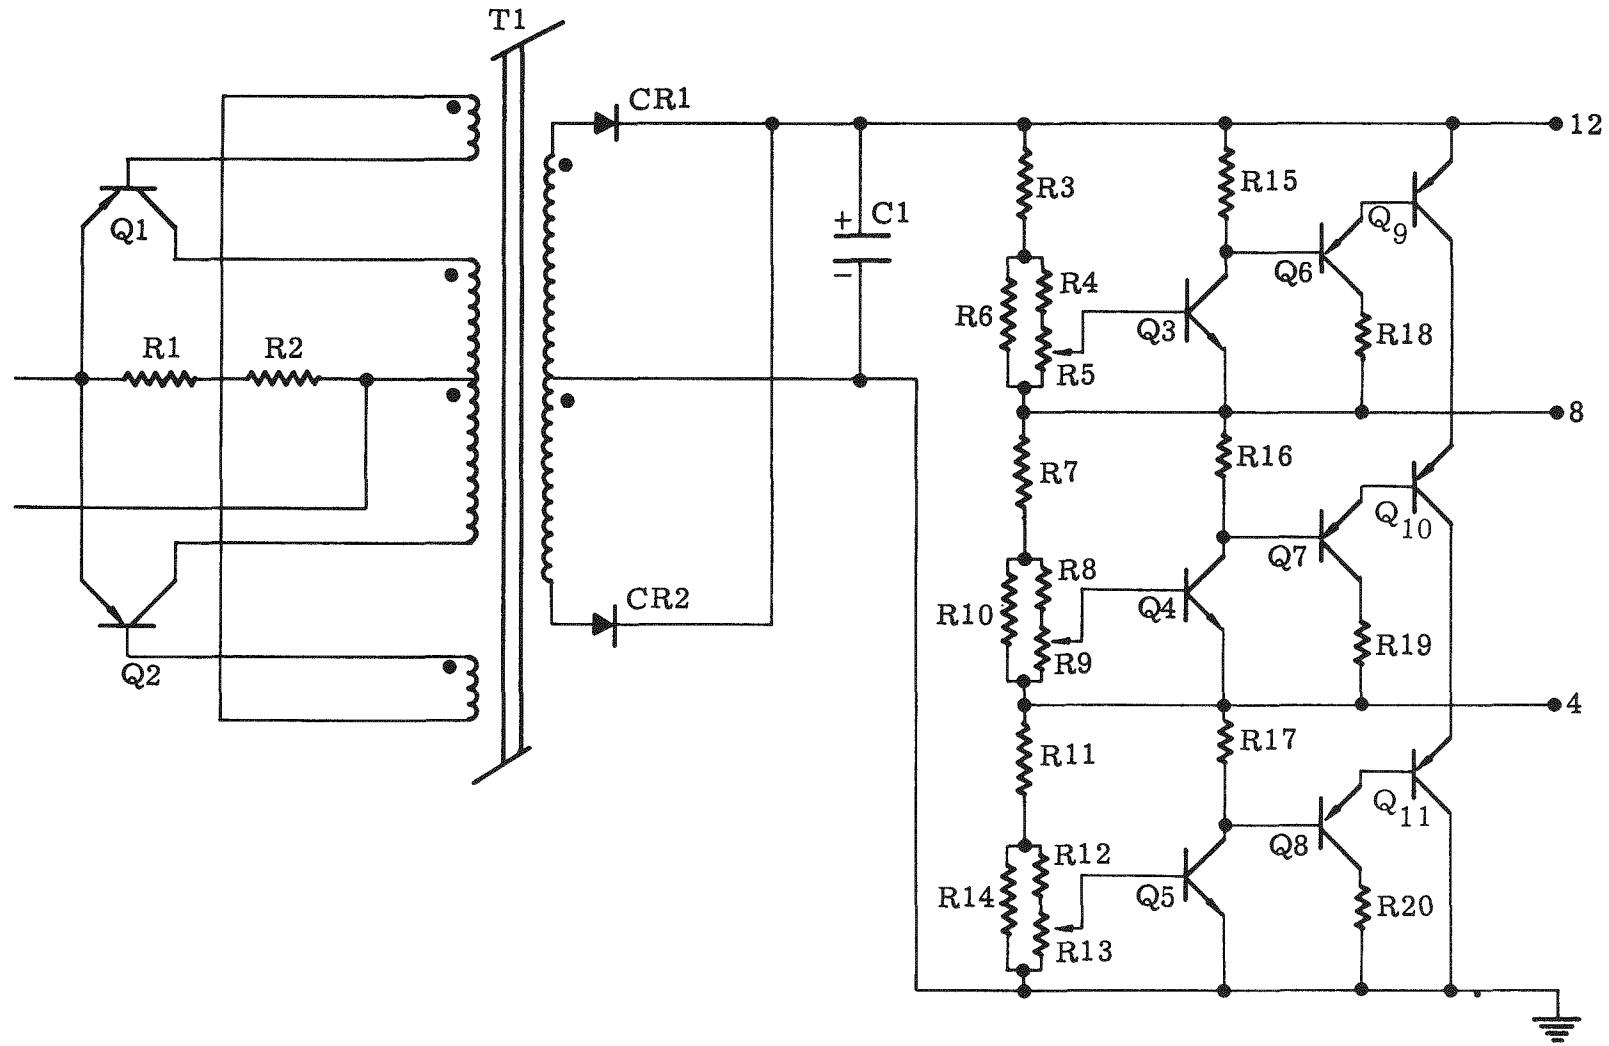
Fig. 7. Schematic of SNAP 7A Converter P/N SIG11119 DC -to- DC Converter
(3 outputs)

During the preceding tests on the system, voltage spread problems occurred. A three-section converter was substituted into the system in place of the single-section converter. Each section controls the voltage across three battery cells. With this arrangement it is possible to hold each of the nine cells used within the desired range of 1.33 to 1.38 volts per cell. The three-section converter proved adequate for voltage control, and displayed excellent stability under temperature variations. The converter had a maximum efficiency of 66%, which is available at the end-of-life condition for the generator. The converter schematic is shown in Fig. 7, and the corresponding parts list is included as Table IV.

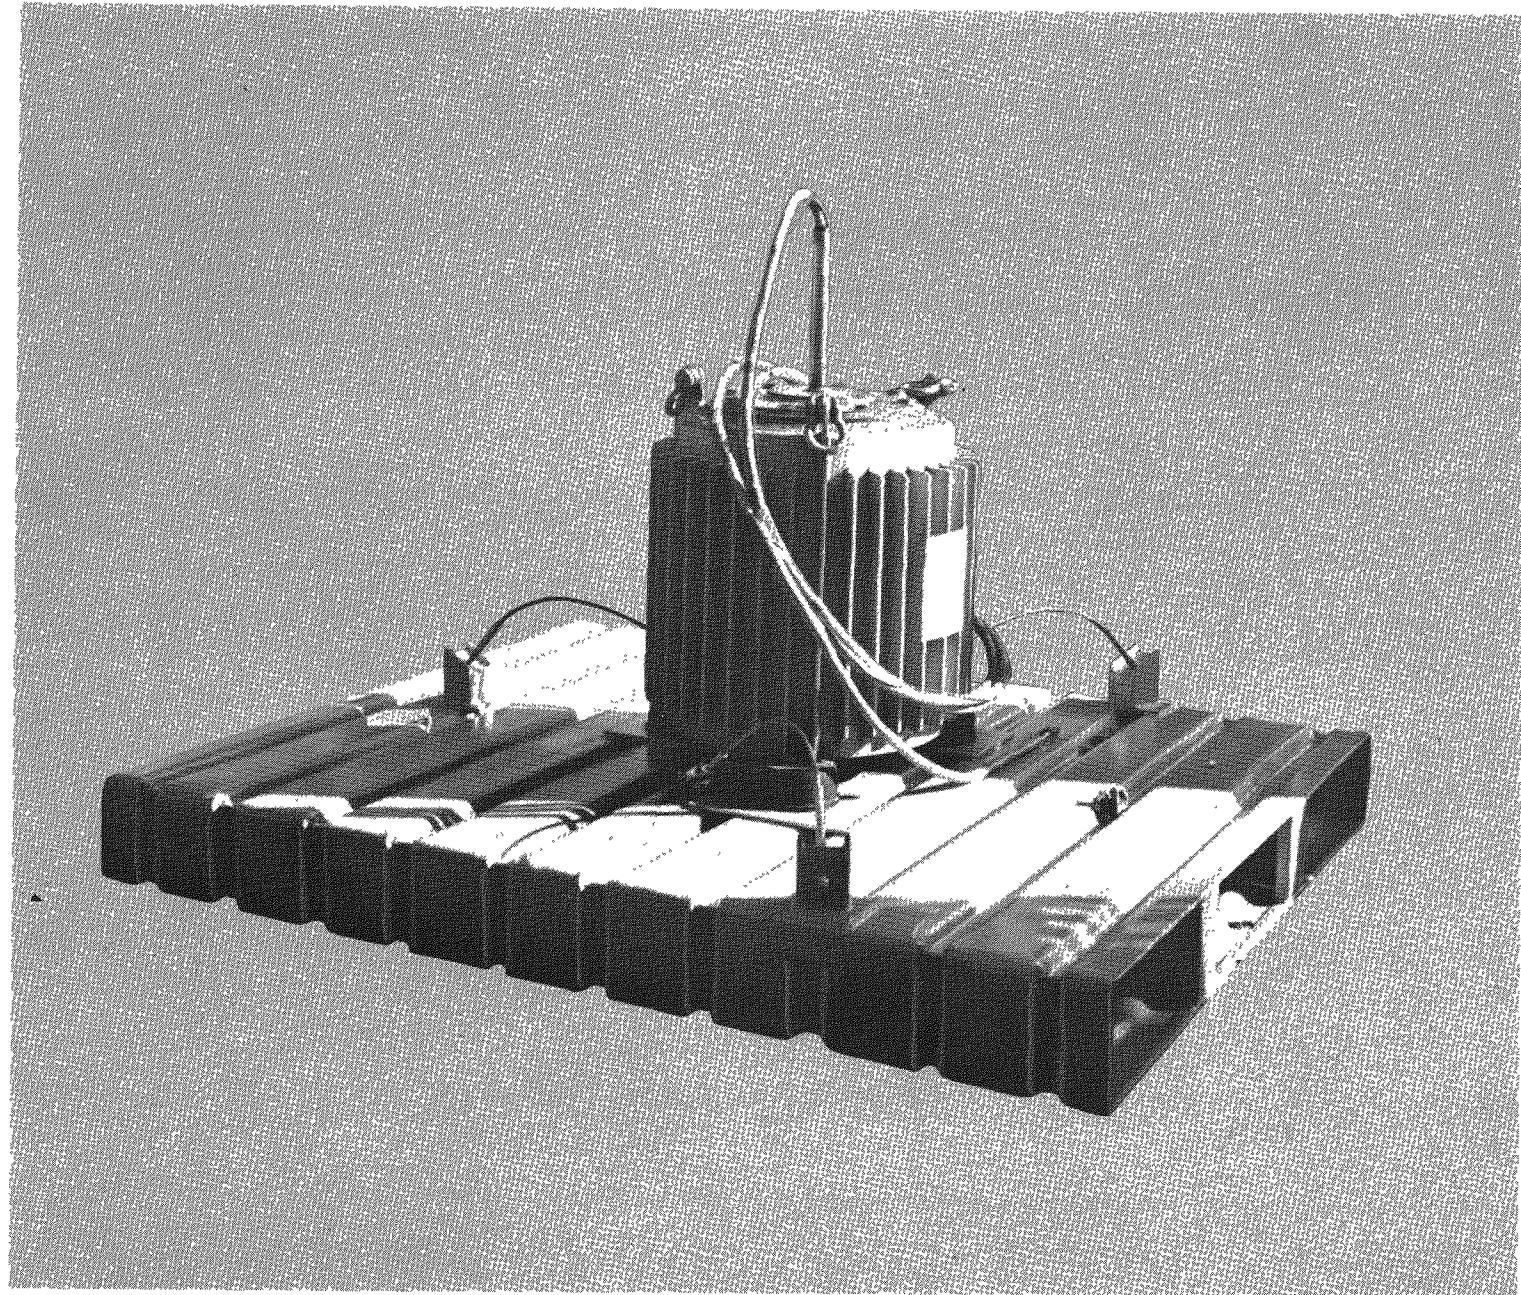
Fig. 8. AP 7A Generator

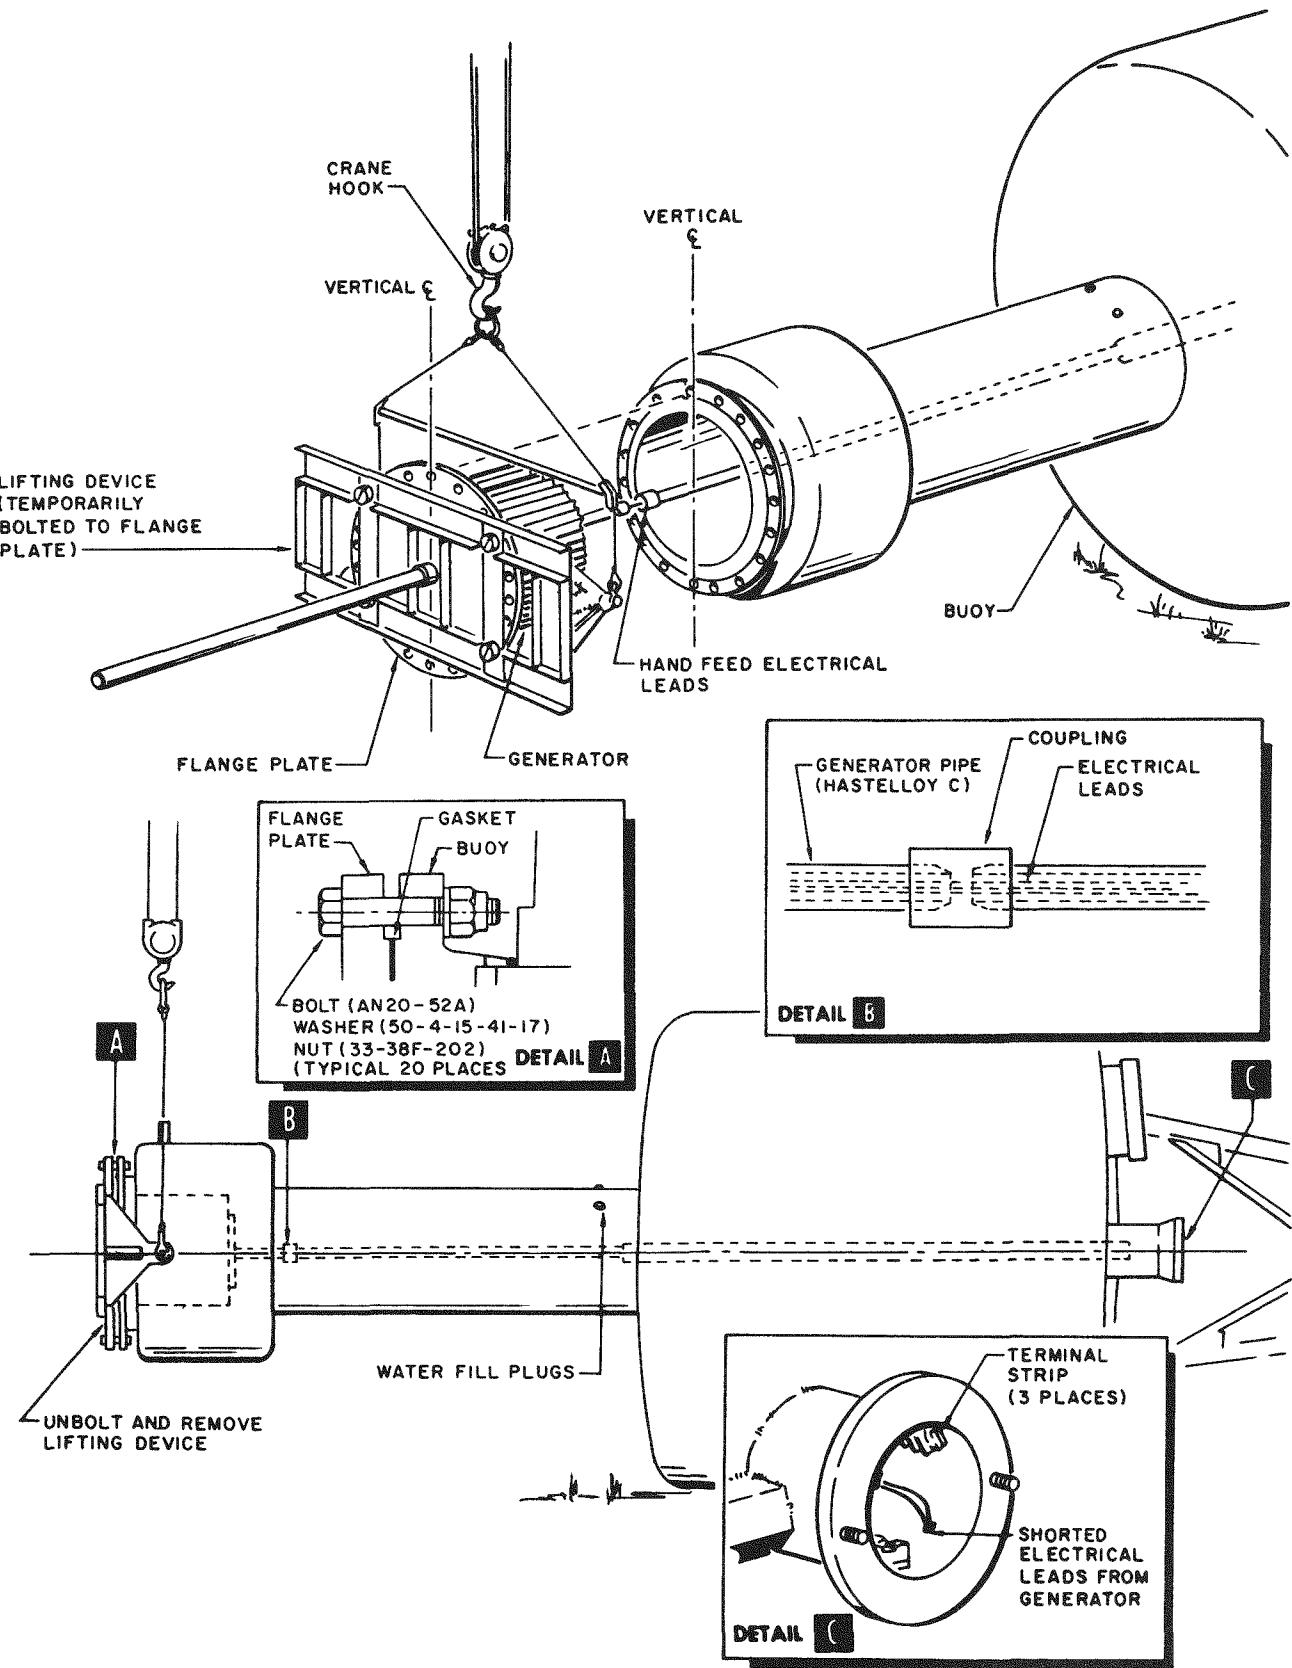
Fig. 9. Generator Installation Details SNAP 7A

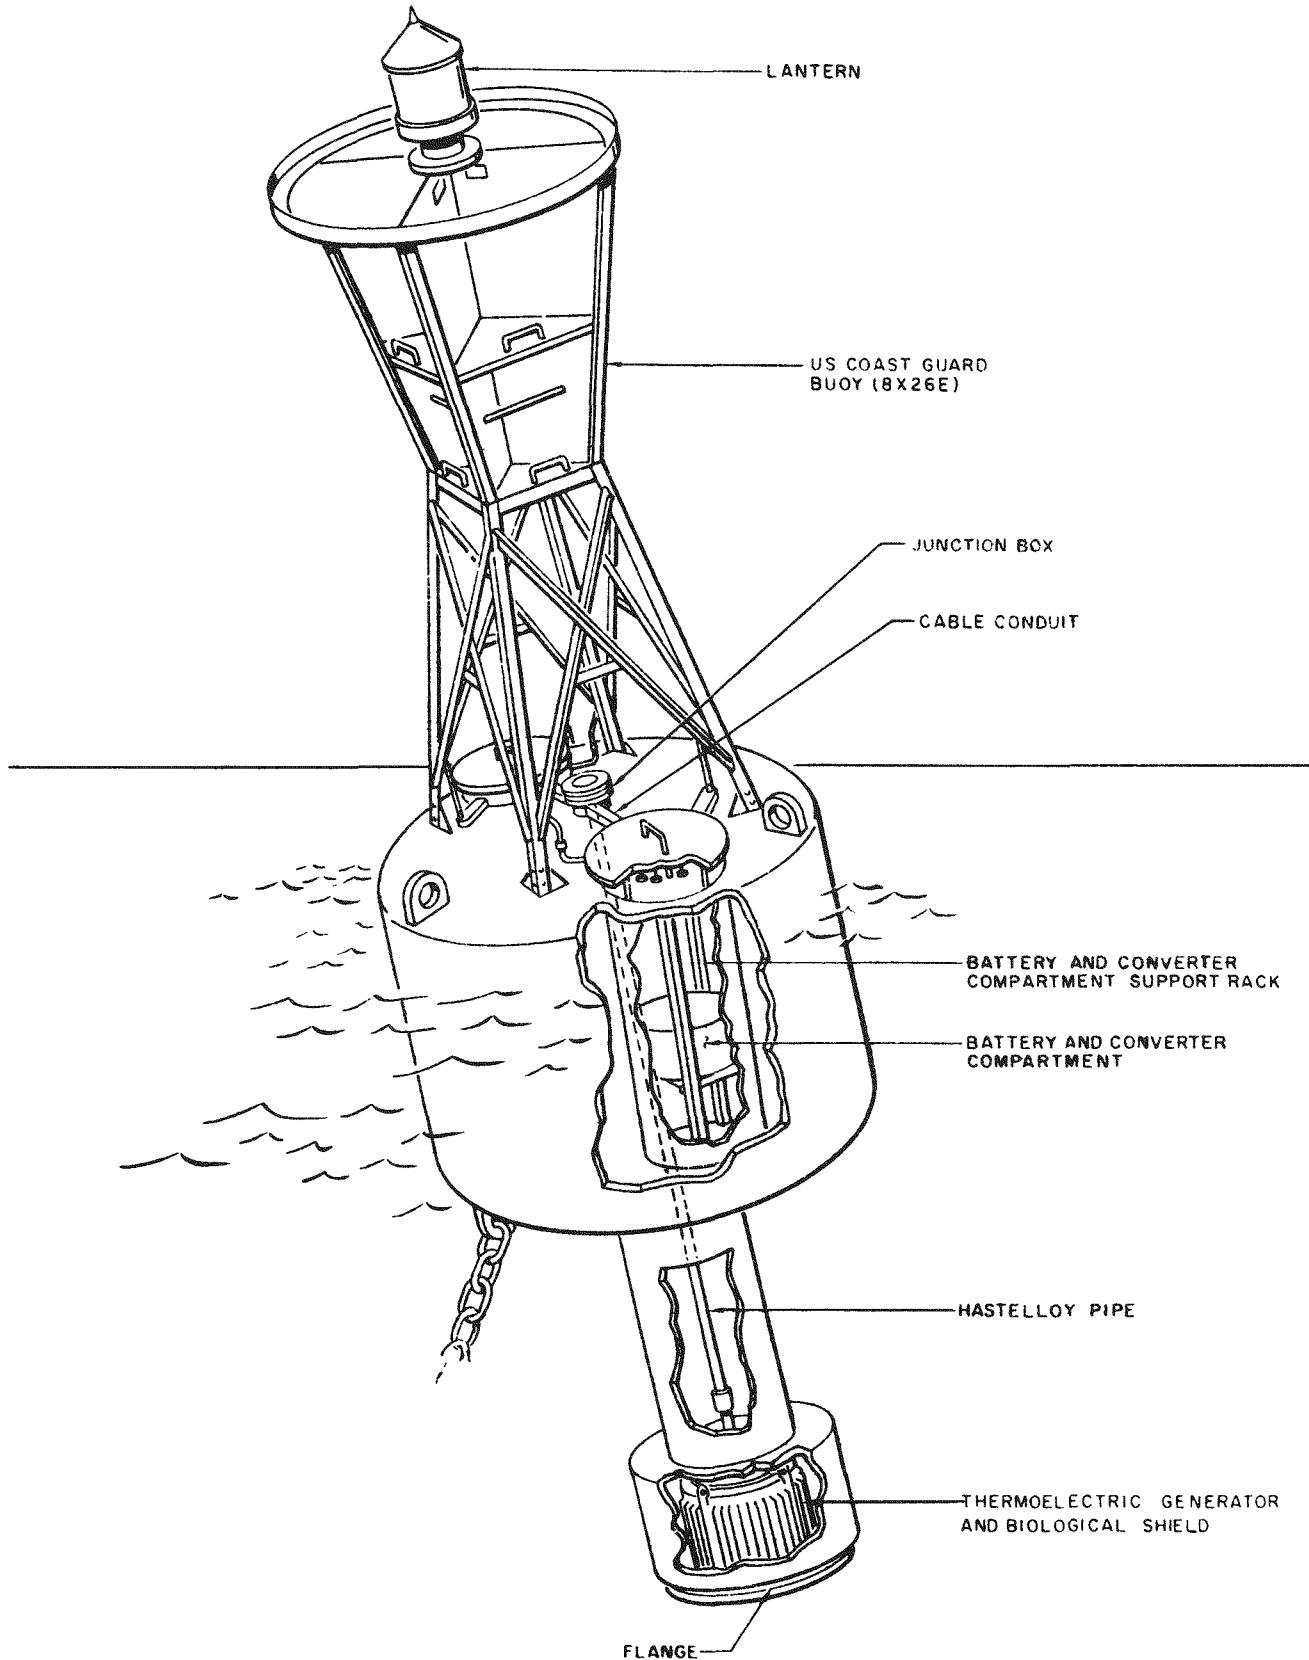
Fig. 10. SNAP 7A Installation

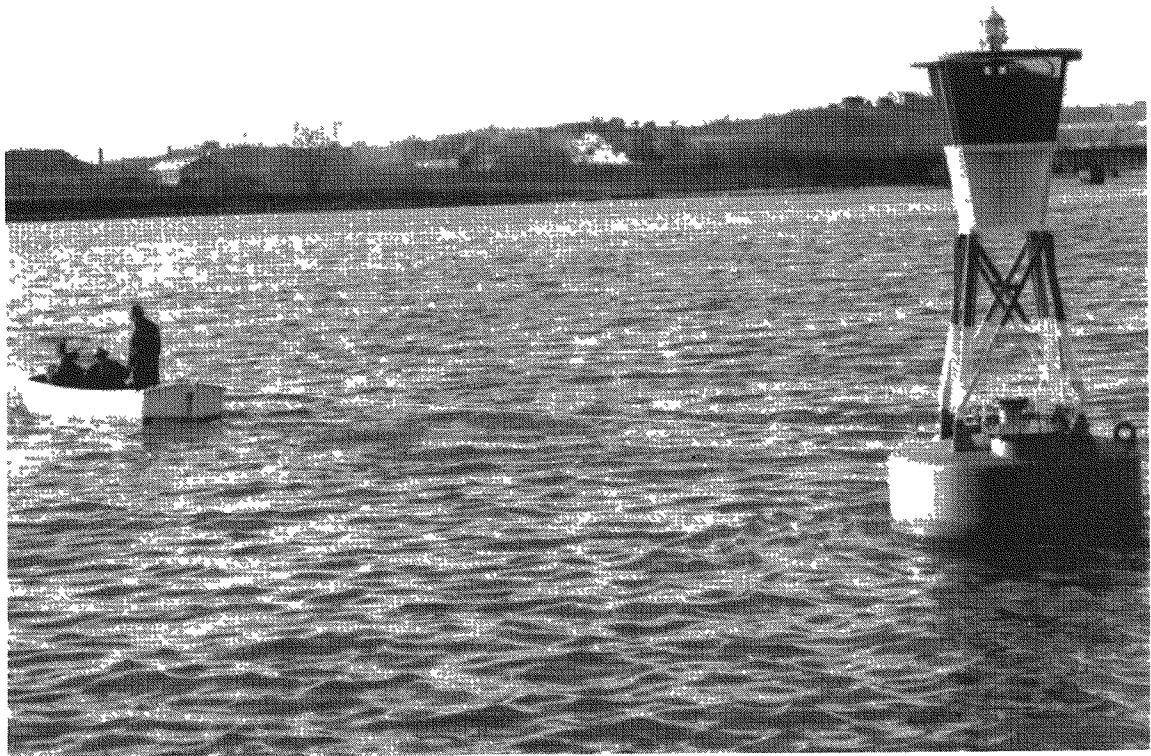
Fig. 11. SNAP 7A Light Buoy

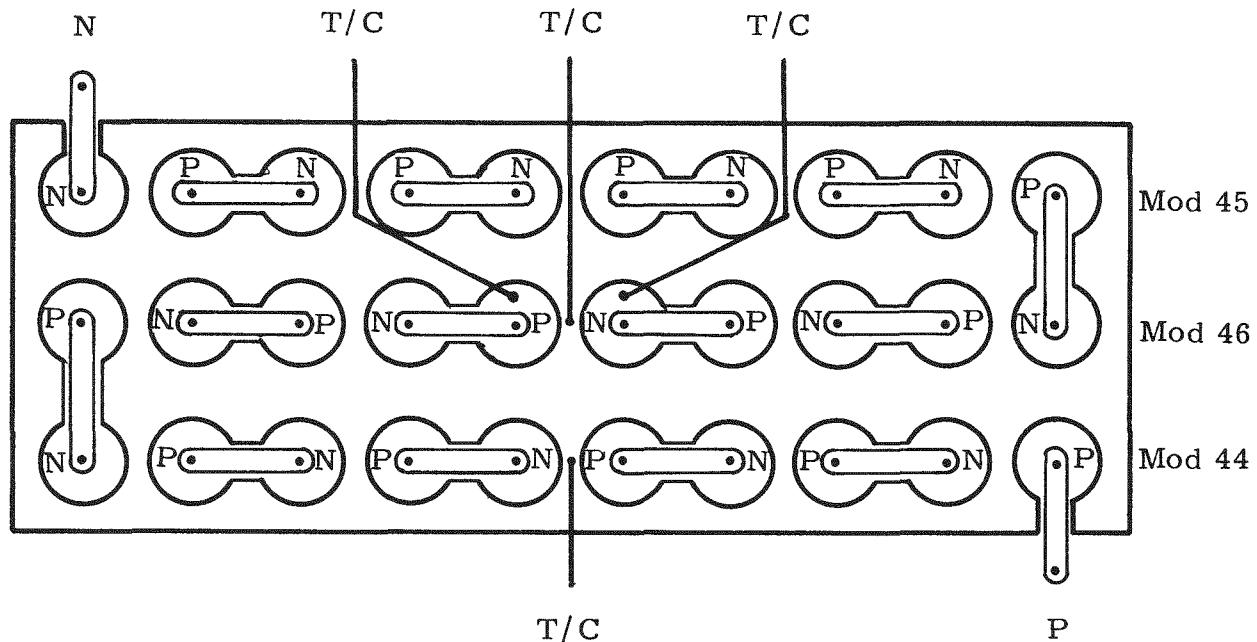
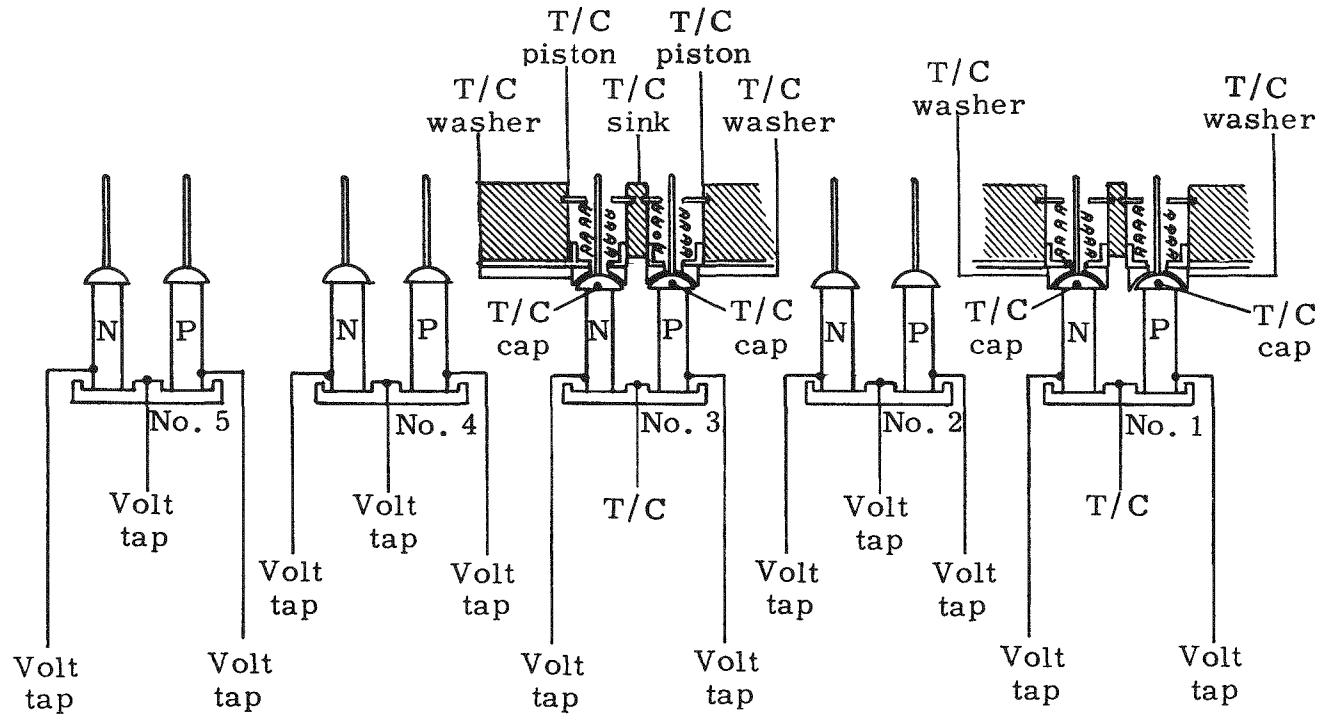
10-Watt Reliability Model Thermocouple and Voltage Tap Location

Module No. 46

Fig. 12. Arrangement of the Thermoelectric Couples and the Locations of the Thermocouples in the Reliability Model

Figure 12 shows the arrangement of the couples and the locations of the thermocouples in the reliability model. The center thermoelectric module, No. 46, was completely instrumented before assembly. Iron wire voltage taps were installed directly above the bonded hot junction on the "P" and "N" elements of all five couples. Voltage taps on couples Nos. 2, 4 and 5 and thermocouples on couples Nos. 1 and 3 were attached to the center of the hot shoe. Thermocouples were also

attached to the cold caps, pistons, and heat sink bar of couple No. 3. The terminal straps of all three thermoelectric modules were provided with voltage taps.

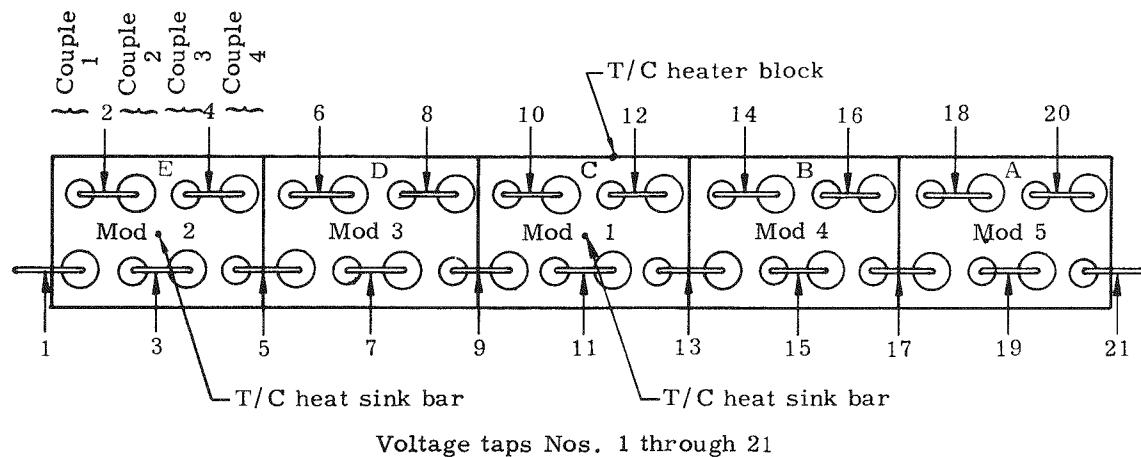
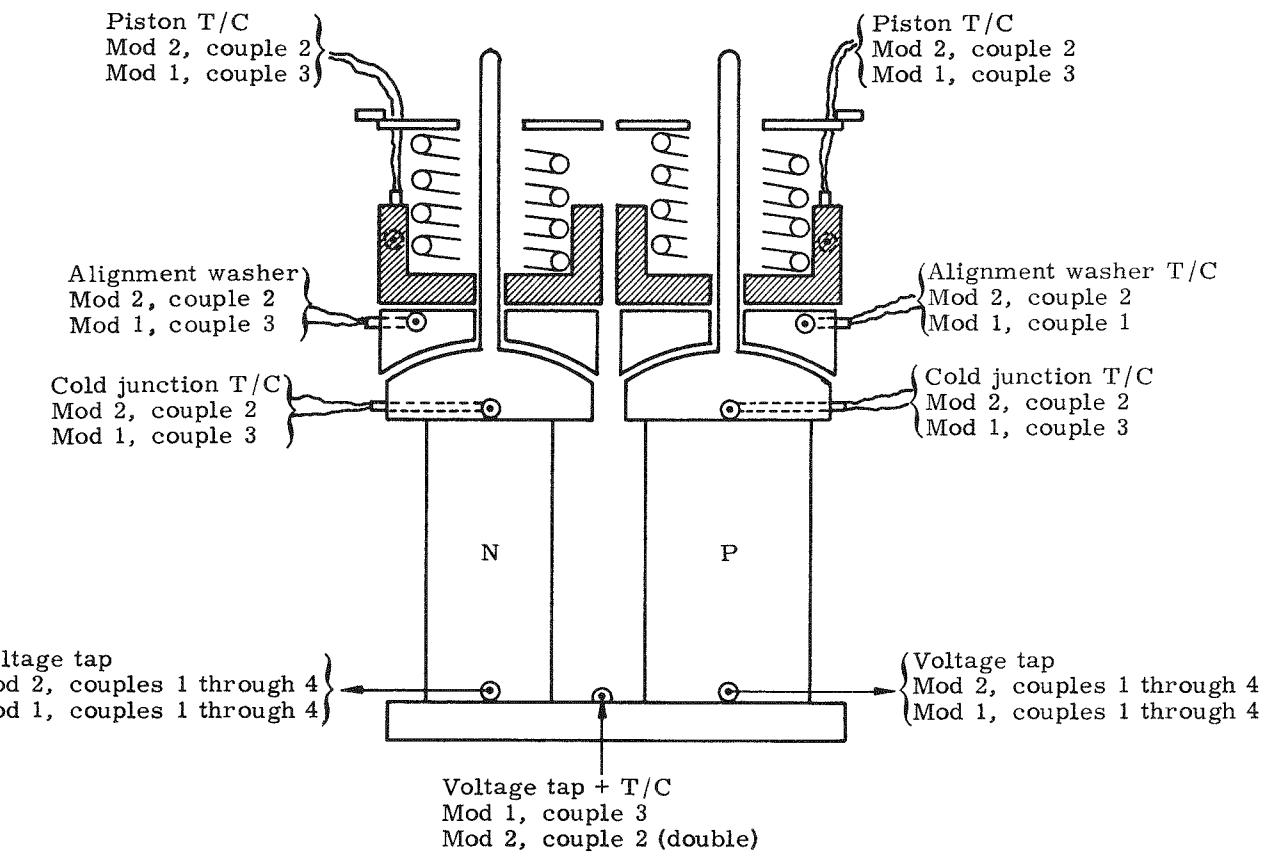
Fig. 13. 60-Watt SNAP 7B and 7D Reliability Model Thermocouple and Voltage Tap Locations

The SNAP 7B and 7D reliability model was completed, and went into operation on January 5, 1962. During the initial warm-up period, one of the power input leads developed an open circuit and the tests were interrupted for repair. The reliability model has operated at high temperature for a period of 23 days. The power outputs for hot junction temperatures of 800°, 850°, 900°, and 950° F are 8.3, 9.8, 11.1, and 12.24 watts, respectively. The output is expected to increase when the new couples are installed. The reliability model represents one-sixth of the SNAP 7B and 7D generator. The arrangement and instrumentation of the reliability model is shown in Fig. 13.

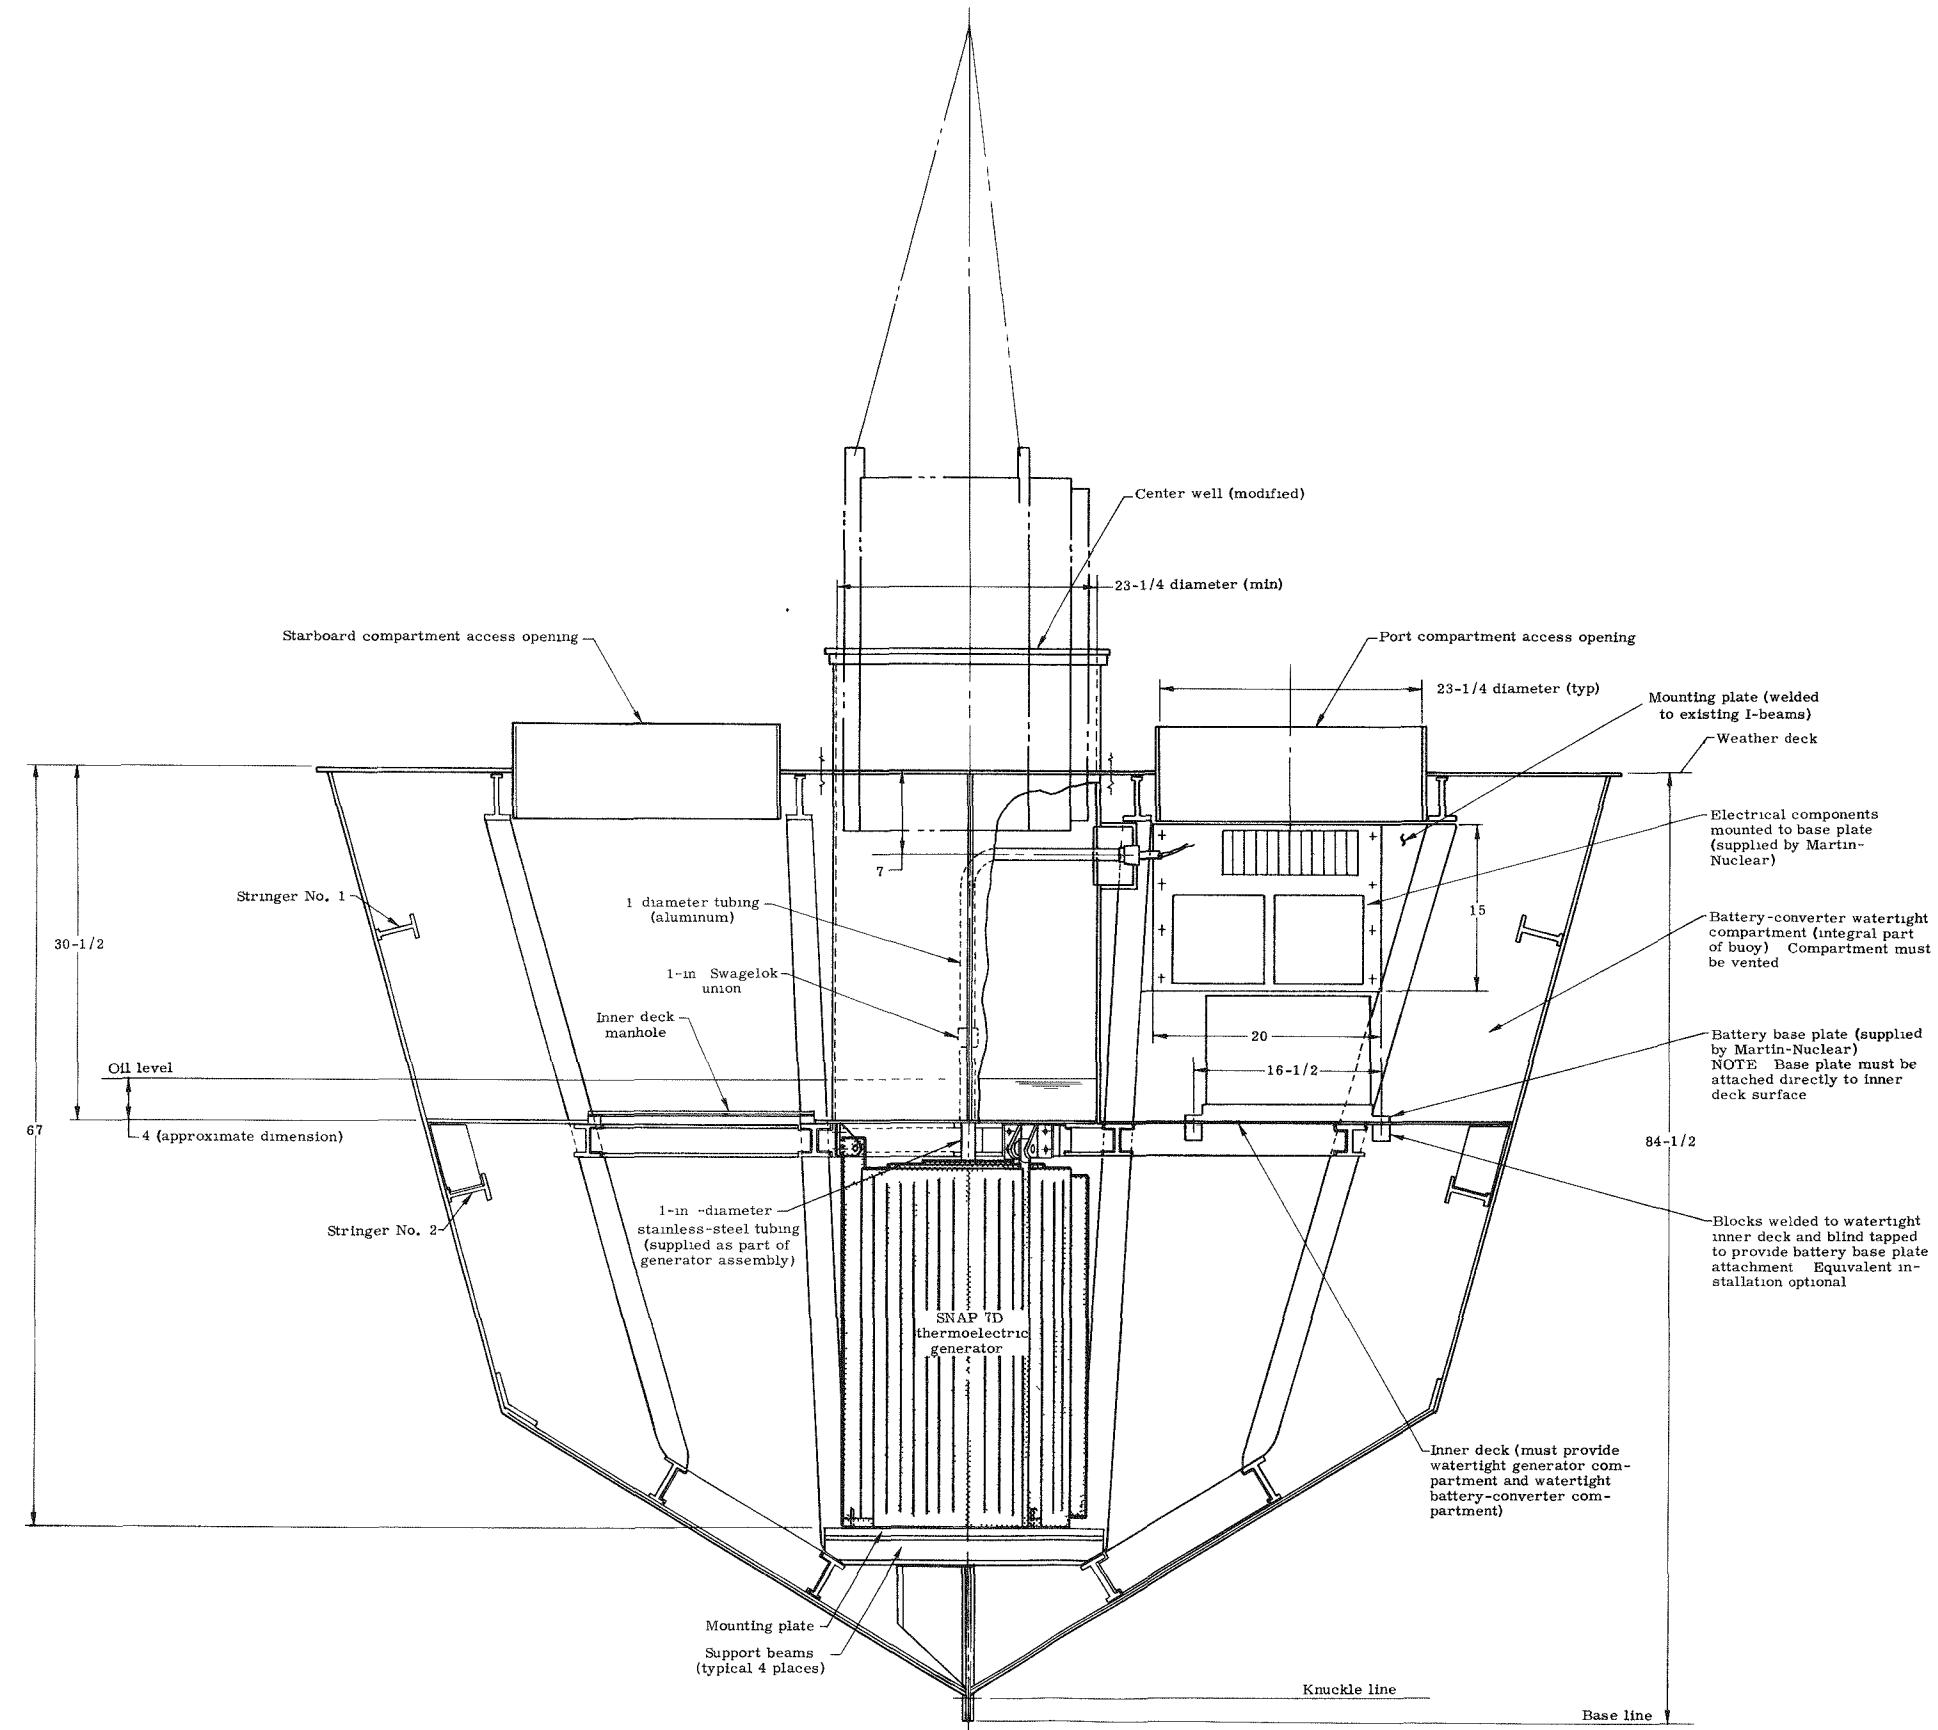
Fig. 14. SNAP 7D Generator Installed in Nomad-class Weather Buoy

The SNAP 7D generator is to be installed as shown in Fig. 14 in a Nomad-class weather buoy. This represents a revision in the installation plan presented in the previous quarterly progress report. The conceptual installation shown requires an extension of the center wall between watertight bulkheads Nos. 3 and 4 and the construction of an inner deck. Approximately 540 gallons of oil are required to fill the compartment to a height of 4 inches over the top of the generator. The heat from the generator is transferred through the oil to the hull and on to the water surrounding the buoy. The inner deck prevents the oil from sloshing, and also serves as a battery compartment. The batteries are to be mounted directly to the inner deck by means of a mounting plate. This permits dissipation of battery heat through the buoy structure. The remainder of the electrical equipment is to be mounted to bulkhead No. 4.
