***Ohio Department of Health study
of radioactivity in drinking water
and other environmental media in
the vicinity of the US Department of
Energy's Feed Materials
Production Center and Portsmouth
Gaseous Diffusion Plant***
Dec 1988

OHIO DEPARTMENT OF HEALTH STUDY OF RADIOACTIVITY
IN DRINKING WATER AND OTHER ENVIRONMENTAL MEDIA
IN THE VICINITY OF THE U.S. DEPARTMENT OF ENERGY'S
FEED MATERIALS PRODUCTION CENTER AND
PORTSMOUTH GASEOUS DIFFUSION PLANT

Ohio Department of Health
Radiological Health Department
1224 Kinnear Road
Columbus, Ohio 43212

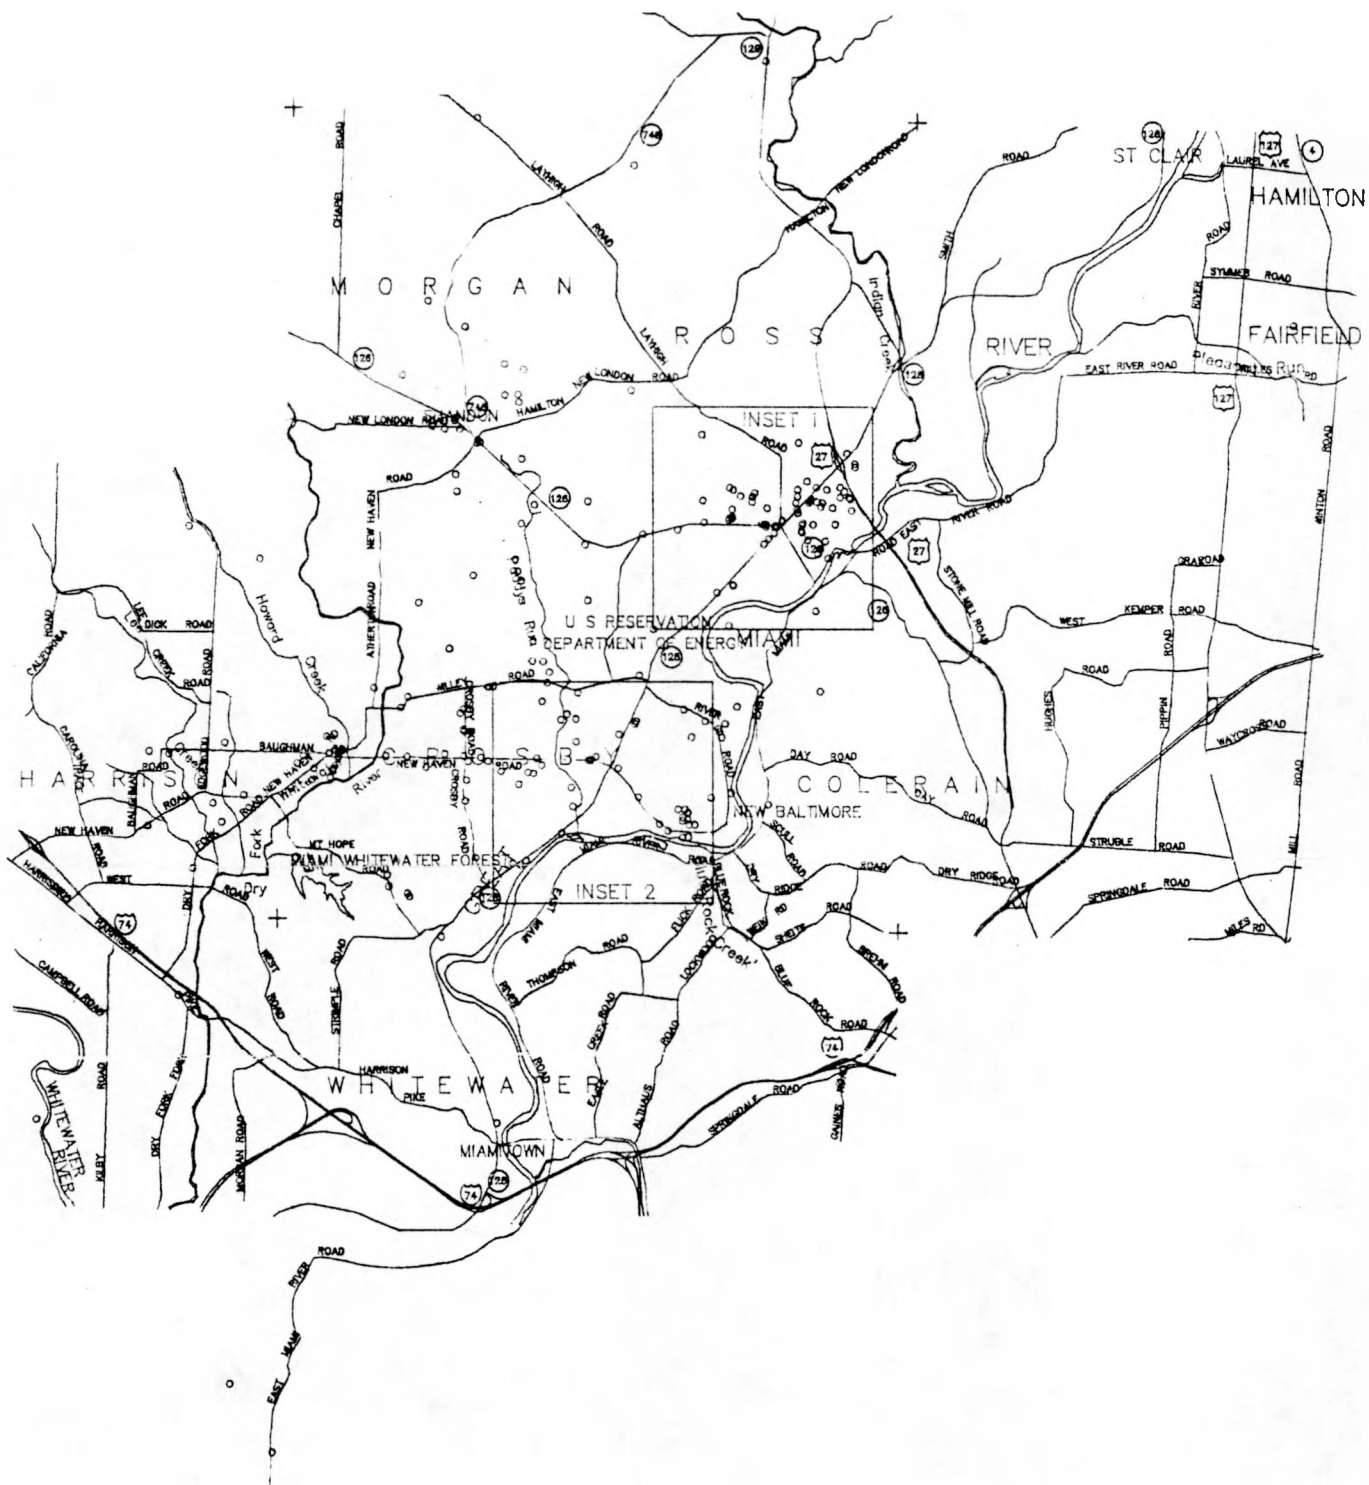
Figure 9 Well Sampling Locations (FMNC)

Well Sampling Locations
24 November, 1986
Scale 1:100000
Consultant: WEGA, Inc. Milford, OH

NUCLIDE SAMPLE	pCi/l		
	BLACK	GREEN	RED
Uranium	≤ 3	> 3 and ≤ 15	> 15
Alpha	≤ 3	> 3 and ≤ 15	> 15
Beta	≤ 4	> 4 and ≤ 15	> 15

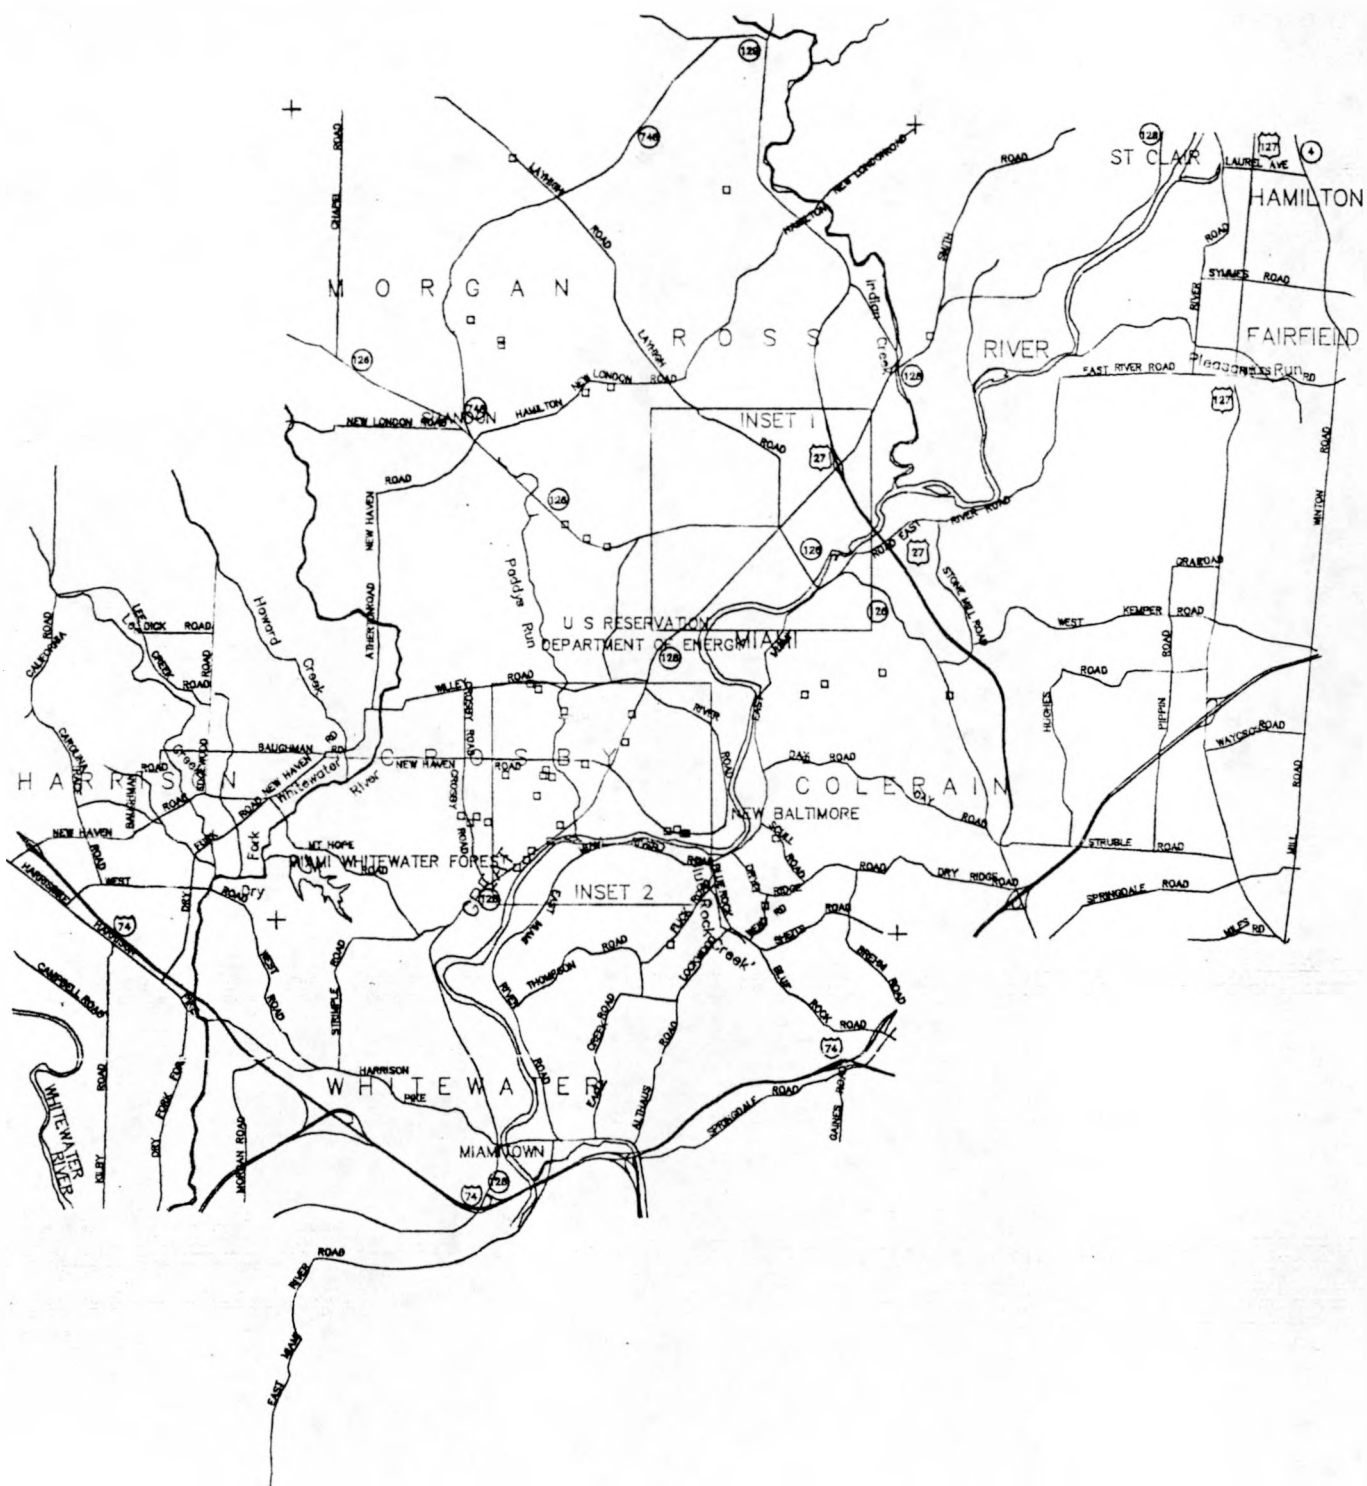
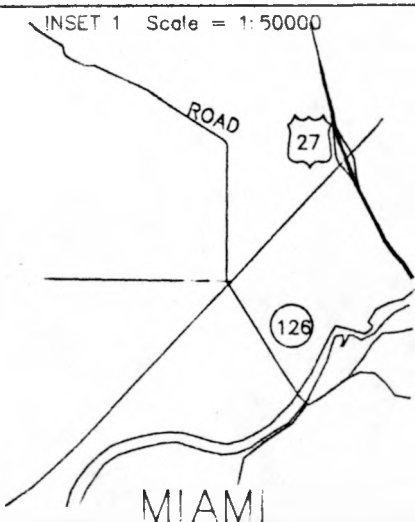
Figure 10 Cistern Sampling Locations (FMP)

Ohio Department of Health Water Sampling Project in the Vicinity of Feed Materials Production Center			
Cistern Sampling Locations 24 November, 1986 Scale 1:100000 Consultant: WEGA, Inc. Milford, OH			
Symbol Key			
O - Well	□ - Cistern	Δ - Surface Water	
+ - Split Sample	⊗ - Log Number of Sample		
Symbol Color Table			
	pCi/l		
NUCLIDE SAMPLE	BLACK	GREEN	RED
Uranium	<= 3	> 3 and <= 15	> 15
Alpha	<= 3	> 3 and <= 15	> 15
Beta	<= 4	> 4 and <= 15	> 15

Only one cistern water sample was found to contain a concentration of uranium significantly above background. This cistern's source of water was rainwater collected via the roof gutters. According to the owner, the cistern had been disconnected from this collection system approximately 2 years prior to sample collection and had not been used for drinking since that time. The water which was present in the cistern at the time of sampling, therefore, had not been disturbed for approximately two years. Prior to sampling, the owner agitated the water in the cistern. A dipper was used to collect water from the cistern.

With regard to the elevated concentration of uranium found in a cistern in the vicinity of the FMPC, it appears that a cistern using rainwater collection may represent a potential collection system for airborne uranium which travels off the FMPC site and is deposited on rooftops. The sample collected from the cistern in question was taken after the water in the cistern had been agitated and was drawn from the cistern via a dipper lowered into the cistern. Under normal circumstances, uranium would tend to settle to the bottom of the cistern and water drawn via a floating intake in a cistern should contain a smaller percentage of this uranium. This may explain why above background concentrations of uranium were not detected in water samples collected from other cisterns in the vicinity of the FMPC. However, any agitation e.g. delivery of water by a water hauler could similarly cause uranium to become suspended in the cistern water and be consumed by the homeowner. A more detailed study of this theory and the possible impact to cistern owners in the vicinity of the FMPC using rainwater collection systems should be investigated.

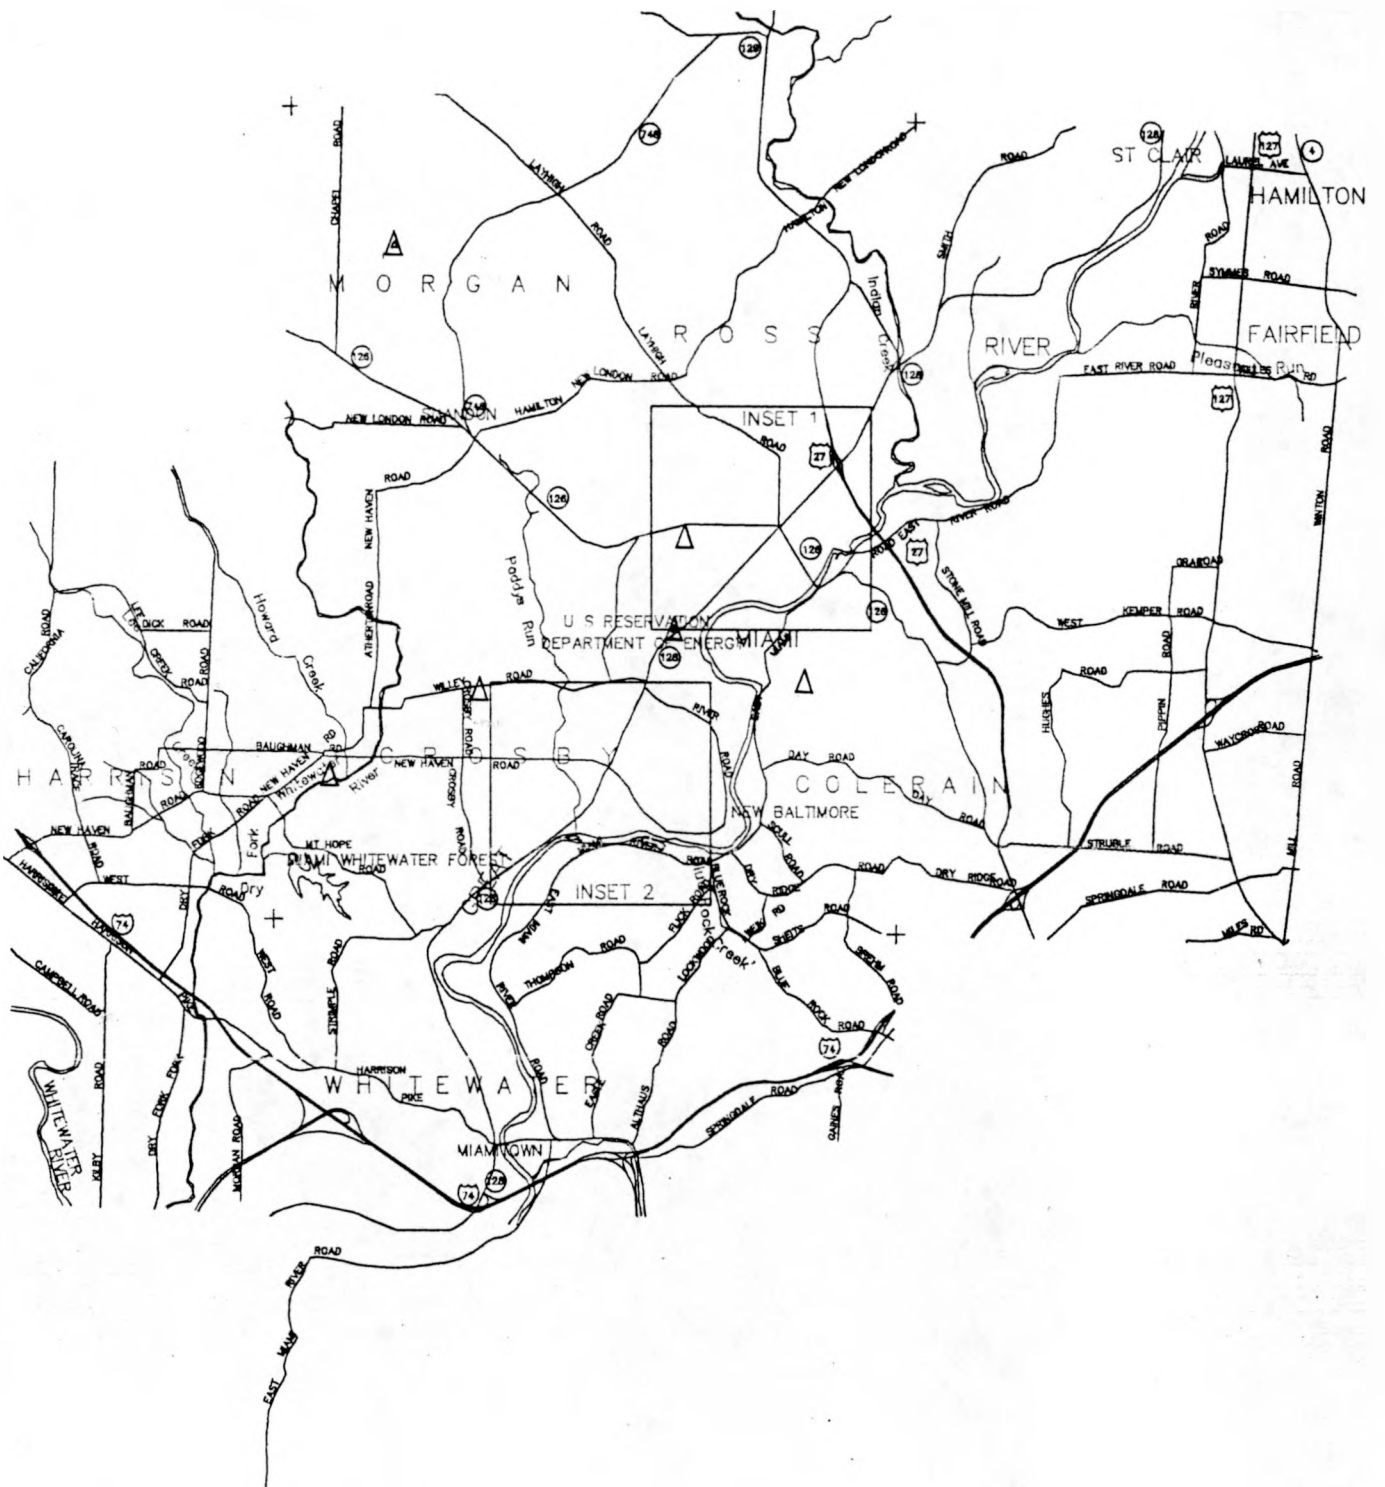
Figure 11 Surface Water Sampling Locations (FMPC)

Ohio Department of Health			
Water Sampling Project			
in the Vicinity of			
Feed Materials Production Center			
Surface Water Sampling Locations			
24 November, 1986			
Scale 1:100,000			
Consultant: WEGA, Inc. Miford, OH			
Symbol Key			
O - Well □ - Cistern Δ - Surface Water			
+ - Split Sample ↻ - Log Number of Sample			
Symbol Color Table			
NUCLIDE SAMPLE	pCi/l		
	BLACK	GREEN	RED
	Uranium	<= 3 > 3 and <= 15 > 15	
	Alpha	<= 3 > 3 and <= 15 > 15	
Beta	<= 4 > 4 and <= 15 > 15

All analytical results for the surface water samples were below ODH investigational action levels except at location #073. Analyses of the water collected from the pond at this location yielded an elevated gross alpha result. The pond water was resampled to corroborate the initial results. The subsequent analysis detected gross alpha activity slightly above the ODH action level. The uranium activity detected in both samples was below the ODH action level. The elevated gross alpha results were most likely due to naturally occurring alpha emitters such as radium. This water was not used for human consumption and should not represent a health concern.

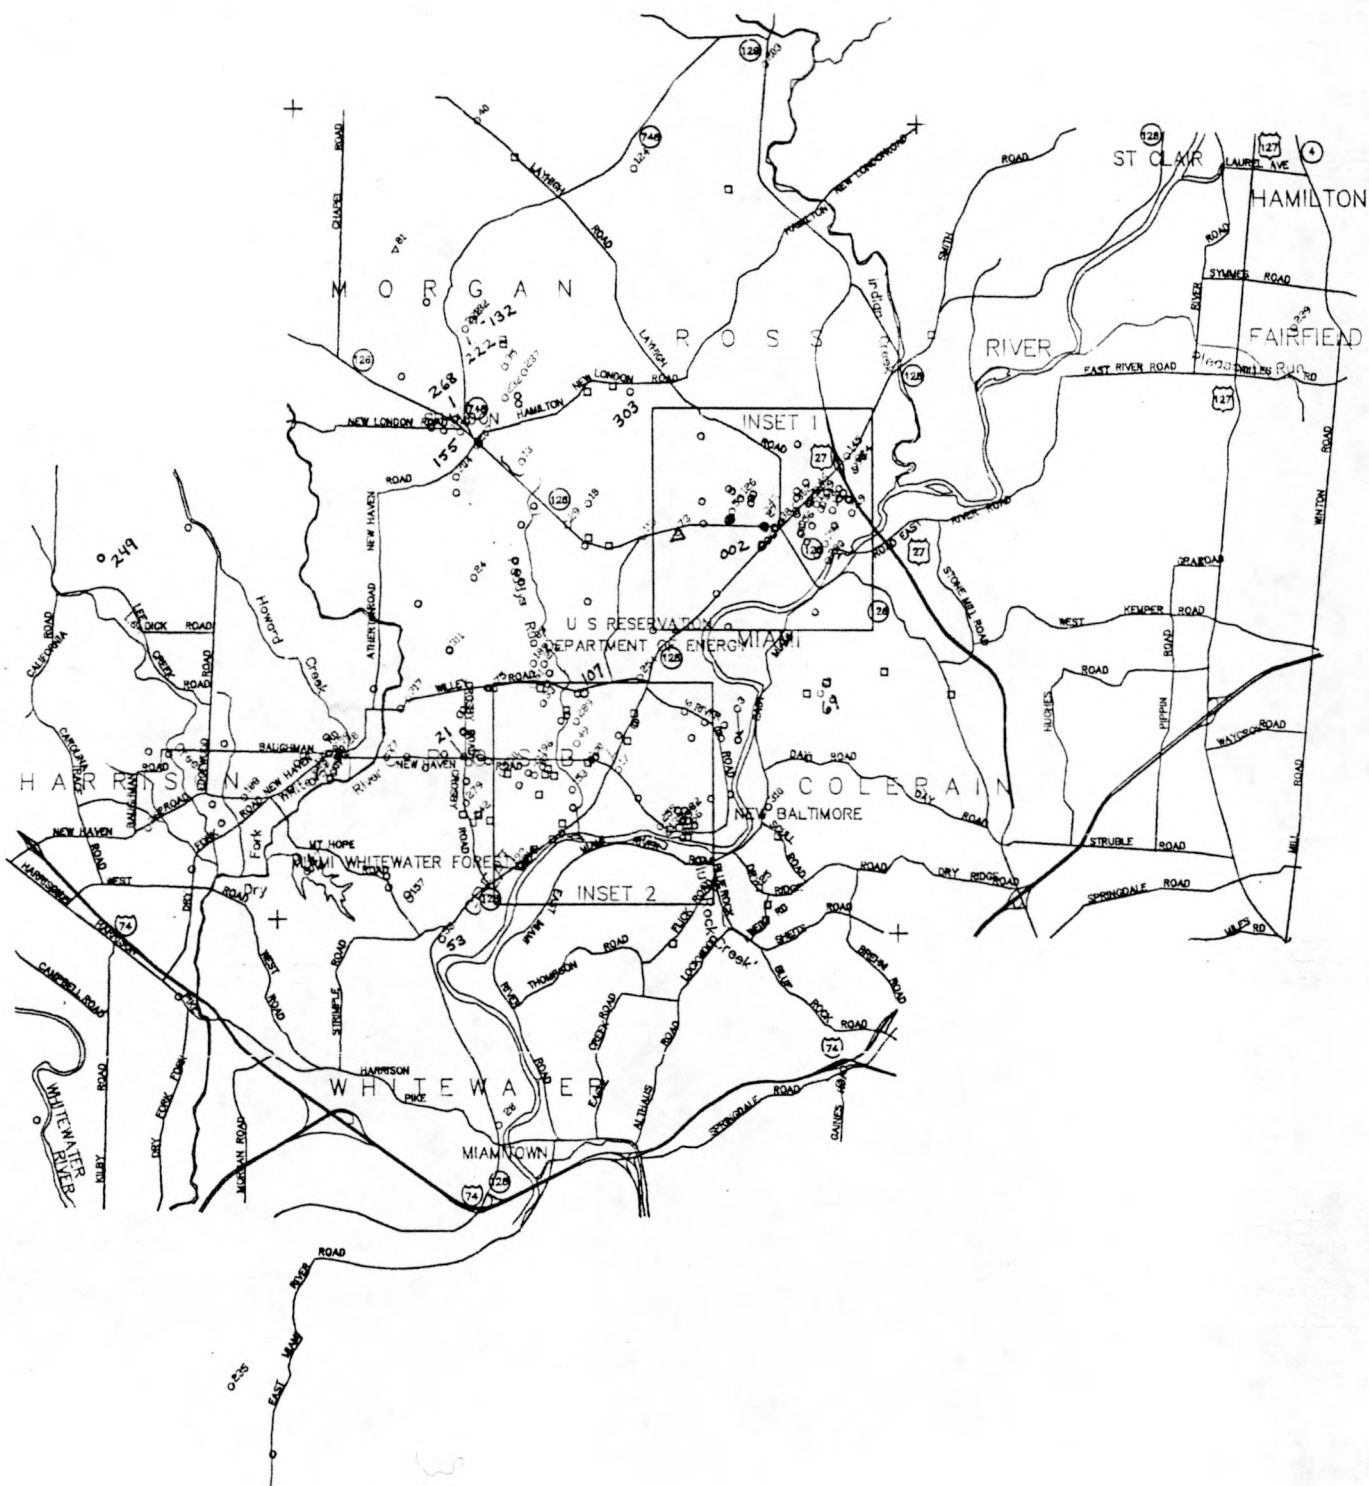
Figure 13 Analytical Results of Water Samples: Cross Beta

Ohio Department of Health Water Sampling Project in the Vicinity of Feed Materials Production Center			
Analytical Results of Water Samples: Cross Beta 24 November, 1986 Scale 1:100000 Consultant: WEGA, Inc. Milford, OH			
Symbol Key			
O - Well □ - Cistern Δ - Surface Water + - Split Sample 2 - Log Number of Sample			
Symbol Color Table			
pCi/l			
NUCLIDE SAMPLE	BLACK	GREEN	RED
Uranium	<= 3	> 3 and <= 15	> 15
Alpha	<= 3	> 3 and <= 15	> 15
Beta	<= 4	> 4 and <= 15	> 15

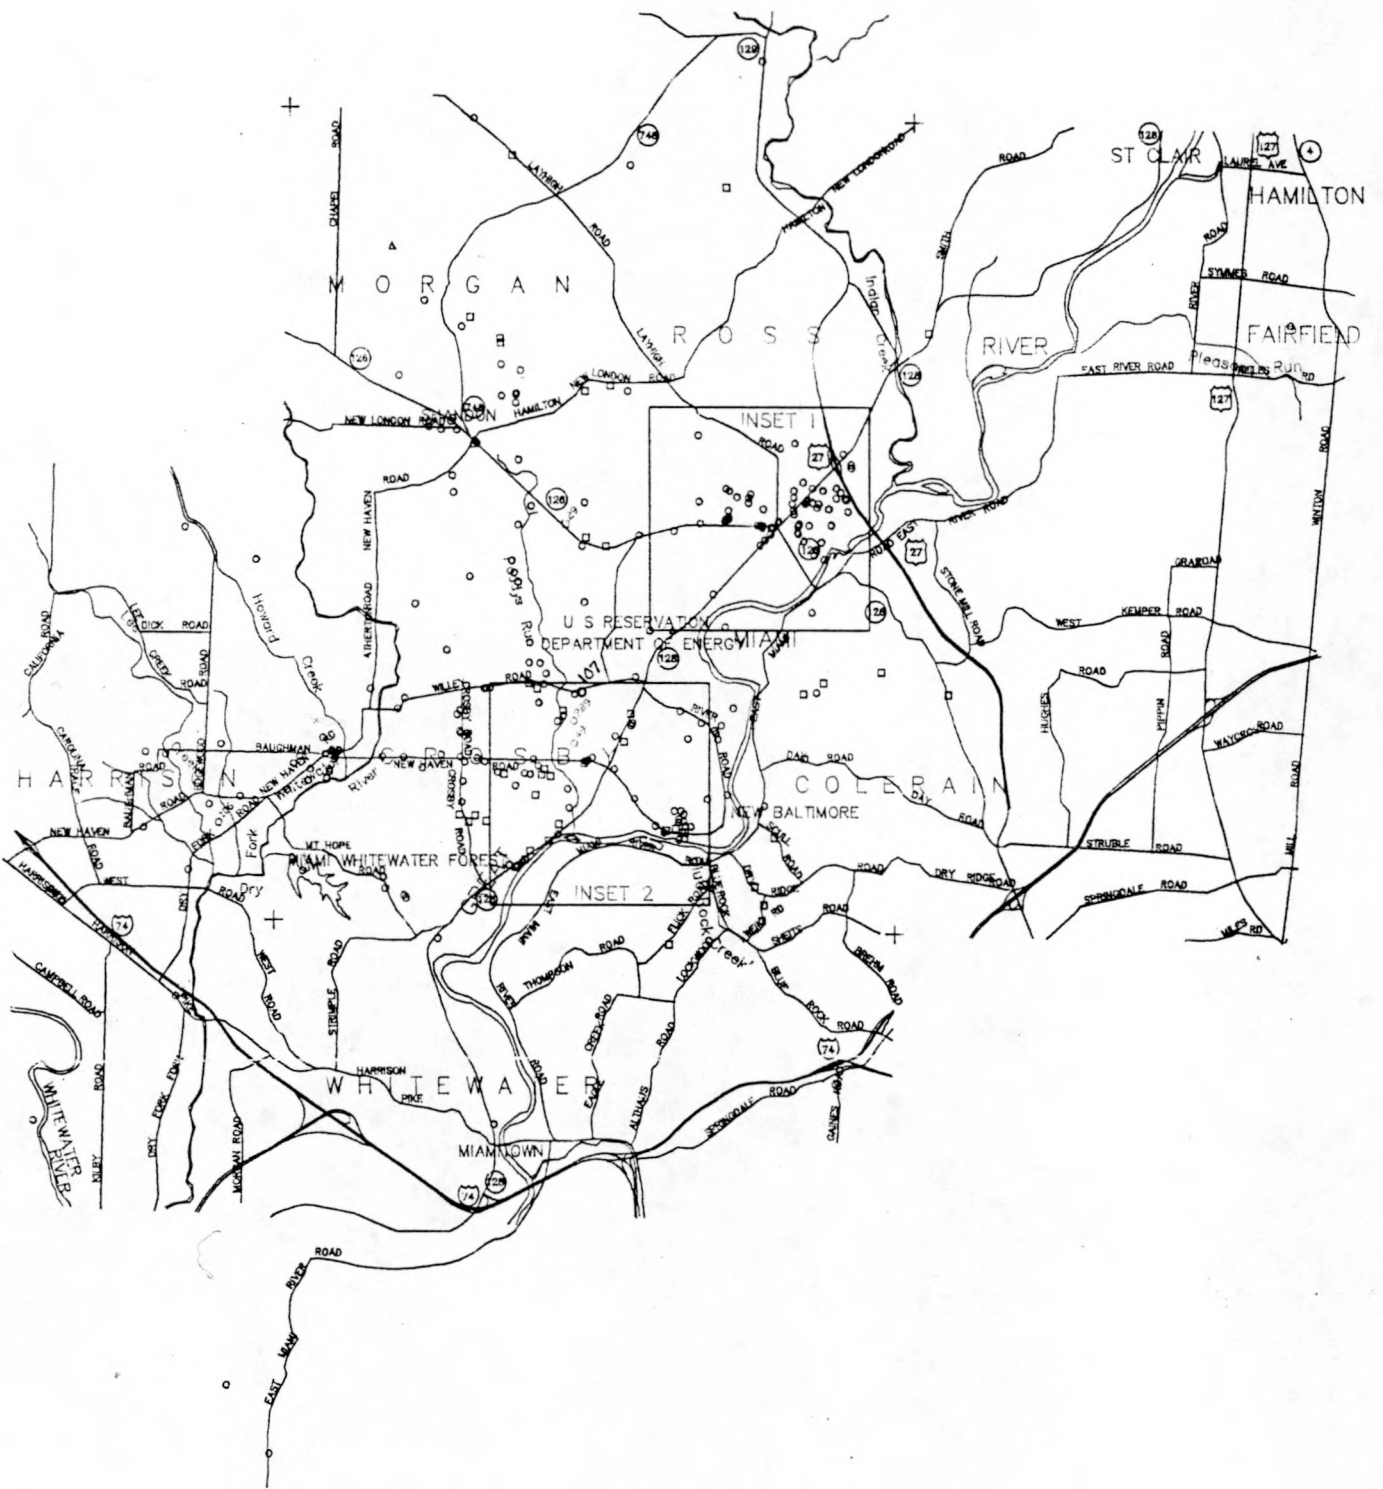
Figure 14 Analytical Results of Water Samples: Uranium

Ohio Department of Health Water Sampling Project in the Vicinity of Feed Materials Production Center			
Analytical Results of Water Samples: Uranium			
24 November, 1986			
Scale 1:100000			
Consultant: WEGA, Inc. Milford, OH			
Symbol Key			
O - Well □ - Cistern Δ - Surface Water			
+ - Split Sample 2 - Log Number of Sample			
Symbol Color Table			
pCi/l			
NUCLIDE	BLACK	GREEN	RED
SAMPLE			
Uranium	<= 3	> 3 and <= 15	> 15
Alpha	<= 3	> 3 and <= 15	> 15
Beta	<= 4	> 4 and <= 15	> 15

Based on these results, the uranium contamination in the ground water appears to be limited to a fairly well delineated area immediately south of the plant. No evidence of contamination was found at a distance greater than 1.6 miles from the FMPC. Log #049, located at a distance of 1.6 miles from the center of the facility, was the most distant well location found to have an elevated concentration of uranium.

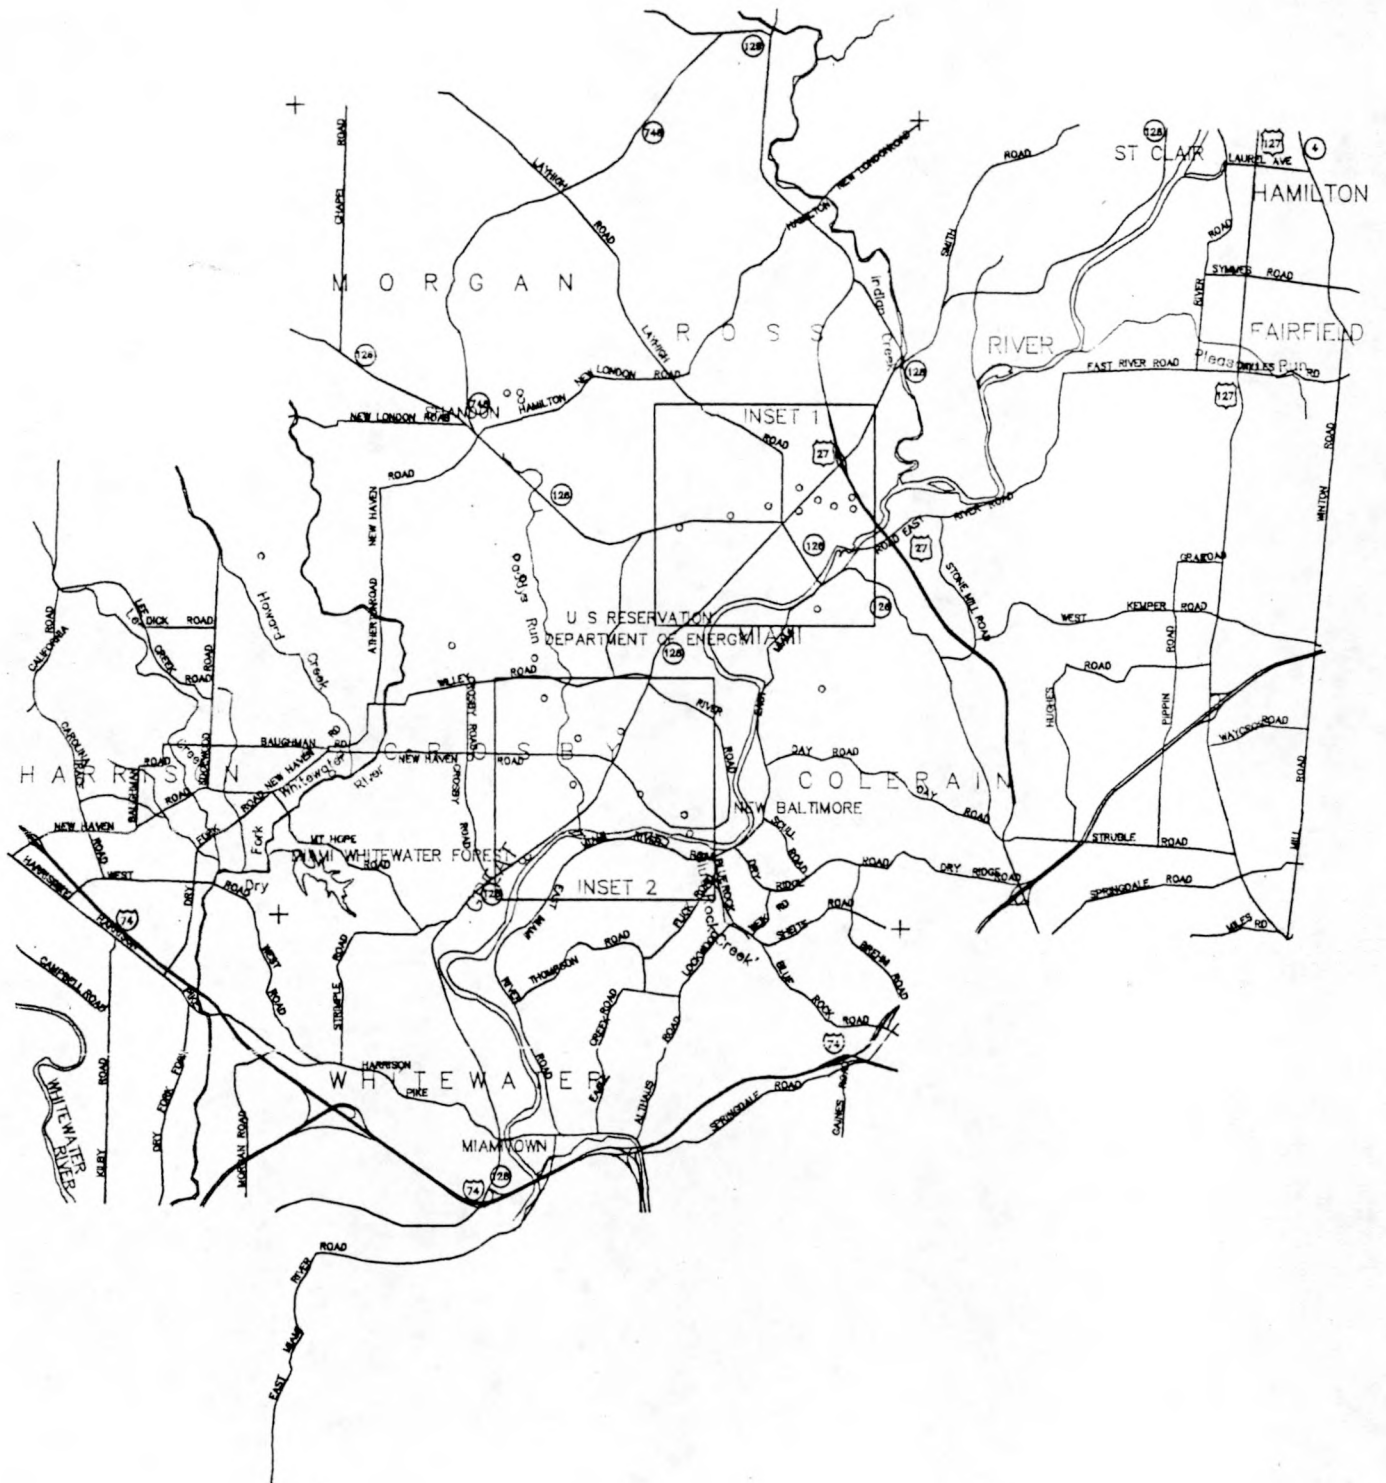
Figure 16 Treated Ground Water Sampling Locations

Ohio Department of Health			
Water Sampling Project			
in the Vicinity of			
Feed Materials Production Center			
Treated Ground Water Sampling Locations			
24 November, 1986			
Scale 1:100000			
Consultant: WEGA, Inc. Milford, OH			
Symbol Key			
O - Well □ - Cistern Δ - Surface Water			
+ - Split Sample ⓧ - Log Number of Sample			
Symbol Color Table			
NUCLIDE SAMPLE	pCi/l		
	BLACK	GREEN	RED
Uranium	≤ 3	> 3 and ≤ 15	> 15
Alpha	≤ 3	> 3 and ≤ 15	> 15
Beta	≤ 4	> 4 and ≤ 15	> 15

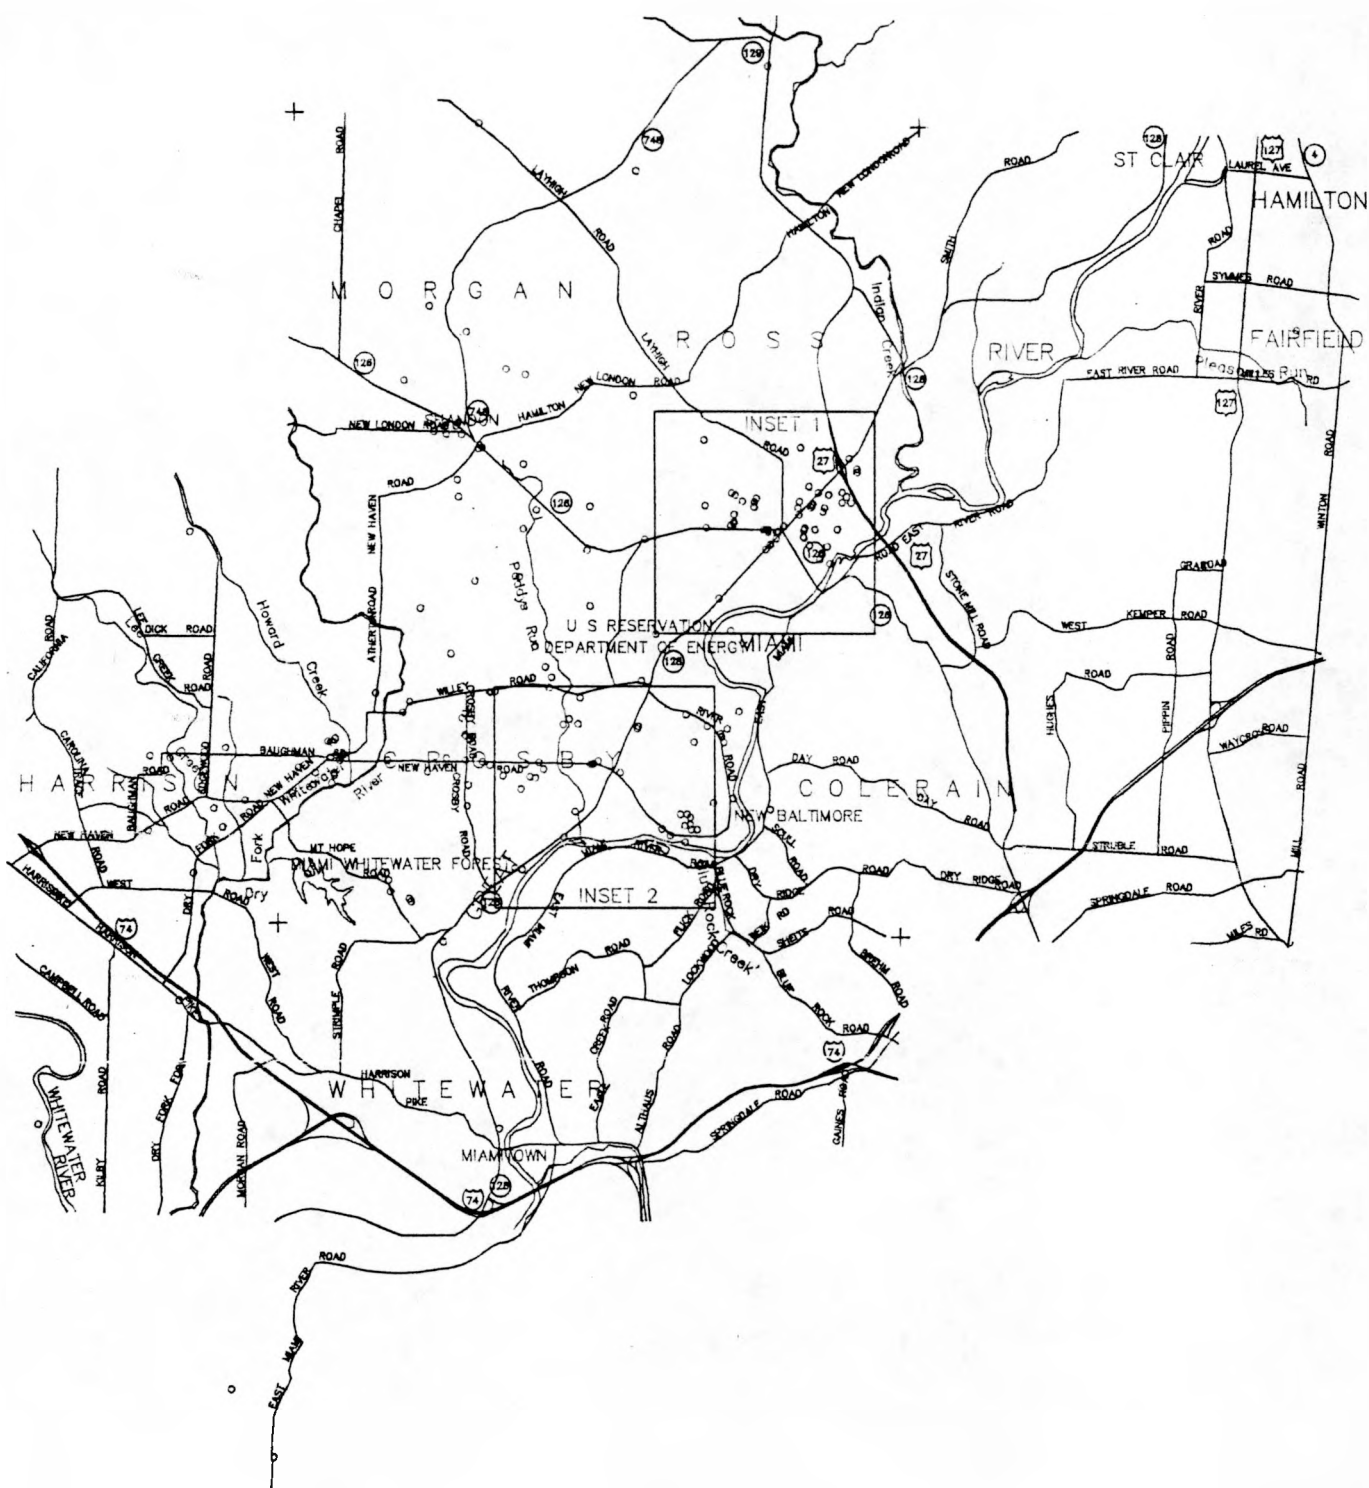
Figure 17 Untreated Ground Water Sampling Locations

Untreated Ground Water Sampling Locations
24 November, 1986
Scale 1:100000
Consultant: WEGA, Inc. Milford, OH

NUCLIDE SAMPLE	pCi/l		
	BLACK	GREEN	RED
Uranium	≤ 3	> 3 and ≤ 15	> 15
Alpha	≤ 3	> 3 and ≤ 15	> 15
Beta	≤ 4	> 4 and ≤ 15	> 15

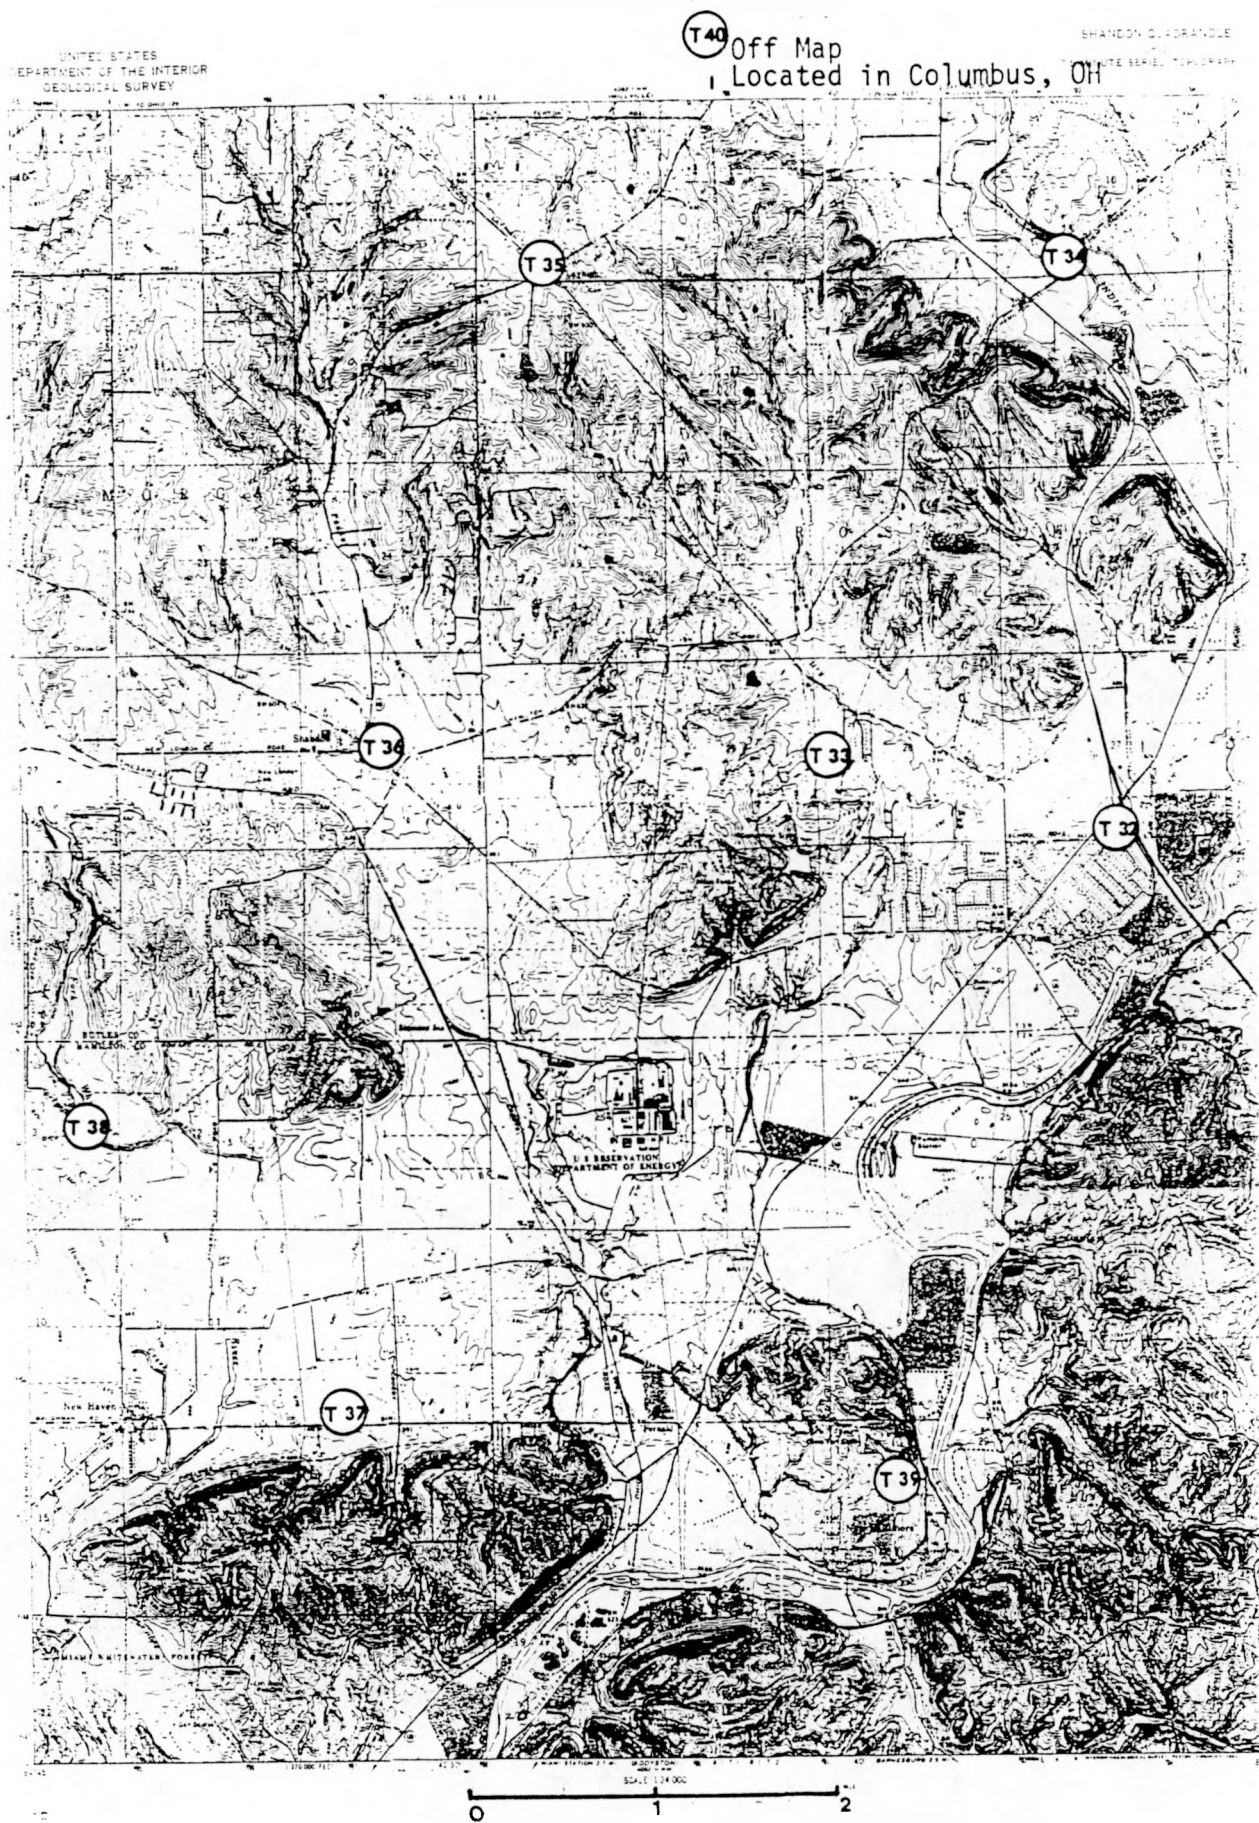
FIGURE 23
TLD LOCATIONS (CONTROLS)

In addition to site boundary dosimeters, dosimeters were installed at 8 control locations. (See Fig. 23). As discussed in Section 2.0, dosimeters were installed in pairs and remained in the field for approximately 6 months. At the end of this time period all dosimeters were replaced with fresh dosimeters which remained in the field for an additional 6 months.
