**SUPPORT RESEARCH FOR DEVELOPMENT OF
IMPROVED GEOTHERMAL DRILL BITS**

Semi-Annual Report

December 1977

Terra Tek, Inc.
Salt Lake City, Utah

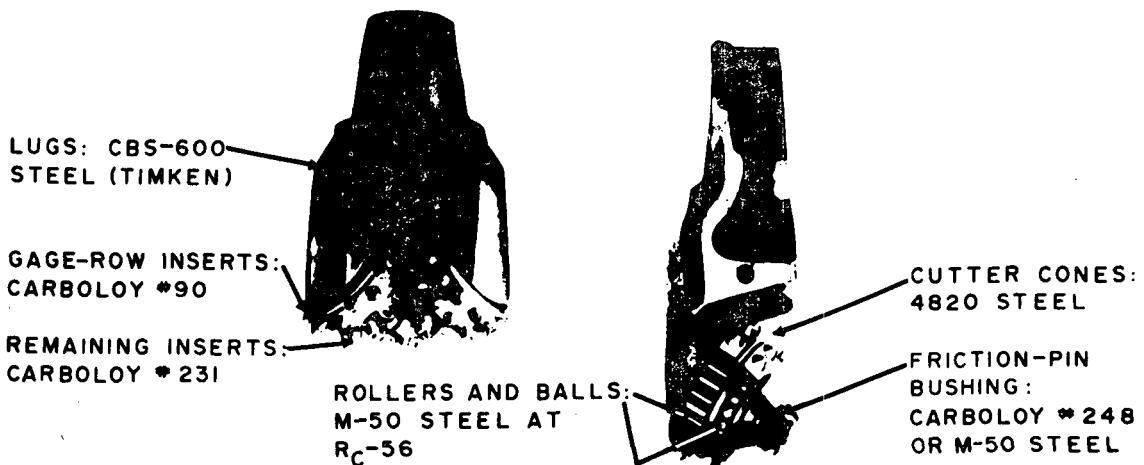
Figure 11

The materials selected for the MK-III bits are illustrated in Figure 11.

MATERIALS SELECTED FOR THIRD GENERATION OF EXPERIMENTAL UNSEALED BITS
